FRACTURE CRITICAL BRIDGE INSPECTION

In-Depth Report

BRIDGE # 9340 (SQUIRT BRIDGE)

I-35W over the Mississippi River at Minneapolis, MN

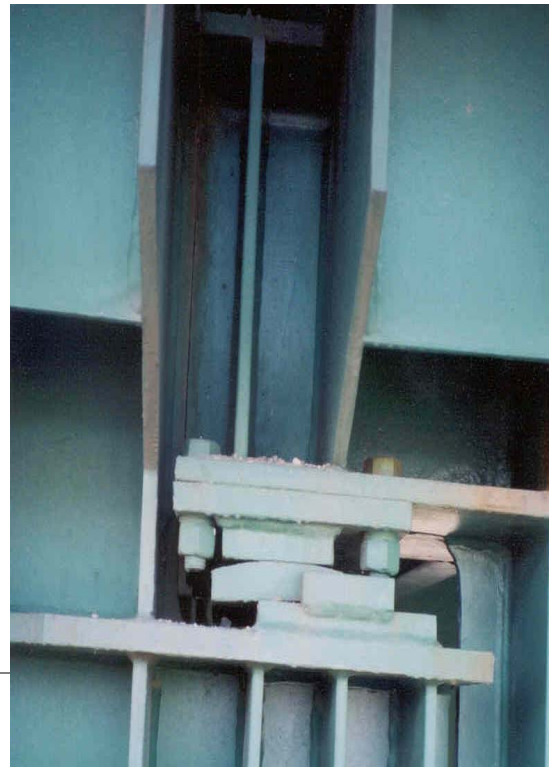
Hinge joint has open finger joint above. [1999] Hinge area re-painted. [2000] Beam-ends have section loss, moderate surface pitting; debris has begun to build up on hinge area. Additionally, the tops of the beam ends are contacting at the top flange or at the web along this joint. [94/2005] All hinge assemblies are expanded beyond tolerance; sliding plates extend 4" or more beyond the base plates, reducing bearing capacity. At beam #10, the sliding plate has tipped, falling off the base plate, and is preventing the joint from opening. [2005] Hinges should be flushed.

Sliding Plate @ West Fascia

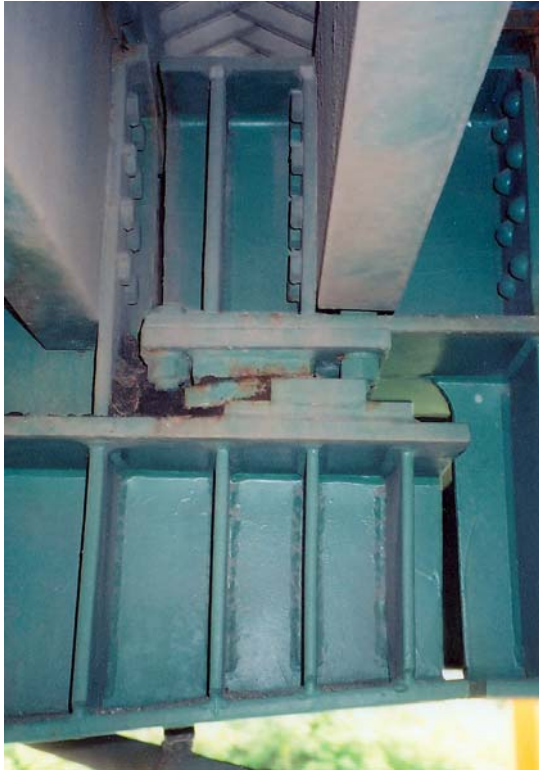
Sliding Plate @ Beam 5 NBL

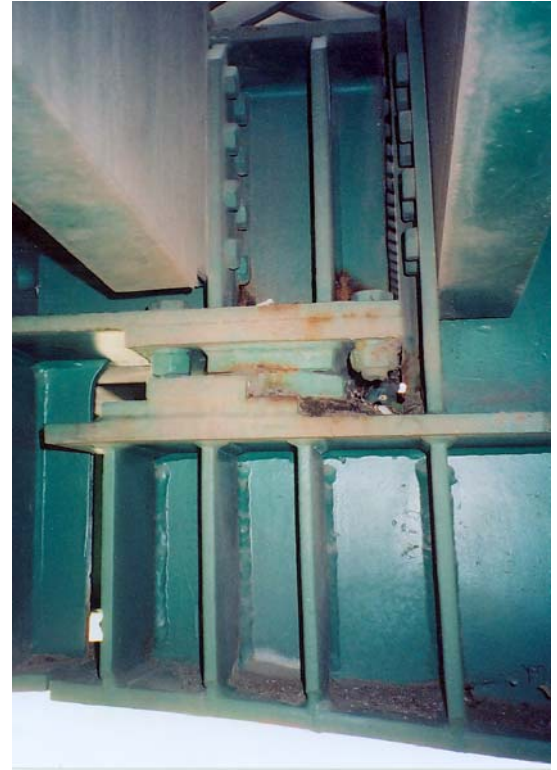
Sliding Plate @ Beam 6 NBL

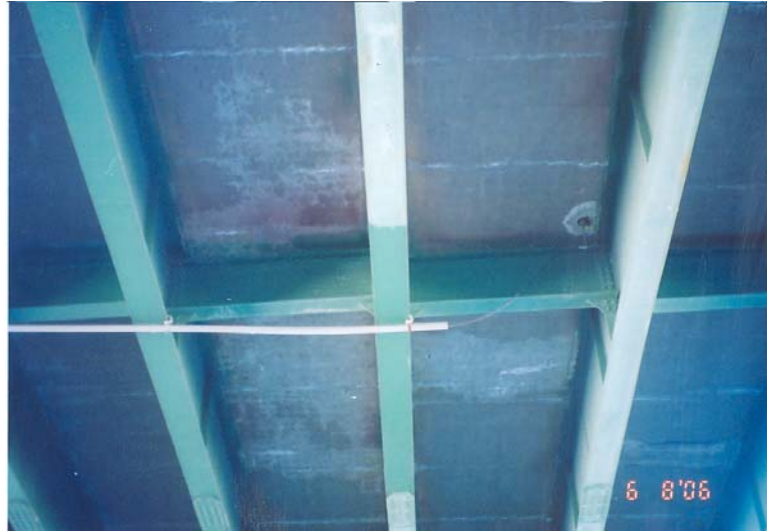
Over contract parking lot (no access) & Bluff St. Span is 110 FT long with fourteen 48" deep welded plate beams. [1978] Second & third bays from the east have full depth deck repairs. [1998] Underside of deck has 200 LF of transverse leaching cracks, 200 SF of spall with exposed rebar below a transverse poured joint, full width of deck. [1999] Beams 6, 7, 8, & 9 were re-painted. Diaphragms lowered, even though the connections have a "positive moment" configuration. Stiffeners are welded to the top flange. Refer to Appendix "A" **First Diaphragm North of Pier #3** graph for crack locations, description & repair to the diaphragm line. [1998/99] Diaphragms lowered with strain gauges placed on beams #2 & 6 (**first diaphragm line south of Pier #4**). [2000] Fourth bay from west has 20 SF of severe leaching. [2005] East fascia beam has section loss, flaking & surface rust on bottom flange.

Water Saturation SBL Bays 9 & 10

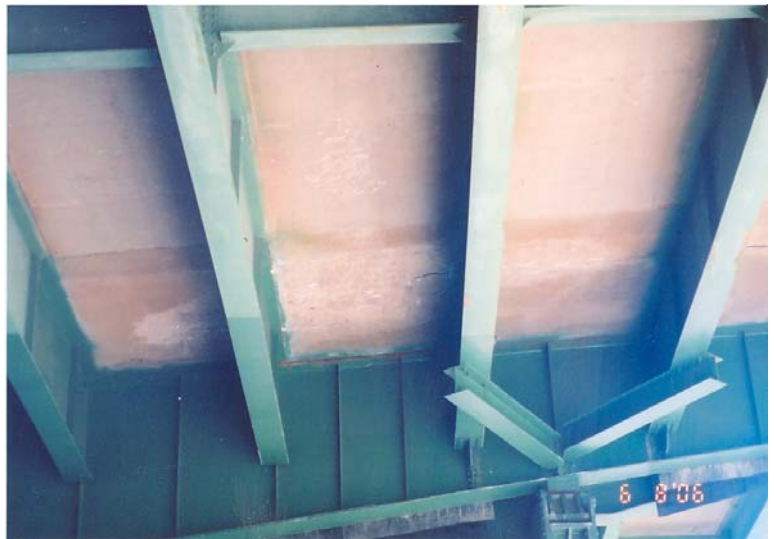
Over contract parking lot; span is 109 FT long with fourteen, 48" deep welded plate beams bolted onto the crossbeam. [1978] Underside of deck is leaching at the finger joint, has two full depth patches in the west bays. [1996] 4 conduit clamps missing on NB fascia beam. Median girder has impact damage from parking lot below. [1998] Bay just east of median has severe spalling on "stool" and the adjacent deck is cracked. [1999] Beams 6, 7, 8, & 9 were re-painted. Refer to Appendix "A" **First Diaphragm North of Pier #4** graph for crack locations, description & repair to the diaphragm line.

Water Saturation NBL Bays 2, 3 & 4

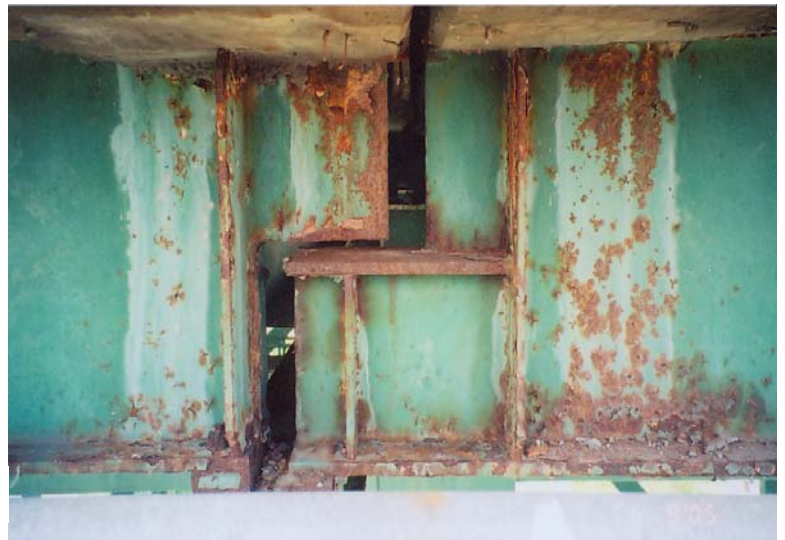
Type H: strip seal deck joint above. [1996] Floorbeam truss bottom chord/vertical member connection gusset plate has a weld overlap. [1999] Gland has 1 LF of gland pulled out at centerline. Junction box cover is missing at catwalk. [2000] Joint gland at east end has concrete in. [2005] Pitting, flaking & surface rust exterior east truss.

Flaking & Surface Rust Exterior East Truss

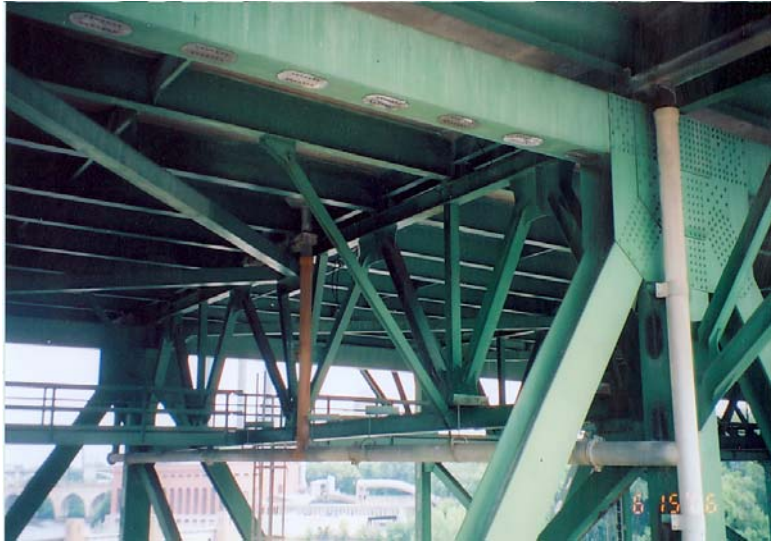
Type H: strip seal and deck drain above. [1999] Missing bolt replaced. Vertical truss member has pitting, section loss, moderate flaking rust. Floorbeam bottom chord & middle bracing connection plate has pitting, moderate section loss, severe flaking rust. Middle bracing connection plate has 1/2" spread from pack rust. Underside of the deck has 50 SF of water saturation. [94/2003] Joint is leaking, small hole & membrane has pulled out. Stringer #4: one bolt broken off at south floorbeam connection. Stringer #2 (south side): bearing block has rotated 90°.

Median Drain Plugged

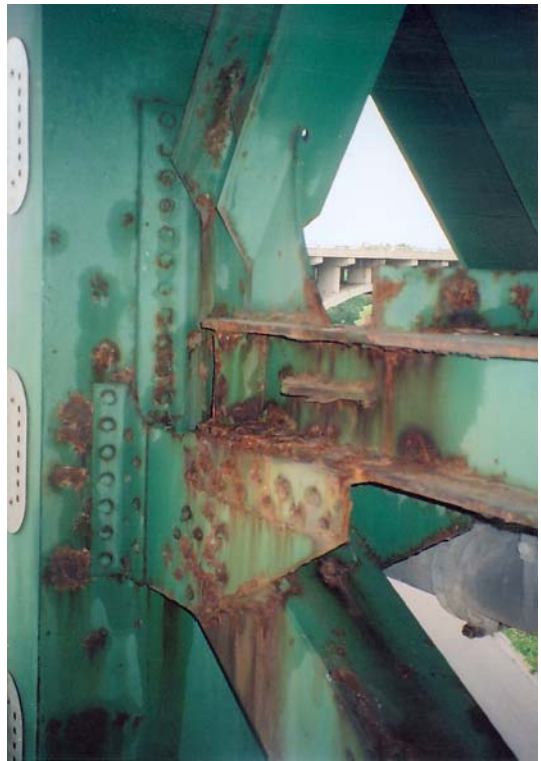
Pier consists of two concrete columns with a pier wall at the base, two “rollernest” bearing assemblies. [1997] Bearings have surface rust, moderate corrosion and show no signs of movement. Deck drain downspouts are clogged, top & bottom at median. [2004] Typical condition & rust at floorbeam connection near deck drain at connection L8.

Floorbeam Truss Condition

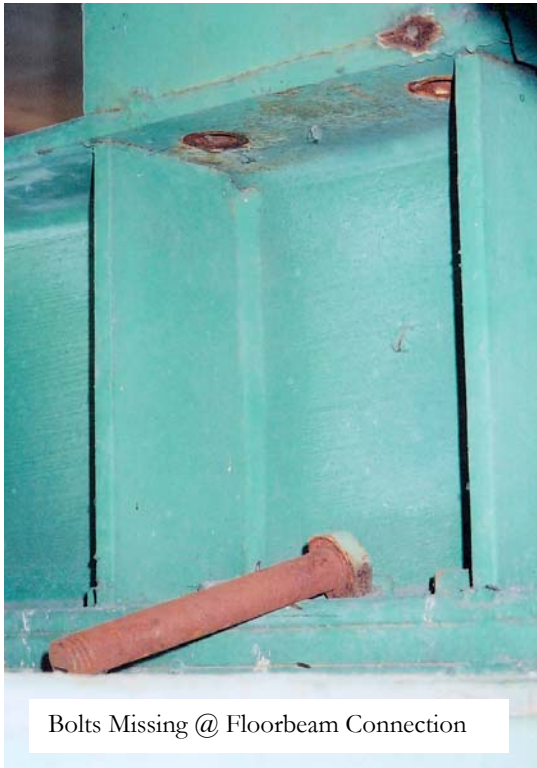
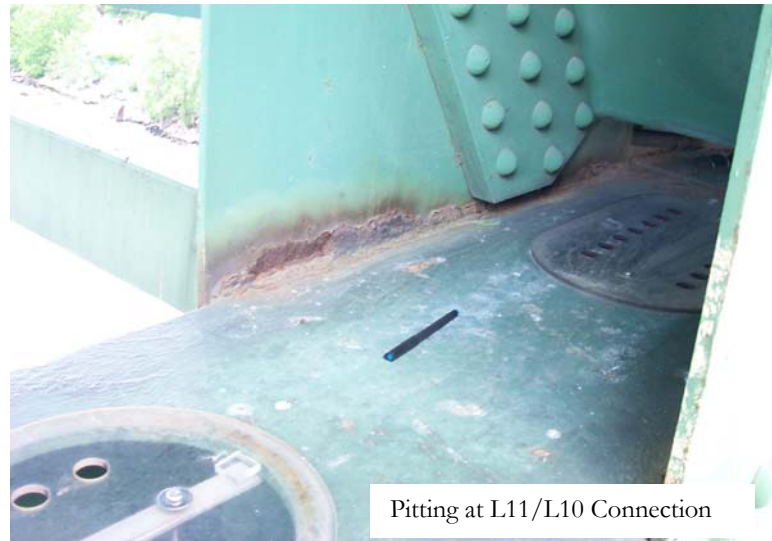
Panel Point #11 (East Truss):

Section loss: at gusset plate bottom chord. [2004] Pitting: inside gusset plate connection at L11 toward L10. [2000/05] Stringer #3 has two bolts missing at the floorbeam connection.

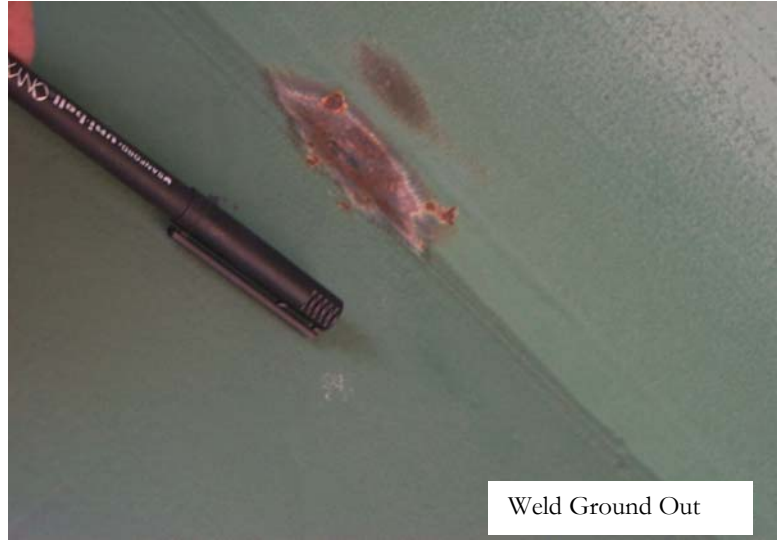
Panel Point #12 (East Truss):

[1999] Truss bottom chord member L12/L13 has a cracked tack weld at an interior stiffener. [2004] Ground out pit from past inspection.

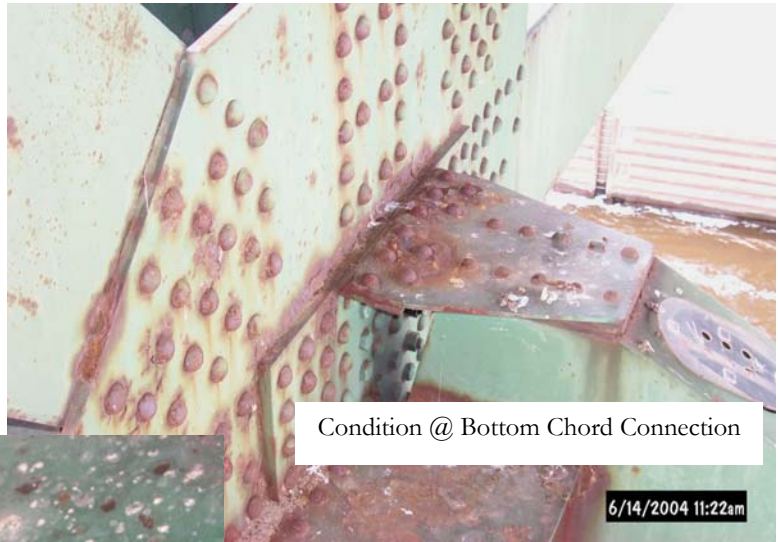
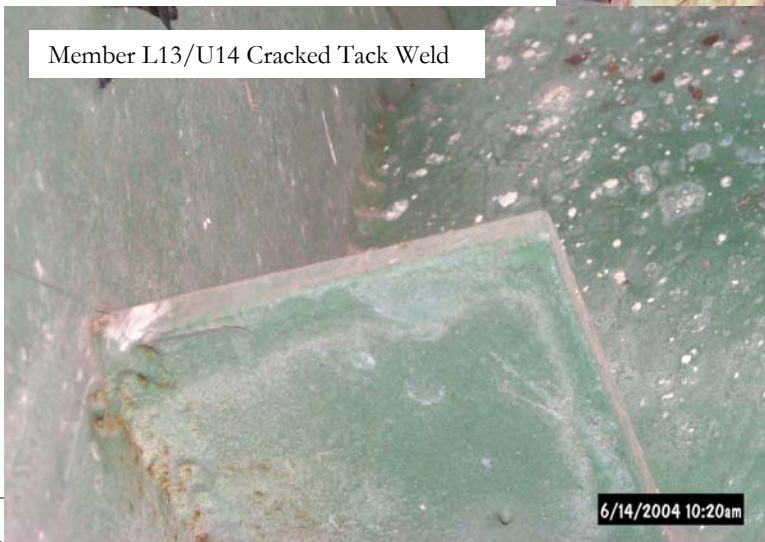
Panel Point #13 (East Truss):

Water from deck drains fall directly into river. [1999] Truss bottom chord member L13/L14 has cracked tack welds at two interior stiffeners. [99/2002] Bottom chord gusset plate has section loss, flaking & pack rust. [2004] Bottom chord member L13/L14 has cracked tack weld at diaphragm tab. Cracked tack weld at diaphragm tab member L13/U14. See photos. [2006] Bottom chord member L13/L14 has a missing bird cover.

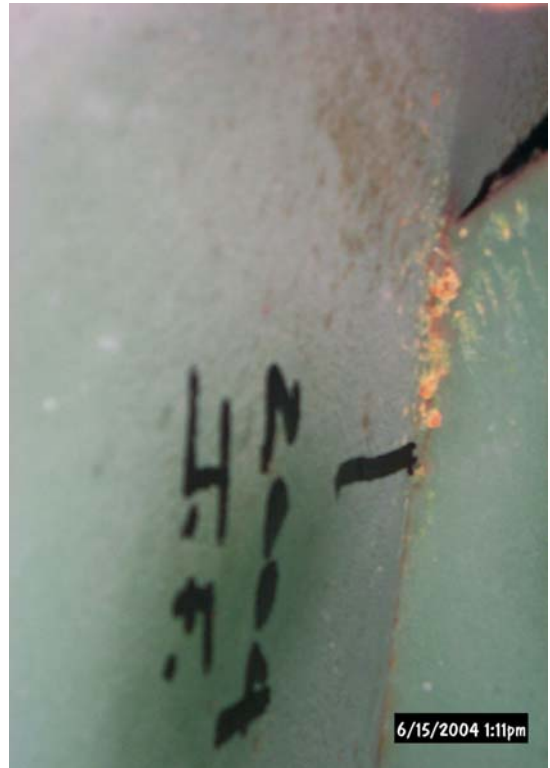
Strip seal expansion joint on the deck. Sway frame rusty. [1999] Truss bottom chord member L14/L13' has a cracked tack weld at an interior stiffener. [2002/03] Floorbeam bottom chord & middle bracing connection plate has 1/2" pack rust. Underside of the deck has 4 SF of delamination. [2004] Bottom chord member L14/L13' cracked tack weld at diaphragm tab.

Member L14/L13' Cracked Tack Weld

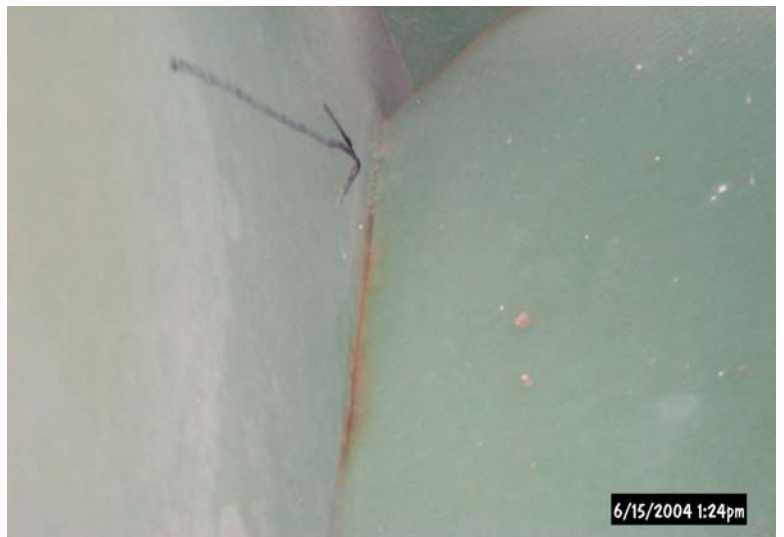
Floorbeam truss top chord has a ground out spot near stringer #4. [1996] Truss bottom chord member L13'/L12' has a cracked tack weld at an interior stiffener. [2003] Truss bottom chord connection plate has 1/2" pack rust. Underside of the deck has 20 SF of water saturation. [2004] Bottom chord member L13'/L12' has cracked tack weld at diaphragm tab.

Member L13'/L12' Cracked Tack Weld

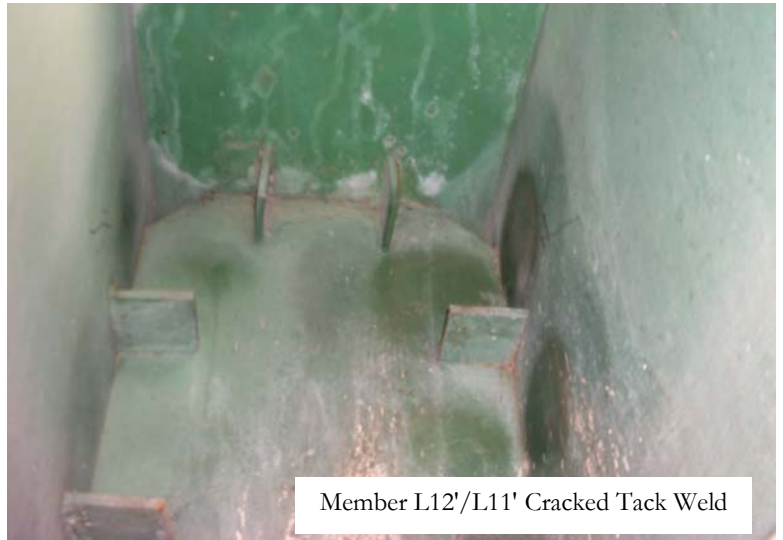
Panel Point #12' (East Truss):

[1998] Truss bottom chord member L12'/L11' has a cracked tack weld at an interior stiffener. [99/2003] Underside of the deck has 65 SF of water saturation. [2004] Bottom chord member L12'/L11' two cracked tack weld at diaphragm tab.

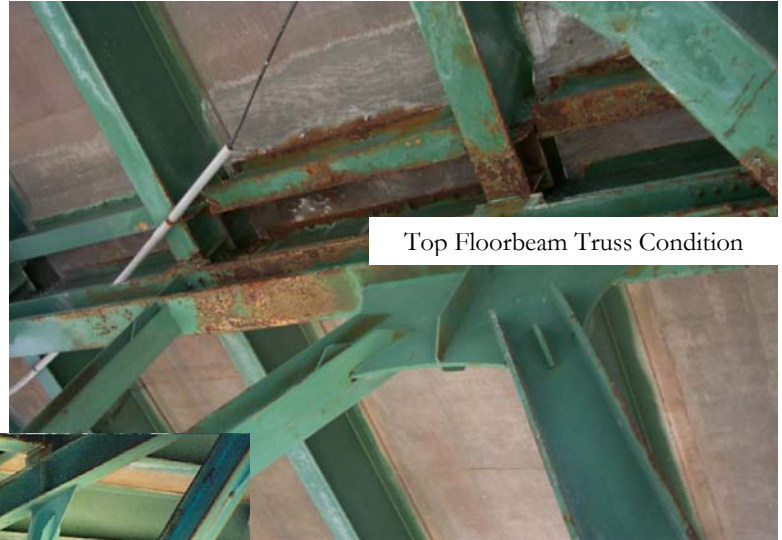
Type H: strip seal expansion joint on the deck. Truss diagonal member U4'/L3' has backer bars along the interior edges. [01/04] Strip seal has 3 LF of gland pulled out. Truss connection plates, the top chord, and floorbeam have moderate section loss, severe flaking rust. Bottom connection plates have 1/2" pack rust.

Top Floorbeam Truss Condition

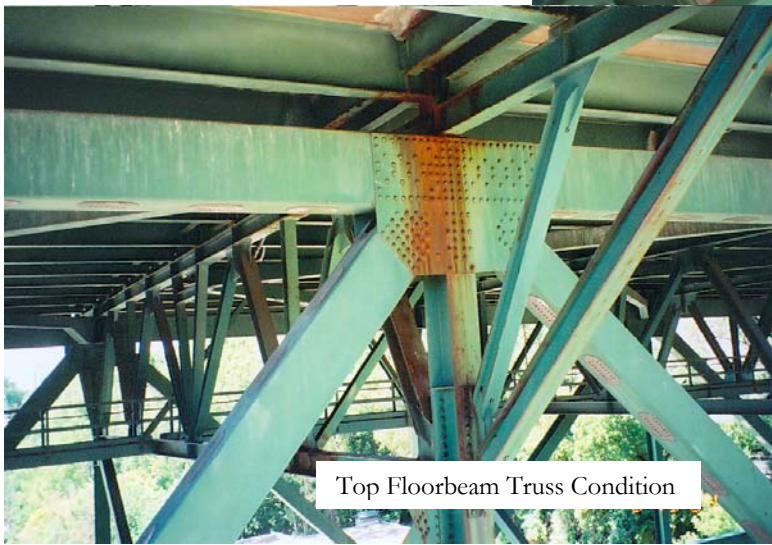
Top Floorbeam Truss Condition

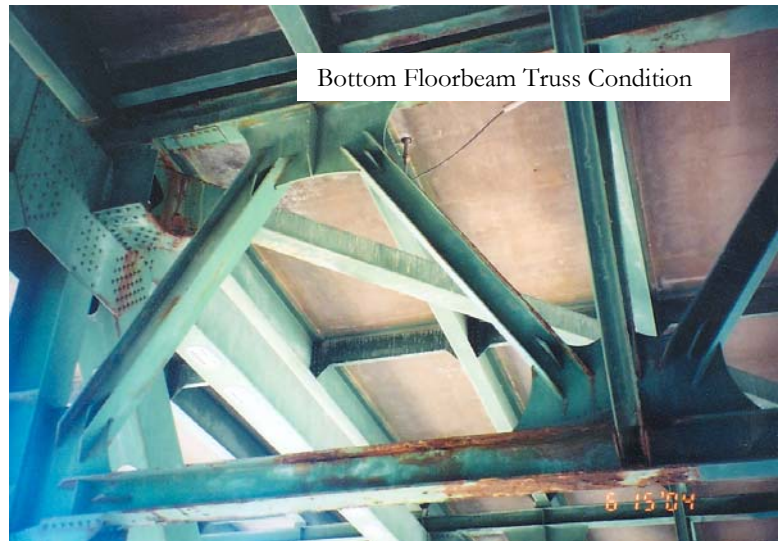
Bottom Floorbeam Truss Condition

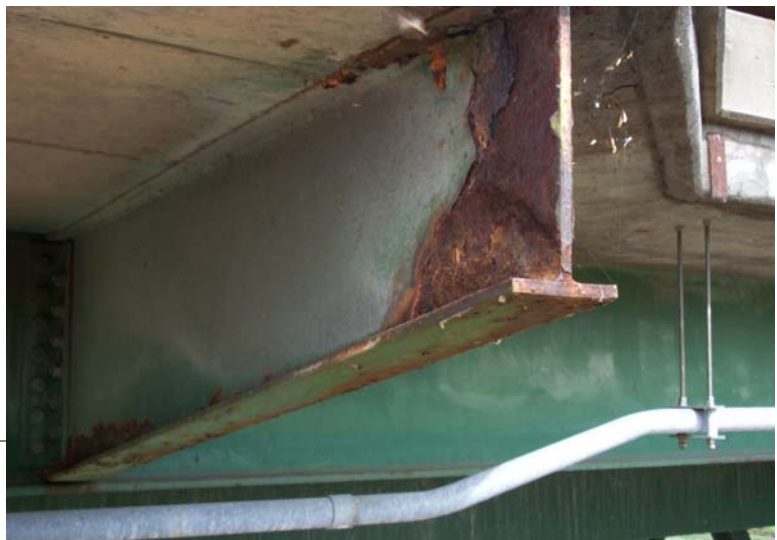
Overhead sign mounted on exterior railings. [1999] Deck in bay #3 has 100 SF of water saturation. [2003] Bottom connection plates have flaking rust. [2004] Area underneath overhead sign has 100 SF of water saturation. [2005] North support beam stringer has severe section loss at end.

North Support Beam Stringer

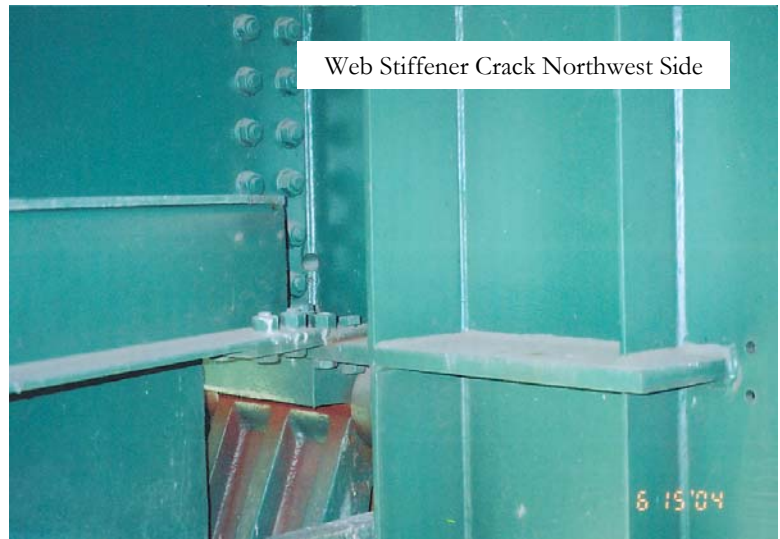
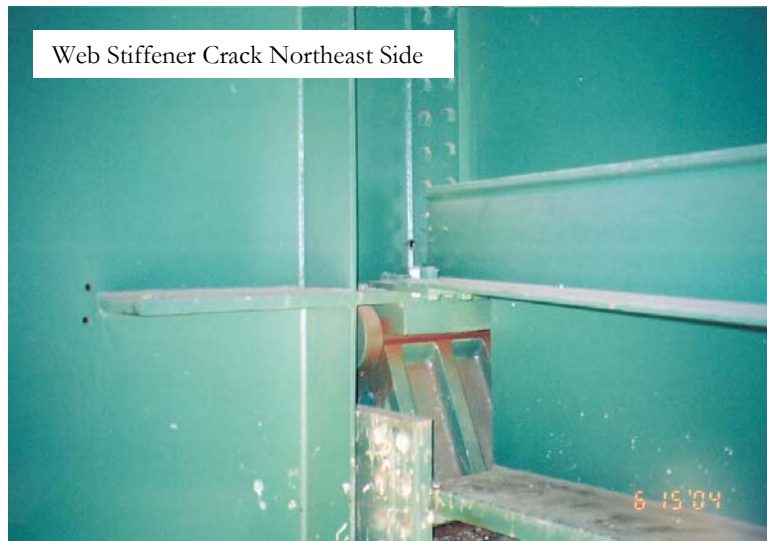
Crossbeam:

[1992] North face has crack in the crossbeam web stiffener, above the rocker at the beam #12 connection. This was drilled out. [1997/98] North face: weld above east rocker bearing, between the horizontal & center vertical stiffener, has cracked through entirely. Weld end at the crossbeam web was partially drilled out. [1998] North face has cracks at both ends of the horizontal stiffener, above rocker bearing. They were drilled out with two small holes drilled in crossbeam web at each location. Bracing installed between crossbeam, above east rocker, and beams #3 & 5. [1998/99] Crossbeam re-painted. Side facing finger joint has section loss, with pitting at base of stiffeners. [1999] Bolted connection between beam #12 and the crossbeam was re-tensioned. Connection had been “working” ** [2000] Gap between crossbeam & floorbeam (at rocker bearing) was 3-5/8" at 40° F. [2001003] Gap between crossbeam & floorbeam (at rocker bearing) was 3-1/2". [2005] Movement at east bearing.

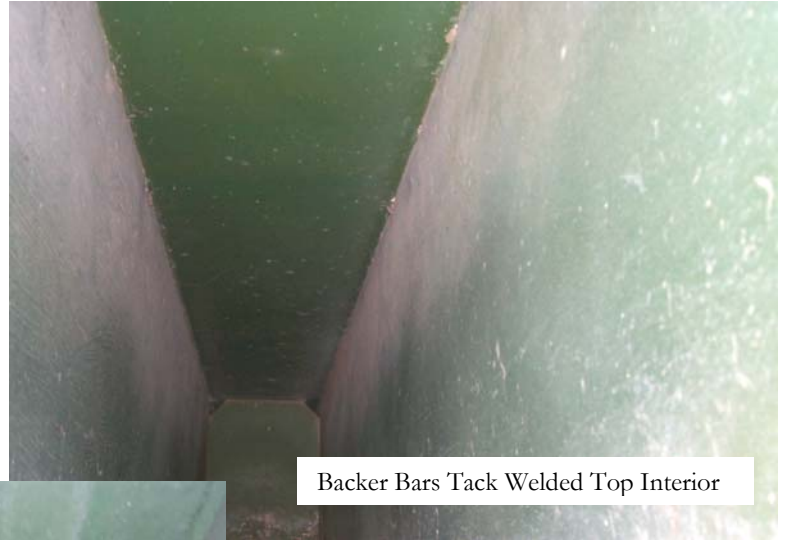
[2004] Truss bottom chord L2/L3 has a nick. Top chord U3/U4 has backer bars tack welded along the top interior corners of member. See photo. Bottom chord L4/L5 has no diaphragm tabs, full weld on side & tack welds on other. See photo. Diagonal member L3/U4 has 4 diaphragms with tabs. See photo.

Backer Bars Tack Welded Top Interior

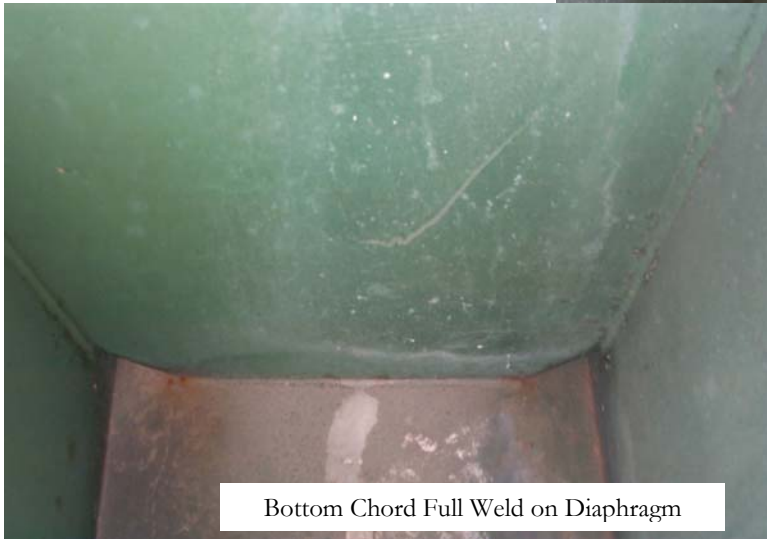
Bottom Chord Full Weld on Diaphragm

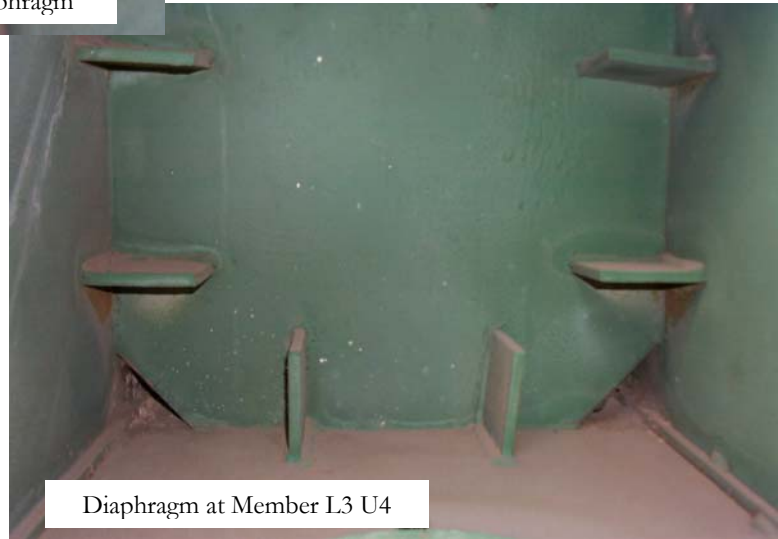
Diaphragm at Member L3 U4

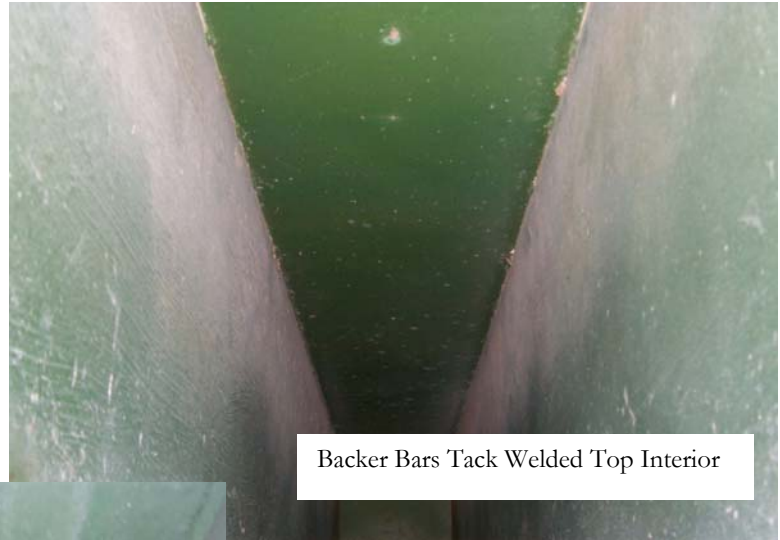
Strip seal expansion joint on the deck, [1998] Stringer #10: bolt replaced at south floorbeam, truss connection. [2000] Lighting conduit is held up with tie wire. [2004] Stringer #11 floorbeam connection has moderate flaking rust. Truss top chord has flaking rust. Floorbeam top chord, stiffener under stringer #10 has cracked tack weld & is working. Top chord U4/U5 has backer bars tack welded along the top interior corners of member. See photo. Bottom chord L4/L5 has no diaphragm tabs, full weld on side and tack welds on other. See photo.

Backer Bars Tack Welded Top Interior

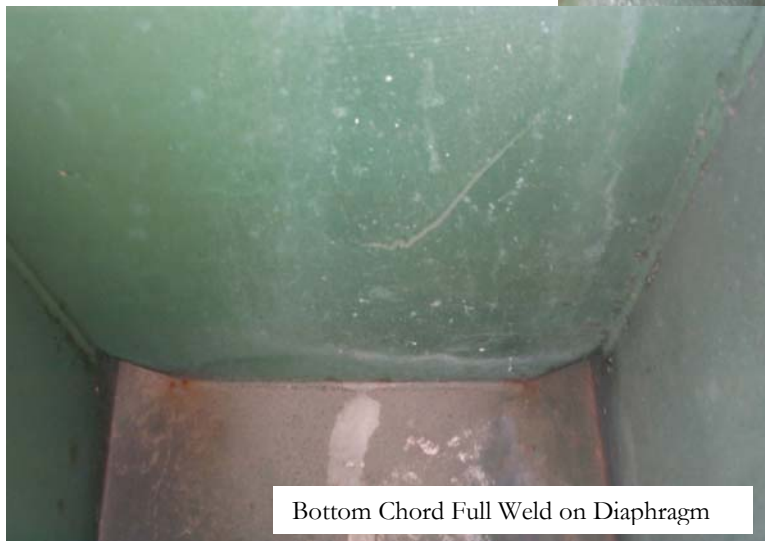
Bottom Chord Full Weld on Diaphragm

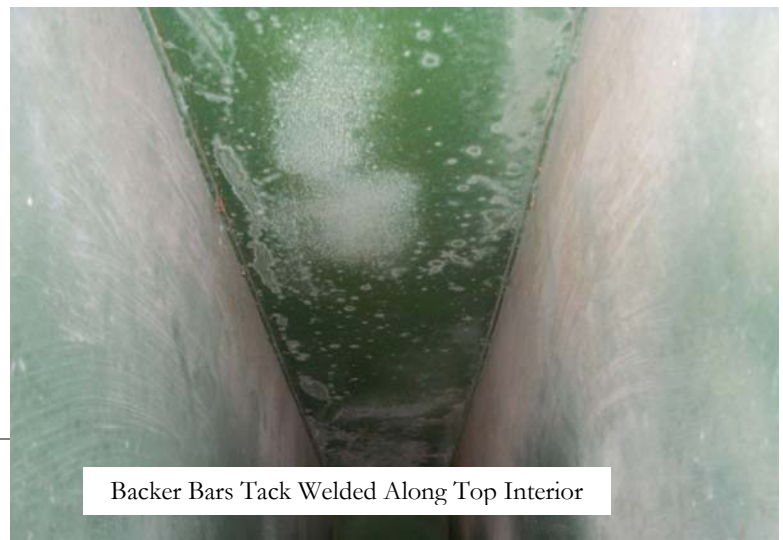
Top chord U5/U6 has backer bars tack welded along the top interior corners of member. [2004] Truss bottom chord, bottom lateral connection plates have spread 3/16" from pack rust.

Backer Bars Tack Welded Along Top Interior

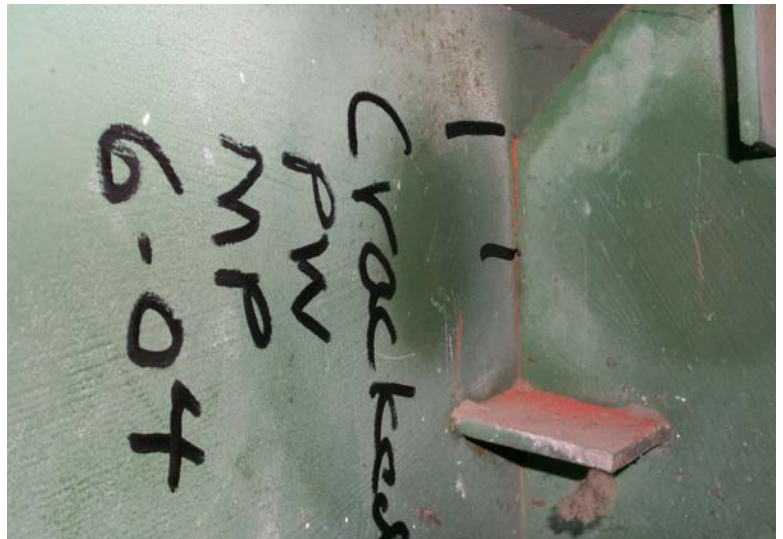
[1996] Bottom chord member L12/L13 has a cracked tack weld at the internal stiffener. [2004] Bottom chord member L12/L13 has a cracked tack weld (diaphragm #2), (not at diaphragm tab). See photo.

Cracked Tack Weld @ Diaphragm #2

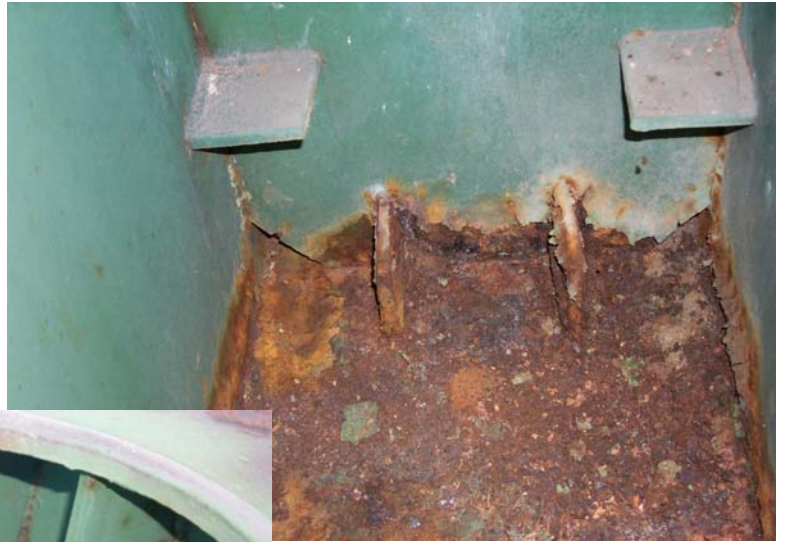
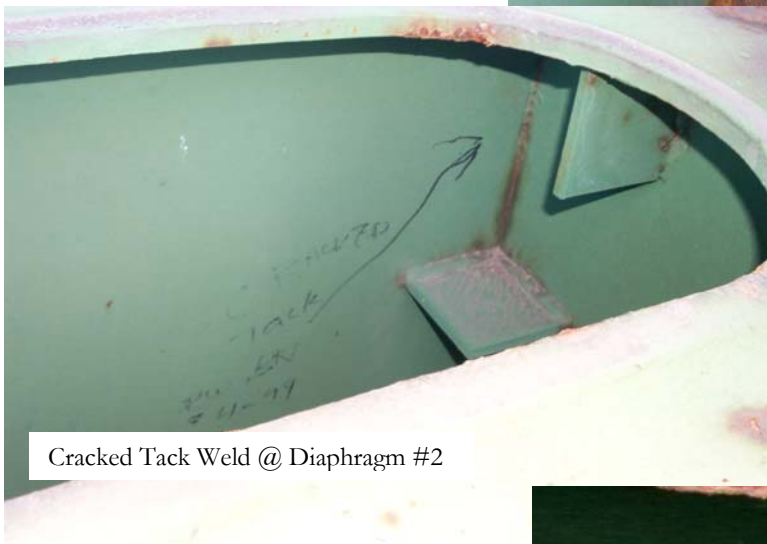
[1996/99] Bottom chord member L13/L14 has cracked tack welds at two internal stiffeners [1999] Truss bottom chord/sway frame connection plates have $\frac{3}{4}$ " pack rust. [2004] Diagonal L13/U14 has corrosion from deck drain. Cracked tack weld (not at diaphragm tab). Cracked tack weld: (diaphragm #3), (not at diaphragm tab), (entire tack weld broken cleanly).

L13/U14 Corrosion @ Diaphragm

Cracked Tack Weld @ Diaphragm #2

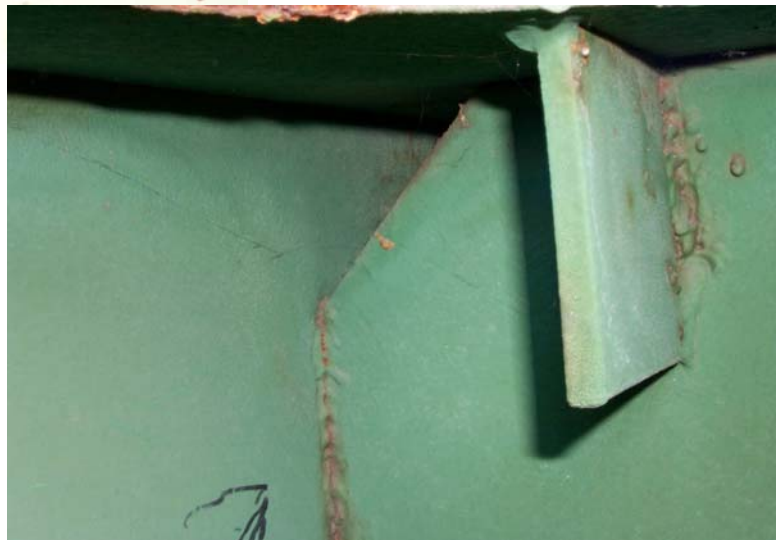
Cracked Tack Weld @ Diaphragm #2

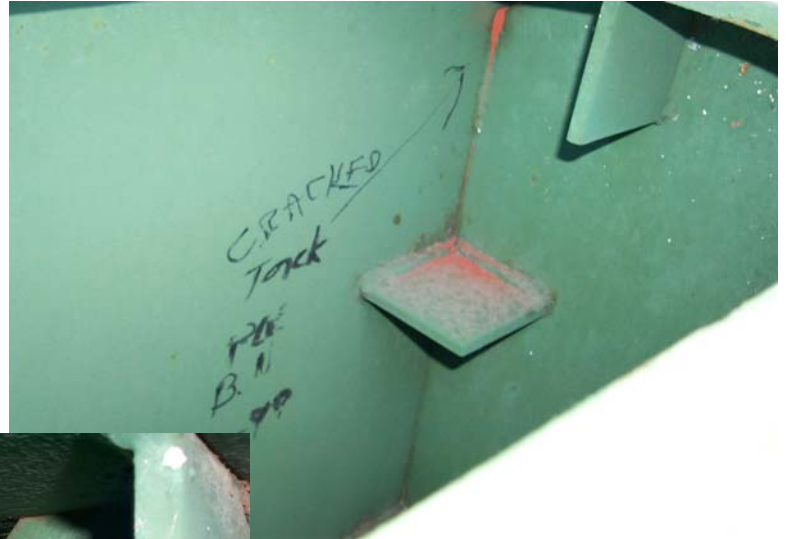
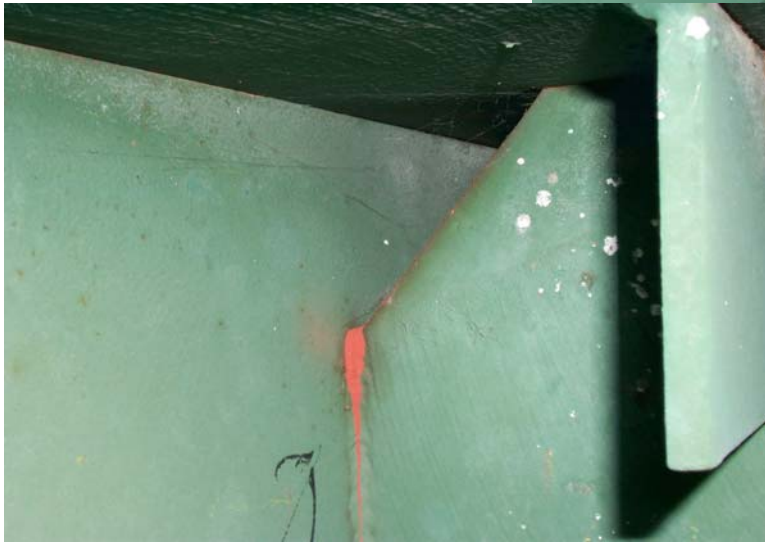
Cracked Tack Weld @ Diaphragm #3

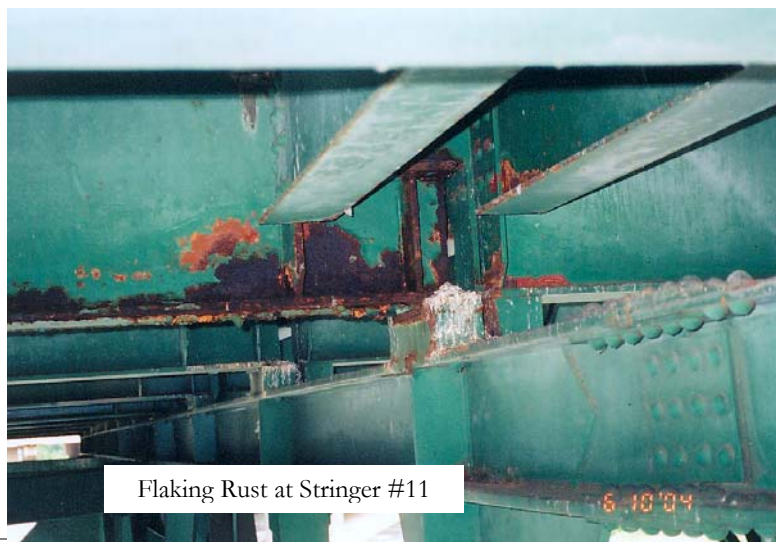
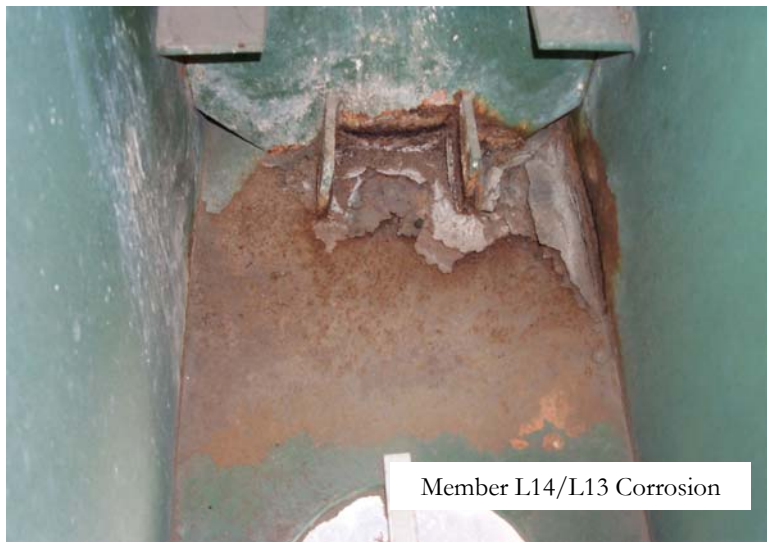
Panel Point #14 (West Truss Midspan Stringer Joint):

Type H: strip seal deck joint above. Deck drains on both sides. [1994] Stringer #11 has section loss, flaking rust near the joint from gland pulled out above. Tack welds along the sway frame/truss, bottom chord, and gusset plate. [1999] Bottom chord member L14/L13' has a cracked tack weld at an interior stiffener. [2003] Stringer #14 connection, south side of the floorbeam, has a cracked tack weld. [2004] Bottom chord member L14/L13' has internal tack welds (full length) at interior diaphragm. Upper chord member U14/U13' has corrosion from deck drain. See photo. [2005] Strip seal gland has 10 LF pulled out. [2006] Reversible diagonal member U14/L13 has section loss with severe flaking rust.

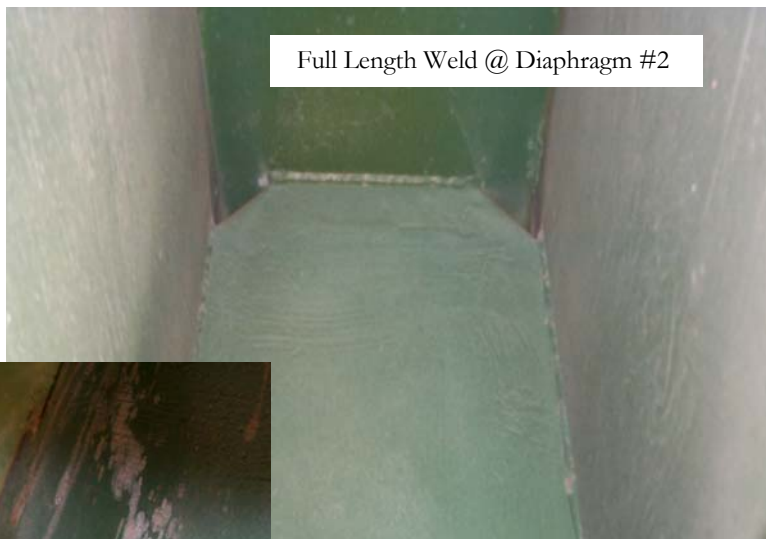
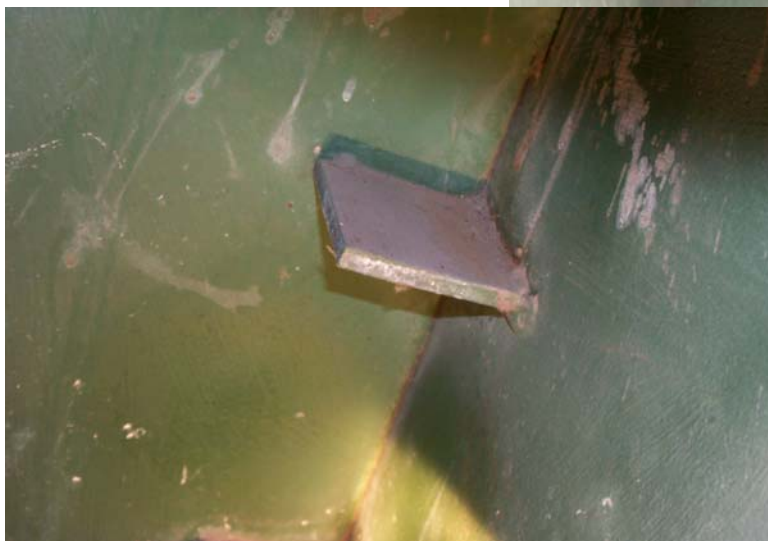
[2004] Upper chord member U13'/U12' (diaphragm #2) has no tabs, diaphragm is welded (full length) one side only. Bottom chord member L13'/L12': cracked tack weld (diaphragm #1), (not at diaphragm tab), (clean break). See photo #2.

Cracked Tack Weld @ Diaphragm #1

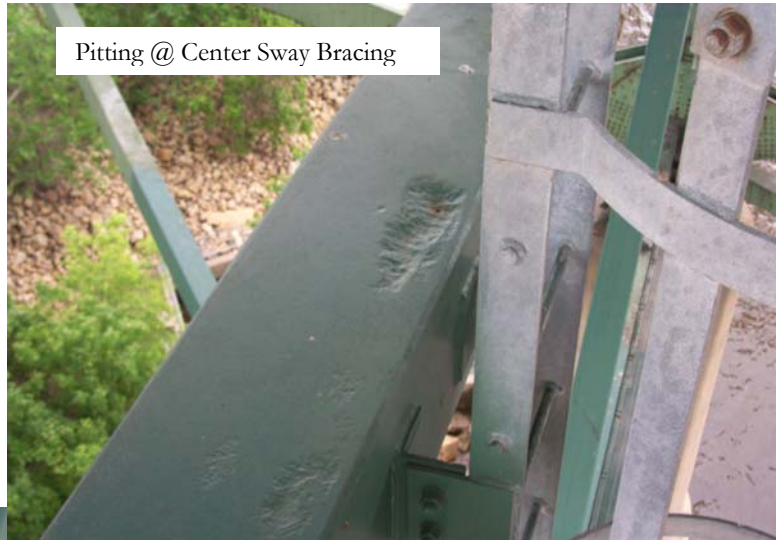
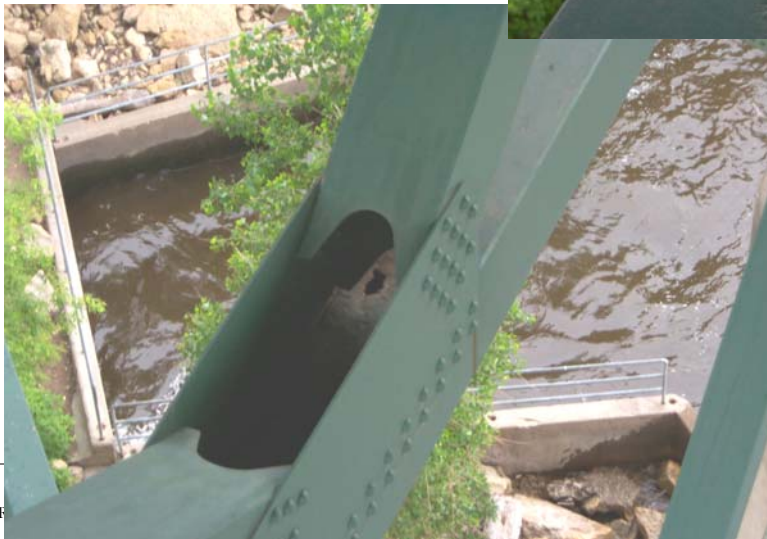
Type H: strip seal deck joint above. [1996] Below stringer #13, the diagonal brace between top and bottom chord of the floorbeam truss is bent, from original construction. [1998] Stringer #11: bolt replaced at floorbeam truss connection. [2001] Truss bottom chord/sway frame connection (gusset plates) has section loss with heavy flaking rust. [2002] Truss bottom chord, L8'/L9', has section loss with heavy flaking rust. [2004/05] Sway bracing center horizontal has 3" x 8" severe pitting & 1/2" diameter hole; bottom sway bracing has a 2" x 3" hole between stringer #11 & stringer #10. See photos. [2005] Strip seal gland has 5 LF pulled out & is leaking onto the crossbeam below, between stringer 10 & 11.

Hole in Bottom Member of Sway Bracing

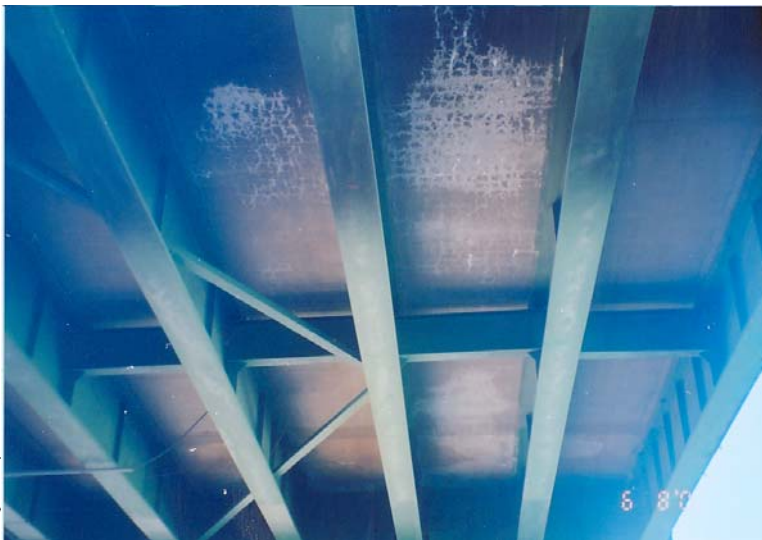
Span is 168 FT long with one floorbeam truss at pier #8, fifteen 48" deep welded plate girders bolted onto the crossbeam. Multi-beam spans resume. NB has 8 girders. SB has 7 girders. There are two active railroad tracks below. [1999] Refer to Appendix "A" **First Diaphragm South of Pier #9** graph for crack locations, description & repair to the diaphragm line. Girders 6, 7, 8, 9, & 10 are re-painted. Lateral bracing welded to web & stiffener. [2003] Bottom of deck has conduit on the east side. [2004] Girder 1C (NBL), crack at the diaphragm bottom cope, NE side measures 2" ("front face") and NW side measures 2-1/2" ("Back face"). Girder 3 (NBL), crack at the diaphragm bottom cutout, measures 1-1/2" (both sides). [1998/2004] Girder #3 has a "tear" in the girder's web at the diaphragm girder connection. The "tear" measured 42" long on one side and 12" long on the other, was caused by out of plane bending between the diaphragm and the girder. Girder Connection Lowered & Girder Web Repaired with Splice Plate. [2002/06] Underside of deck has 260 SF of water saturation, & 4 SF of delamination. [2006] Girder #12 has paint failure from leaking de-icing system.

Water Saturation SB Bays 12, 13 & 14

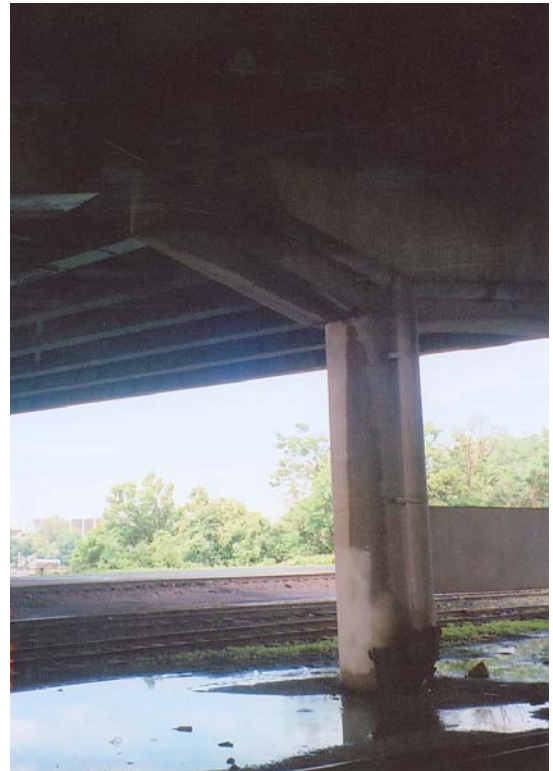
Plate bearing assemblies have 13 fixed, and four sliding. Pier consists of four columns and cap, with a railroad crash strut between the columns. 2 Deck drain: downspouts. [1969] East column damaged by train derailment: the column has minor scrapes and spalls, downspout had to be reconnected. [1999] Bearings 9, 10, 11, &. 12 were re-painted. [2004/05] West vertical & median deck drain plugged.

Median Drain Plugged Pier 9

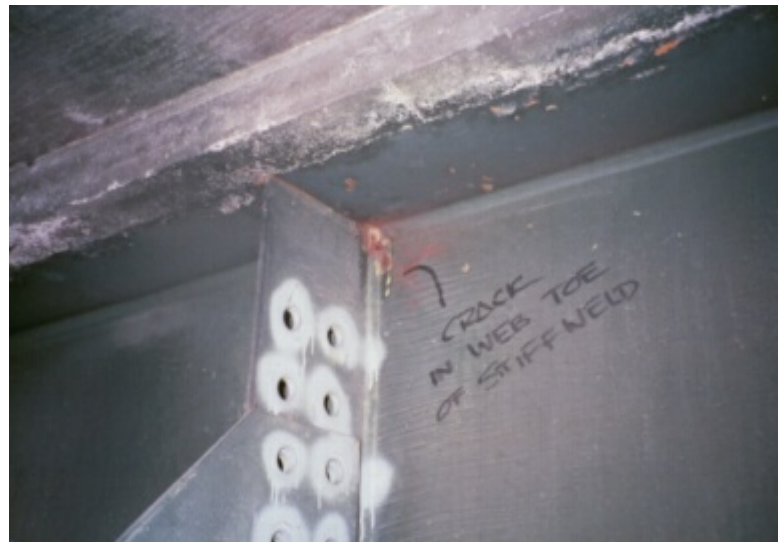
Span is 94 FT long with 17 steel beams. NB has 10 beams; SB has 7 beams (the welded beams transition from 48" to 33" depth just north of pier #9) with active railroad tracks below. One track splits into two. Refer to Appendix "A" **First Diaphragm North of Pier #9** graph for crack locations, description & repair to the diaphragm line. [1999] Beams 9, 10, 11, & 12 were re-painted. Diaphragms were inverted & lowered, even though the beam connections have a "positive moment" configuration. Connections welded to top flange. [2003] Conduit: at east side bottom of deck. [2000] Beam #6 appears to be "working" at the top connection. [2004/06] Underside of the deck has 550 LF of transverse leaching cracks, 500 SF of water saturation, & 8 SF of delamination.

Girder #10 Vertical Stiffener/Girder Web

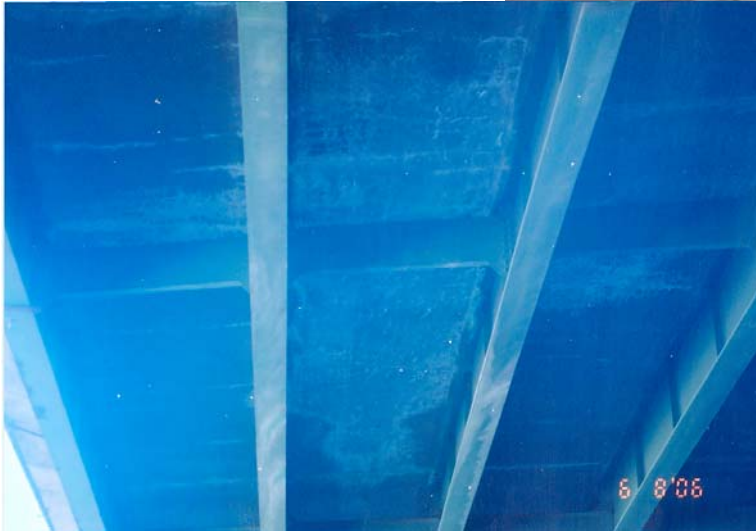
Water Saturation SB Bays 12, 13 & 14

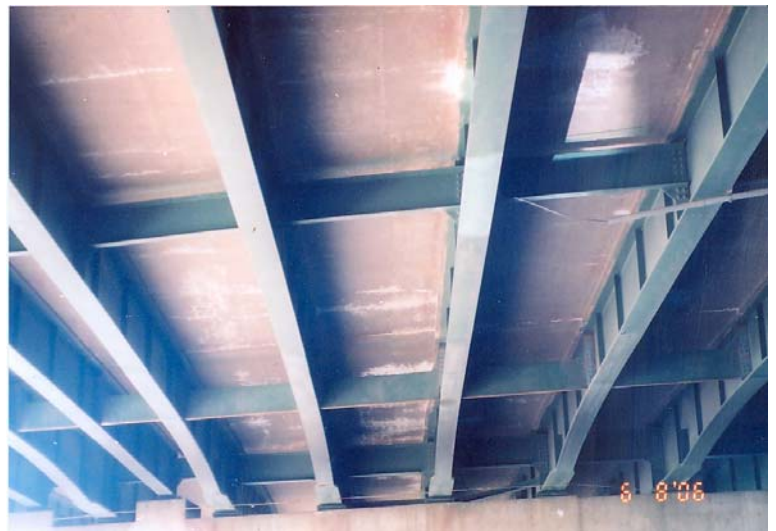
Water Saturation NB Bays 5, 6 & 7
