FRACTURE CRITICAL BRIDGE INSPECTION

In-Depth Report

BRIDGE # 9340 (SQUIRT BRIDGE)

I-35W over the Mississippi River at Minneapolis, MN

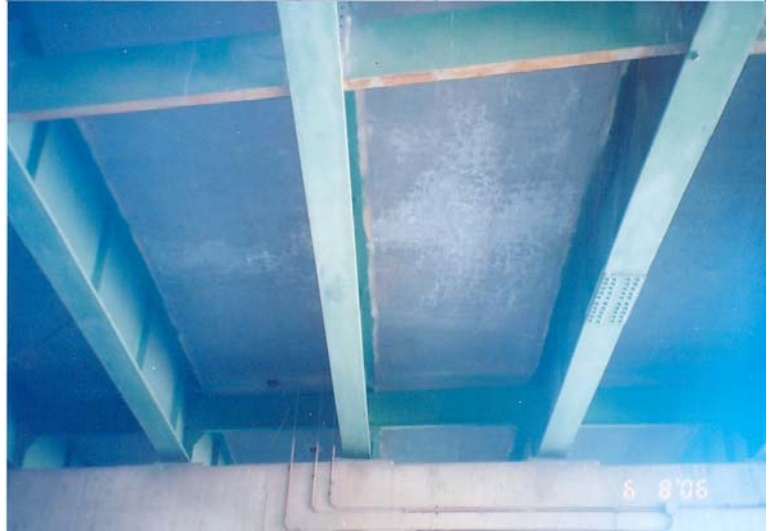
Span is 68 ft. long with 18 steel beams. Northbound has 11 beams; southbound has 7 beams, and the parking lot below. [1999] Beams 9, 10, 11, & 12 were re-painted. Connections welded to top flange. Diaphragms were inverted & lowered, even though the beam connections have “positive moment” configuration. [2003] Conduit: east side bottom of deck. [2004] 50 SF of water saturated deck underneath.

Water Saturation SB bays 15 & 16
