INVESTIGATIVE REPORT TO JOINT COMMITTEE TO INVESTIGATE THE I-35W BRIDGE COLLAPSE

APPENDIX: Volume II

MAY 2008

Appendix Volumes II and III

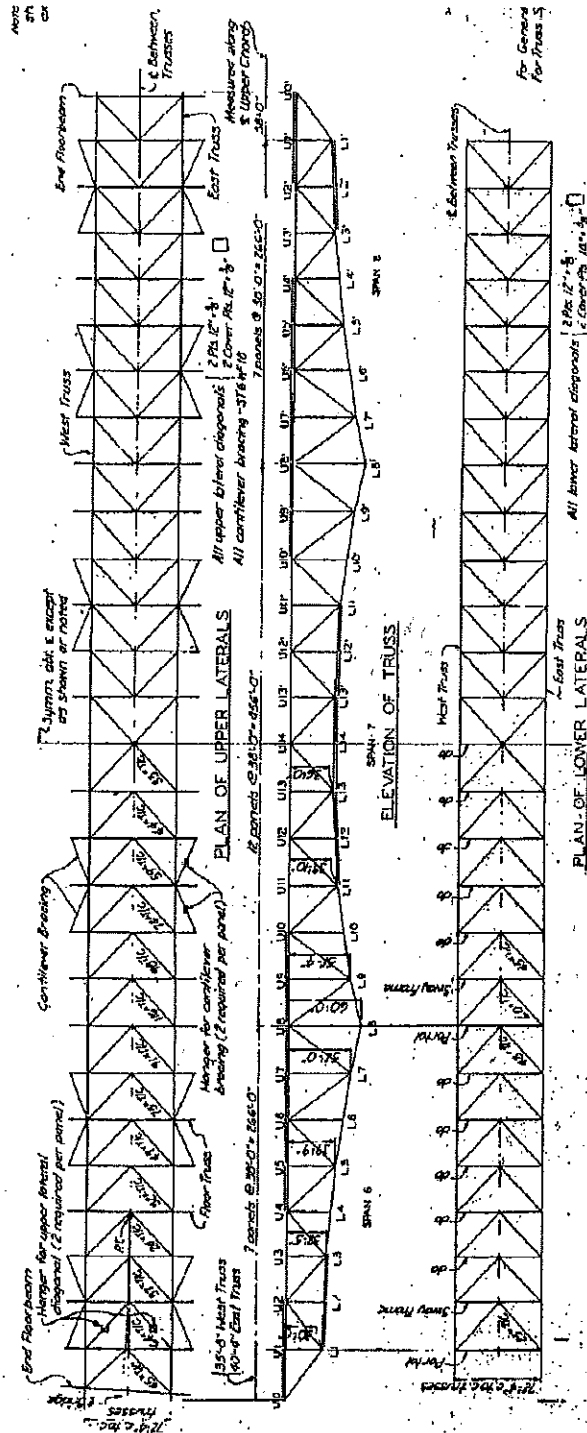
Figure 1: Deck Truss Framing Plan and Elevation from Original Contract Plans
 (Highlighted Members are Identified Fracture Critical Members)

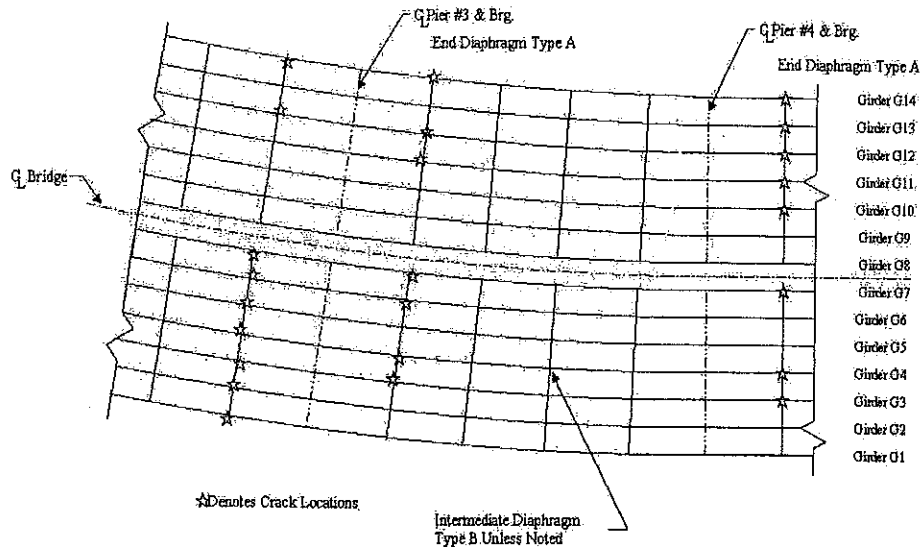
Refer to chart titled **Diaphragm Crack Locations South of Pier #3** for crack locations, description & repair. [1999] Diaphragms lowered.

Diaphragm Crack Locations South of Pier #3	
Girder Location	Crack Description and or Repair Description
G1 (East Fascia NB)	[99/2000] 1/4" crack on top of interior stiffener weld. [2003] No change.
G2 (NB)	* [1998] Two 2" holes drilled in web. Crack is contained.
G3 (NB)	* [1998] Two 1/4" intersecting diagonal holes drilled in top of stiffener welds. [2003] No crack.
G4 (NB)	* [1998] Two 2" holes drilled in web. Crack is contained.
G5 (NB)	* [1998] Two 2" holes drilled in web. Crack is contained.
G6 (NB)	[1998] One 2" hole drilled in web. [2000] Other end of crack is turning downward into the web & was drilled out. Crack is contained.
G7 (NB)	* [1998] One 2" hole drilled in web & other end of crack was ground out. [2003] The ground out end is cracked, visible on both sides web, should be drilled out.
G8 (SB)	
G9 (SB)	
G10 (SB)	
G11 (SB)	
G12 (SB)	* [1998] Two 2" holes drilled in web & 1 hole drilled in stiffener. [1999] Crack extends 1" beyond the hole (ground out). [2003] No change.

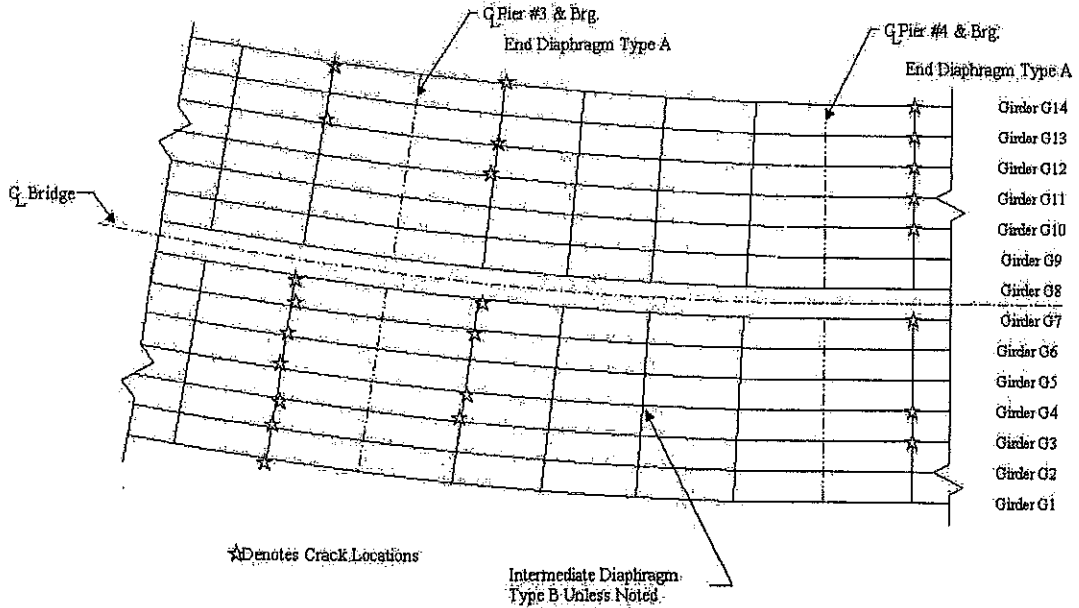
Refer to chart titled **Diaphragm Crack Locations North of Pier #3** for crack locations, description & repair. [1998/99] Diaphragms lowered with strain gauges placed on beams #2 & 6. *Denotes locations where cracks were found in 1998.

Diaphragm Crack Locations North of Pier #3	
Girder Location	Crack Description and or Repair Description
G1 (East Fascia NB)	
G2 (NB)	Strain gauges on both faces.
G3 (NB)	* [98/2000] West side, top flange web weld has 1/2" crack. Eastside, stiffener weld has a small crack. [2003] No change.
G4 (NB)	* [1999] West face, top of stiffener weld small crack. [2003] Crack is growing down toe of weld 3/4", drill out.
G5 (NB)	* [2003] Small crack at the top of stiffener weld.
G6 (NB)	* [1999] Small crack at top of stiffener weld. Strain gauges on the east face. [2003] No change.
G7 (NB)	* [2003] Small crack at the top of the interior stiffener weld.
G8 (SB)	
G9 (SB)	
G10 (SB)	
G11 (SB)	* [1998] Two 2" holes drilled in web. Crack is contained.
G12 (SB)	* [1998] Two 2" holes drilled in web. Crack is contained.
G13 (SB)	
G14 (West Fascia SB)	* [1998] Two 2" holes drilled in web. Crack is contained.

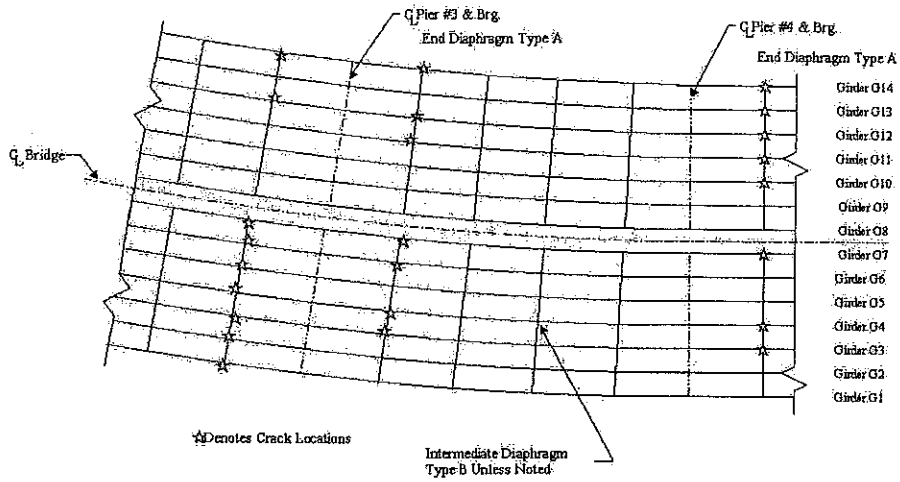
Diaphragm Crack Locations North of Pier #4	
Girder Location	Crack Description and or Repair Description
G1 (East Fascia NB)	
G2 (NB)	
G3 (NB)	* [1998] Two 2" holes drilled in web. Crack is contained.
G4 (NB)	* [1998] Two 2" holes drilled in web. Crack is contained.
G5 (NB)	
G6 (NB)	
G7 (NB)	* [1998] Two 2" holes drilled in web. [2001/03] Both sides, small crack at top of stiffener weld.
G8 (SB)	
G9 (SB)	
G10 (SB)	* [1998] Two 2" holes drilled in web. Crack is contained.
G11 (SB)	[99/2000] Small crack at top of stiffener weld. [2003] No change.
G12 (SB)	* [1998] Two 2" holes drilled in web & 1/4" hole drilled in stiffener weld. Crack is contained.
G13 (SB)	* [99/2000] Small crack at top of stiffener weld. [2003] No change.
G14 (West Fascia SB)	[1999] Small crack at top of interior stiffener weld. [2003] No change.

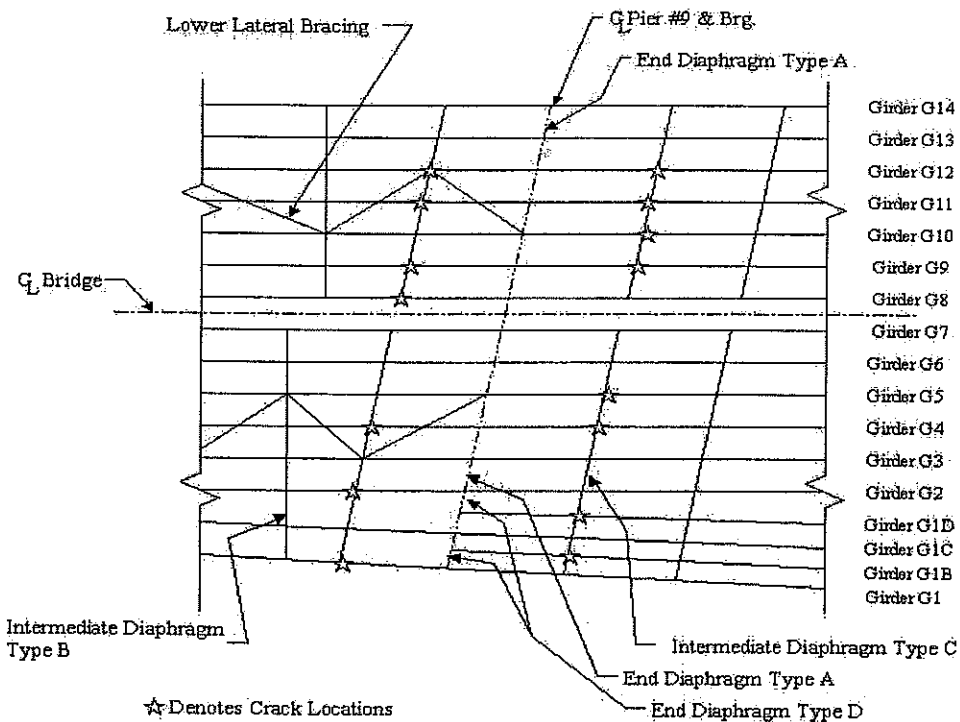
Refer to chart titled **Diaphragm Crack Locations South of Pier #9** for crack locations, description & repair. [1999] Diaphragms lowered.

Diaphragm Crack Locations South of Pier #9	
Girder Location	Crack Description and or Repair Description
G1 (East Fascia NB)	[2000] Exterior top flange/web weld has a 1/2" indication. [2003] No change.
GC (NB)	
G2 (NB)	* [1998] 4 ft. long inverted "U" shaped crack in web (reinforced with bolted plates).
G3 (NB)	
G4 (NB)	* [98/2000] Small crack in top flange/web weld. [2003] No change.
G5 (NB)	
G6 (NB)	
G7 (NB)	
G8 (SB)	
G9 (SB)	* [1998] Crack in top of stiffener weld. [2003] No change.
G10 (SB)	
G11 (SB)	* [98/2000] Small crack in top of stiffener weld (east side). [2003] No change.
G12 (SB).	* [98/2000] Small crack in top of stiffener weld (east side). [2003] No change.
G13 (SB):	
G14 (West Fascia SB)

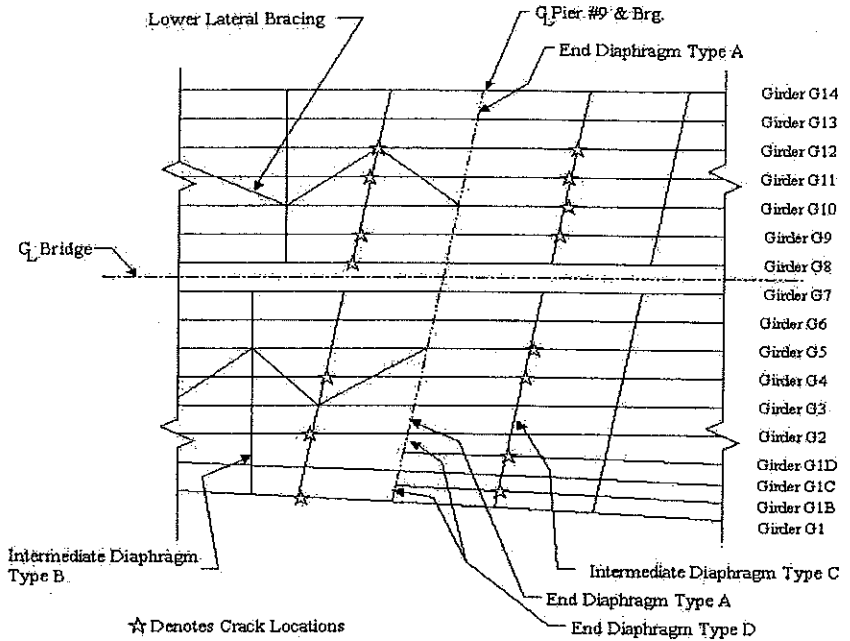
Refer to chart titled **Diaphragm Crack Locations North of Pier #9** for crack locations, description & repair. [1999]
Diaphragms lowered.

Diaphragm Crack Locations North of Pier #9	
Girder Location	Crack Description and or Repair Description
G1 (East Fascia NB)	
G1B (NB)	Stiffeners are welded to the top flange (positive moment).
G3 (NB)	
G1D (NB)	Stiffeners are welded to the top flange (positive moment)
G2 (NB)	
G3 (NB)	
G4 (NB)	* [2000] Two 2" holes drilled in web. Crack contained.
G5 (NB)	* [2000] Two 2" holes drilled in web. Crack contained.
G6 (NB)	
G7 (NB)	
G8 (SB)	
G9 (SB)	* [98/2000] Crack in top flange/web weld & top of stiffener weld (west side). [2003] No change.
G10 (SB)	* [2000] Crack in top flange/ web weld (east side) This crack has grown; see photos.
G11 (SB)	* [2000] Two 2" holes drilled in web. Crack contained.
G12 (SB)	* [2000] Two 2" holes drilled in web. Crack contained.
G13 (SB)	
G14 (West Fascia SB)

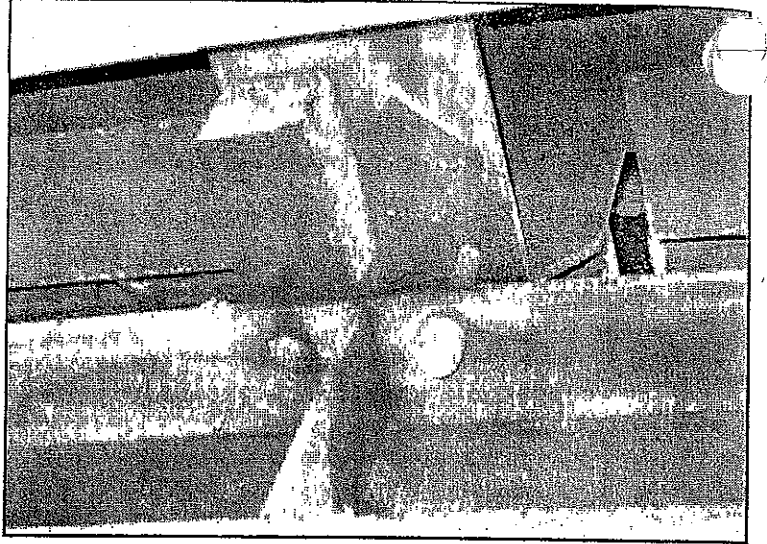
Stringer #4 Bolt Missing

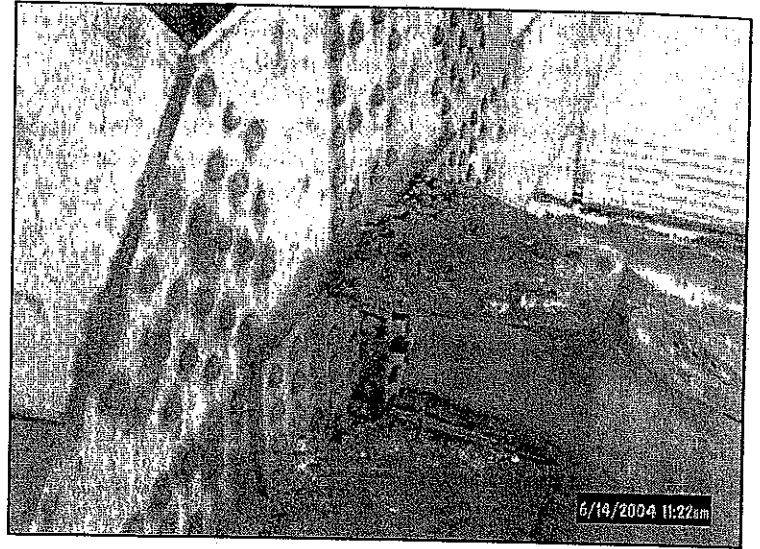
Member L13/L14 Cracked Tack Weld

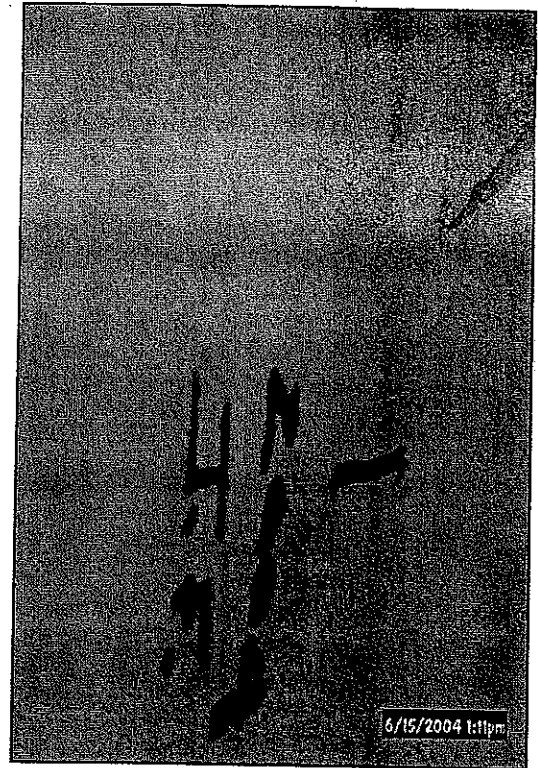
Panel Point #14 (East Truss Midspan Stringer Joint):
Strip seal expansion joint on the deck. Sway frame rusty.
[1999] Truss bottom chord member L14/L13' has a cracked tack weld at an interior stiffener. [2002/03]
Floorbeam bottom chord & middle bracing connection plate has 1/2" pack rust. Underside of the deck has 4 SF of delamination. [2004] Bottom chord member L14/L13' cracked tack weld at diagram tab (diagram #3?) see photo.

Member L14/L13' Cracked Tack Weld

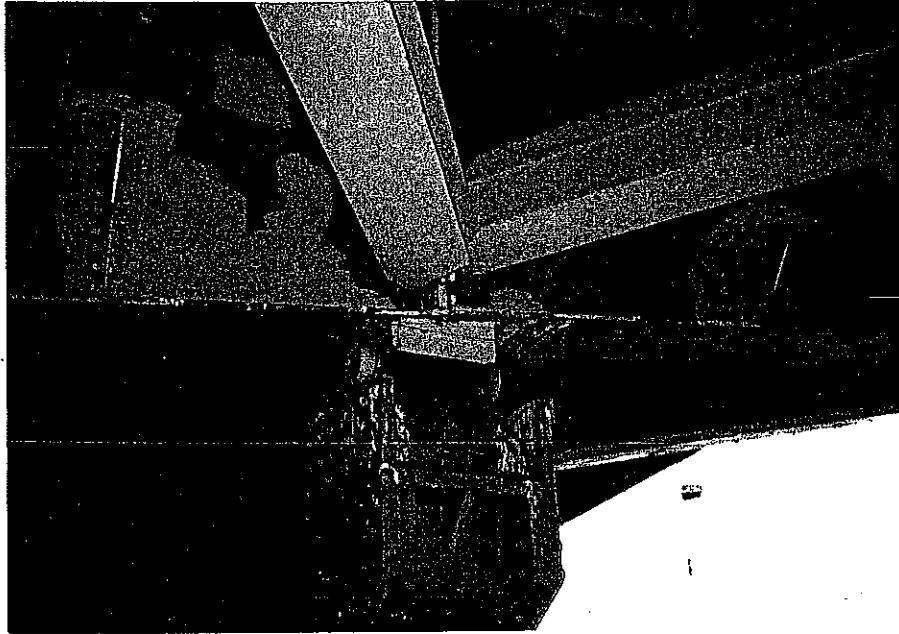
Picture #5
Repair to Floorbeam @ End of Multi-Beam Span
No. B'nd., Span #5, Deck Truss #2

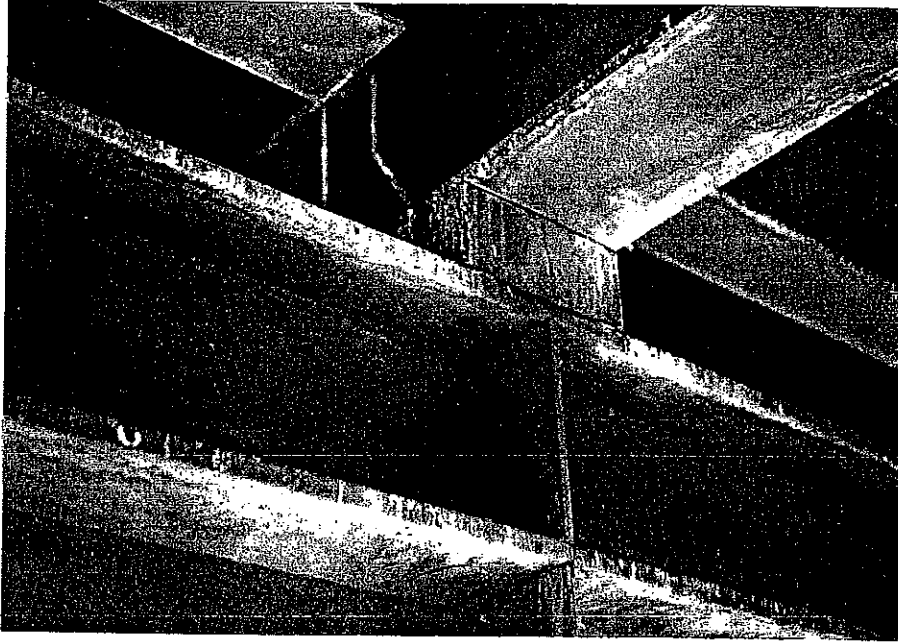
Picture #11
Missing Bolt @ Stringer #11
Span #6, P/P-U8, No. B'nd.

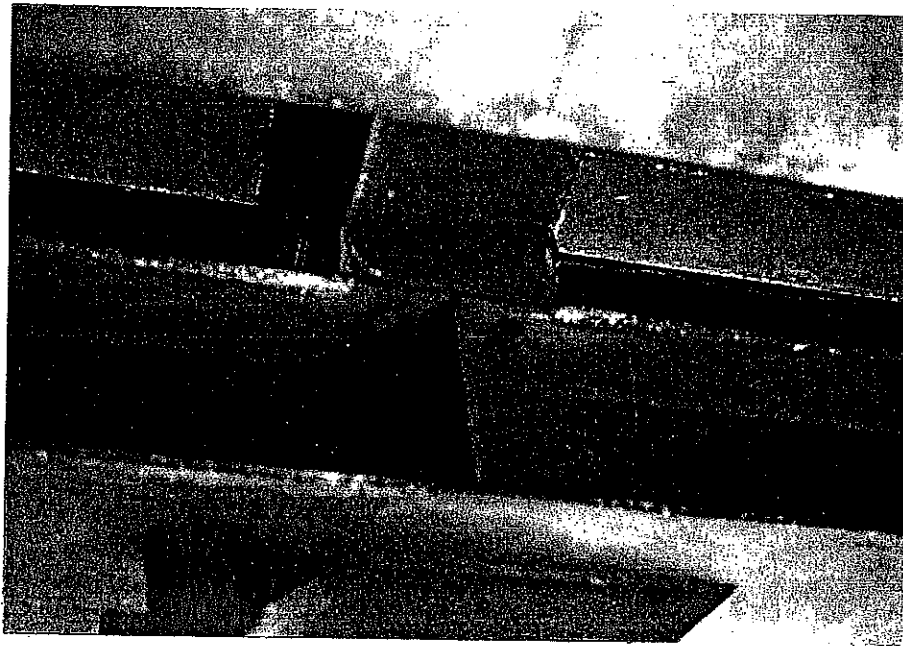
Picture #12
Missing Bolt @ Stringer #13
Span #6, P/P-U8, No. B'nd.

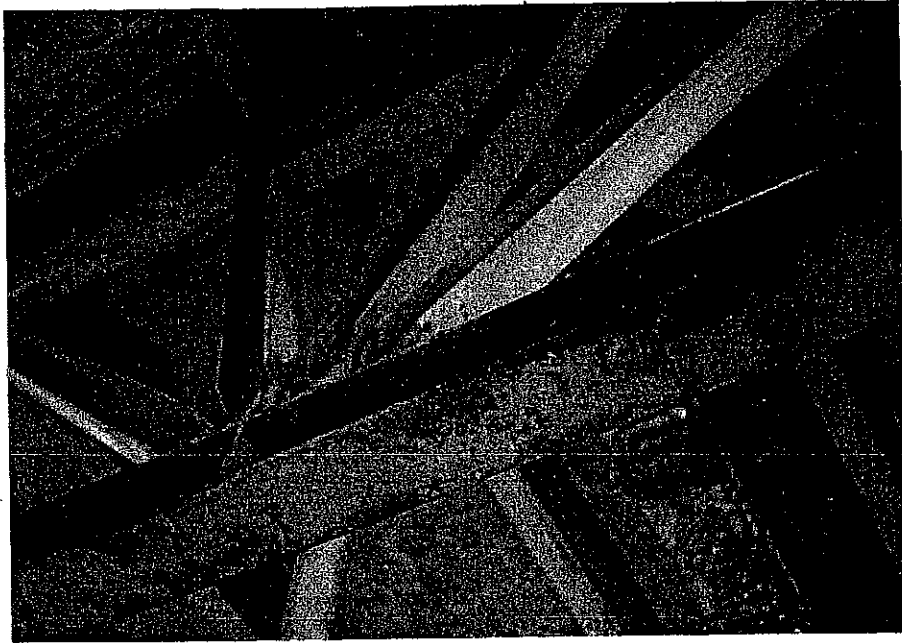
Picture #17
Condition of Paint on Floor Truss
Span #7, P/P-U8', No. B'nd.

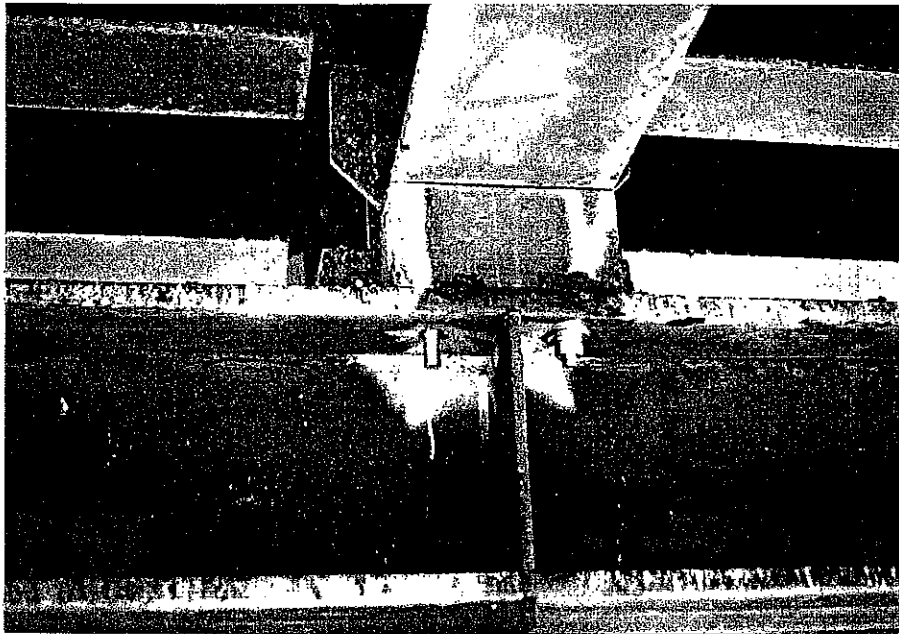
Picture #18
Broken Bolts Repaired with Red-Rod, Nut Missing
Stringer #11, Span #8, P/P-U8', No. B'nd.

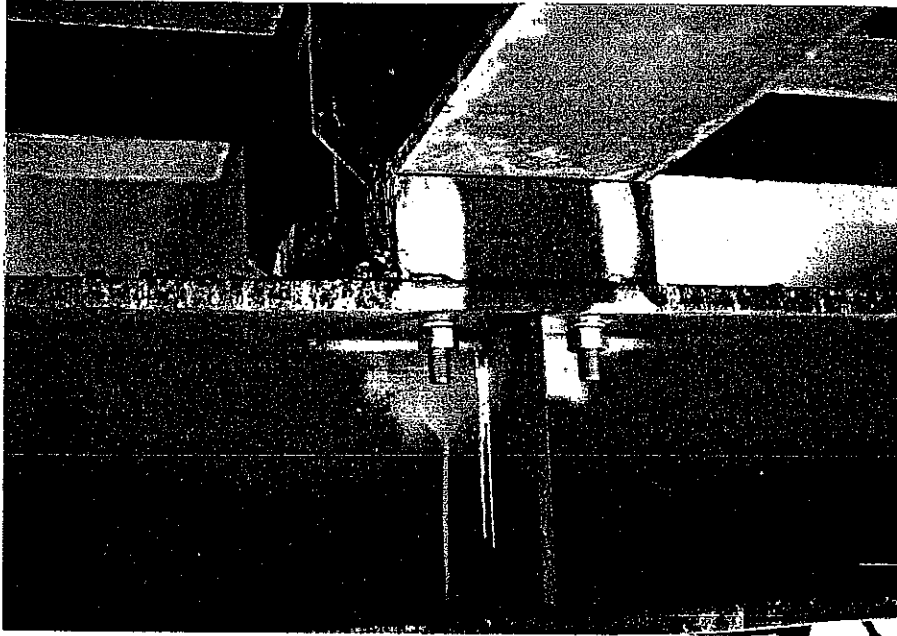
Picture #19
Broken Bolts Repaired with Red-Rod
Stringer #10, Span #8, P/P-U8', No. B'nd.

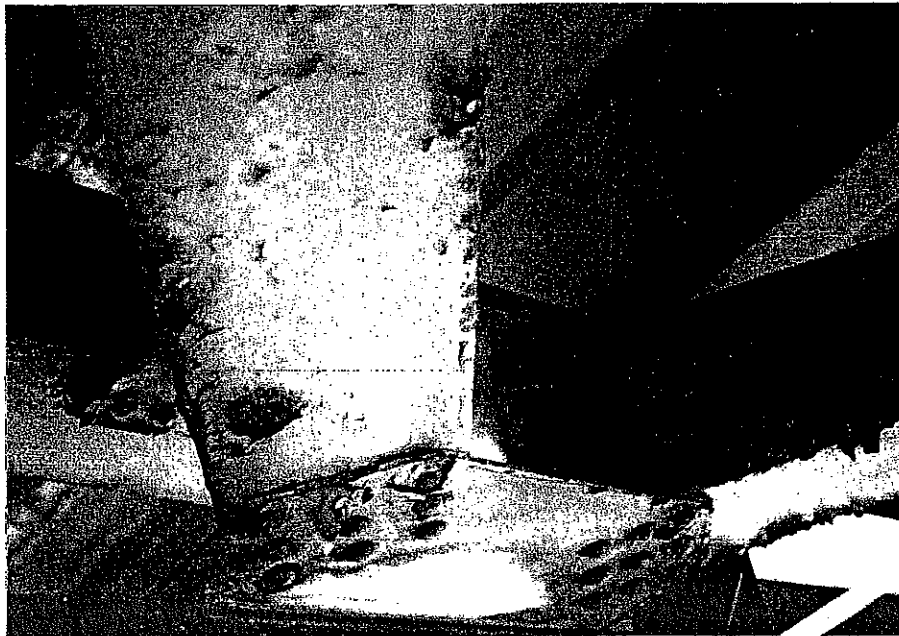
Picture #20
Typical Condition of Paint Under Median
Top Chord of Floor Truss to Diagonal Bracing Connection
Span #8, No. B'nd.

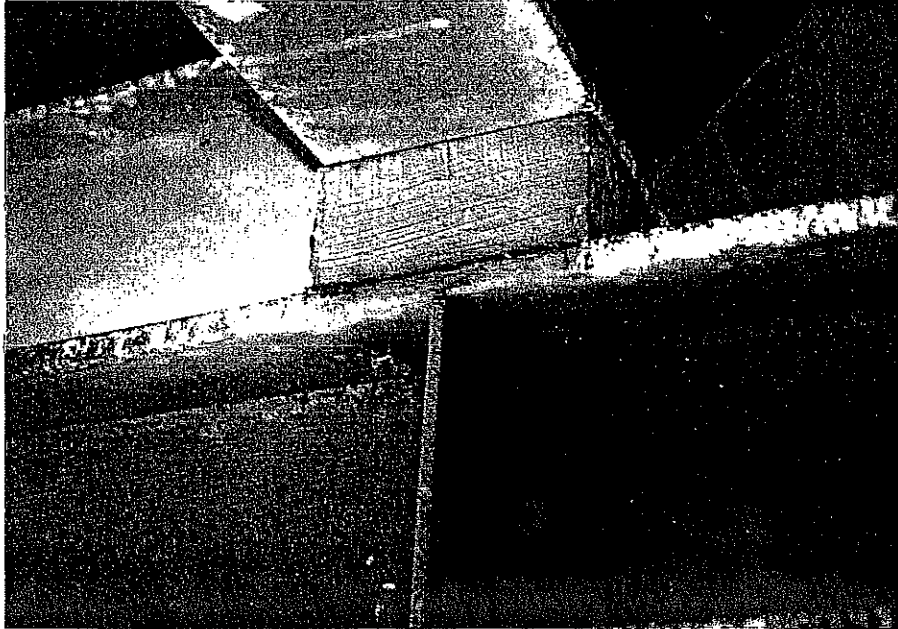
Picture #22
Bolts Working - Probably Near Failure
Stringer #11 to Floor Truss Connection
Span #8, P/P-U6', No. B'nd.

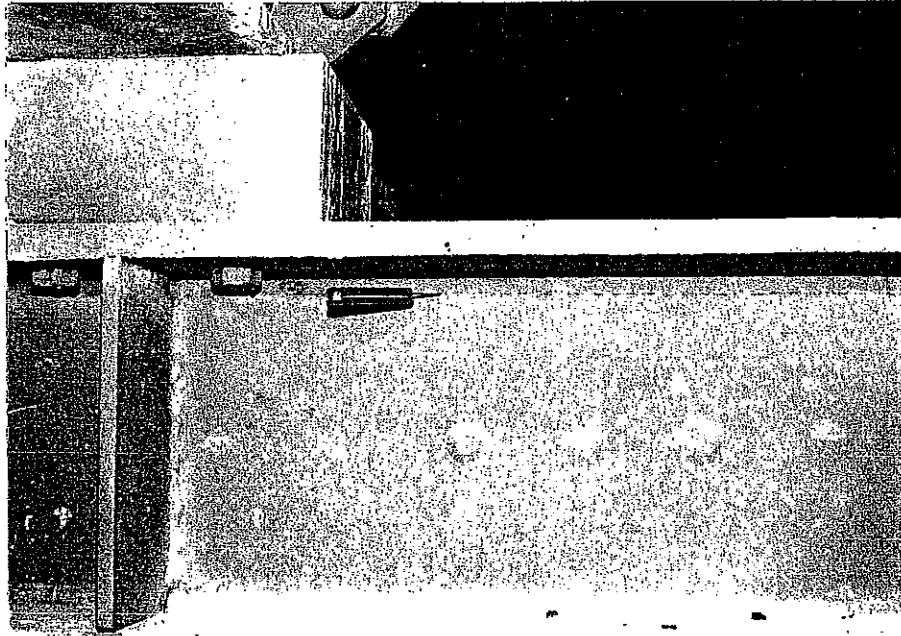
Picture #23
Incomplete Weld of Reinforcement Plate to Top Flange
Floor Truss - Span #8, P/P-U3', No. B'nd.

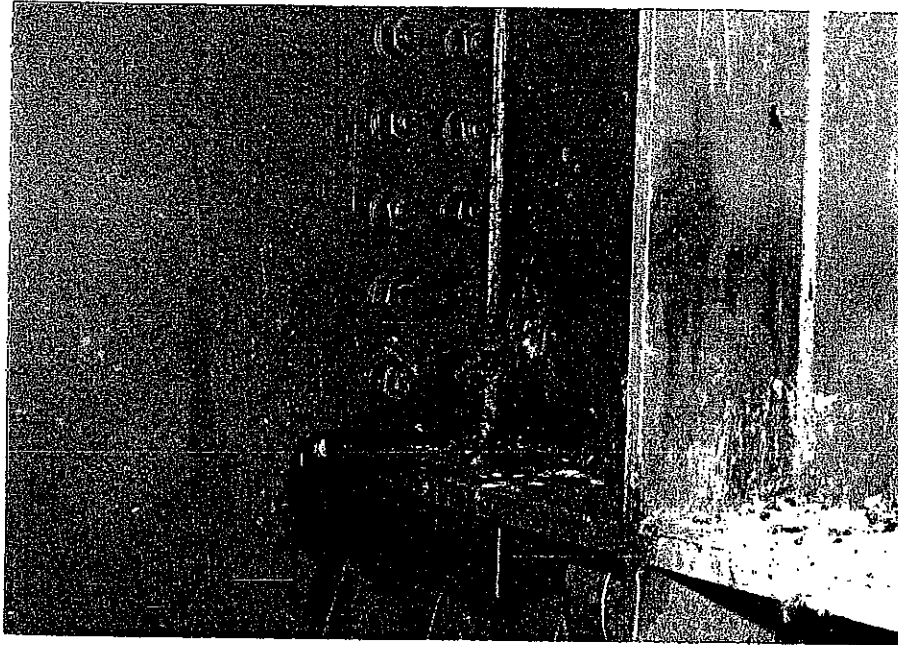
Picture #27
Fatigue Crack Drilled Out
Girder #12 to Floor Beam Connection
Span #9, Deck Truss #2, No. B'nd.

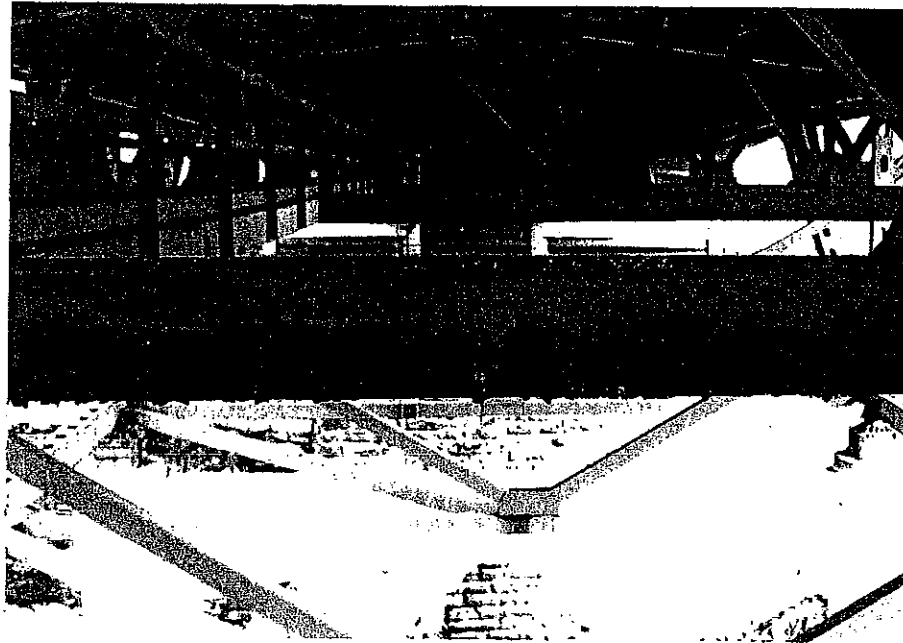
Picture #31
Paint Condition - Bottom Chord of Floor Truss
Span #8, P/P-U5', So. B'nd.

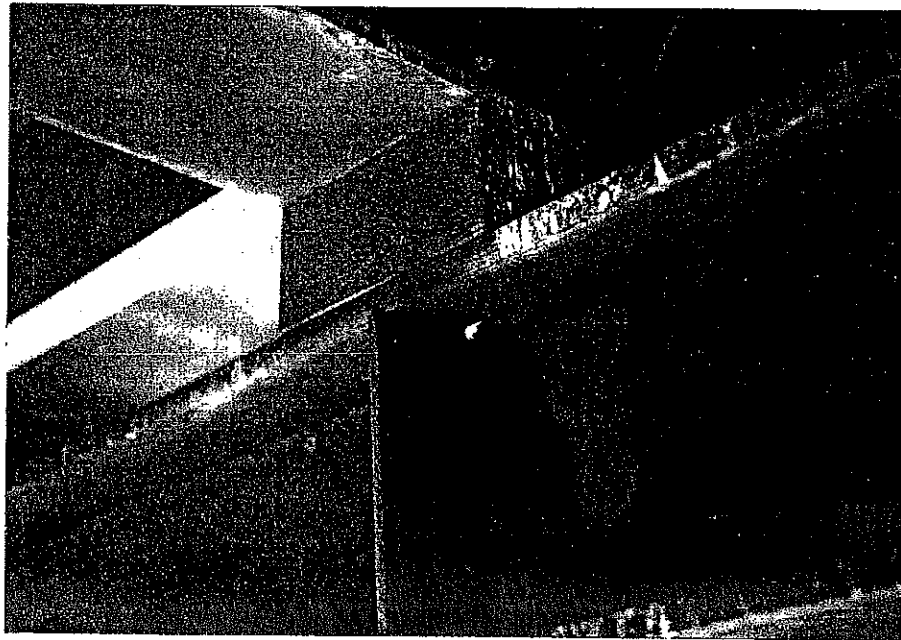
Picture #32
Broken Bolt - Stringer #4 to Floor Truss
Span #8, P/P U6', So. B'nd.

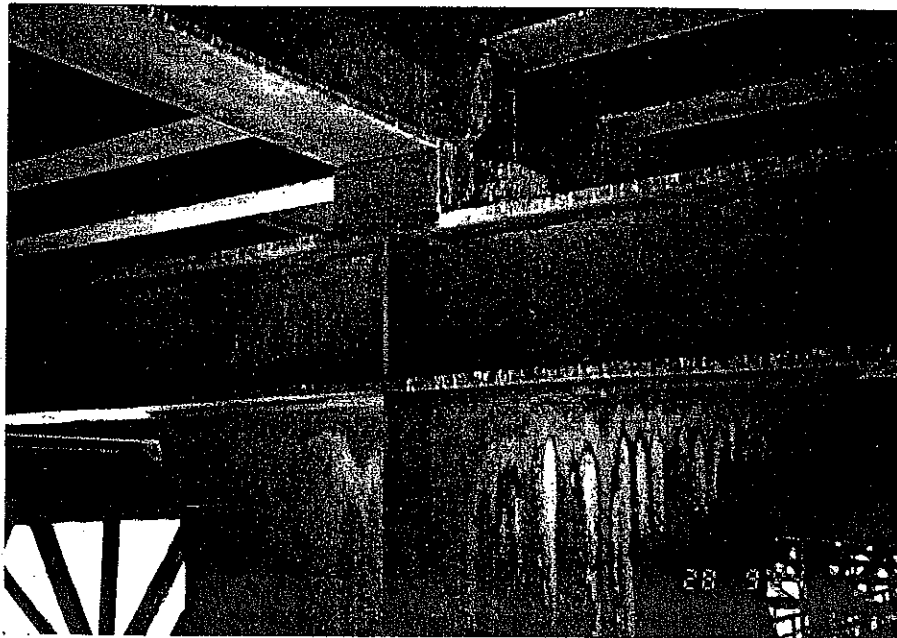
Picture #34
Broken Bolt - Stringer #4 to Floor Truss
Span #8, P/P U8', So. B'nd.

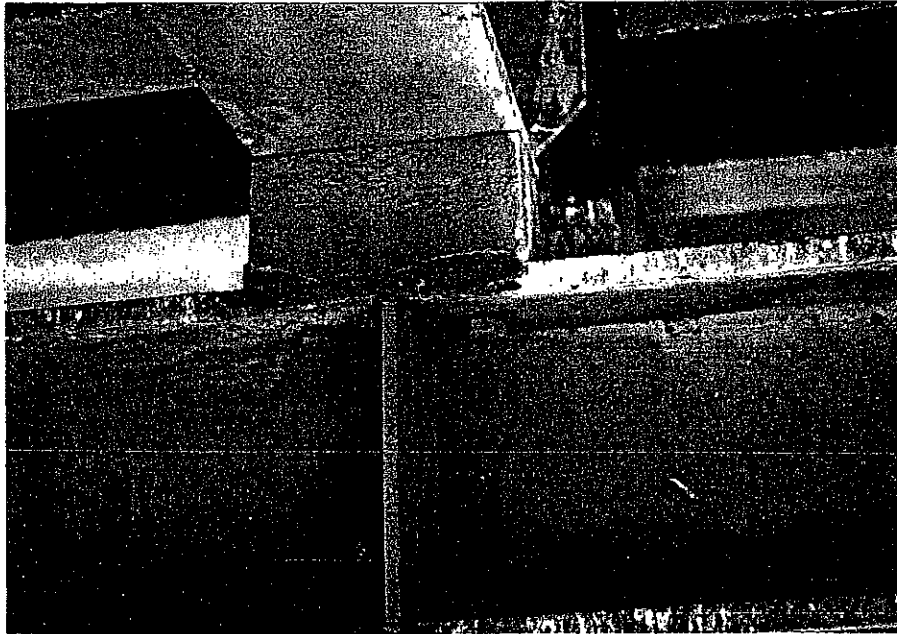
Picture #35
Broken Bolt - Stringer #4 to Floor Truss
Span #8, P/P U8', So. B'nd.

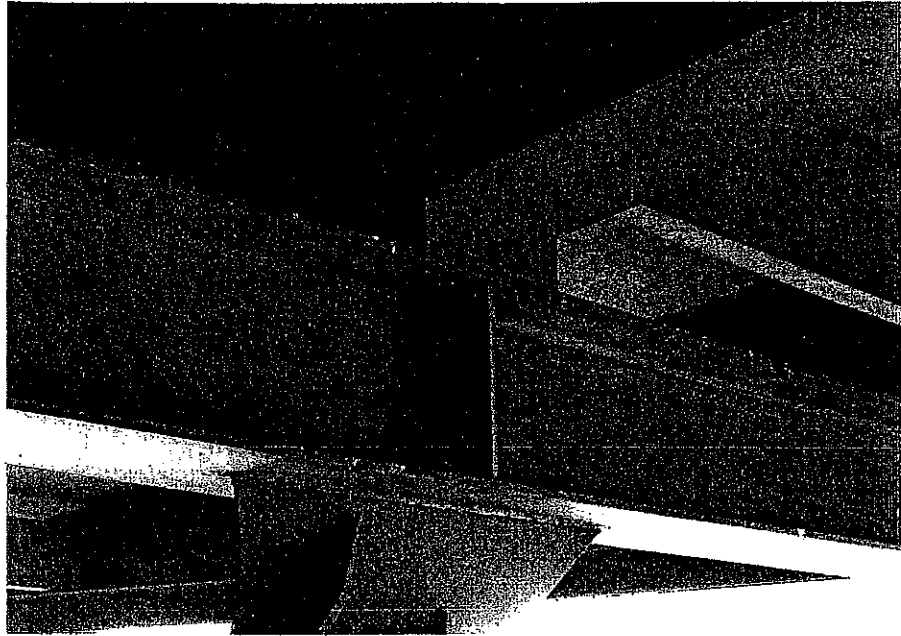
Picture #37
Loose Bolt - Stringer #2 to Floor Truss Connection
Span #7, P/P-U10', So. B'nd.

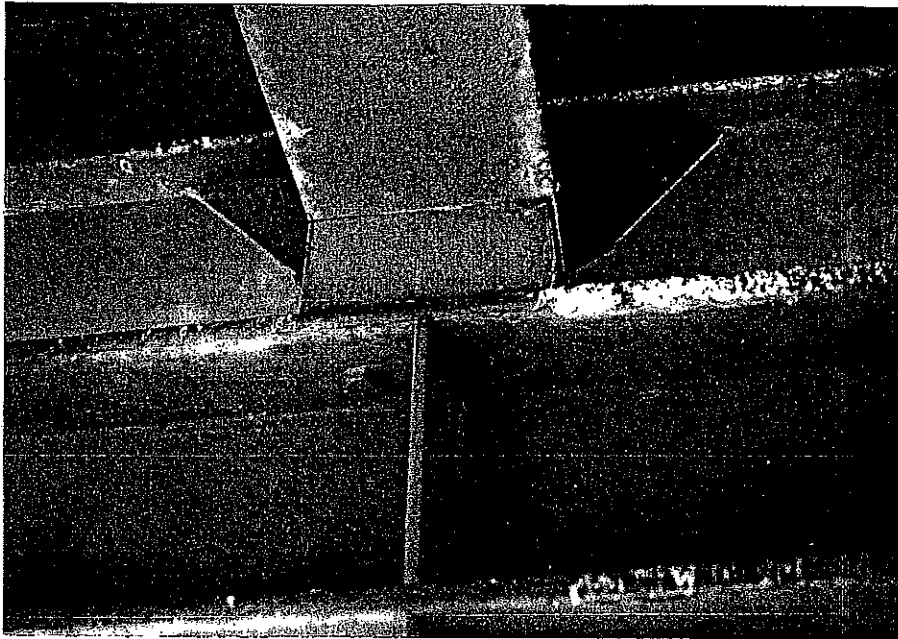
Picture #41
Broken Bolt - Stringer #4 to Floor Truss
Span #7, P/P U11, So. B'nd.

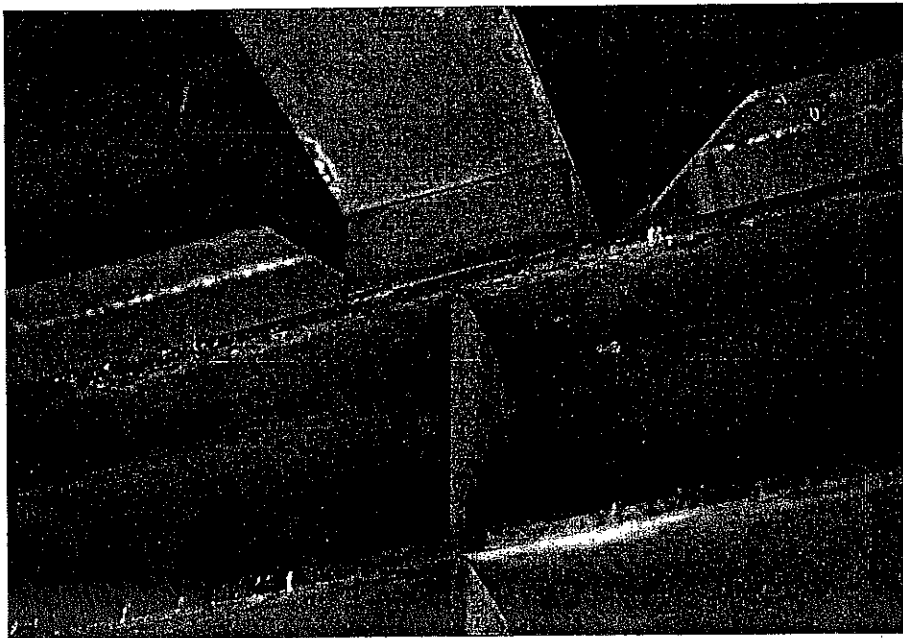
Picture #42
2 Broken Bolts - Stringer #4 to Floor Truss
Span #7, P/P U11, So. B'nd.

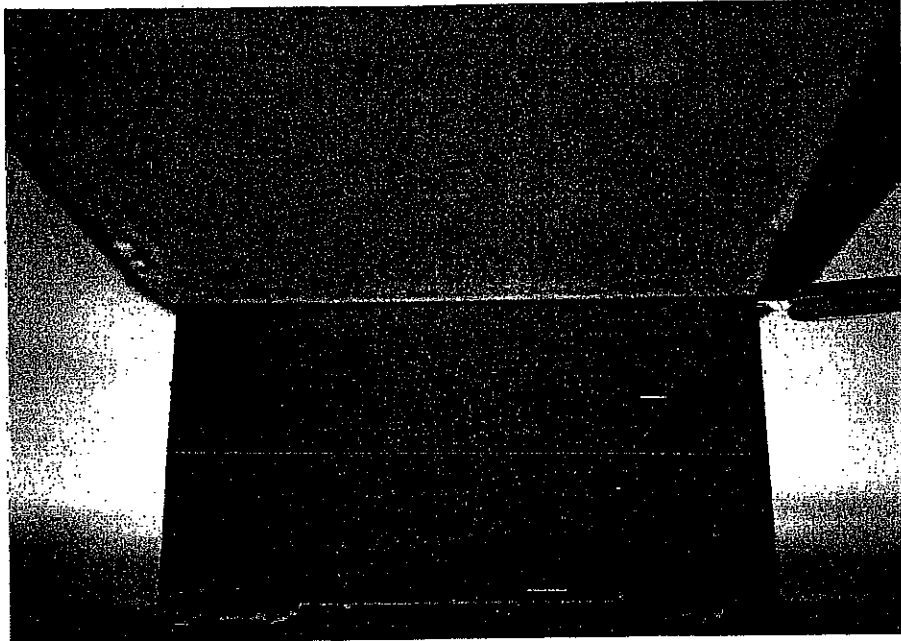
Picture #43
Stringer #4 Lifted 3/32"
Span #7, P/P-11, So. B'nd.

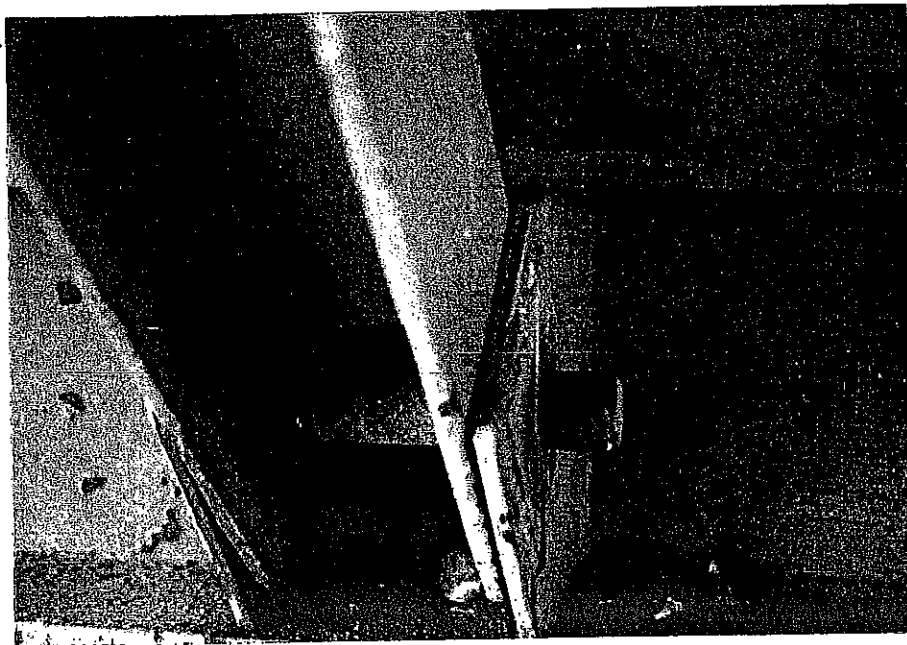
Picture #46
Missing Cotter Pin
Vertical Brace to Lower Chord of Floor Truss
Span #6, P/P-U1, So. B'nd.
