# **INVESTIGATIVE REPORT TO JOINT COMMITTEE TO INVESTIGATE THE I-35W BRIDGE COLLAPSE**

**APPENDIX: Volume IV**

### Bridge Inspection Reports

*Bridge # 9340  
I-35W over the Mississippi River  
(Downtown Minneapolis)*

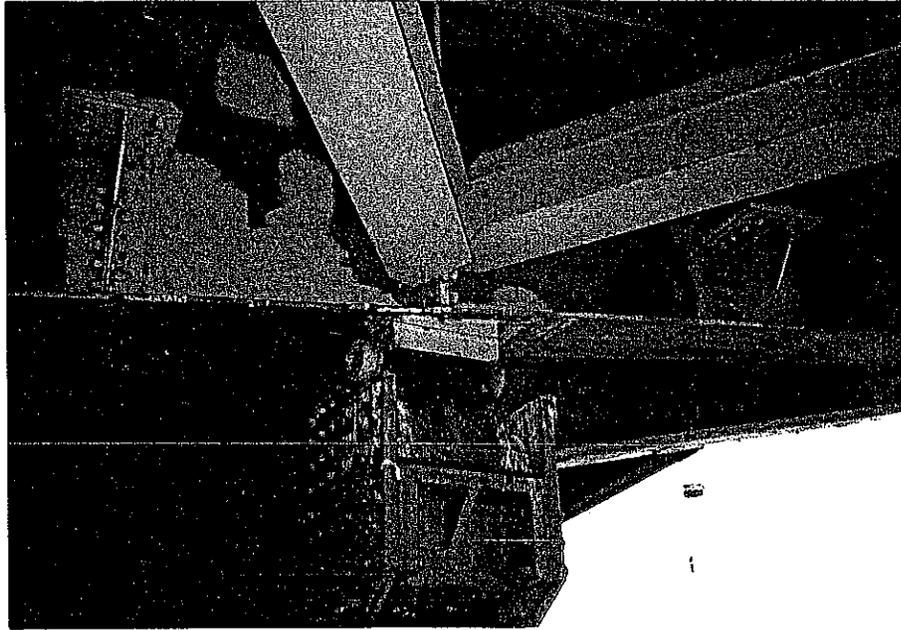
Picture #5  
Repair to Floorbeam @ End of Multi-Beam Span  
No. B'nd., Span #5, Deck Truss #2

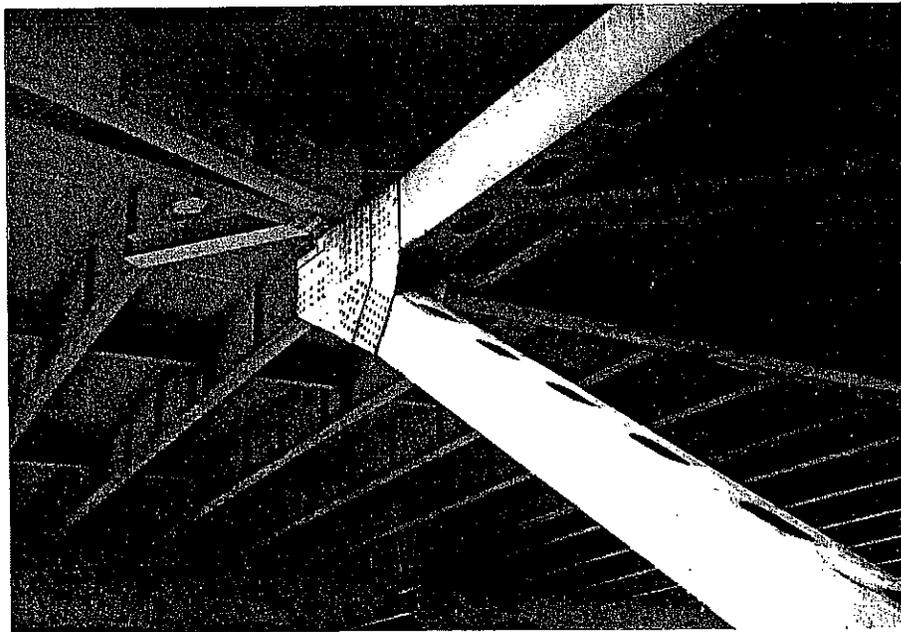
Picture #6  
Deck Truss #2  
Span #4, P/P-U0, No. B'nd.

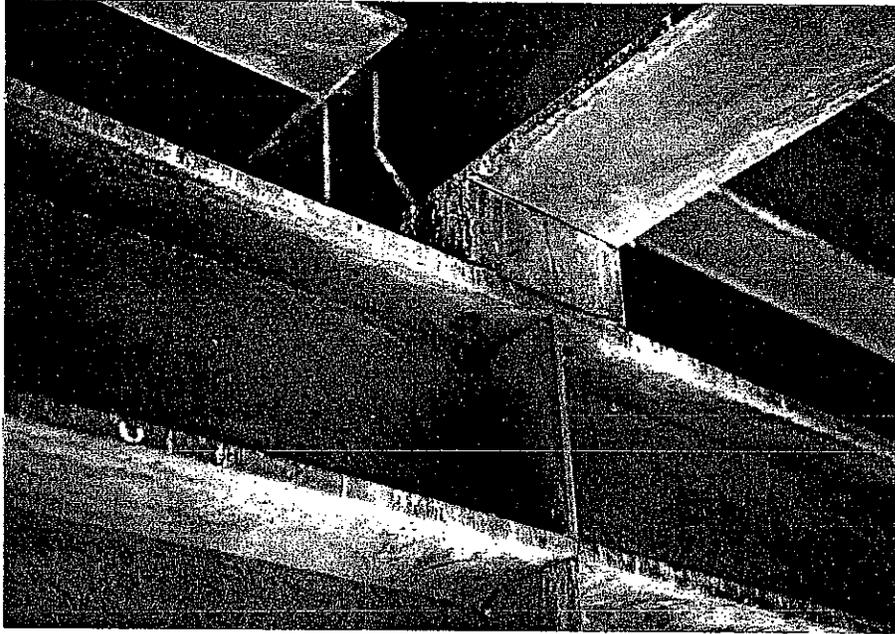
Picture #11  
Missing Bolt @ Stringer #11  
Span #6, P/P-U8, No. B'nd.

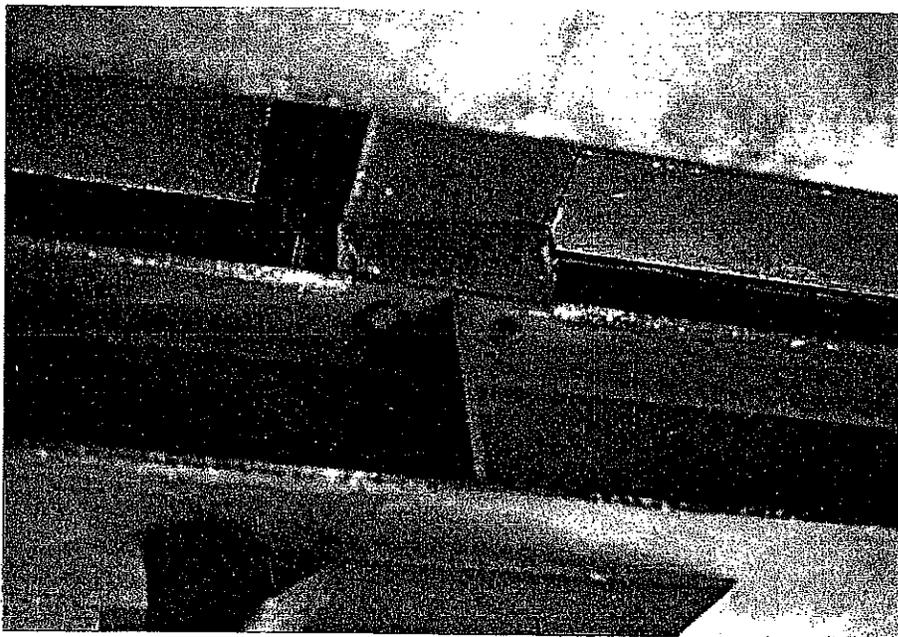
Picture #12  
Missing Bolt @ Stringer #13  
Span #6, P/P-U8, No. B'nd.

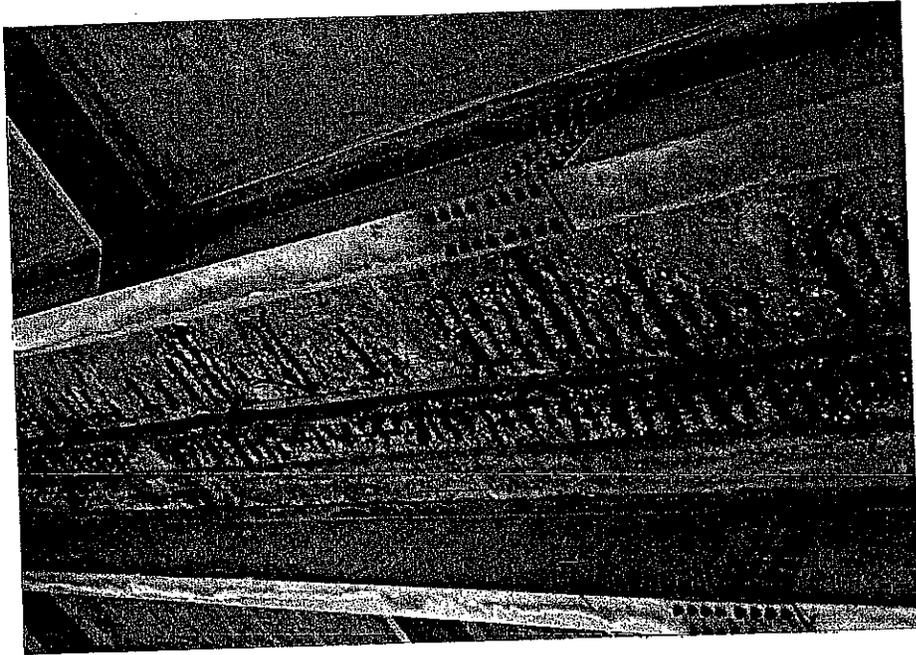
Picture #13  
Chipped Concrete - Underside of Deck @ Median  
Span #7, P/P-U14 (midspan), No. B'nd.

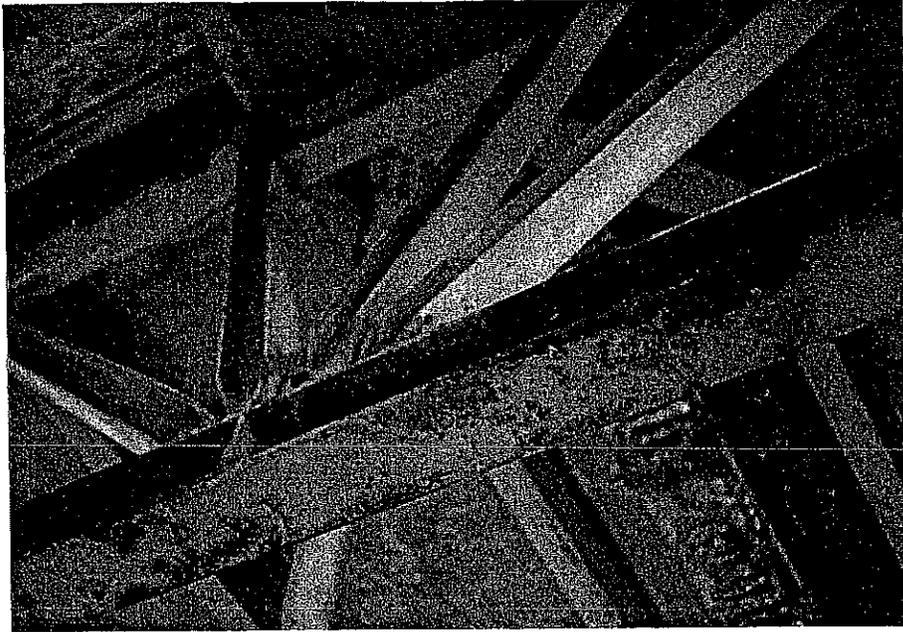
Picture #17  
Condition of Paint on Floor Truss  
Span #7, P/P-U8', No. B'nd.

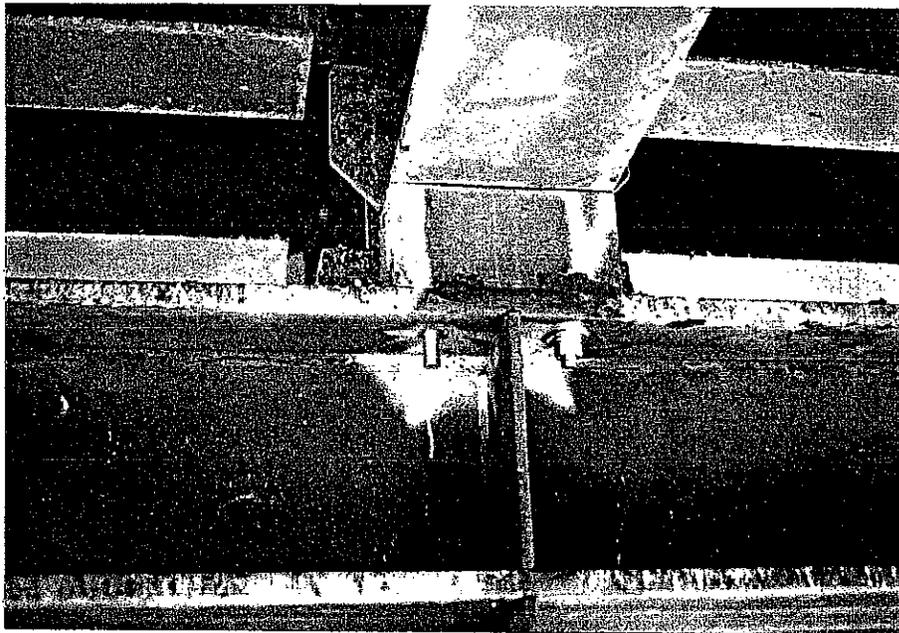
Picture #18  
Broken Bolts Repaired with Red-Rod, Nut Missing  
Stringer #11, Span #8, P/P-U8', No. B'nd.

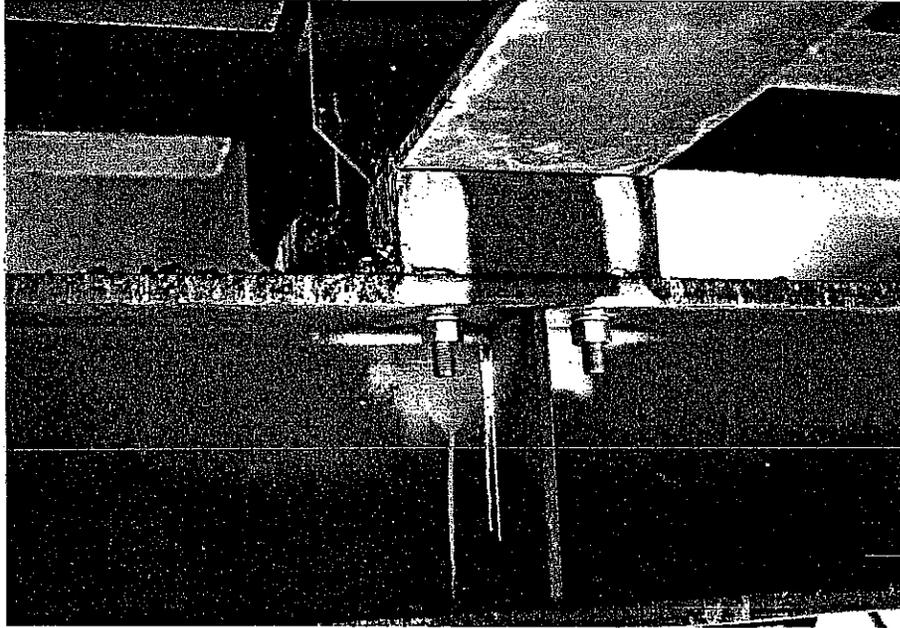
Picture #19  
Broken Bolts Repaired with Red-Rod  
Stringer #10, Span #8, P/P-U8', No. B'nd.

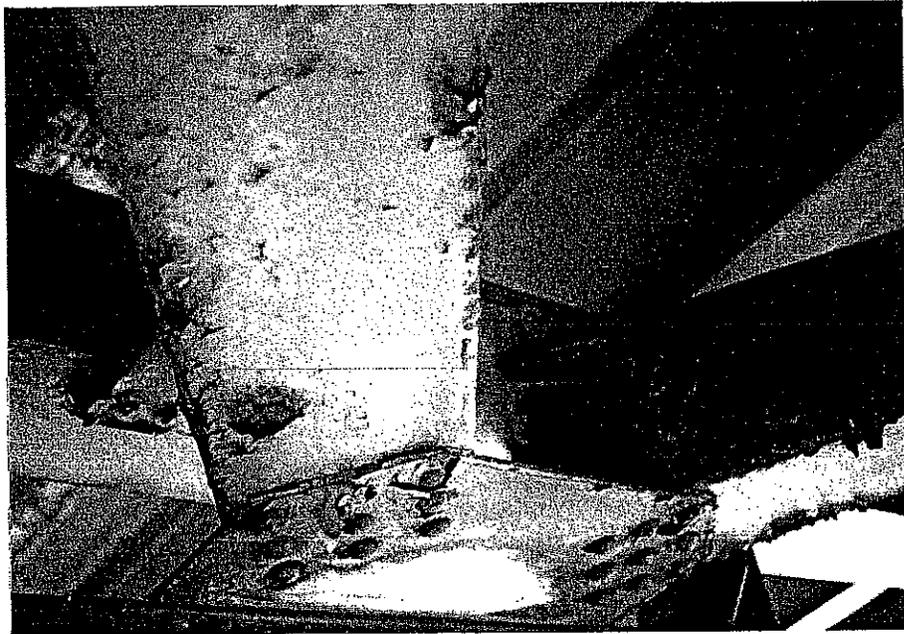
Picture #20  
Typical Condition of Paint Under Median  
Top Chord of Floor Truss to Diagonal Bracing Connection  
Span #8, No. B'nd.

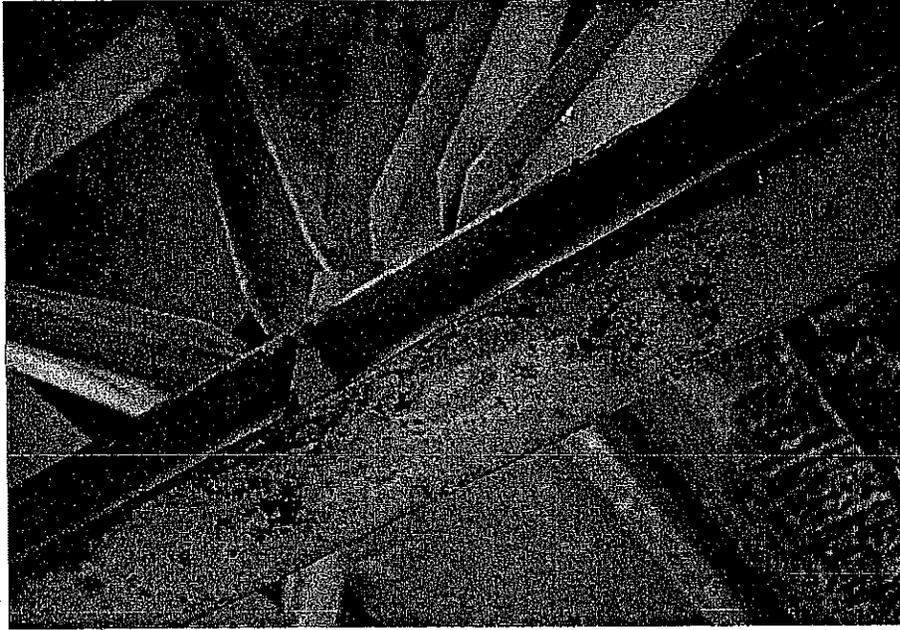
Picture #21  
Heavy Rust on Bottom Chord of Floor Truss Under Median  
Span #8, P/P-U6', No. B'nd.

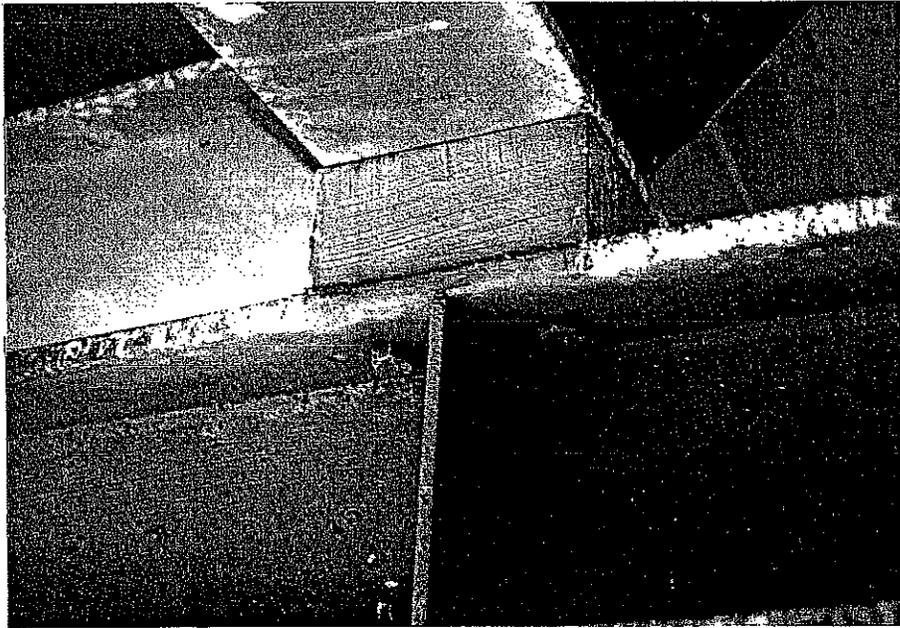
Picture #22  
Bolts Working - Probably Near Failure  
Stringer #11 to Floor Truss Connection  
Span #8, P/P-U6', No. B'nd.

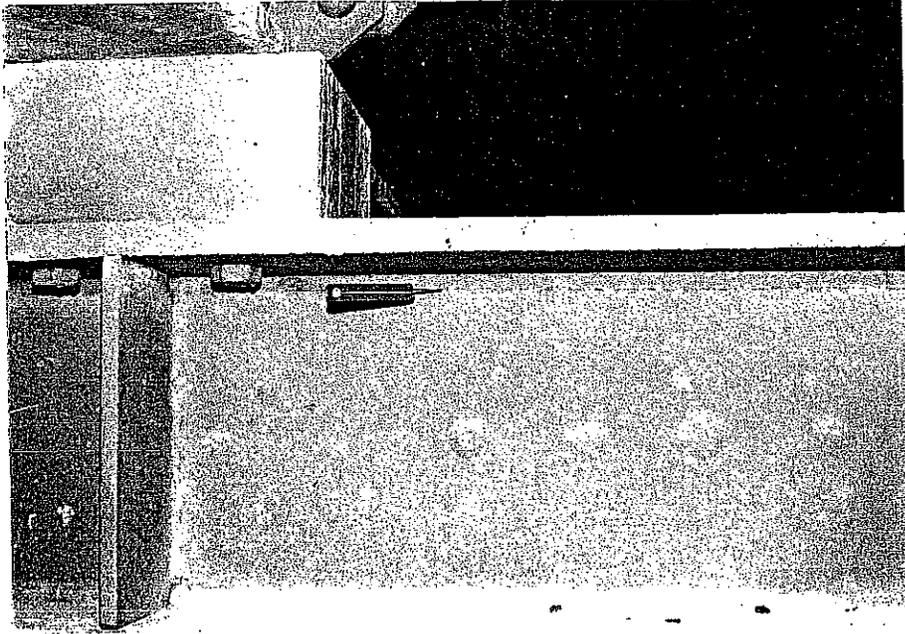
Picture #23  
Incomplete Weld of Reinforcement Plate to Top Flange  
Floor Truss - Span #8, P/P-U3', No. B'nd.

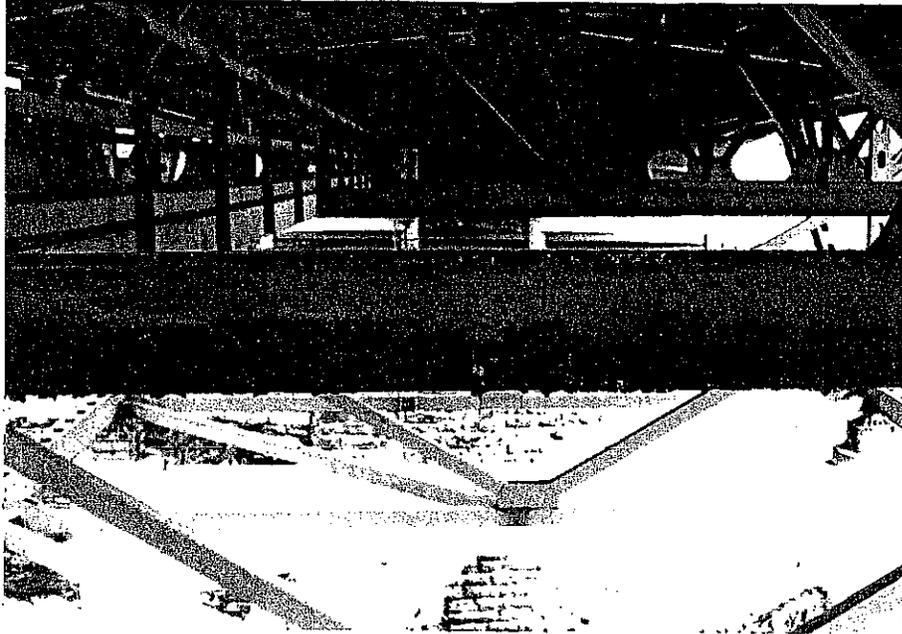
Picture #31  
Paint Condition - Bottom Chord of Floor Truss  
Span #8, P/P-U5', So. B'nd.

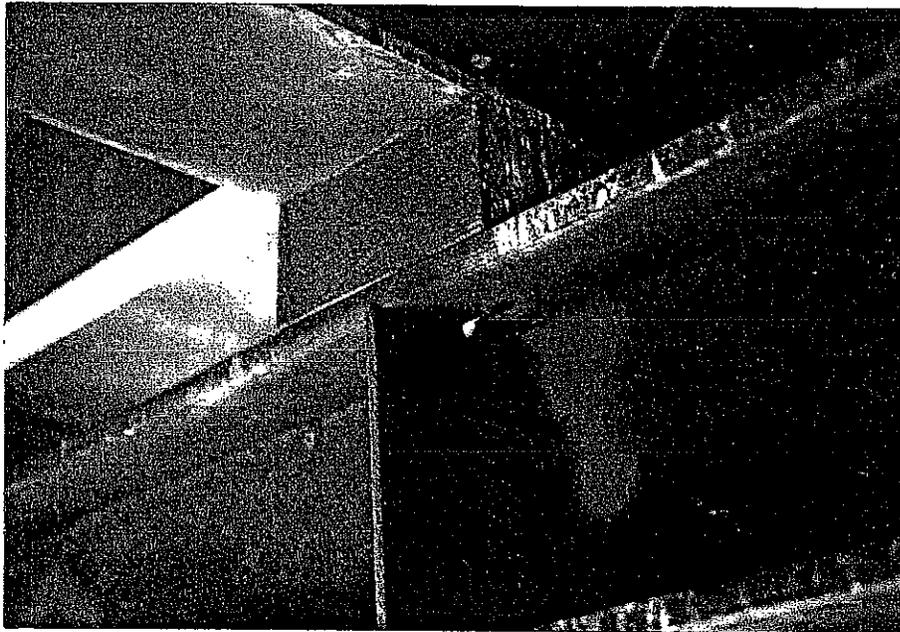
Picture #32  
Broken Bolt - Stringer #4 to Floor Truss  
Span #8, P/P U6', So. B'nd.

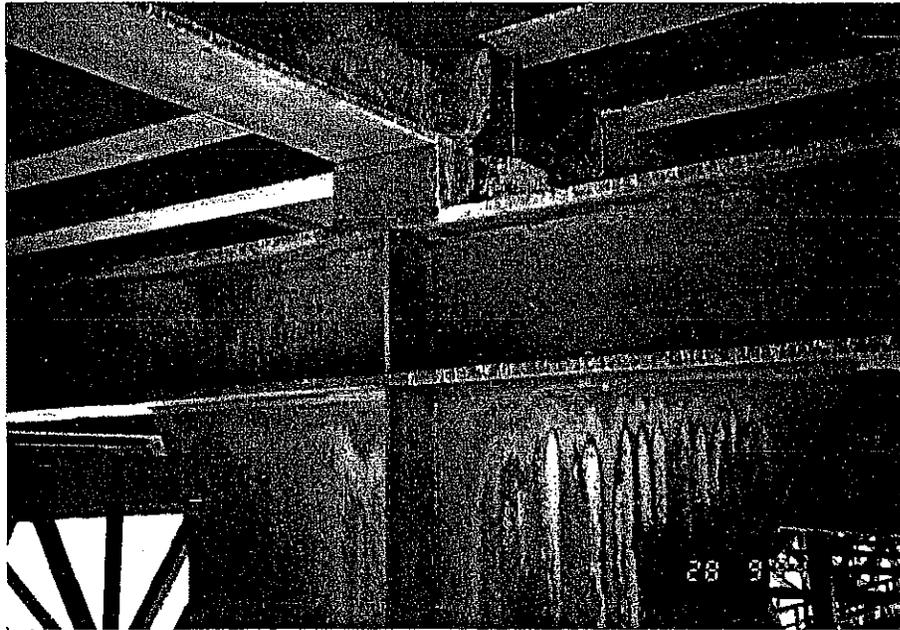
Picture #34  
Broken Bolt - Stringer #4 to Floor Truss  
Span #8, P/P U8', So. B'nd.

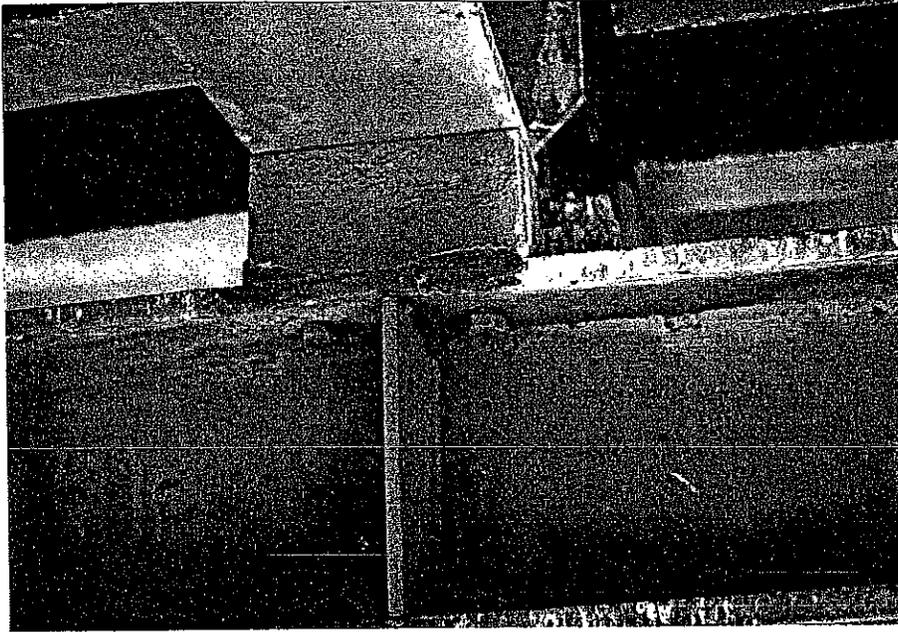
Picture #35  
Broken Bolt - Stringer #4 to Floor Truss  
Span #8, P/P U8', So. B'nd.

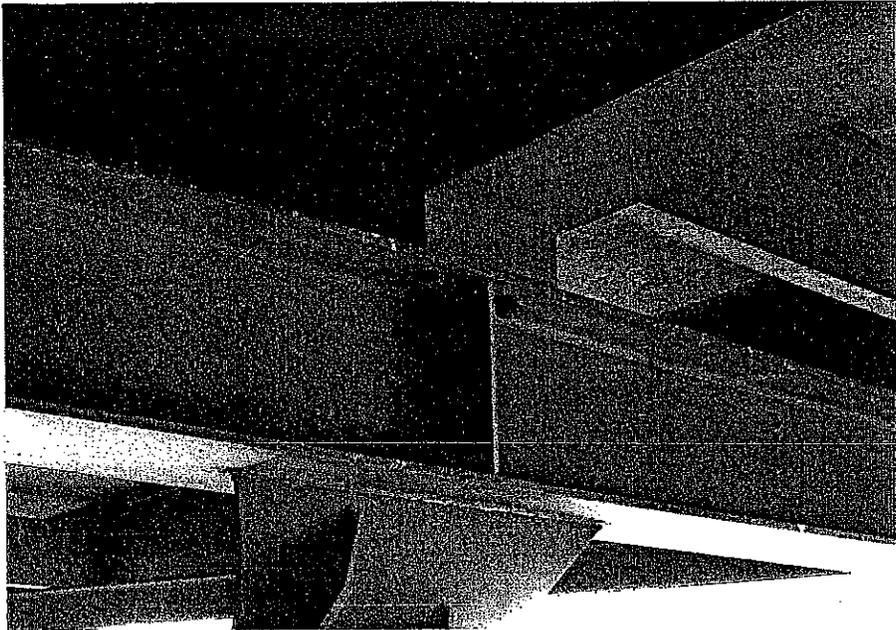
Picture #37  
Loose Bolt - Stringer #2 to Floor Truss Connection  
Span #7, P/P-U10', So. B'nd.

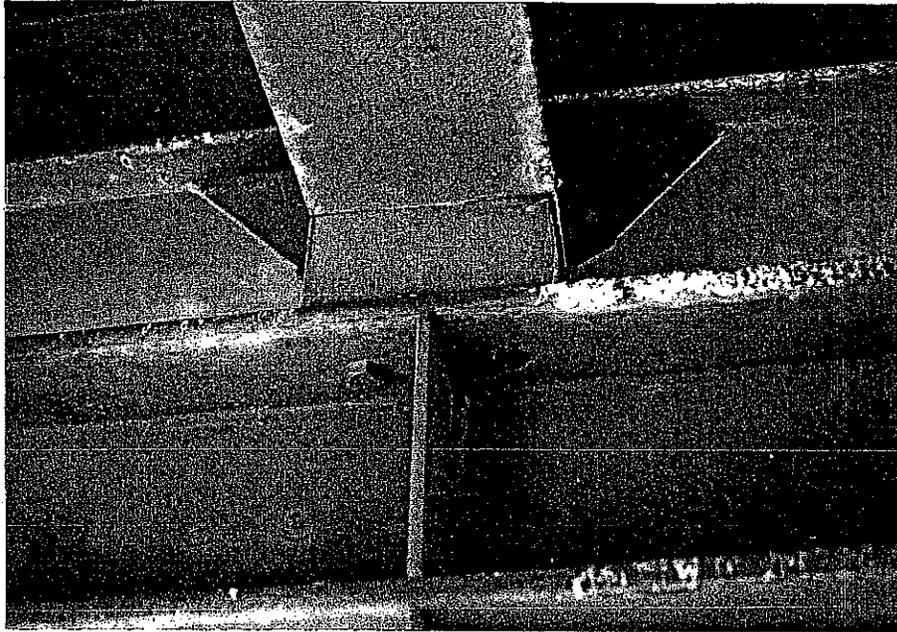
Picture #41  
Broken Bolt - Stringer #4 to Floor Truss  
Span #7, P/P U11, So. B'nd.

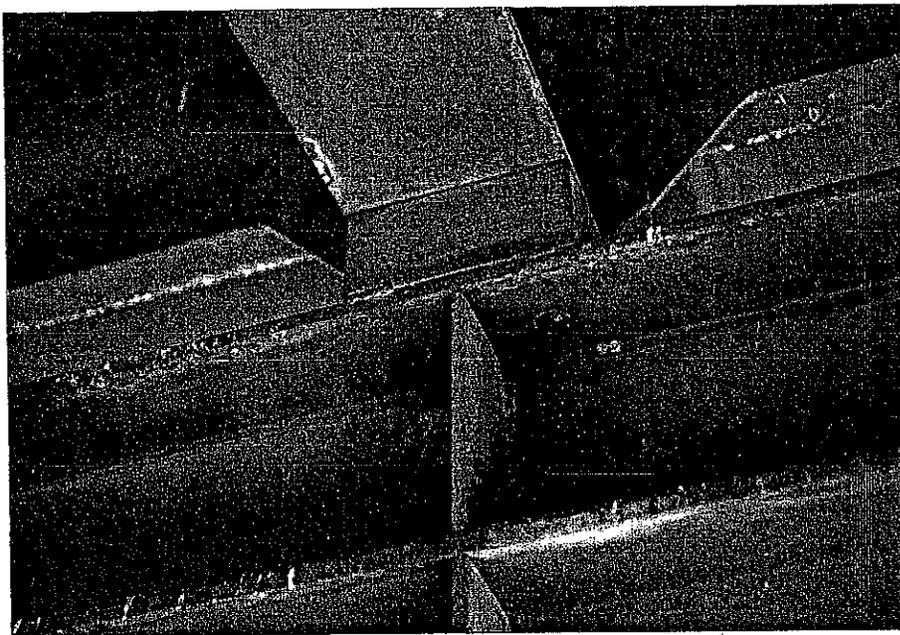
Picture #42  
2 Broken Bolts - Stringer #4 to Floor Truss  
Span #7, P/P U11, So. B'nd.

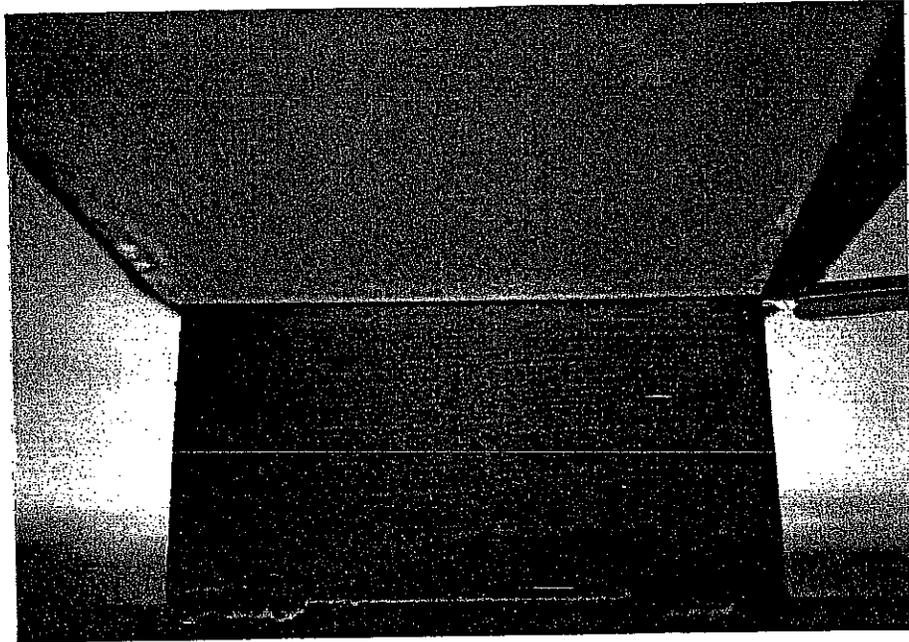
Picture #43  
Stringer #4 Lifted 3/32"  
Span #7, P/P-11, So. B'nd.

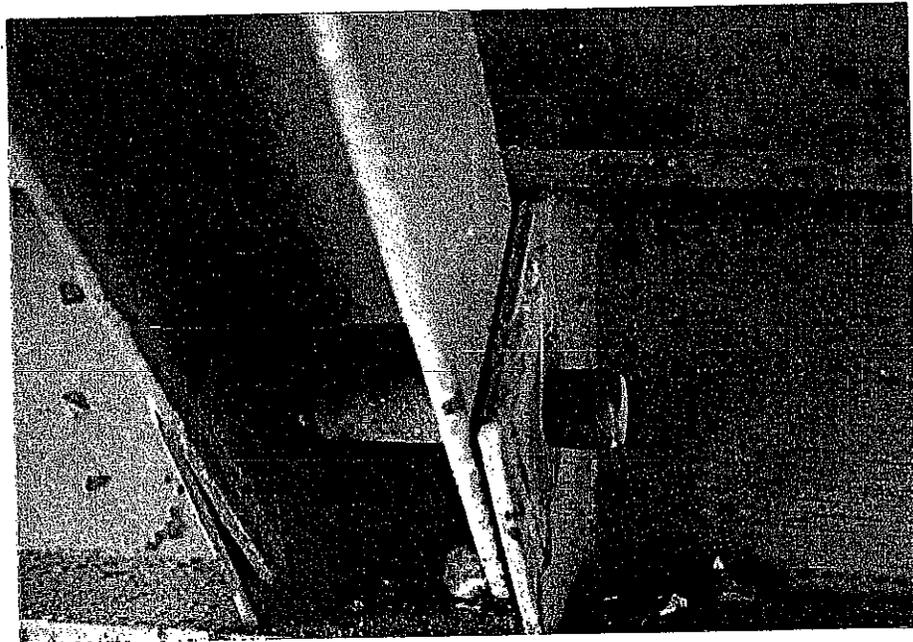
Picture #46  
Missing Cotter Pin  
Vertical Brace to Lower Chord of Floor Truss  
Span #6, P/P-U1, So. B'nd.

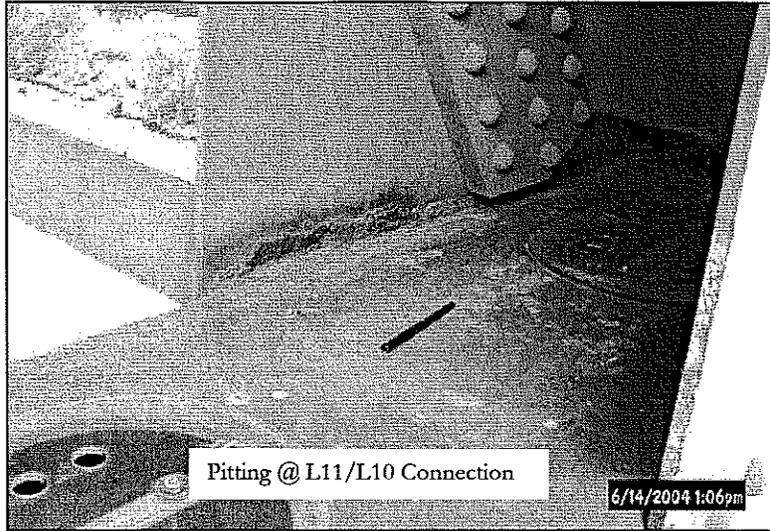
Section loss: at gusset plate  
bottom chord. [2000] Stringer  
#3 has a bolt missing at the  
floorbeam connection. [2004]  
Pitting inside gusset plate  
connection at L11 toward  
L10

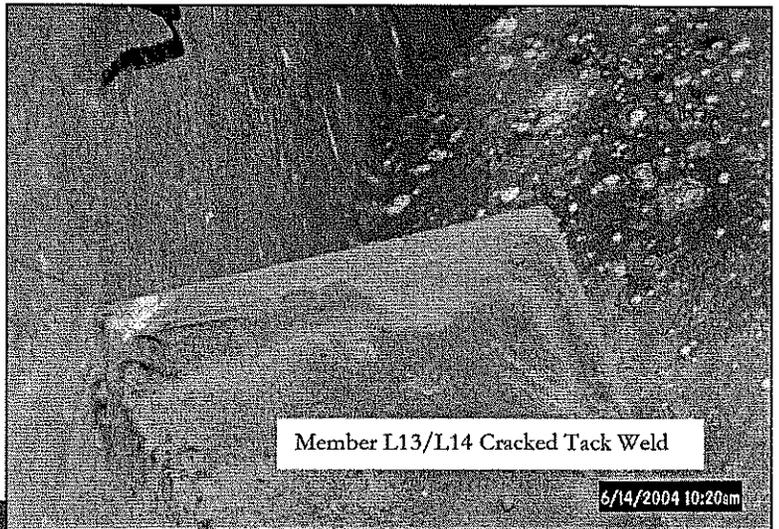
Member L13/U14 Cracked Tack Weld

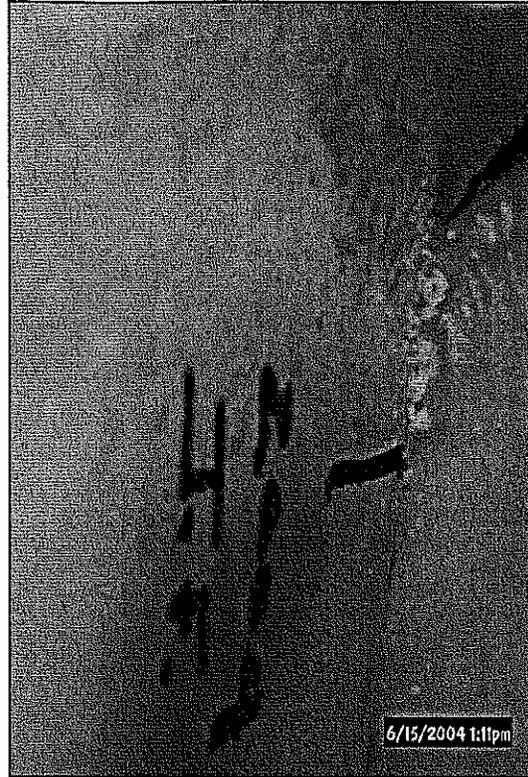
Strip seal expansion joint on the deck. Sway frame rusty. [1999] Truss bottom chord member L14/L13' has a cracked tack weld at an interior stiffener. [2002/03] Floorbeam bottom chord & middle bracing connection plate has 1/2" pack rust. Underside of the deck has 4 SF of delamination. [2004] Bottom chord member L14/L13' cracked tack weld @ diagram tab (diagram #3?) see photo.

Member L14/L13' Cracked Tack Weld

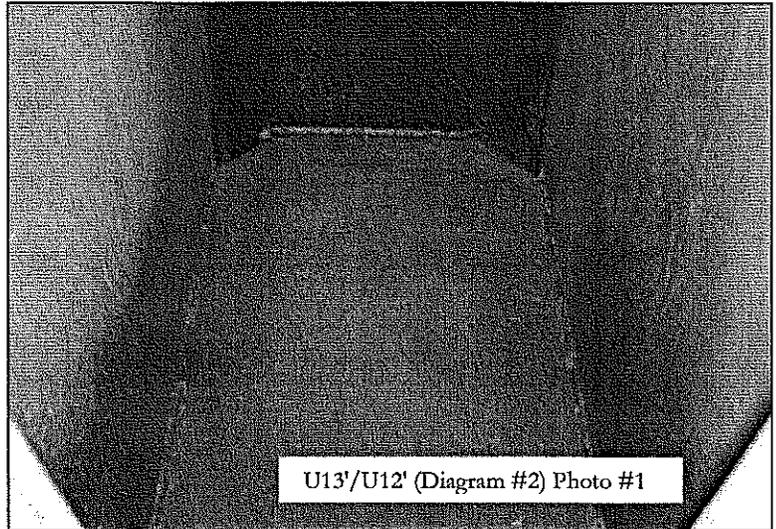
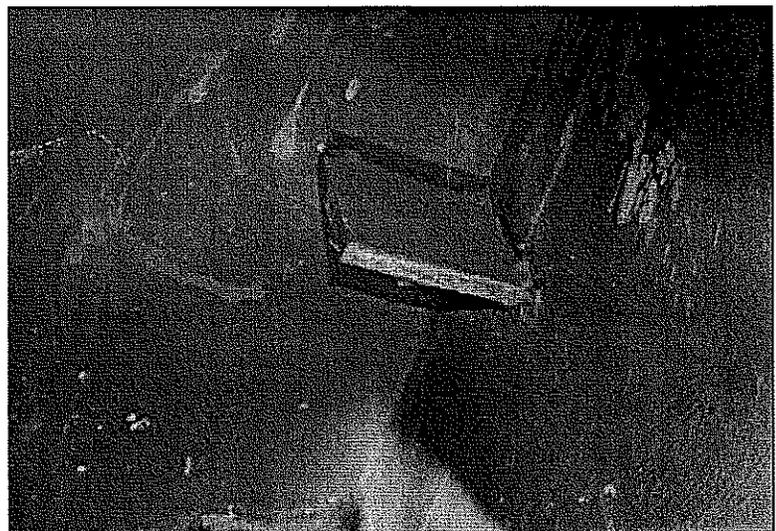
[2004] Upper chord member U13'/U12' (diagram #2) has no tabs, diagram is welded (full length) one side only see photo #1. Bottom chord member L13'/L12' cracked tack weld (diagram #1), (not @ diagram tab), (clean break) see photo #2.

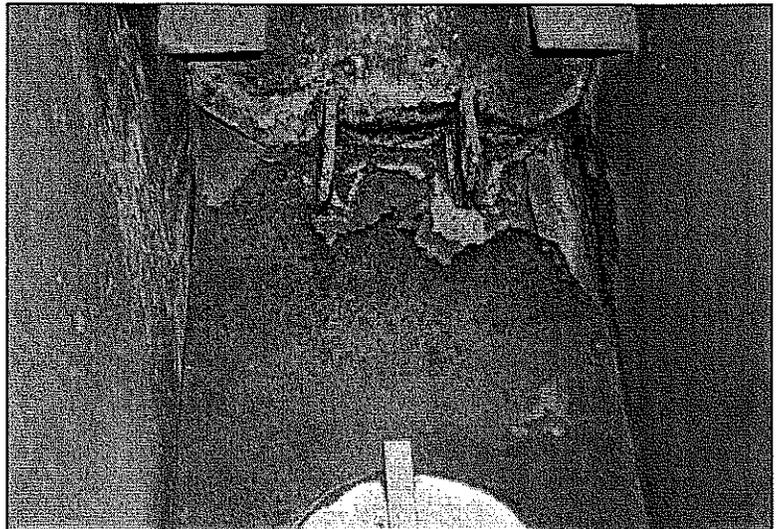
Member L14/L13' Corrosion

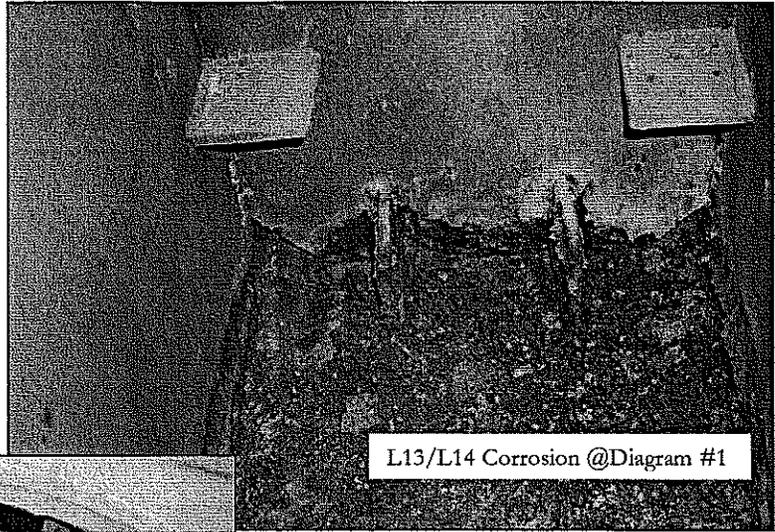
**Panel Point #13 (West Truss):**  
 [1999] Truss bottom chord/sway frame connection plates have 3/4" pack rust. [1996/99] Bottom chord member L13/L14 has cracked tack welds at two internal stiffeners. [2004] Bottom chord member L13/L14 has corrosion from deck drain (P), (diagram #1). Cracked tack weld (diagram #2) (not @ diagram tab) see photo #2 & #3. Cracked tack weld (diagram #3), (not @ diagram tab), (entire tack weld broken cleanly) see photo #4 & #5.

L13/L14 Corrosion @Diagram #1

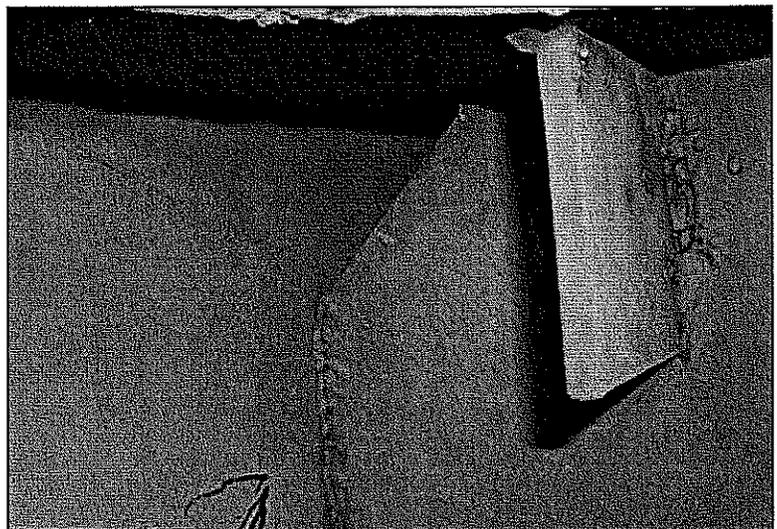
Cracked Tack Weld Diagram #2 Photo #3

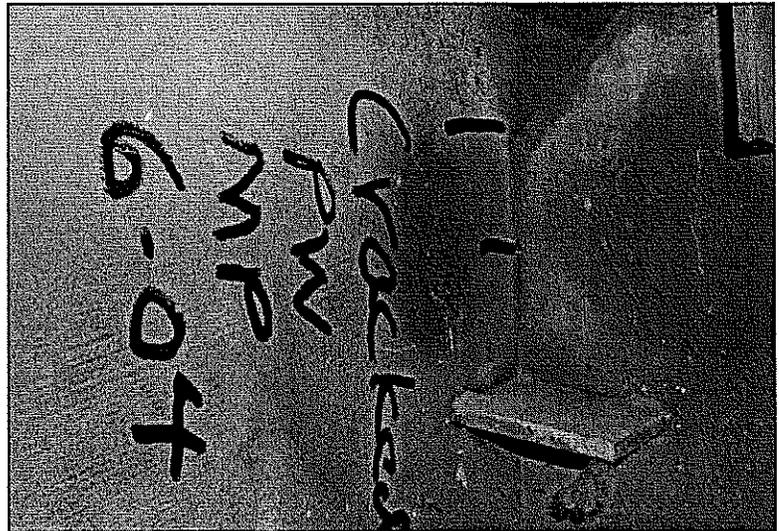
[2004] Bottom chord member L12/L13 has a cracked tack weld (diagram #2), (not @ diagram tab) see photo.

Member L12/L13 Cracked Tack Weld Diagram #2

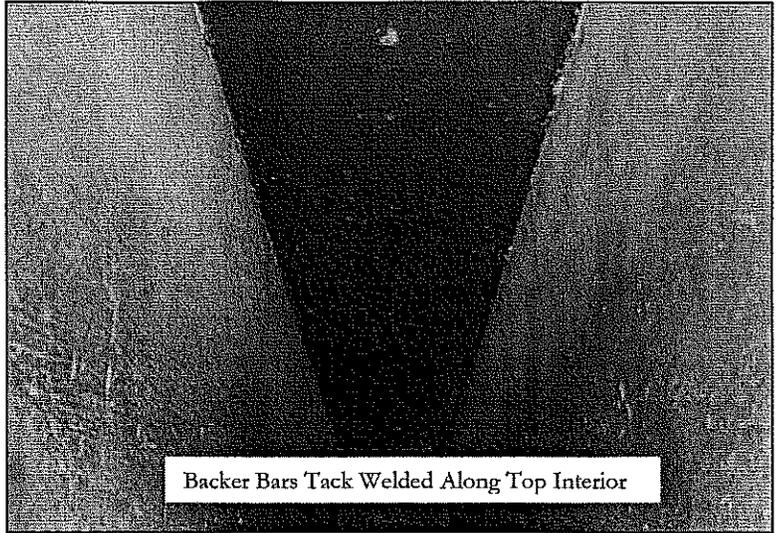
Floorbeam top chord, stiffener under stringer #9 has cracked tack weld & is working.

Backer Bars Tack Welded Along Top Interior
