Coon Rapids Dam Fish Barrier and Improvements Preliminary Design

Minnesota Department of Natural Resources
St. Paul, Minnesota

FINAL

February 17, 2011

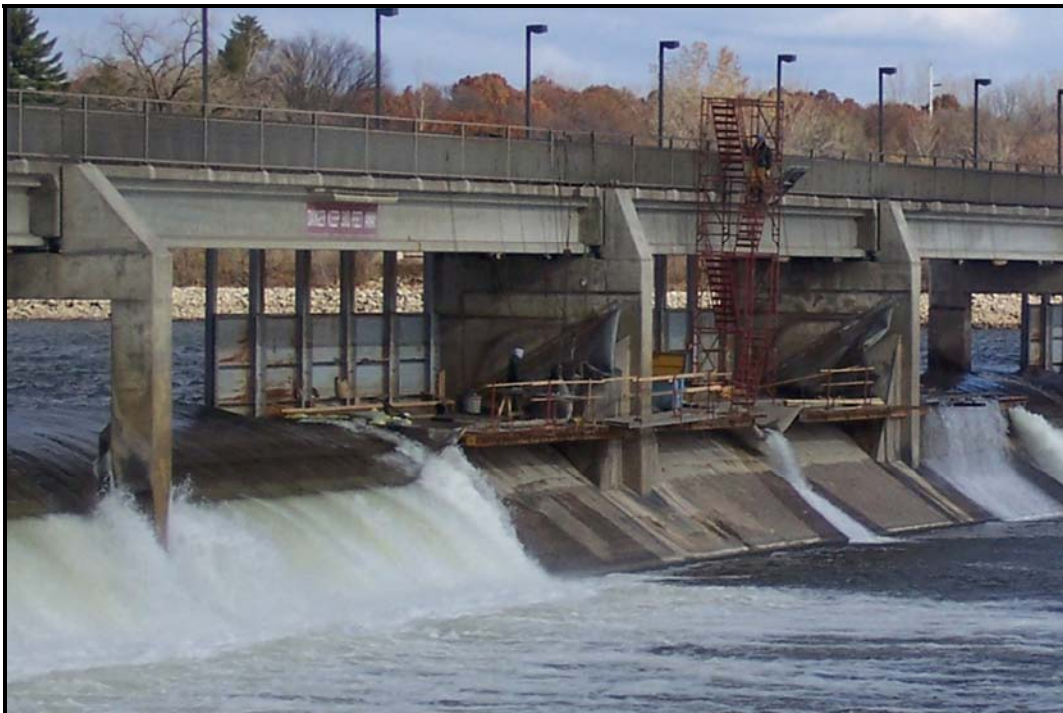
Photograph 20
Hydraulic Jump on Apron Portion of Dam

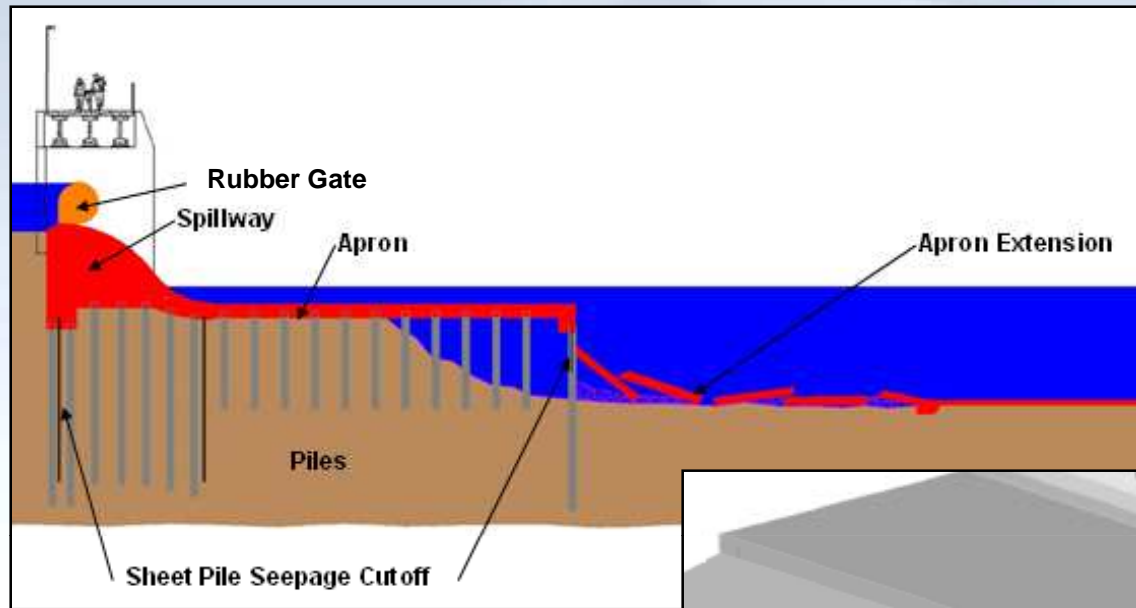
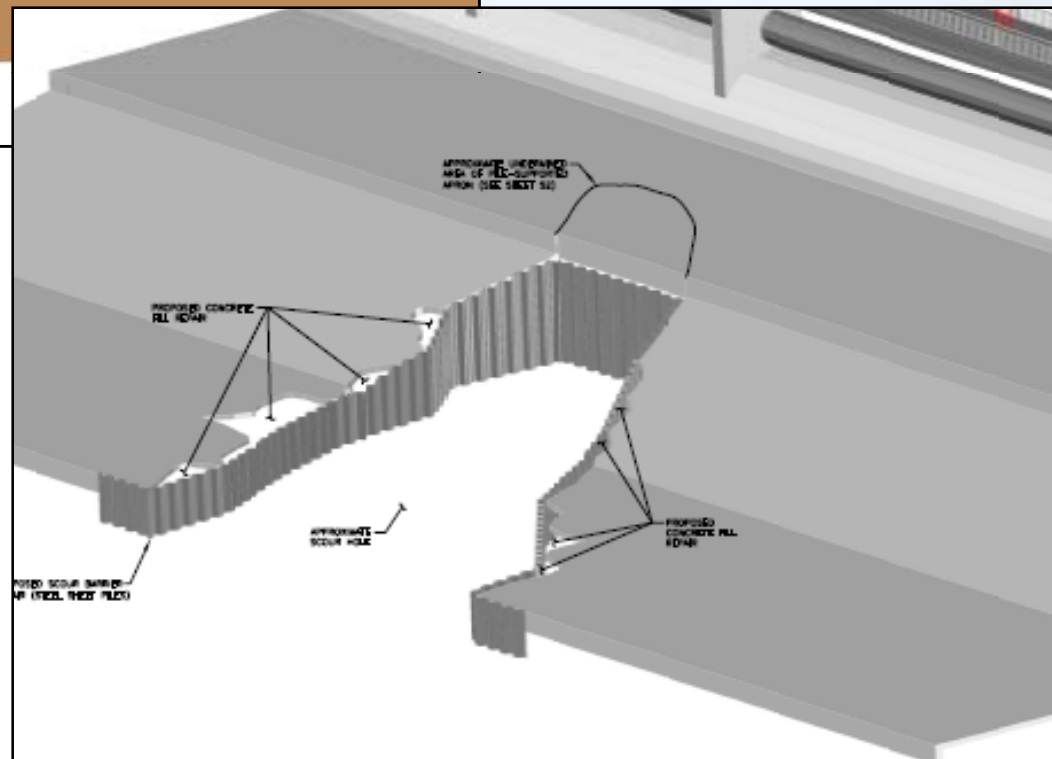
On the Anoka side, the spillway flows across a series of more shallow concrete aprons that were intended to armor the river channel and contain the hydraulic jump within the protected area. Although the length of aprons is adequate, over time, these apron features have been undermined and portions have collapsed and subsequently been repaired.

Apron Scour

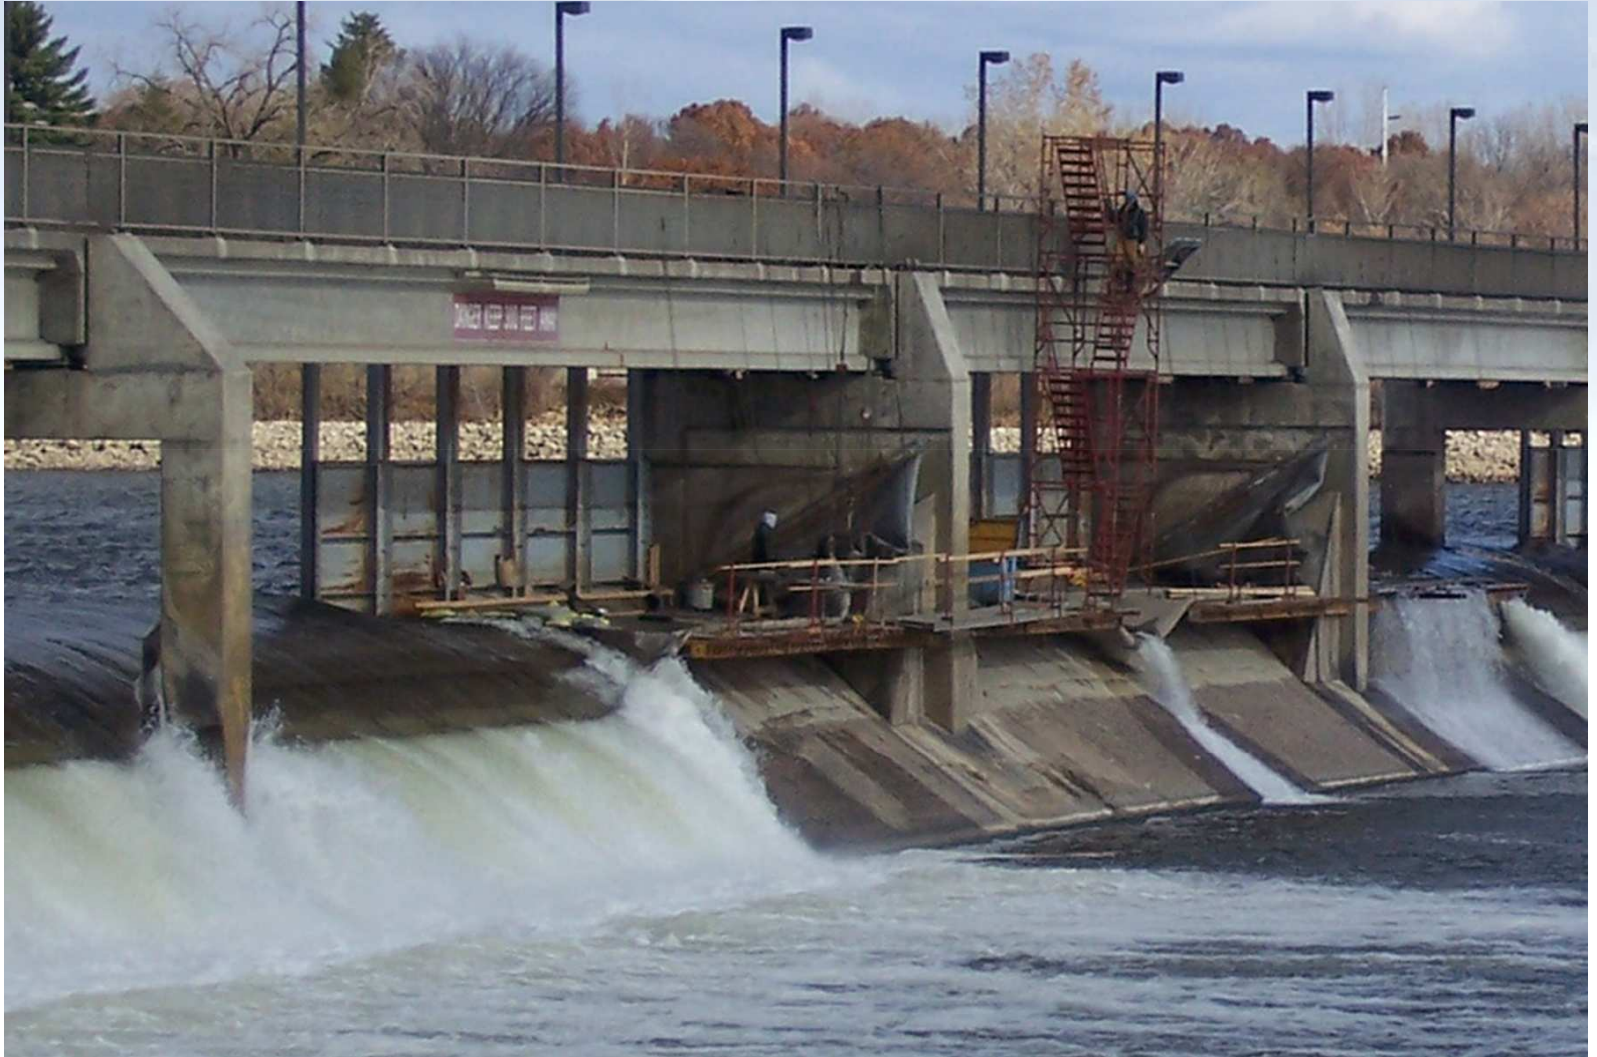
Rubber Gates

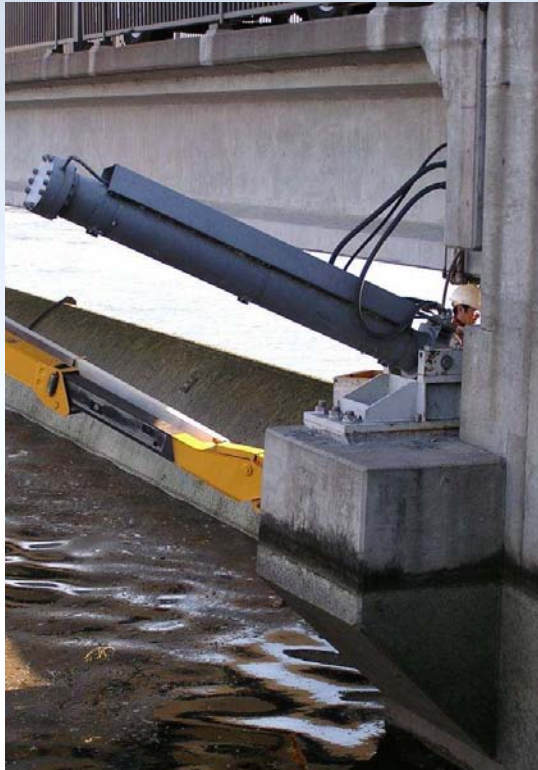
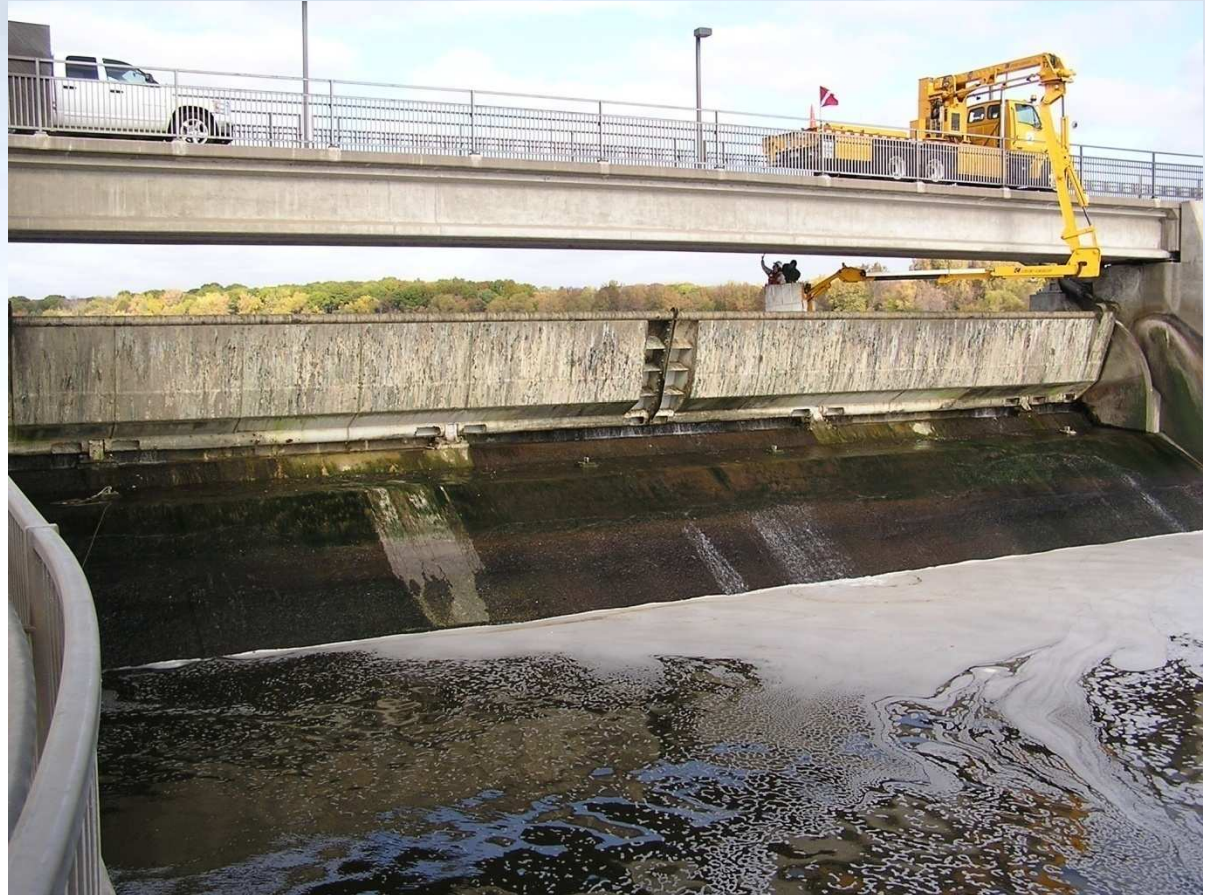
Control Gate Maintenance
