#### FIELD TEST REPORT

**PROJECT:** New Replacement Windows – Phase I

State Capital Building St. Paul, Minnesota

Report No.: D7138.01-201-43

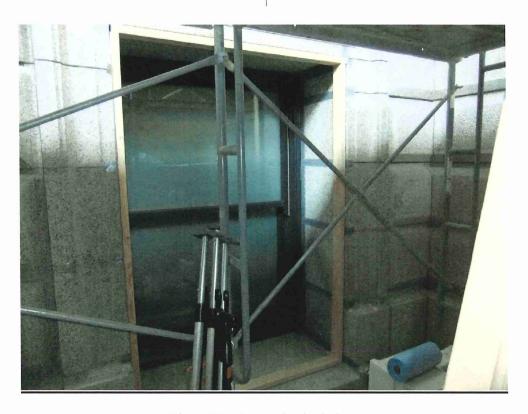
Photo No. 1: exterior isolation.

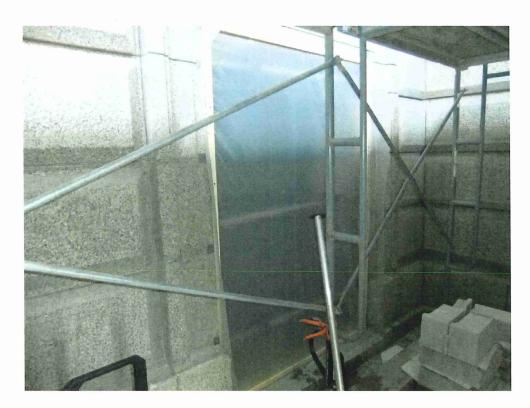
Photo No. 2: Exterior view with chamber installed.

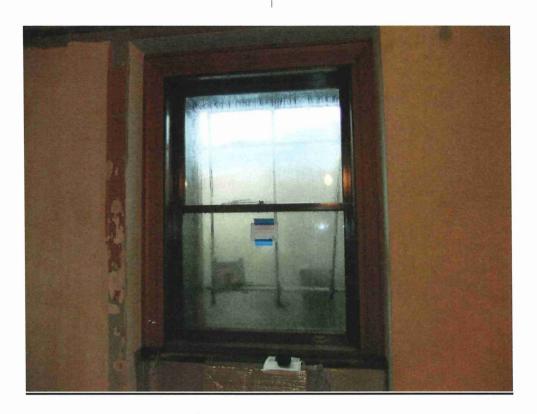
Photo No. 3: Interior view.
