Railroad Yard Lighting Report

August 2015

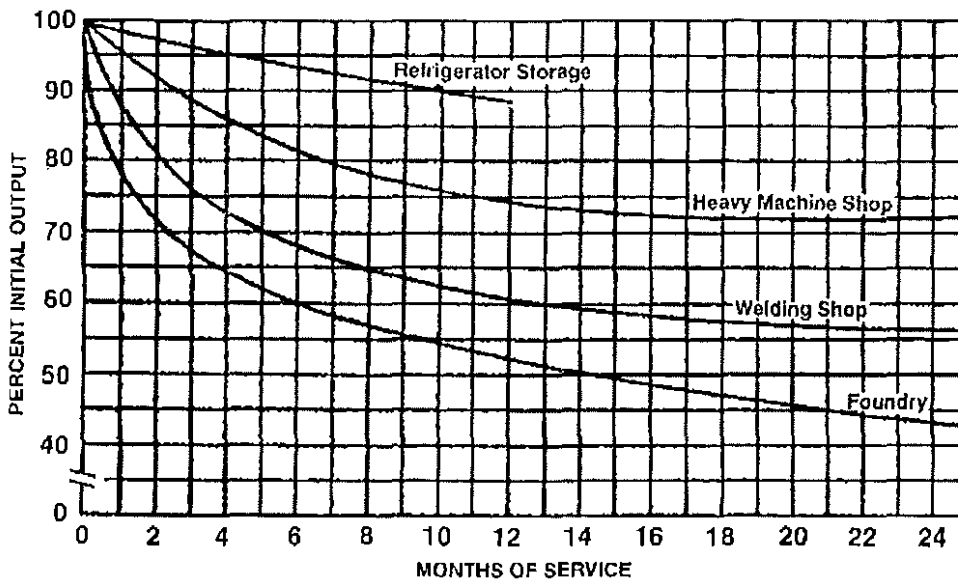
Figure 33-10-2. Decline in Light Output Due to Dirt, High-bay Areas

- d. In many installations it will be found the light output is only 50% as high as it should be. Light output can be increased by repainting, cleaning fixtures, and by correcting the voltage to designed levels.

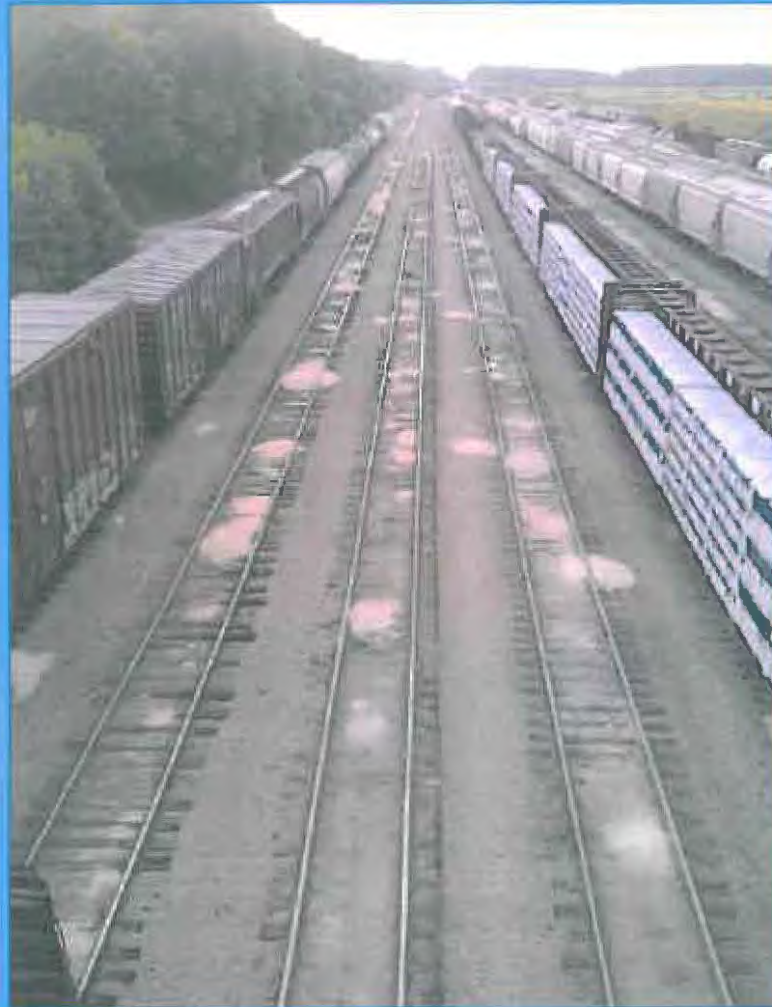
Railroad Yard – Fouled Walkway
