# **Bridge 9103 Rehabilitation Study Final Report Red Wing, Minnesota**

**August 2013**

**Submitted to  
Minnesota Department of Transportation**

**Prepared by  
HDR Engineering, Inc.  
and  
Gemini Research**

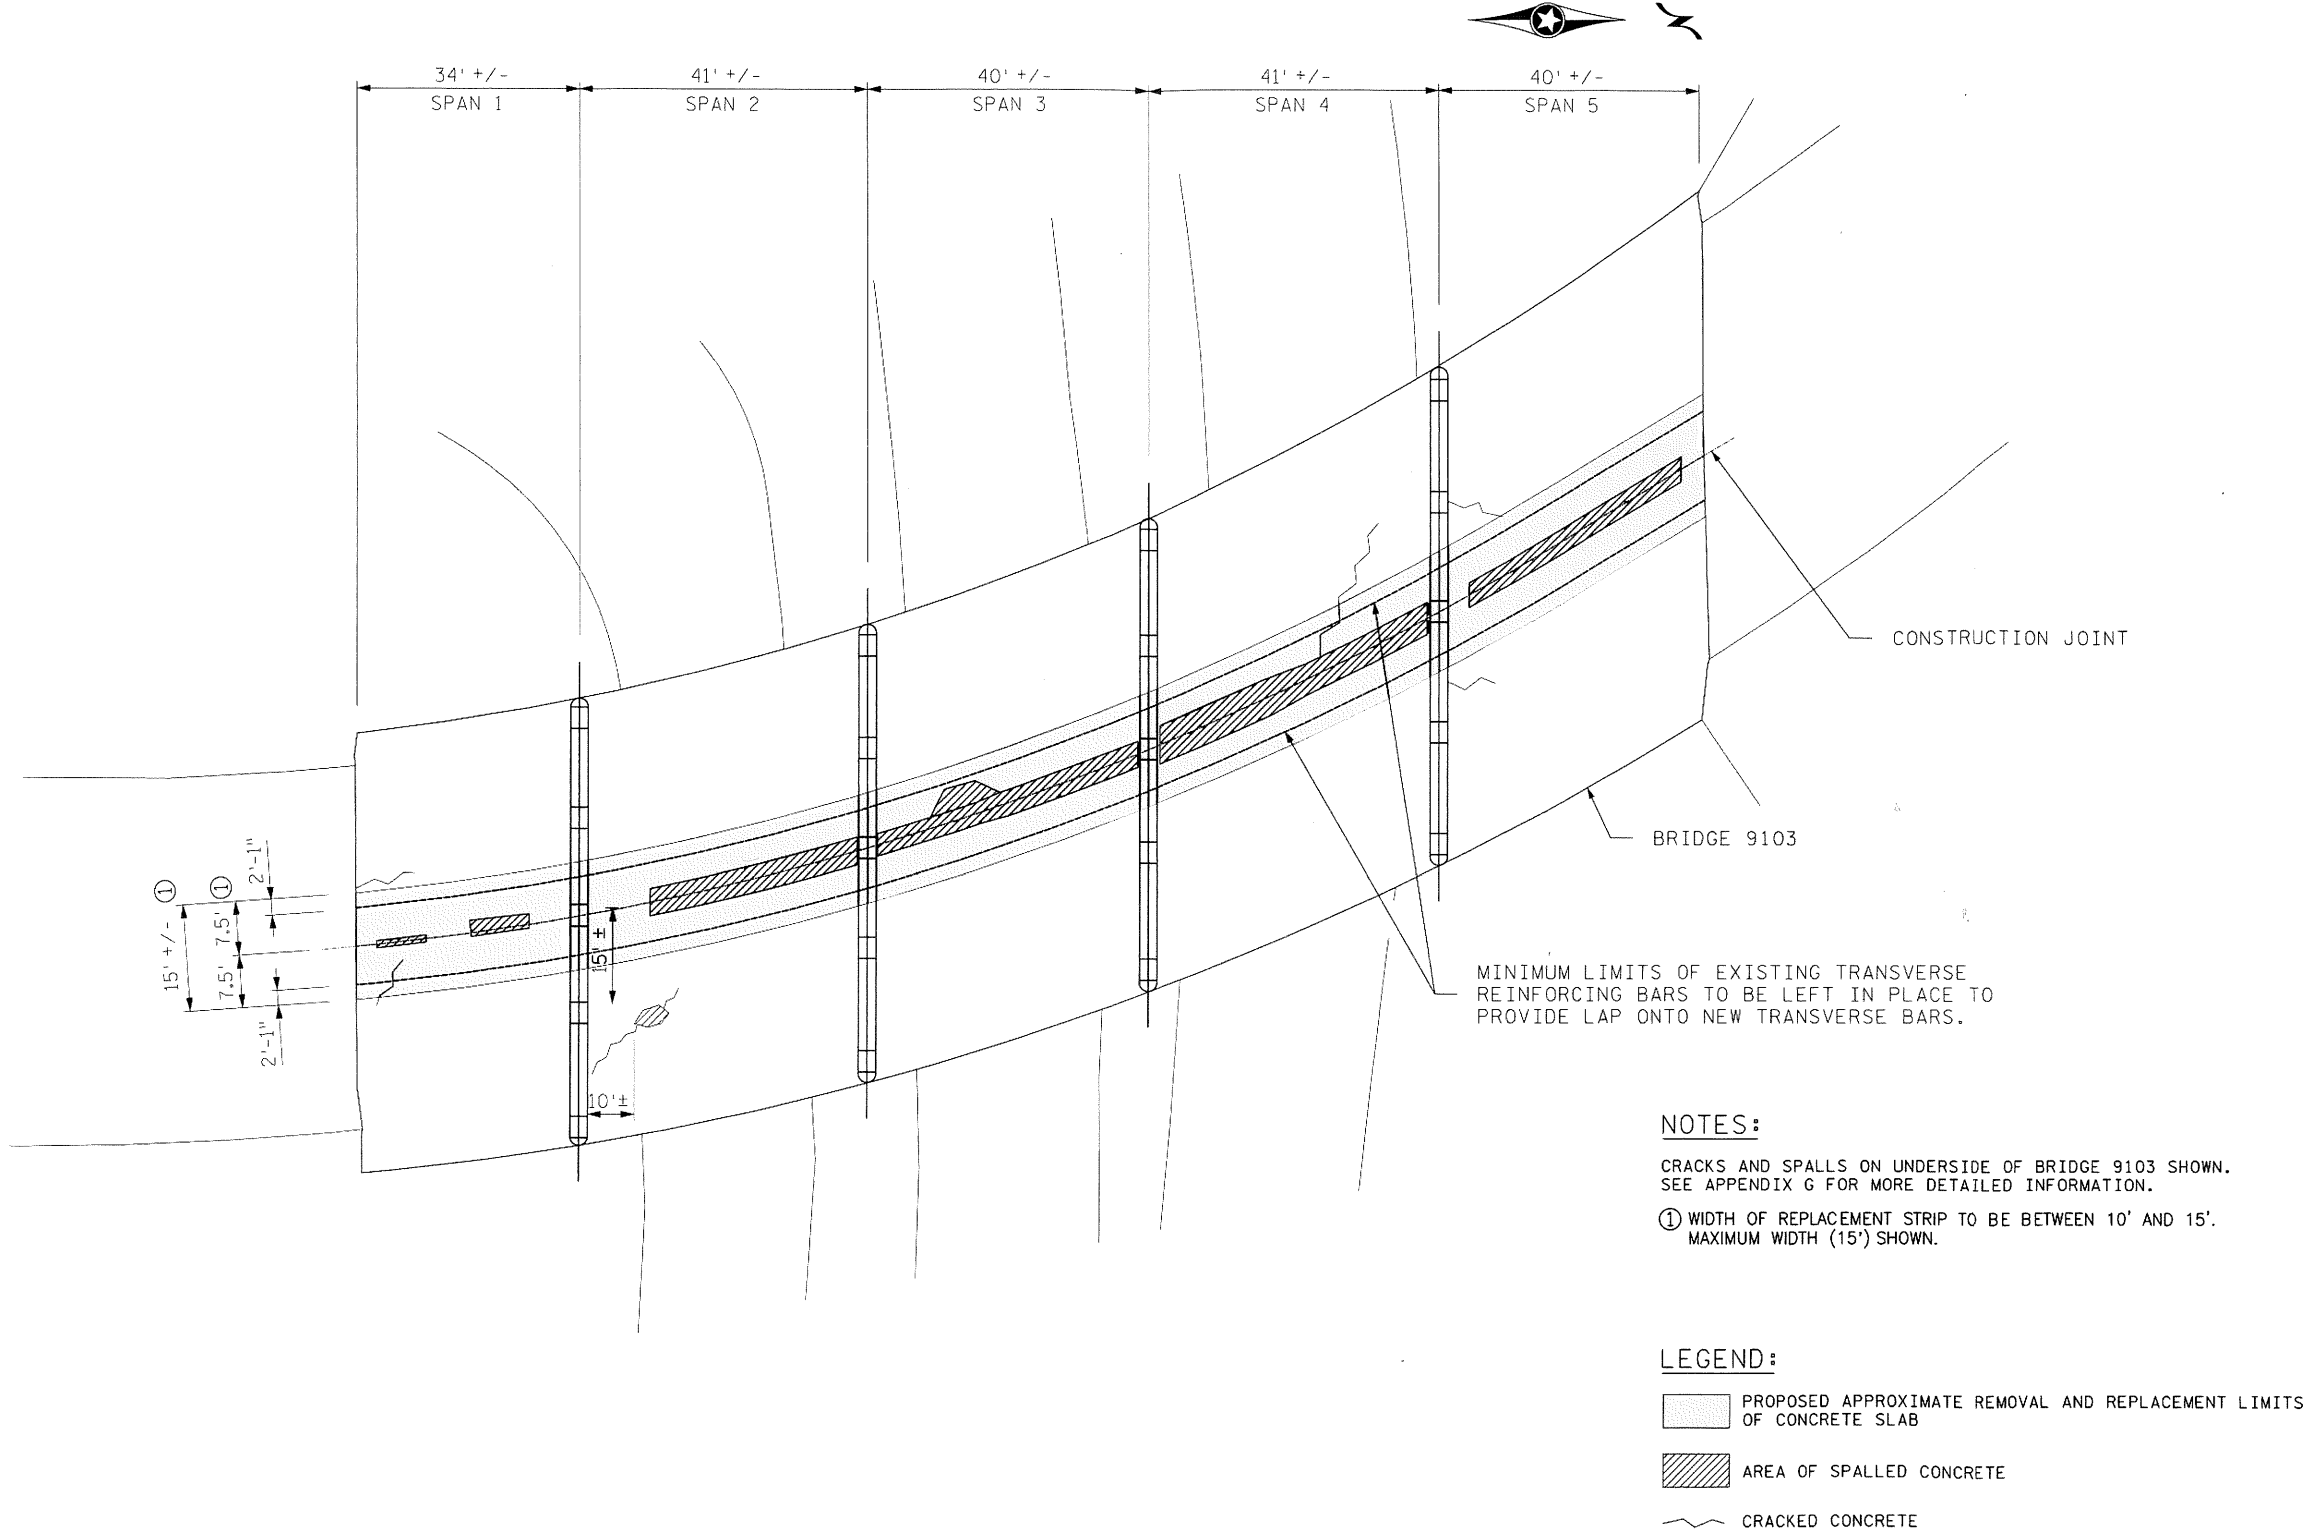
Figure 11. Plan view showing existing cracking and spalling of concrete slab on underside of Bridge 9103 and the approximate limits of removal and replacement for Alternatives 1 and 2 (HDR drawing).

It is recommended that the replaced strip be a constant width for several reasons. The first is based on how the continuous concrete slab functions, as described above. If the removed strip is wider in one span than in an adjacent span, the redistribution of loads would cause the dead load being carried by the adjacent span to be greater than was originally intended. Secondly, a constant-width strip helps maintain the continuity of the reinforcing bars. Varying the width would cause the cut line for the removal to cross the longitudinal reinforcing steel, potentially at sharp angles. This would make it very difficult or not possible to lap onto existing longitudinal bars. Construction would be complicated and time consuming for the contractor, requiring field-cutting of numerous reinforcement bars to fit varying widths and lengths of deck replacement. Although using a variable-width strip would remove slightly less material, all of the construction operations (i.e., concrete removals, erecting falsework, forming, reinforcement placement, and finishing the concrete) would still be required regardless of the removal width at any particular location. There would not be any time savings, and, in fact, constantly varying the width would delay the construction crew as they would have to continually stop and assess the limits of removal. The inefficiencies would offset any savings from decreased quantities of concrete and reinforcing.

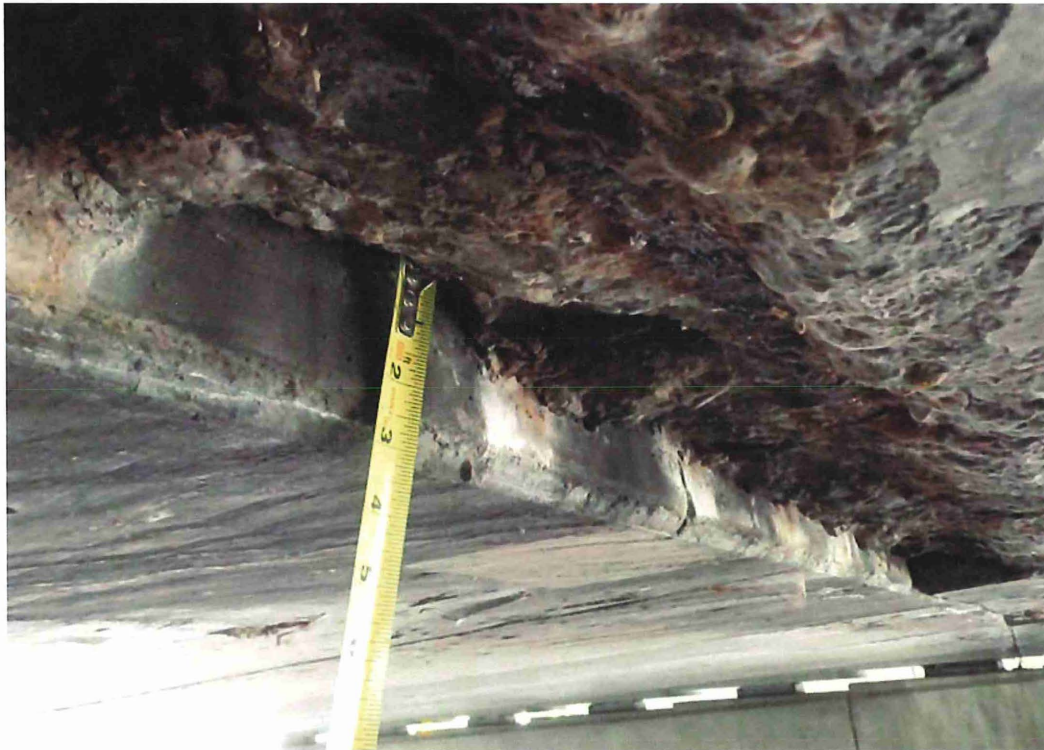
Photo 7

Span 1 - Close-up view of spalled areas. Approximately 2' either side of centerline joint is either spalled or delaminated full length of span. The exposed reinforcement bars have corrosion with some initial section loss and the spall depth extends up to 3" deep.

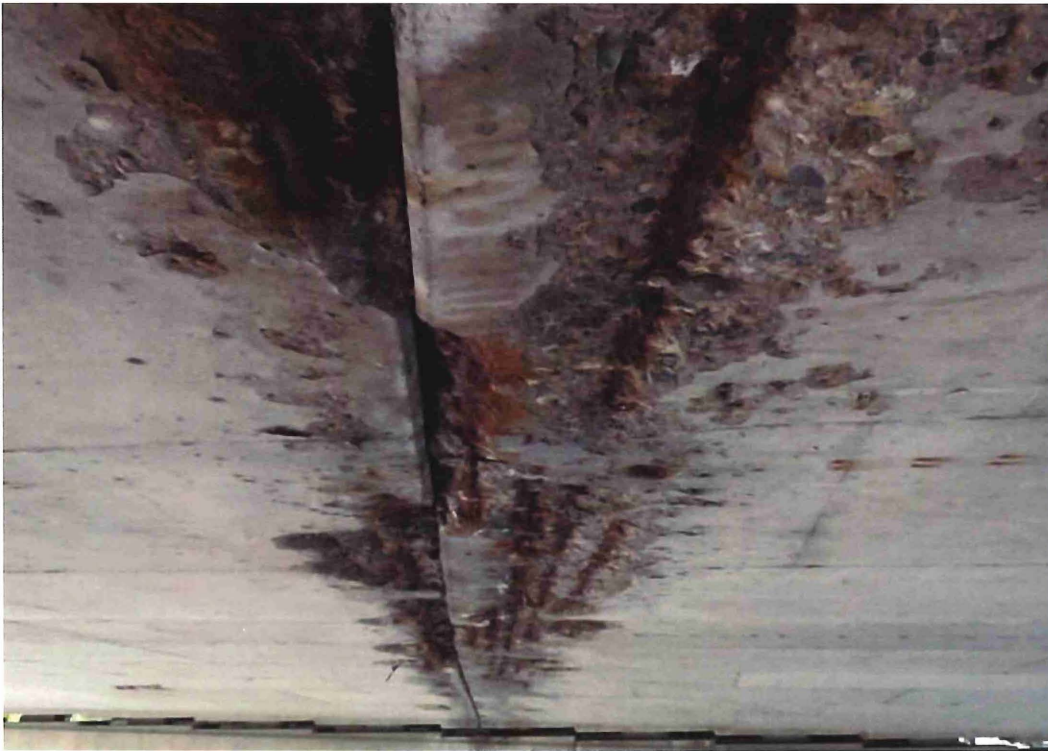
Photo 8

Span 2 - Close-up view of spalled areas. Approximately 2'-6" either side of centerline joint is either spalled or delaminated full length of span. The exposed bars have corrosion with some initial section loss and the spall depth extends up to 3" deep. Some loss of bond is occurring on some longitudinal reinforcement bars.

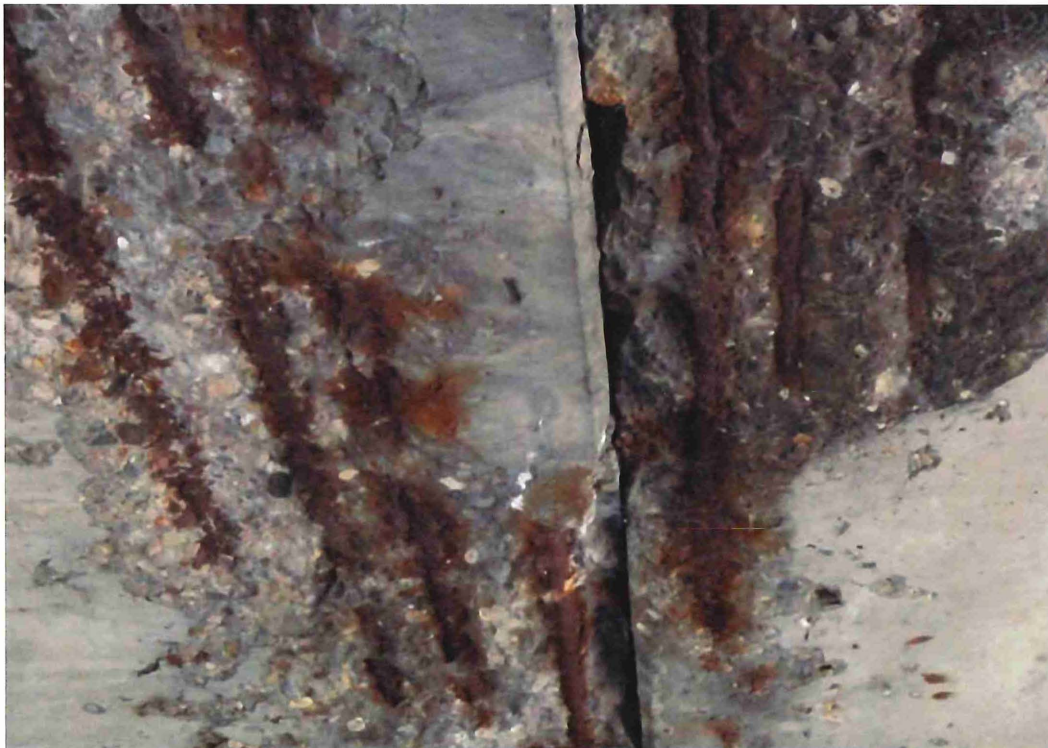
Photo 9

Span 2 - Additional close-up view of spalled areas.

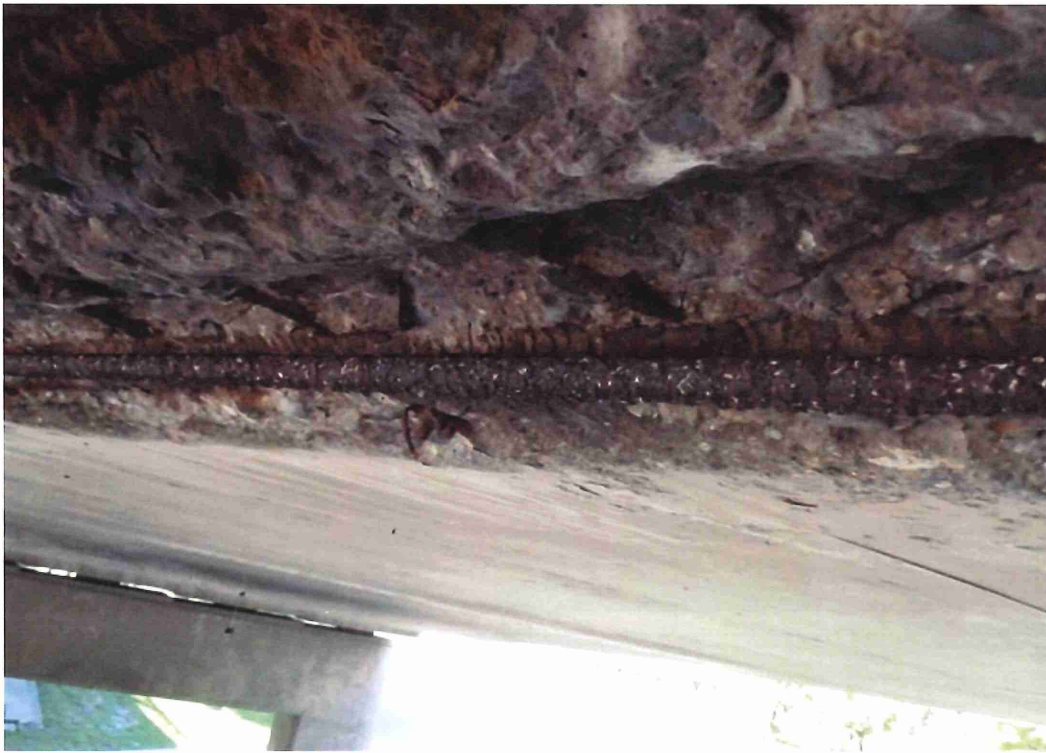
Span 3 - Close-up view of spalled areas. Some loss of bond is occurring on four longitudinal reinforcement bars. One longitudinal bar with 3/4" remaining section.

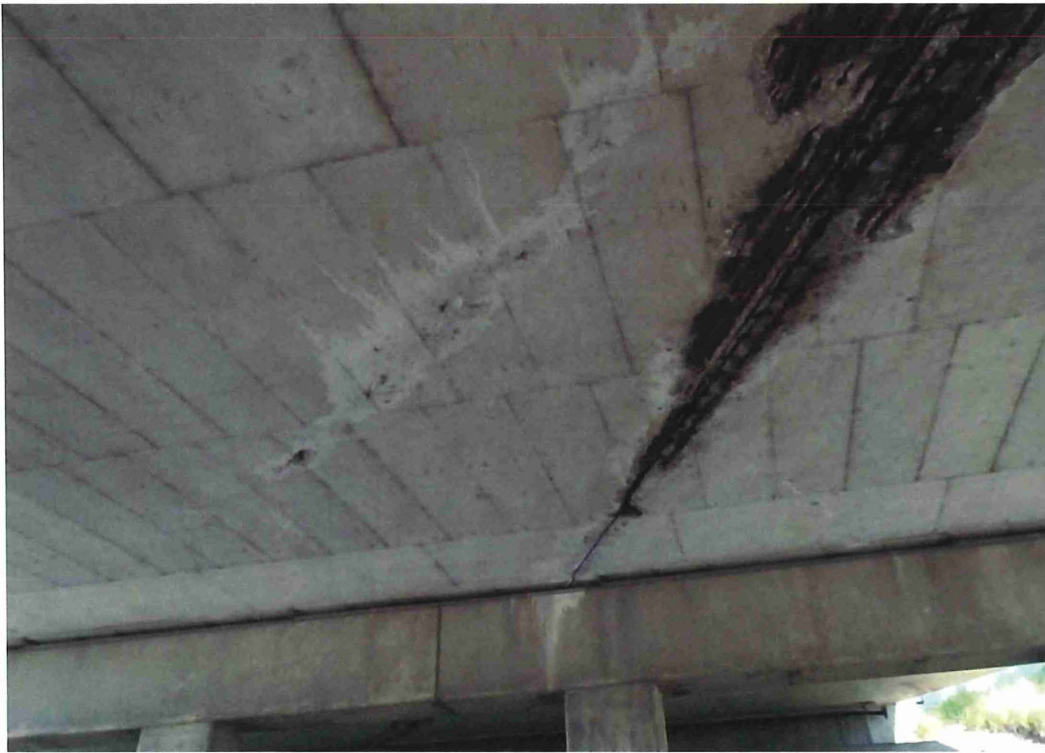
Span 4 - Circular structural crack with efflorescence starting 20' from the west edge of the deck at Pier 4, and extending to the CL bridge joint at approximately the midspan of Span 3.

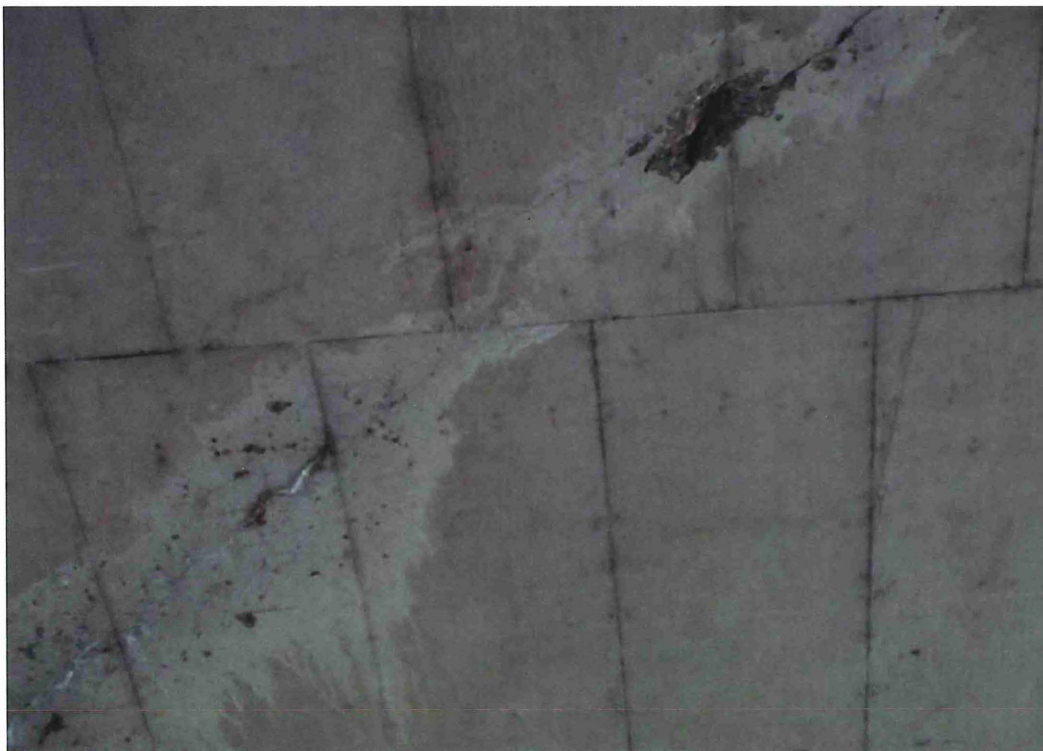
Span 4 - Additional photo of structural crack

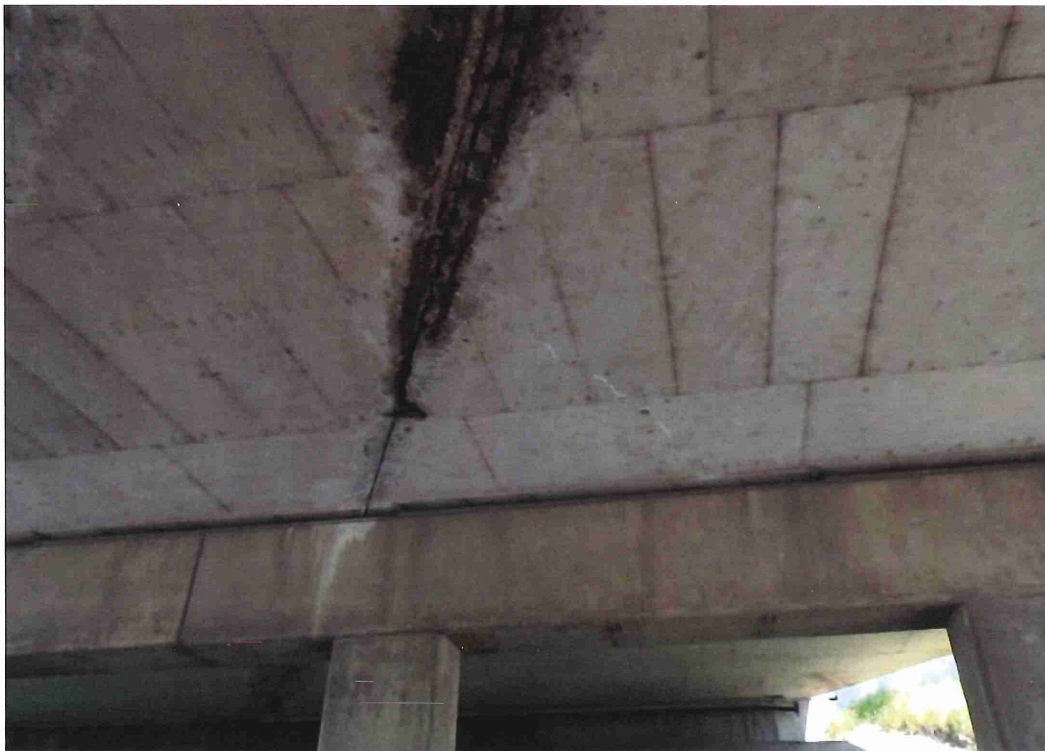
Span 4 - Diagonal structural crack with efflorescence starting 24' from the east edge of deck at Pier 4, and extending to the CL bridge joint 12' from Pier 4.

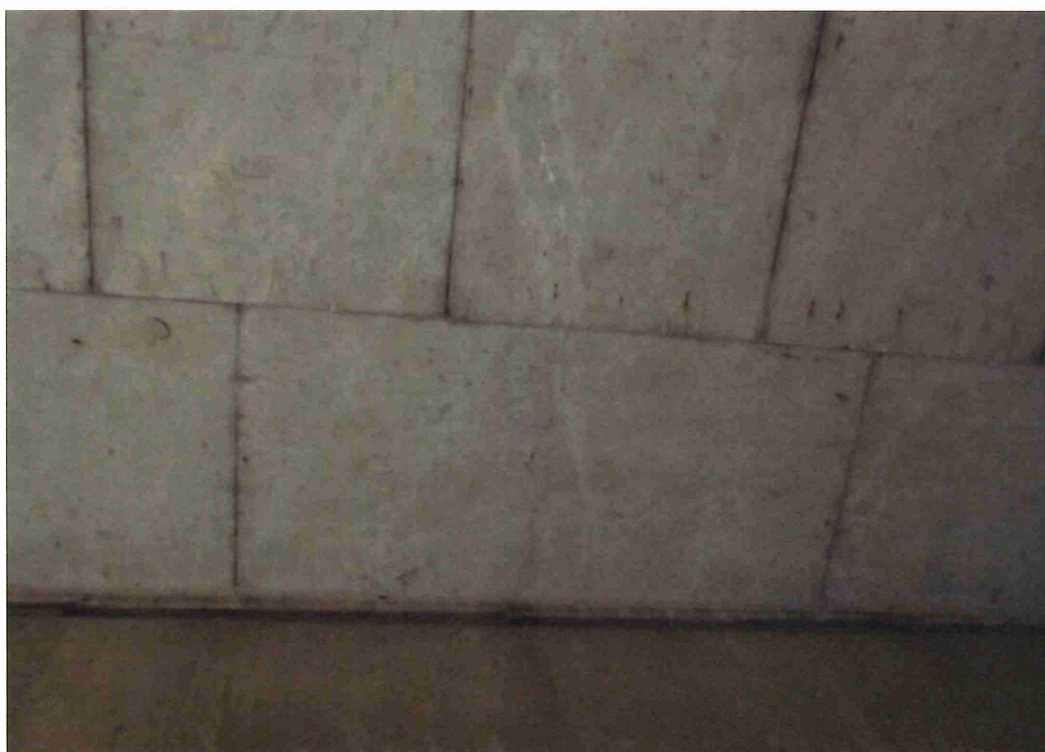
Span 4 - Several areas of map cracking most prevalent in the south half of the span.

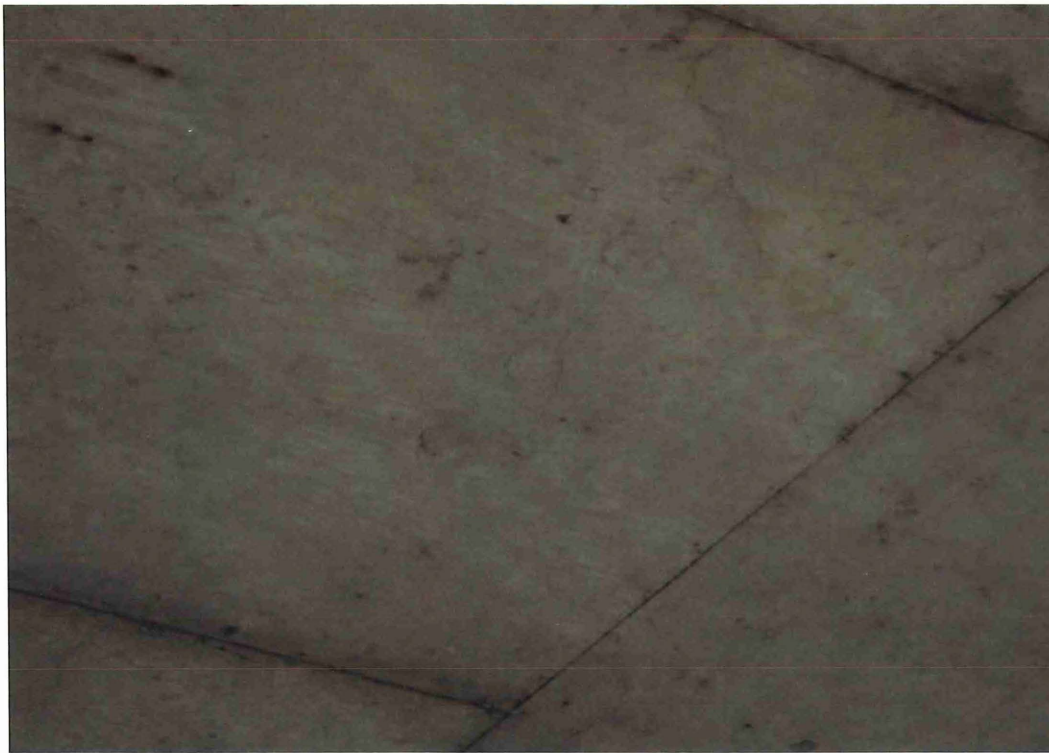
Span 4 - Additional photo of areas of map cracking.

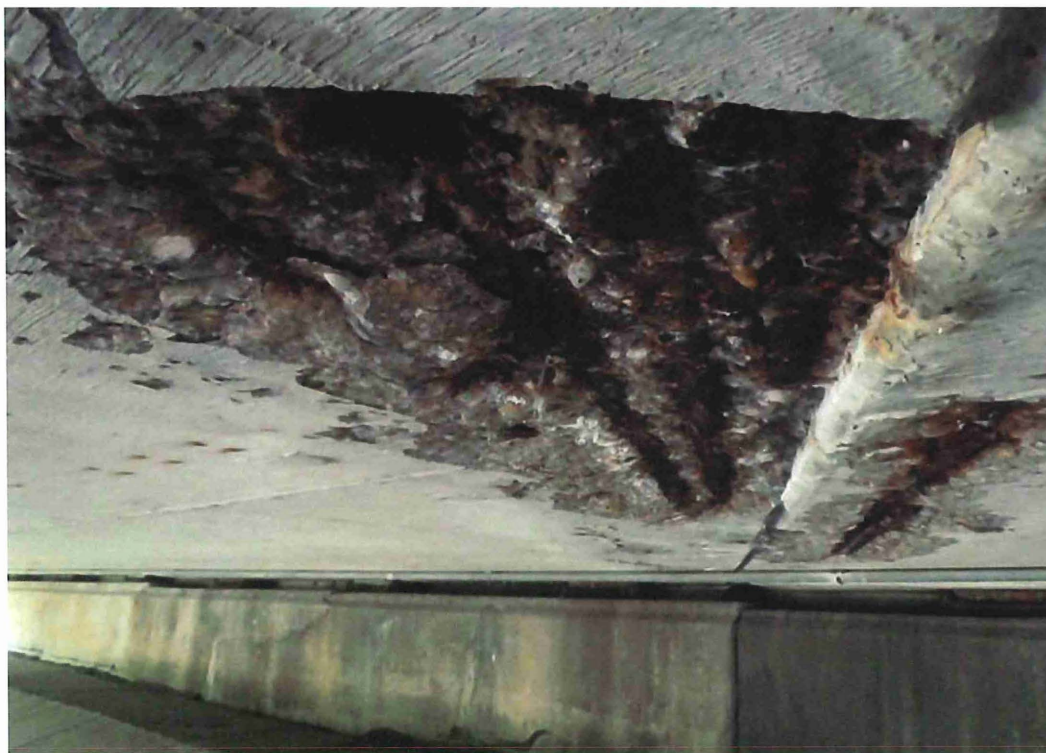
Span 5 - Close-up view of spalled areas. Approximately 2' either side of centerline joint is either spalled or delaminated full length of span. The exposed reinforcement bars have corrosion with some initial section loss and the spall depth extends up to 3" deep.

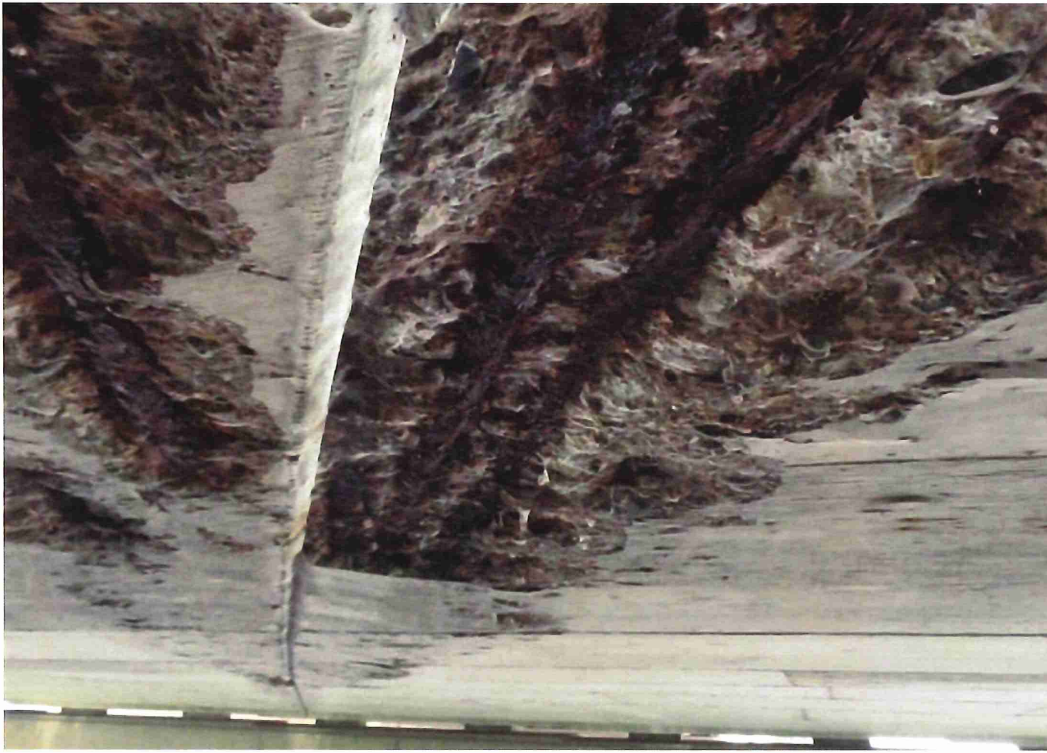
Span 5 - Additional photo of spalled areas.

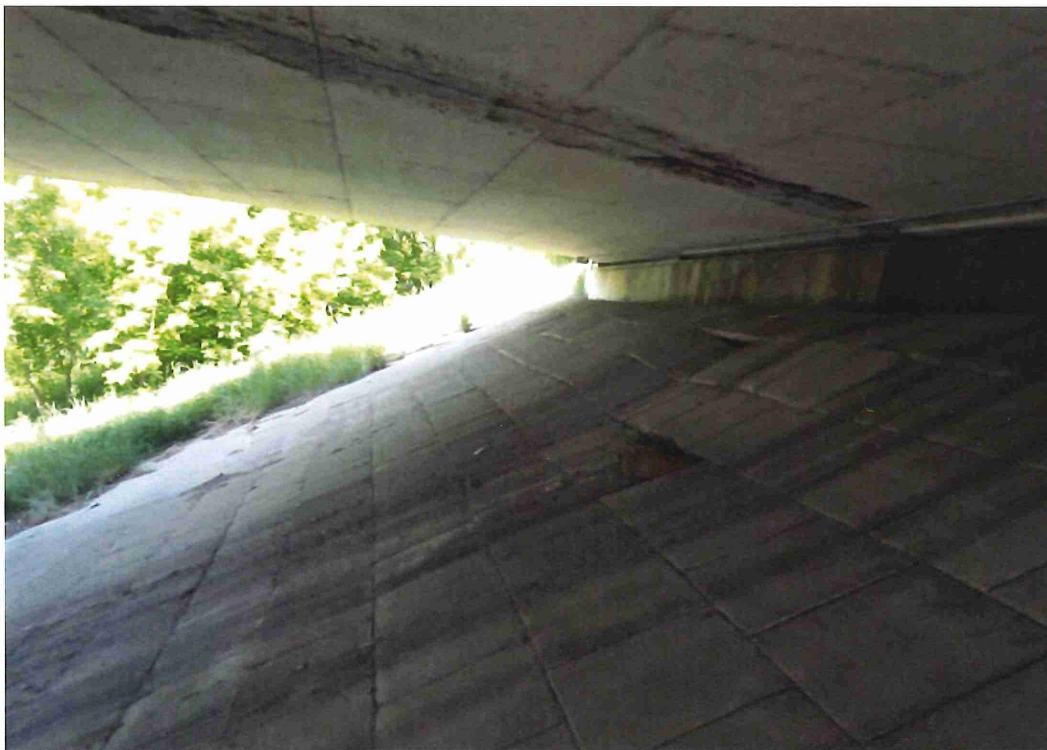
North Abutment slope paving - Slope paving has several areas of severe settlement up to 12".

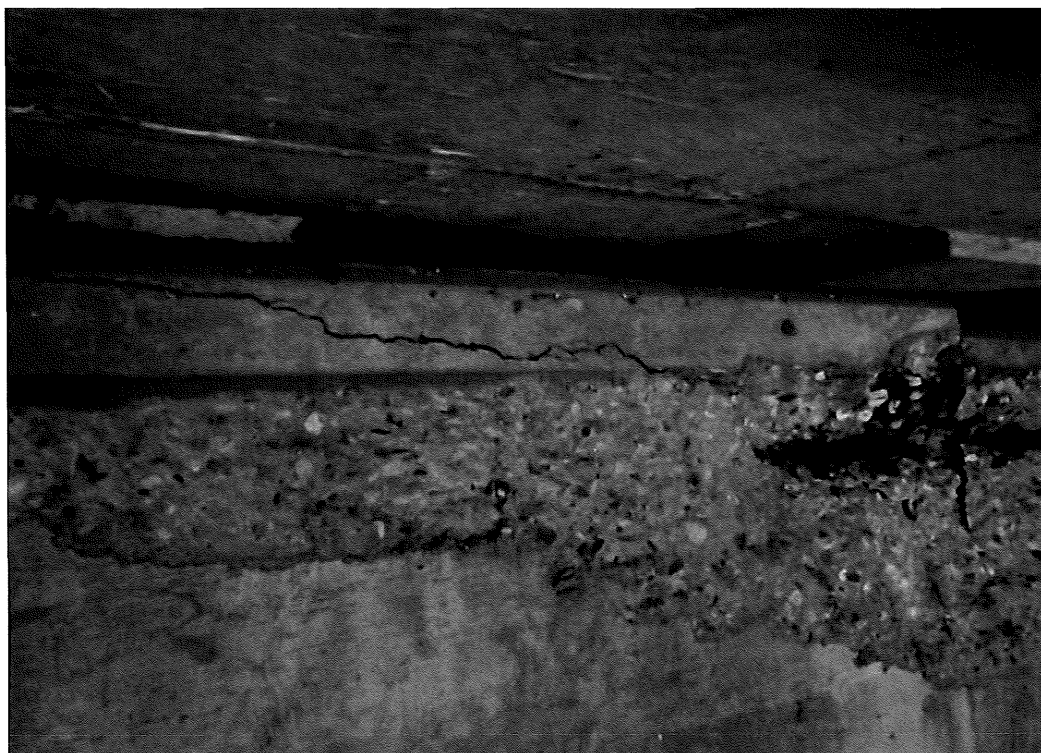
North Abutment - Corner spall/delamination starting at Bearing #3 (from west) and extending to Bearing #5. Spall measures up to 4" deep on abutment face x 16" vertical by 12' long, and delamination on top of cap in same location extends to 8" deep.

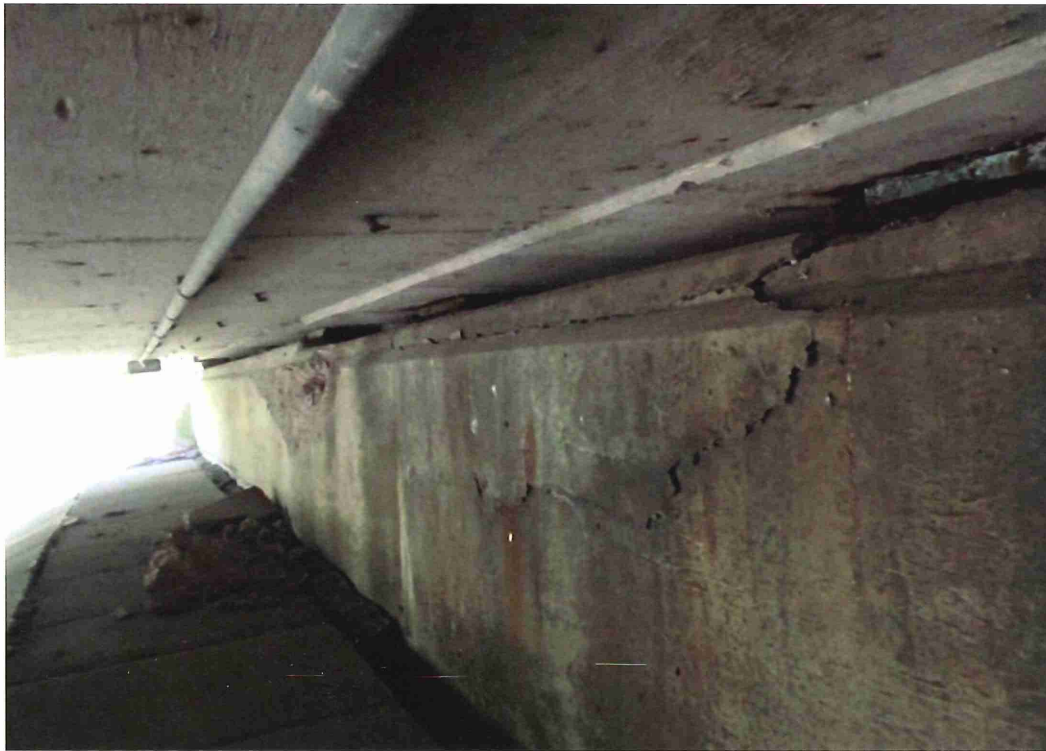
North Abutment - Additional corner spall/delamination photo.

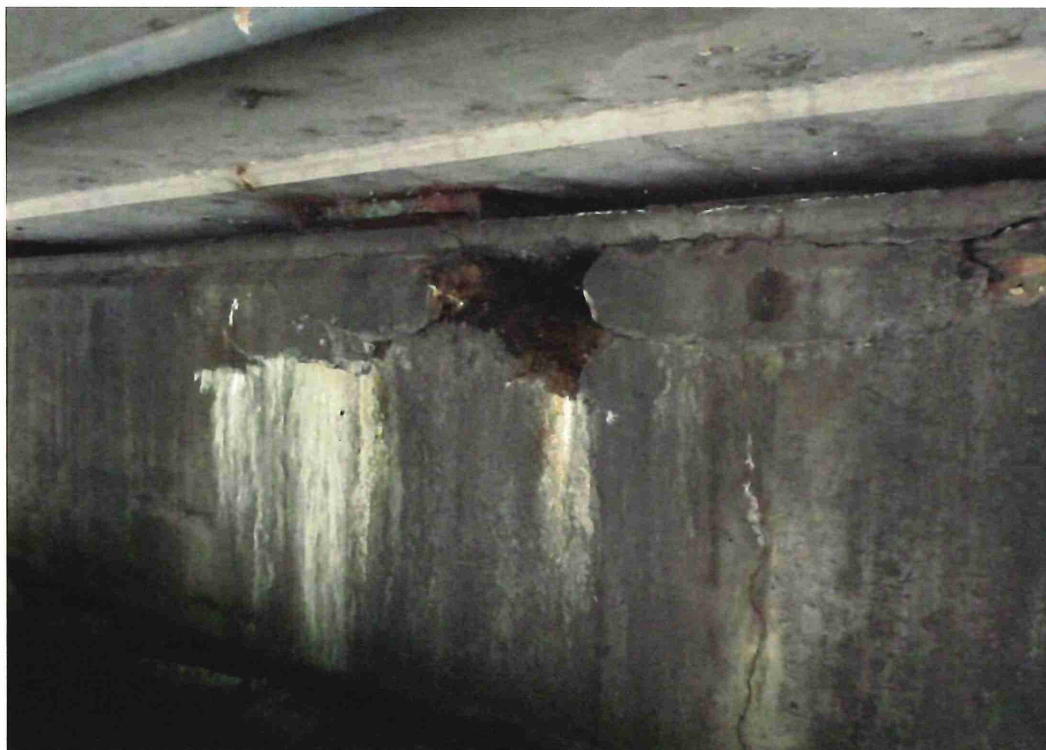
North Abutment - Corner spall/delamination between Bearing #8 (from west) and Bearing #9. Spall measures up to 3" deep on abutment face x 12" vertical by 6' long, and delamination on top of cap in same location extends to 4" deep.

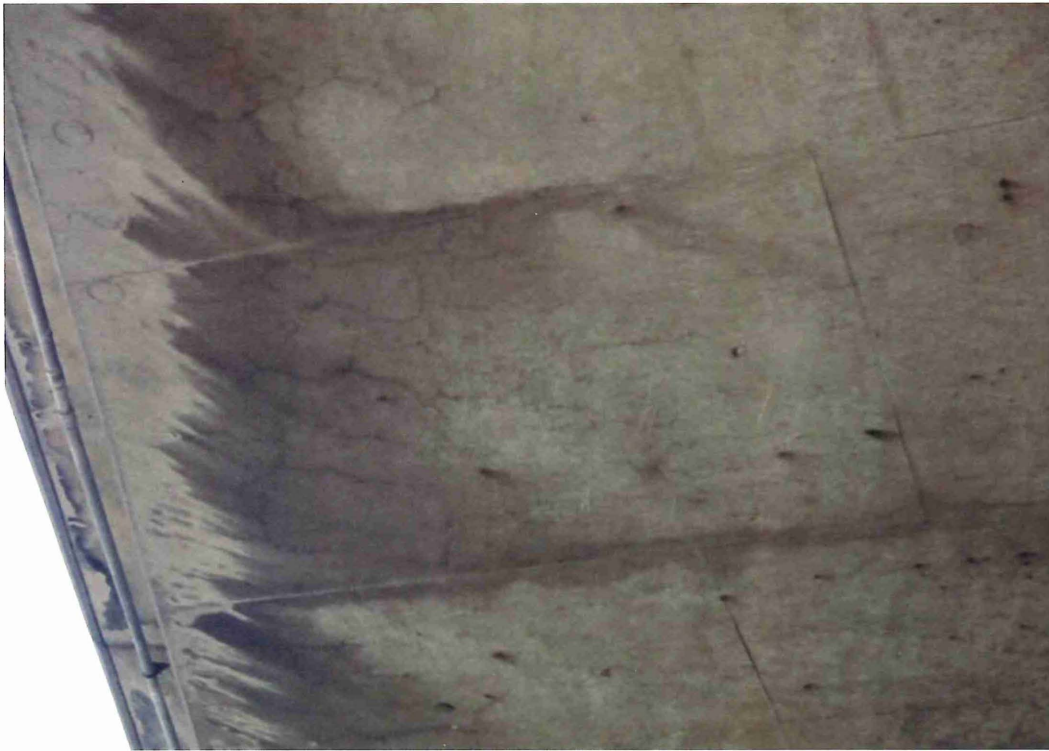
Deck underside (typical) - Map cracking along east edge of deck extending in approximately 4'-0" with signs of chloride contamination and staining.

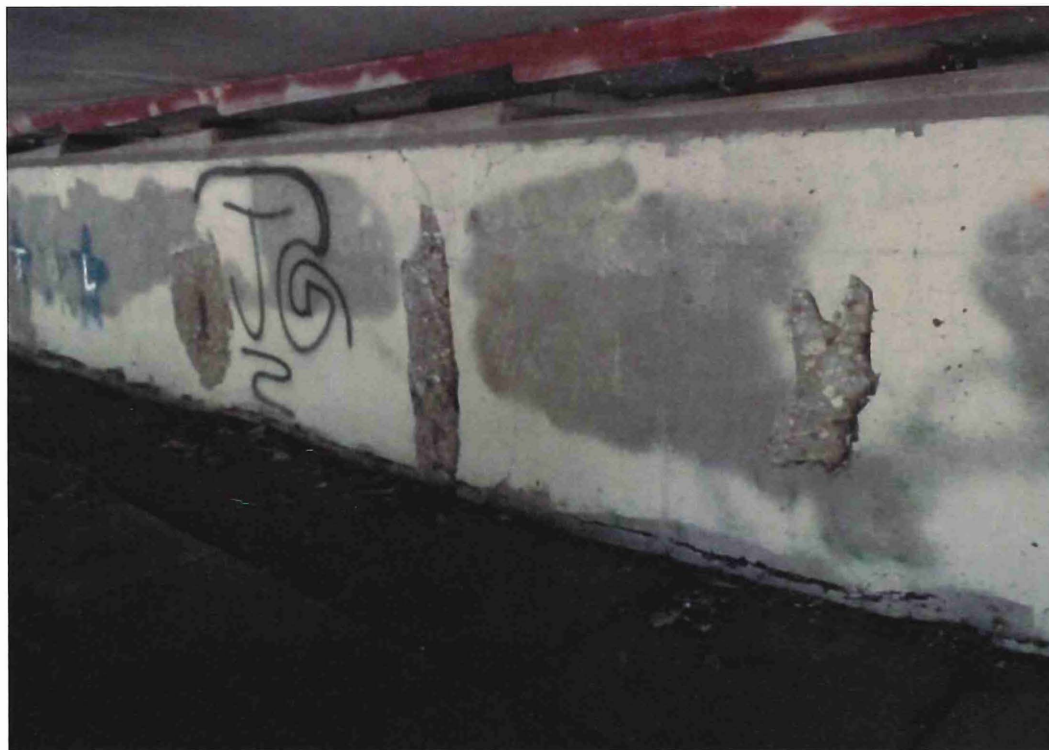
South Abutment - Several areas of spalling extending to 2" deep with some exposed reinforcement bars.

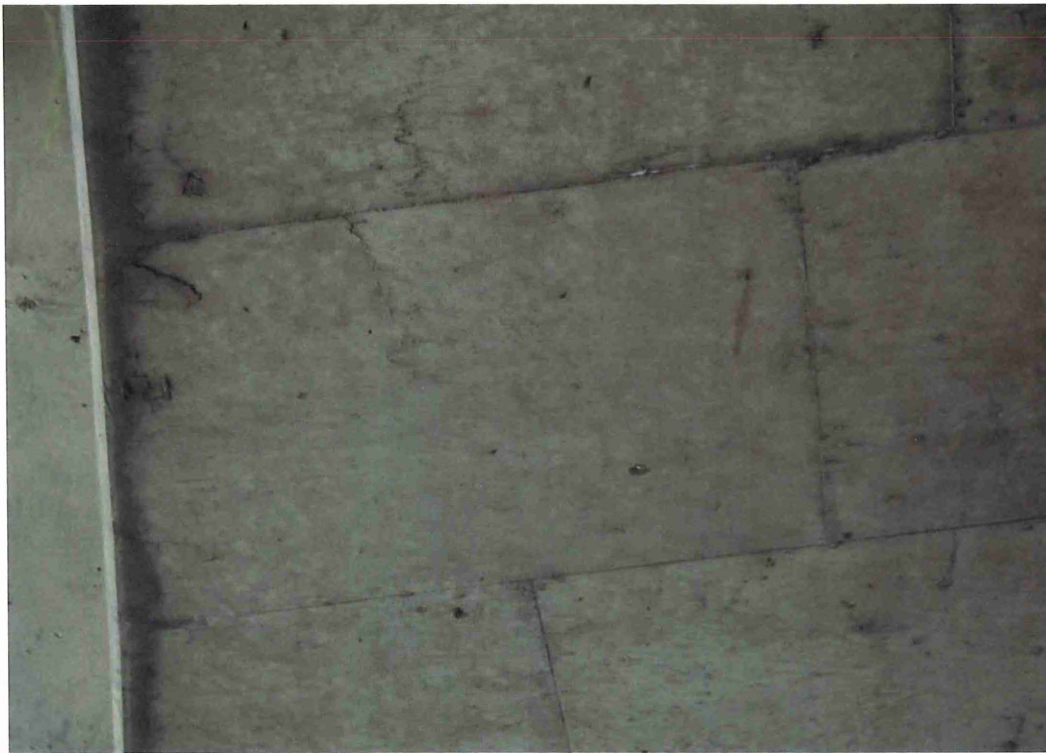
Deck underside (typical) - Map cracking along west edge of deck extending in approximately 4'-0" with signs of chloride contamination and staining.

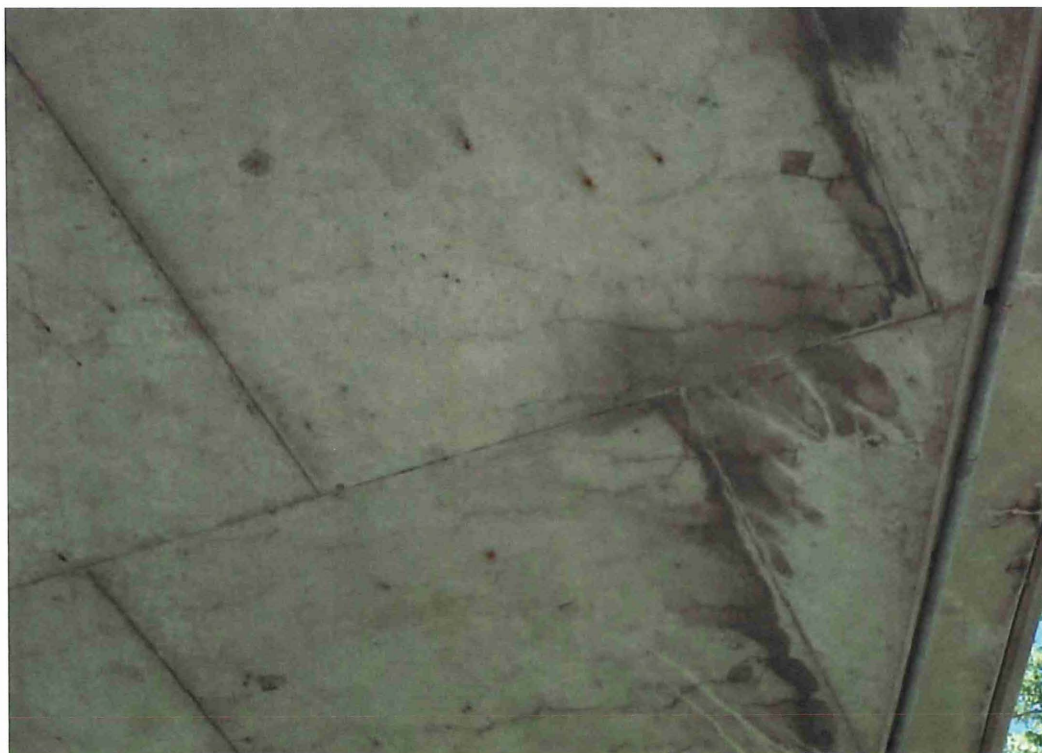
Deck underside (typical) - Additional photo of map cracking along west edge of deck with signs of chloride contamination and staining.

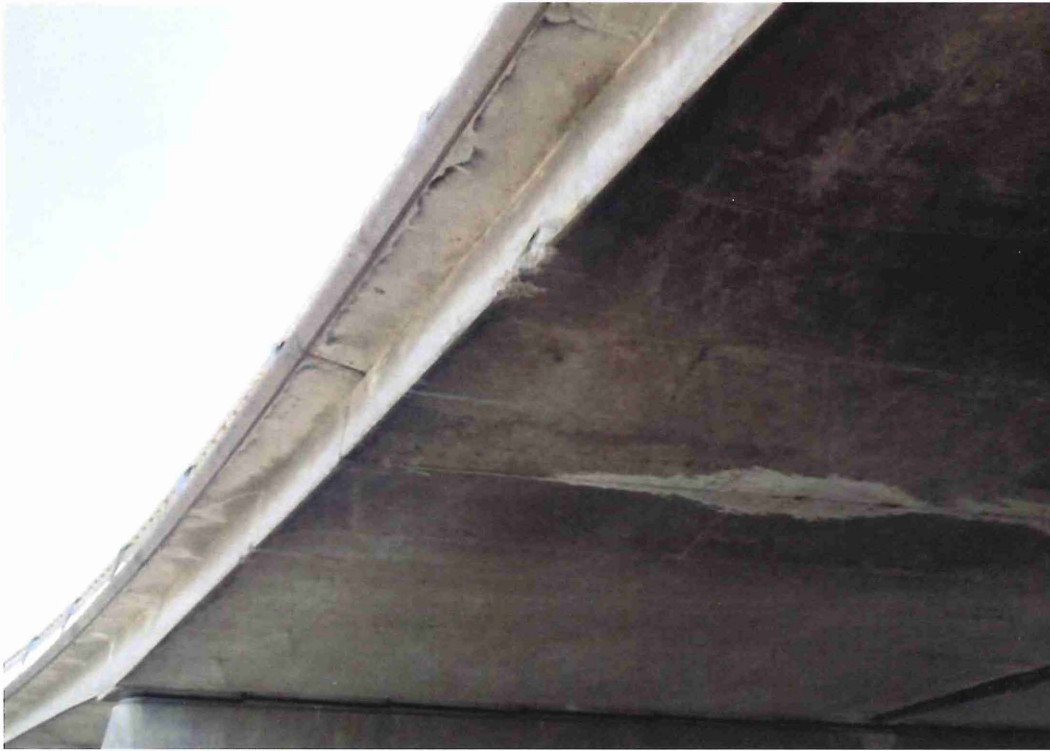
There are two spalls and a scrape on the western side of the slab over southbound TH 61 that appear to have been caused by impacts from high-load vehicles traveling on southbound TH 61 under the bridge.

West fascia - Minor impact damage on west fascia above the SB 61 lanes.

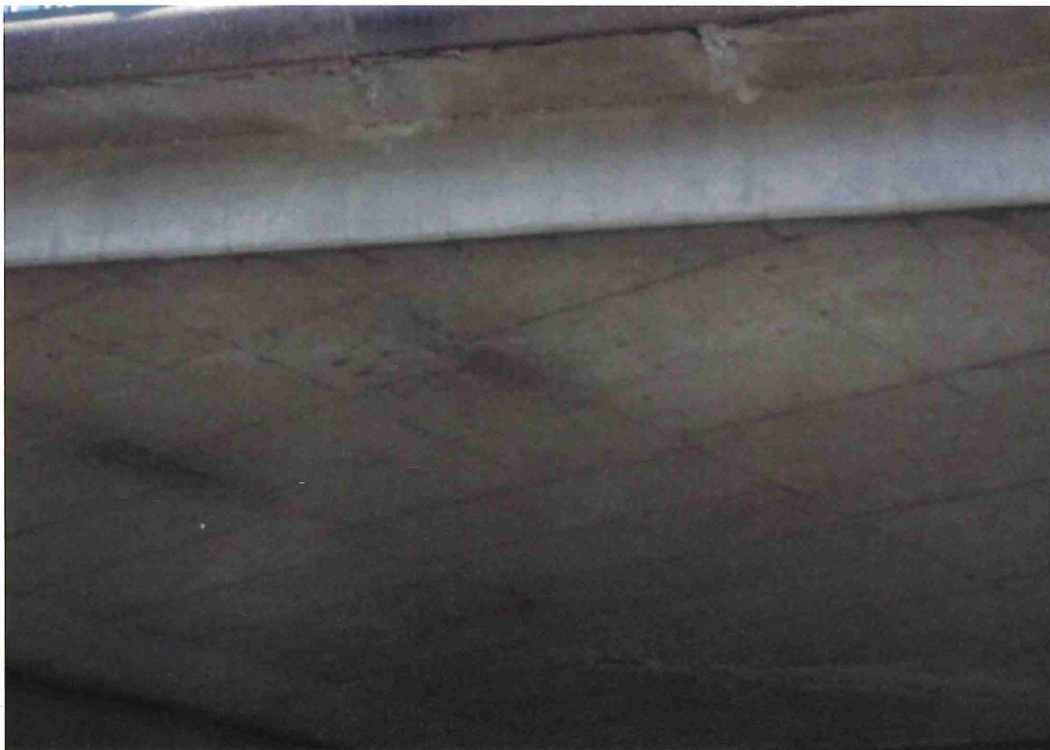
West fascia (typical) - Vertical hairline cracks at approximate 12" centers (typical).

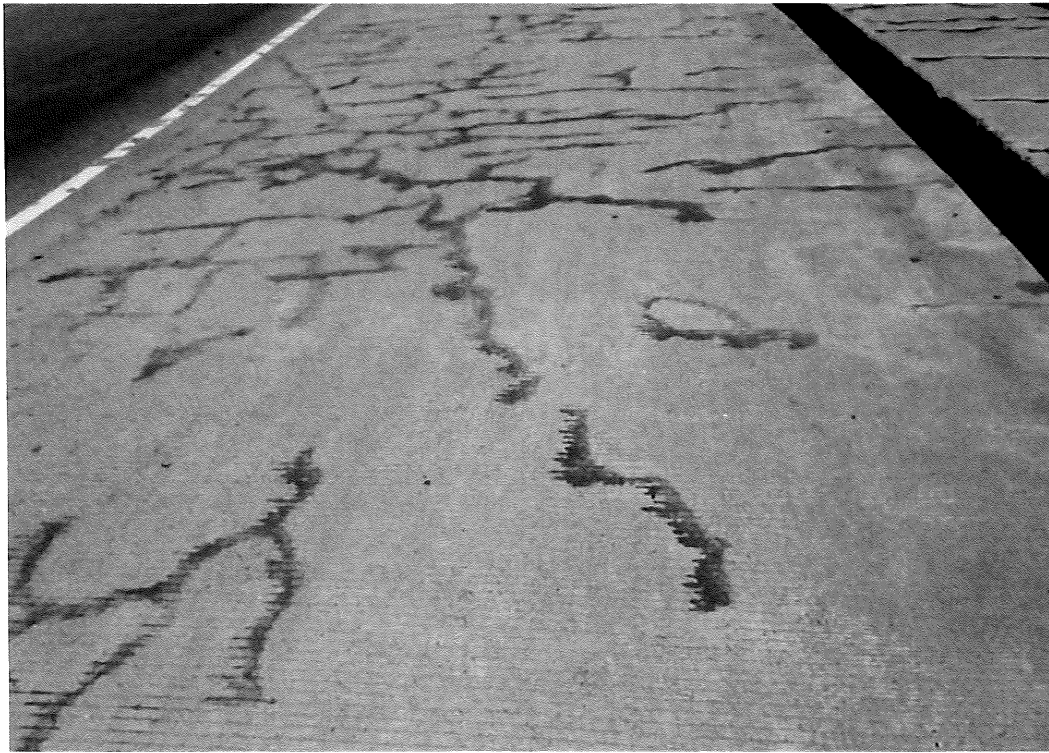
Deck surface - Map cracking on deck surface (NB lane shown, typical throughout).

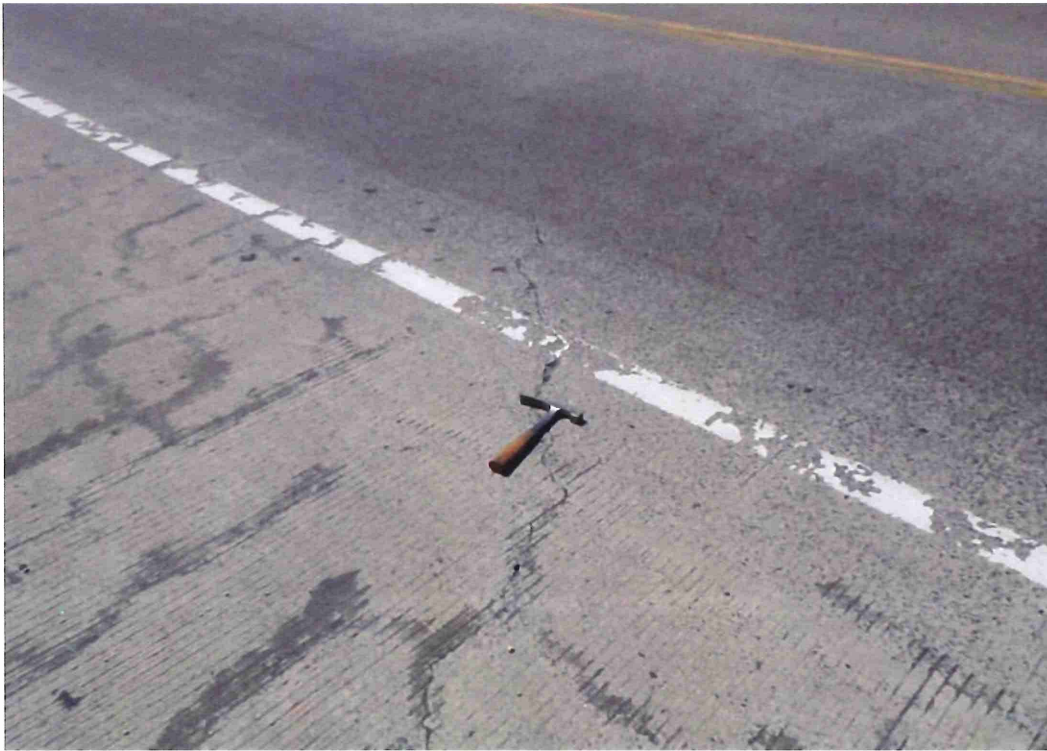
Deck surface, Span 5, NB lane - Structural crack with delamination along length.
