# **Bridge 9103 Rehabilitation Study Final Report Red Wing, Minnesota**

**August 2013**

**Submitted to  
Minnesota Department of Transportation**

**Prepared by  
HDR Engineering, Inc.  
and  
Gemini Research**

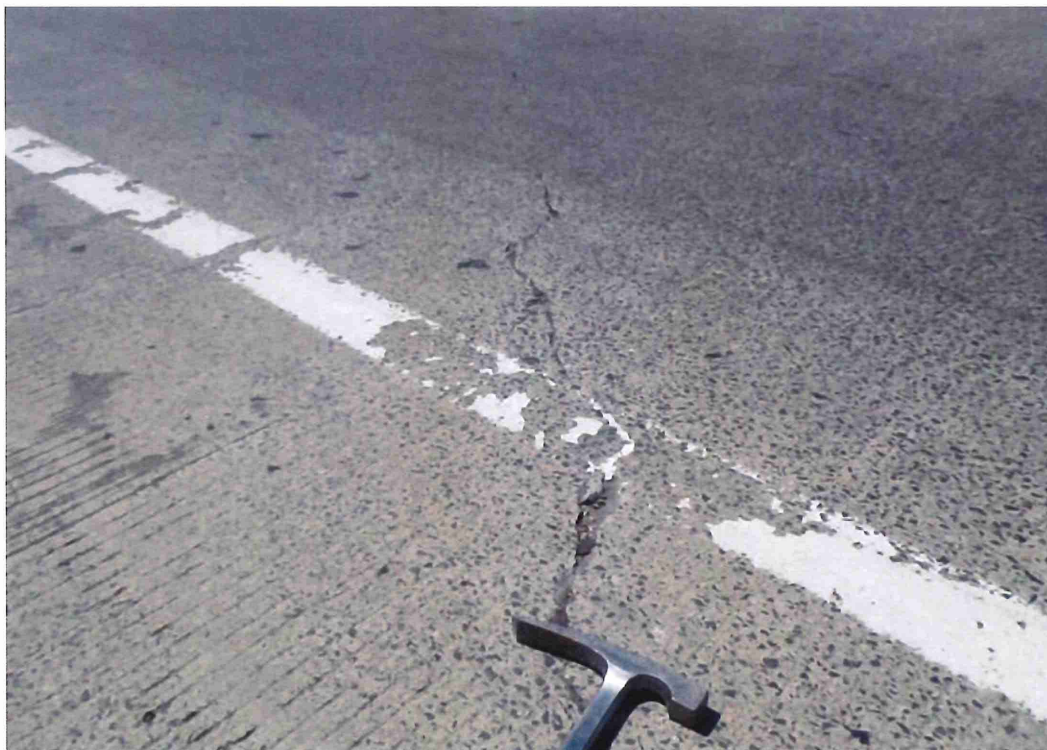
Deck surface, Span 5, NB lane - Additional photo of a structural crack with delamination along length.

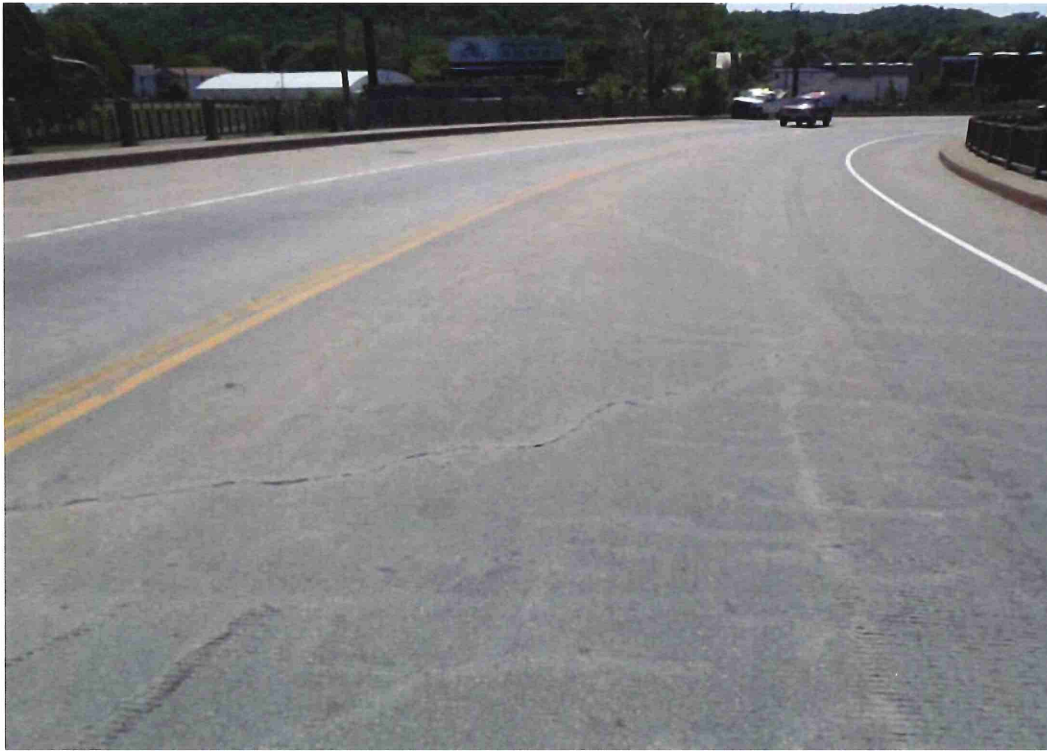
Deck surface, Span 4/5, SB lane - Structural cracks with delamination along length.

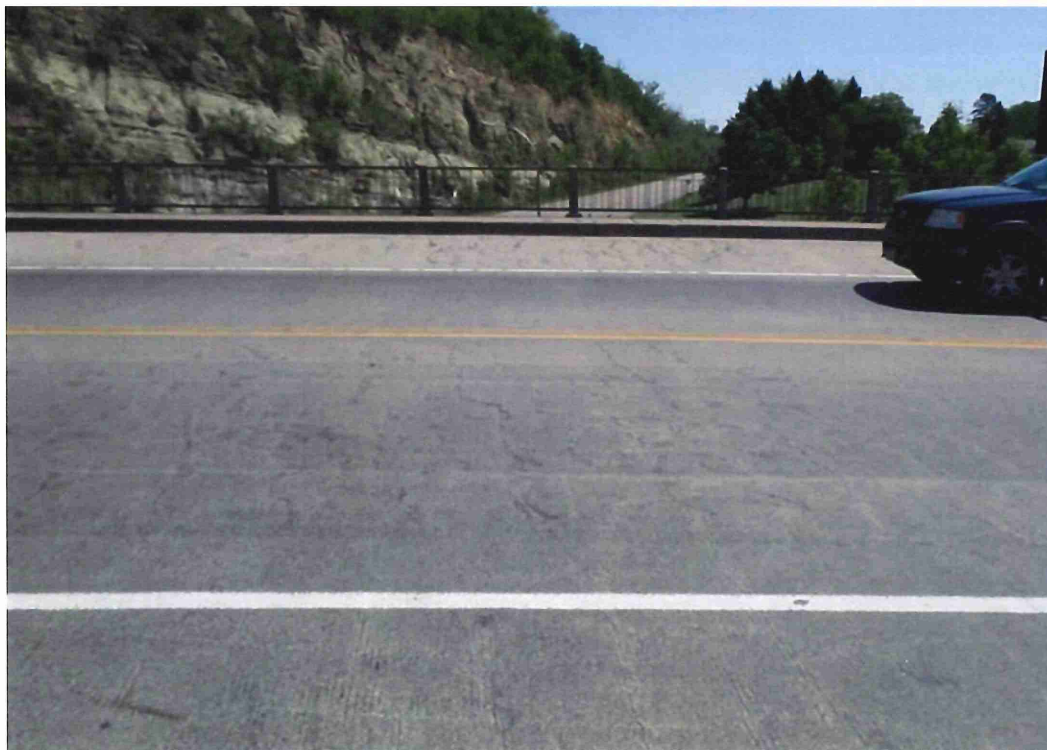
Deck surface - Map cracking on deck surface (NB/SB Lane above Span 2 shown, typical throughout).

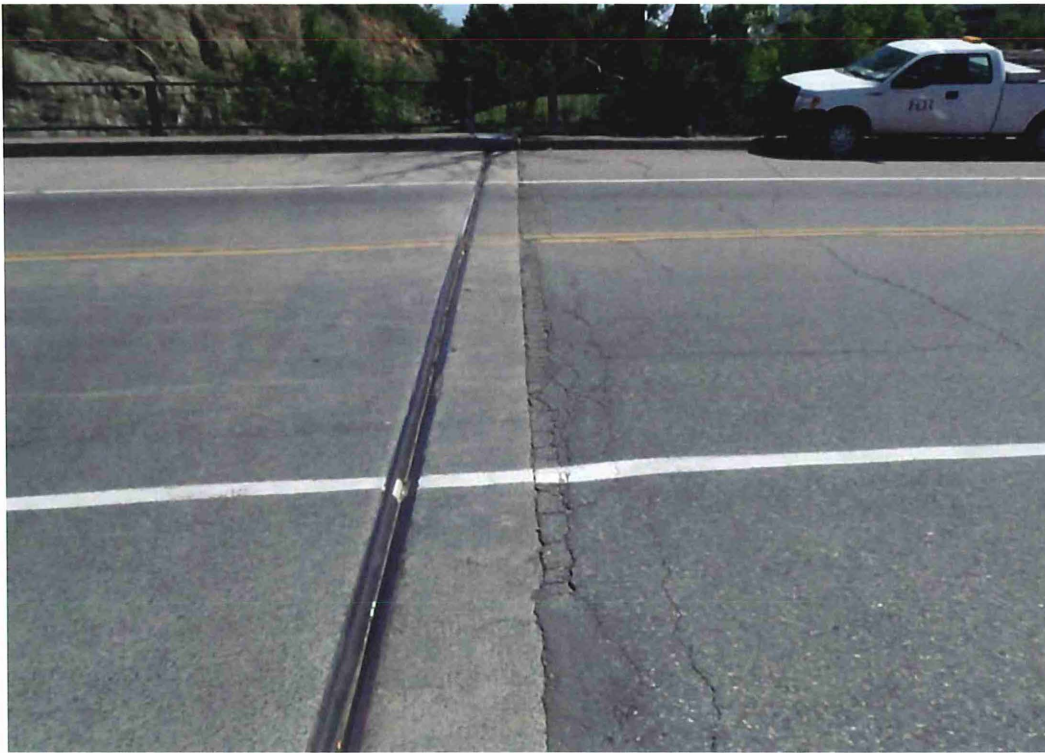
South approach pavement - Minor settlement and poor condition of bituminous pavement noted.

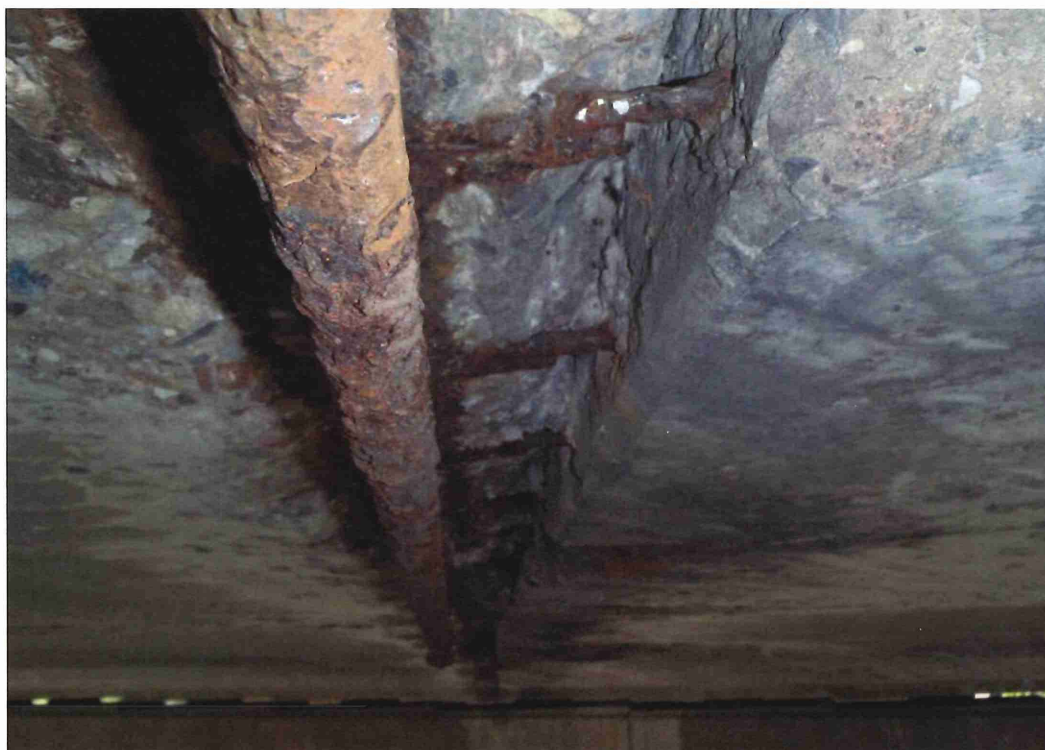
Span 3 - Broken / 100% Section loss in transverse bars.

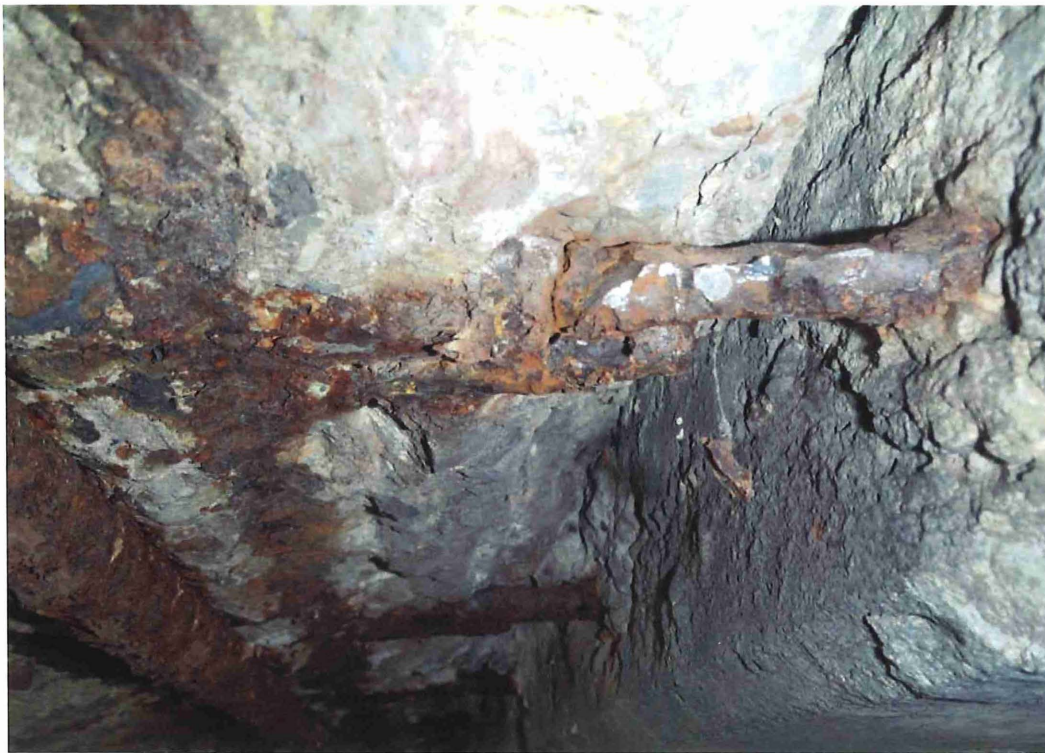
Span 3 - Close up of Broken / 100% section loss in transverse bars.

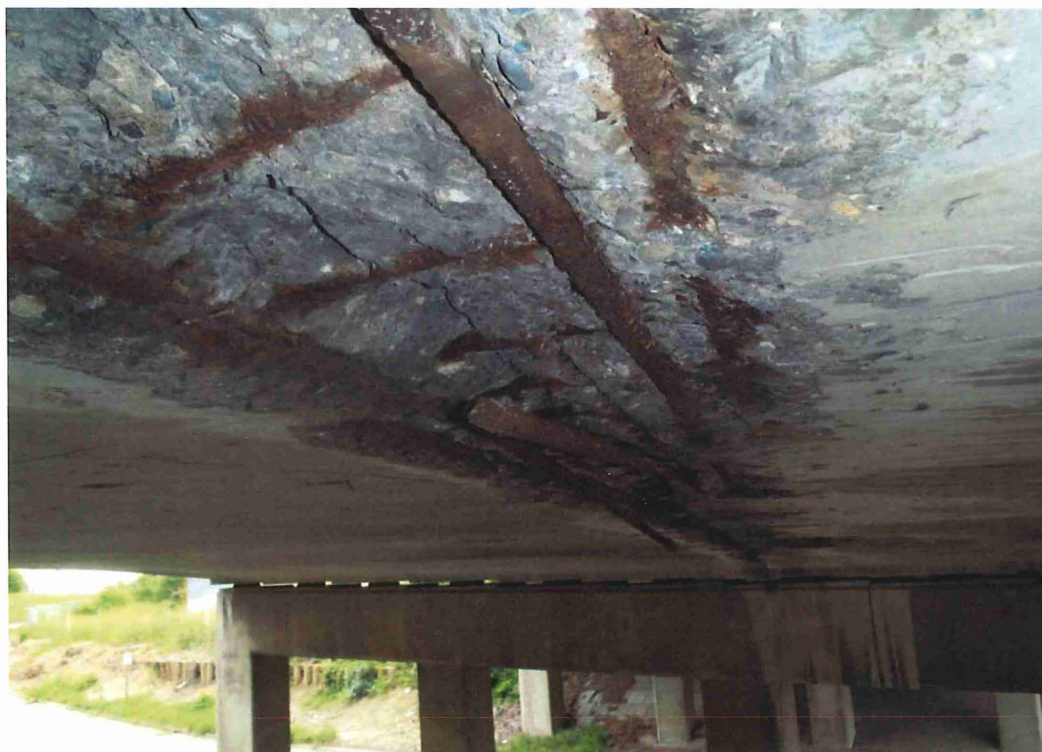
Span 3 - General view along the centerline joint.

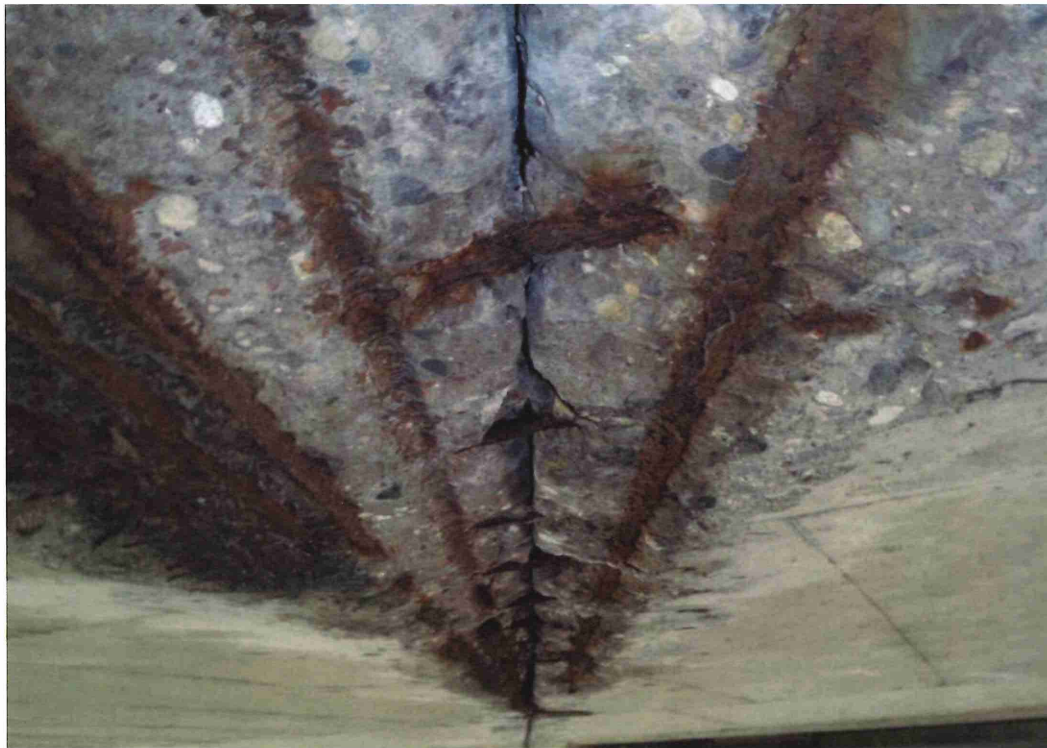
Span 4 - Missing rebar along 2/3 of span.

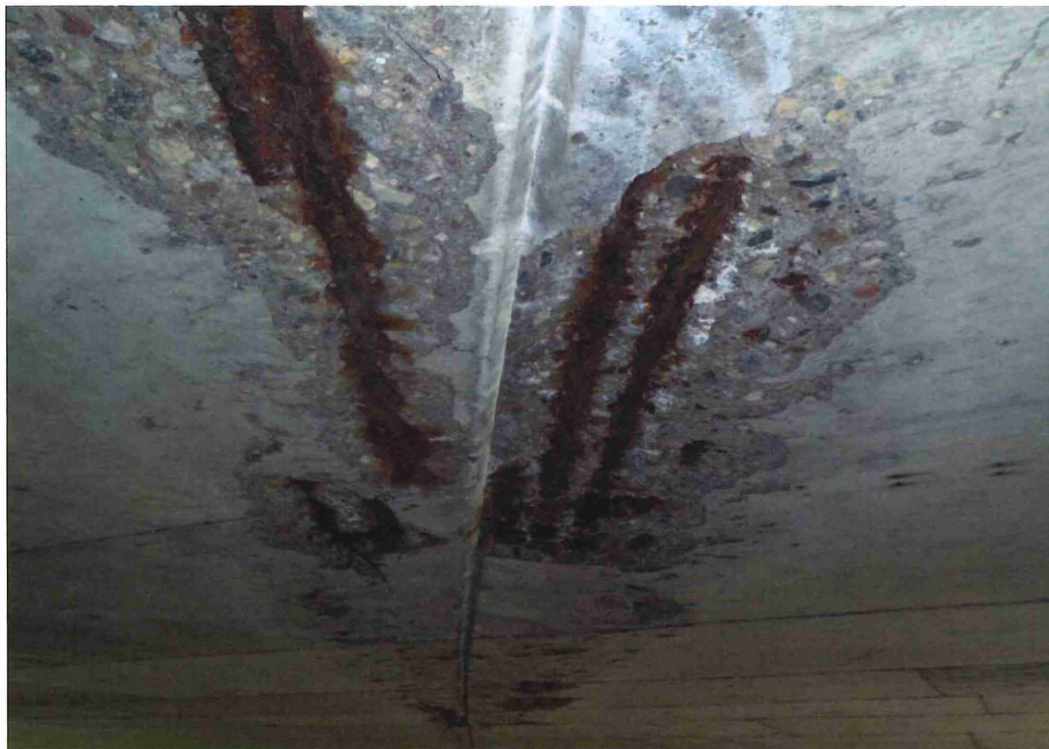
Span 5 - General view along the centerline joint showing areas of spalling and delamination.

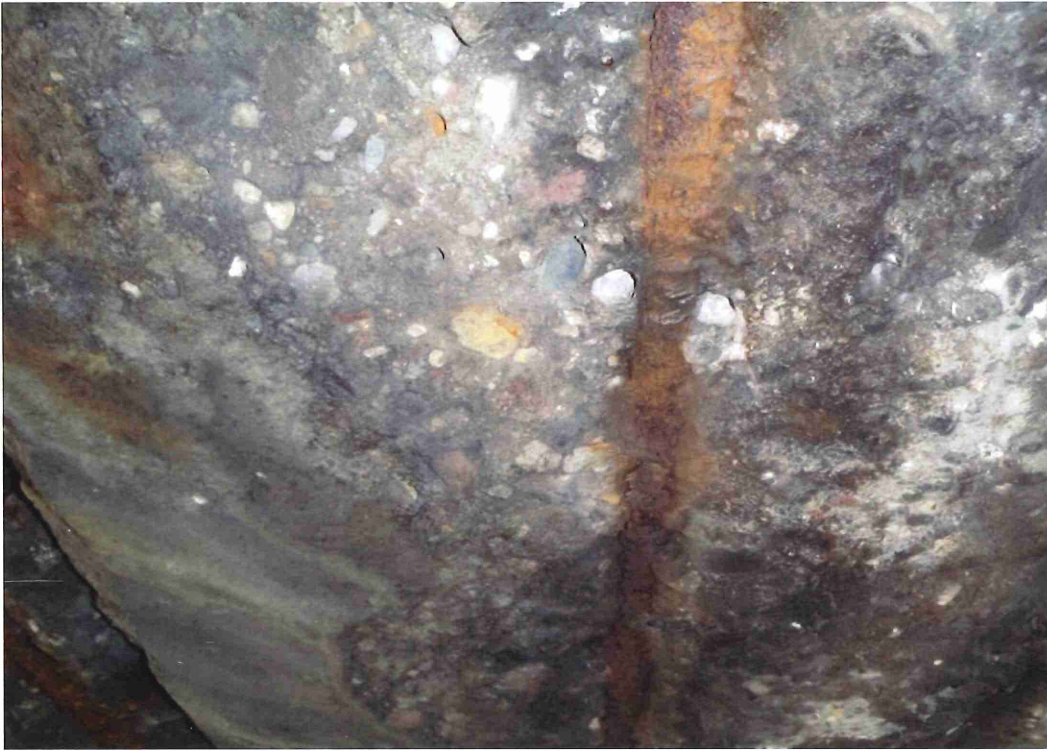
Span 3 - Close up of spalled areas occurring in half of span 3

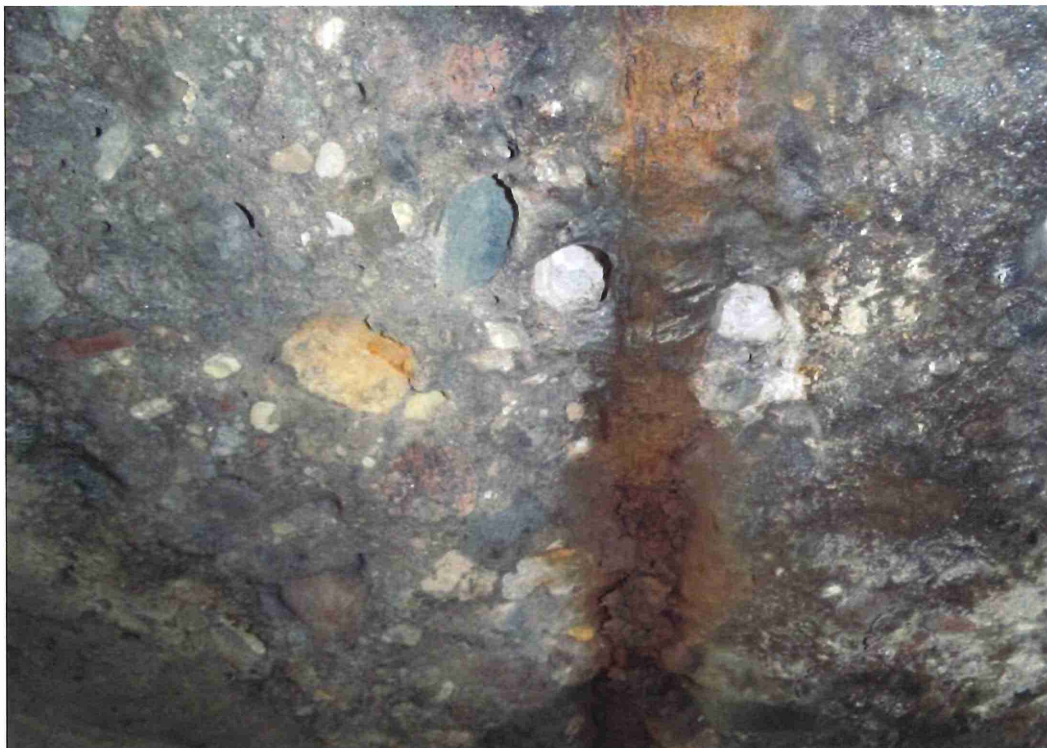
Span 3 - Additional close up of spalled areas occurring in half of span 3

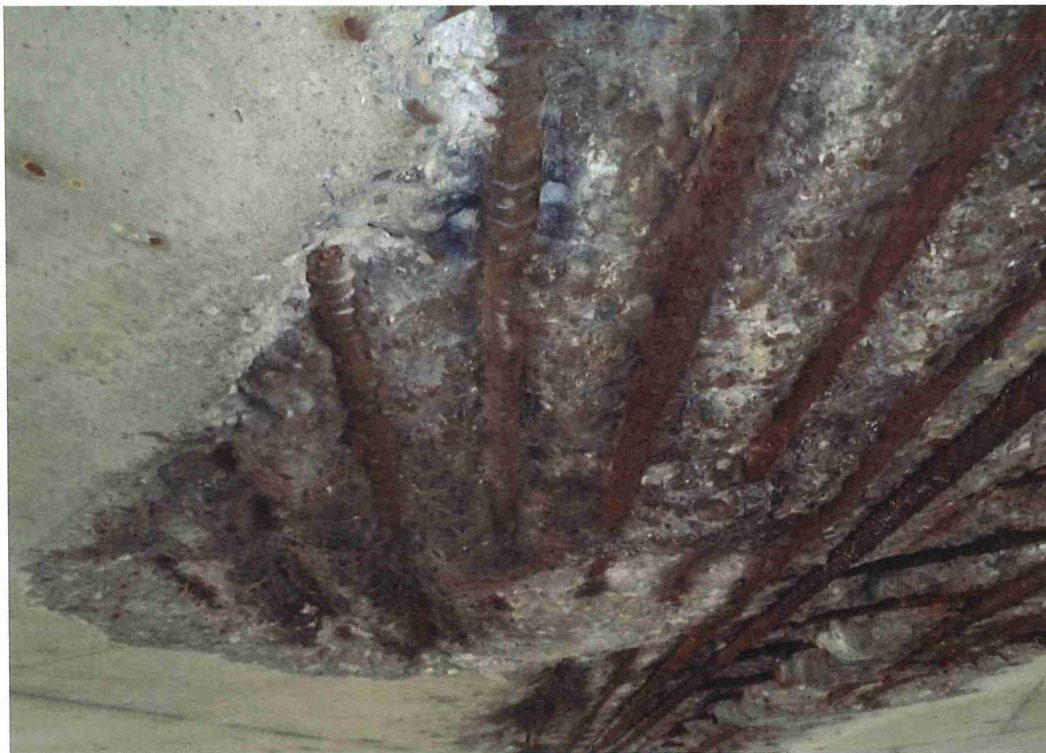
Span 4 - Spalled deck area with 6 exposed rebar measuring 1" in diameter.

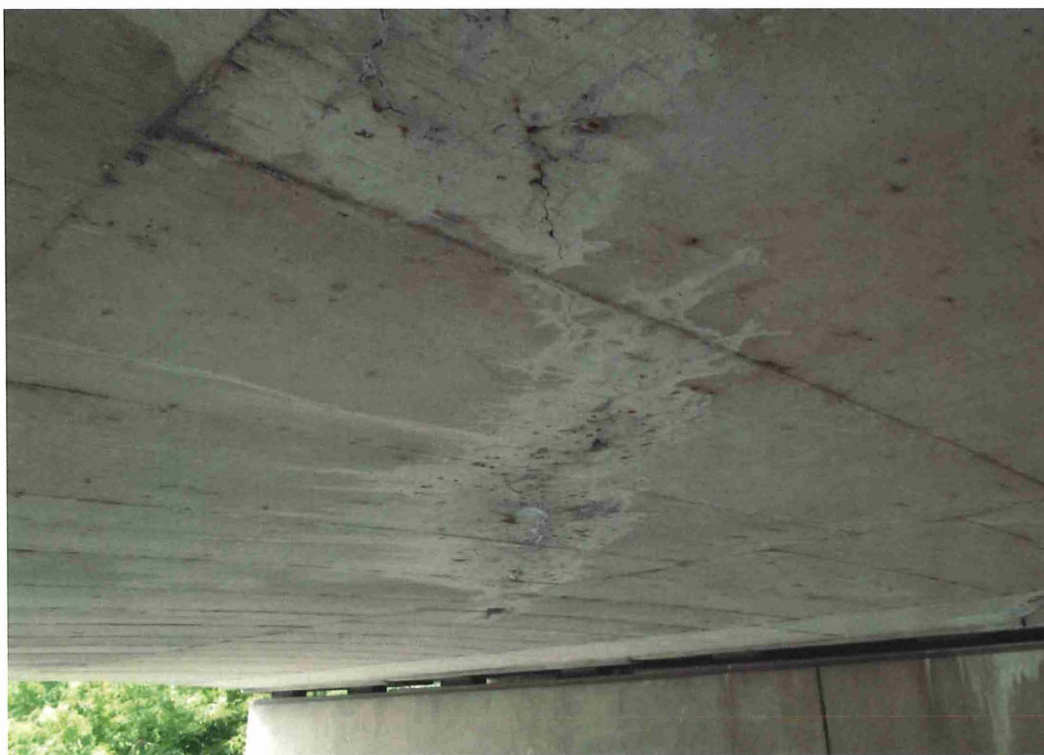
Span 4 - Hairline crack with efflorescence. The concrete is sound around the crack.

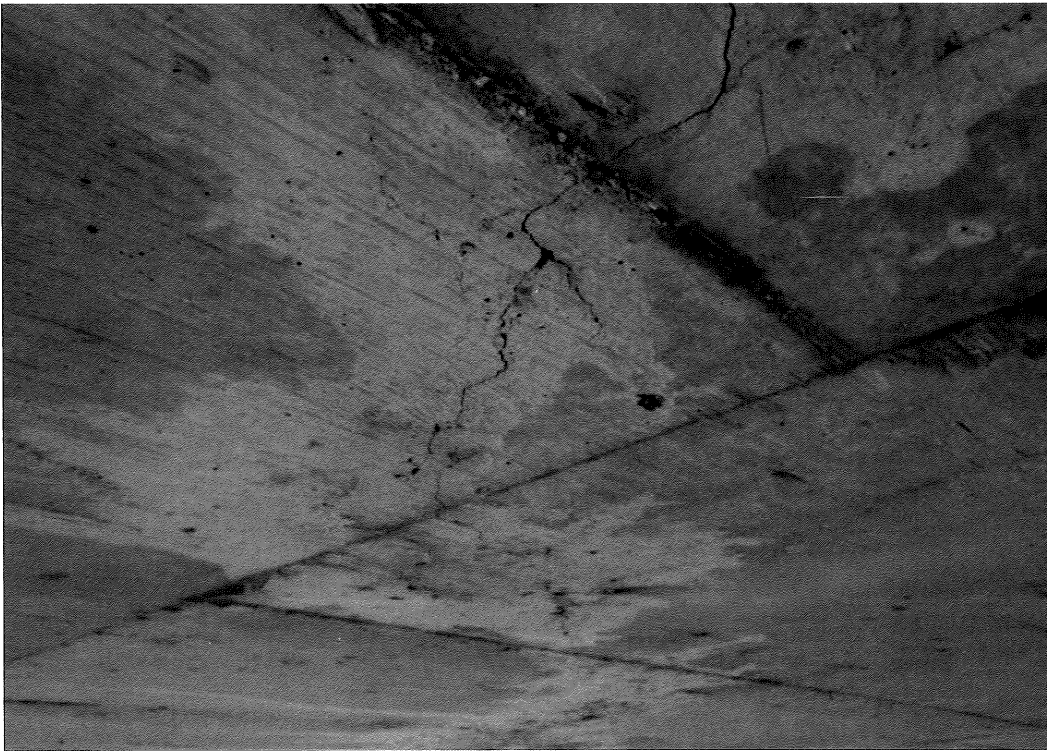
Span 4 - Close up view of hairline crack.

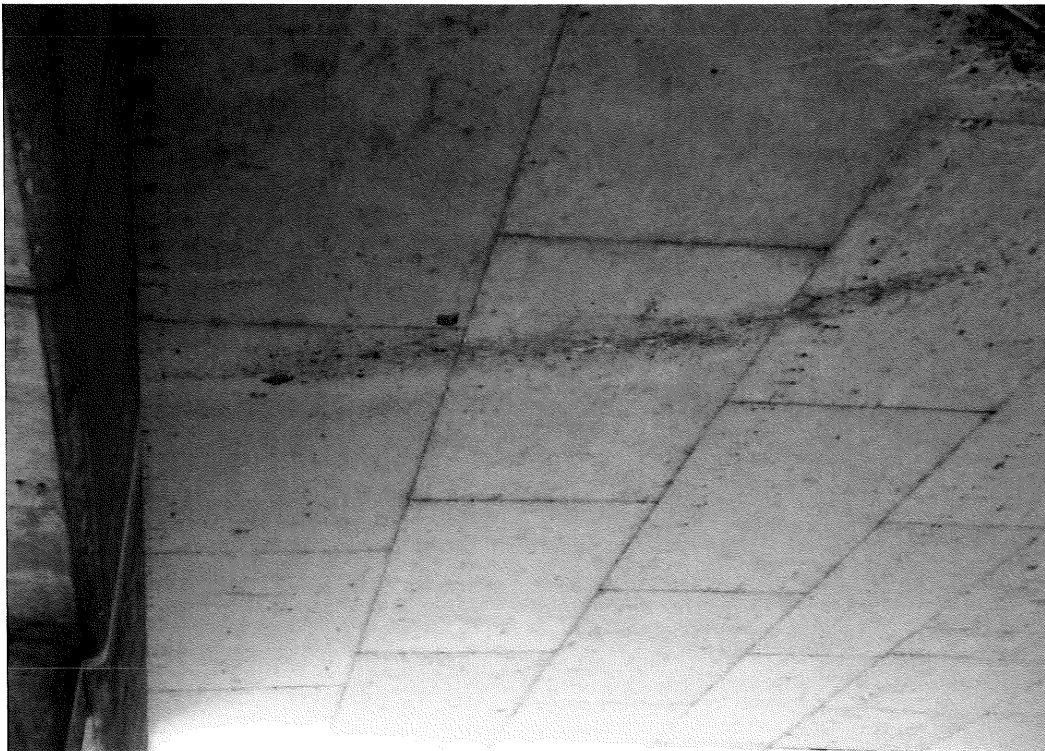
Span 5 - Additional view of the hairline crack.

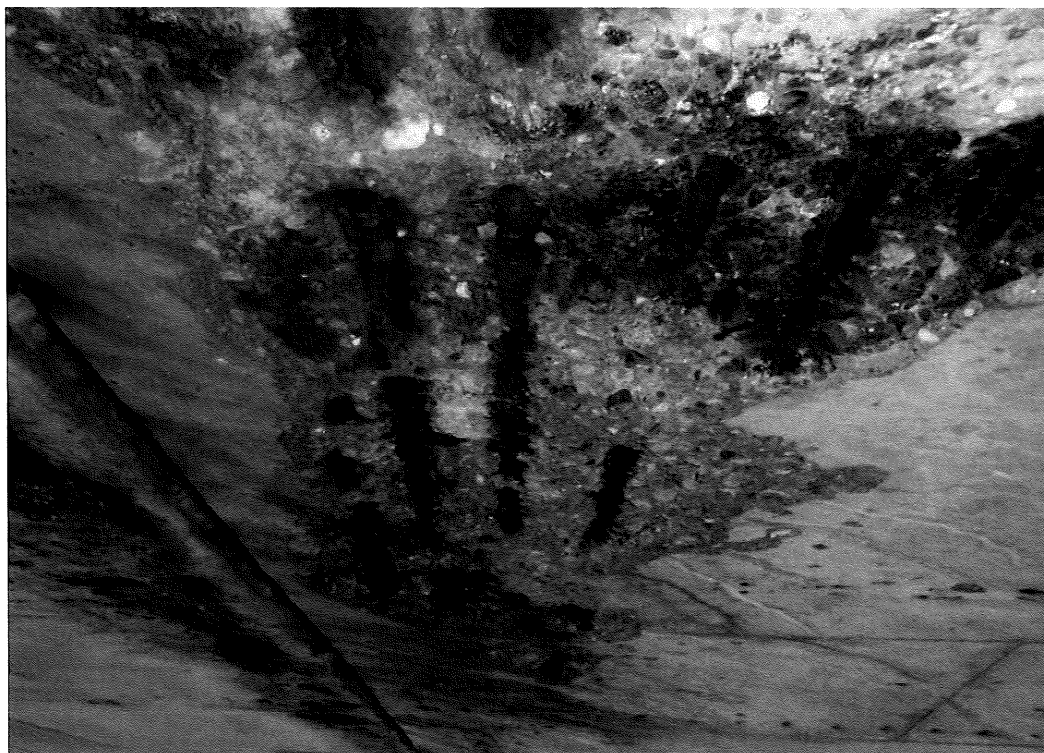
Span 2 - Section loss and spalling in areas of Span 2.

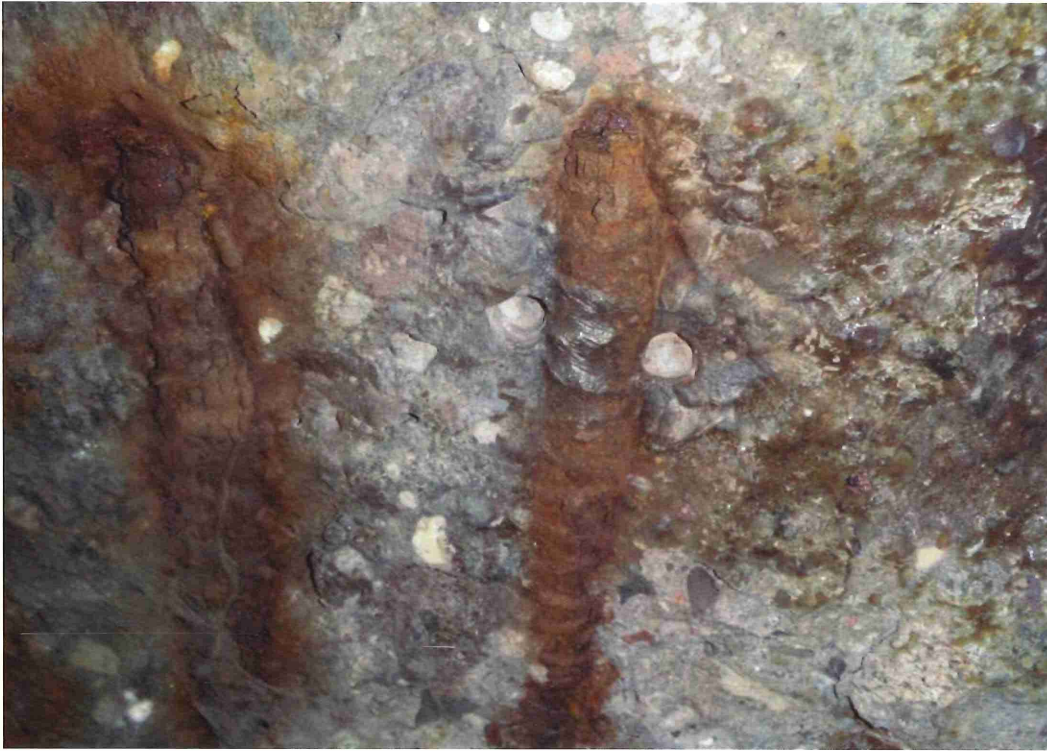
Span 2 - Close up view of spalling in areas of Span 2.

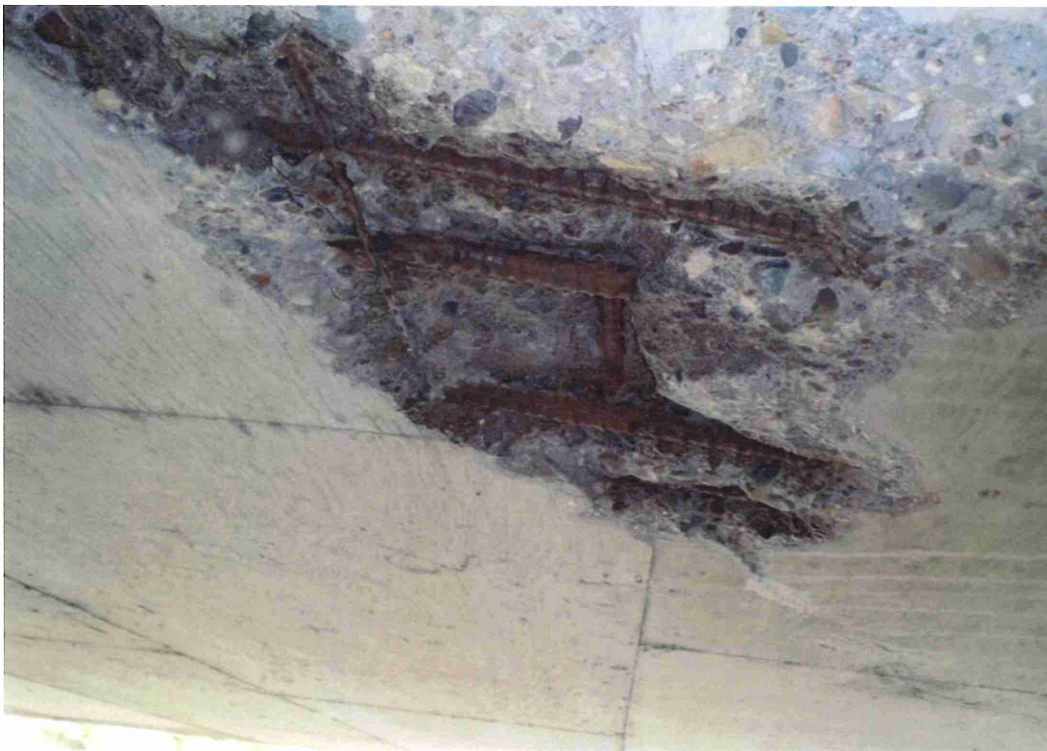
Span 2 - Spalled concrete near Pier 1.

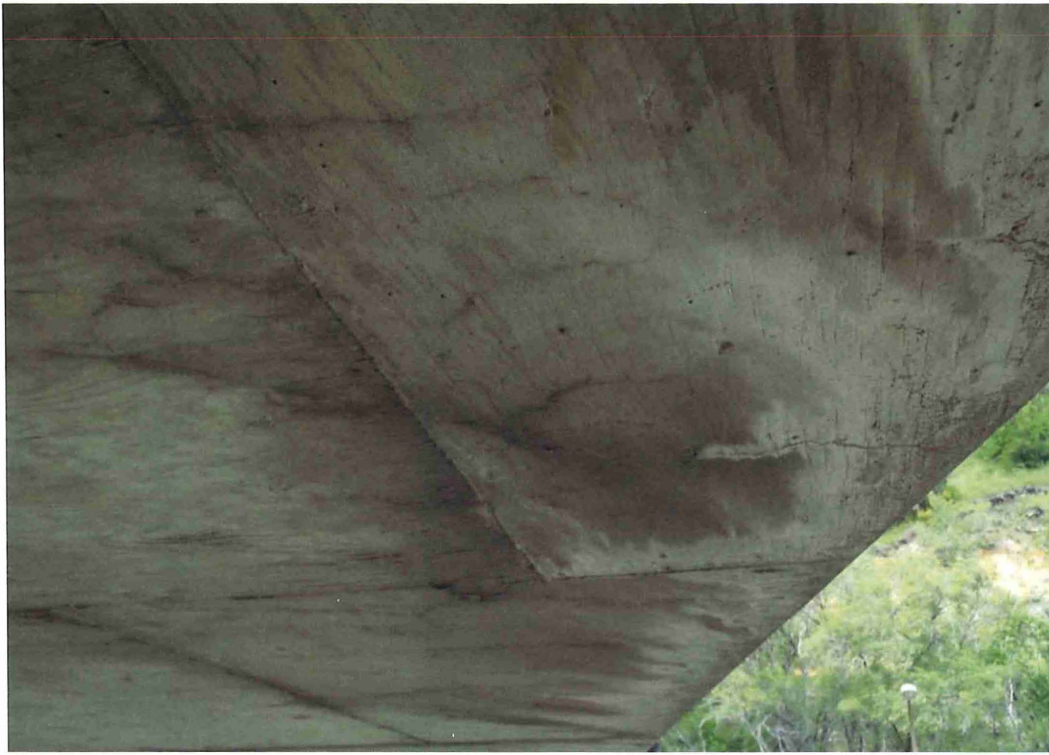
Span 1 - Cracking on the outside East face of the bridge, the concrete is sound.

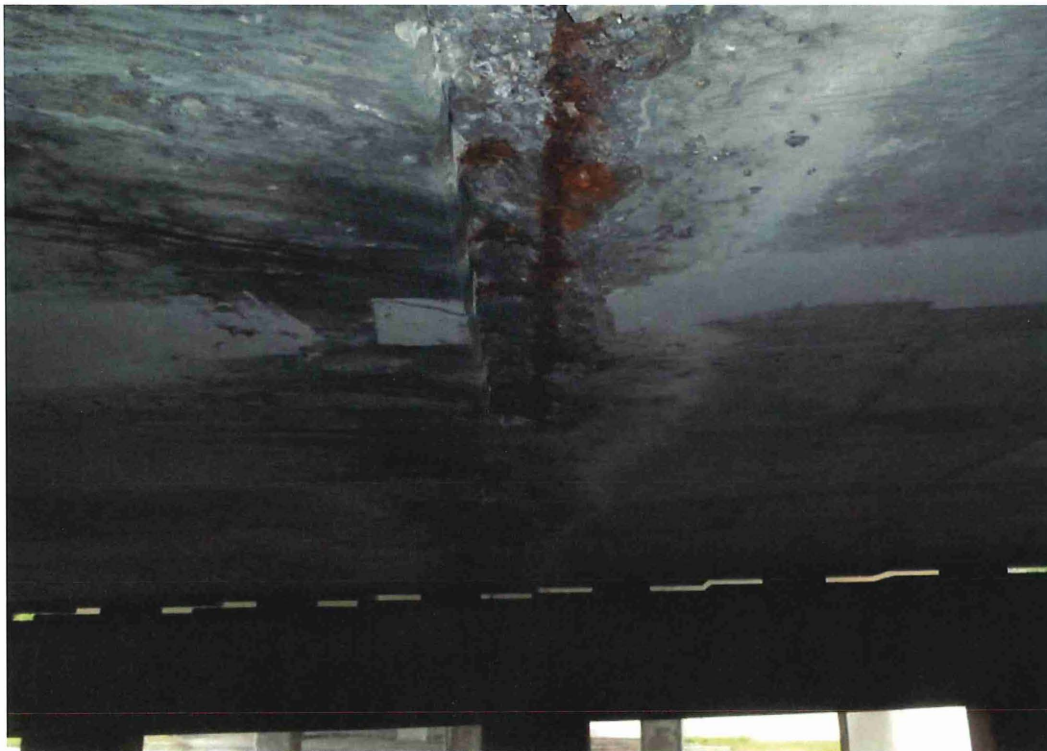
Span 1 - Spalling in the interior of Span 1.

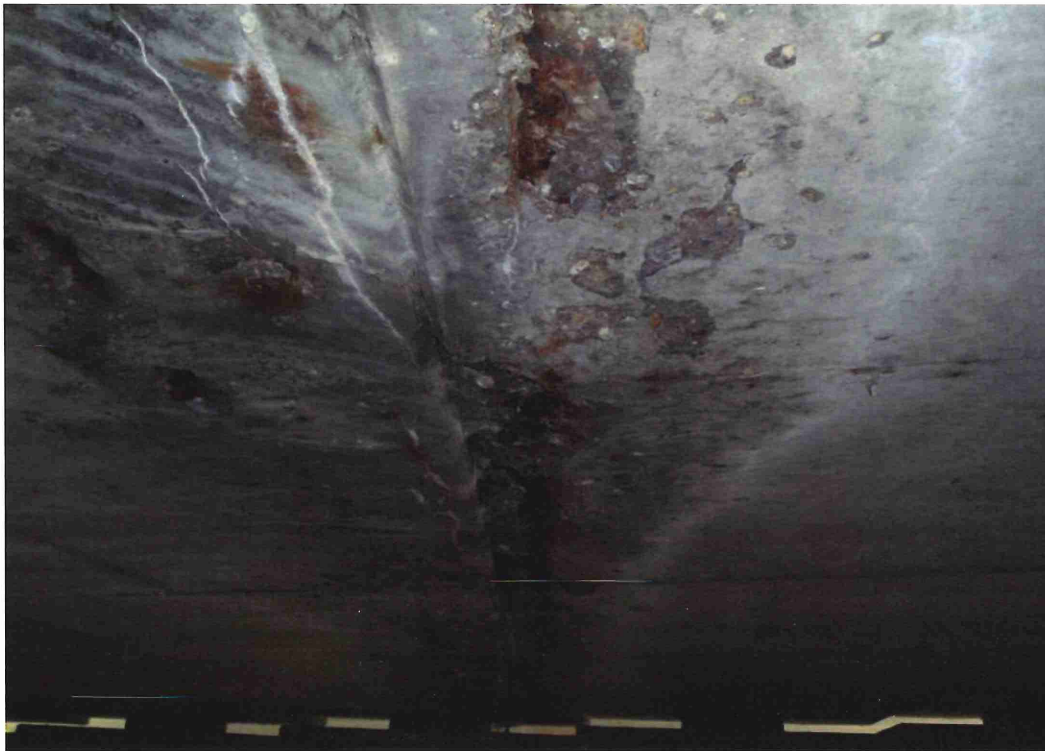
Span 1 - Additional photo of spalling in the interior of Span 1.

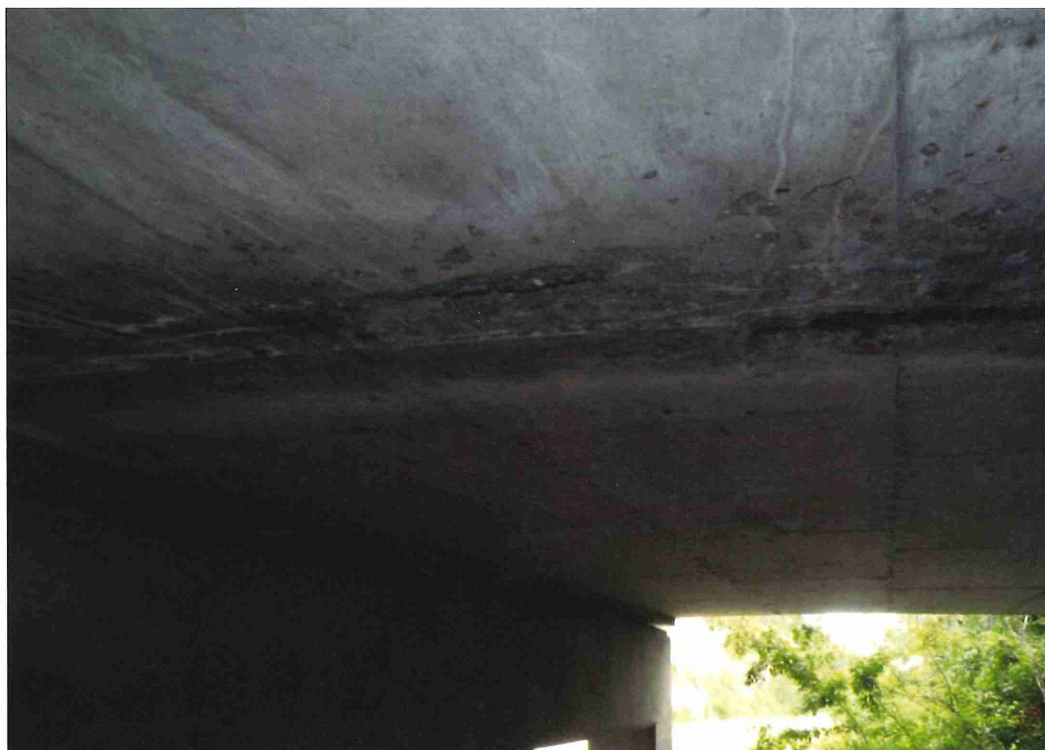
Span 1 - Additional photo of spalling in the interior of Span 1.

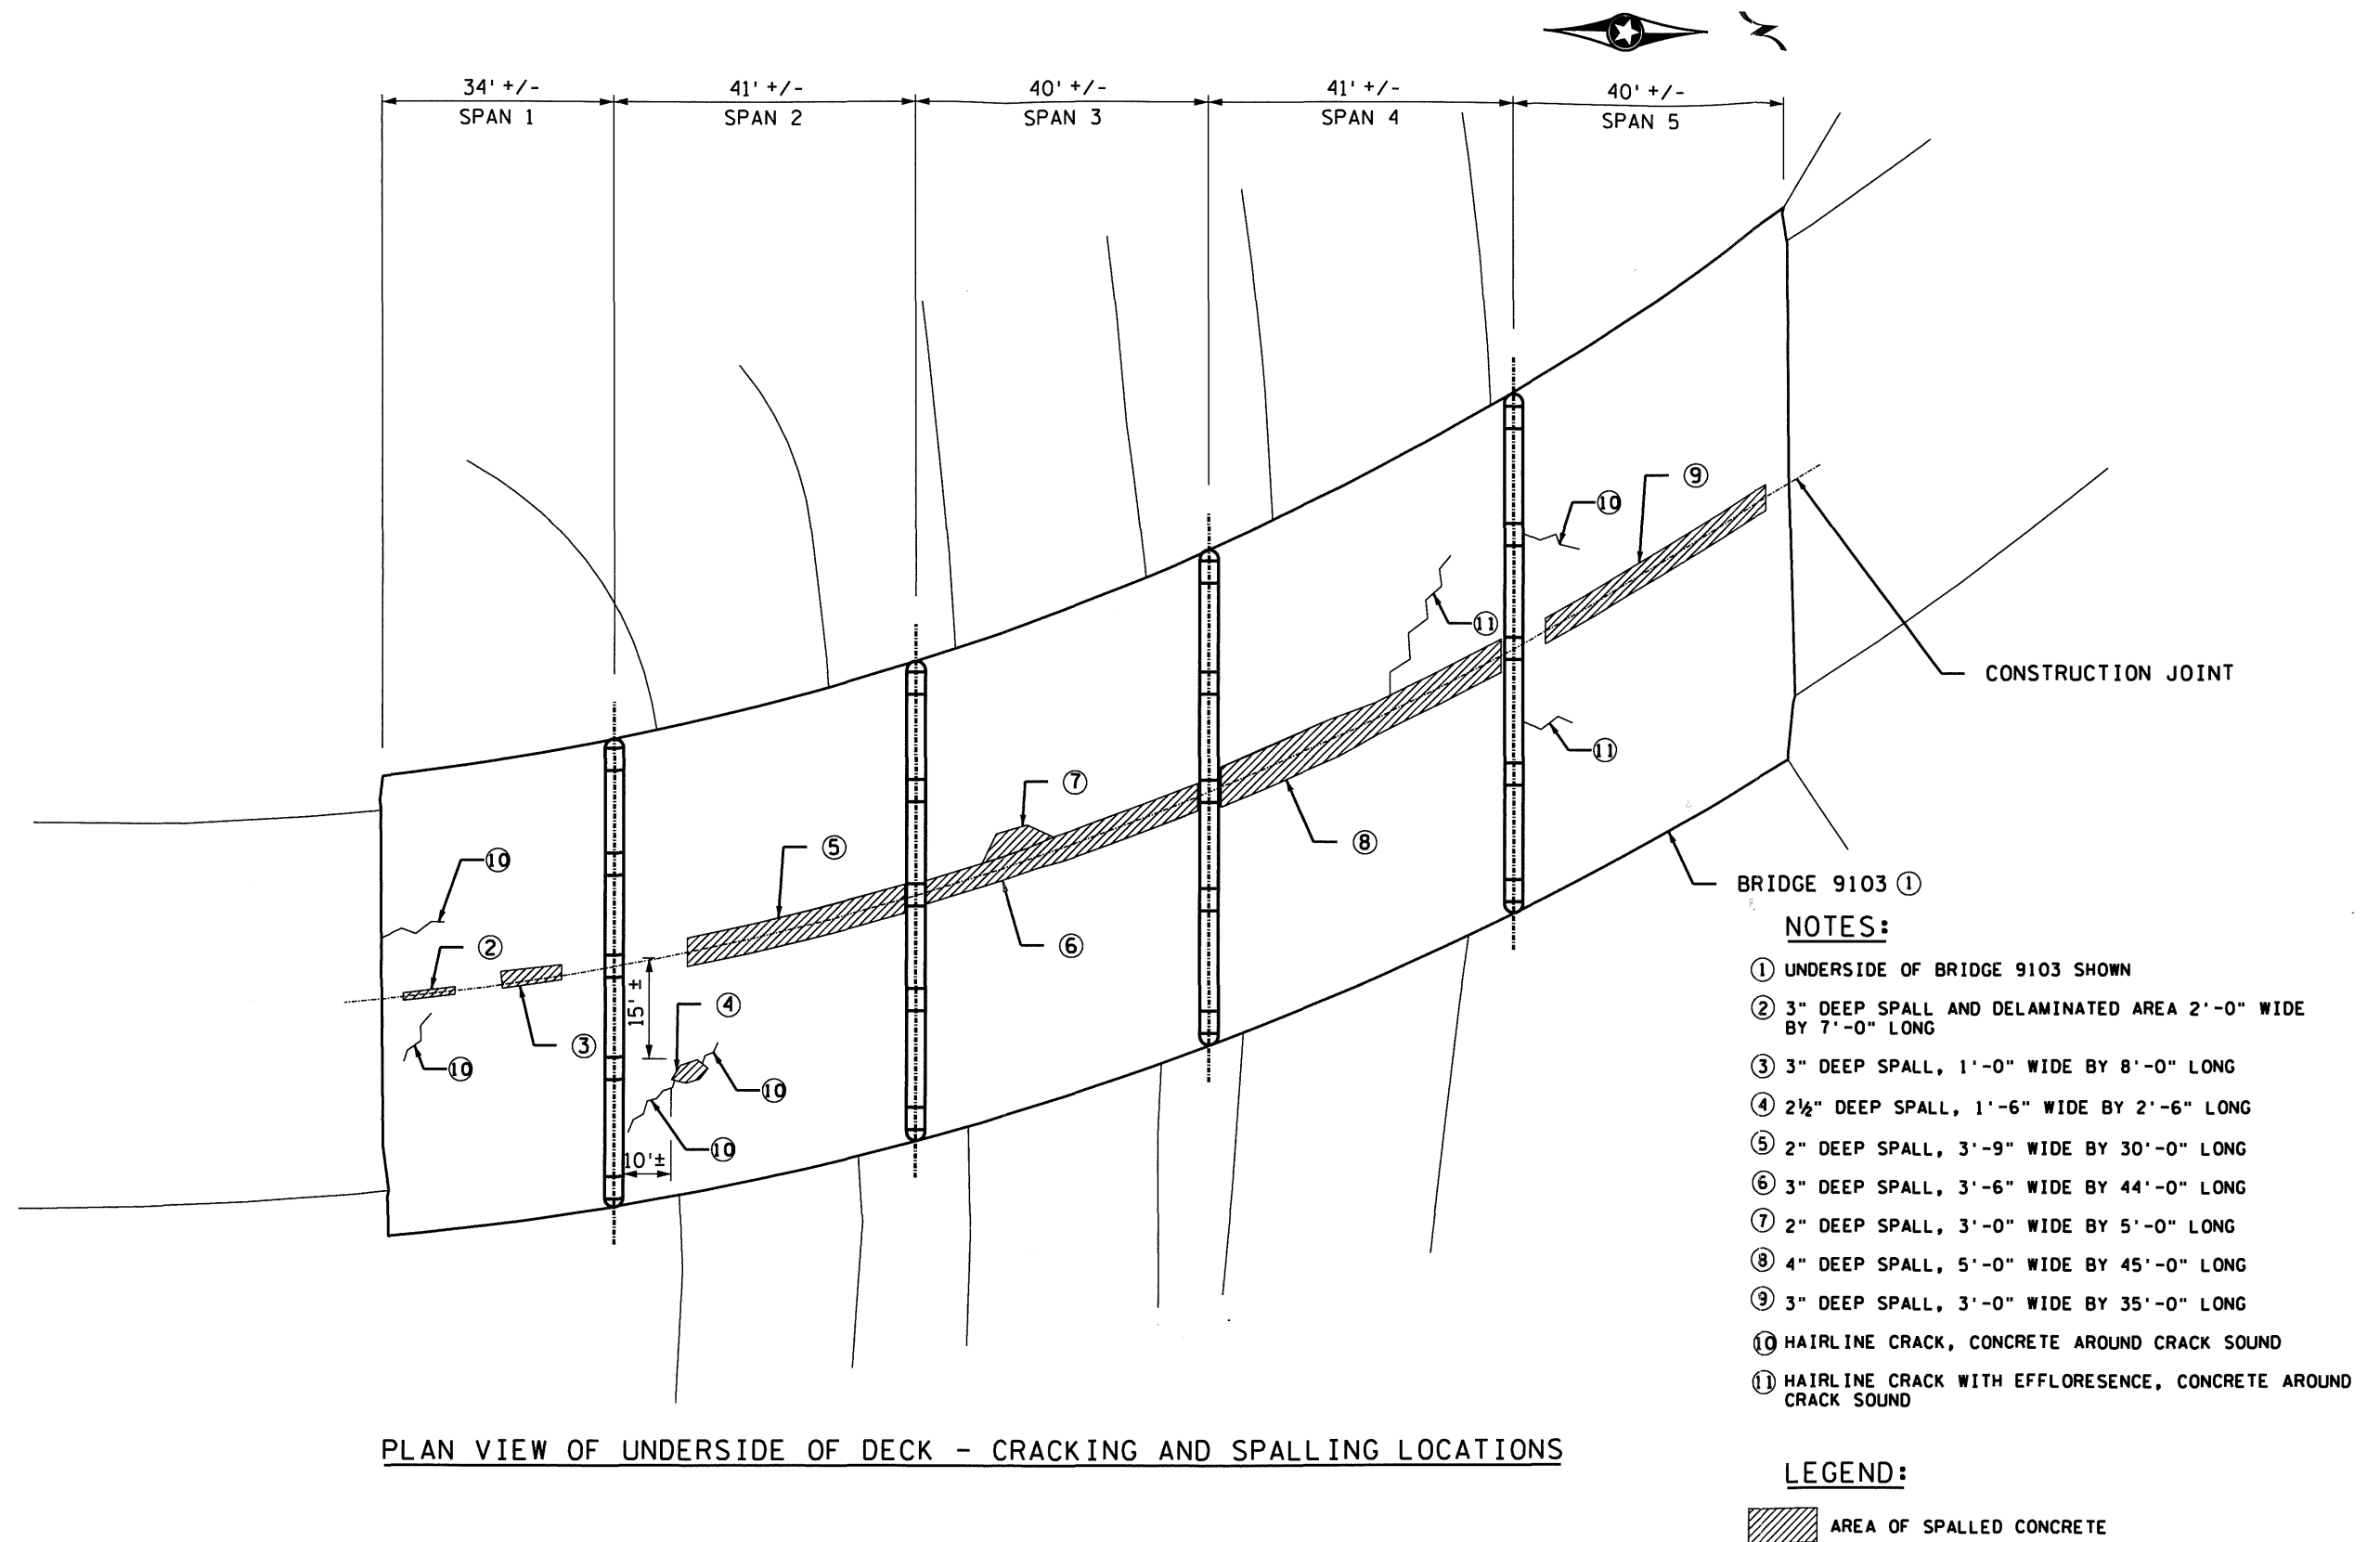
**APPENDIX G**  
**MAPPED AREAS OF CRACKING, SPALLING,**  
**AND DELAMINATION**

All of the areas of cracks, spalling and delamination have been mapped on a plan view of the bridge on Sheet 1 and 3 in Appendix G. All of the exposed reinforcing steel and the remaining diameter of several exposed bars have been recorded on Sheet 2 in Appendix G. The mapping of the areas of spalling and delamination was accomplished by visual inspection and by sounding the entire underside of the slab with a hammer from a bucket truck. When areas of sound concrete are hit with a hammer they make a solid "ping" sound while delaminated concrete makes a hollow "clunk" sound.

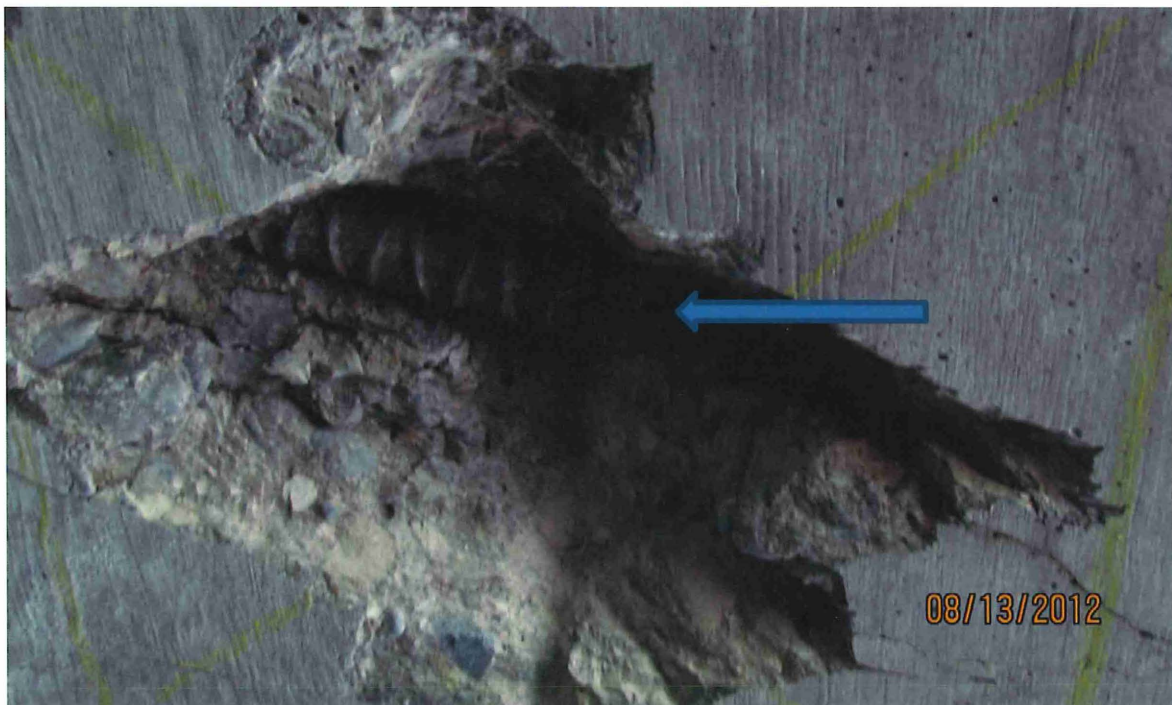
Sample # 1 Location 2' North of South abutment centered over a crack east of center line.
