# **Bridge 9103 Rehabilitation Study Final Report Red Wing, Minnesota**

**August 2013**

**Submitted to  
Minnesota Department of Transportation**

**Prepared by  
HDR Engineering, Inc.  
and  
Gemini Research**

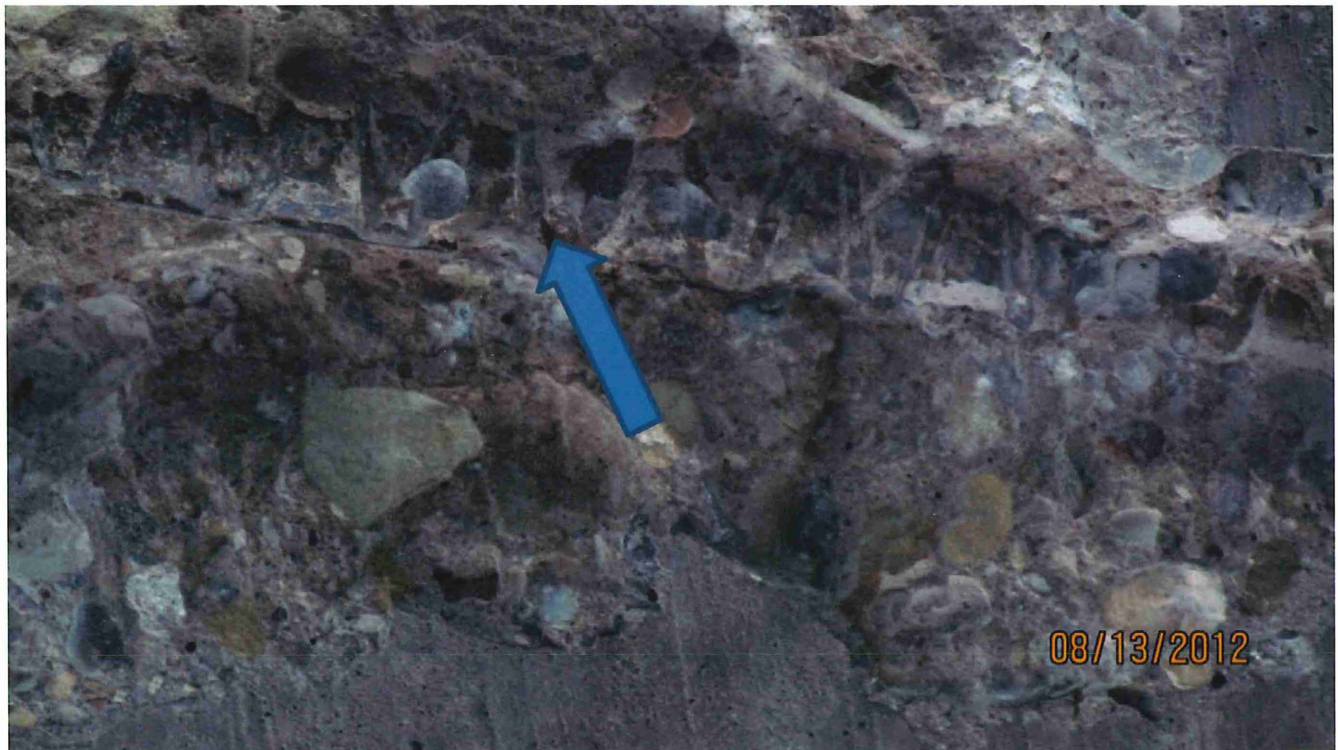
Sample # 5 is 10' North of Pier #2 and 3' west of center line near an area of delamination and spalls.

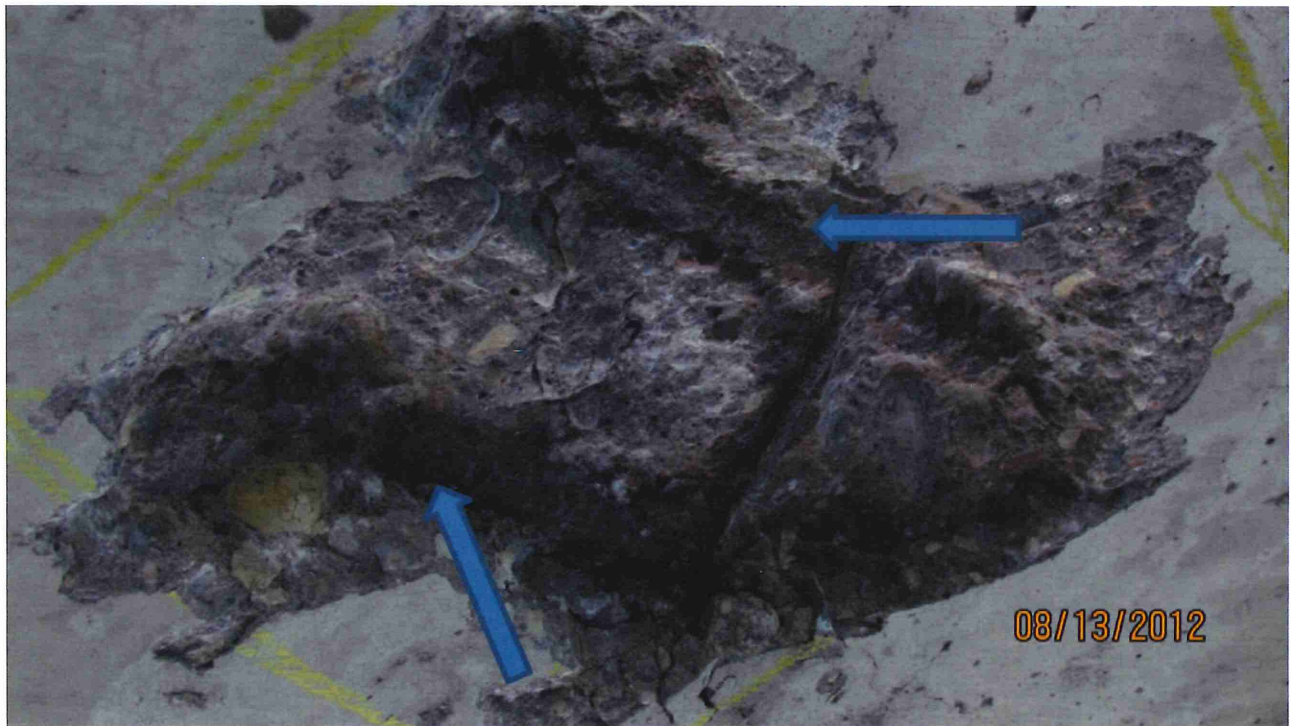
Sample # 6 is 16' 5" South of Pier #4 and West 5' of center line. This location show signs of cracking and pour consolidation of concrete.
