**PROJECT: Senate / New Legislative Office Building
St. Paul, Minnesota**

Consultant's Report

Report No.: E8666.01-201-43

Report Date: 08/07/15

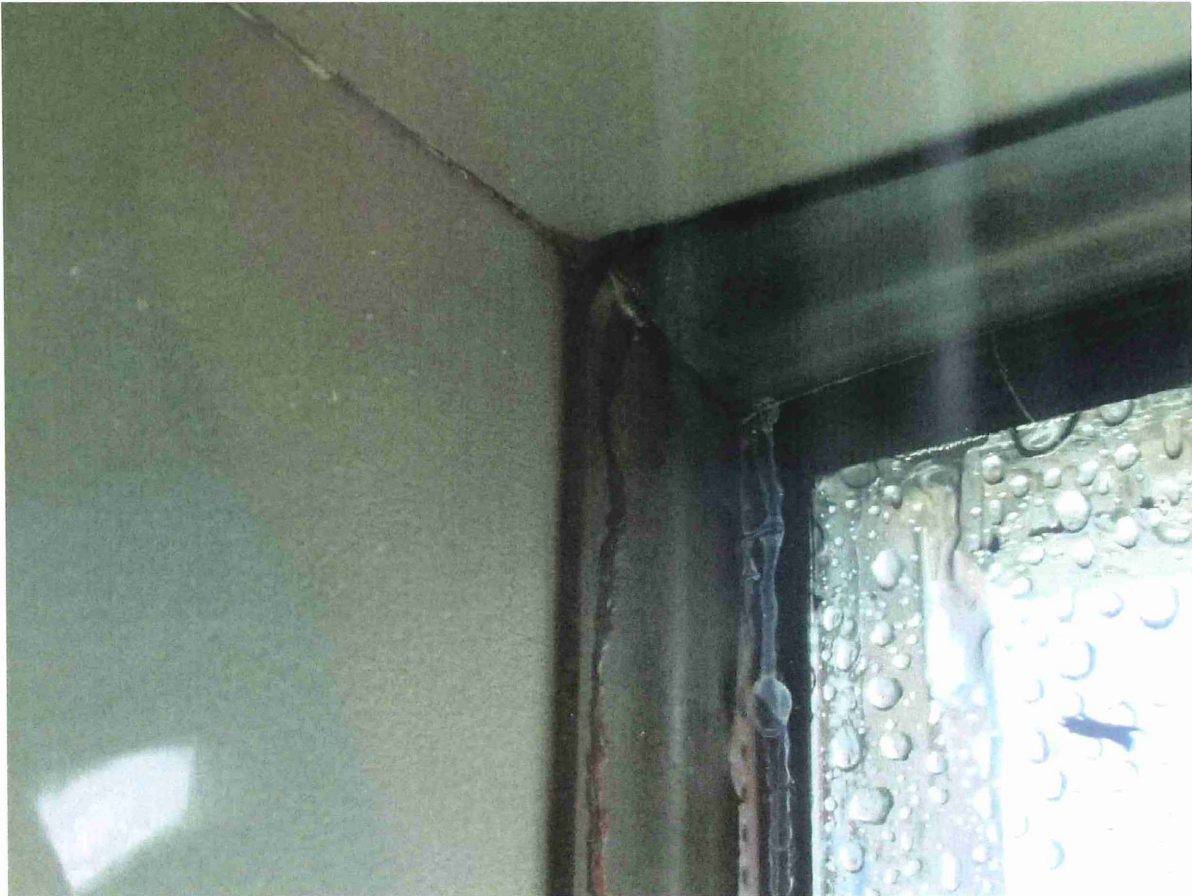
Note 1: 3-1/2 minutes into the test moisture was observed on the top glazing gasket of the lower left lite. At the completion of testing dampness was observed on the precast below the lower right lite. InterClad personnel removed the exterior snap trim and pressure plates exposing the primary seal and zone dams. No anomalies were observed.

Glazing leak at the upper left corner of lower left lite.

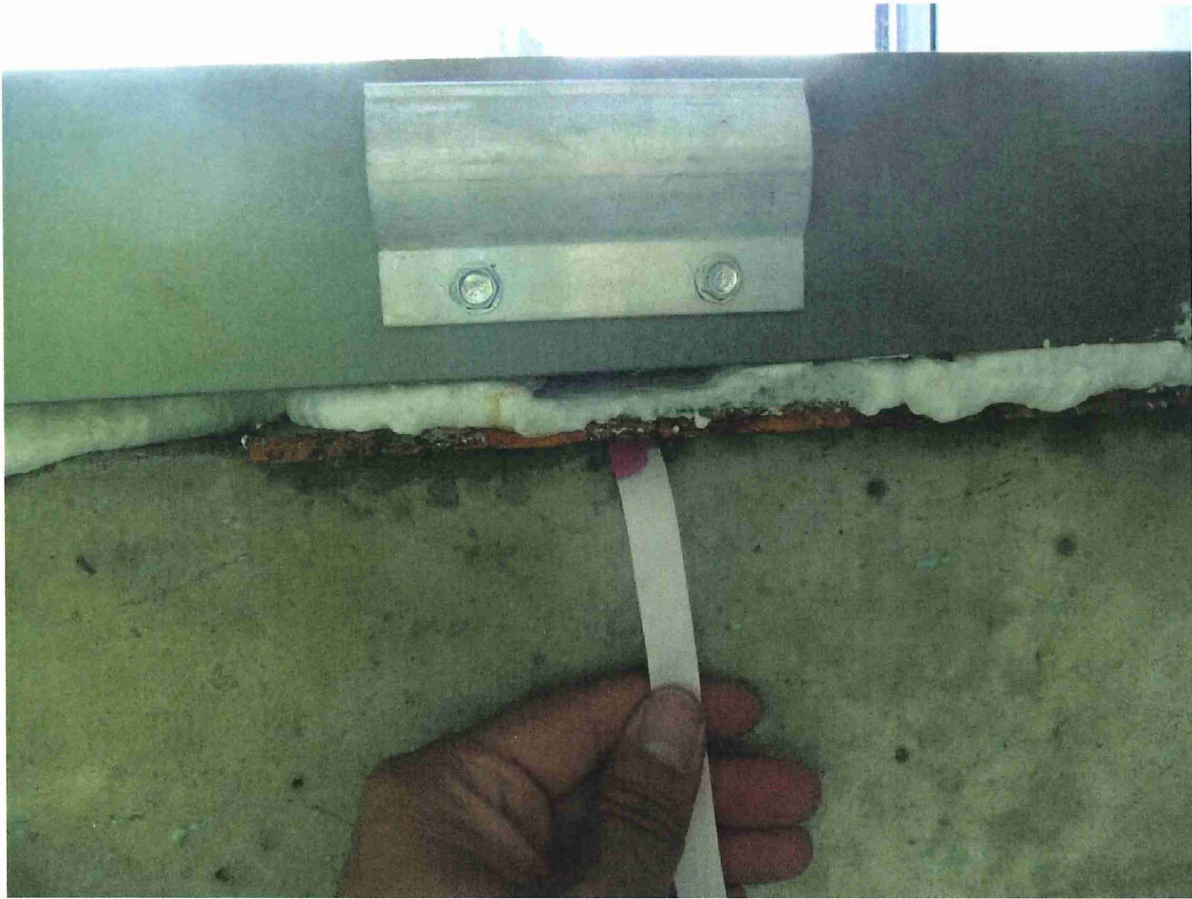
Water observed below the anchors at the sill.
