FIELD TEST REPORT

**PROJECT: New Replacement Windows – Phase III
State Capitol Building
St. Paul, Minnesota**

Report No.: D7138.03-201-43
**Test Dates: 07/22/15
07/23/15
07/24/15**
Report Date: 08/07/15

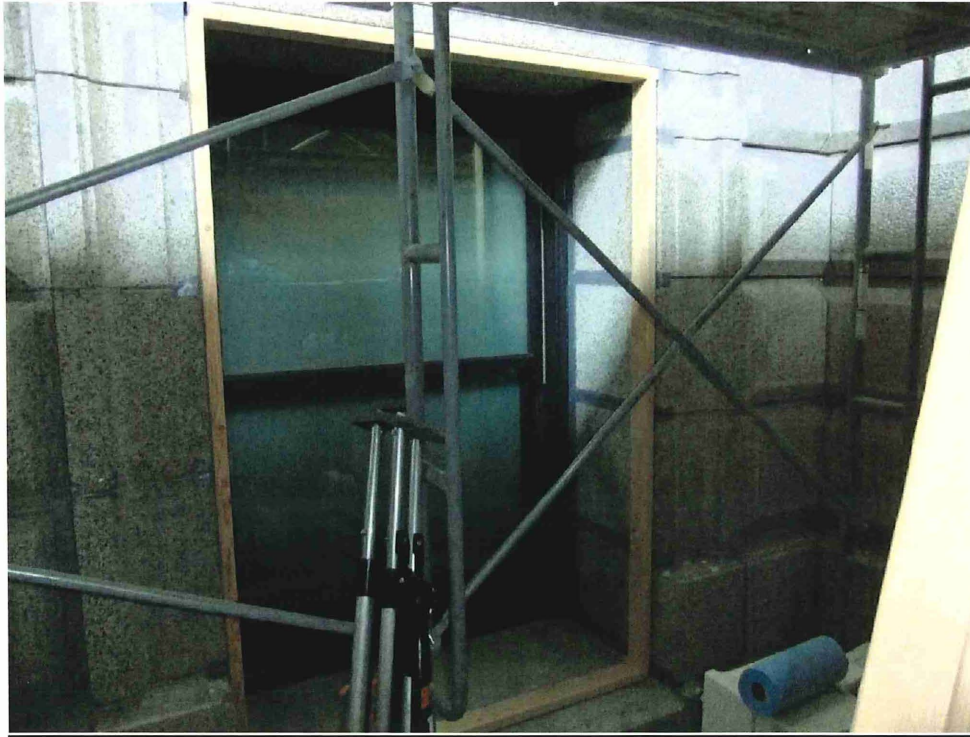
Photo No. 1: Exterior isolation (typical).

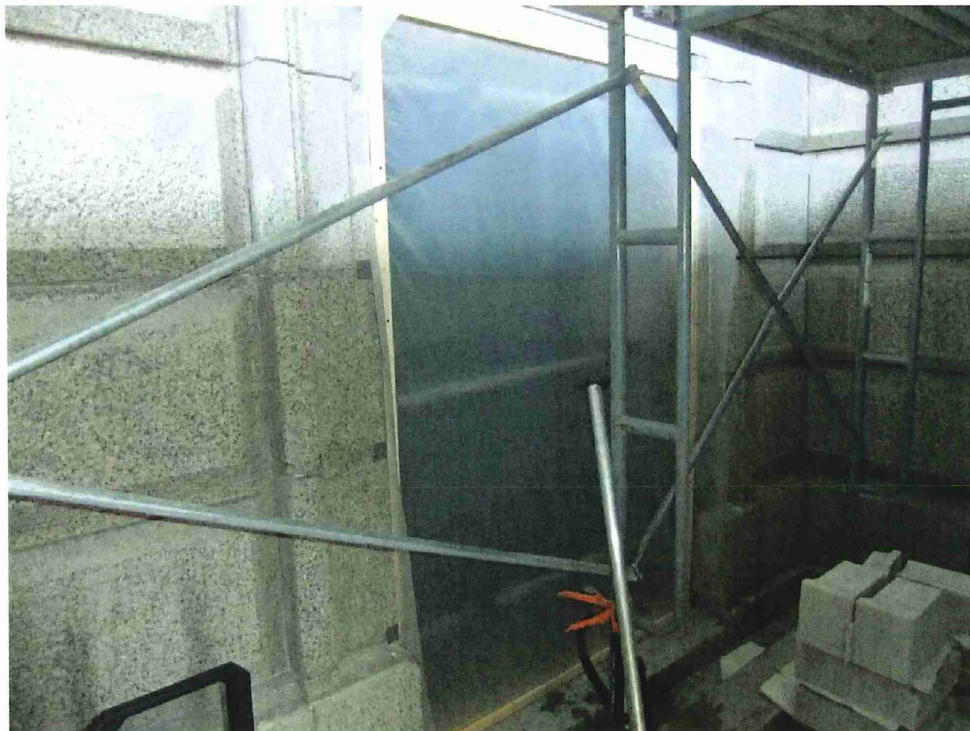
Photo No. 2: Exterior view with chamber installed (typical).

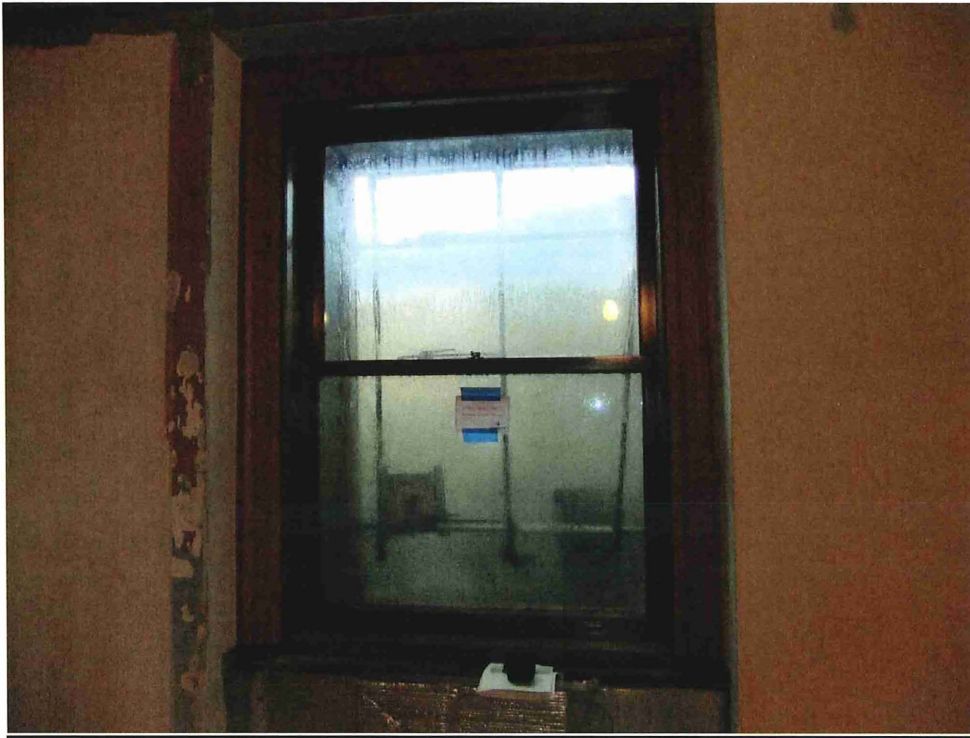
Photo No. 3: Interior view (typical).
