# *Prosperity & Chariot Top* Installation Report

May 7, 2015

## JENSEN CONSERVATION SERVICES, INC.

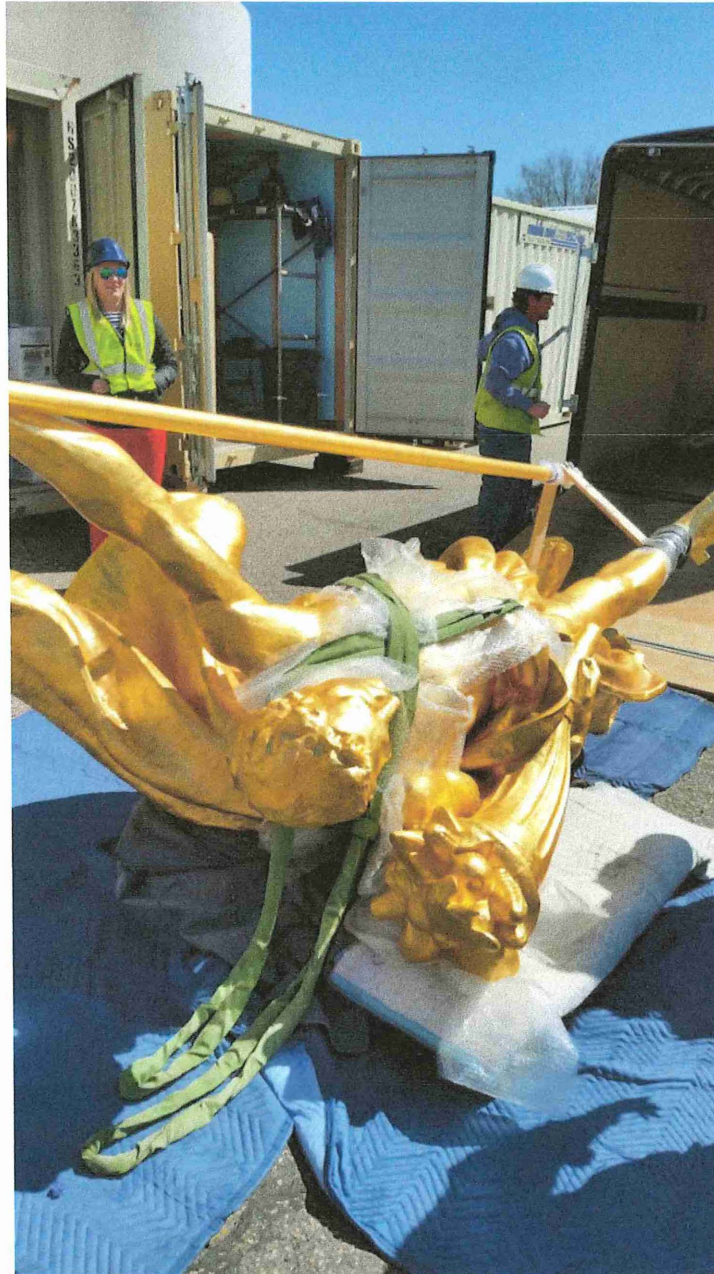
*Prosperity* is illustrated with rigging and braces, ready for the lift to the *Quadriga*. Bubble wrap protects gold surfaces during the lift.

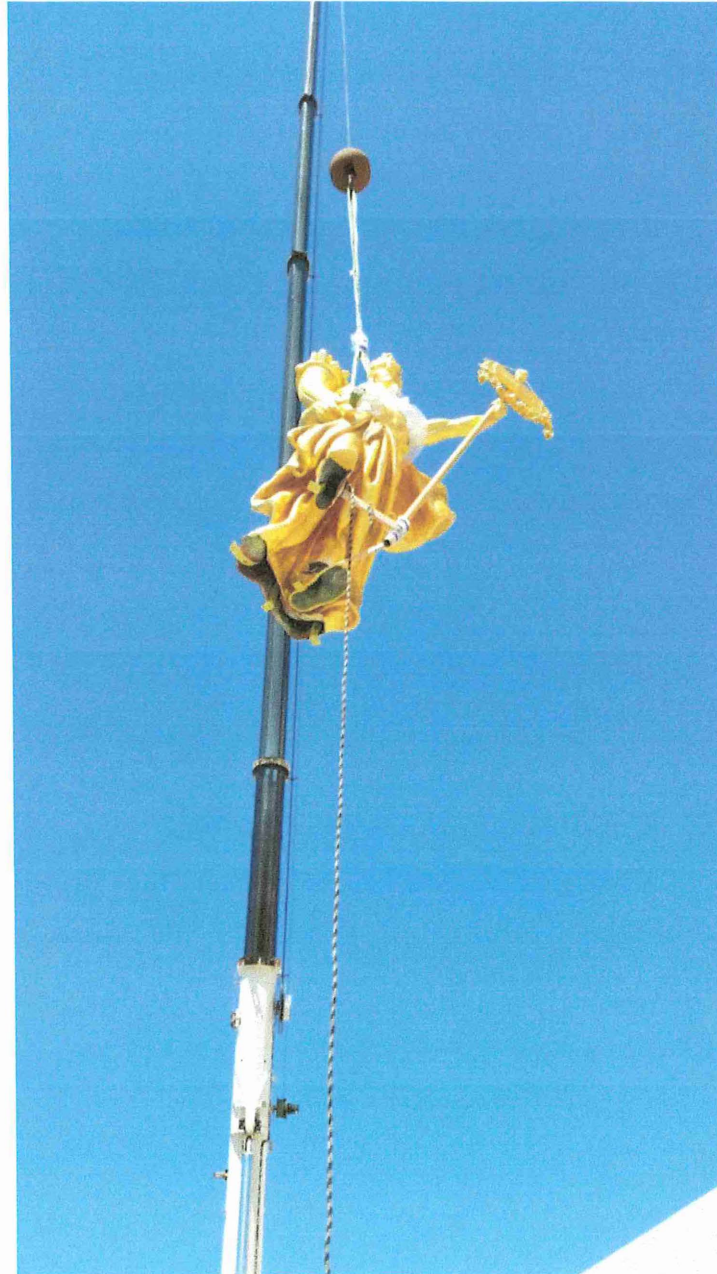
*Prosperity* is illustrated during the lift by Rocket Crane of New Hope, MN.

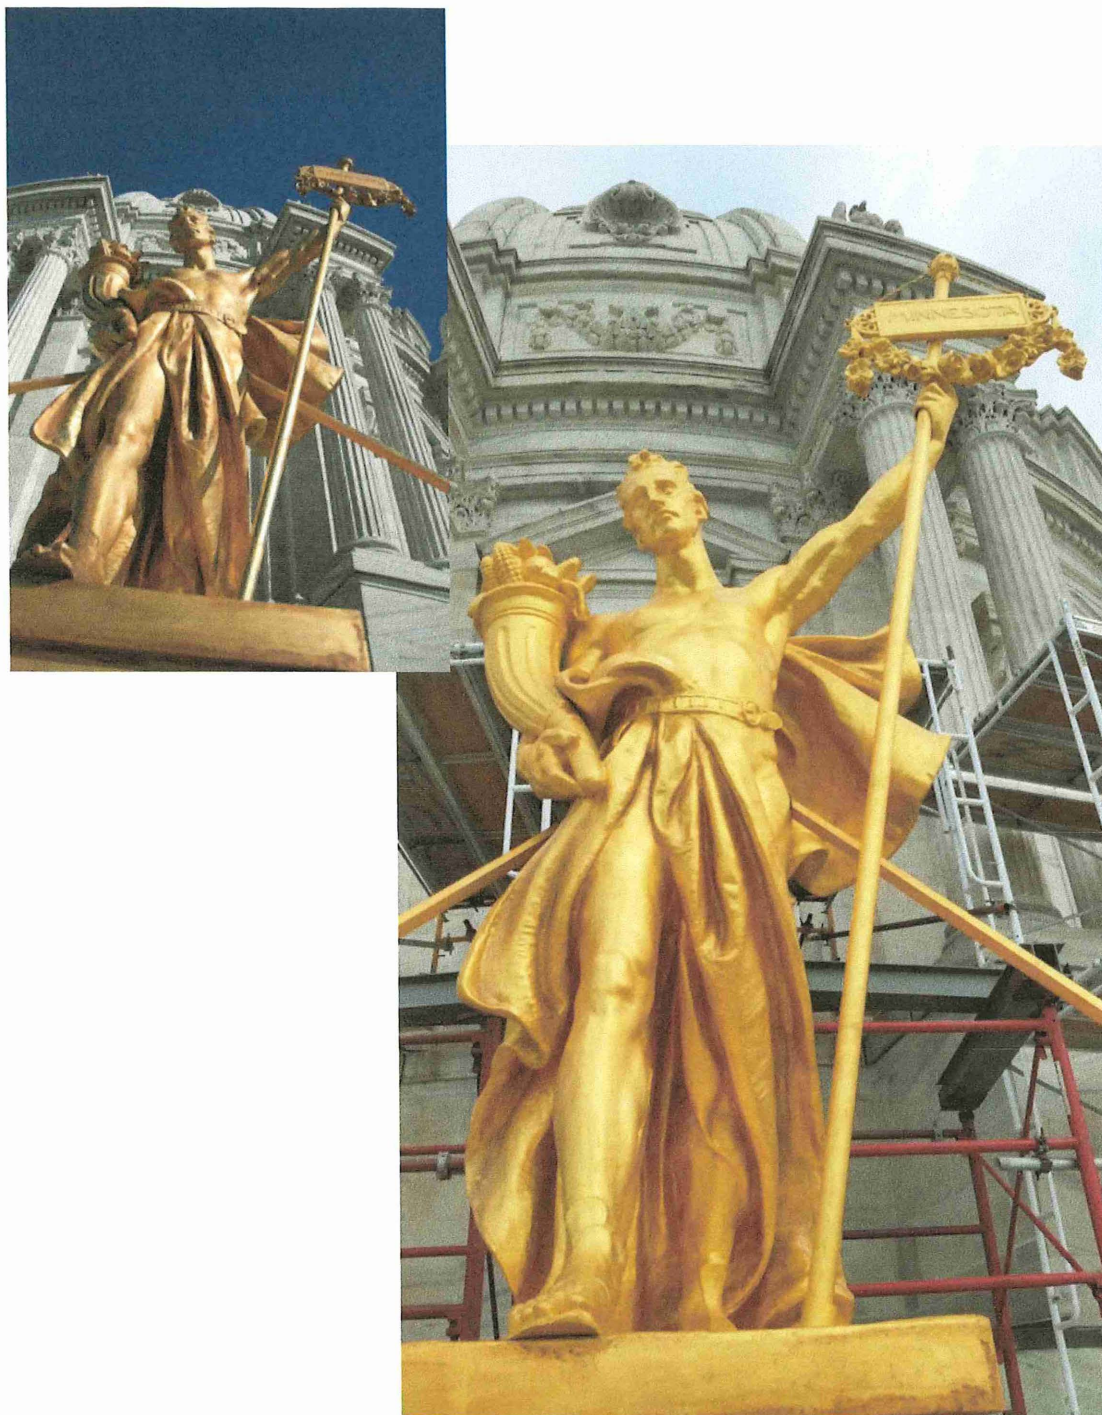
*Prosperity* is illustrated after installation, front view. Smaller insert is before treatment.

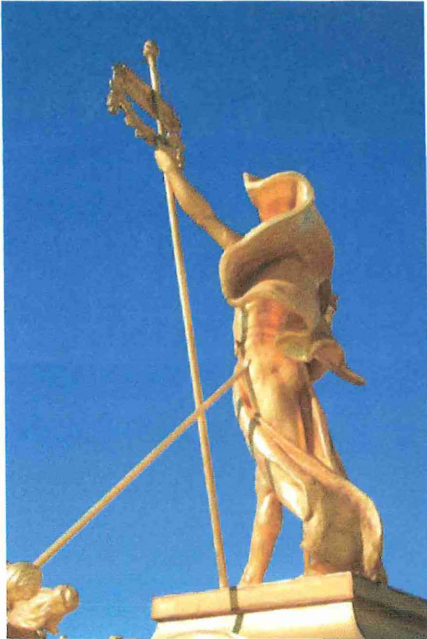
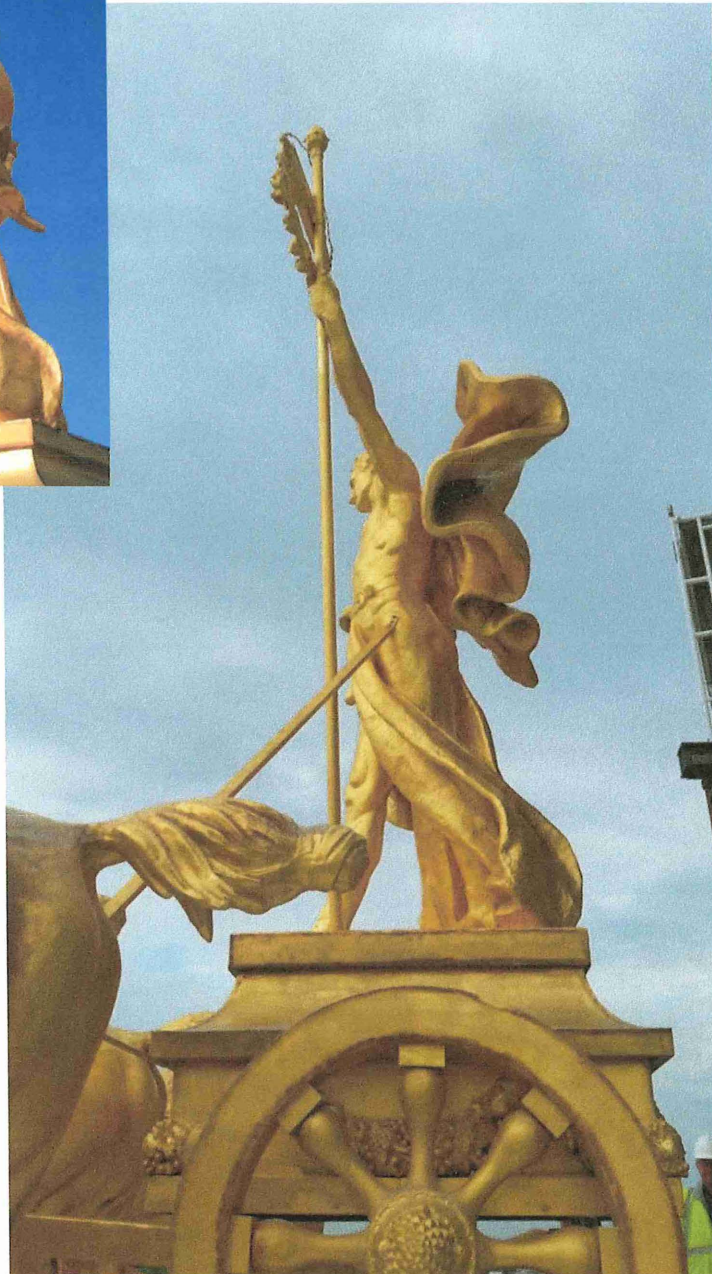
*Prosperity* is illustrated after installation, proper left side. Smaller inset image is before treatment.

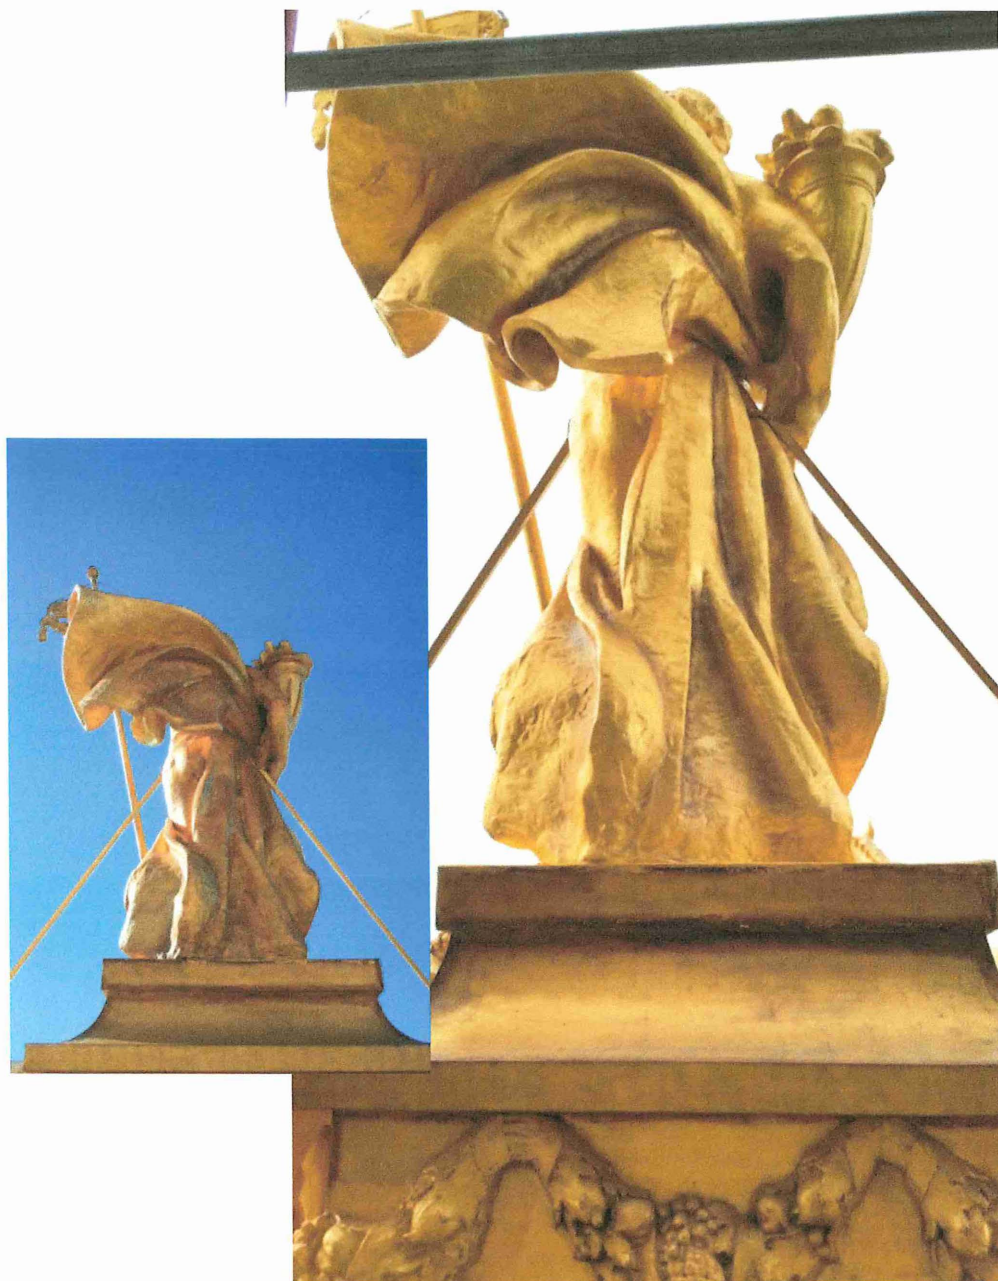
*Prosperity* is illustrated after installation, proper right side. Smaller insert is before treatment.

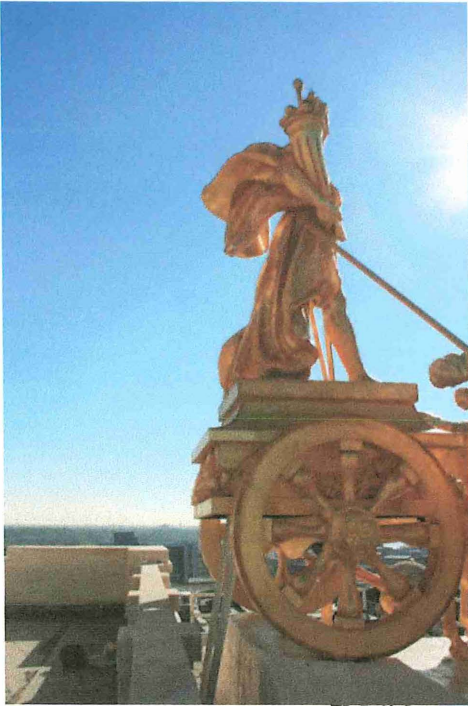
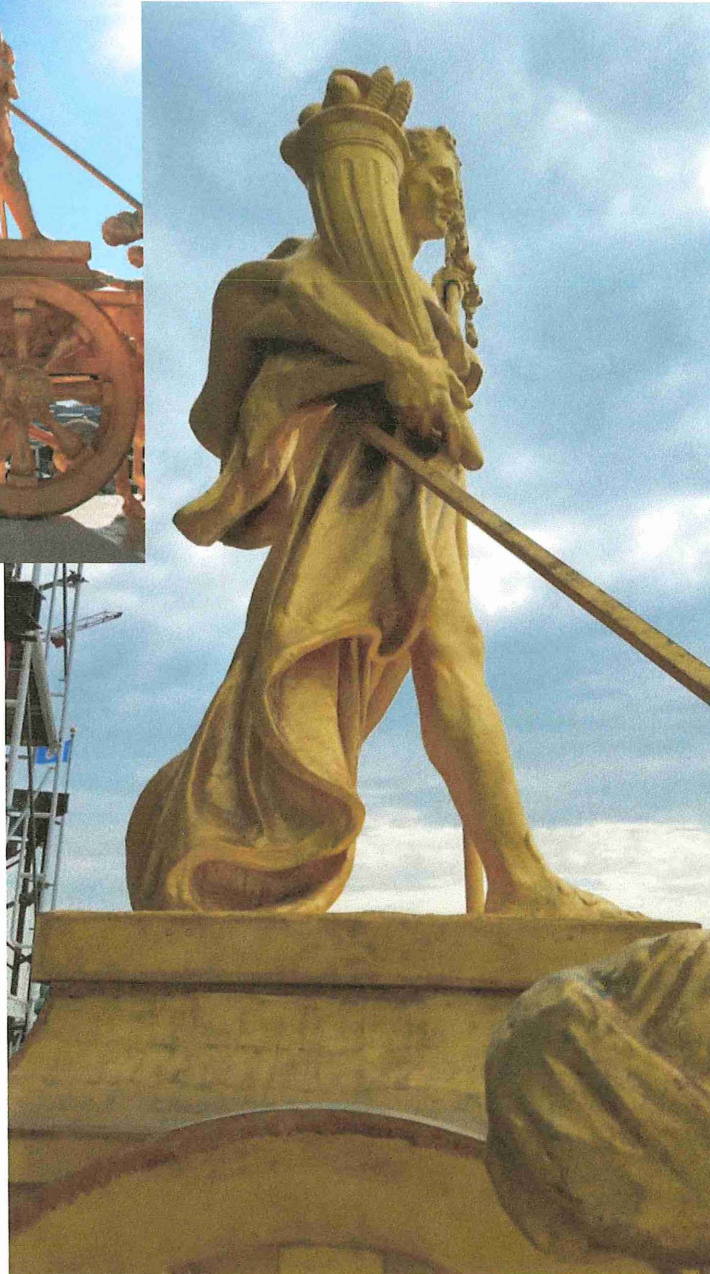
*Prosperity* is illustrated after installation, proper right side. Smaller insert is before treatment.

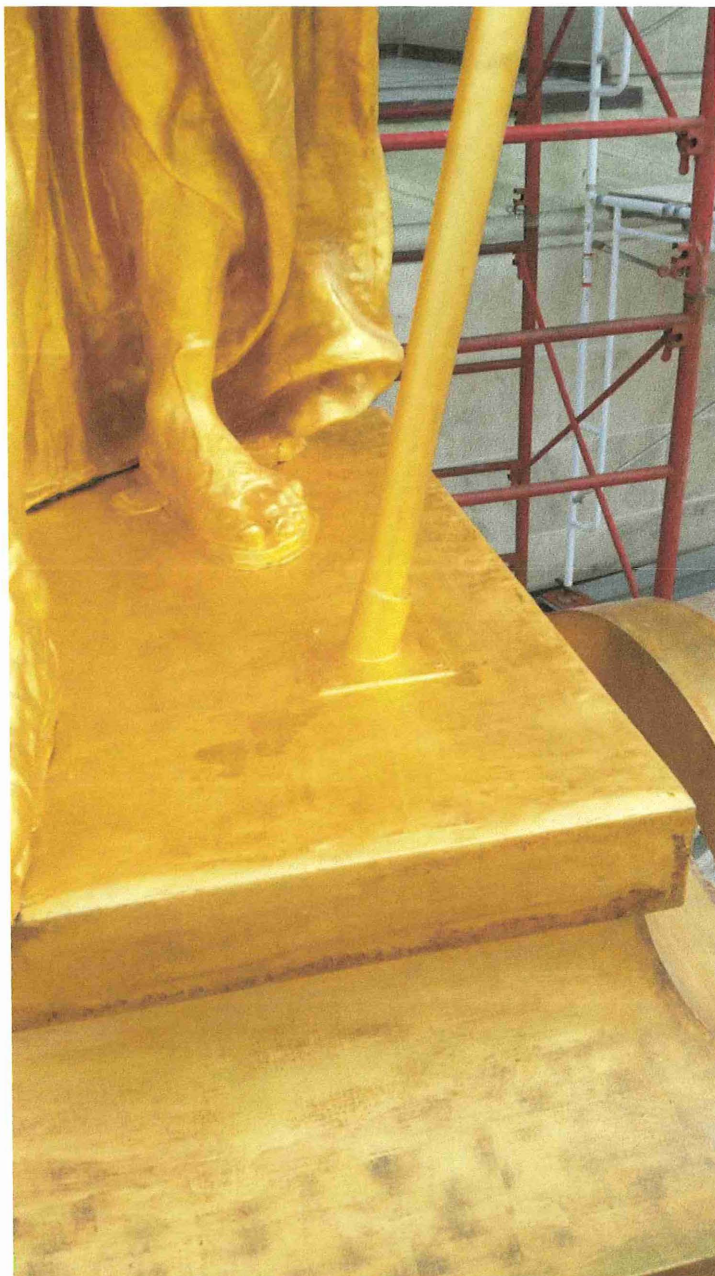
The top of the chariot, proper left side, is illustrated after installation of *Prosperity* is complete. Two stainless steel bolts were used to secure the newly fabricated copper support at the base of the pole. The leading edge of the gap between the cylinder and the pole was closed with silicone caulk. The perimeter of the square footprint of the support was closed with polyester spot putty and all surfaces were gilded. Beneath the pole, weep holes drilled through all three layers of metal will accommodate drainage of condensate. Set screws through the support cylinder secure the pole in a fixed position.

The pole supporting the MINNESOTA banner was secured to the copper and stainless steel plates of the chariot top with a newly fabricated stainless steel support. The support includes a cylindrical collar welded to a square base. Surfaces are primed and gilded. The support is secured to the copper and stainless steel plates with two stainless steel bolts of 1/4" diameter. Weep holes were included in the support and both copper and stainless steel plates. Two set screws, installed through tapped holes in the cylinder wall secures the upright, slanted pole at

the desired placement. The leading edge of the gap between the cylinder wall and pole was filled with silicone caulk and covered in 23 carat gold leaf.

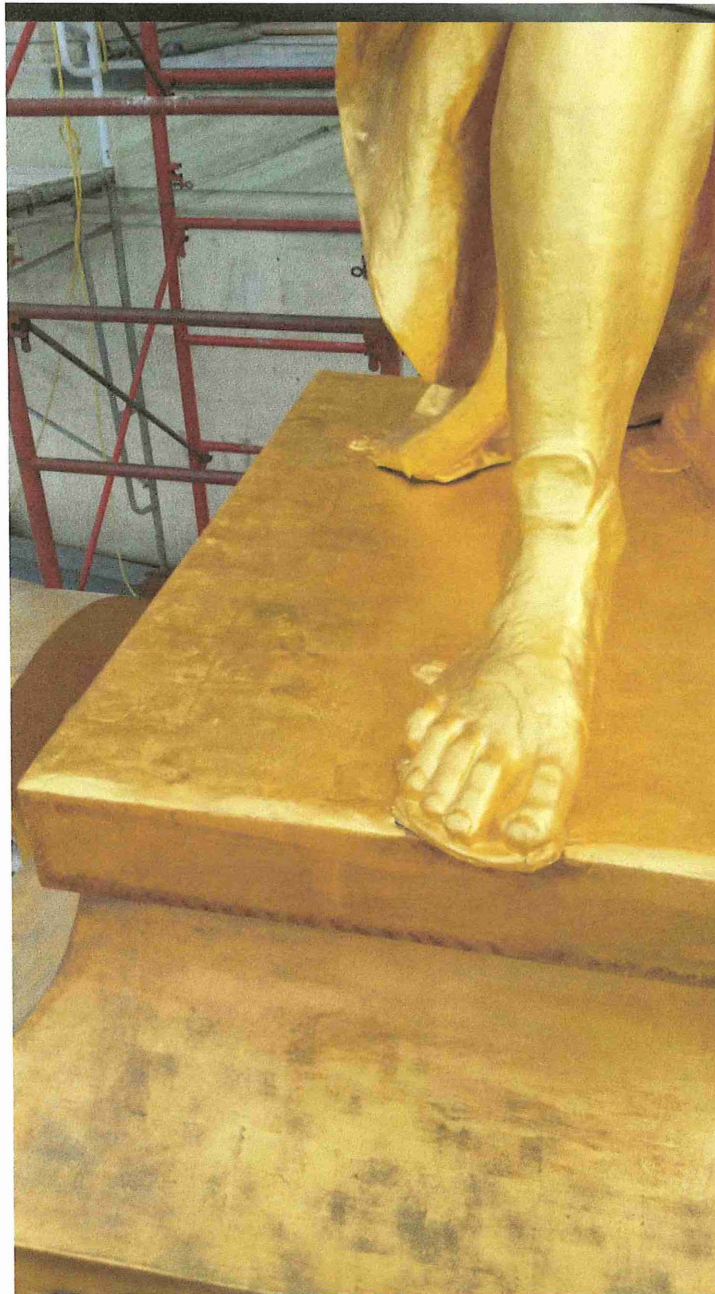
The chariot top is illustrated after installation, proper right side. Bolt heads have been covered with polyester body putty and gold leaf.

Five newly manufactured internal "statue hold down straps" or stainless steel "brackets" were secured to the chariot using stainless steel anchor bolts measuring 5/16" diameter to replace the failed 1/4" diameter bronze bolts. A total of 10 anchors were installed. Proper right and left sides of the copper top of the chariot were secured using 1/4" diameter pan head stainless steel bolts to replace former rivets. Bolts were installed through existing holes. Bolt heads were disguised with polyester fill material (Bondo body putty) and 23 karat gold leaf.

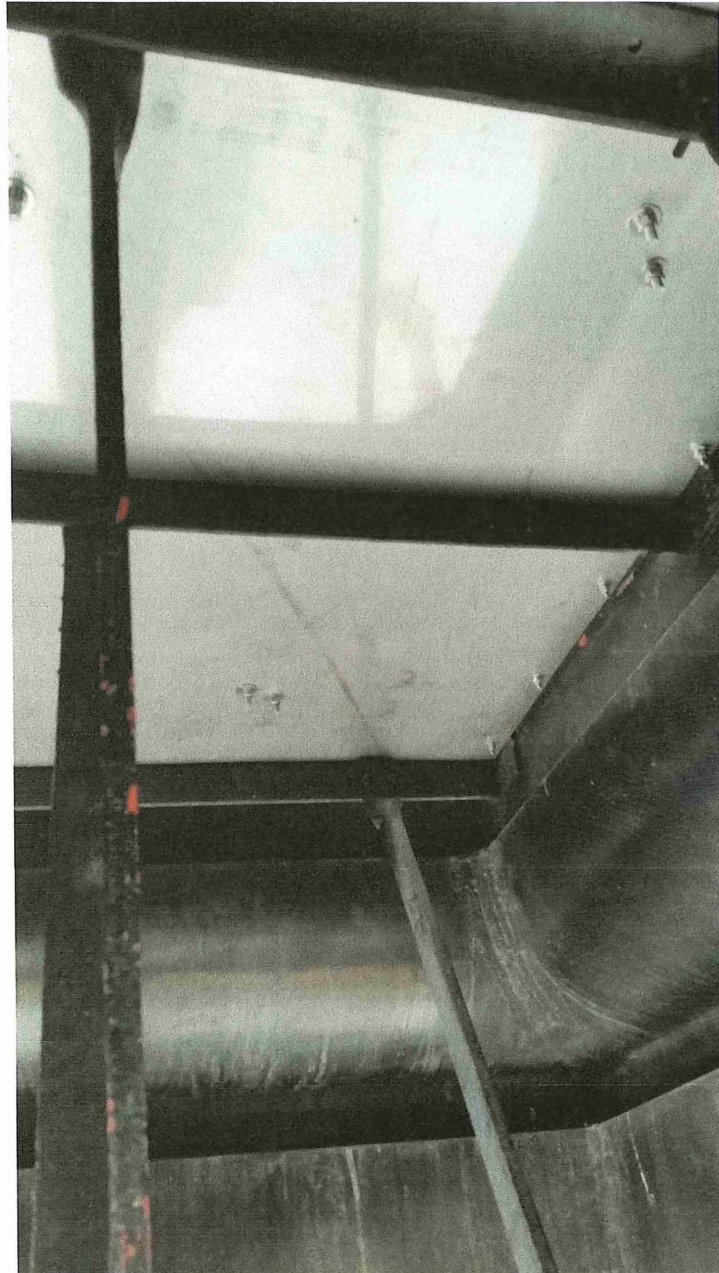
The underside of the chariot is illustrated with the stainless steel plate in place and stainless steel bolts visible.

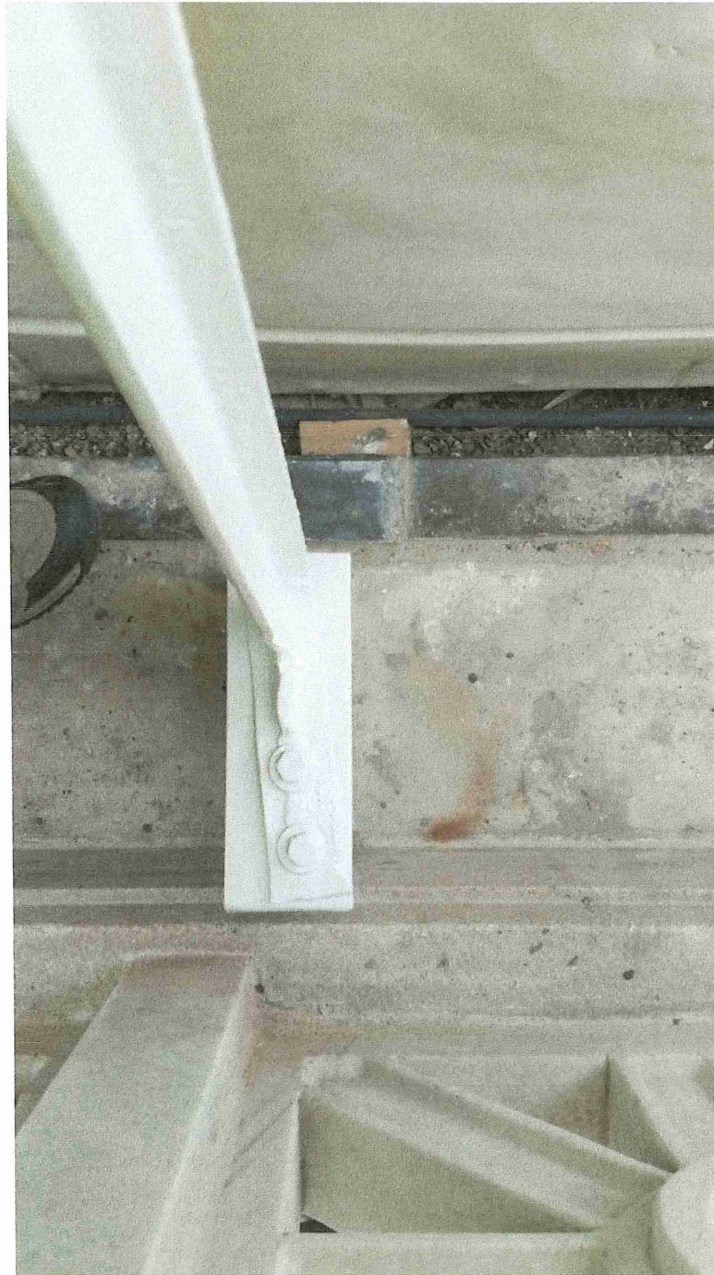
Two tie down straps located at the rear of the chariot (extending from the chariot to steel boxes attached to the building masonry) were cleaned of flaking paint and loosely adhering products of corrosion. The corrosion thought originally to be cracked metal proved to be a loose flake of corrosion and it was brushed away. The metal is not cracked. Shallow depressions inside the bends of the tie down straps were filled with polyester body putty, shaped and smoothed to direct drainage of rainwater away from the depression.
