APPLETON AREA OHV RECREATIONAL PARK

Richard Otten
Certified Energy Manager, #16973
Association Energy Engineers
608 North Freeman
Luverne, MN 56156
(507) 227-5103
richardaotten@yahoo.com

Consultant's Report

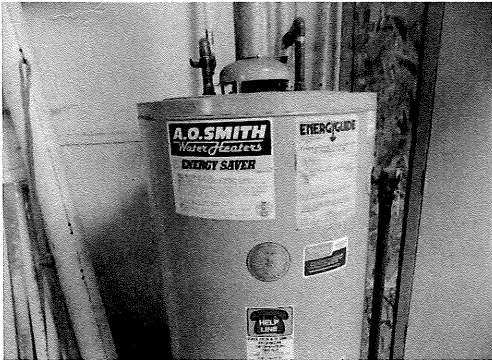
This is a 50 Gallon AO Smith water heater. Most of the operation costs are standby losses. Recommend replacement with 4 gallon under the sink unit.

The gas water heater can be replaced with an electric under the counter water heater. This will save on standby losses incurred by the 50 gallon electric.

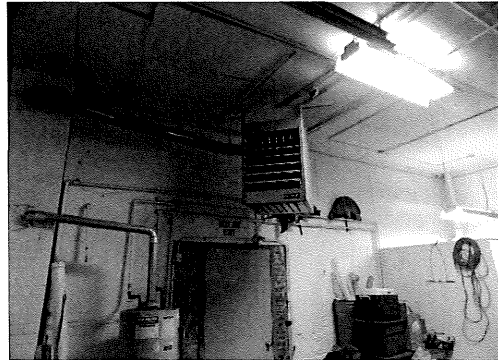
The hanging reznor furnace heats the south portion of the building.

The furnace should be replaced with a high efficiency forced air furnace which could be hung in the same location as the existing Reznor furnace the condensate line run to the bathroom drain system.

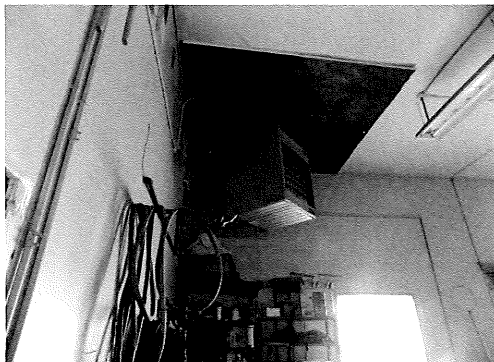
The space heater on the unheated side of the building is not used.

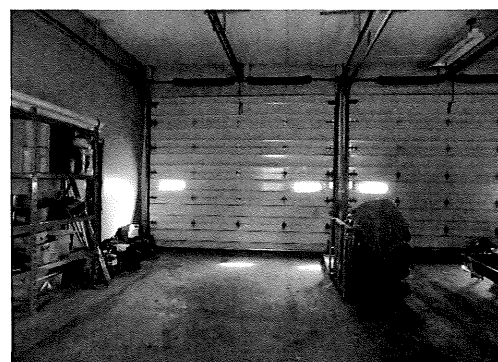
The overhead doors on heated side are insulated and the weather-strip is good.

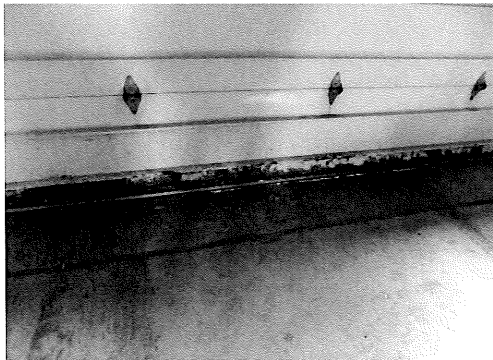
The heated side overhead doors weather-stripping is good, the unheated side weather-stripping is in poor condition. The windows of the unheated side are also in poor condition. These items have little relevance to energy consumption.

The garage door astragal is deteriorated on unheated side of building.

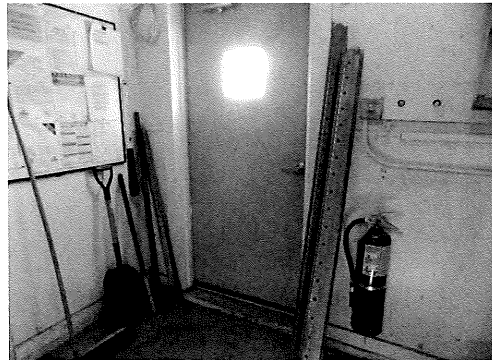
The side entry door should be replaced with a steel insulated door both for security and energy savings.

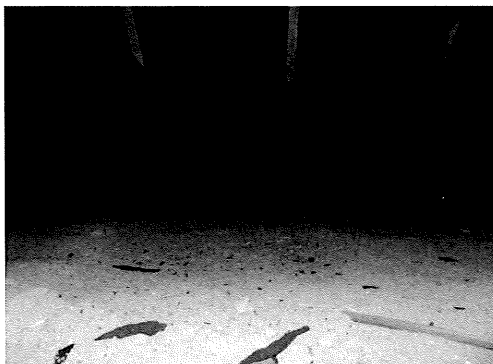
There is about 12" insulation in the attic. There would not be a considerable savings by adding 4" to attic. The walls contain expanded foam which appears to be contracted. Not much that can be done without major renovation of the sidewalls.

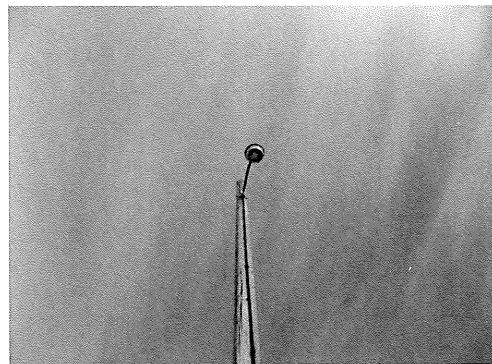
This security light was not consider as part of the usage because manager thought it may be a separate billing. An LED retrofit would save on energy costs if it is part of the existing usage.
