LEGACY FUND RESTORATION EVALUATION REPORT

Technical Panel Findings and Recommendations—Fiscal Year 2015

Report to the Legislature

October 2016

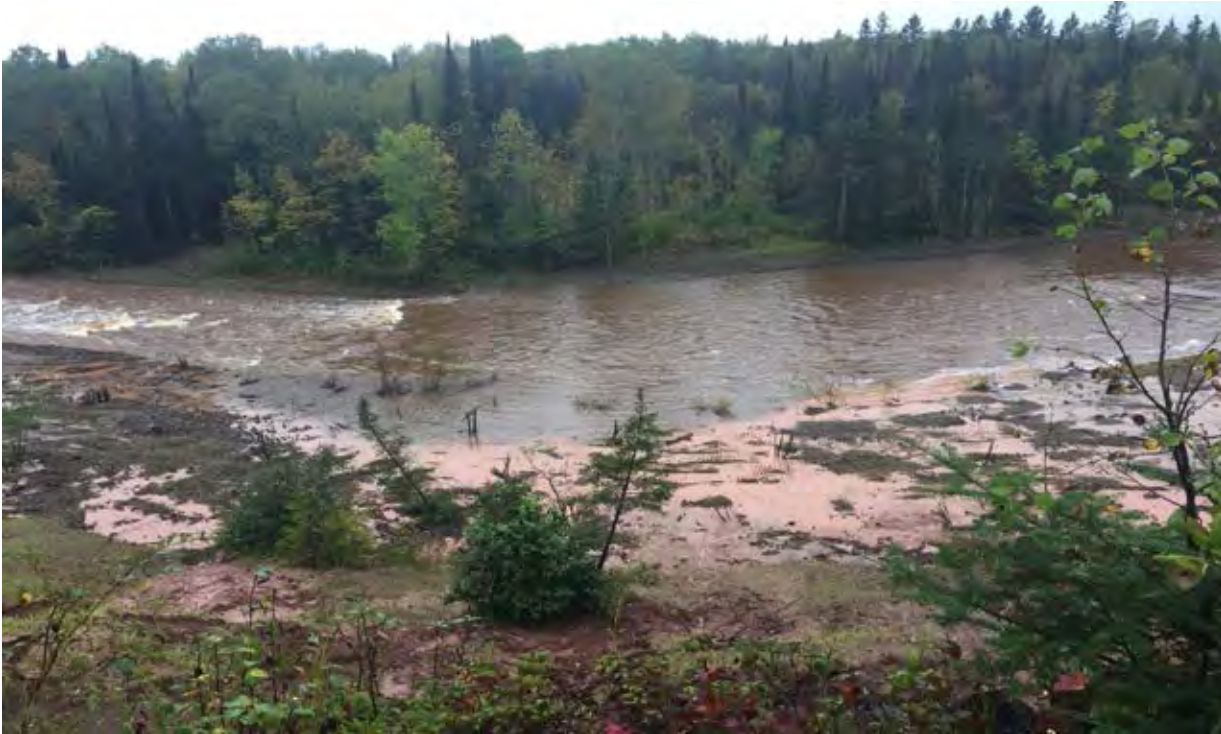
Figure 5 - Representative image of stabilization (bankfull bench). As illustrated in the photograph the created bankfull bench was appropriately being accessed (over-topped) by a near bankfull flow event.

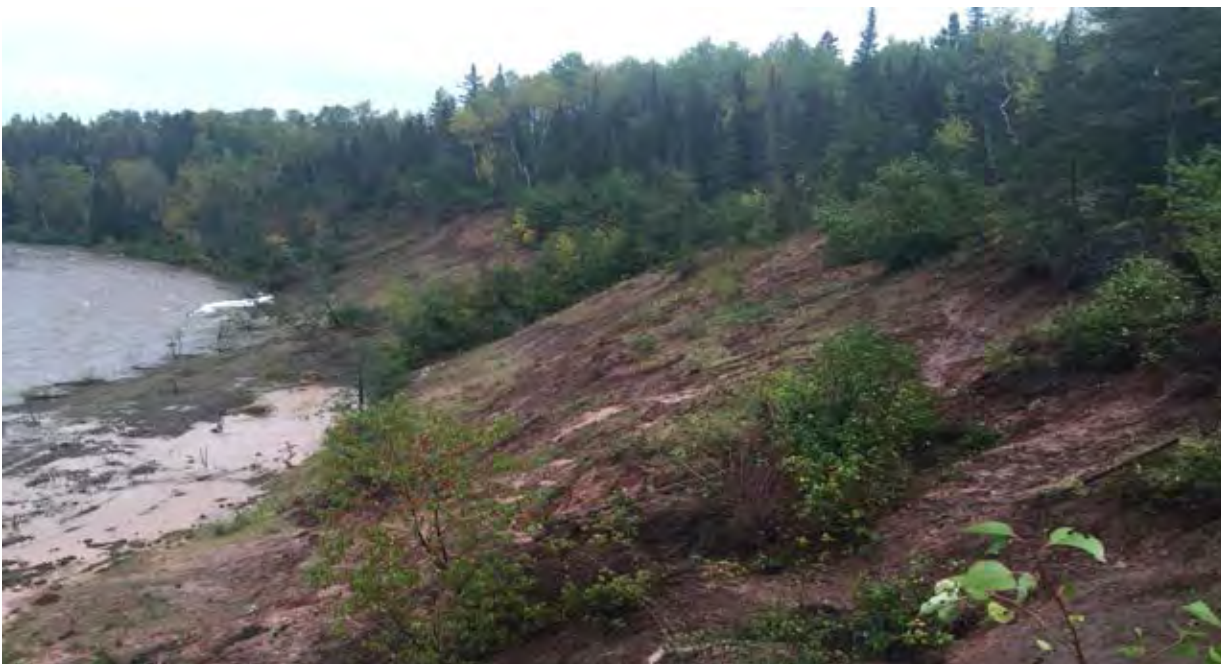
Figure 6 - Representative image of stabilization (bluff). As visible in photograph the attempt to establish vegetated cover on the clay bluff in question (right side of image) via hydroseeding is showing early signs of failure. It is acknowledged though that the primary project means for reducing sediment from the bluff is the realignment of the stream away from the bluff and the creation of a stable bluff toe and associated bankfull bench.

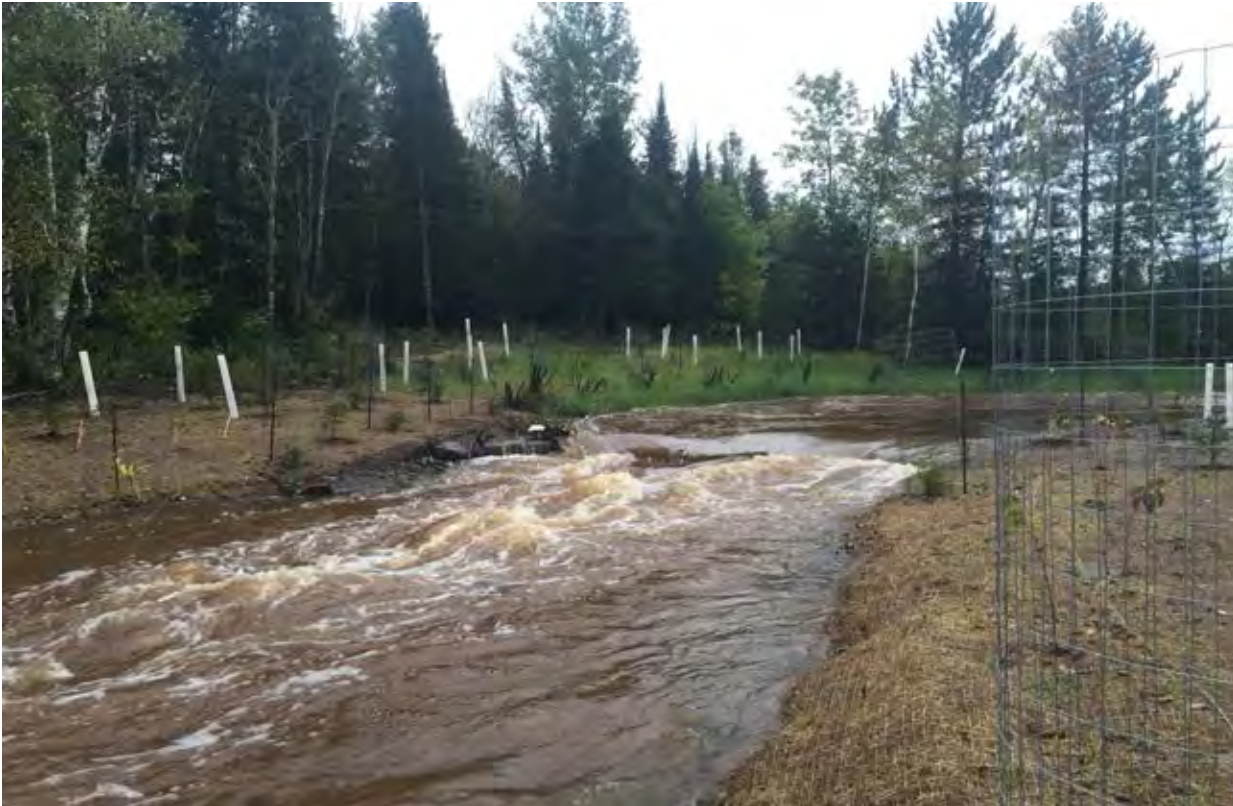
Figure 3 - Representative image of stabilization. Note the grade control structure (center images) was a project add-on (understood to have been requested and/or funded separately by Minnesota Trout Unlimited).

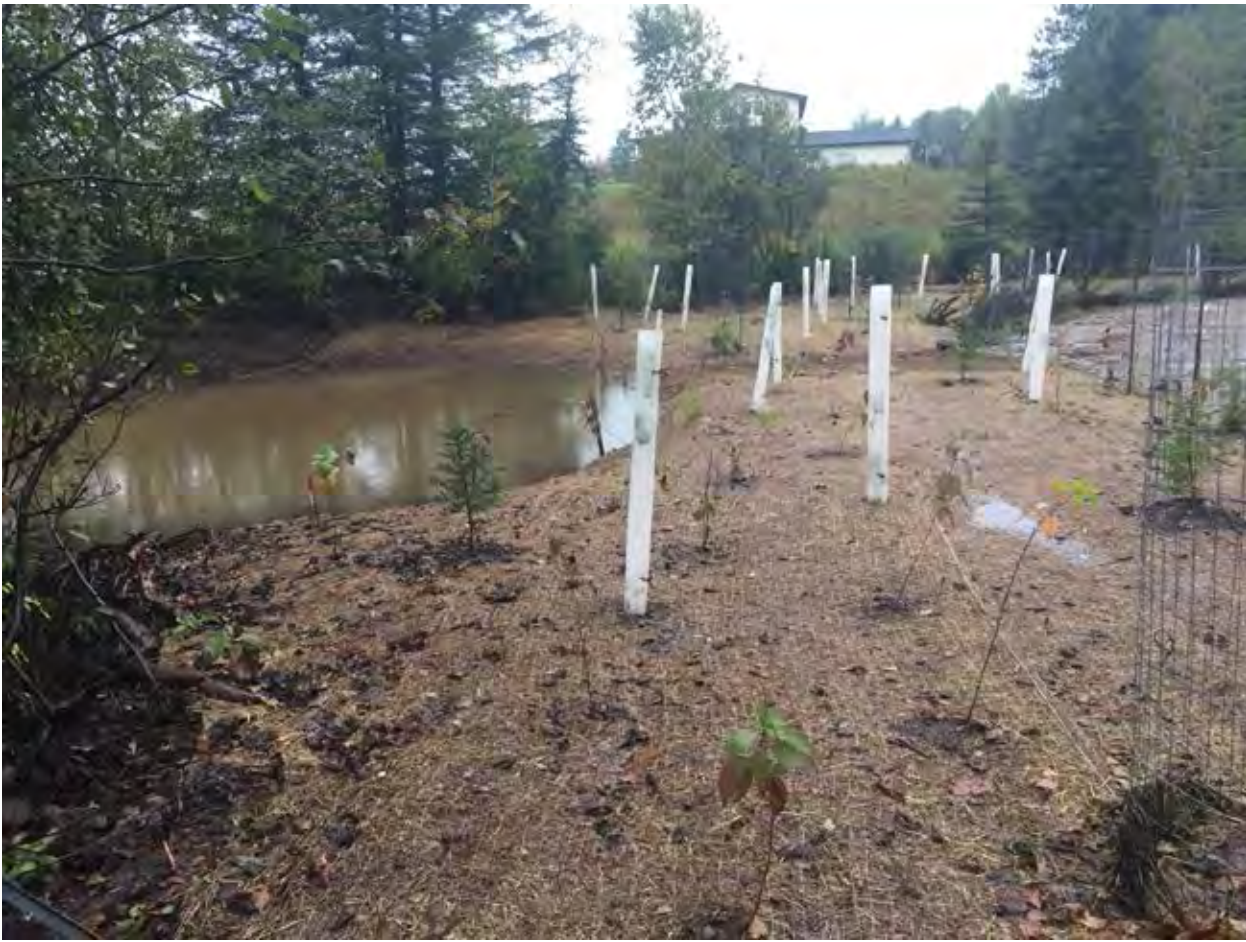
Figure 5 - A constructed offline "wildlife pond" (left side of image), a minor project change, was a product of balancing cut & fill.

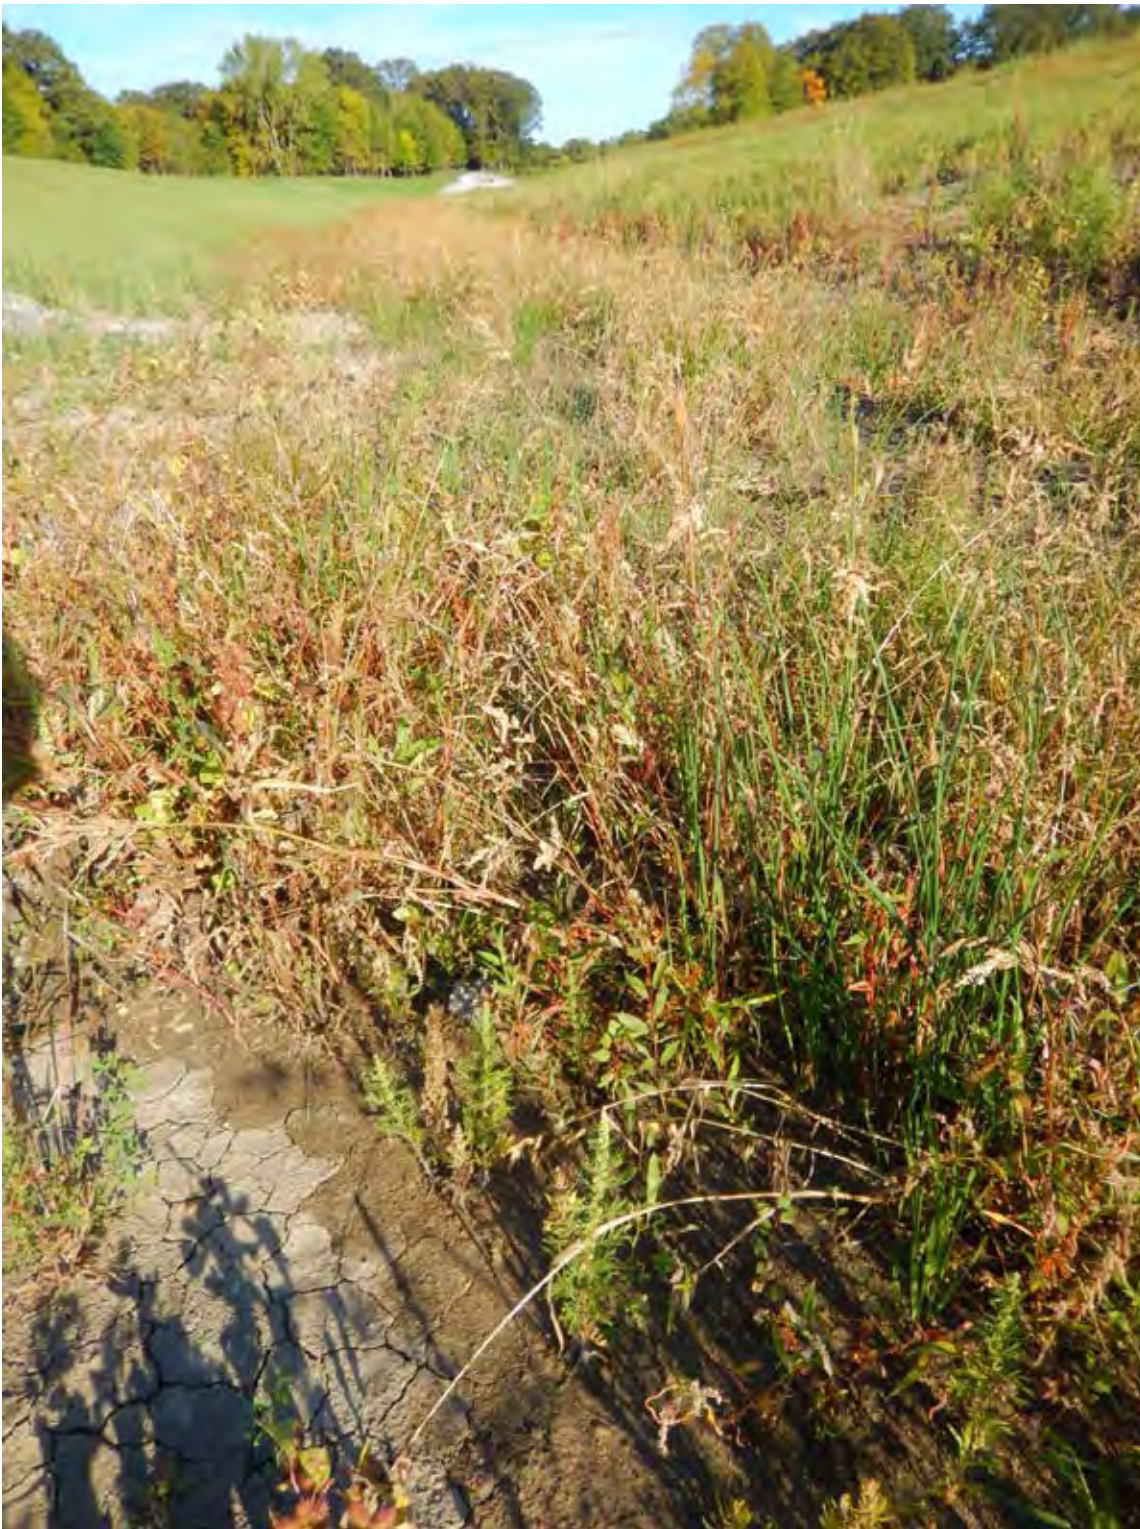
CC Photo 3: vegetation growing in the bottom of the cut channel.

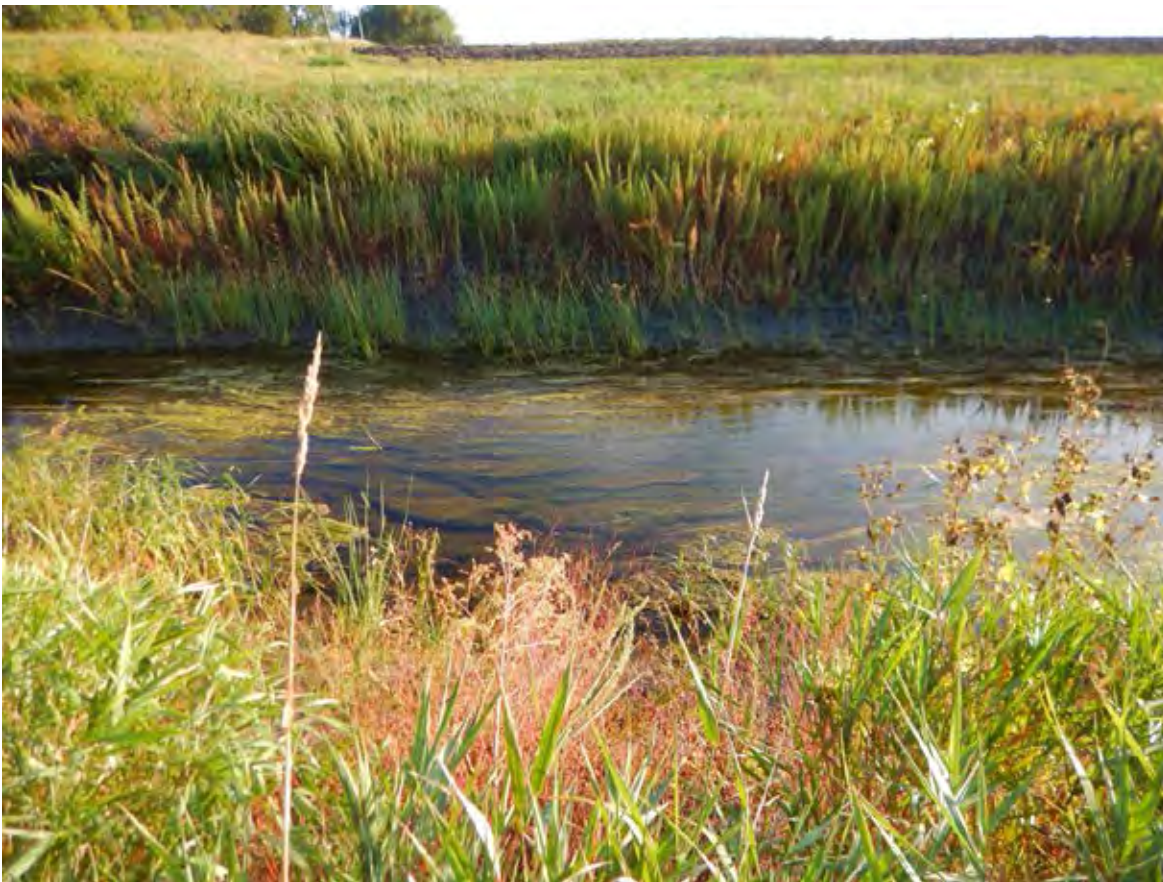
SR Photo 14: Unseeded slopes revegetating with predominantly annual weedy species.

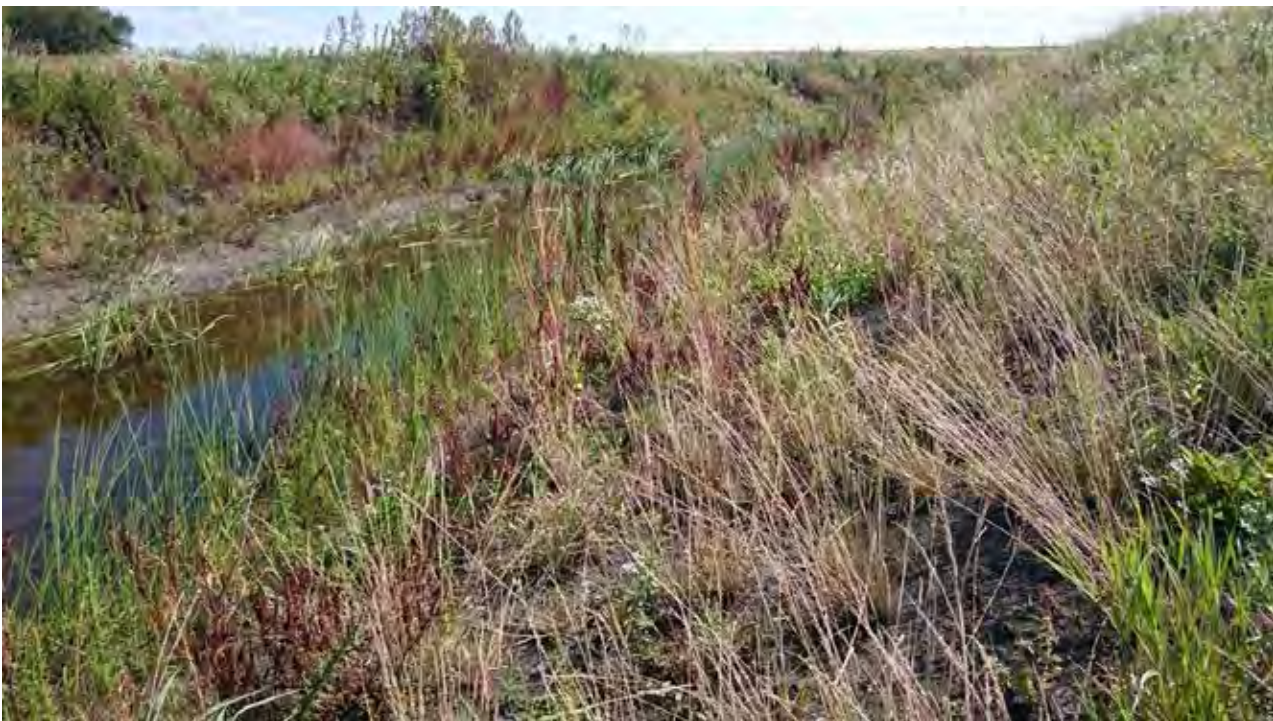
SR Photo 16: American Sloughgrass *Bechmannia syzigachne* dominates the lower unseeded slope in this location.

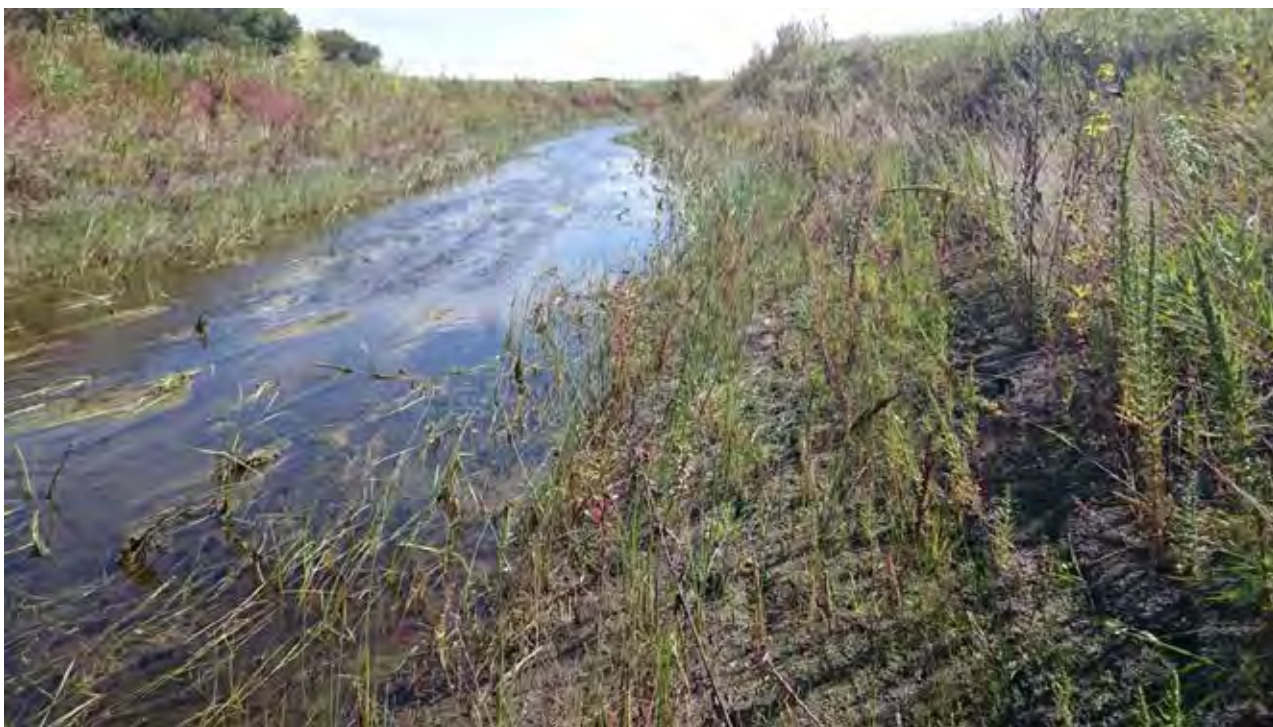
SR Photo 17: Softstem Bulrush in channel and saturated zone. Mostly annual weedy species inhabit the zone above.

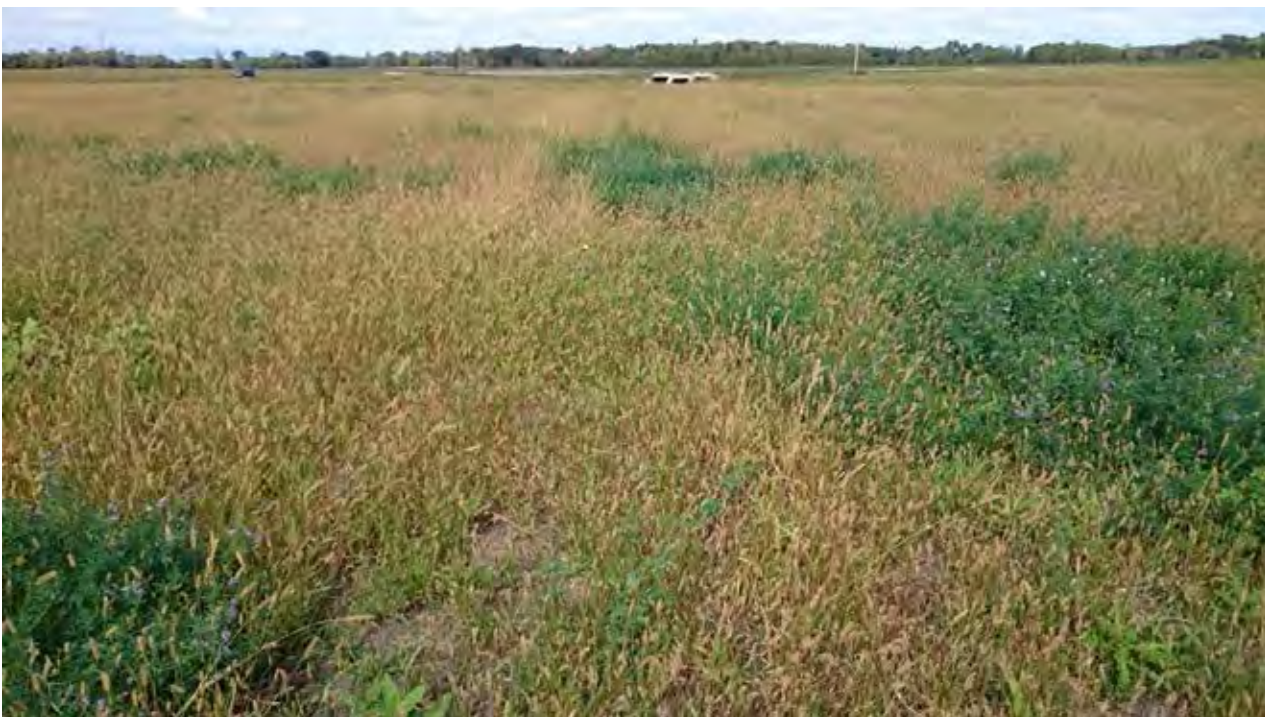
SR Photo 19: Upland area south of 130th St. NW. Appears to be seeded to CP-23A, similar to adjacent areas seeded to this mix, and not areas seeded to "Mixture Special Mix." *Setaria glauca* dominates.

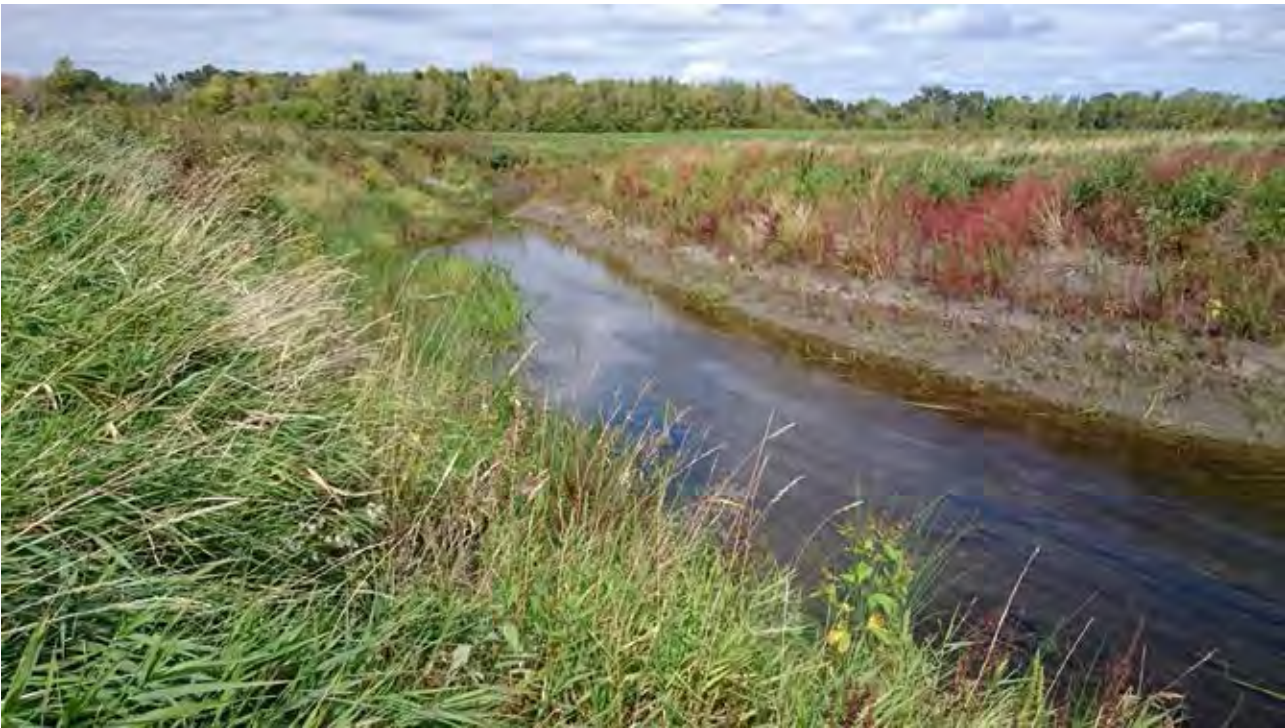
SR Photo 20: Restored Channel north of 130th Street NW. Above the channel, Seed Mix MnDOT 250 was used. Uplands largely dominated by Smooth Brome with Reed Canary grass common near/in channel.

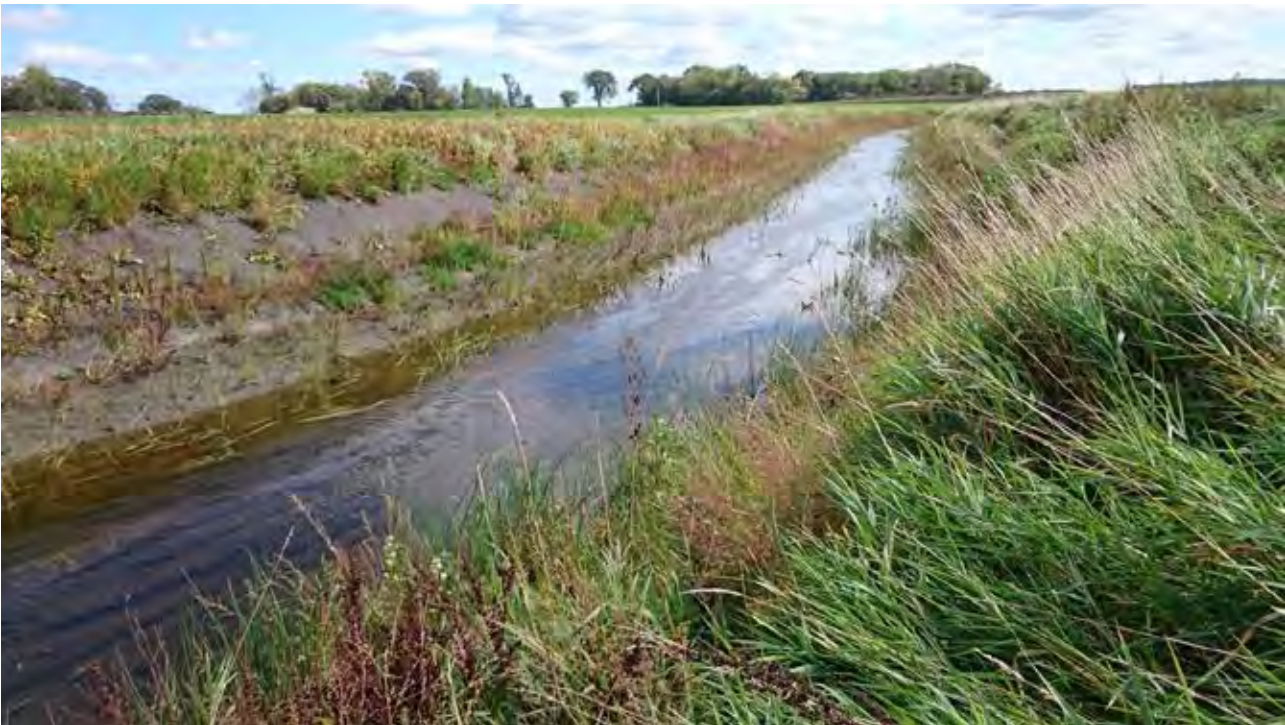
SR Photo 21: Dense Smooth Brome above channel with bare soils below.

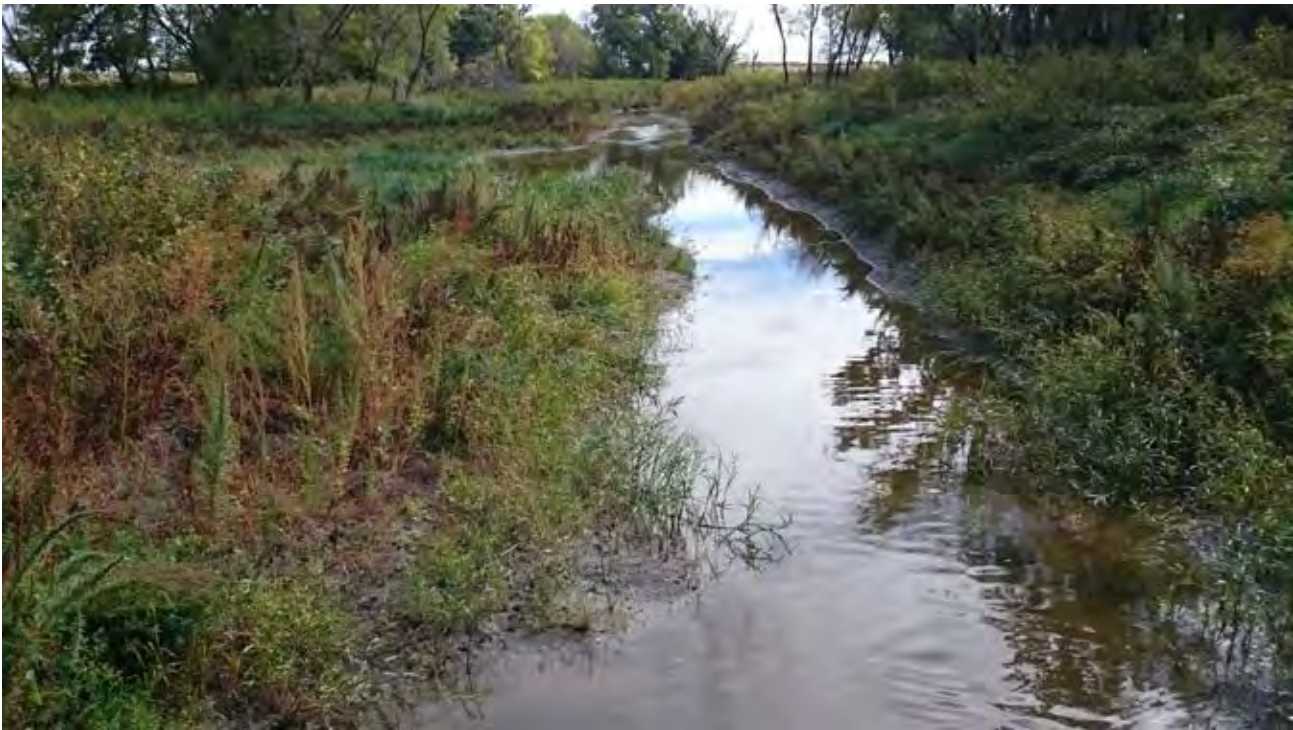
SR Photo 22: Excavated channel in cleared woodlands. Immediately above water, annual weedy species dominate. River bulrush is common in channel.

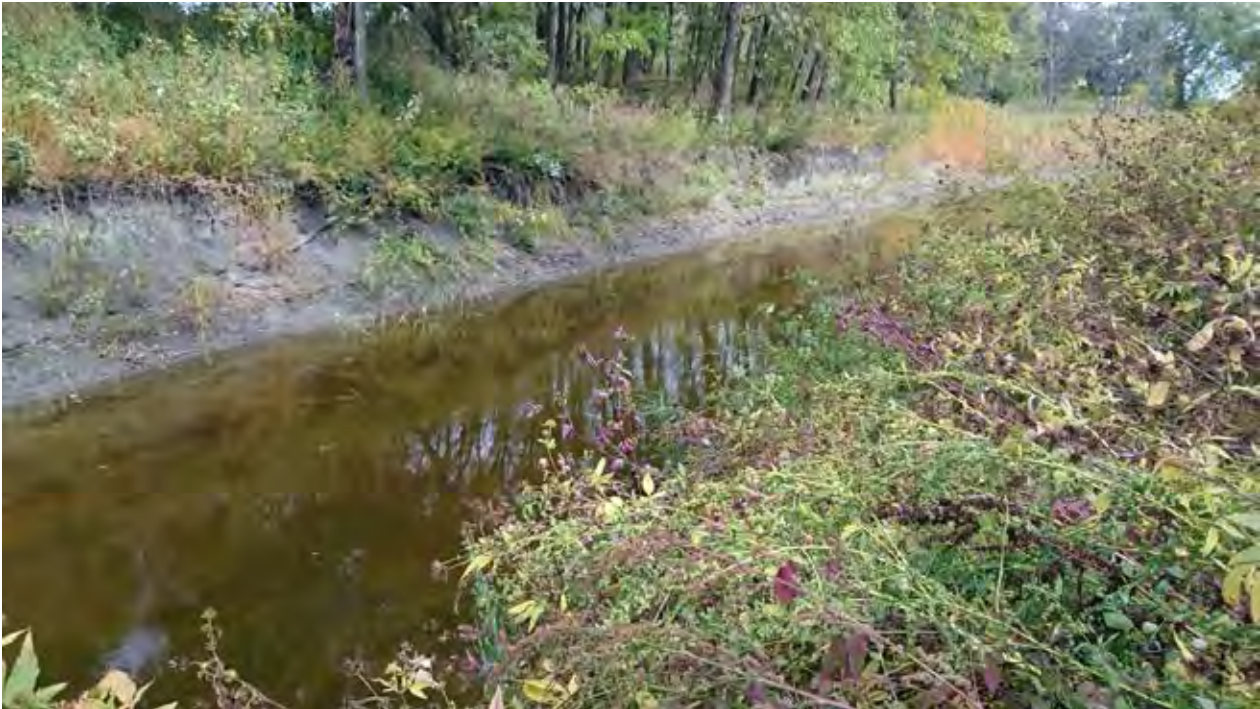
SR Photo 25: Exposed banks where channel was excavated in forested areas.

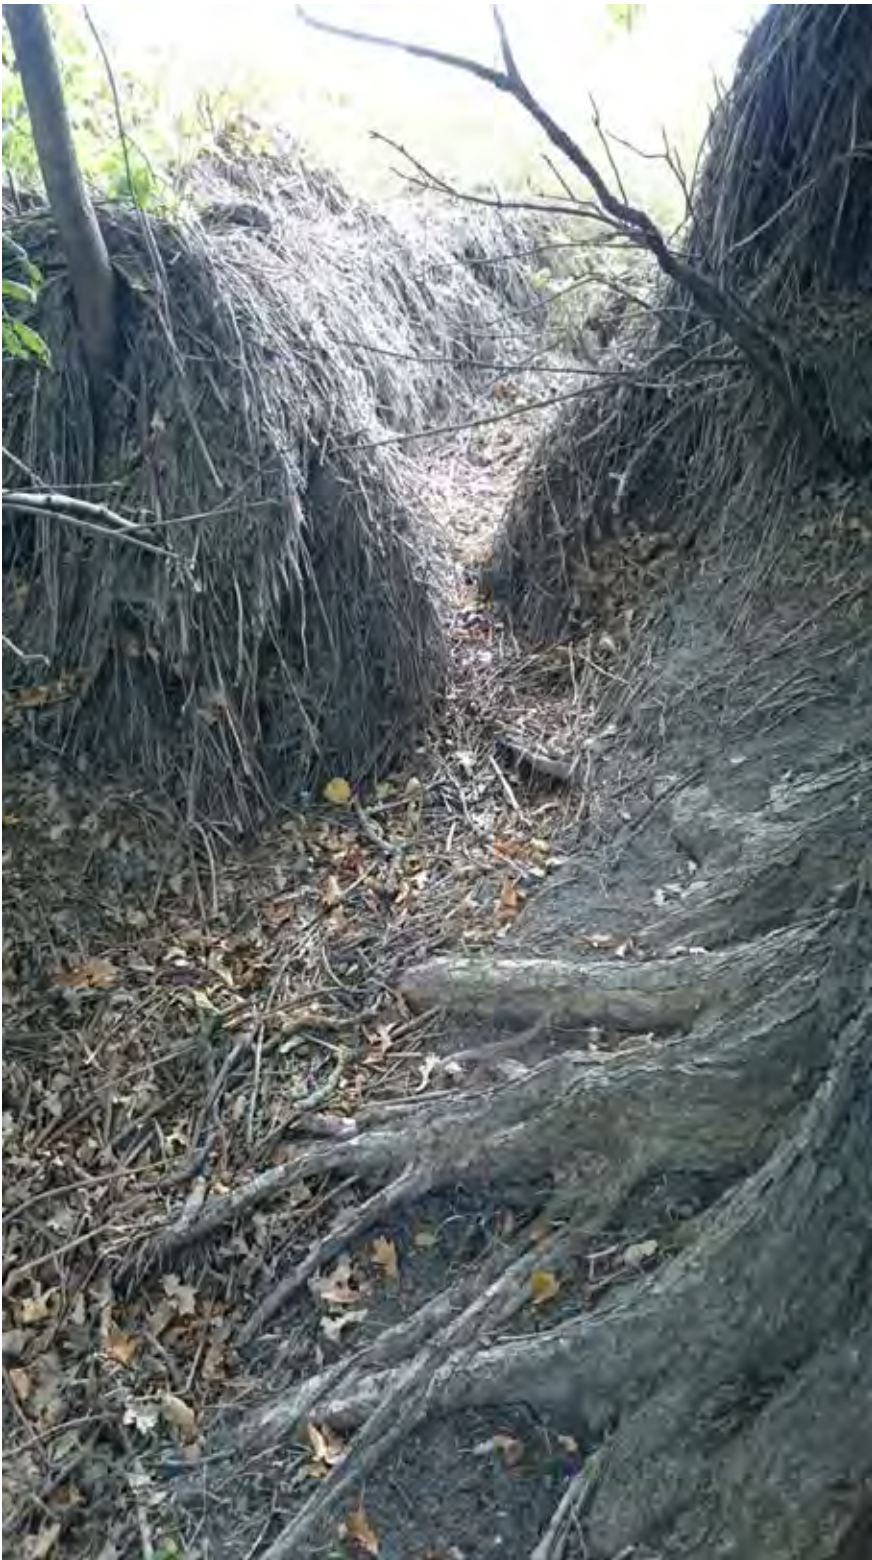
SR Photo 28: Gully above construction area in wooded area. Likely predates project as it is above existing exposed roots.

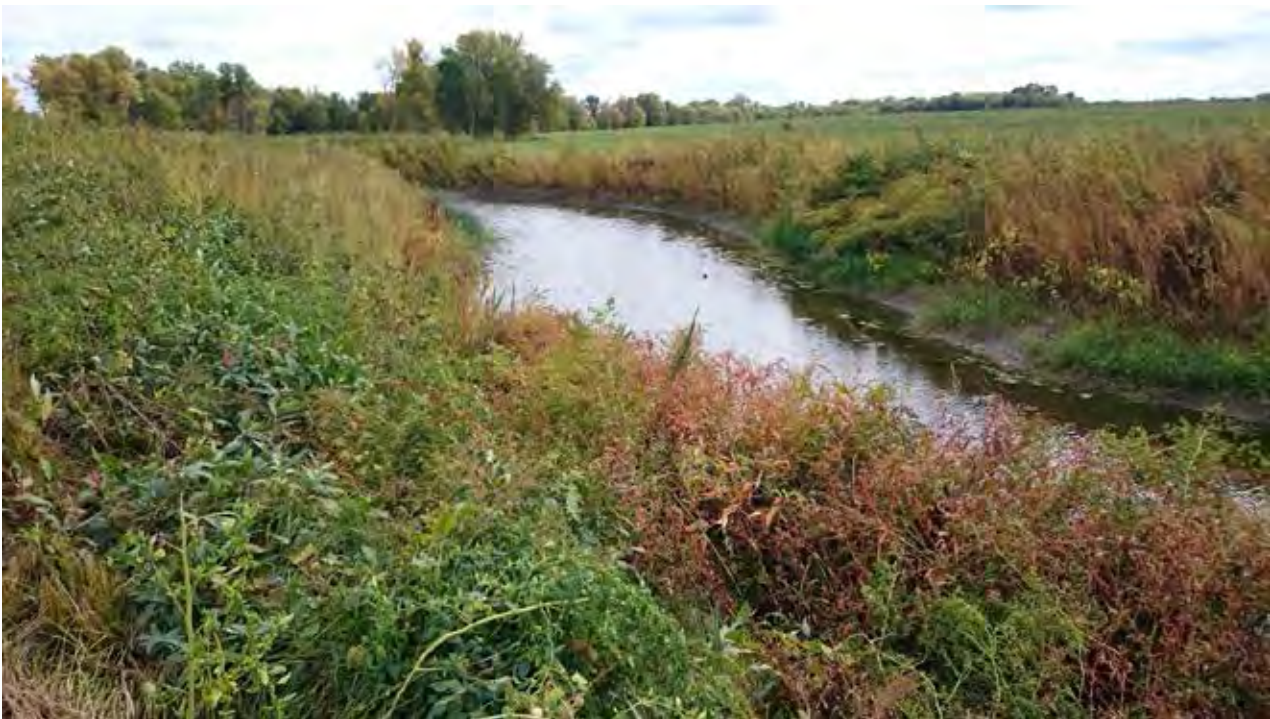
SR Photo 31: Heavily vegetated banks in the openings below cleared woods. Annuals dominate.

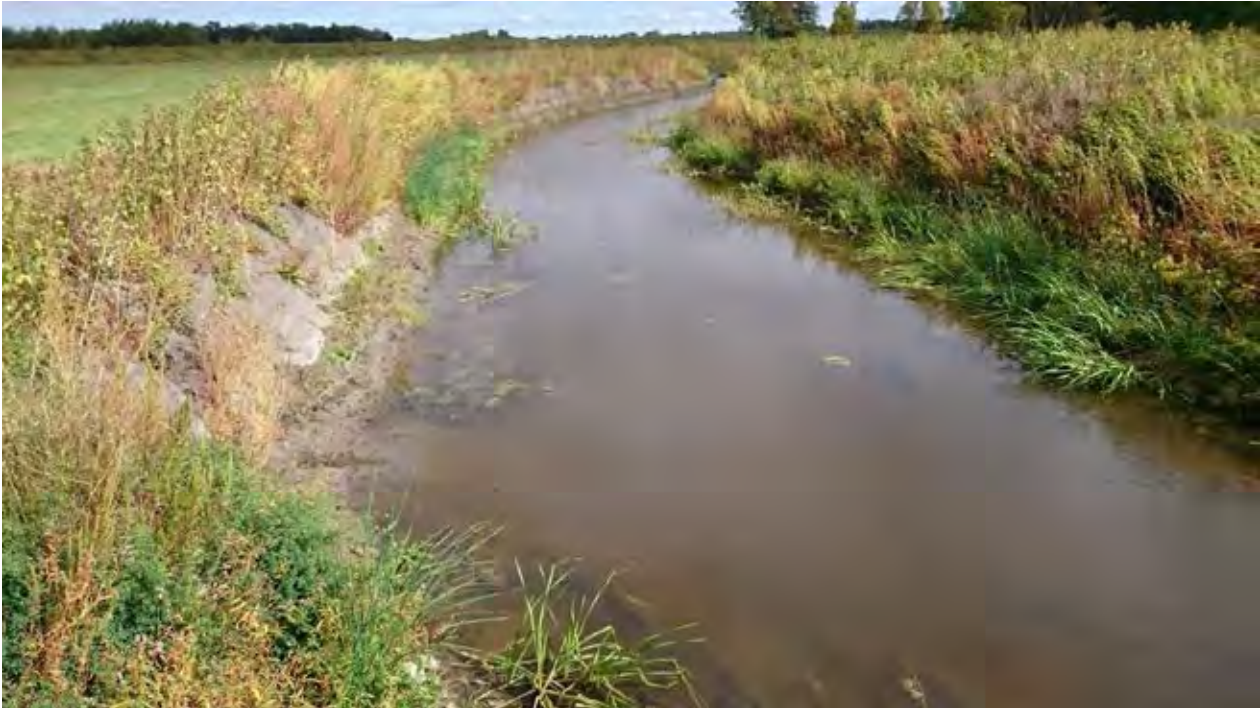
SR Photo 32: Exposed banks along slopes downstream of cleared woods.

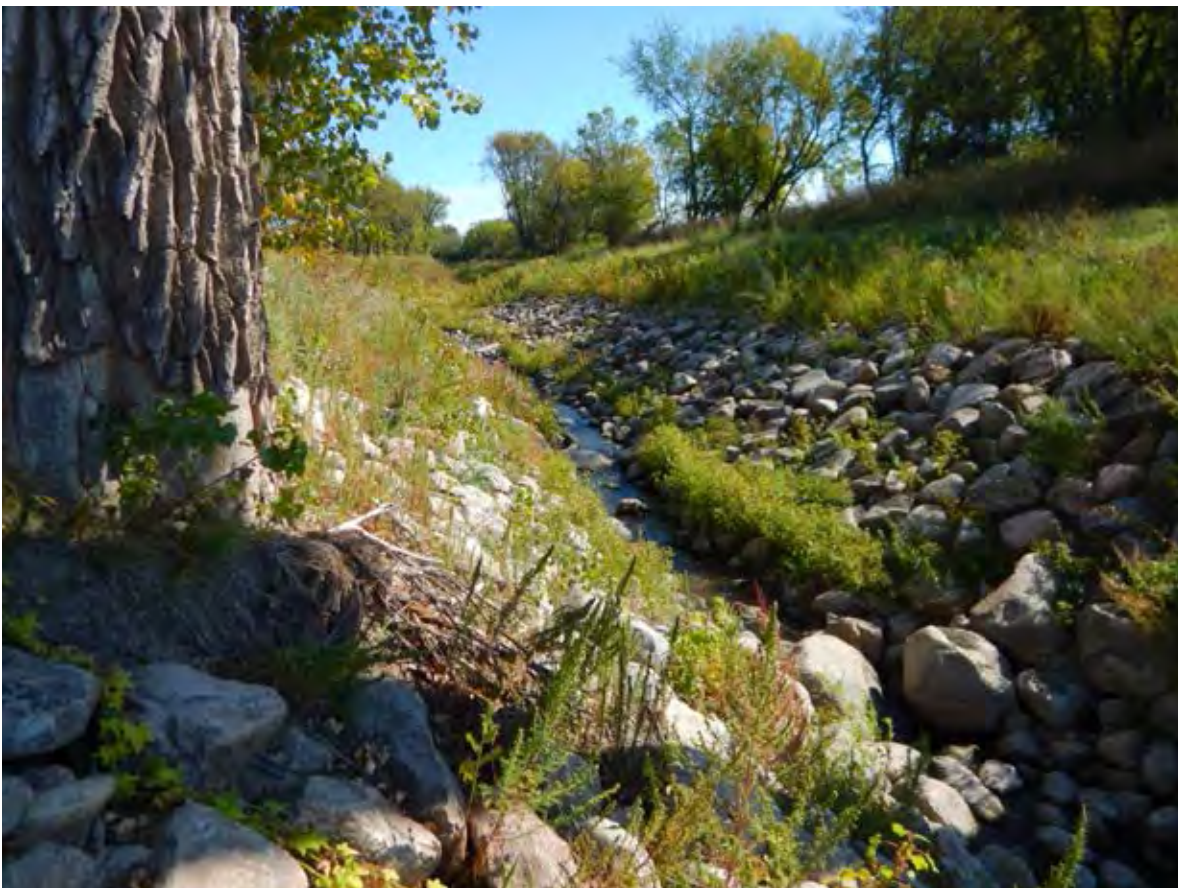
SR Photo 36: V Channel immediately upstream of confluence with the Red River.
Note scour at base of cottonwood tree at top of slope.
