**WATER CONSERVATION STUDY FOR CAMP RIPLEY  
STATE PROJECT NUMBER 15124**

For Facilities Management Office  
Minnesota Department of Military Affairs

March 2016

**Consultant's Report**

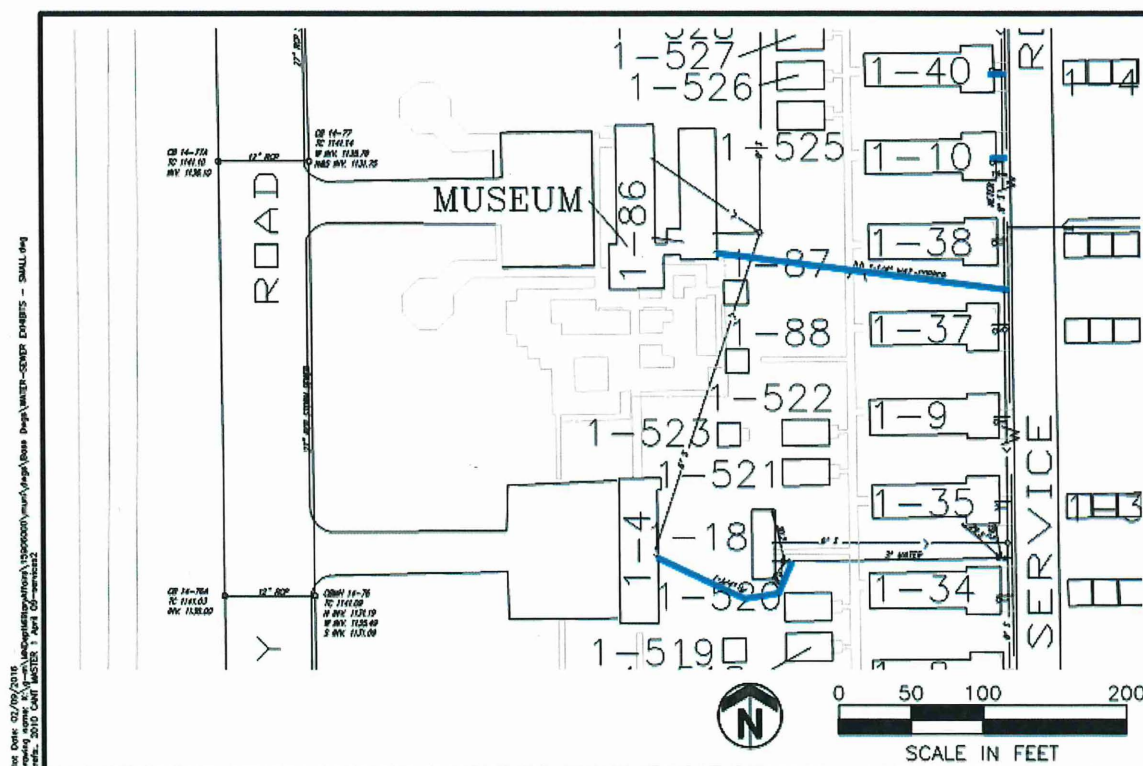
- The 1-1/4" service line for Building 1-4 is connected to the 3" service to Building 1-18 on the east side of building 1-18 and runs around the south side of Building 1-18 to Building 1-4. Electronically measured depths of the 1-1/4" service line were as follows: around the south east corner of Building 1-18 measured between 5'-5" to 6'-6", around the southwest corner of Building 1-18 was 8'-2", and 24' east of Building 1-4 was 7'-2".

**Recommendation** – Lower the 1-1/4" water service line along the existing alignment from the connection with the 3" service line for Building 1-18 for approximately 90' until an existing depth of 8' is achieved.

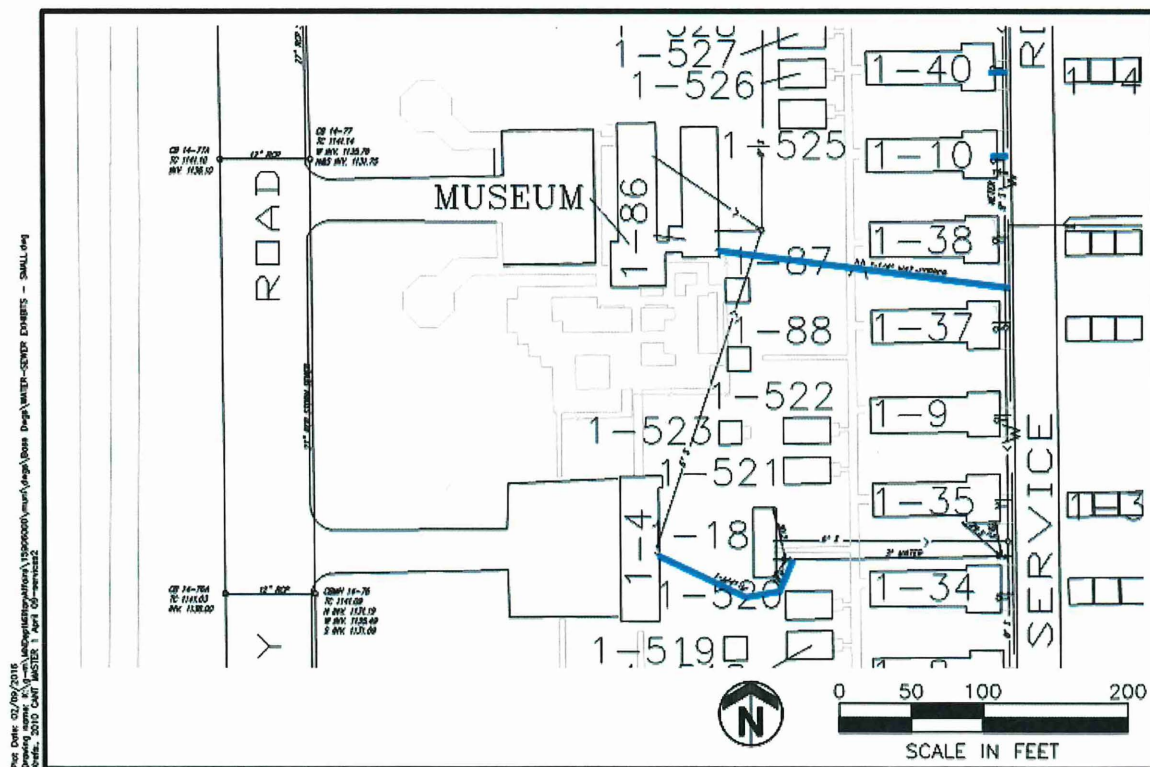
4. **Building 1-86 (Museum)** – Water Service - The 1-1/4" water service for Building 1-86 is approximately 190' long from the East Service Road watermain to building 1-86 and has been reported by Camp personnel as "shallow". Electronic depth location was unsuccessful due to the length of the service and interference with other underground utilities.

Recommendation – Lower the entire 190' length of 1-1/4" service from the East Service Road watermain to Building 1-86.

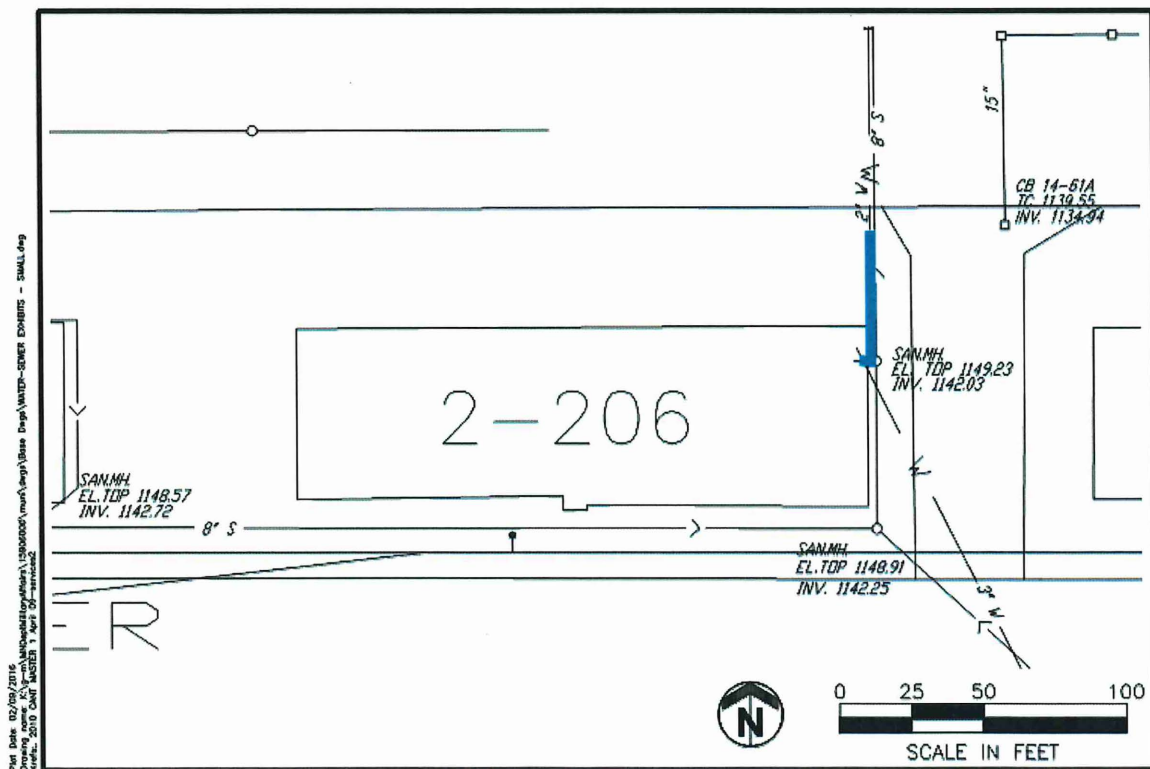
6. **Building 2-206 – Water Service** – The 2" water service for Building 2-206 extends from the watermain in the north boulevard of Bettenburg Avenue south across the roadway, turns west and enters the east side of the building. This service has been reported as "shallow" by Camp personnel and has been kept running every year. Electronic depth location was unsuccessful on this service. The water line was observed during Phase 1 & 3 Road and Utility Infrastructure Improvements, but the on-site inspector made no notes about the line being shallow at the sewer crossing in the north half of Bettenburg Avenue. At the northeast corner of Building 2-206 the service continues on to serve other nearby buildings whose services were not reported as "shallow" by Camp personnel and not listed as having its water run. If the service for Building 2-206 is shallow it is likely shallow near Building 2-206 south of the sewer line in Bettenburg Avenue under the paved boulevard.

Recommendation – Perform exploratory excavation, starting at the building and extending to the curb line. If the line is found to be shallow, provide insulation or lower service.

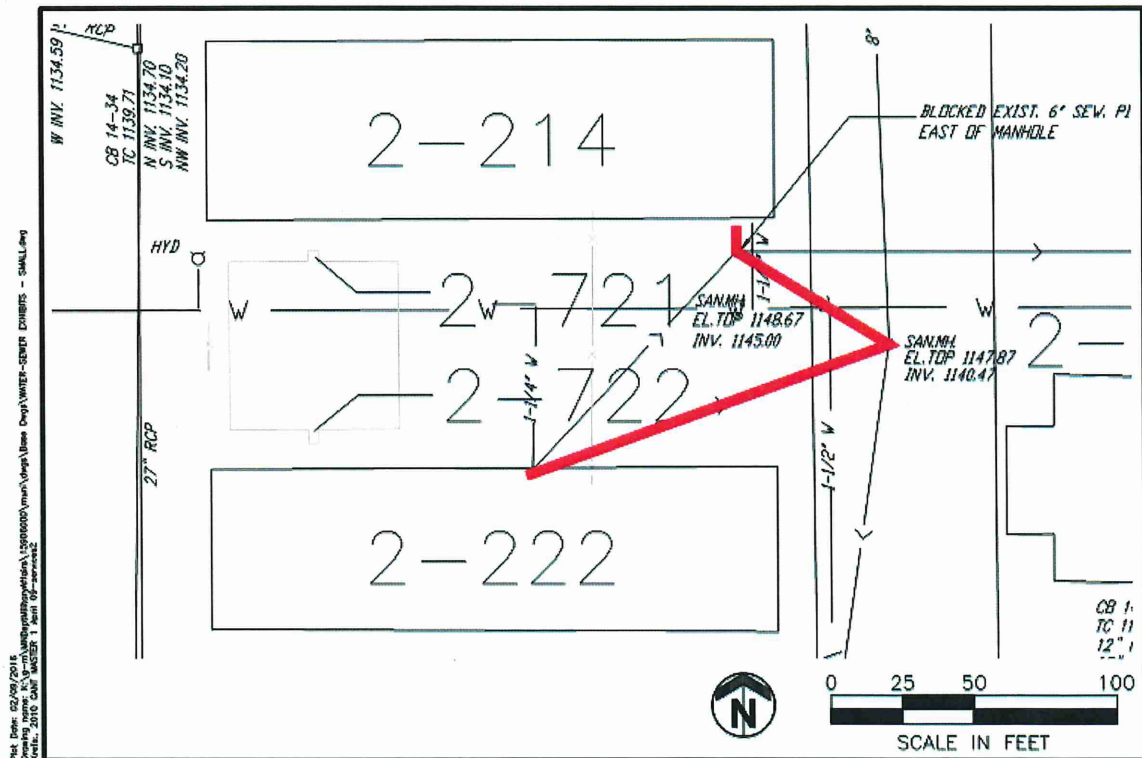
8. **Building 2-214 & Building 2-222 – Sanitary Sewer Service** – The sanitary sewer services to these two buildings have been evaluated together because they are serviced by the same sewer main. Both services have been reported as “shallow” by Camp personnel. The sanitary sewer main that both services are connected to flows north and connects to the Bettenburg trunk sewer. The sanitary sewer main has sufficient depth, with manhole depths to invert vary from 8.8’ to 7.4’ along this line. The services for both buildings come together into the same manhole on the main. Service depths are listed as shallow as 3.6’.

Recommendation – Lower the entire service for both buildings from the manhole on the sanitary sewer main to each building.

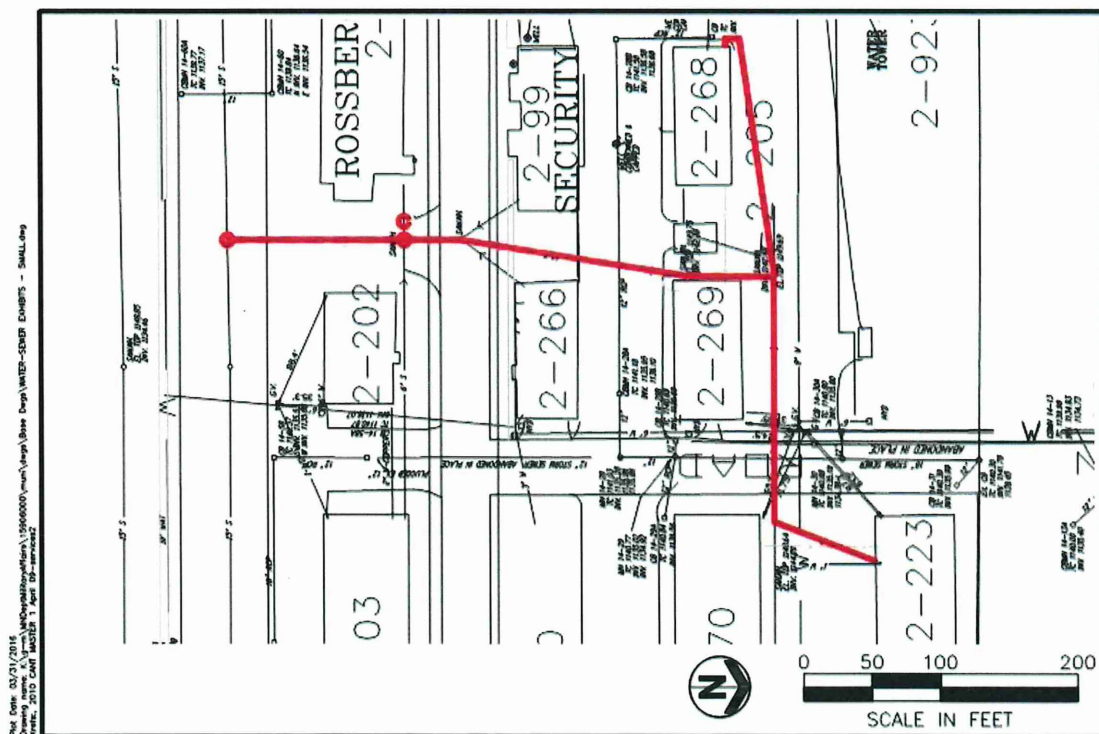
- 10. Building 2-223 & Building 2-268 – Sanitary Sewer Service –** The sanitary sewer service lines for Building 2-223 and Building 2-268 have been listed by Camp personnel as shallow. The Building 2-223 service exits the northeast corner of the building and connects to a manhole off the southwest corner of Building 2-270. This manhole only has 4' of depth. The depth of cover over the service as it leaves Building 2-223 is unknown. Building 2-270 appears to also be served by this sewer, but Building 2-270 has no reported problems.

The Building 2-268 service leaves the building in the southeast corner and discharges to the manhole near the southeast corner of Building 2-269. The depth of cover over the service as it leaves Building 2-269 is unknown.

**Recommendation –** Replace and insulate the dist ' of 6" sewer from Building 2-223 and 215' from Building 2-269 to the existing manhole near the southeast corner of Building 2-269. If it is determined that Building 2-270 is not served by this sewer or does have problems, the replacement and insulation should be continued downstream to where either acceptable depth is reached or to where buildings without problems connect to the line.

**Optional Consideration –** The sewer main that serves 2-223 is a 6" line that also serves at least Buildings 2-270, 2-269, 2-268, 2-266, 2-99, 2-203, and 2-202. This sewer line passes under Rossberg Hall to the main in the west boulevard of Walsh Drive. Passing under Rossberg Hall is of great concern to Camp maintenance personnel. This sewer could be rerouted, starting on the west side of Rossberg Hall north to the trunk sanitary sewer in Bettenburg Avenue. A manhole should be added to the line passing under Rossberg Hall to facilitate maintenance of the line. This sewer replacement also increases the sewer size to 8" sewer line and lowers the service to provide proper cover for the entire line to Buildings 2-223 and 2-268.

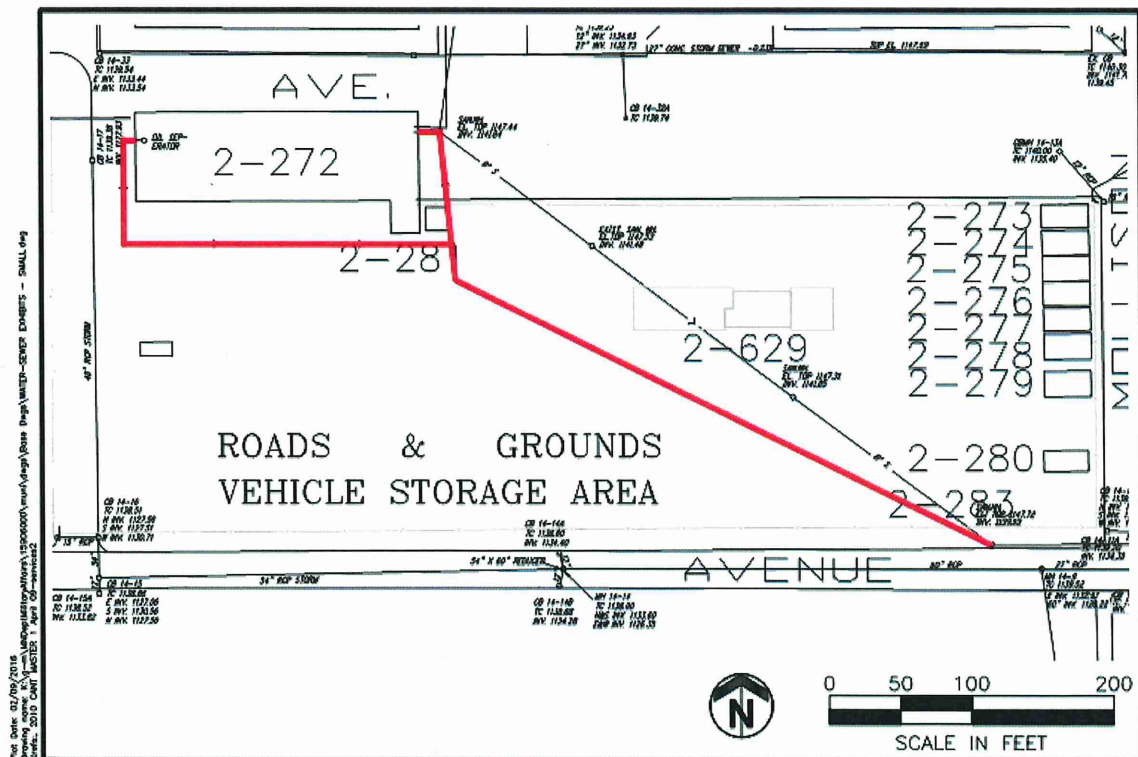
- 12. Building 2-272 – Sanitary Sewer Service –** Building 2-272 has two sanitary sewer services that discharge to a main sewer line on the east side of the building. One service exits the building in the northwest corner and heads south, east, then north to the mainline on the northeast corner of the building. The other service exits the building in the northeast corner of the building and connects to the main line. It is believed that the northeast service handles sanitary waste and the northwest service handles the oil/water separator. Camp records indicate that the sanitary sewer mainline flows both north and southeast from the northeast corner of the building

**Recommendation –** Reconstruct and insulate the service lines on the east, south, and west sides of the building. Replace and insulate the sewer main line starting at the southeast corner of Building 2-272, heading southeasterly approximately 440' to an existing manhole in Leach Avenue. The existing sanitary sewer mainline was steeper than necessary so approximately 1.0' of additional cover can be obtained by installing the new sewer at a shallower grade. Cleanouts and manholes near Building 2-272 must be protected from damage caused by large vehicle traffic especially turning movements.

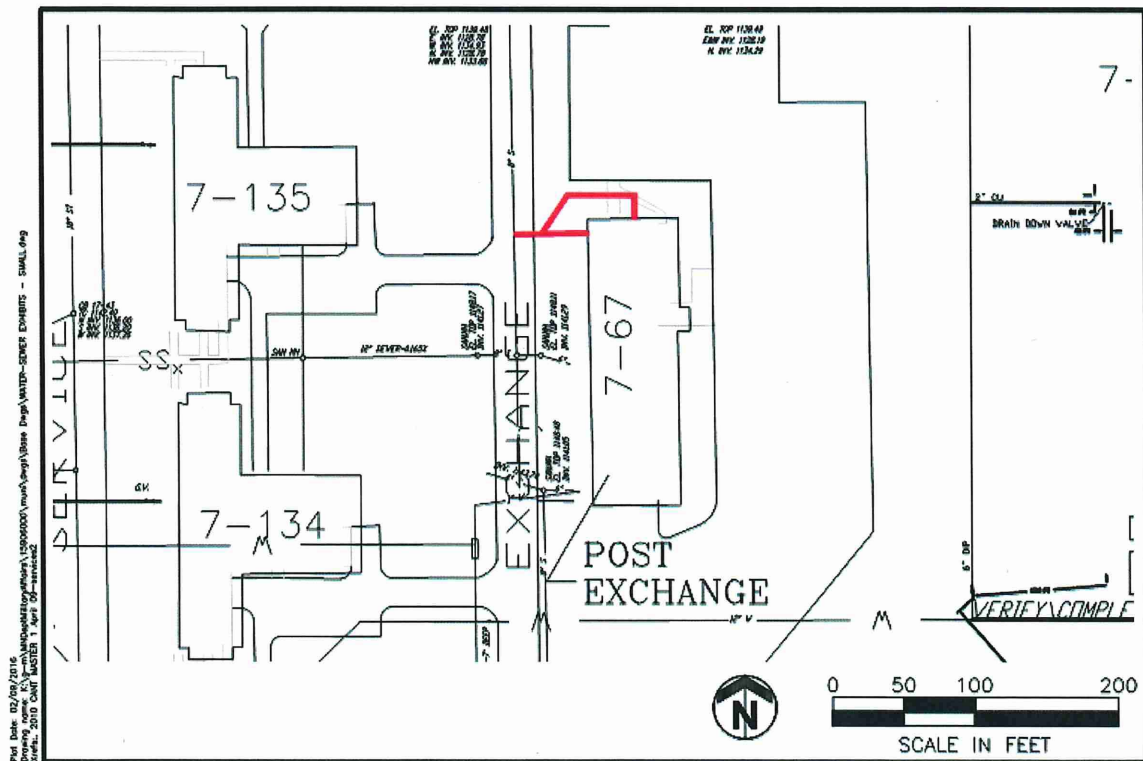
- 13. Building 7-67 – Sanitary Sewer Service –** Building 7-67 has three sanitary sewer services. Camp personnel have identified the northerly two services as shallow. One northerly service exits the northwest corner of the building and discharges to the west into the sanitary sewer main in East Exchange Road. The other northerly service exits the north side of the building and turns west then southwest and connects to the other northerly service.

The sanitary sewer main in E Exchange Road was reconstructed as part of Phase 2 & 5 Road and Utility Infrastructure Improvements in 2010. The existing 6" sewer service was connected to the deep main with a service rise and then wye'd to the two 4" services.

Recommendation – Replace and insulate new service lines at the proper depth, starting at the outside building wall and continuing into the street until the service riser is intercepted. The new service line will be reconnected to the service riser at a lower elevation.

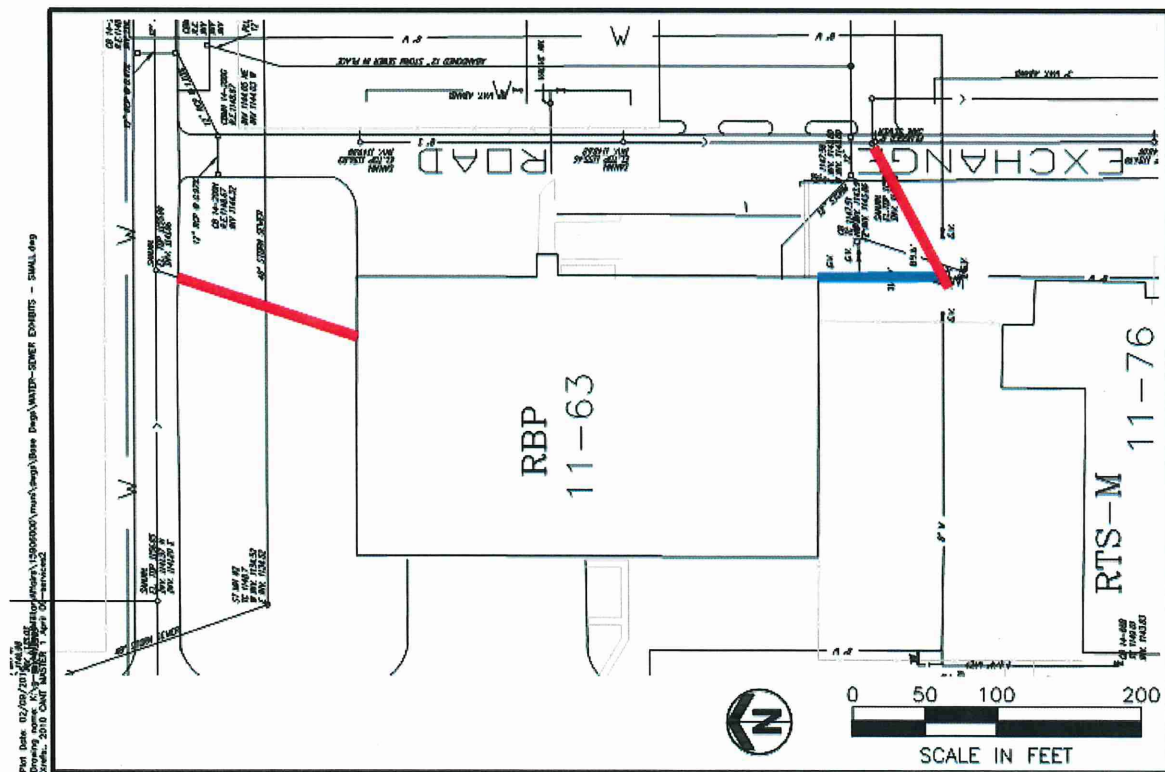
15. **Building 11-63 – Water Service & Sanitary Sewer Service** – The water service for Building 11-63 extends from the southeast corner of the building to an 8" watermain south of the building. The water service size and depth are unknown. The 8" watermain is a looped watermain in the yard area south of the building. Historically the water service for Building 11-63 has been left running during the winter. Camp personnel are unsure if this is necessary.

The sanitary sewer service is 6" diameter and exits the north side of the building near the northeast corner. The sanitary sewer service discharges to a sanitary sewer main in Libbey Avenue. The depth of the sanitary sewer service is unknown, but the depth of the sanitary sewer main in Libbey Avenue is about 14 feet.

Recommendation – Perform exploratory excavation over the water service and the sanitary sewer service beginning near the building and progressing towards the main lines. If less than 7' of cover on the sanitary sewer service and 8' of cover on the water service is found the lines should be insulated until the recommended cover is achieved.

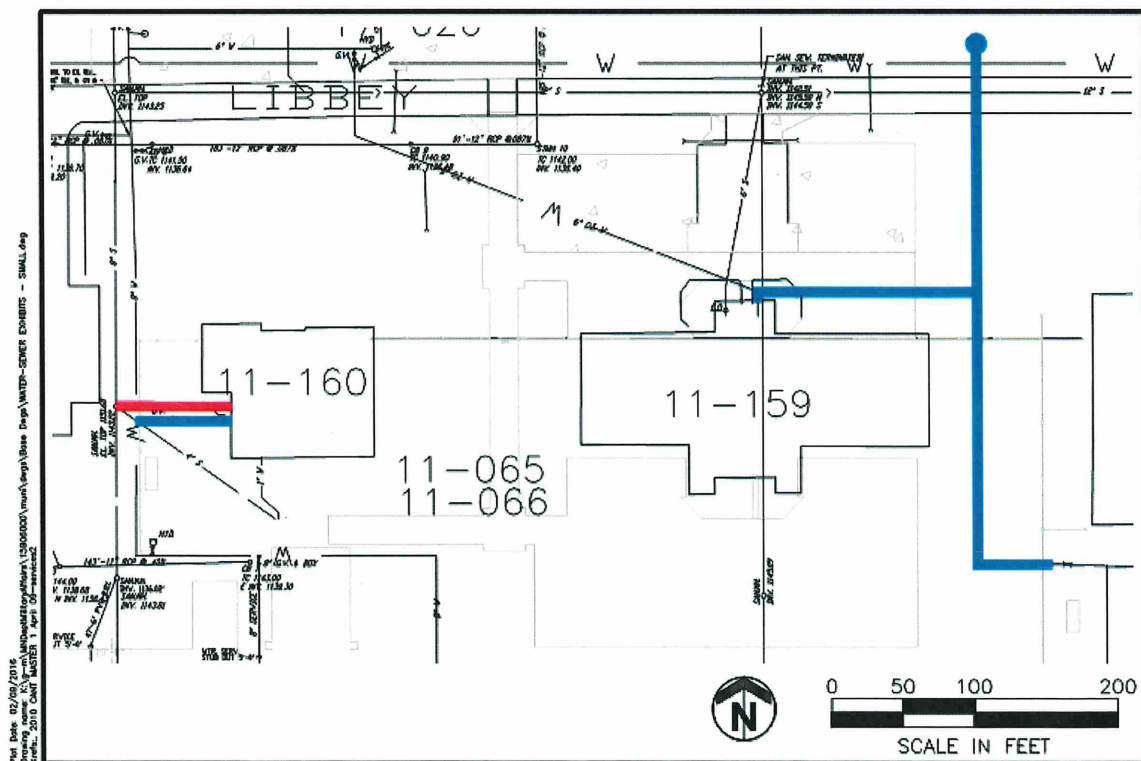
- 18. Building 11-160 – Water Service & Sanitary Sewer Service –** Both the water and sewer service exit the west side of the building and run west to connections with the main lines. The water service is left running through the winter, Camp personnel are unsure if this is necessary. The 2" water service was electronically located at a depth of 5'-6" for the entire 60' from the building to the main. This is insufficient cover, especially under the paved portion immediately adjacent to the building. The sanitary sewer service connection depth at the main is 8', but the depth at the building is unknown.

Recommendation – Lower the 2" water service to a depth of 8 feet for the entire length of the service. Insulate the service at the building if necessary. Exposed and insulate the sanitary sewer service from the building heading towards the main until an appropriate depth is achieved. It should be noted that the depth of the 8" watermain west of Building 11-160 is unknown. The Camp may wish to investigate the depth of this watermain also.

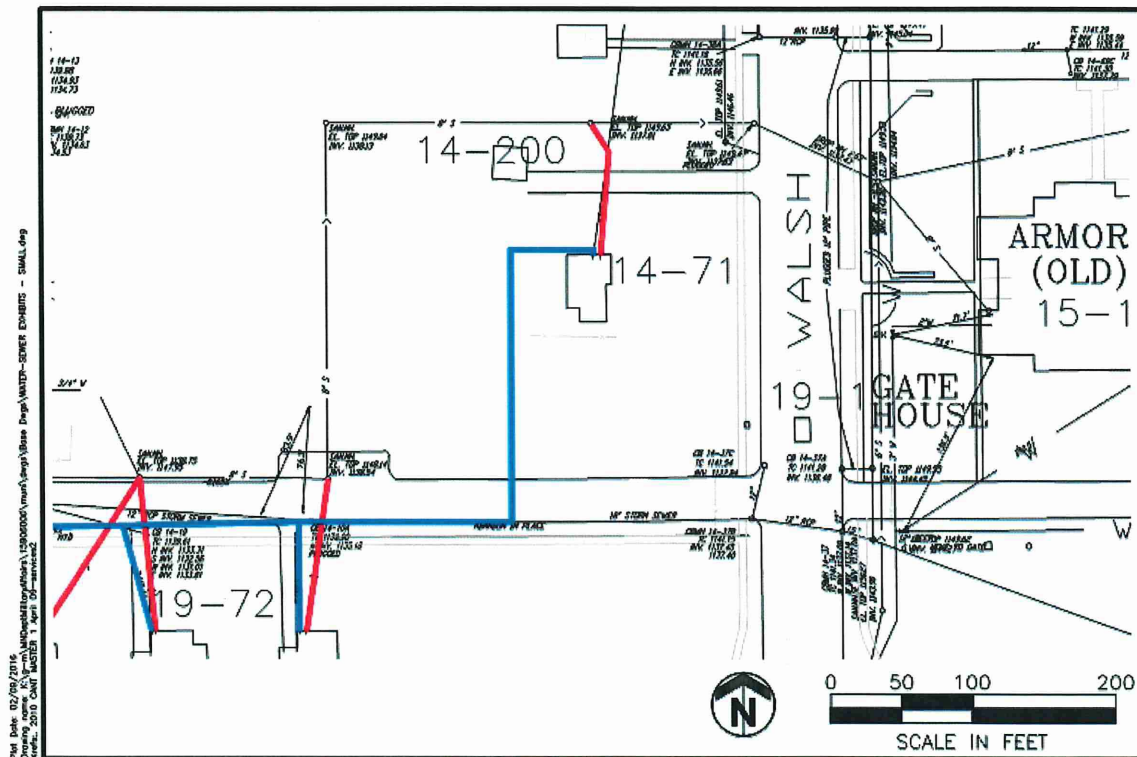
19. **Building 14-71** –Watermain & Sanitary Sewer Service –This building was added to the project after discussions with Camp personnel. Camp personnel listed this building as having “shallow sewer and water”. The sanitary sewer service exits the north side of the building and extends approximately 115' north to a deep sanitary sewer main. The water service exits the north side of the building and extends north. The depth of the water service is unknown.

Recommendation – Replace the sanitary service along the existing alignment at an appropriate depth. Insulate at the building entrance if necessary. Replace the water service with a new service line from the watermain north of Building 19-71 on the south side of Leach Avenue. The water service would cross Leach Avenue and enter the north side of Building 14-71 at the existing water service entrance.

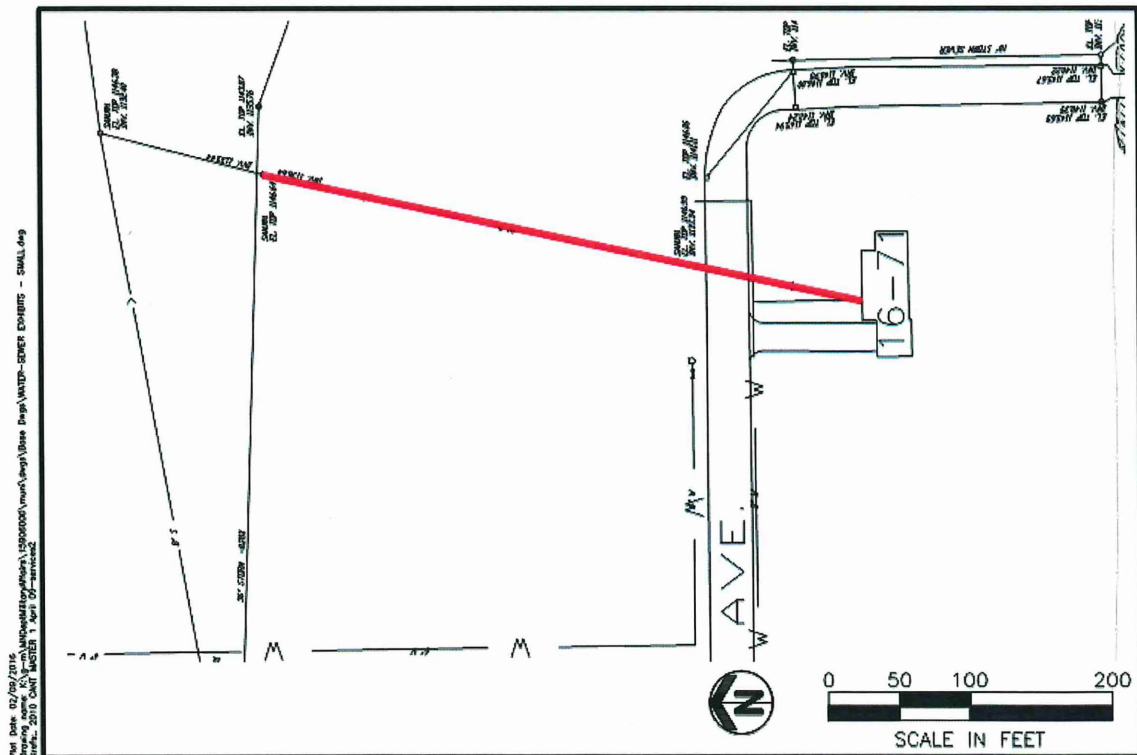
- The water service proceeds straight north from the north side of the house connecting with a 3" main in the south boulevard of Leach Avenue. The depth was electronically measured at 7'-4" to 8'-0", which is sufficient cover in a turfed area. Camp personnel question whether water needs to be left running in the winter.

**Recommendation** – Replace the sanitary sewer service with an appropriately sized pipe for at least 430' to the drop manhole.

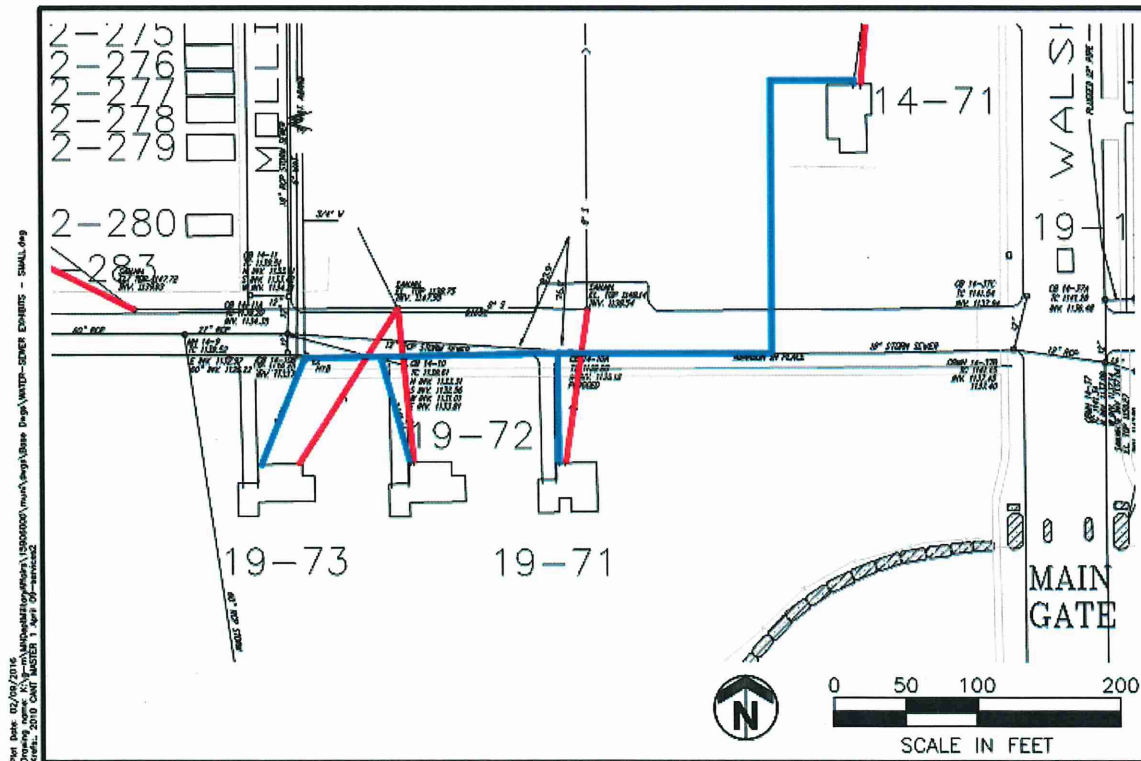
**23. Building 19-71, Building 19-72, Building 19-73 –Watermain & Sanitary Sewer Service –** These buildings will be discussed together. Camp personnel list these buildings as having “shallow sewer”. Each building has one sanitary sewer service which leaves the north side of the building and discharges into manholes on a sanitary sewer main on the north side of Leach Avenue. The services average about 115' in length. The depth of the sanitary sewer main in this location is between 8.8' to 9.5' and is therefore sufficiently deep. It appears there should be sufficient elevation drop to the main. Most of the service is in turf area except for the Leach Avenue crossing.

The water services were not identified as having a problem, but the electronic depth locator indicates that the water services are shallow at the main; varying from 4' to 6'. Therefore, the water services are at risk for freeze-up.

Recommendation – Replace both the sanitary sewer services and water services at recommended depth, adding insulation where the sewer services would cross under Leach Avenue if necessary.
