ARCHITECTURAL  
ASSESSMENT FOR  
PRAIRIE CORRECTIONAL  
FACILITY

Appleton, Minnesota

Final Report

January 5, 2018

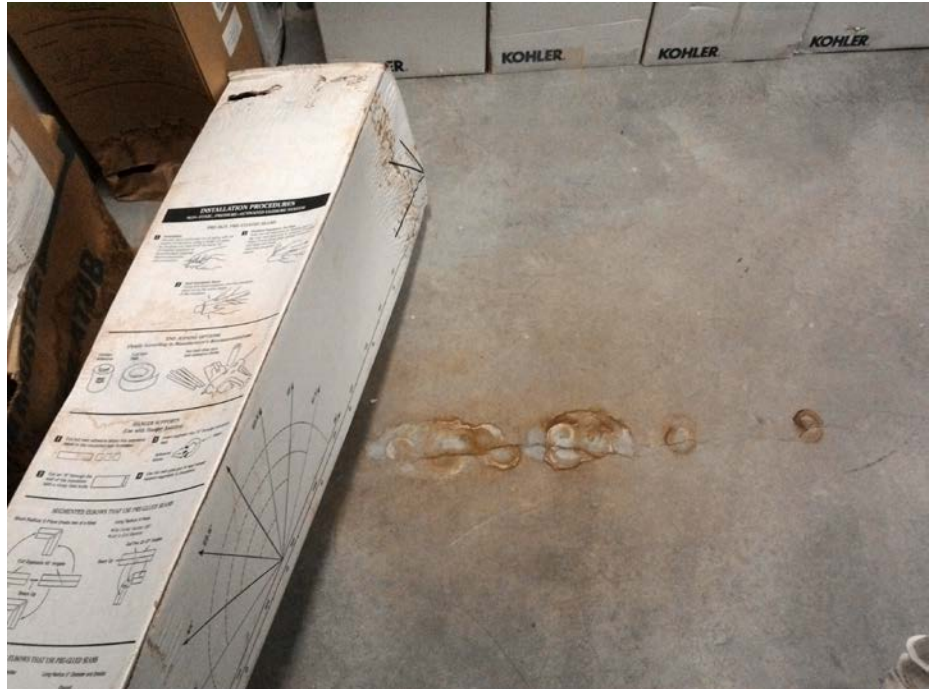
Photograph No. 1

COMMENTS:  
View of floor stains in  
the storage room  
adjacent A Pod C-Unit  
cell C25. The roof of  
the room has leaked in  
multiple areas.

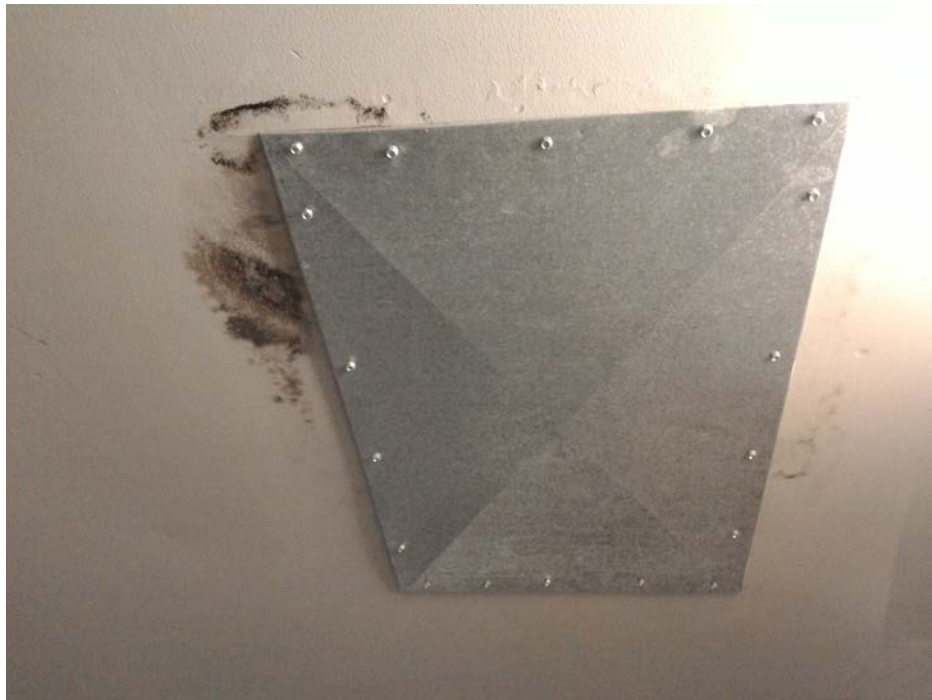
Photograph No. 2

COMMENTS:  
View of a sheet metal  
plate with signs of  
mold around it. The  
plate covers an  
opening used to clean  
the ducts adjacent to  
the area in Photo 1.

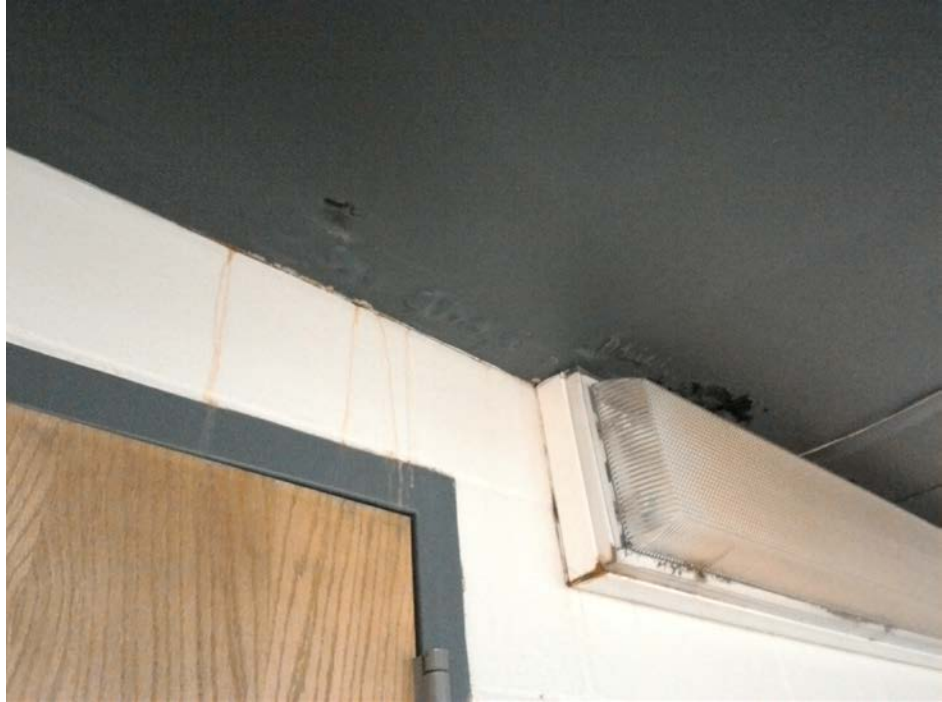
Photograph No. 3

COMMENTS:  
View of water damage  
from a leak to the  
ceiling adjacent to A  
Pod, E-Unit cell E48.

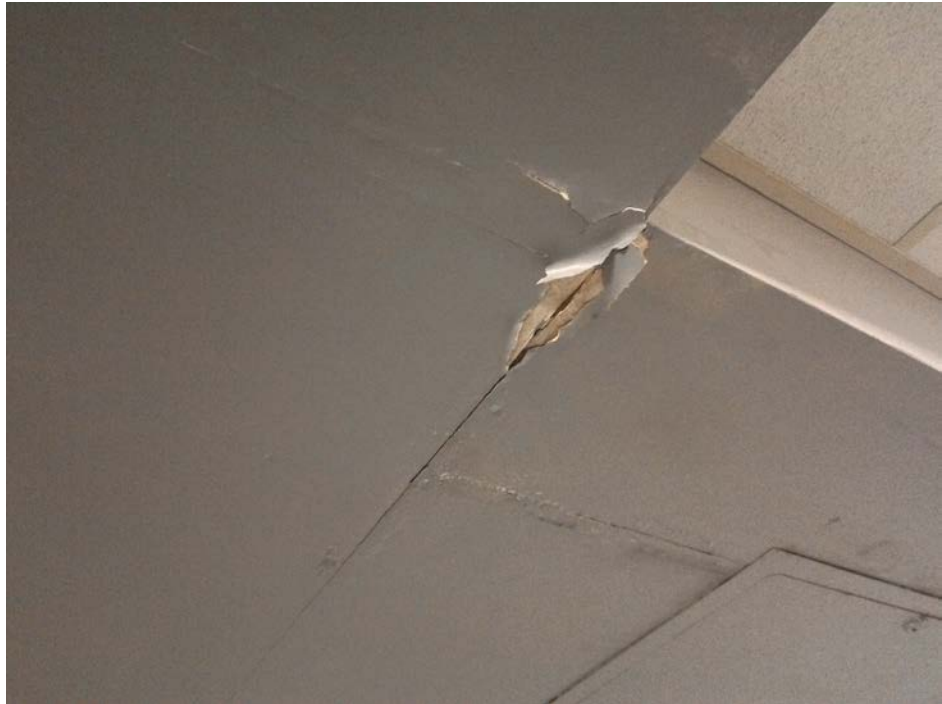
Photograph No. 4

COMMENTS:  
View of water damage  
to the duct above the  
door in A Pod leading  
from A-Unit to B-Unit.  
Water damage was also  
observed on a mirror  
below this area.

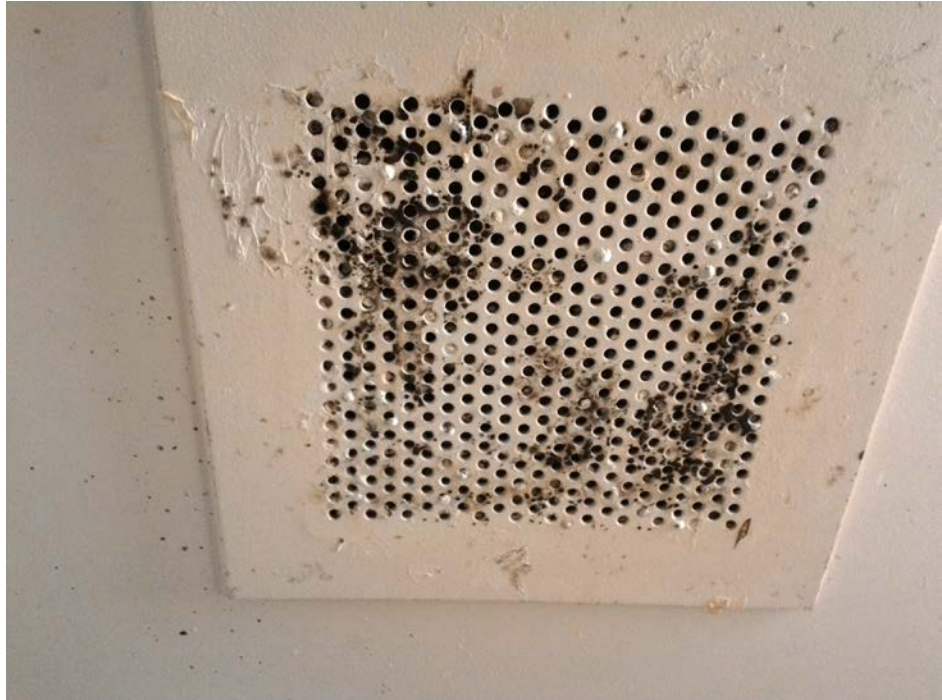
Photograph No. 5

COMMENTS:  
View of the air vent in  
D Pod, D-Unit, cell  
D204 with signs of  
mold on the grate.

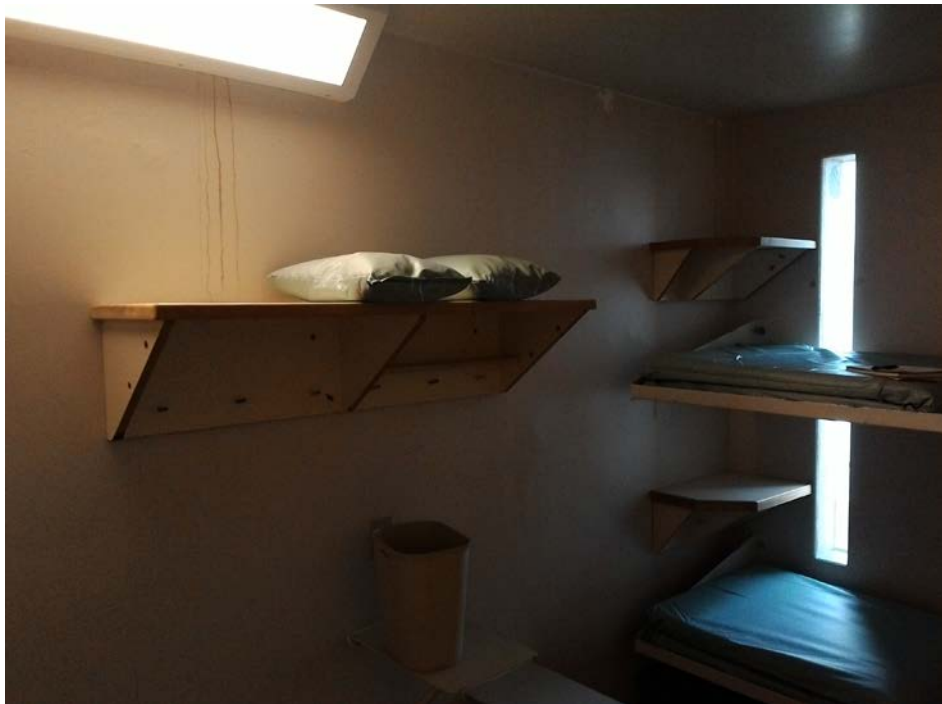
Photograph No. 6

COMMENTS:  
View of typical signs  
of water leaks in F  
Pod, F-Unit cells  
F108, F207 and F208.  
Water streaks are seen  
below the light fixture.

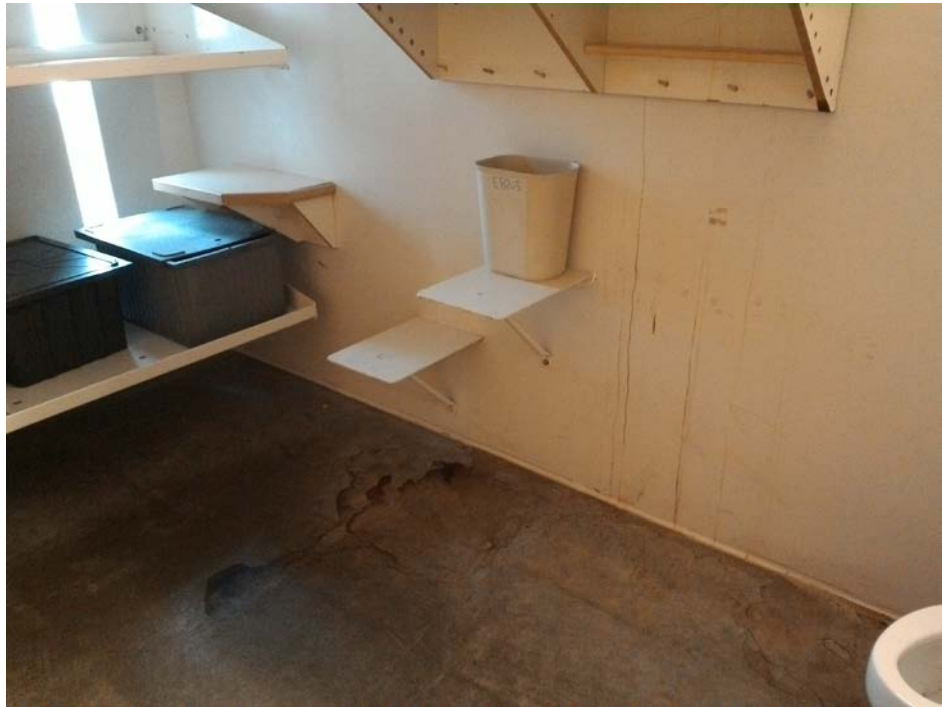
Photograph No. 7

COMMENTS:  
View of water damage  
streaks from the ceiling  
running down the wall  
in E Pod, A-Unit cell  
A203.

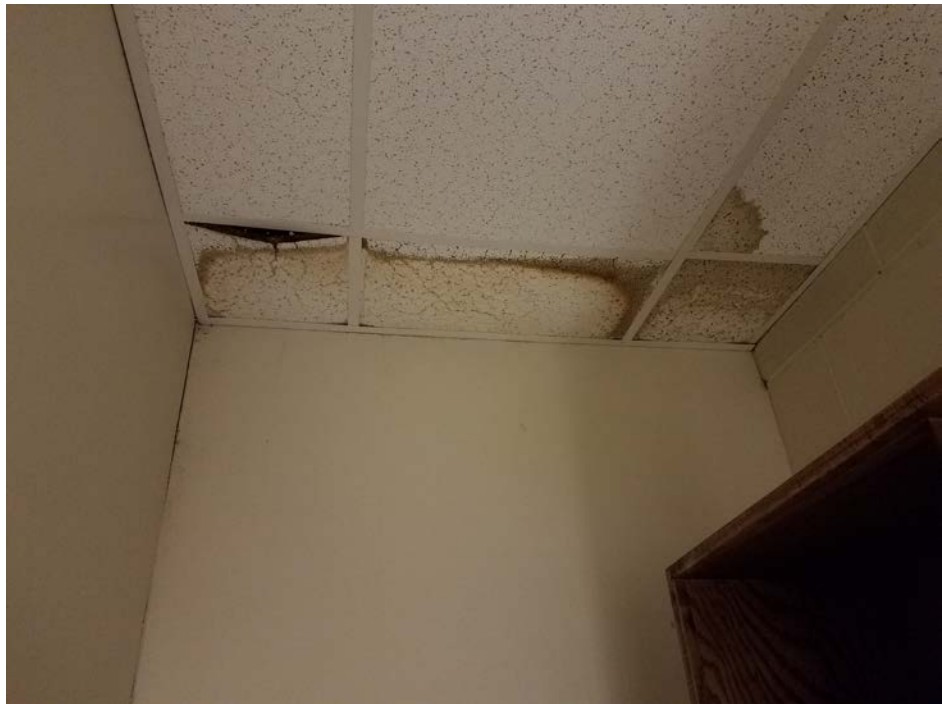
Photograph No. 8

COMMENTS:  
View of water damage  
to the drop ceiling  
panels in the closet  
room in office F115.

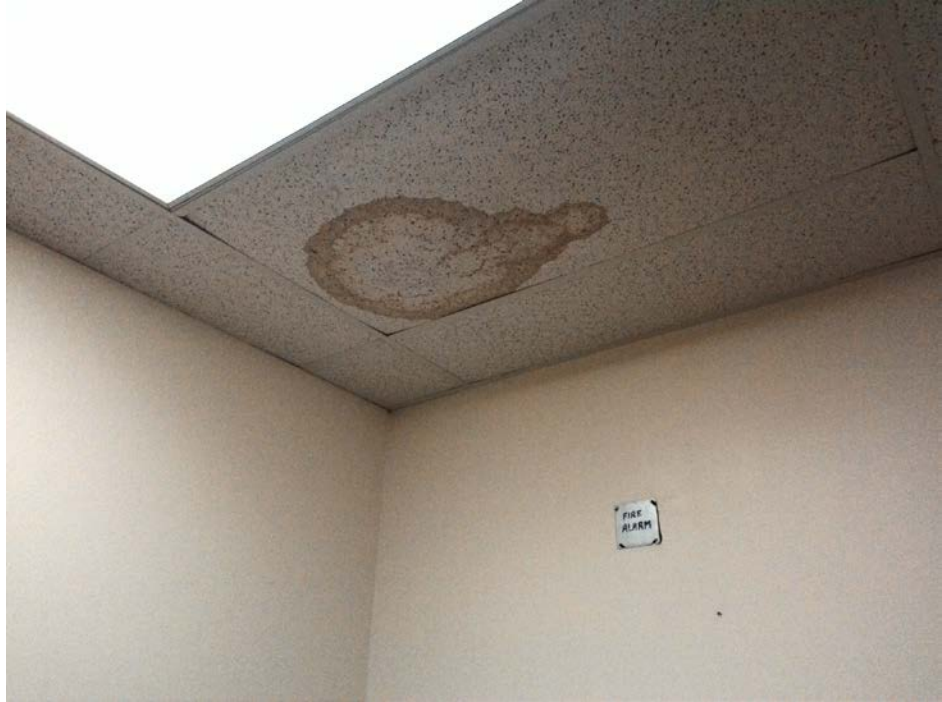
Photograph No. 9

COMMENTS:  
View of a drop ceiling  
panel with water  
damage in the Support  
Services area, the  
office of the Regional  
Director for Health  
Services.

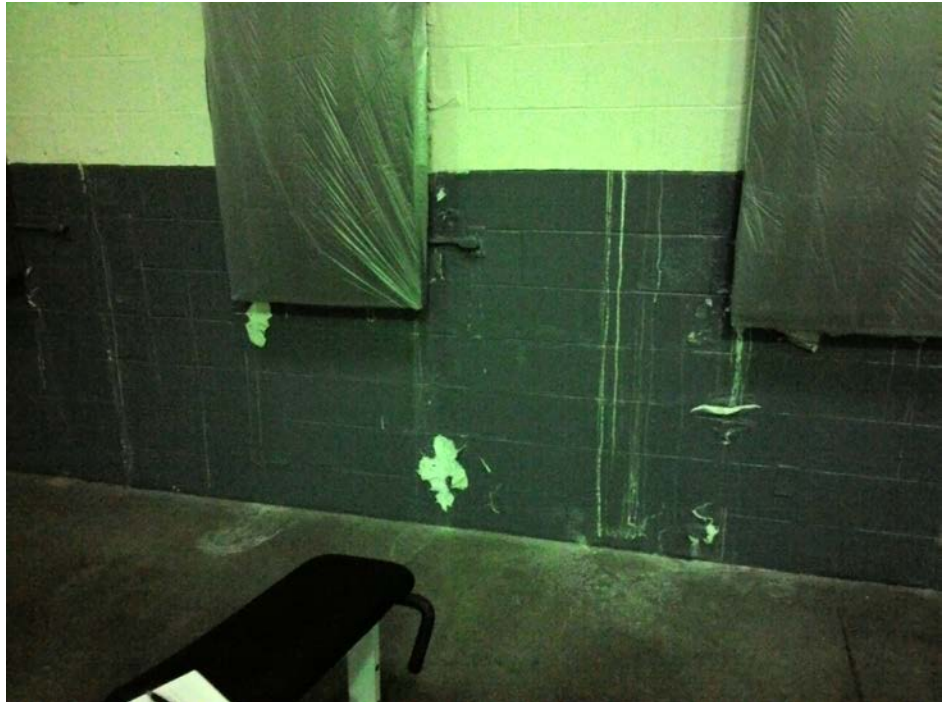
Photograph No. 10

COMMENTS:  
View of water damage  
down the walls of A-  
gym.

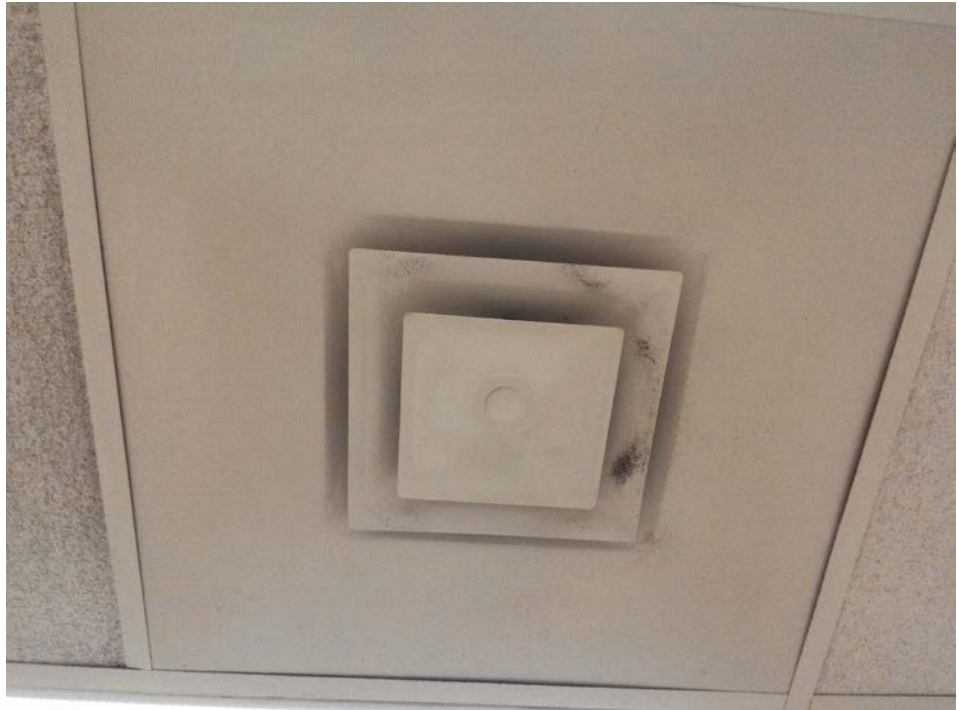
Photograph No. 11

COMMENTS:  
View of mold on an  
air vent in office B117  
in the case  
management area.

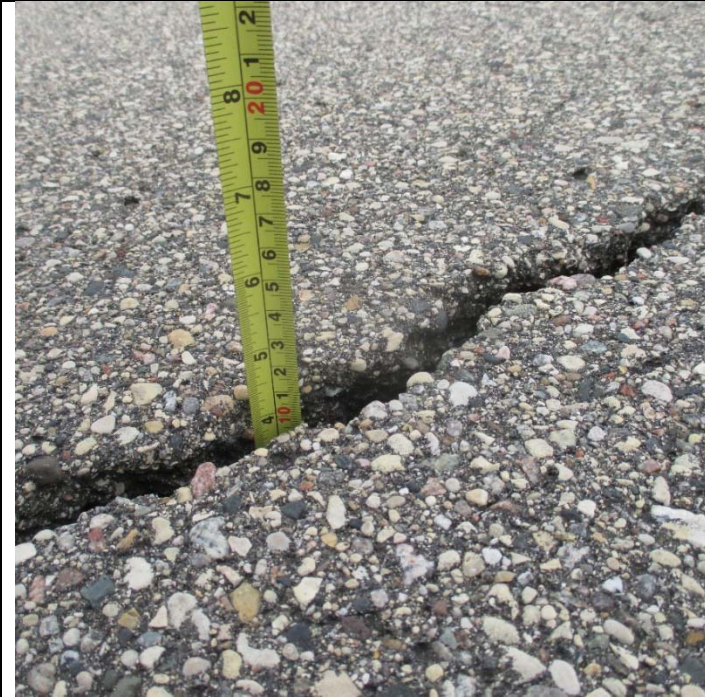
**Photograph No. 7**

Full depth cracking at carpark

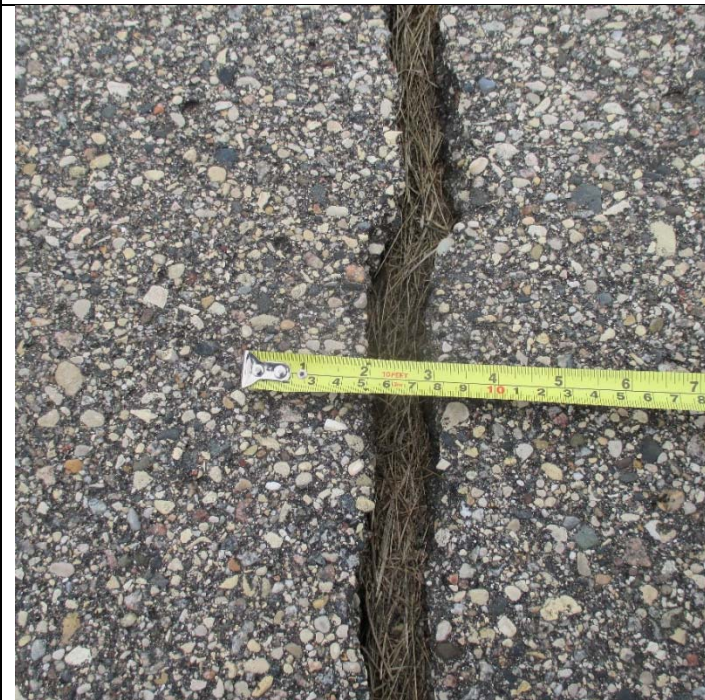
**Photograph No. 8**

Cracking pavement adjacent to Armory

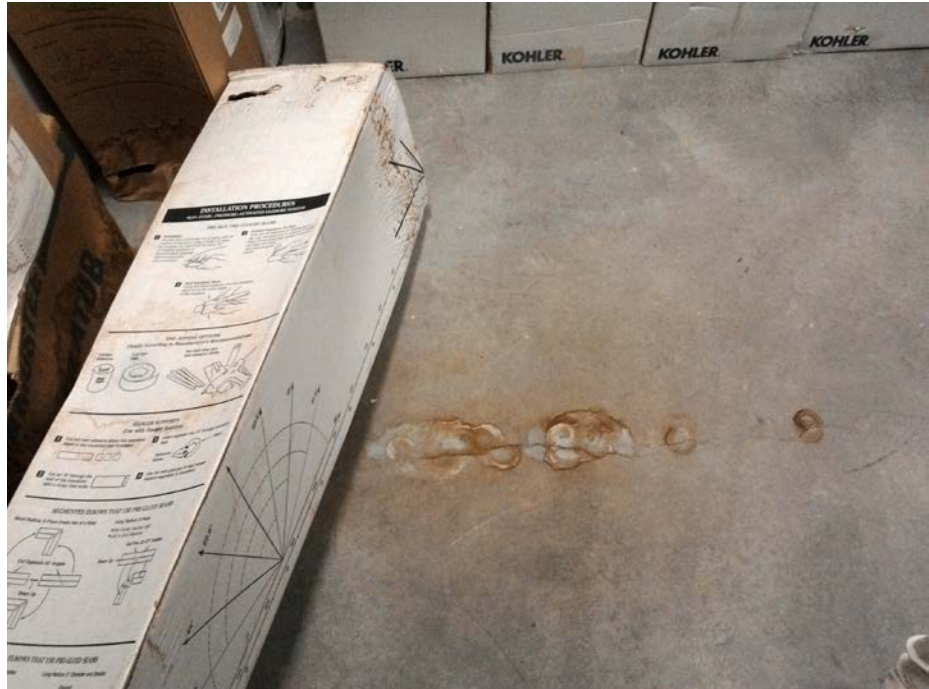
Photograph No. 1

COMMENTS:  
View of floor stains in  
the storage room  
adjacent A Pod C-Unit  
cell C25. The roof of  
the room has leaked in  
multiple areas.

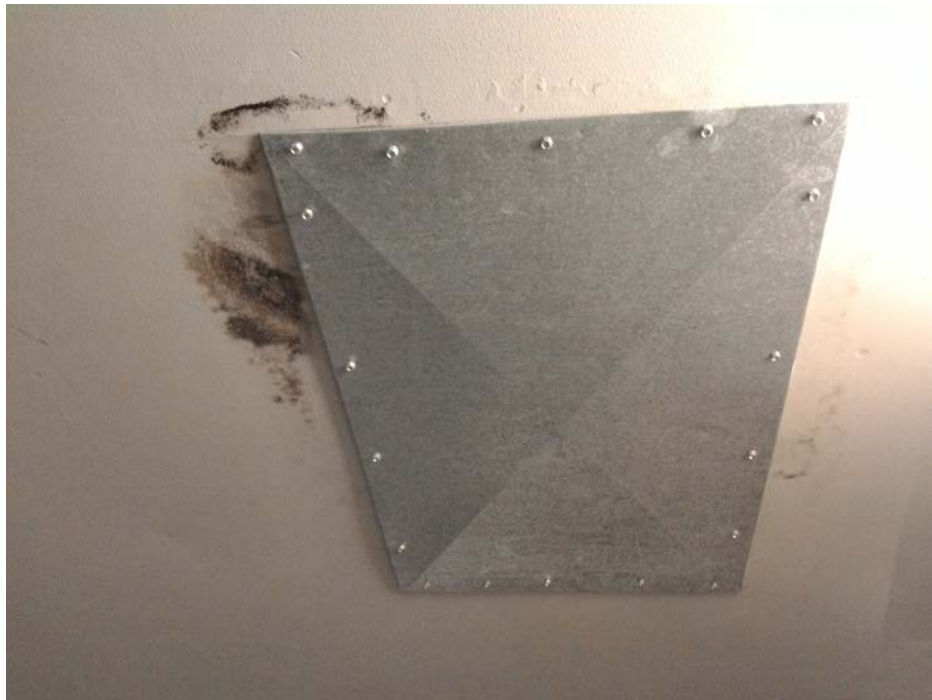
Photograph No. 2

COMMENTS:  
View of a sheet metal  
plate with signs of  
mold around it. The  
plate covers an  
opening used to clean  
the ducts adjacent to  
the area in Photo 1.

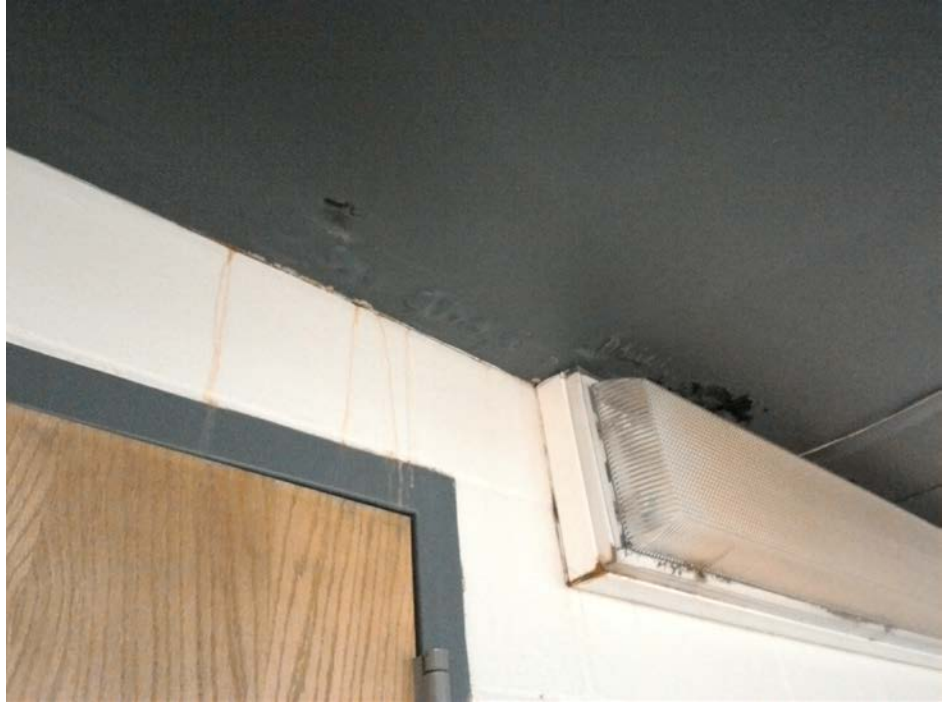
Photograph No. 3

COMMENTS:  
View of water damage  
from a leak to the  
ceiling adjacent to A  
Pod, E-Unit cell E48.

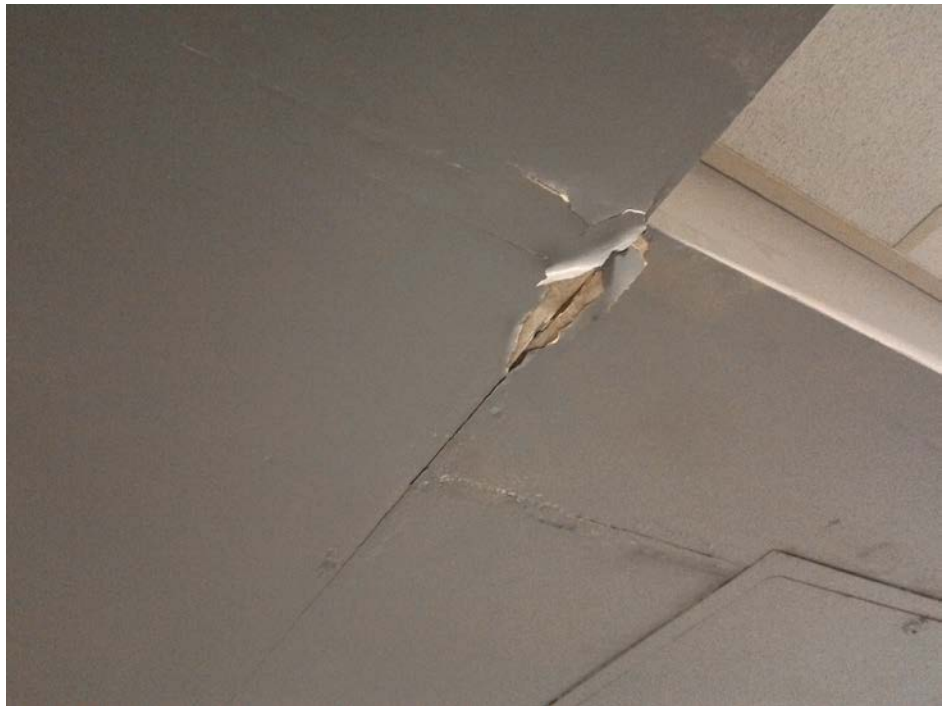
Photograph No. 4

COMMENTS:  
View of water damage  
to the duct above the  
door in A Pod leading  
from A-Unit to B-Unit.  
Water damage was also  
observed on a mirror  
below this area.

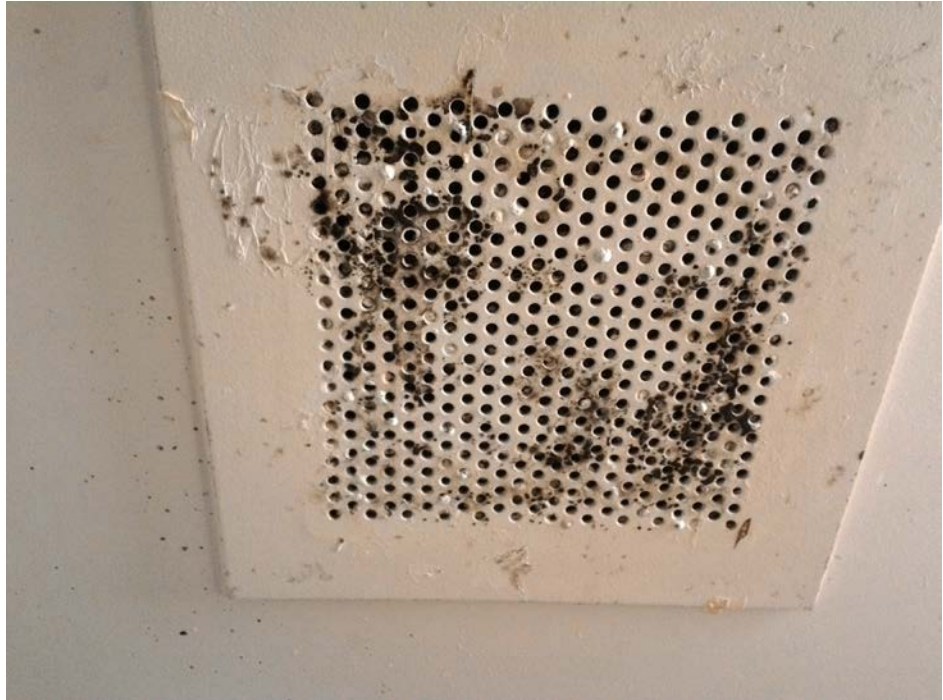
Photograph No. 5

COMMENTS:  
View of the air vent in  
D Pod, D-Unit, cell  
D204 with signs of  
mold on the grate.

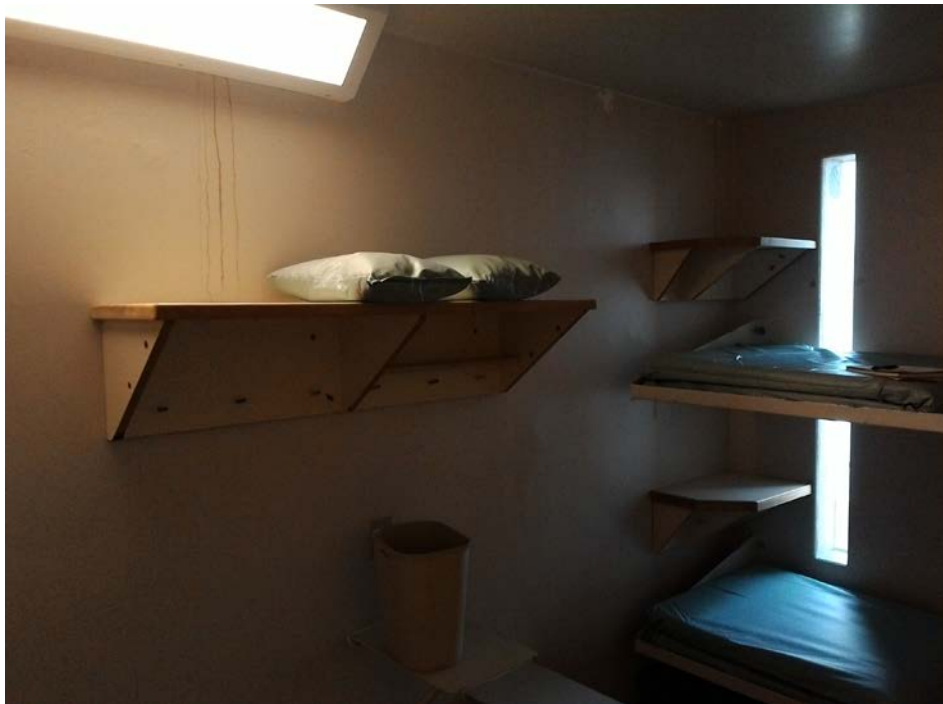
Photograph No. 6

COMMENTS:  
View of typical signs  
of water leaks in F  
Pod, F-Unit cells  
F108, F207 and F208.  
Water streaks are seen  
below the light fixture.

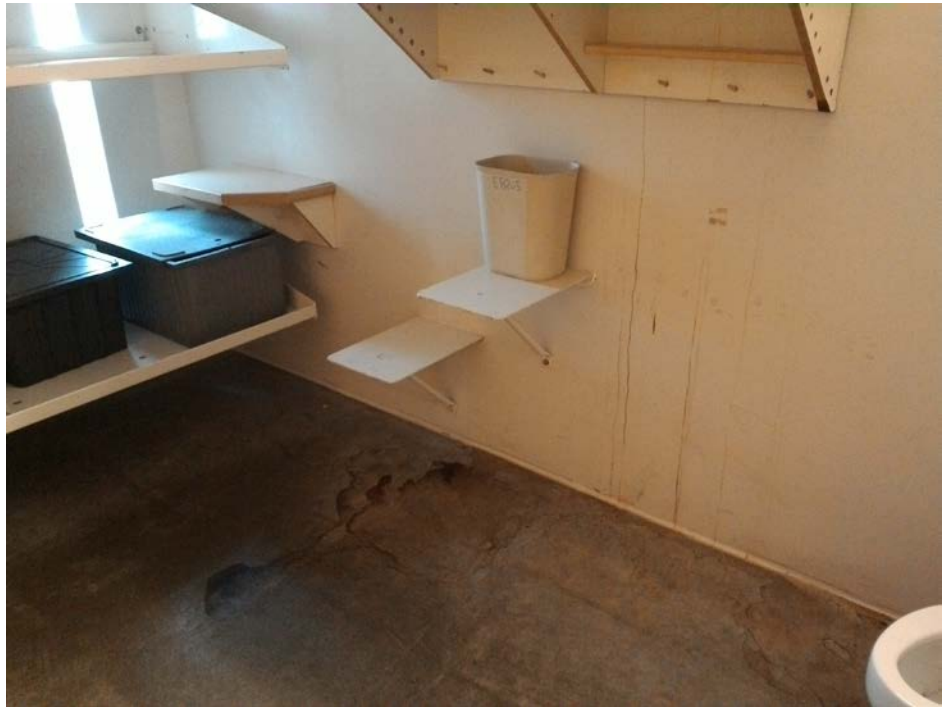
Photograph No. 7

COMMENTS:  
View of water damage  
streaks from the ceiling  
running down the wall  
in E Pod, A-Unit cell  
A203.

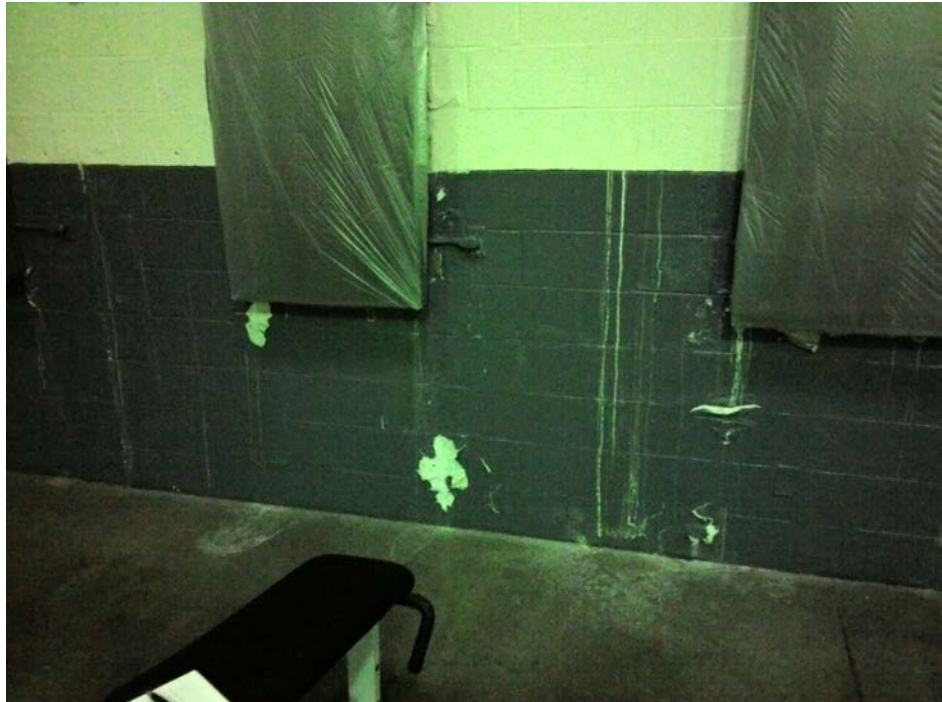
Photograph No. 10

COMMENTS:  
View of water damage  
down the walls of A-  
gym.

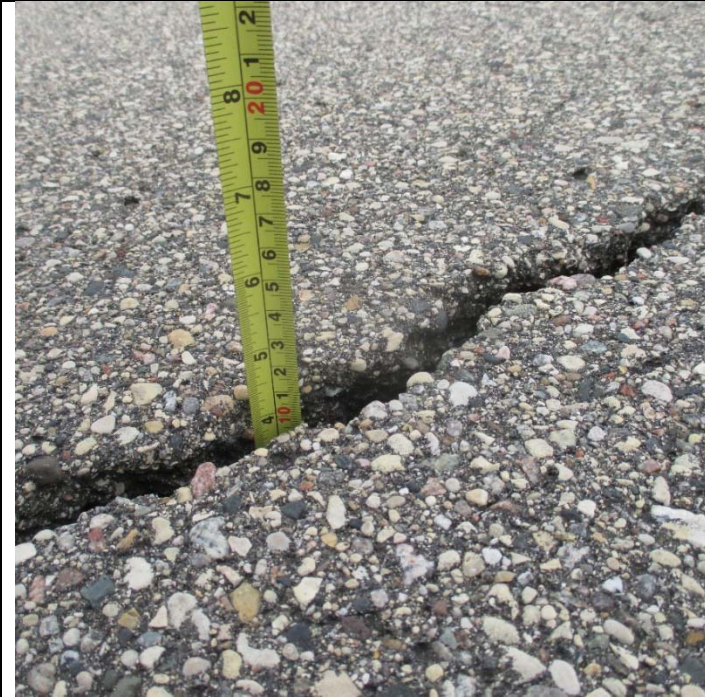
**Photograph No. 7**

Full depth cracking at carpark

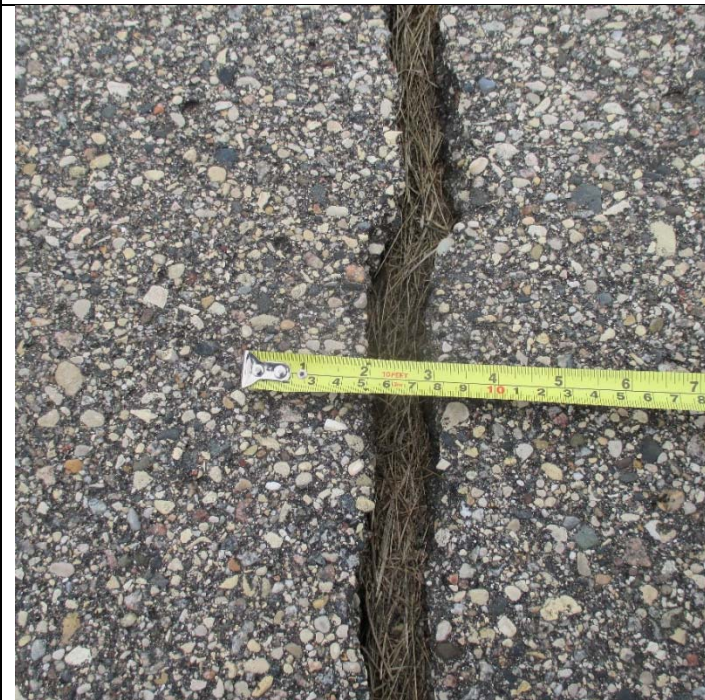
**Photograph No. 8**

Cracking pavement adjacent to Armory
