Clean Air Group

September 8, 1998

ETC Building Evaluation of Part of the Third Floor 1450 Energy Park Drive St. Paul, Minnesota

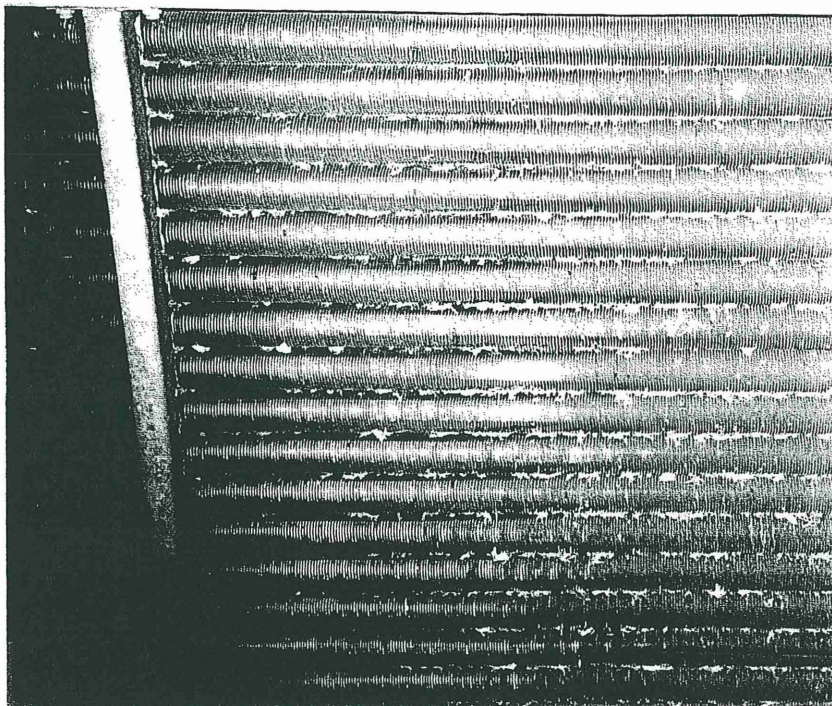
Photo #: 1 Date: 9/1/98

1. Significant by pass of air around the air filters in the AHU-1 was observed. Visible debris and some dead insects were observed on the upstream side of the cooling coils and in adjacent ductwork. This must have been a recent problem because the supply air ductwork generally appeared to be clean. This problem needs to be corrected but likely has not caused long term problems for the HVAC system.

The cooling coils were a little dirty, see Photo 1. In addition to debris a number of insects were observed on the upstream side of the cooling coils. Small piles of dead insects were also observed on the floor of the air handling unit, see Photo 3. The presence of the insects indicates significant bypass around the filters. These filters need to be inspected for bypass and this problem corrected. The drain pans for the cooling coils allow 1 ½ inches of standing water to be present, see Photo 4. Biocide capsules have been used in these drainage pans and the water appeared to be clean and free of microbial growth. The pans were rusting out as can be seen in Photo 4. Drainage pans of this type should be designed to drain to a dry condition.

Description: Dirty cooling coils
upstream from fan.

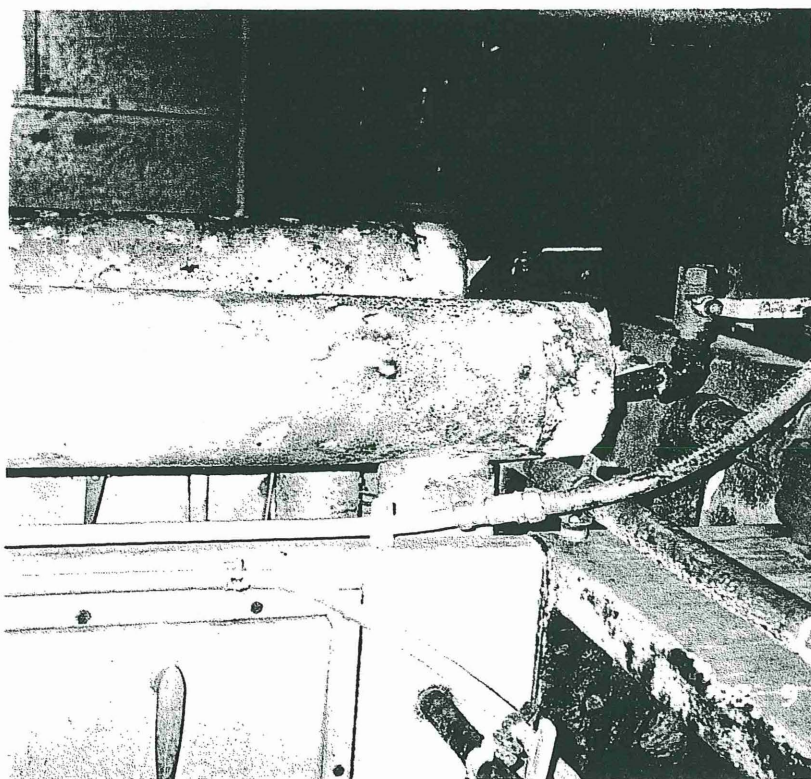
Photo #: Date: 9/1/98

2. Some of the insulated chilled water pipes on the downstream side of the cooling coils have absorbed moisture and have surface microbial growth occurring. Fibrous glass insulation should not have been used in this location. Closed cell foam insulation works best in these high moisture areas. The insulation in this areas should be removed and replaced with a closed cell foam insulation.

Immediately downstream of the cooling coils several chilled water pipes were insulated on the exterior with fibrous glass, see Photo 2. This insulation has become discolored with possible microbial growth. This insulation should be removed and replaced with a closed cell foam type insulation.

Description: Moldy insulation on pipes.

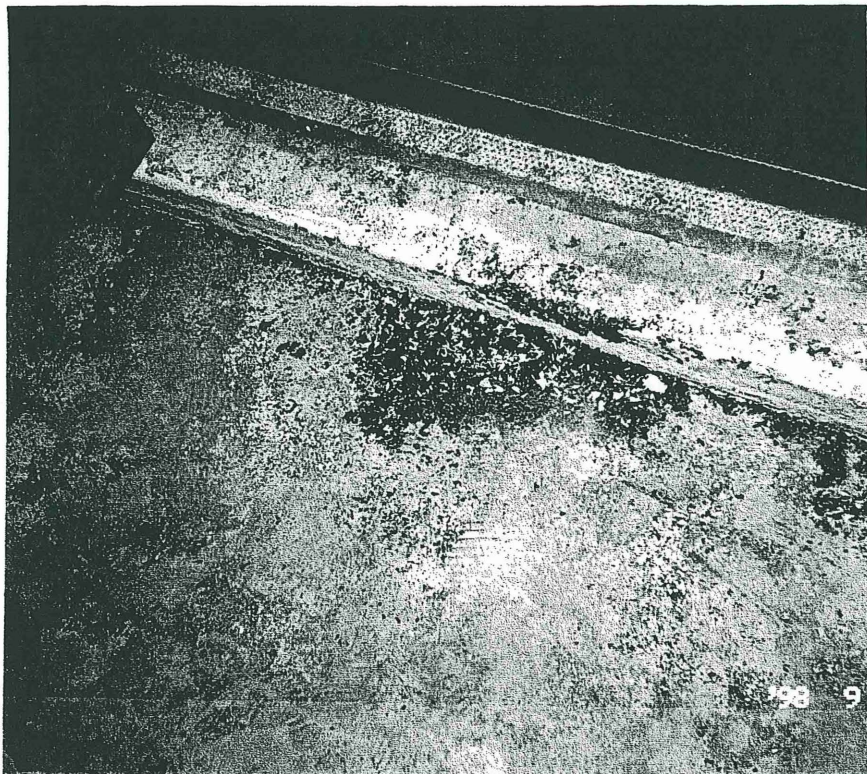
Photo #: 3 Date: 9/1/98

Description: Dead bug debris due to
 bypass around filter.

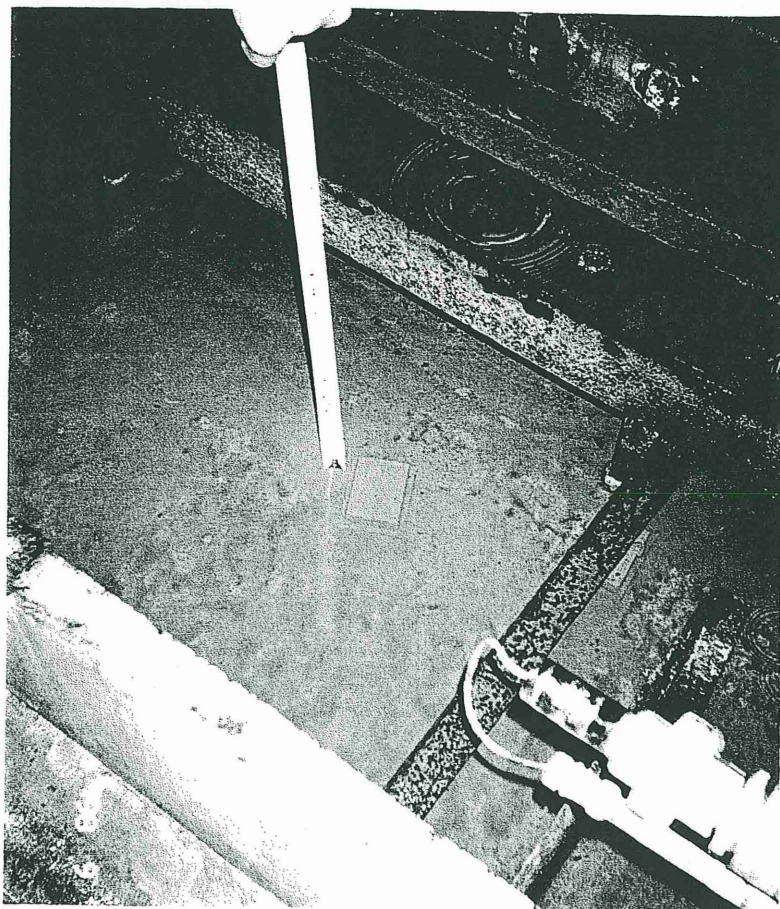
Photo #: 4 Date: 9/1/98

Description: 1½" of standing water
 in drain pan.

3. The cooling coil drip pans should be redesigned to drain to a dry condition. This lowers the moisture levels near the cooling coils and help prevent microbial growth in this area.

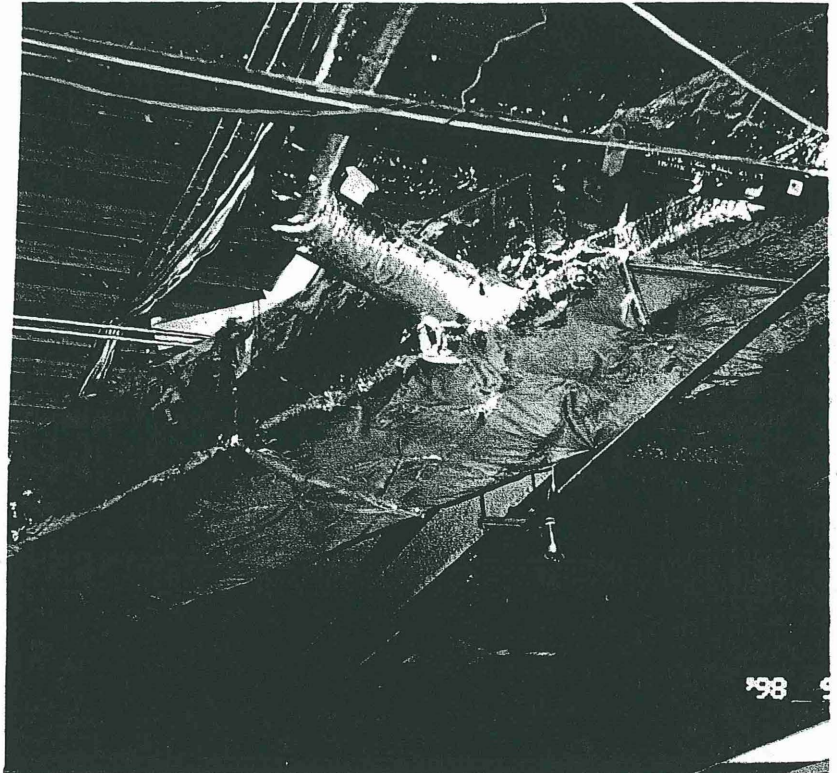
Photo #: 5 Date: 9/1/98

Most of the ductwork in this building is insulated on the exterior, see Photo 5. The internal surfaces are mostly bare galvanized metal. The supply air ductwork in the mechanical room was inspected and was found to be clean. Internal fibrous glass liners were observed in two locations inside the HVAC system. Inside the VAV boxes and for about ten feet downstream of the VAV boxes. The return air ductwork inside the mechanical room was also lined internally with fibrous glass. Samples of internal liners were collected from both of these locations to determine their condition. The results of this testing will be amended to a future report. These internal fibrous glass liners appeared to have some visible debris present on them but did appear to be free of microbial growth.

Description: External liner on ductwork
 in ceiling.

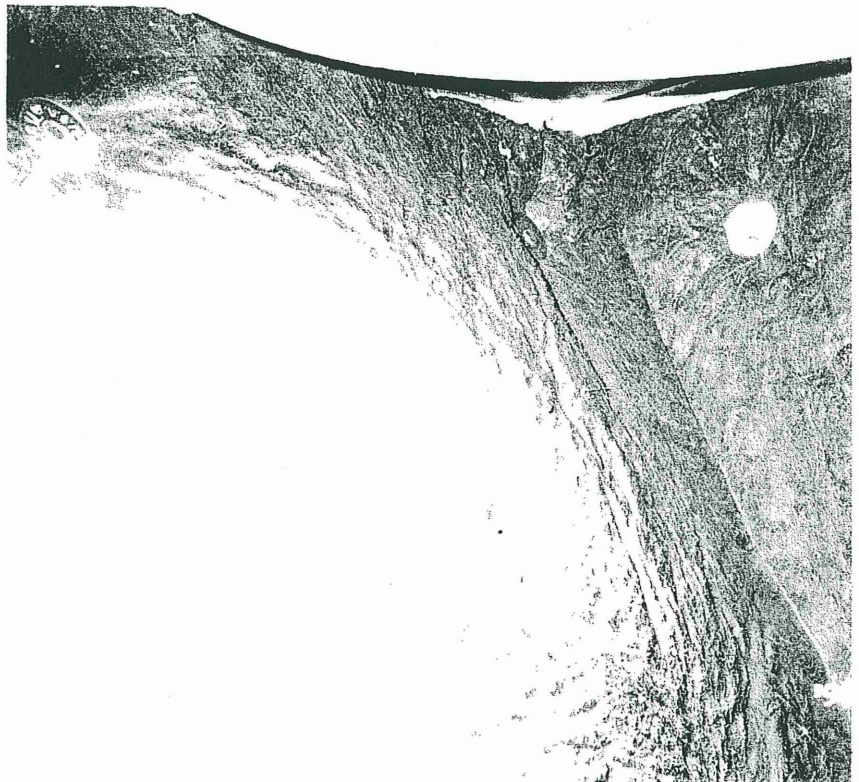
Photo #: 6 Date: 9/1/98

Description: Internal liner in VAV box.

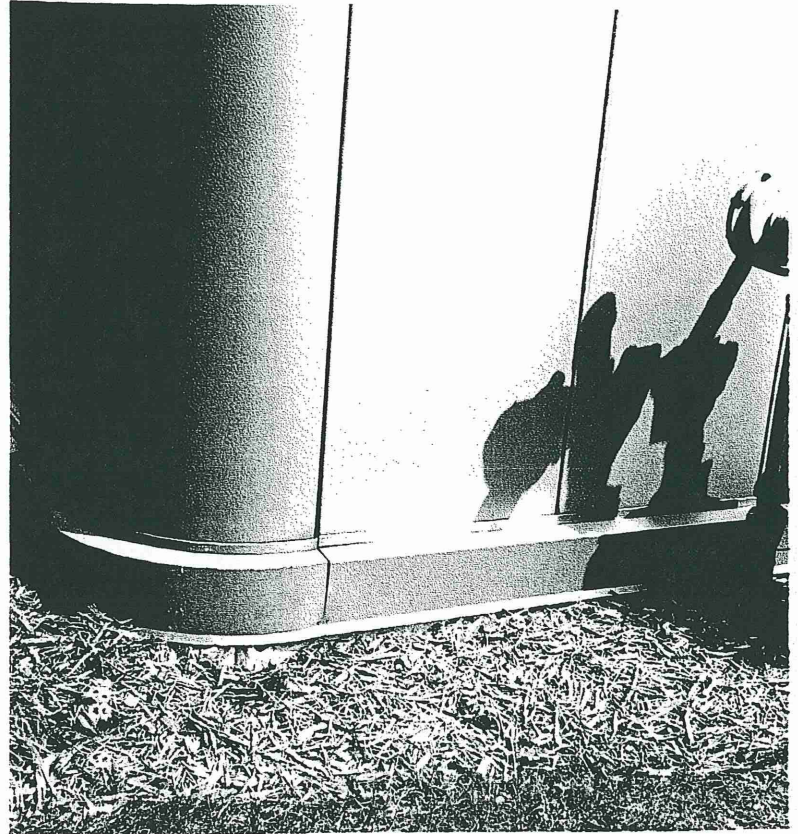
Photo #: 7 Date: 9/1/98

The exterior wall construction consisted of an aluminum and glass exterior surface, approximately 3" of foam insulation, ½" waterproof gypsum sheeting, 6" steel studs and ½ inch gypsum sheetrock. Vinyl wallpaper is used on some interior walls but is not present on any exterior walls.

Description: Exterior wall.

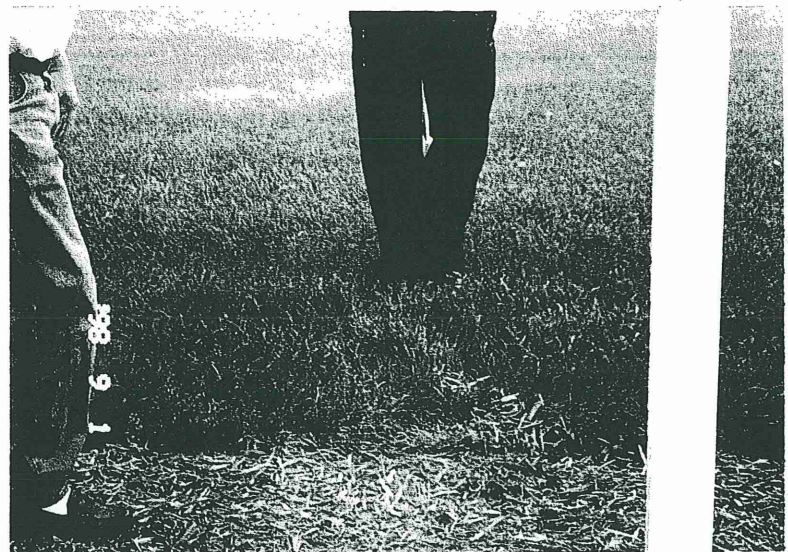
Photo #: 8 Date: 9/1/98

The exterior walls of this building which are not windows are covered with aluminum see Photos 7 and 8. An evaluation of the exterior walls did find weep holes above the windows and doors which allow internal moisture to weep to the exterior, See Photo 8. Effective drainage planes in exterior walls of buildings have weep holes above windows and doors and at the base of the walls to allow internal moisture to weep to the exterior.

Description: Weepholes above
 windows in exterior walls.

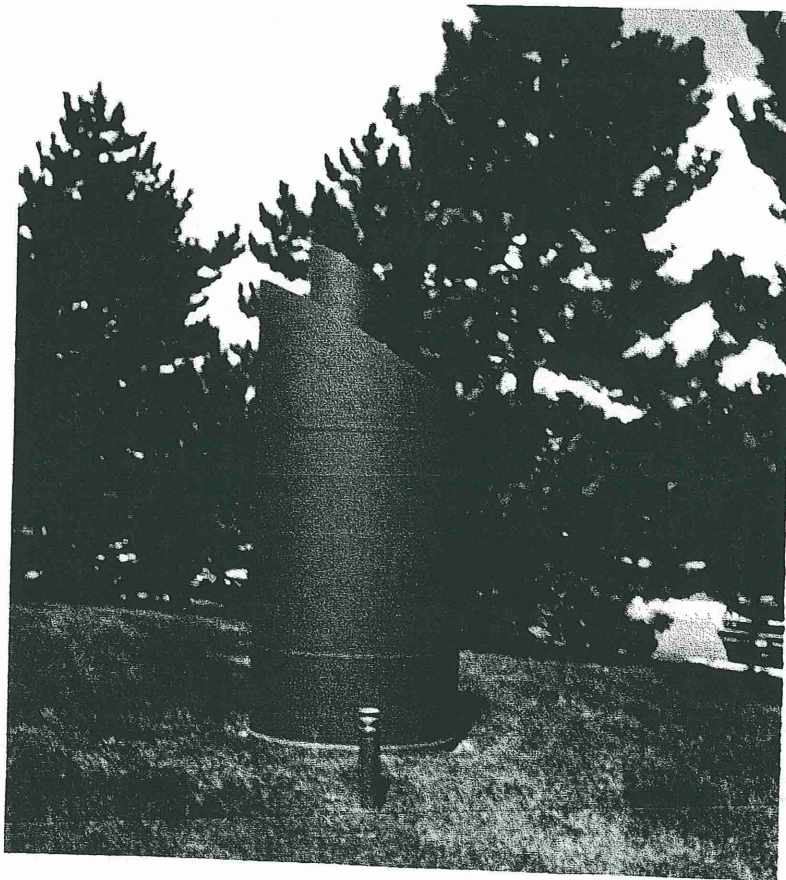
Photo #: 9 Date: 9/1/98

The fresh air intakes (FAI) for the building are away from the building and resemble stacks, See Photo 9. These are good locations for the fresh air intakes.

Description: A fresh air intake outside
 building.

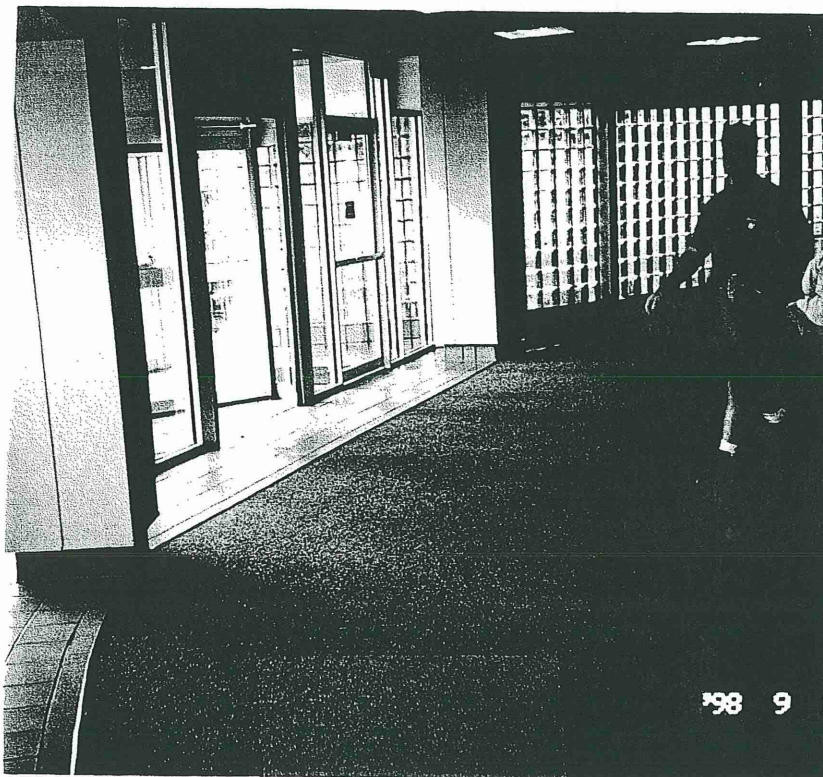
Photo #: 10 Date: 9/1/98

The carpet in the space will be replaced as part of the build out. Carpet dust samples were taken of the carpet in place and carpet in other areas of the building for comparison. Carpet is present at ground level near the exterior doors, see Photo 10. Carpet in this area should be replaced with a cleanable hard surface floor. Microbial carpet dust samples were collected from the carpet in this location to determine microbial loading.

Description: East entrance of building.
 Carpet dust sampling done.

4. Carpet is present at ground level near the exterior doors. Carpet in these locations is much more difficult to keep clean and free of microbial growth. Carpet in this location should be replaced with a cleanable hard surface floor. Cleanable floor mat can be used on top of the hard surface flooring.
