# ***Study Memorials / Monuments Capitol Complex***

***August 2013  
RECS #: 02CP0034***

**Consultant's Report**

Re: Study Memorials / Monuments, Capitol Complex  
RECS # : 02CP0034

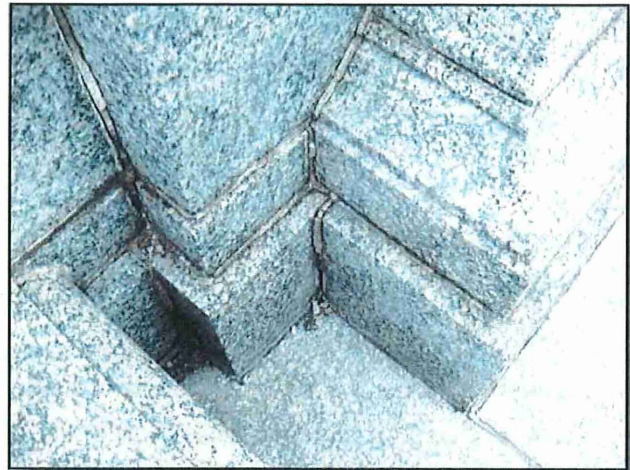
*Detail of failed caulking and mortar joints*

Number one priority since it is so close in proximity to the Capitol and one of the earliest installations (1931). The bronze sculpture has a dark chocolate brown patina that has discoloration of the coating. The wax is separating and very distracting. The granite base at the steps is coming apart and the mortar and caulking have failed.

- 2.Reset loose granite stair pieces only including adding pinning to prevent separation.\*  
The rest of the stone monument base does not need reassembly.(\$45,000)
- 3.Tuckpoint all mortar joints.
- 4.Remove all caulking and caulk all sealant joints.
- 5.Clean stone when complete.(\$26,000 for 3,4,5)
6. Landscape shrub replacement at perimeter of Monument.(\$19,000)

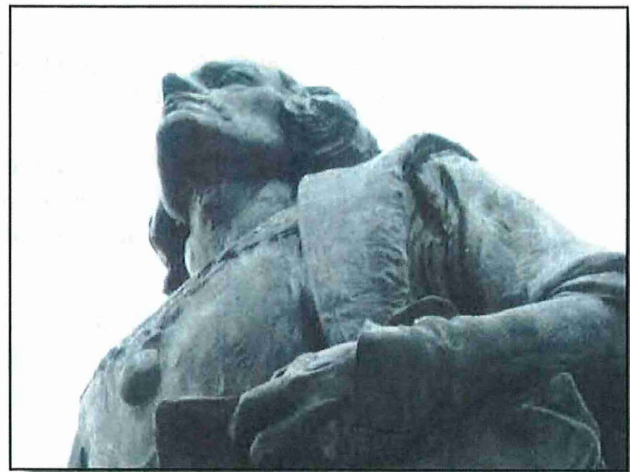
*Detail of streaking and wax separation*

- 1.Repair lacquer and scratched areas.
- 2.Sculpture treatment plan of new wax.(\$15,000 for 1&2)

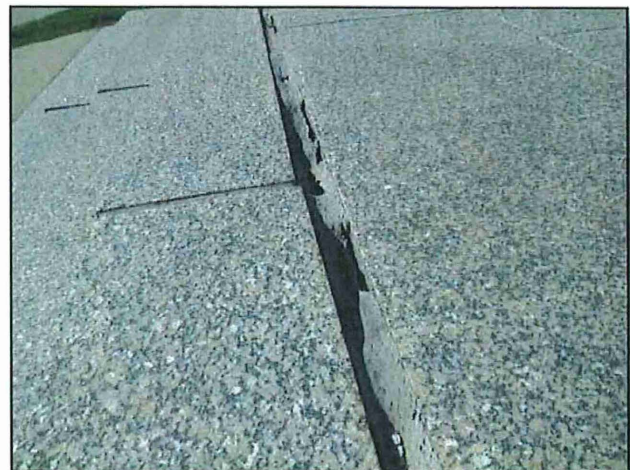
*Detail of hazard in stairs. Stone needs to be reset and pinned at stairs.*

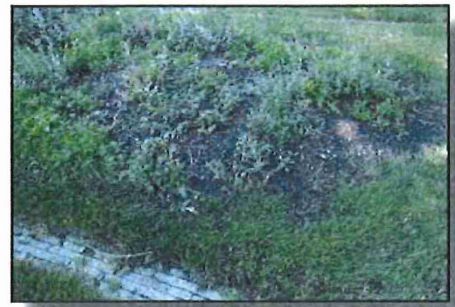
*Landscape needs attention and some replacement.*

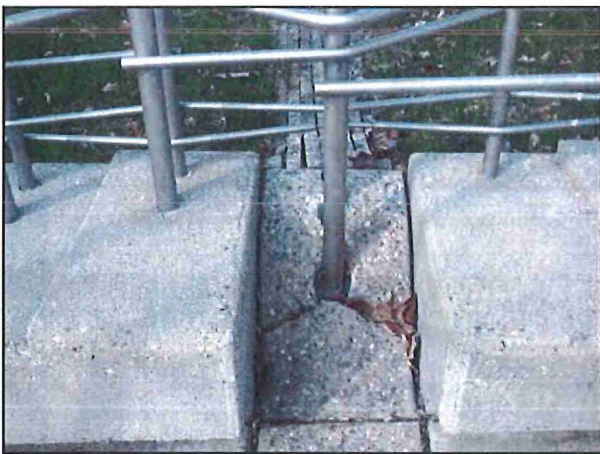
*Failed concrete support, typical at post wall.*

The Memorial has a number of issues. The lattice steel wall is embedded in concrete that has cracked and failed at supports and inscriptions. The lattice framework is rusting, plaques need to be renewed with wax for readability. Pavement requires work to eliminate trip hazards and landscape needs annual attention to maintain its intent.

2. Replace broken concrete(see photo) with granite at supports and inscription.(\$90,000)

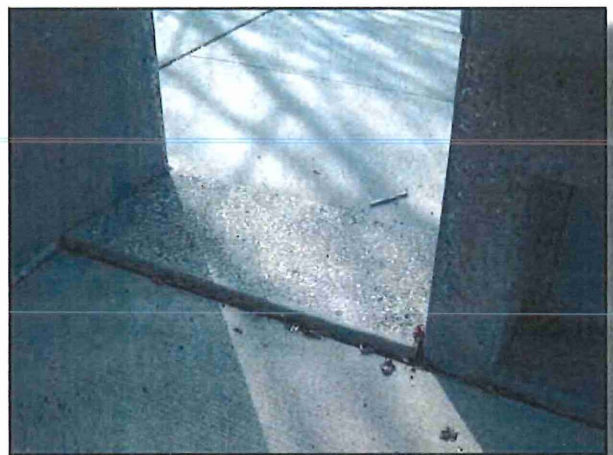
*Trip hazard at adjacent podium.*

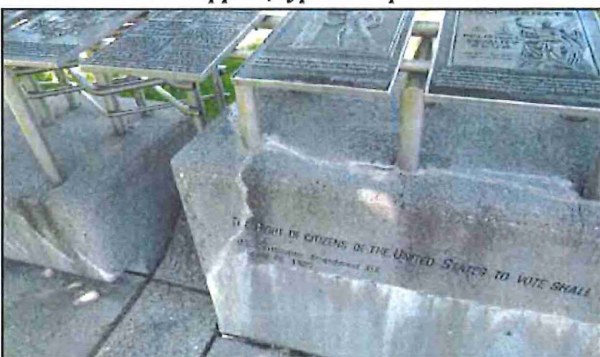
*Wall has cracked and needs granite replacement for inscription.*

11 - The concrete Memorial is breaking apart and the metal is rusting.

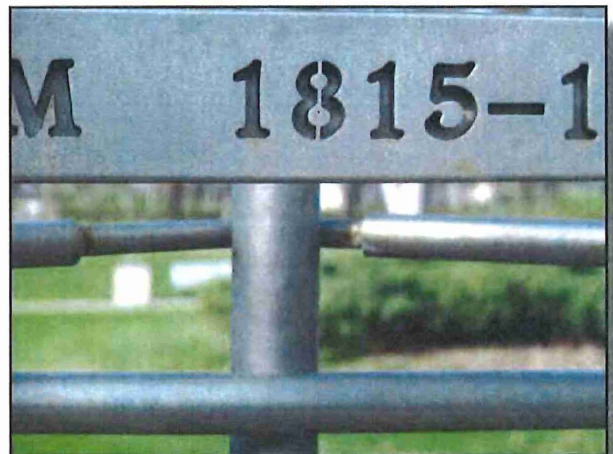
*Rusting surface needs protective coating.*

3. Remove rust from lattice and provide protective finish.(\$20,000)

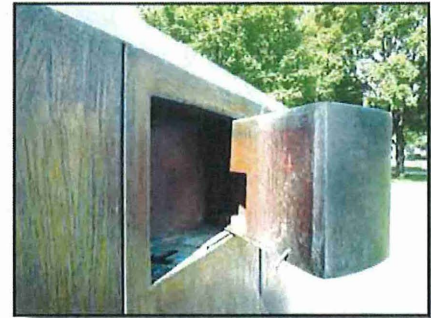
*Doors of memorial need repair to avoid personal injury.*

16 - Temporary chain fence detracts visually. Doors need repair.

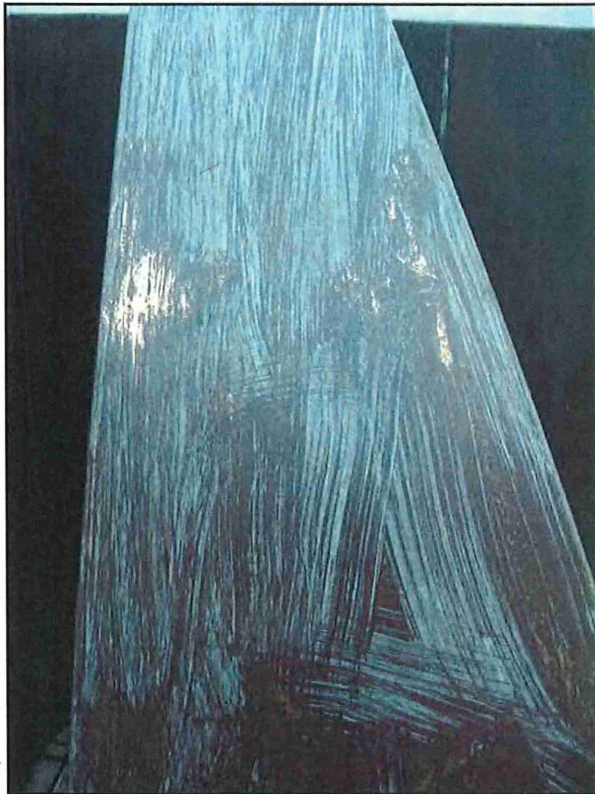
*Irregular finish needs conservation treatment.*

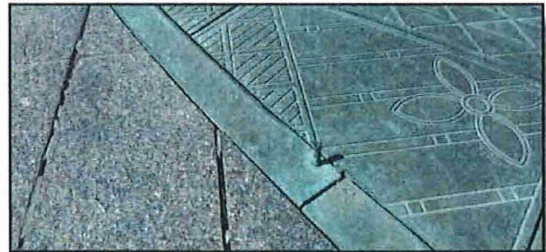
*Metal pin is a trip hazard.*

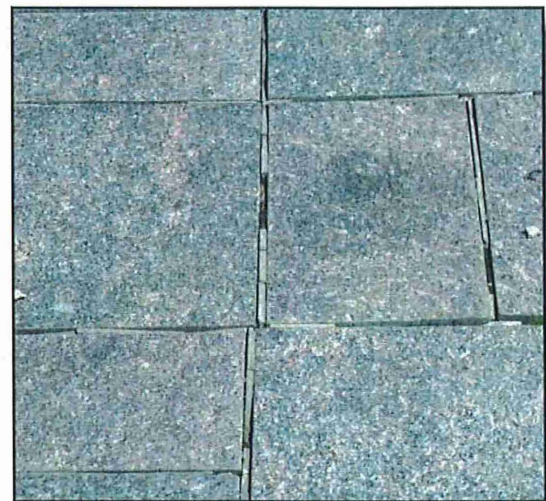
*Granite pavers need to be reset to eliminate trip hazard.*

11 - Some pavers are cracked. Eight (8) wood benches need replacement.

4. Replace 8 wood benches.\*((\$40,000)
5. Reset granite paver plaza and replace broken pieces.\*((\$65,000)

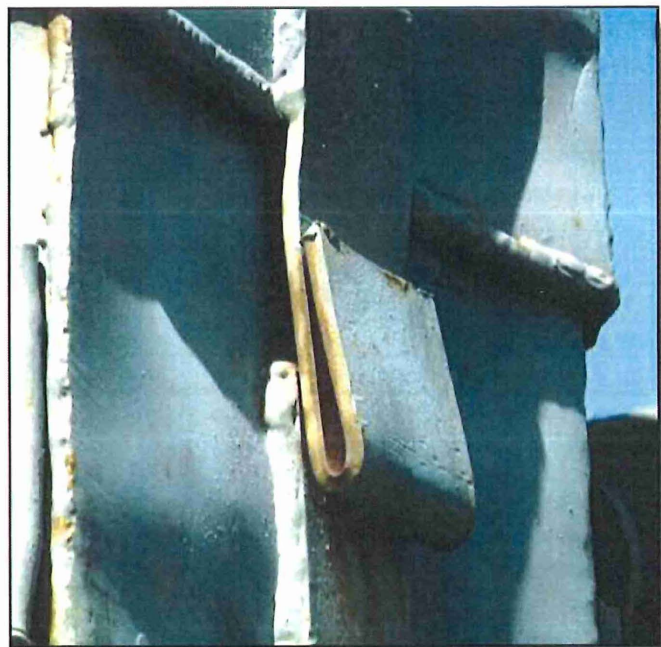
*Memorial requires repainting.  
Wax treatment*

This sculpture is a galvanized steel figure that is obscured by rust spots and is fading. The plaque on the base needs its patina renewed. Pests/ wasps have found their way inside and need to be removed. These openings will be closed.

11 & 15 - Current paint is rusting.

1. Prep for new finish including repairing bondo on the head. Paint with epoxy.
2. Re-patina plaque.
3. Cold wax and buff.(\$35,000 for 1,2 &3)

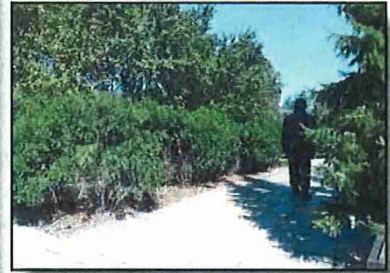
*Overgrown landscaping requires replacement and pruning to improve security.*

3. New landscape surround. The new plants could match the original intent but not be as tall when mature.\*(\$60,000)
4. Repair paving and new caulking.\*
5. Clean stone.(\$40,000 for 4&5)

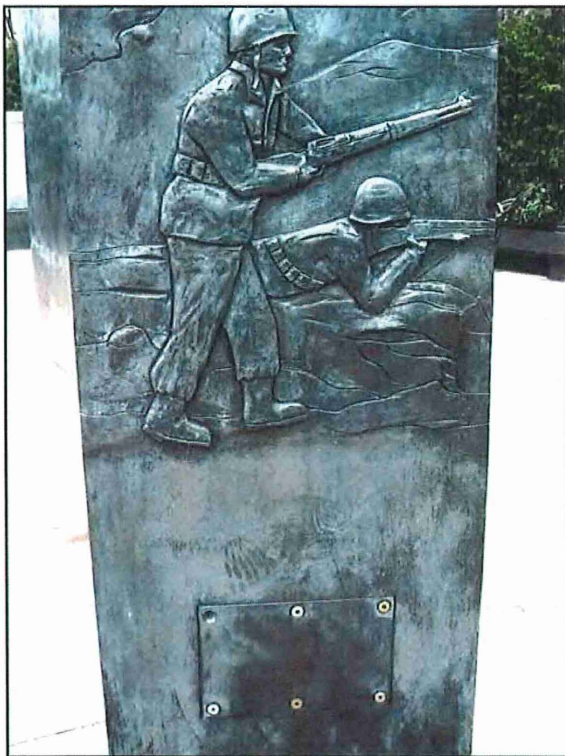
*Requires cleaning and removal of haze on wax coating.*

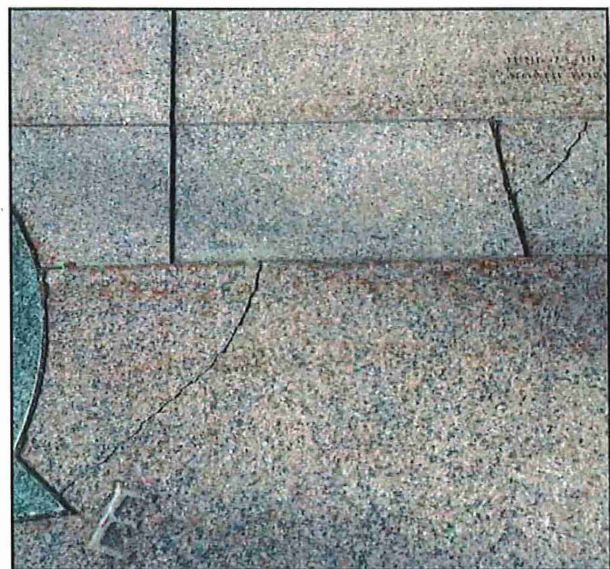
*Eliminate trip hazards and replace broken granite pavers.*

16 - Replacement of some granite and granite paving.

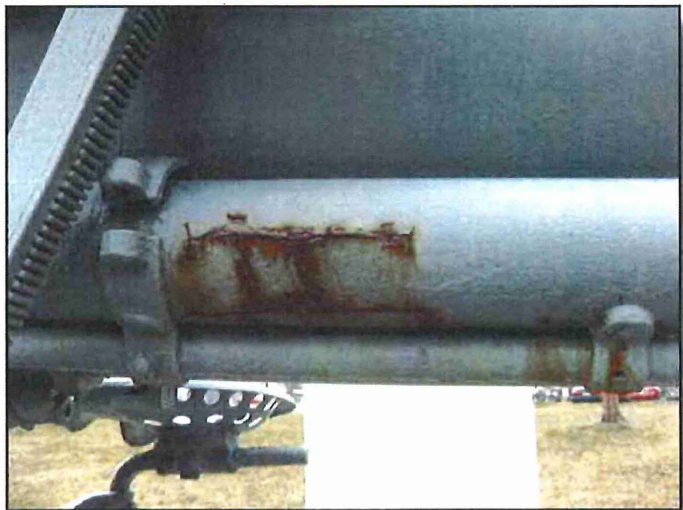
*Repair rusted areas and repaint entirely.*

The World War II destroyer gun requires repair of rust damage. The concrete base surround should be replaced as it has cracked. The barrel should have a permanent welded plug installed as the existing one is temporary.

1. Strip existing paint entirely, repair rust, prime and paint entirely.
2. Wax coat to help finish.(\$51,000 for 1&2)

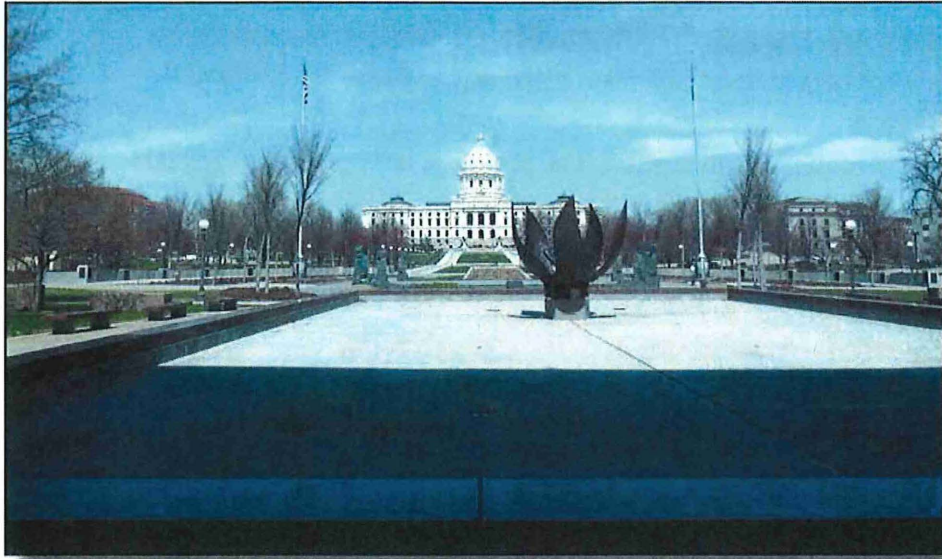
*Former fountain area  
needs an aesthetic finish.*

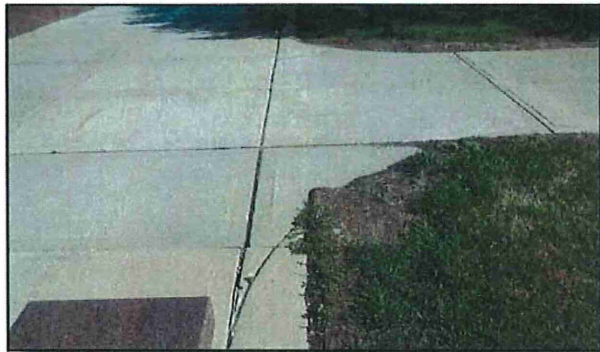
*Sidewalk and turf need replacement.*

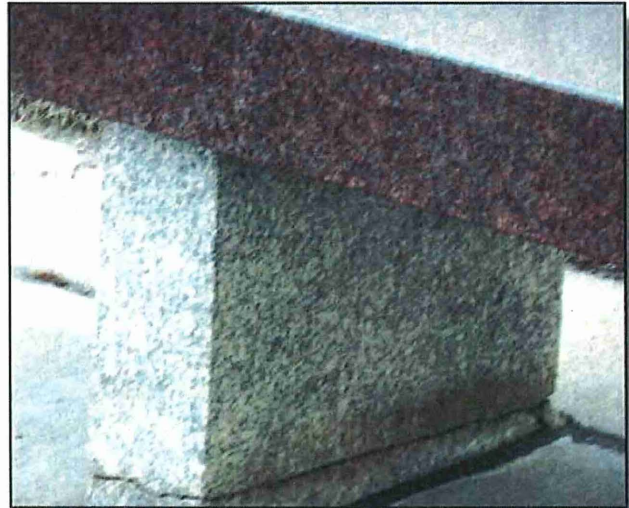
*Cracked granite bench support  
needs replacement.*

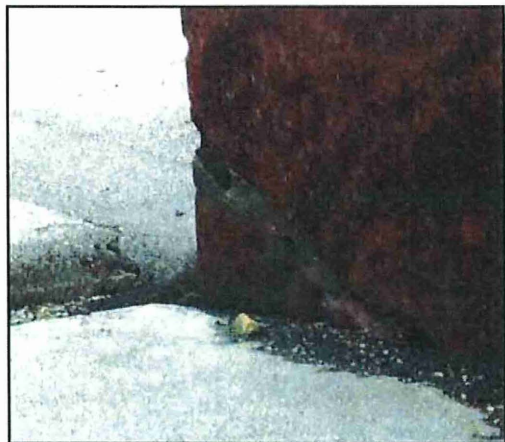
*Raised concrete walk trip hazard and  
granite corner need correction at foundation.*

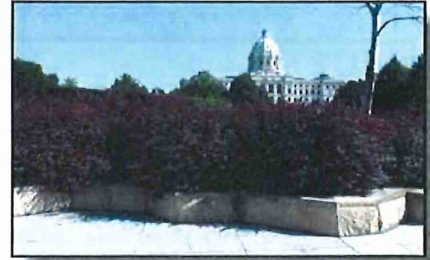
*Landscaping is overgrown and needs pruning/replacement.*

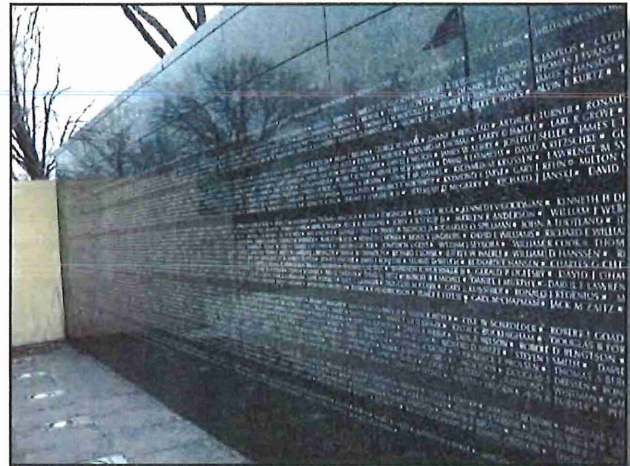
*Failed ground lighting needs replacement with overhead wall wash lighting.*

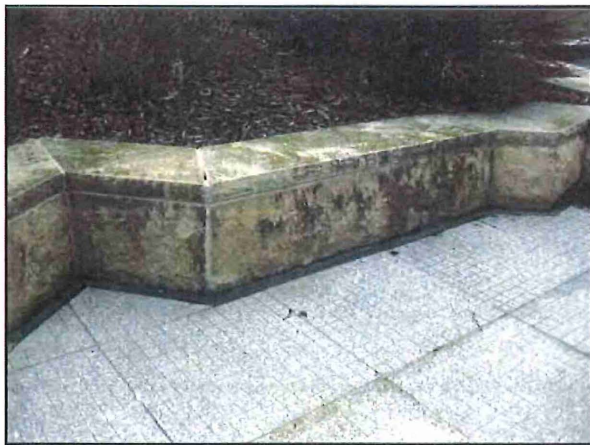
*Kasota stone needs cleaning.*

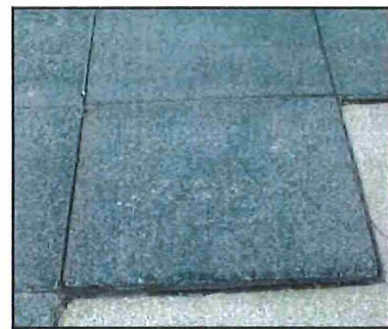
*Paving trip hazard needs correction.*

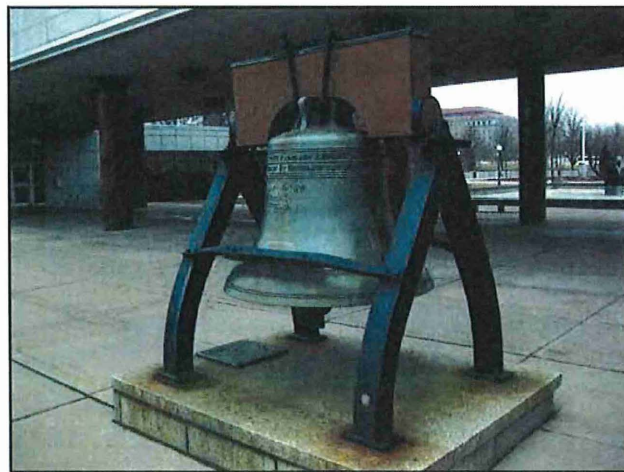
Stain removal and conservation of bell  
required.

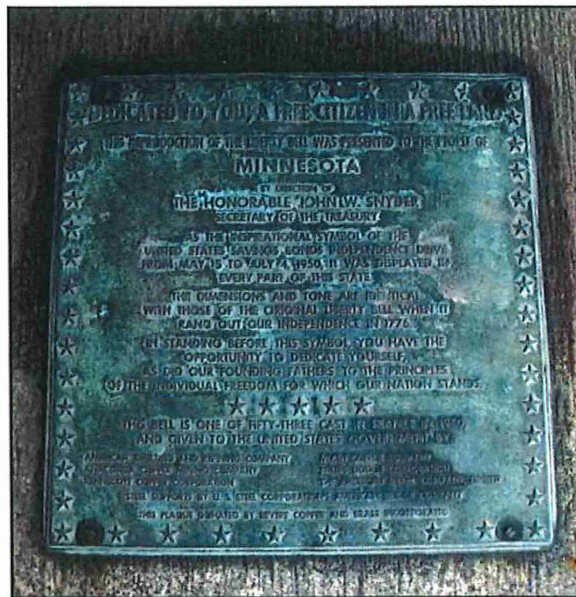
Conservation of plaque required.

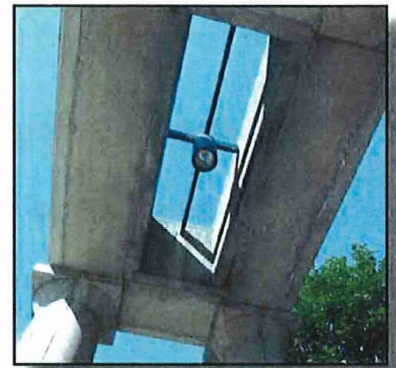
*A translucent roof cover could eliminate staining.*

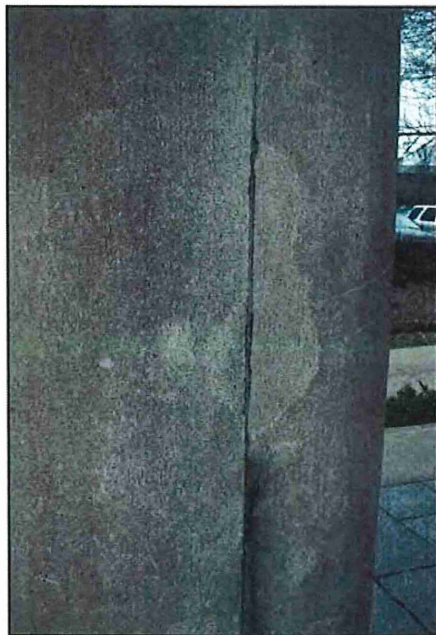
*Pre-cast columns need cleaning and joint repair.*

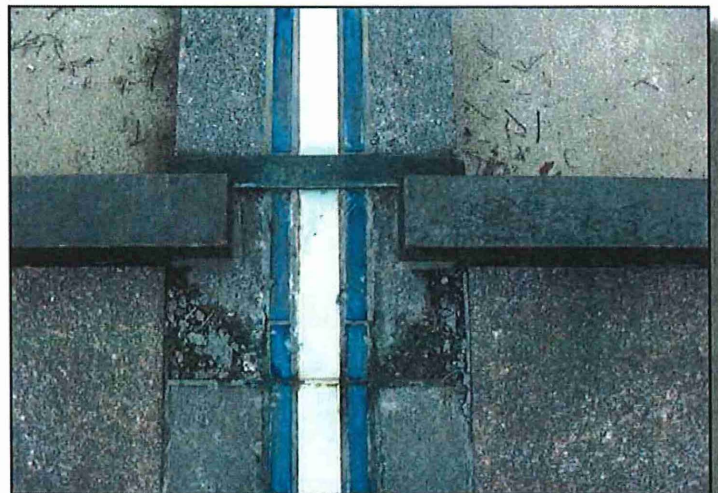
*Paving needs reconstruction in some areas.*

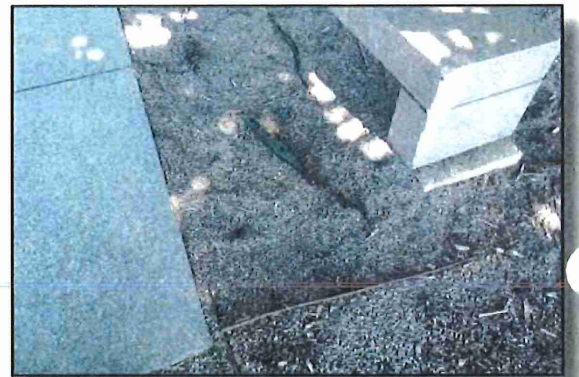
*Landscape fabric under pea gravel is a trip hazard.*

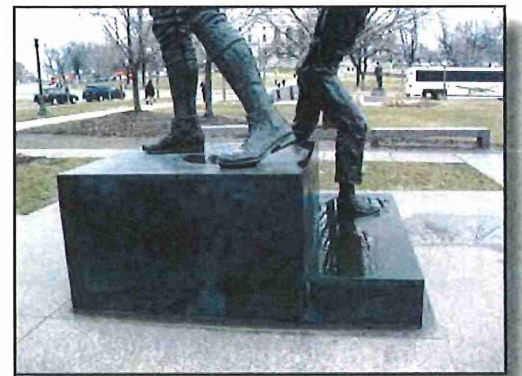
*Sculpture requires conservation treatment.*

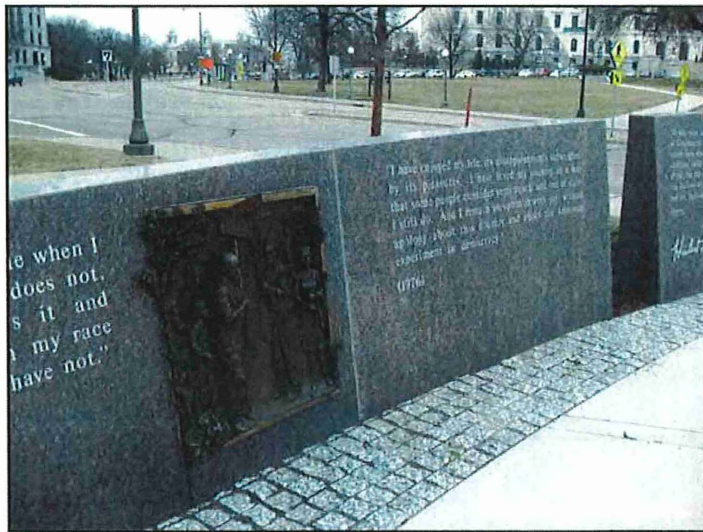
*Plaque requires cleaning and waxing.*

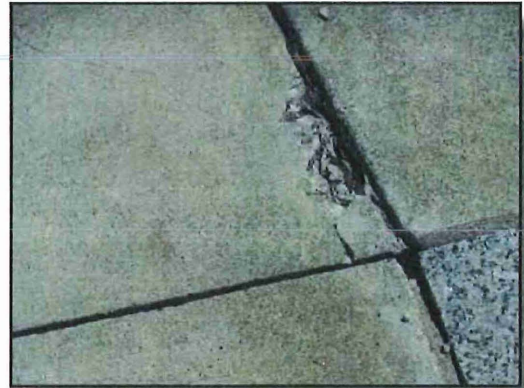
*Sidewalk and pavers need replacement.*

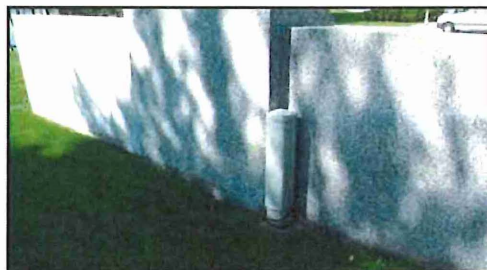
*Phone box needs relocation and memorial needs landscape buffer*

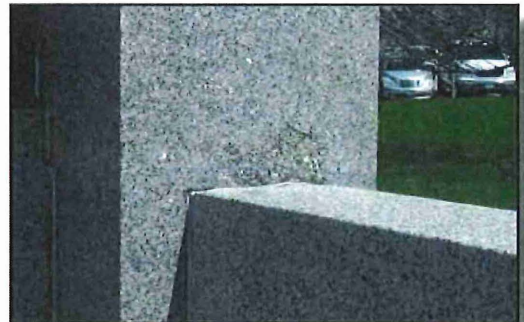
*Joint needs work to prevent additional spalling of stone.*

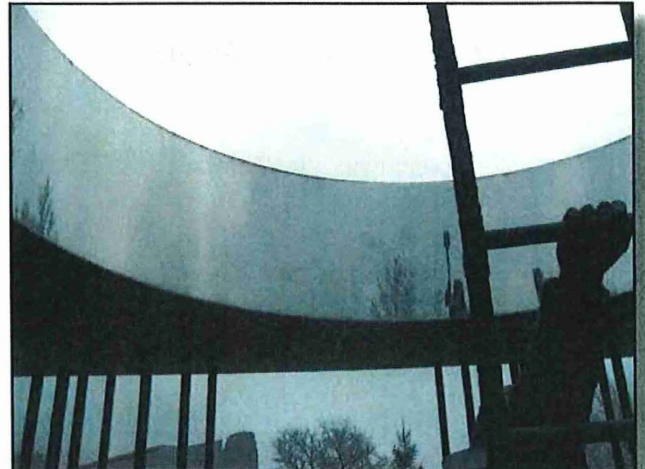
***Oculus needs rust removed.***

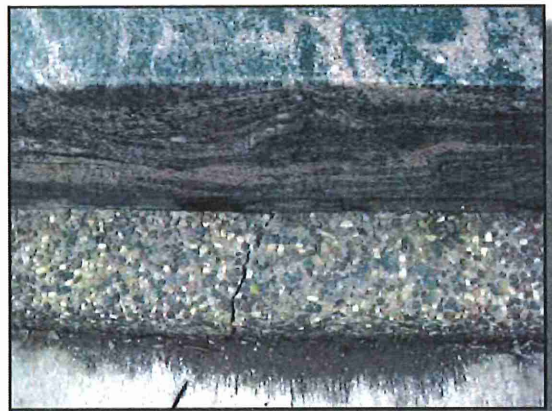
*Base needs to be replaced as it is cracked.*

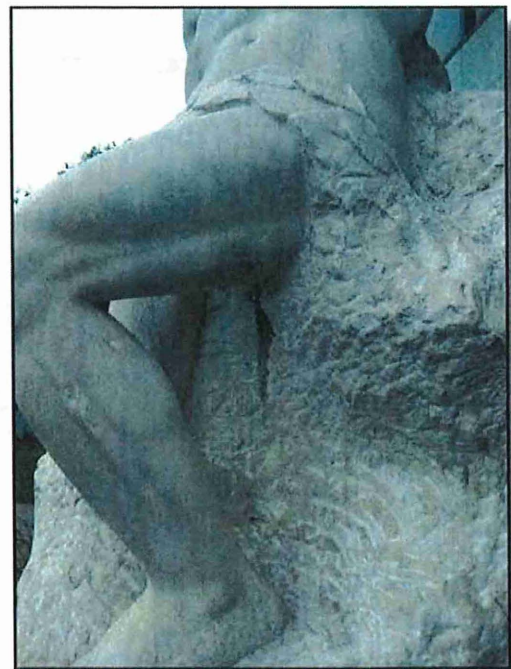
***Cleaning of marble sculpture required.***

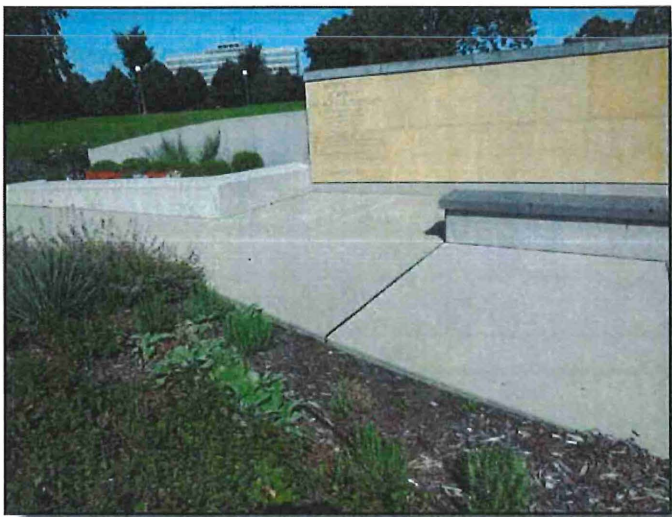
*Landscape requires attention and plant material replaced where it has died.*

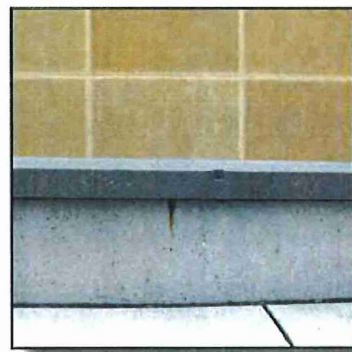
*Remove staining from stone and concrete.*

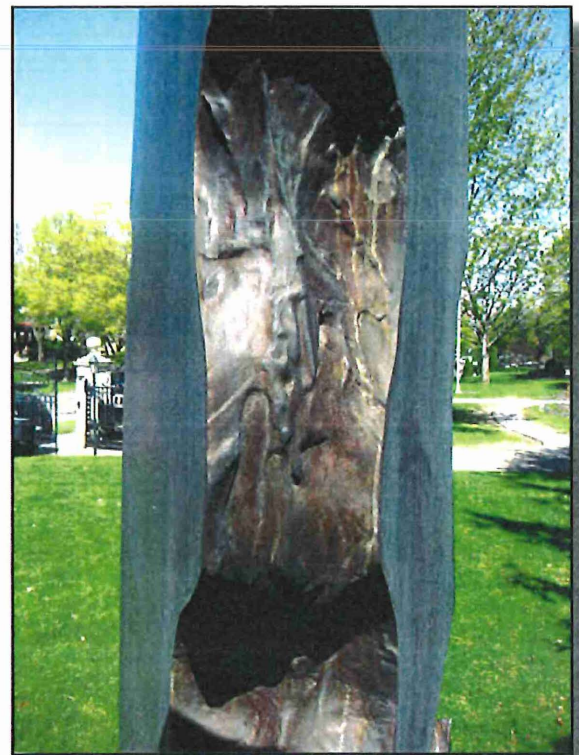
***Sculpture requires conservation  
treatment.***

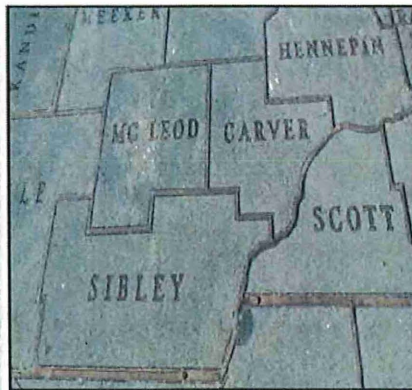
**Plaza "Counties" need to be leveled/  
repaired and recaulked.**

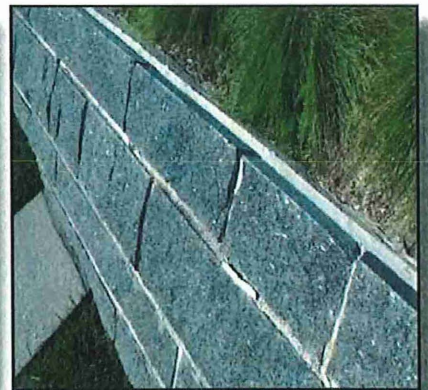
**Wall needs tuckpointing.**
