LEGACY FUND RESTORATION EVALUATION REPORT

Technical Panel Findings and Recommendations—2022

REPORT TO THE MINNESOTA LEGISLATURE

Date of Report: August 2023

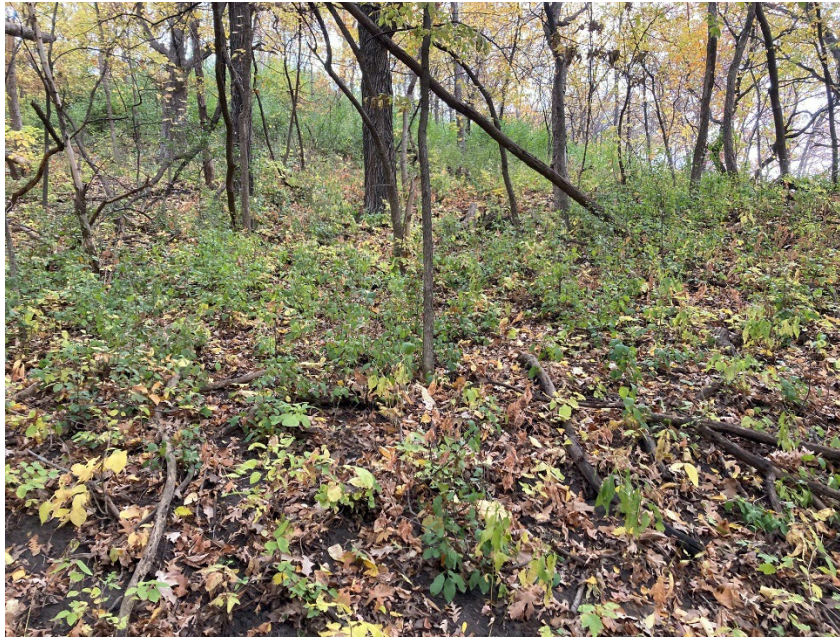
Photo 22 West goat grazing area with moderate treatment efficacy (25-50% buckthorn cover) in foreground and 75-100% buckthorn cover farther upslope where rubble dumping/poor footing may have limited accessibility (Indian Mounds Regional Park, photo taken during site visit 10/17/2022).

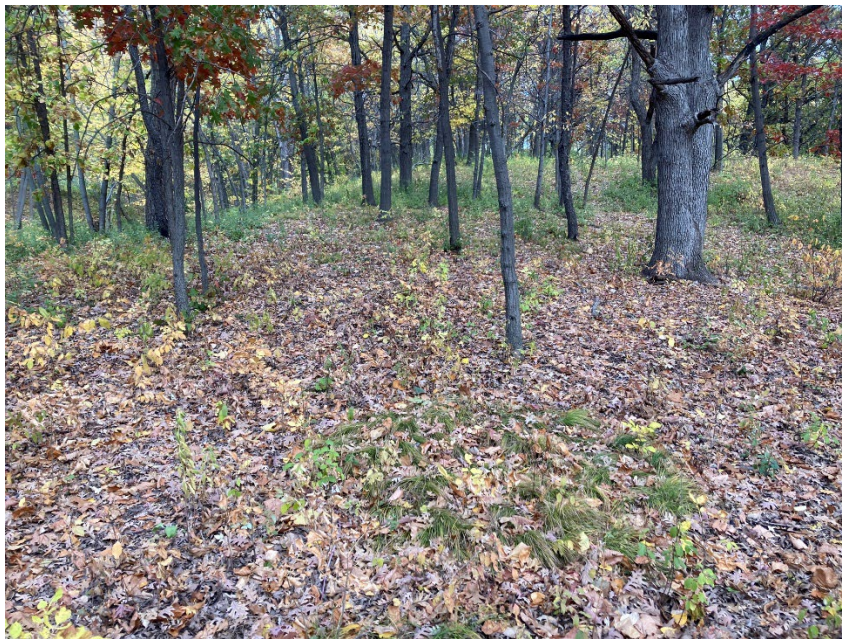
Photo 25 Overview of east goat grazing area where prescribed burn was completed. Buckthorn resprouts are more variable. The foreground is dominated by native species such as Pennsylvania sedge, snowberry (*Symphoricarpos* sp.), and aster (*Symphyotrichum* sp.). The background is co-dominated with 25-50% cover of buckthorn. (Indian Mounds Regional Park, photo taken during site visit 10/17/2022).

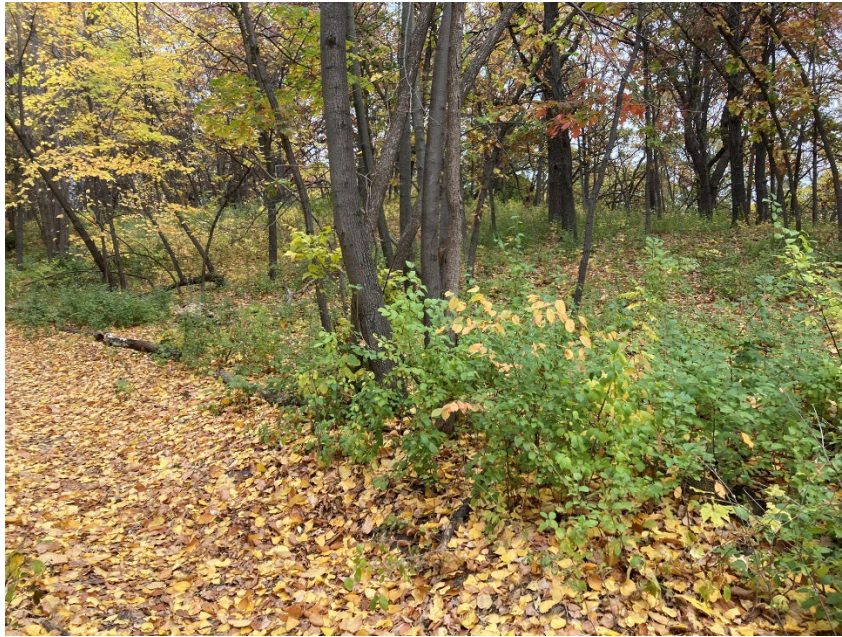
Photo 26 Overview of east goat grazing area where prescribed burn was completed. Re-sprouted buckthorn comprises 50-75% cover. (Indian Mounds Regional Park, photo taken during site visit 10/17/2022).

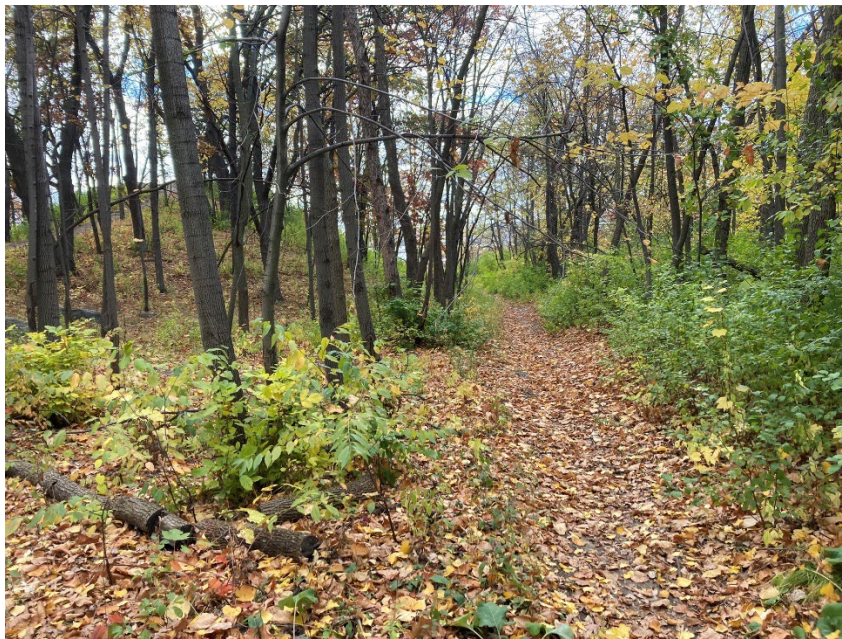
Photo 27 Looking approximately south along the boundary of the goat grazing/prescribed burn treatment area. The area to the left was grazed, chemically treated (by roving hand crew), and burned; the area to the right only received chemical treatment by roving handing crew. (Indian Mounds Regional Park, photo taken during site visit 10/17/2022).

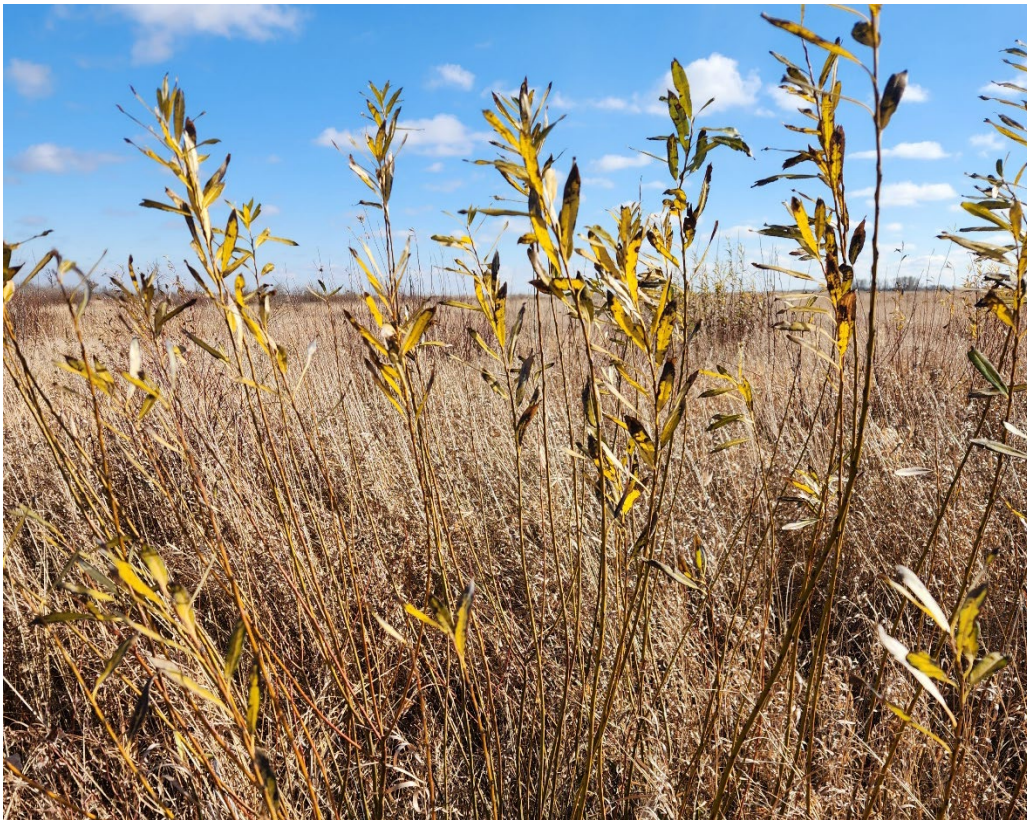
Photo 35. Willows shoots that will require future control efforts (Four Square Mile Unit - 10/26/2022).

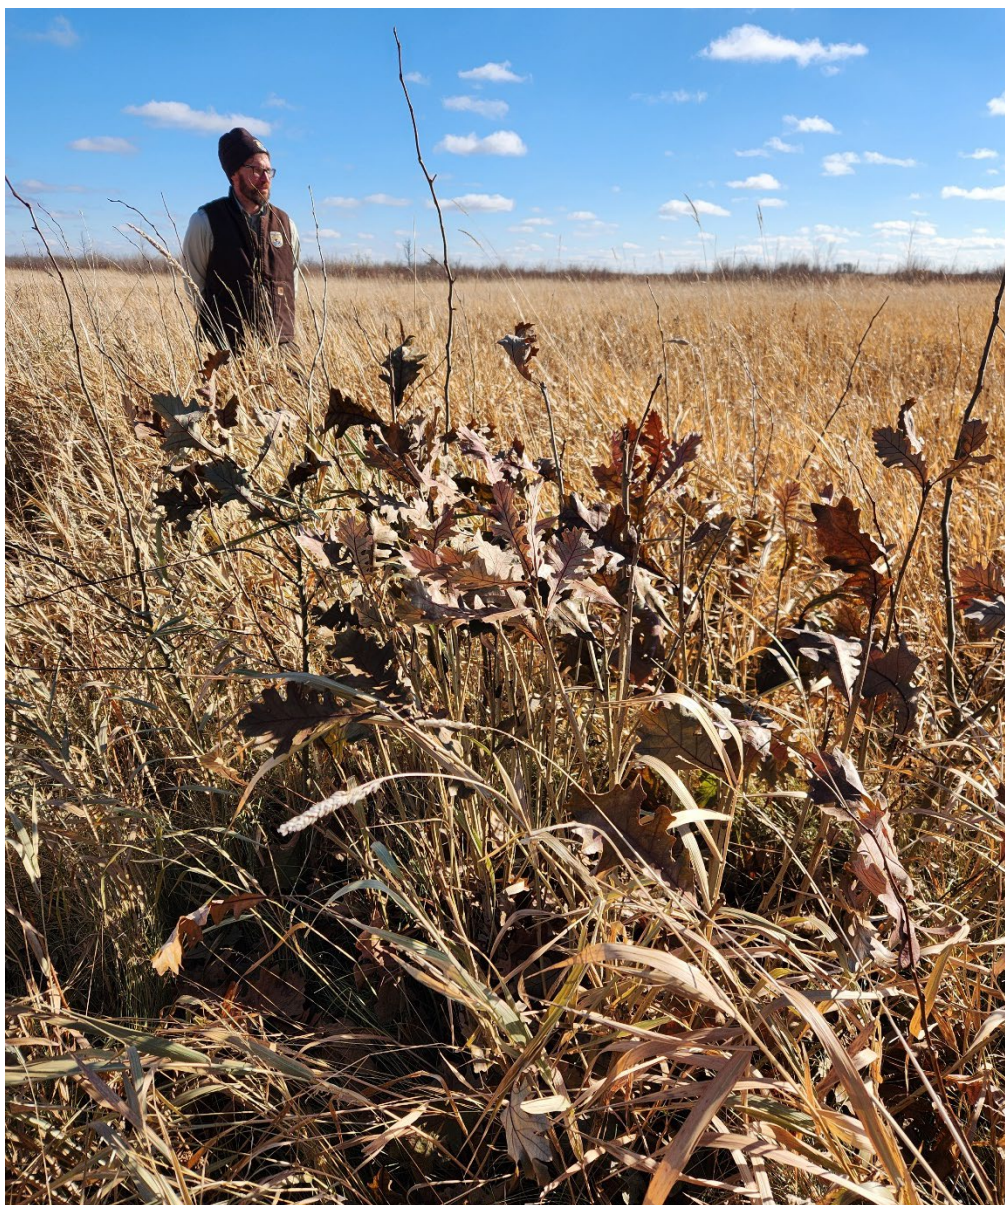
Photo 37. Bur oak stump sprouts observed during the site visit (Four Square Mile Unit - 10/26/2022).

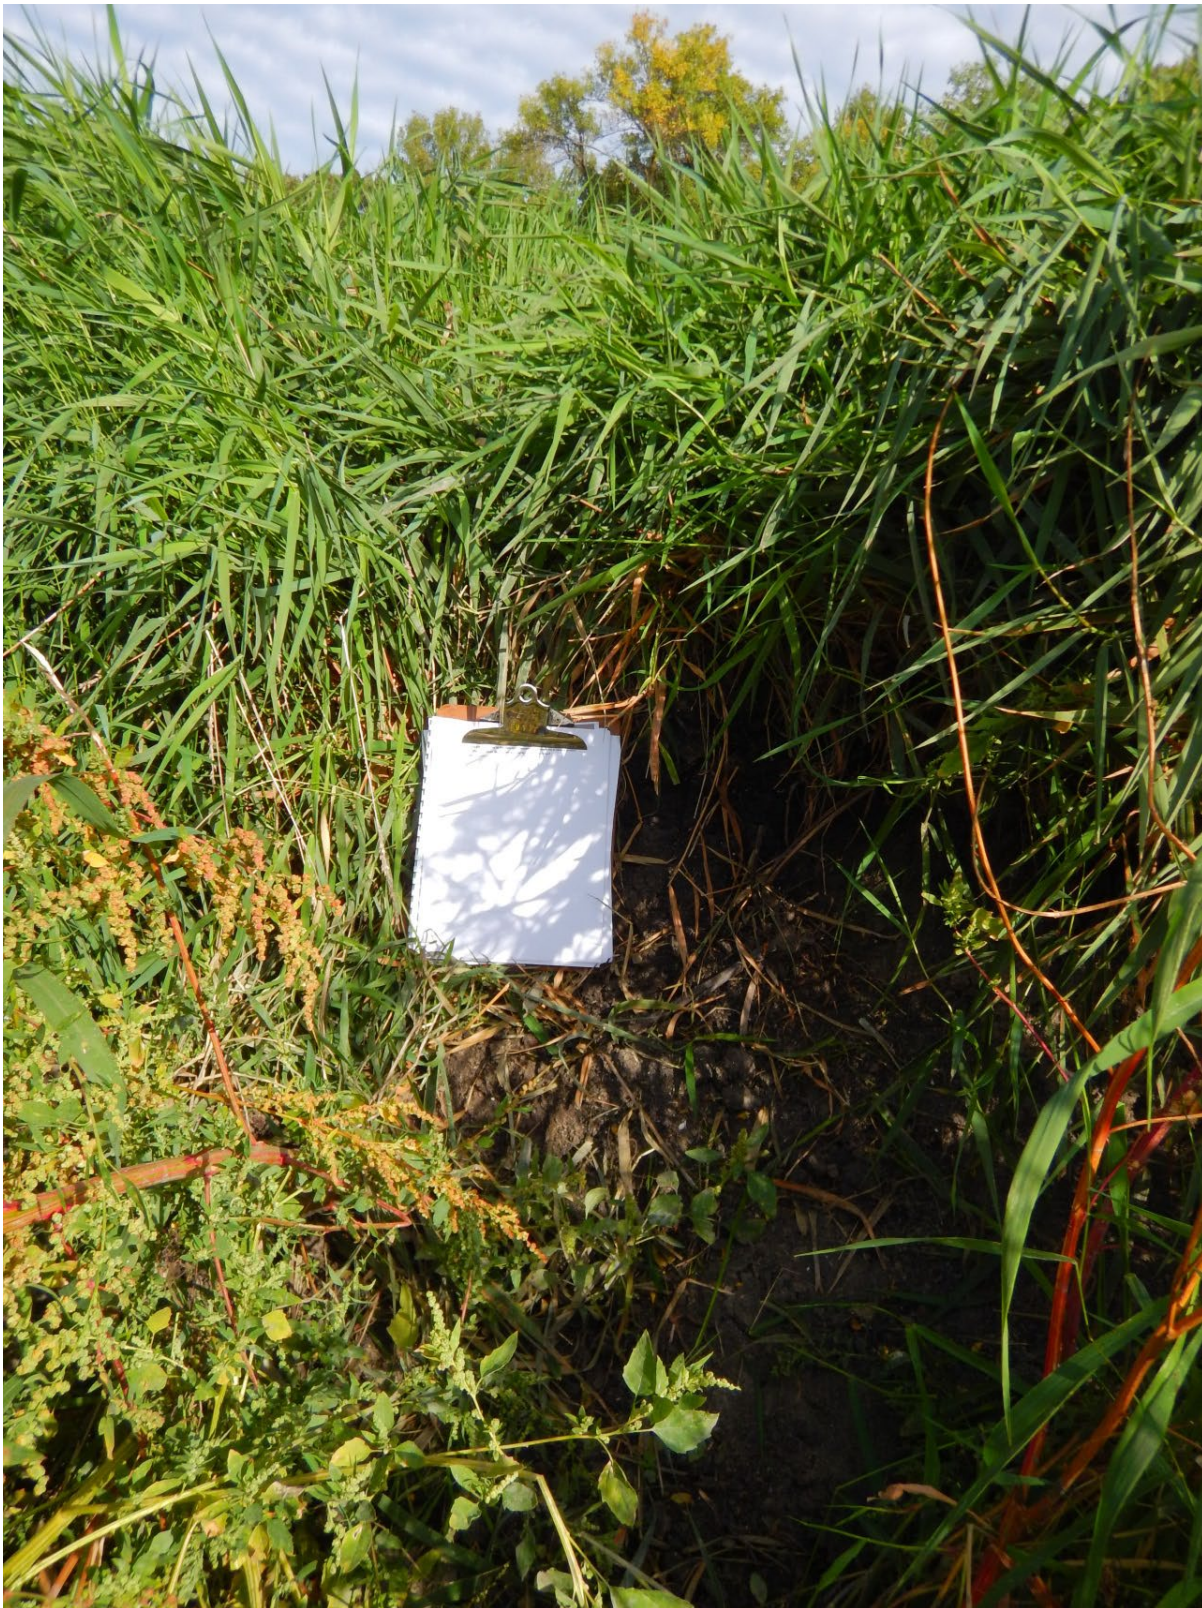
SR Photo 3: Area beneath vegetated bank dominated by reed canary grass.

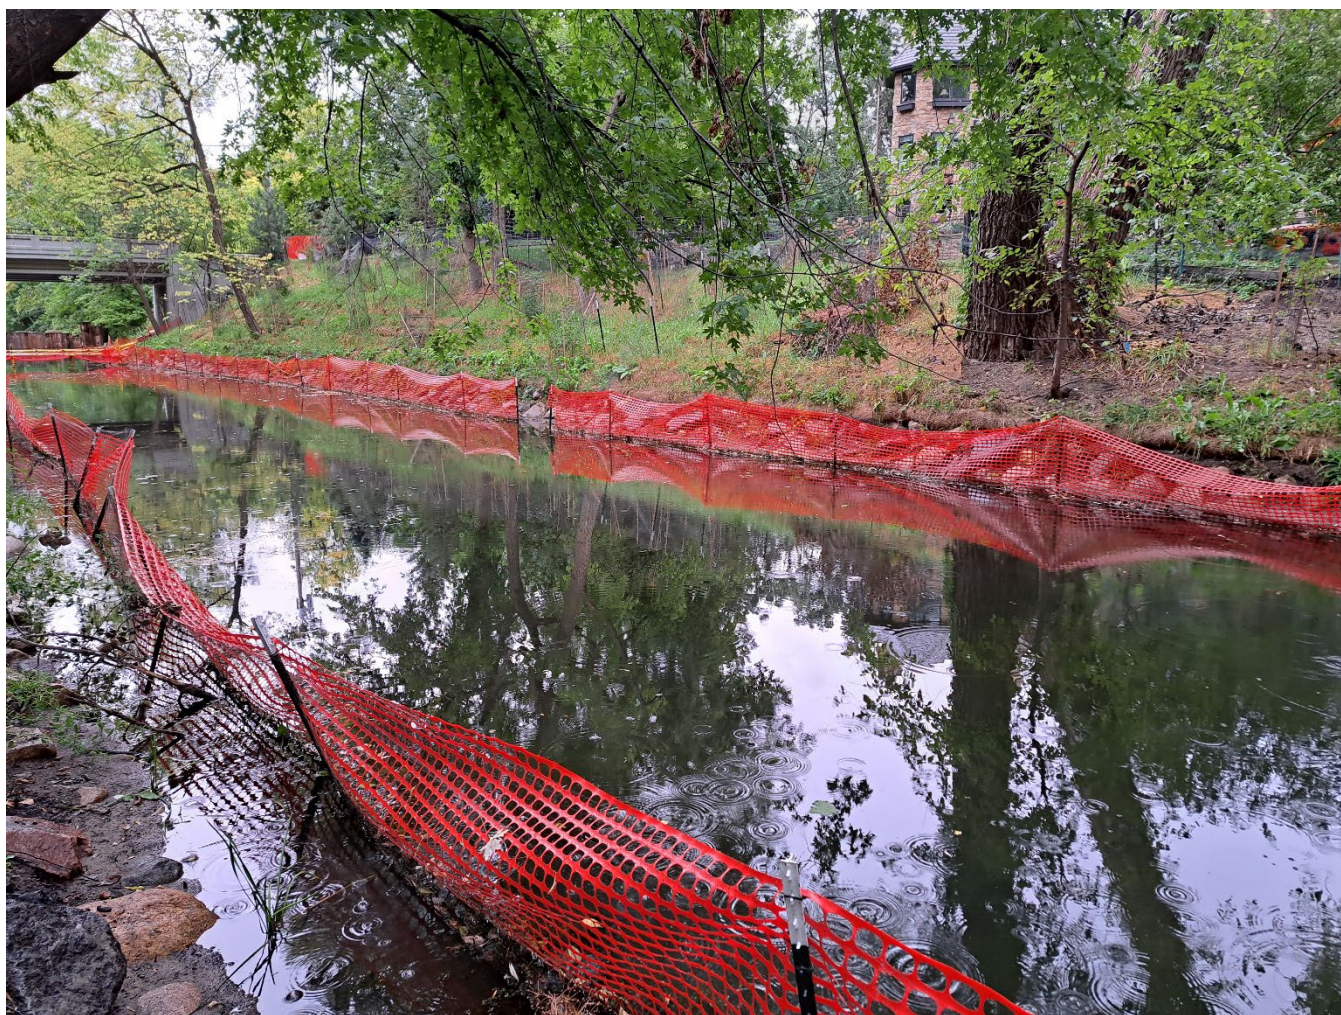
Photo 71. Looking to the southeast along Kenilworth Channel towards Burnham Road bridge. Note the snow fencing alongside the rocky toe to protect the native plantings from both geese and public disturbance (Kenilworth Channel Shoreline Stabilization, photo taken during site visit 9/23/2022).

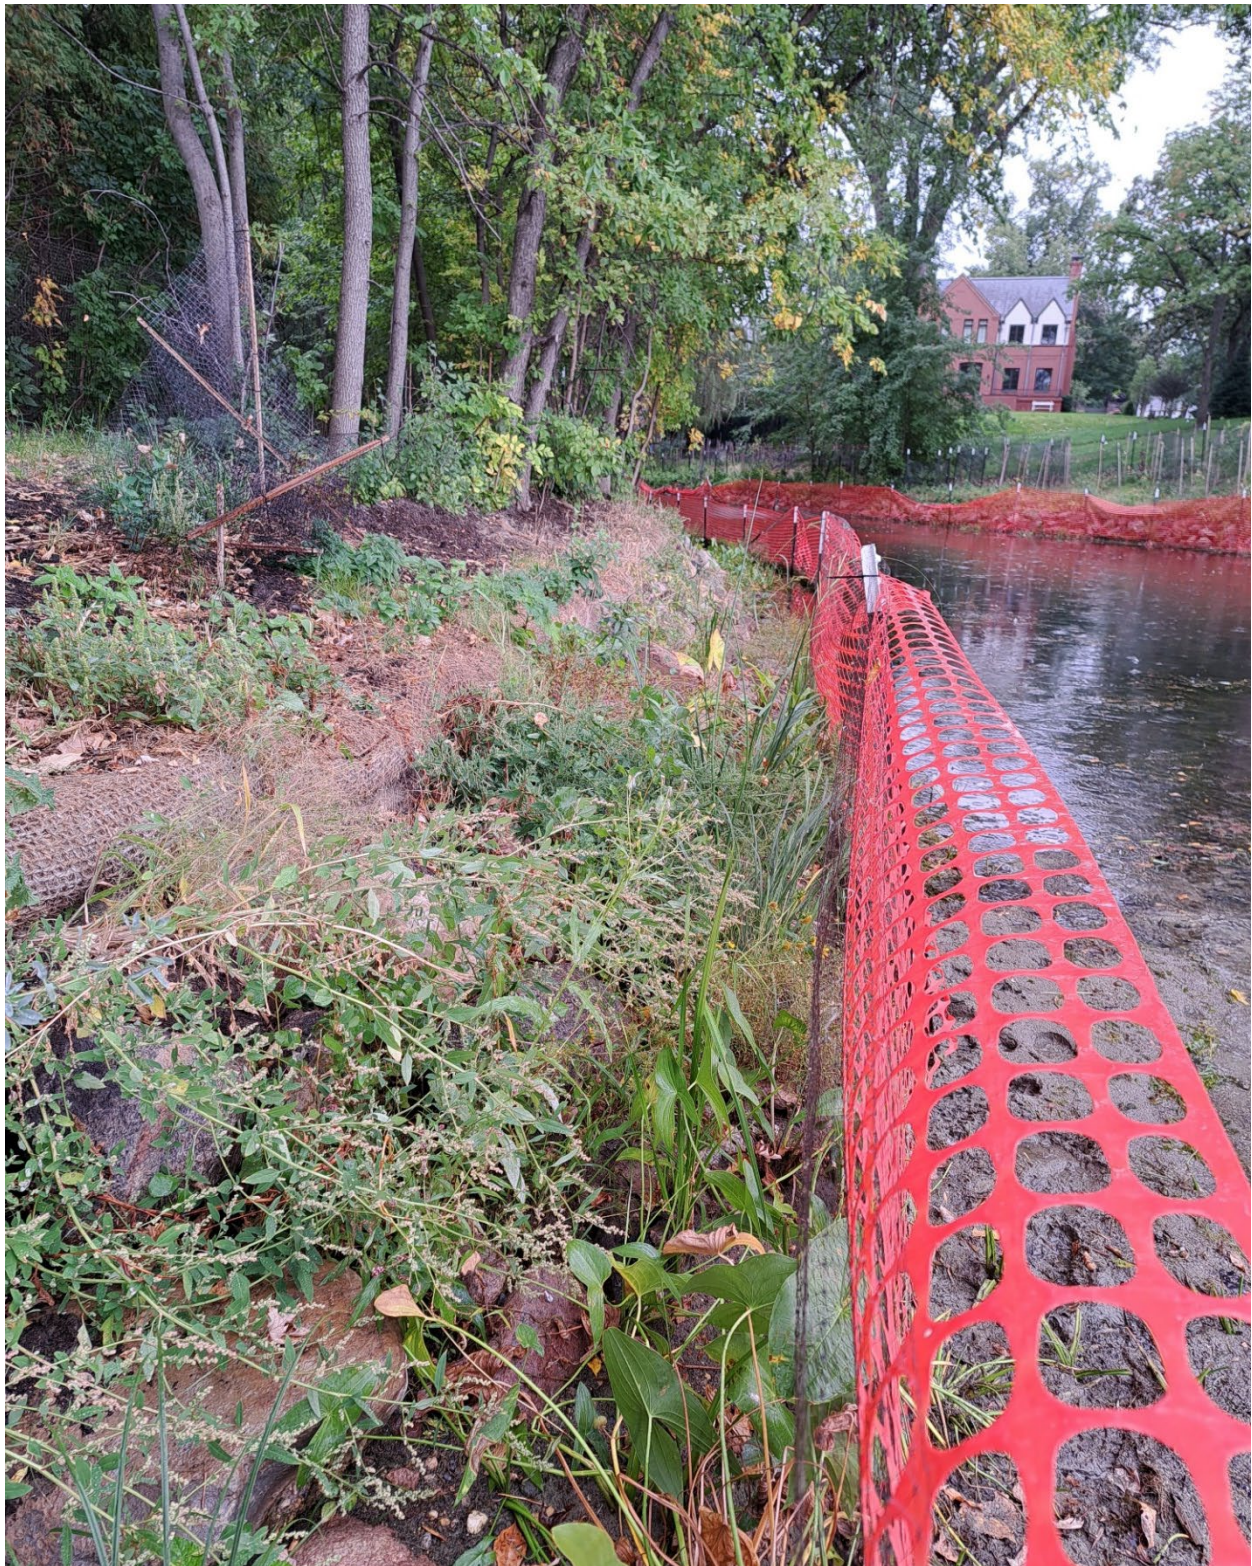
Photo 74. Looking towards Kenilworth Channel at the outlet location of Cedar Lake. Note the presence of planted emergent plugs such as arrowhead, prairie cordgrass and sweet flag (Kenilworth Channel Shoreline Stabilization, photo taken during site visit 9/23/2022).

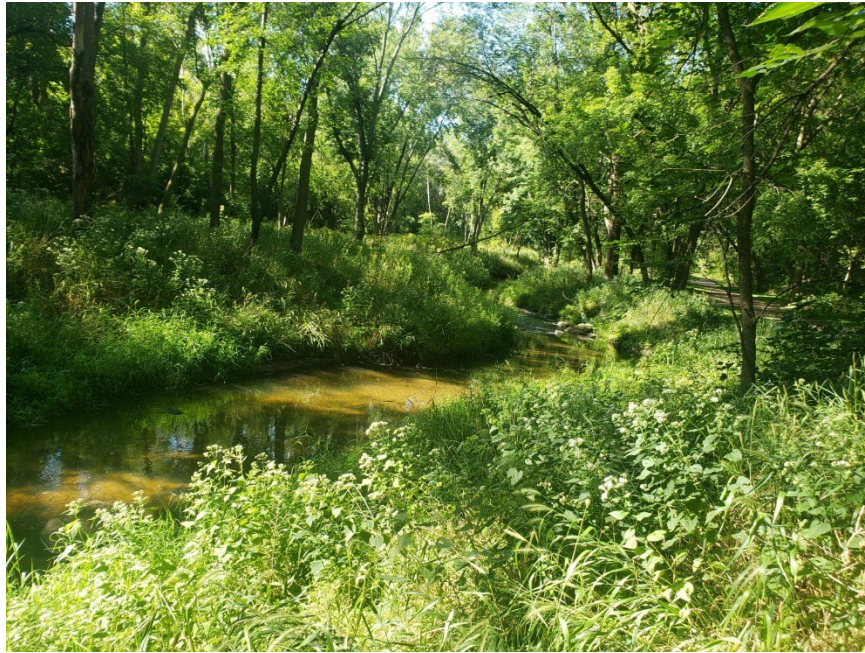
Photo 81. Looking downstream along Sand Creek. Banks are well-vegetated. Tree thinning has allowed for areas of full sun, partial sun, and shade over the course of the day, which provides conditions for a variety of plant species. (Photo taken by Mark Prankus, Cardno now Stantec, on 9/1/22).

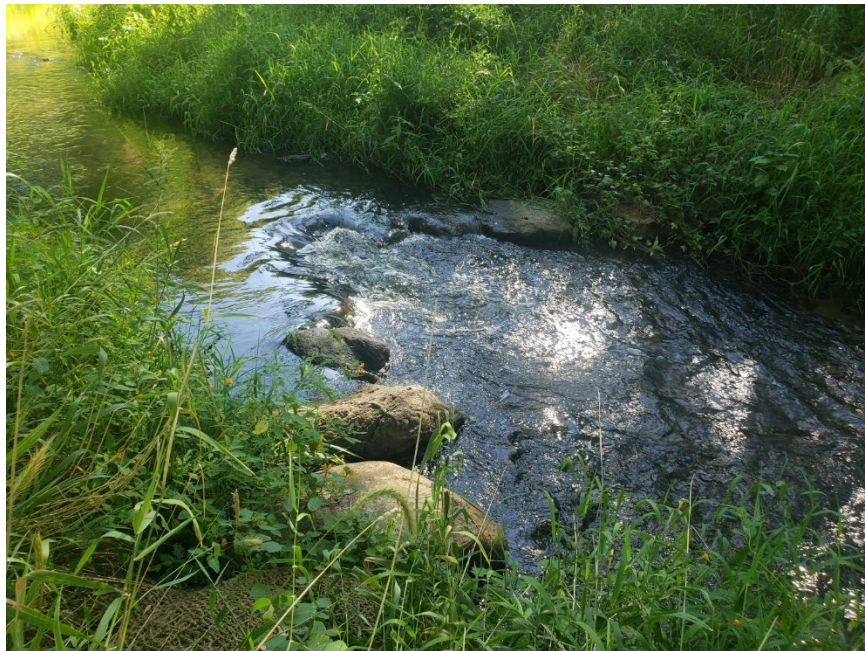
Photo 82. Example of stone grade control. The structure points upstream with the arms angled up and towards the bank to direct flows into the center of the channel and away from banks while providing grade control to the stream bed. (Photo taken by Mark Prankus, Cardno now Stantec, on 9/1/22).

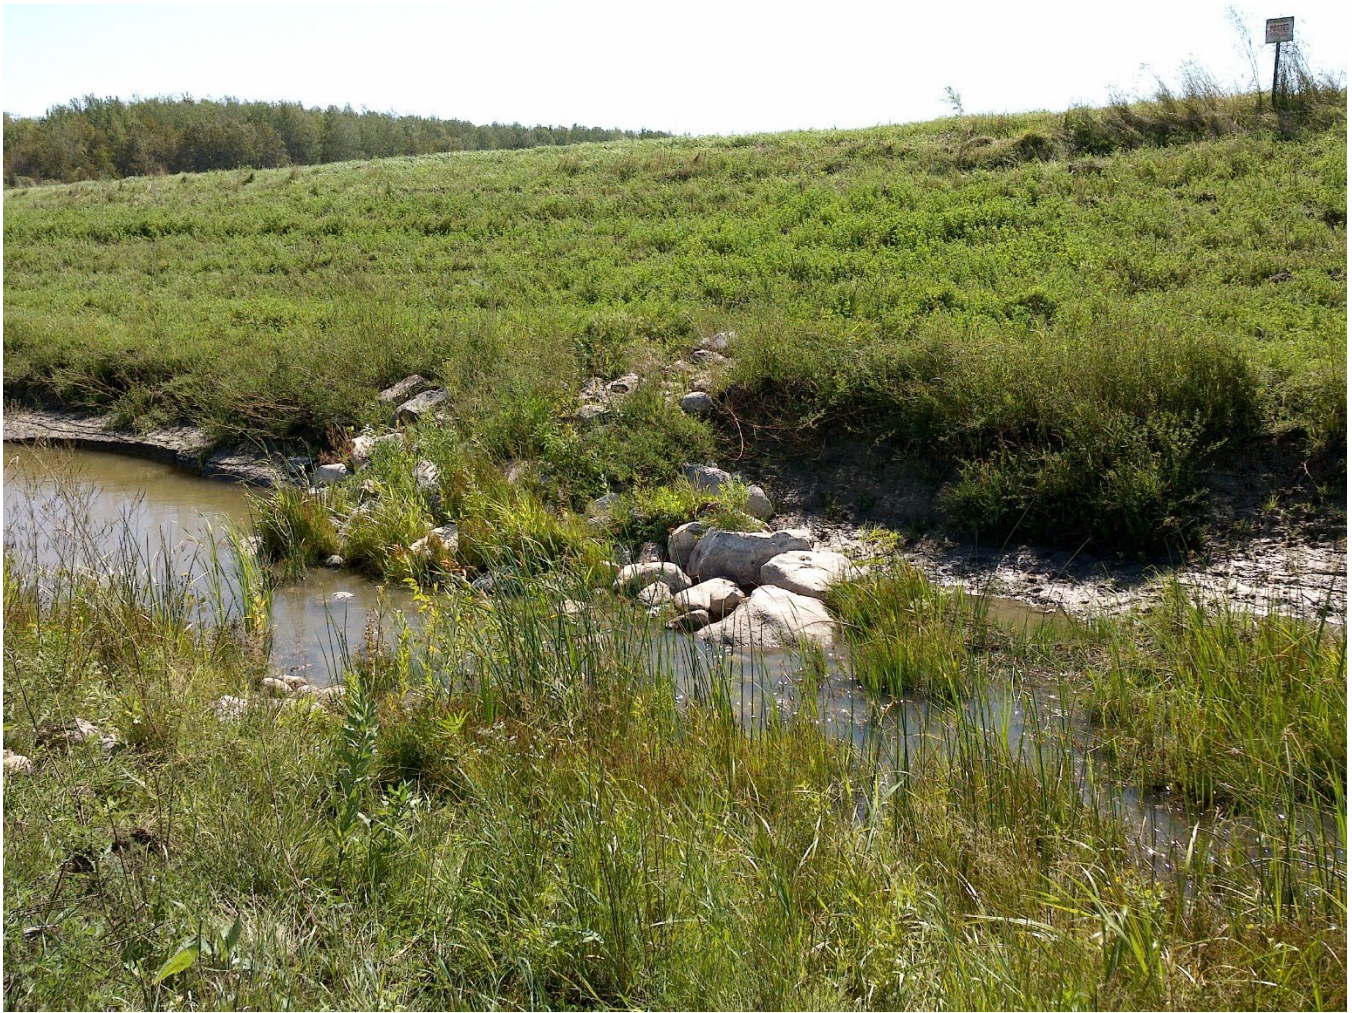
Photo 102. Looking south along riffle where erosion was observed after spring flooding (Bostic Creek Grade Stabilization, photo taken during site visit 8/30/2022).

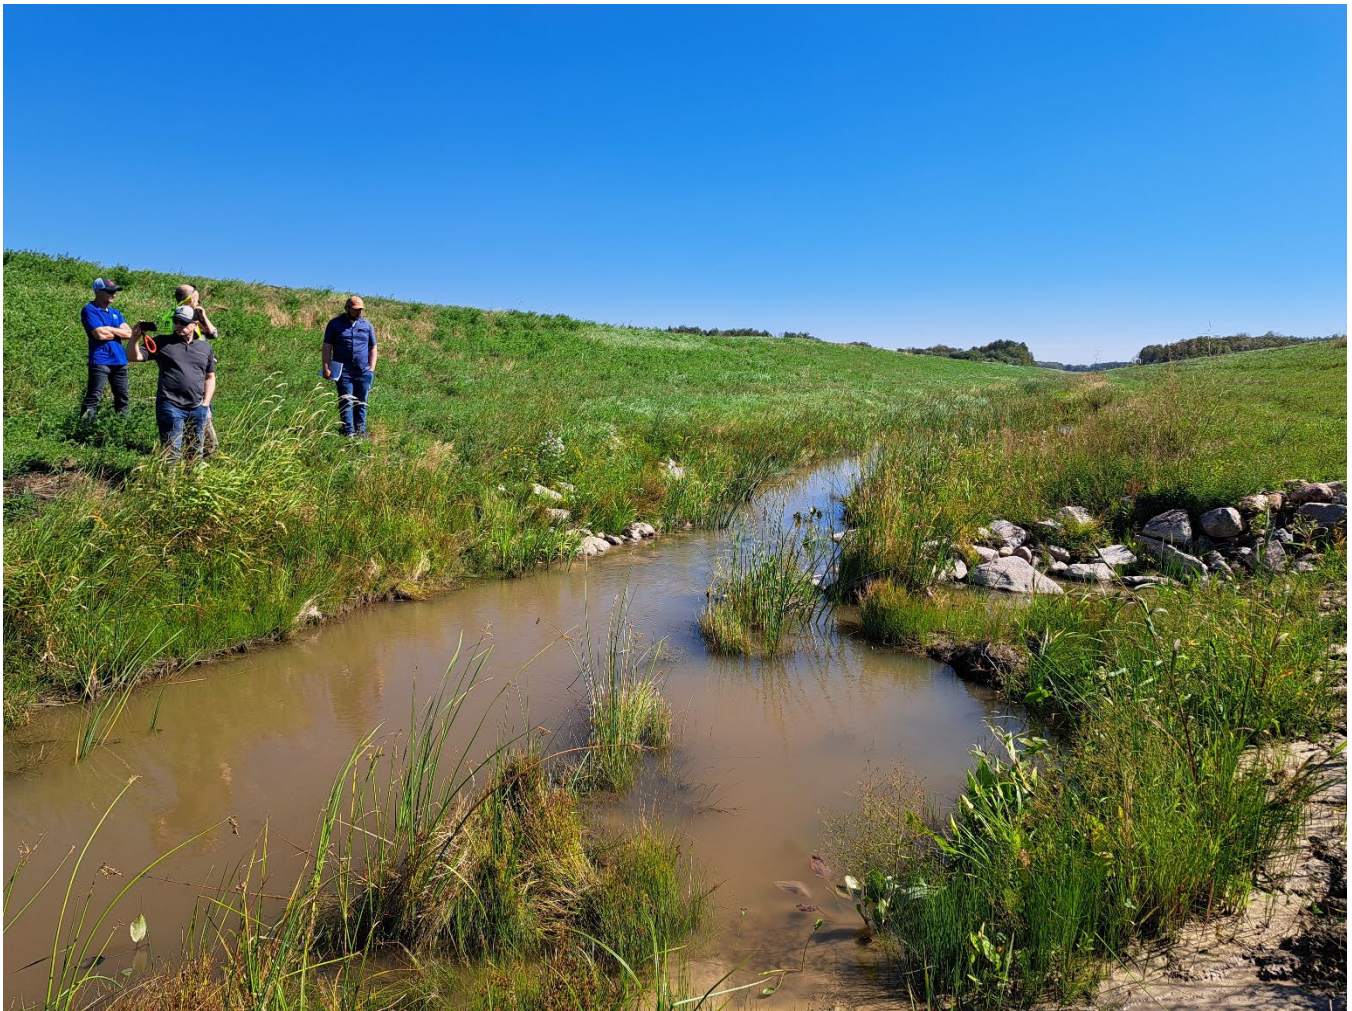
Photo 103. Looking east along 2-stage ditch where spring rains washed out 3 riffles at Bostic Creek (Bostic Creek Grade Stabilization, photo taken during site visit 8/30/2022).

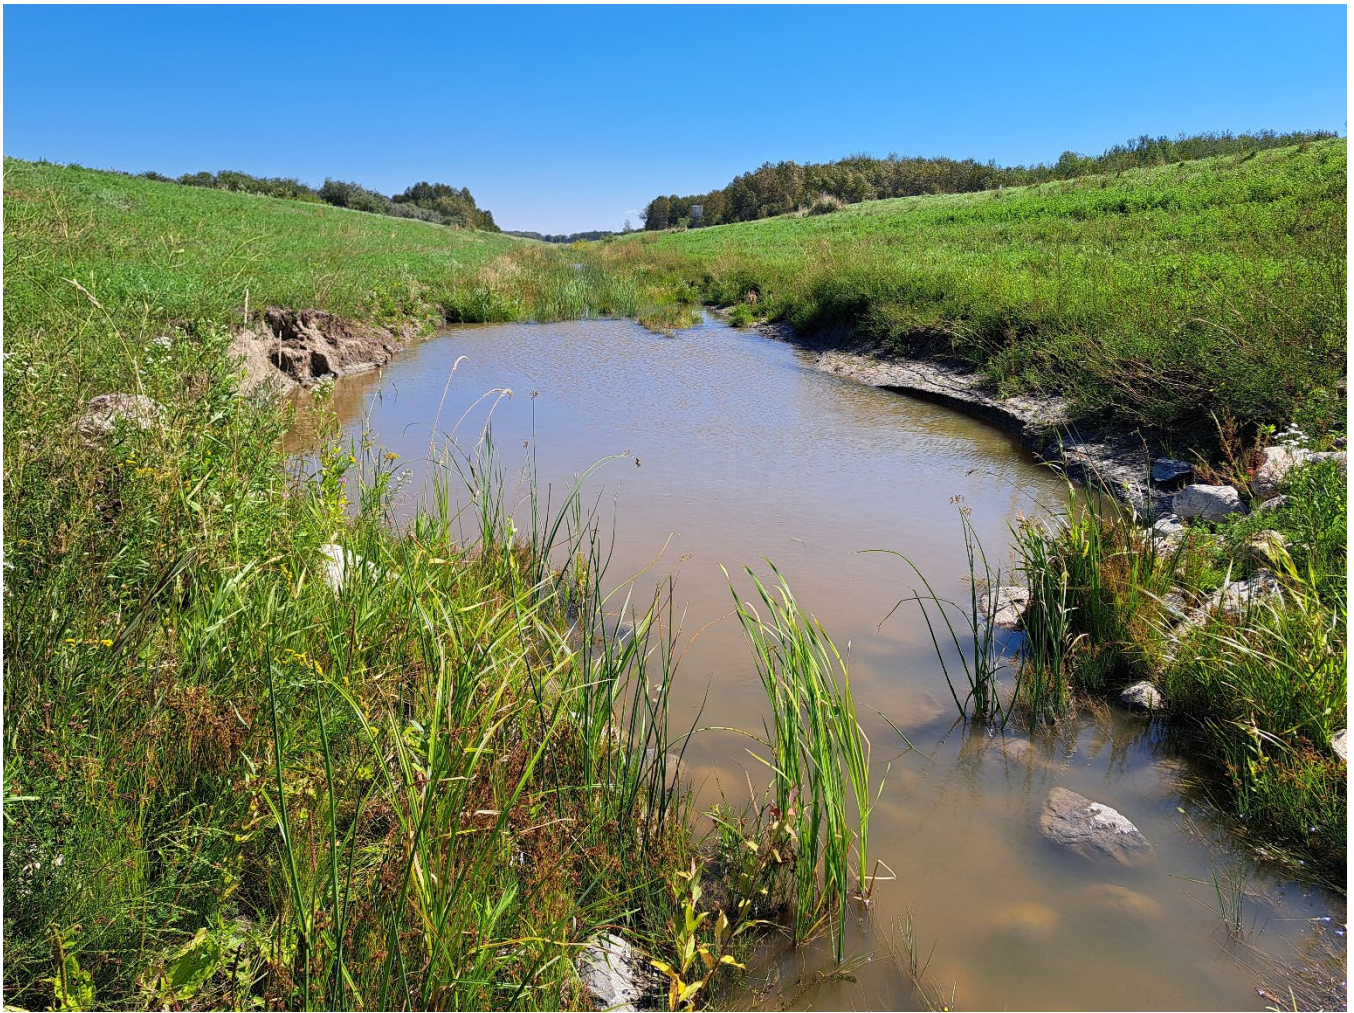
Photo 105. Looking east/downstream below failed riffle where scouring occurred during spring flooding (Bostic Creek Grade Stabilization, photo taken during site visit 8/30/2022).
