**MINNEAPOLIS METRODOME**

**DECEMBER 2010 ROOF DEFLATION ASSESSMENT**

**SUMMARY AND RECOMMENDATIONS**

Walter P Moore Project S02.10026.01

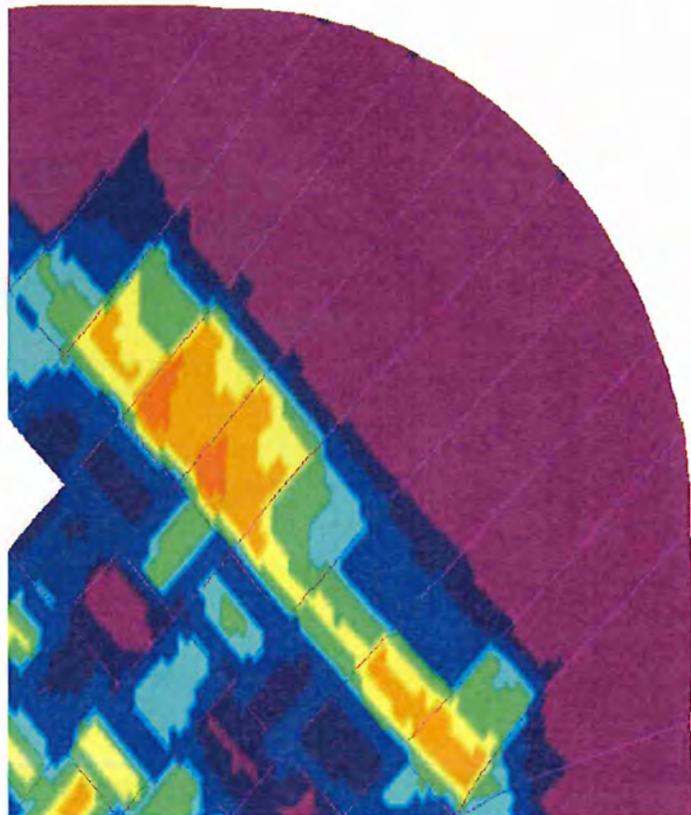
Our findings show that a number of the more heavily loaded panels experienced stresses above normal allowable values. However, where overstresses occurred the predicted stresses are generally less than the expected fabric strength excluding safety factors, which explains why these particular panels did not fail following the deflation event. Though

Figure 3: Deflated Position Fabric Stress Results

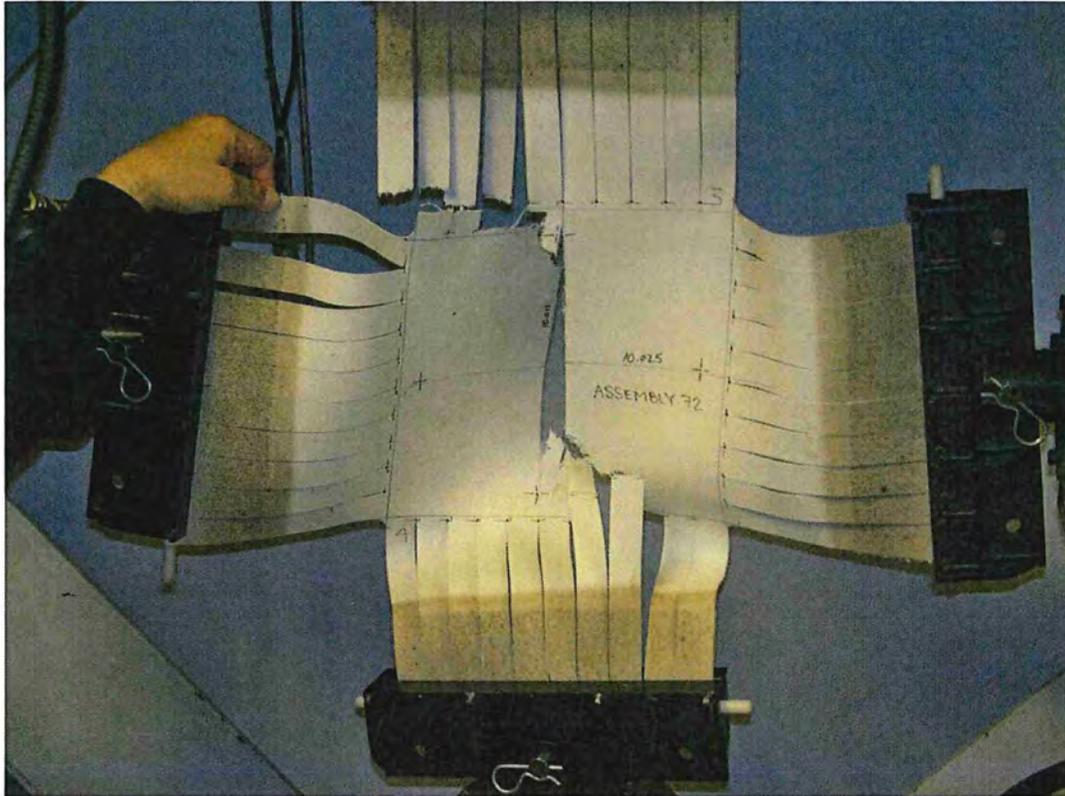
Of particular interest are several very low tear test results at Panel 72, followed by the failure of a biaxial test (Figure 5) of material from the same sample at a very low load. Such correlated test results are indicative of base yarn material damage, which is likely caused by exposure to moisture.

Figure 5: Panel 72 Biaxial Test

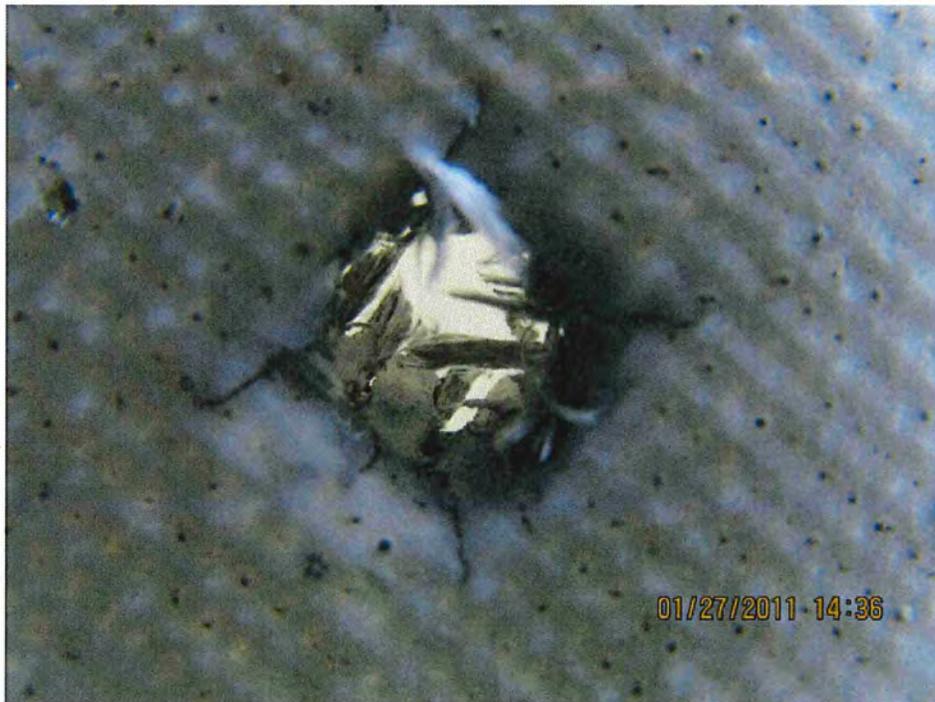
In general, the visual survey indicates that the condition of the fabric material is poor. Numerous cuts, abrasions, scratches, tears (Figure 6), and exposed yarns (Figure 7) were observed. In addition, long-term retained water (Figure 8) in the deflated position was observed on numerous panels. Widespread creasing both from snow sliding as well as subsequent wind flutter (Figure 9) was observed. All observed conditions have been cataloged on a panel by panel basis and are shown in Part 3 of the report.

Figure 6: Typical Tear Damage

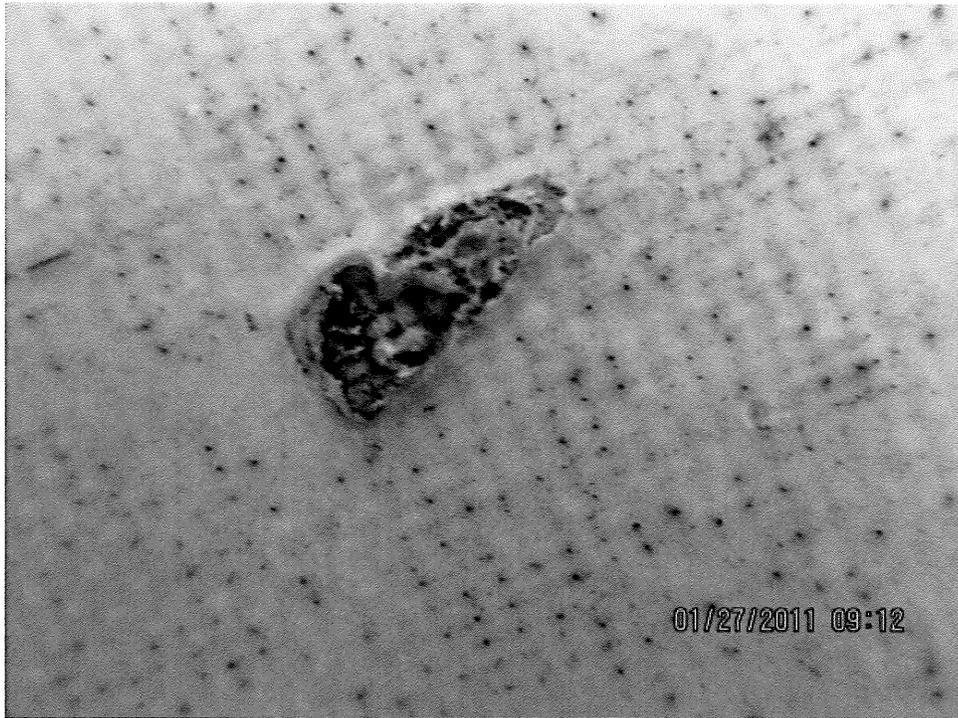
Figure 7: Typical Exposed Yarn

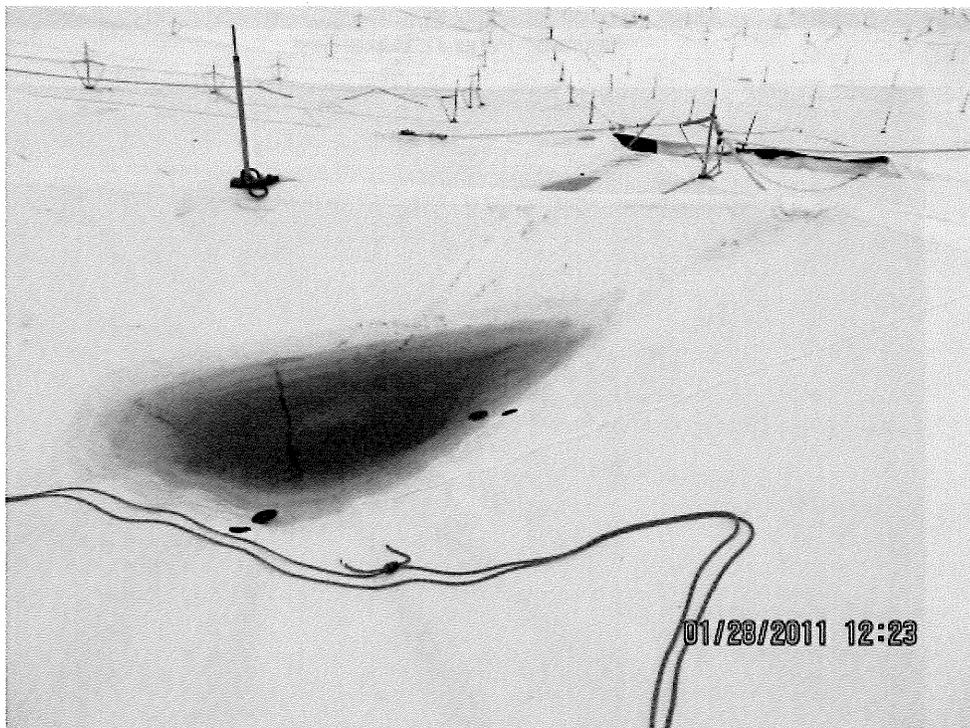
Figure 8: Typical Roof Moisture Retention

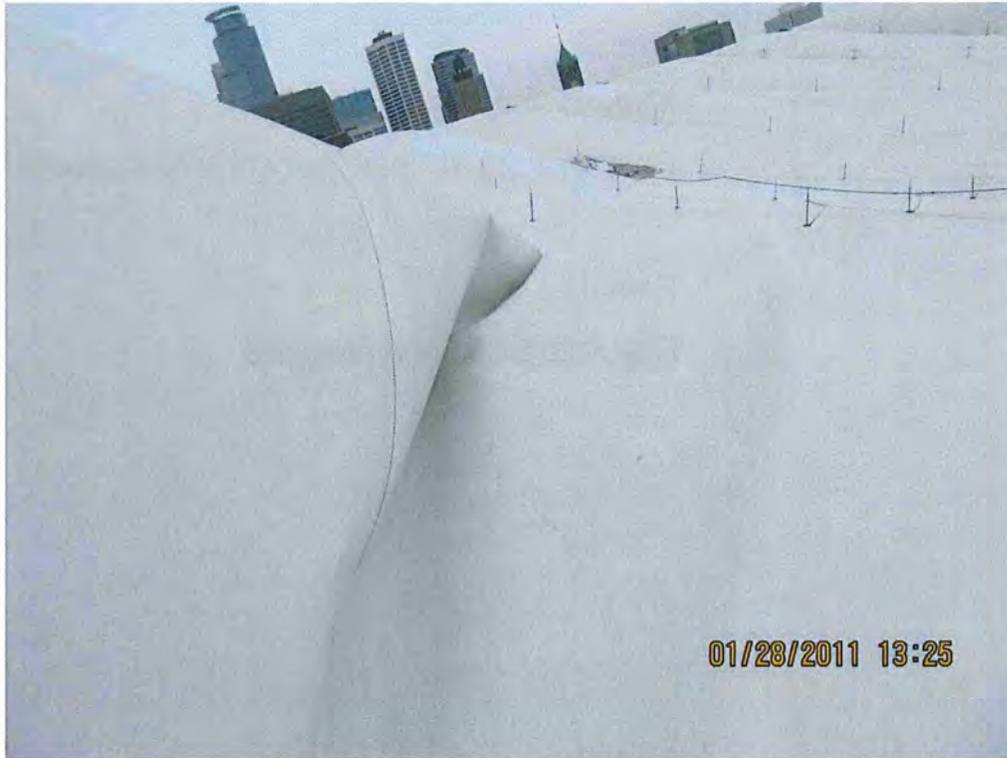
In addition to directly observable damage, the panels remain at high risk in the deflated condition because the tensile membrane structure is not tensioned by air pressure. Significant "flutter" of the roof panels has been observed at relatively low wind speeds. Such action presents a strong risk for introducing damage to the fabric material due to repeated working of the yarns over a large displacement range. This risk is particularly high directly adjacent to the aluminum clamping system, which is covered by a weather seal and has not been available for direction visual inspection. In

Figure 9: Creasing Caused by Wind Flutter

order to eliminate this risk, we recommend that the remaining membrane panels also be replaced.

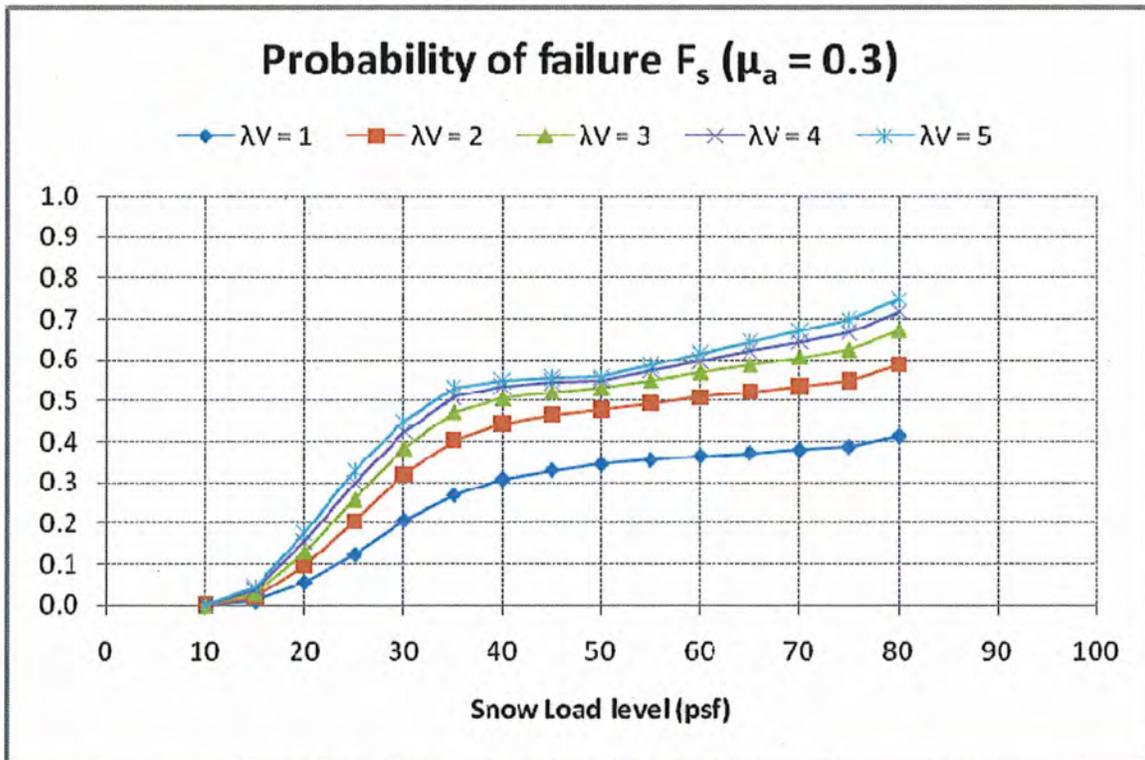
The results of the reliability analysis (Figure 10 representative) show levels of risk of future deflation in the presence of distributed flaws that exceed normal acceptable levels referenced in the structural building codes and standards. Note that if all currently existing flaws in the roof could be identified and repaired, the risk levels would reduce to normal acceptable levels. However, in our opinion it is not practical to conduct the reviews necessary to ensure confidence that all flaws have been identified in a reasonable timeframe. Instead, the reliability analysis provides a tool for evaluating the potential risks of a future deflation if it is not possible to identify and repair all fabric damage and flaws.

Figure 10: Representative Reliability Analysis Results

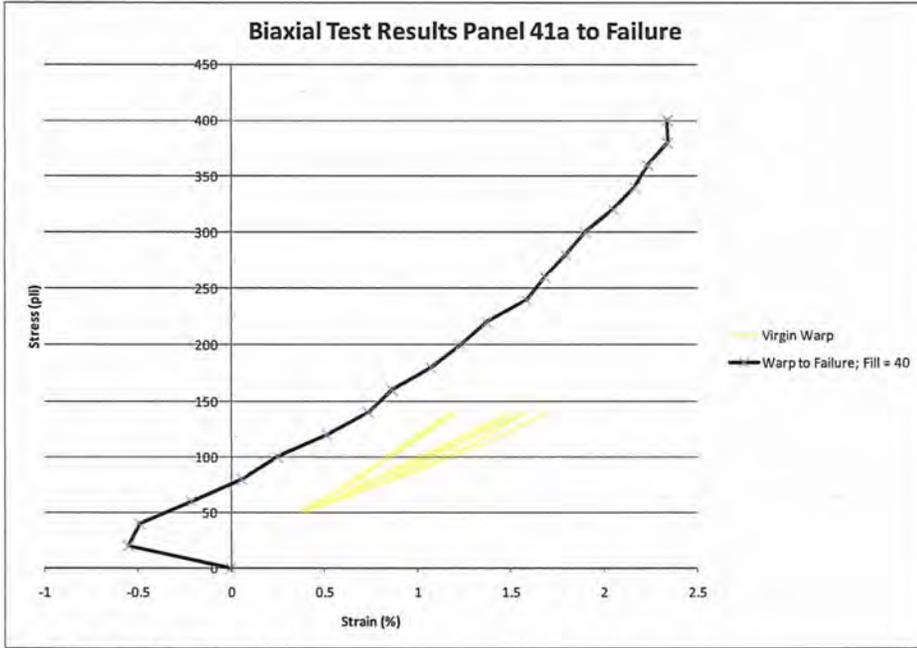
subsequently loaded to failure (Figure 16 and 17) and results were within expectations for biaxial testing.

Figure 16: Panel 41A Biaxial Test to Failure

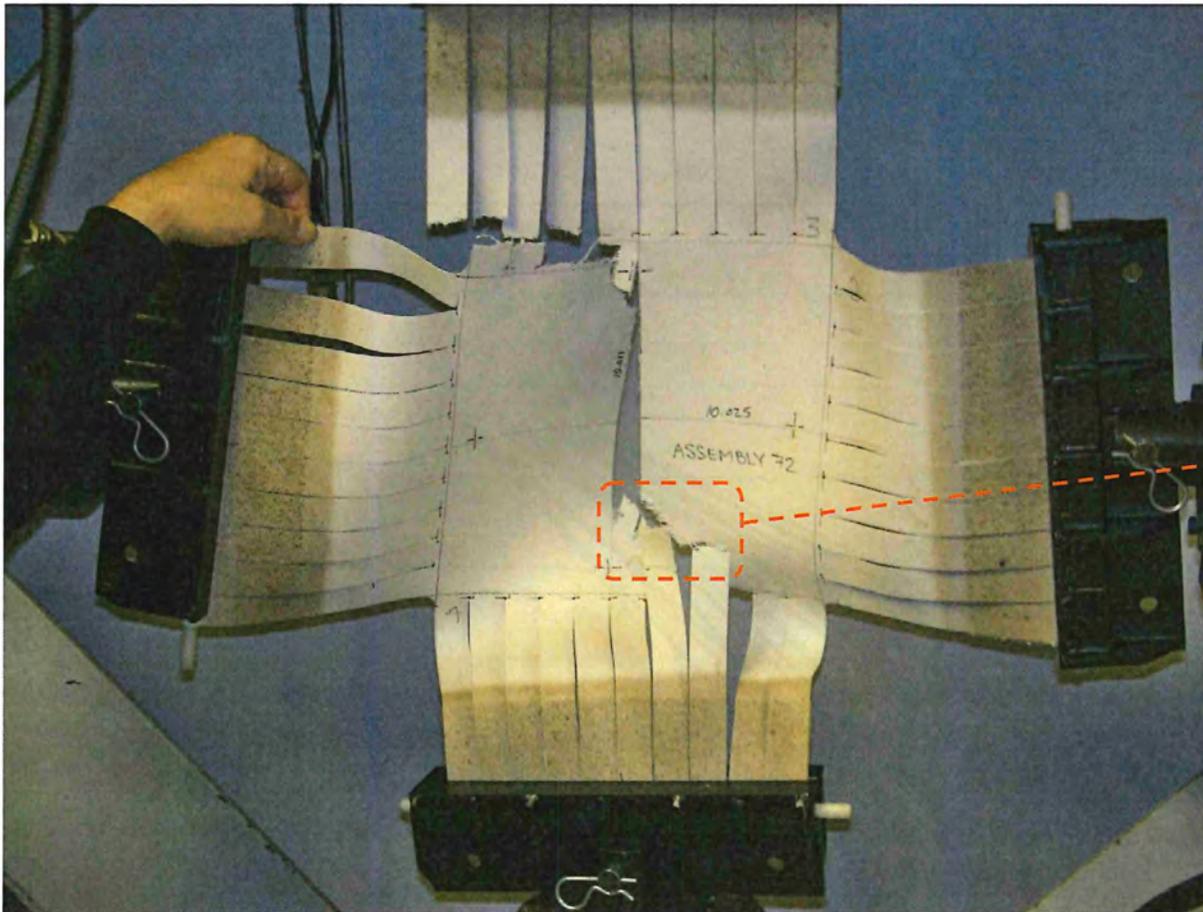
Figure 21: Panel 72 Biaxial Test
