Minnesota State Capitol
Exterior Stone Repair Project
Stone Repair Trials Evaluation and
Preliminary Preservation Planning

May 10, 2013

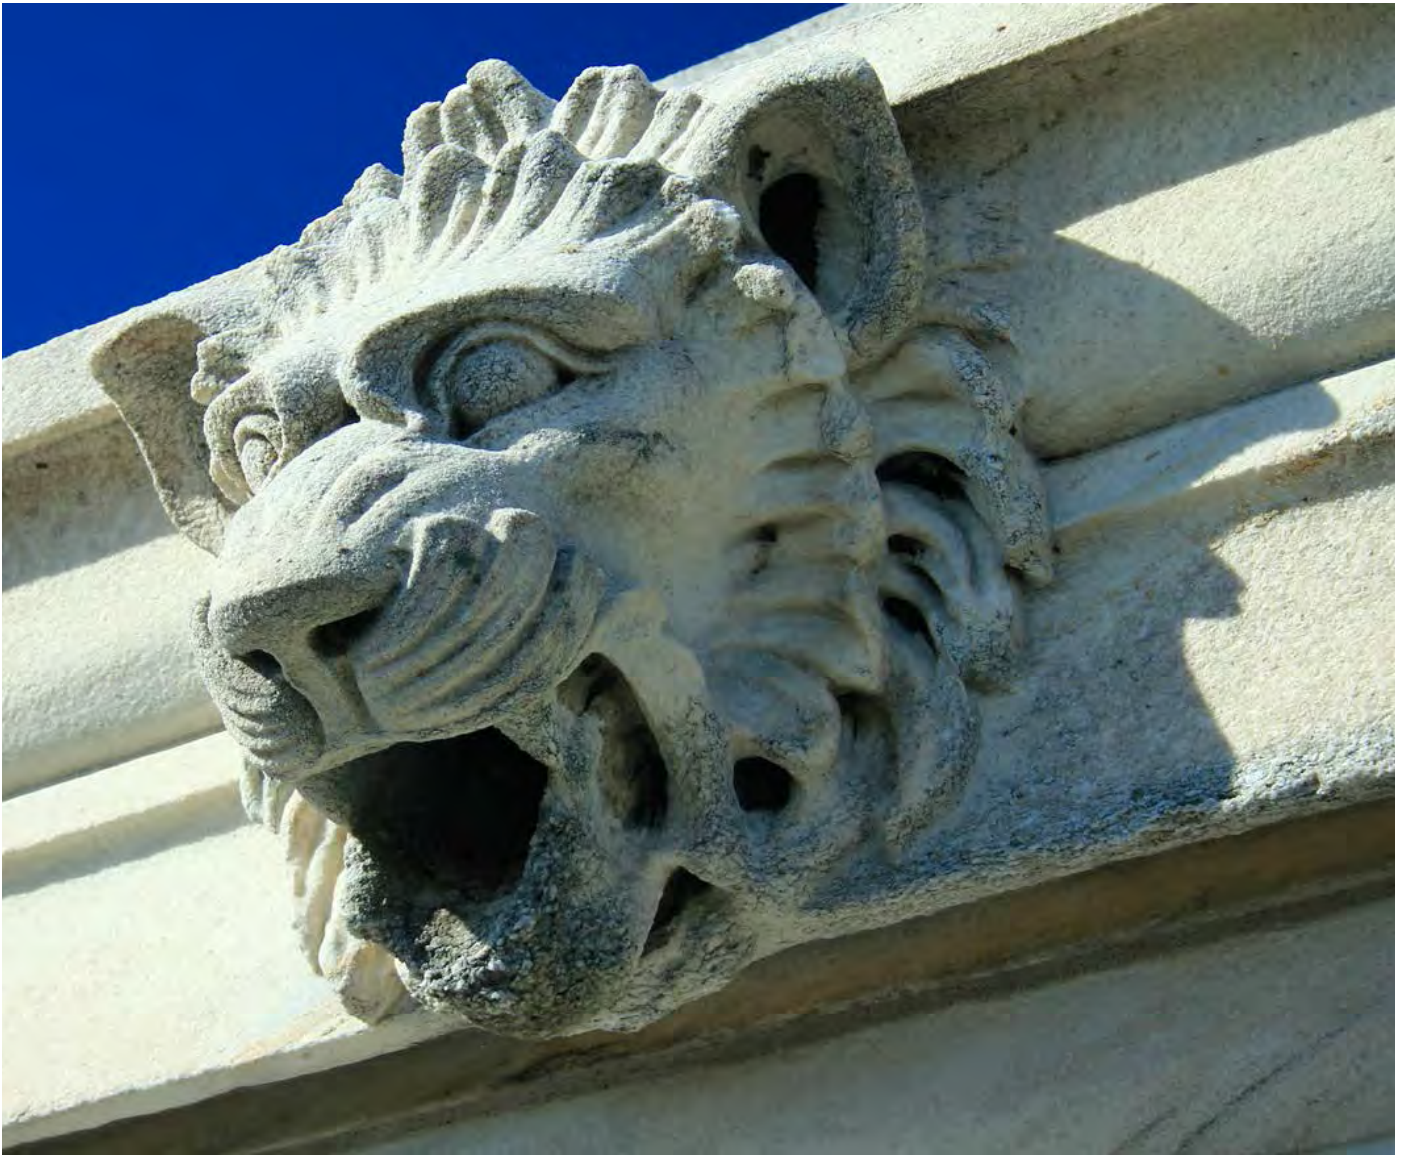
Fig. 1. Lion scupper at north roof pediment. The lower portion of carved detail and fascia drip edge are severely deteriorated. Because the location is far removed from public access, continued deterioration will not evolve into a life safety concern. Although this character defining feature functions to move water away from the building, its impact on building integrity and overall appearance is low compared to other primary or secondary water shedding features. For these reasons, this condition has been assigned a lower priority and is therefore not included in the current scope of work for the Project. As conditions worsen, the effectiveness of this feature to move water from the gutter system to the roof below will become more compromised, putting the stone below at higher risk for accelerated decay.

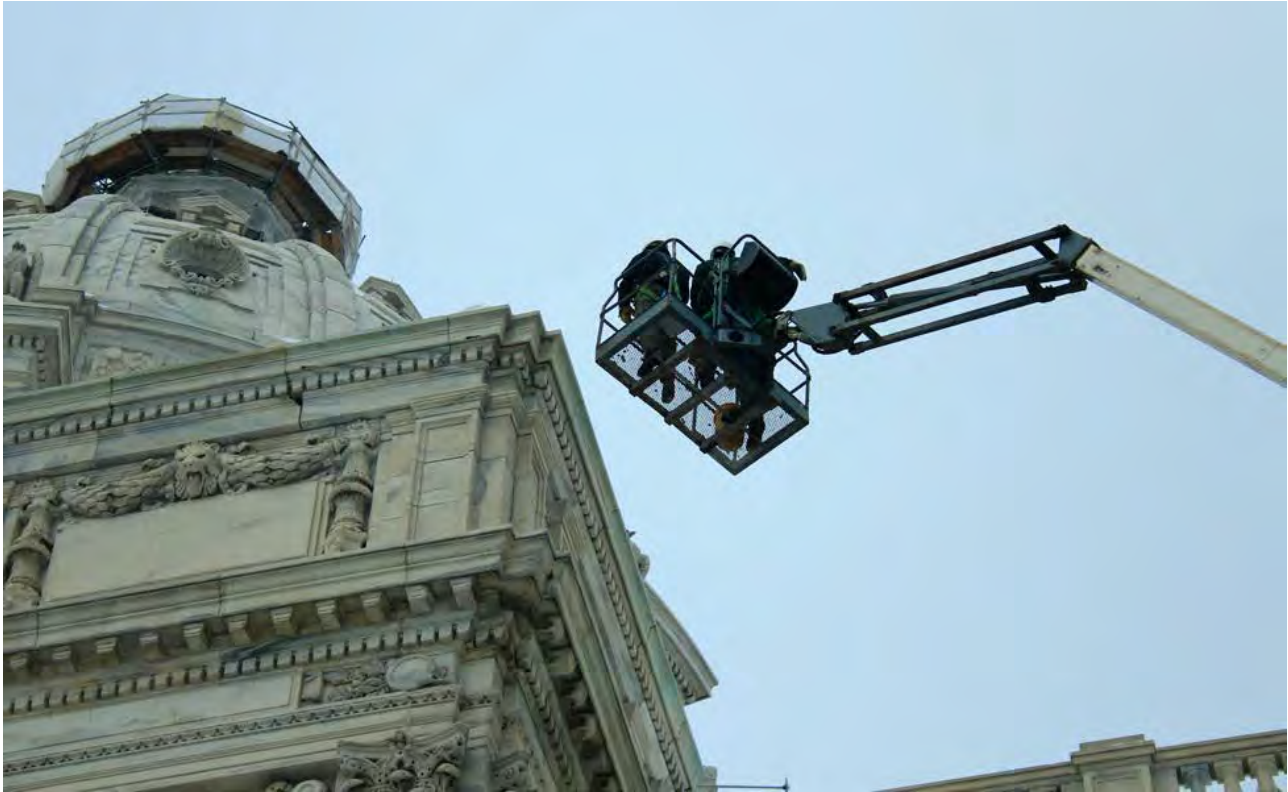
Fig. 2 (above). Investigators from HGA performed a preliminary conditions survey in 2010 to identify potential life safety hazards. One pilaster unit at the east elevator tower was found to be unsound. Emergency repairs were performed to stabilize the unit in place.

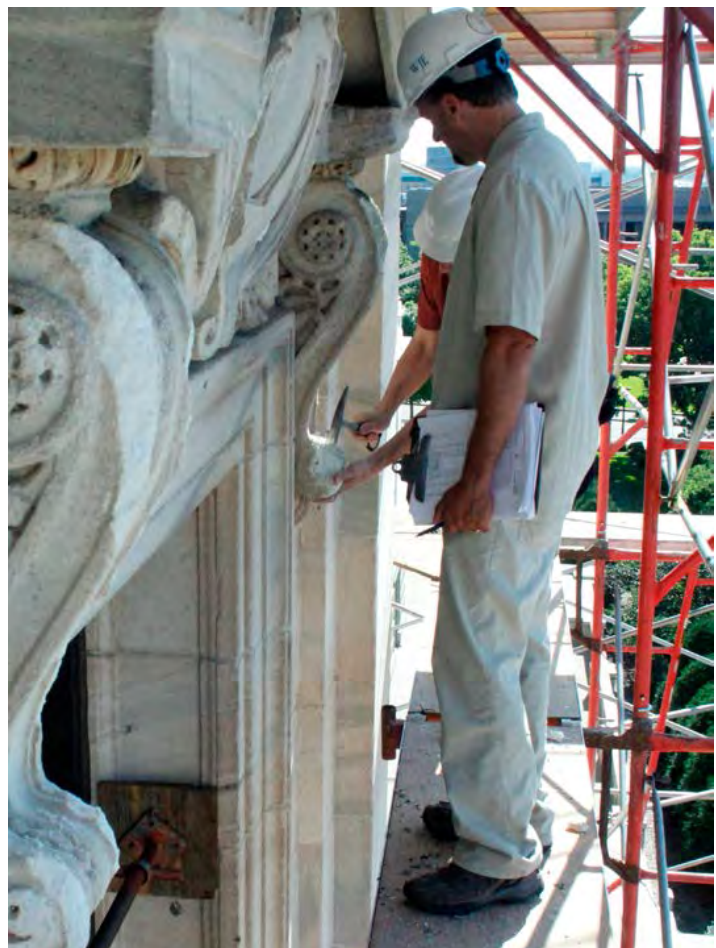
PRELIMINARY INVESTIGATION

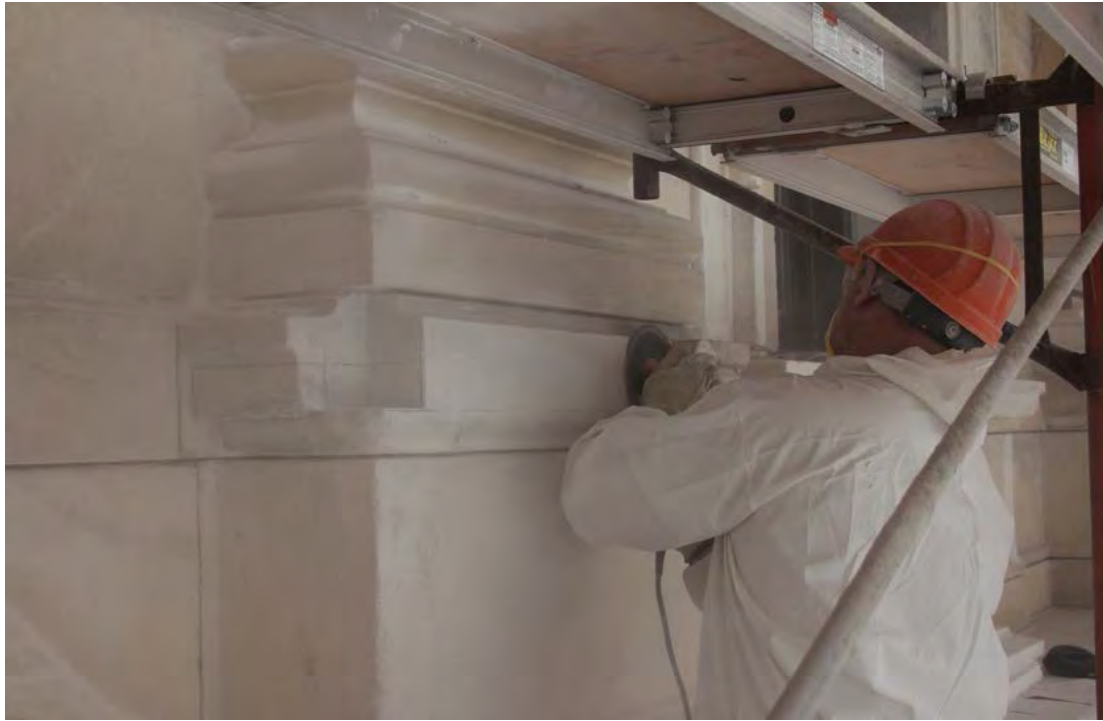
Fig. 4. West wing south facade. Mark 1 stone mason Jarek Sienkiewicz prepares a pilaster pedestal to receive new stone dutchman repair.

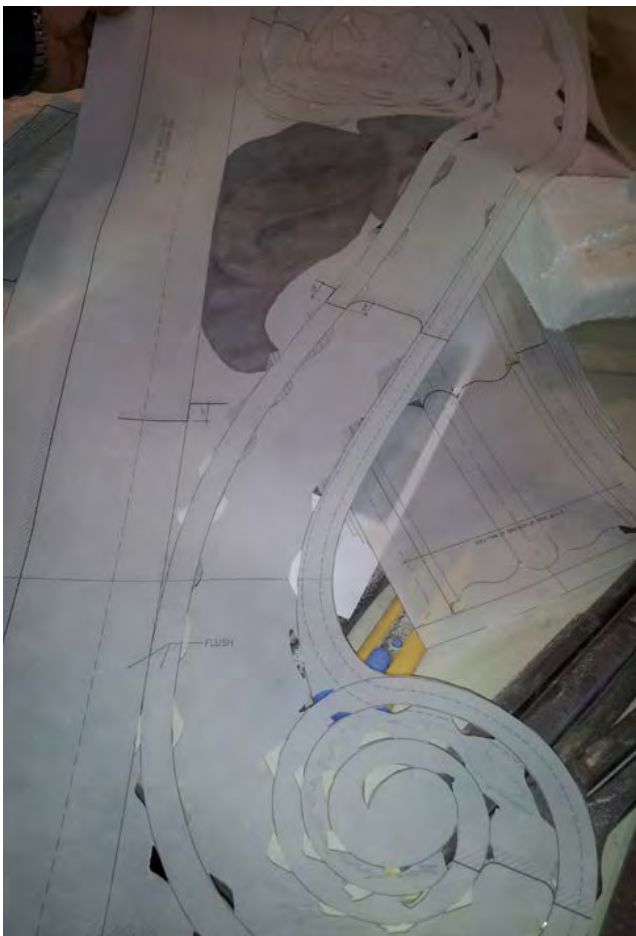
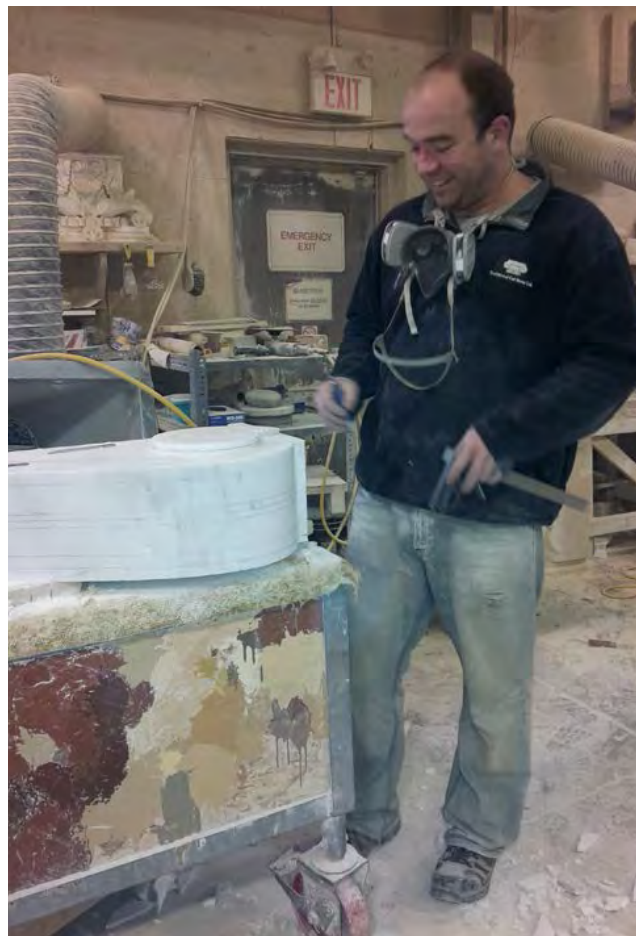
Fig. 5-6. Traditional Cut Stone master carver Robin Halton using a template to transfer pattern to a bracket scroll.

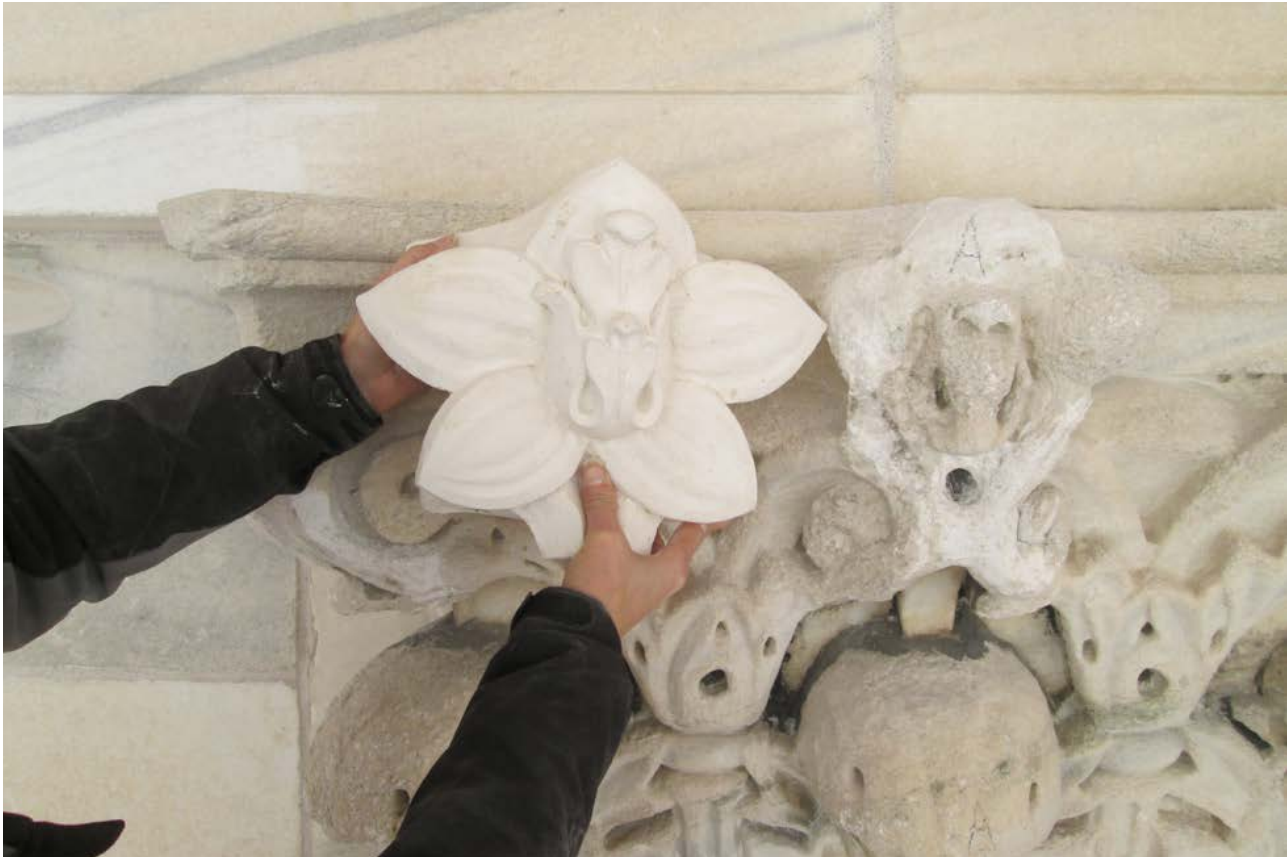
Fig. 7. Plaster model of a fleuron compared to severely eroded stone feature. Plaster models were used to evaluate size, depth, character and level of detail prior to stone fabrication.

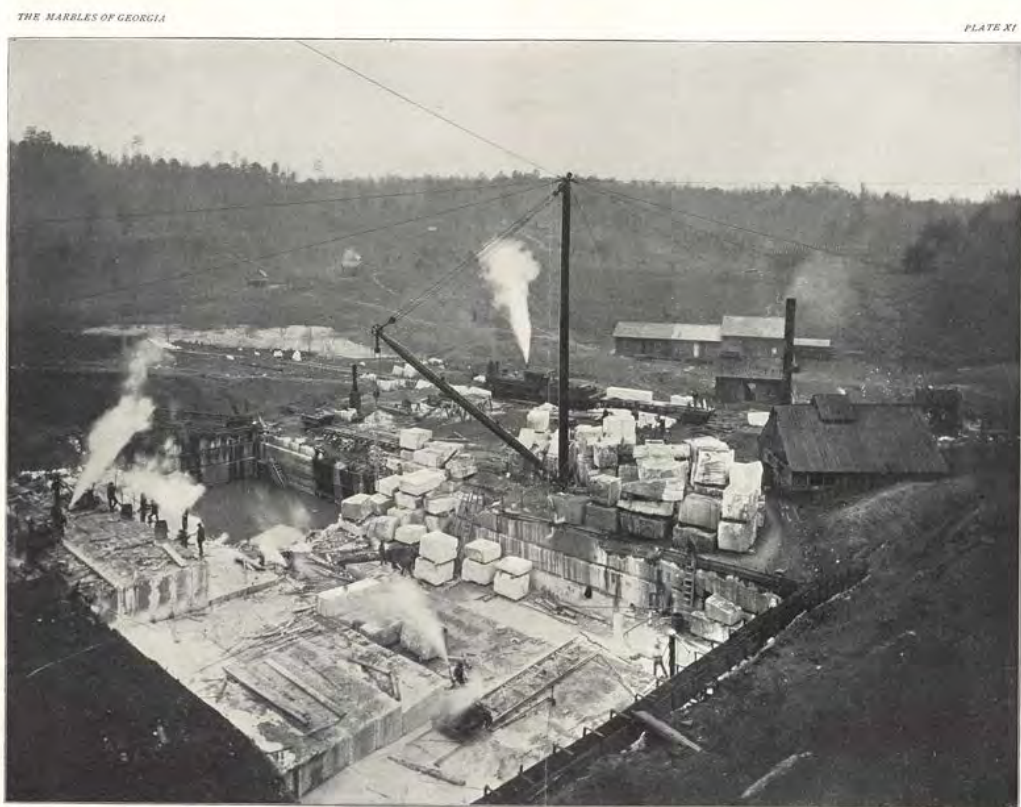
Fig. 8. Amicalola quarries, Atlanta Marble Company, Pickens County, Georgia (ci. 1900).

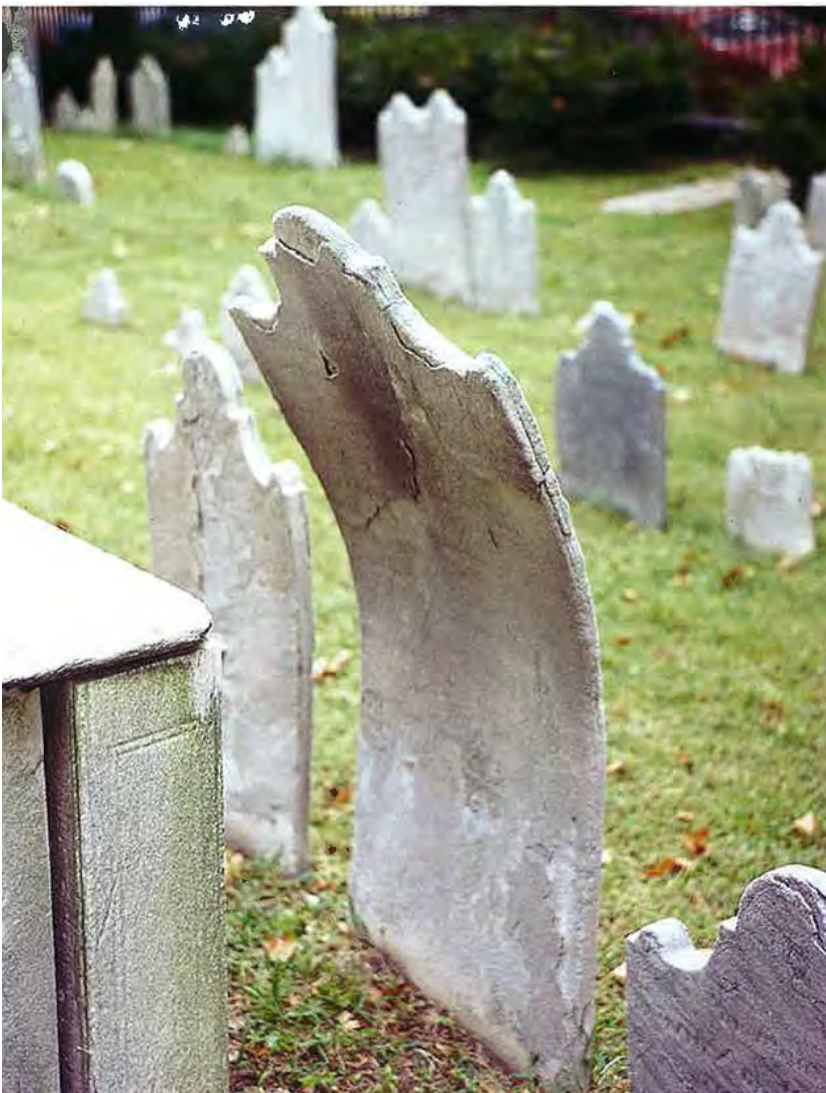
Fig. 9 (above). Cumulative effect of thermal hysteresis on a grave marker in Philadelphia.

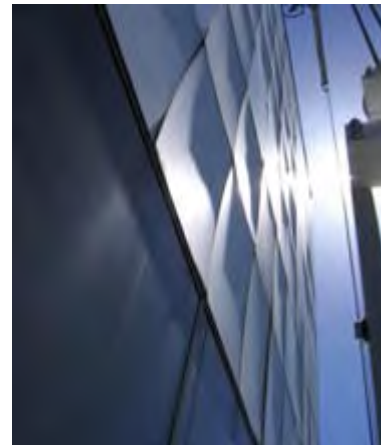
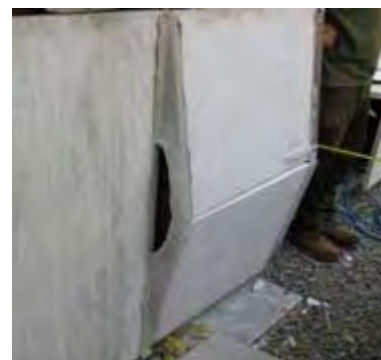
Fig. 10-11 (above). Bowed white Georgia marble panels on the First Canadian Place Building in Toronto (constructed in 1975). Marble tiles were inspected every 6 months and had been routinely replaced once considered at risk. In spite of frequent inspections, a marble tile fell off the 55th floor in 2007. Nearly 40,000 panels were removed and the building was completely reclad (2010-2012).

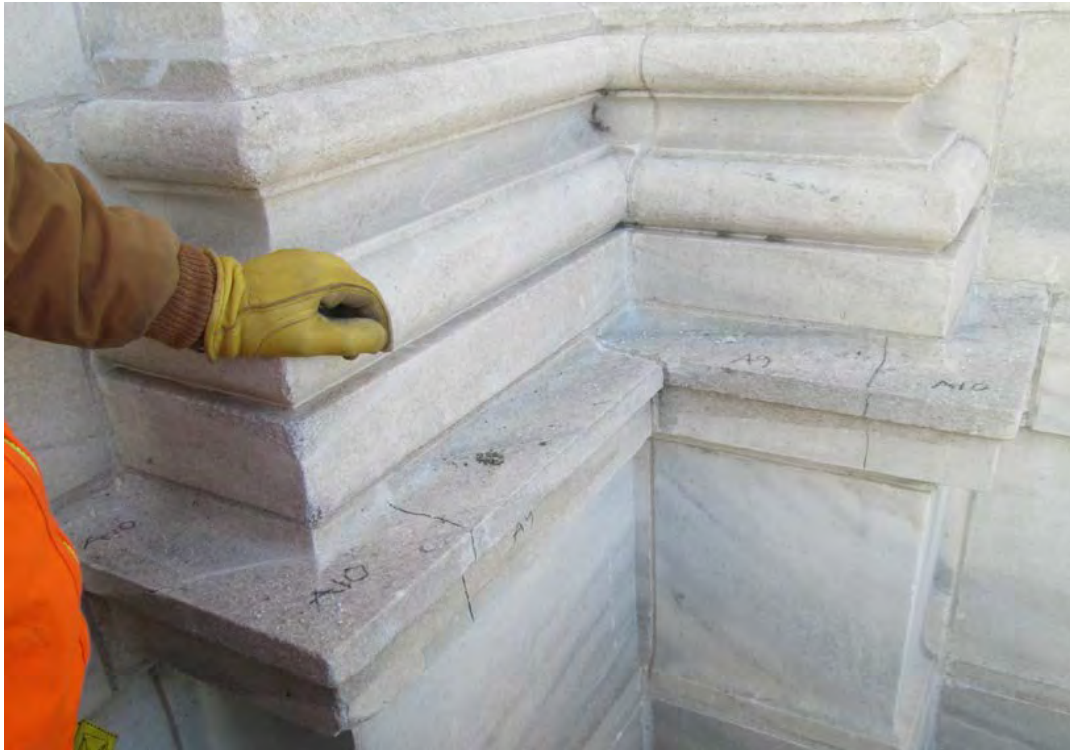
Fig. 12 (left). Pilaster base field marked by the design team. This is done prior to implementation to communicate to masons the intent or extent of repair.

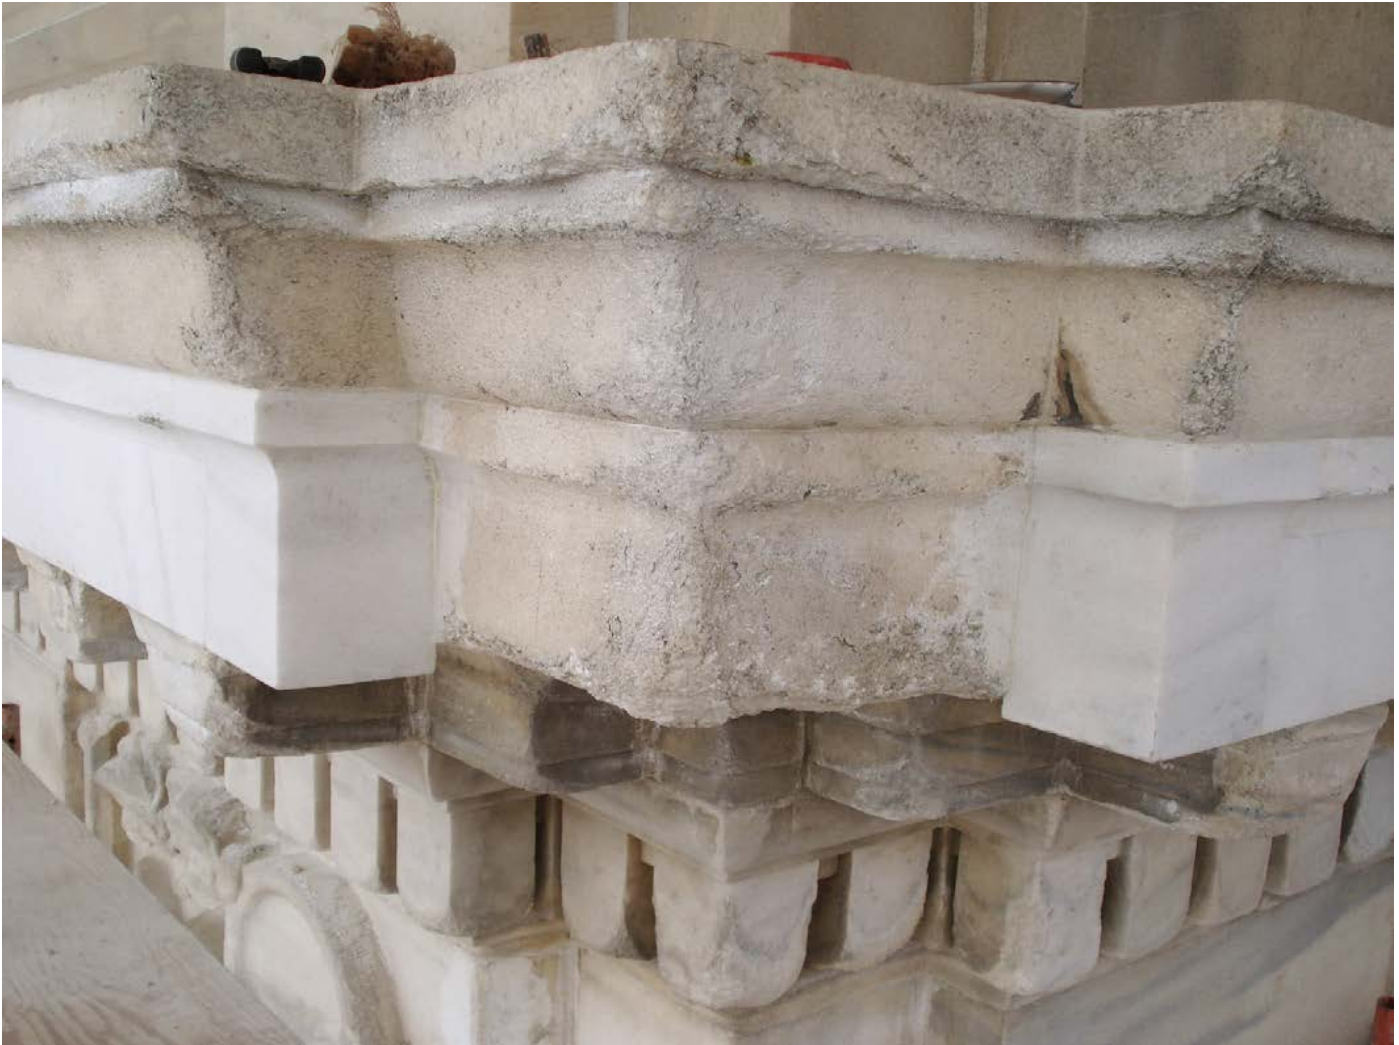
Fig. 14 (above). Stepped corner at east elevator after dutchman repairs are executed in the trial phase. The inside corner was left in place for comparison. A dutchman repair will be installed during the construction phase.

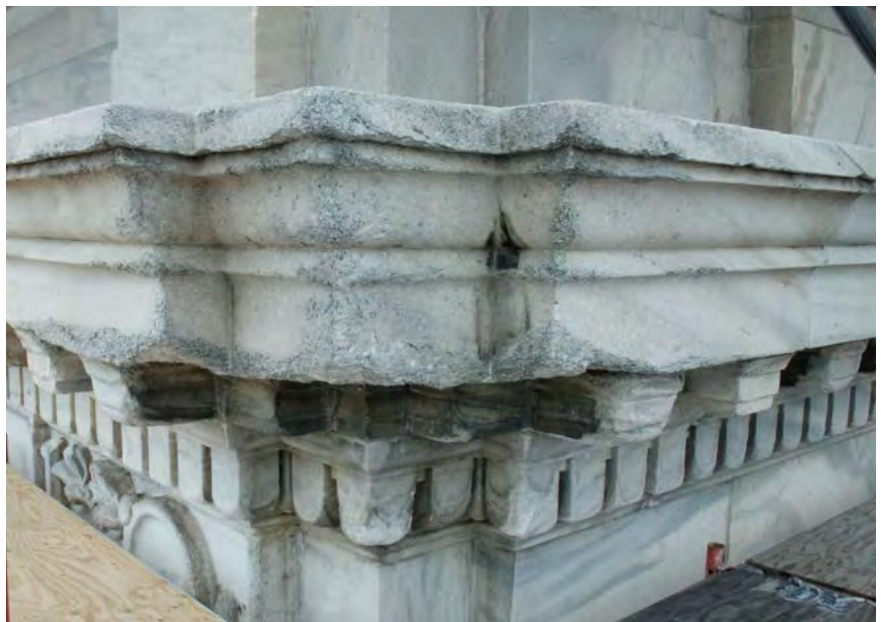
Repair Class A - Dutchman Repair (New stone, partial replacement)

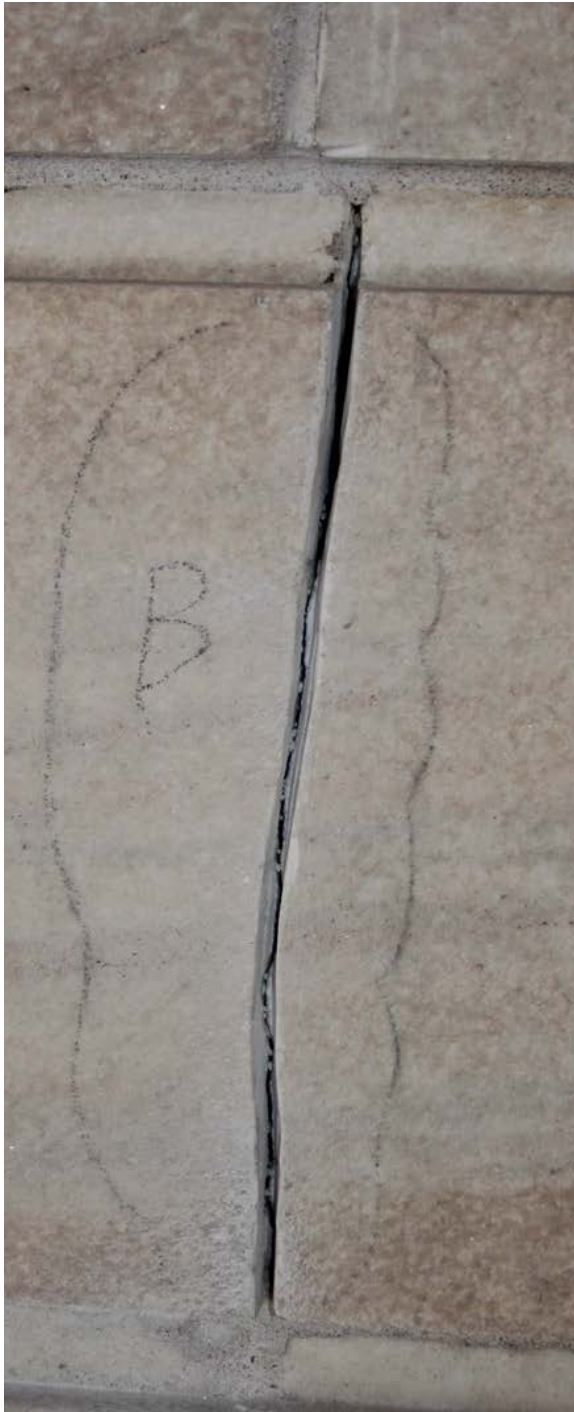
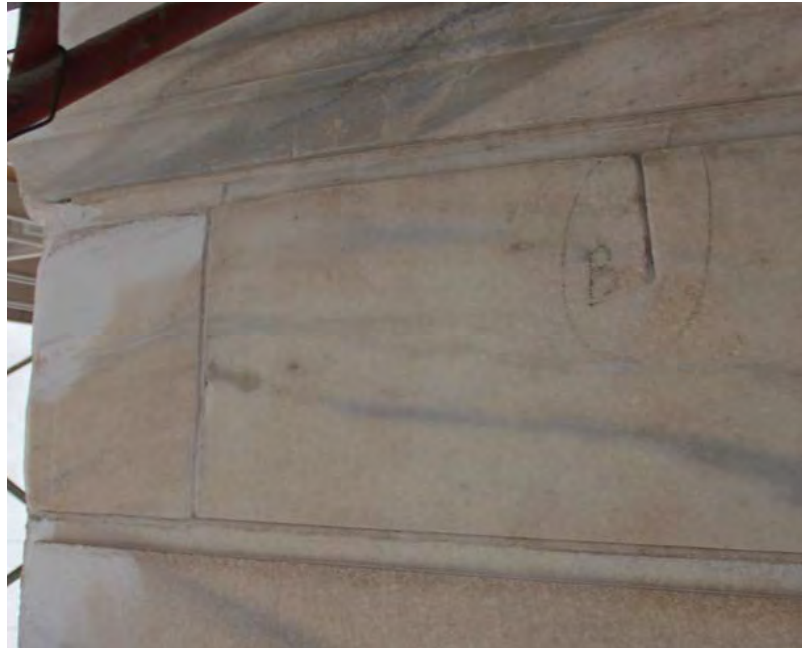
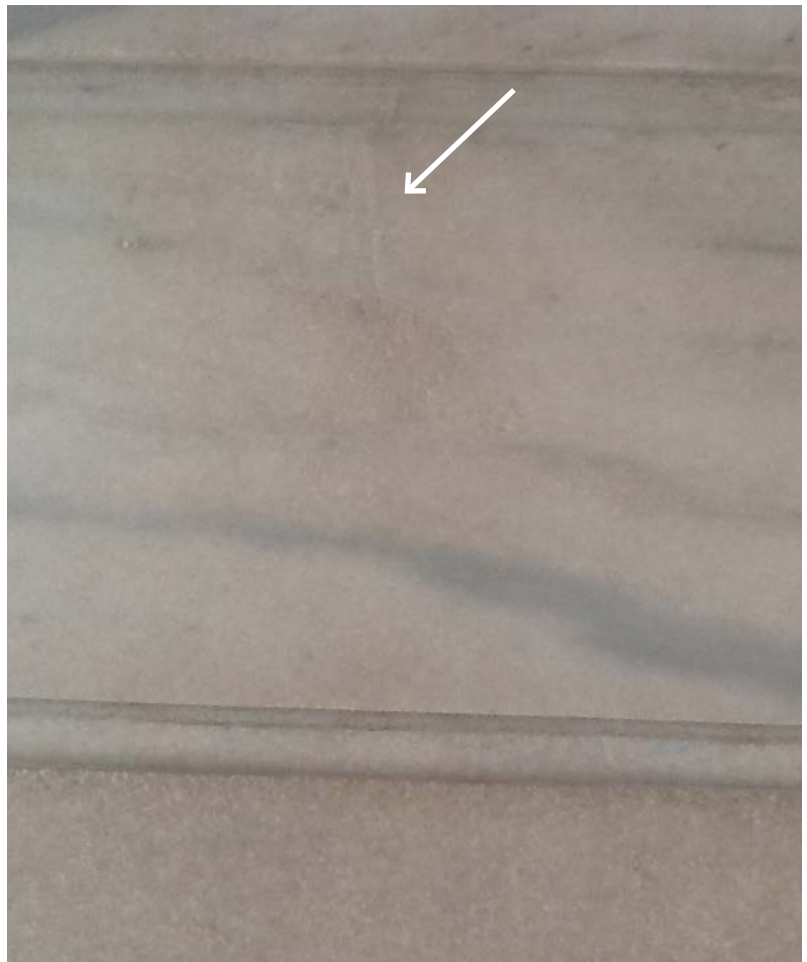
Additional Observations:

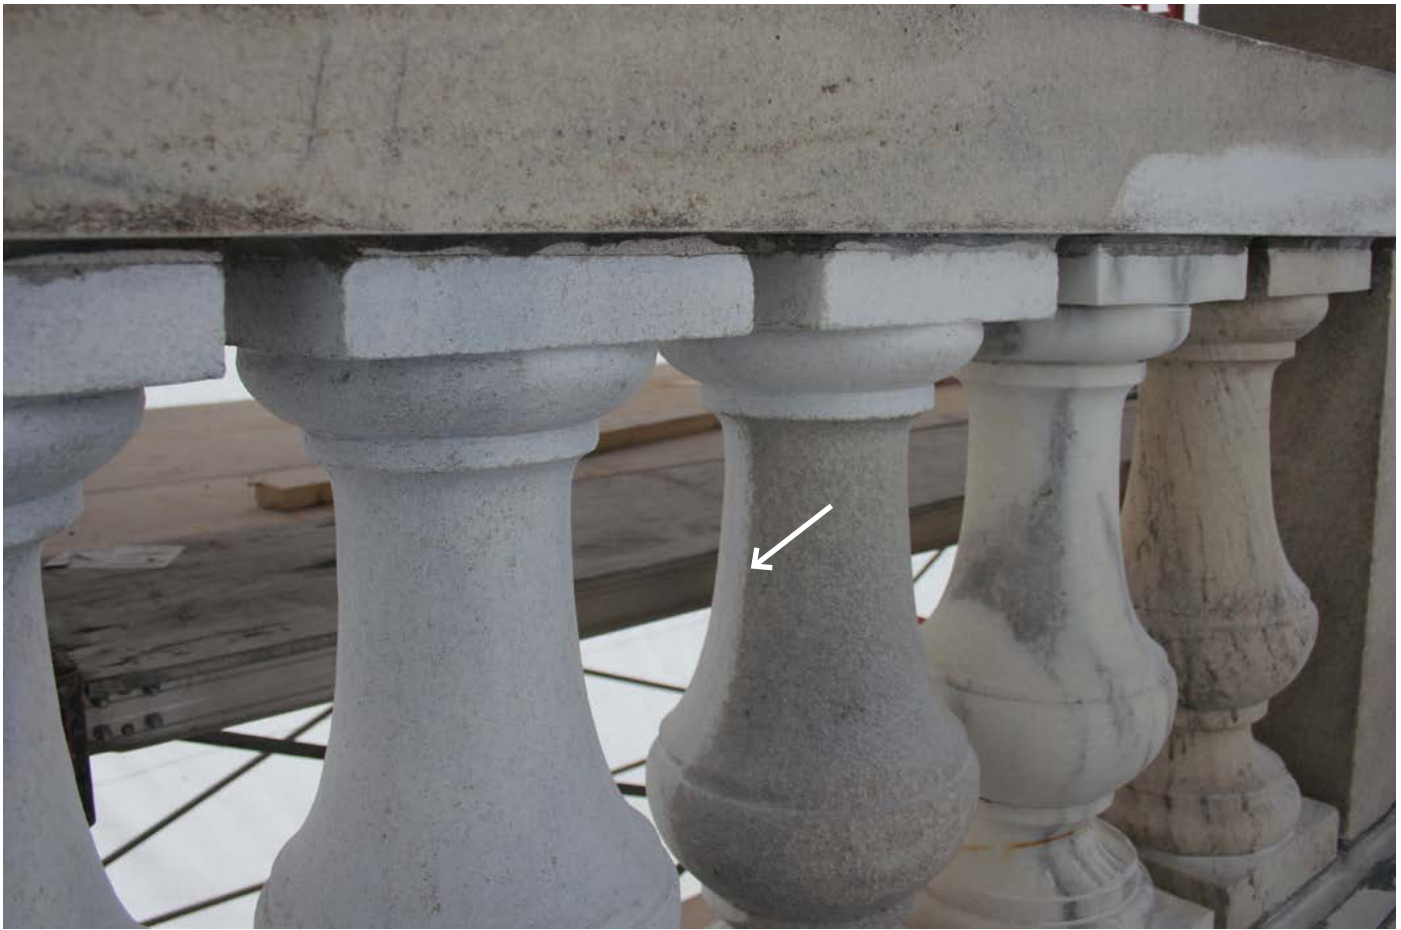
Fig. 18 (above). Example of grind repair that effectively improved water runoff by smoothing the surface. The profile and character of the feature was not altered. The contrast between the rough weathered surface and the repaired surface, which is very similar to the original finish, is clearly visible (arrow). The second baluster from the right was replaced in an earlier project with white Cherokee marble.

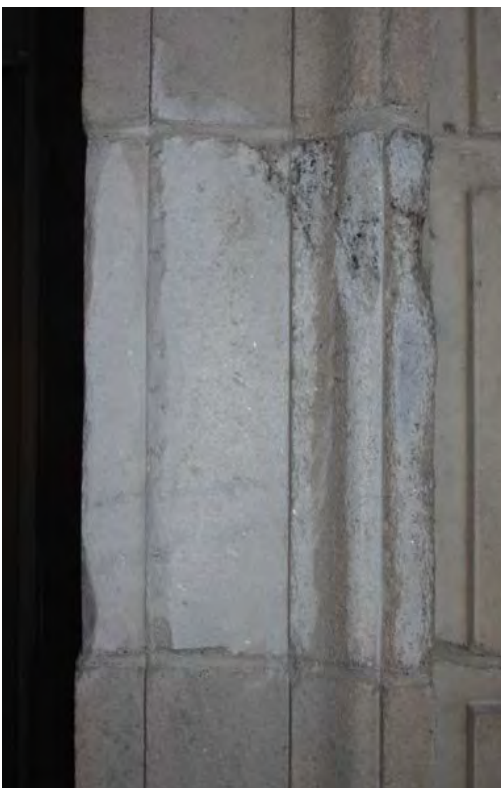
Fig. 19 (far left). Severe deterioration at a typical second floor window surround. Grinding to remove decay alters the profile and creates a scalloped pattern.

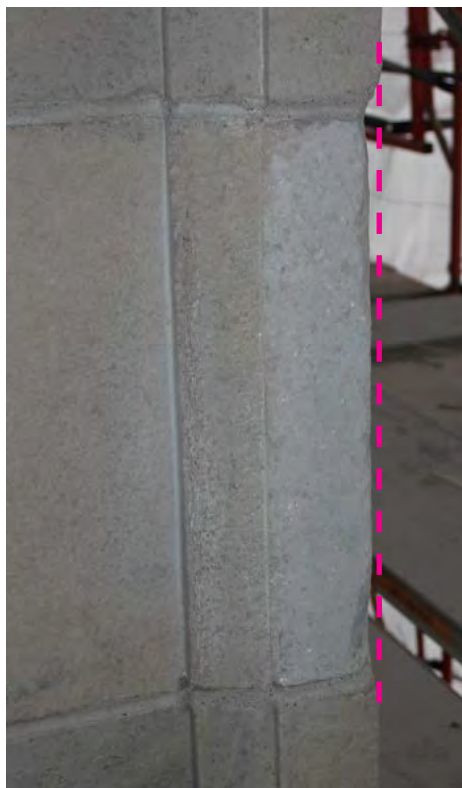
Fig. 20 (left). Even after truing the edge (Fig. 20), significant material removal is noticeable.

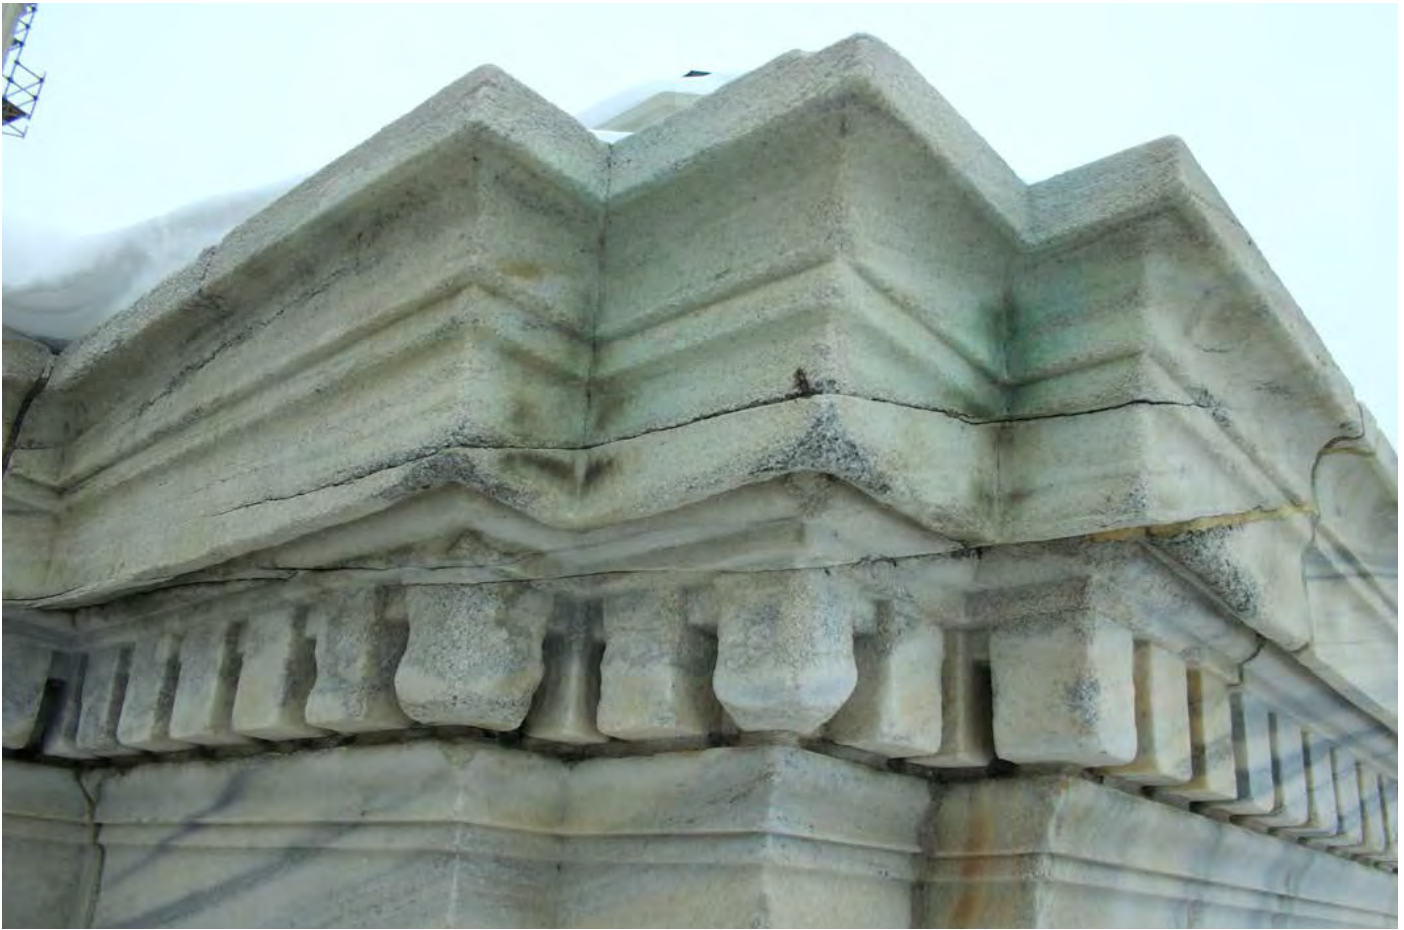
Fig. 21. Cornice at east elevator tower. Significant cracks and vein erosion cut diagonally across the unit. Because of the orientation of the cracks, the size of the unit (3000 +lbs), and the location (over the main entry) this is assigned to the highest priority repair class, Life Safety (Tier 1). The unit is currently sound but will be stabilized in place as a protective safety measure.

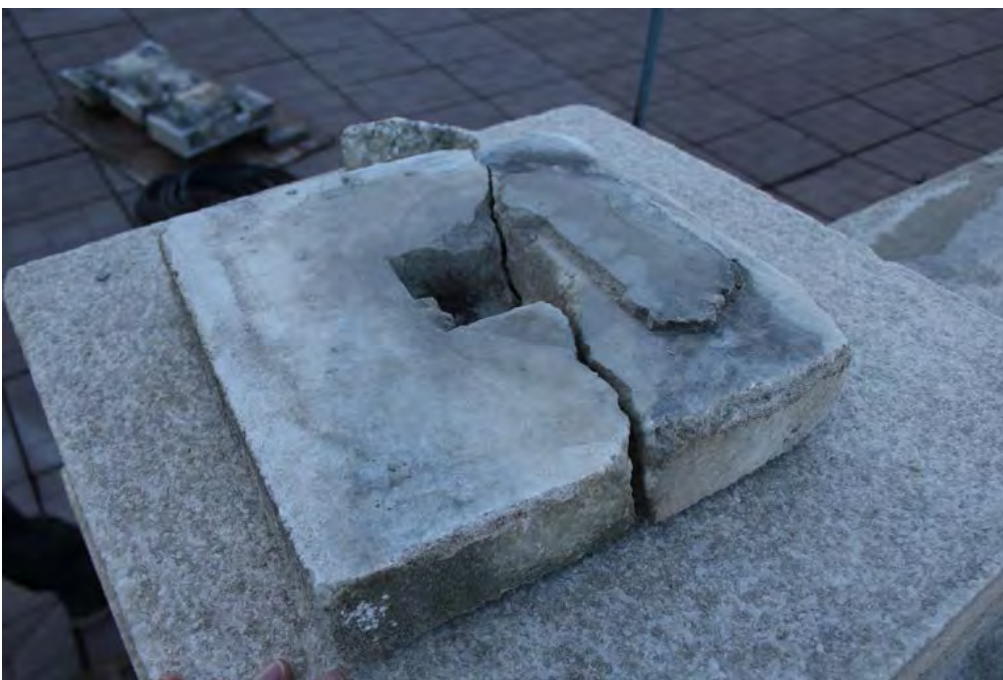
Fig. 22. West wing baluster cap.

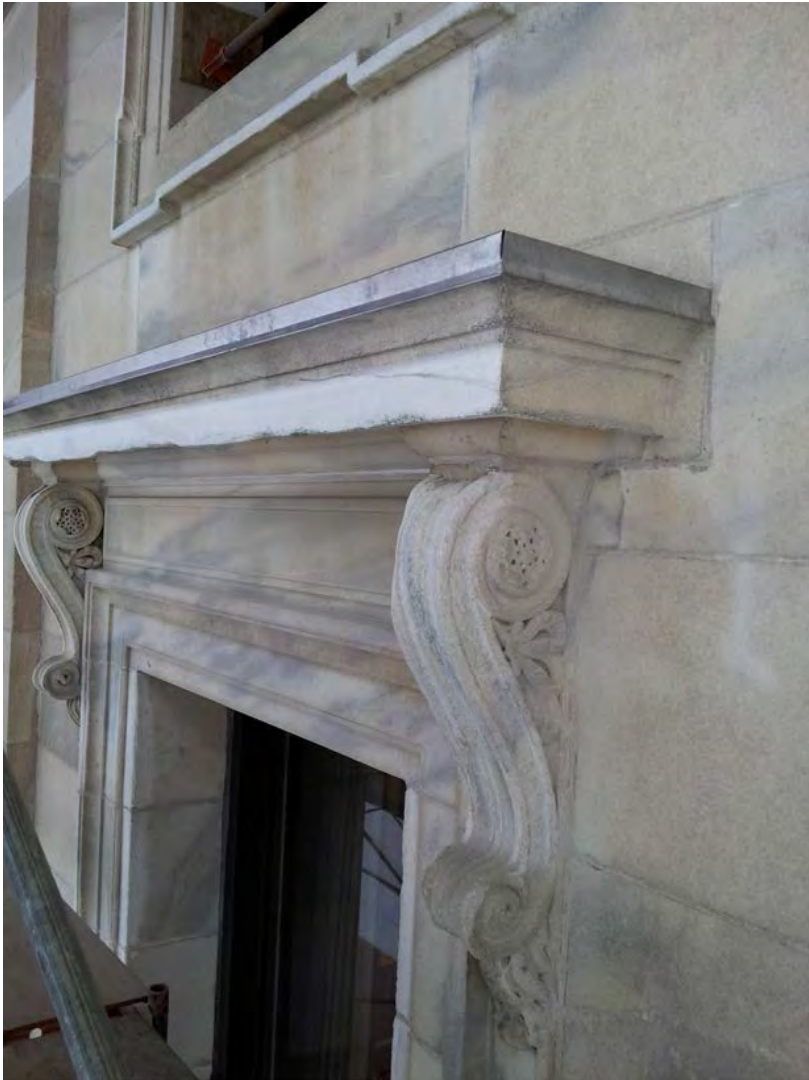
Fig. 23 (top left). Window hood flashing at second level. From street level the metal flashing repair is minimally intrusive.

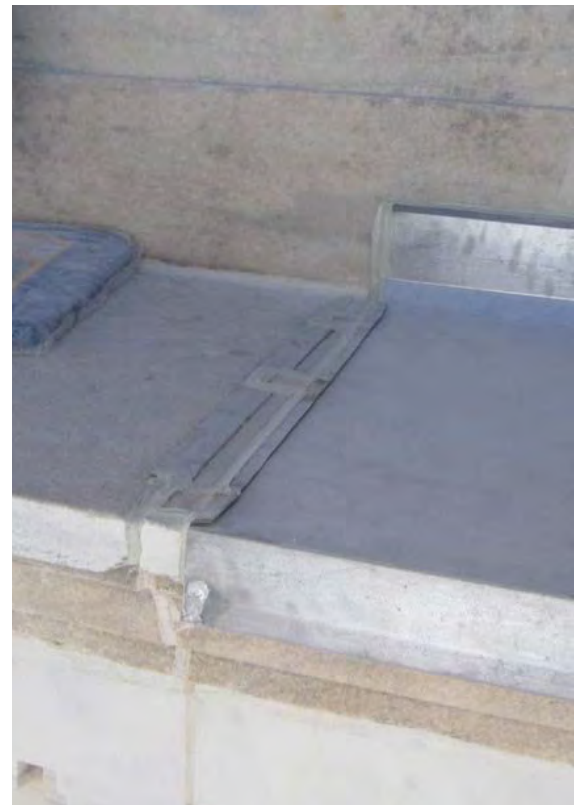
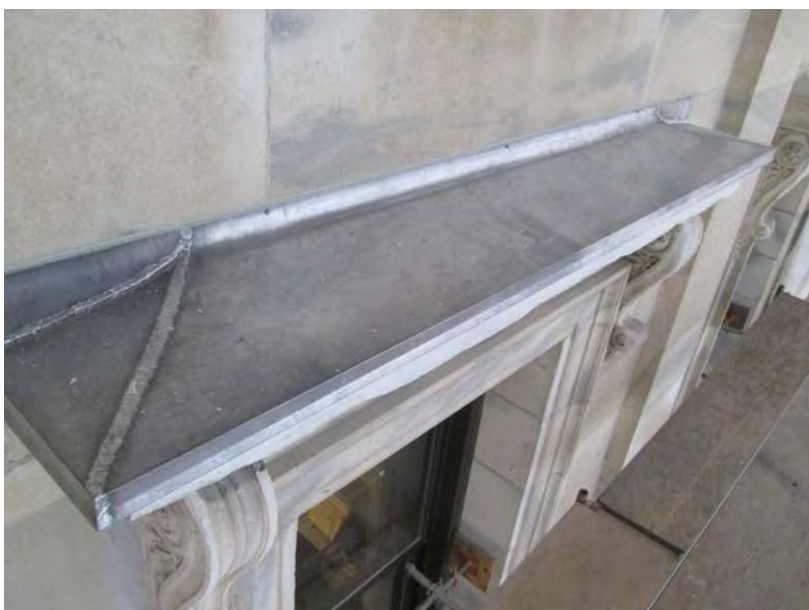
Repair Class I - Unit Protection (Metal flashing)

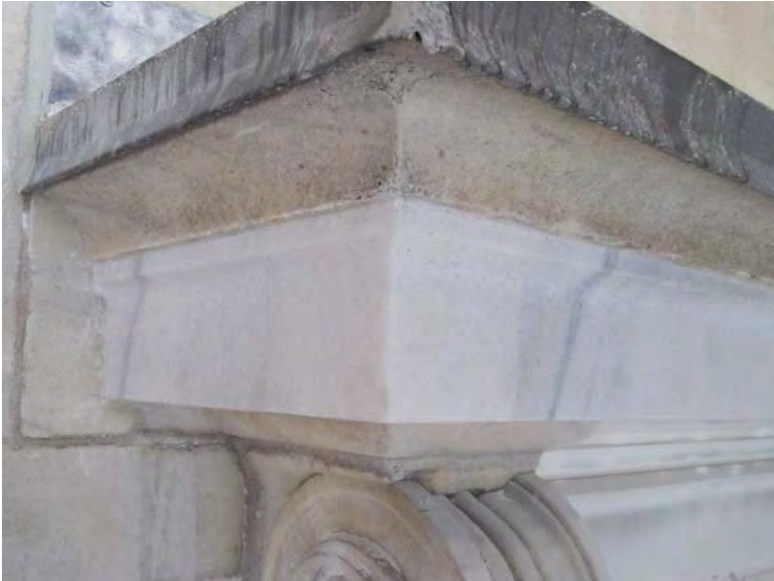
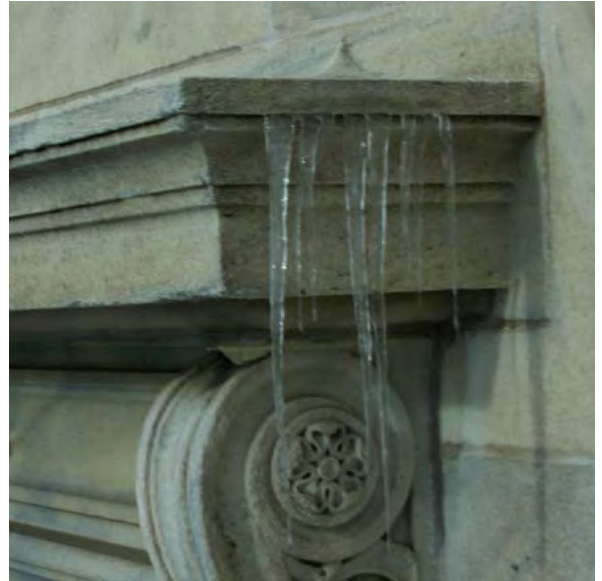
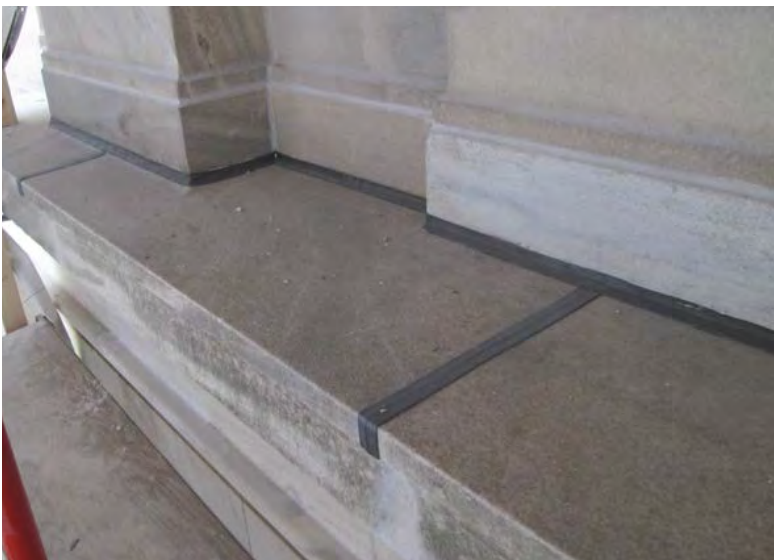
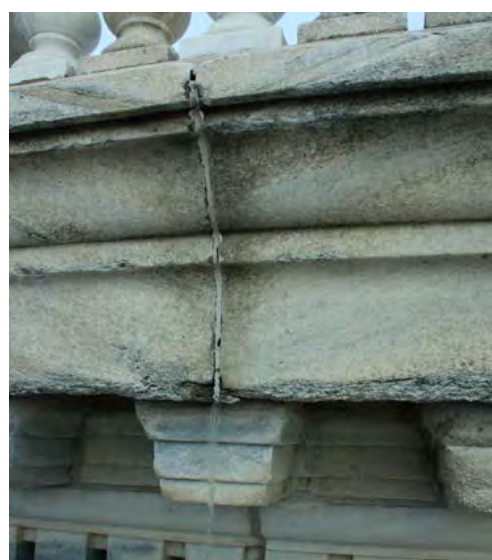
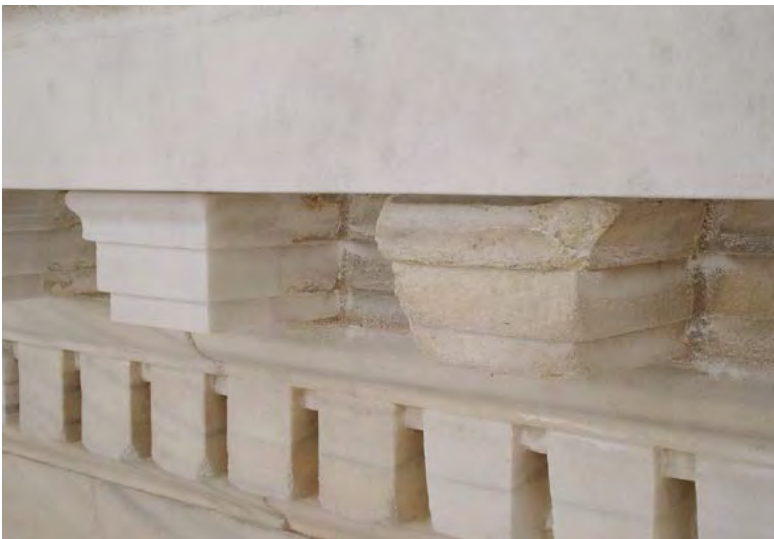
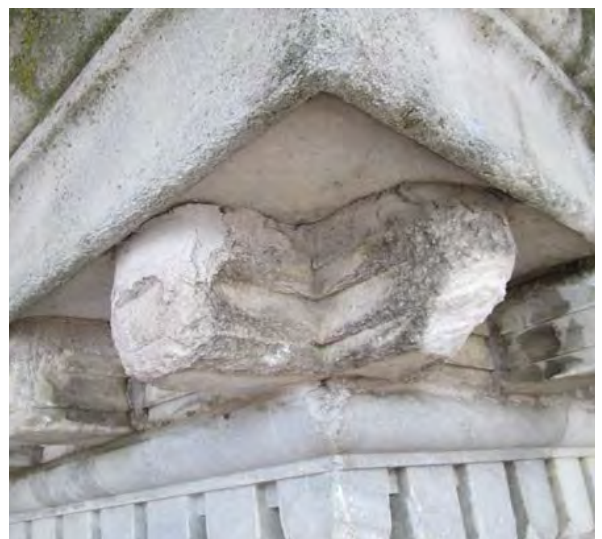
Upward facing joints, projecting hoods and ledges were observed to be severely deteriorated during previous surveys. Repair options implemented at these locations during the trial phase repairs included installation of lead weather caps in joints. Lead weather caps, a joint treatment that provides a weather proof barrier, were installed on the dome several years ago. During the trial phase, lead caps were installed at upward facing joints at the cornice and water table zones of the building to protect joints with high exposure to water, snow and ice.
