Minnesota State Capitol
Exterior Stone Repair Project
Stone Repair Trials Evaluation and
Preliminary Preservation Planning

May 10, 2013

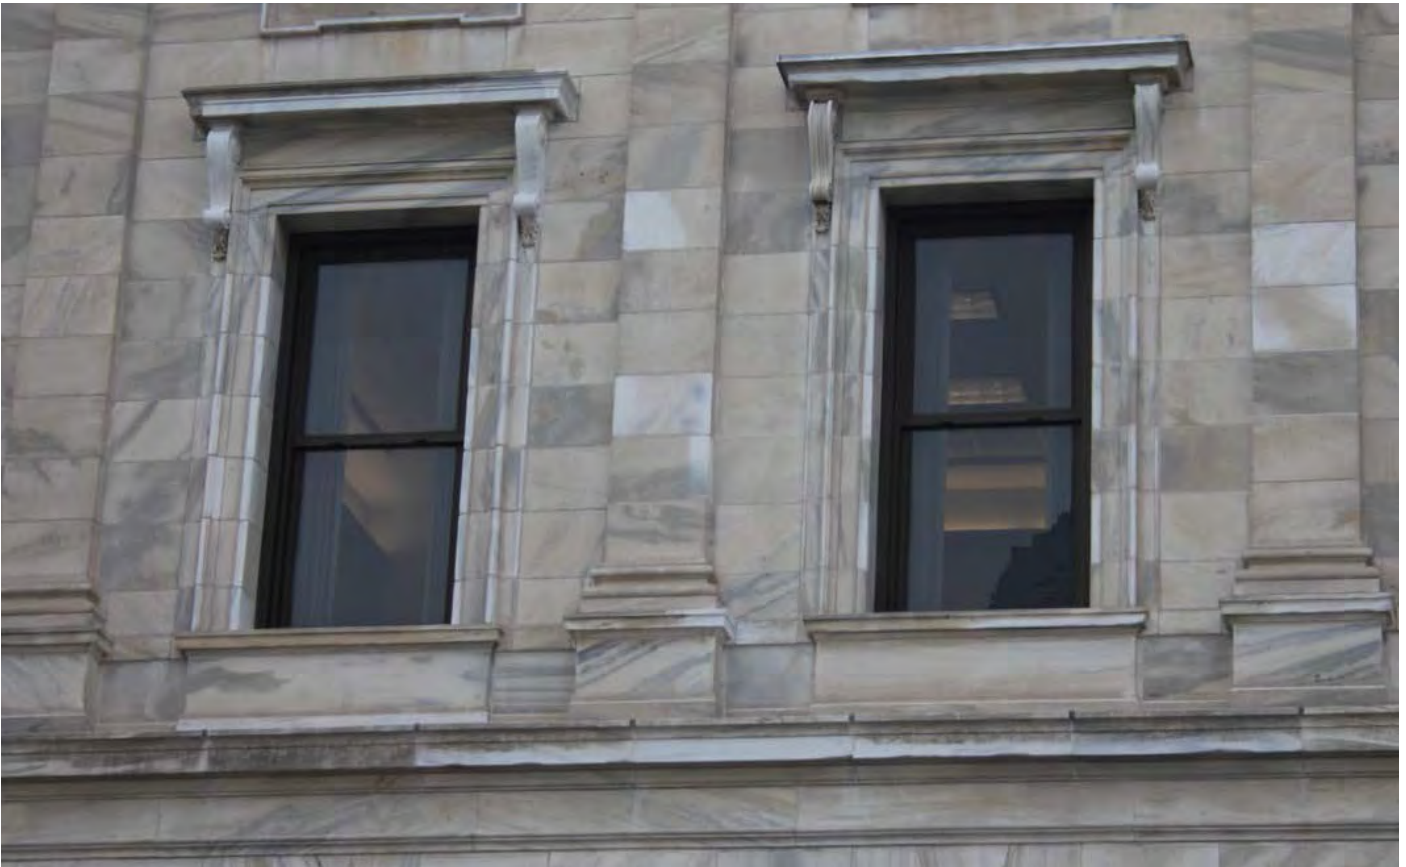
Fig. 32. West wing, north facade. Second level windows following trial phase.

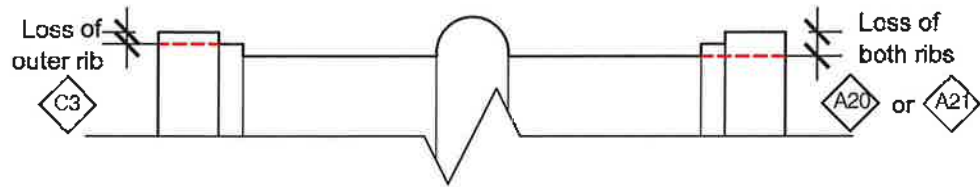
- 4. Review repair assignments in the context of scroll pairs at same window surround.
- 5. Edit repair assignments as necessary after contextual review.

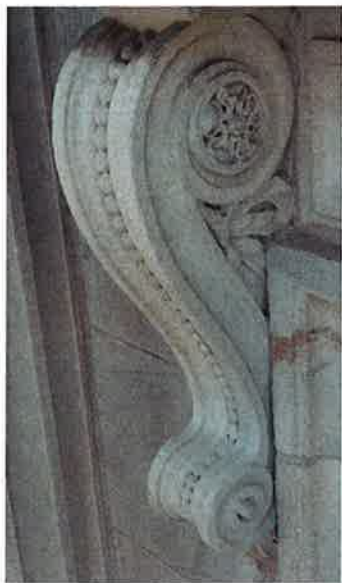
Example of scroll unit requiring carve and smooth repair

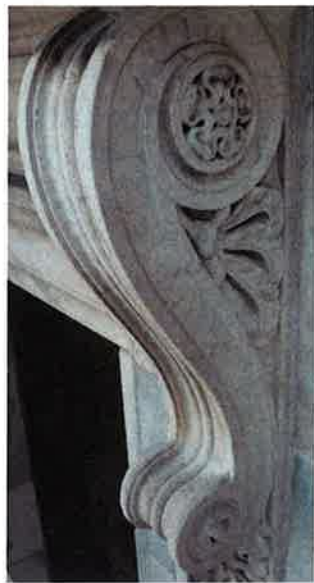
Examples of scroll units requiring partial scroll dutchmen repair, pending loss of profile assessment on upper portion of scroll

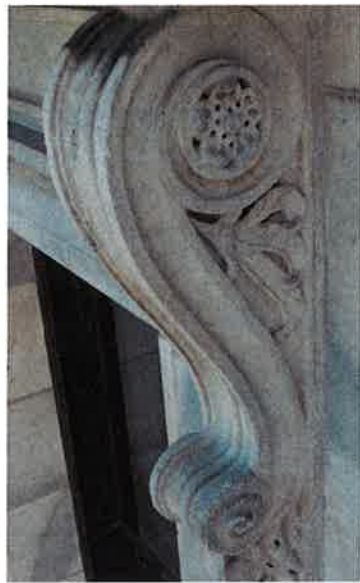
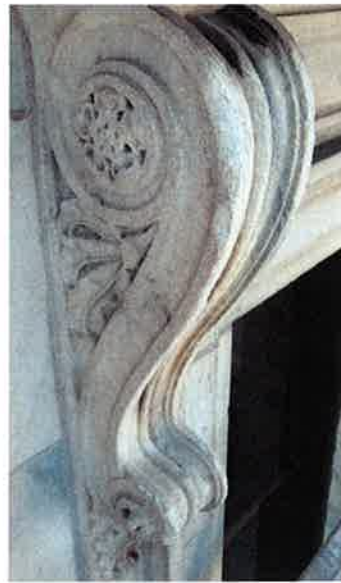
Example of scroll requiring partial or full dutchman repair, based on context and loss of profile assessment

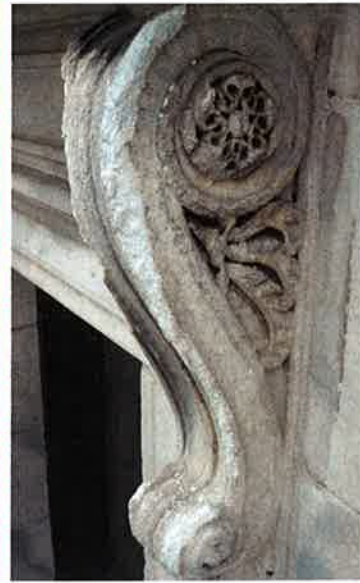
Example of scroll unit requiring full face dutchman repair, regardless of context

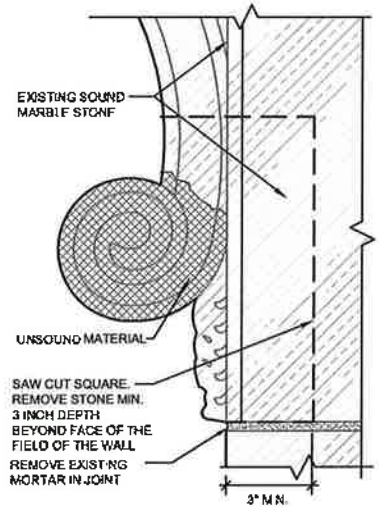
A SECTION PRIOR TO REPAIR
1-1/2\"/>

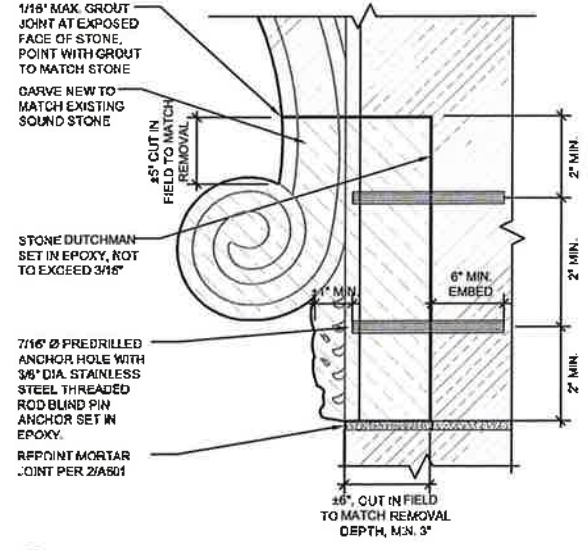
B SECTION AFTER REPAIR
1-1/2\"/>

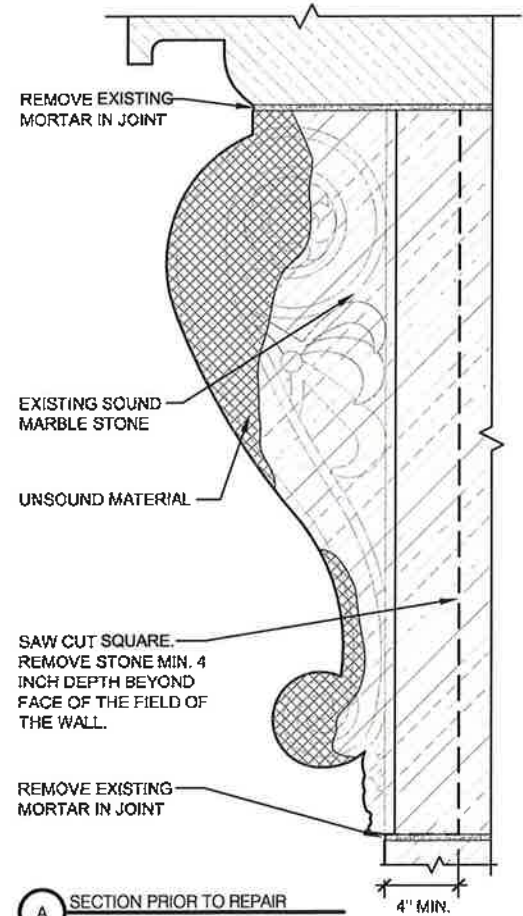
A SECTION PRIOR TO REPAIR
1-1/2\"/>

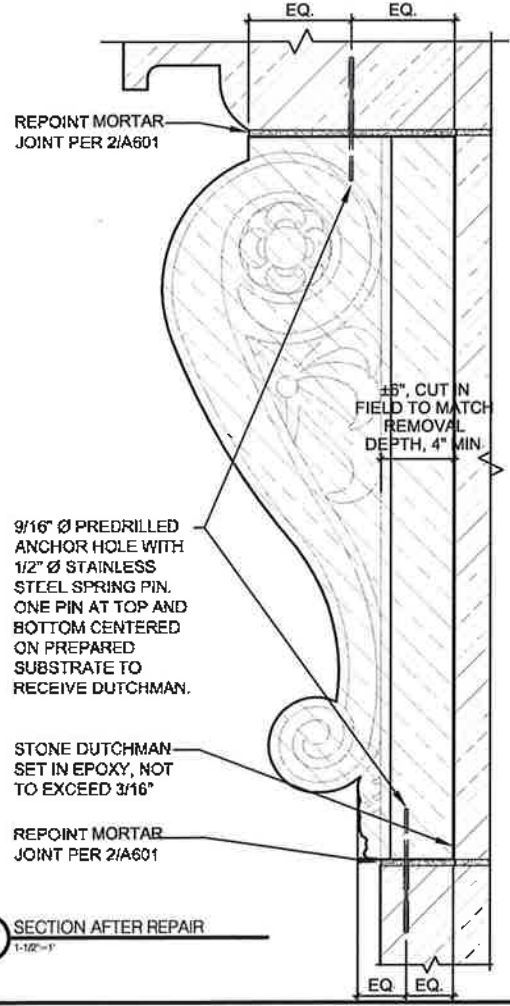
B SECTION AFTER REPAIR
1-1/2\"/>

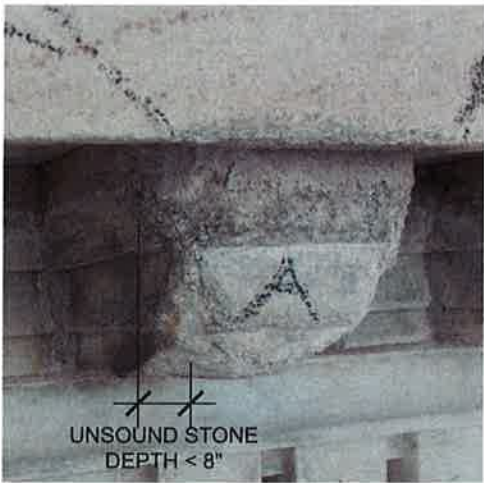
PARTIAL DUTCHMAN A23

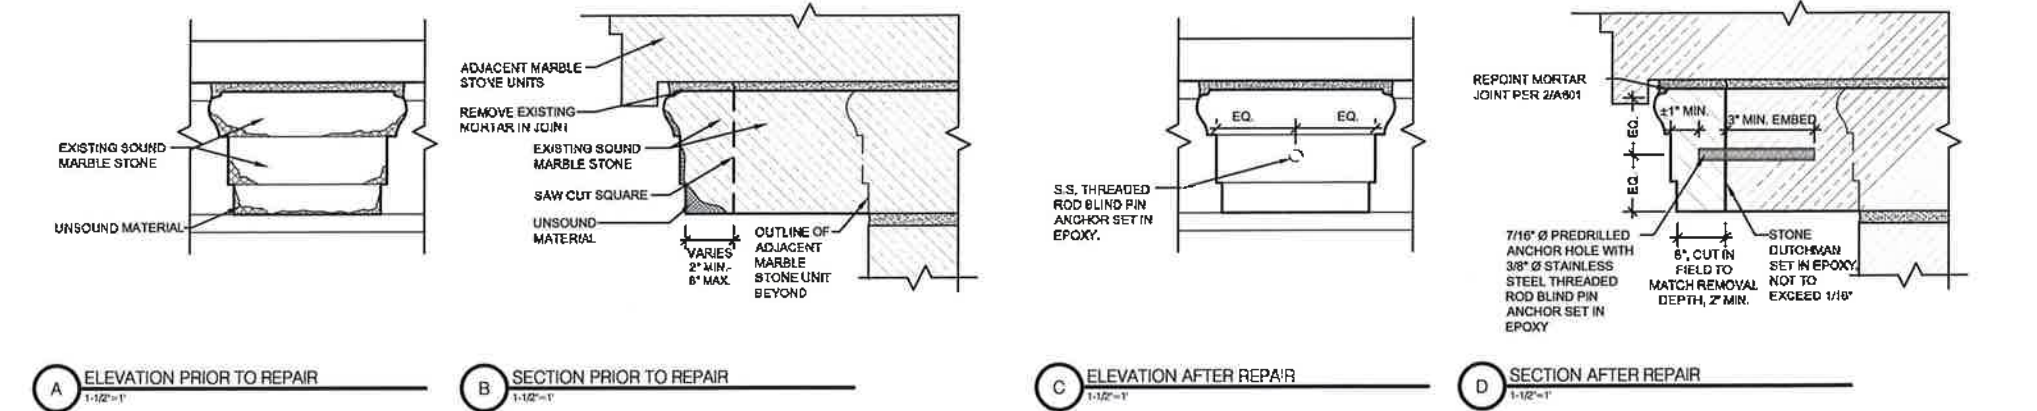
A23 PARTIAL DUTCHMAN REPAIR AT MODILLION BLOCKS NTS

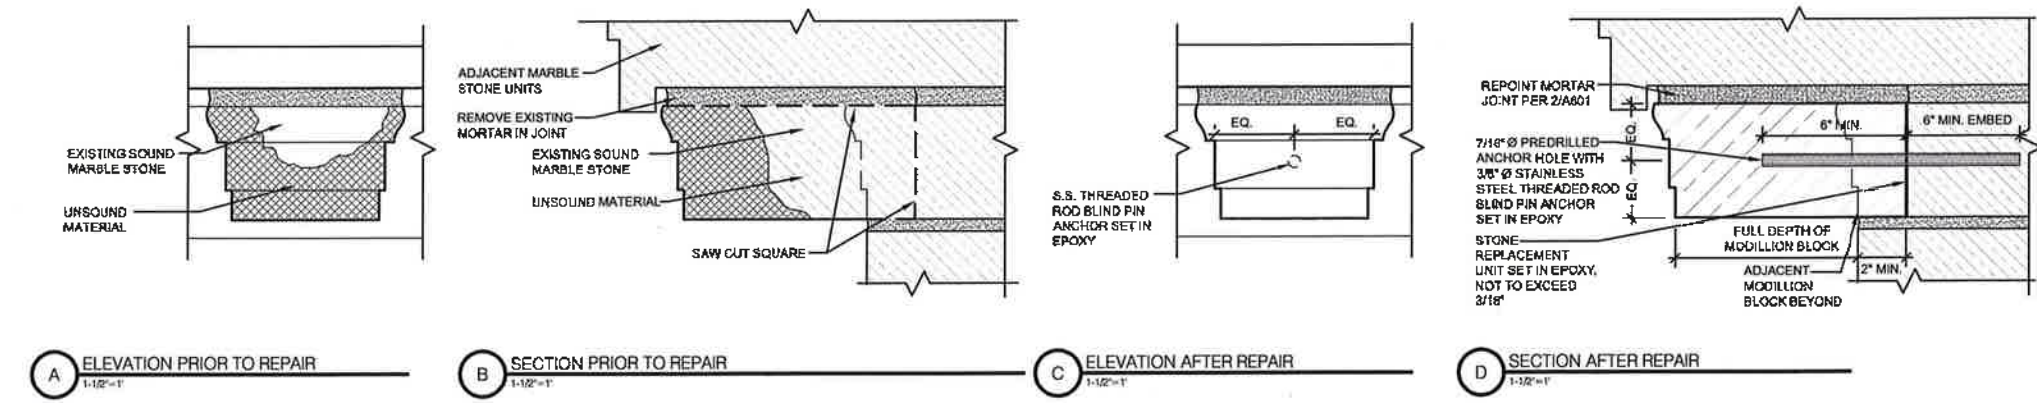
A24 FULL FACE DUTCHMAN REPAIR AT MODILLION BLOCKS NTS

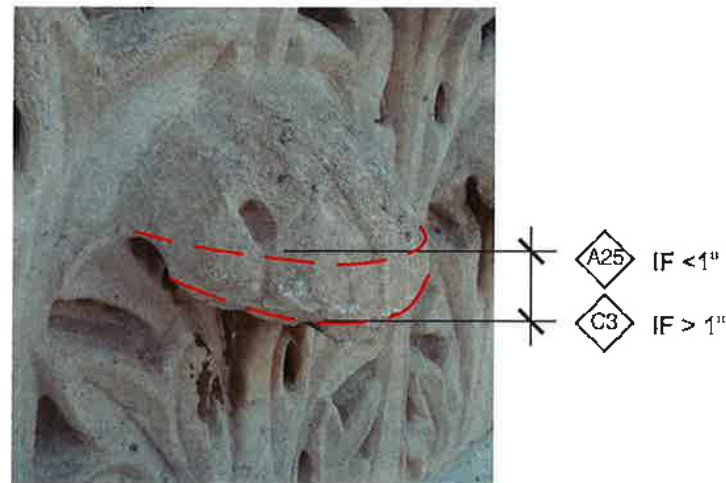
3. Lower row of acanthus:
Carve and smooth- sound material > 1" below "nostrils"
Pending dutchman- sound material > level of "nostrils" and < 1"
Dutchman- sound material < level of "nostrils"

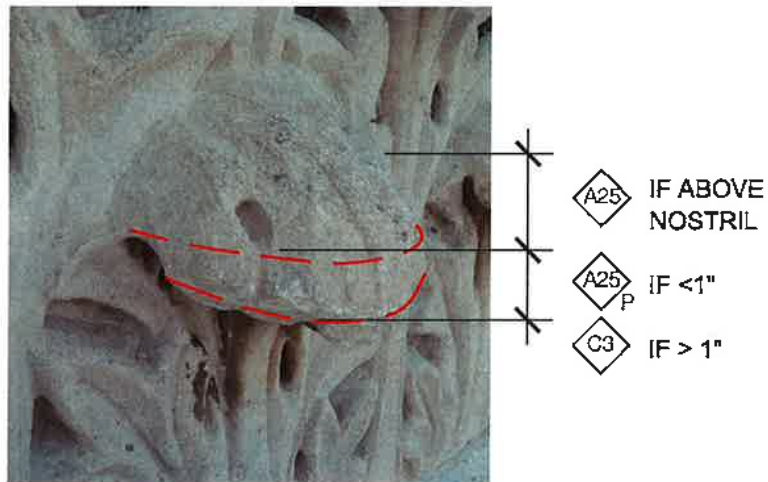
4. Repeat for each acanthus on capital
5. Review repair assignments in the context of the full capital.
6. Edit repair assignments as necessary after contextual review.

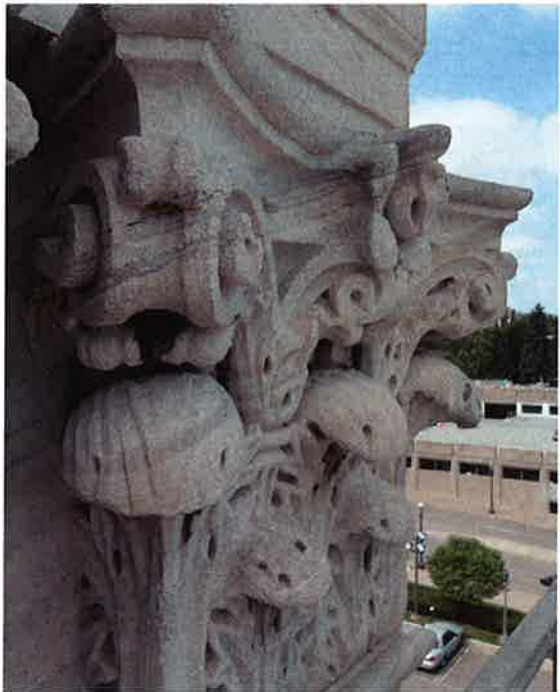
PILASTER CAPITAL
NTS

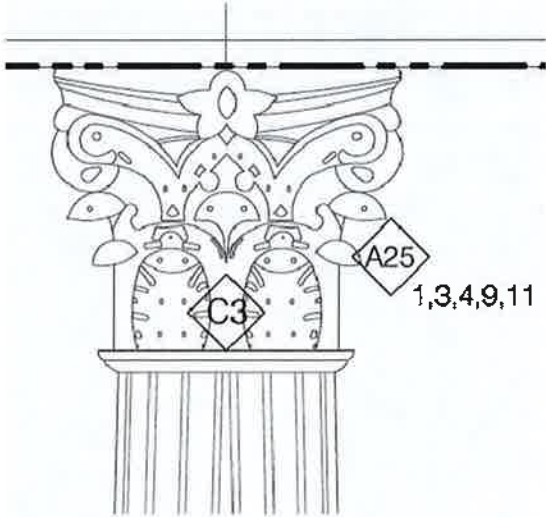
Number acanthus repairs on column capitals starting at the back of the column in plan, moving clockwise around the column.

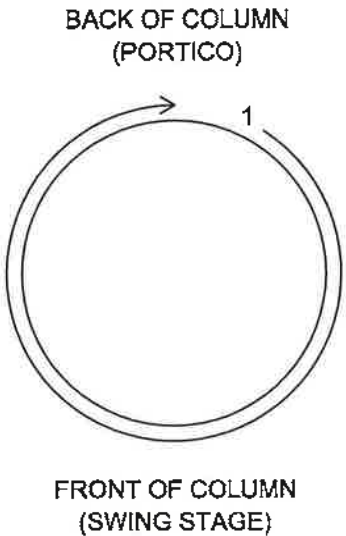
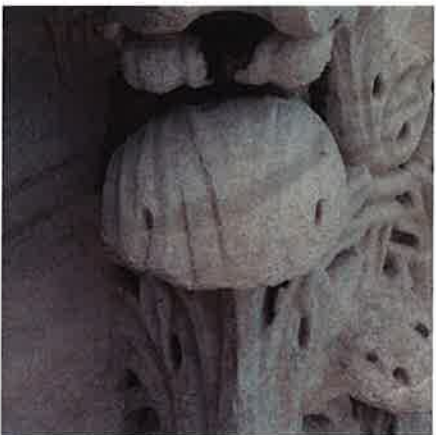
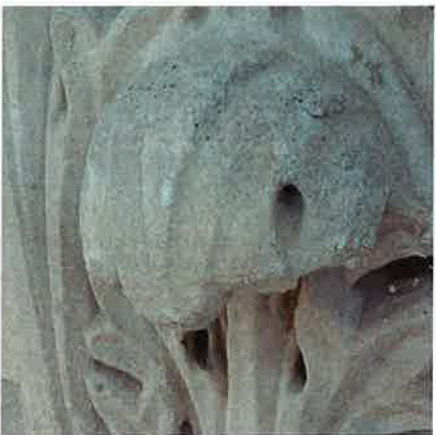
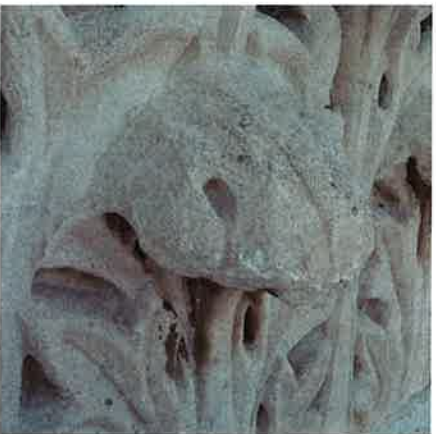
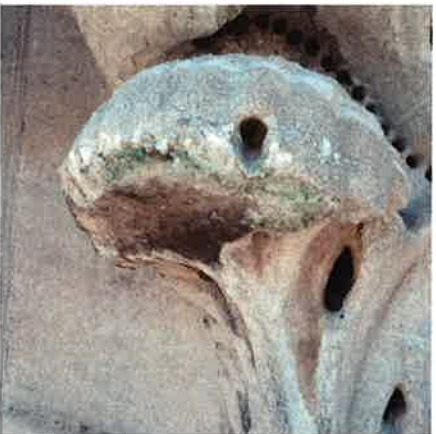
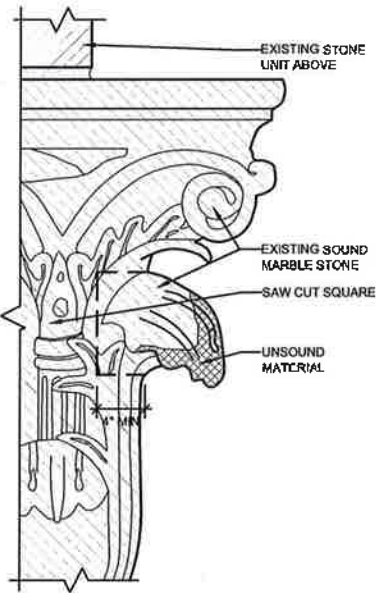
A SECTION PRIOR TO REPAIR
1-1/2"=1'

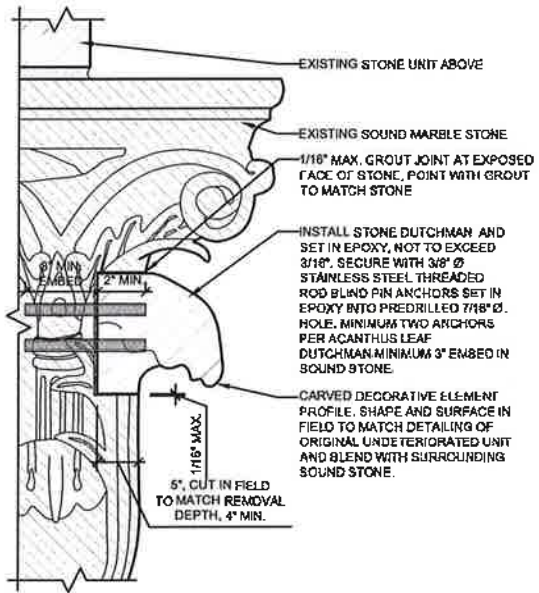
B SECTION AFTER REPAIR
1-1/2"=1'

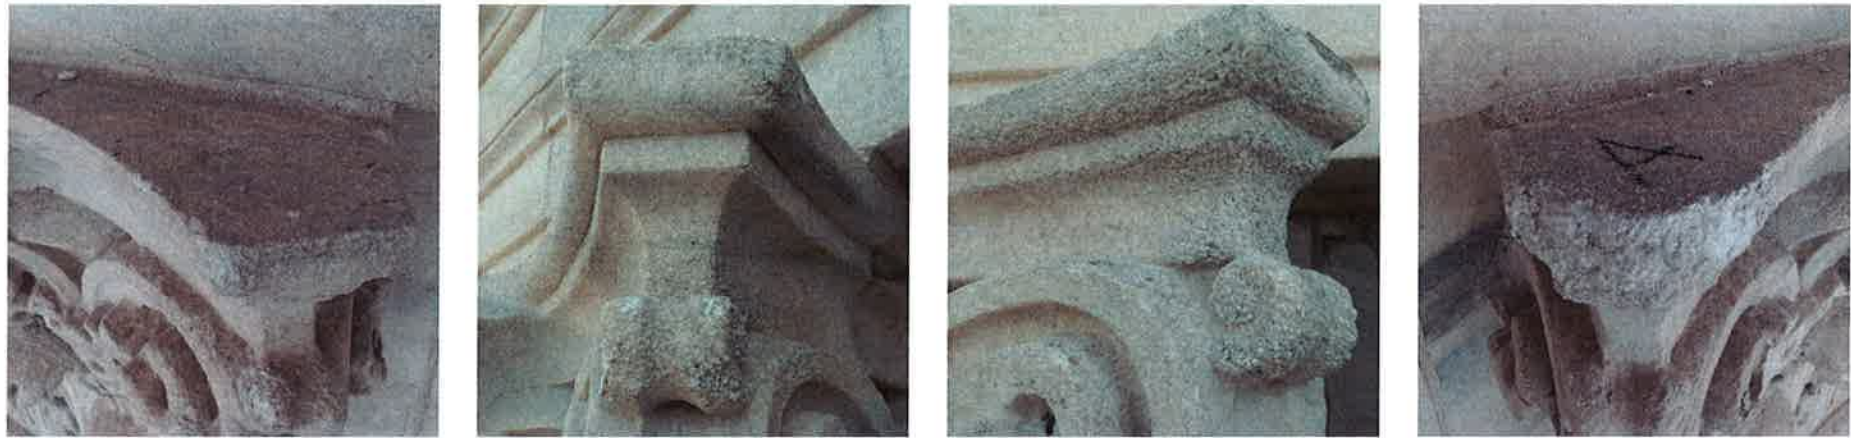
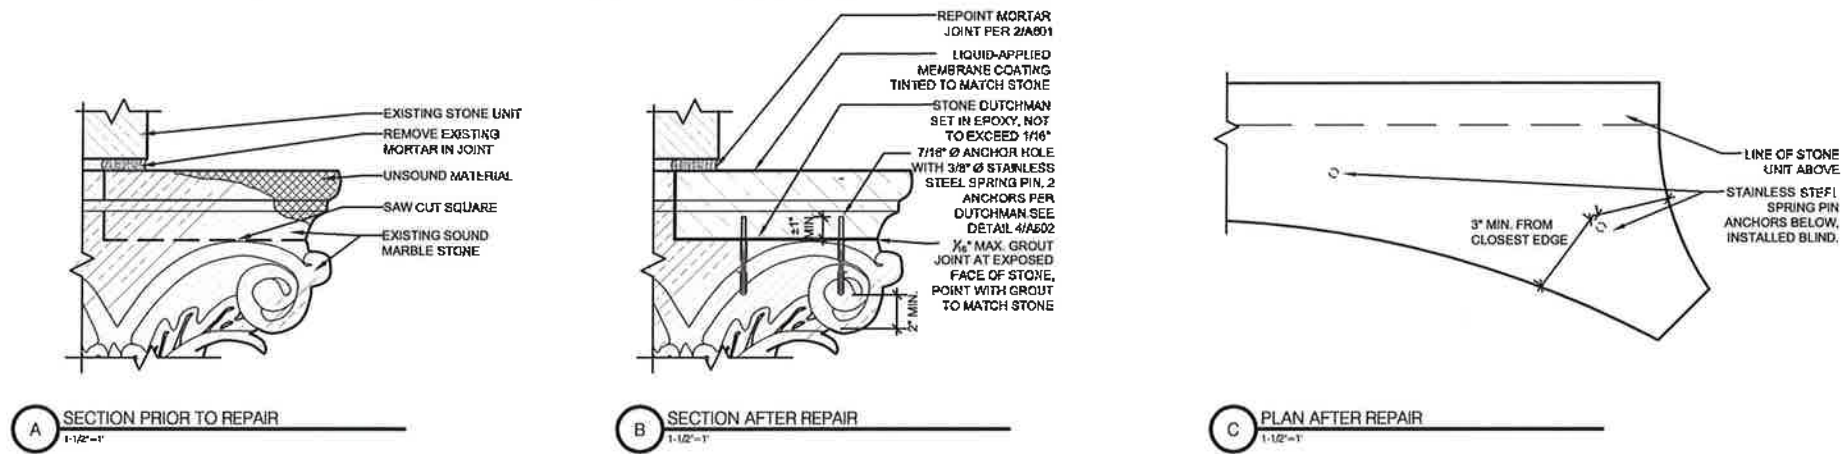
A28 REPAIRS AT COLUMN OR PILASTER CAPITAL ABACUS
NTS

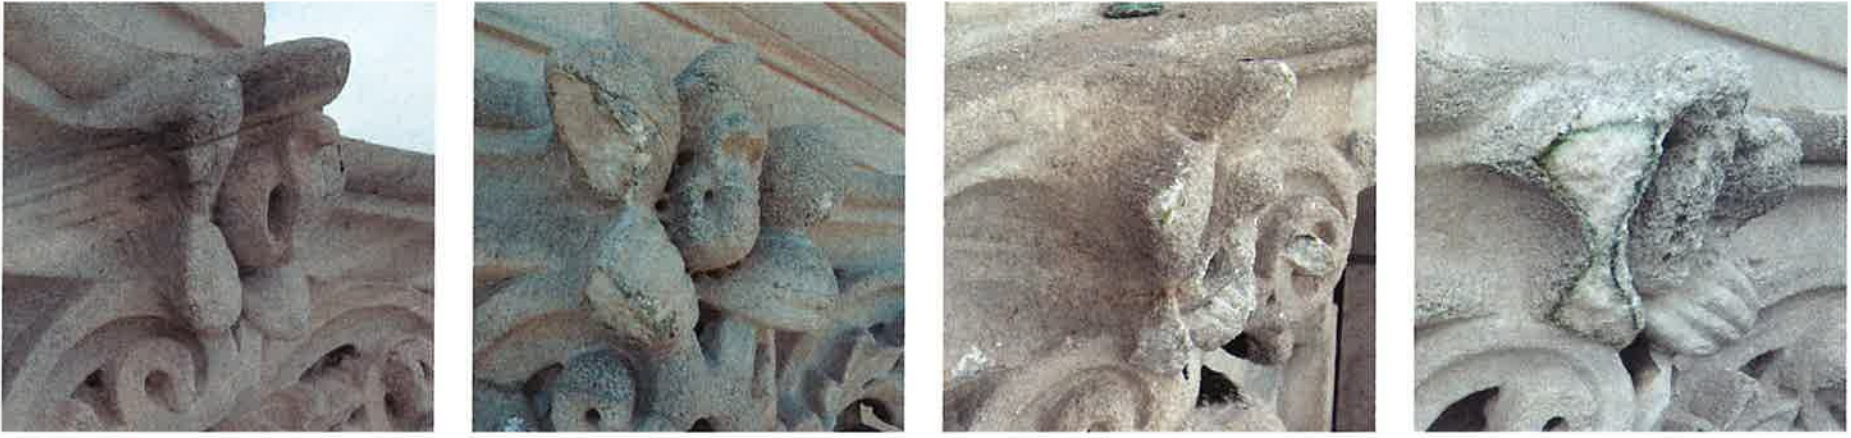
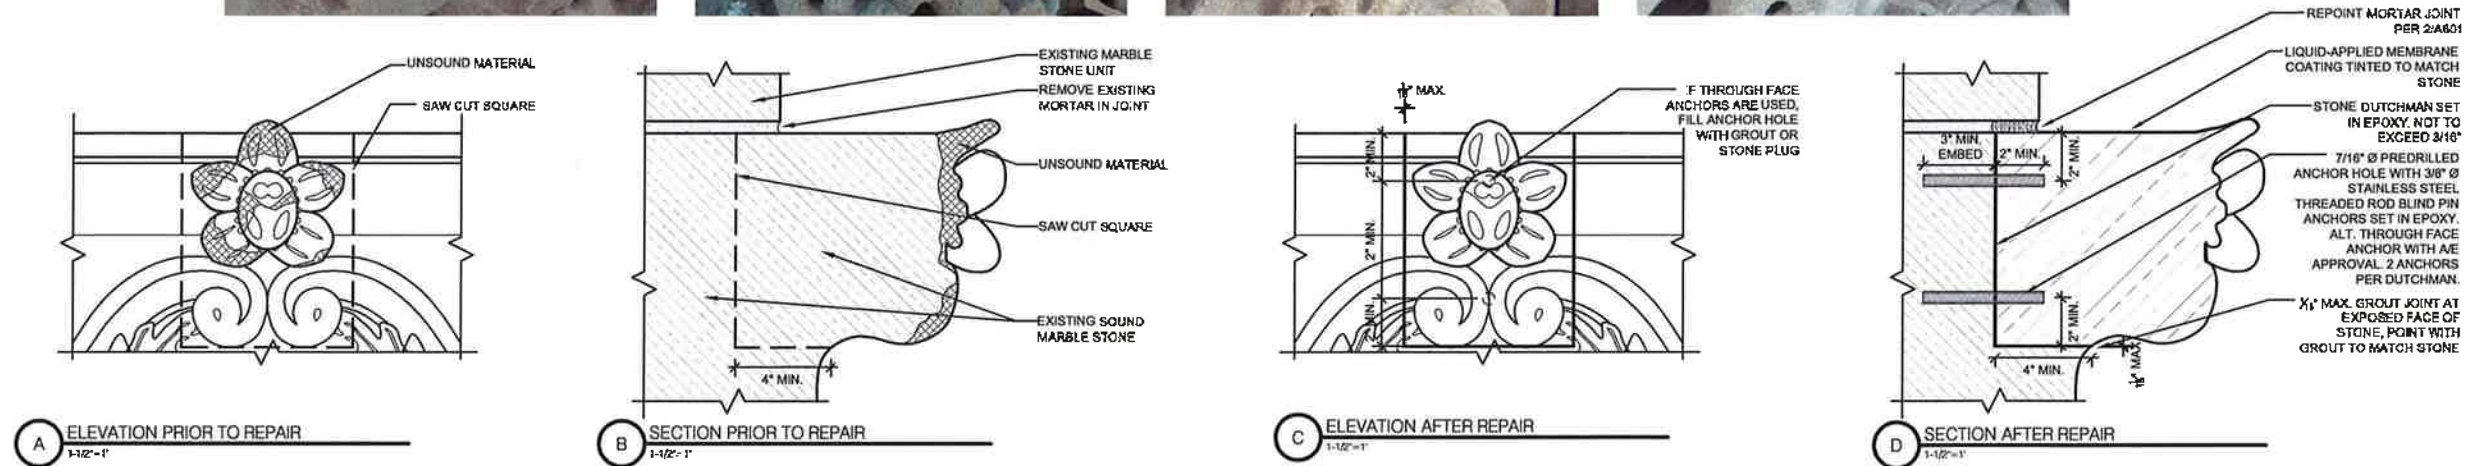
A27 REPAIRS AT COLUMN OR PILASTER CAPITAL FLEURON
NTS

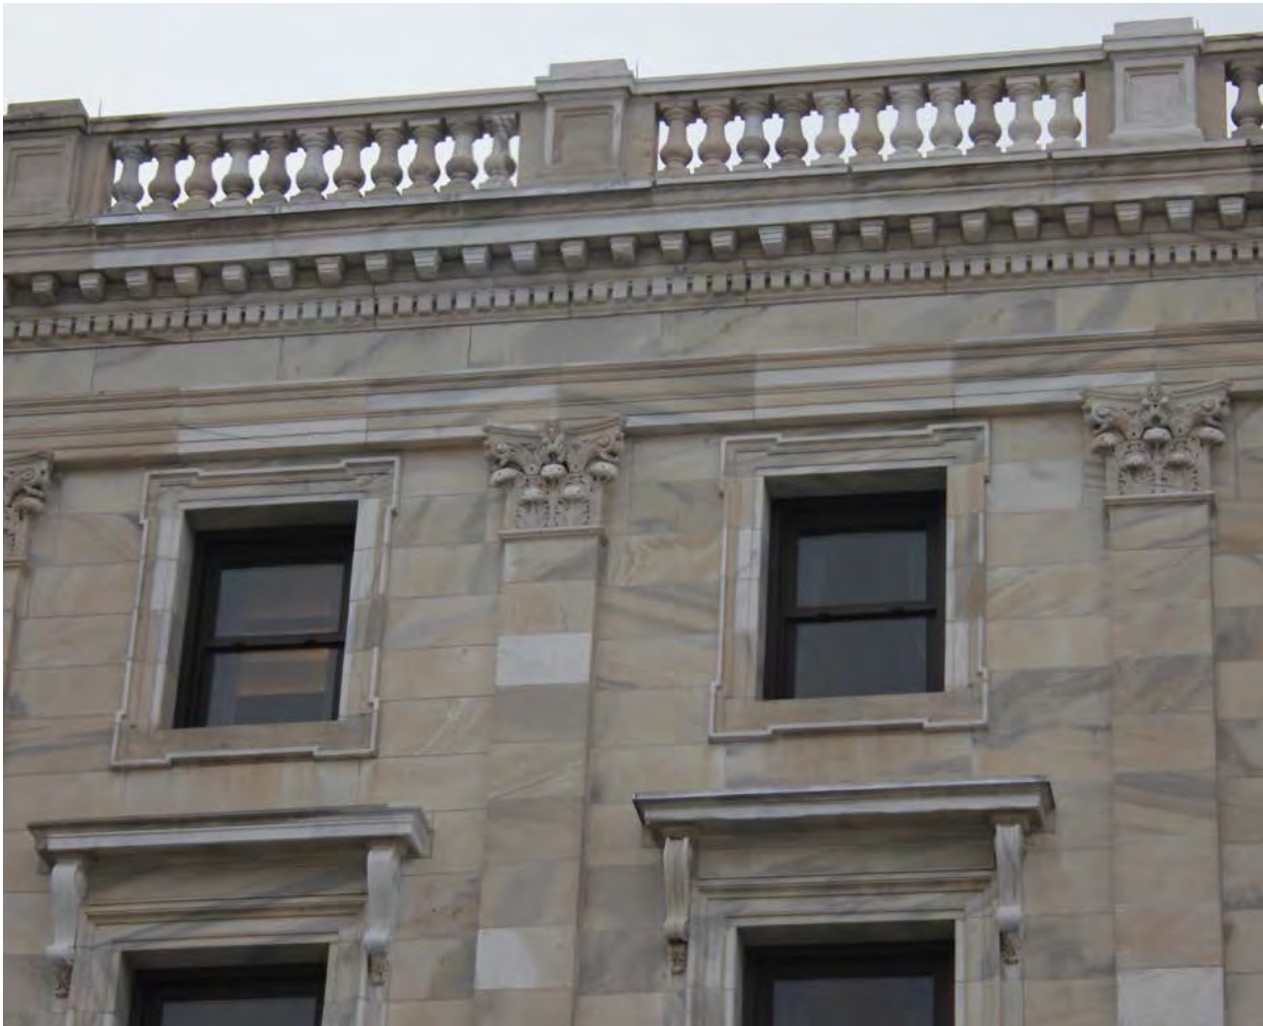
Fig. 34. West wing, north facade following trial phase, viewed from the parking lot.

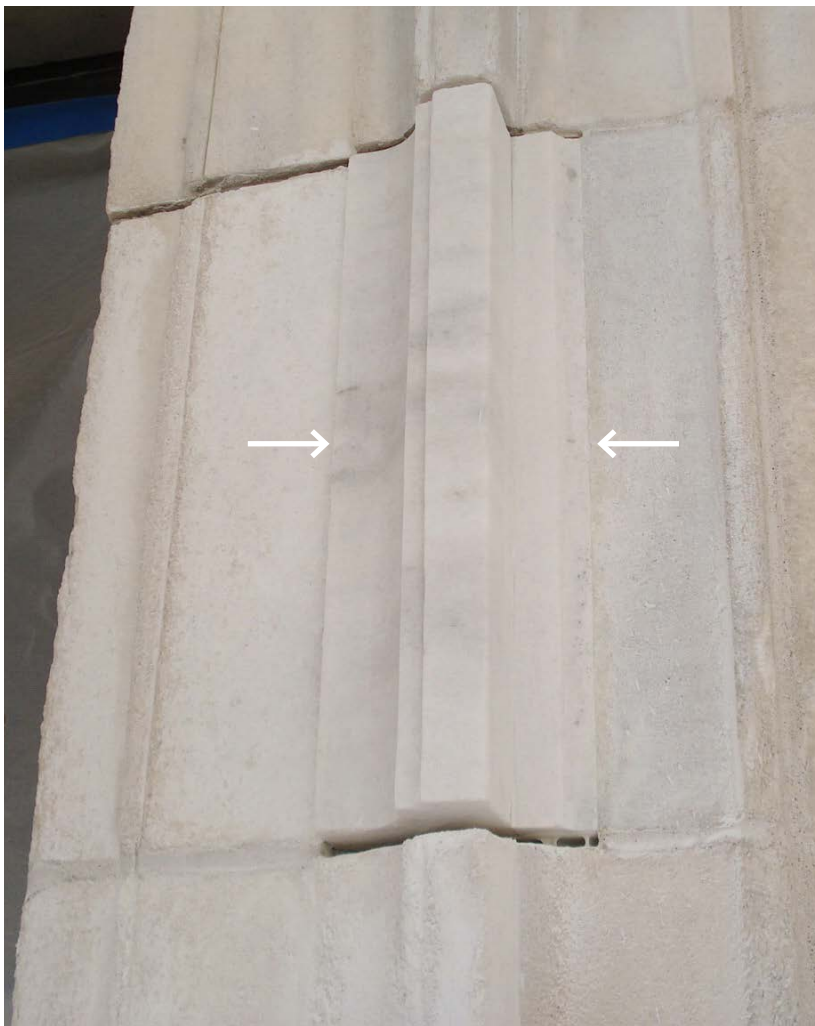
Fig. 36 (top left). Dutchman repair at window surround. New white Georgia marble (between arrows) blends seamlessly with historic material. The existing condition prior to repair is shown below (Fig. 37)

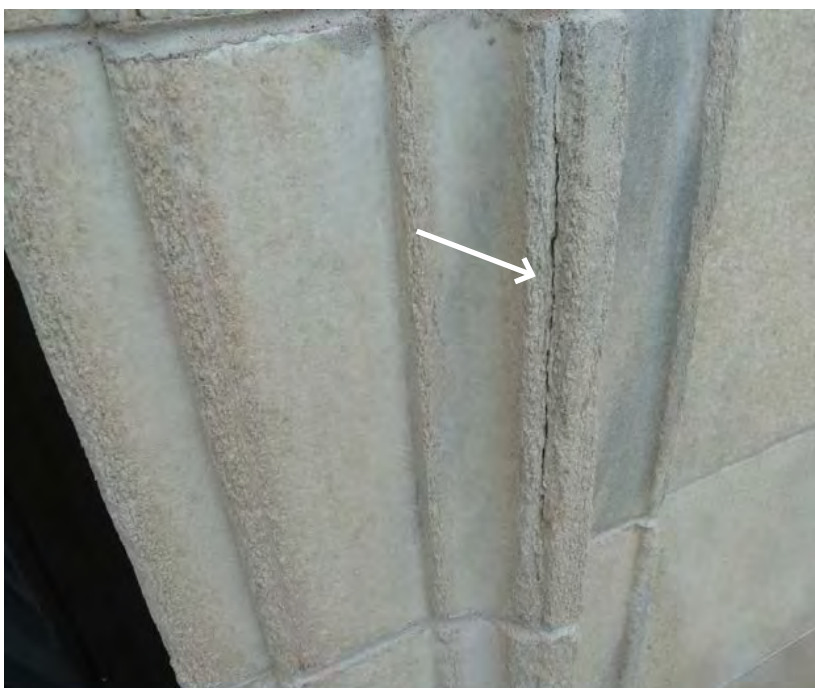
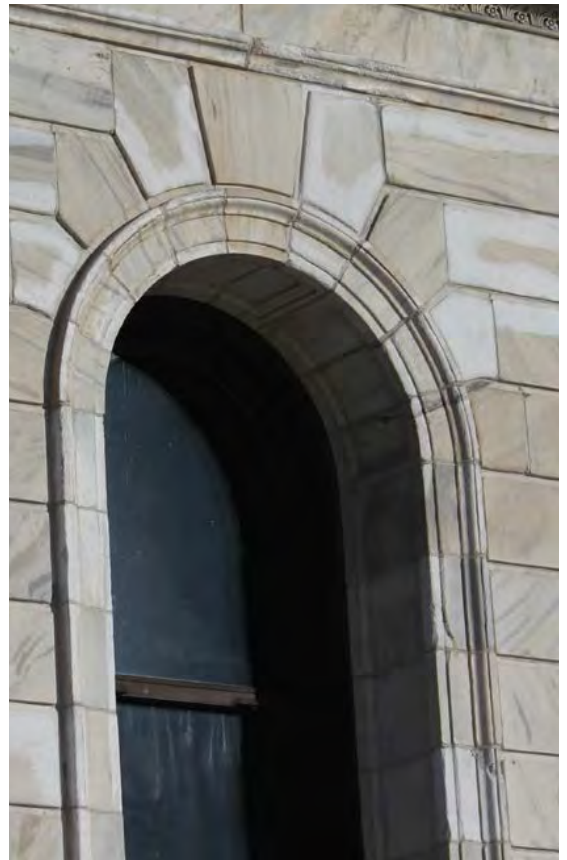
- Where general repair is not practical due to the level of decay, or for situations where significant loss of historic detail has occurred, limited replacement using new stone to match the original was explored. Replacement is a more viable option now that compatible stone resources have been made available. Furthermore, the team of master stone carvers and masons that has been assembled will execute replacement repairs using tools and techniques that are much the same as those employed a hundred years ago.

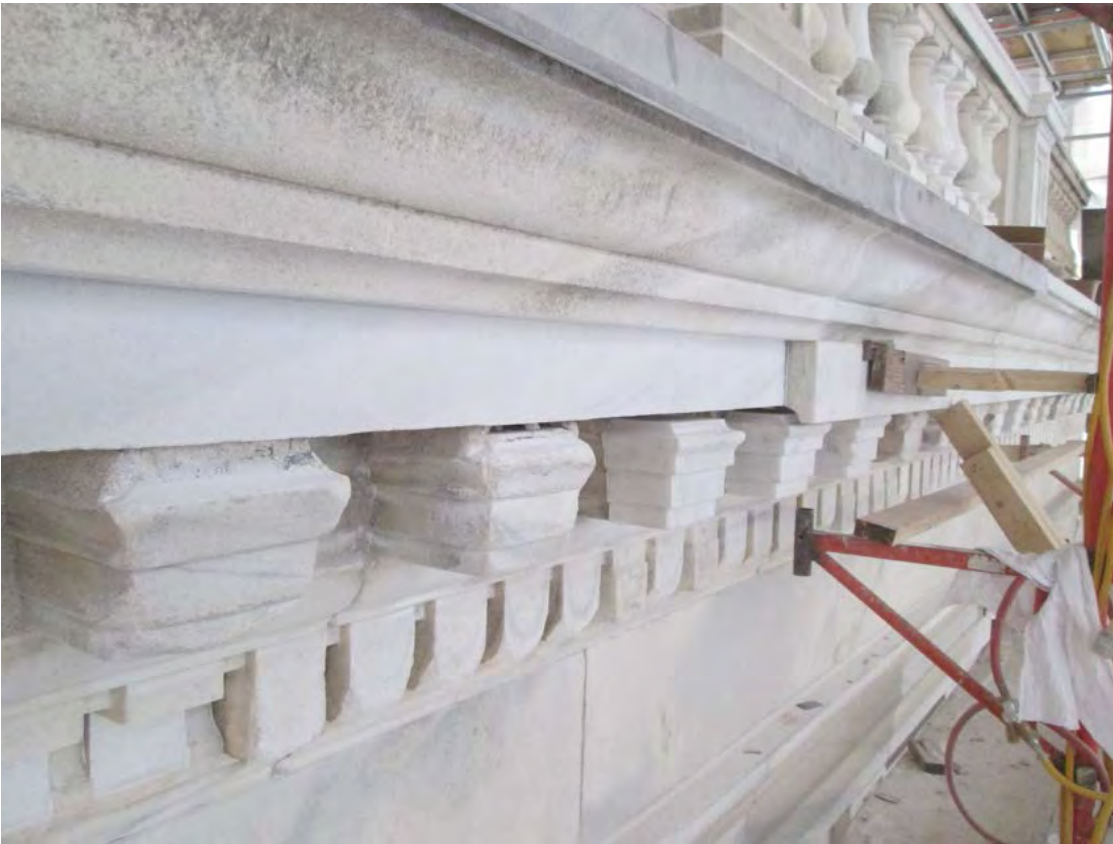
Fig. 39 (top). Dutchman repair at cornice drip edge and modillion blocks.

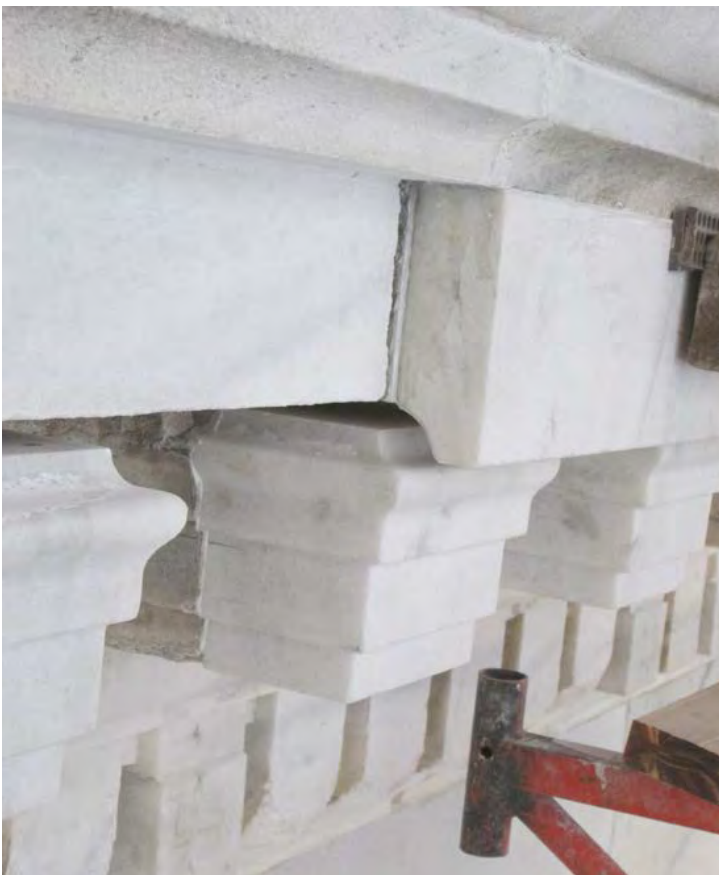
Fig. 40. Close up of fascia drip edge dutchman repair showing overlapping material. Construction sequencing can complicate future repairs.

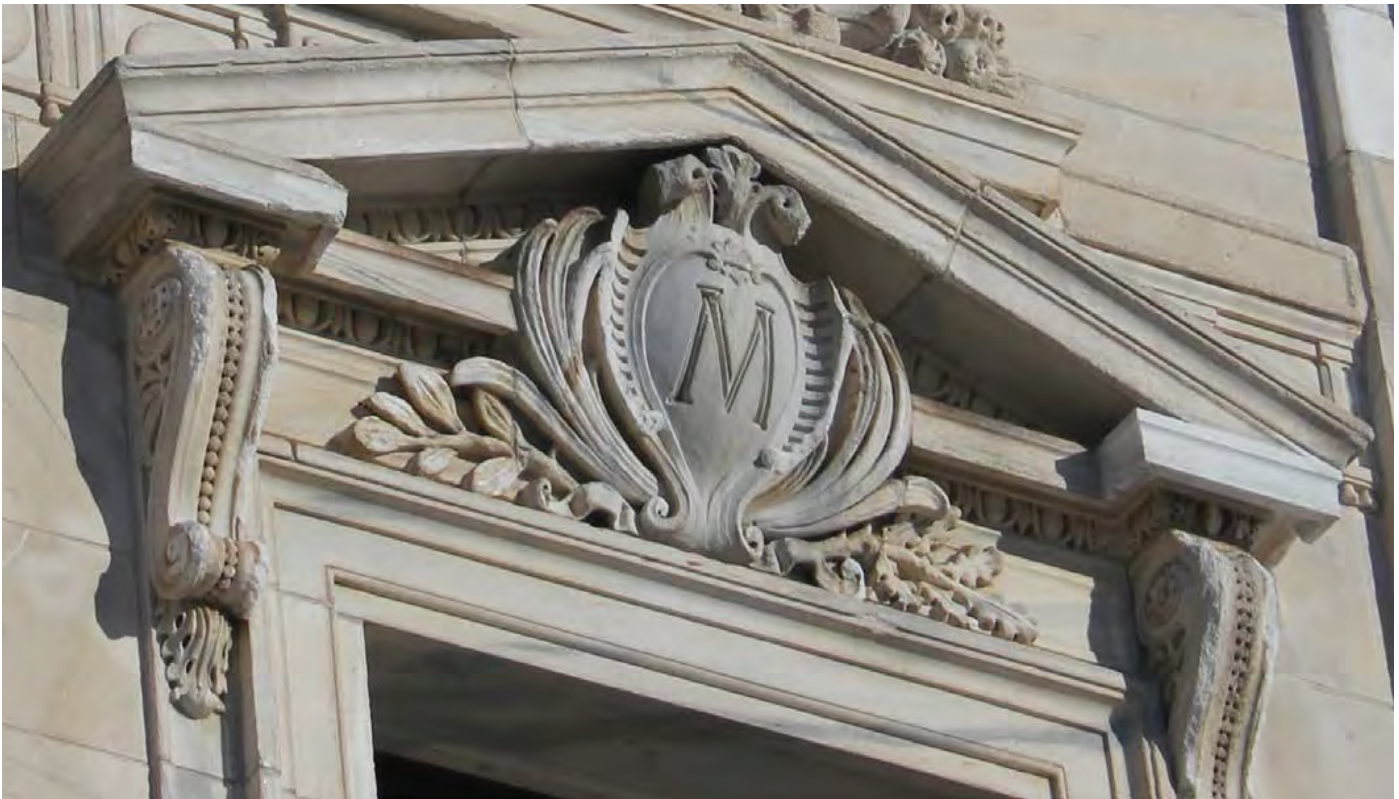
Fig. 41. East elevator tower gabled window hood and cartouche. The hood return on the right was repaired with new stone. Removal of unsound material on the left gable return results in irregular profiles and eroded corners. The cartouche and surrounding detail was lightly ground and smoothed. Unsound material was removed from both scrolled brackets.

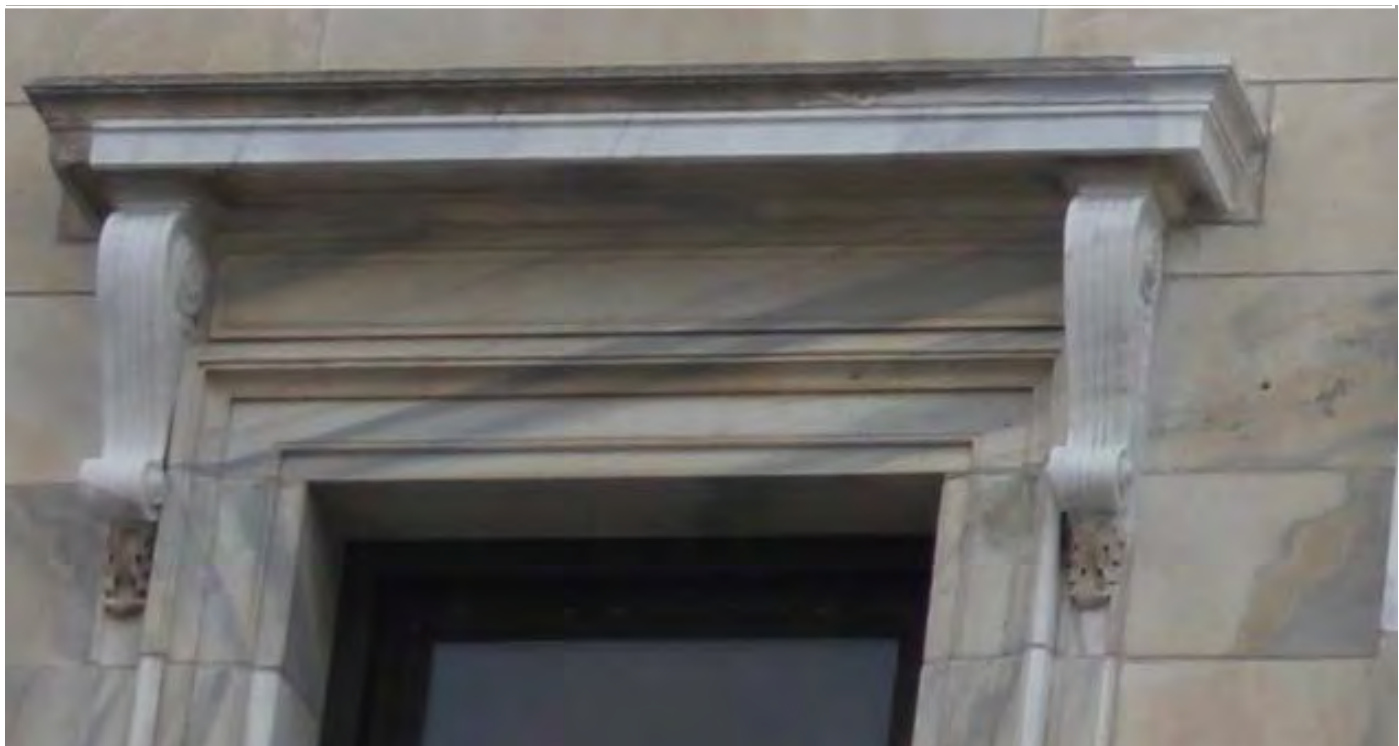
Fig. 42. West wing, north facade window hood. Severely deteriorated scrolled brackets were replaced with new stone. The ledge corner on the right (removed to mitigate a potential safety hazard) was repaired with a new stone dutchman. The front drip edge is also a dutchman repair. The left corner and wash ledge show the existing condition prior to repair.

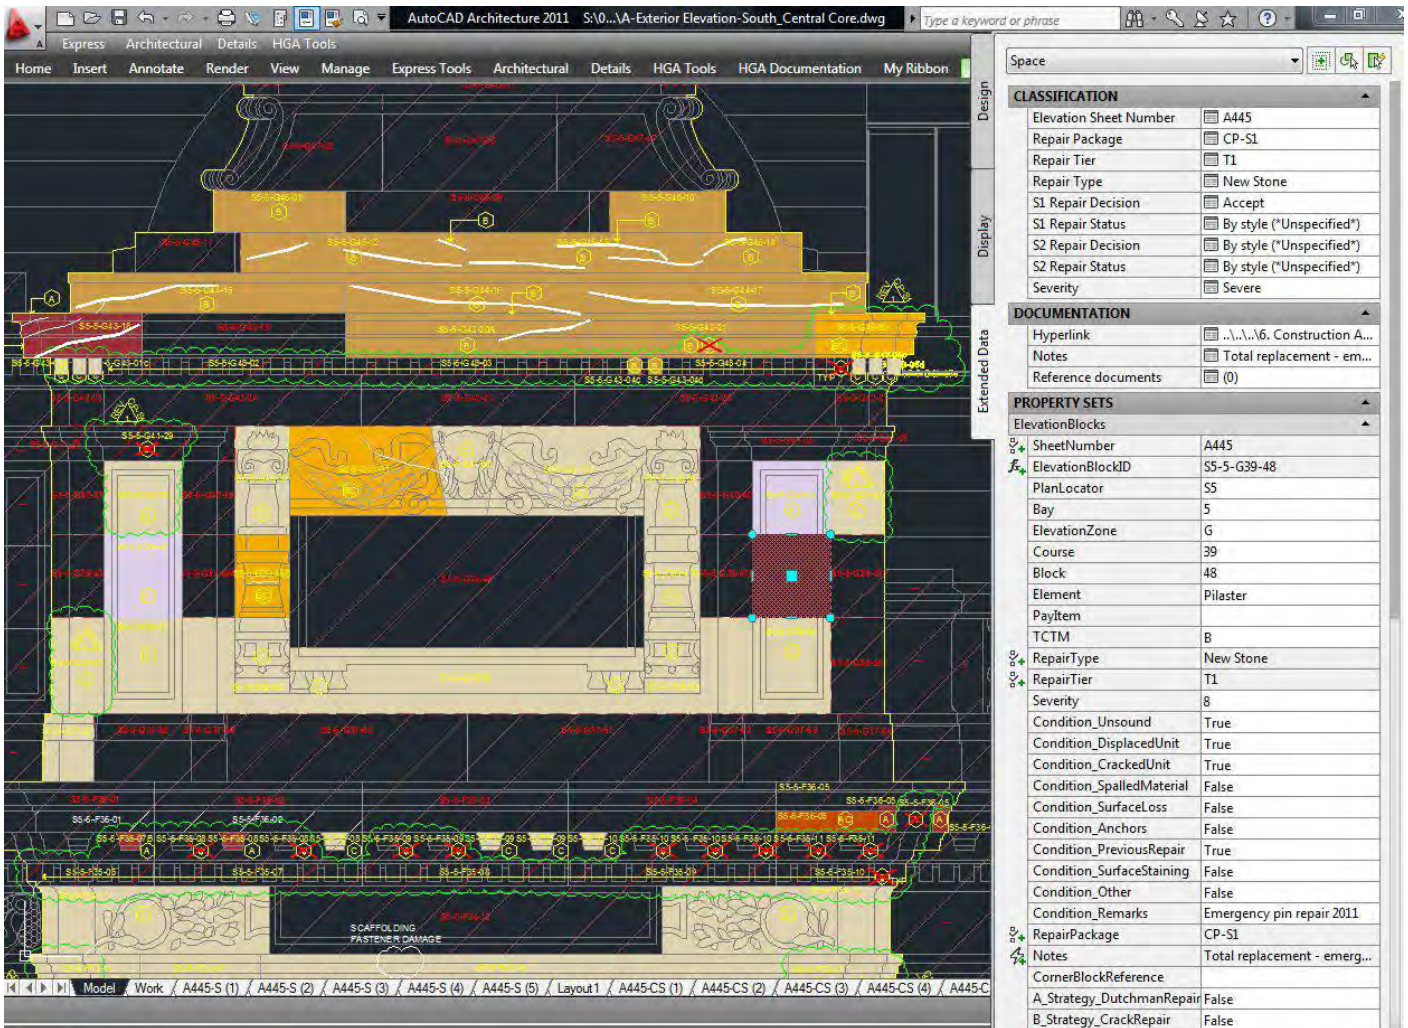
Fig. 44. Screen capture of customized CAAD database used to generate the Construction Documents.

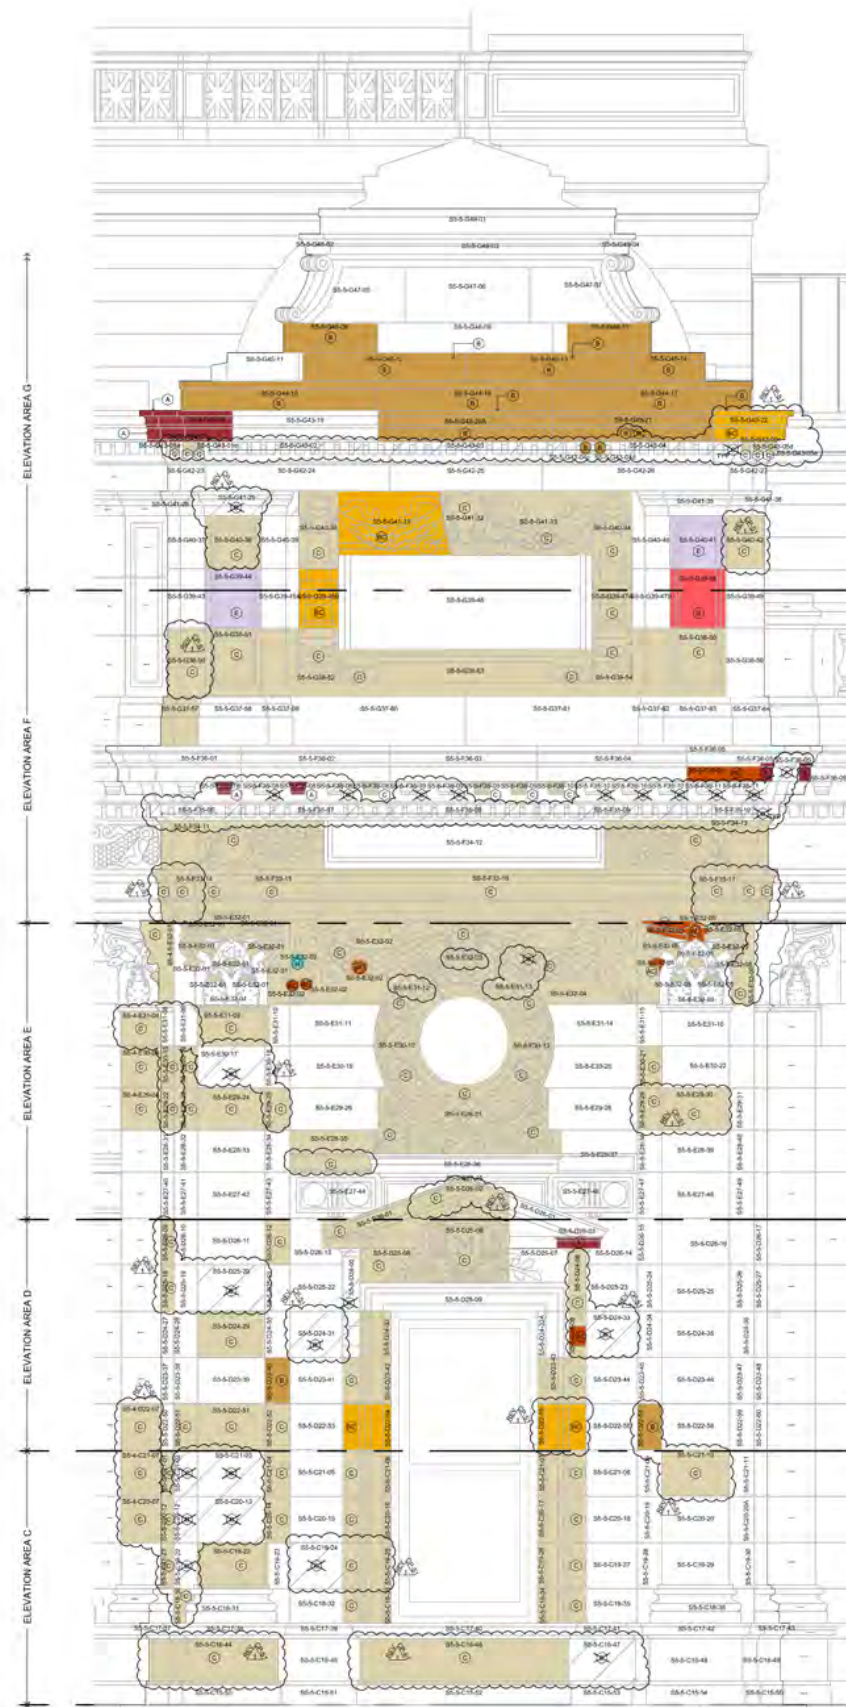
1 EAST ELEVATOR TOWER SOUTH ELEVATION BAY S5-5, SECTIONS C THROUGH G
