Minnesota State Capitol
Exterior Stone Repair Project
Stone Repair Trials Evaluation and
Preliminary Preservation Planning

May 10, 2013

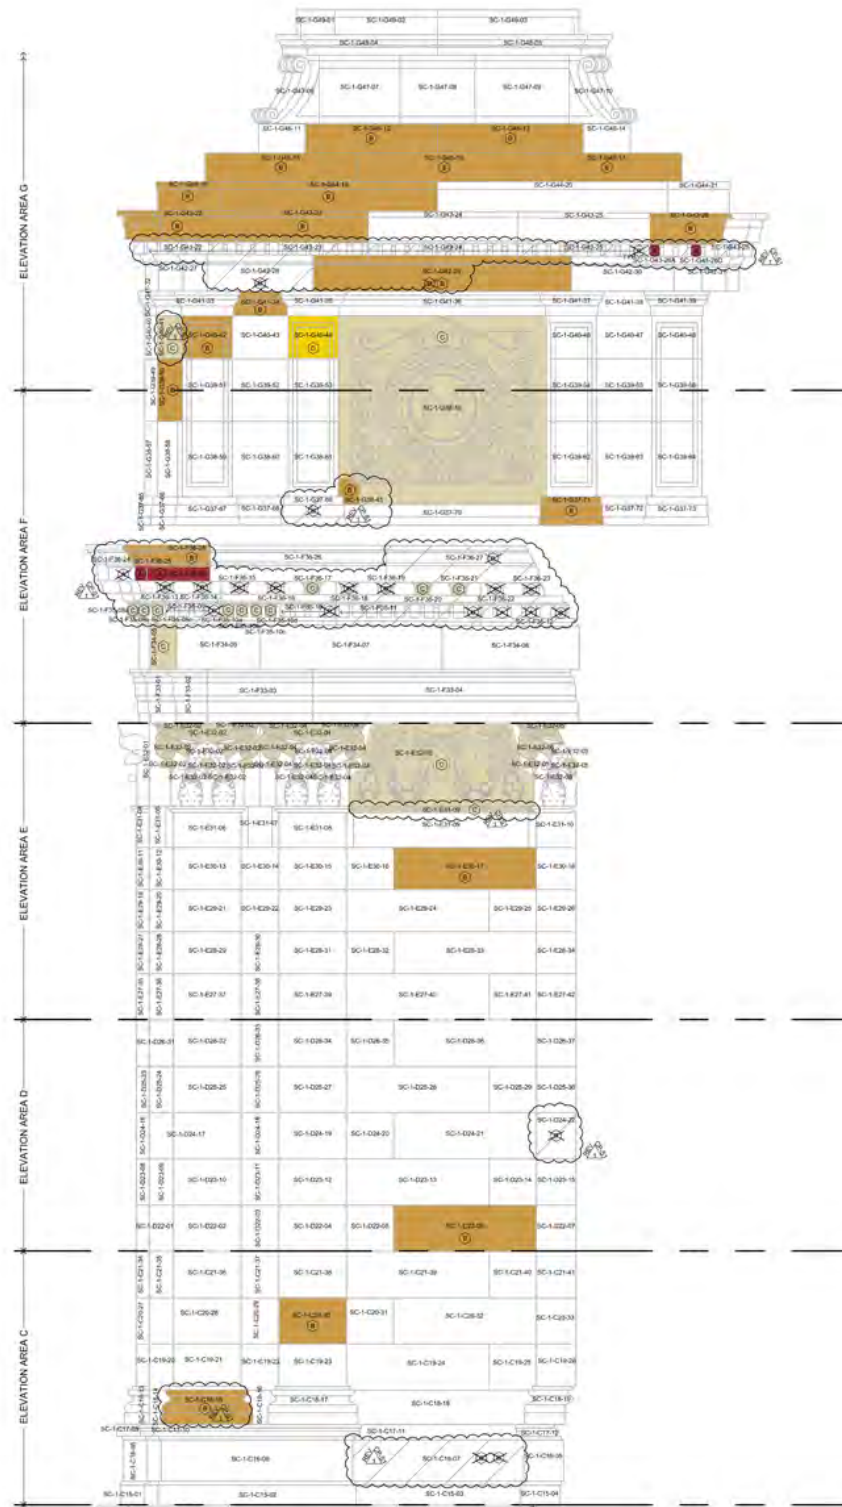
2 EAST ELEVATOR TOWER EAST ELEVATION BAY SC, SECTIONS C THROUGH G

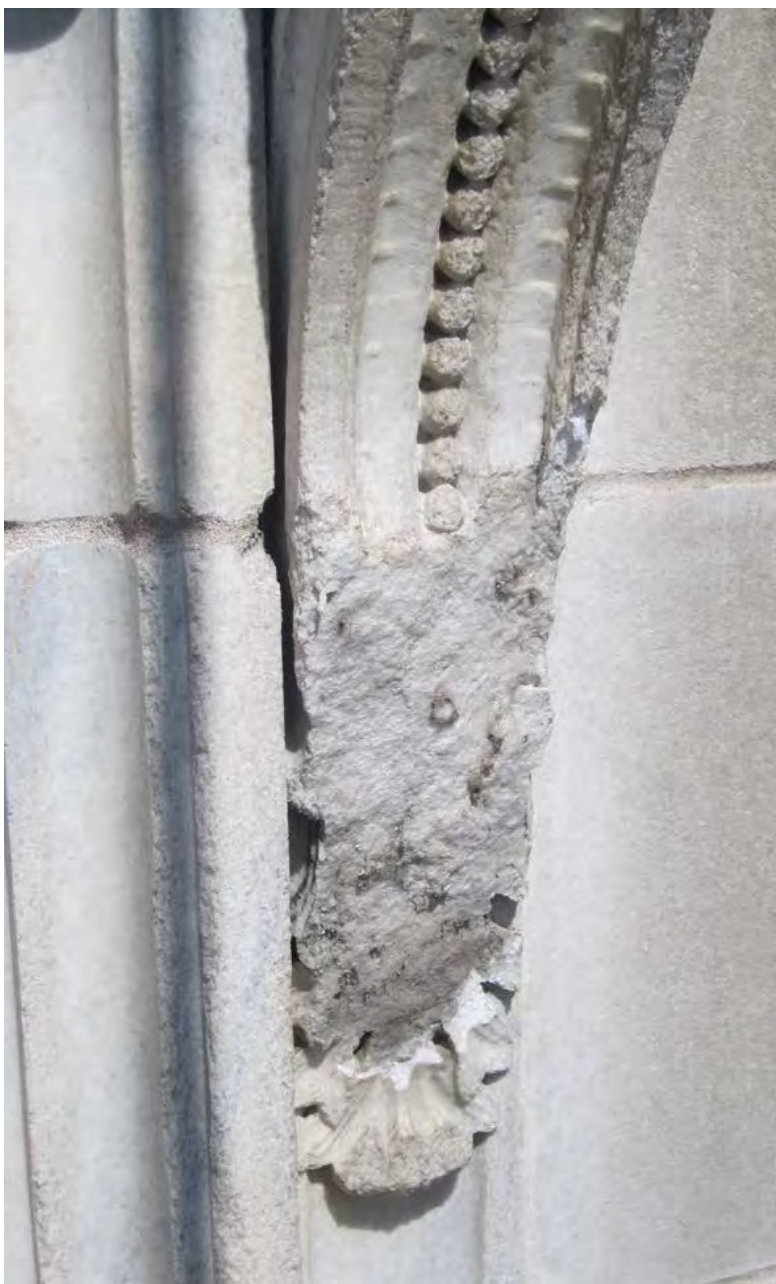
Fig. 46 (above). Window hood bracket (west wing, south pavilion) outside of Governor's reception area. Condition following removal of cracked lower scroll. Tier 1 and Tier 2 level work scope does not include additional repair. This condition would remain as is unless Tier 3 level repairs are implemented.

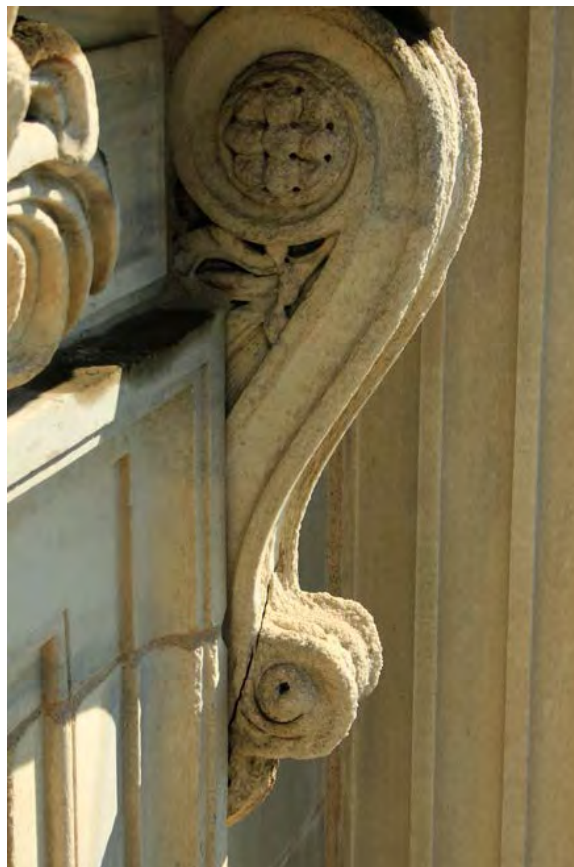
Fig. 45. Window hood bracket (west wing, south pavilion) outside of Governor's reception area. The cracked lower scroll, a Tier 1 priority repair, was removed by hand in 2010. Removed material was too unstable to reinstall.

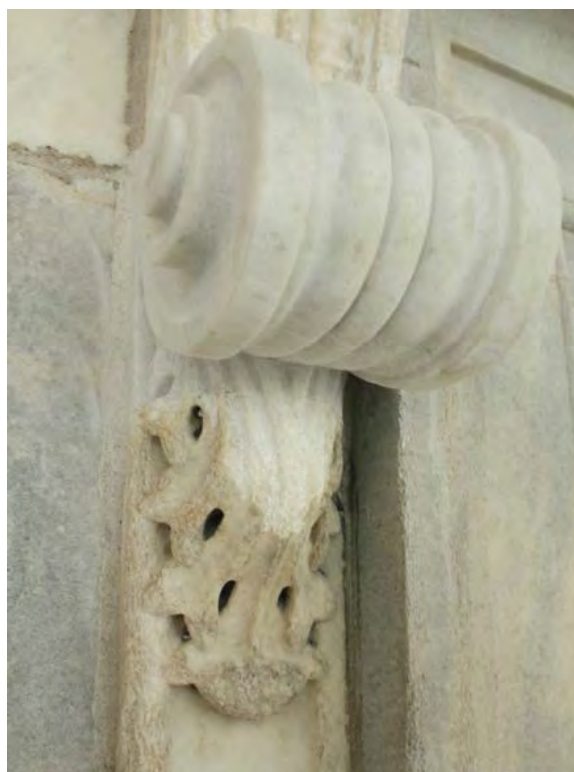
REPAIR STRATEGY COMPARISON

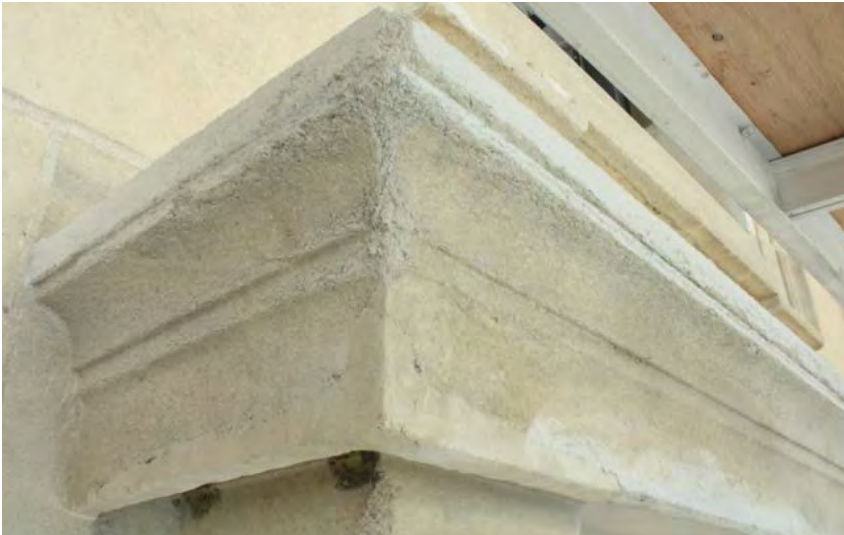
Fig. 48. Second floor window hood (west wing, south). Existing condition showing previous repair with patching material at the corner and fascia drip edge. Patching material was found to be consistently unsound and has since been removed.

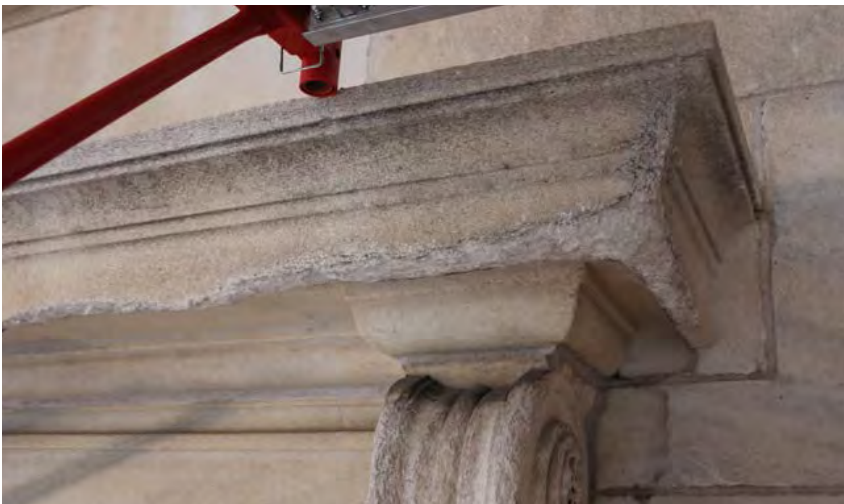
Fig. 49. Second floor window hood (west wing, south). Condition following removal of unstable patching material at the corner and fascia drip edge. Water shedding capabilities of severely degraded drip edges are significantly reduced. Diminished function puts adjacent material, in this case the bracket scroll, at higher risk for accelerated damage due to water runoff.

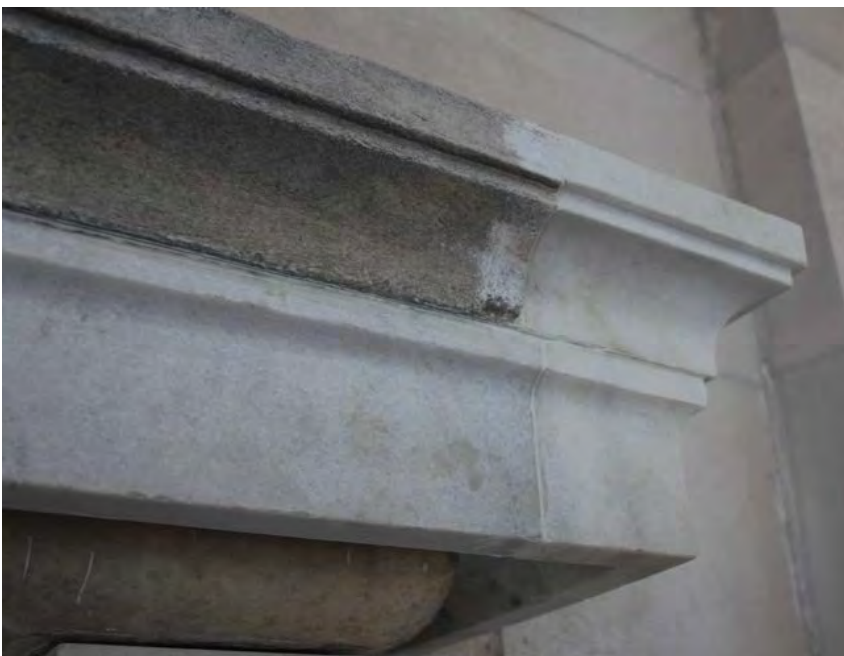
Fig. 50. Second floor window hood (west wing, north). Unstable material at the corner wash ledge and severely deteriorated material at the fascia drip edge were removed and replaced with new stone as part of the trial phase. Function is fully restored.

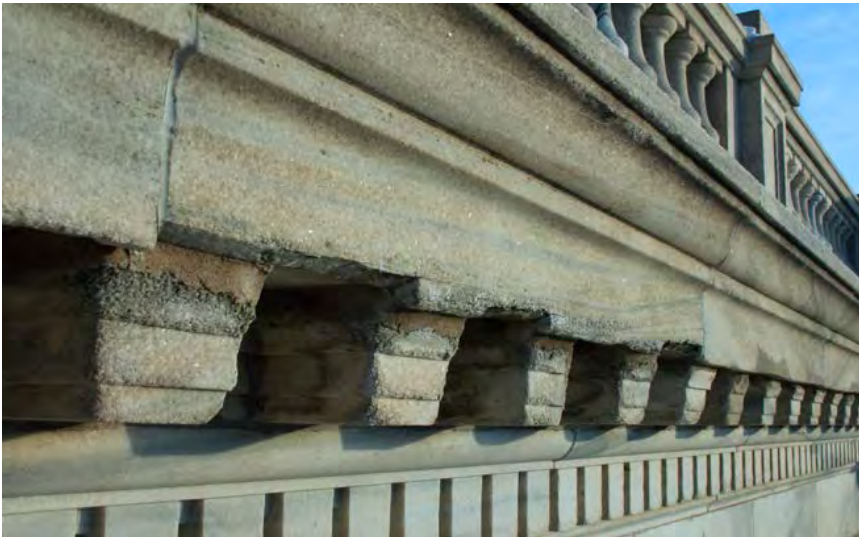
Fig. 51. Cornice (east wing, south). Unstable material at the fascia drip edge was removed during the investigative phases to mitigate life safety concerns. Water shedding capabilities of the drip edge are compromised.

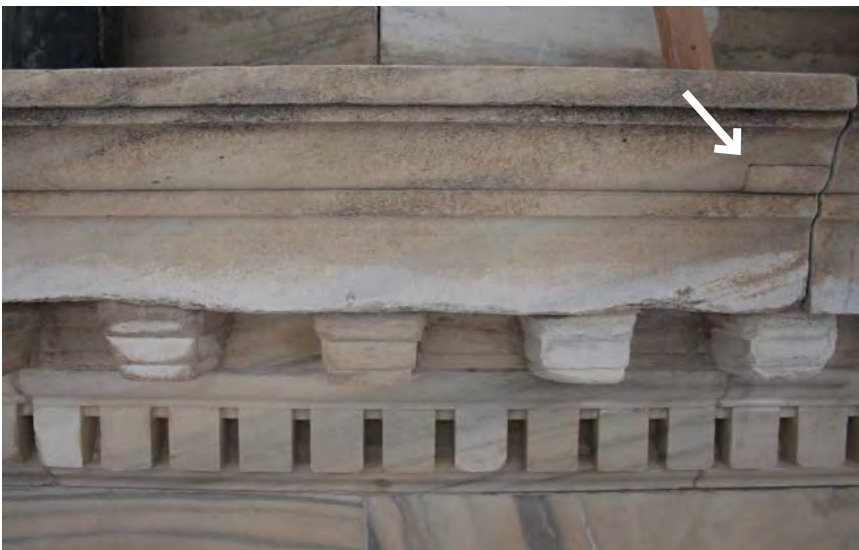
Fig. 52. Cornice (west wing, south). Unstable material at the fascia drip edge, removed during the investigative phases to mitigate life safety concerns, has been ground smooth to improve water-shedding capabilities. Decayed and weathered material remains in place and will continue to deteriorate over time.

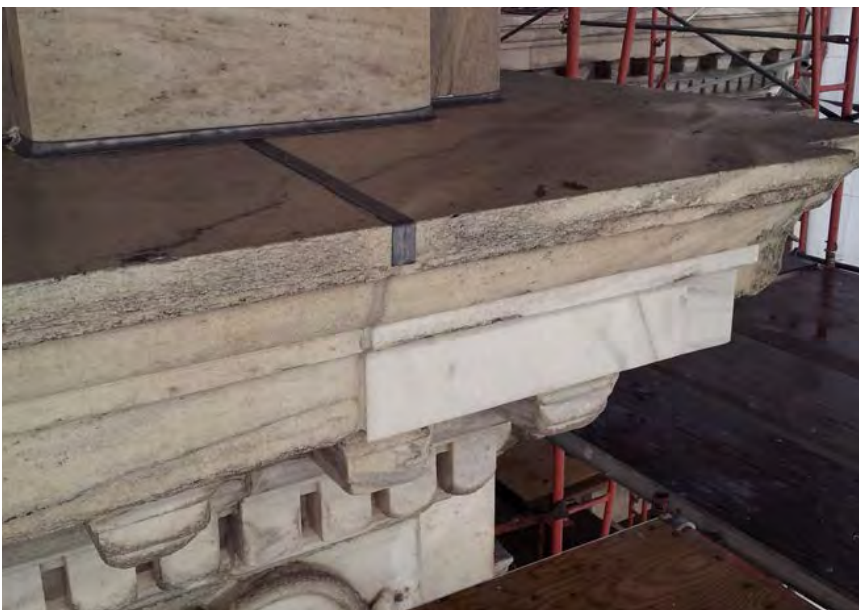
Fig. 53. Cornice (east elevator, southeast corner). Unstable material at the fascia drip edge was replaced during the repair trials to demonstrate restored water-shedding functionality.

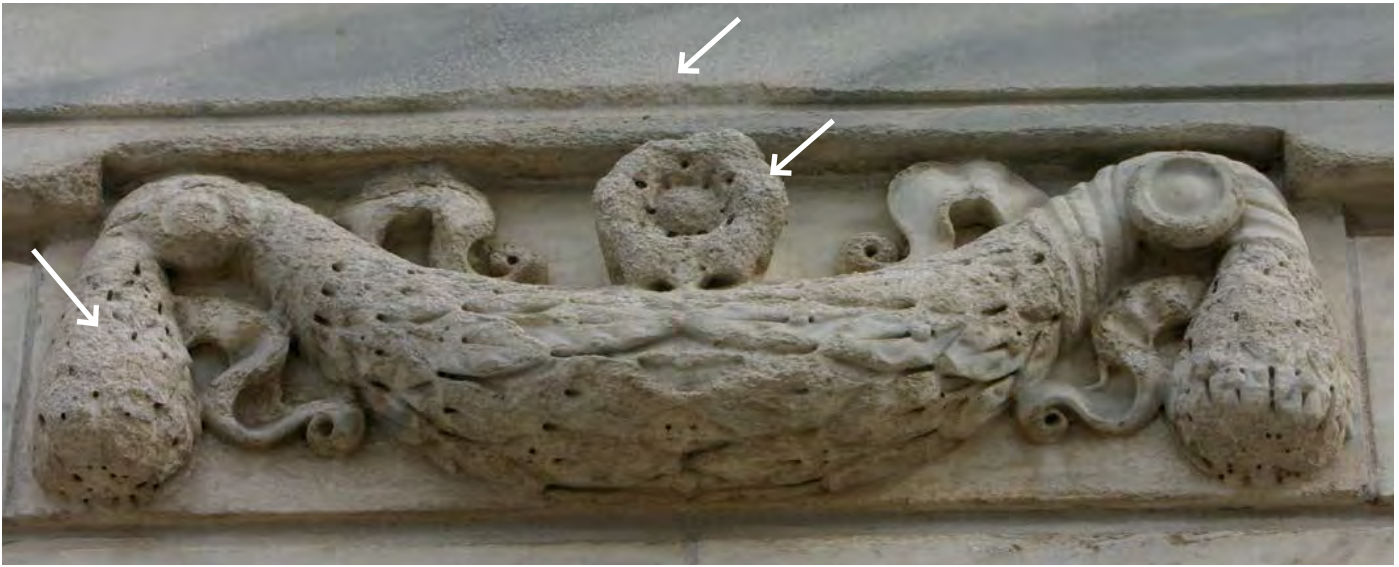
Fig. 54. Eroded detail at main (south) entry.

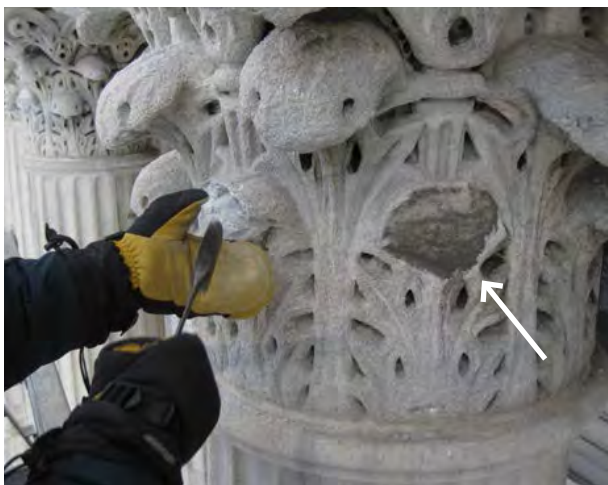
Fig. 55. Missing material at west entry loggia column.

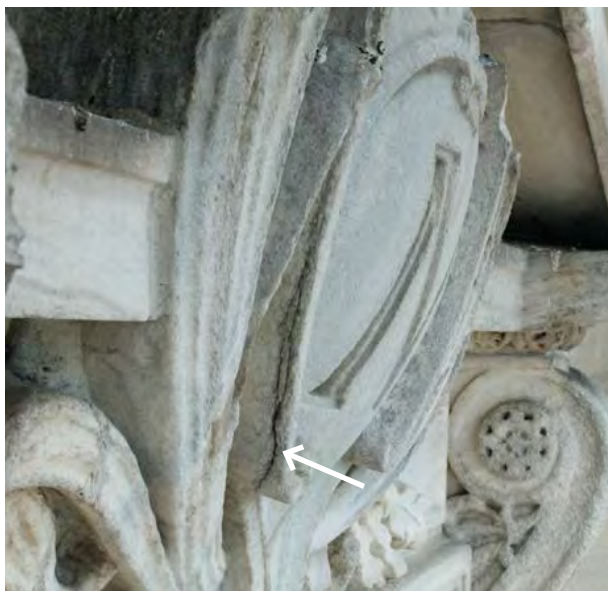
Fig. 56. Cracked east elevator cartouche

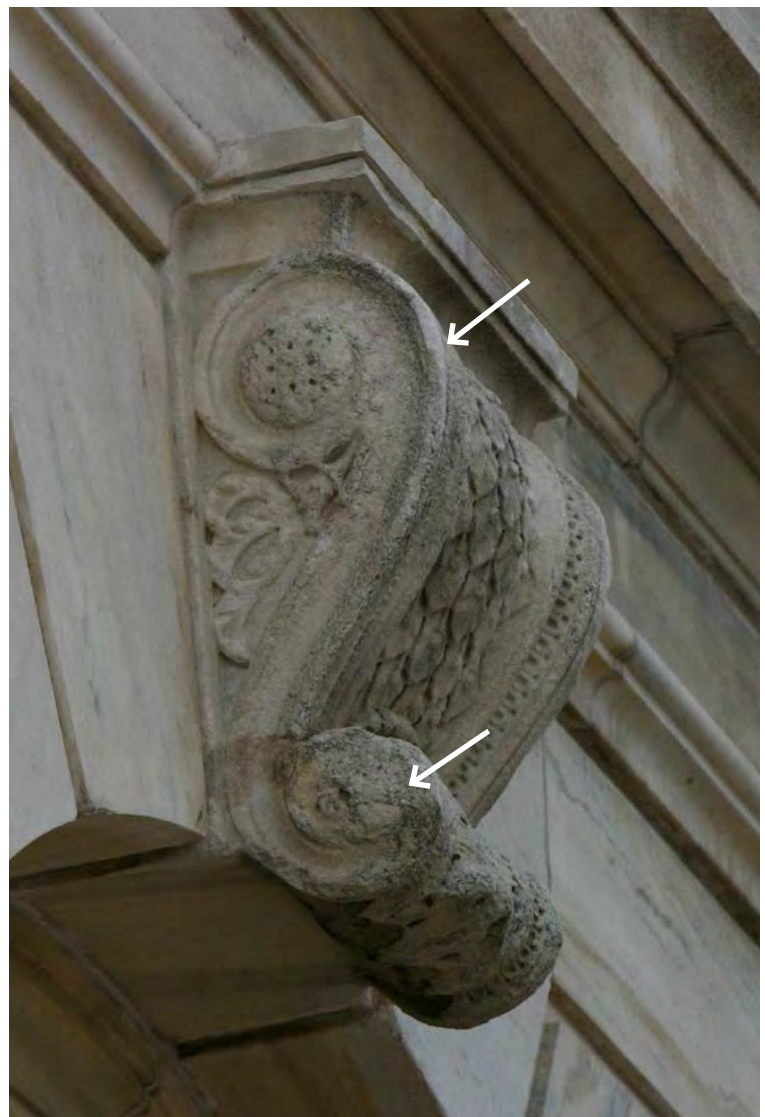
Fig. 57. Eroded detail at north entry arch keystone.

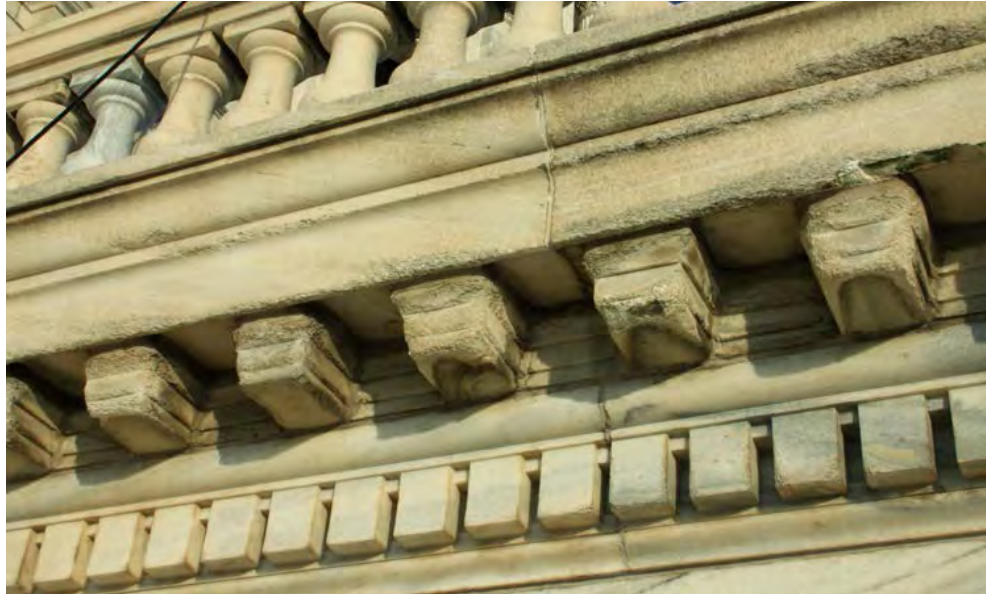
Fig. 59 (below): An unstable modillion block has been removed to mitigate a potential life safety hazard. The existing condition would remain as shown at either Tier 1 or Tier 2 level of repair. Replacement of missing material to restore character occurs as a Tier 3 level repair.

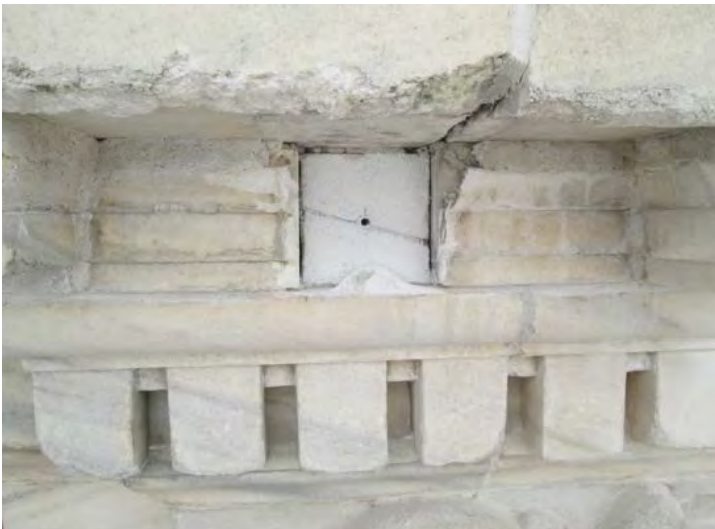
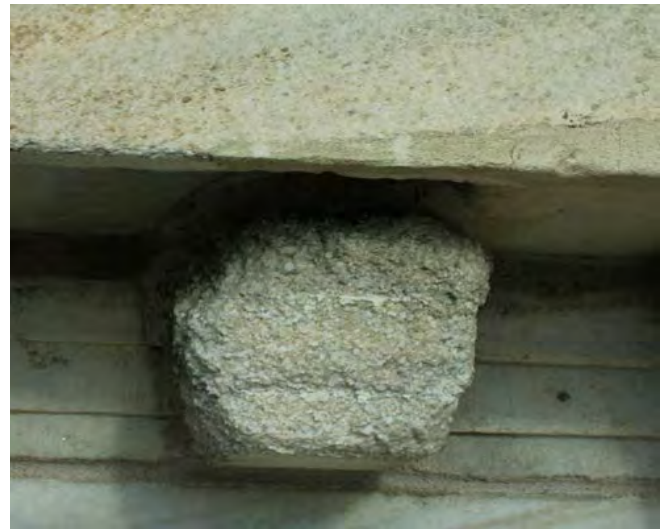
Fig. 60 (above): This modillion block, although demonstrating extreme loss of detail, is structurally sound. Not currently considered a hazard, the existing condition would remain as shown at either Tier 1 or Tier 2 level of repair. Replacement of deteriorated material to restore character occurs as a Tier 3 level repair.

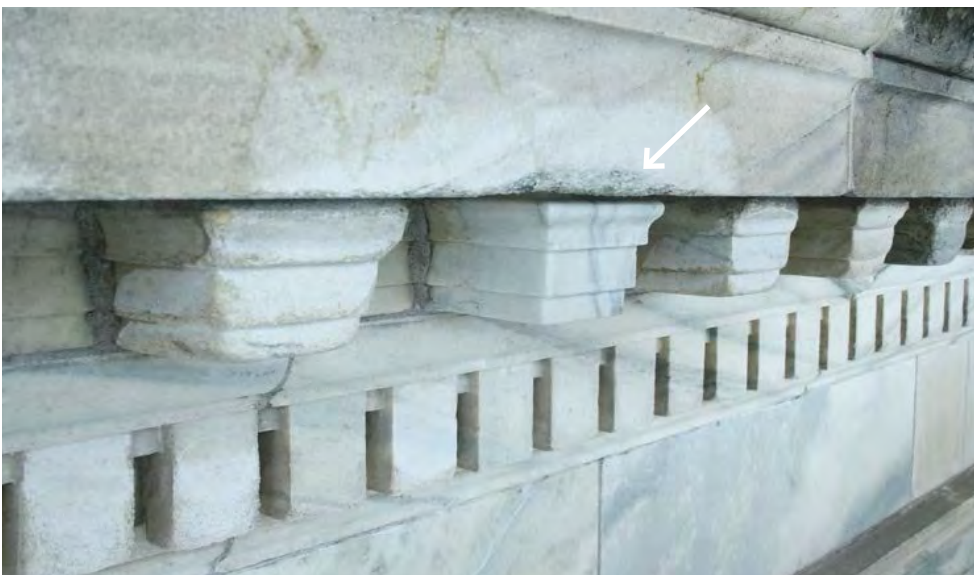
Fig. 61 (left): At repair Tier 3, significant character defining features and compromised water-shedding features are replaced. Sound historic material still capable of conveying historic character remains. Although not repaired in the trial phase, deterioration along the drip edge (arrow), would likely trigger replacement as a Tier 3 repair.

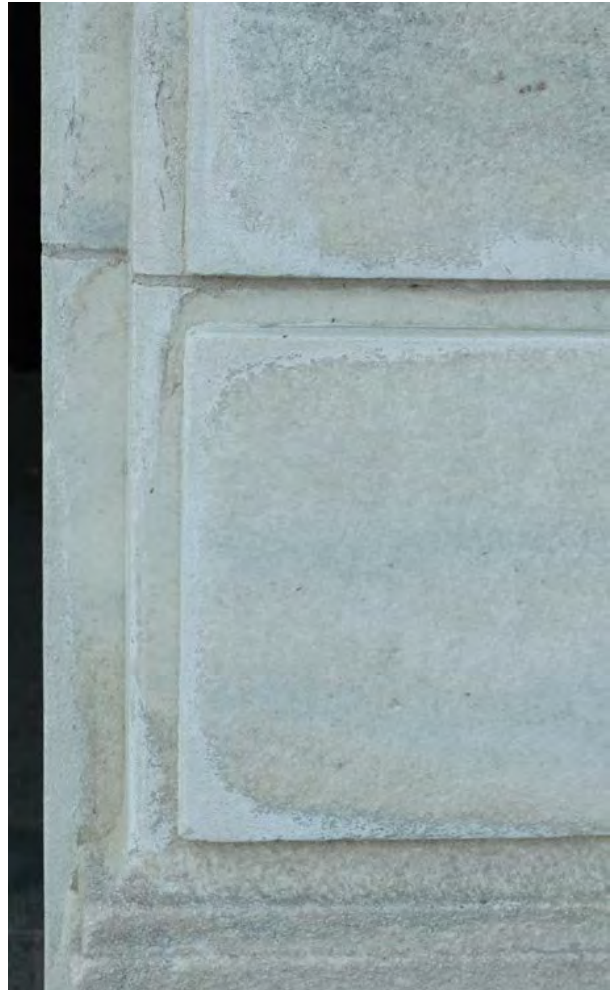
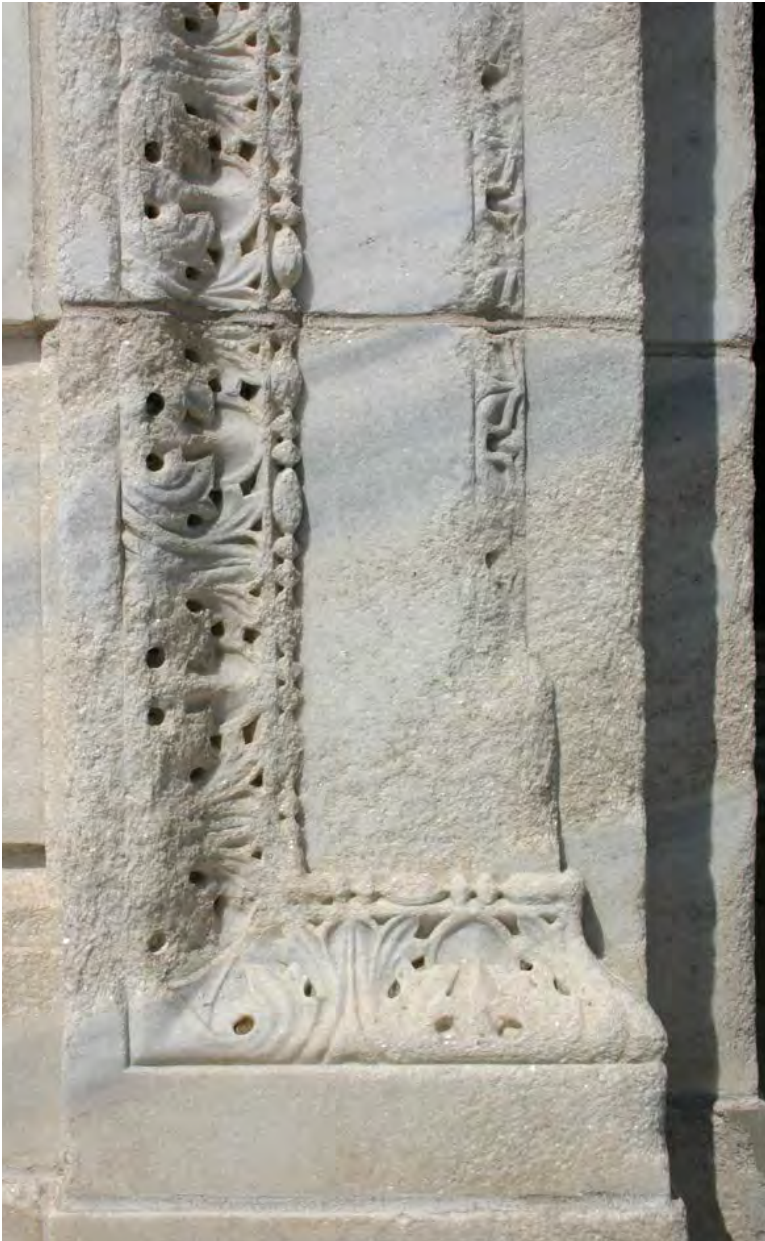
Fig. 63 (above): Typical portal jamb (south entry). Erosion of detail is extensive at the south entry. Replacement required to restore deteriorated material at this level would be extensive.

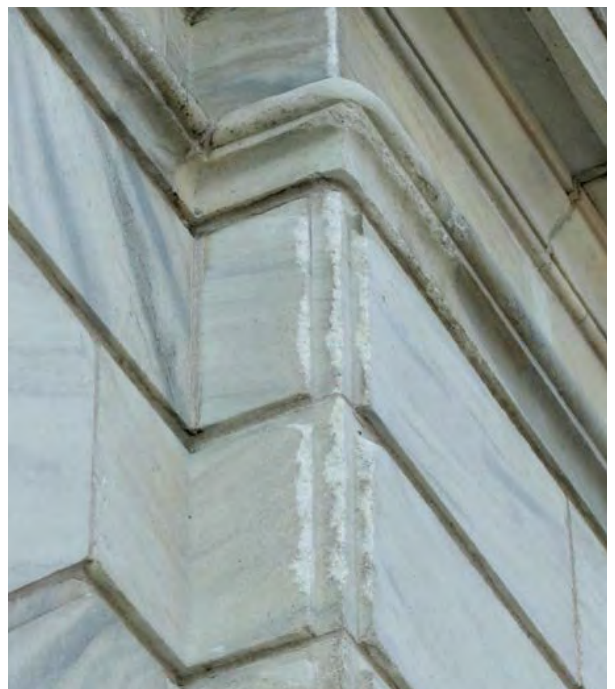
Tier 4 (T4) Restoration / Reconstruction. The strategy for repair at this level is to remove all deteriorated material. To maximize long-term durability, replacement is favored over repair. Considerably more original material would be disrupted in the process and this contradicts sound preservation practice. Not all deteriorated material can, or should be removed. Although repairs will theoretically last longer, maintenance and inspection will still be required. Tier 4 repairs, involving more extensive restoration, are beyond the scope of work anticipated for this Project but are included for reference. (Figs. 62-64)

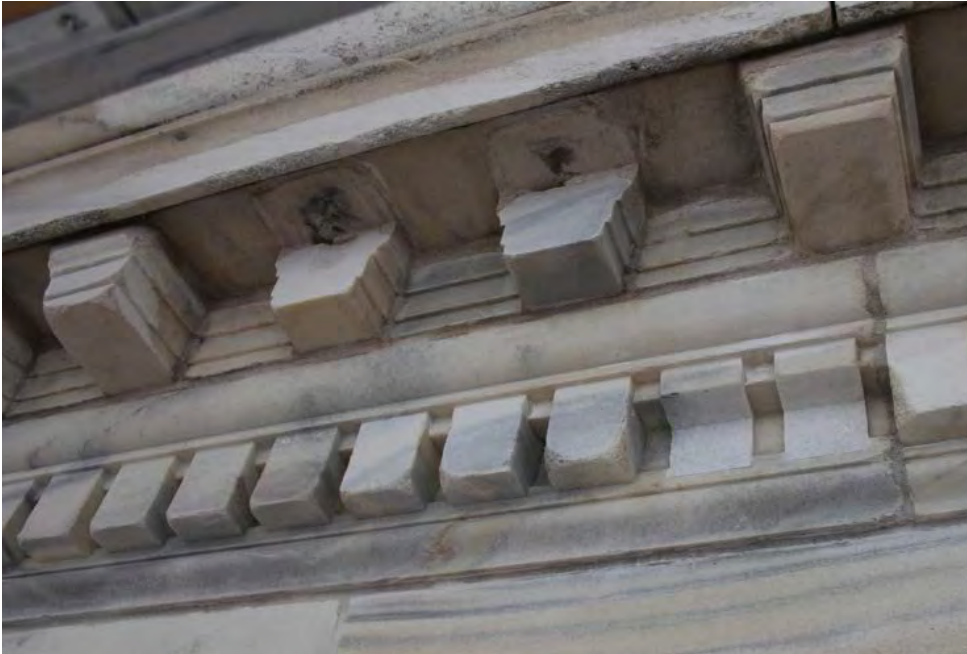
Fig. 65: Typical cornice ledge. Several unstable modillion blocks and dentils have been removed.

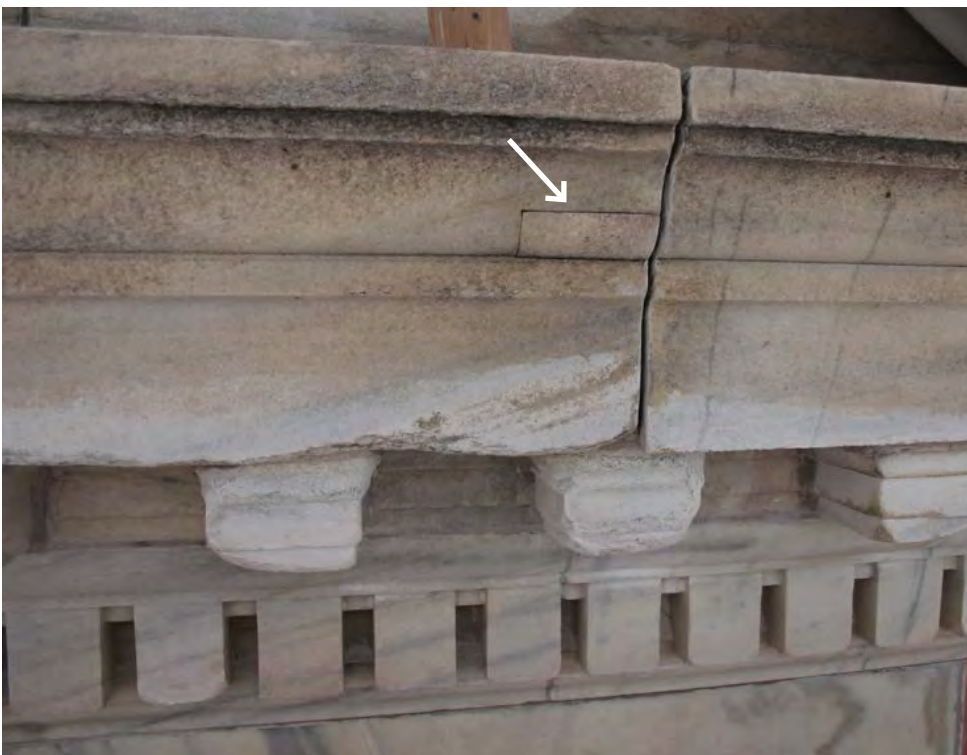
Fig. 66: Typical cornice ledge. Eroded surface material has been ground smooth to facilitate water shedding capabilities at the drip edge. Note original dutchman (arrow) which has held up extremely well for over 100 years.

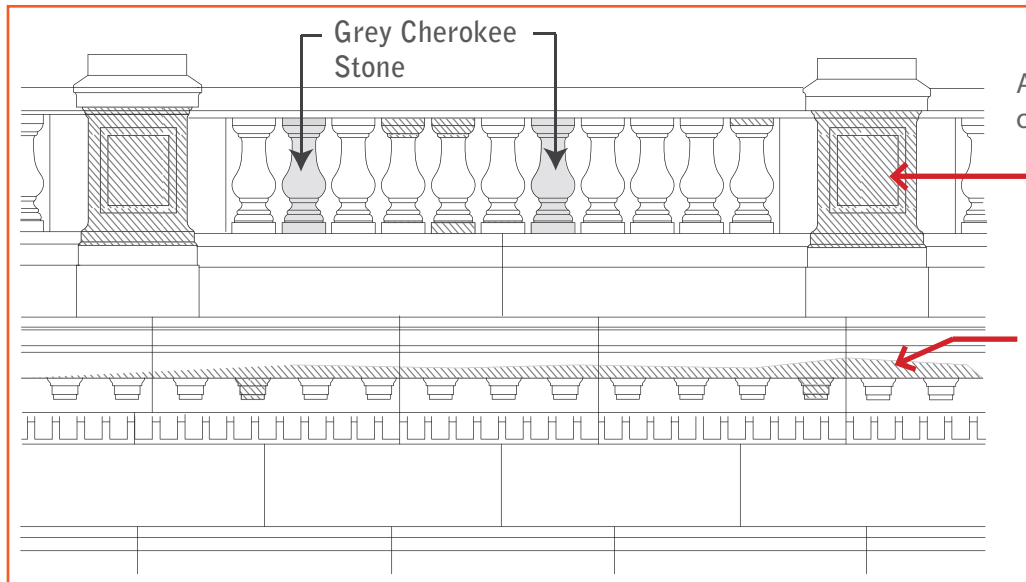
All unsound material is removed or stabilized

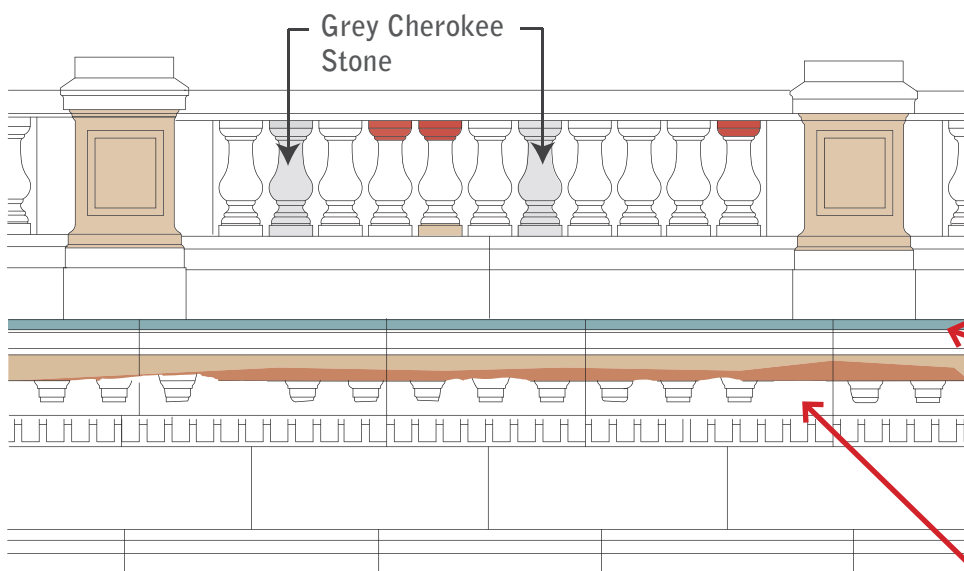
Repairs are made to reduce the potential for further water damage to stone and masonry exterior:

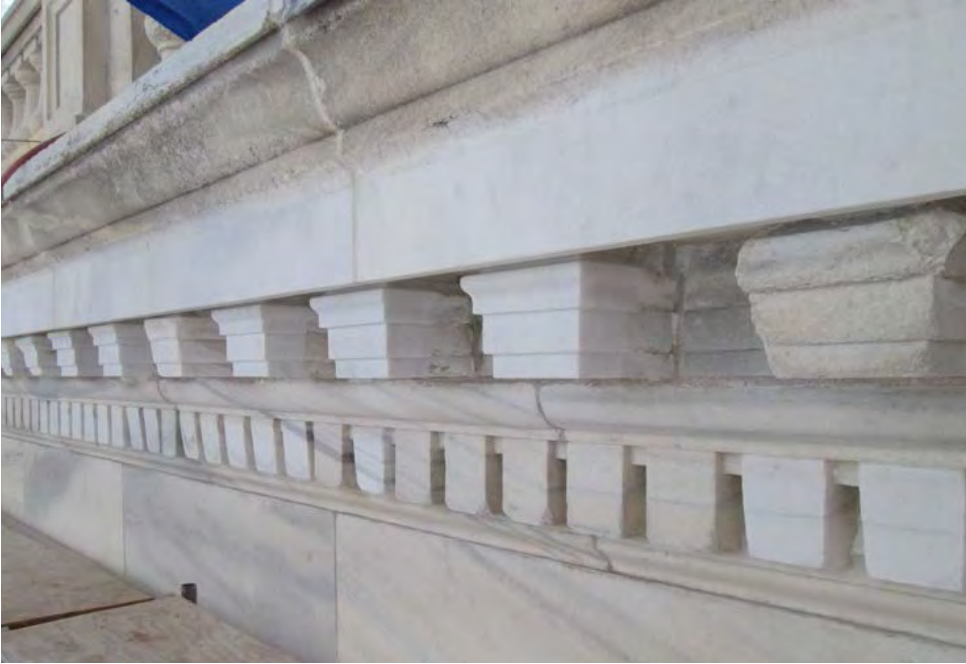
Fig. 67: Typical cornice ledge. Deteriorated material is selectively replaced with new stone.

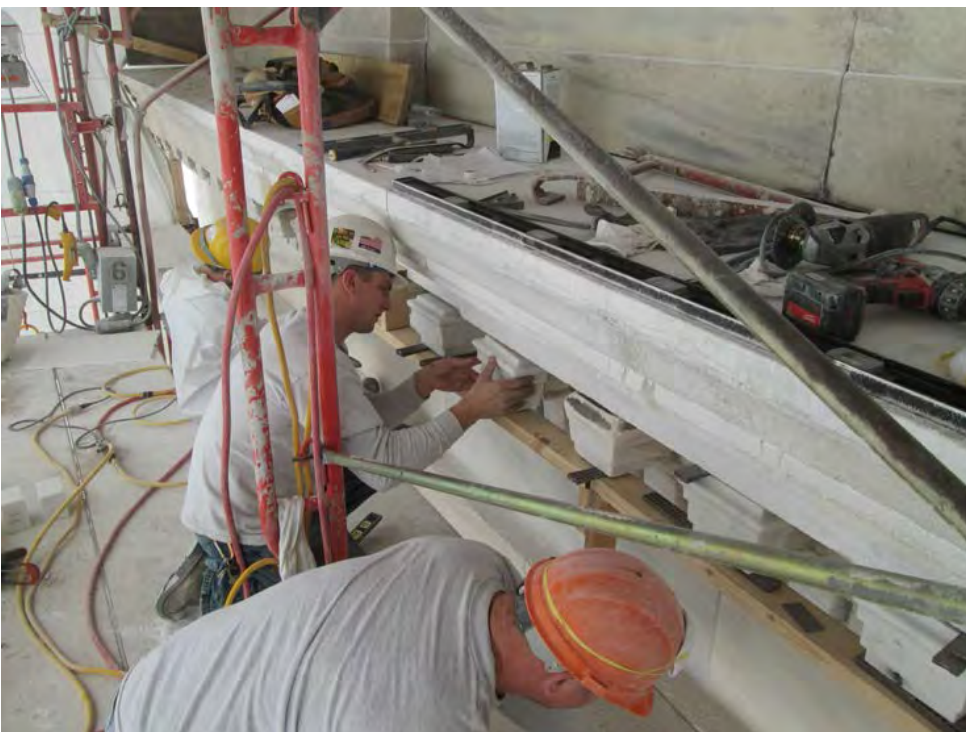
Fig. 68: Typical cornice ledge. All deteriorated material is replaced with new stone.

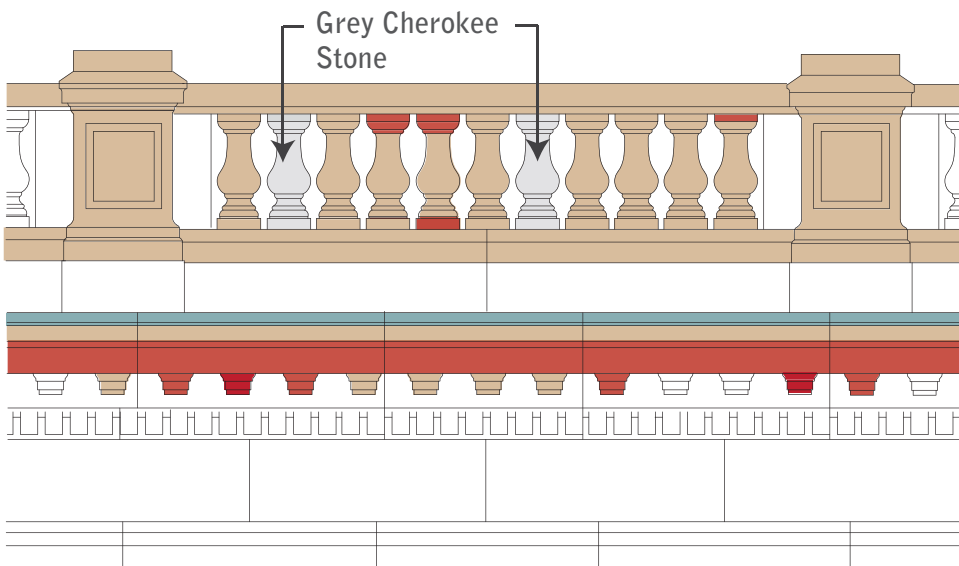
Select character-defining features are restored:

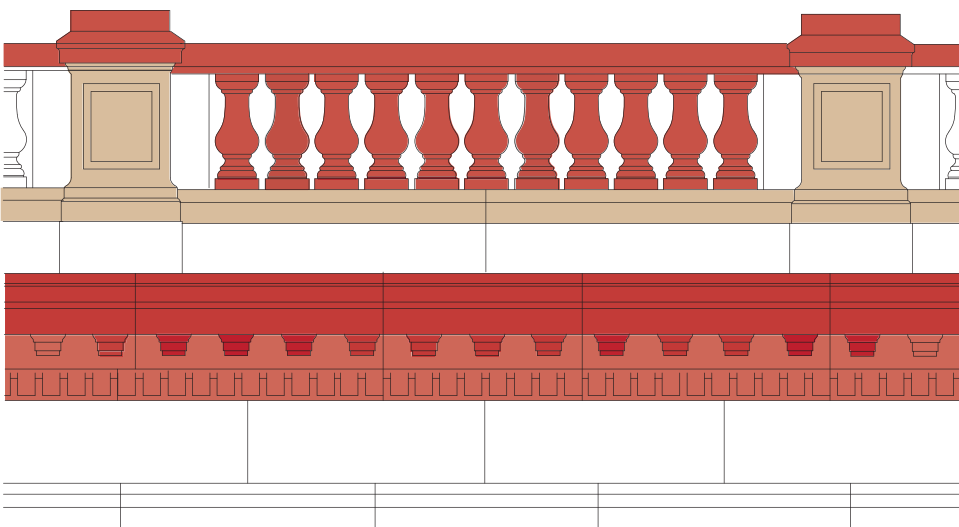
Deteriorated material is removed and replaced to improve long-term durability and preserve character:

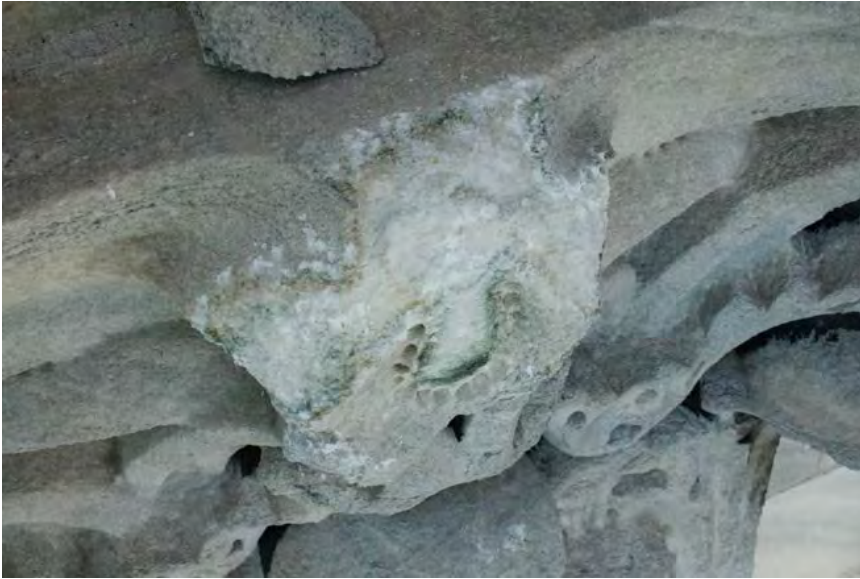
Fig. 69: Typical fleuron. Unstable material is removed.

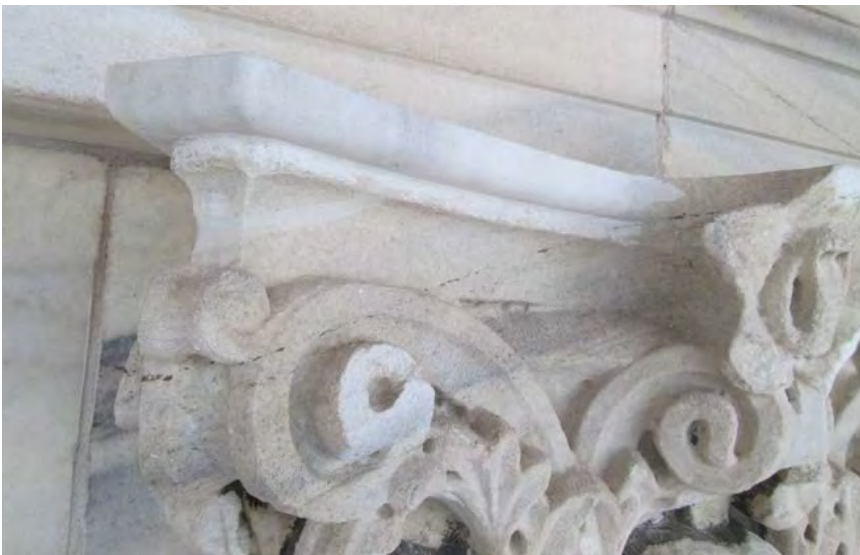
Fig. 70: New abacus. Unstable material is replaced and blended with original stone.

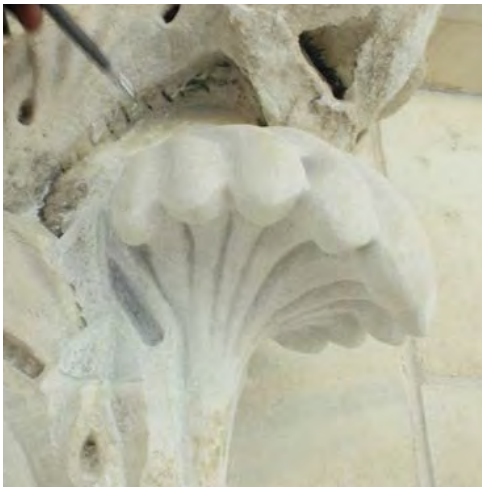
Fig. 71: New acanthus leaf.

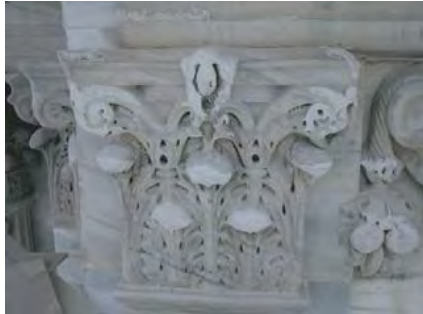
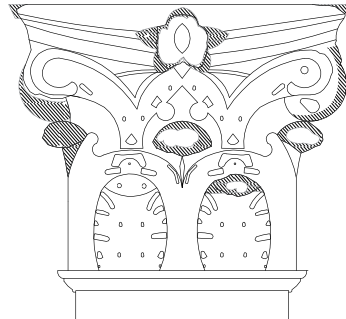
All unsound material is removed or stabilized:

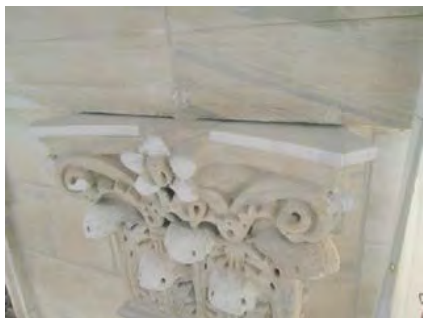
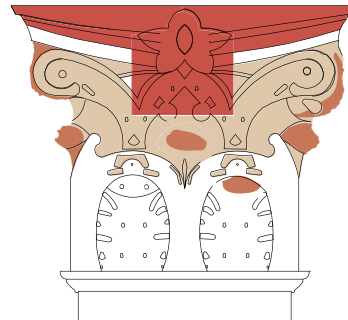
Repairs are made to reduce the potential for further water damage to stone and masonry exterior:

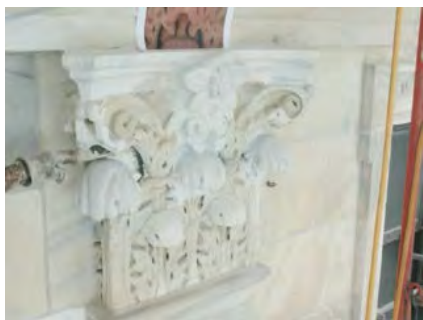
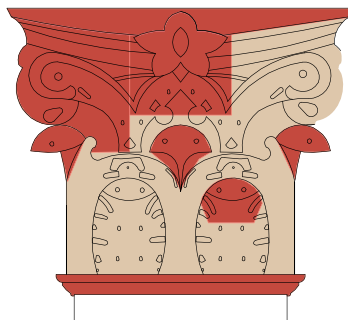
Select character-defining elements are restored:

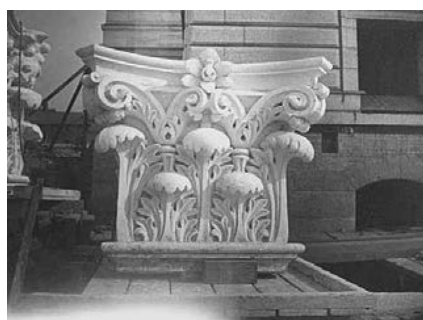
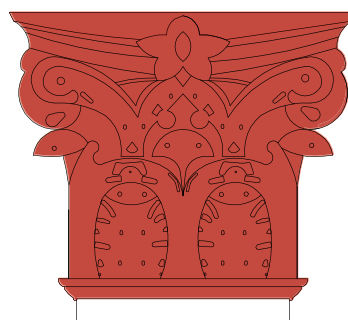
Complete character-defining feature is restored:

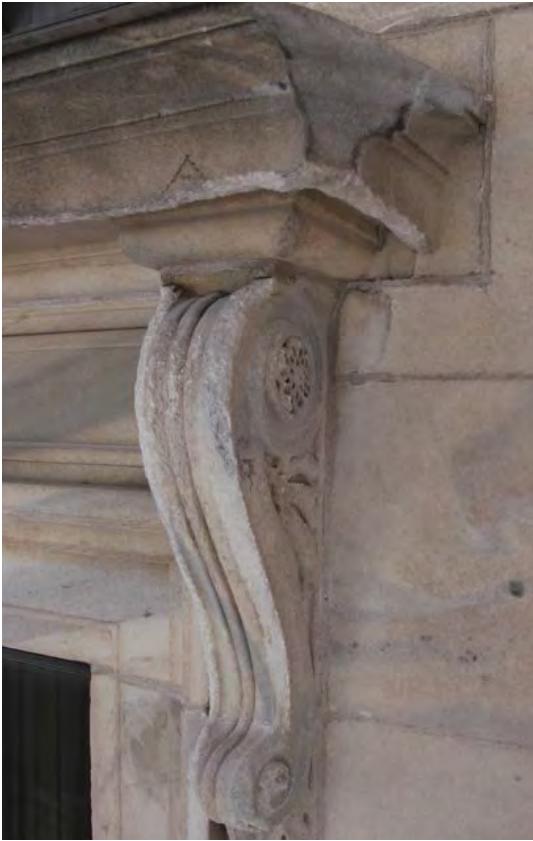
Fig. 73: Degraded material at bracket and drip edge condition is typical. Missing corner at the ledge was removed during hazard mitigation

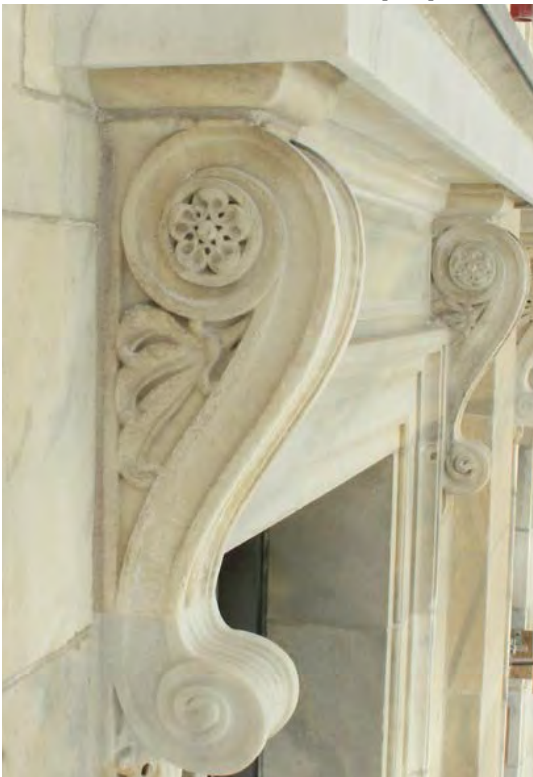
Fig. 75: New drip edge and partial lower scroll replacement

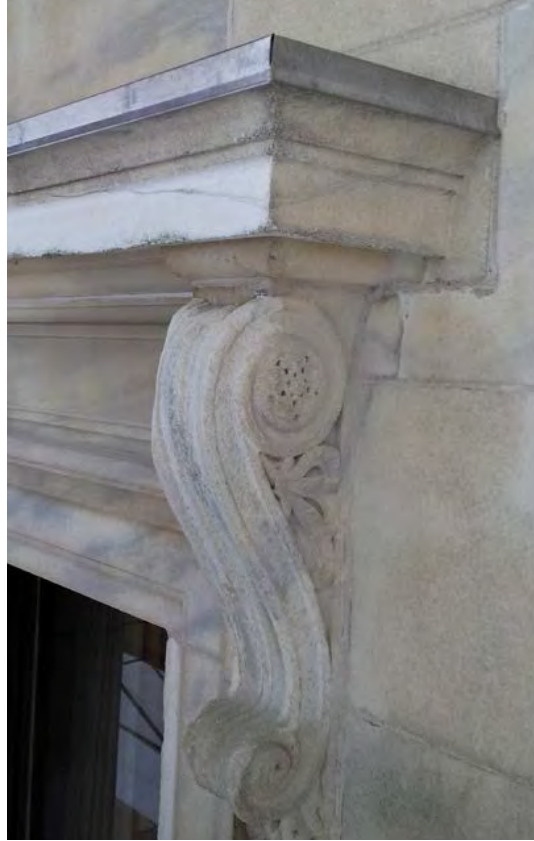
Fig. 74: Original material at drip edge is deteriorated but did not meet the threshold for replacement. Metal flashing is installed to protect wash ledge.

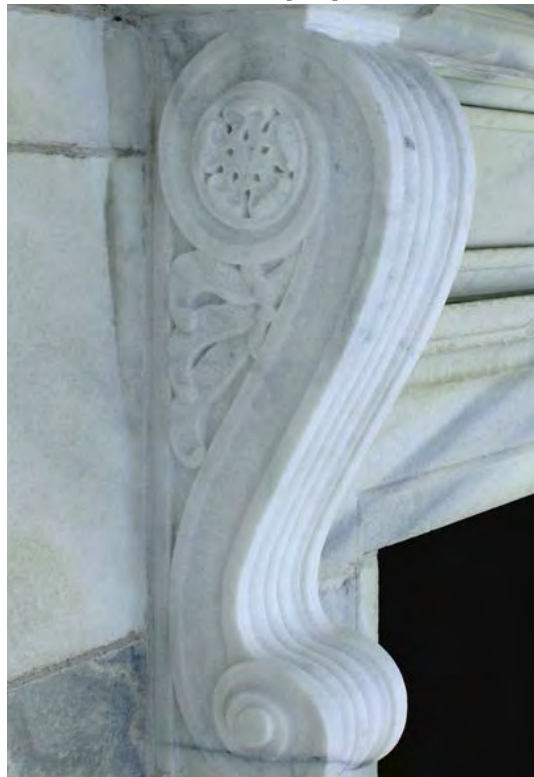
Fig. 76: New full bracket replacement

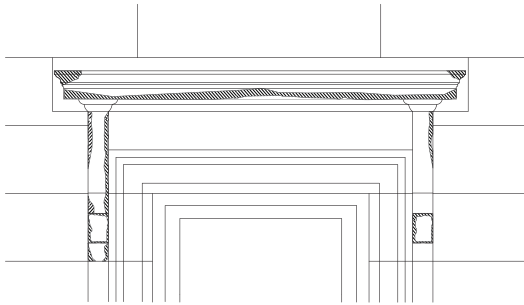
All unsound material is removed or stabilized:

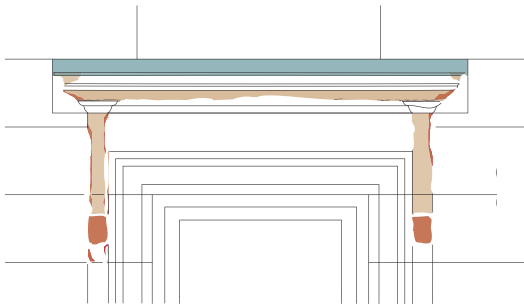
Repairs are made to reduce the potential for further water damage to stone and masonry exterior:

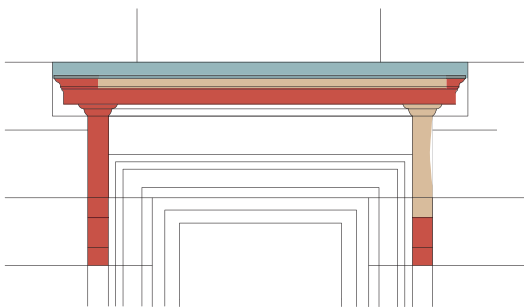
Select character-defining elements are restored:
