Minnesota State Capitol
Exterior Stone Repair Project
Stone Repair Trials Evaluation and
Preliminary Preservation Planning

May 10, 2013

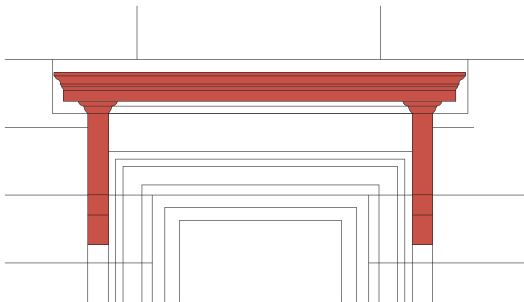
Complete character-defining feature is restored:

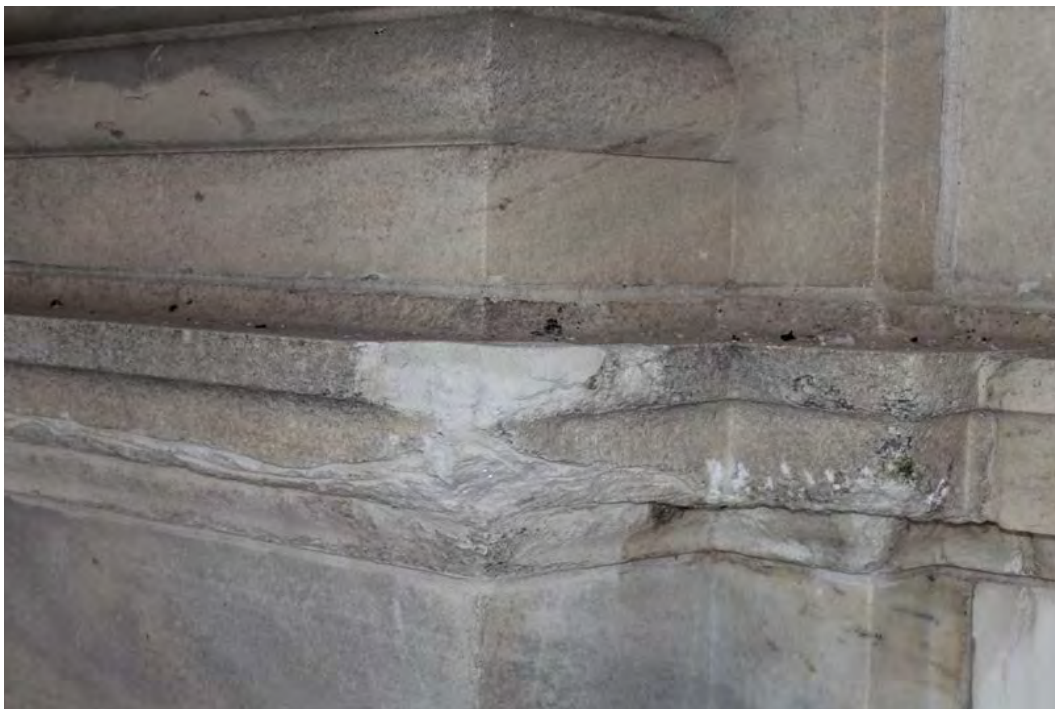
Fig. 77: Degraded material at pilaster pedestal wash band is typical. Conditions are typically most severe at outside corners

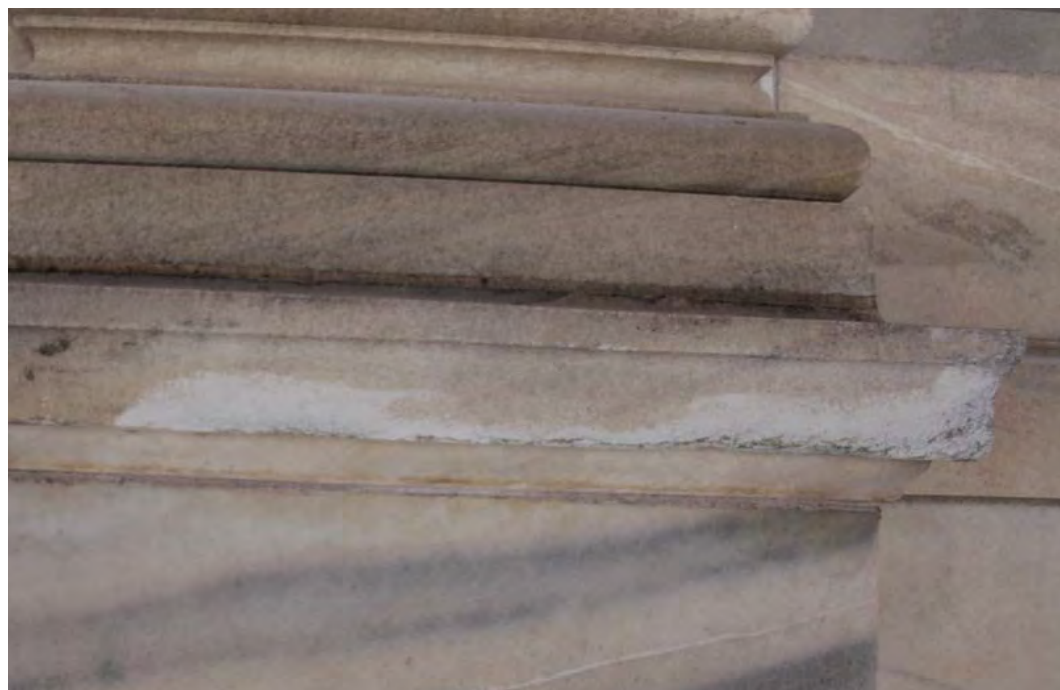
Fig. 78: Degraded material at pilaster pedestal wash band after grinding and smoothing. Decay, visible as darker grained material along the bottom of the drip edge, is still present following repair.

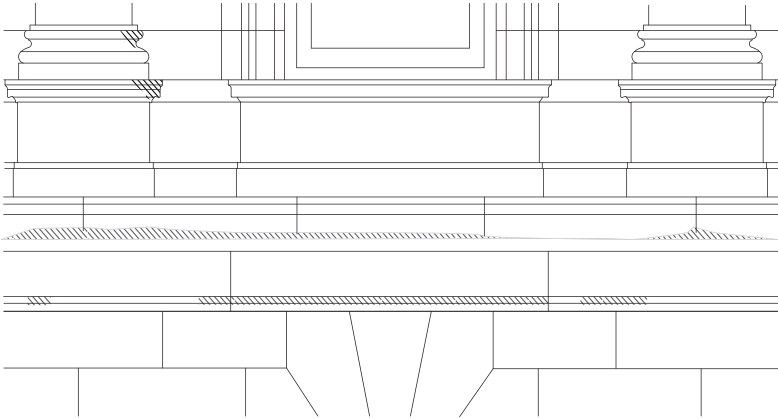
All unsound material is removed or stabilized:

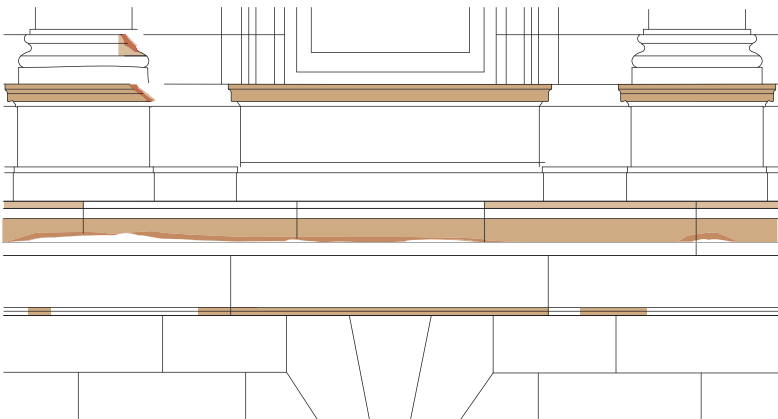
Repairs are made to reduce the potential for further water damage to stone and masonry exterior:

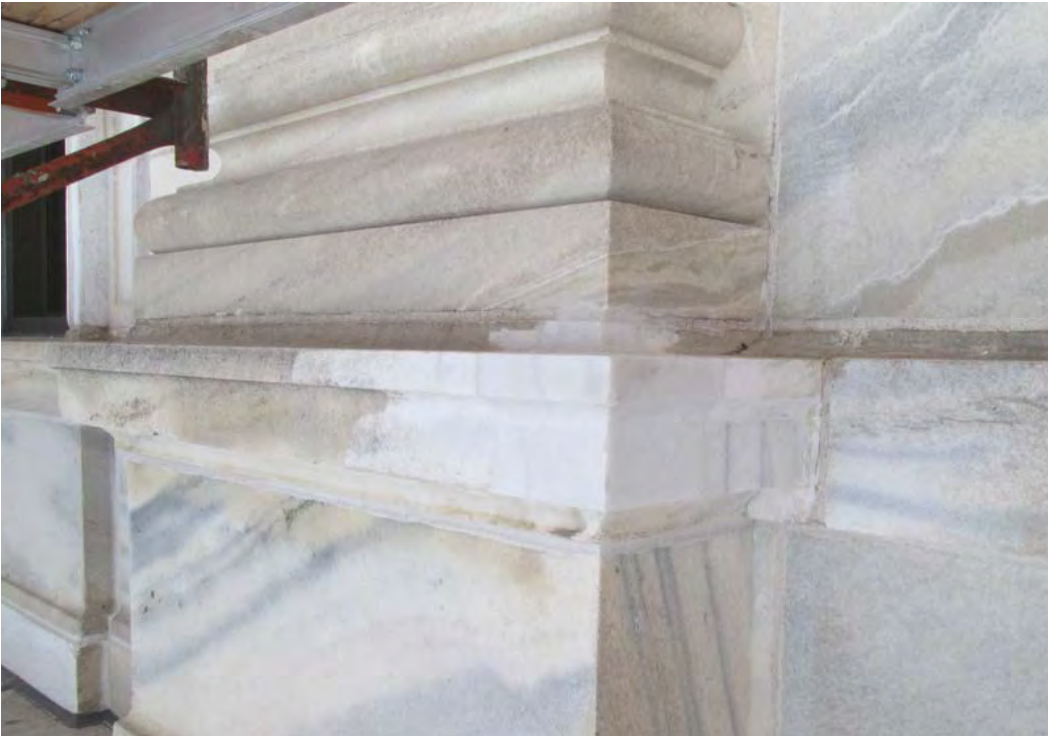
Fig. 79: Degraded corner after replacement with new stone Dutchman.

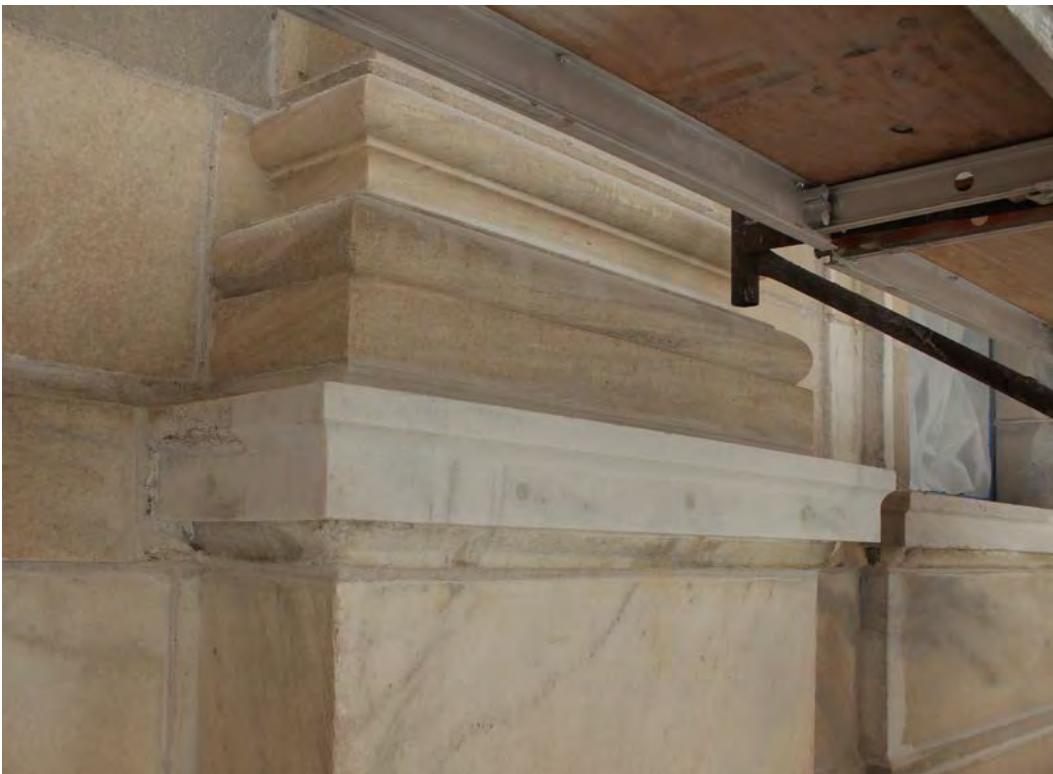
Fig. 80: Complete ledge replacement. The detail has been revised so that stone plugs visible in the trial repair are no longer necessary.

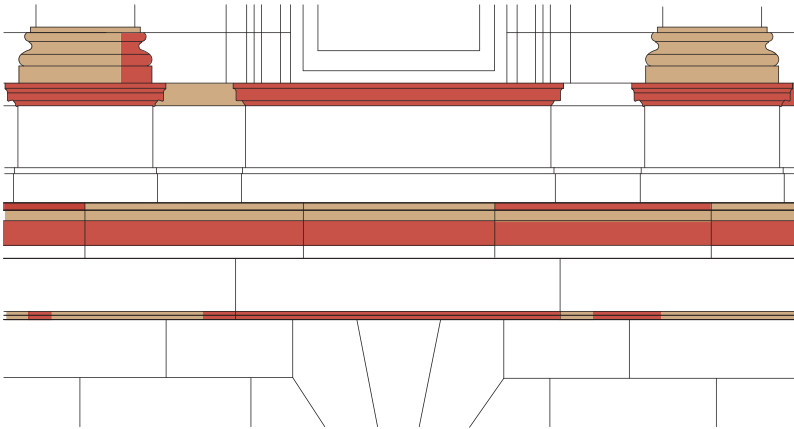
Select character-defining features are restored:

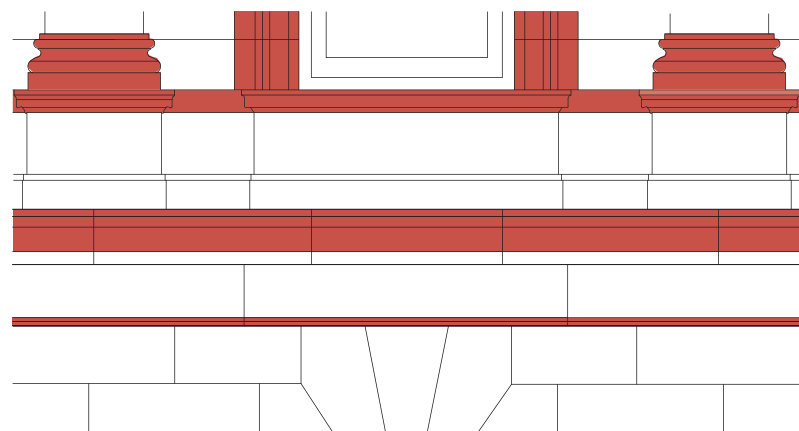
Deteriorated material is removed and replaced to improve long-term durability and preserve character:

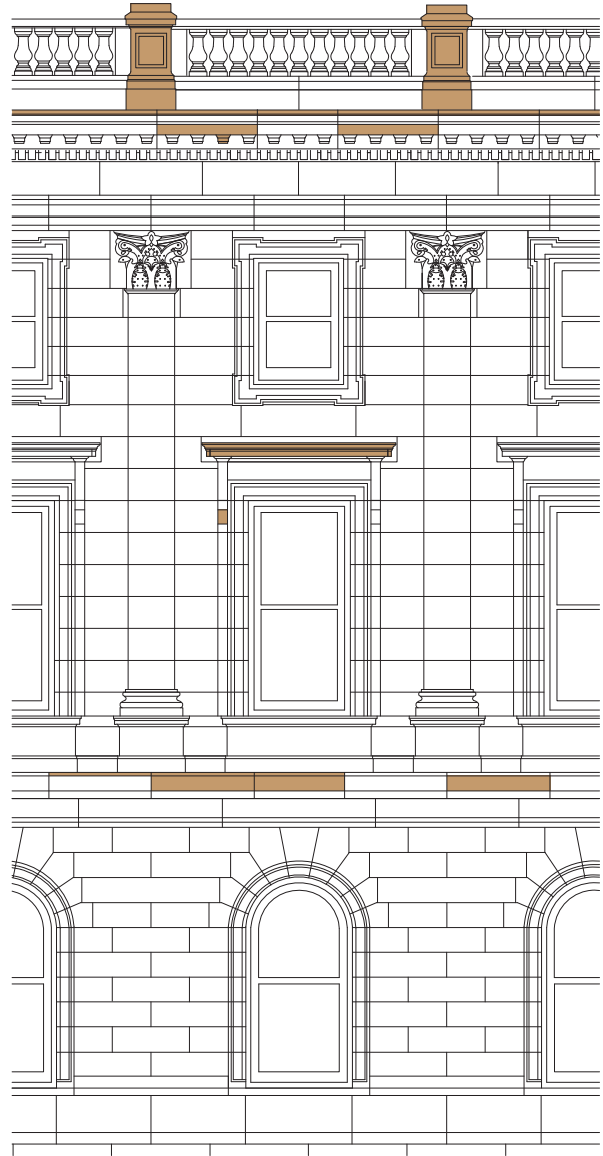
Fig. 80 -81: A typical building bay is used to show areas and elements that are focused on at each level of repair.

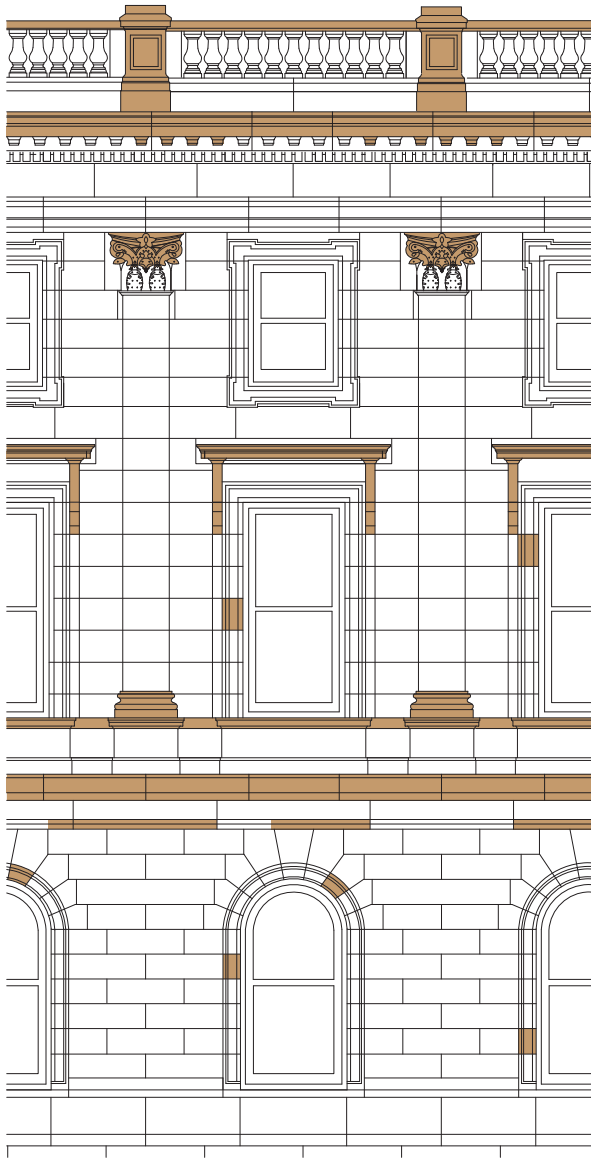
Tier 4 - Restoration/Reconstruction (T4)

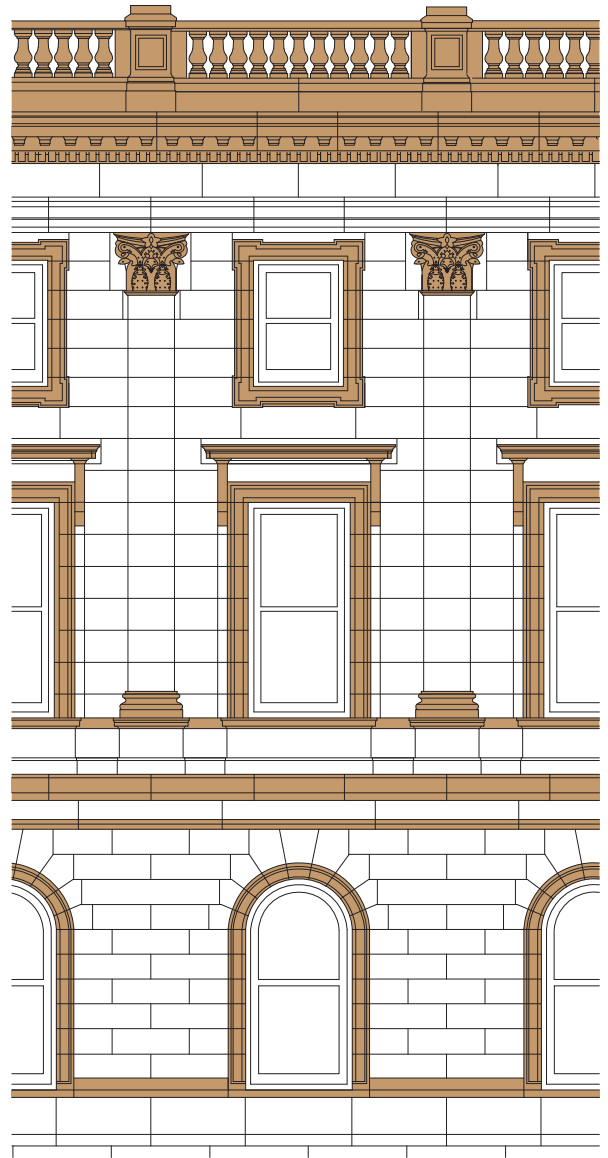
Fig. 82 -83: A typical building bay is used to show areas and elements that are focused on at each level of repair.

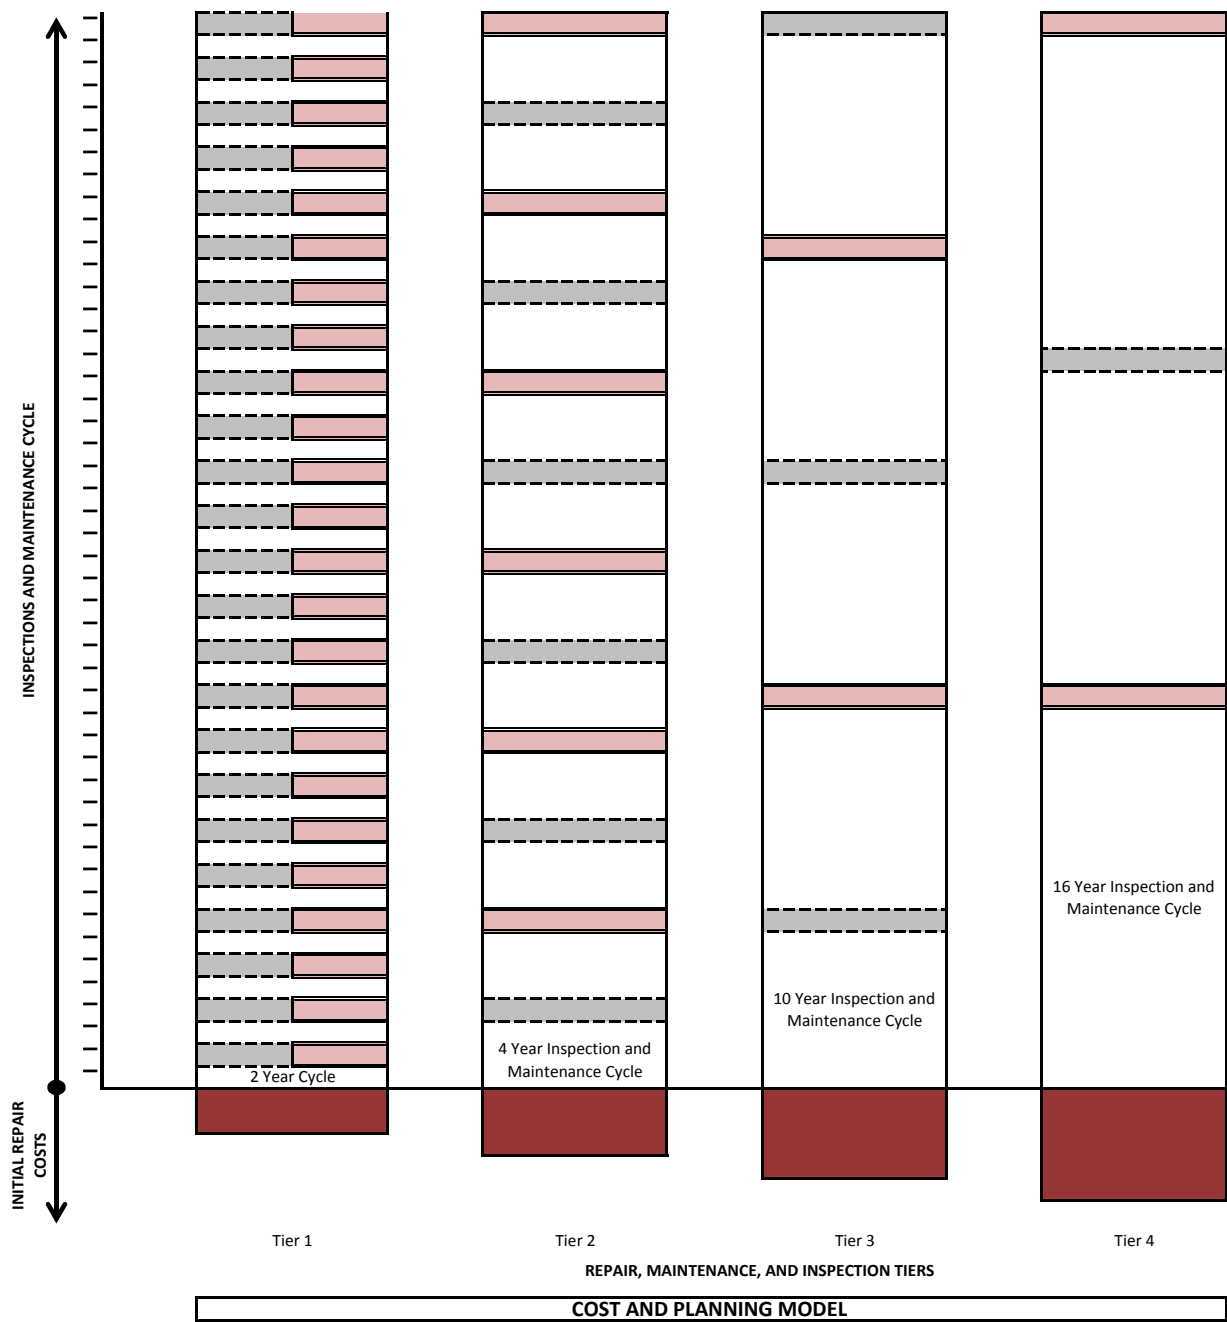
- Inspection cycle with estimated cost in current dollars. The scope of the inspection will vary based on the initial repair option performed.
- Maintenance cycle with estimated cost in current dollars. The scope of maintenance will vary based on the initial repair option performed.
- Cost of initial repairs

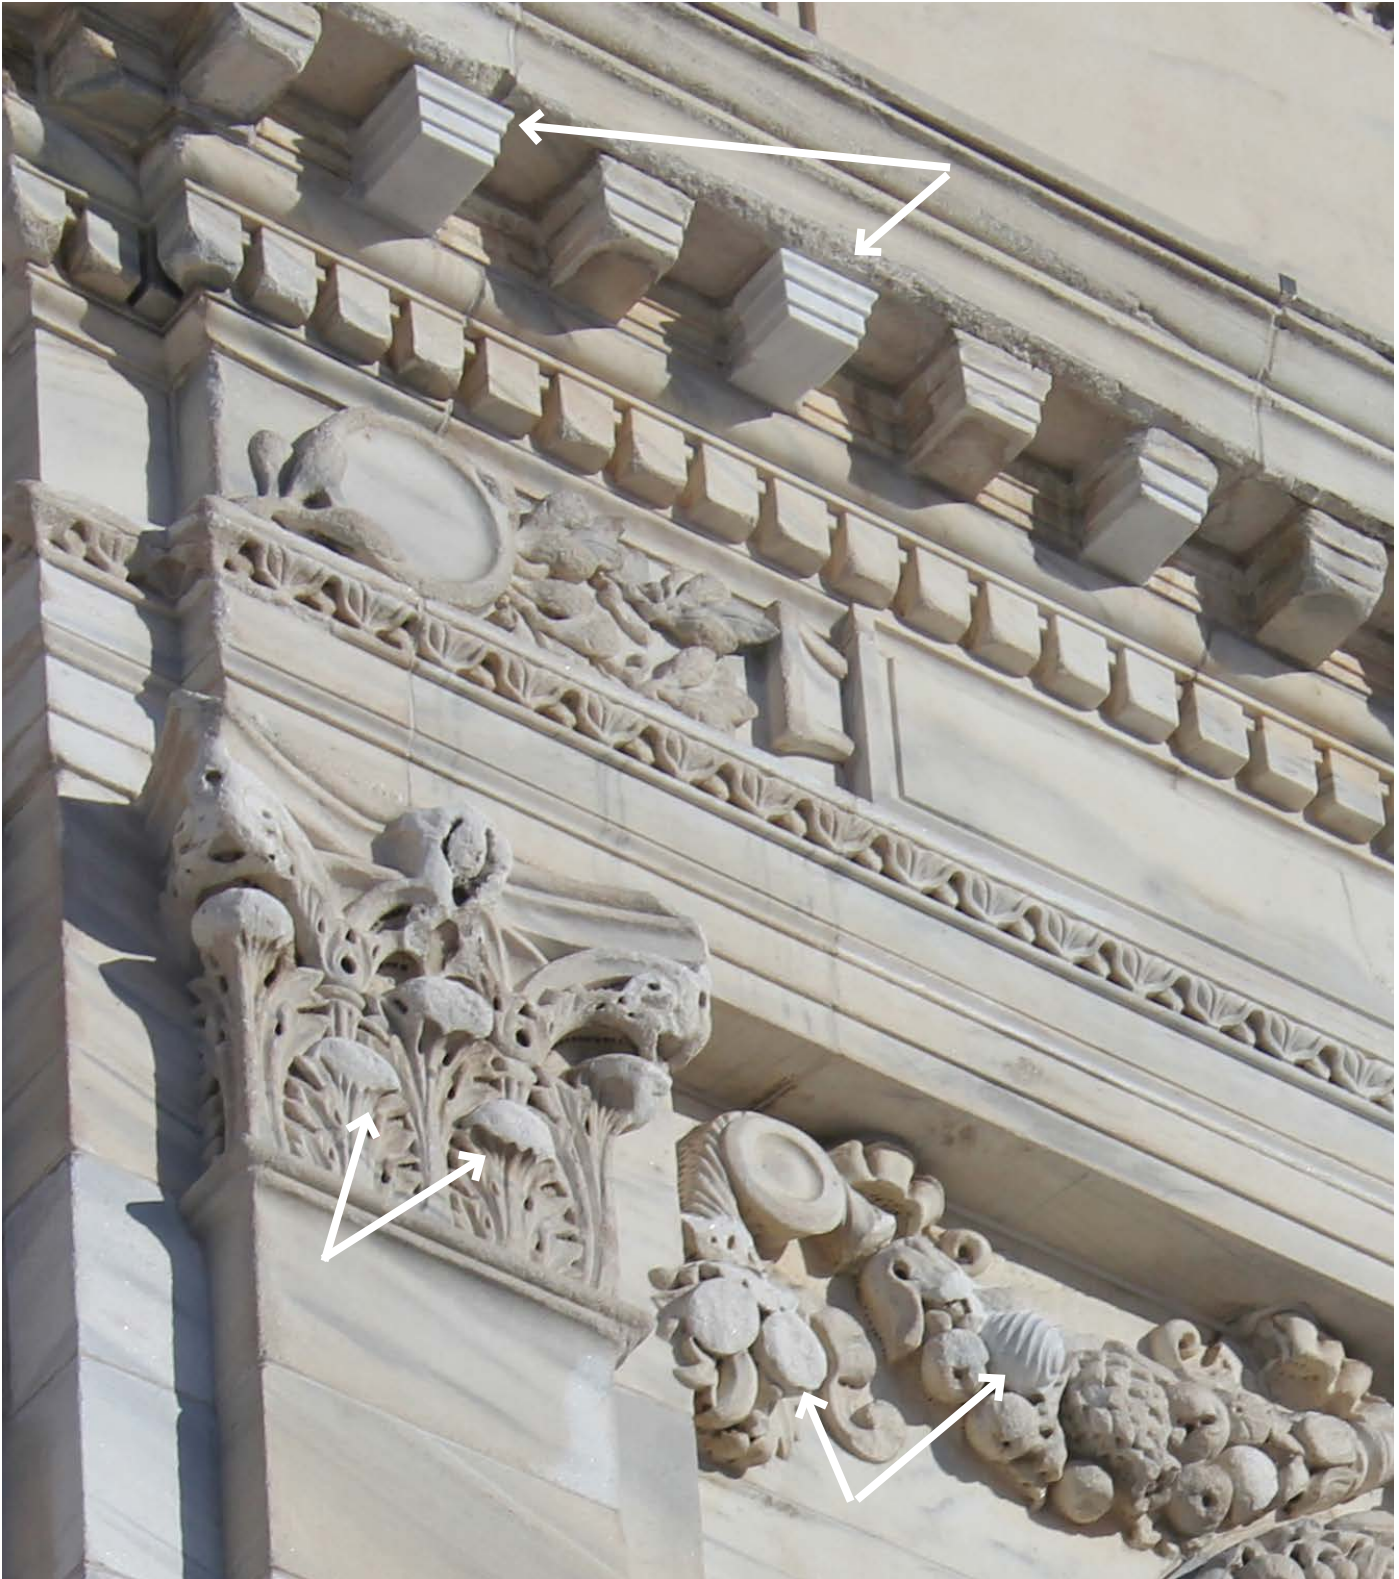
Fig. 86. Crisp new modillion blocks, a Tier 3 level repair priority, have strong visual impact. The effect can be compared and contrasted with the Tier 1 level approach taken at the pilaster capital. In this case, unsound material has been removed but not restored. In lieu of replacement, surfaces are ground smooth to facilitate water runoff. Highly carved detail to the right of the pilaster also shows a range of repairs - two similar pieces have been removed, one other missing element of approximately the same size was replaced.
