# Exterior Stone Repair at the Minnesota State Capitol

## Introduction

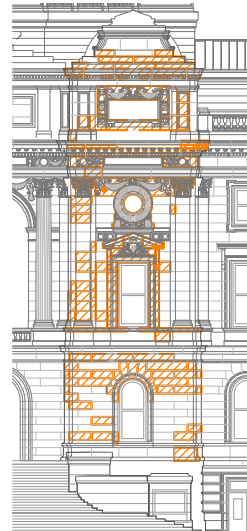
MOCKUP AREA A -  
East Elevator Tower

conducted a preliminary "hands-on" investigation to identify any façade conditions that were potential life-safety risks. Loose stone material and marginally attached sculptural elements were removed. One large, cracked and unstable unit at the east elevator tower was pinned in place as an emergency repair. HGA recommended that a comprehensive stone evaluation be completed to determine the nature and full extent of stone deterioration.

This phase involves installing a variety of prototype repairs in order to evaluate, compare, and contrast a range of strategies from conservative repair to aggressive replacement. Areas selected for trials include two central bays of the west wing south and north façade, and both facades of the east elevator tower. Processes already underway include:
