# **COMPREHENSIVE STUDY OF BUILDING #35 MCF – MOOSE LAKE**

**MINNESOTA DEPARTMENT OF CORRECTIONS**

**MN RECS Project No. 78ML0085**

**FINAL REPORT:**

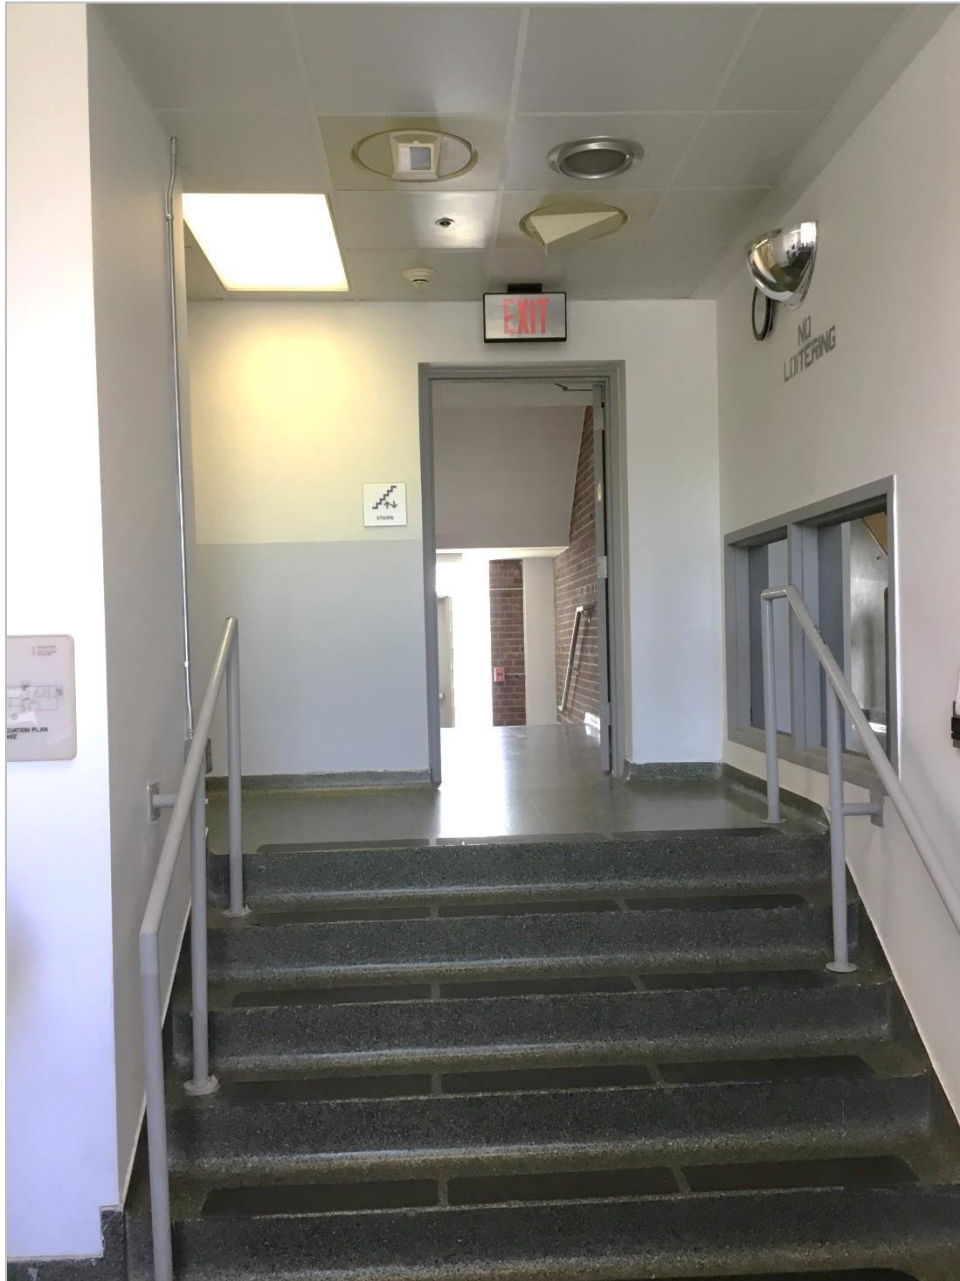
Main entry to the first floor

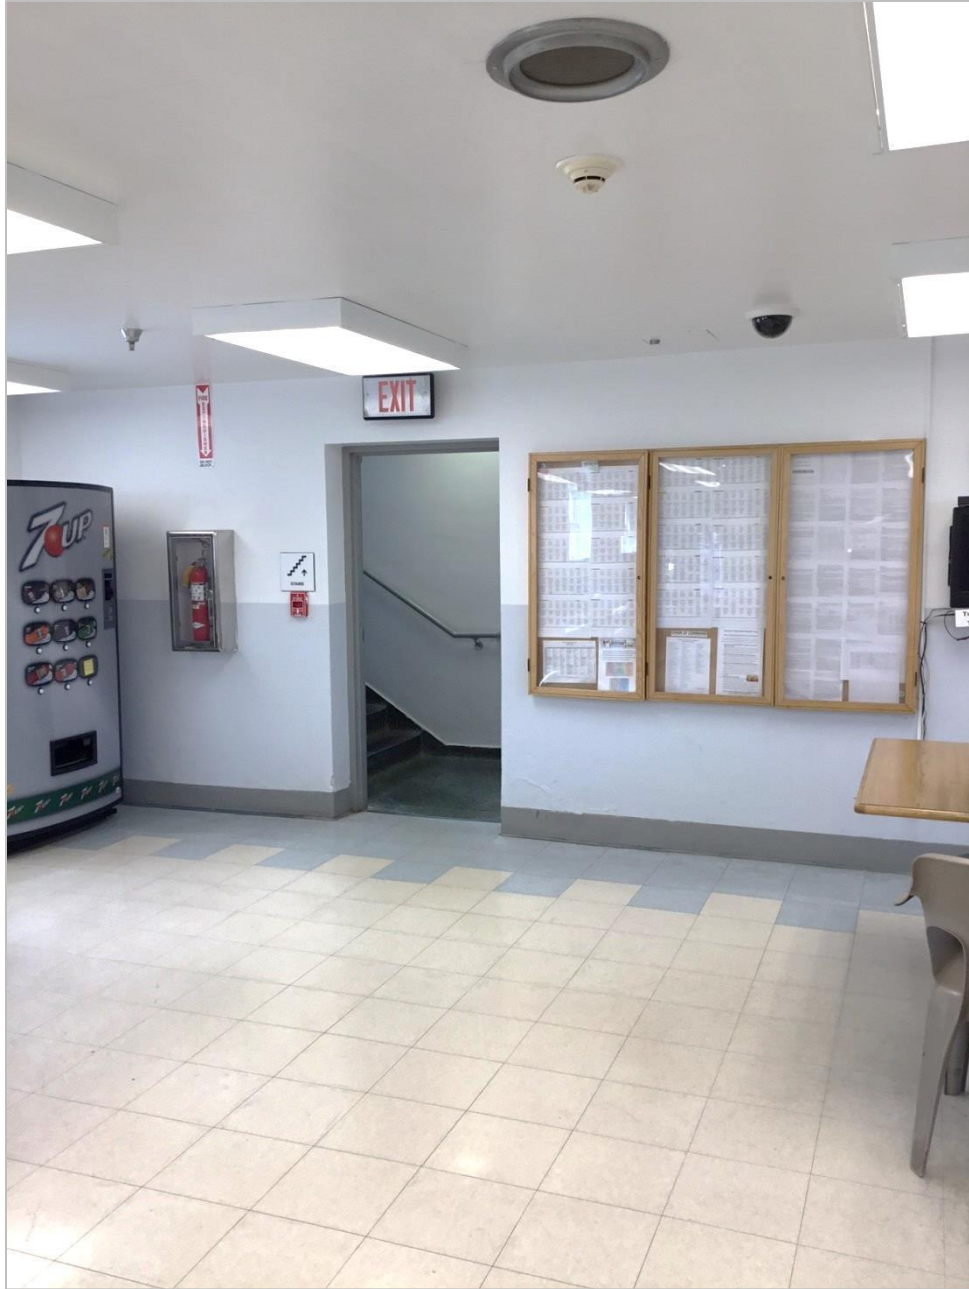
Basement Commons / Stair to 1<sup>st</sup> Floor

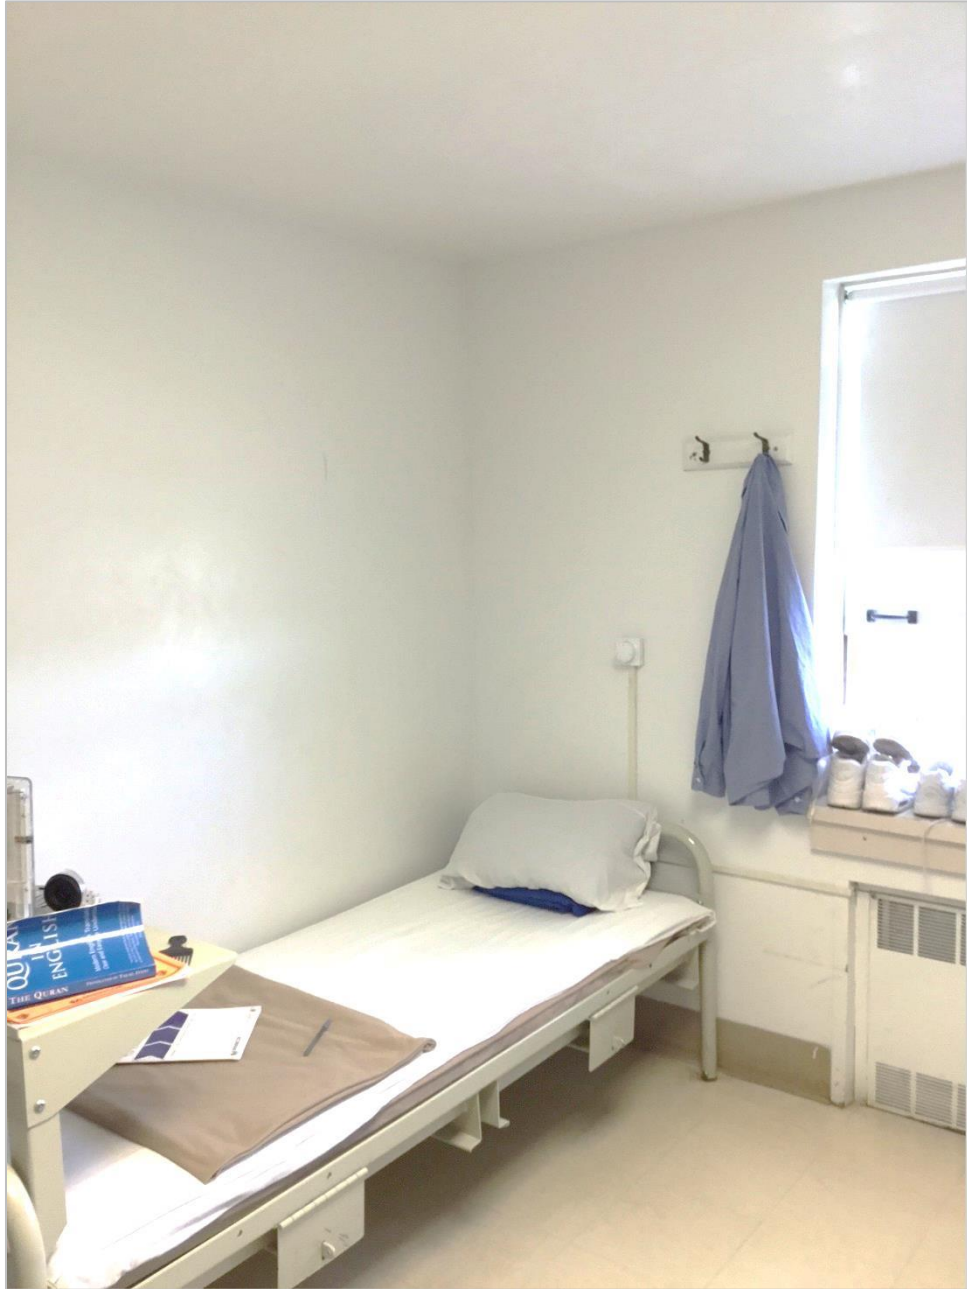
Typical Room

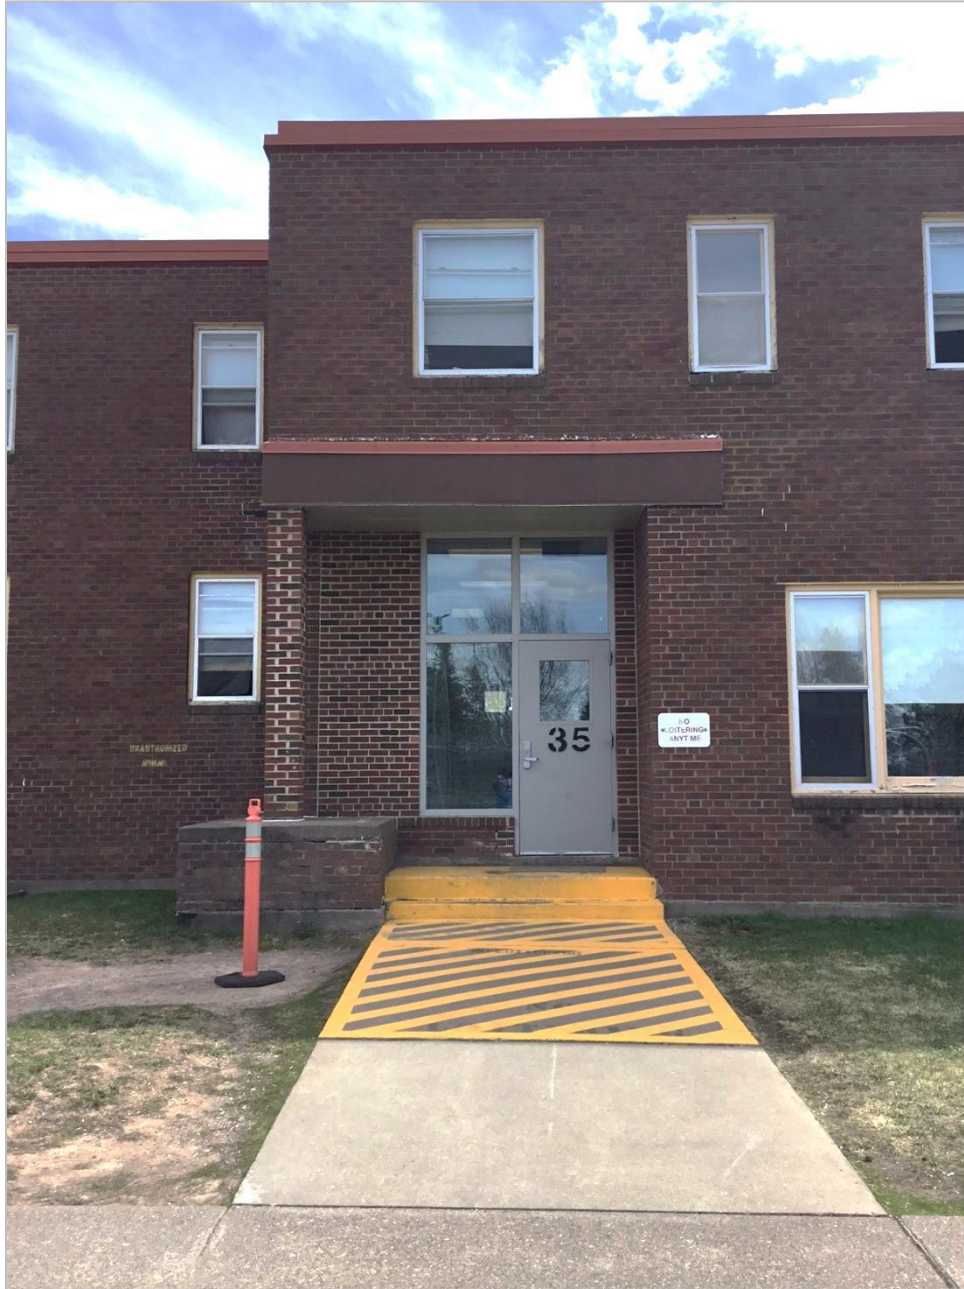
Long term moisture entry has occurred at the stairwell leading to the north wall entry. This has resulting in efflorescence, vegetation growth, and displacement of bricks.

Main Entry Exterior

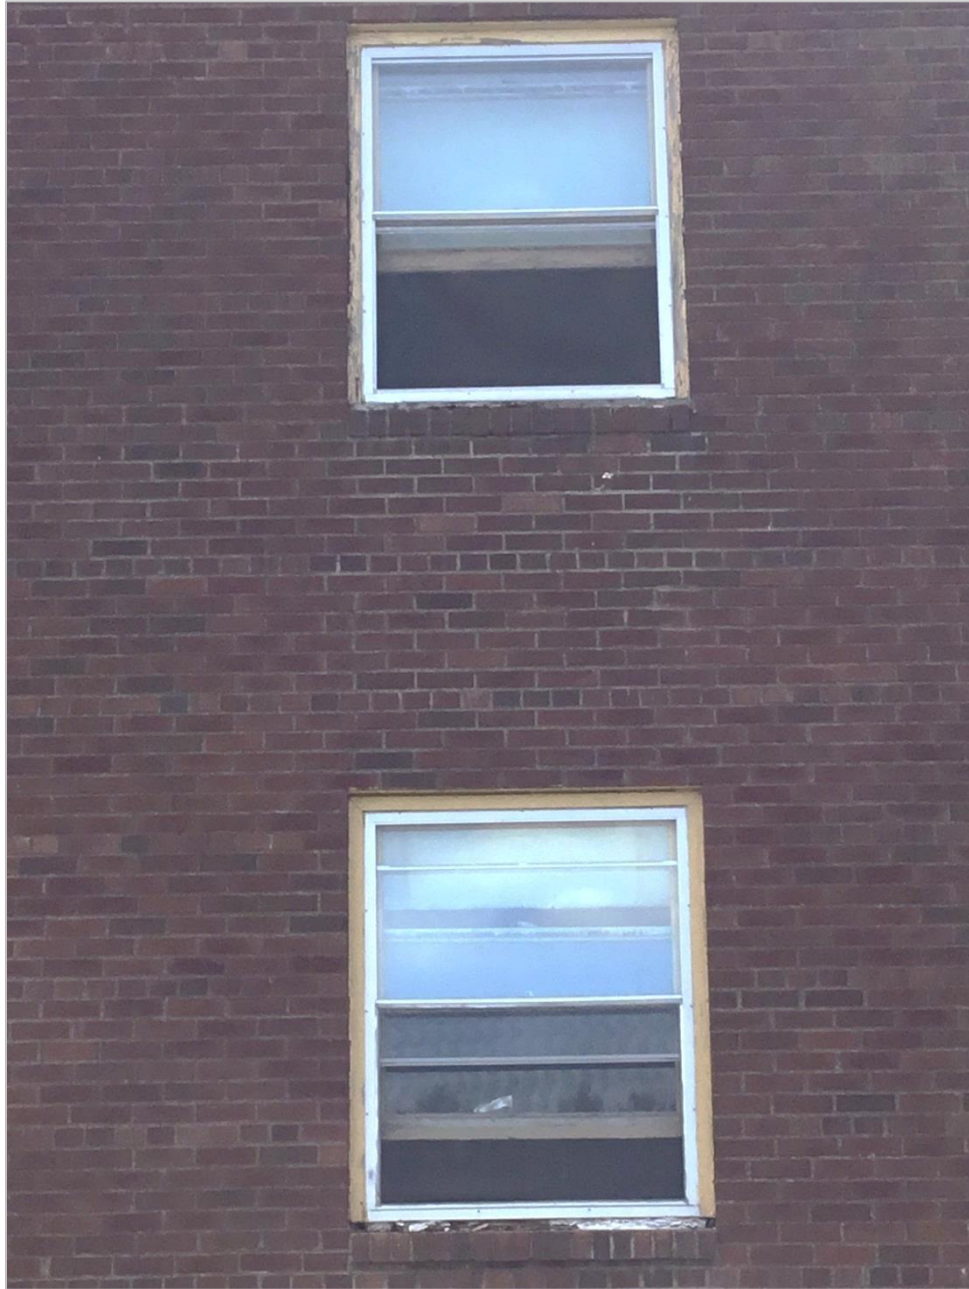
The existing exterior wood double hung windows, original to the building construction, are severely deteriorated allowing air infiltration into the living space and water infiltration into the masonry wall. The building entrances, hollow metal doors, frames and sidelights are in good condition. The main entrance being hollow metal door with sidelight and transom frame installed in brick masonry opening. The stair egress doors are hollow metal door and frame installed in glass block masonry opening. Both of the original stair locations have two-story exterior glass block unit panels.

Tuckpointing is good except at window sills where moderately to heavy loss as occurred due to window leakage. Masonry deterioration at the windows has extended into the wall beneath the openings on some windows.

The wood frame windows are in poor condition with heavy decay on sills and lower portions of the jams.

Exterior Windows

**Replace all windows, caulk around openings, tuck point all sills and restore masonry as needed below sills.**

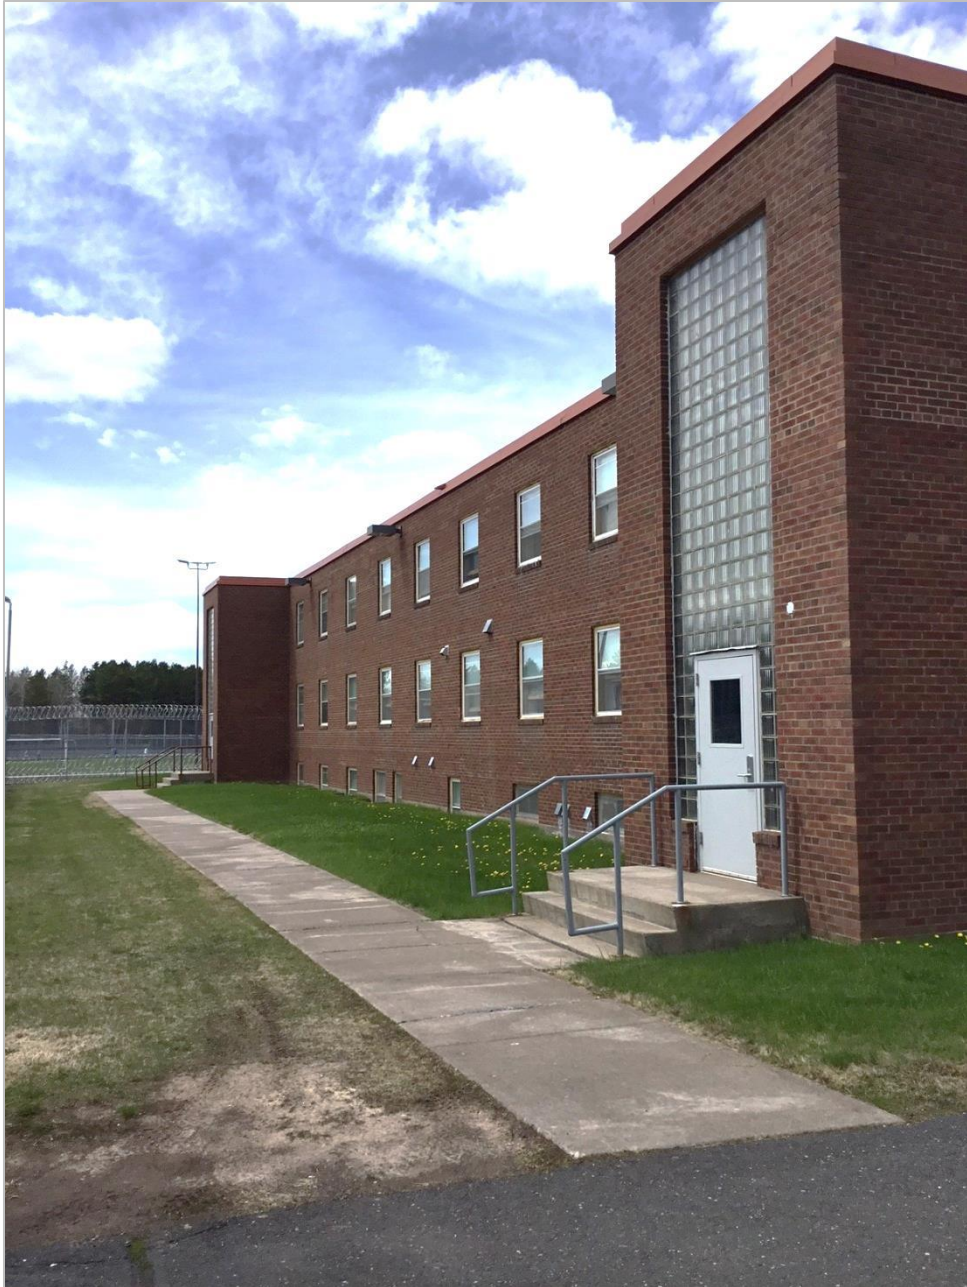
Exterior (South Elevation)
