I-35W BRIDGE OVER THE MISSISSIPPI RIVER: COLLAPSE INVESTIGATION

BRIDGE NO. 9340
MINNEAPOLIS, MINNESOTA

FINAL REPORT
NOVEMBER 2008
WJE No. 2007.3702

Prepared for:
Minnesota Department of Transportation
Bridge Office
Oakdale, Minnesota

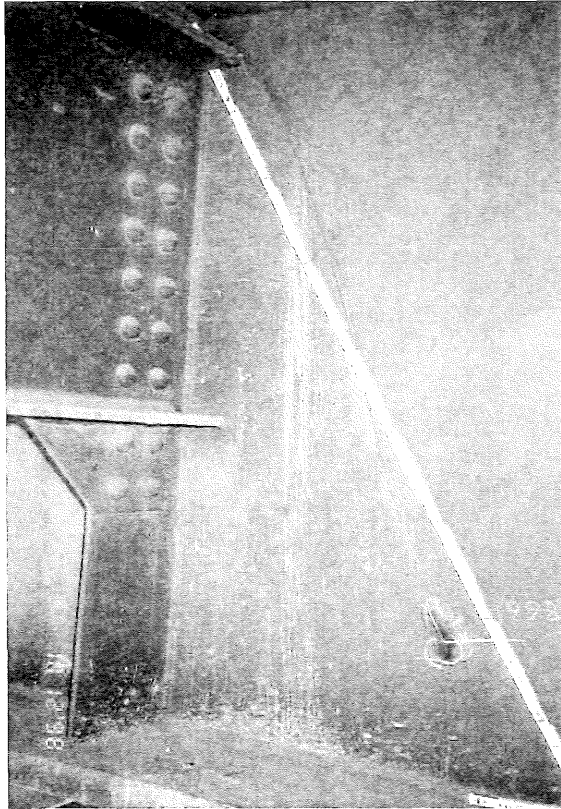
Figure 2.10. Crack observed in 1998 at Span 9 Girder G2 diaphragm connection extending into web plate.

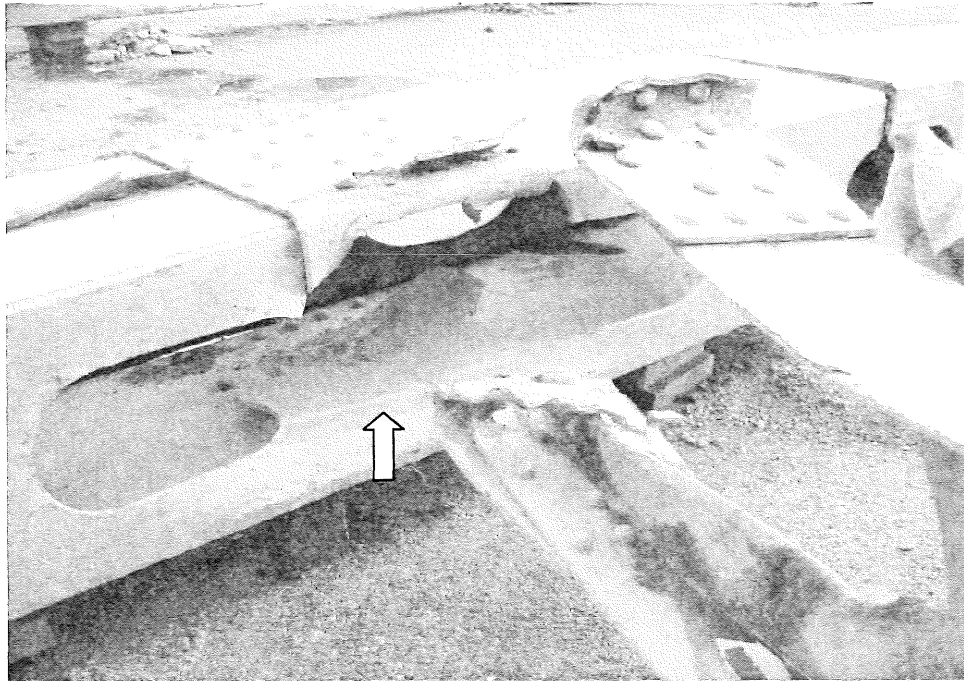
Figure 4.22. Impact damage on top cover plate of lower chord at L12'E.

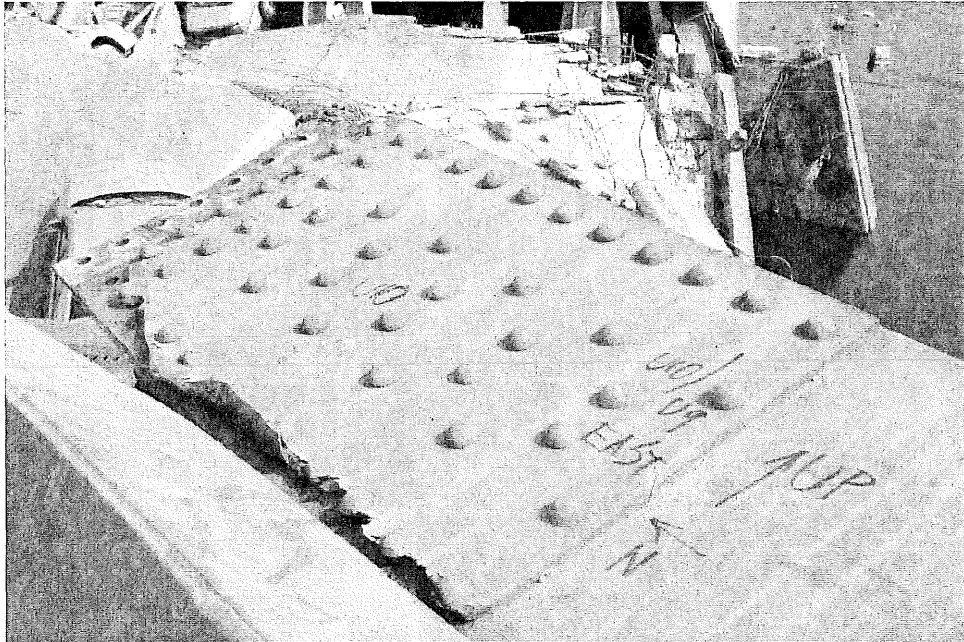
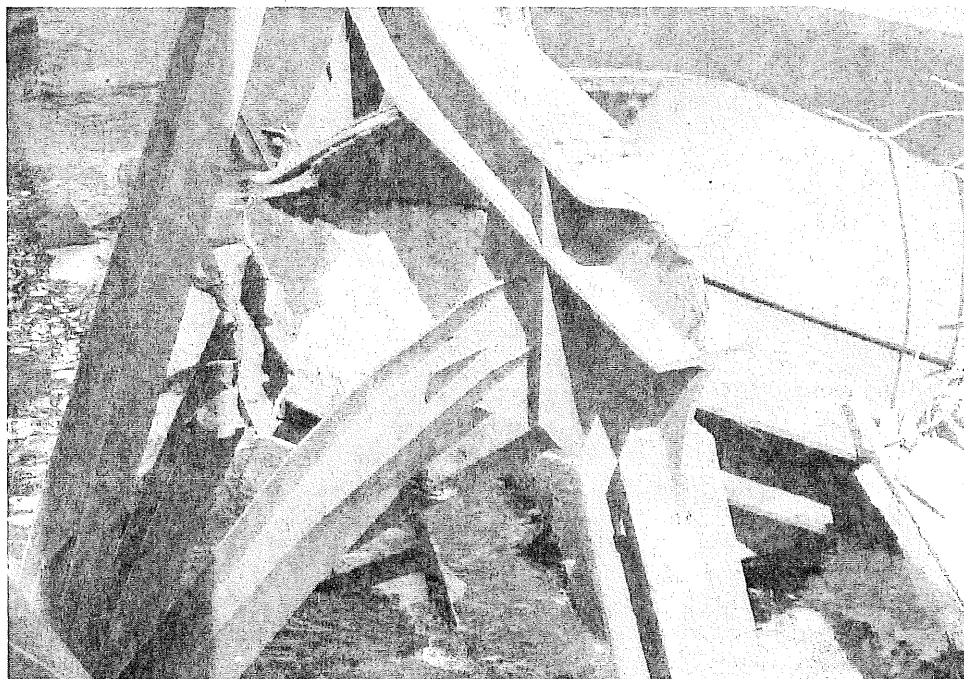
Figure 4.23. Node U10E post-collapse condition.

a) West side gusset at U10 end of Upper Chord U9E-U10E

b) Node U10E, east elevation

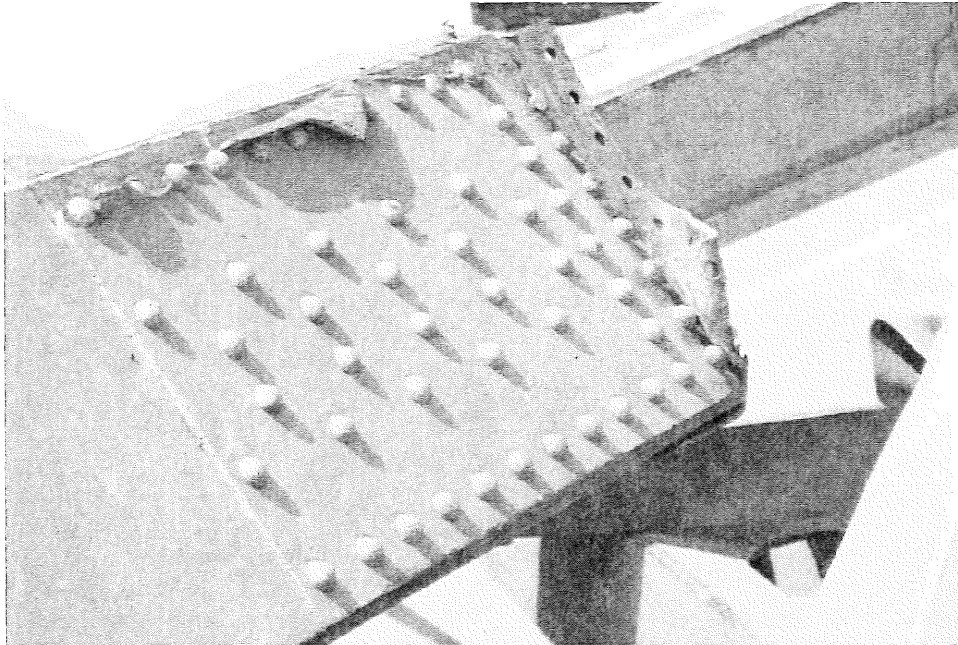
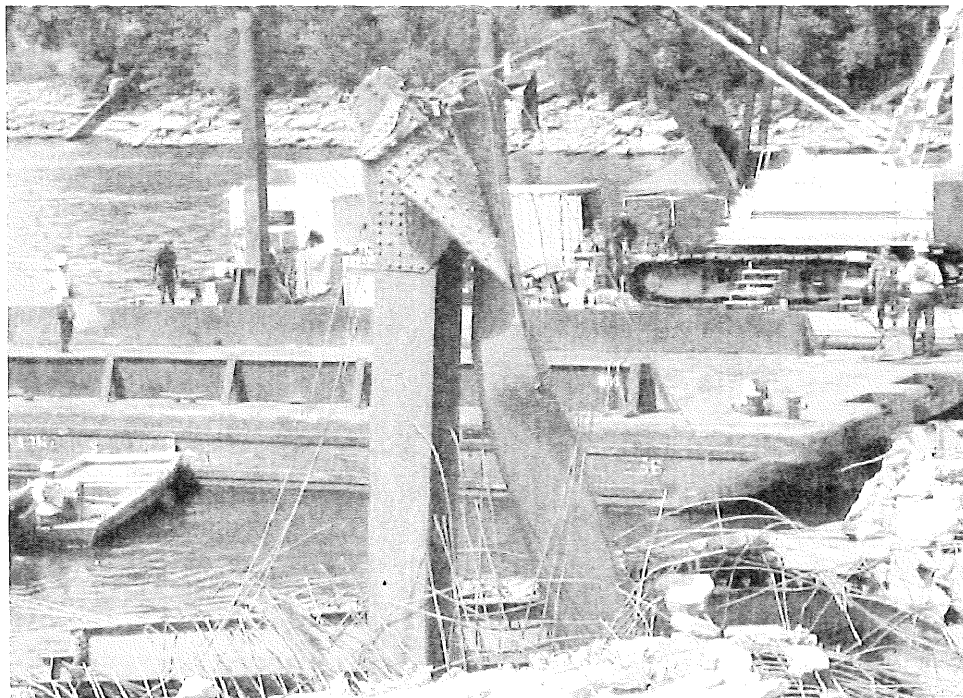
Figure 4.24. Node U10W post-collapse condition.

a) U10 end of Upper Chord U9-U10W, west gusset (top cover plate of U9-U10W facing down)

b) Node U10W, east elevation.

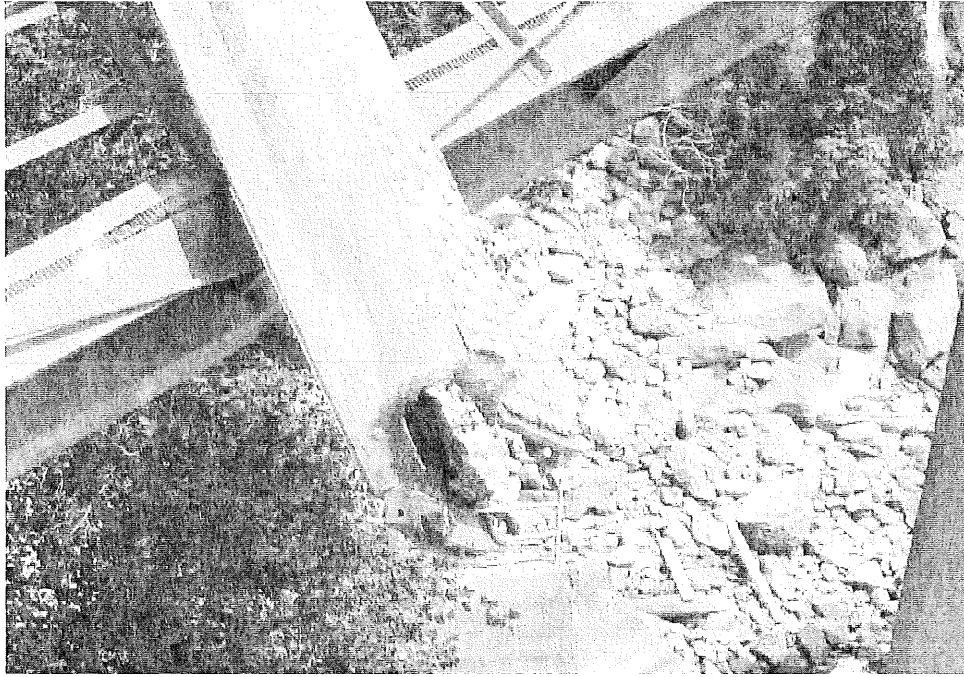
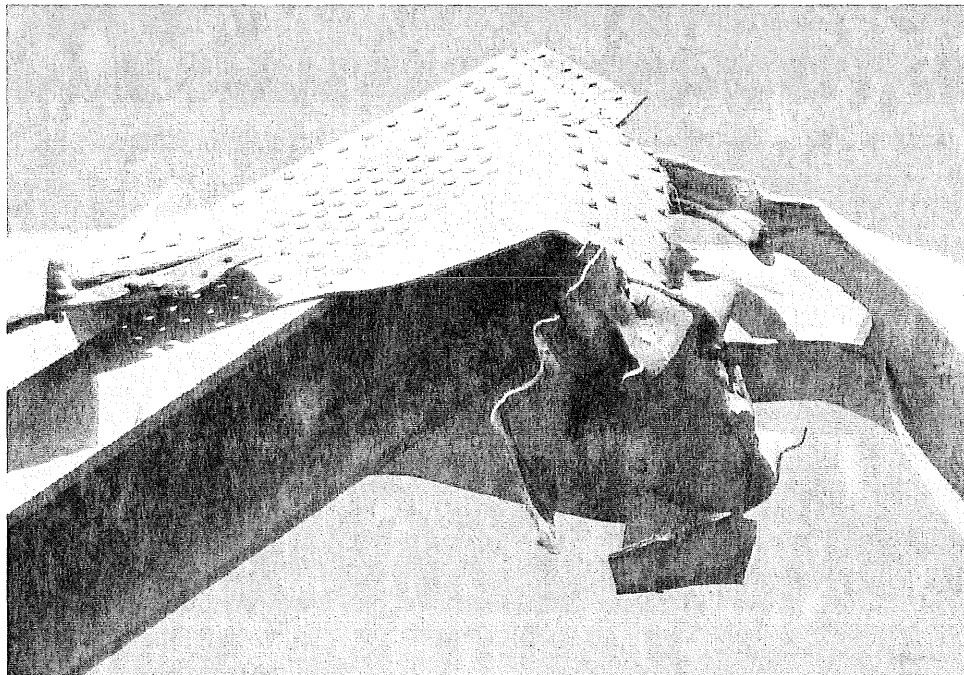
Figure 4.25. Node U10'E post-collapse condition.

a) U10' end of Upper Chord U9'-U10'E (top cover plate, and east gusset shown)

b) Node U10'E, east elevation.

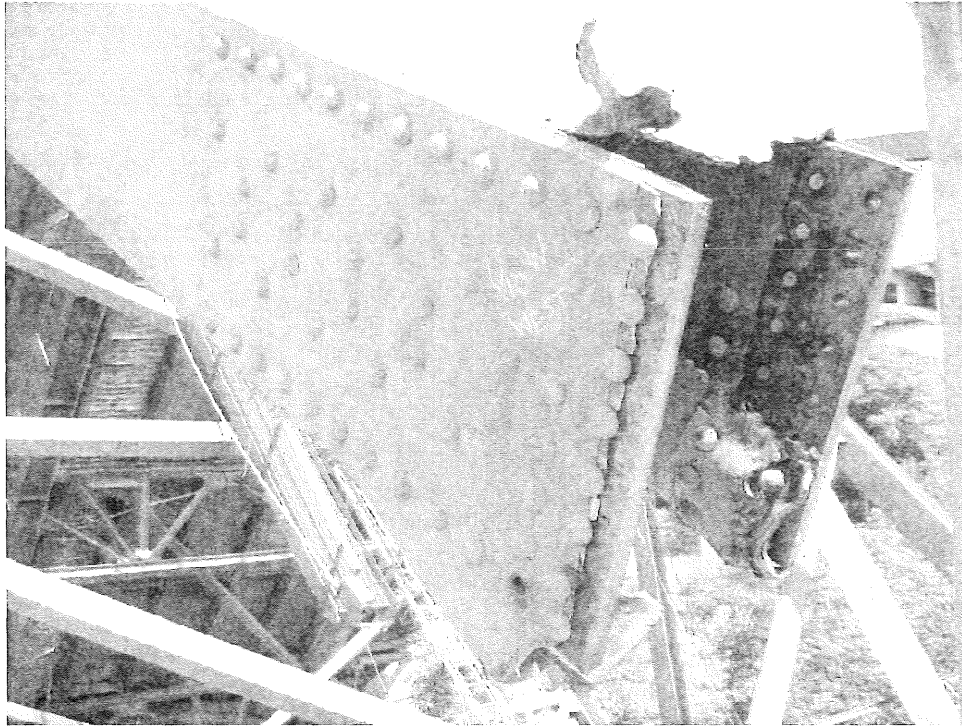
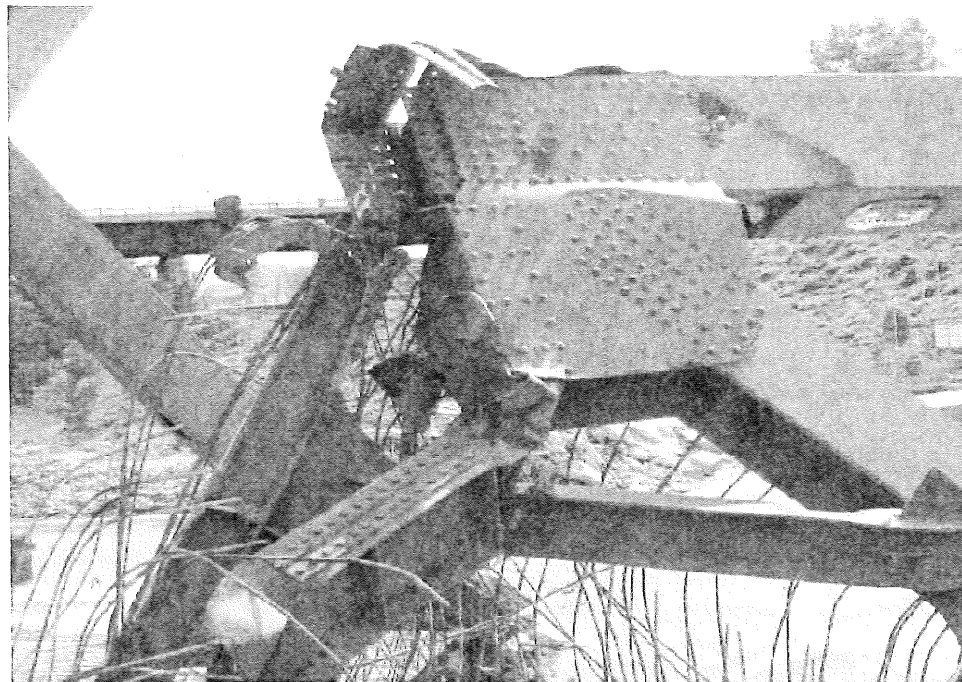
Figure 4.26. Node U10'W post-collapse condition.

a) U10'end of Upper Chord U9'-U10'W, west gusset

b) Node U10'W, west elevation.

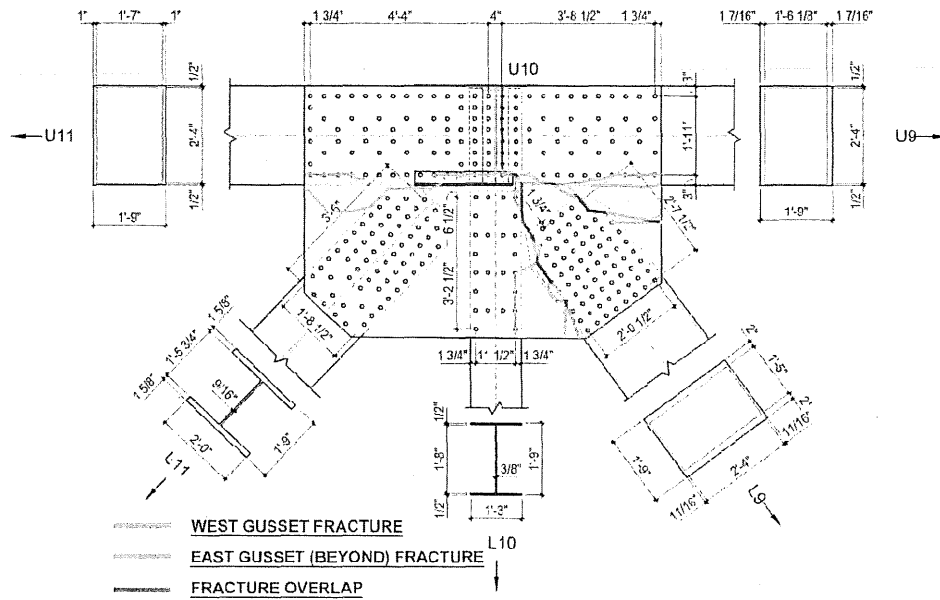
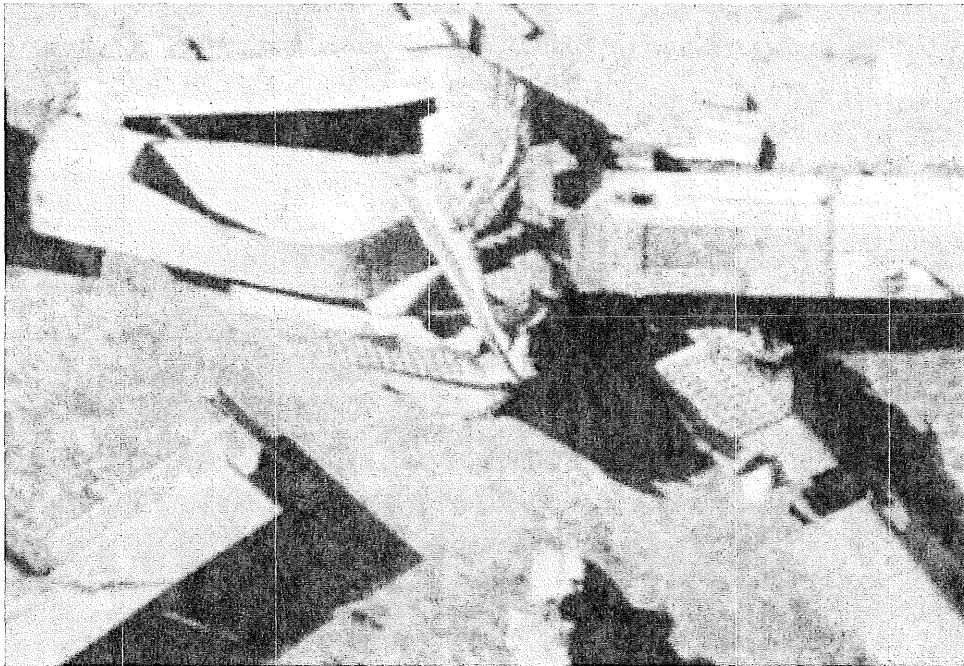
Failure of the I-35W Bridge began with the failure of the improperly designed gusset plates at a U10 node, in the vicinity of the L9-U10 compression diagonal. Failure at this node was followed very quickly by a similar failure at the other U10 node, which then led to the complete collapse of the deck truss system. The ability of the structure to carry the collapse-level construction loads and associated traffic loads for a few hours was most likely due to one or both of the following factors:

a) Schematic of fractures in U10E gusset plates (base drawing by FHWA).

b. Node U10E in lay-down yard, west elevation facing up.

Figure 4.27. Node U10E gusset plate fractures locations.

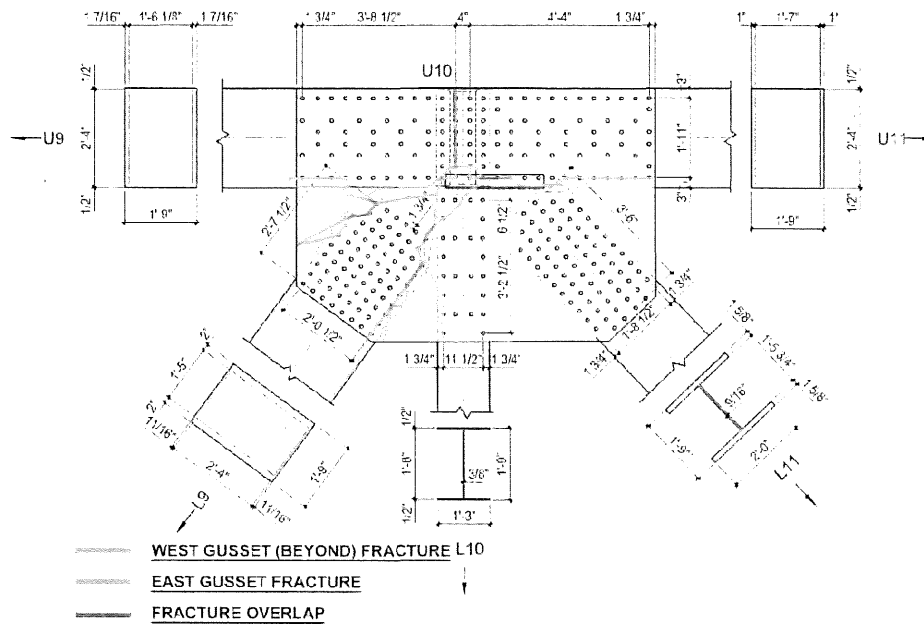
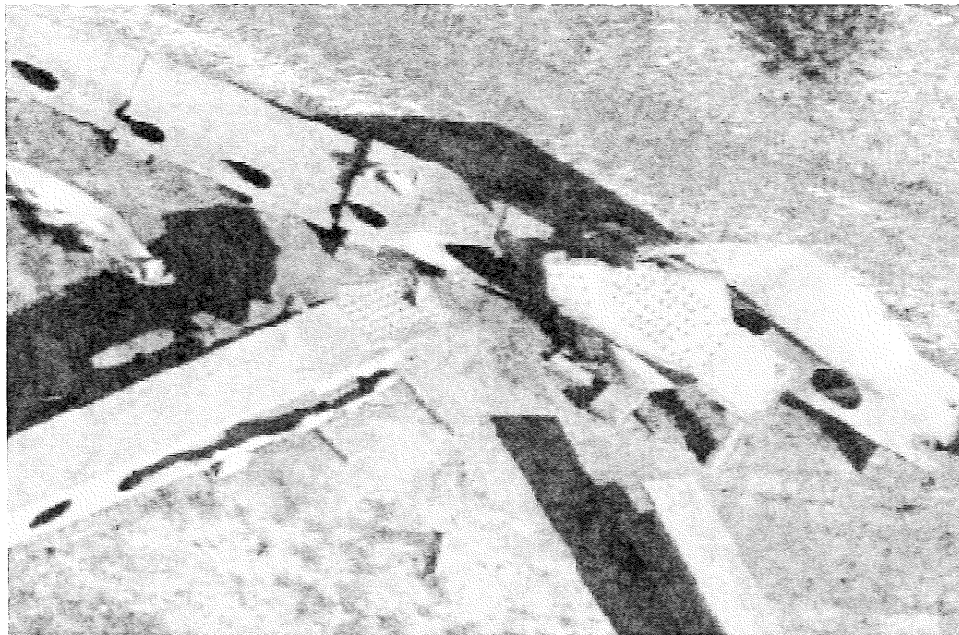
a) Schematic of fractures in U10W gusset plates (base drawing by FHWA).

b) Node U10W in lay-down yard, east elevation facing up.

Figure 4.28. Node U10W gusset plate fracture locations.

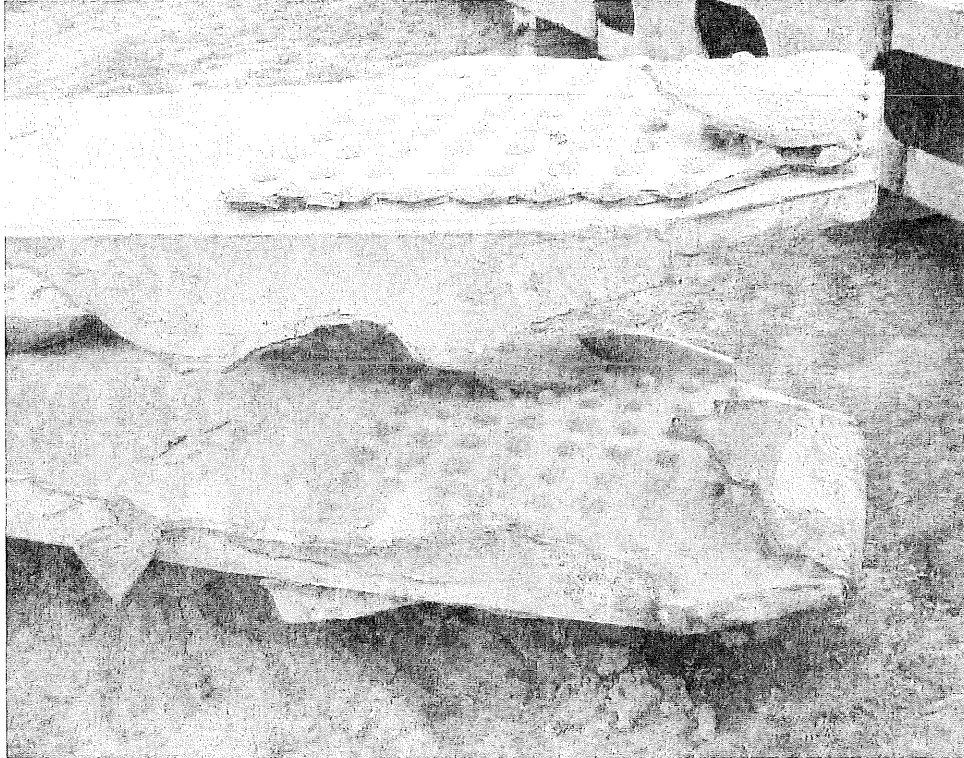
Figure 4.29. L9-U10W, U10W end, east elevation facing up.

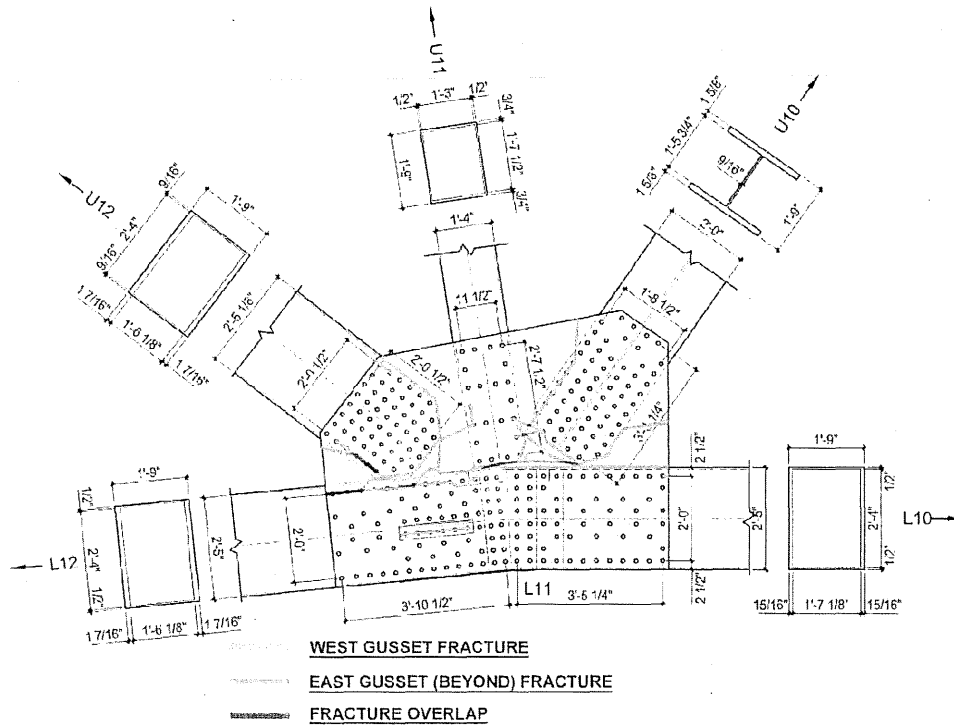
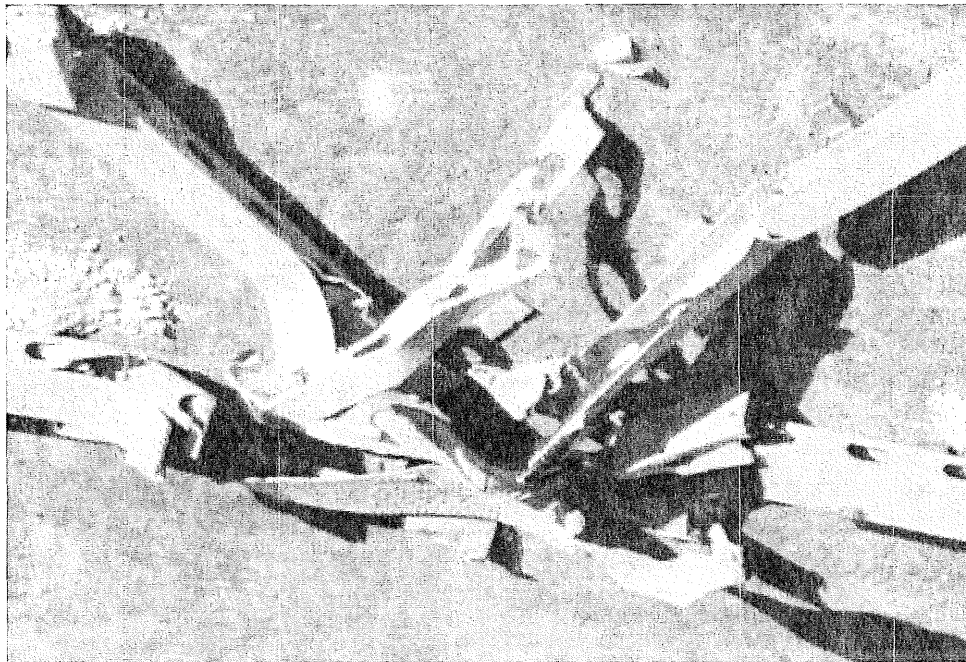
a) Schematic of fractures in L11E gusset plates (base drawing by FHWA).

b) Node L11E in lay-down yard, west elevation facing up.

Figure 4.33. Node L11E gusset plate fracture locations.

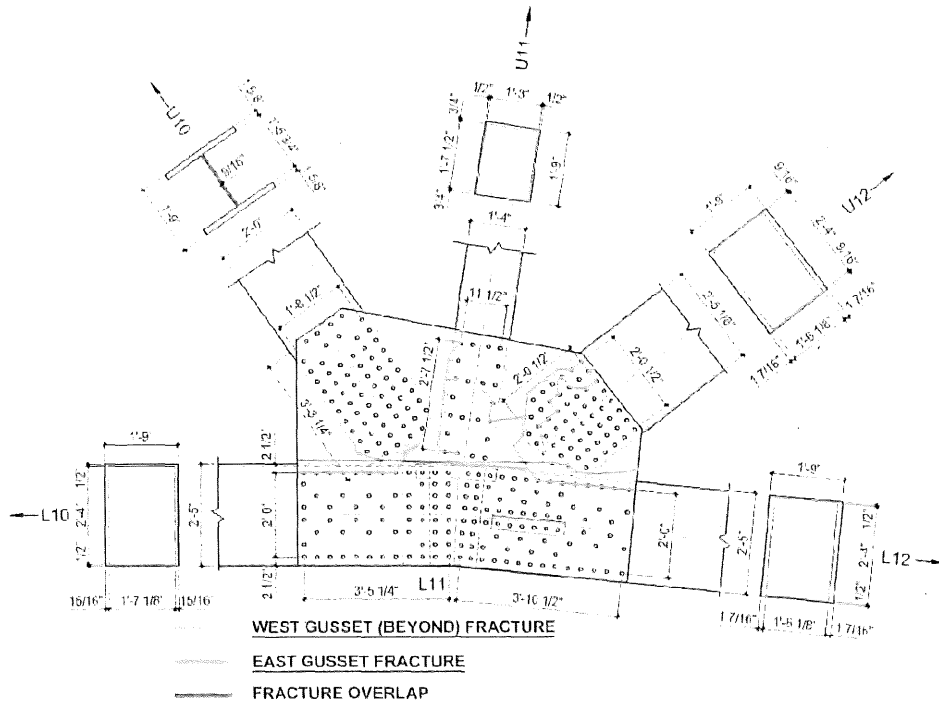
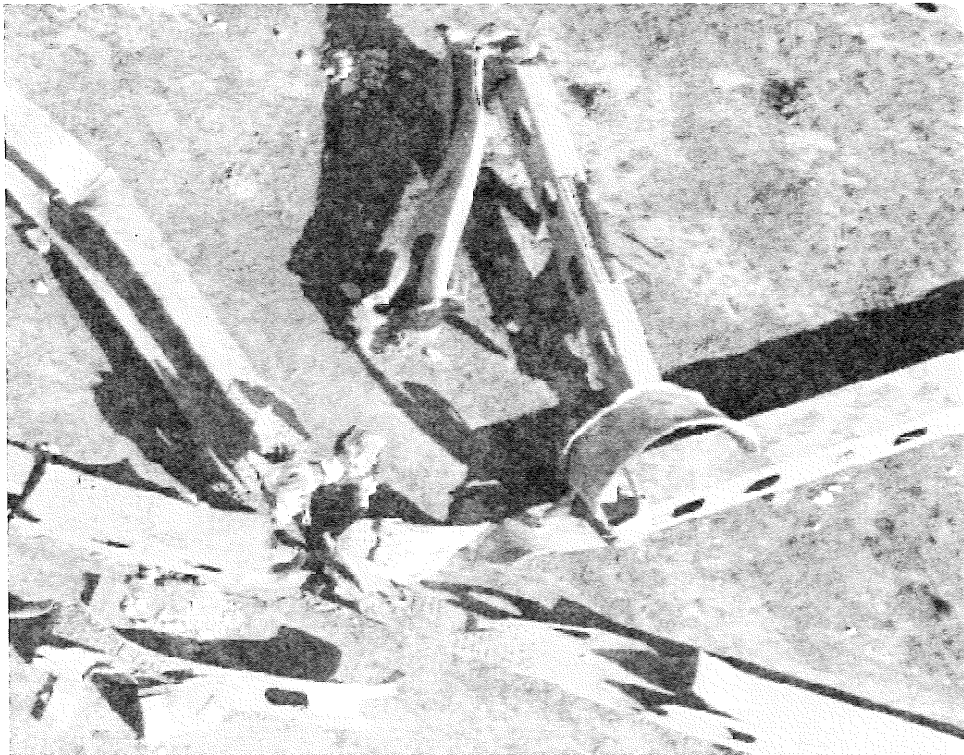
a) Schematic of fractures in L11W gusset plates (base drawing by FHWA).

b) Node L11W in lay-down yard, east elevation facing up.

Figure 4.34. Node L11W gusset plate fracture locations.

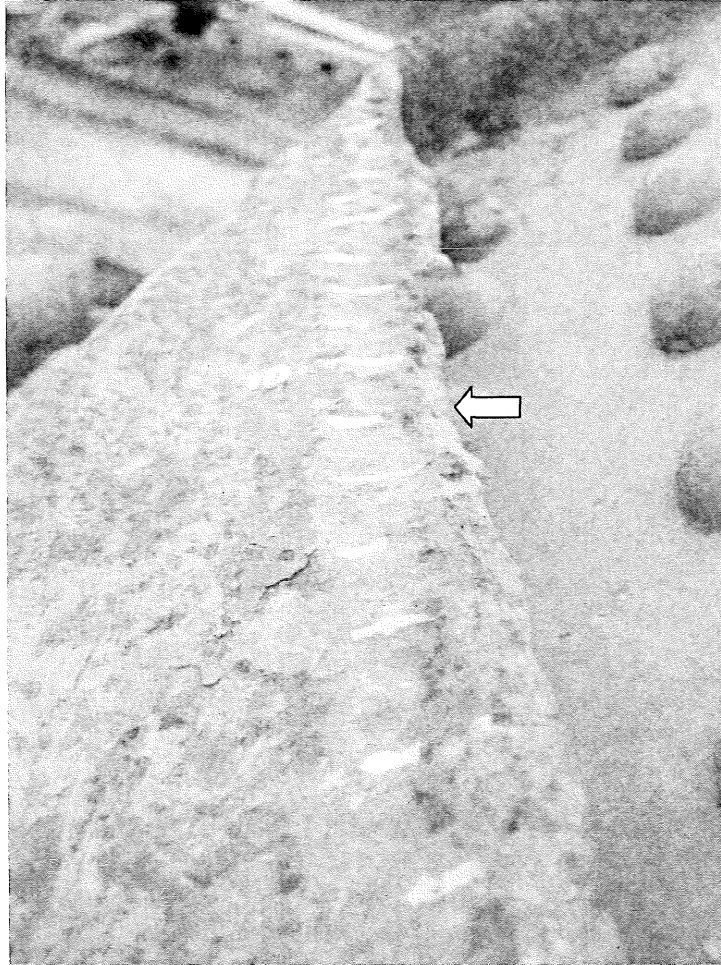
Figure 4.37. Pitting resulting from corrosion near the fracture surface of L11W. Note fractured edge adjacent to plate section loss.

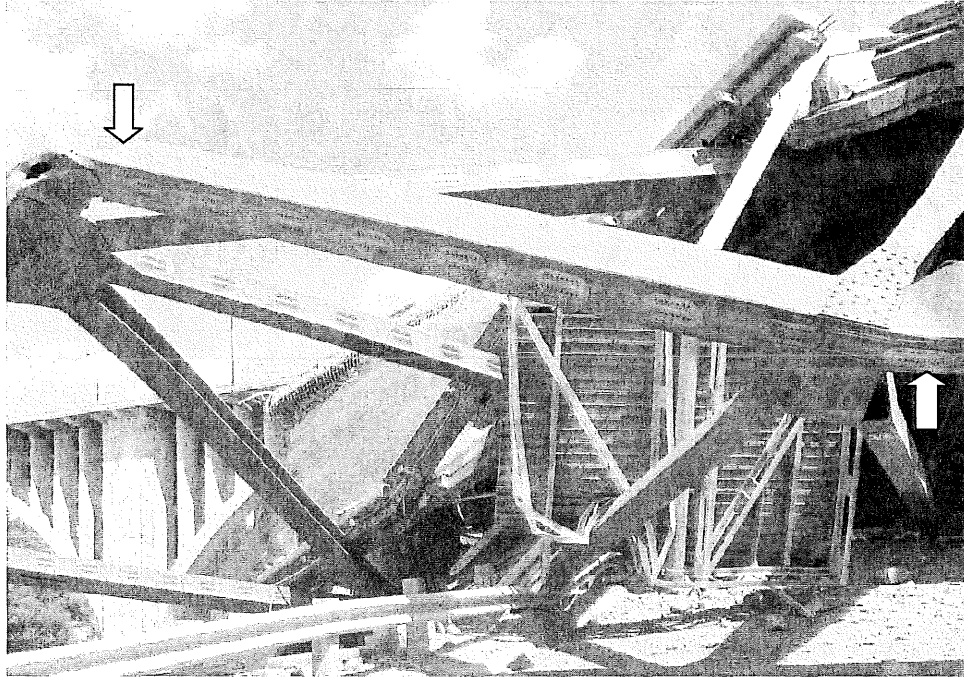
Figure 4.38. Lower chord L6W-L7W looking east. Note plastic hinging south of Node L7W and south of Node L6W.

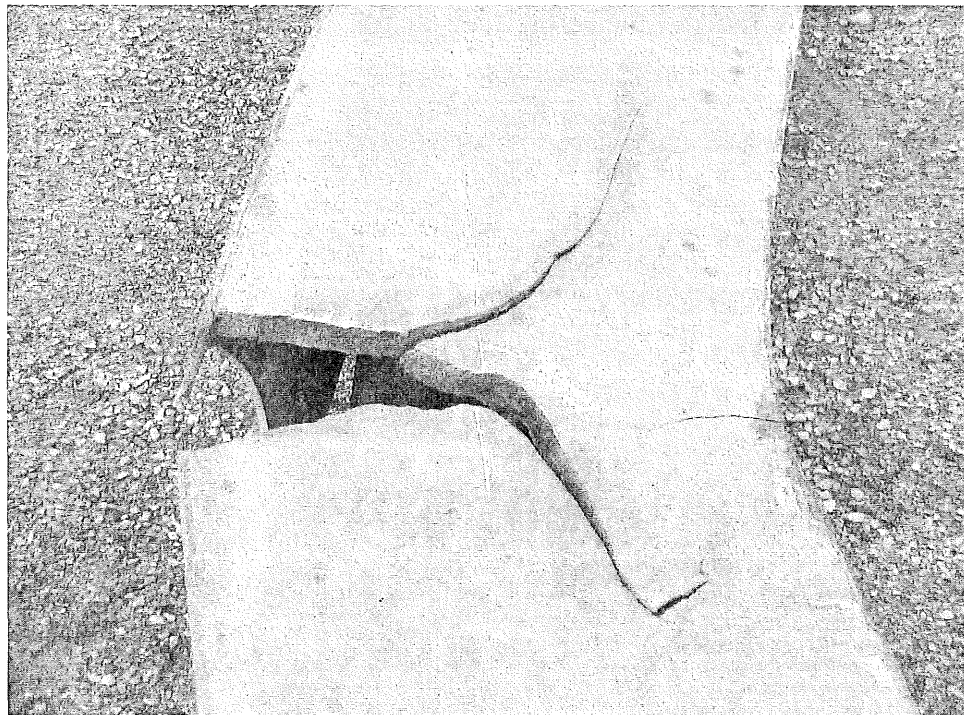
Figure 4.39. Partial fracture in Lower Chord L7E-L8E.

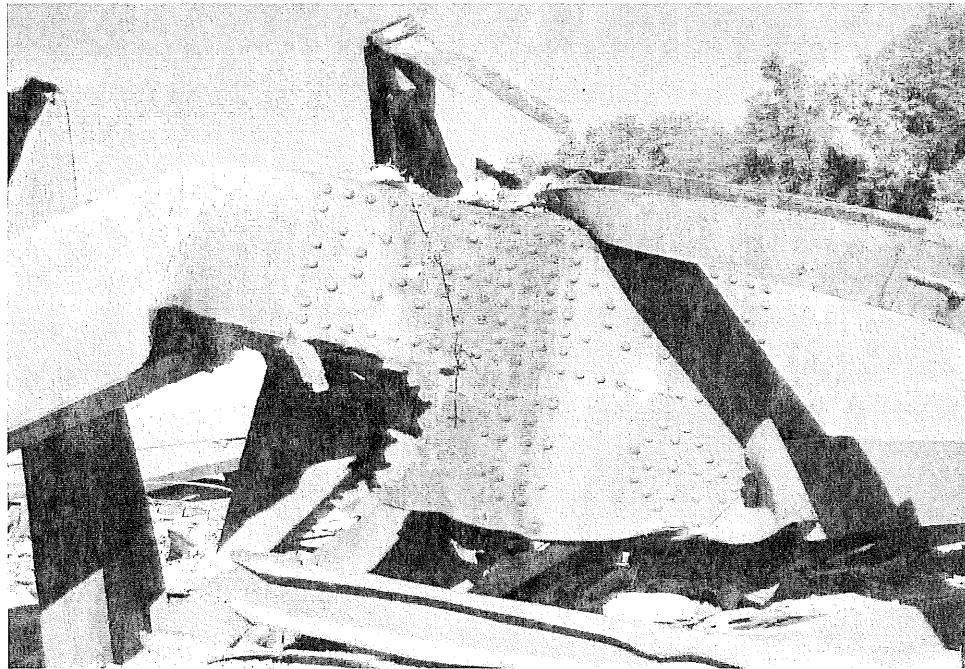
Figure 4.43. Corrosion on east gusset at U4'E.

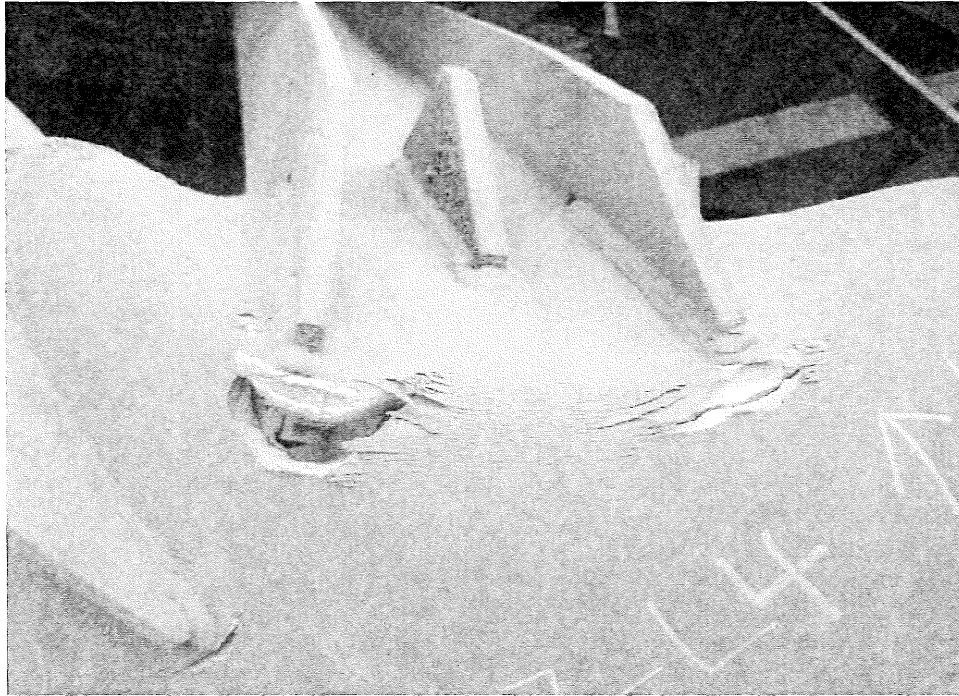
Figure 4.44. Tearing in gusset plate at flange tips of floor truss diagonals (FT7L4).

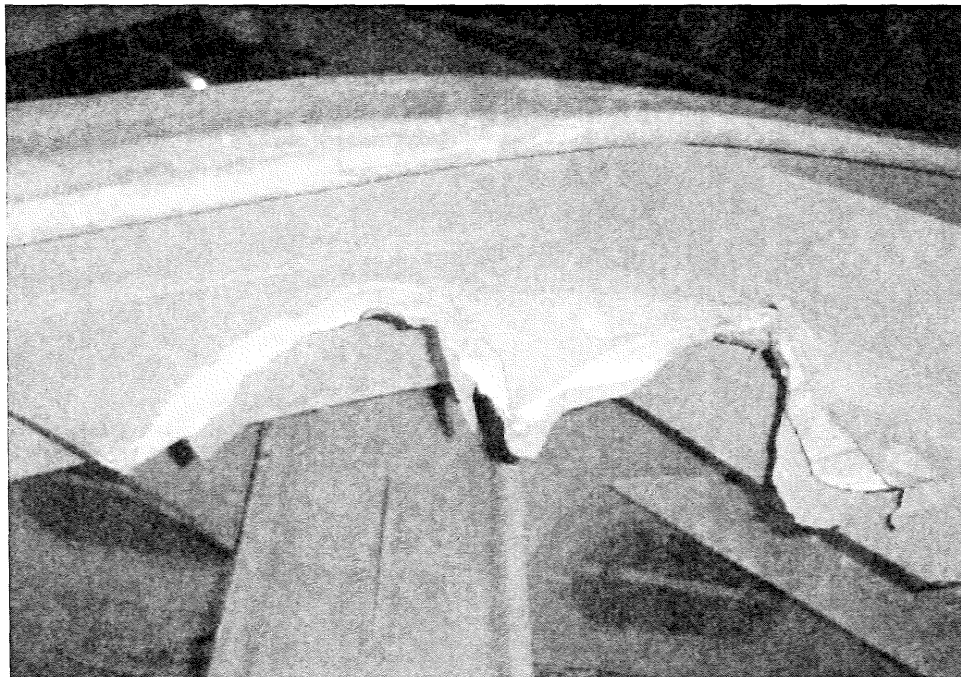
Figure 4.45. Fracture in gusset around floor truss diagonal (FT7U10).

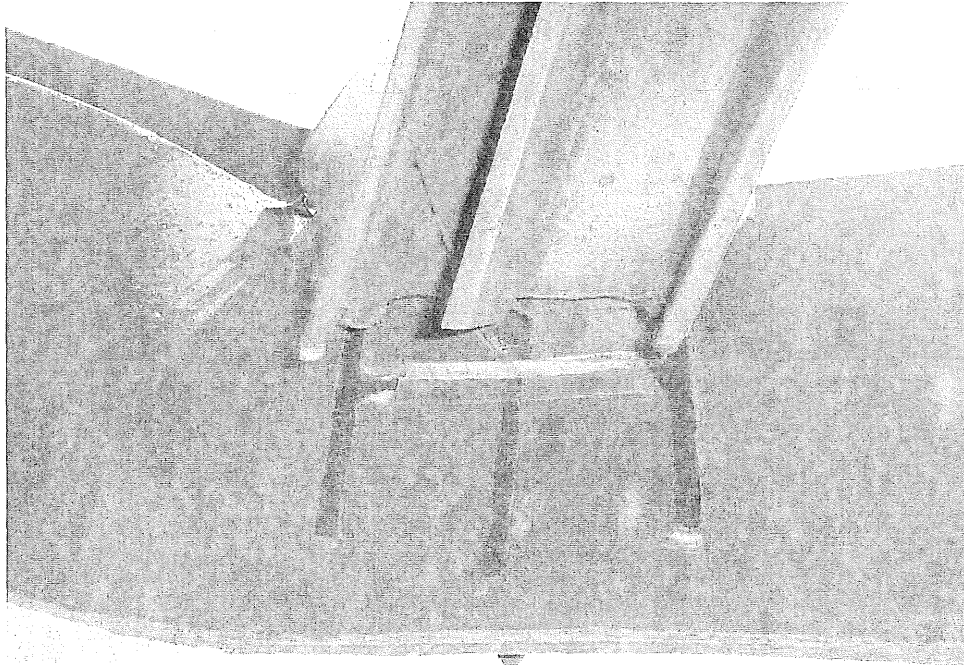
Figure 4.46. Separation of web diagonal from weld to upper chord (FT8U6).

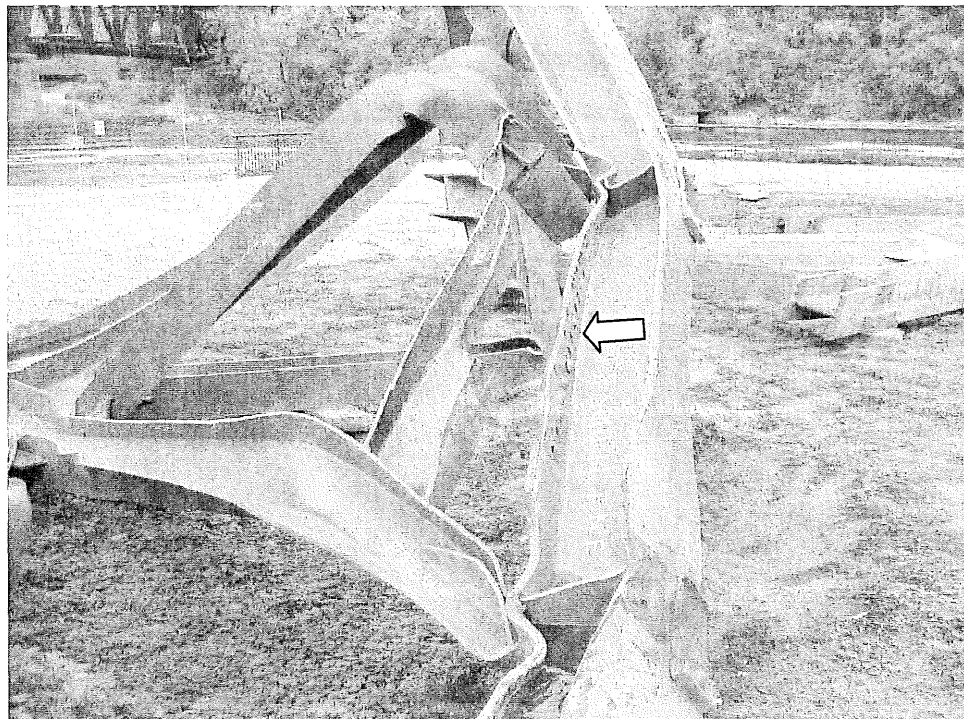
Figure 4.47. Fracture at connection of upper lateral braces to FT8.

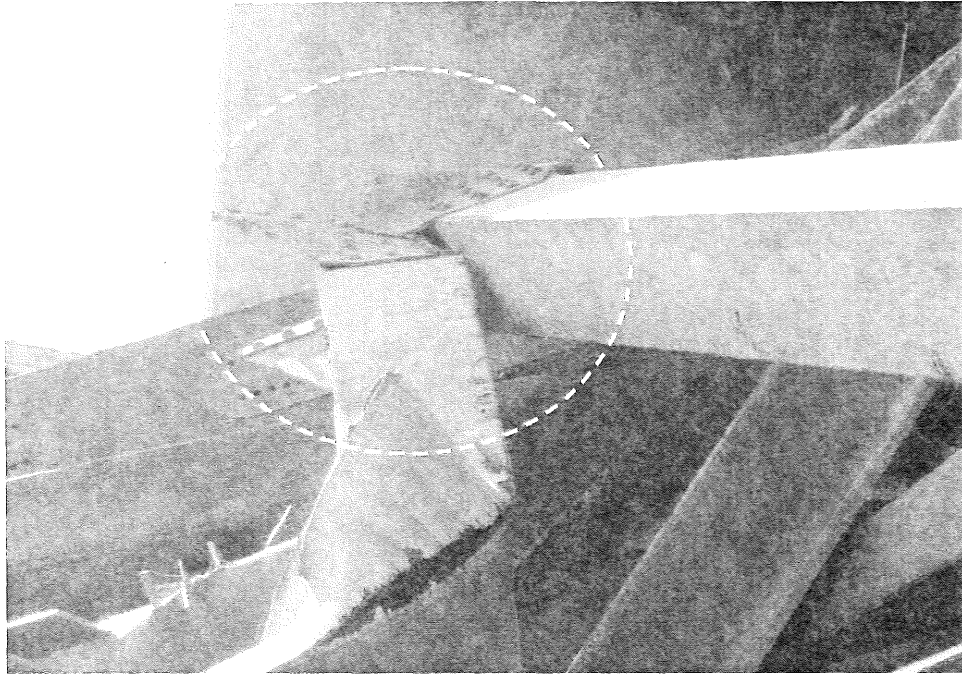
Figure 4.48. Detached end of mid-horizontal sway CM8-M8W and lower sway diagonal CL8-M8W.

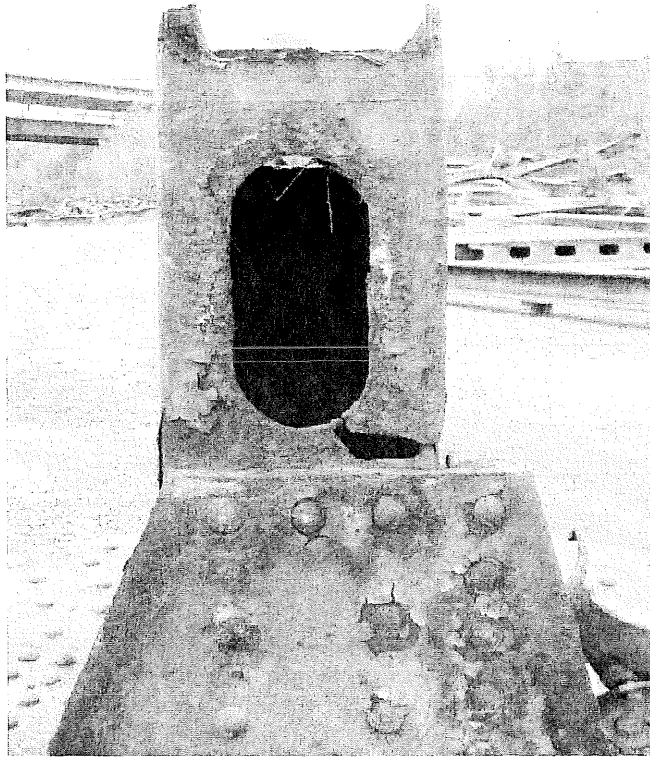
Figure 4.50. Corrosion on bottom of lower sway horizontal CL8'-L8'E at L8'E.

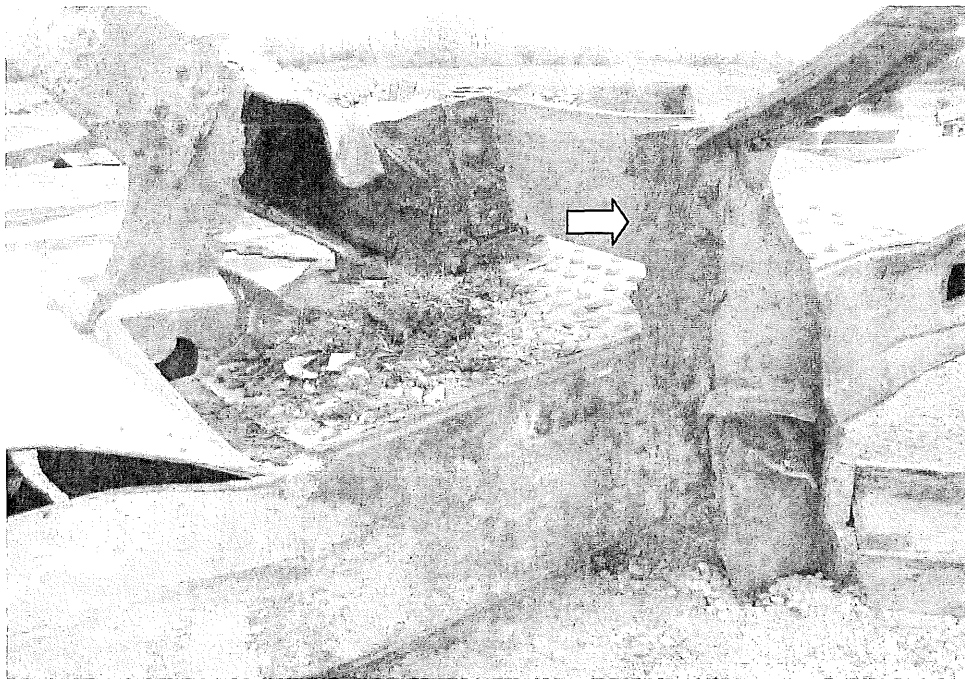
Figure 4.51. Corrosion on top connection plate to upper lateral at U4'E.

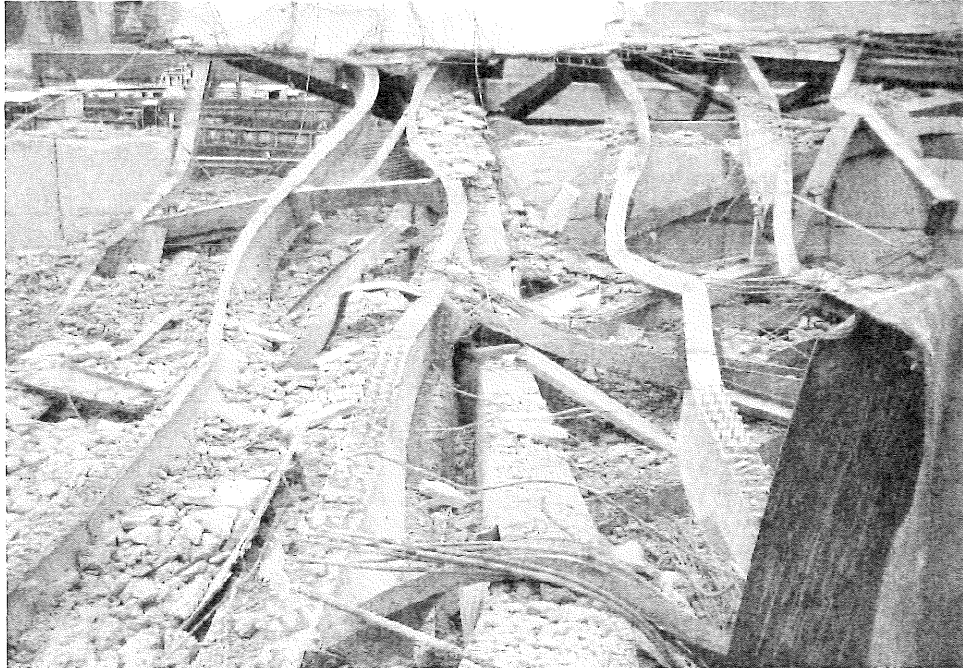
Figure 4.52. Typical distortion of stringers (Nodes 2' to 4', southbound lanes).

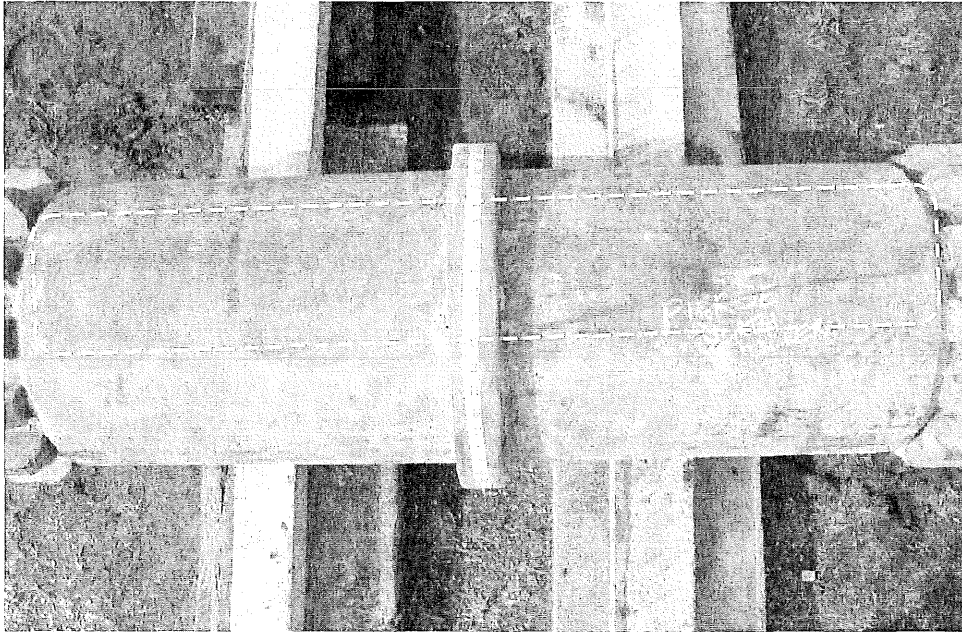
Figure 4.54. Wear marks on north roller of Pier 5 east bearing.

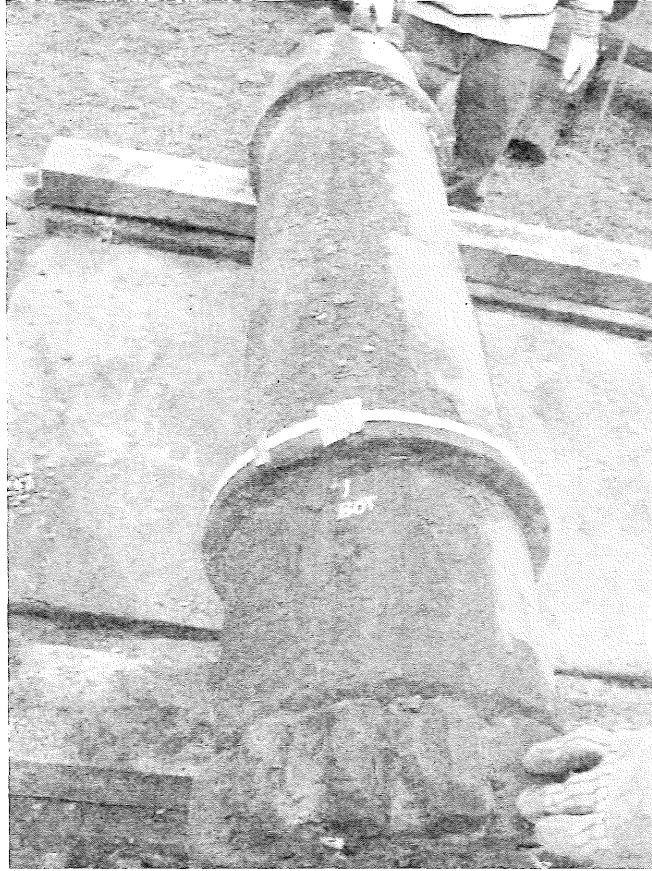
Figure 4.56. Corrosion on bottom of roller of west bearing at Pier 6.

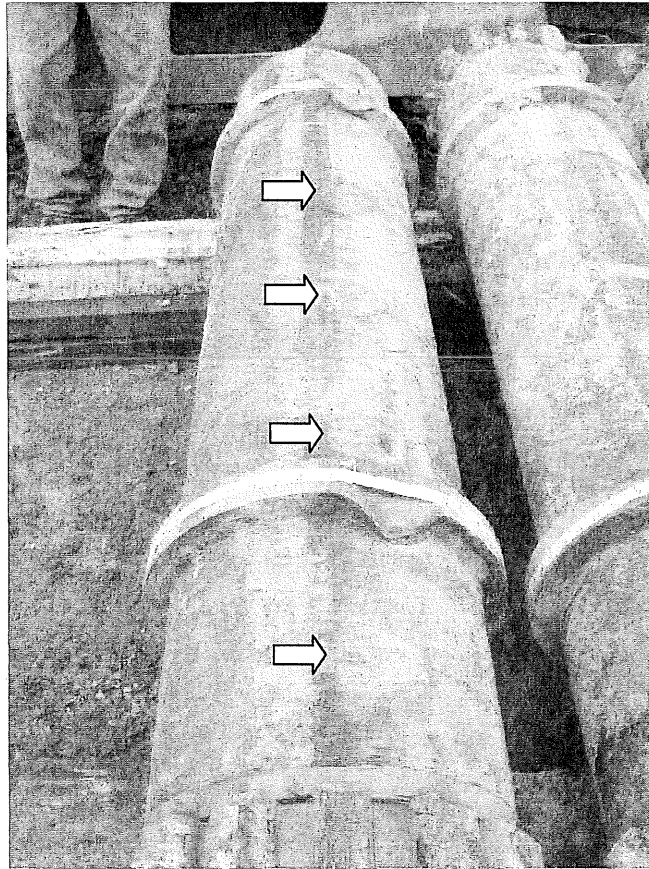
Figure 4.57. Impact markings from base plate anchor bolts on second roller from north in Pier 6E bearing.

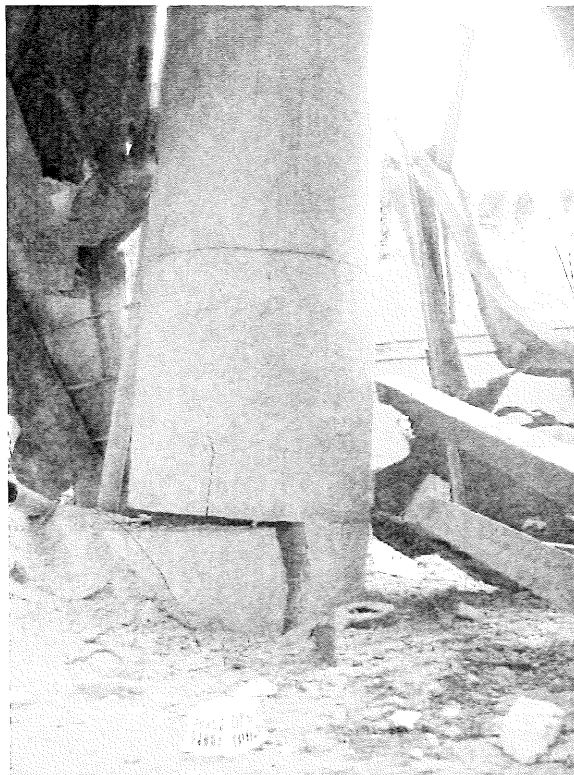
Figure 4.60. Pier 8 fractured at base.
