I-35W BRIDGE OVER THE MISSISSIPPI RIVER: COLLAPSE INVESTIGATION

BRIDGE NO. 9340
MINNEAPOLIS, MINNESOTA

FINAL REPORT
NOVEMBER 2008
WJE No. 2007.3702

Prepared for:
Minnesota Department of Transportation
Bridge Office
Oakdale, Minnesota

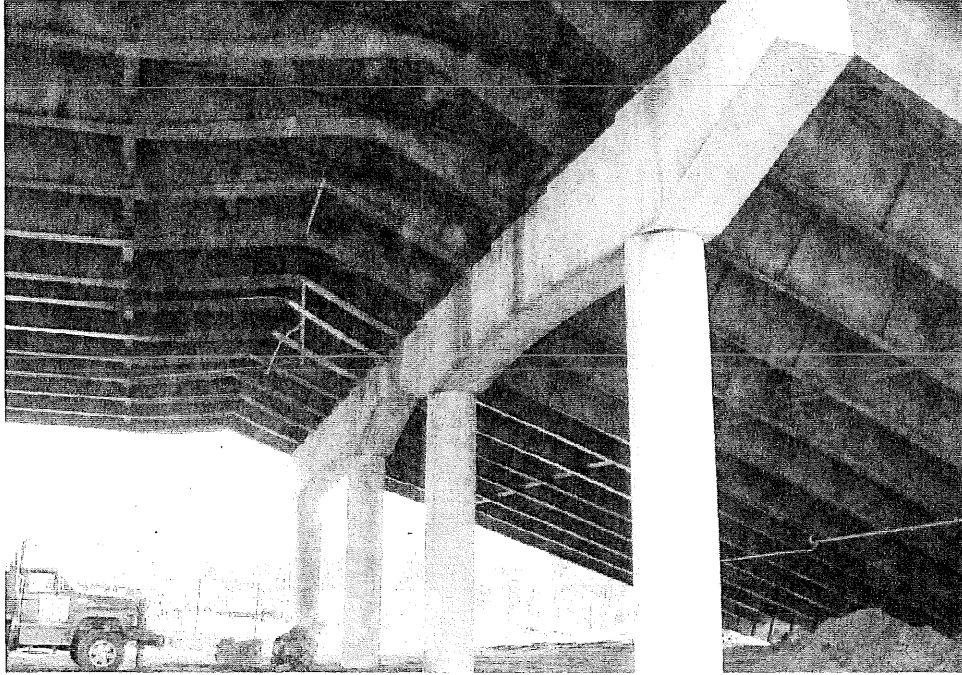
Figure 4.61. Plastic hinging in steel girders south of Pier 4, looking west.

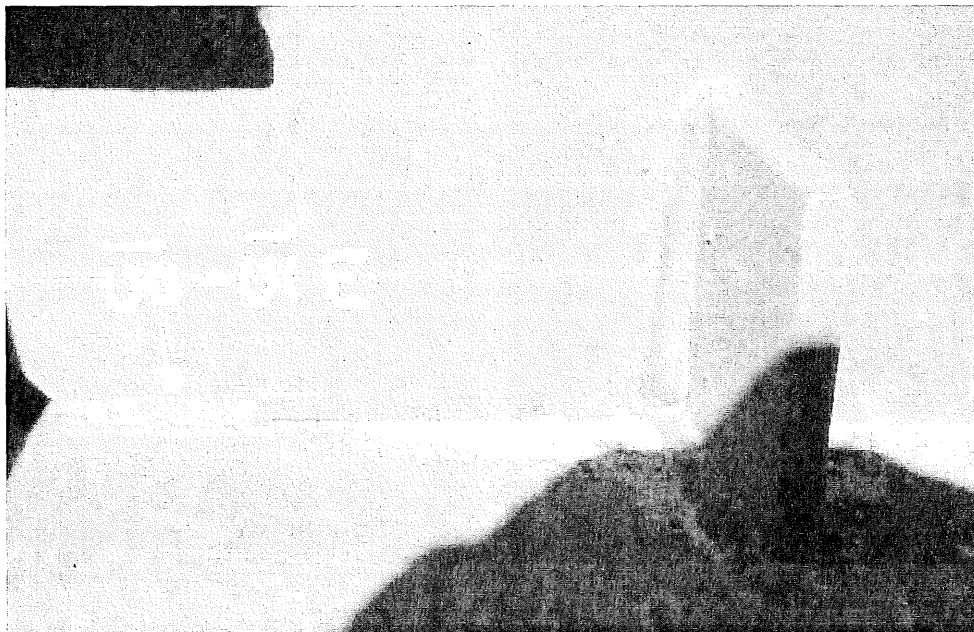
Figure 4.71. Typical cracked tack weld at an intermediate diaphragm.

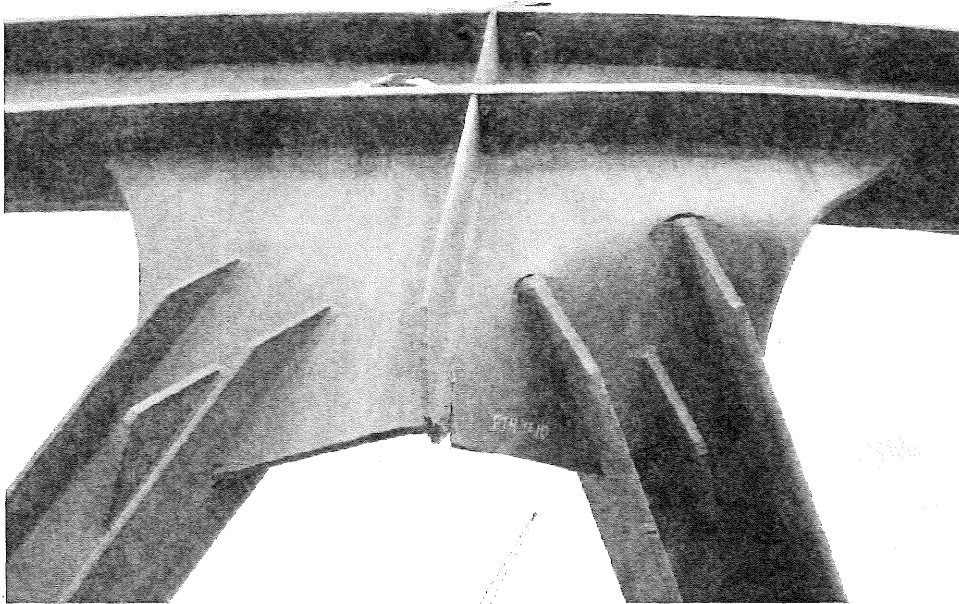
Figure 4.74. Typical cracking at floor truss weld terminations due to collapse.

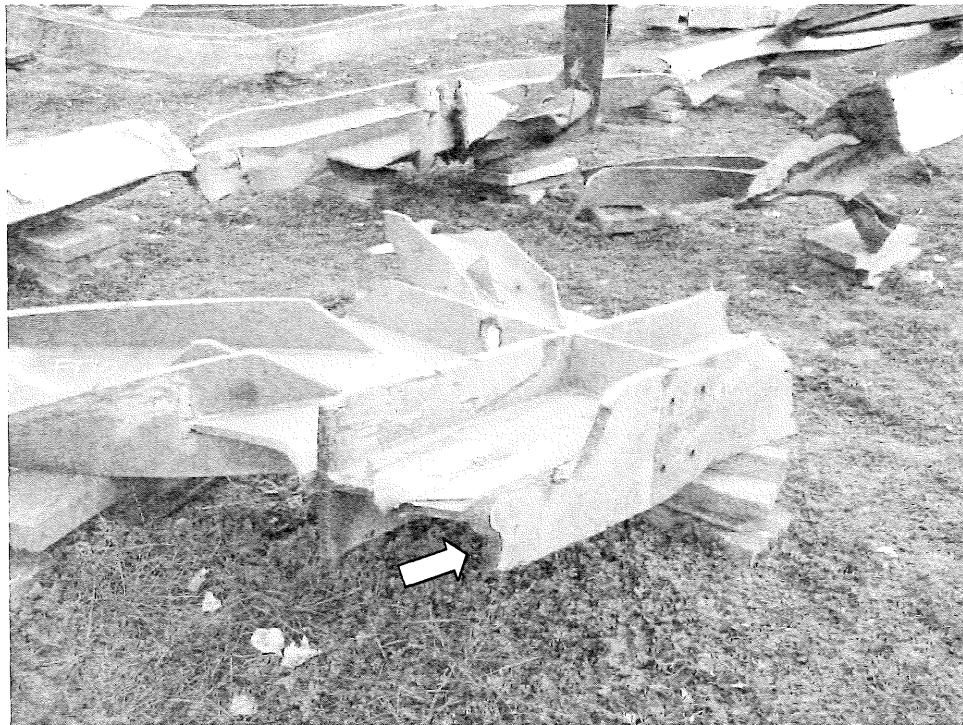
Figure 4.75. Fracture in the top chord of FT10 near Node U10 East. View looking west.

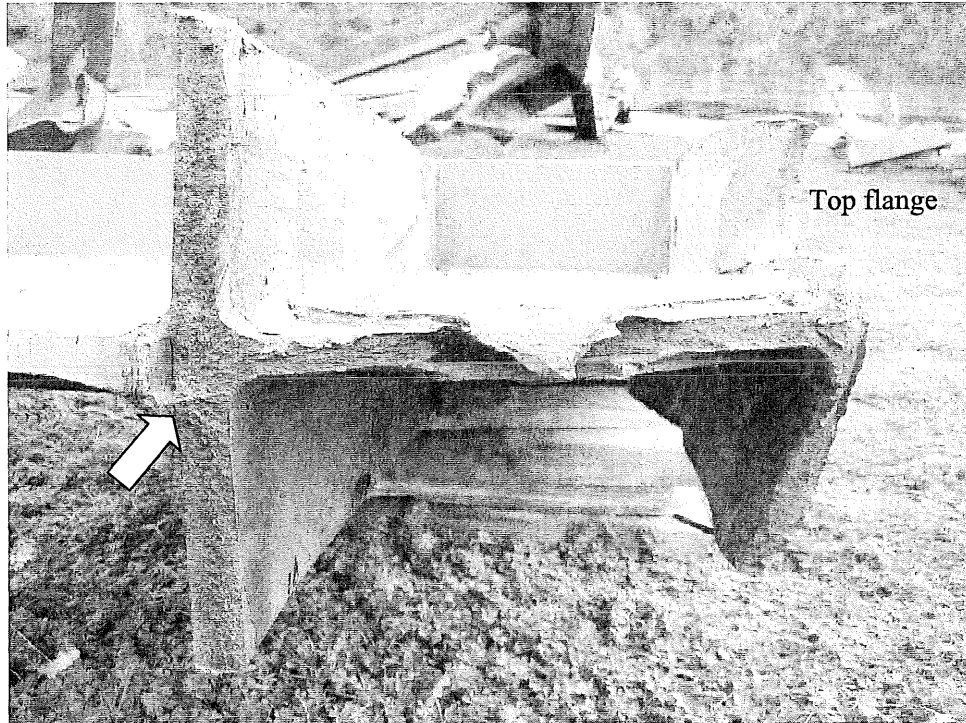
Figure 4.76. Close-up of fracture. Arrow indicates the origin location.

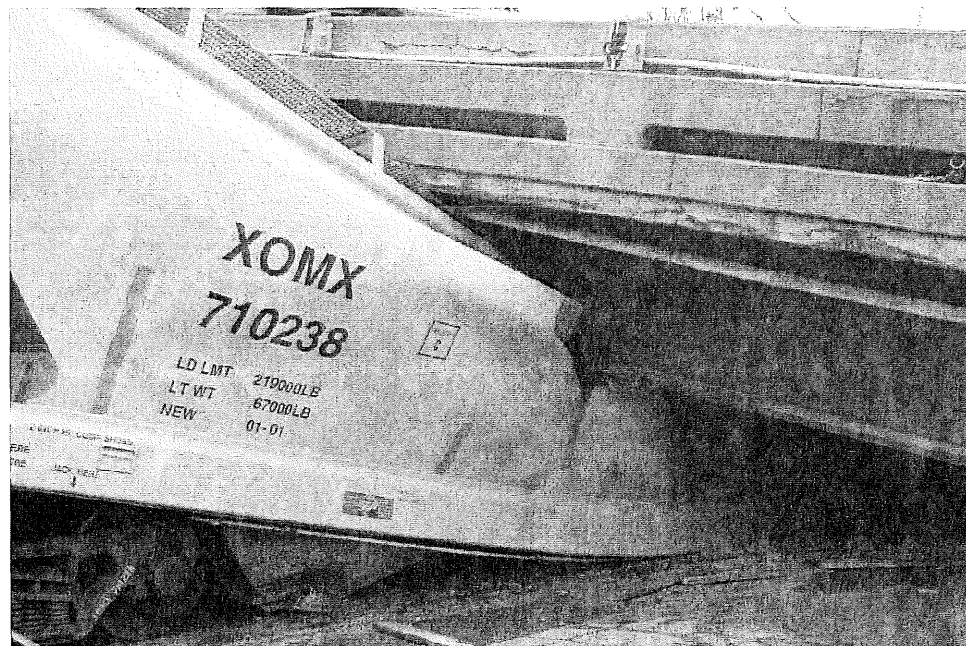
Figure 4.77. Railcar crushed under north approach.

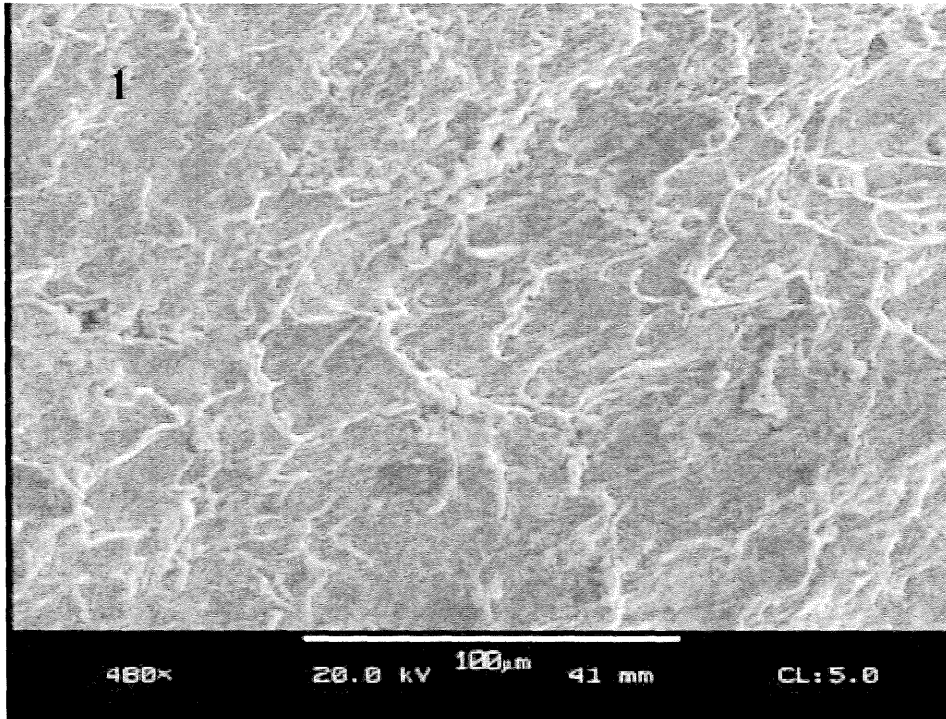
SEM examination by Fisher confirmed the characteristic brittle and ductile fracture surfaces on either side of the non-characteristic fracture surface. The isolated non-characteristic fracture surface shows evidence of rubbing or abrasion. This surface was further examined and identified by Fisher to contain ductile shear dimple features near the brittle fracture boundary. Refer to Figure 5.12. The orientations of the dimples were found to be consistent and indicative of a shear direction nearly parallel to the plate surface. Based on these observations, the uncharacteristic fracture surface is a continuation of the ductile tear region and not an independent crack.

Figure 5.12. Ductile shear dimples observed in location of non-characteristic fracture surface (courtesy Figure 4 of Fisher report).

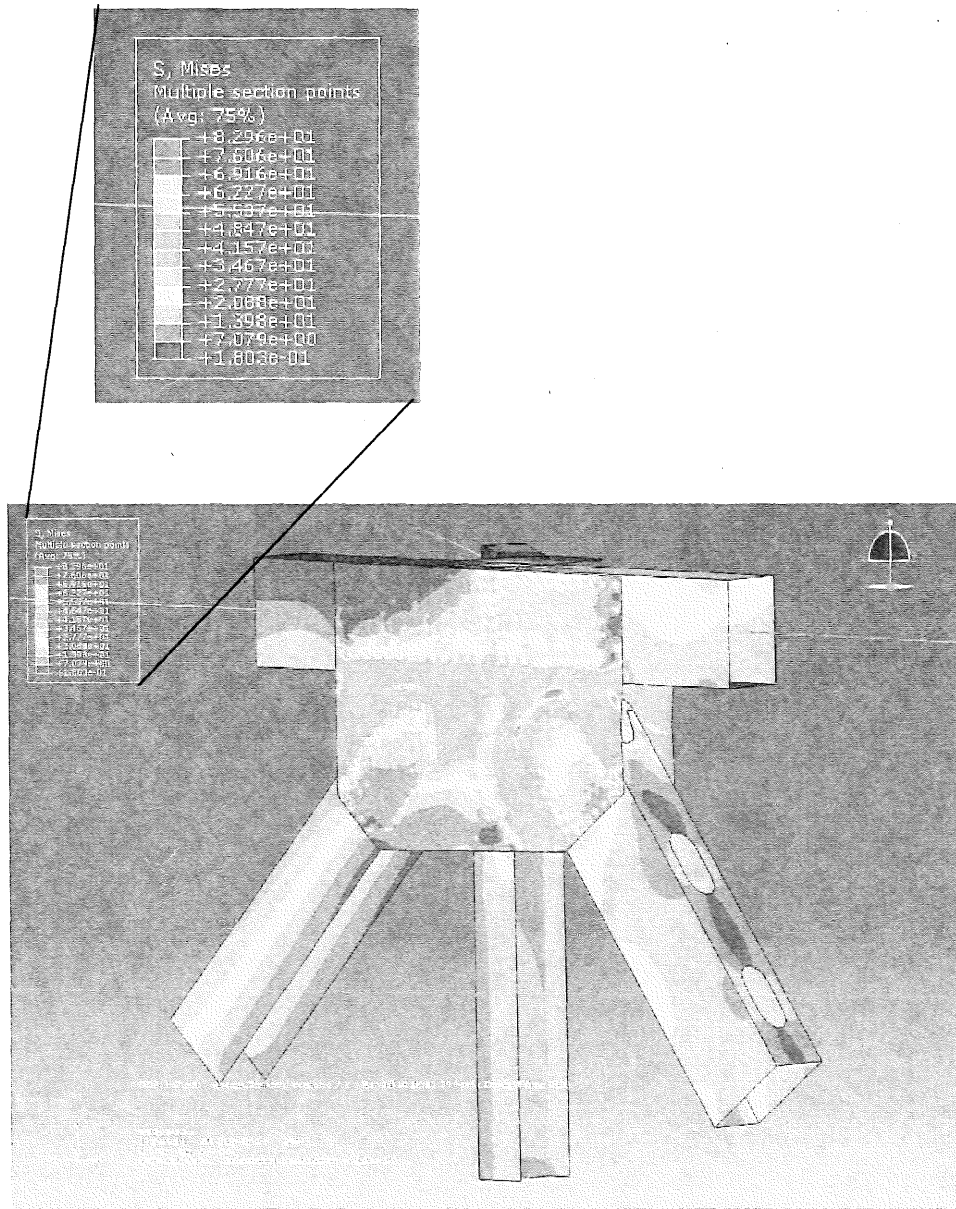
Figure 6.8. Abaqus plot showing stress levels at Node U10.
