# Testing of Alternative Asphalt Trail Surfaces for Resistance to Damage from Snowmobiles With Carbide Studs

*Minnesota Department of Natural Resources  
in cooperation with the Minnesota Asphalt Pavement Association and  
the Minnesota Department of Transportation Office of Materials and  
Road Research*

*December 15, 1998*

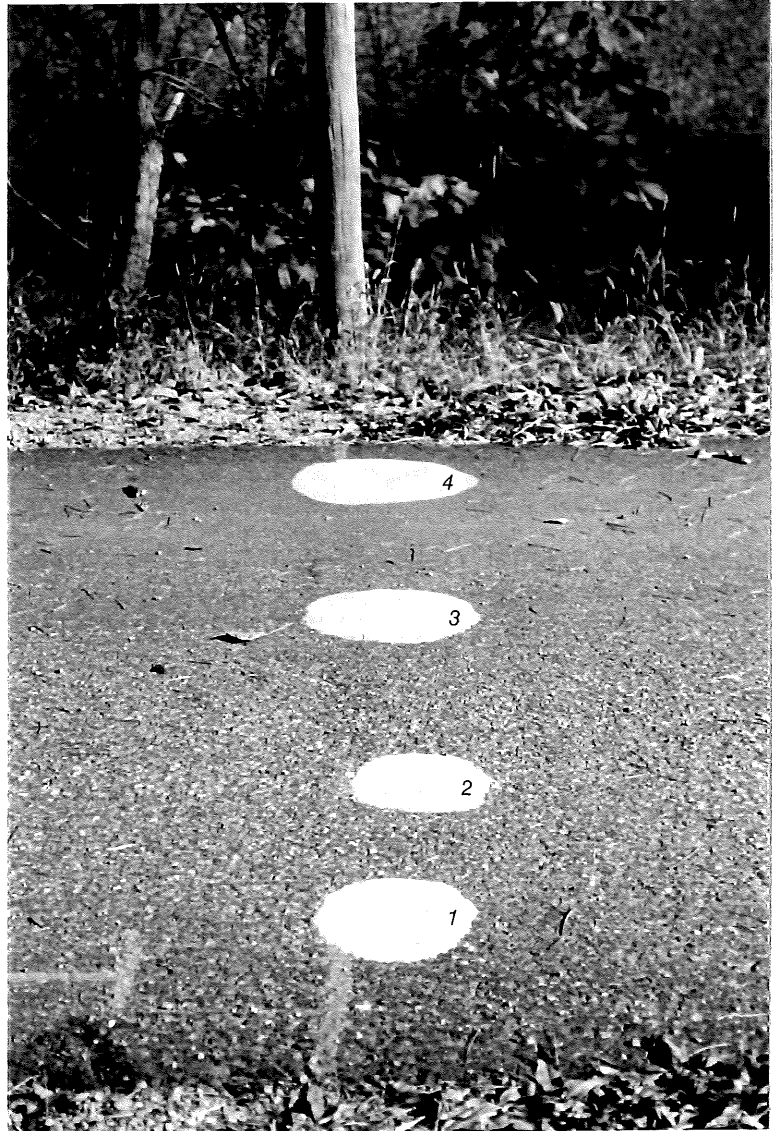
<u>(Average surface macrotexture depth) ASMD(inches)</u>	<u>Average Diameter (inches)</u>
Circle 1	.050	7.84
Circle 2	.052	7.72
Circle 3	.026	10.94
Circle 4	.016	13.91

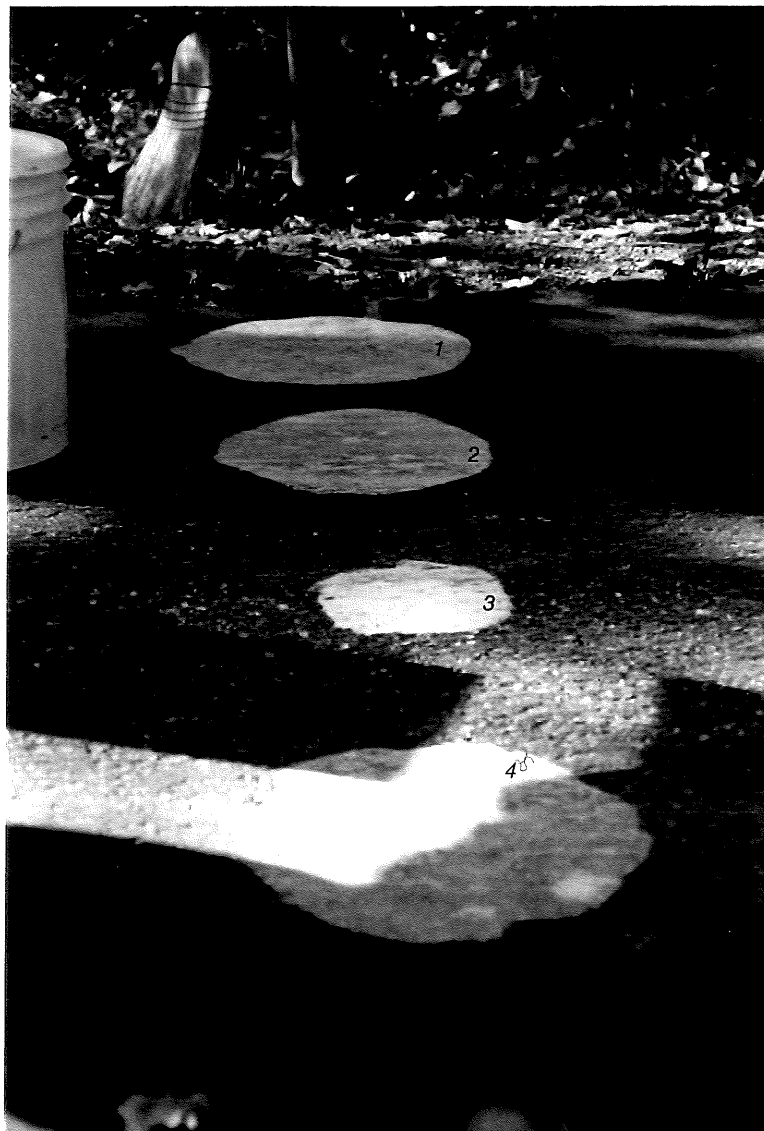
**Segment 2:** Luce Line State Trail and  
Hennepin County 19, West Approach

<u>ASMD</u> (in)	<u>Average</u> <u>Diameter</u> (in)
Circle 1	.012	15.75
Circle 2	.019	12.68
Circle 3	.055	7.53
Circle 4	.022	11.84

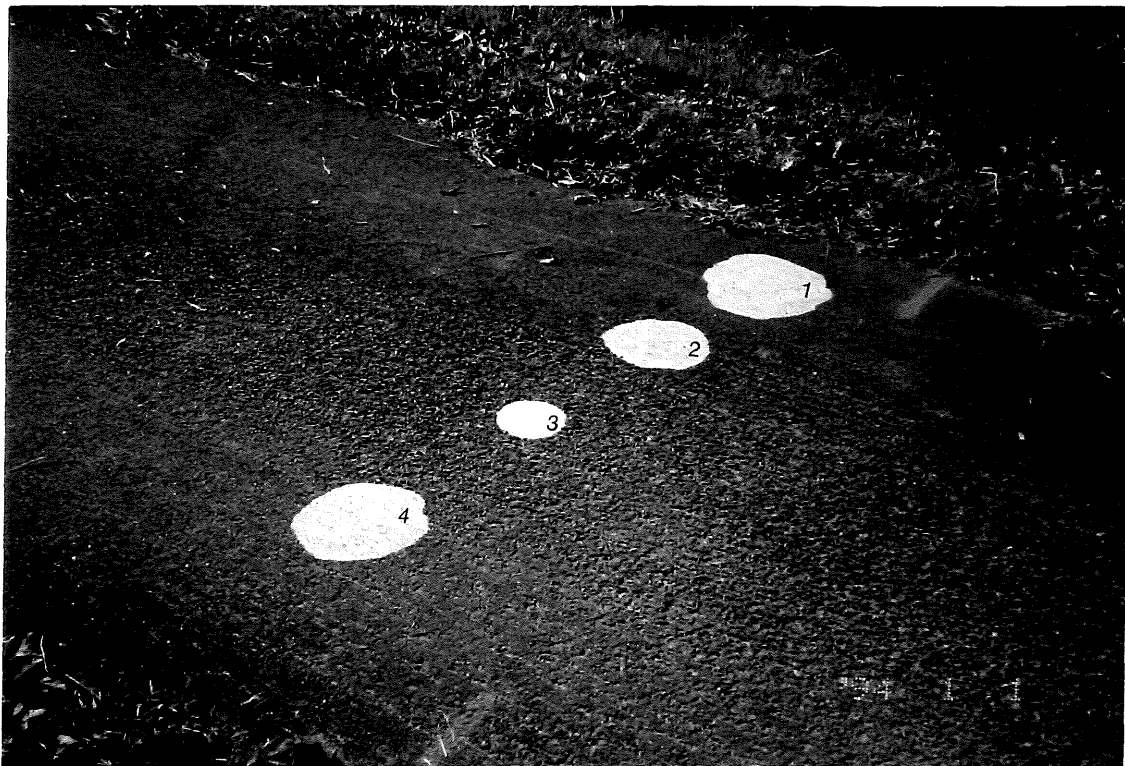
**Segment 3:** Luce Line State Trail and Hennepin County 110, East Approach

<u>ASMD(inches)</u>	<u>Average Diameter (inches)</u>
Circle 1	.018	12.94
Circle 2	.036	9.31
Circle 3	.096	5.69
Circle 4	.036	9.22

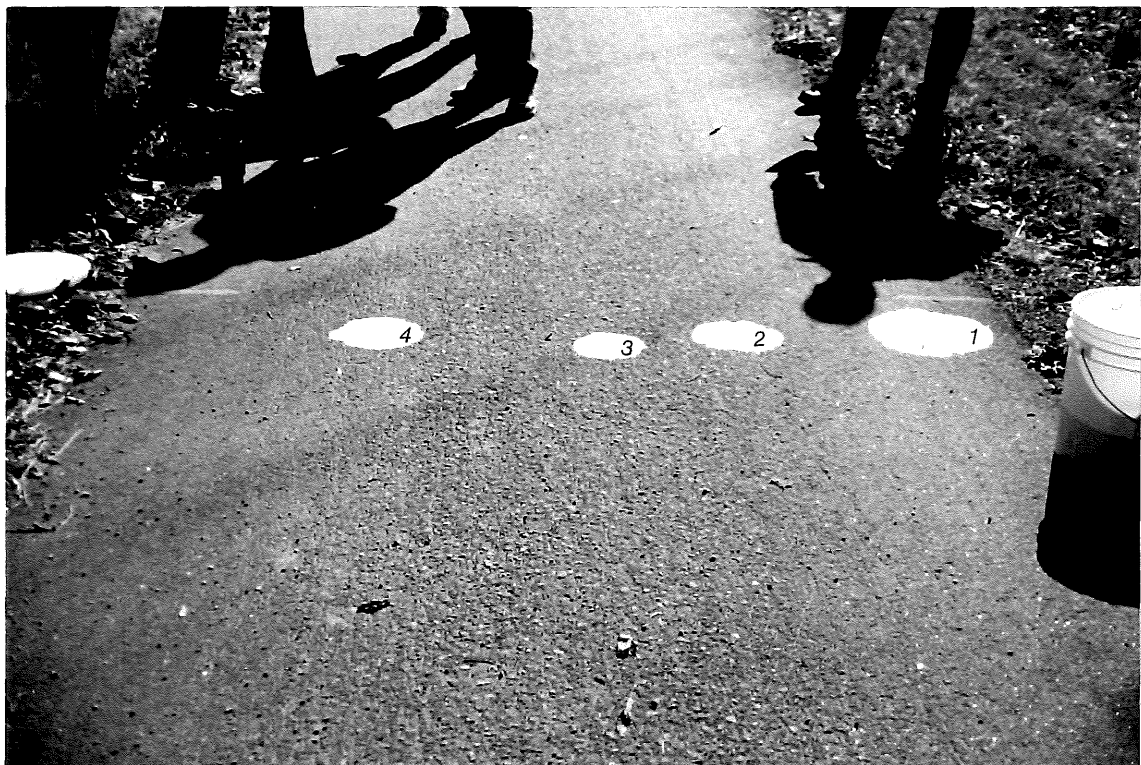
**Segment 4:** Luce Line State Trail and Hennepin County 110, West Approach

<u>ASMD (in)</u>	<u>Average Diameter (in)</u>
Circle 1	.018	13.00
Circle 2	.042	8.59
Circle 3	.063	7.00
Circle 4	.043	8.47

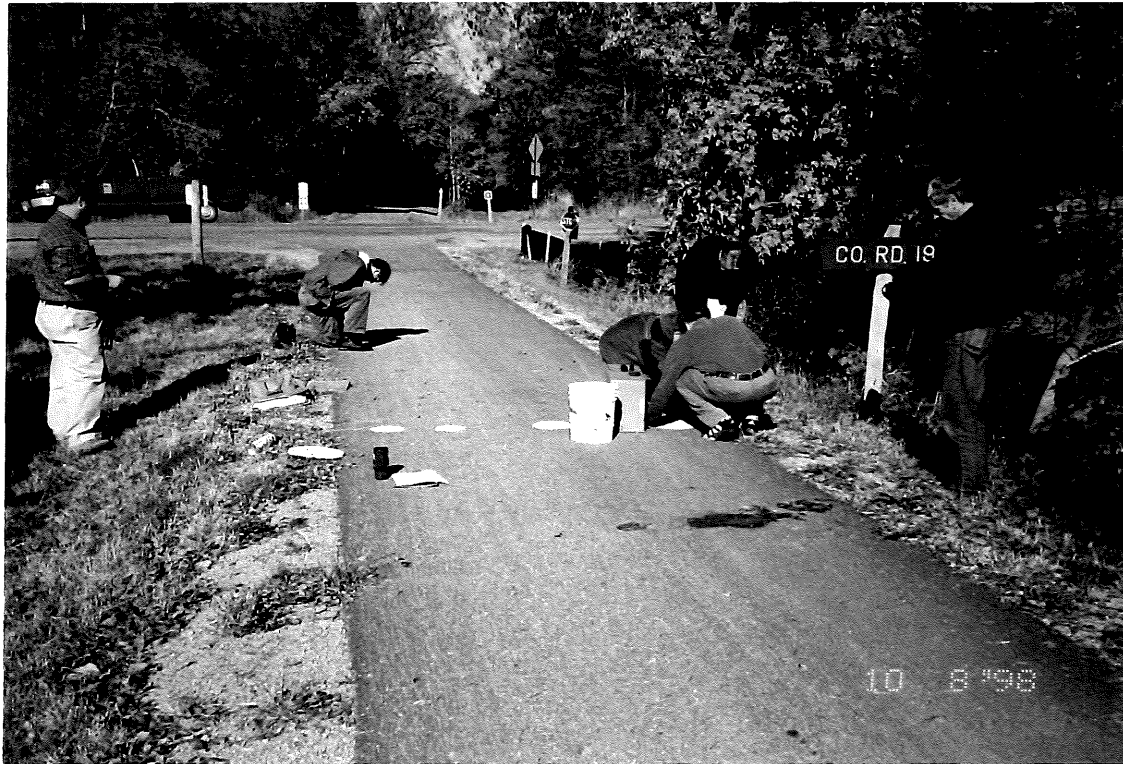
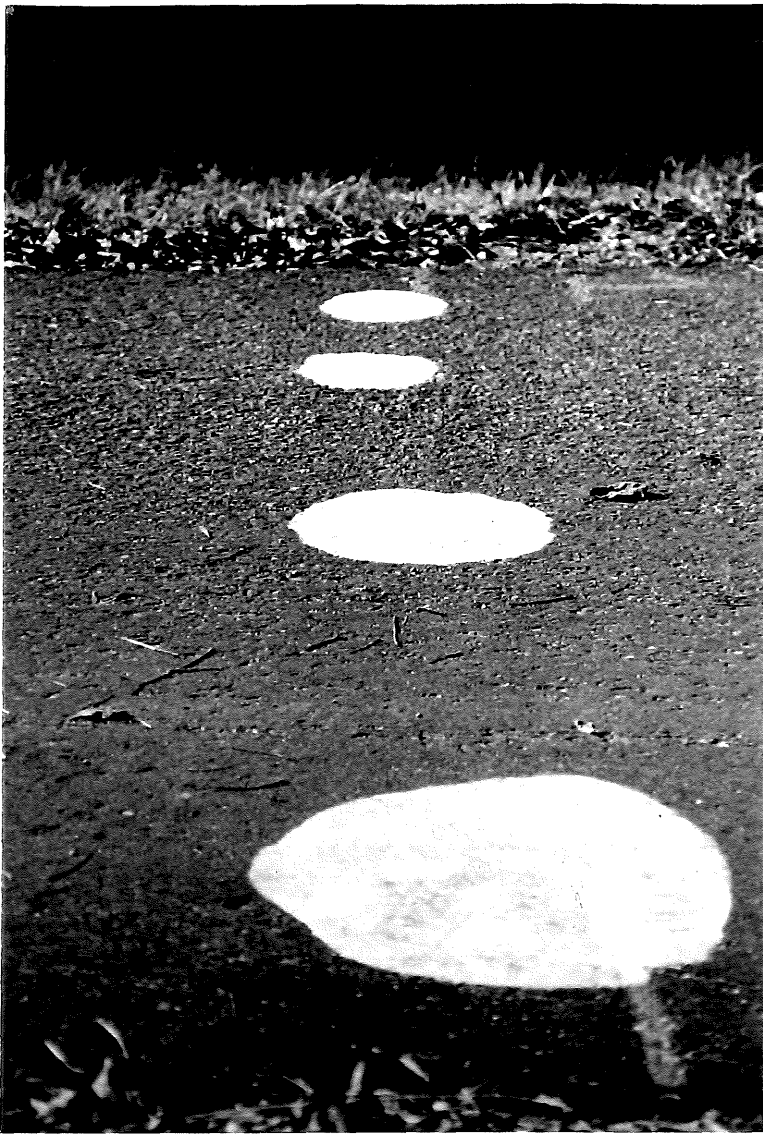
Segment 1 (Hennepin County 19, East, Type 41A)

**Segment 1 (19East, Type 41A):** This segment showed considerable abrasion and loss of aggregate on the south half of the trail, which would probably be the acceleration lane for snowmobiles that have crossed the intersection. The northern half of the trail is not as heavily damaged.

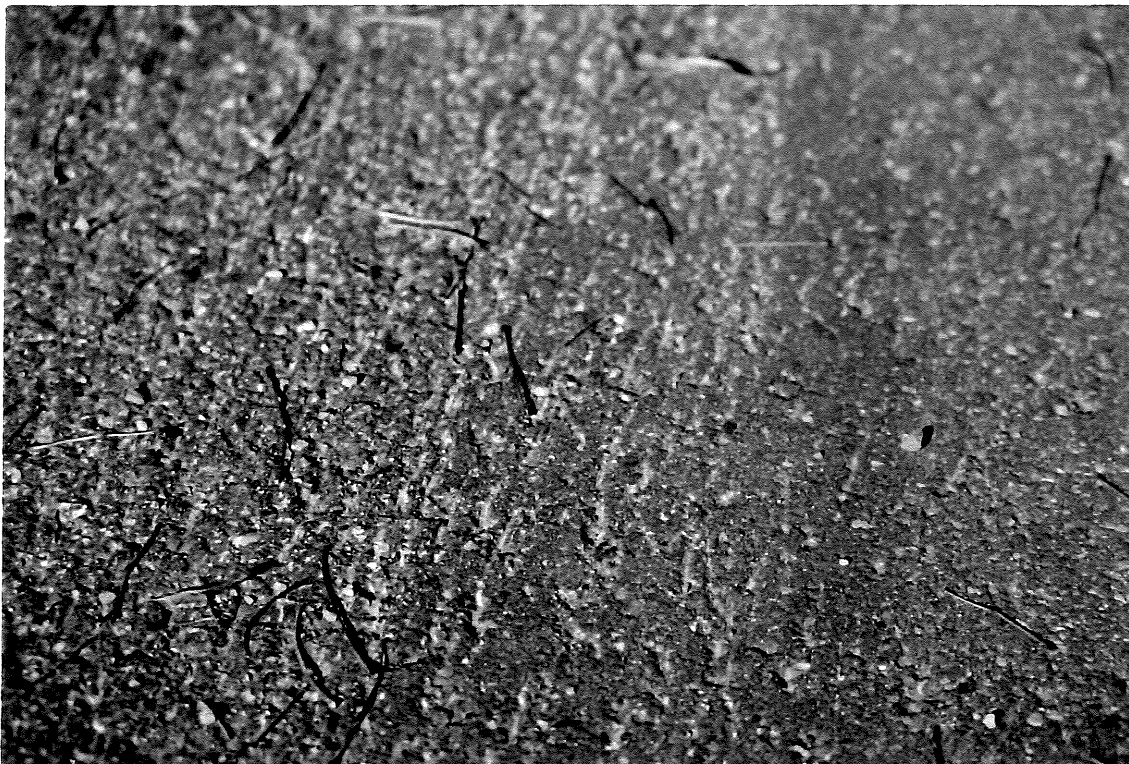
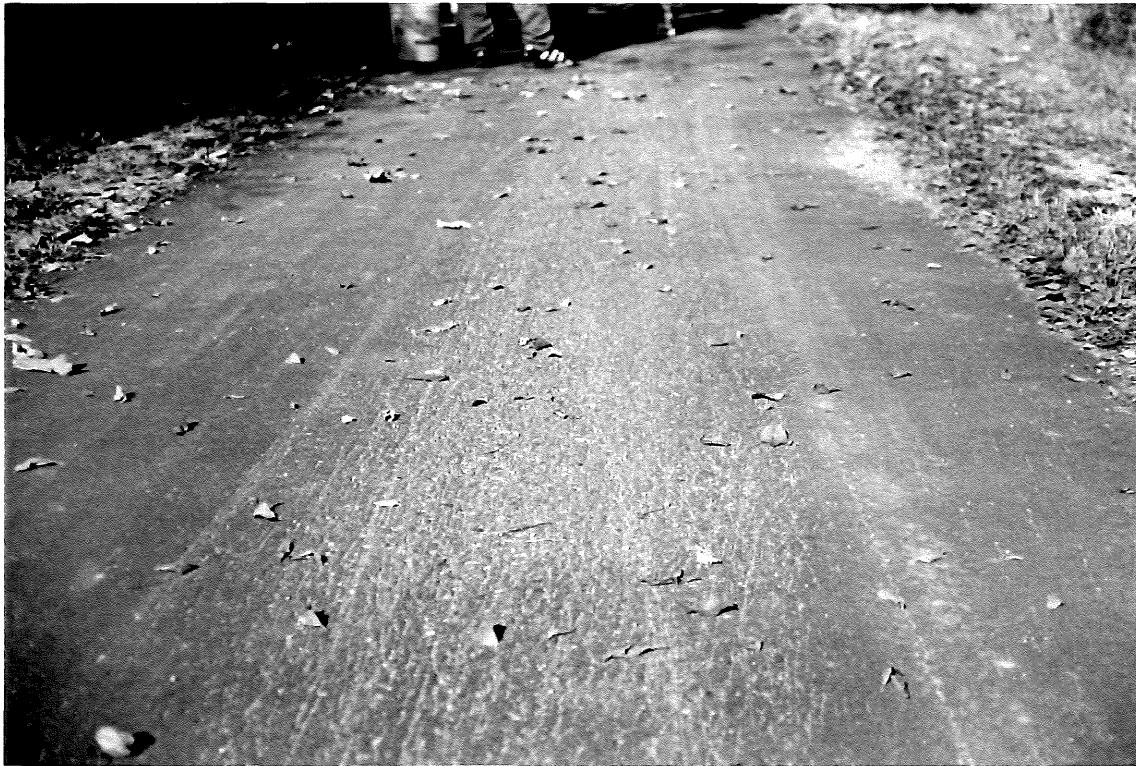
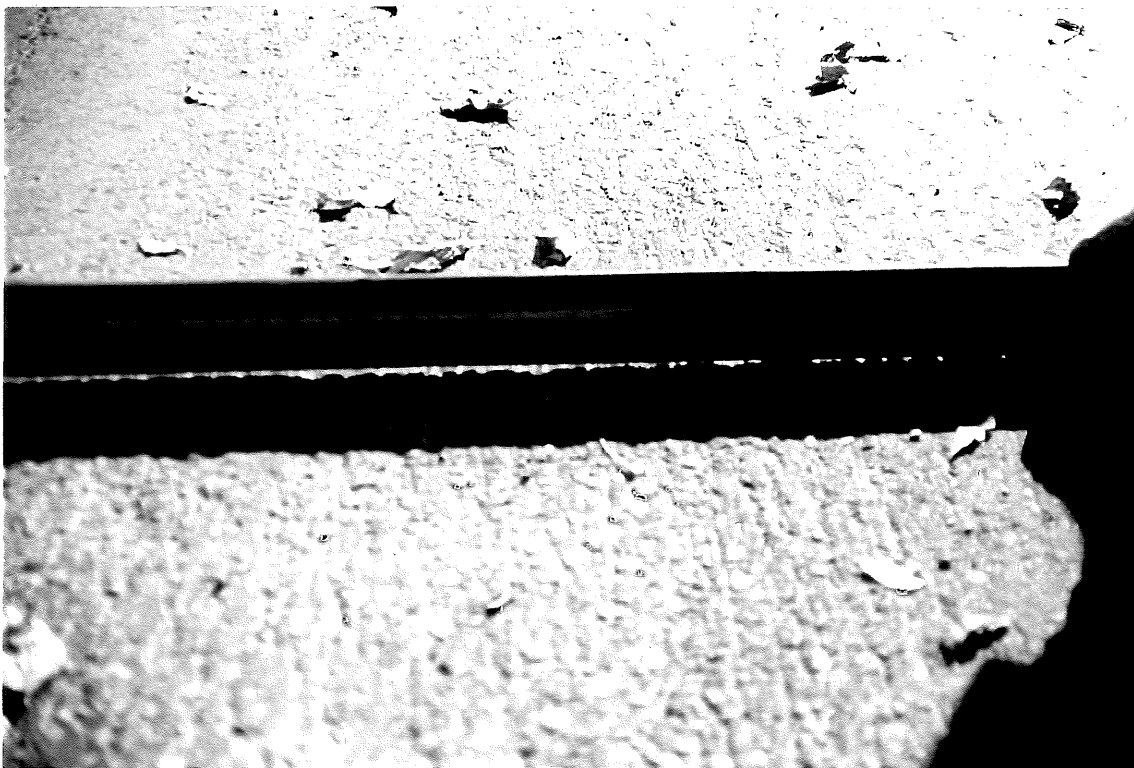
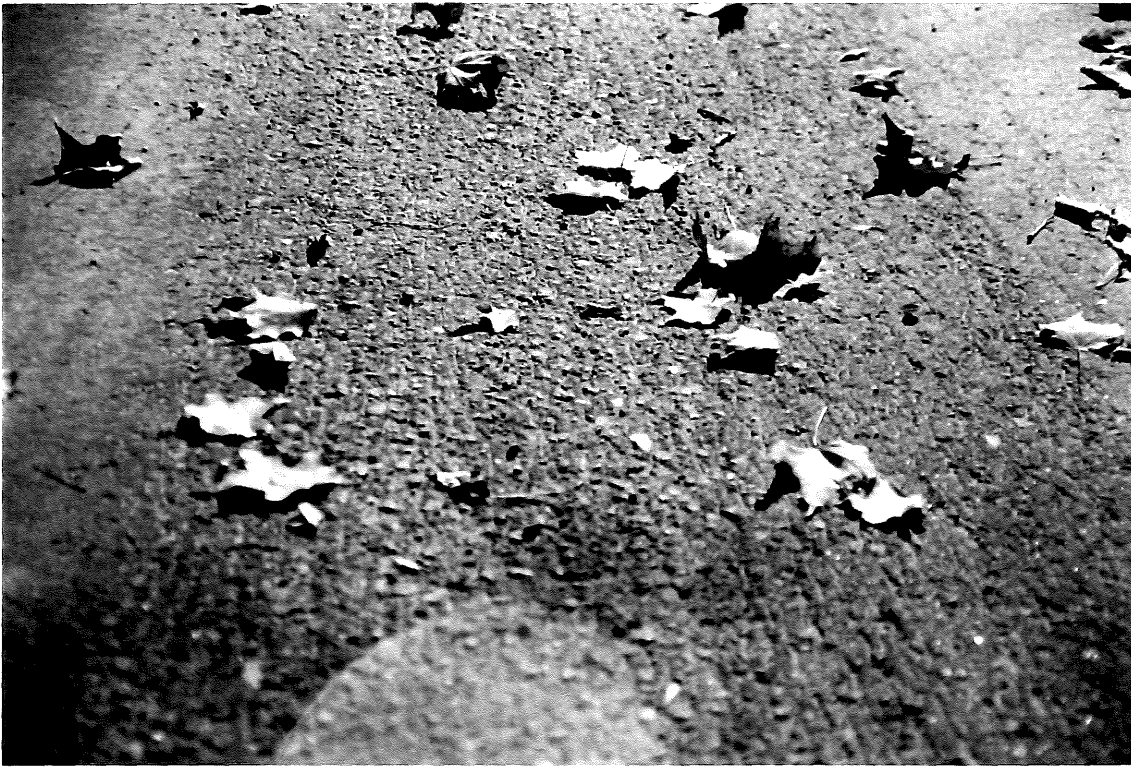
Segment 2 (19 West, Type 41 B)

**Segment 2 (19West, Type 41B):** Middle 1/3 of the trail is most heavily damaged, with some spalling of aggregate. Little or no damage on edges of the trail.

Straight-edge across the trail illustrates surface irregularities

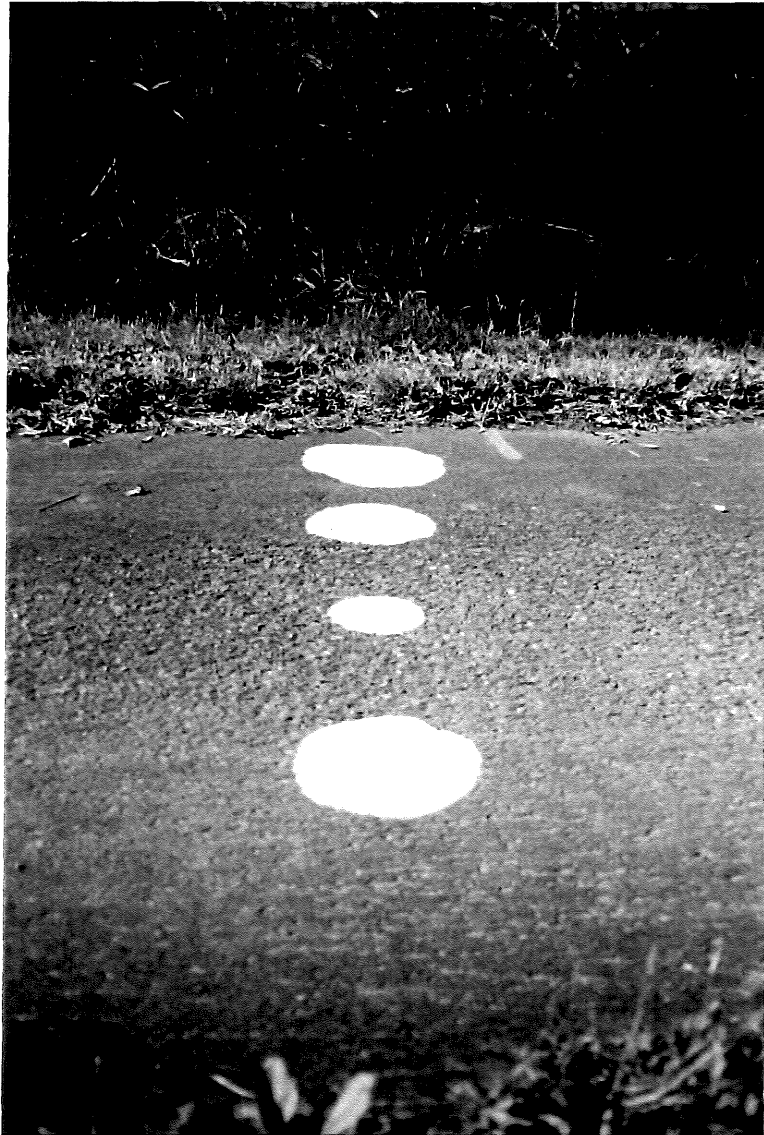
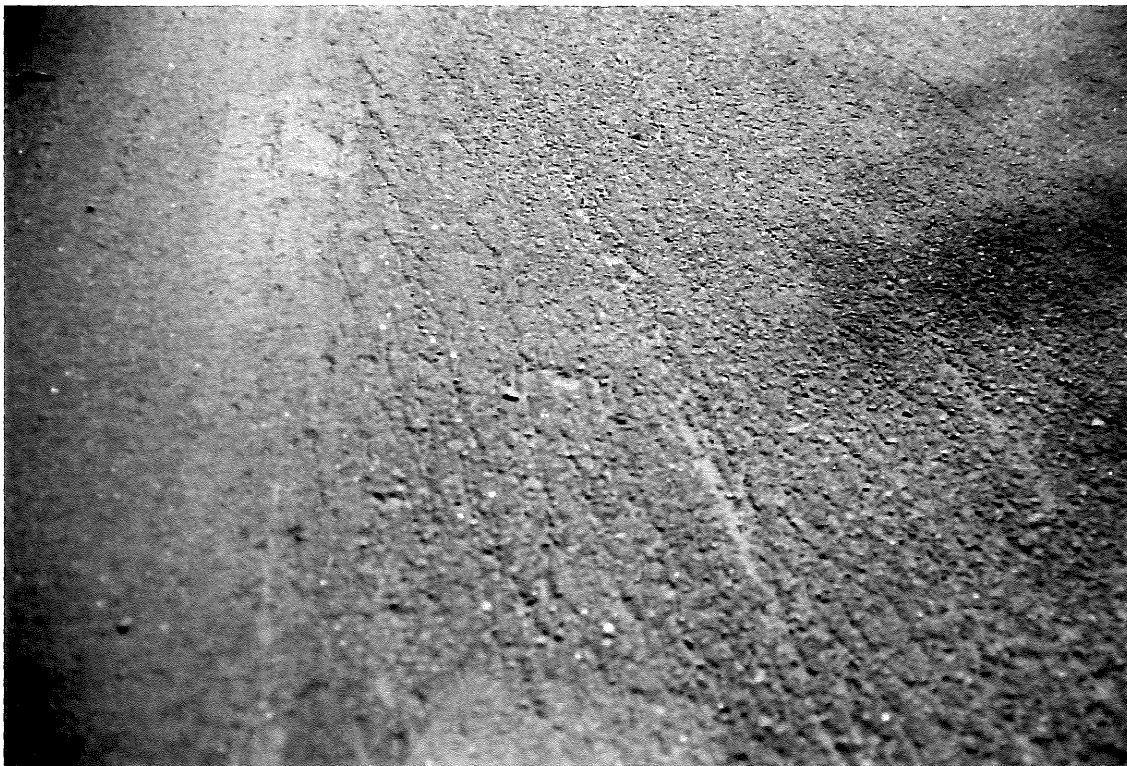
Segment 3 (110 East, Type 61A)

Segment 3 (110 East, Type 61A Granite Aggregate): Damage over middle half of the trail, visible aggregate spalling. Damage appears worse than Segments 1 and 2.

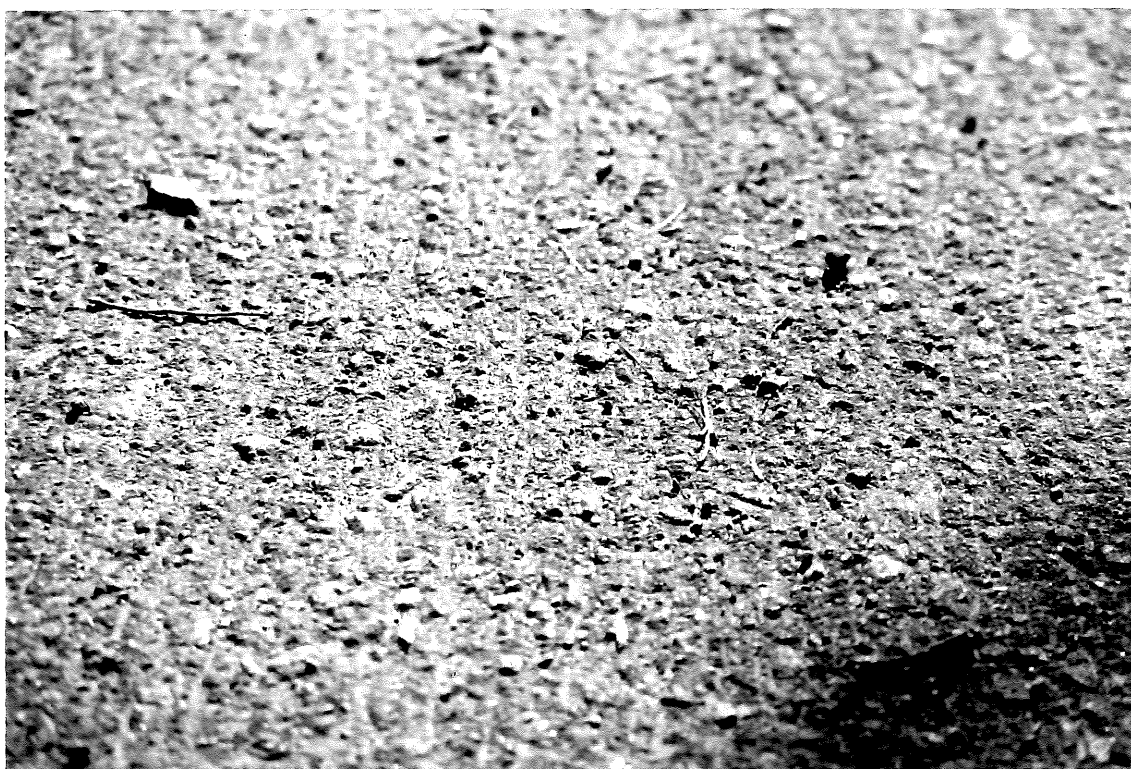
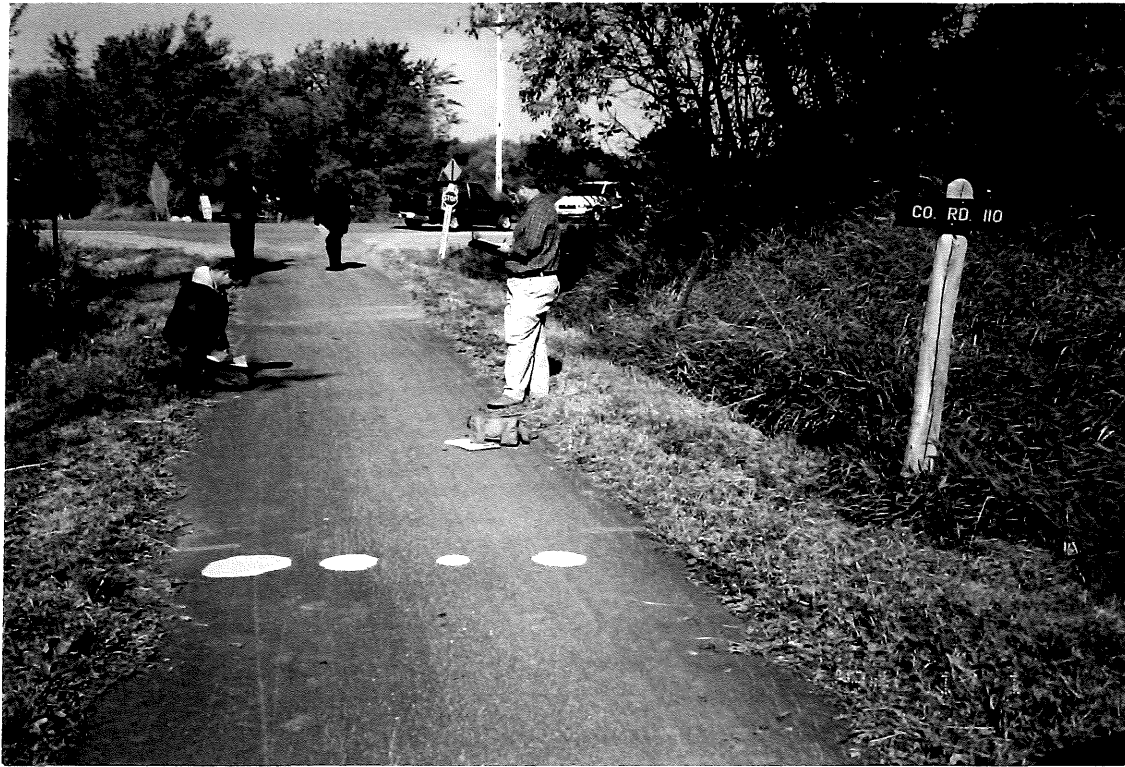
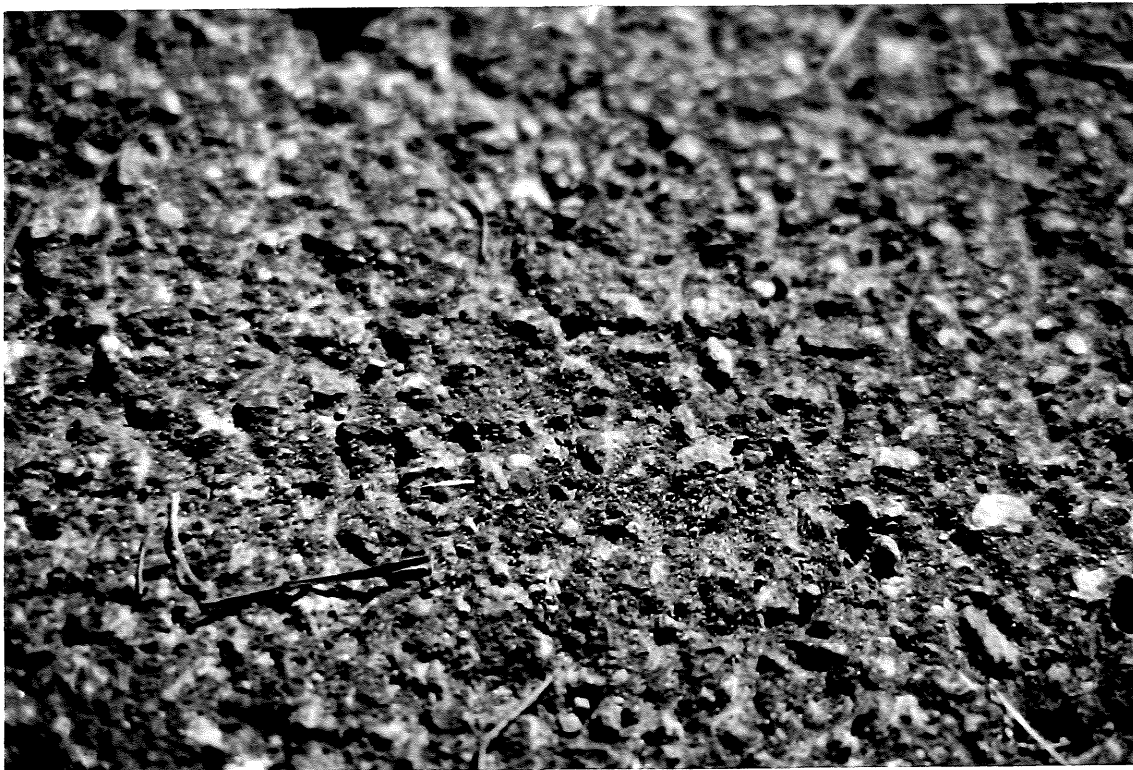
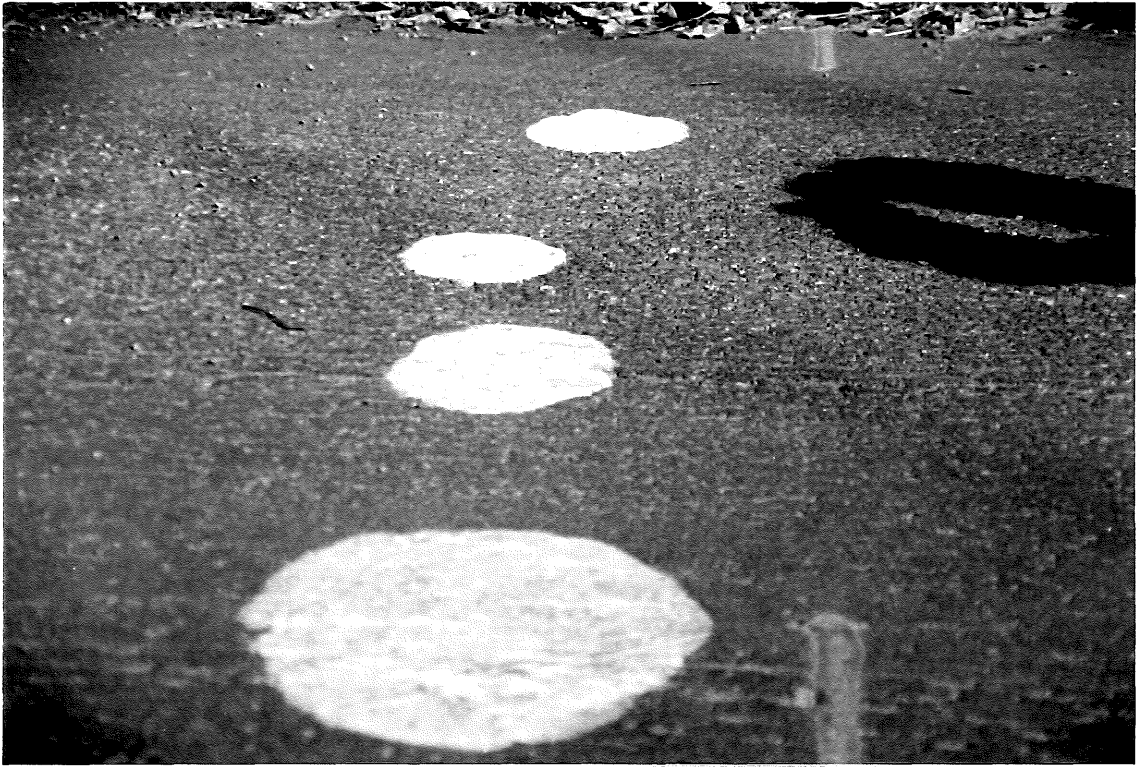
Segment 4 (110 West, Type 61 B Granite Aggregate)

Segment 4 (110 West, Type 61B Granite Aggregate): Some damage across entire trail width. 1/4" grooves on edges of the trail. Visible spalling of 3/4" aggregate, damage appears worse than Segments 1 and 2.

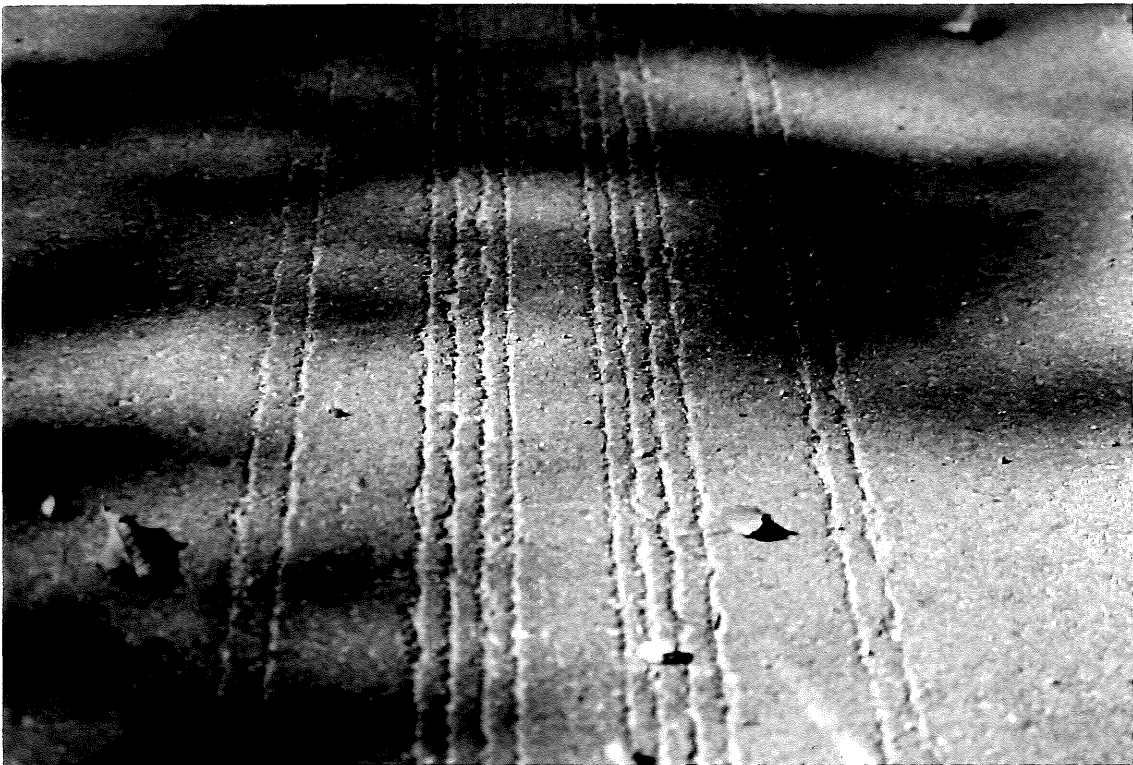
**Segment E1 (ProPoxy):** No penetration or grooving, little abrasion. However some longitudinal cracking is present, separating from the asphalt and pulling the asphalt surface apart. Cracking seems to be due to epoxy expanding and contracting at a different rate than asphalt during temperature changes.

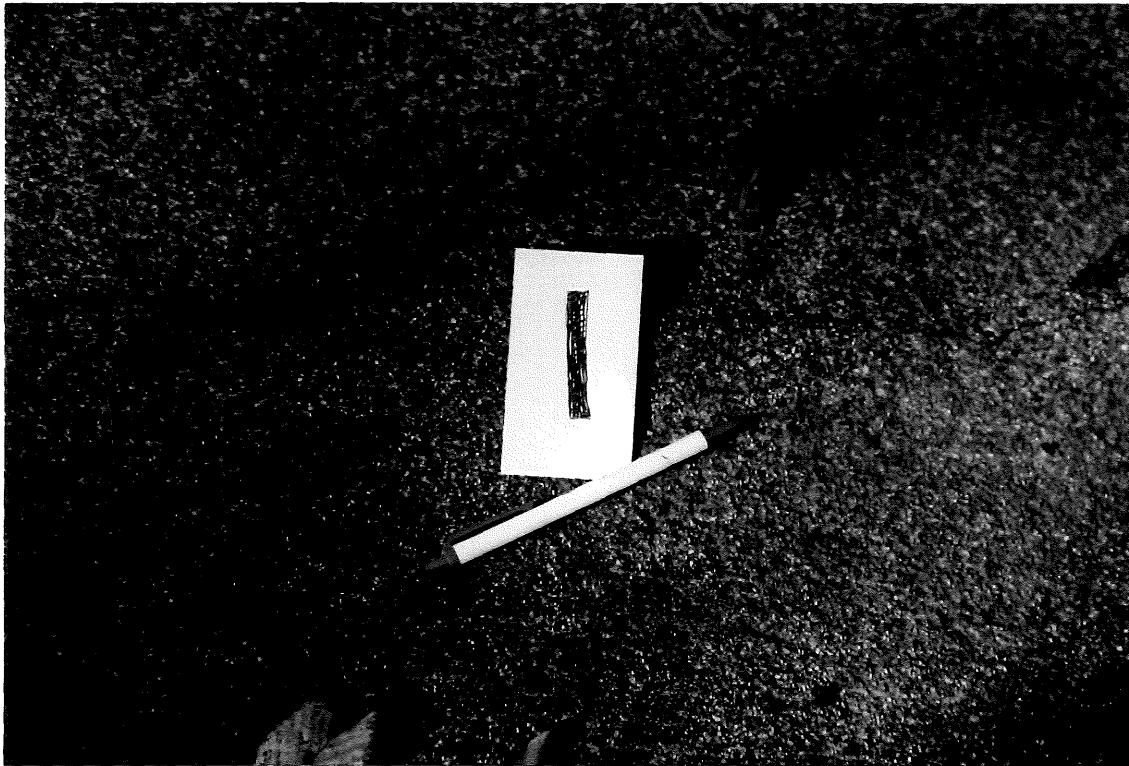
**Segment E2 (CB700):** No penetration or grooving, little abrasion. However, severe longitudinal cracking is present, separating from the asphalt and pulling the asphalt surface apart. As in the previous segment, cracking seems to be due to epoxy expanding and contracting at a different rate than asphalt during temperature change.

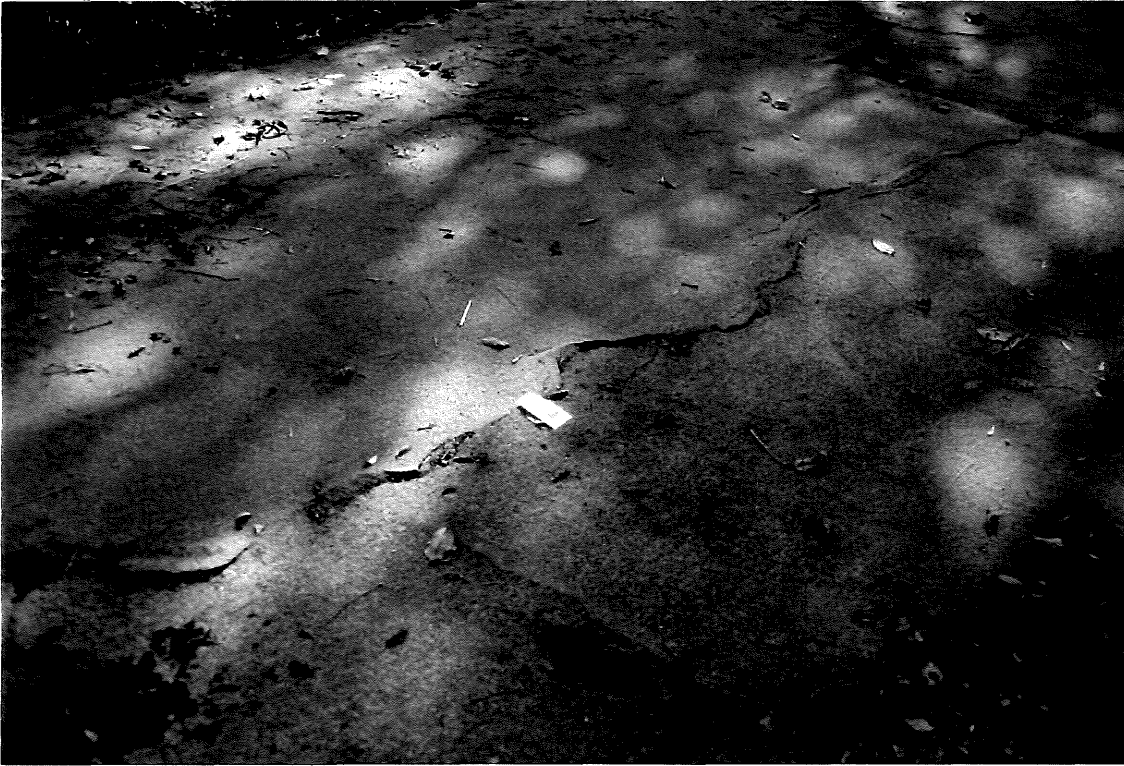
**Segment E3 (Sikadur):** Epoxy seems to have delaminated and much of the coating is missing. Not suitable for trail use.

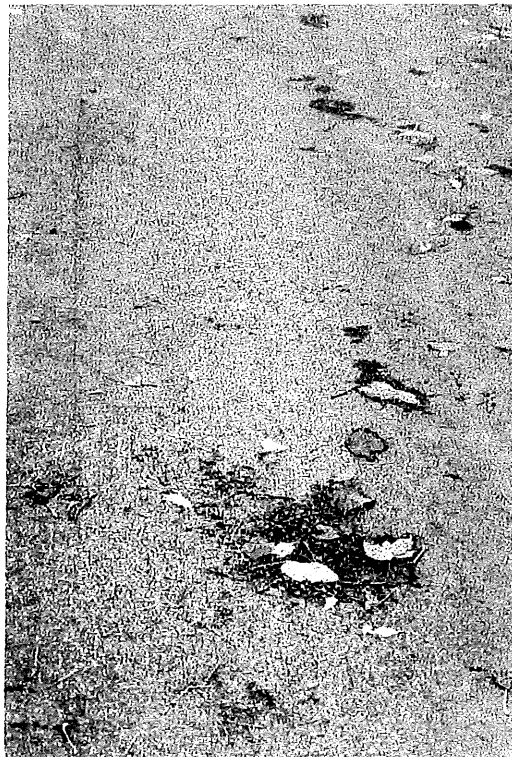
There was evidence of damage caused by studs and snowmobile traffic at this site. Grooves in the pavement were about 1/4" into the surface. Figure 2 shows these grooves.

**Figure 2.** Pavement surface before application.
