Minnesota State Capitol

A Preservation & Planning Study for Public & Ceremonial Areas

Prepared for The Capitol Area Architectural Planning Board

October 1984

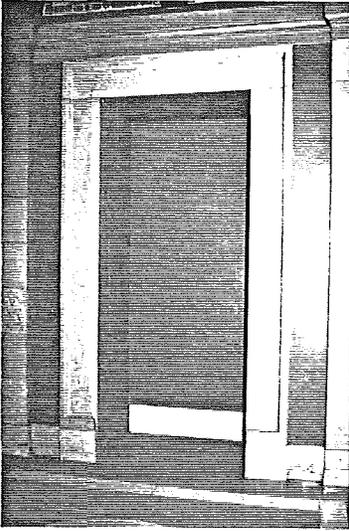
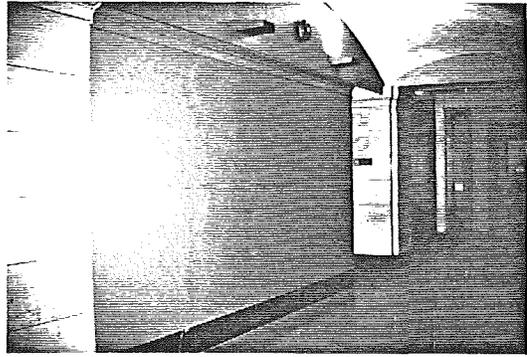
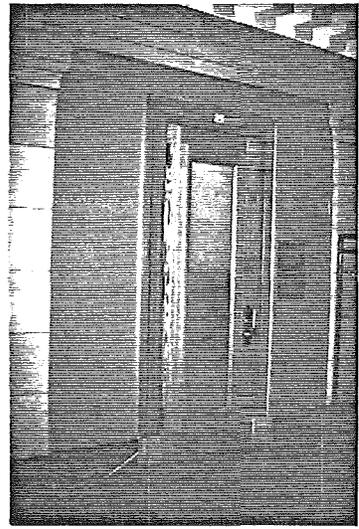
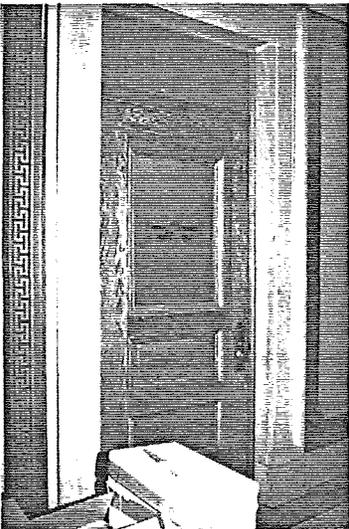
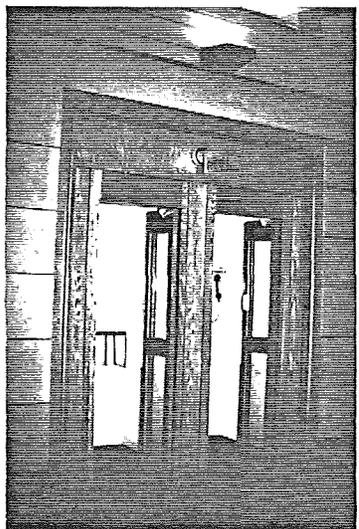
Examples of Altered Architectural Details

The wood used for interior millwork in the public and ceremonial areas of the Capitol was generally quarter-sawn white oak. Doors, door frames, borrowed lights, interior trim, and other architectural millwork in the interiors followed standard details and molding profiles developed for the building. Later additions and alterations to the building have often been carried out with little regard for these

materials and details. We would recommend that the interior public and ceremonial spaces be restored matching the original materials in composition, detail, profile and finish.

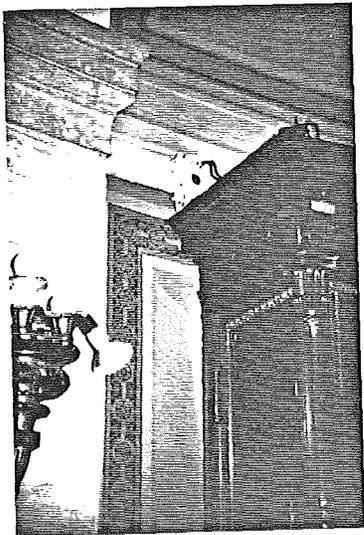
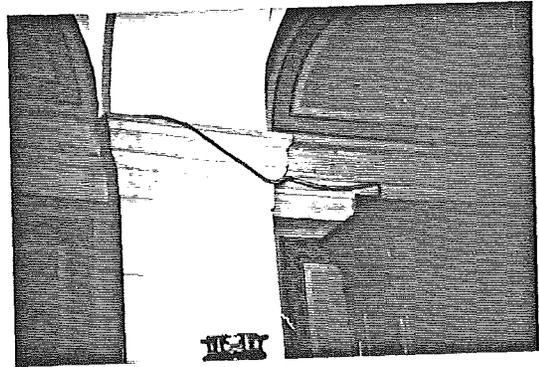
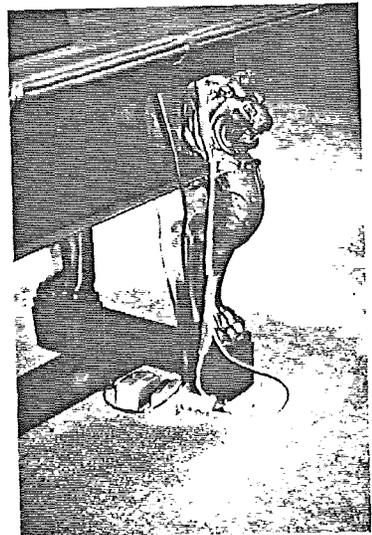
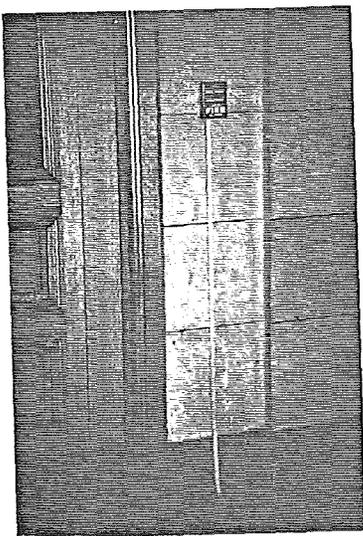
Examples of Intrusive Electrical Installations

interior. Inappropriate grilles of modern design, exposed wiring, modern light fixtures, emergency lighting, surface mounted wire mold and junction boxes, electrical cords taped to marble walls, exposed plumbing piping, surface-mounted public address speakers, public telephone booths and altered light fixtures are common occurrences throughout the building.

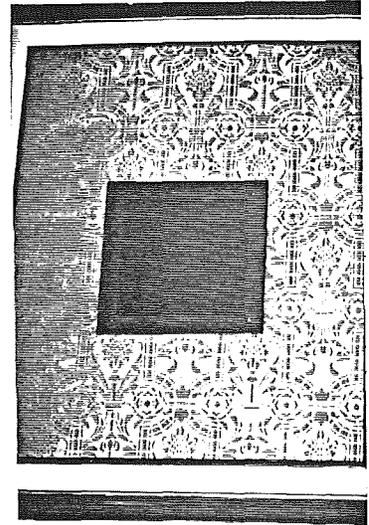
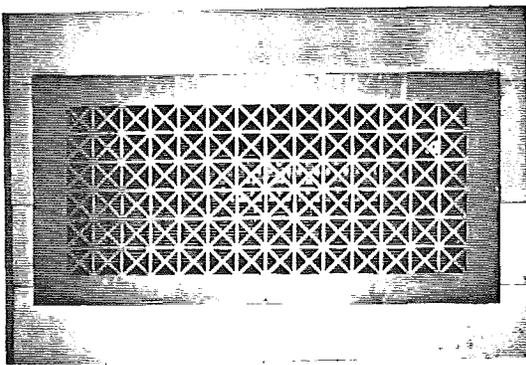
Examples of Intrusive HVAC Elements

Heating and ventilating alterations have brought with them the introduction of modern wall grilles and temperature controls as well as the replacement or removal of historic grilles. We

would recommend that the installations be evaluated on a case by case basis. Intrusive wall grilles should be removed, relocated or replaced with grilles that match the design, materials and profiles of the original grilles in the building.

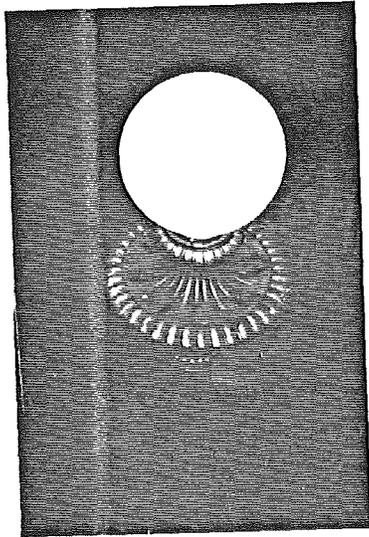
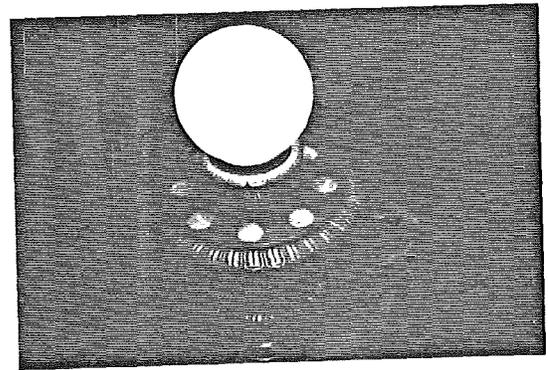
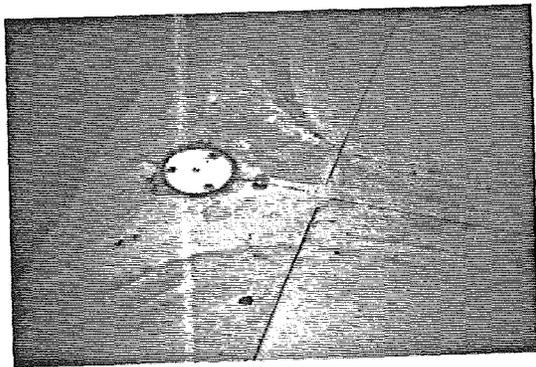
Examples of Altered Candelabra

In addition, many of the floor-mounted candelabra have been relocated within the Capitol. We would recommend that they be returned to their original locations and restored.

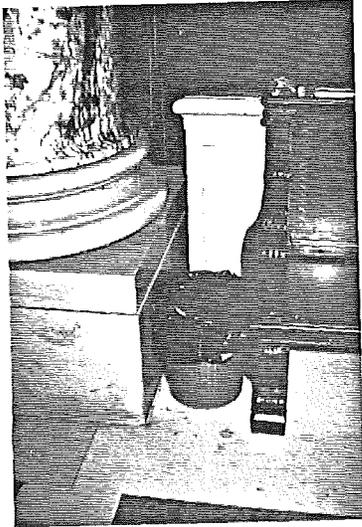
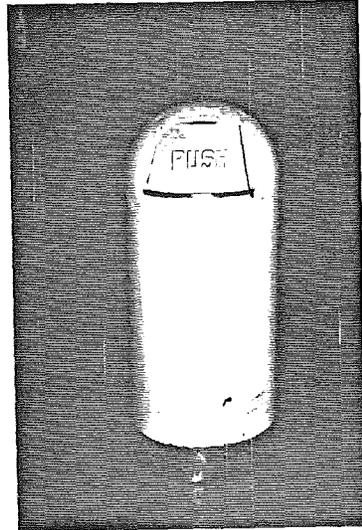
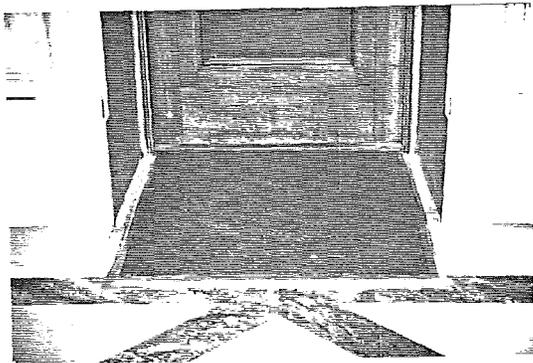
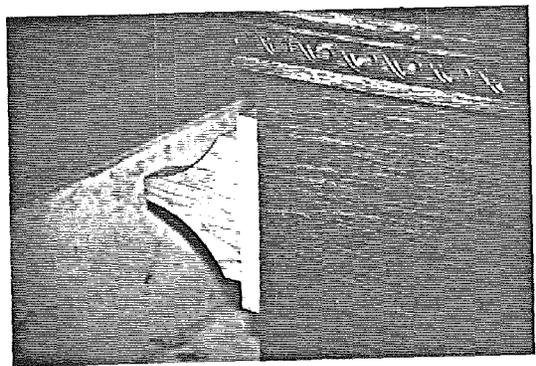
Examples of Intrusive Furnishings

In addition, modern furniture and furnishings have been introduced into the public and ceremonial areas of the building with little regard for their appropriateness or impact on the historic integrity of the space. For example, a wide variety of modern ashtrays and trash receptacles have been installed throughout the building. White porcelain enamel, gray plastic and brushed aluminum are finishes that seem inappropriate adjacent to imported marble. We would recommend that a standard design for ashtrays and trash

receptacles be selected for use in the building that is in character with the historic interior.

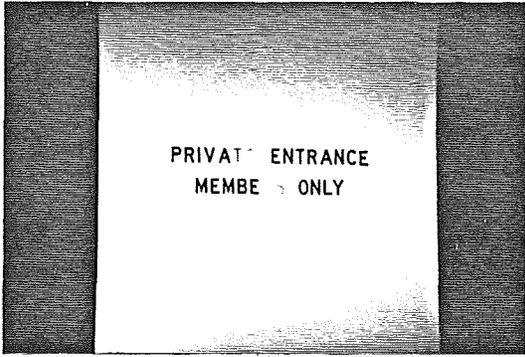
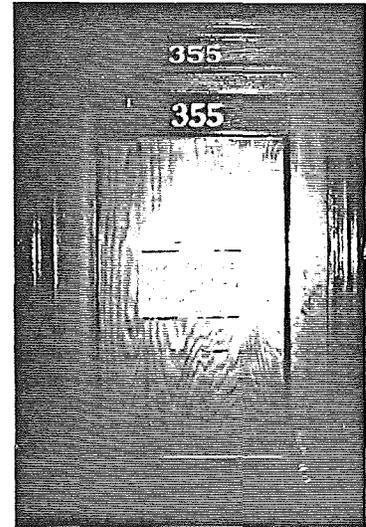
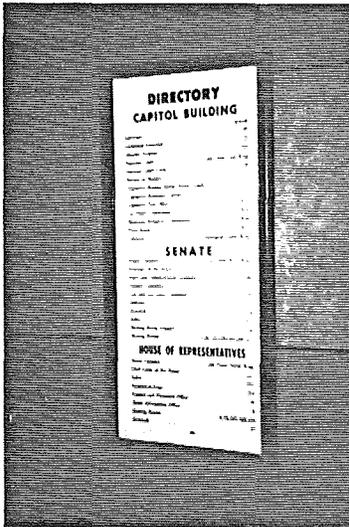
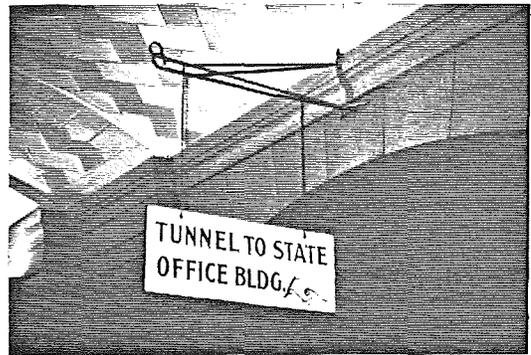
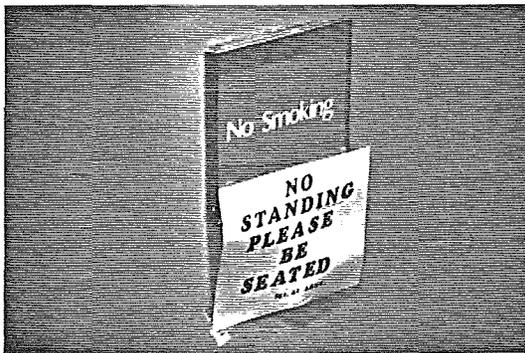
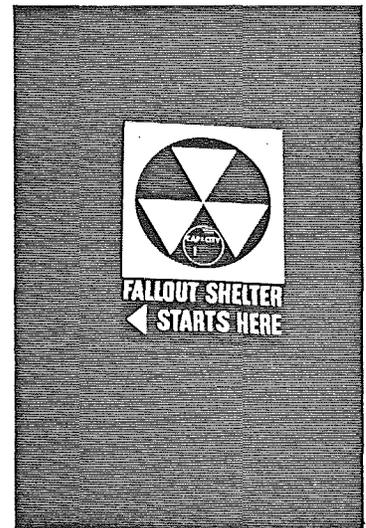
Examples of Inappropriate Signage

A comprehensive plan for interior signage was developed in 1977. The goal was to bring order, give direction and establish standards for signage throughout the building. Although new identification and directional signs were installed at that time, there continues to be a great variety of additional identification and directional signage in the interior. Many of these signs are poorly executed and intrusive to the historic interiors. We would recommend the removal of signs that do not conform to the comprehensive plan and the development of a policy for control and implementation of additions and alterations to signage in the building.

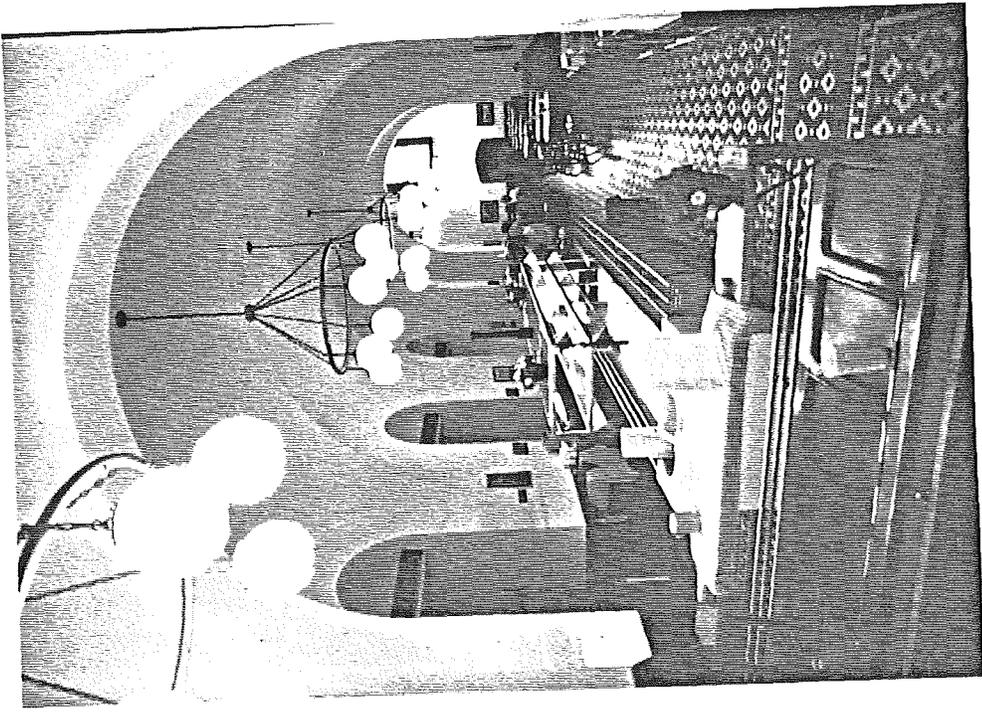
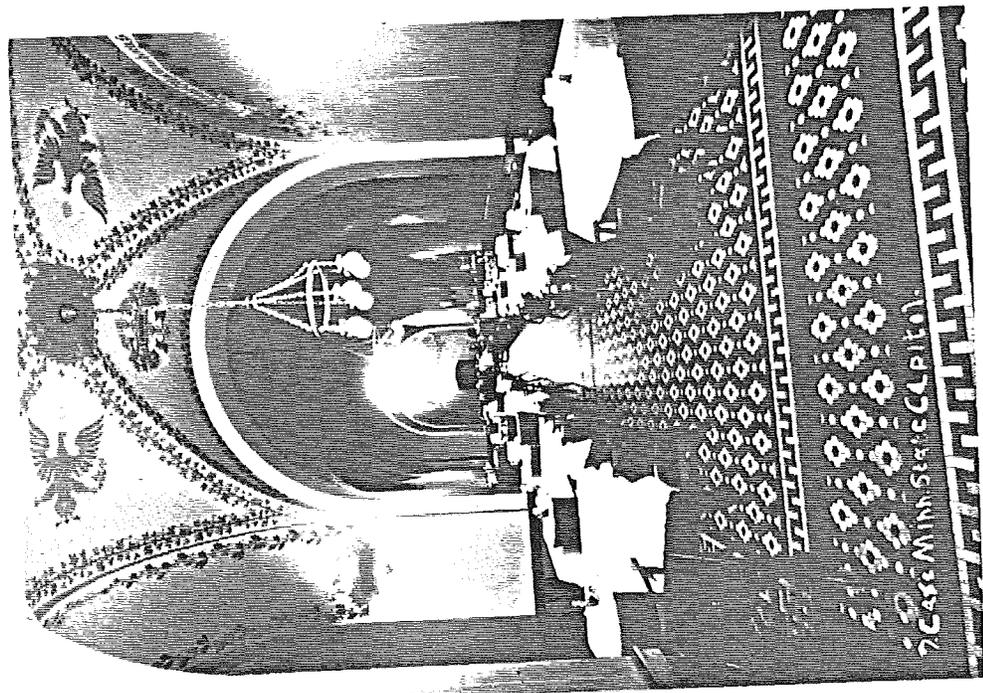
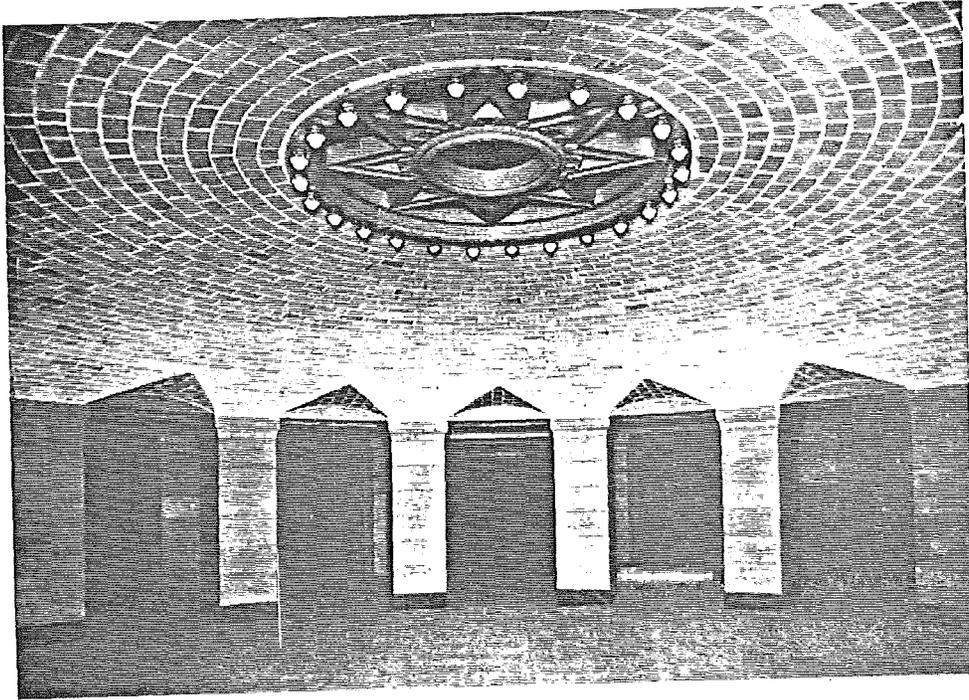
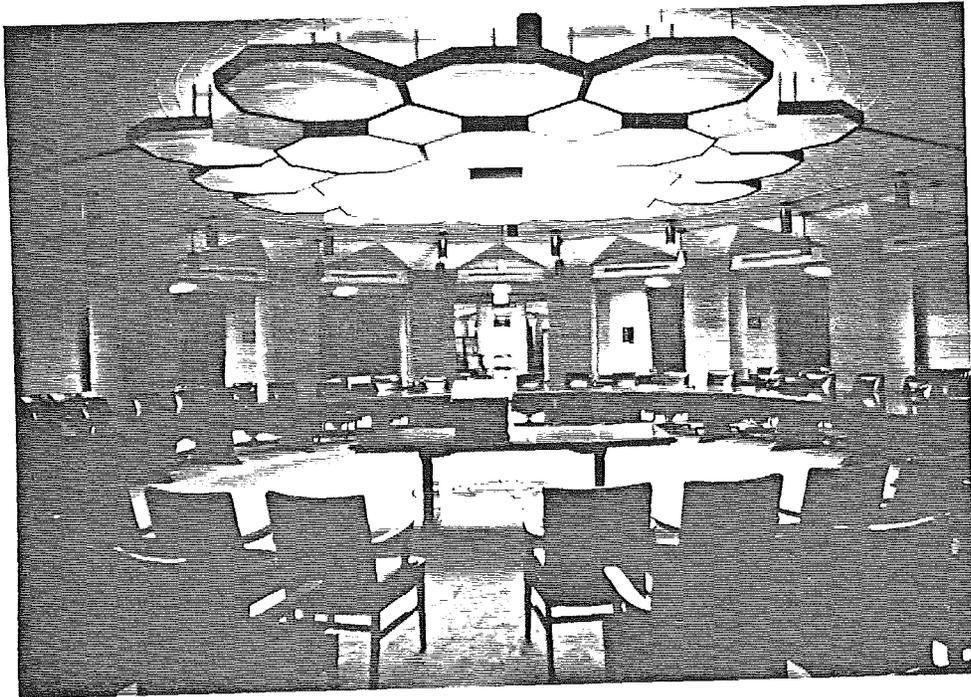
Cafeteria

Room No. 15 under the first floor Rotunda was originally public circulation space. The glazed bronze star in the Rotunda floor above was outlined with electric lamps on this level and let natural daylight into this room. The floor is of decorative marble of a similar design to the surrounding corridors. In recent years Room No. 15 has been converted to a public hearing room. The room is currently undergoing remodelling for continued use as a hearing room. We recommend that the room be rehabilitated to recapture its original design elements in the process.

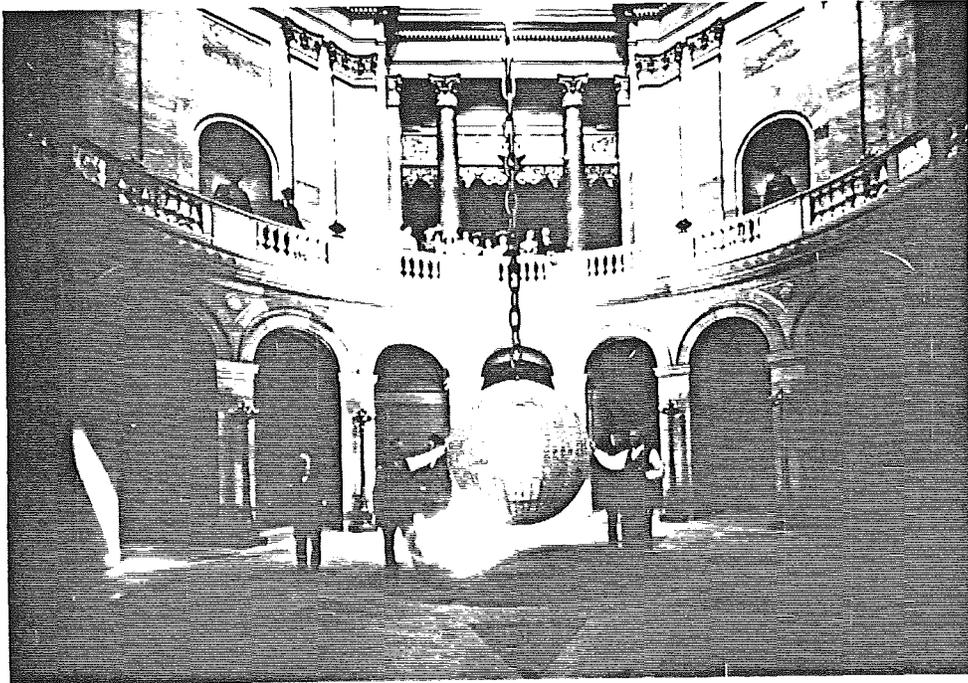
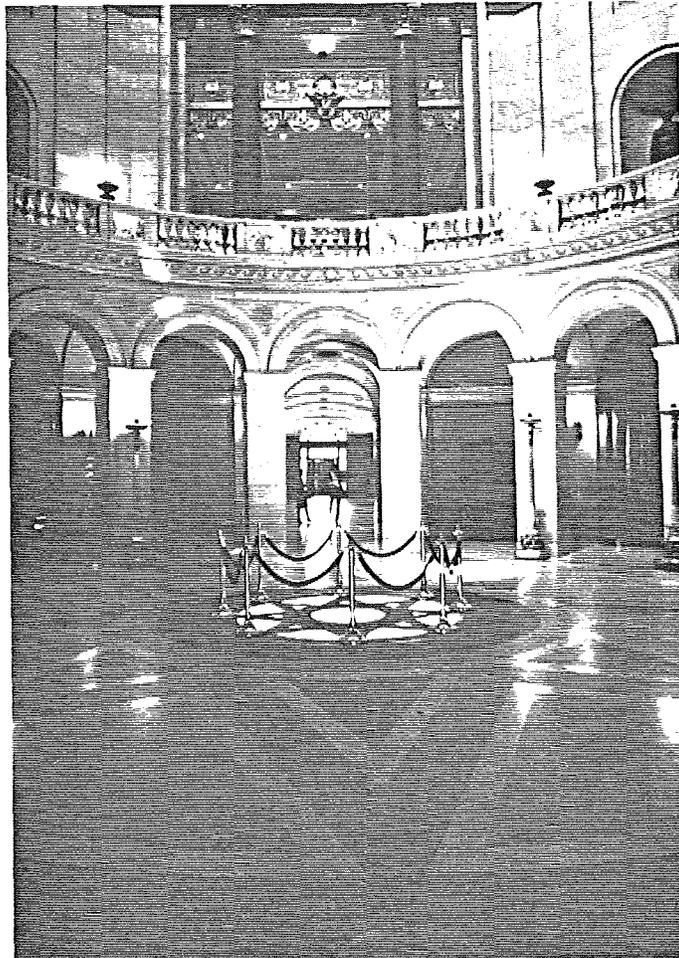
Electrical connections to the four large flag cases have been made with exposed conduit, sometimes draped along the bronze cornices. Utilitarian surface-mounted 4-plex outlets have been installed over each case. If these outlets are required, they should be installed in a concealed manner. We would recommend that all four flag cases be rewired with concealed conduit.

Modern metal grilles have been installed at opposite ends in the marble base of each flag case. One of these has been covered over with duct tape. These grilles should be removed or replaced with bronze grilles fabricated to replicate the

details of existing historic grilles throughout the building.

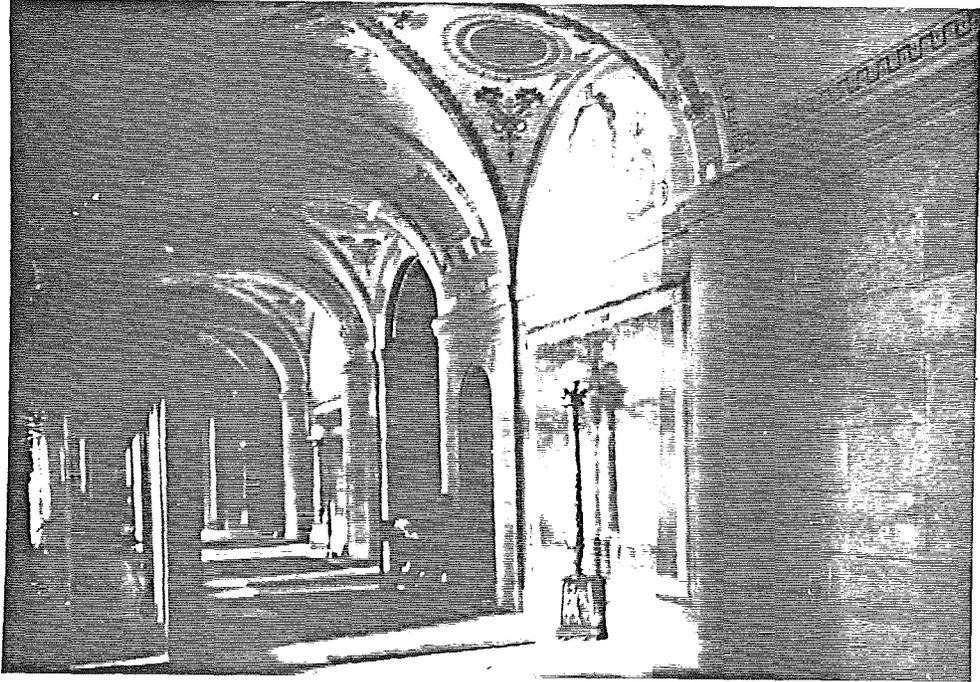
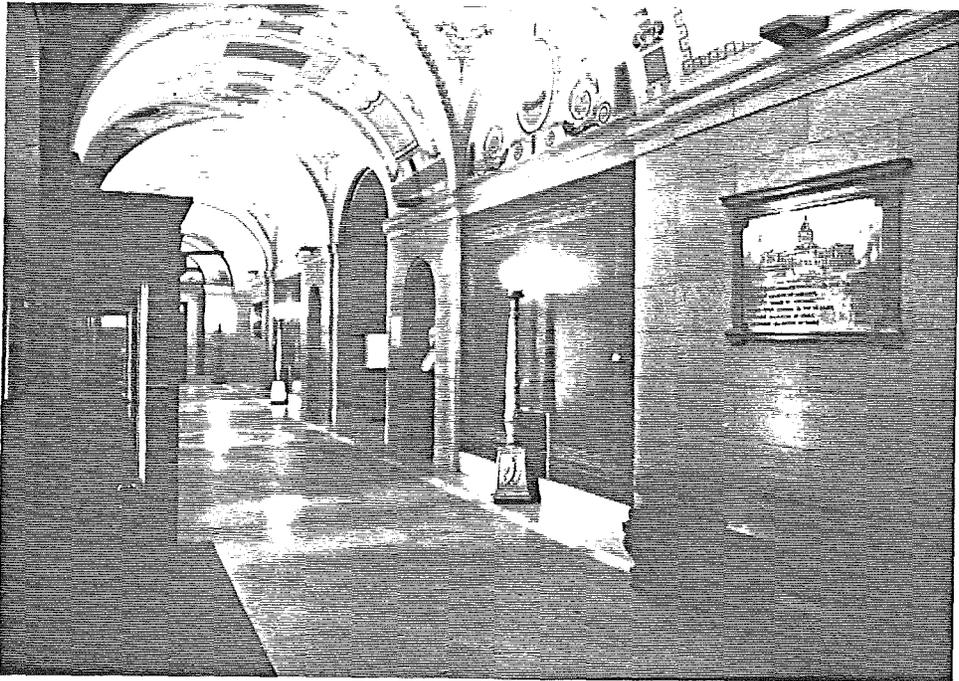
Wear in the marble floor and the presence of a center pivot indicates that at one time, the center exterior door was a revolving door. Additional research should attempt to determine whether this was an original feature. If so, a revolving door should be restored in this location.

The waste receptacle along the north wall is inappropriate to the space. We would recommend that it be removed or replaced with a standardized design in character with the historic

interior.

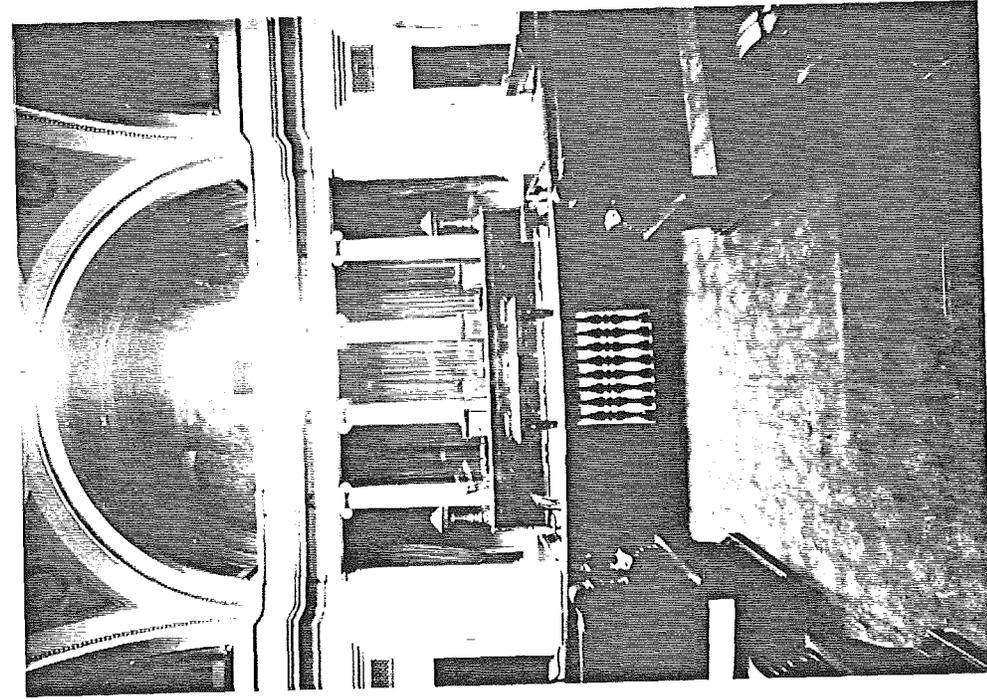
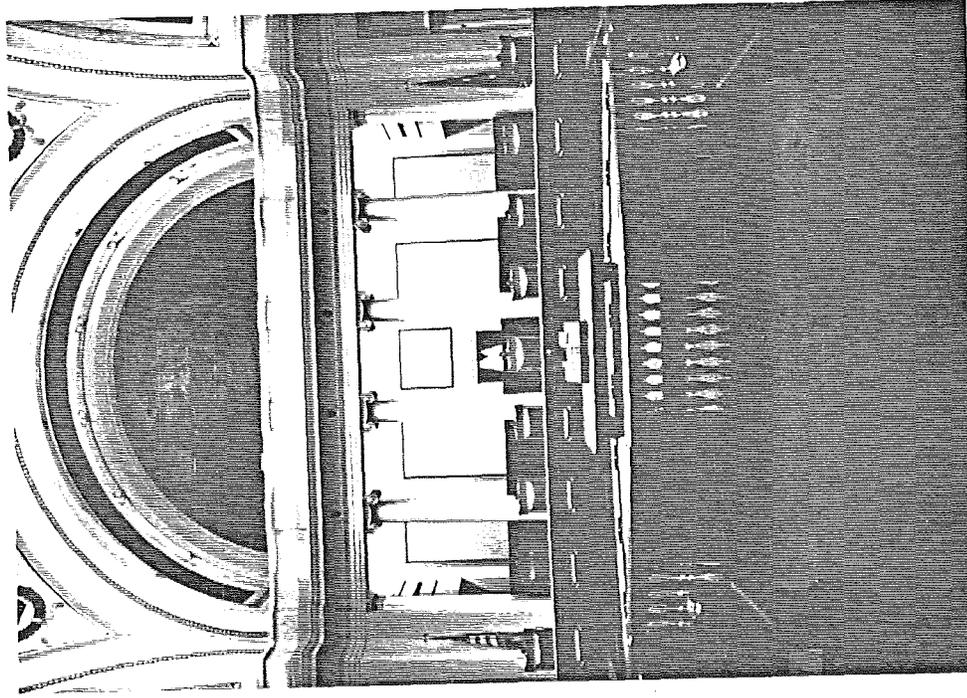
Supreme Court Chamber

Six floor-standing candelabra have been removed from the Chamber. Two of these stood along the north wall, two along the south wall and two flanked the main entrance to the chamber. We would recommend that these fixtures be returned to their original locations.

Two bronze lamps with Tiffany shades that originally stood at each end of the Justices' bench have disappeared. We would recommend that a search be conducted for these fixtures. If the fixtures cannot be found, we would recommend that reproductions be made to replace them and the fixtures be restored to their original locations.

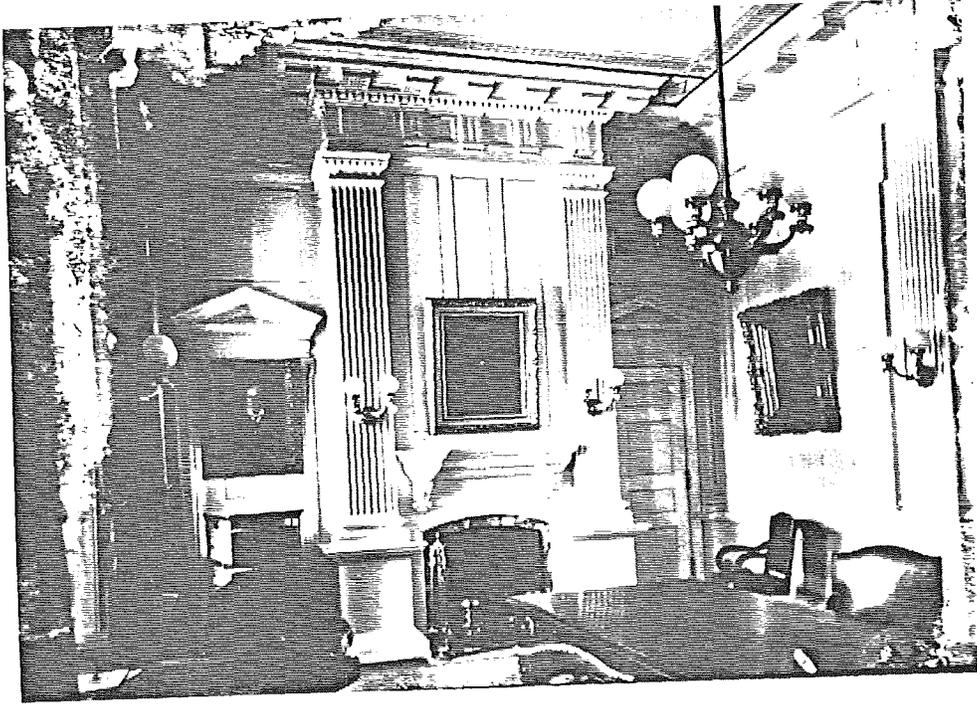
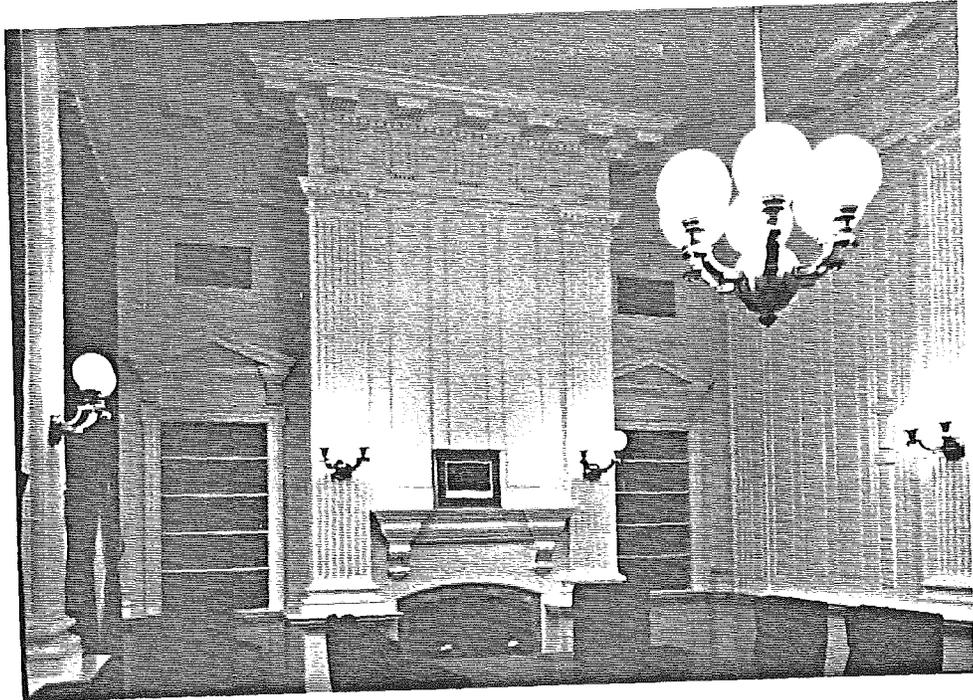
The Supreme Court Consultation Room was originally designed to be a scaled-down replica of the Supreme Court Room in Independence Hall in Philadelphia. The resemblance has been somewhat obscured by subsequent alterations.

Two doors into the room have been removed--one at the west end of the south wall and an opposite door at the west end of the north wall. The door frames have been left in place and shelving installed in the openings. Similarly, two false doors that were intended to provide symmetrical design elements in the original plan have been converted to bookcases--one at the east end of the south wall and one opposite at the east end of the north wall. Thus what was intended to give the appearance of two doors at each end of the room has been replaced with bookcases. We would recommend the bookcases be removed and the north and south walls restored to their original appearance.

On the north and south walls, modern heating grilles have replaced the original cast bronze grilles and two new grilles, also of modern design, have been added. We would recommend that the original grilles be returned and matching grilles of bronze produced to replace the modern grilles.

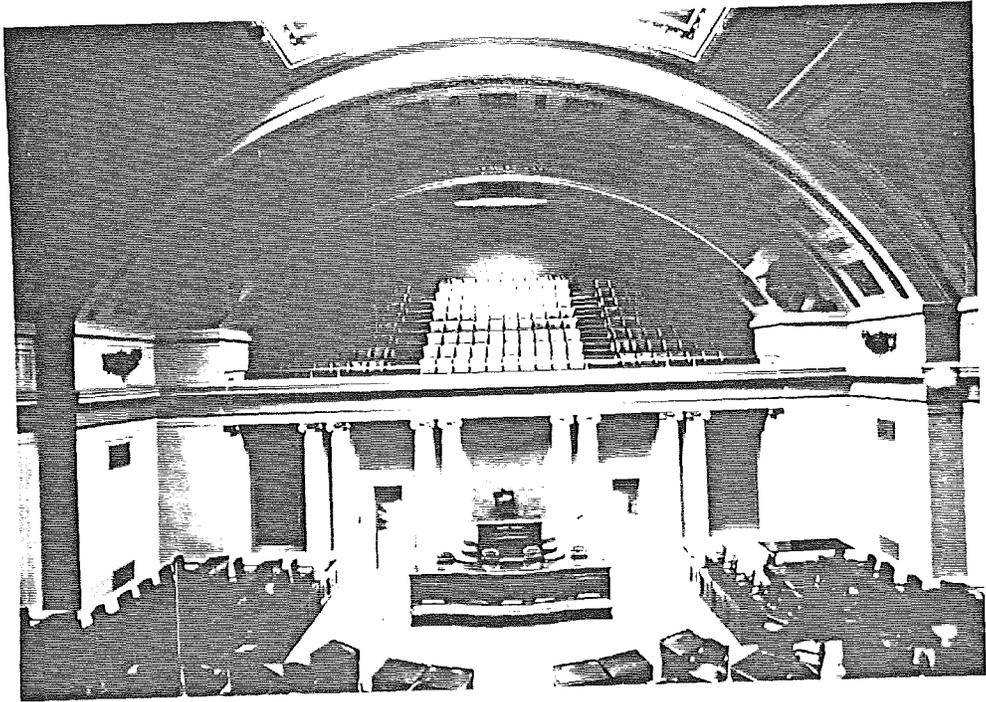
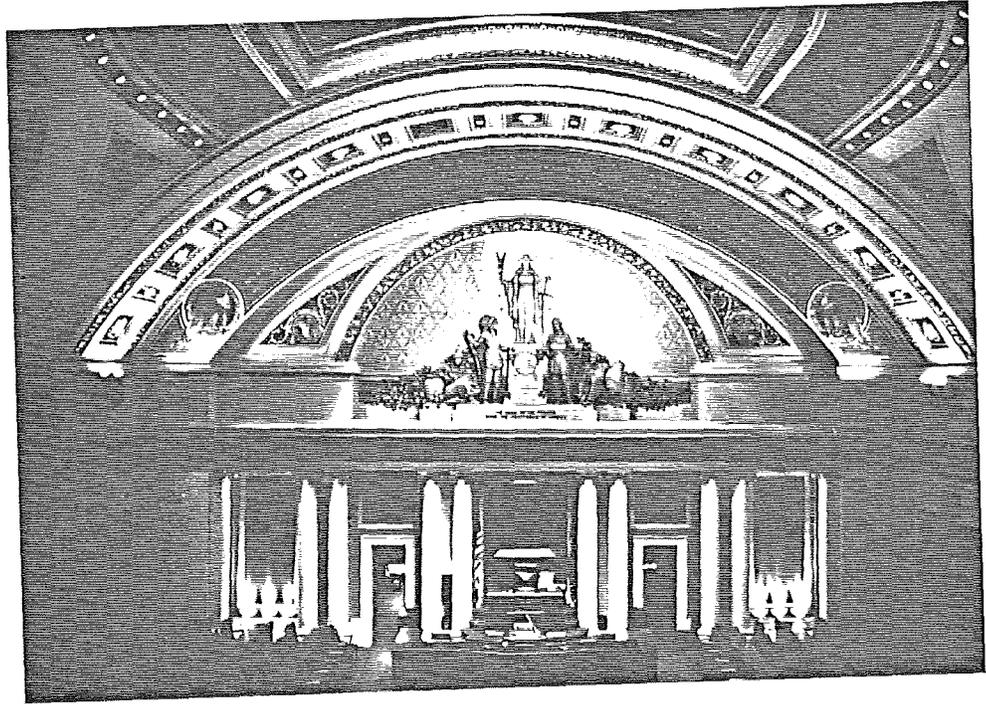
The North Spectators' Gallery, a major design element, has been enclosed and converted to office space. The arched

opening has been filled in and a large symbolic sculptured group, the work of Carl Brioschi of St. Paul, has been installed on the north wall of the Chamber. We would recommend that consideration be given to restoring the original North Spectators' Gallery.

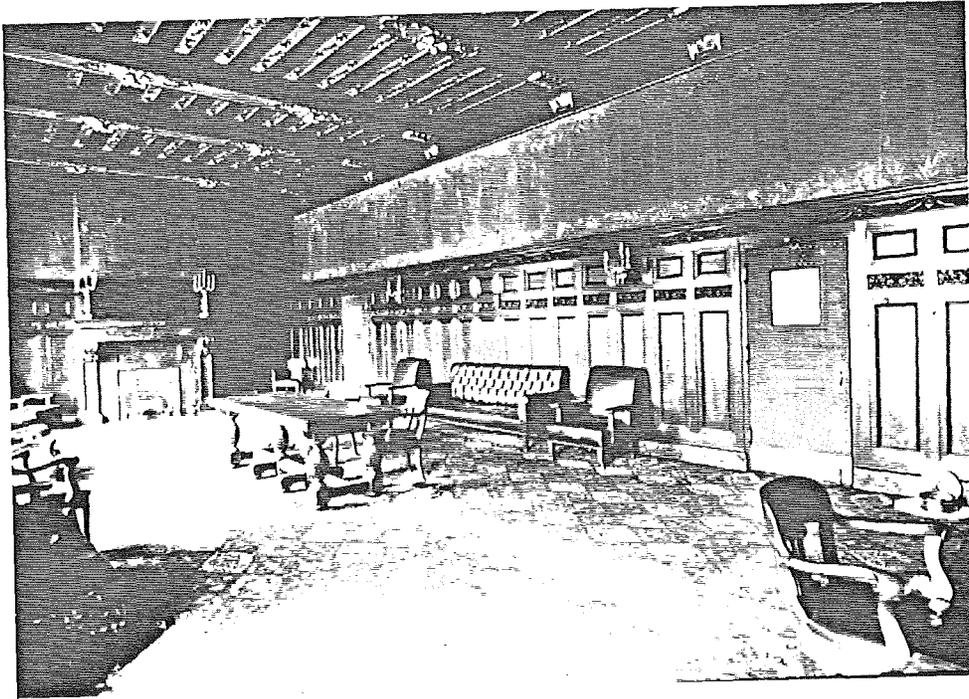
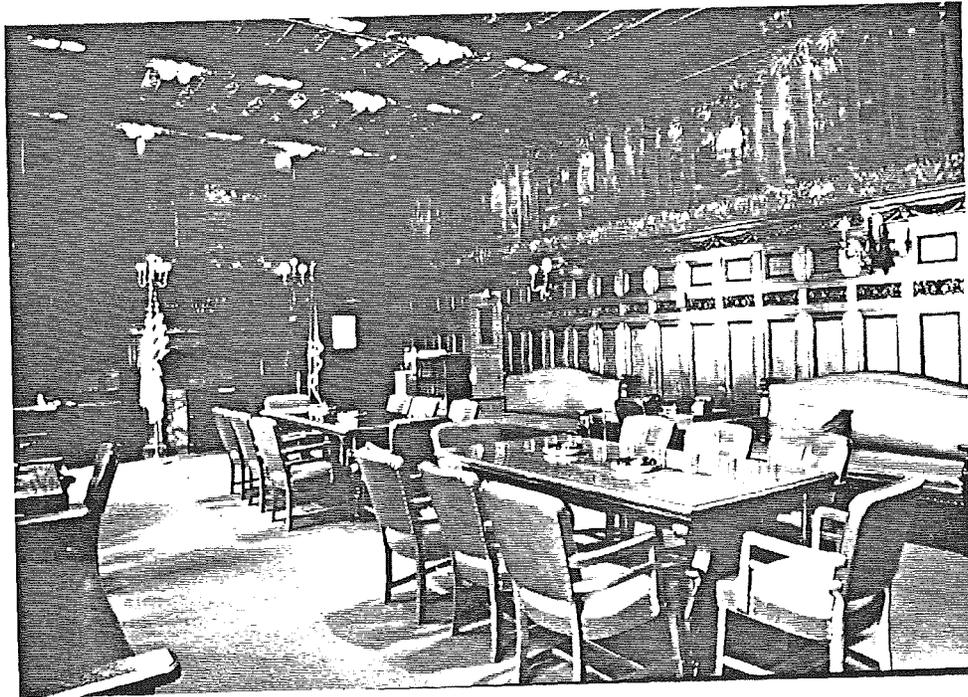
House Retiring Room

Modern heating grilles have replaced the original grilles on the east and west walls of the room. These should be removed and replaced with grilles that replicate the material, pattern

and finish of the original grilles in this room.

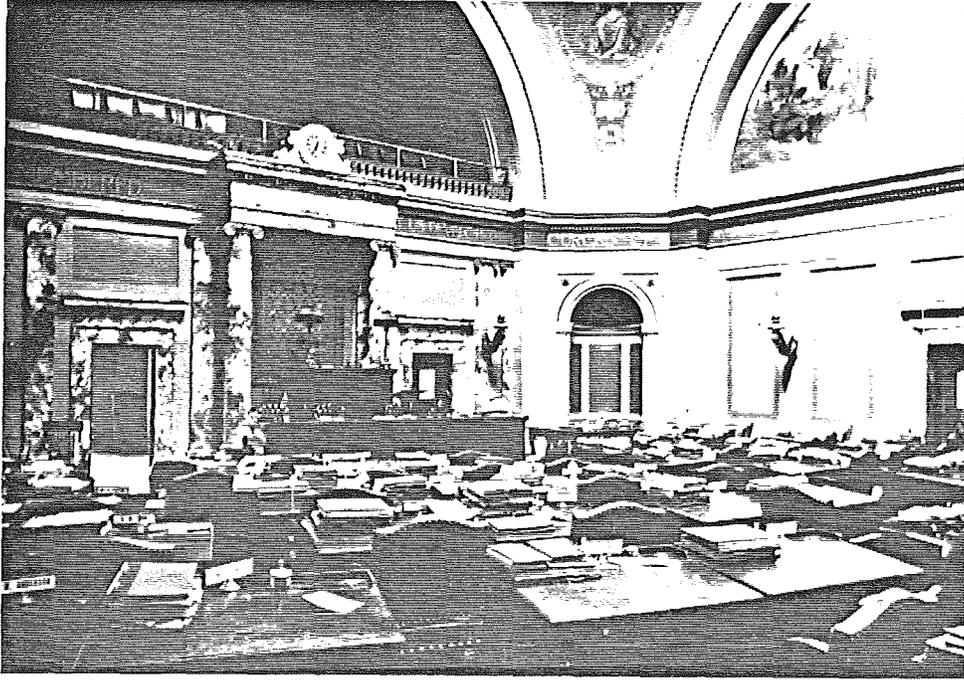
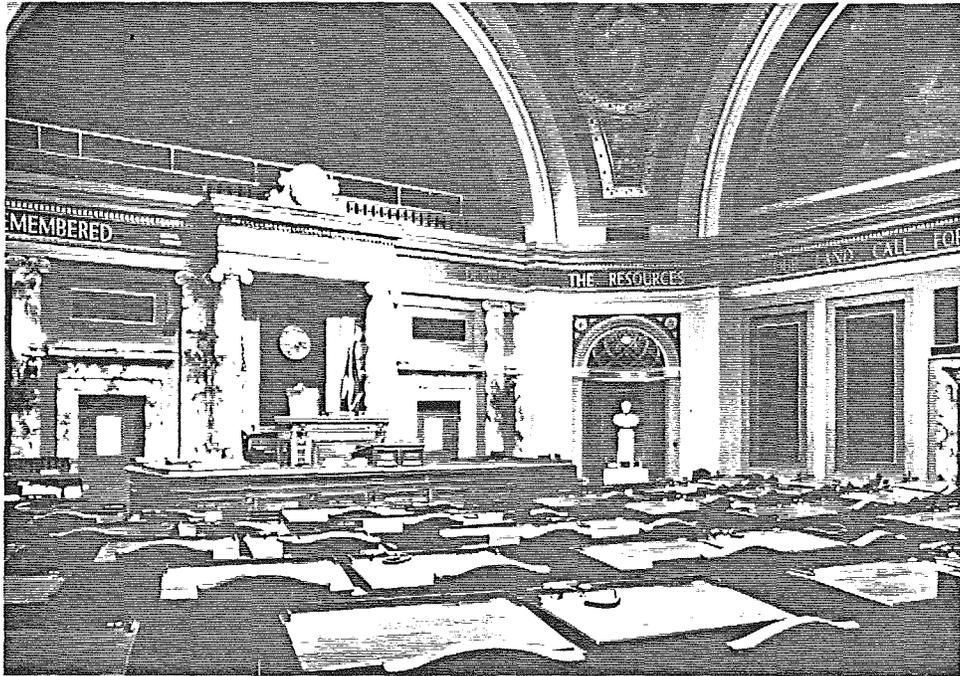
A great deal of artificial lighting has been added to offset the loss of natural daylight. Unfortunately, this lighting has not always been sensitively integrated into the historic interior. We would recommend that the lighting be evaluated on a case by case basis to assess its impact on the space. Based upon this analysis, we would recommend that the lighting be revised to integrate it in a less intrusive manner and minimize its impact on the historic interior.

Similarly, other electrical installations in the Chamber--outlets, switches, public address systems, telephones, etc.--should be evaluated to determine measures to reduce their impact on the historic fabric of the building.

Six wall-bracketed fixtures matching those existing on the west wall have been removed from the Chamber. Originally there were two of these fixtures on each wall. We would recommend that they be restored to their original locations.

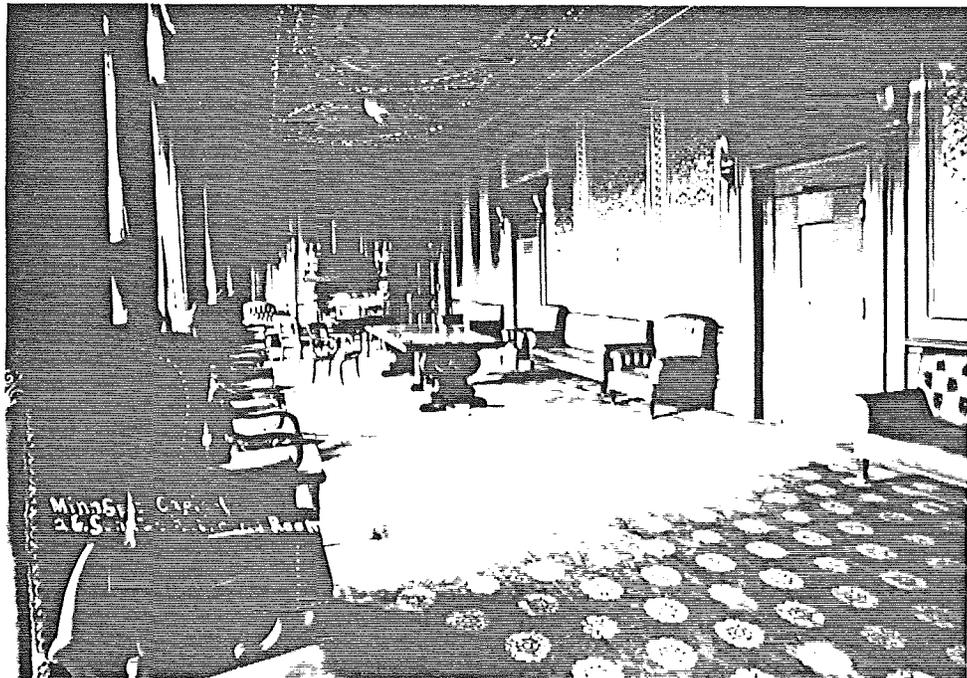
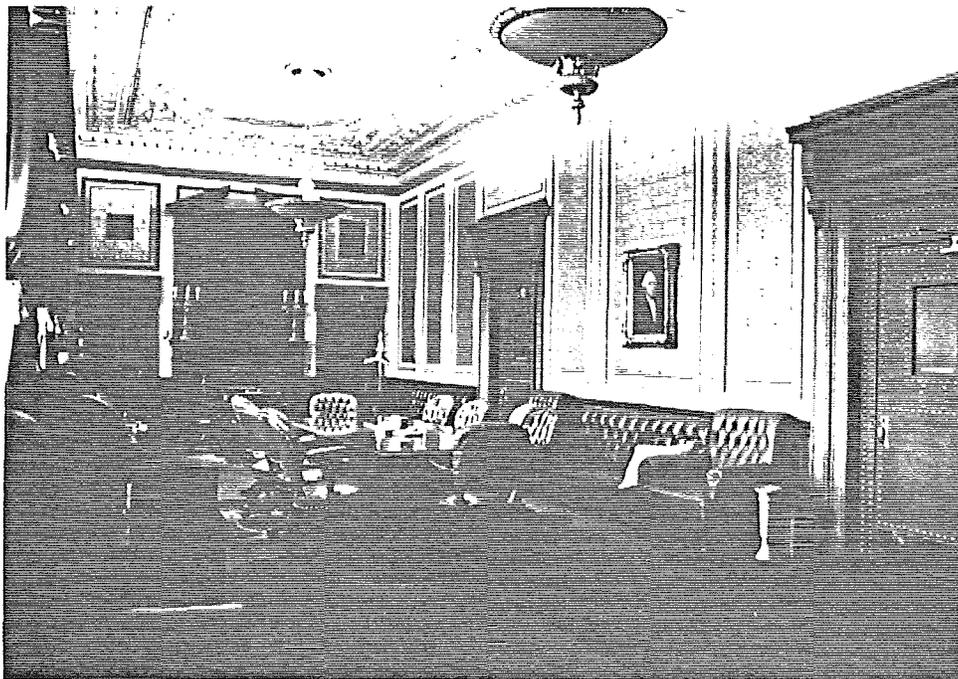
Senate Retiring Room

A number of changes have taken place in the Senate Retiring Room.

The original crystal chandeliers have been replaced with large suspended indirect lighting fixtures. Modern recessed light fixtures have been added in the decorative ceiling as well.
