FIELD TEST REPORT

PROJECT: Senate / New Legislative Office Building St. Paul, Minnesota

> Report No.: E8666.02-201-43 **Test Date: Report Date:**

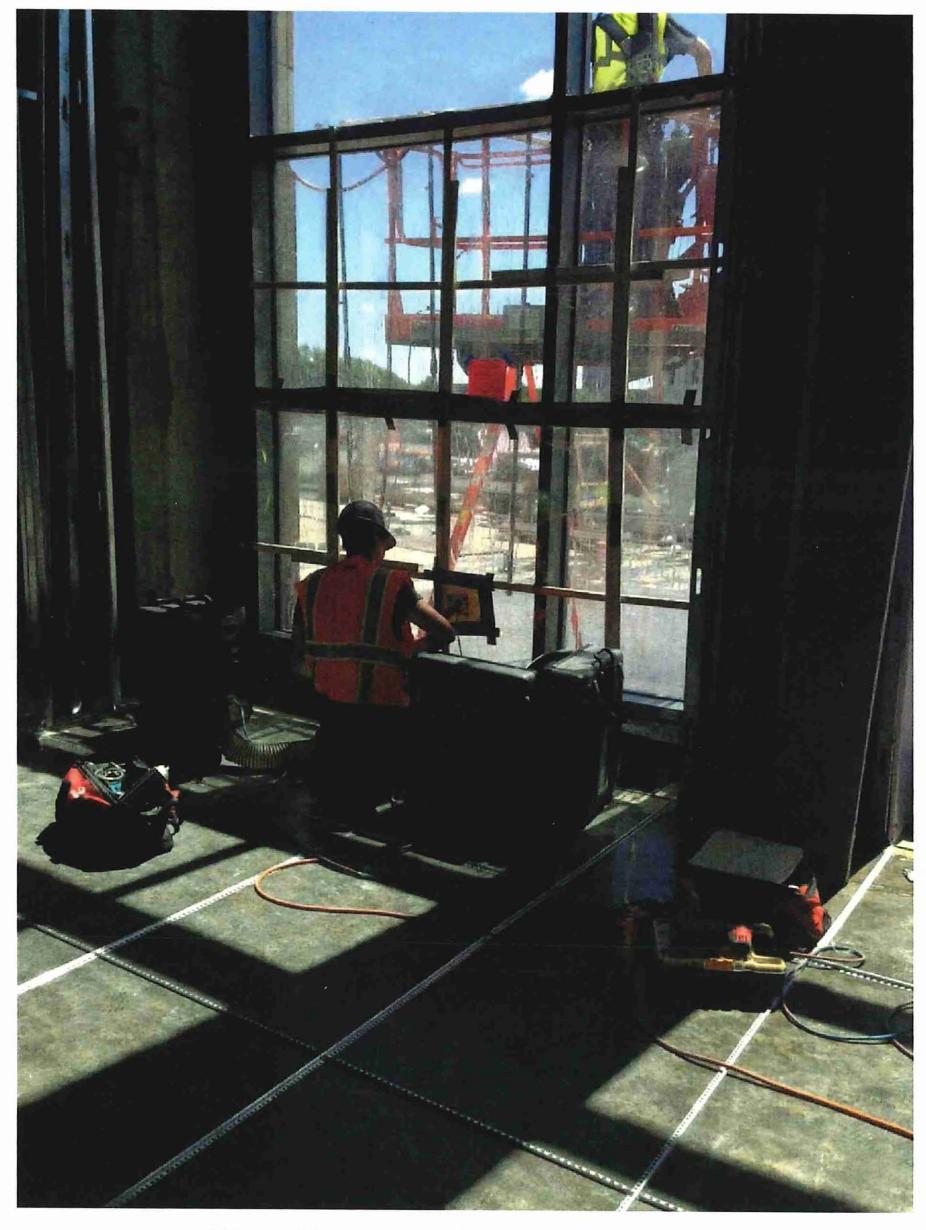
Photo No. 1 - Interior view of test area.

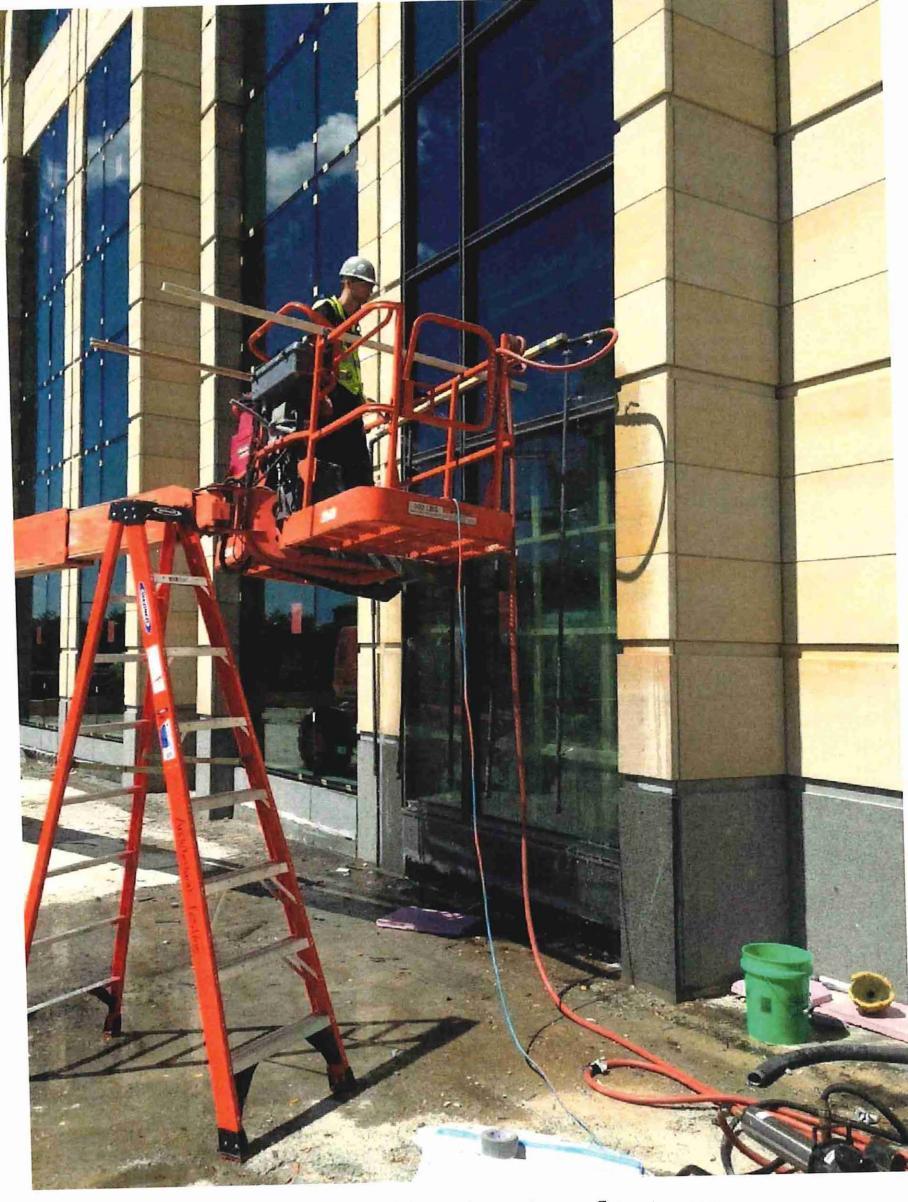
Photo No. 2 - Exterior view of test area.
