# Flandrau State Park - Contact Station (B40402)

5/11/2015

Consultant's Report

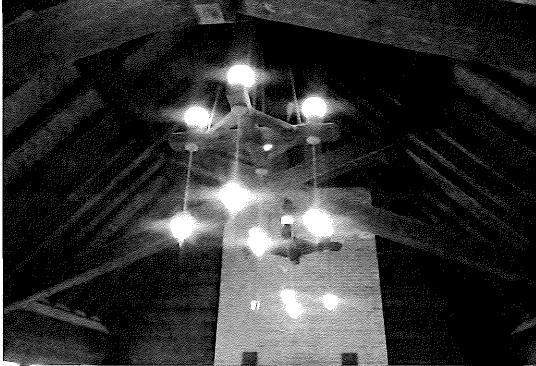
Incandescent lamps are used throughout the beach house. You may want to consider replacing these lamps with LED's, especially if they are left on for extended periods of time. LED lamps use 75% less energy than incandescent and last up to 20x longer before needed replacement. Estimated savings were based upon replacing (43) incandescent lamps with (43) LEDs.

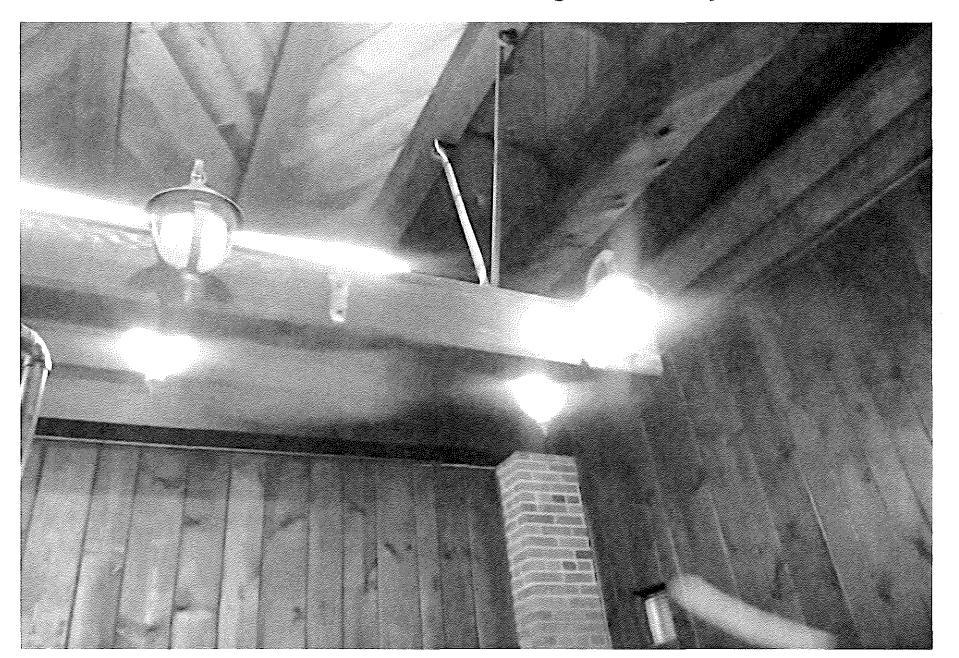
You may want to install Occupancy Sensors to automatically turn lights off in areas such as restrooms, storage rooms, or other rooms where lights could get left on. Occupancy sensors limit the amount of time the lights in each room are left on while unoccupied. Sensors can be purchased fairly inexpensively, for roughly \$20-\$100 each depending on type and style. The savings for installing these sensors varies greatly depending on the quantity of fixtures controlled as well as the amount of human traffic through the room. The typical payback for a break room and restroom installation is under two years. The most beneficial locations would be the kitchen and general hallways

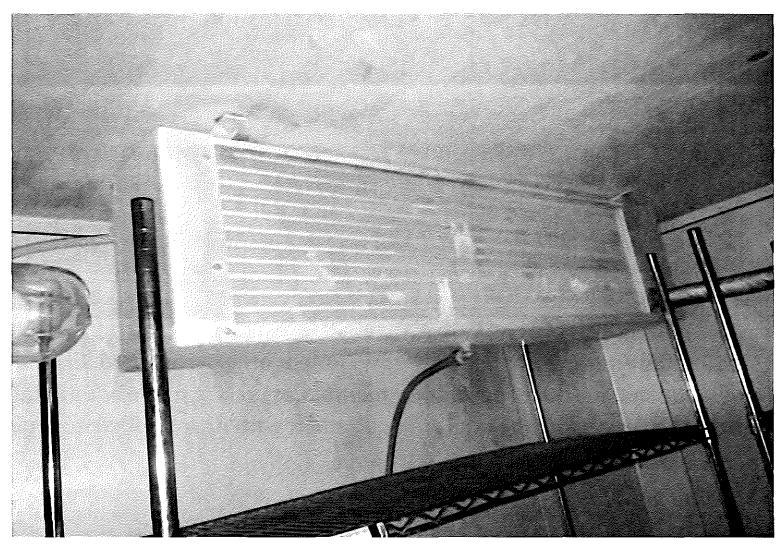
Standard fan motors commonly used in refrigeration equipment are major energy wasters. They run inefficiently and generate excess heat, causing the refrigeration system to work harder and use more energy. An Electrically Commutated Motor (ECM) is a DC motor designed for evaporators in walk in coolers and freezers. The DC motor runs up to 40% more efficiently than a shaded pole motor and generates less heat resulting in refrigeration savings. Overall, ECMs typically save up to 65% more than your current system. ECMs do however, cost about twice as much as a regular shaded pole motor, but often require less maintenance and replacement. Often larger electrical consumers are on a demand based rate so the ECM's save on both the consumption and demand charges.

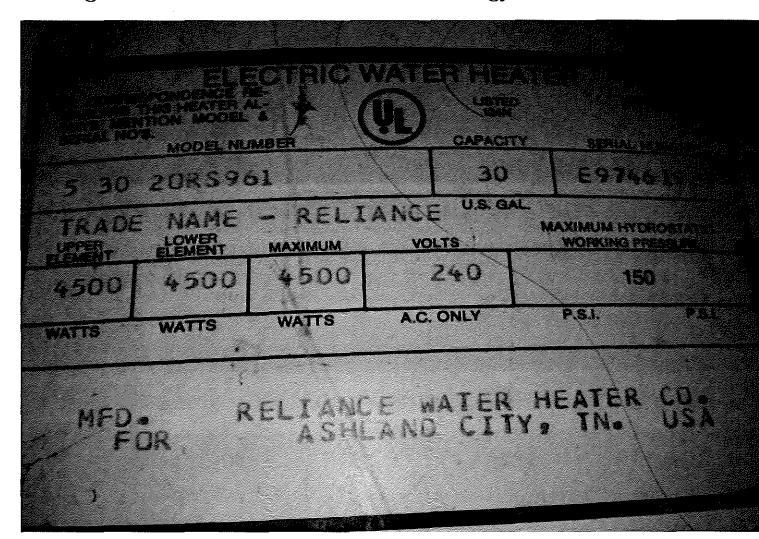
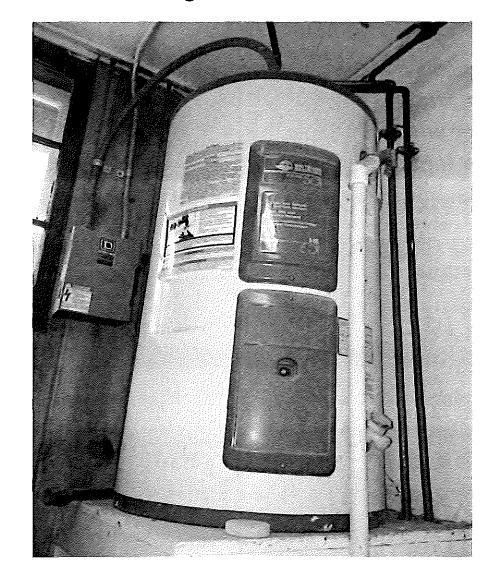
The water heater inside the shop is a 30 gallon water heater used for bathrooms and the kitchen faucet. The existing water heater has reached end of life and contains (2) 4,500 watt elements and has a 30 gallon capacity. You may want to consider a point of use water heater as a replacement more on the magnitude of a 1,500 watt or 2,000 watt element with a 15-20 gallon tank. There would be less energy to heat the water and less total water being stored.

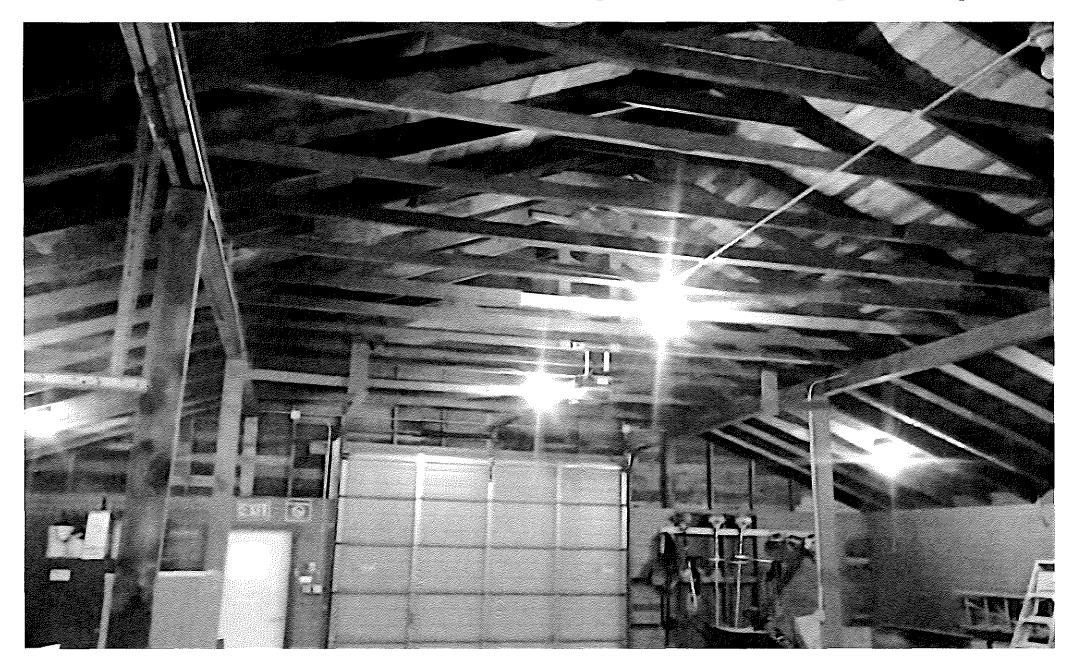
You may want to install Occupancy Sensors to automatically turn lights off in areas such as restrooms, storage rooms, or other rooms where lights could get left on. Occupancy sensors limit the amount of time the lights in each room are left on while unoccupied. Sensors can be purchased fairly inexpensively, for roughly \$20-\$100 each depending on type and style. The savings for installing these sensors varies greatly depending on the quantity of fixtures controlled as well as the amount of human traffic through the room. The typical payback for a break room and restroom installation is under two years. The most beneficial locations would be the attic storage areas as well as the general shop area.

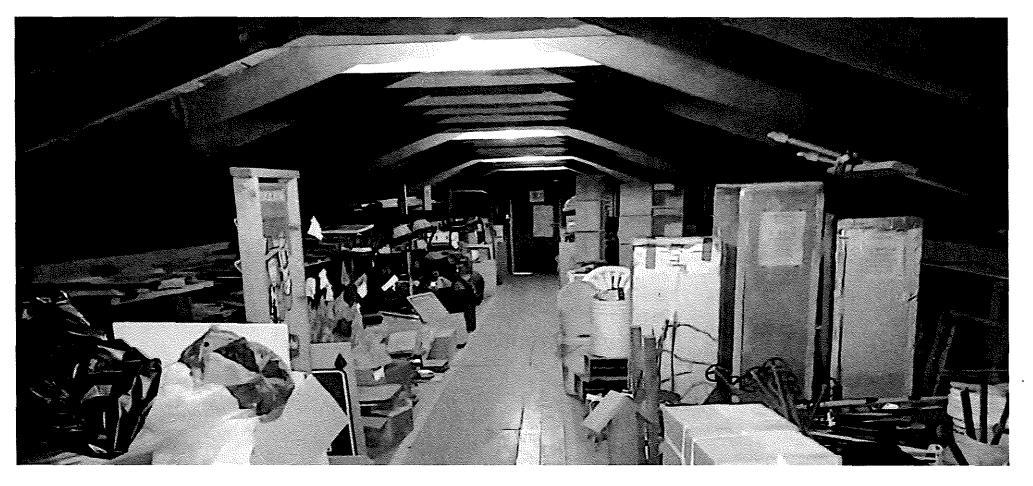
Incandescent lamps are used in the upstairs attic storage area. You may want to consider replacing these lamps with LED's, especially if they are left on for extended periods of time. LED lamps use 75% less energy than incandescent and last up to 20x longer before needed replacement. Estimated savings were based upon replacing (11) incandescent lamps with (11) LEDs.
