Minnesota Department of Natural Resources
Minnesota Board of Water and Soil Resources

Program Process Project Evaluations

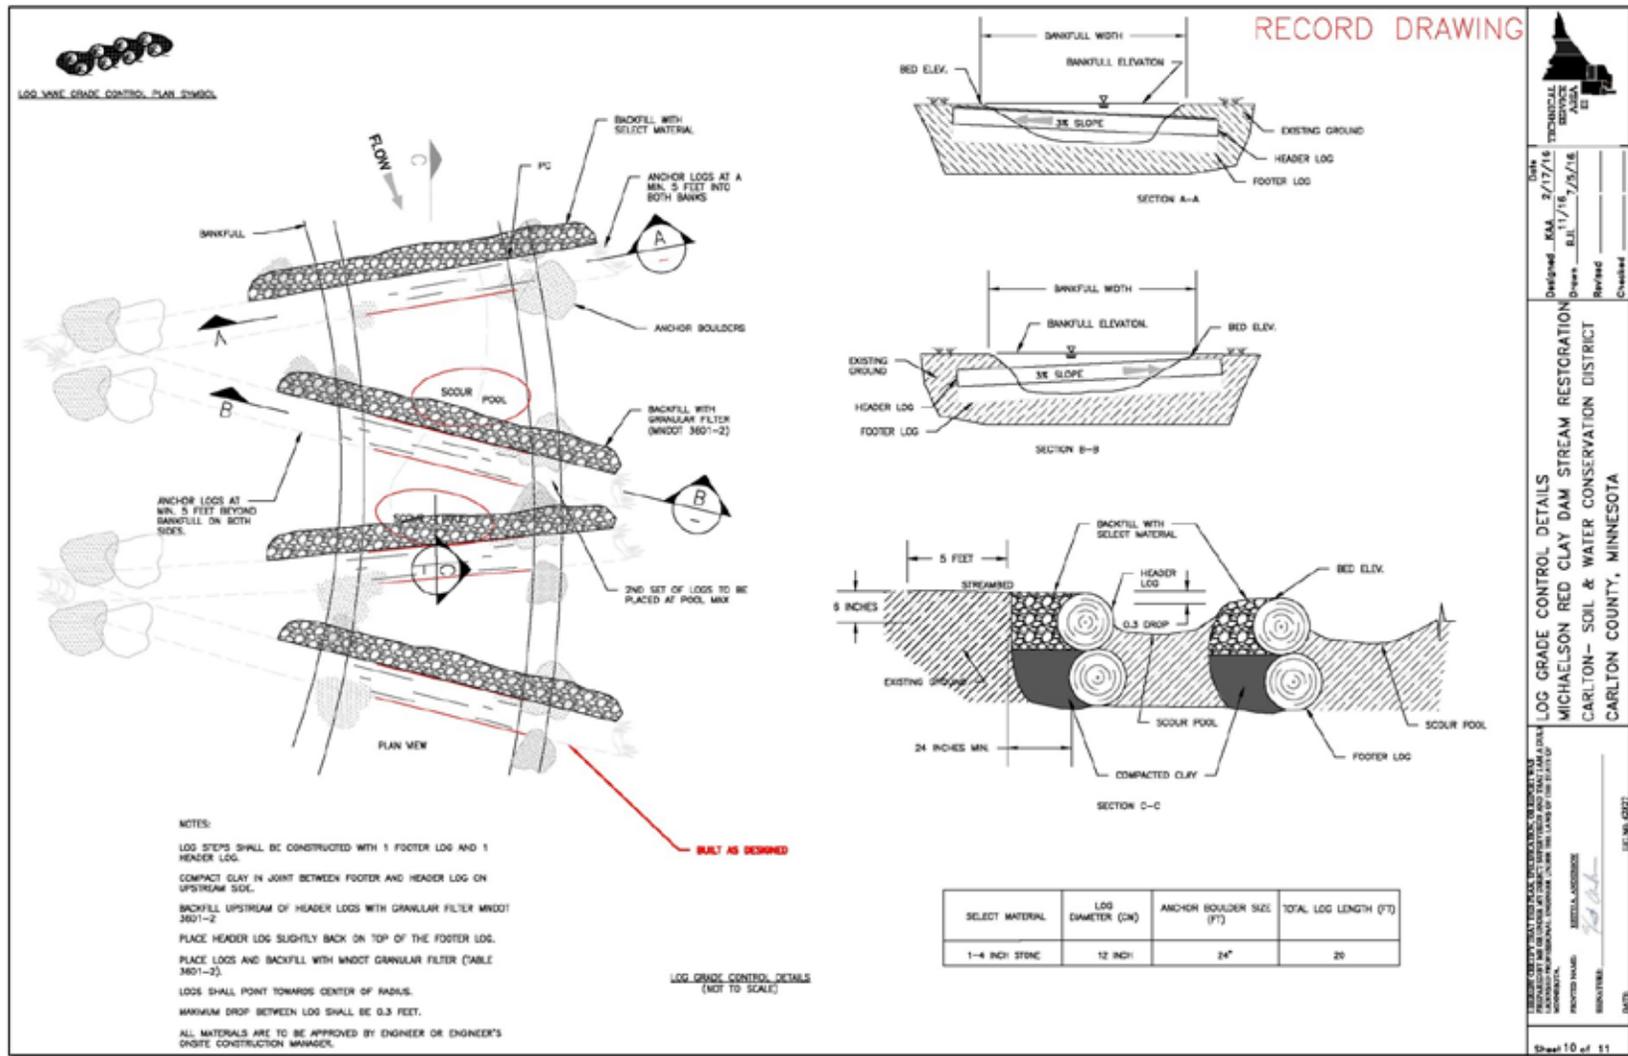
Figure 1-3 Michaelson Red Clay Dam Project Plan Set (Page 10) provided by the Carlton SWCD.

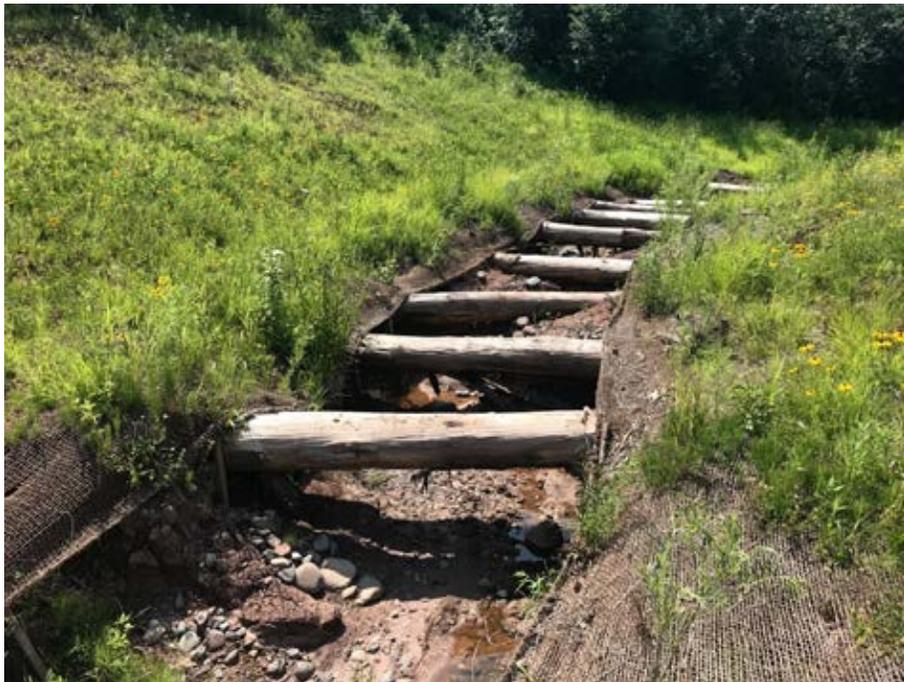
Photo 1-3 Failed log grade control structures within the old dam impoundment. A headcut has advanced throughout the middle section of the project site in an area where sediment deposits were likely the deepest. Photo taken by Mike Majeski on 7/23/2019.

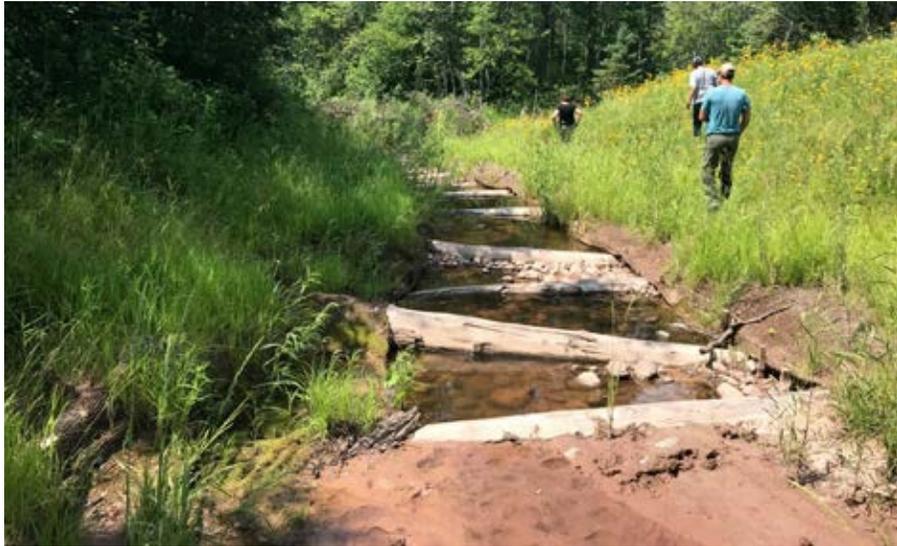
Photo 1-4 Log grade control structures near the confluence with Deer Creek. These structures are intercepting some sediment and are providing small pool habitat for aquatic organisms. Photo taken by Mike Majeski on 7/23/2019.

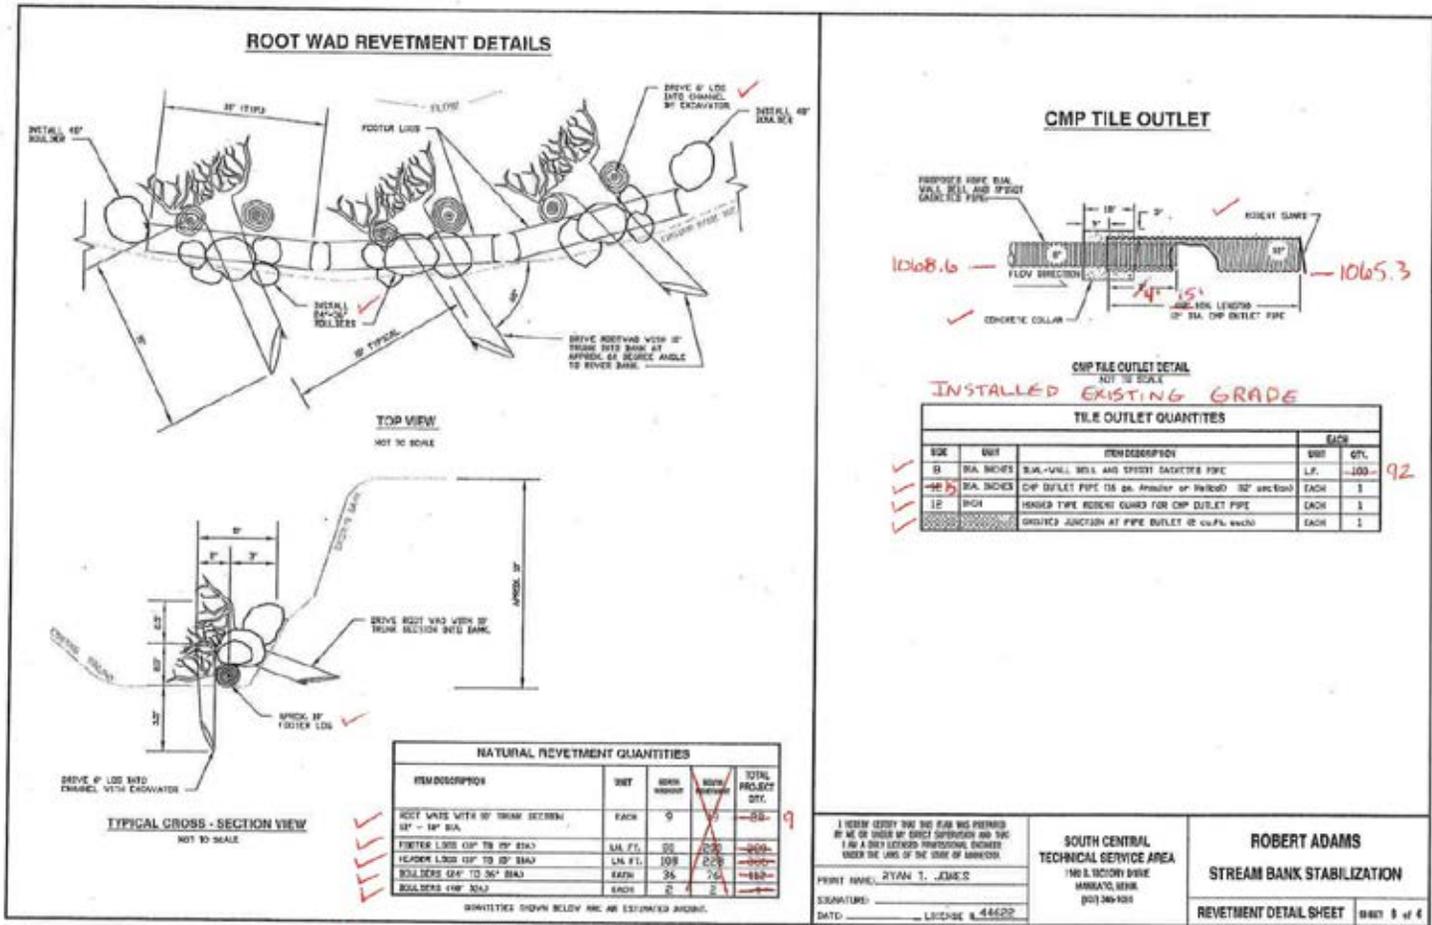
Figure 2-7 Adams Streambank Restoration Sheet 6 of 6. Revetment Detail Sheet.

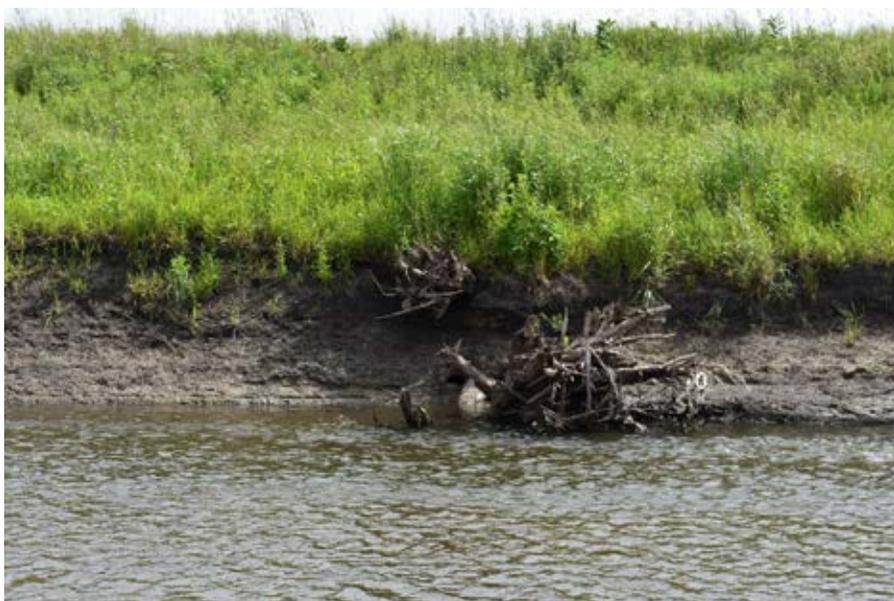
Photo 3-2 View of Elm Creek project showing a single exposed rootwad. Evaluator recommends rock/boulders on both sides of the rootwad near station 7+00 to prevent bank scour behind the rootwad. Photo taken by Ed Matthiesen during site visit (8/13/19).

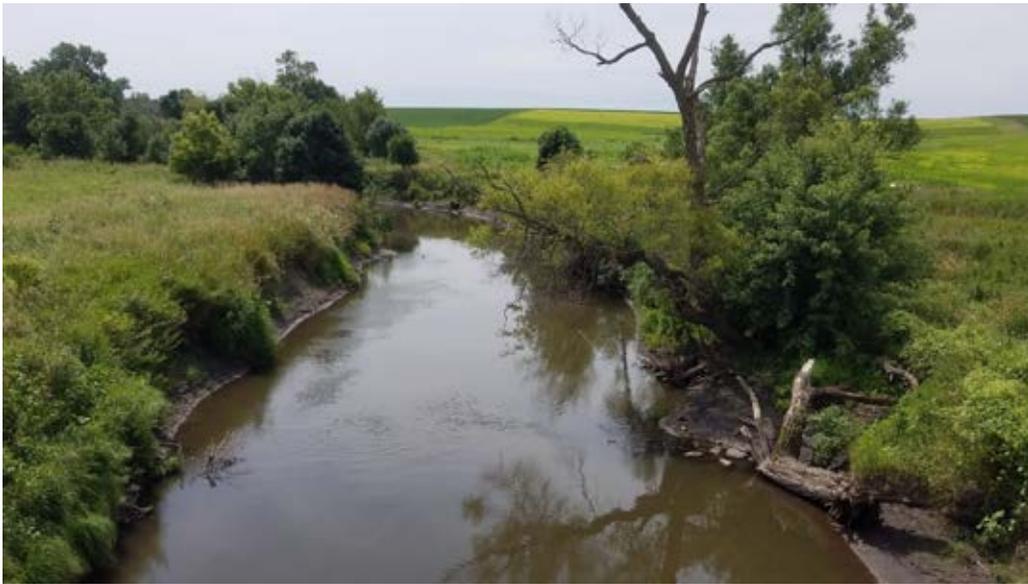
Photo 3-3 View of Elm Creek downstream of the project area from the County Highway 36 bridge as a reference of the natural channel width outside of the project area. Photo taken by Ed Matthiesen during site visit (8/13/19).

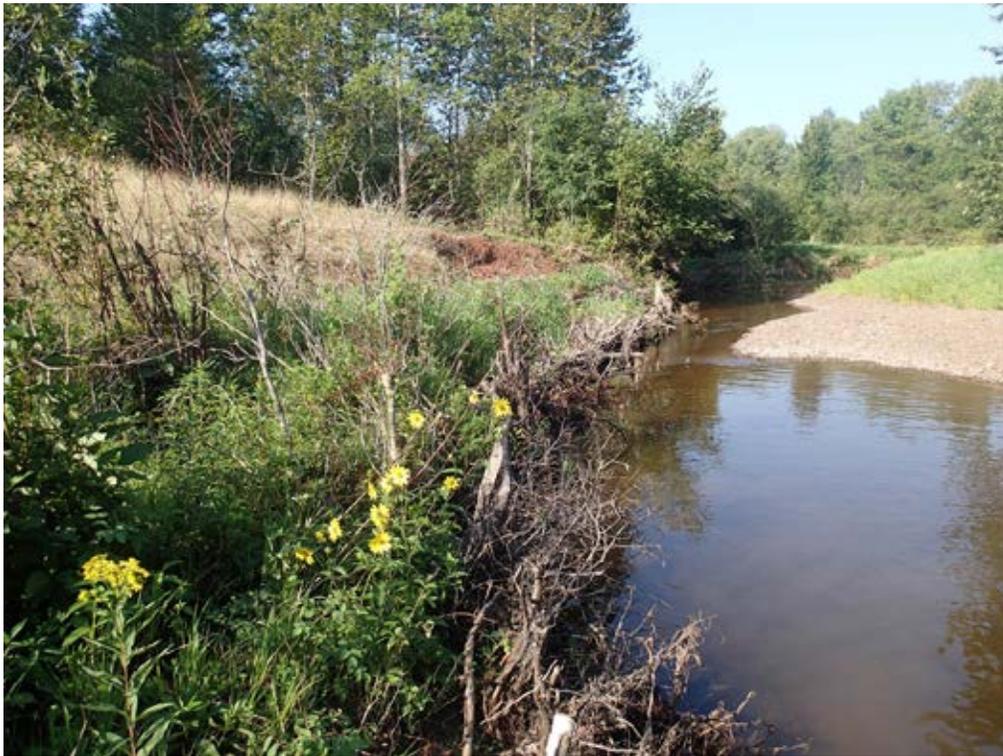
Photo 4-7 Toewood rootwads and vegetation growth, facing downstream during low water conditions. Site visit 08/24/2012.

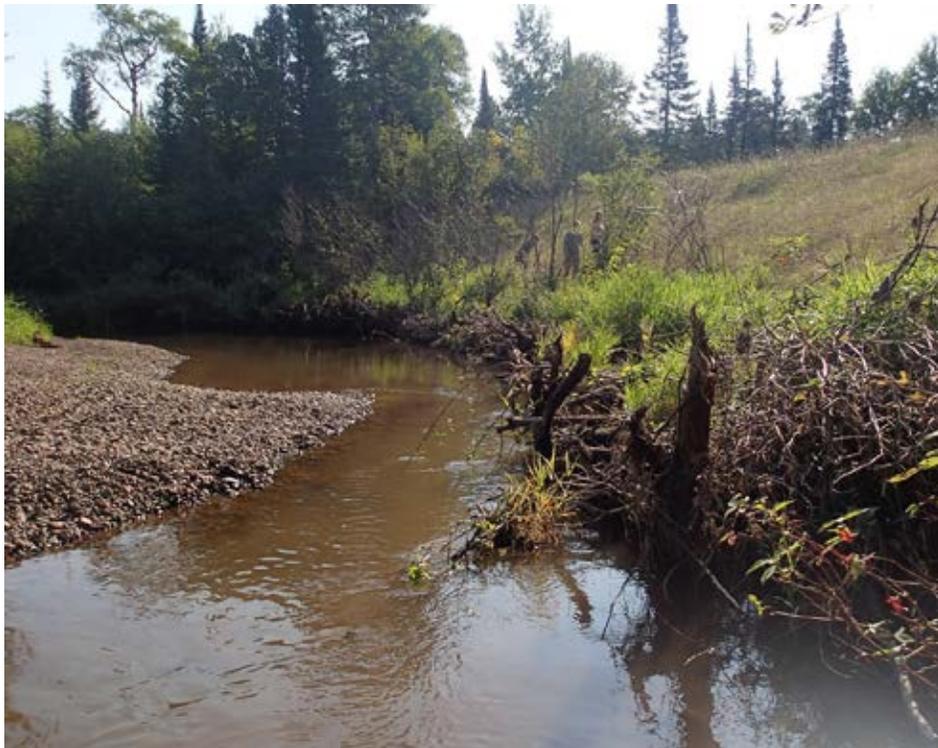
Photo 4-8 Toewood rootwads and first year's vegetation growth on slope. Facing upstream during low water conditions. Site visit 08/24/2012.

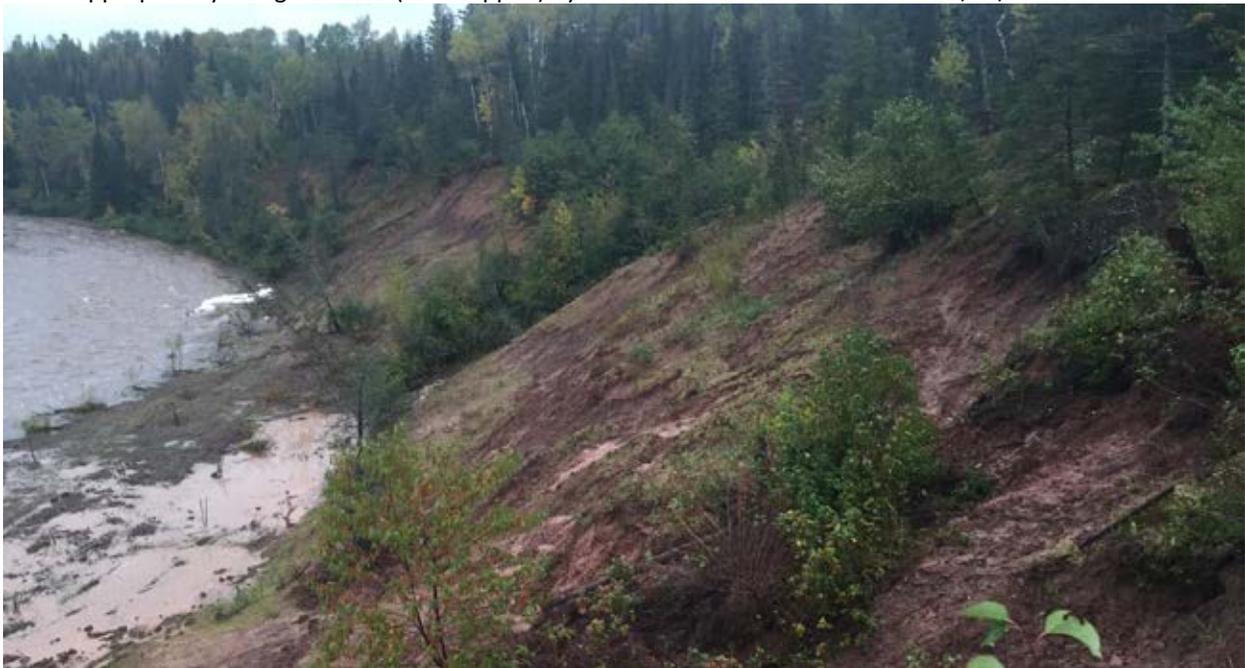
Figure 5-6 - Representative image of stabilization (bluff). As visible in photograph, the attempt to establish vegetated cover on the clay bluff in question (right side of image) via hydroseeding is showing early signs of failure. It is acknowledged though that the primary project means for reducing sediment from the bluff is the realignment of the stream away from the bluff and the creation of a stable bluff toe and associated bankfull bench. Date 09/24/2015.

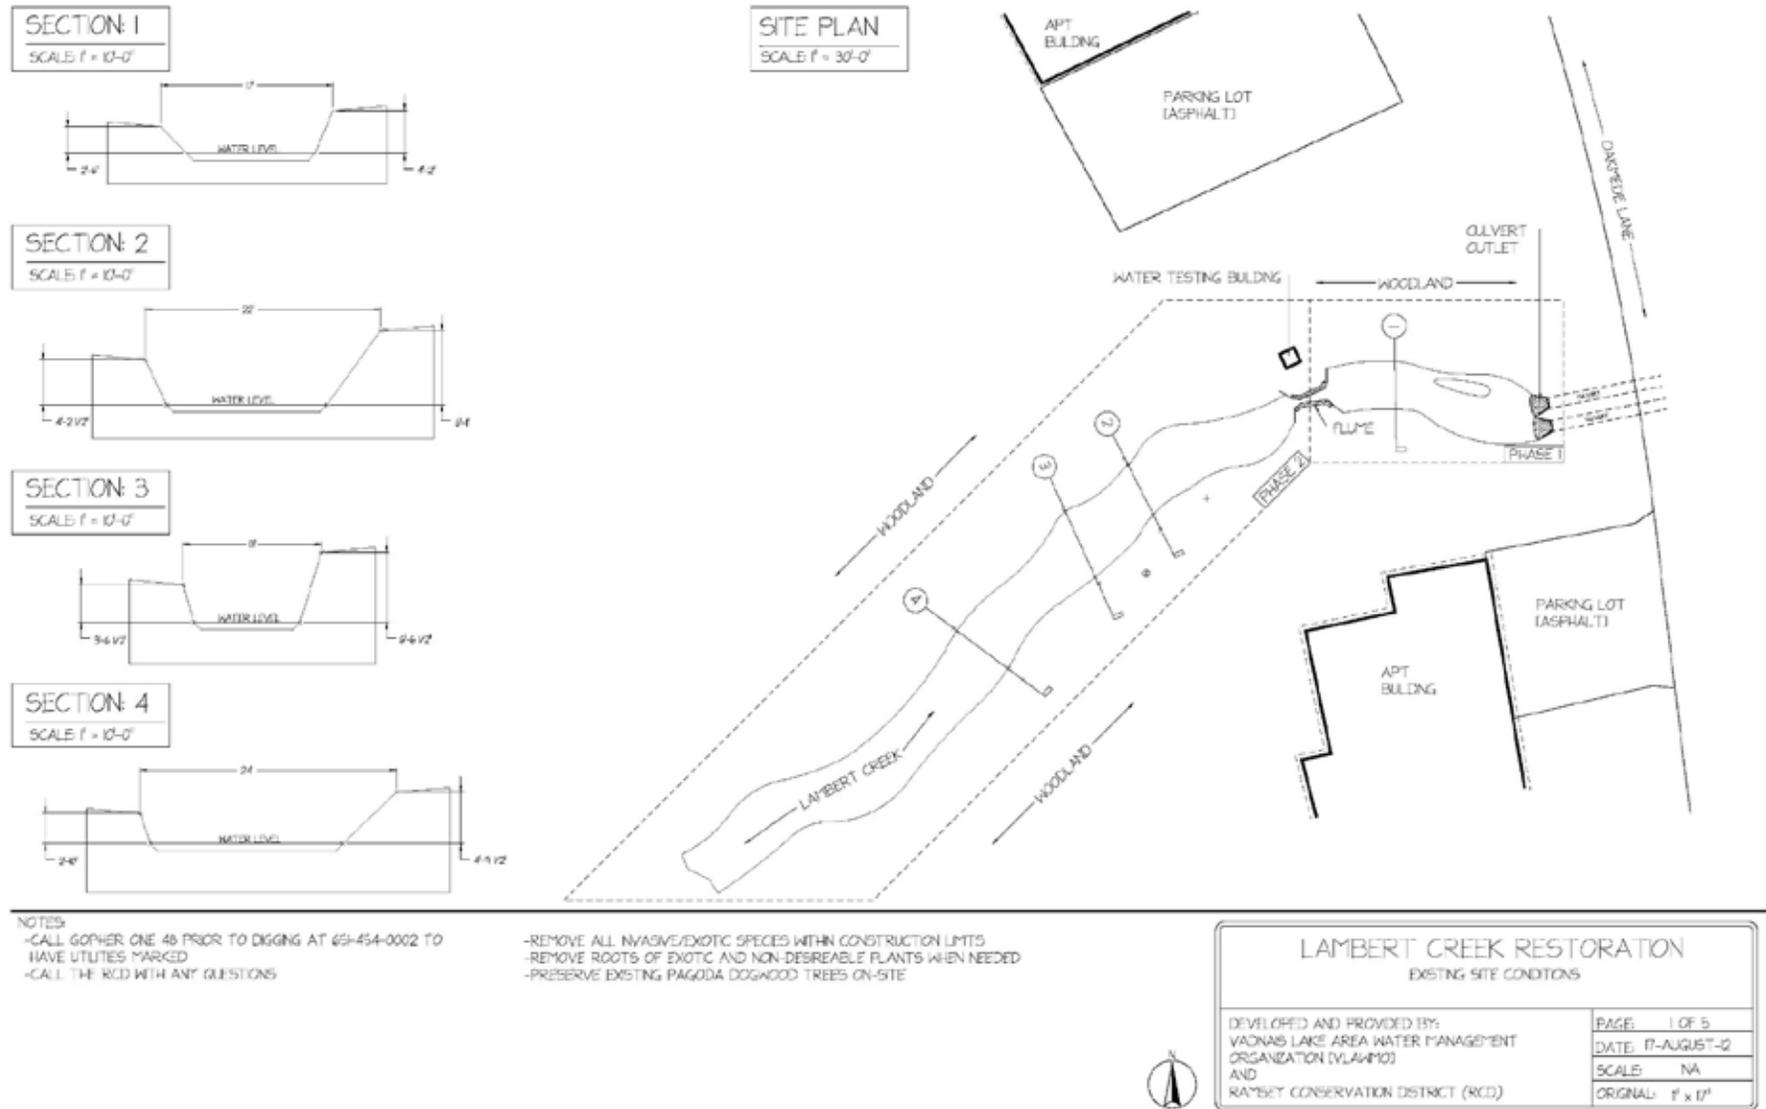
Figure 7-1 Construction Documents –Existing Conditions Plan Sheet, dated 8/17/2012

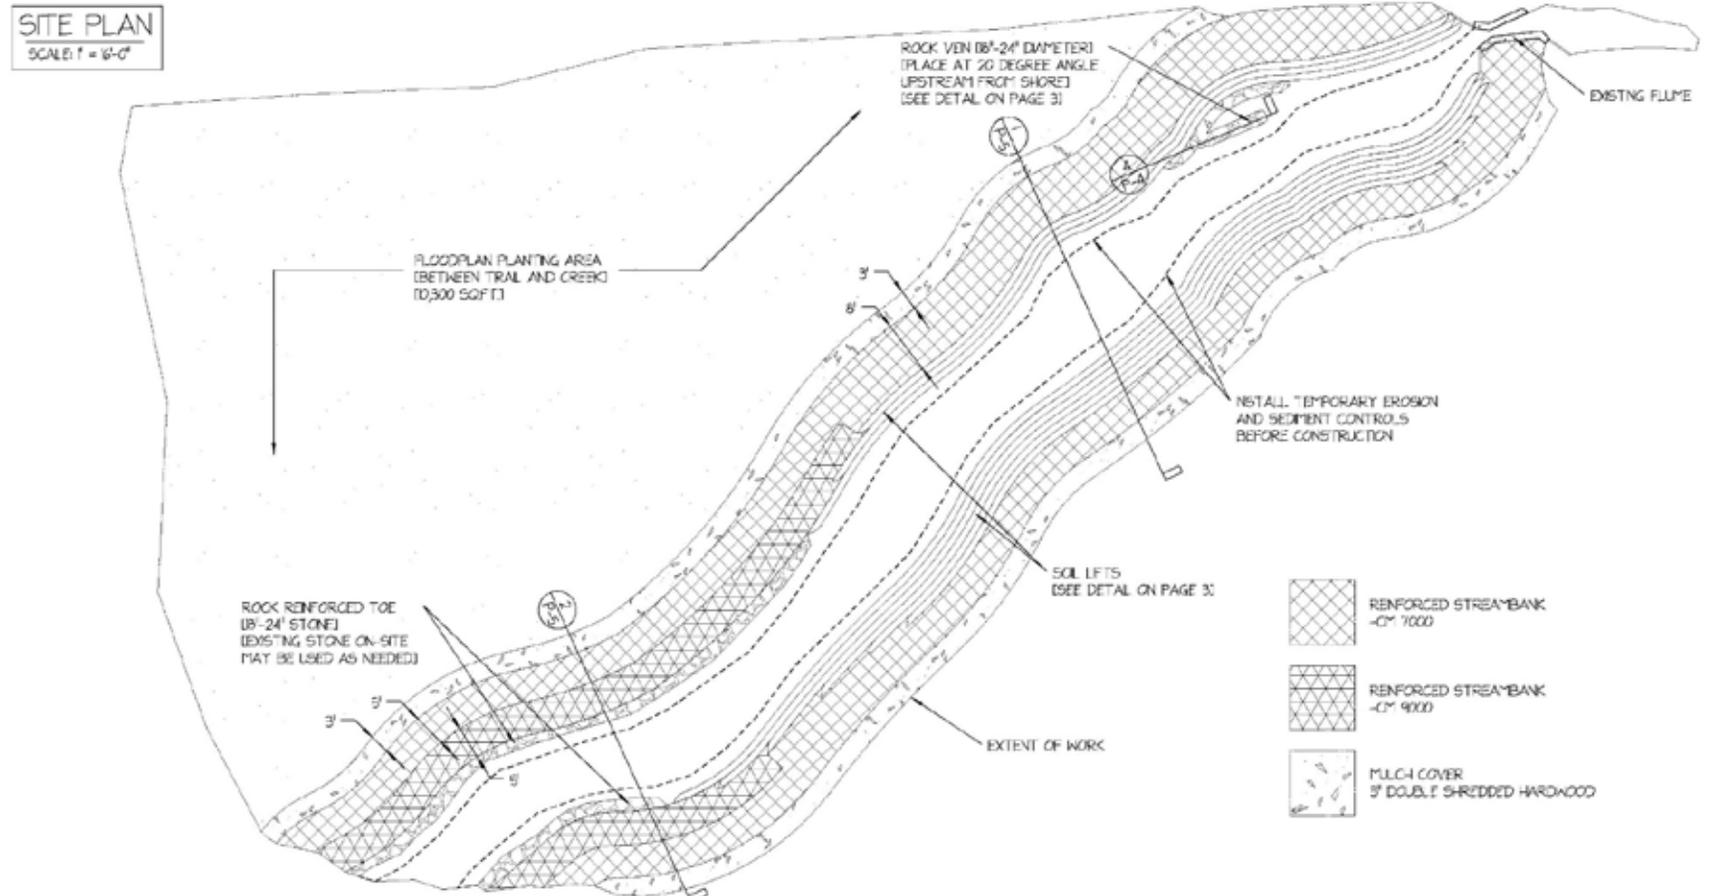
NOTES
 -CALL GOPHER ONE 48 PRIOR TO DIGGING AT 698-454-0002 TO HAVE UTILITIES MARKED
 -CALL THE RCD WITH ANY QUESTIONS

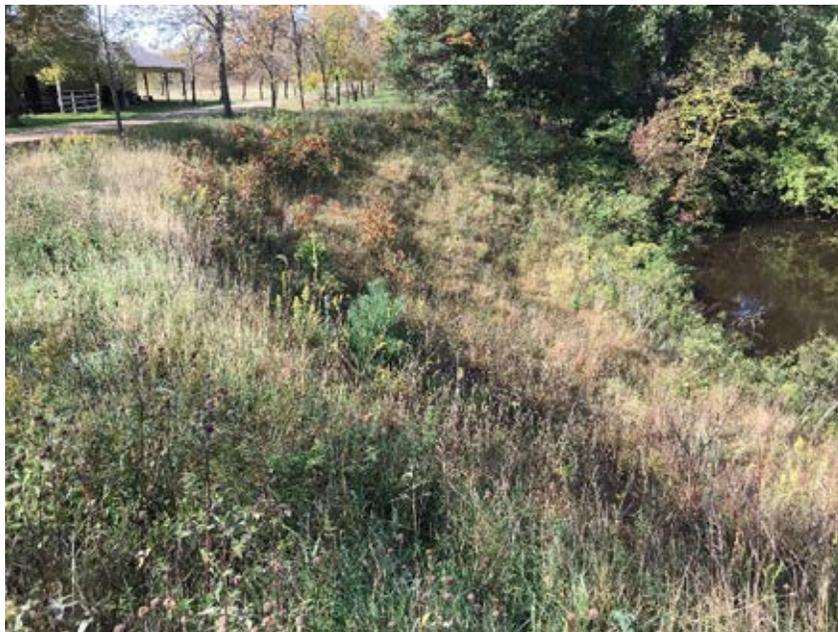
Photo 8-6 Resloped project area observed during the site visit. (Rum River West River Branch – Miskowic property, photo taken by Lucius Jonett during site visit 09/19/2019).

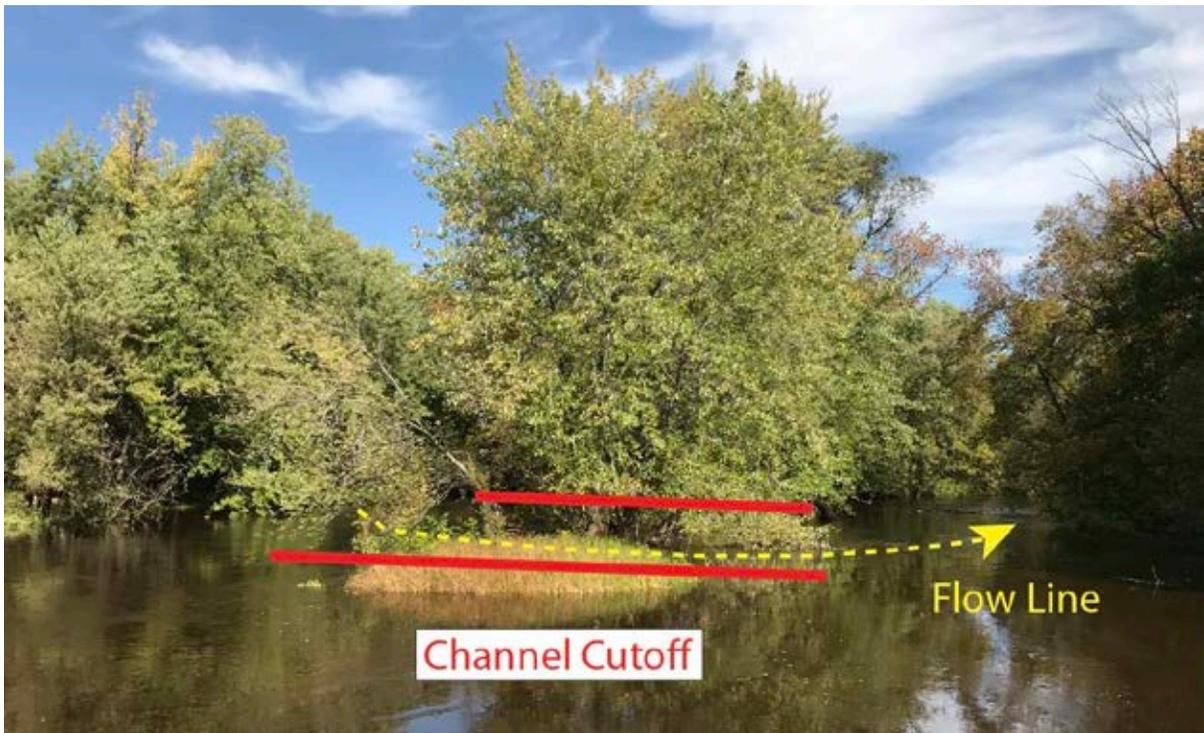
Photo 8-7 Point bar by-pass channel through the inside bend of the meandering channel to allow high flow to short-cut across the inside bend instead of the natural flow path through the outside bend, (Photo taken by Lucius Jonett during site visit 09/19/2019).

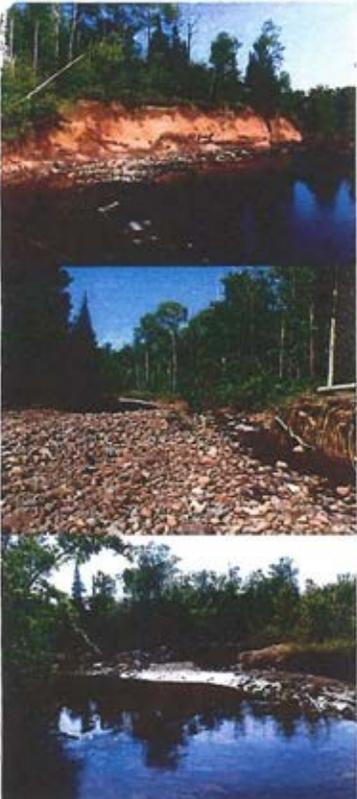
Stewart River Restoration Project

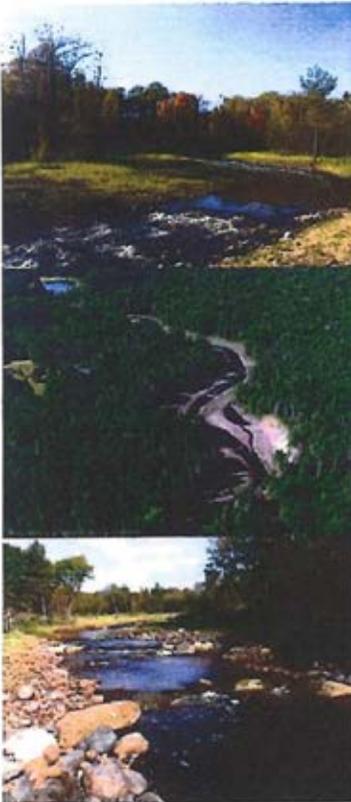
Funding was provided by the Minnesota Clean Water Land and Legacy Amendment Clean Water Fund and Lessard-Sams Outdoor Heritage Council, as well as grants from the Minnesota Department of Natural Resources and Sustain Our Great Lakes.

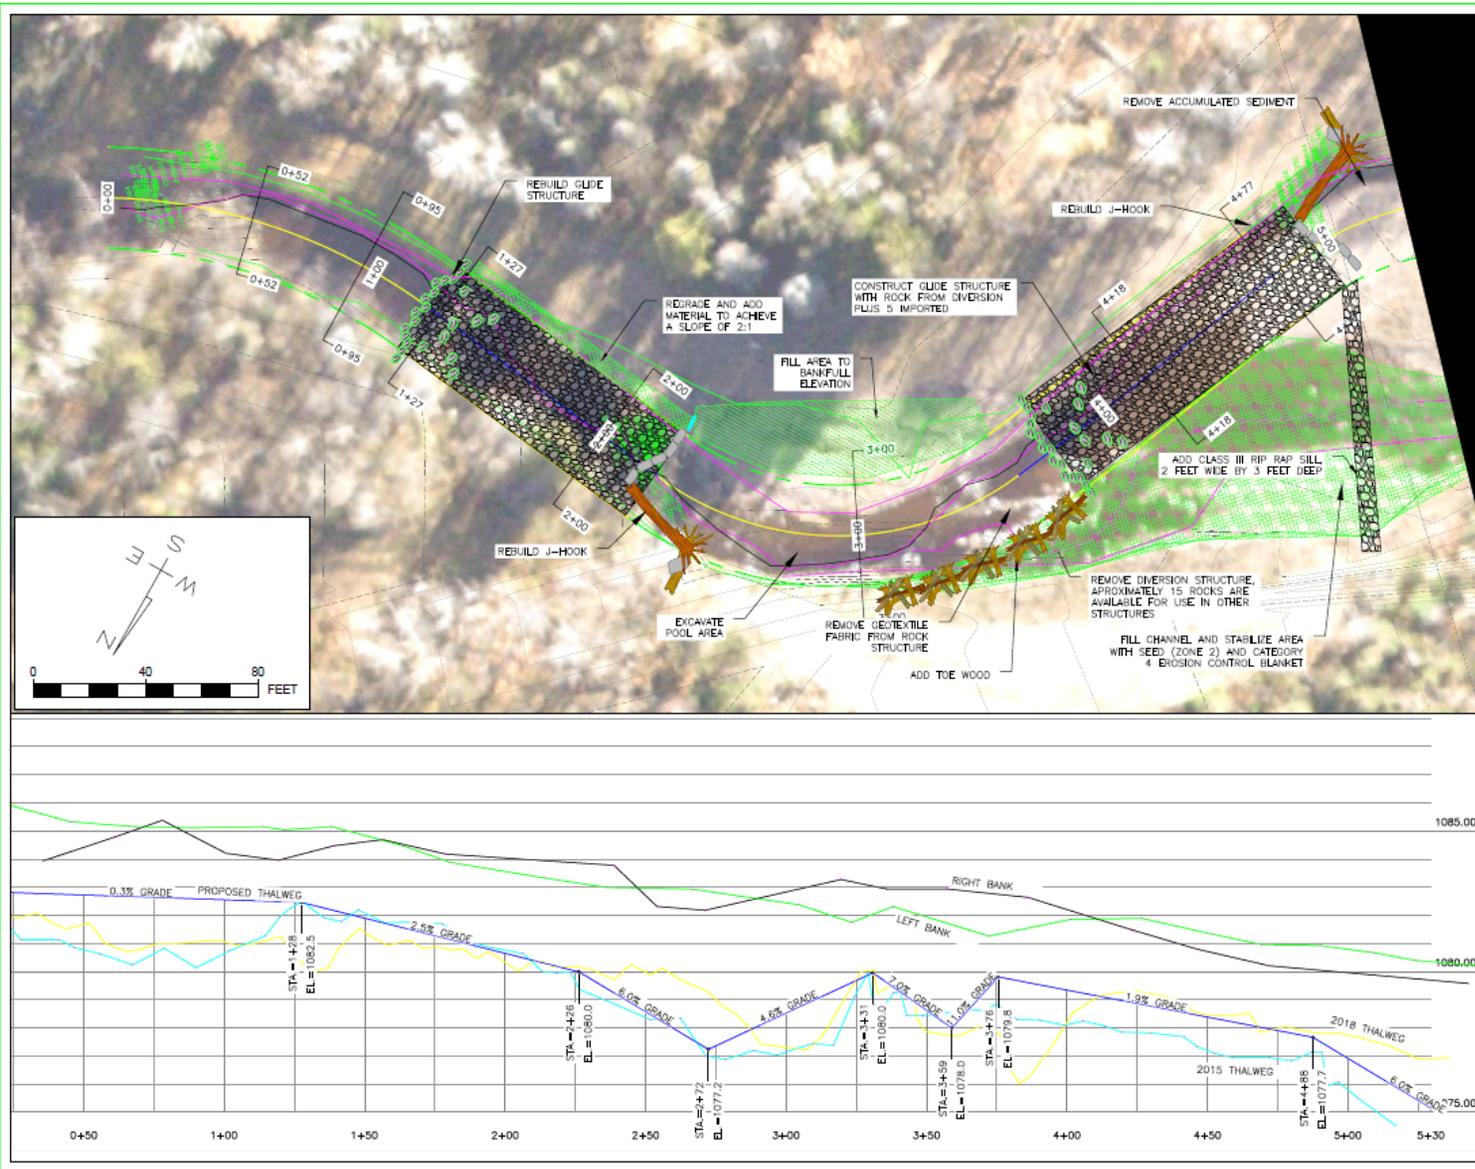
T:\ACTIVE PROJECTS\lake02018\stewart\2018\plan\c:\repair.dwg, 6/21/2019 11:00:27 AM, AutoCAD PDF (General Documentation).pl

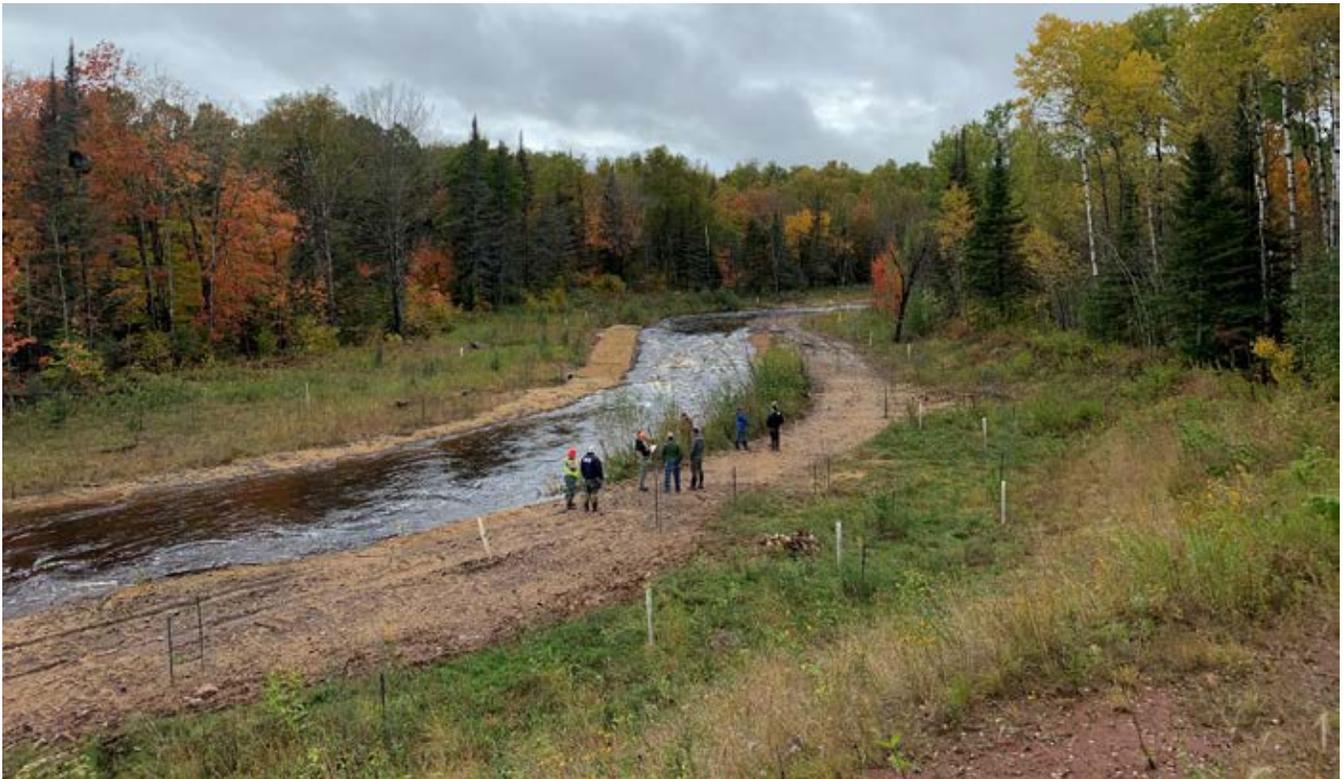
Photo 9-5 Disturbance and associated site restoration that parallels both side of the stream is a product of 2018-19 repairs and modifications. Photograph taken by Kevin Biehn during 10/1/2019 site visit.

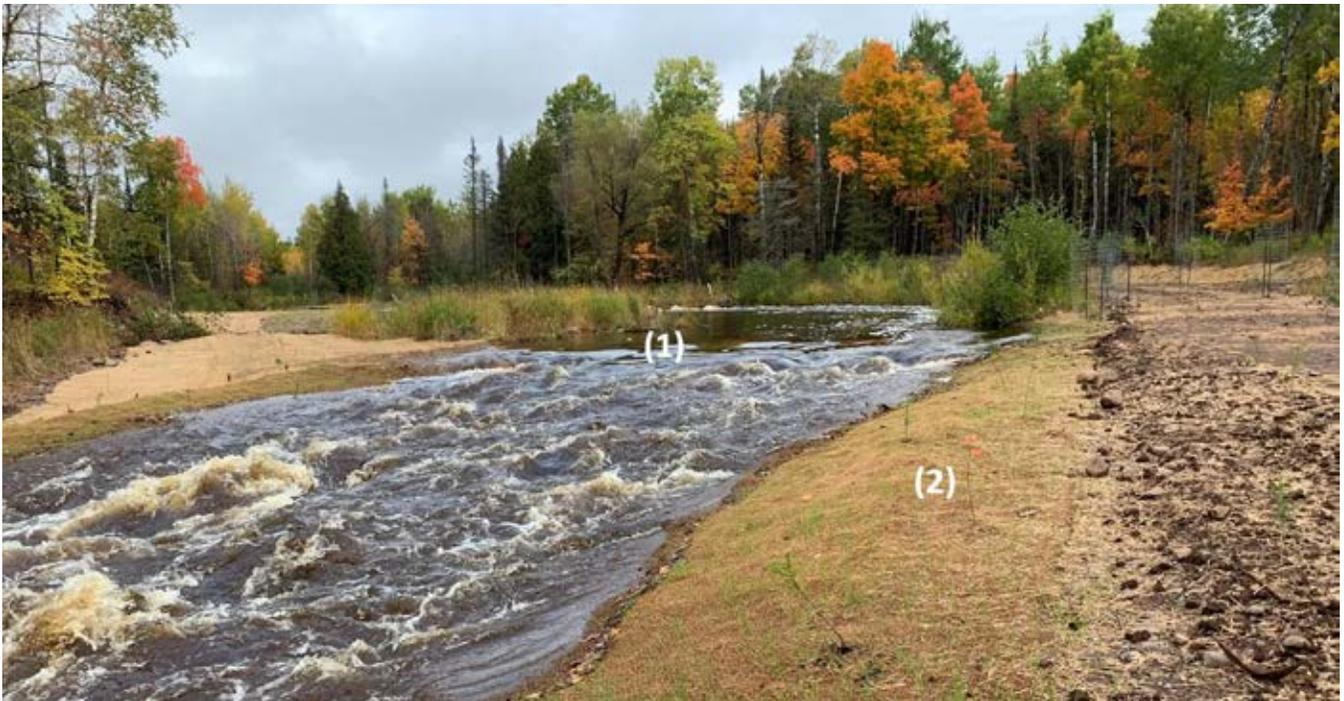
Photo 9-6 Representative image of high gradient segment of river and repaired grade control structure (1) looking upstream. Note saplings recently planted along stream edge (2). Photograph taken by Kevin Biehn during 10/1/2019 site visit.

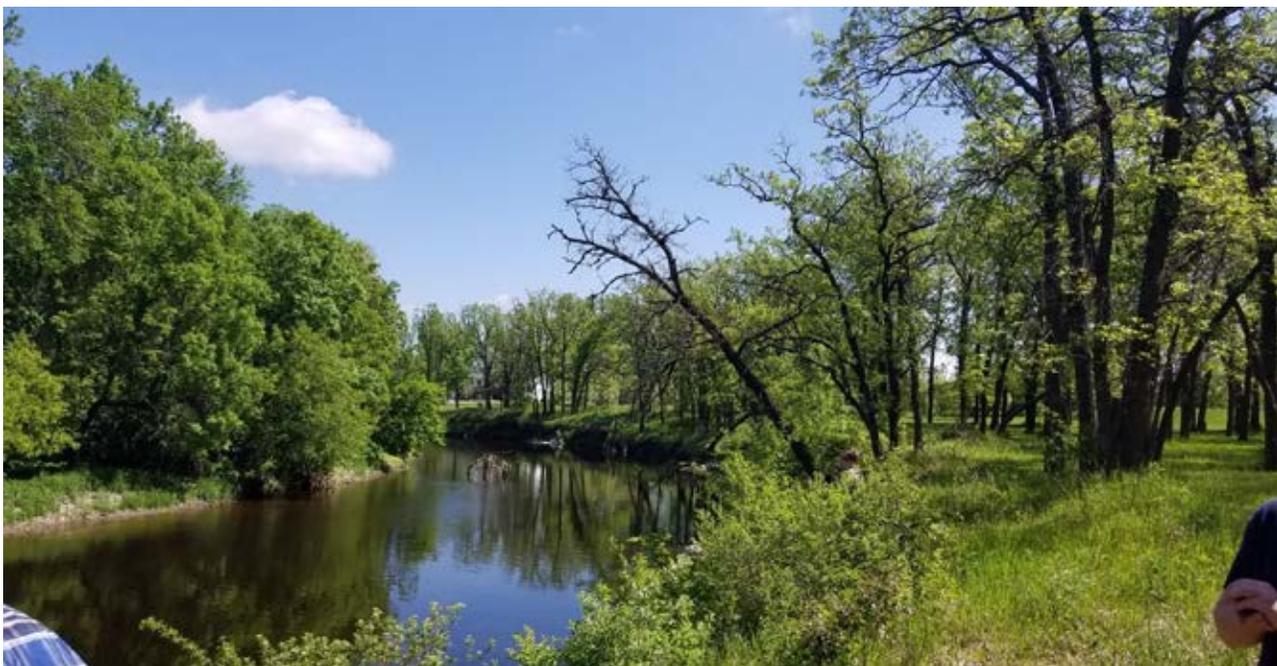
Photo 11-1 Upstream view of stream barbs 3 and 4 with some bare slopes downstream and trees leaning over the river. It is recommended to install live stakes on the bare slopes, provide a buffer to the top of the bank, and remove the leaning trees and limbs. Photo taken by Ed Matthiesen during site visit (6/5/2019).

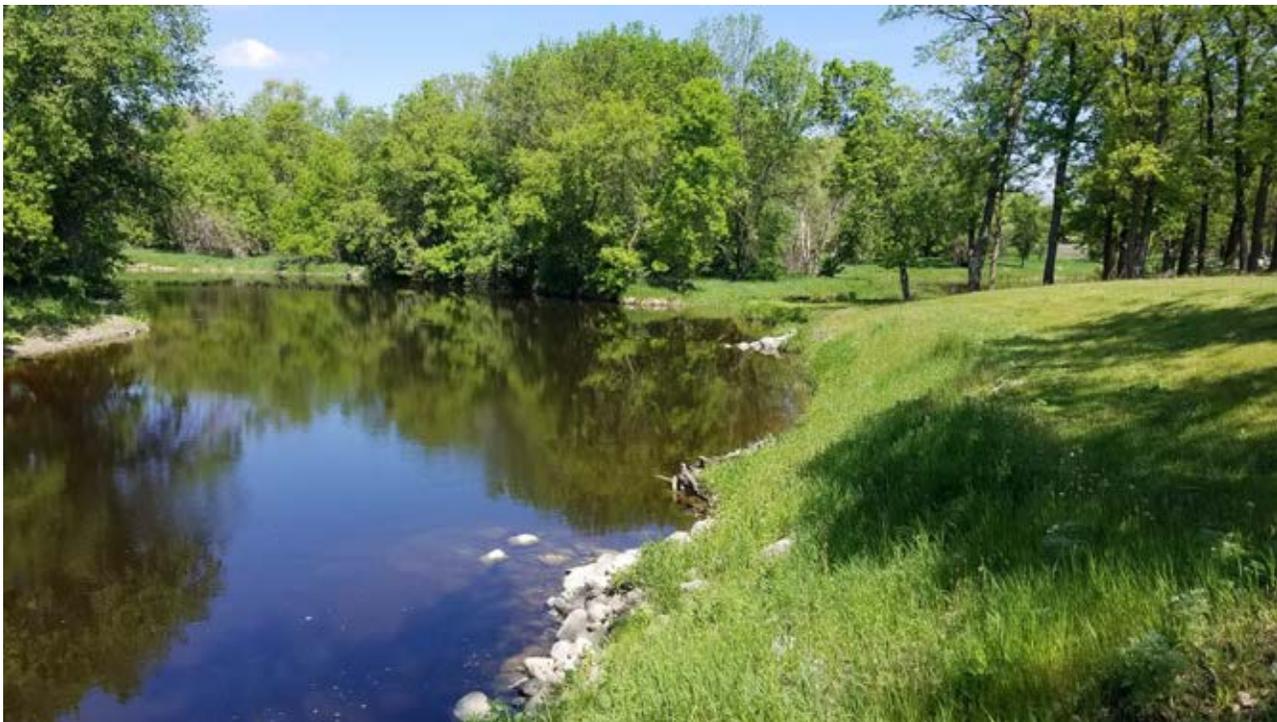
Photo 11-2 Upstream view of stream barbs 1, 2, and 3. Photo taken by Ed Matthiesen during site visit (6/5/2019).

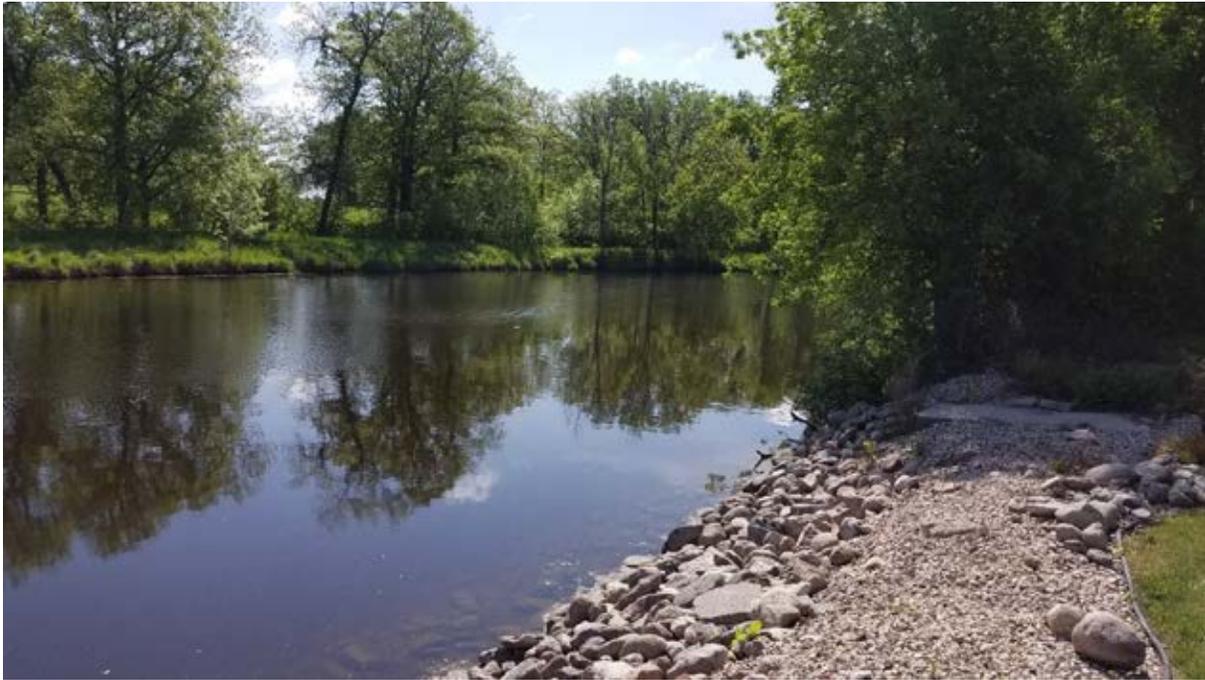
Photo 12-1 Upstream view of 0+25. It is recommended to consider vegetated riprap on slopes. Photo taken by Ed Matthiesen during site visit (6/5/2019).

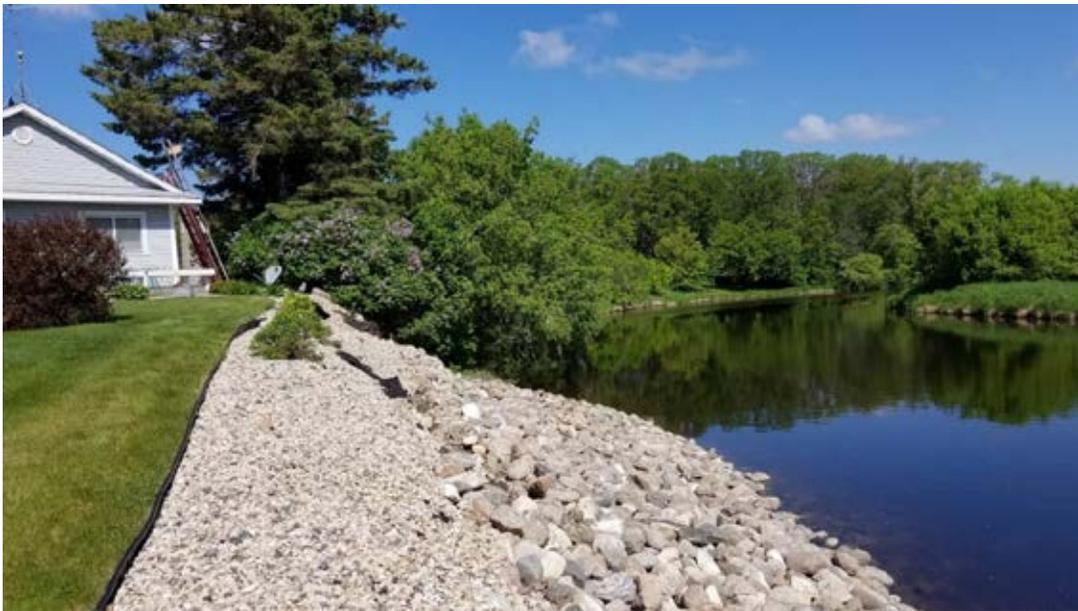
Photo 12-2 Downstream view from 0+50. There is a slope failure present on the upper slope resulting from a freeze-thaw or a quick drop in water level. It is recommended to add biological improvements. Photo taken during site visit 06/05/2019.

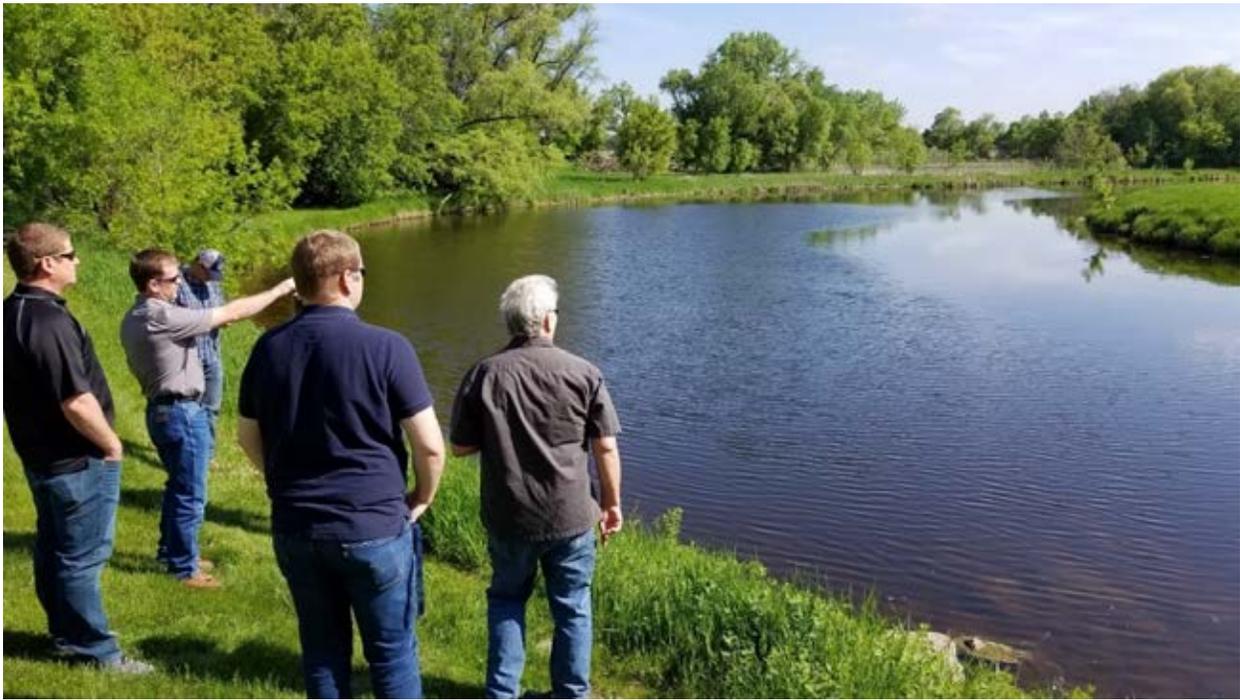
Photo 12-3 Downstream view of Stream Barb #1. Slopes of both banks are stable. There is an NRCS-type vane redirecting flow. Photo taken during site visit 06/05/2019.

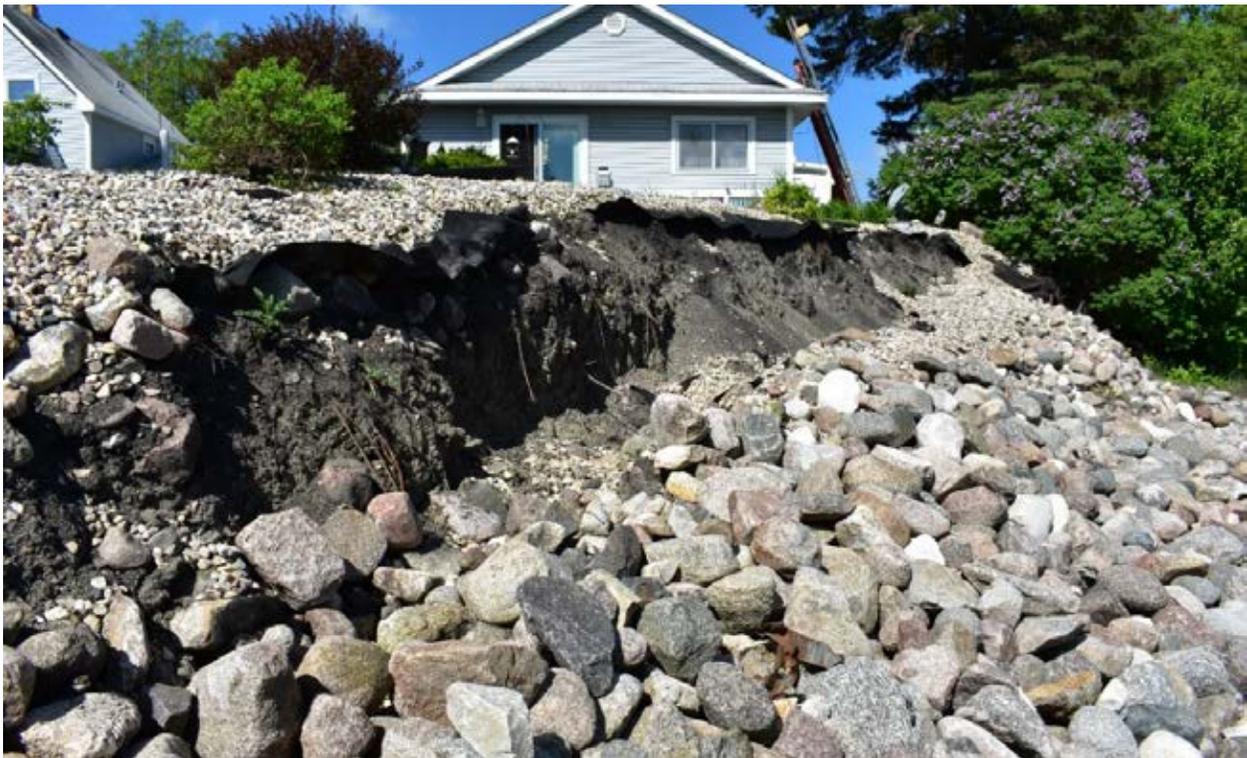
Photo 12-4 View of the disturbance at the top of the streambank which may be signs of a rotational failure or slump. Regrading of this ridge back toward the homes is recommended along with revegetation on the new slope. Photo taken during site visit 06/05/2019.
