Minnesota Department of Natural Resources
Minnesota Board of Water and Soil Resources

Program Process Project Evaluations

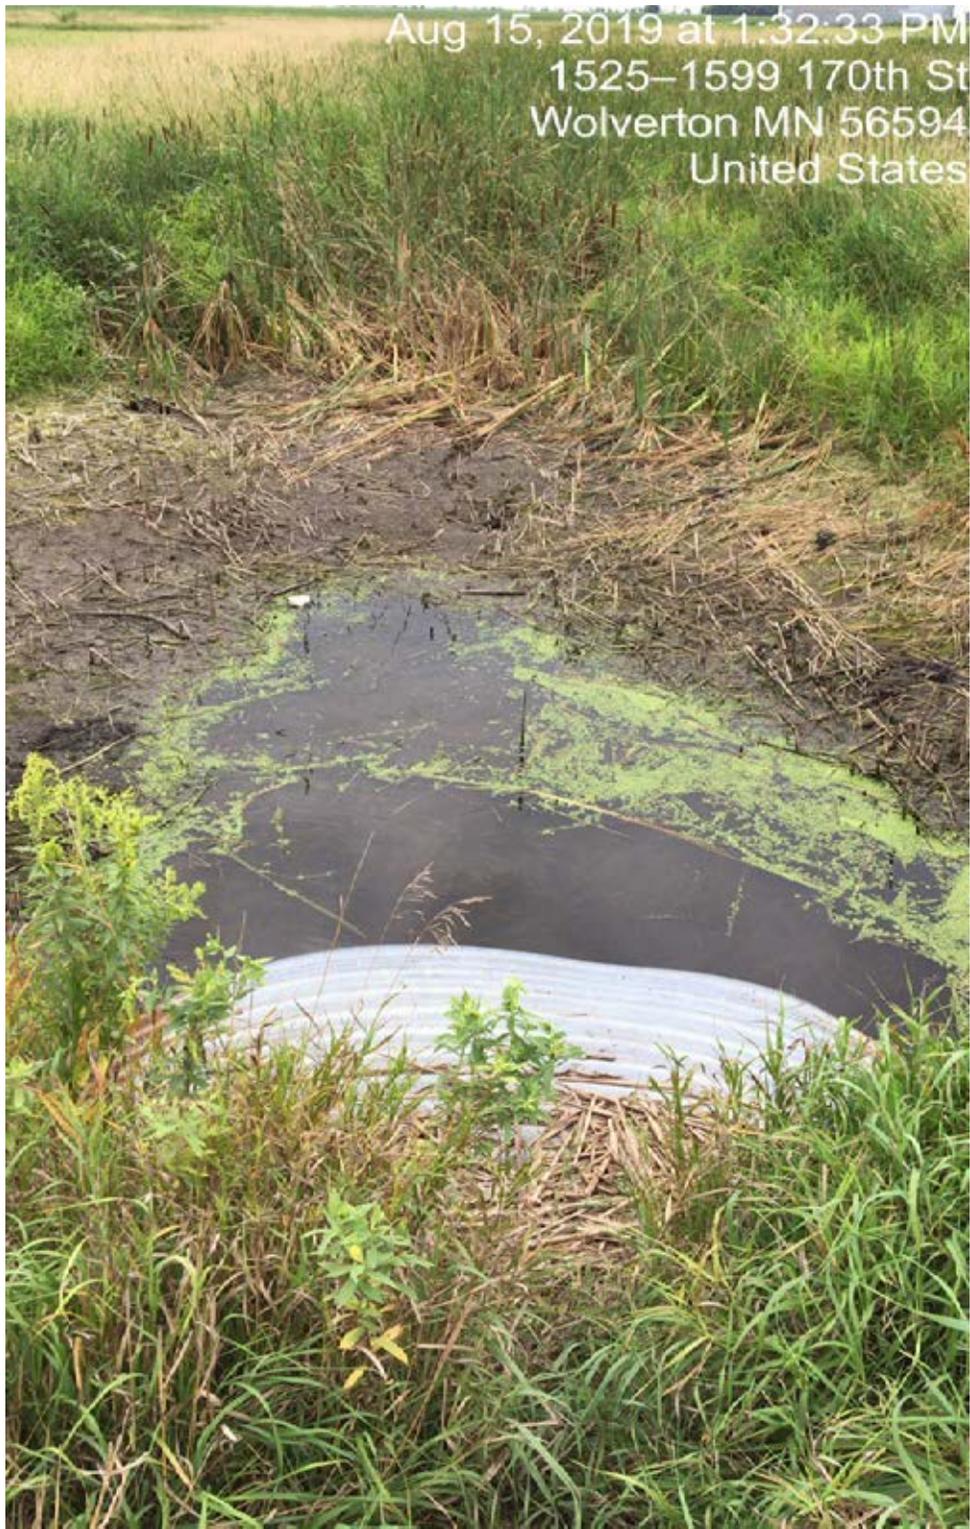
Photo 13-6. View of existing condition at a location just upstream from the Phase 1 construction. Water is stagnant and channel is choked with sediment and vegetation. Photo taken by Anna Varian during site visit (8/15/2019).

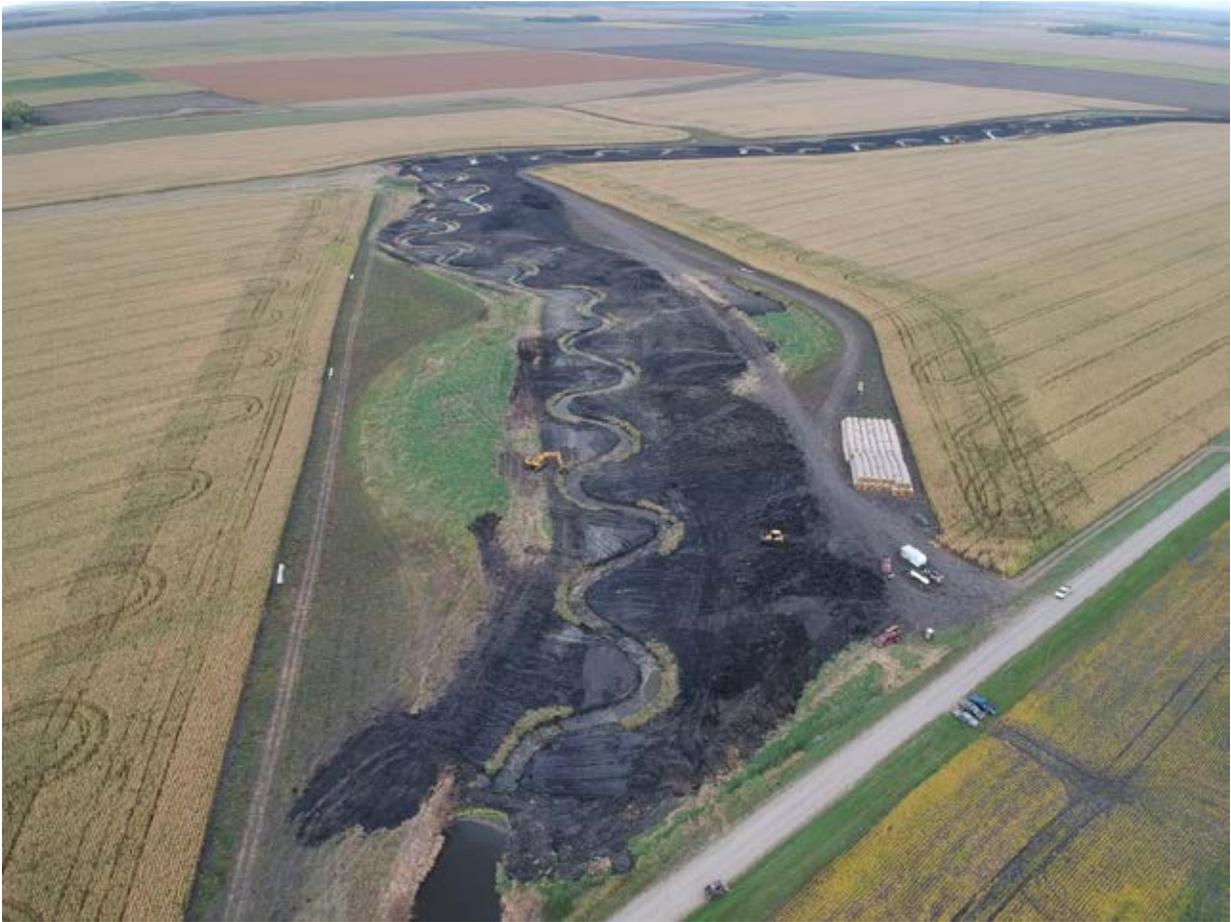
Photo 13-7. Aerial view during construction. Photo provided by the BRRWD.

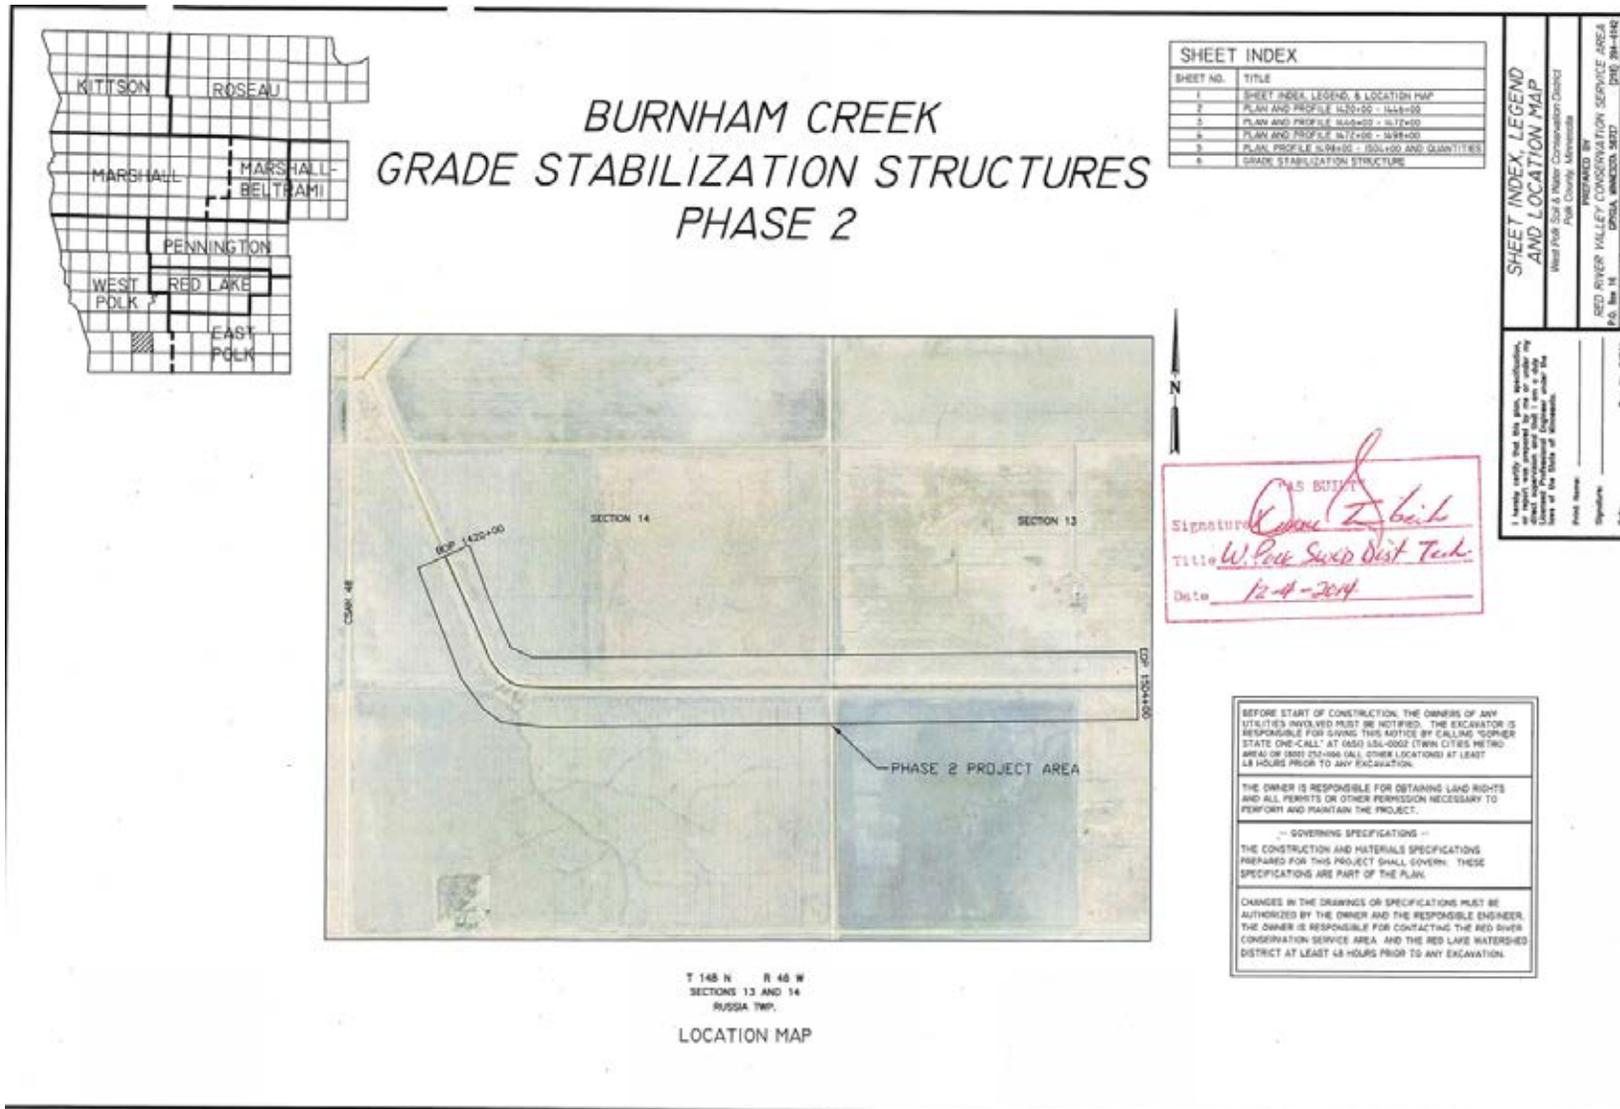
Figure 14-1 Burnham Creek – Grade Stabilization Structures Phase 2 sheet 1 of 16. Project site map showing location of site on Burnham Creek.

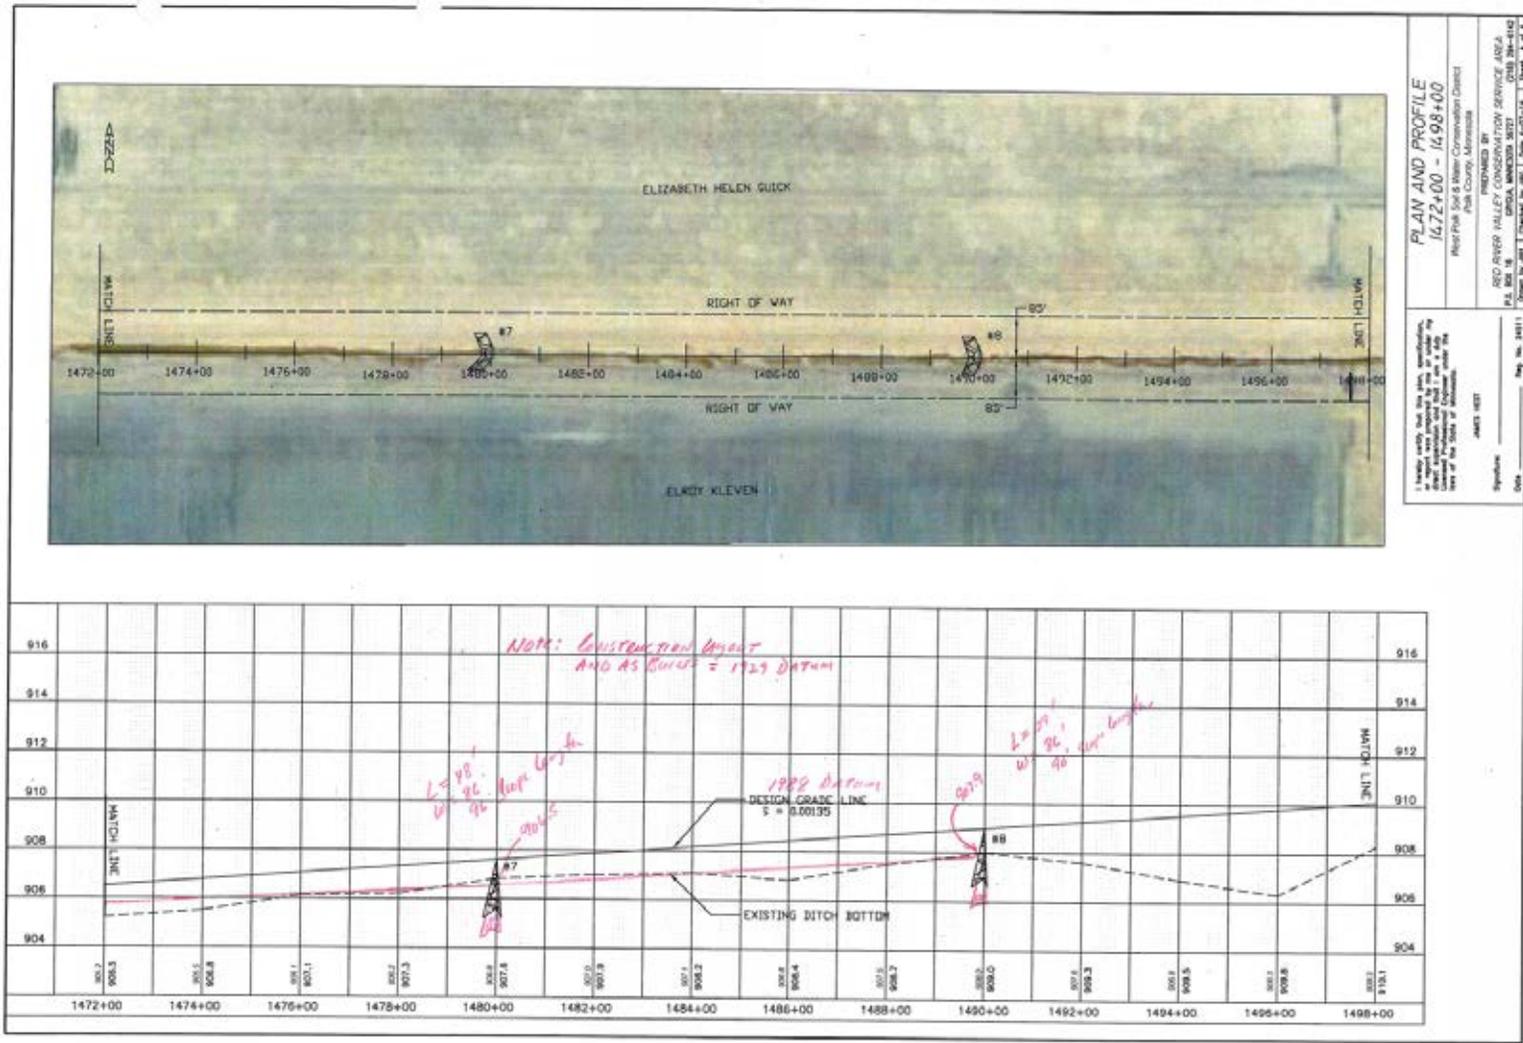
Figure 14-2 Burnham Creek – Grade Stabilization Structures Phase 2 sheet 4 of 16. Project map and site plans showing locations of riffles 7 and 8. Elevations and details are listed below.

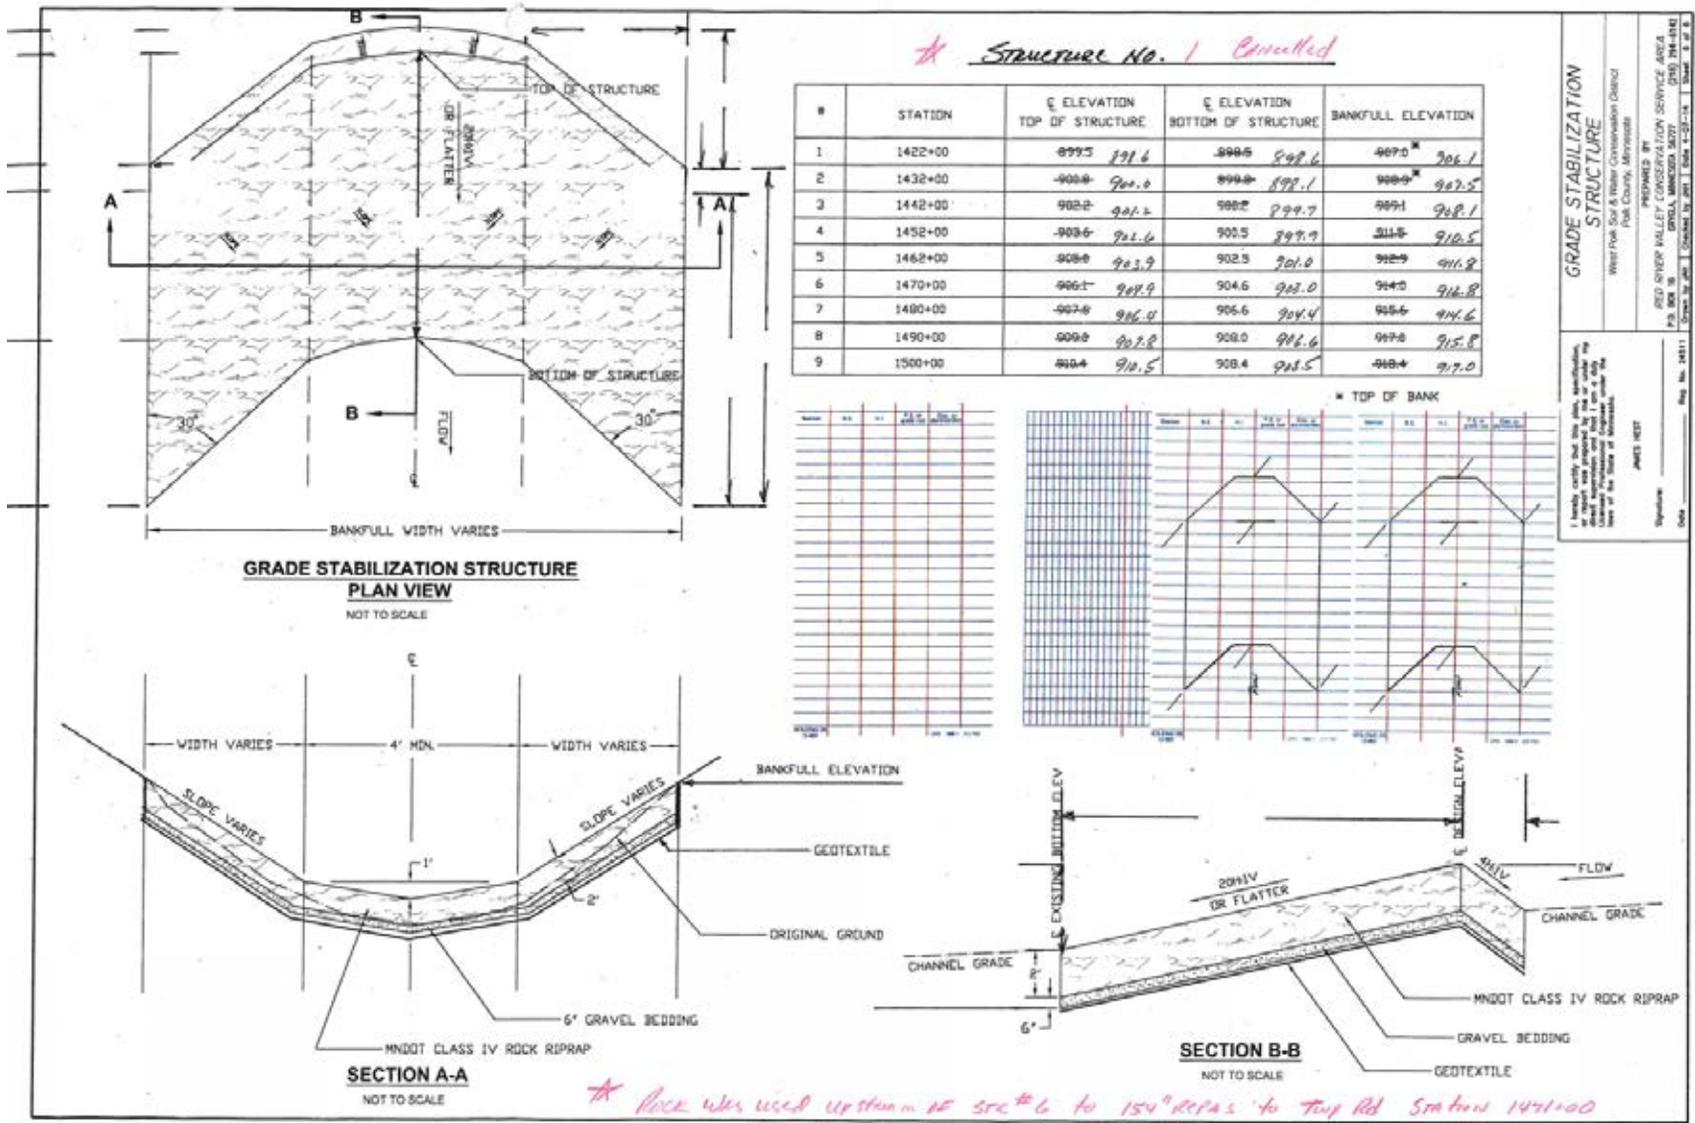
Figure 14-3 Burnham Creek – Grade Stabilization Structures Phase 2 sheet 6 of 16. Typical detail and quantities of riffle structure.

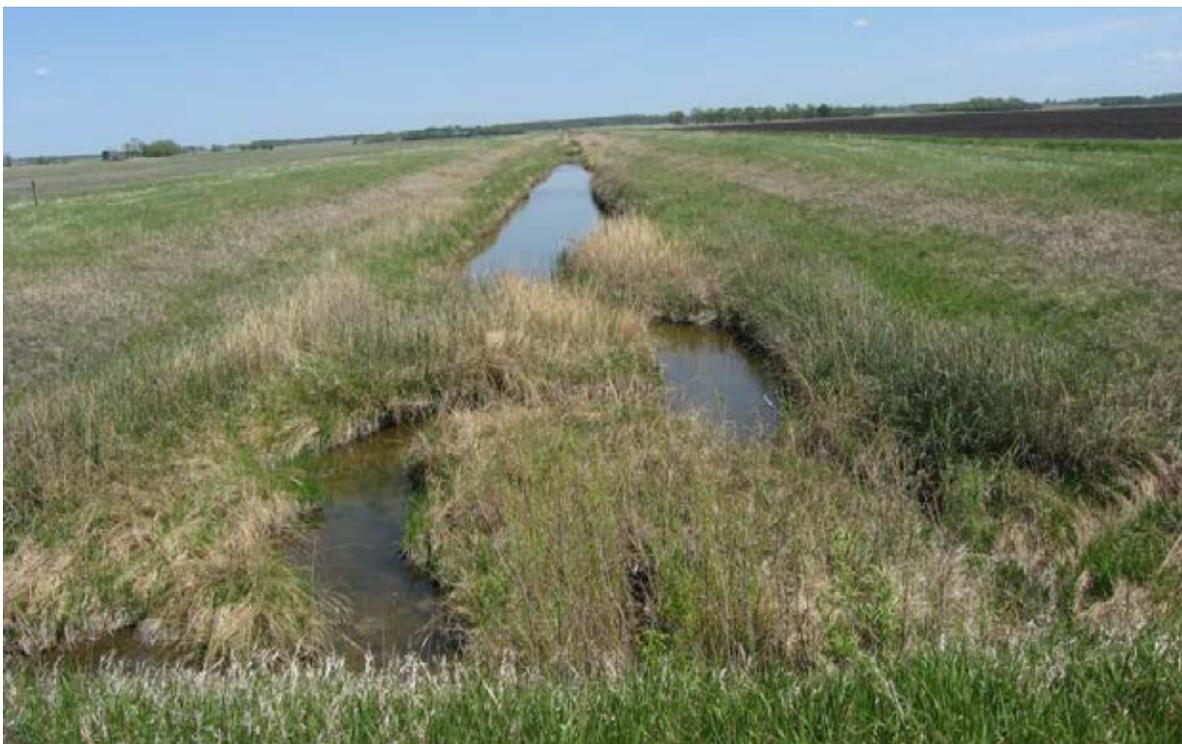
Photo 14-1 Burnham Creek pre construction and channel cleanout. Photo taken by project partners (5/2/2012).

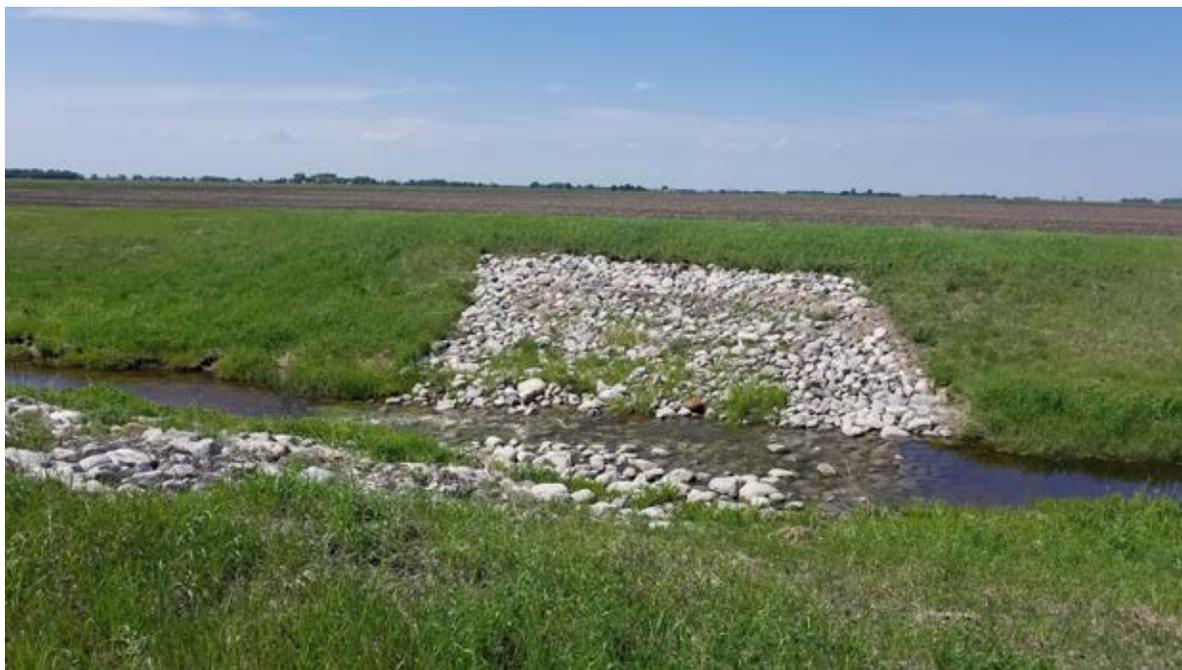
Photo 14-2 View of Burnham Creek riffle #3. Creek is 1-2 channel widths upstream (right) and 2-5 channel widths downstream (left). It is recommended to add live stakes. Photo taken by Ed Matthiesen during site visit (6/4/19).

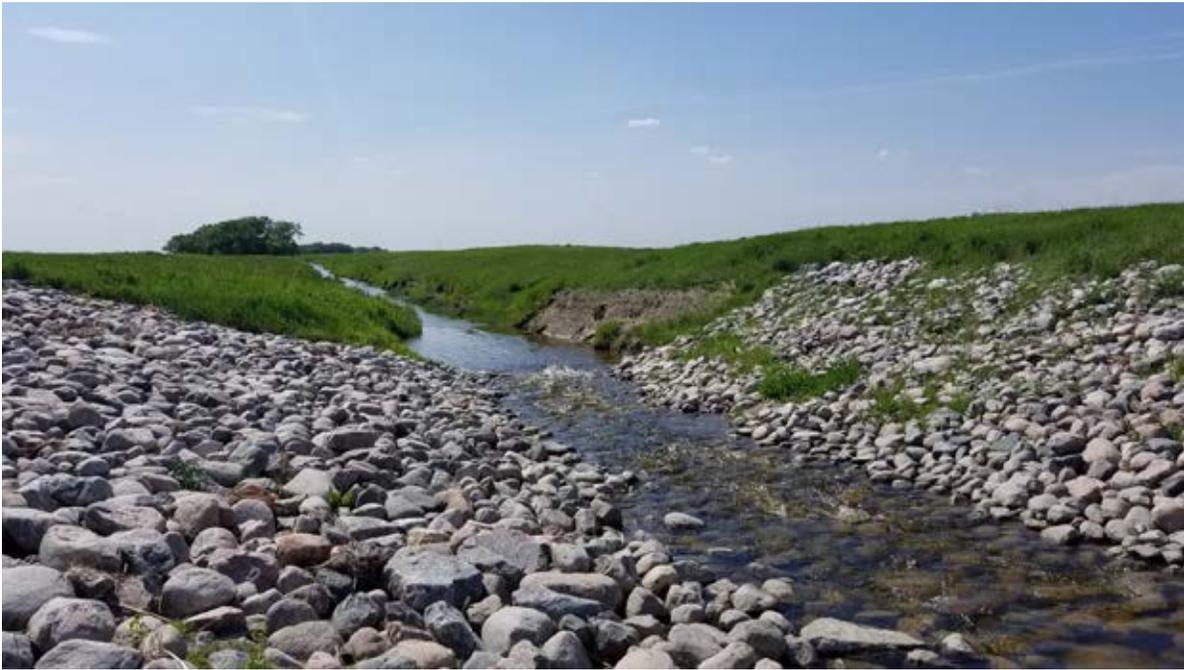
Photo 14-3 View of Burnham Creek riffle #4. Creek is 1-2 channel widths upstream (right) and 2-5 channel widths downstream (left). It is recommended to add live stakes to 2 channel widths downstream. Photo taken by Ed Matthiesen during site visit (6/4/19).

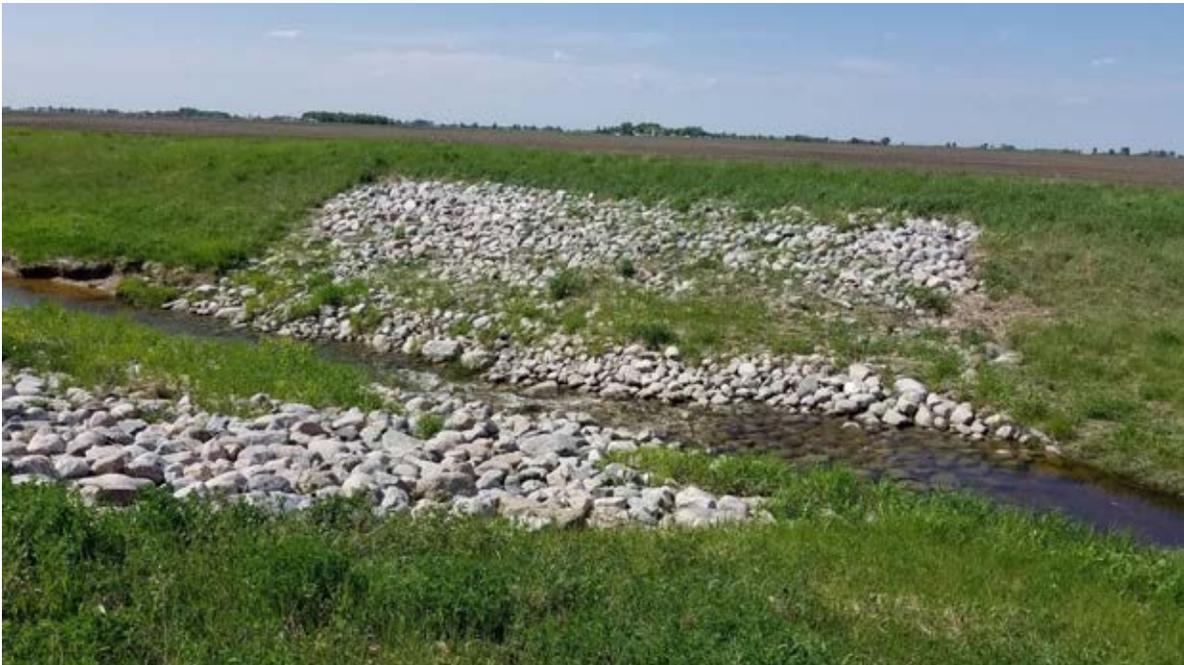
Photo 14-4 Upstream view of riffle #5. Creek is 1-2 channel widths upstream (right) and 2-5 channel widths downstream (left). It is recommended to add live stakes. Photo taken by Ed Matthiesen during site visit (6/4/19).

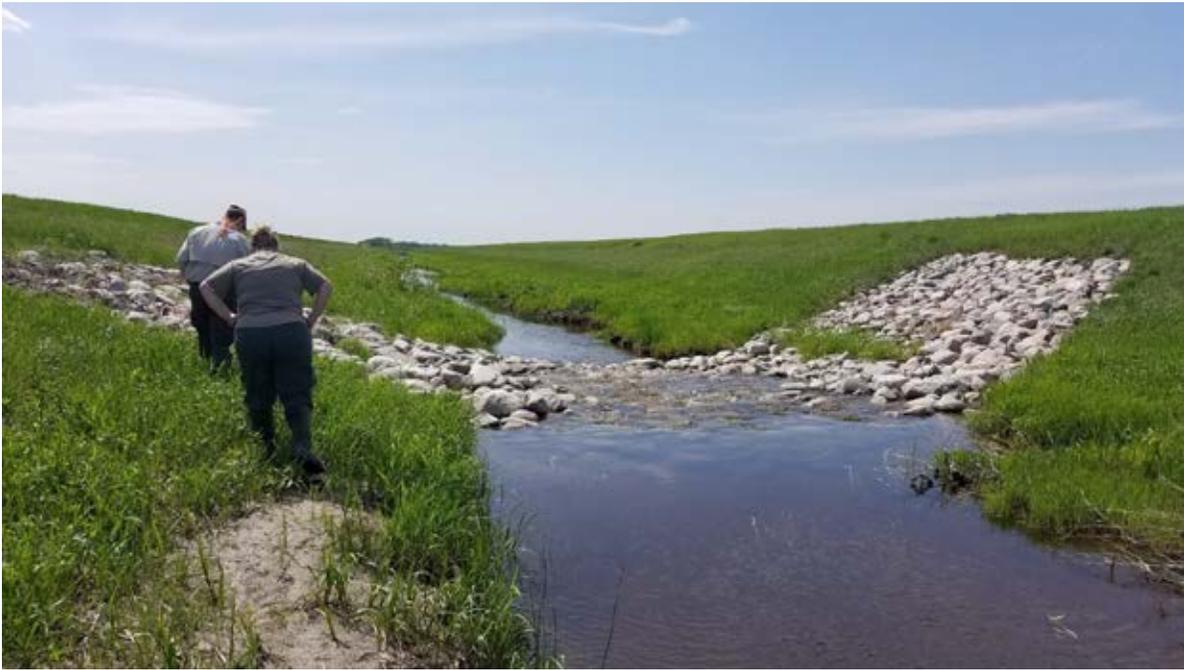
Photo 14-5 Upstream view of riffle #8. Creek is 1-2 channel widths upstream (front) and 2-5 channel widths downstream (back). This riffle is meeting project goals of reducing bank erosion. Photo taken by Ed Matthiesen during site visit (6/4/19).

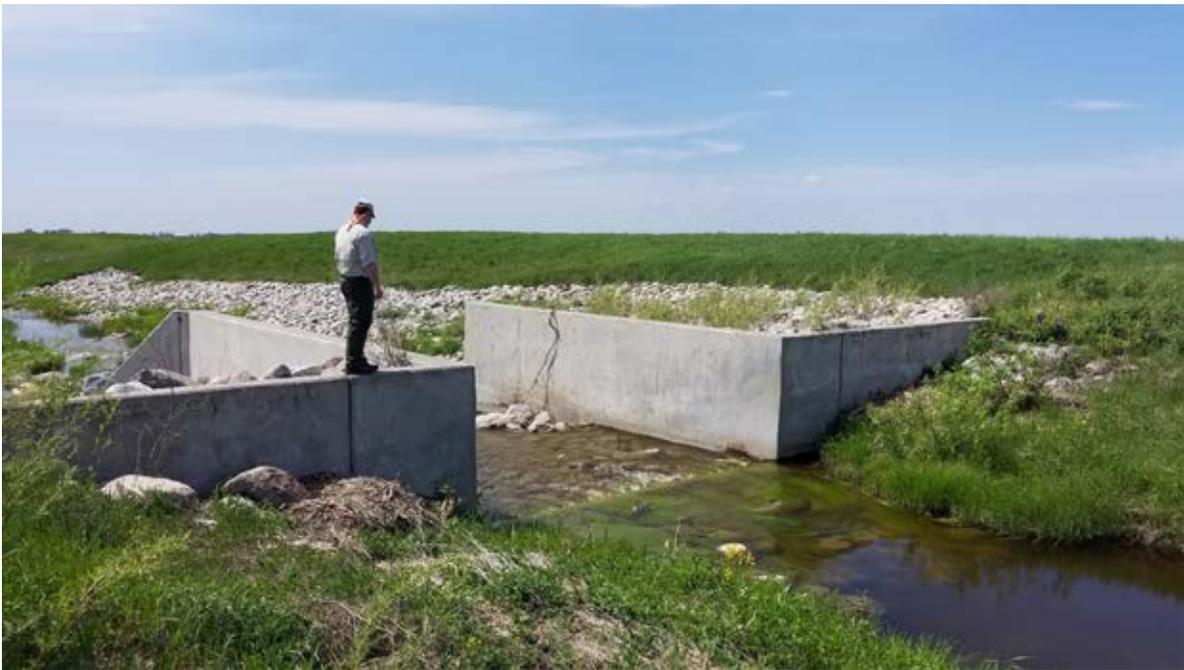
Photo 14-6 Upstream view of NRCS Rock Flume at project location 1502+00 on Burnham Creek. It is recommended to reduce the rise of the structure to less than 12 inches. Photo taken by Ed Matthiesen during site visit (6/4/19).

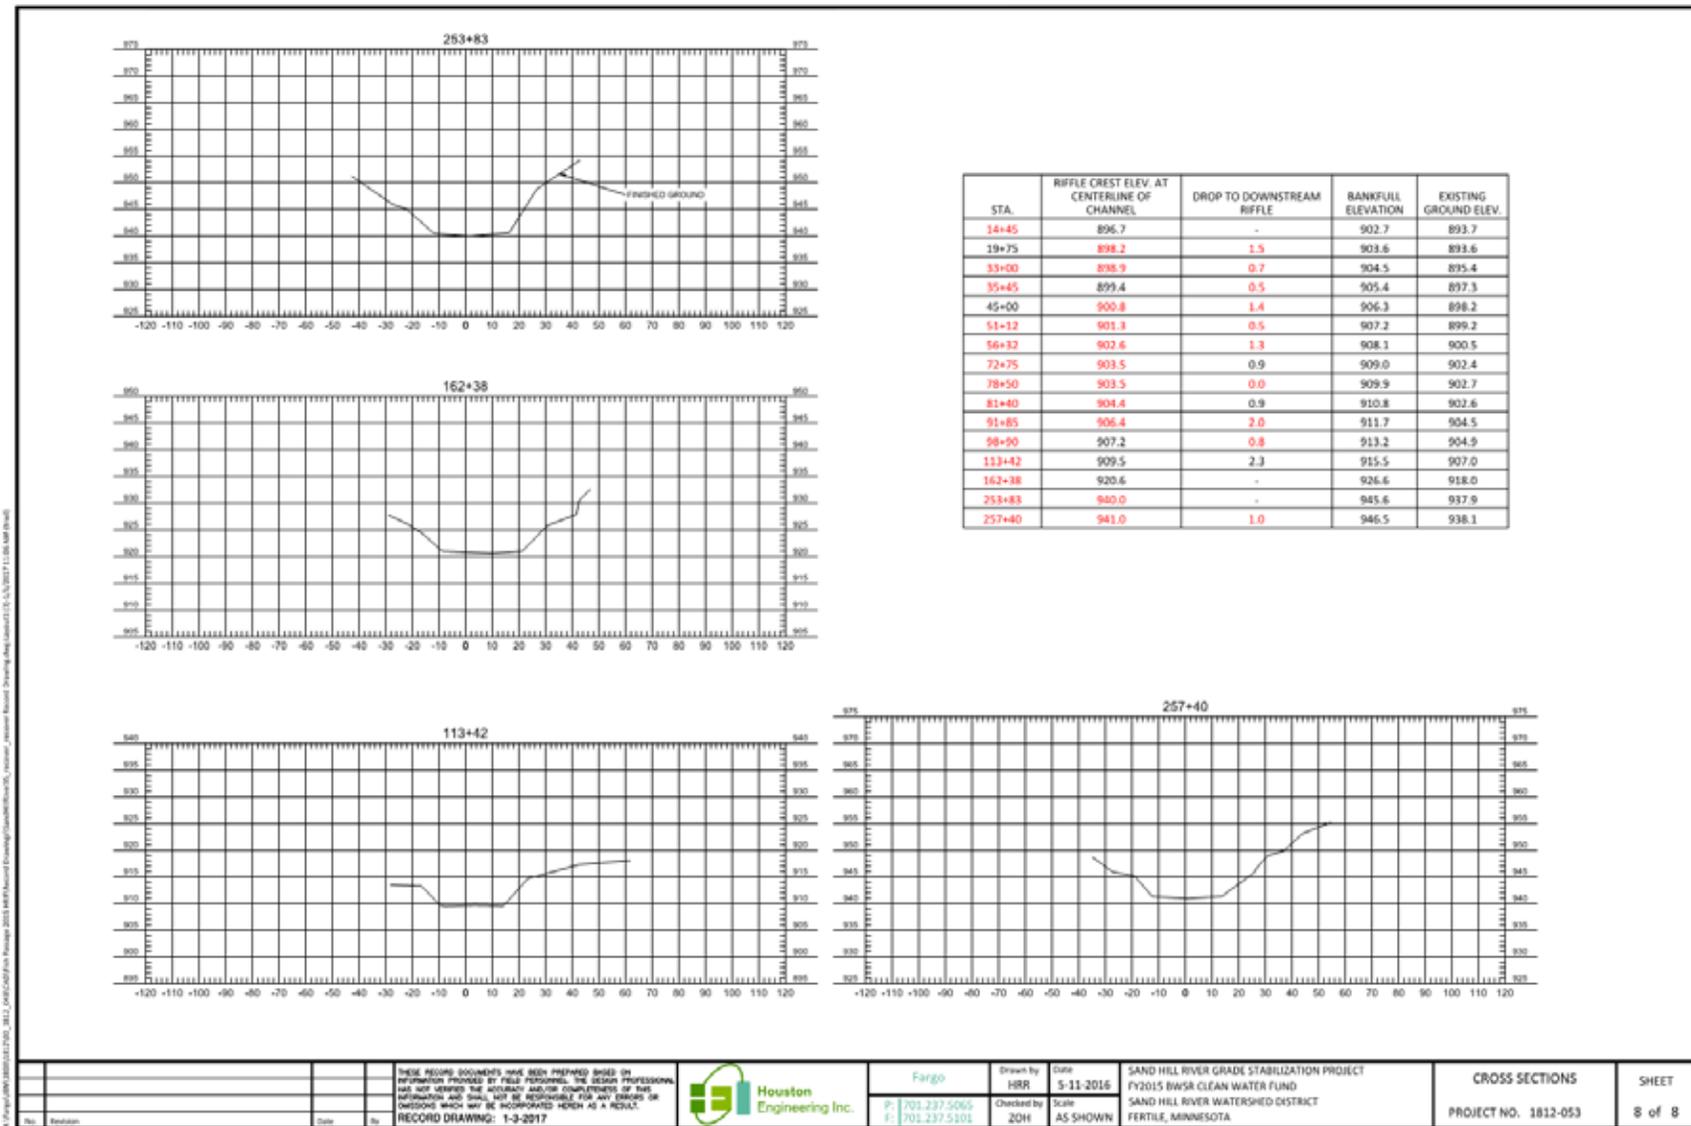
Figure 15-4 Sand Hill River Grade Stabilization Project sheet 8 of 8. Stream cross-section profile at locations of proposed structures.

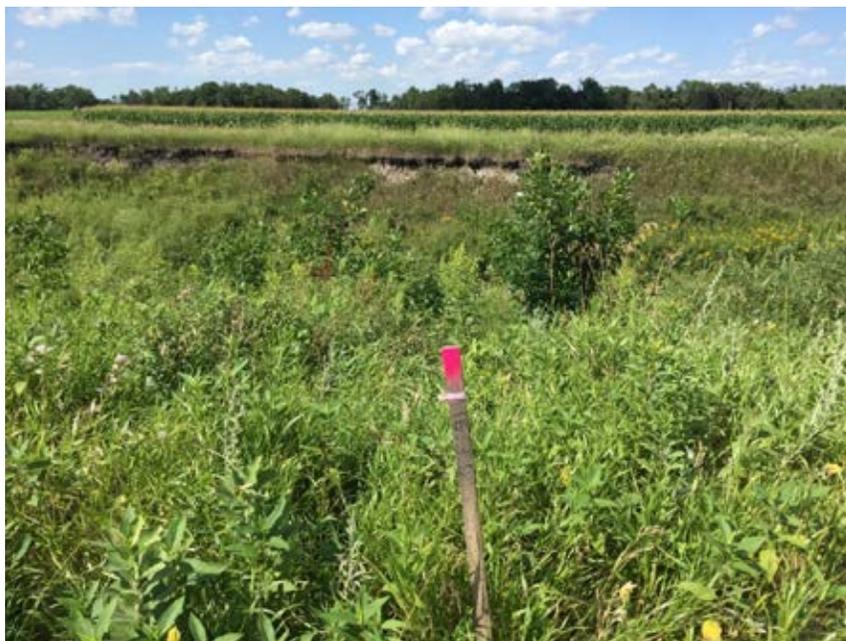
Photo 15-1 View of existing bank slump failure at project Station 91+85. Photo taken by others during pre-construction visit (8/2/2016).

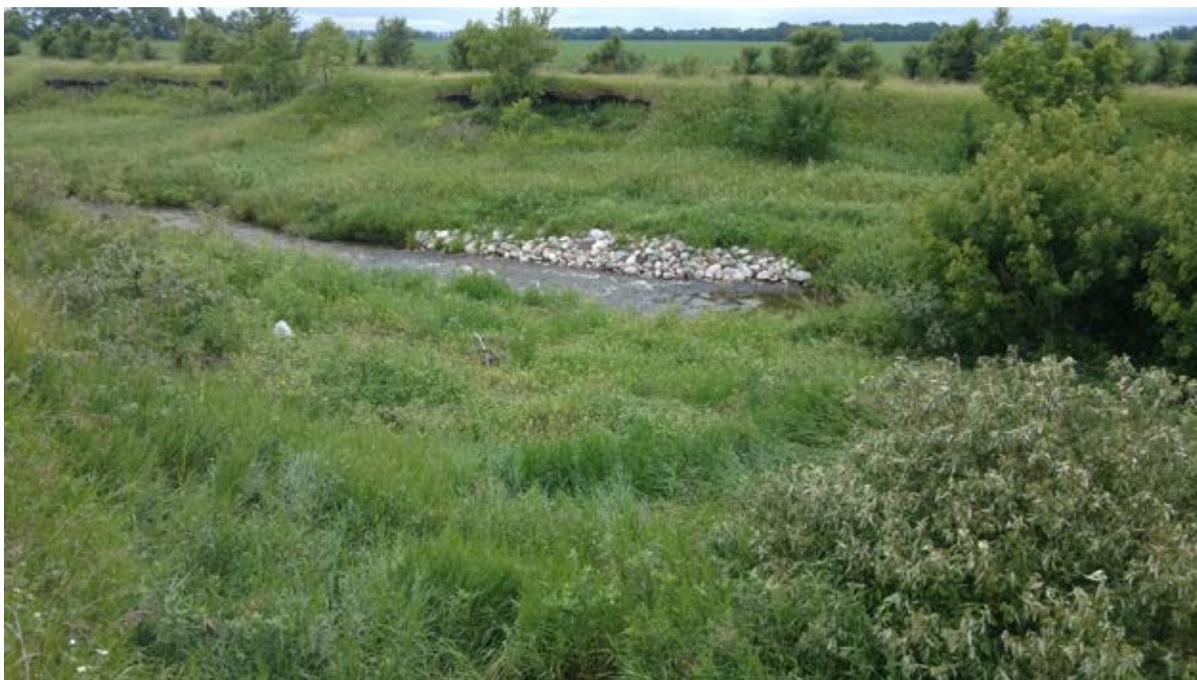
Photo 15-2 View of constructed riffle at project station 91+85. Pre-existing bank slump failures are still visible in the background. Photo taken by others during a post-construction, final inspection (6-29-2017).

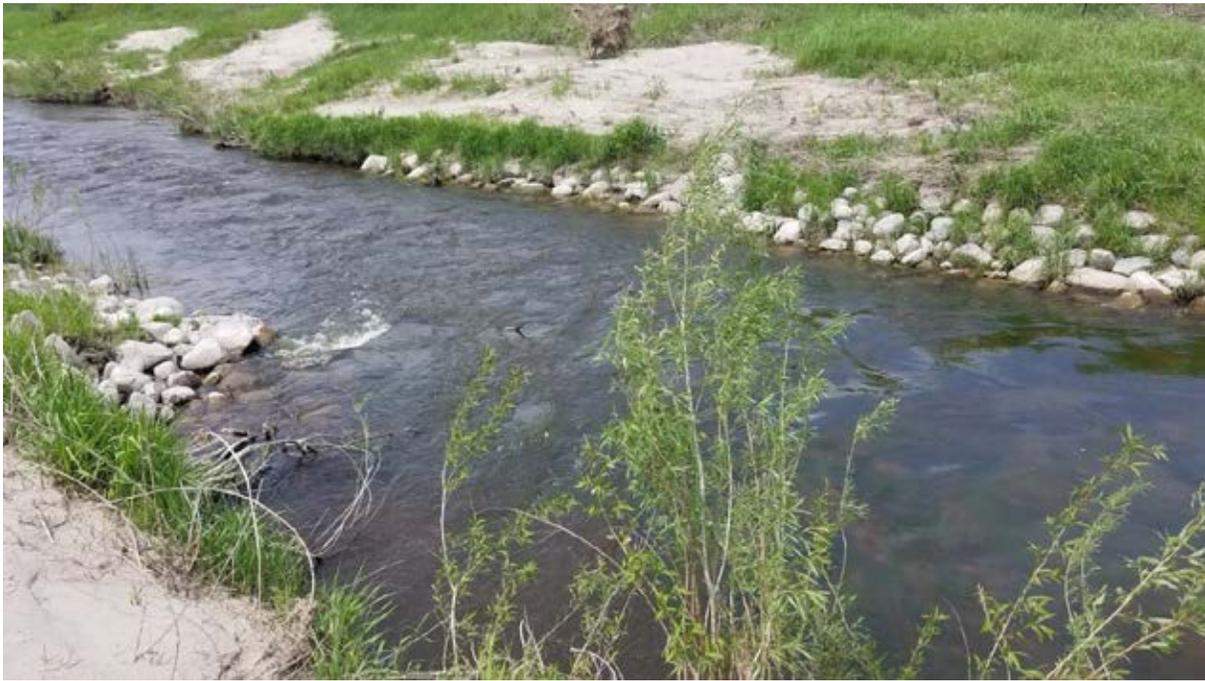
Photo 15-3 Upstream view of riffle #12. Note the sand accumulation. An observed opportunity for improvement is to add sandbar willow. Photo taken by Ed Matthiesen during site visit (6/4/2019).

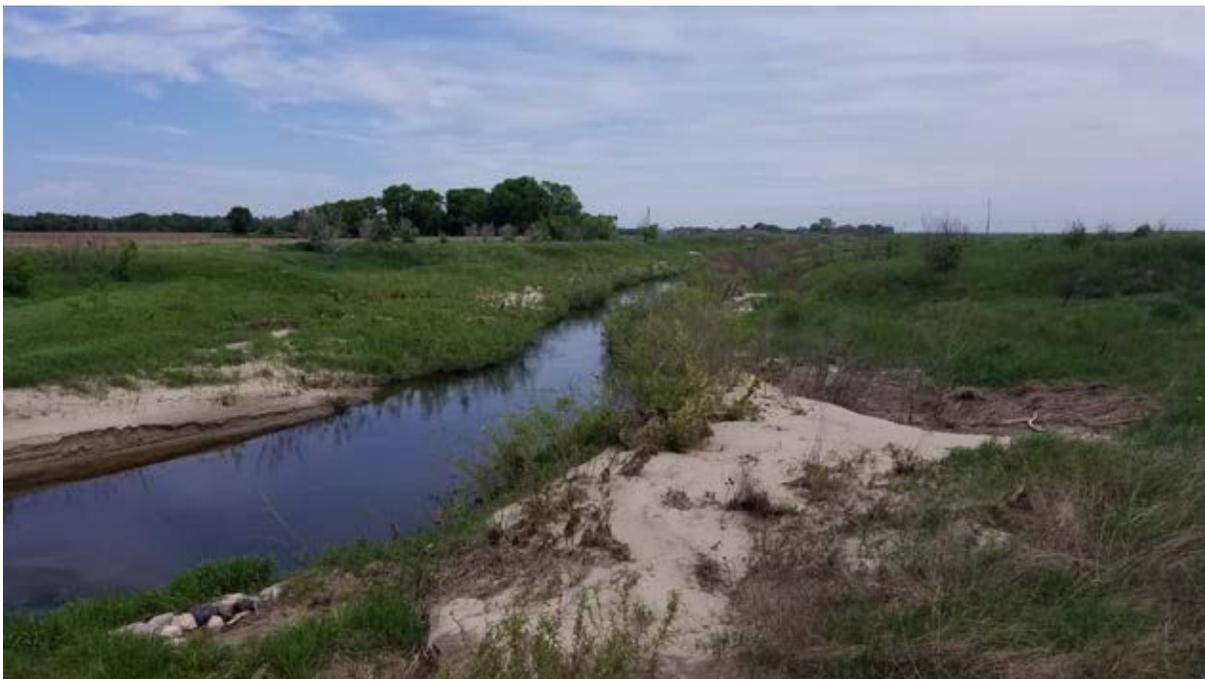
Photo 15-4 Upstream view of riffle #13. Note erosion on the bare bank (left). An observed opportunity for improvement is to add sandbar willow. Photo taken by Ed Matthiesen during site visit (6/4/2019).

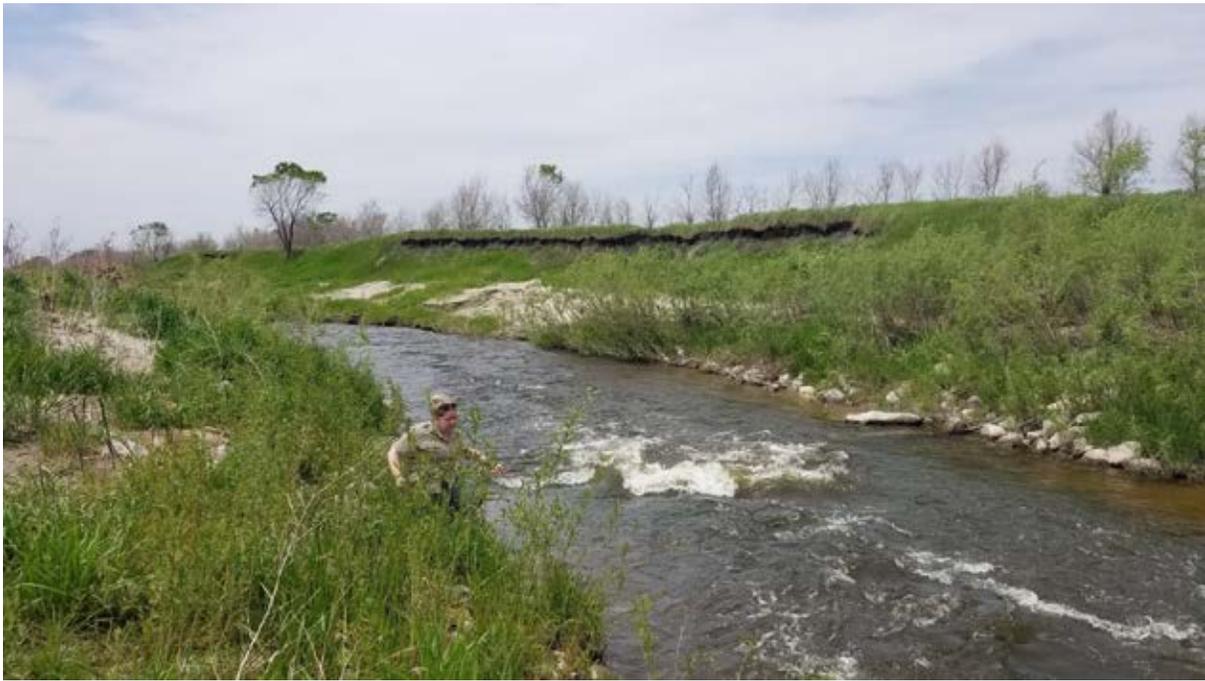
Photo 15-5 Upstream view of riffle #13. Photo taken by Ed Matthiesen during site visit (6/4/2019).

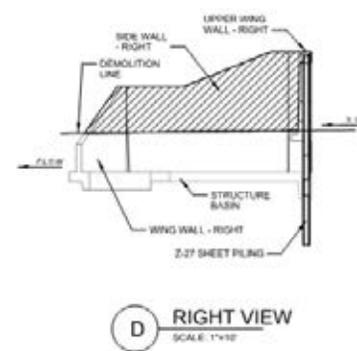
D RIGHT VIEW
SCALE: 1"=10'

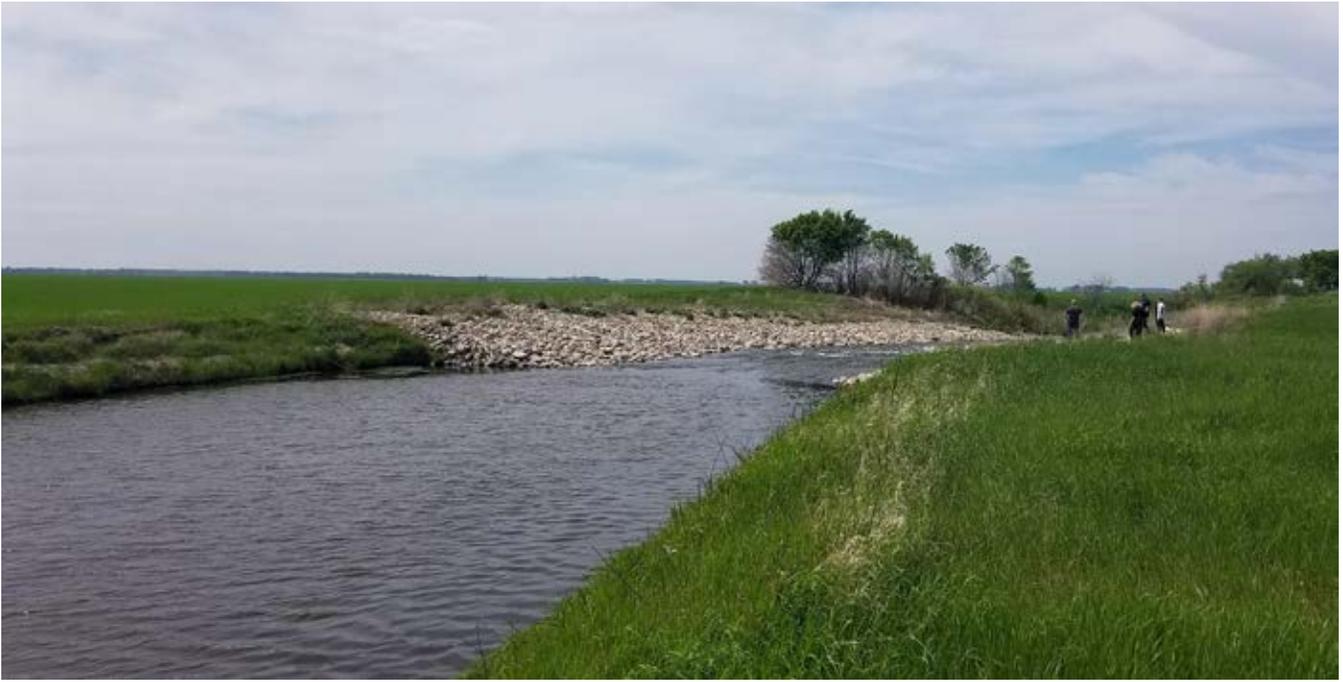
Photo 16-10 Upstream view of fishway ramp #3 with well-established vegetation and no noted erosion on the banks. Photo taken by Ed Matthiesen during site visit (6/4/2019).

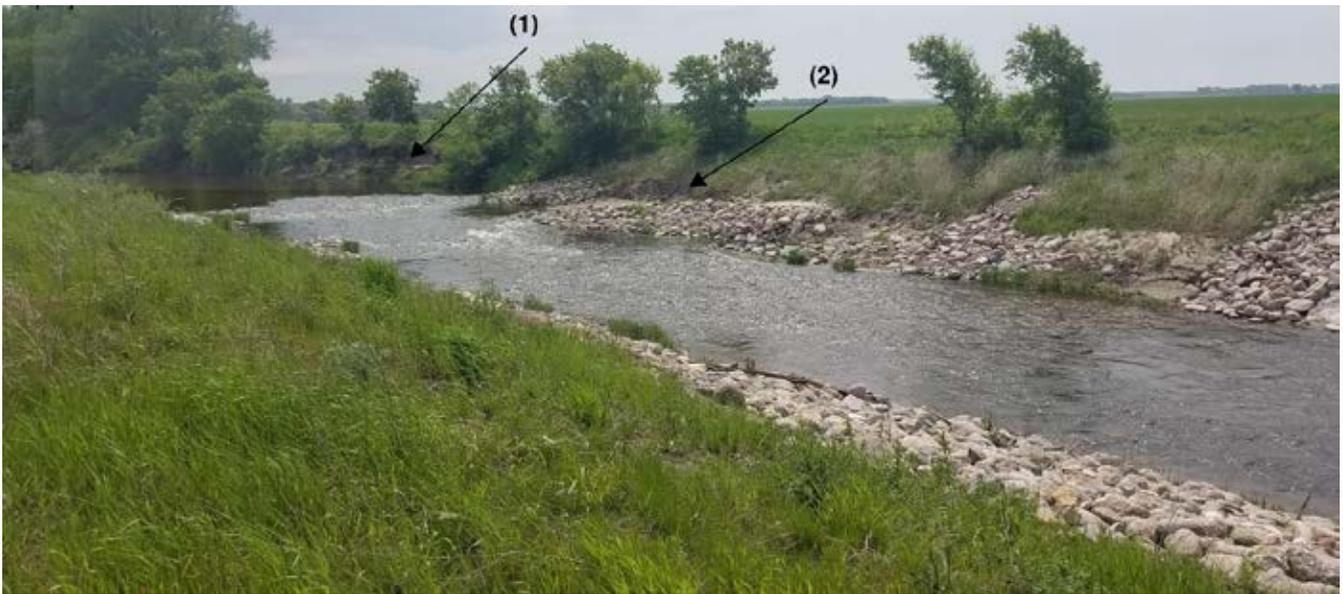
Photo 16-11 Sand Hill River fishway ramp #4 after the original drop structure was modified for fish passage. Upstream of the project area a washout is visible (1). Washout area will be repaired after the culvert connecting the reach to a side channel is addressed. There are also limited bare spots that could be reseeded in the project area (2). Photo taken by Ed Matthiesen during site visit (6/4/2019).

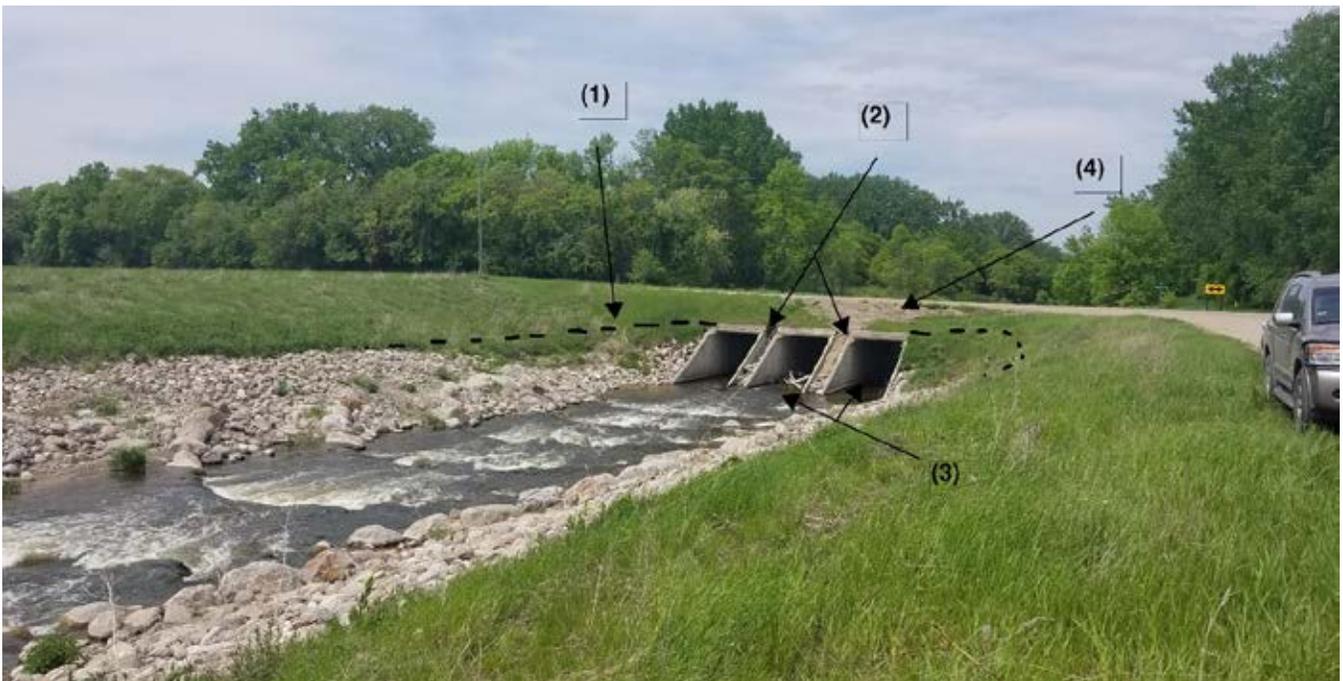
Photo 16-12 Sand Hill River fishway ramp #4. This area of the project has experienced some changes after high flows in spring 2019 came up over the road. Further damage could be mitigated by adding riprap of the same size to the top of the culvert on both sides (1) hand-placing riprap between culverts (2) and repairing the slop with topsoil/seed/25 blanket (4). Project partners also discussed considering rock or a barrier to force low flow into one box. Photo taken by Ed Matthiesen during site visit (6/4/2019).

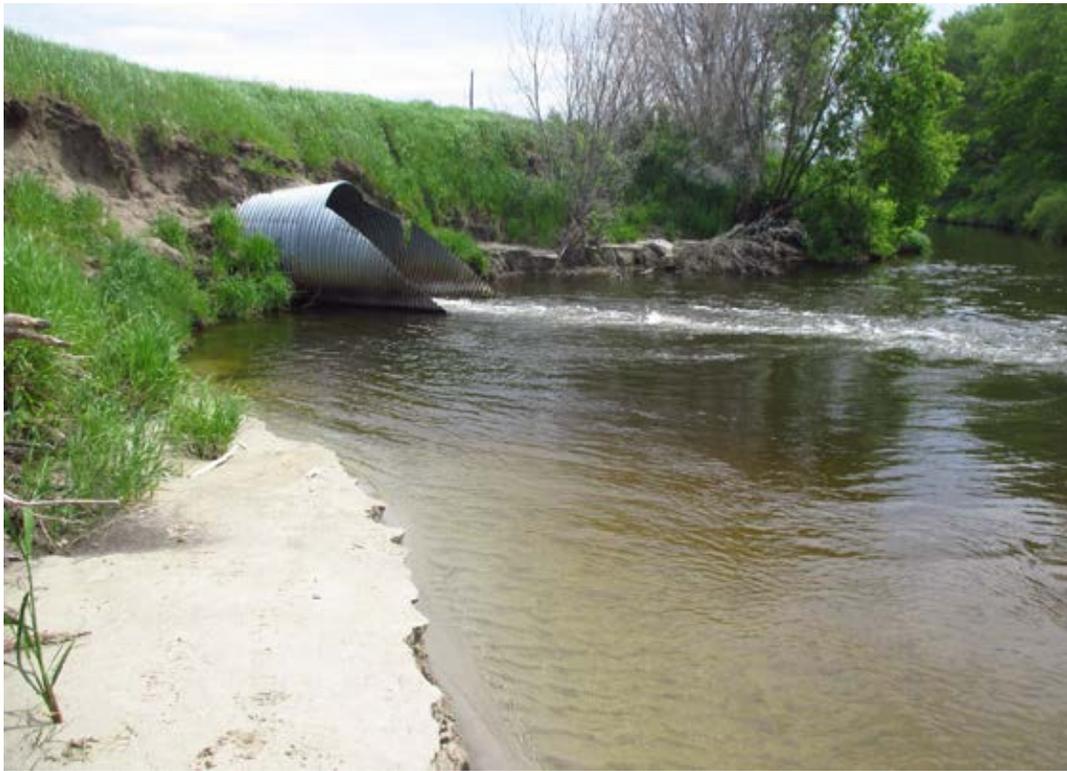
Photo 16-13 Perched culvert with erosion upstream of structure #4. Funds remaining because fishway work was completed under budget will be used to address fish passage and habitat work in this reach. Photo taken during site visit (6/4/2019).
