Minnesota Department of Natural Resources
Minnesota Board of Water and Soil Resources

Program Process Project Evaluations

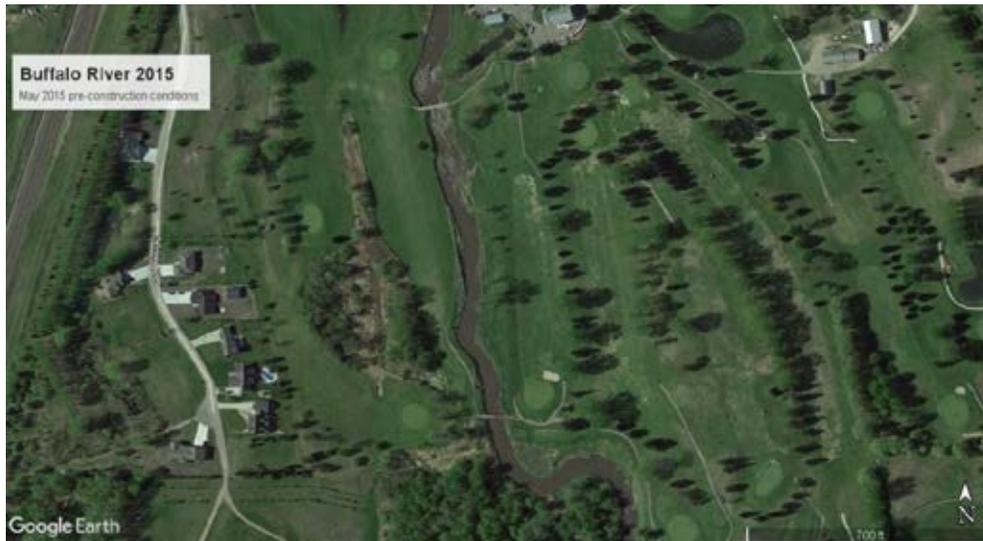
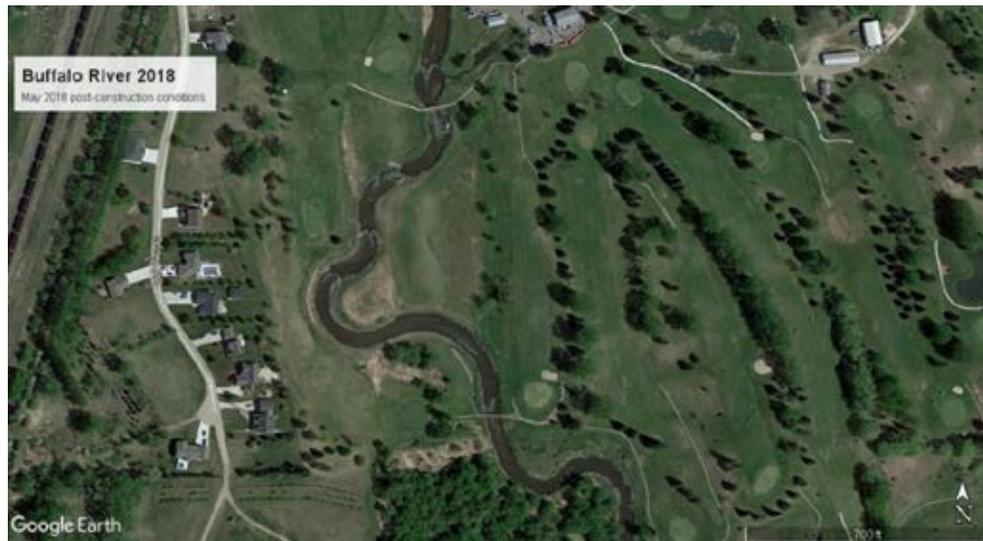
Figure 17-5. Aerial imagery of project site pre and post construction. Imagery provide by Google Earth (<https://www.google.com/earth/>)

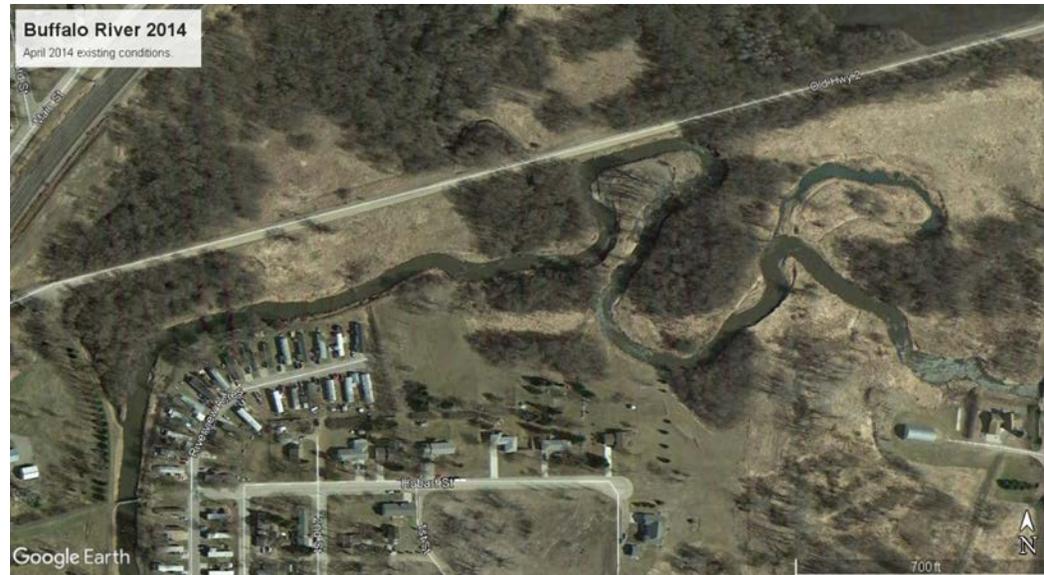
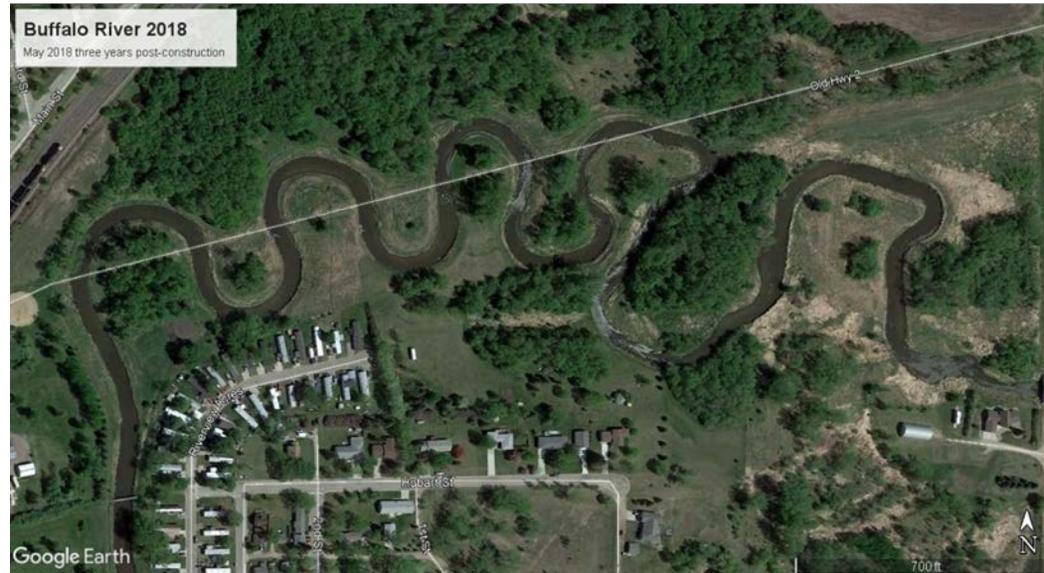
Figure 18-8. Aerial imagery of project location pre and post construction. Imagery provided by Google Earth (<https://www.google.com/earth/>)

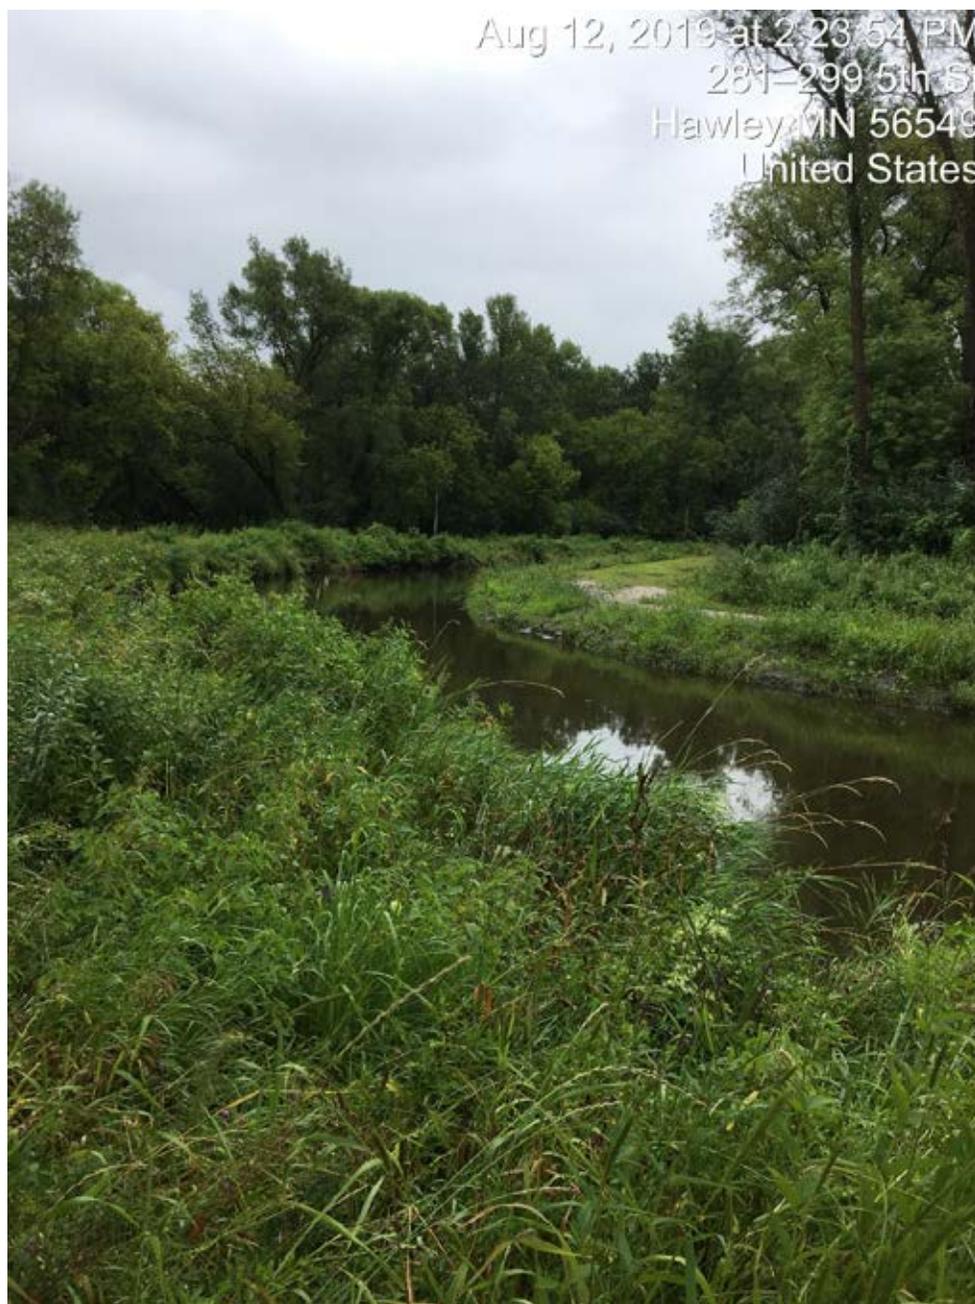
Photo 18-1. View of restored meander. Photo taken by Anna Varian during site visit (8/12/2019).

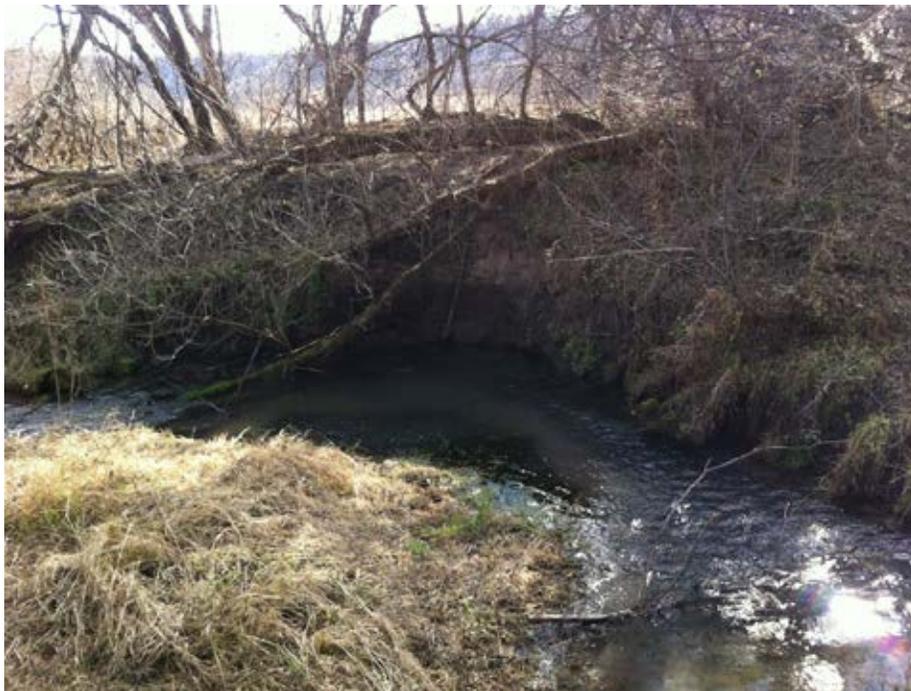
Photo 19-1 Pre-project conditions, photo taken in November 2012.

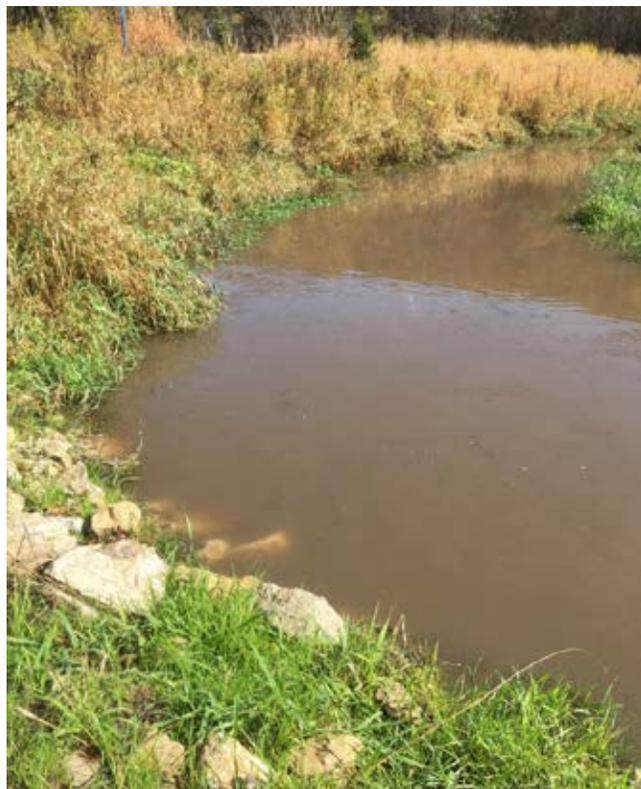
Photo 19-2 Bend in the river where toe-wall was installed, and rock added in 2019. Photo taken 10/21/2019 by Anna Varian.

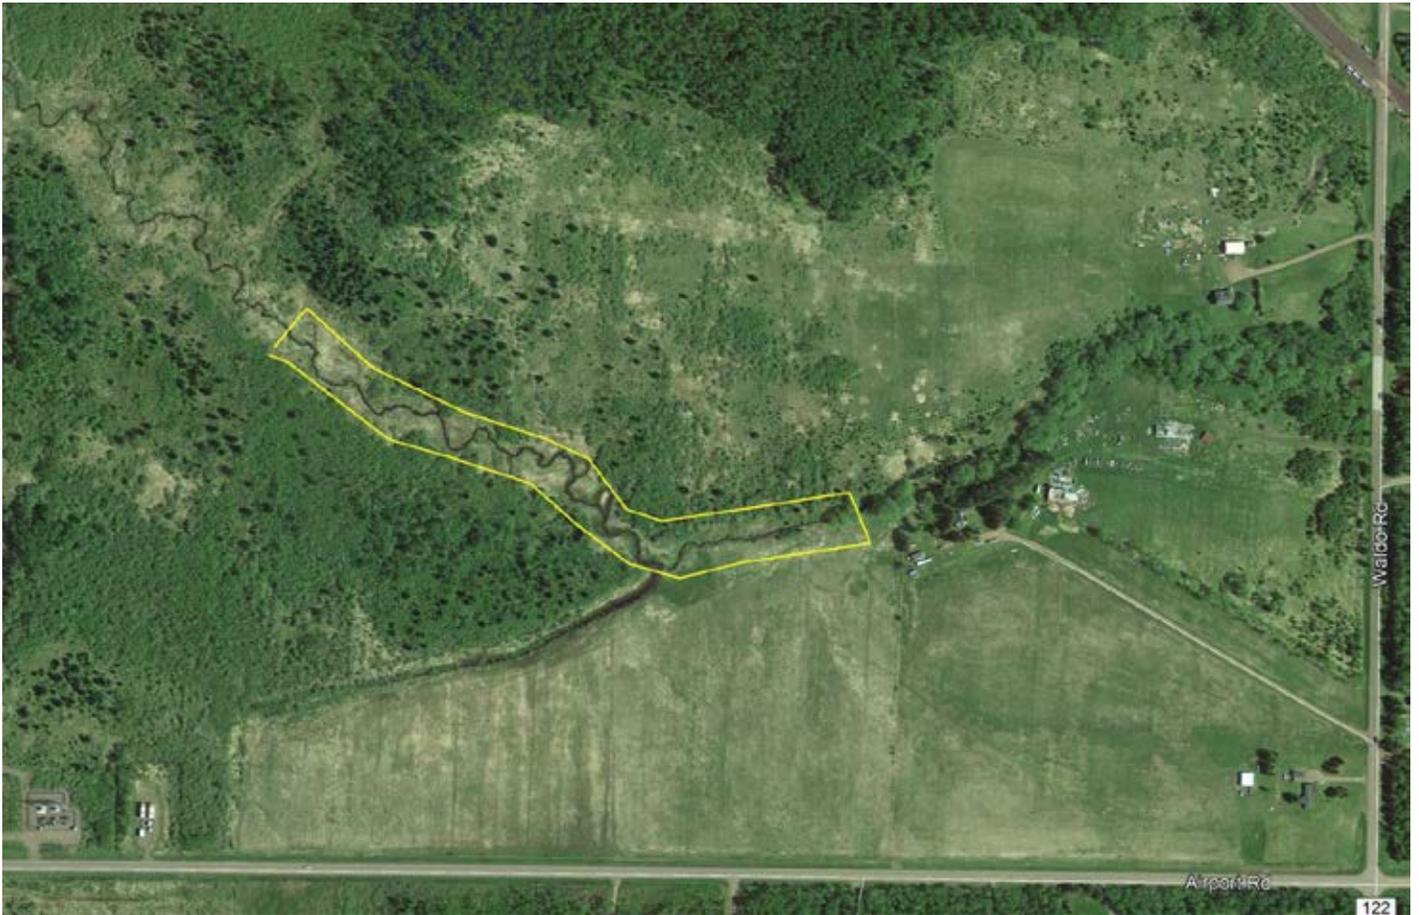
Photo 20-1 Aerial photo of the Little Stewart River tree planting project area. The yellow box highlights the approximate planting area.

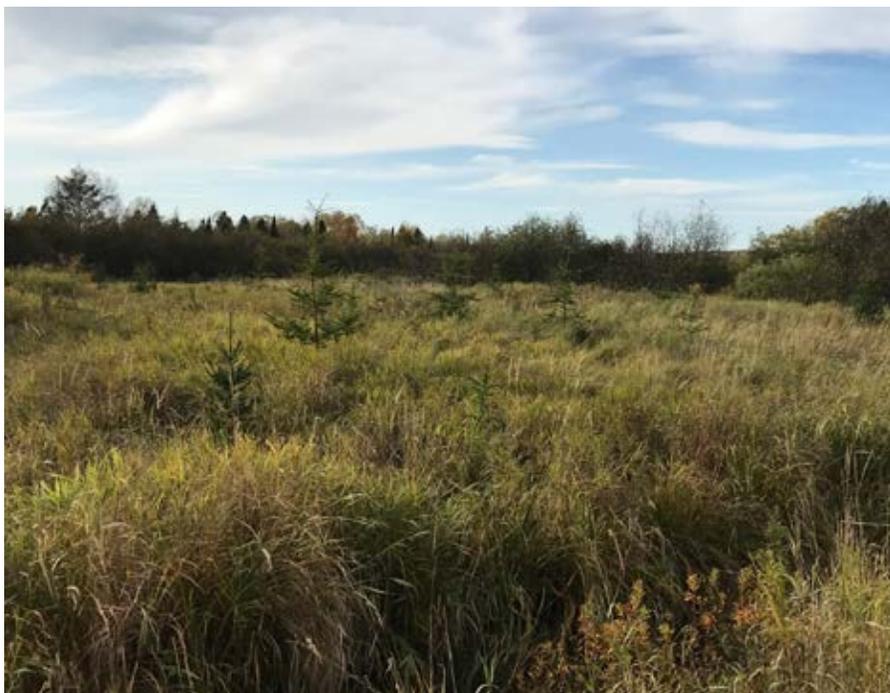
Photo 20-2. Little Stewart River tree planting area. The taller trees within the sedge meadow are primarily planted tamarack, white pine, and white spruce.

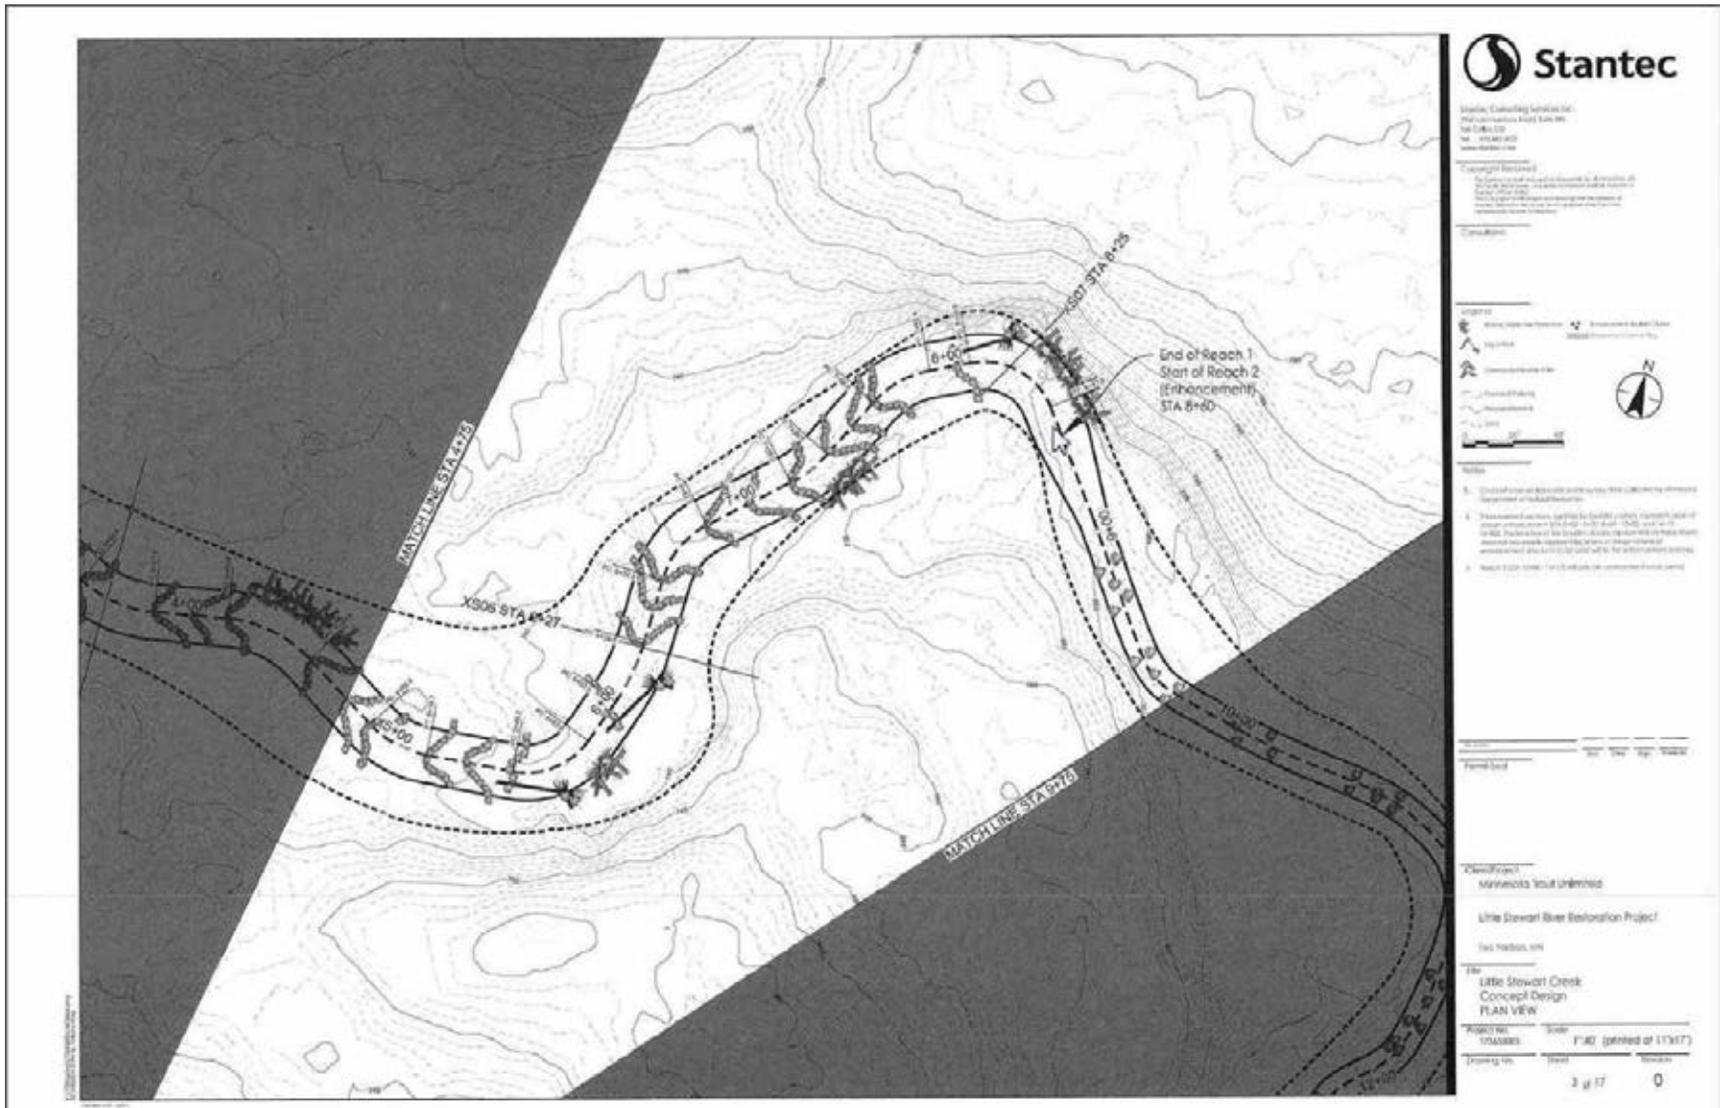
Figure 21-3 Little Stewart River Project Plan Set (Page 3 of 17) provided by Stantec.

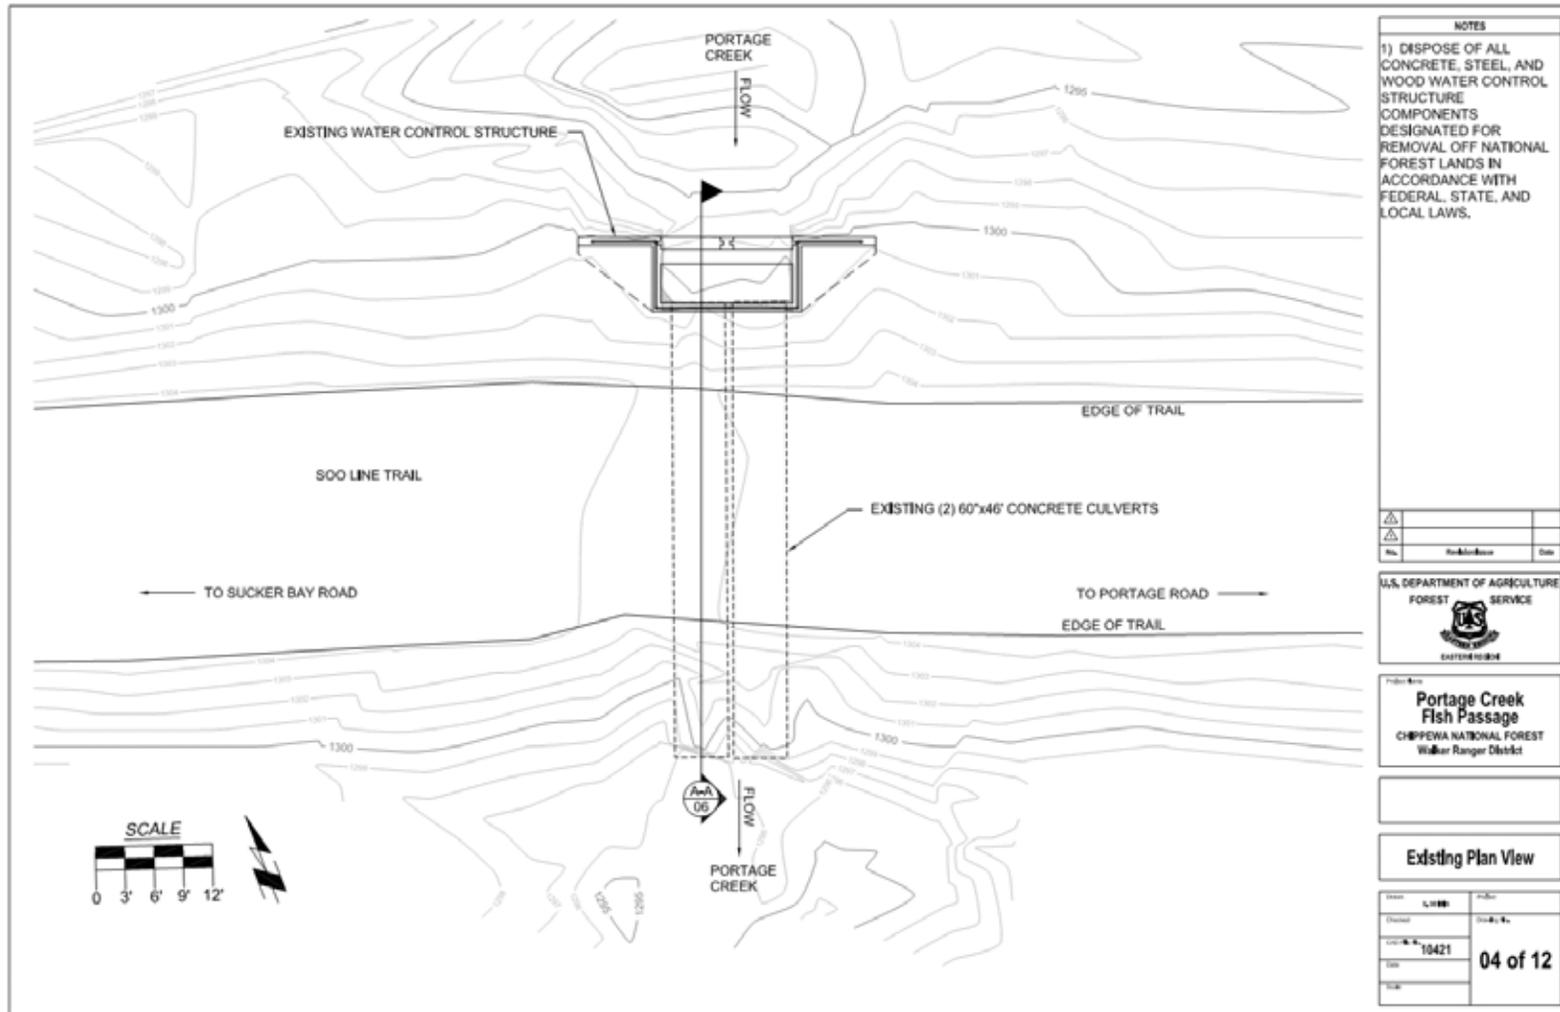
Figure 23-1 Construction plans sheet 4 of 12, existing conditions.

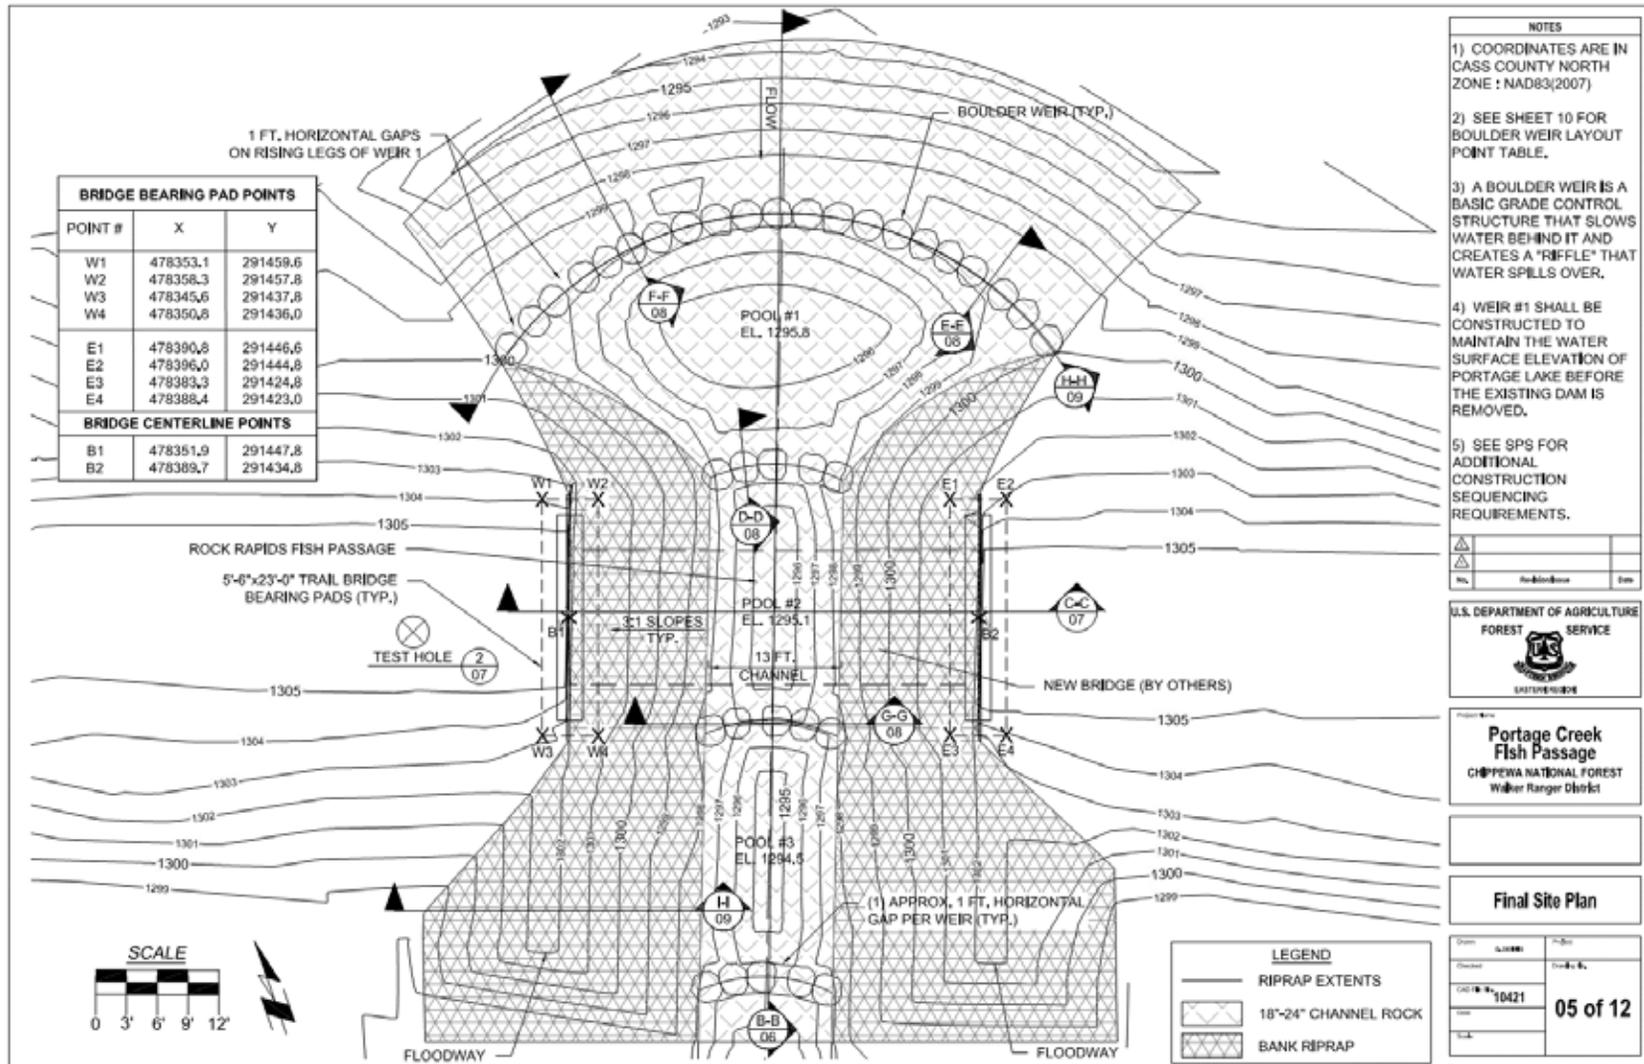
Figure 23-2 Construction plans sheet 5 of 12, project design.

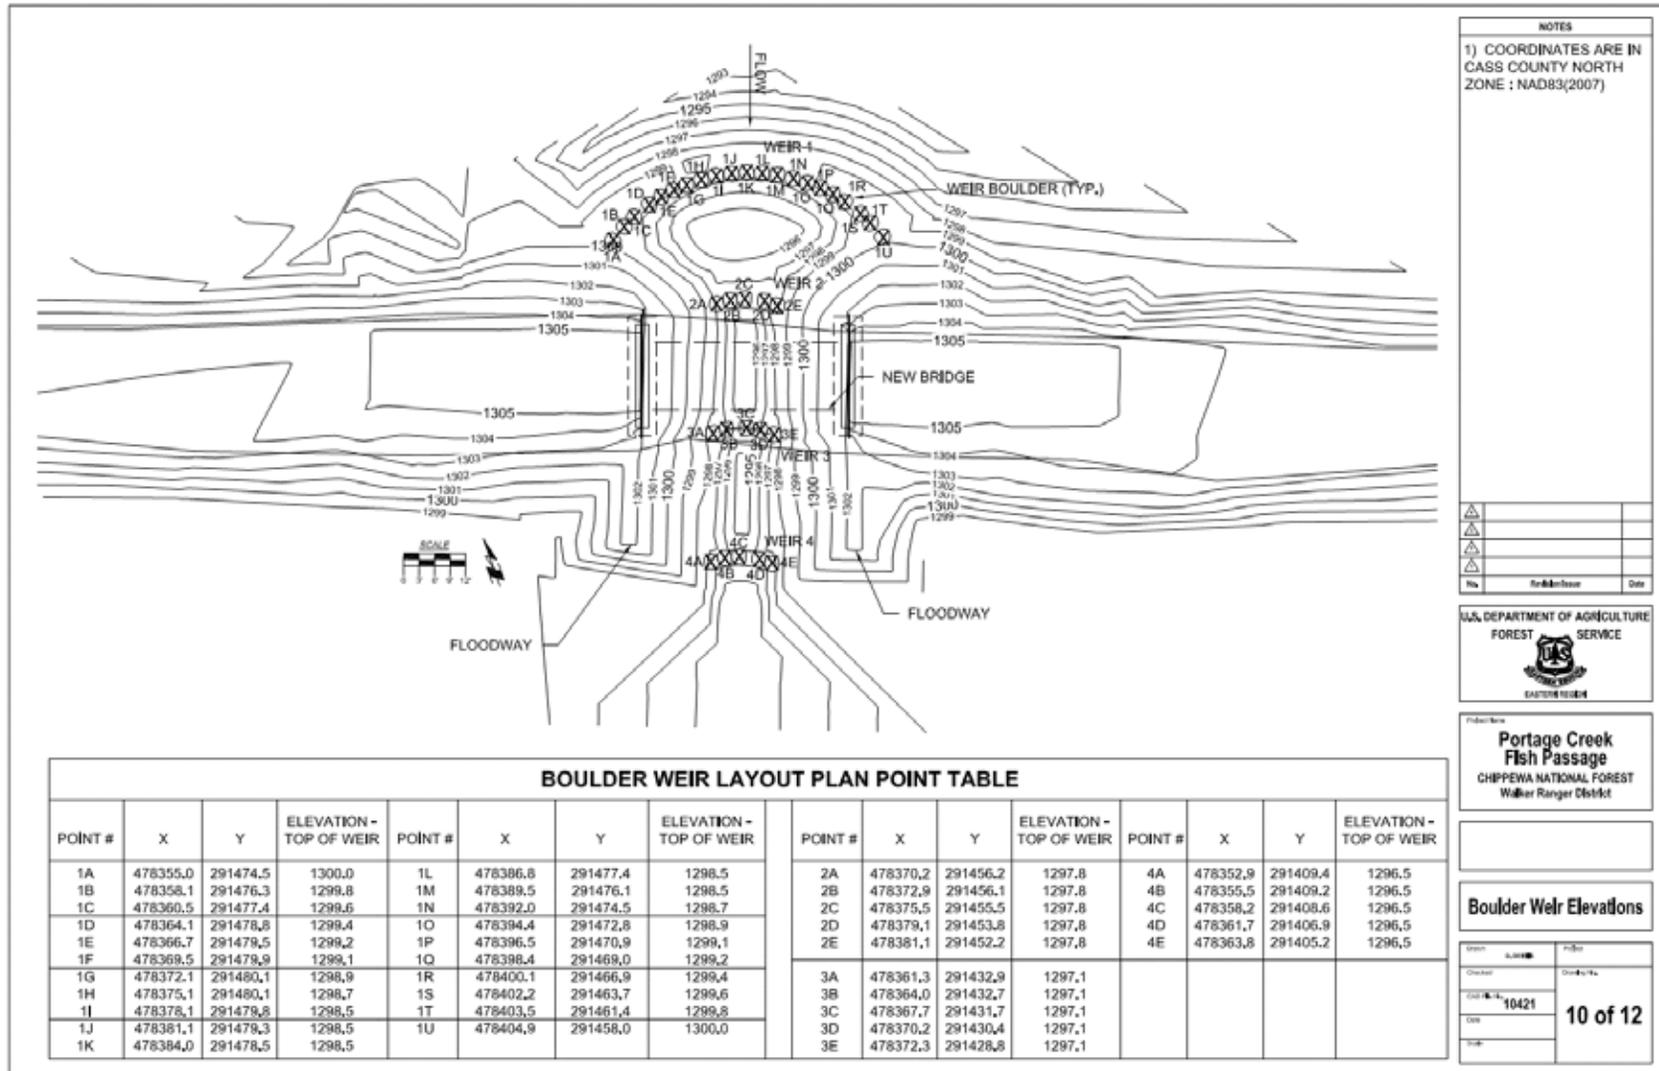
Figure 23-6 Construction plans page 10 of 12, boulder placement details.

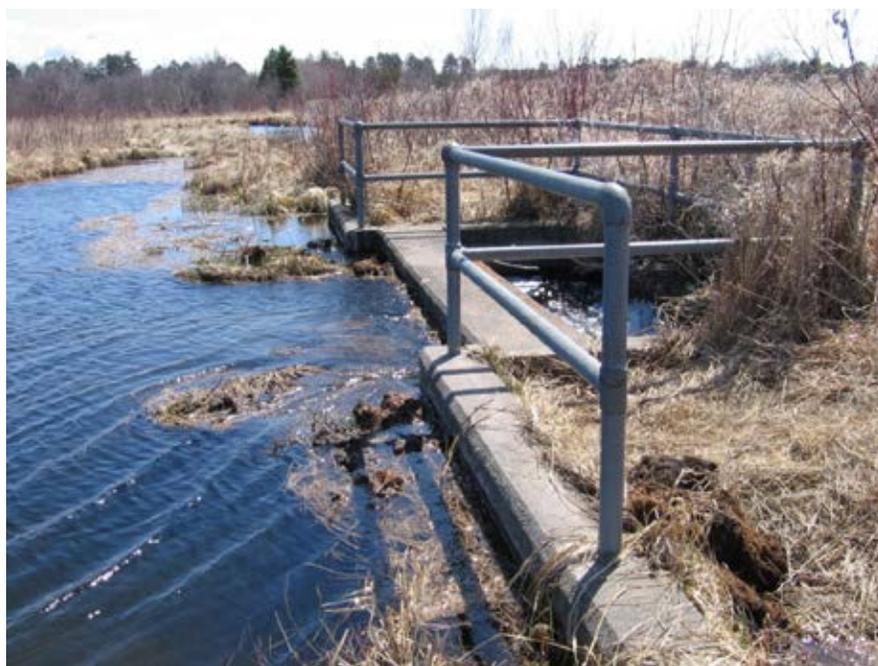
Photo 23-1 Upstream view of the Portage Lake dam prior to removal.

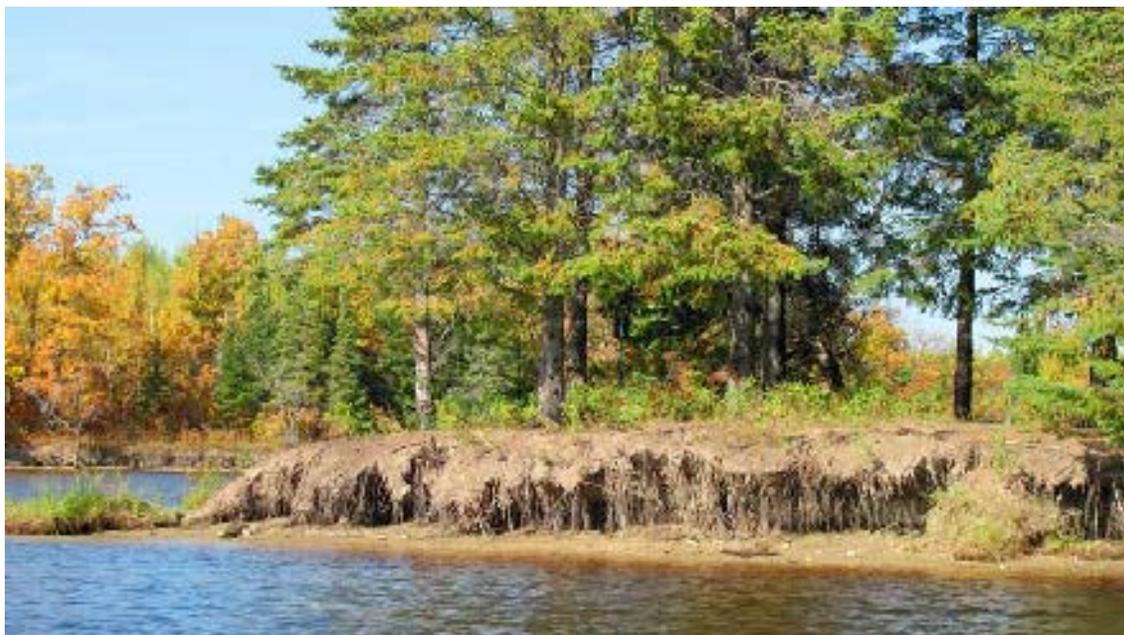
Photo 25-1. Example of the Fish Camp bank stabilization site on the Rat Root River in 2011 prior to construction. Photo provided by Koochiching County SWCD.

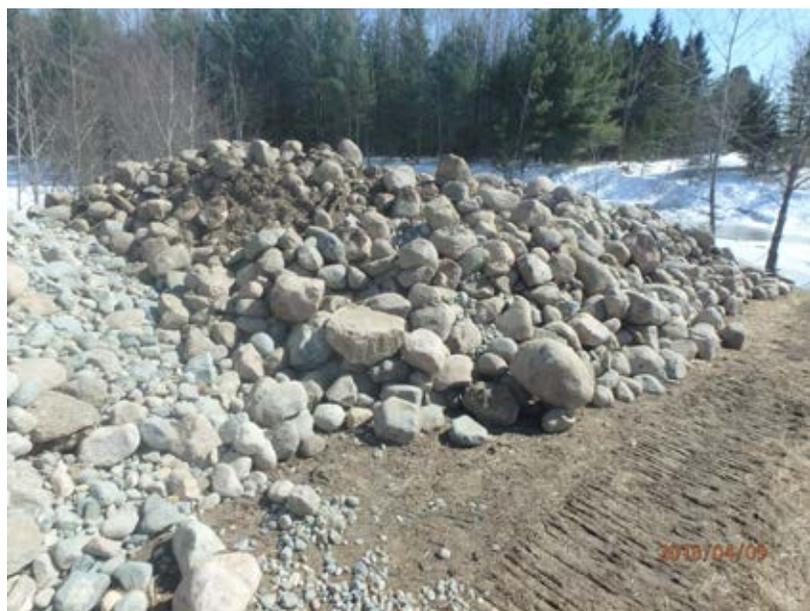
Photo 26-2. Example of the stone material installed at the County Rd 98 riffle location in 2018. Material is similar to what is naturally found in the adjacent areas of the Rat Root River. Photo provided by Koochiching County SWCD.

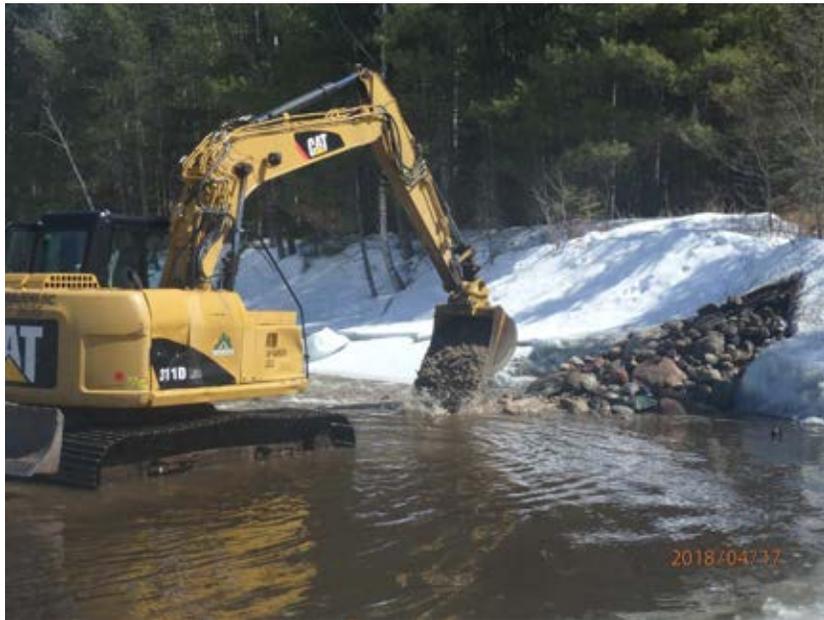
Photo 26-3. Example of installation of the riffle material at the County Rd 98 riffle in 2018. Stone material is installed to the bankfull elevation and throughout the channel width. Photo provided by Koochiching County SWCD.

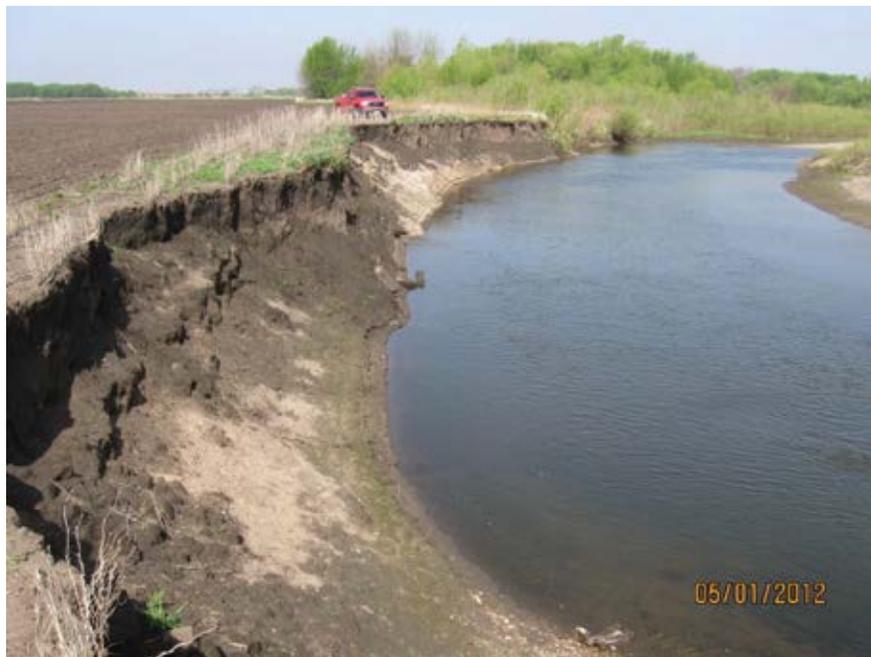
Photo 27-2. Looking upstream at the Upstream Bank (Bank 1) in 2012. In 2014, a significant flood event caused additional bank erosion prior to construction of the project (Photo provided by Scott Ralston, USFWS).

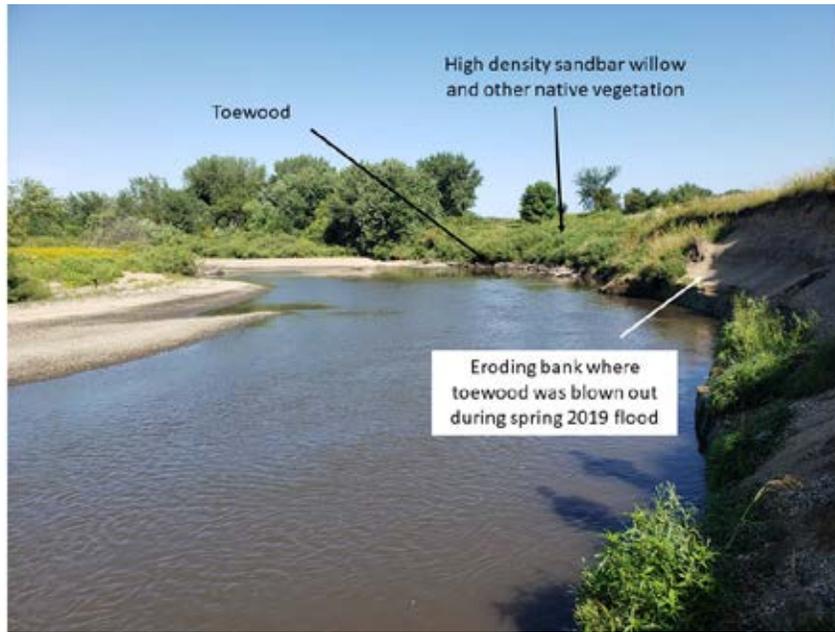
Photo 27-3. Looking upstream at the Downstream Bank (Bank 3). The upstream portion of the bank demonstrates the existing toewood used to stabilize the bank. Above the toewood, sandbar willow have colonized the lower and upper banks. At the top of the bank, primarily smooth brome and other comprise the majority of the cover. Approximately the last 150 feet of toewood blew out during spring 2019 flooding. (Photo taken 8/22/19 by Mark Pranckus, Cardno).

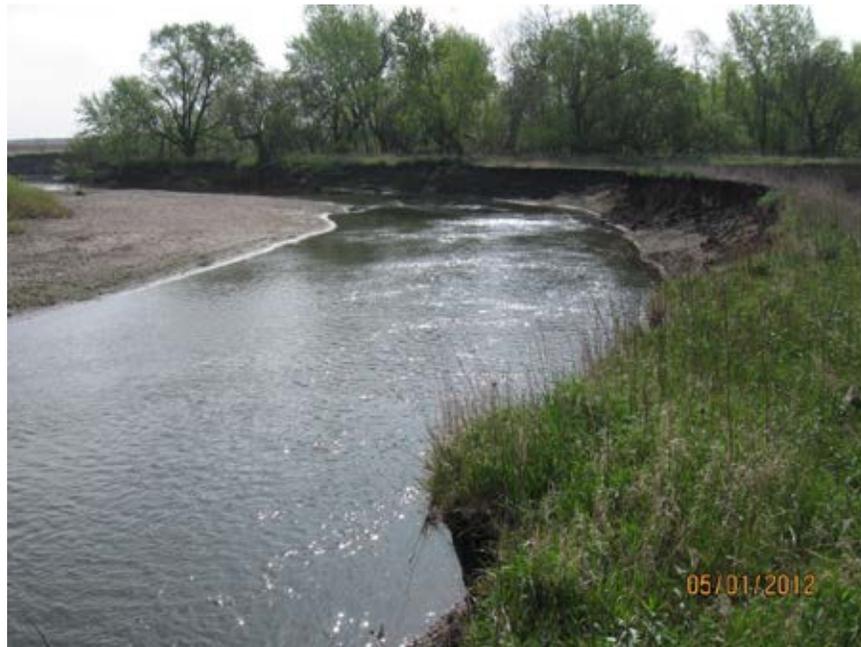
Photo 27-4. Looking upstream at the Downstream Bank (Bank 2) in 2012. In 2014, a significant flood event caused additional bank erosion prior to construction of the project (Photo provided by Scott Ralston, USFWS).

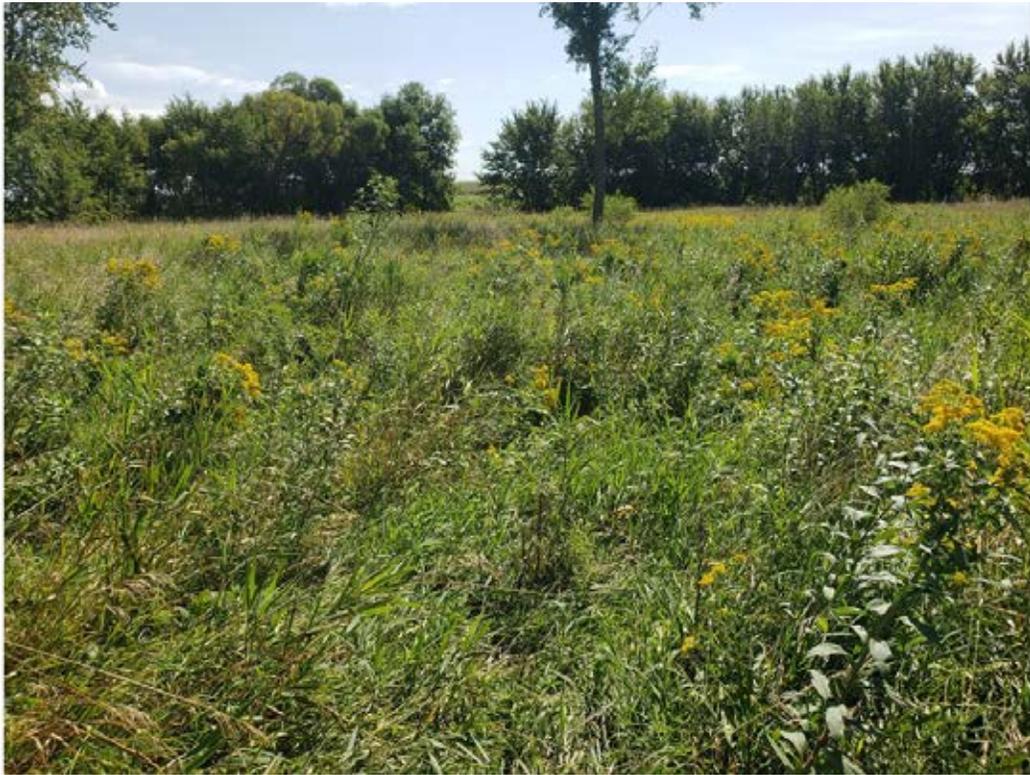
Photo 27-5. Looking at the area adjacent to the Upstream Bank where trees for the toewood were harvested. The site was re-seeded with a combination of native grasses and forbs. (Photo taken 8/22/19 by Mark Pranckus, Cardno).

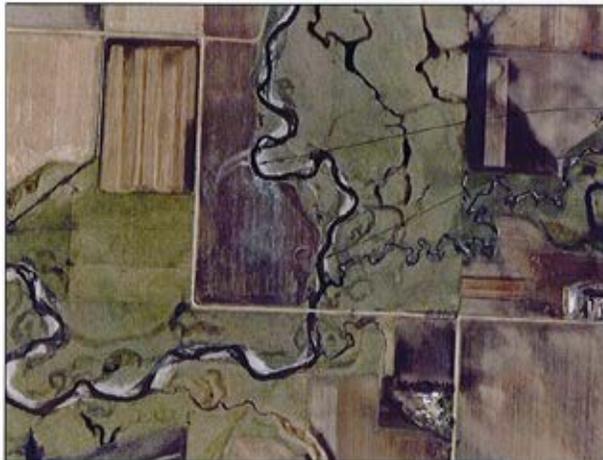
BEND #1
(SEE SHEET 2 OF 9)
BEND #2
(SEE SHEET 3 OF 9)

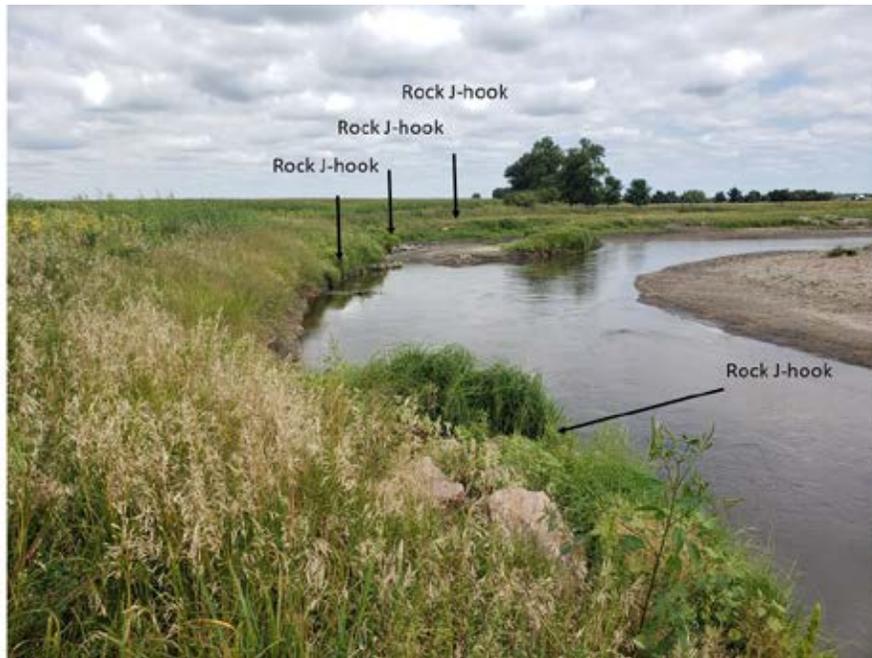
Photo 28-1. Looking upstream at the upstream project area. Locations of four of the six rock J-hook vanes are identified. Vegetation along the bank is 3 to 4 feet tall and well-established. (Photo taken 8/22/19 by Mark Prankus, Cardno).

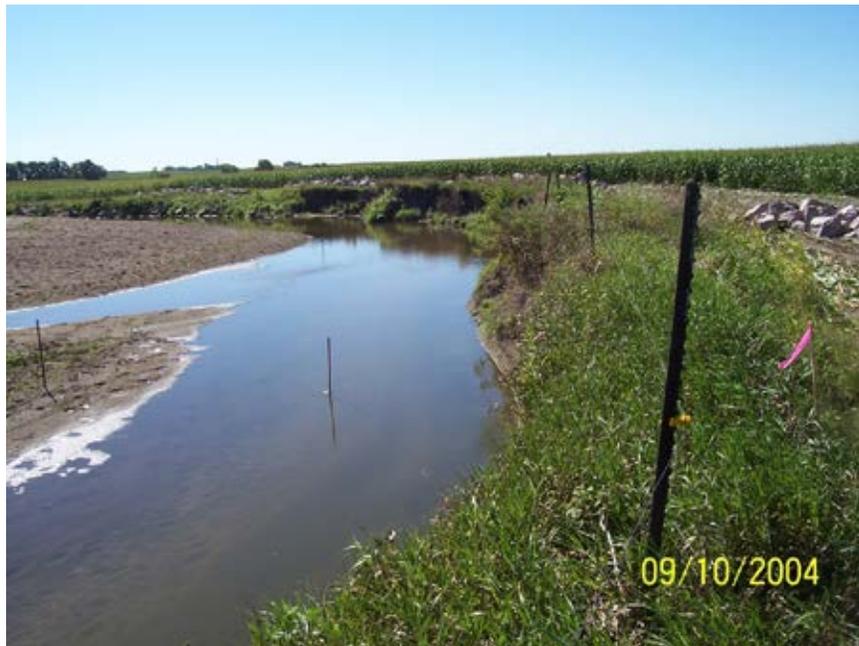
Photo 28-4. Looking downstream near the upstream end of the upstream project area prior to construction in 2014. Note the nearly vertical, severely eroding banks. Rocks used to create the J-hook vanes can be observed along the top of the bank. Photo provided by Scott Ralston (USFWS).

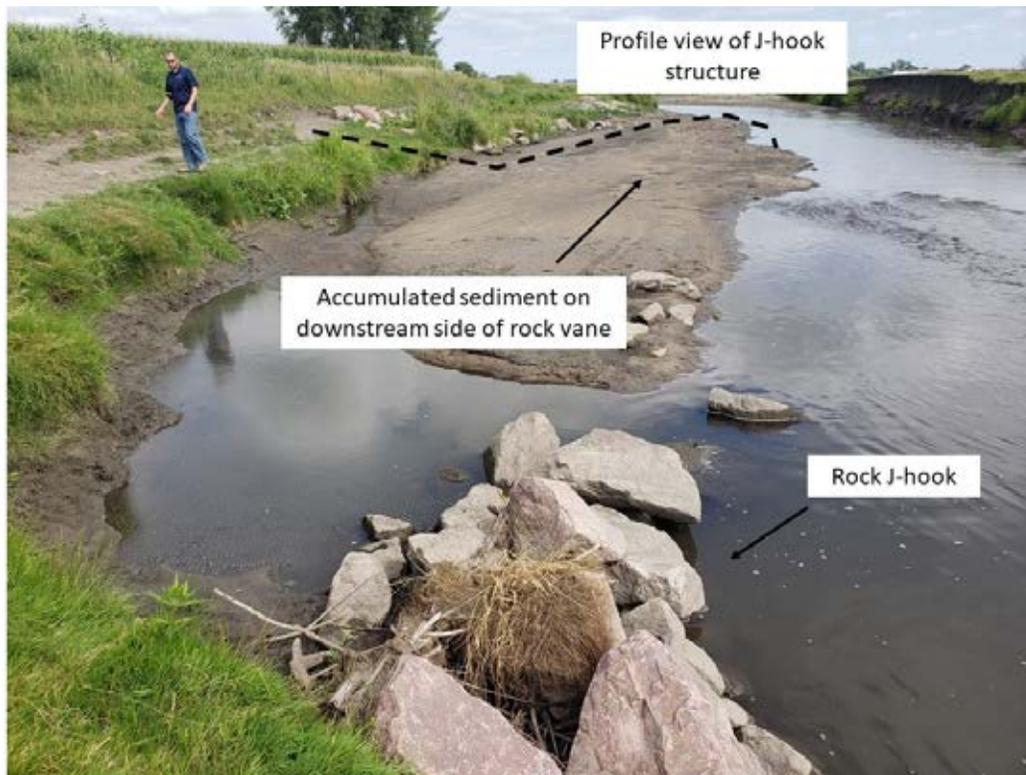
Photo 28-5. Looking upstream at the downstream project area. The two rock J-hook vanes installed in the project area can be seen. A large amount of sediment has accumulated between the structures, which helps to build the bank and protect against erosion. If the upstream vane angle was greater and extended into the channel more, the sediment in the hook of the vane would likely be scoured out, creating pool habitat. (Photo taken 8/22/19 by Mark Pranckus, Cardno).

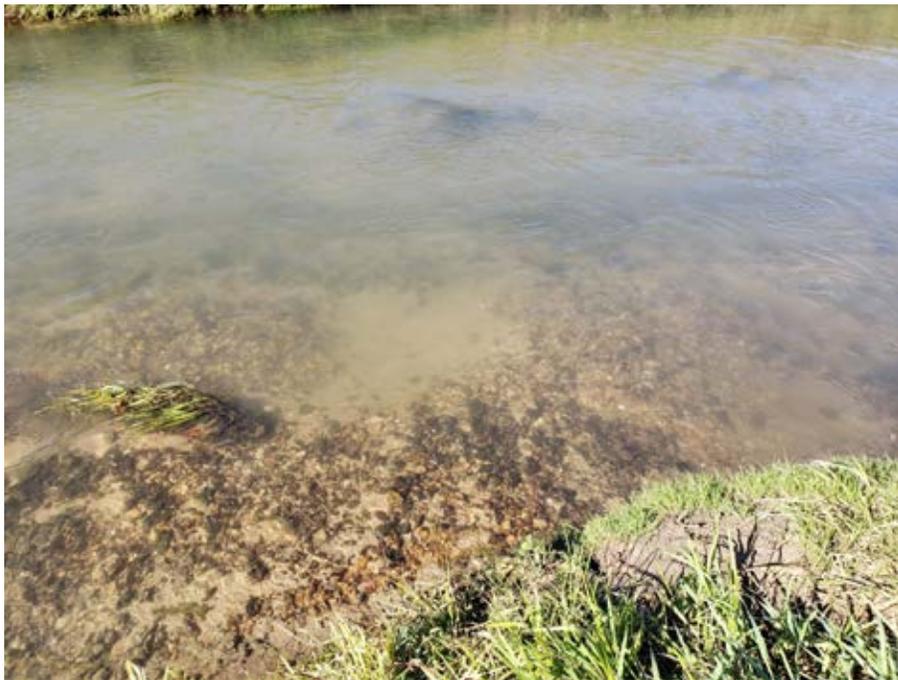
Photo 29-10 Example of small gravel associated with a downstream cross vane and upstream random boulder cluster. Gravel serves as a spawning location for trout where they make a depression to lay eggs (redd). Adults were observed on a redd during the field assessment. Photo taken on 10/18/19 by Mark Pranckus, Cardno.

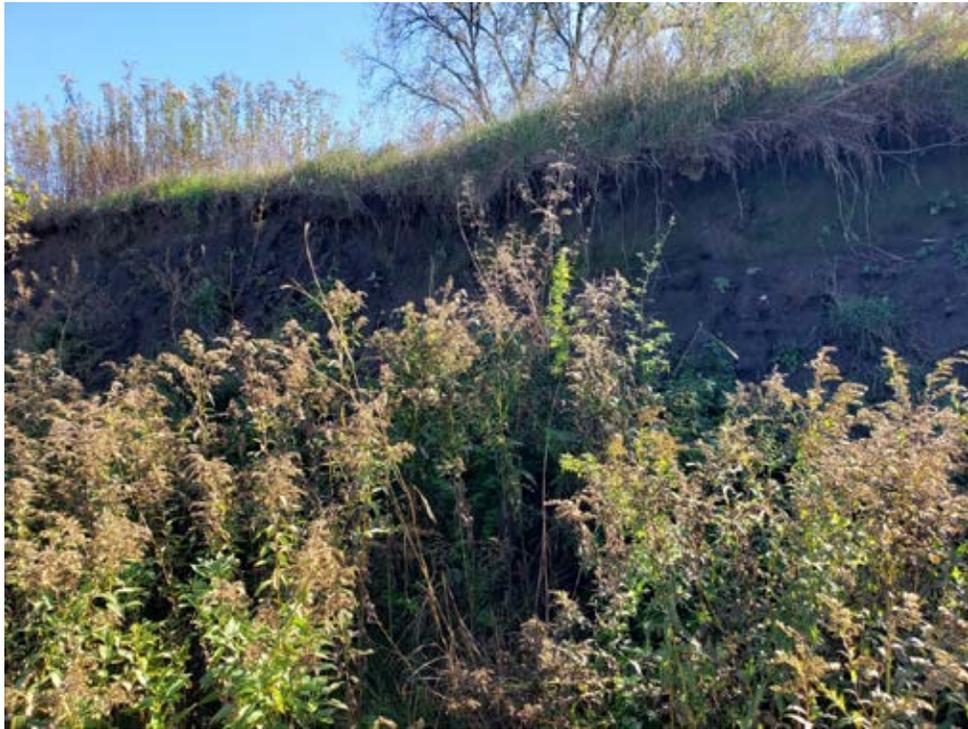
Photo 29-11 Example of non-game benefits to the project. An embankment made of excavation spoils in the uplands was left with a sheer face to provide bank swallow habitat. Eight years later and the bank is still available for bank swallow nesting. Photo taken on 10/18/19 by Mark Pranckus, Cardno.
