Minnesota Department of Natural Resources
Minnesota Board of Water and Soil Resources

Program Process Project Evaluations

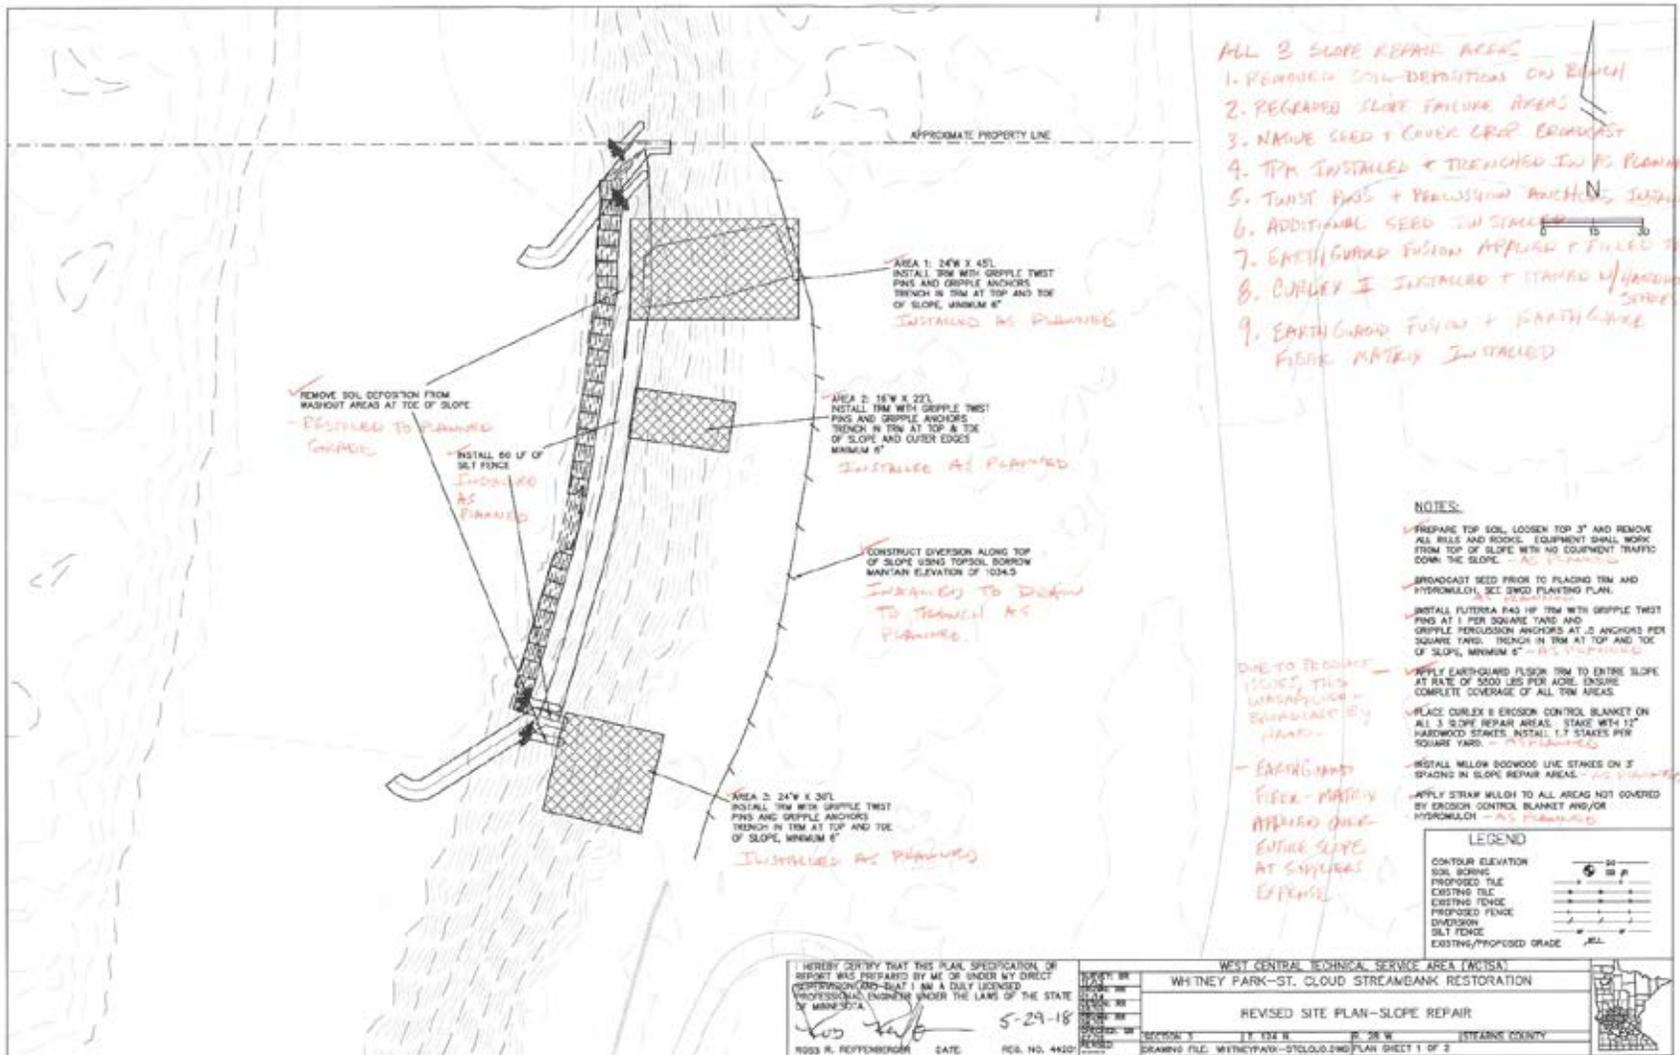
Figure 30-11. Sheet 2 of the as-built construction plan set for the slope repairs following construction. The sheet details the drain tile slope and details of the tile installation.

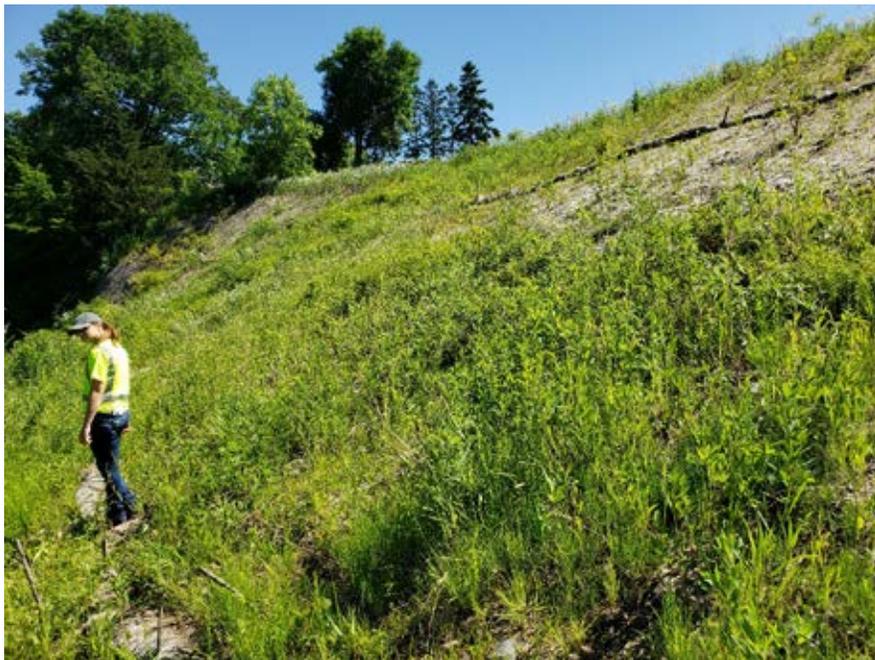
Photo 30-8. Example of vegetation development on the treatment bank. Vegetation on the bench and the lower portion of the slope are developing nicely. Bare areas on the upper slope where additional repairs were completed can be observed, but will fill in over time. (Photo taken 6/26/19 by Mark Pranckus, Cardno).

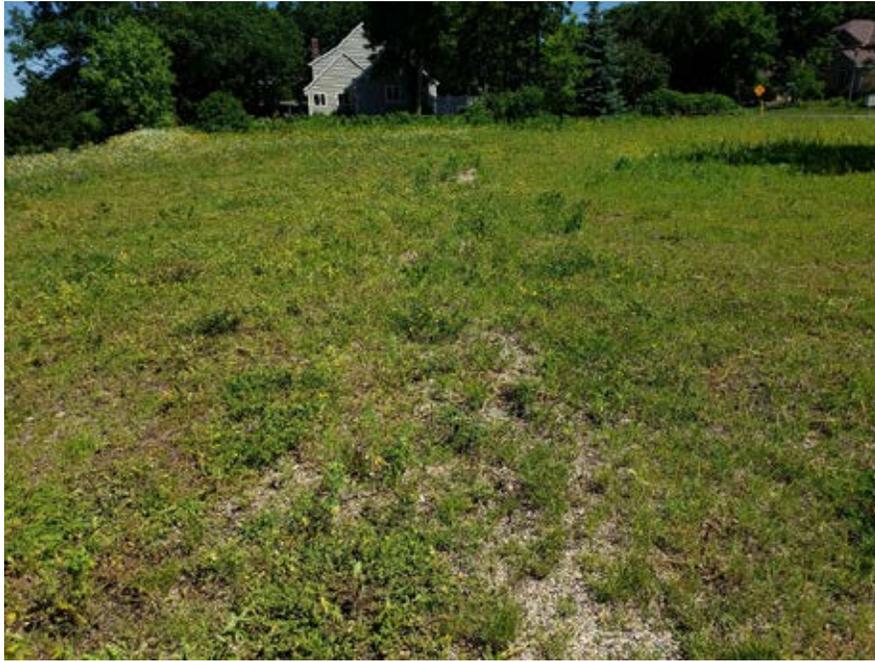
Photo 30-9. Example of the native vegetation seeded at the top of the slope to control surface water. Water flowing on the surface during storm events is ponded and captured in the French drain and is routed via drain tile to the base of the slope. (Photo taken 6/26/19 by Mark Pranckus, Cardno).

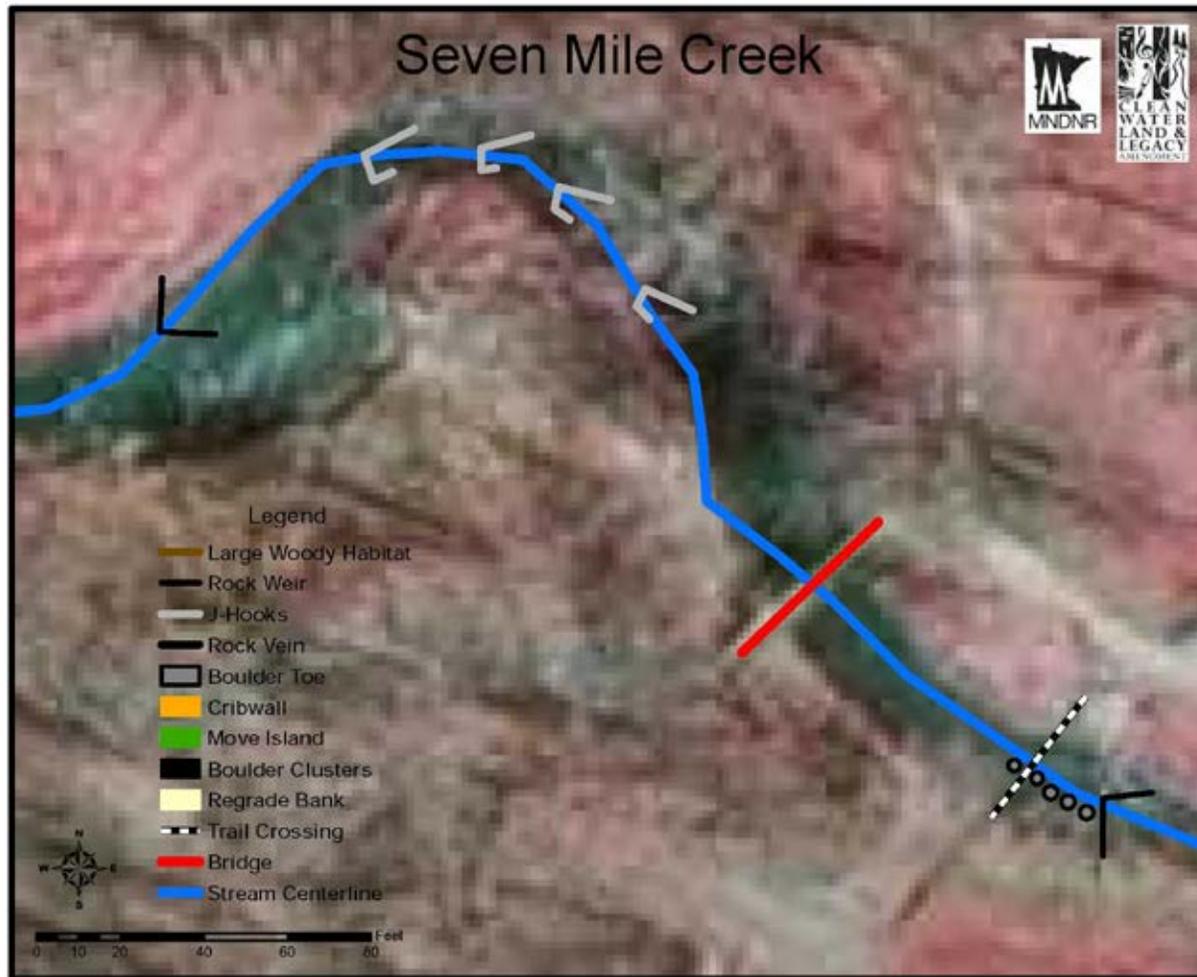
Figure 31-3 Seven Mile Creek project design plans sheet 2 of 5. Zoomed in plan sheet showing stream improvements and locations. Field observed changes from the plan include relocating the upstream cross vane to downstream of the J-hooks and using the downstream cross vane material to harden the existing riffle at the trail crossing instead of creating a new cross vane. It was noted that the J-hooks were actually single vanes previously constructed by the DNR in the early 2000's and material was used to strengthen those vanes in the single-vane configuration instead of converting them to J-hooks.

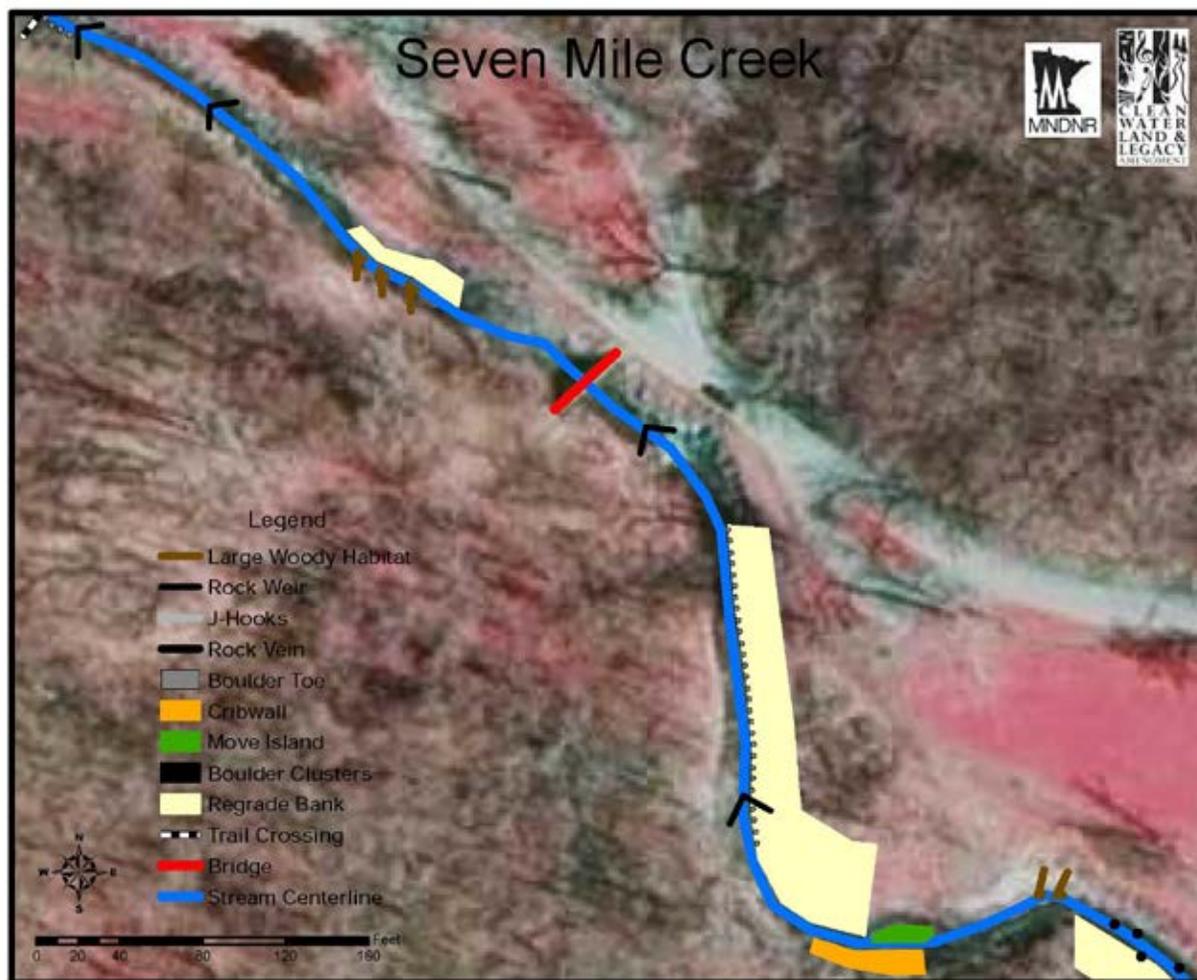
Figure 31-4 Seven Mile Creek project design plans sheet 3 of 5. Zoomed in plan sheet showing stream improvements and locations. Field observed changes from the plan include the large woody habitat upstream being removed. Three of them had been removed by unauthorized public members so that final rootwad was removed during final maintenance in August 2019.

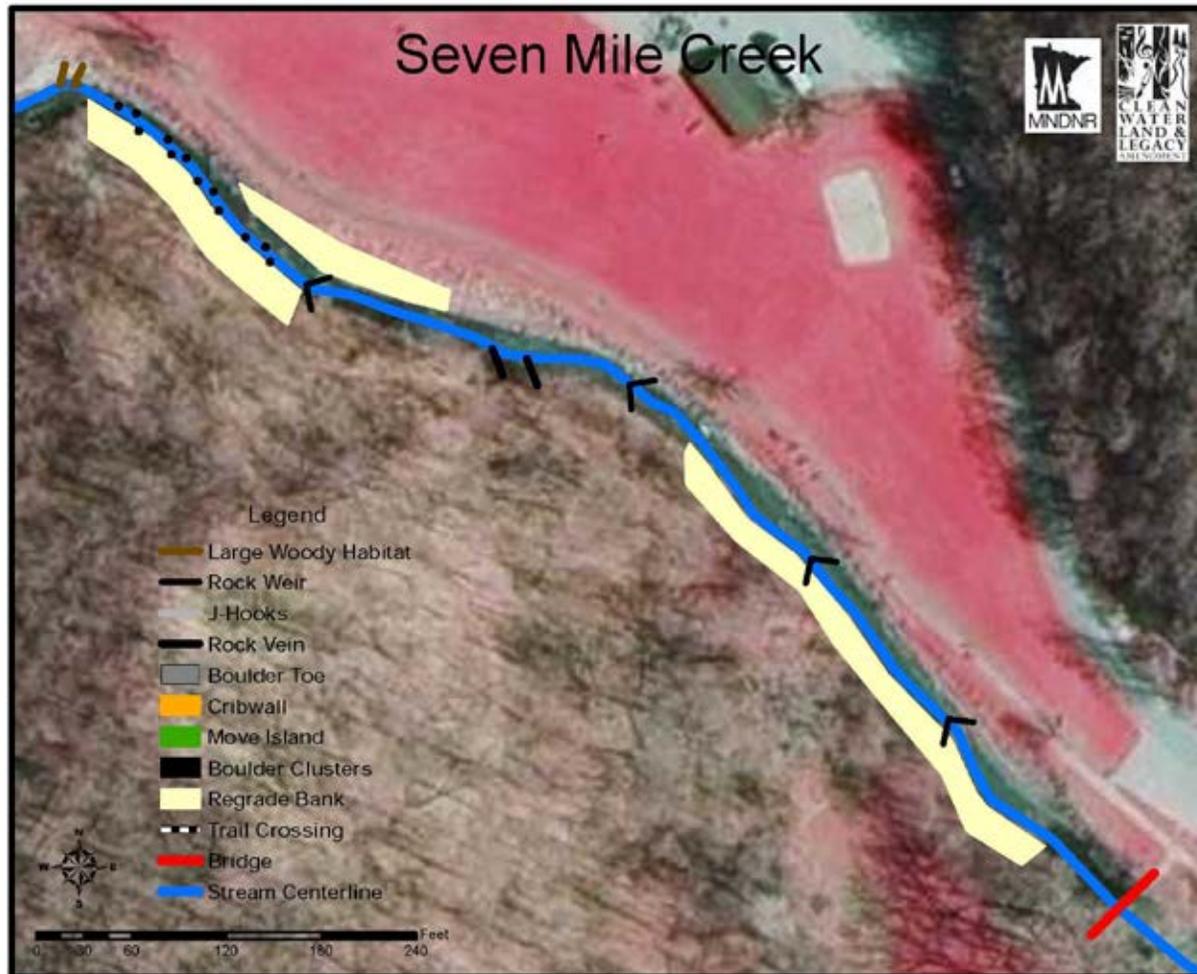
Figure 31-5 Seven Mile Creek project design plans sheet 4 of 5. Zoomed in plan sheet showing stream improvements and locations. Field observed changes from the plan include combining the two single vanes in the middle of the pictured reach into a single cross vane.

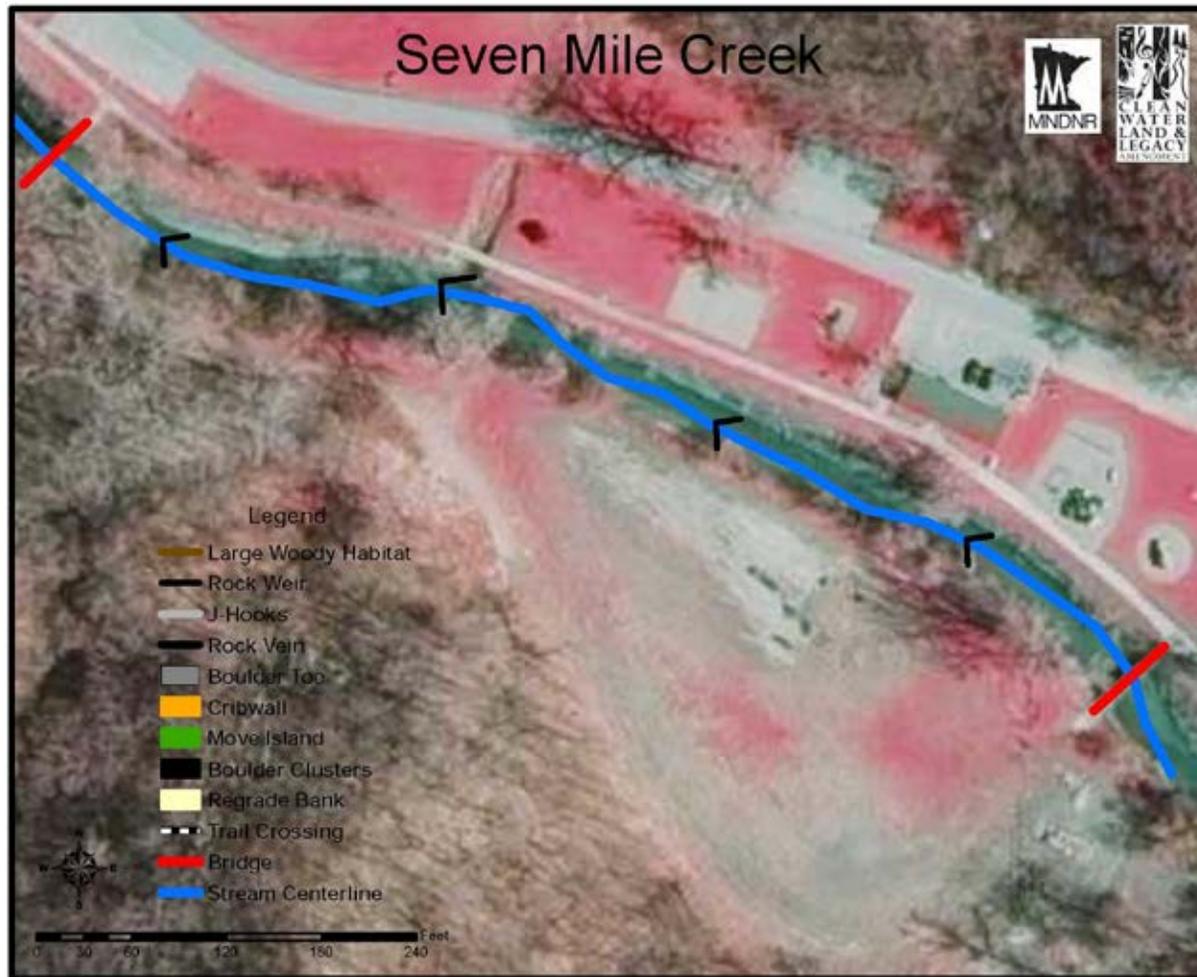
Figure 31-6 Seven Mile Creek project design plans sheet 5 of 5. Zoomed in plan sheet showing stream improvements and locations. Field observed changes from the plan include some of the proposed cross vanes being converted into single vanes and the remaining material used for bank protection.

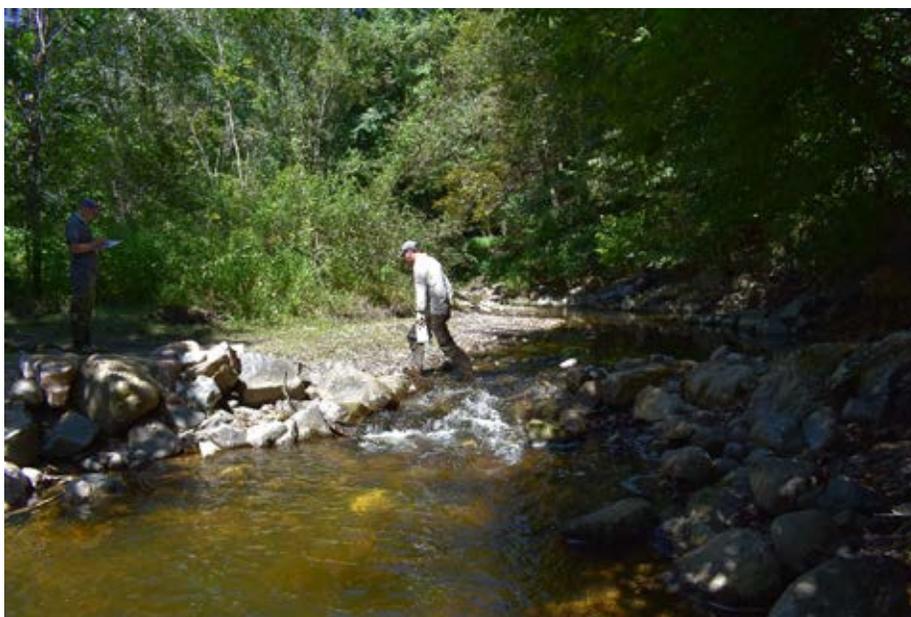
Photo 31-2 Upstream most riffle observed during site visit. (Seven Mile Creek County Park, photo taken during site visit 08/30/2019).

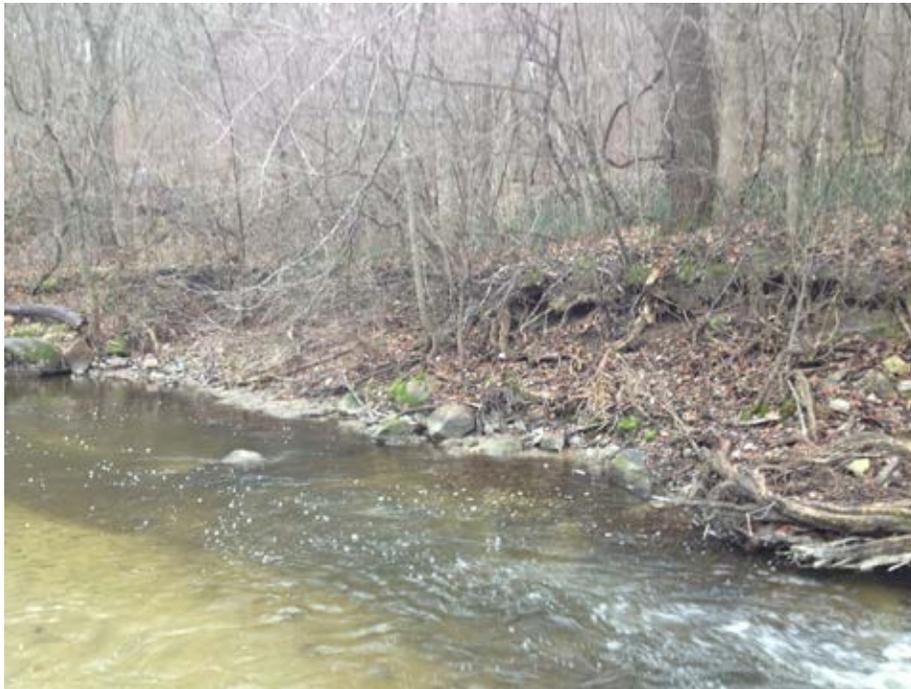
Photo 31-3 Cribwall location before construction. (Seven Mile Creek County Park, November 2016).

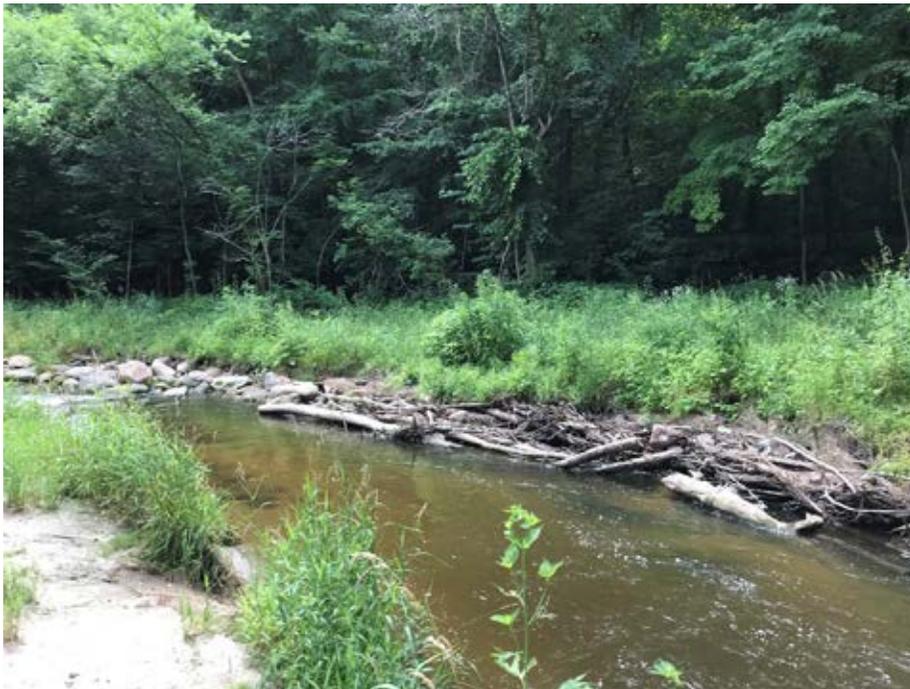
Photo 31-6 Cribwall after vegetation establishment and prior to reconfiguration repairs. (Seven Mile Creek County Park, photo taken by Mike Majeski at EOR, Inc. July 2019).

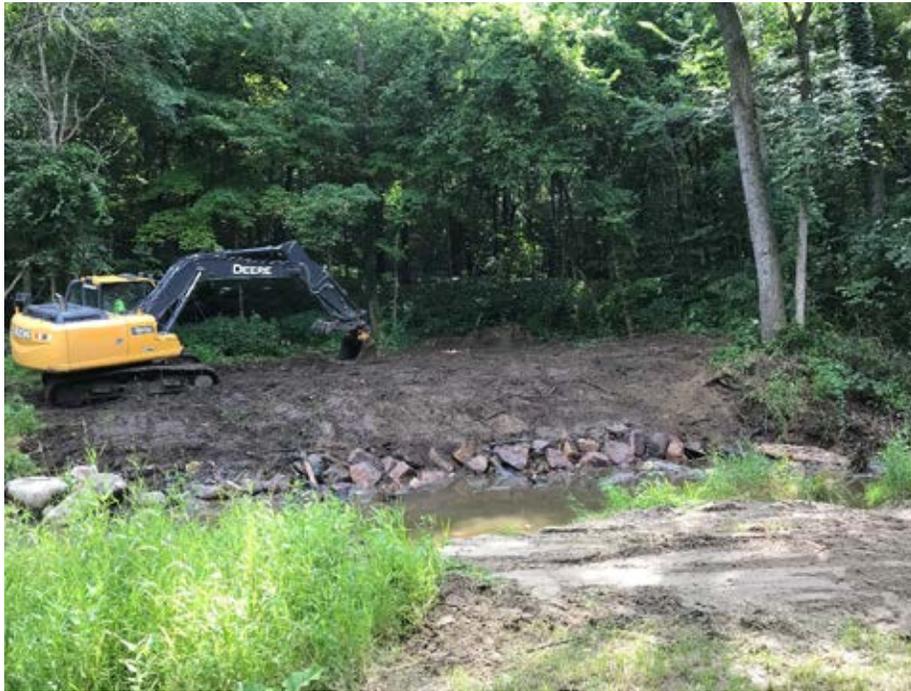
Photo 31-7 Cribwall during reconfiguration repairs. (Seven Mile Creek County Park, photo taken by Mike Majeski at EOR, Inc. August 2019).

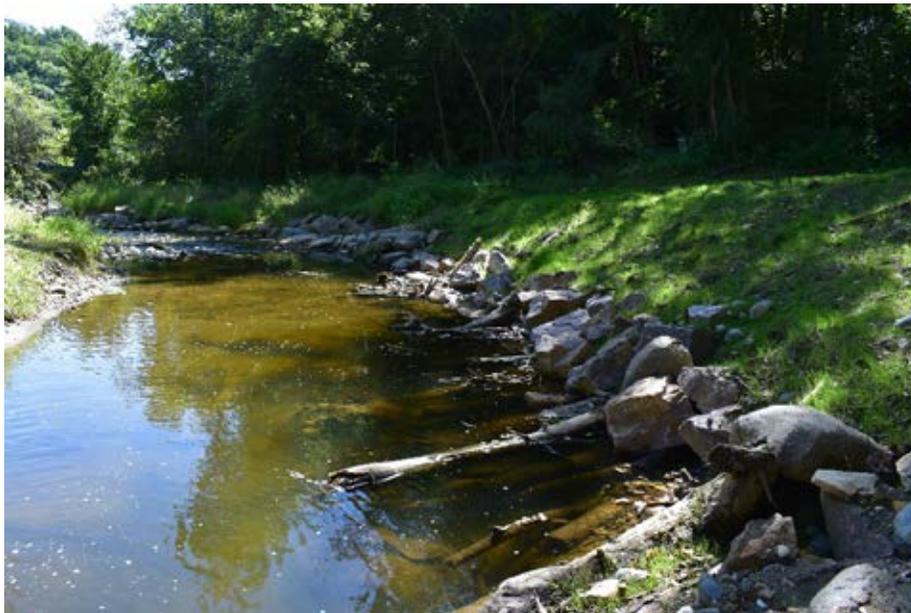
Photo 31-8 Cribwall bank after reconfiguration from parallel to streambank to perpendicular and placement of additional stone for ballast during final stream maintenance activities in August 2019. (Seven Mile Creek County Park, photo taken during site visit 08/30/2019).

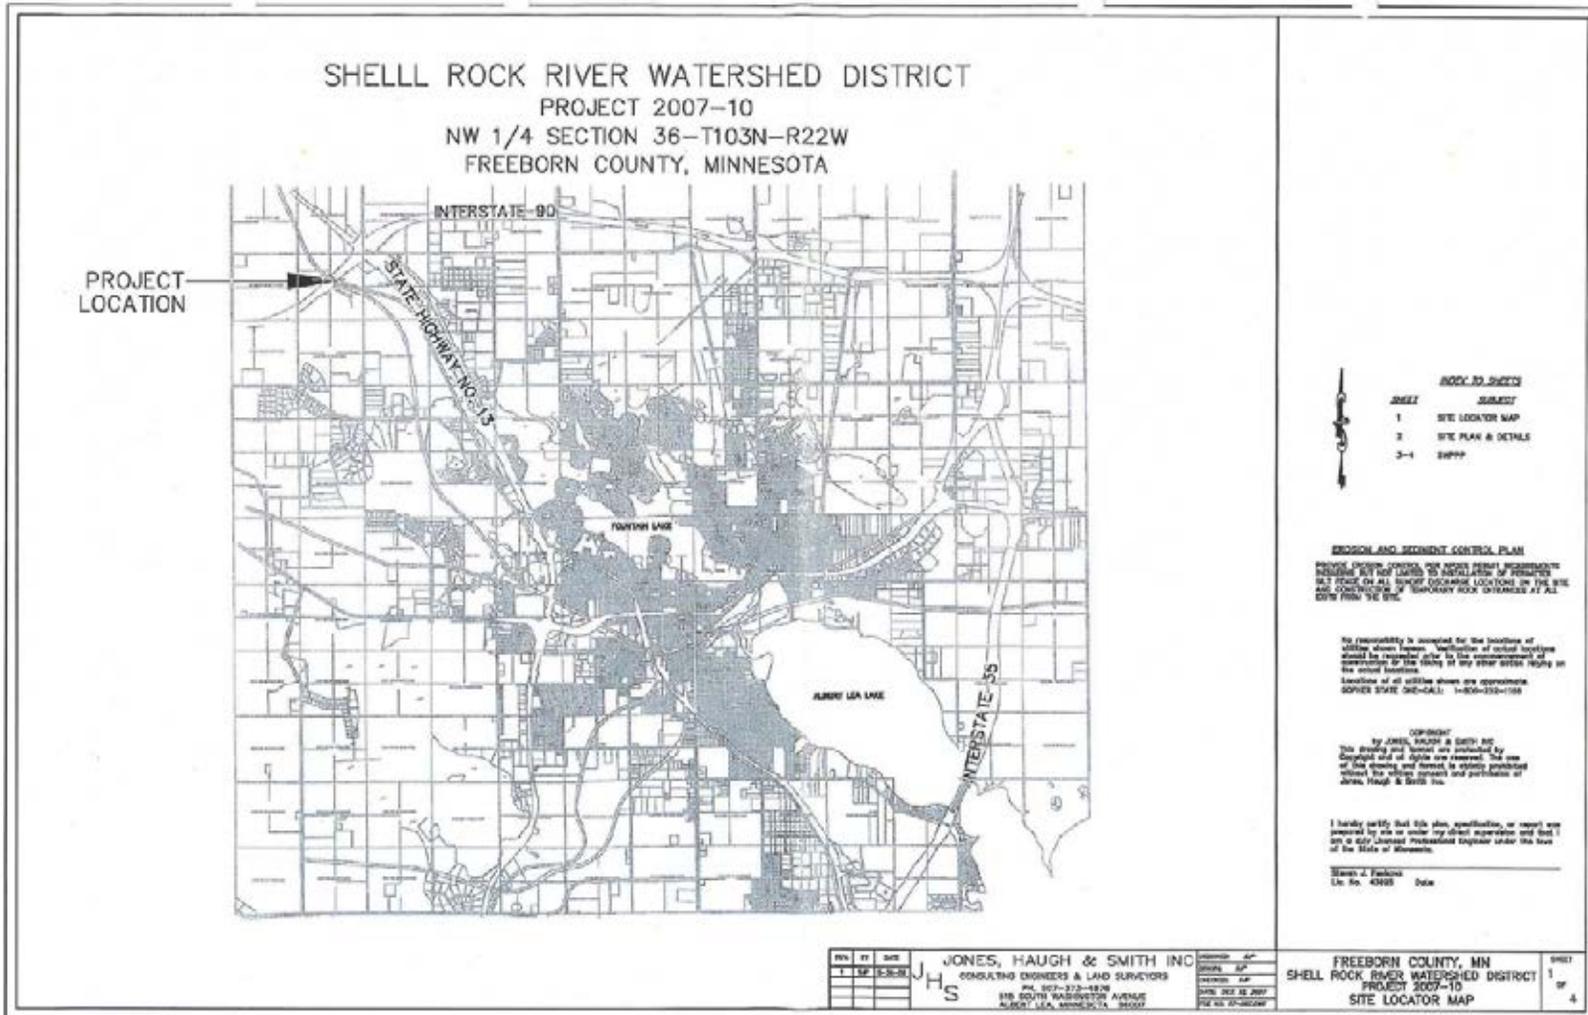
Figure 32-19 Wedge Creek Reach 6 culvert replacement construction project overview.

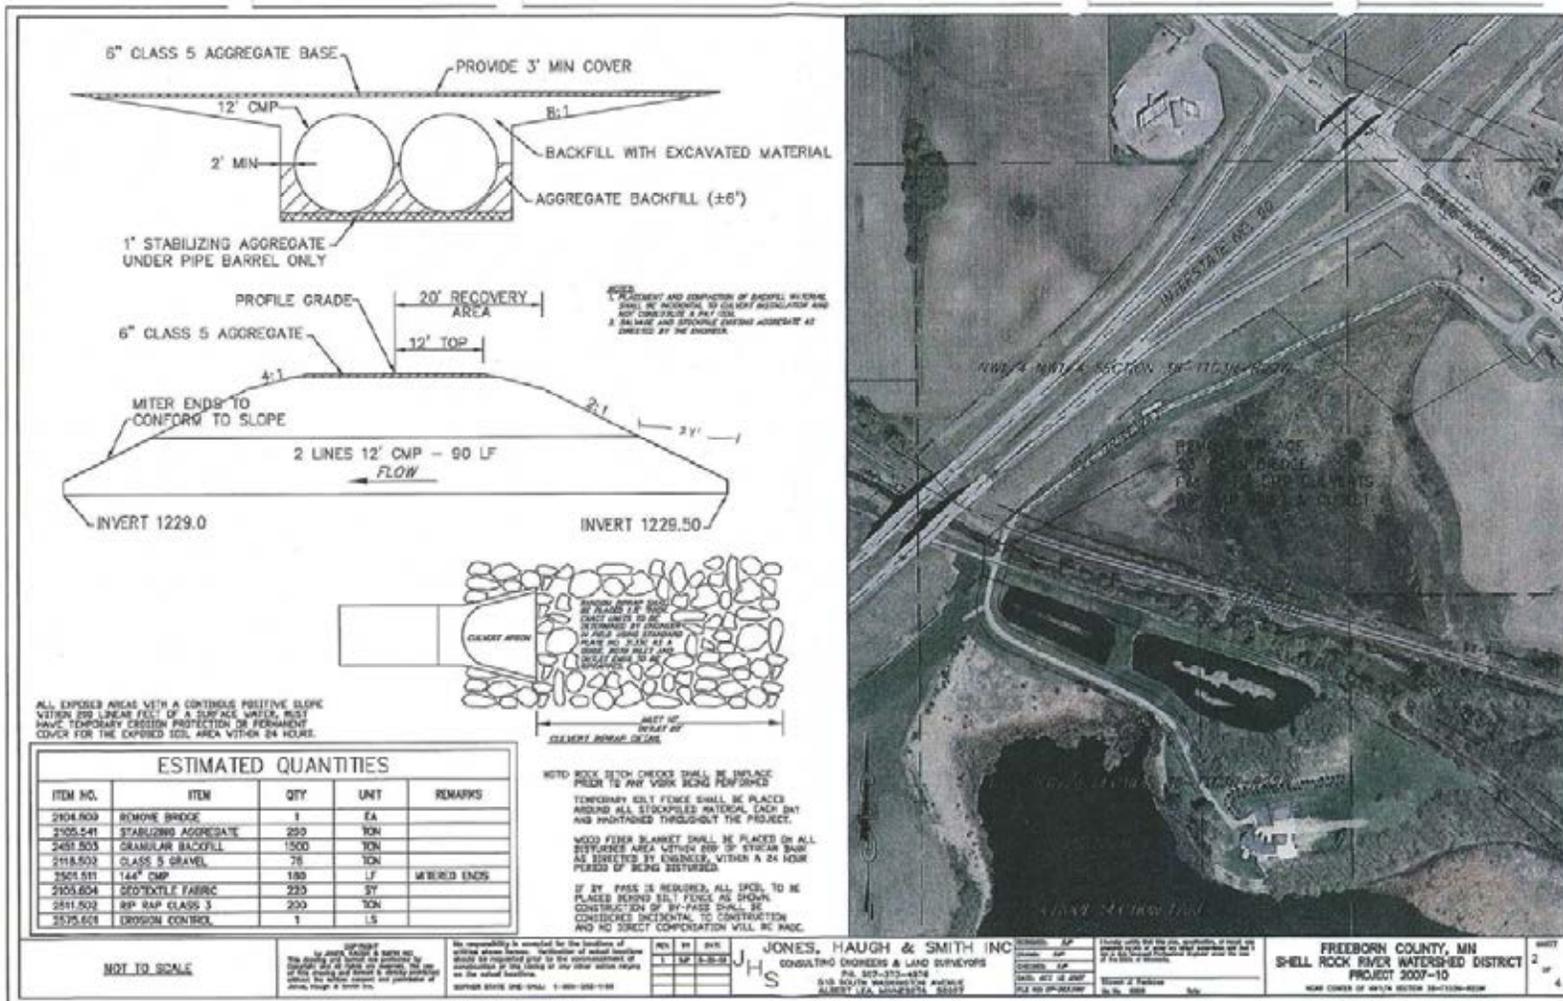
Figure 32-20 Wedge Creek Reach 6 culvert replacement construction plan and detail.

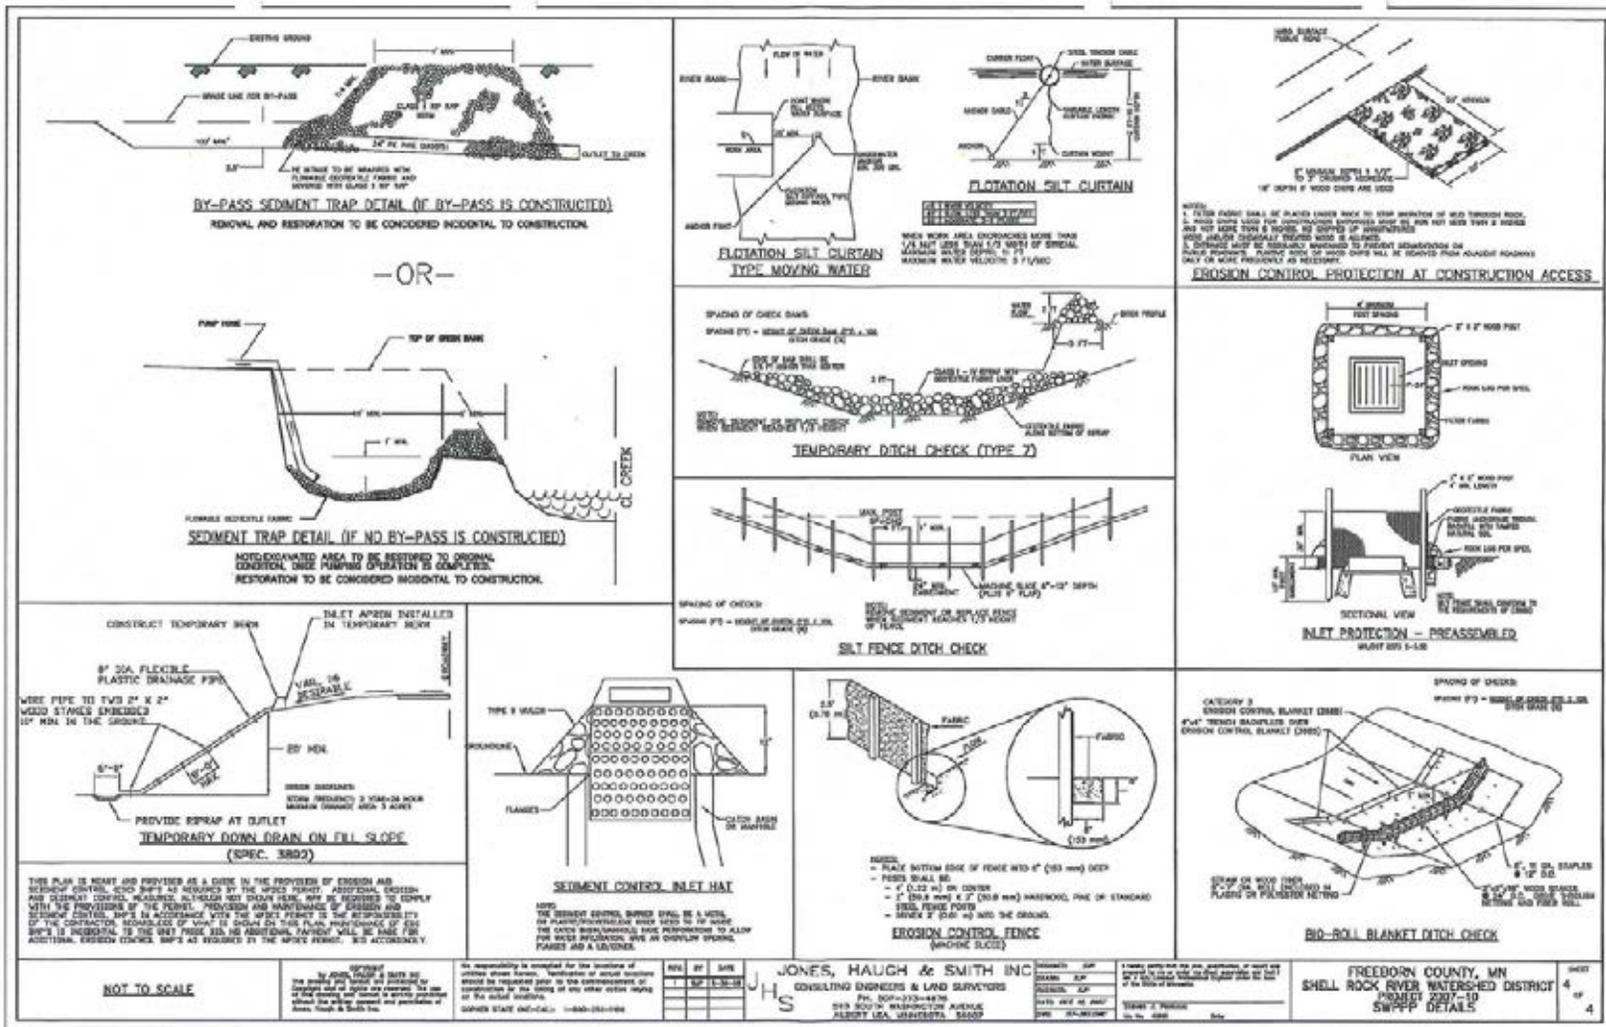
Figure 32-22 Wedge Creek Reach 6 culvert replacement construction details.

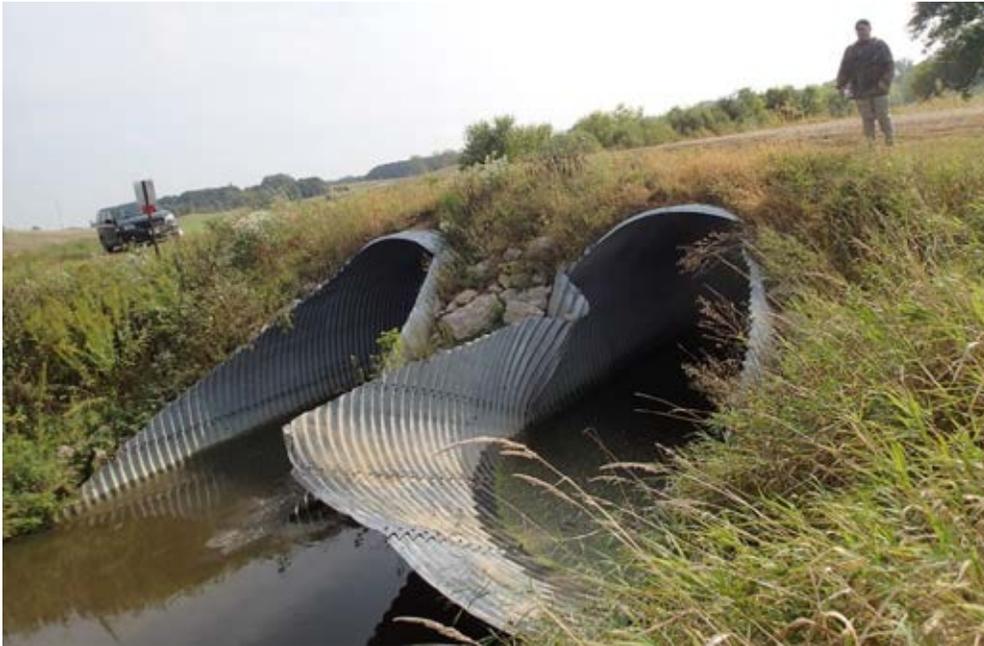
Photo 32-1 These two 12' culverts were installed on the upstream end of the project, on the upstream end of Reach 6, to replace an existing culvert that was undersized. Both culverts were incorrectly installed with an upstream invert 1.7' higher than specified. Spring runoff and ice flow in 2019 pushed up and bent the upstream end of one culvert making it non-functional. (Wedge Creek – Reach 6, photo taken by Lucius Jonett during site visit 09/20/2019).

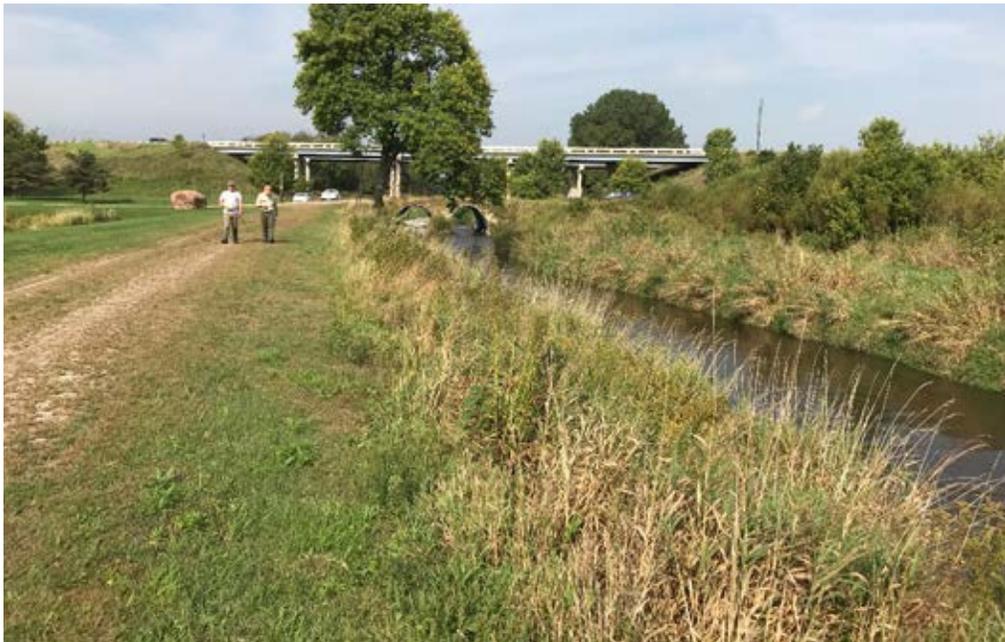
Photo 32-2 Photo looking upstream at the 12' replacement culverts. Straightened channel is typical of what is found upstream in the agriculture landscape. (Wedge Creek – Reach 6, photo taken by Lucius Jonett during site visit 09/20/2019).

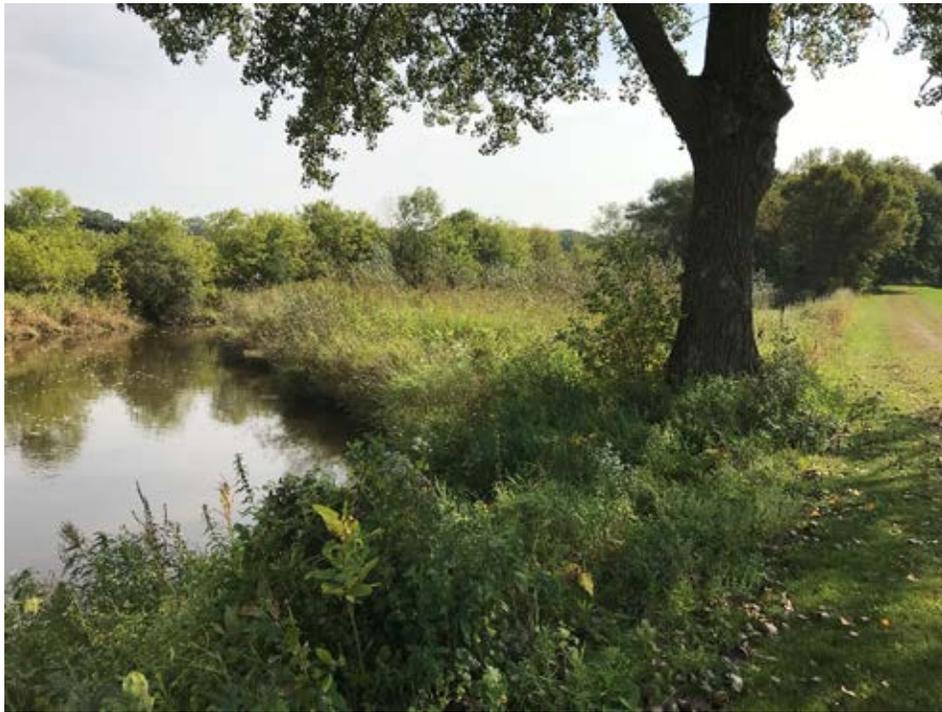
Photo 32-3 View of a lowered point bar to create a wetland terrace that is fully vegetated making it appear at almost the same elevation as the surrounding landscape. (Wedge Creek – Reach 6, photo taken by Lucius Jonett during site visit 09/20/2019).

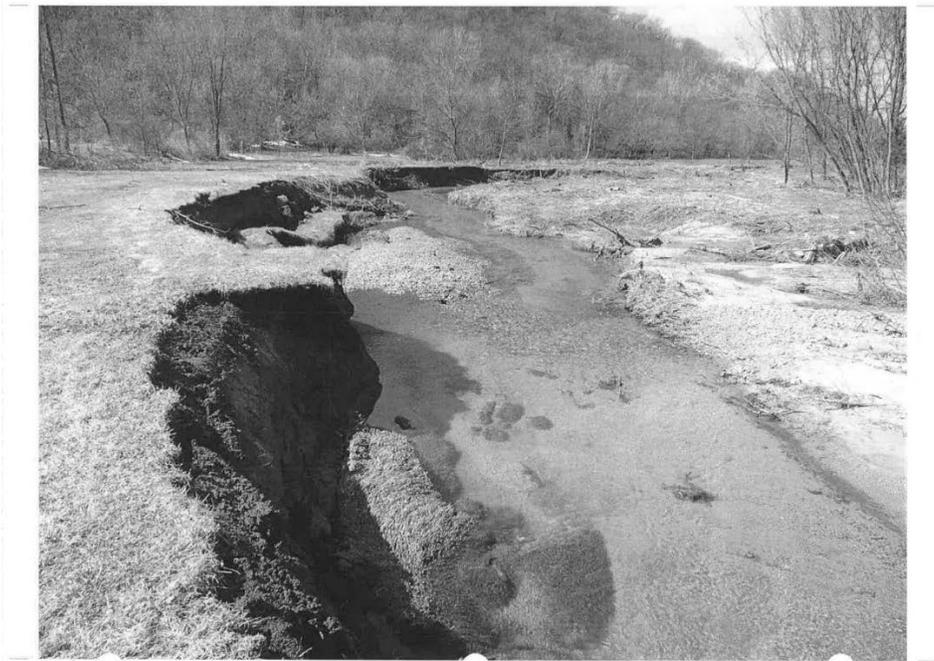
Photo 33-1 Stream conditions pre-construction. High vertical banks and overly wide stream with reduced instream habitat.

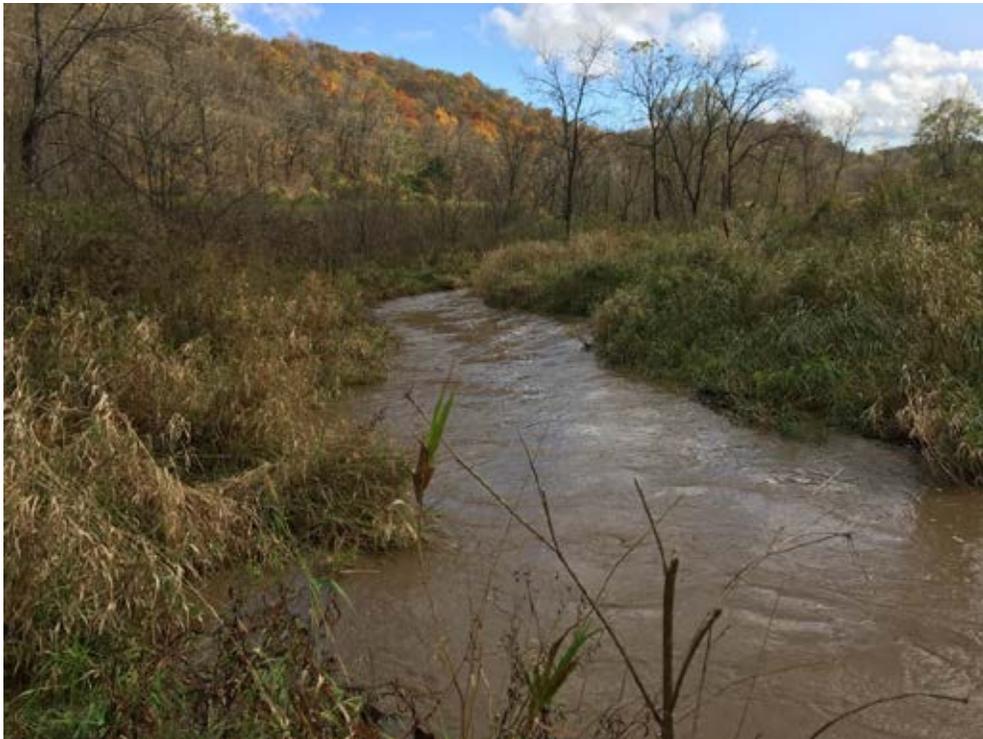
Photo 33-2 View of upstream reaches of habitat improvement project

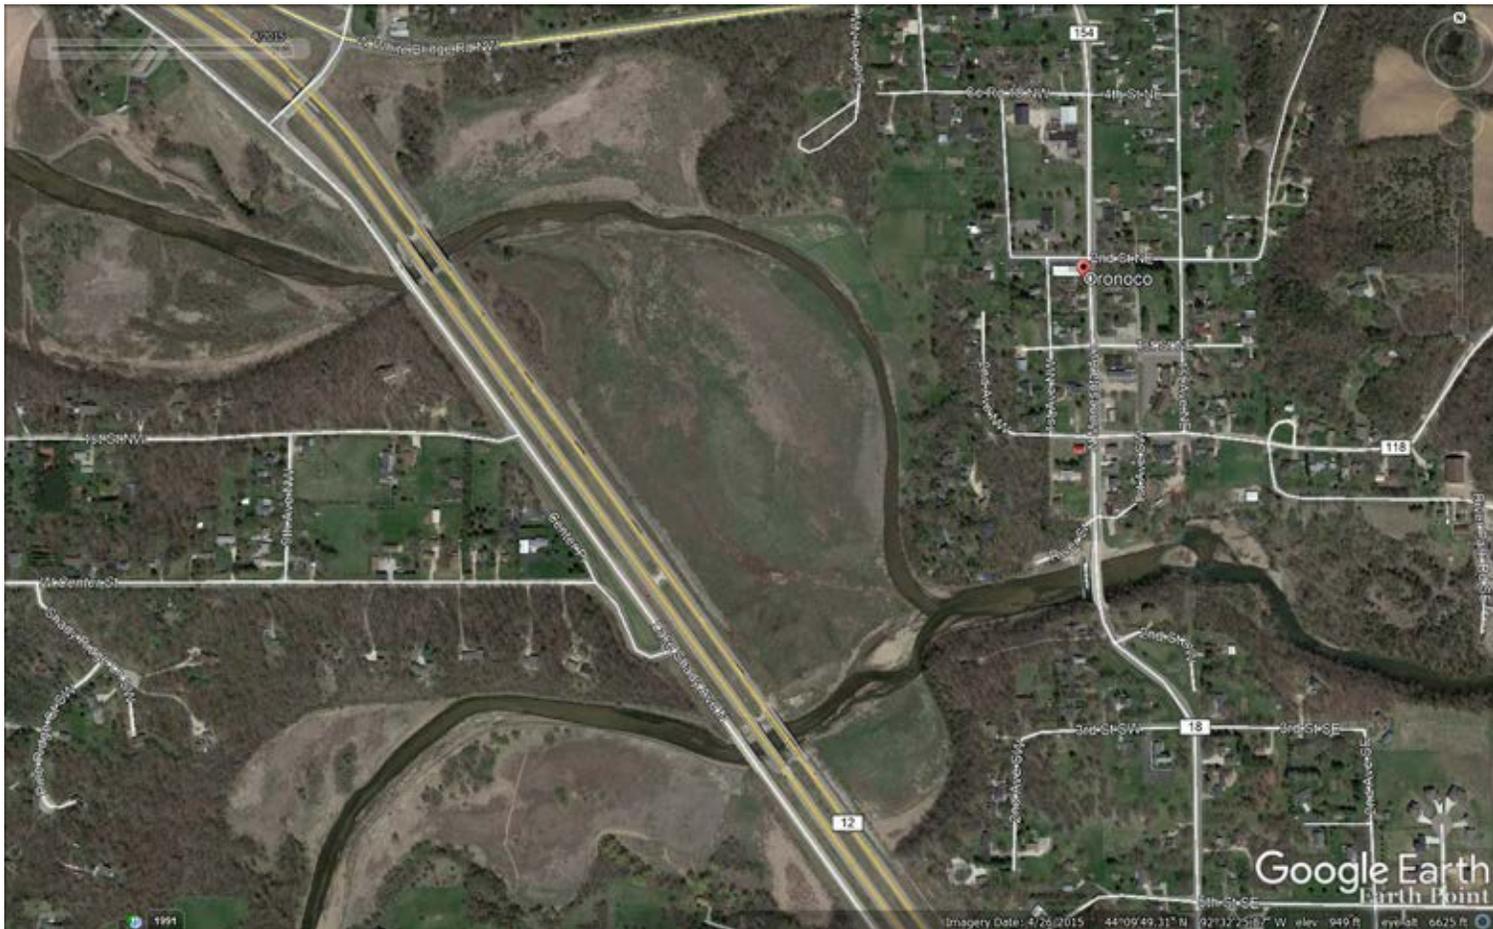
Figure 34-2 Aerial image of the former Lake Shady in 2015 prior to work. The channel through the former lake bed formed after the dam failed. Aerial photography is from April 2015 and provided by Google Earth.

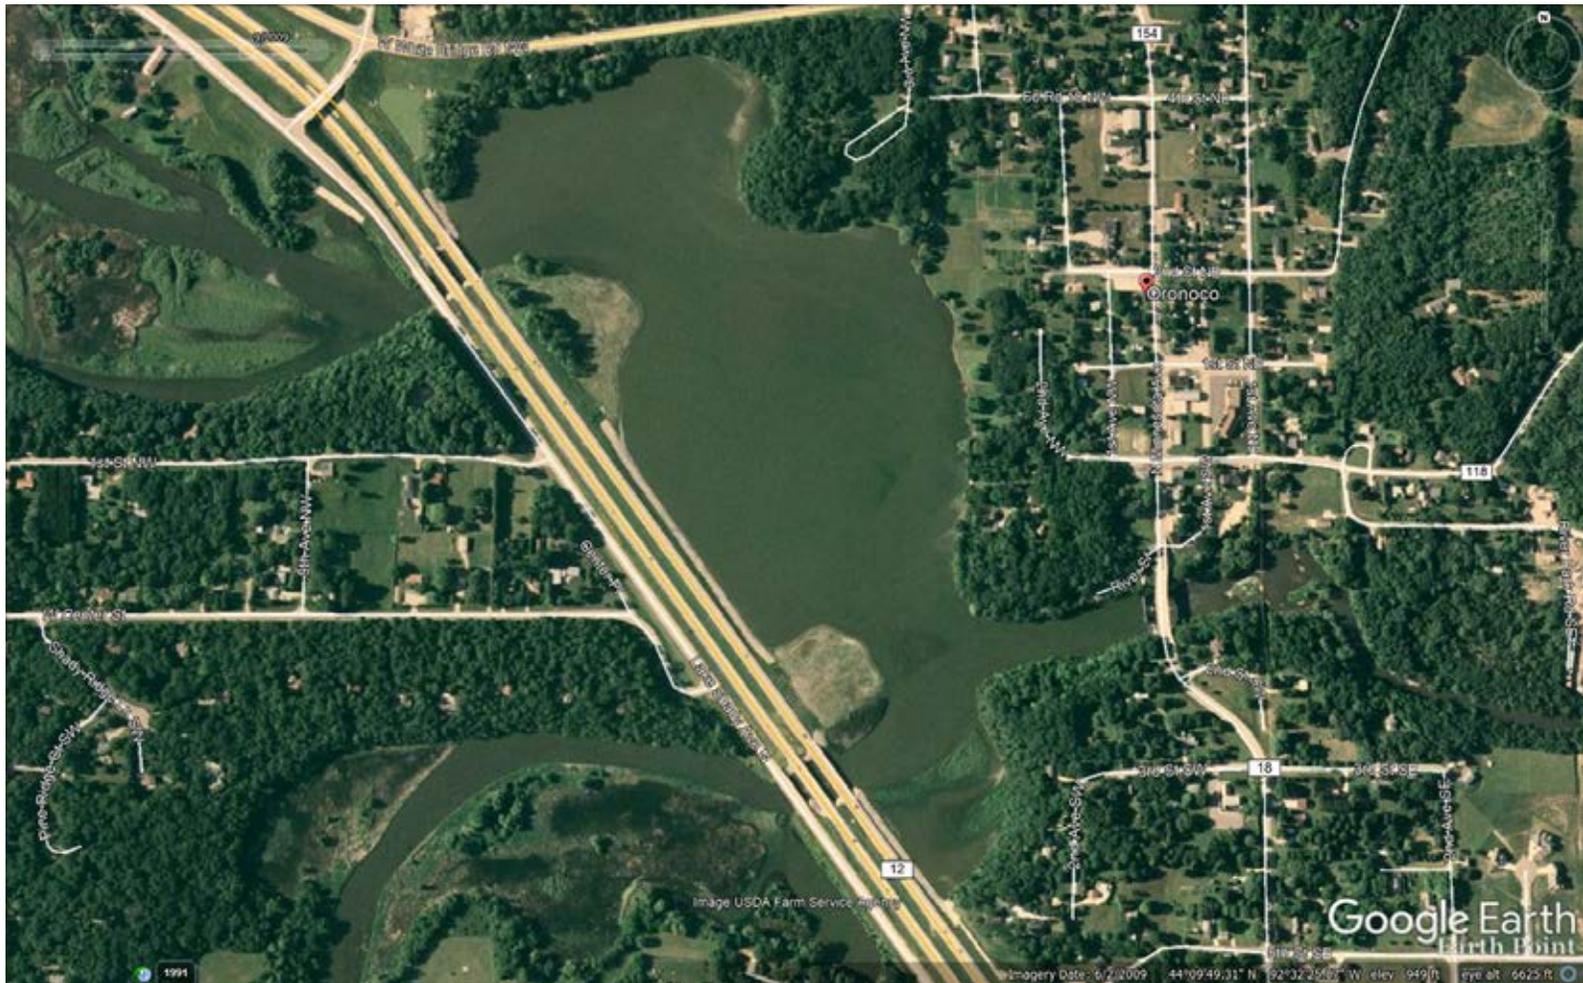
Figure 34-3 Aerial photo from 2009 prior to the dam failure showing the extent of open water of Lake Shady. Approximately one year later the day would fail. Aerial photography is from September 2009 and provided by Google Earth.
