Minnesota Department of Natural Resources
Minnesota Board of Water and Soil Resources

Program Process Project Evaluations

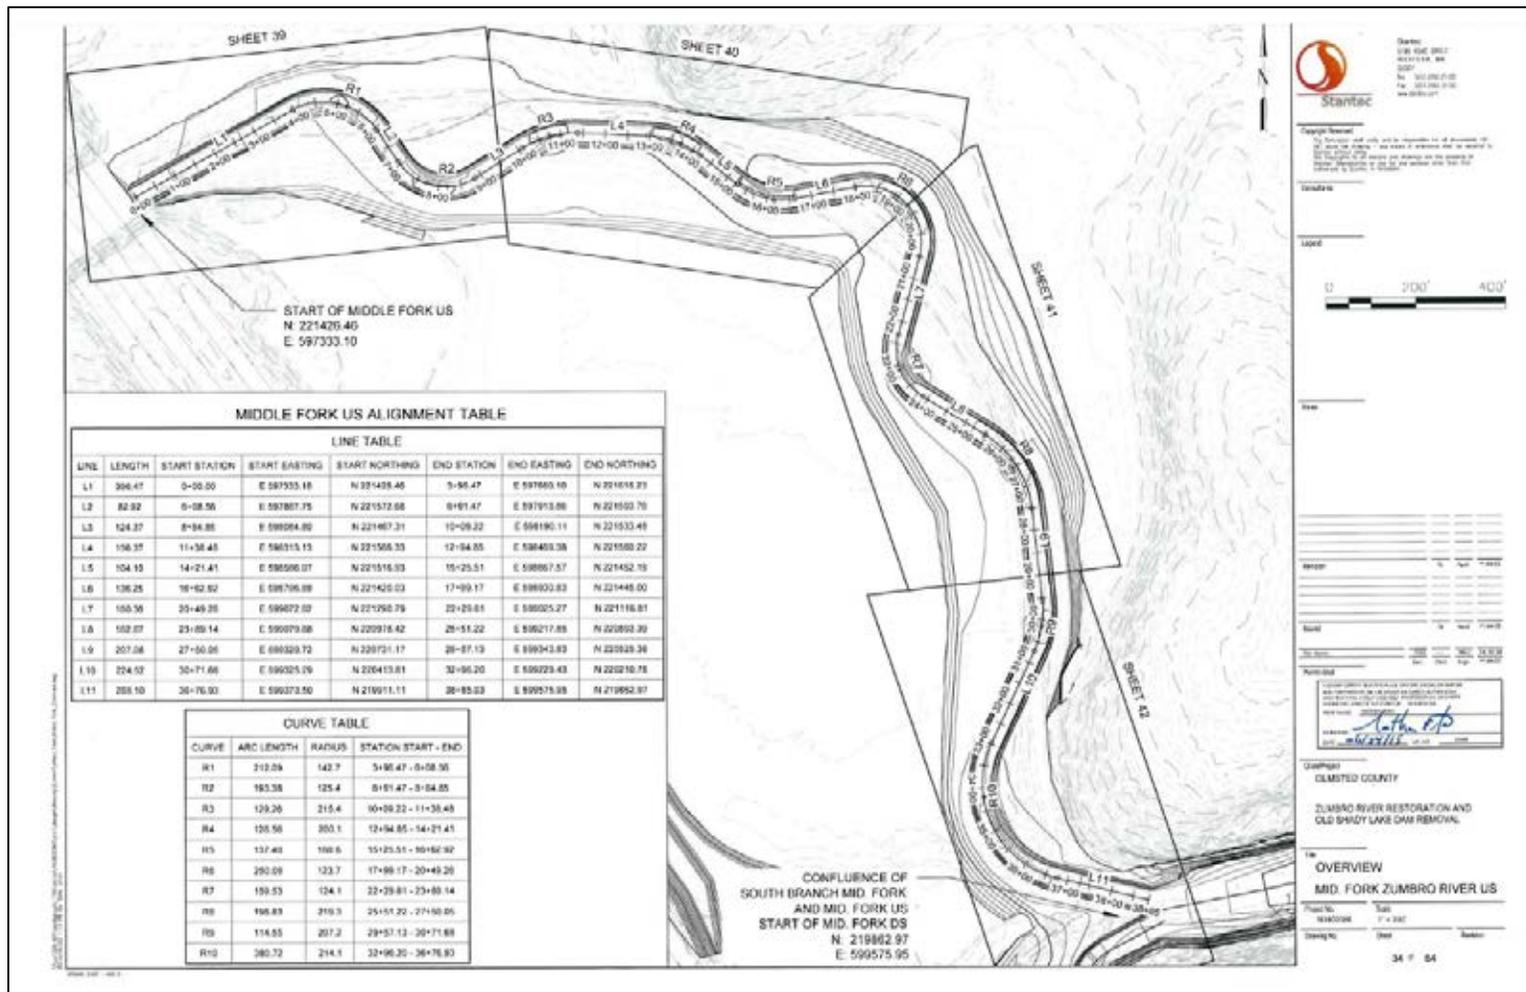
Figure 34-5 Sheet from construction plan set showing overview of the Middle Fork of the Zumbro River construction.

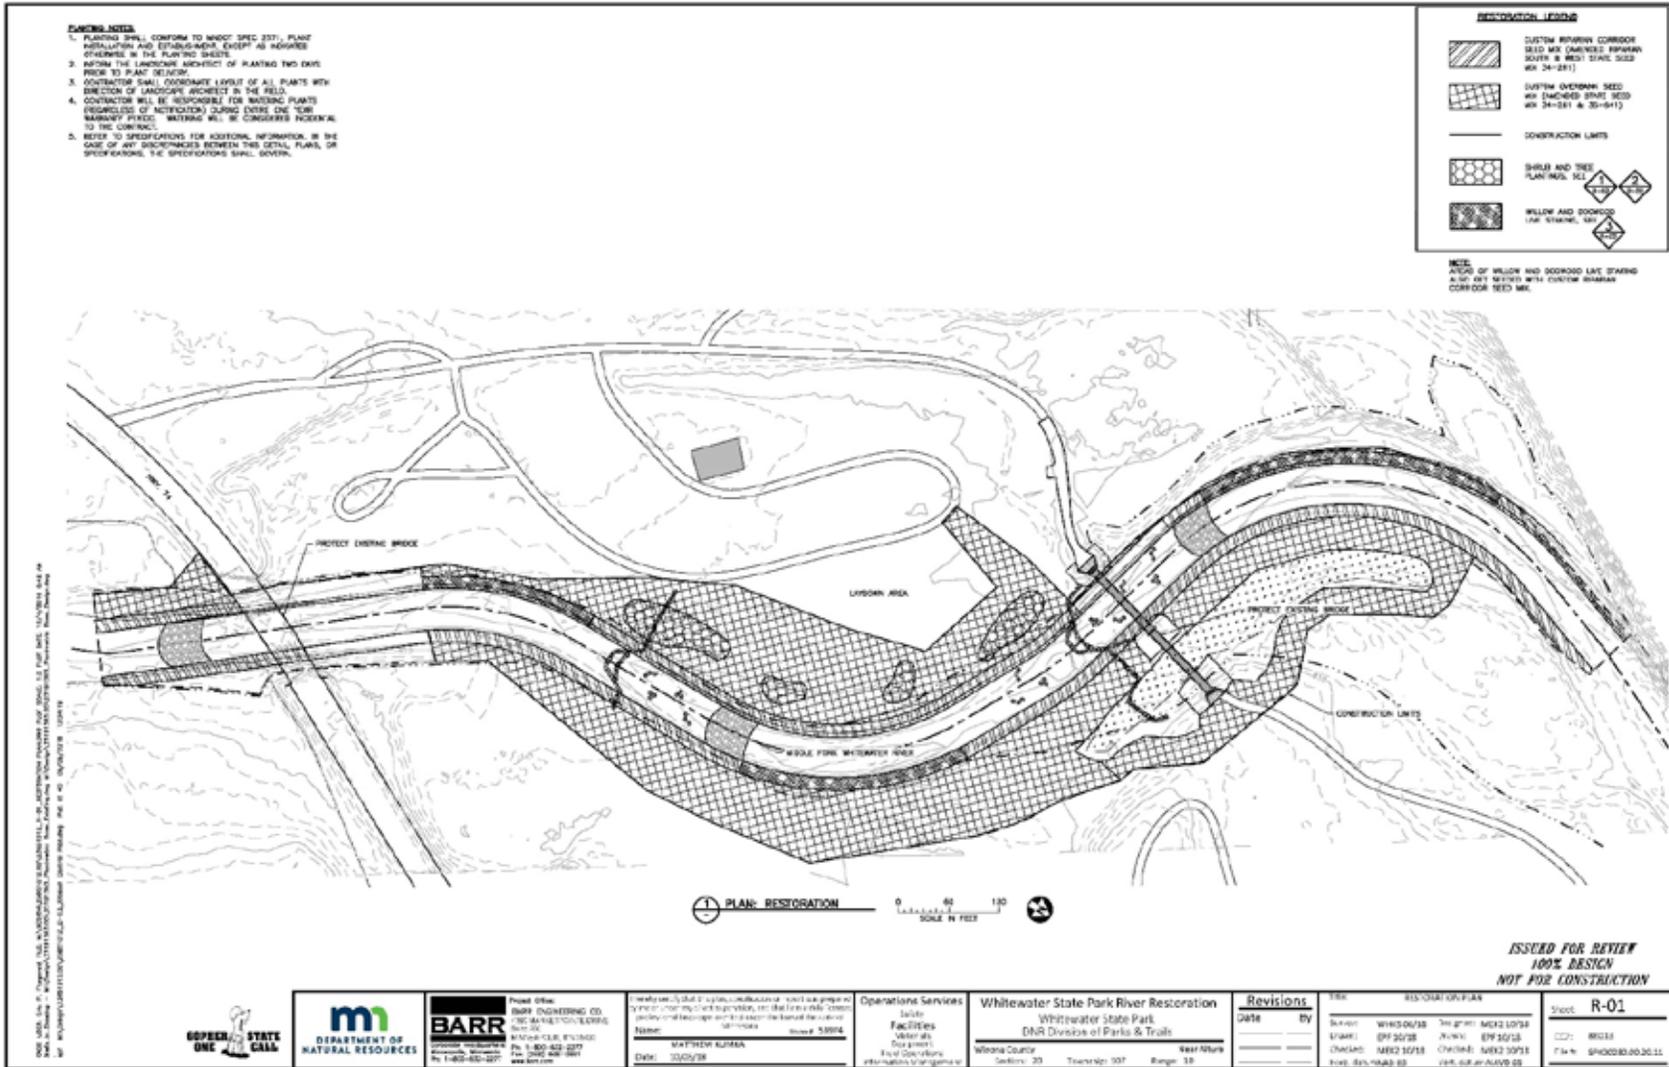
Figure 36-6 Restoration plans from construction plans.

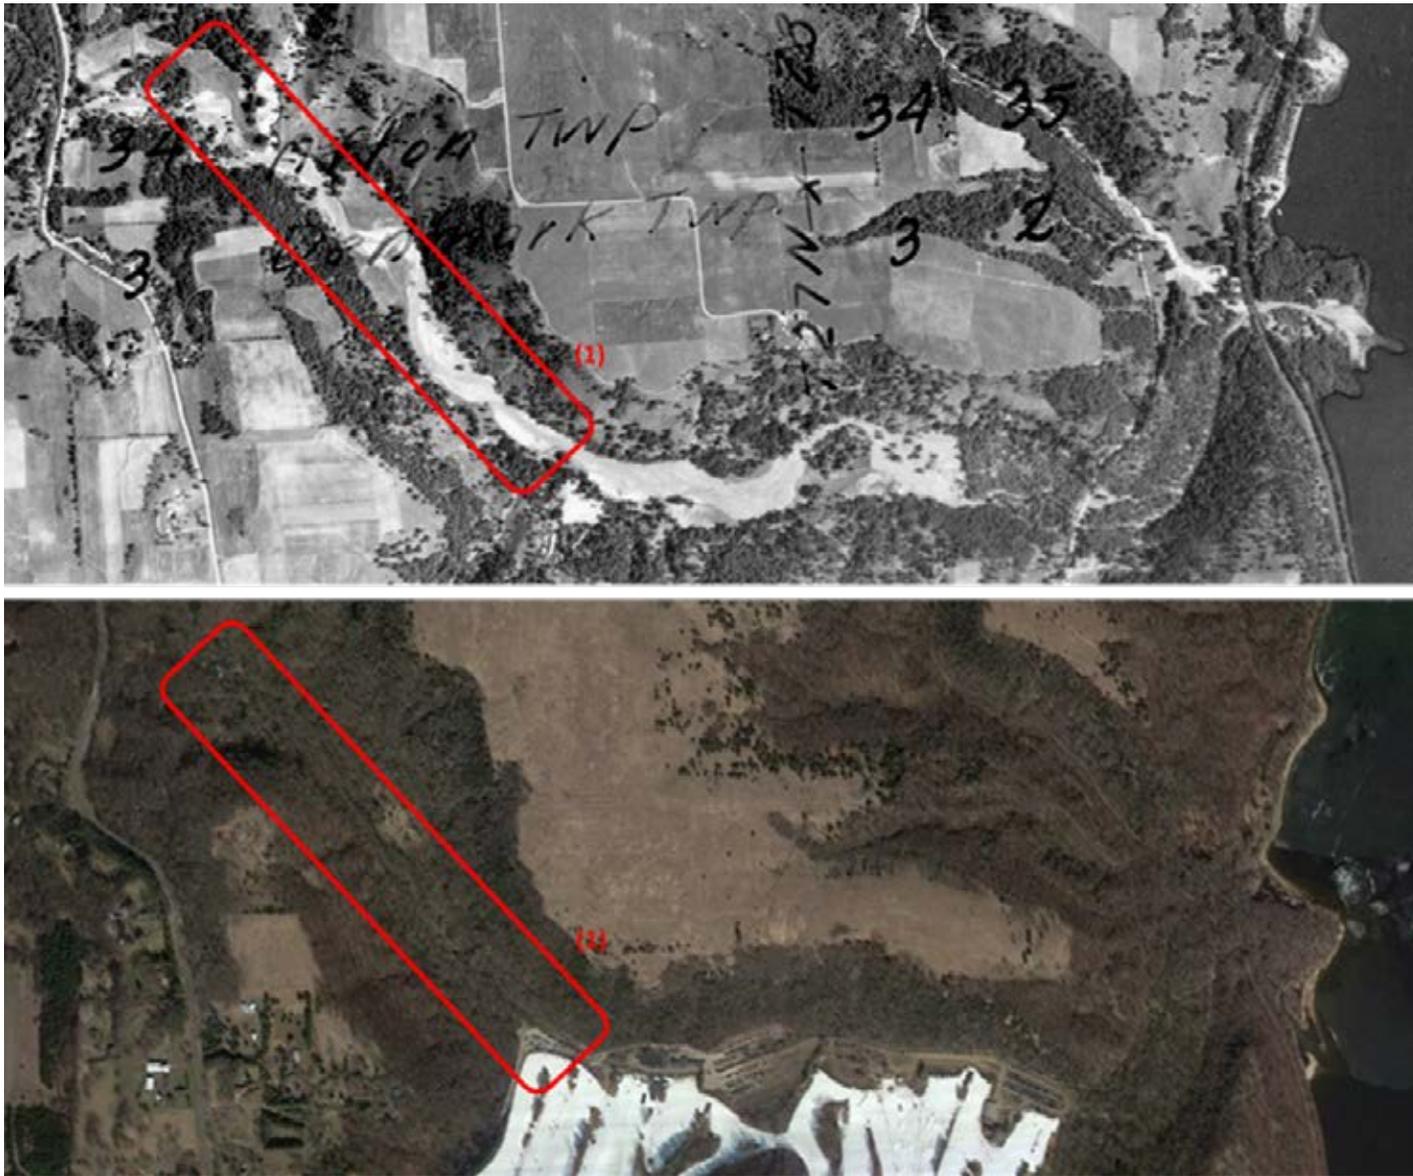
Figure 39-2 Aerial Photo comparison of 1938 imagery (upper) and 2016 imagery (lower). Note lateral instability and aggradation of project area (1) apparent 1938 photograph.

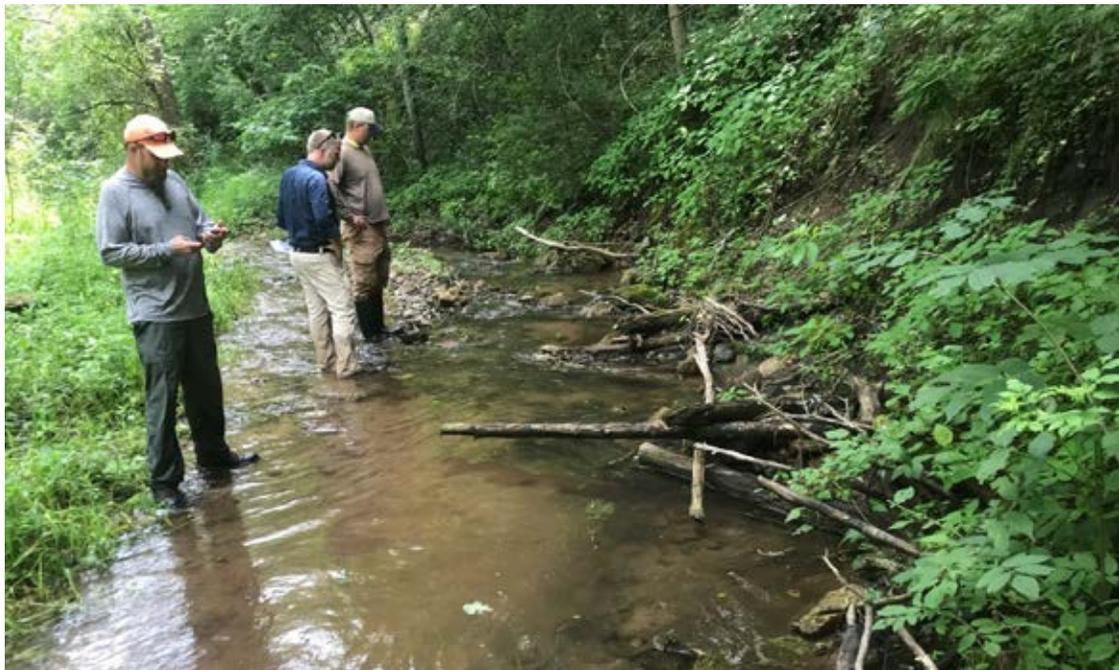
Photo 39-4 Photograph of Toewood Stabilization (right side of photo) constructed by hand labor. Structure has degraded substantially in 4 to 5 years since installation but is still provide some habitat and stability benefit. Photograph taken by Kevin Biehn during 7/18/2019 site visit.
