Minnesota Department of Natural Resources Minnesota Board of Water and Soil Resources

Appendix A: 2020 Legacy Fund Restoration Evaluation Report

April 2020

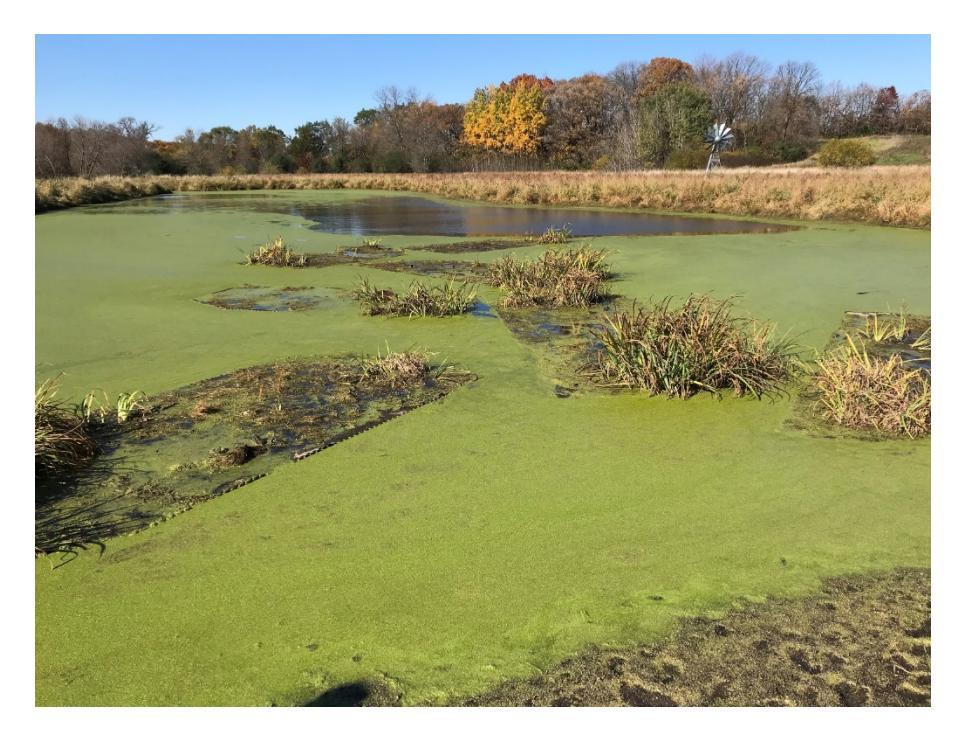
Photo 10-1 Excavated pond, floating mats, and windmill aerator in the background (note the dense population of lesser duckweed on the water surface). Photo taken during site visit on 10/13/2020.

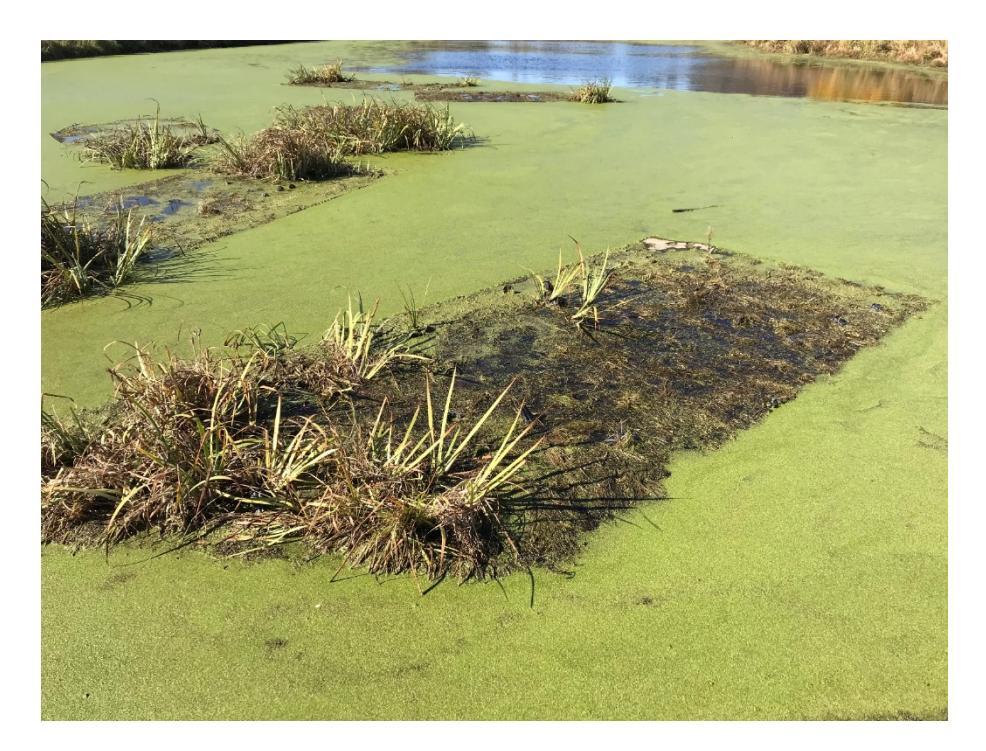
Photo 10-2 Close-up of a floating mat showing denuded/ failed vegetation and clumps of northern blue flag. Photo taken during site visit on 10/13/2020.

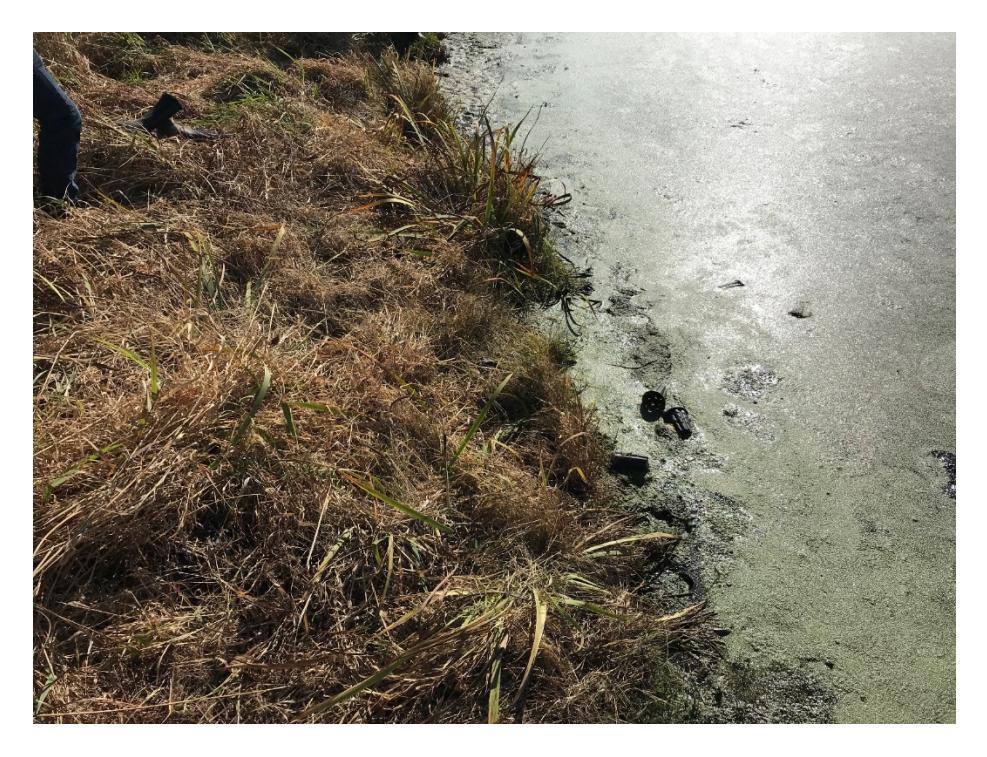
Photo 10-3 Close-up of a floating mat that washed ashore in the excavated pond. The floating mat has become integrated into the shoreline vegetation of the pond. Photo taken during site visit on 10/13/20.

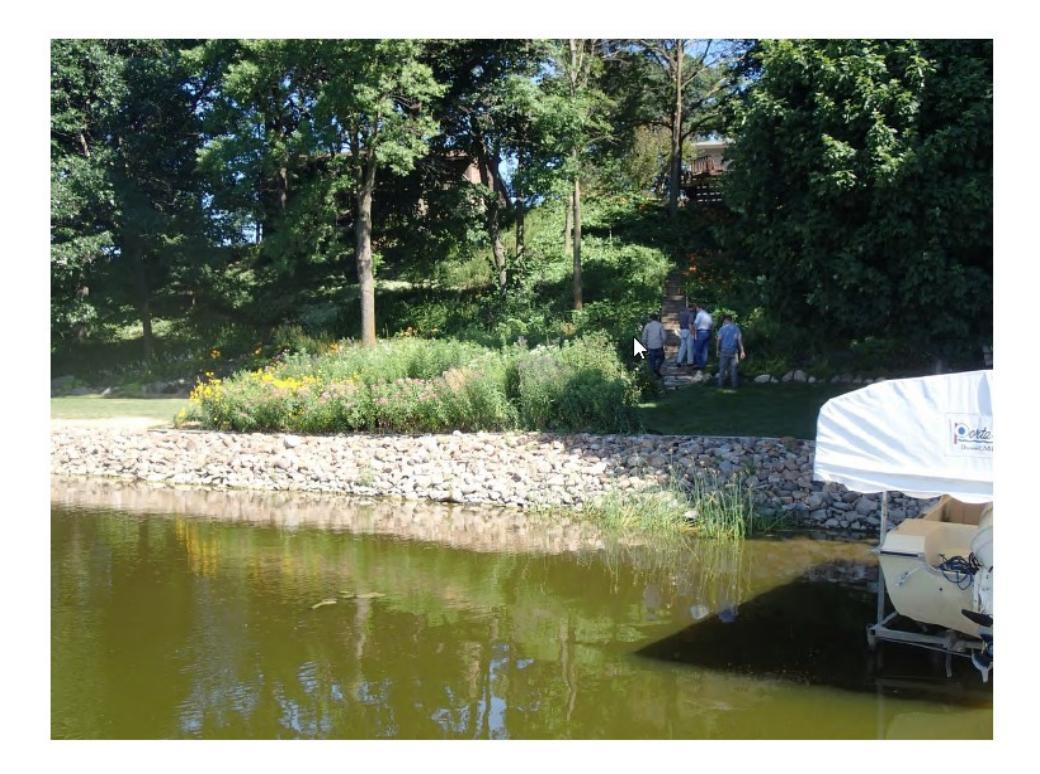
Photo 11-4 Site photo from July 2013 showing the location of the rain garden/ native planting buffer that has since been removed and replaced by turfgrass.

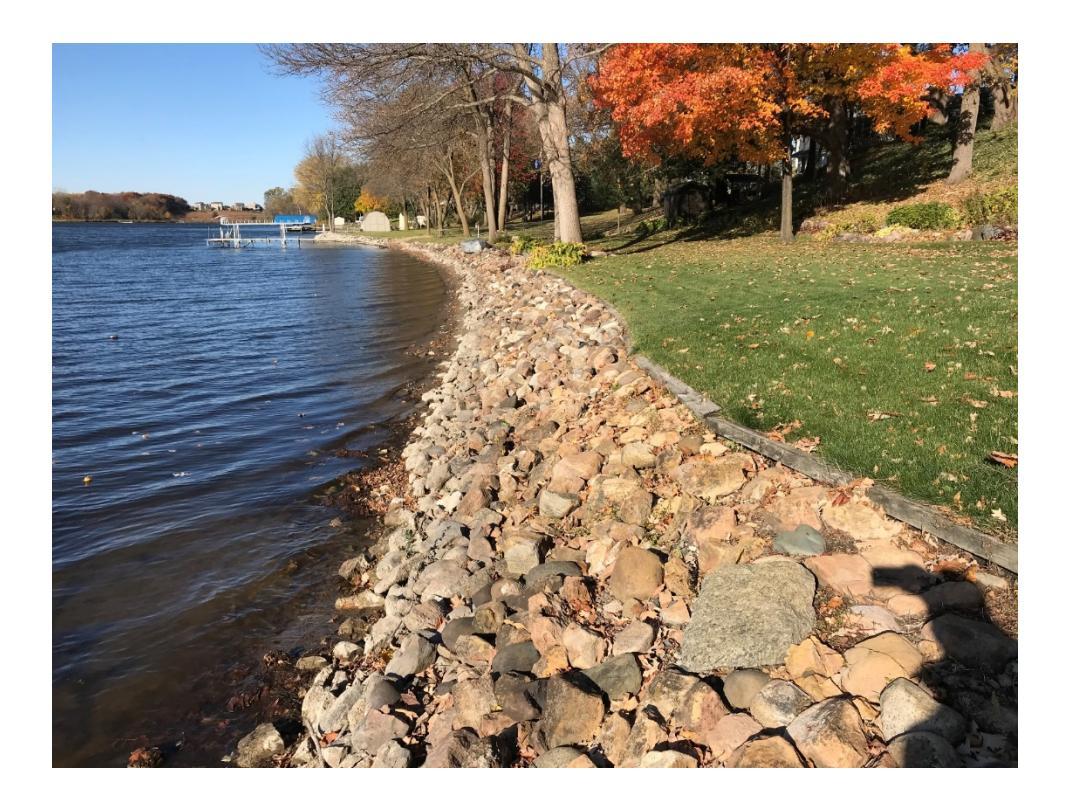
Photo 11-5 Reitz Lake shoreline with turfgrass that replaced a rain garden/ native planting buffer originally installed at the top of the bank. Refer to Figure 11-5 above for comparison. Photo taken during site visit 10/13/2020.

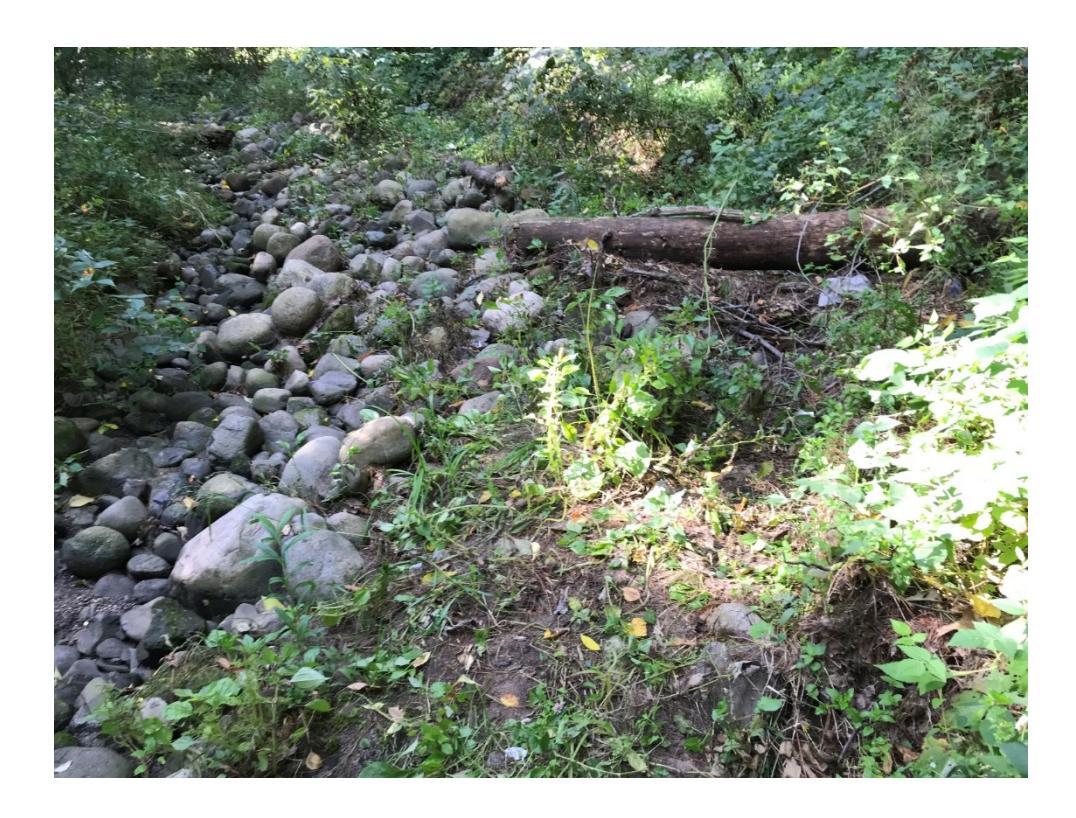
Photo 12-4 Mora ravine stabilization. Floodplain erosion was observed in areas where flows occurred above the installed boulders. Down woody debris has captured sediment along the toe. Photo taken during site visit 09/16/2020.

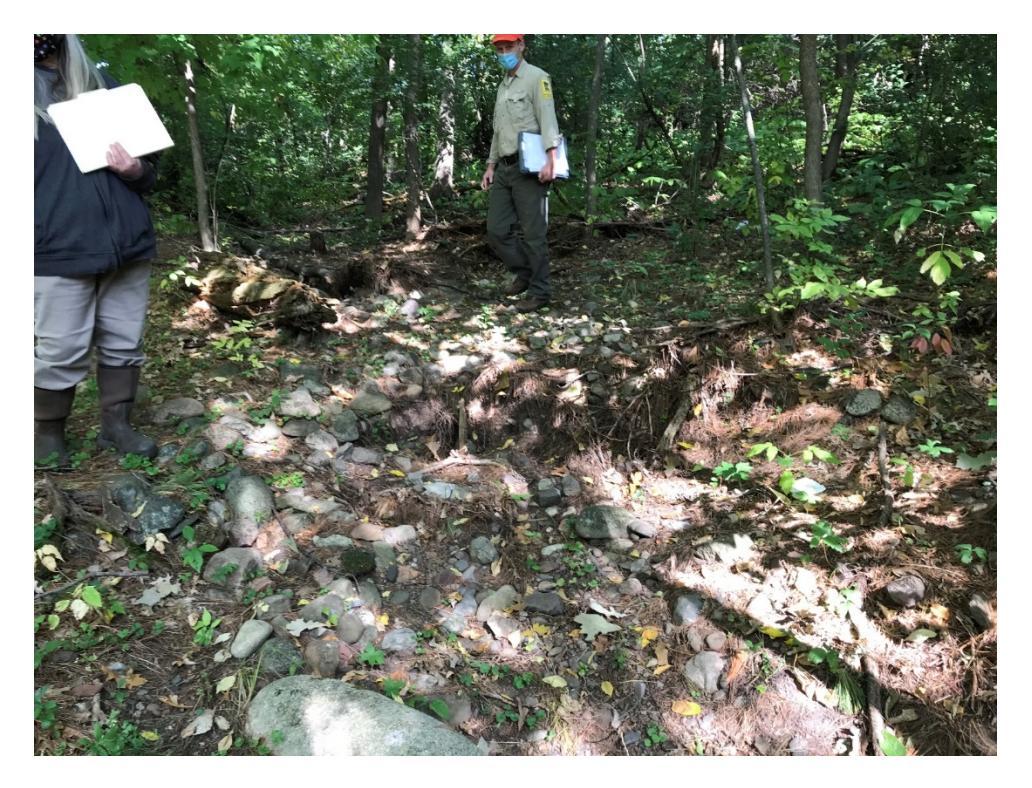
Photo 12-5 Mora ravine stabilization. This is the upstream end of the project site where field stone boulders were installed. A headcut occurs immediately upstream of the project site. Photo taken during site visit 09/16/2020.

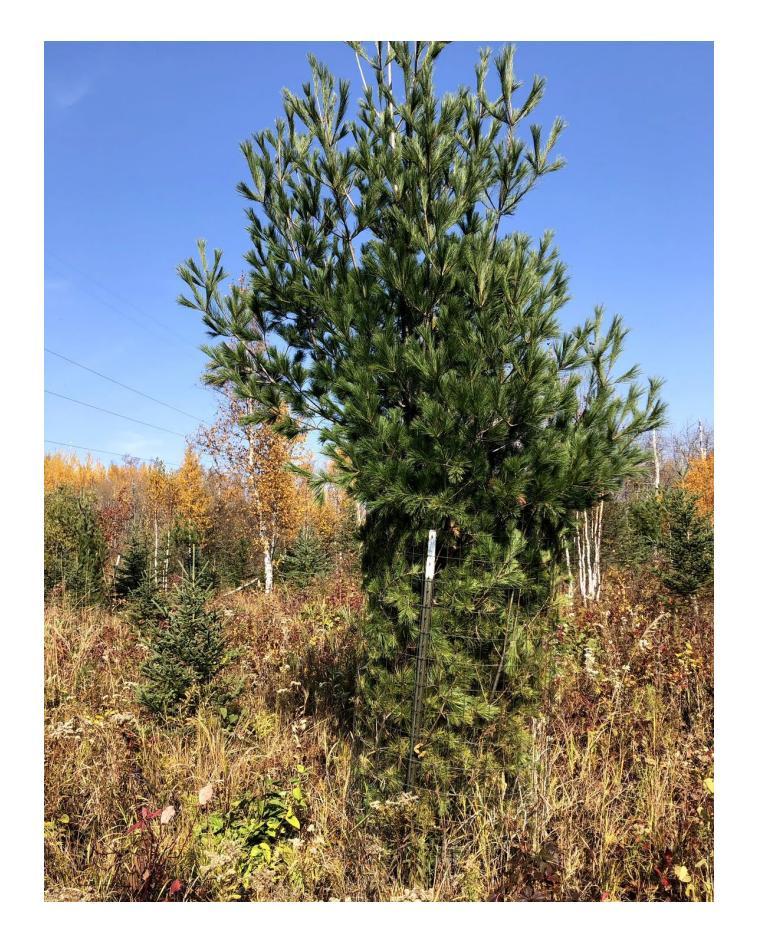
Photo 20-1 White pine on the Wolf Ridge site in need of pruning and removal of tree cage.

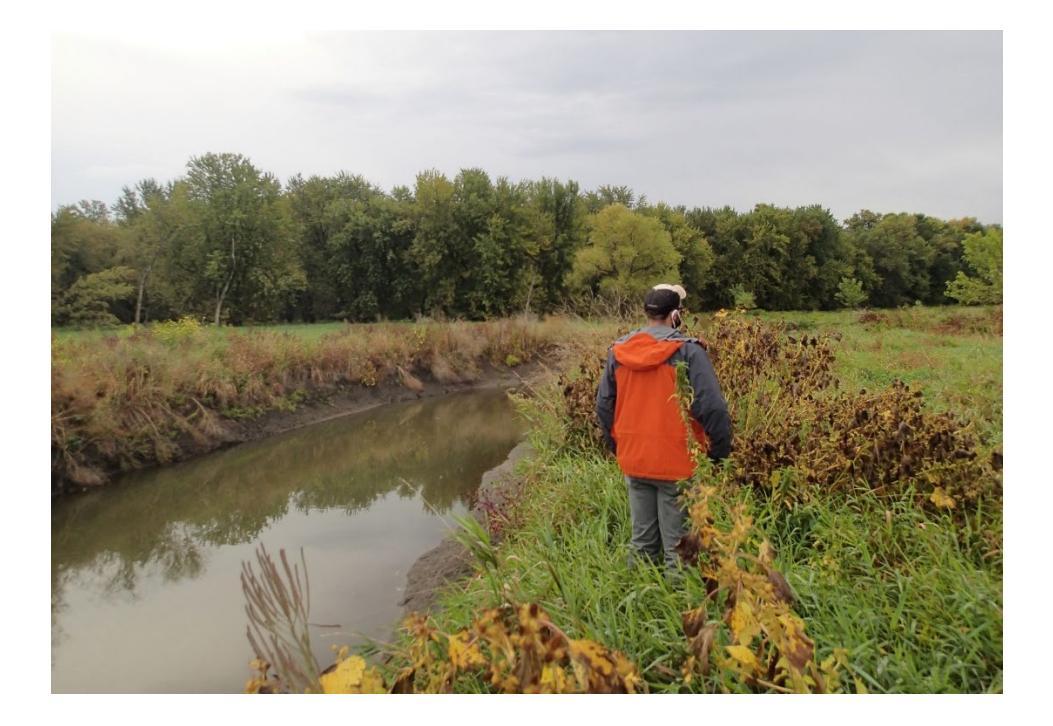
Photo 22-4 Representative condition of the channel streambank that bisects the site. Photo from site visit September 24, 2020.

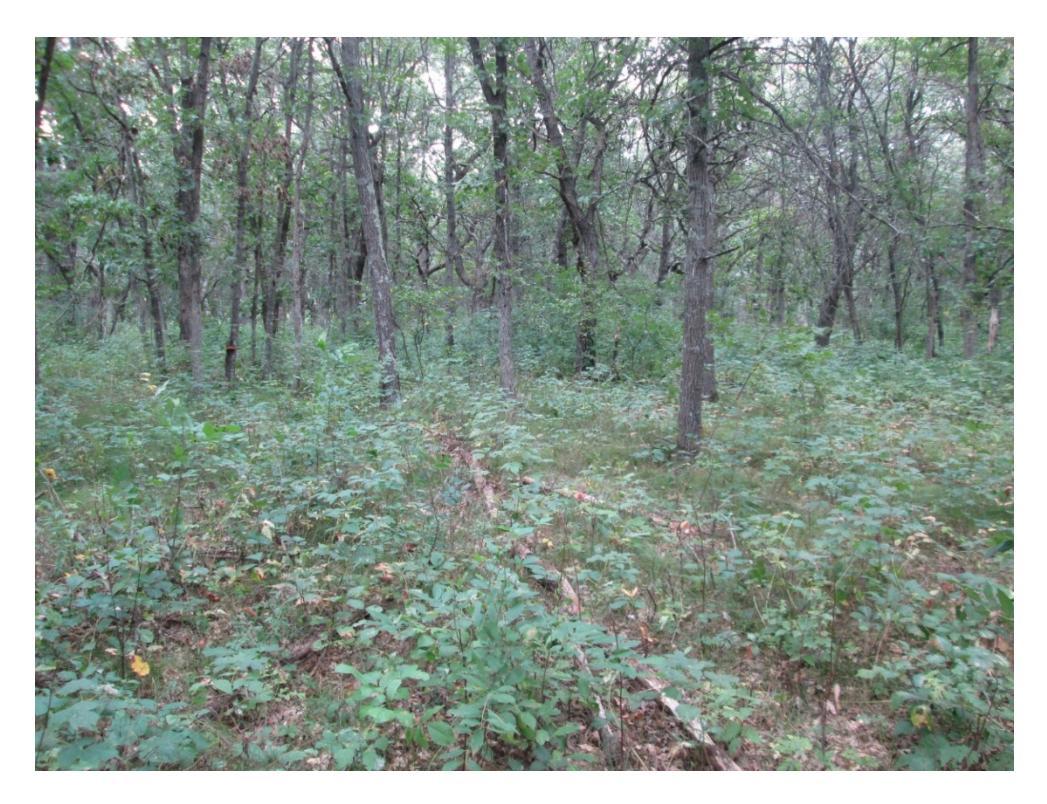
Photo 24-3 Showing the condition of the site in August of 2016. The brush is showing signs of regrowth. (photo taken 8/24/16)

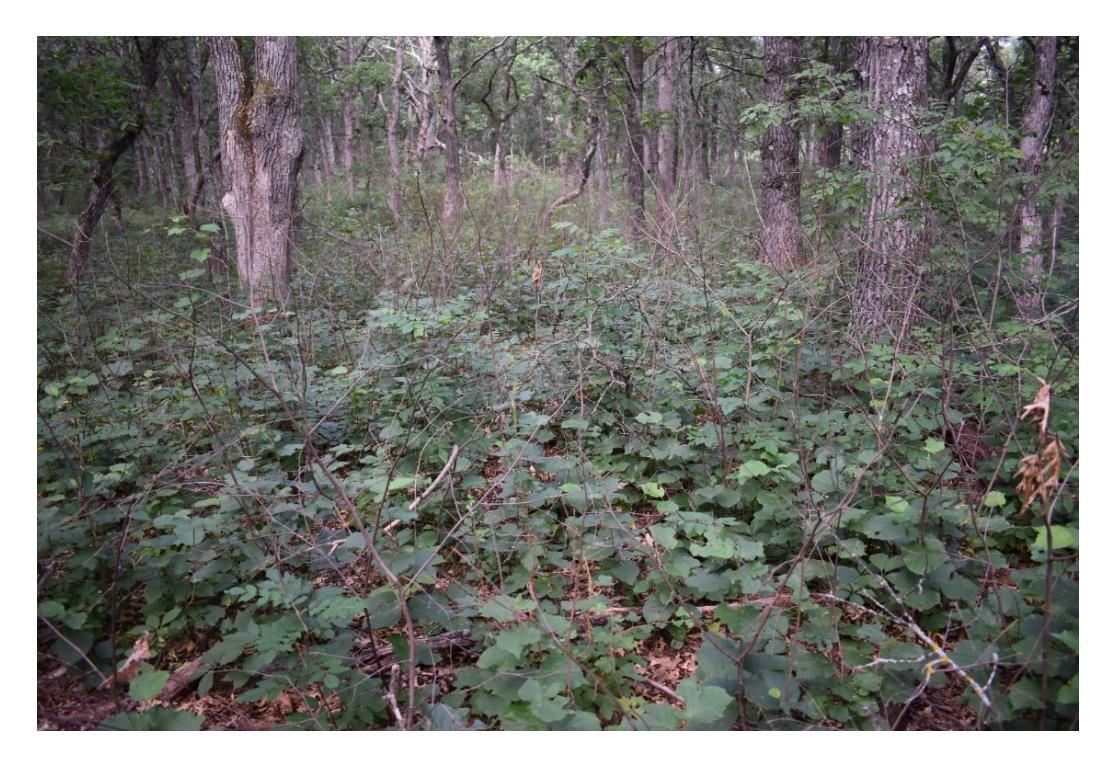
Photo 24-6 As can be seen above, the woody brush was effectively top-killed by the prescribed fire treatment. (photo taken 8/3/20)

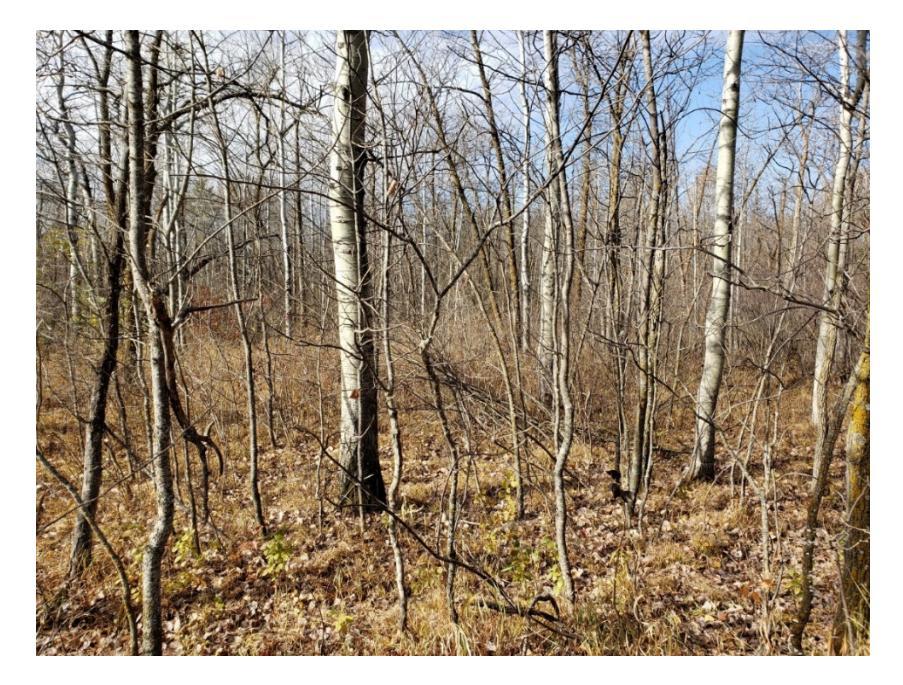
Photo 29-4. Example of the adjacent area with the management unit where buckthorn was not present prior to logging. In the near future, buckthorn may become established in the understory. (Thief Lake Wildlife Management Area, photo taken during site visit 10/15/2020 by Mark Pranckus, Cardno).

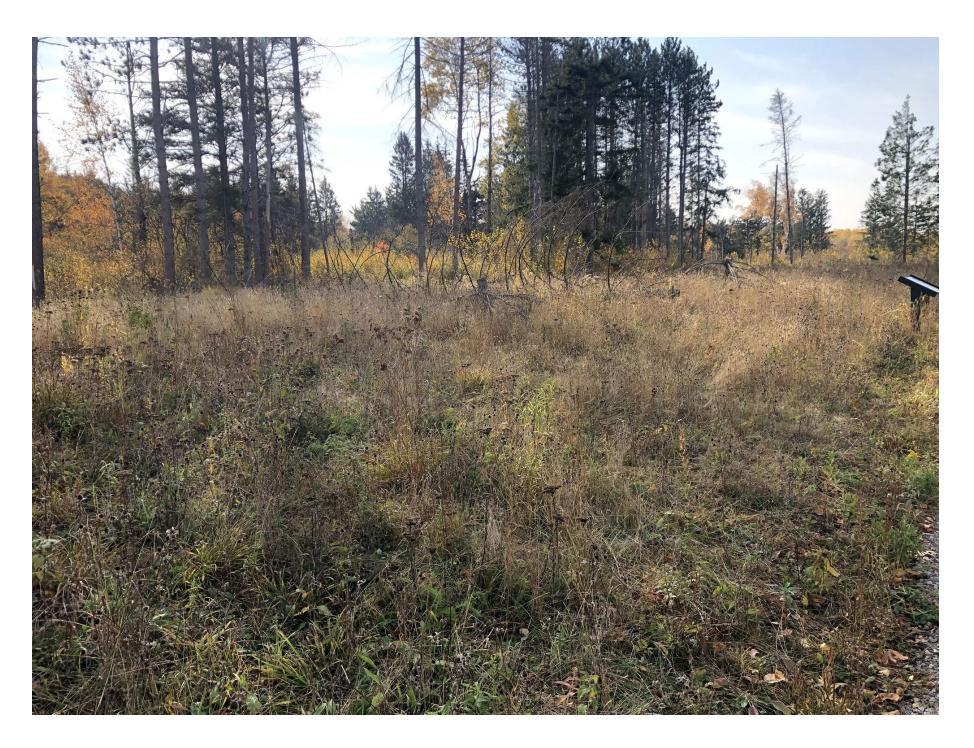
Photo 33-1 Prairie restoration area of Hartley Park October 2020. Buckthorn management practices have been fairly successful at this location, with very few seedlings present and less than 5% cover of Buckthorn. This area was planted with a native seed mix after the removal of the buckthorn. The native seed mix appears to have reduced the amount of buckthorn revegetation.
