ZUMBRO LAKE DAM Wabasha County, Minnesola Inventory no 358

INSPECTION REPORT

DEPARTMENT OF THE ARMY ST. PAUL DISTRICT, CORPS OF ENGINEERS ST. PAUL, MINNESOTA

SEPTEMBER 1979

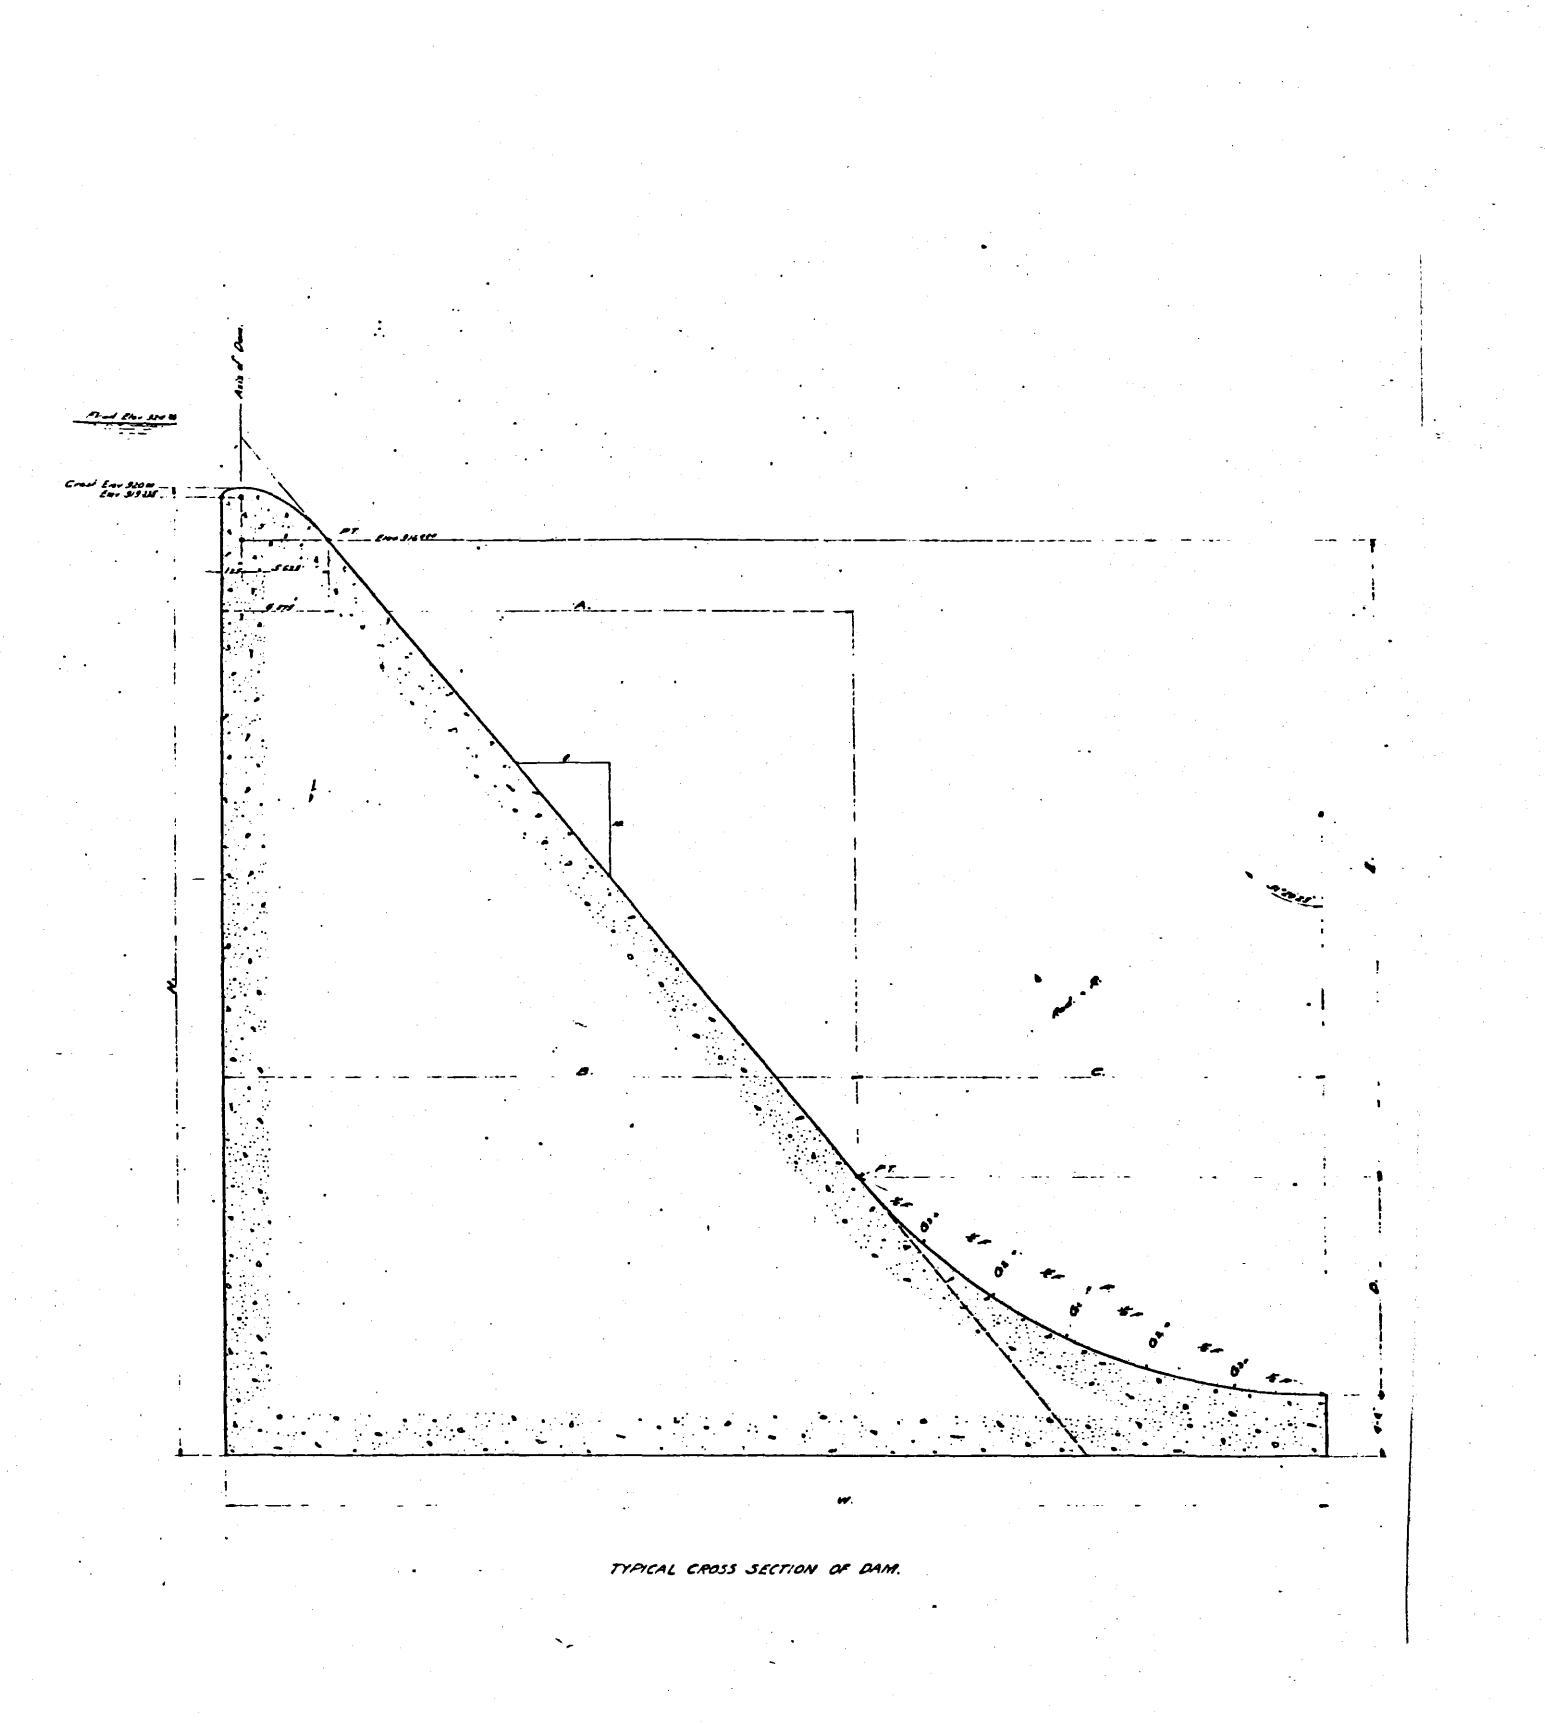
TYPICAL SECTION

The spillway, ranging in heights from 43 to 55 feet, is an uncontrolled overflow ogee spillway constructed of mass concrete. The spillway is abutted on the right by a concrete abutment wall and on the left by the powerhouse. An ice chute is located on the spillway adjacent to the powerhouse. The ice chute gate appears to be in fair condition; however, it has reportedly not been operated in recent years. A typical spillway section is presented as Plate 1-3.
