MINNESOTA STATE OFFICE BUILDING

ISSUES AND VULNERABILITIES

State Office Building Facility Condition Assessment

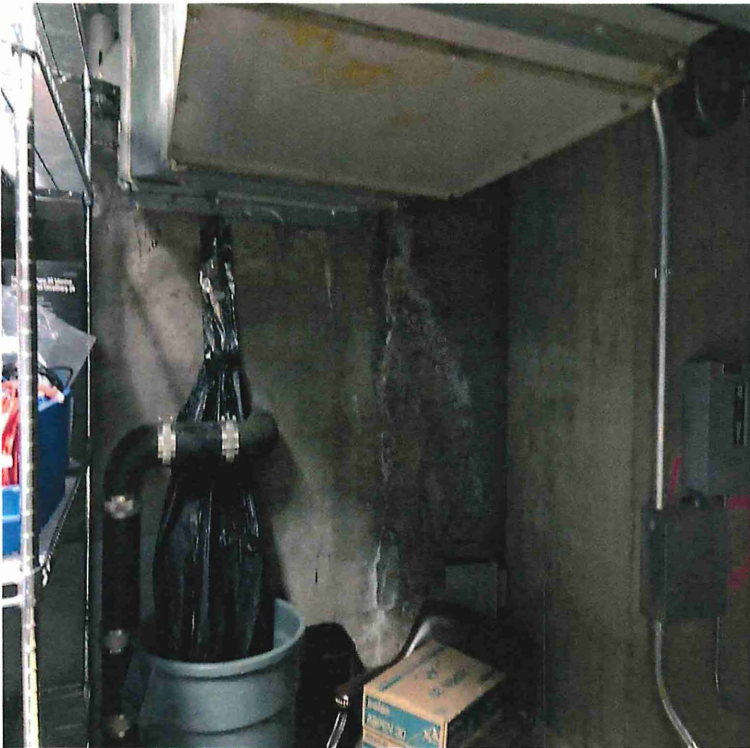
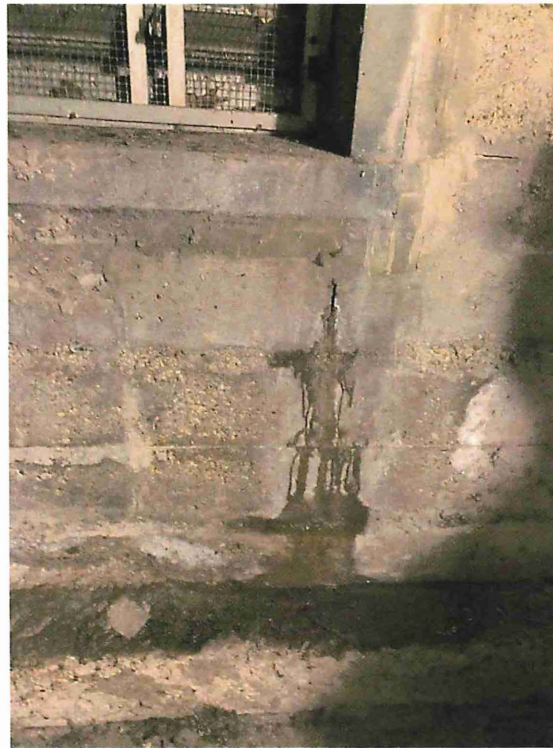
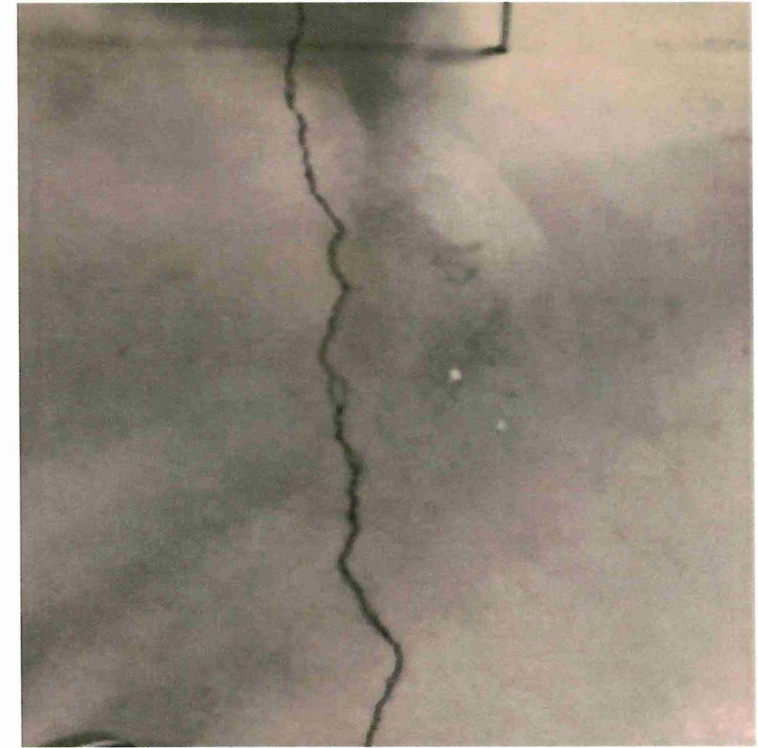
Slab & Basement Walls

Fair

Stress Cracks, Leakage

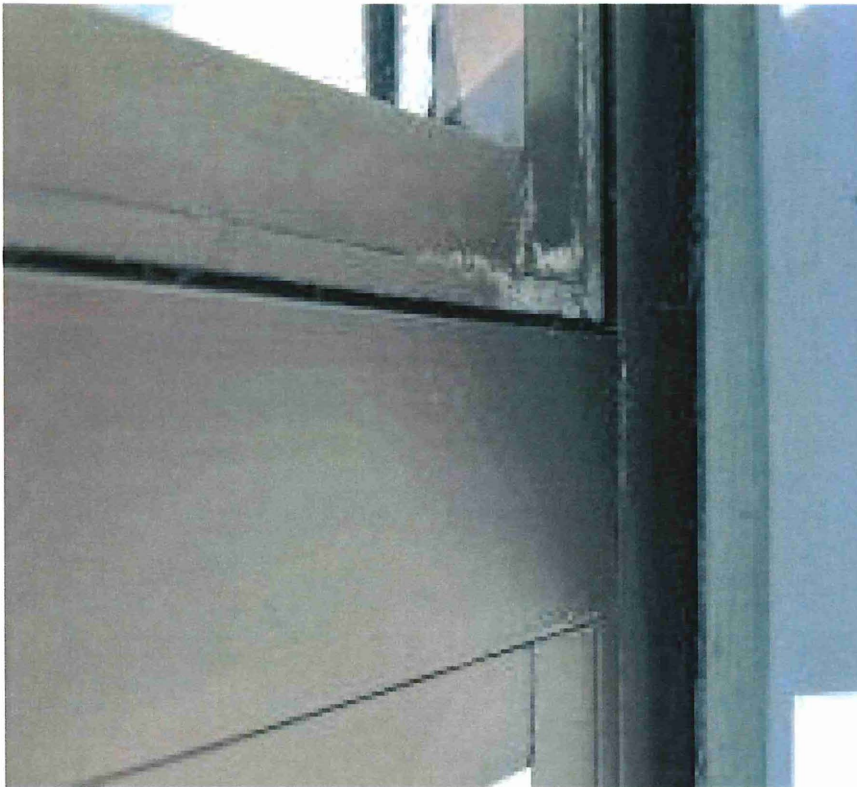
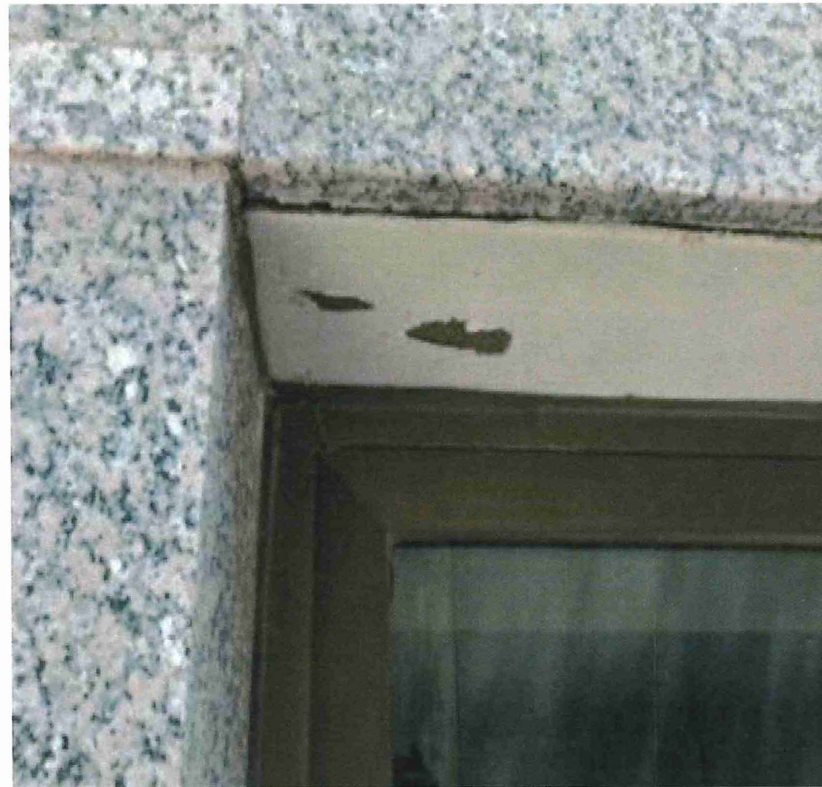
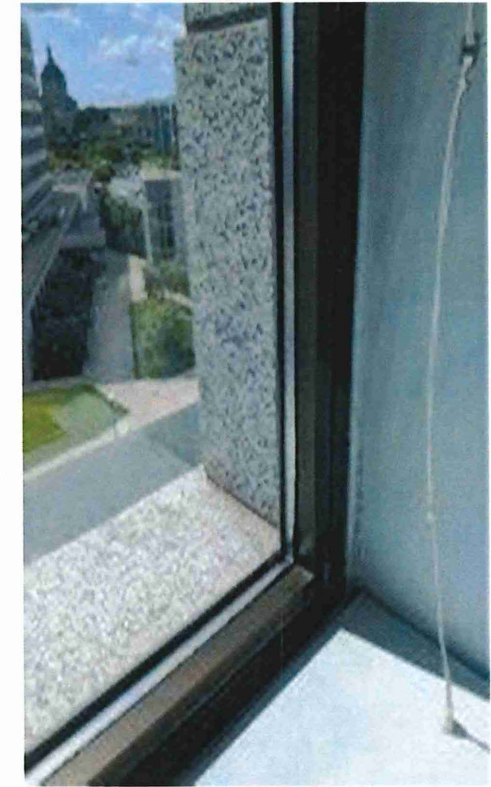
Exterior Windows

Poor

Age, Lintels Corroding, Thermal Breaks Failing, Energy Inefficient

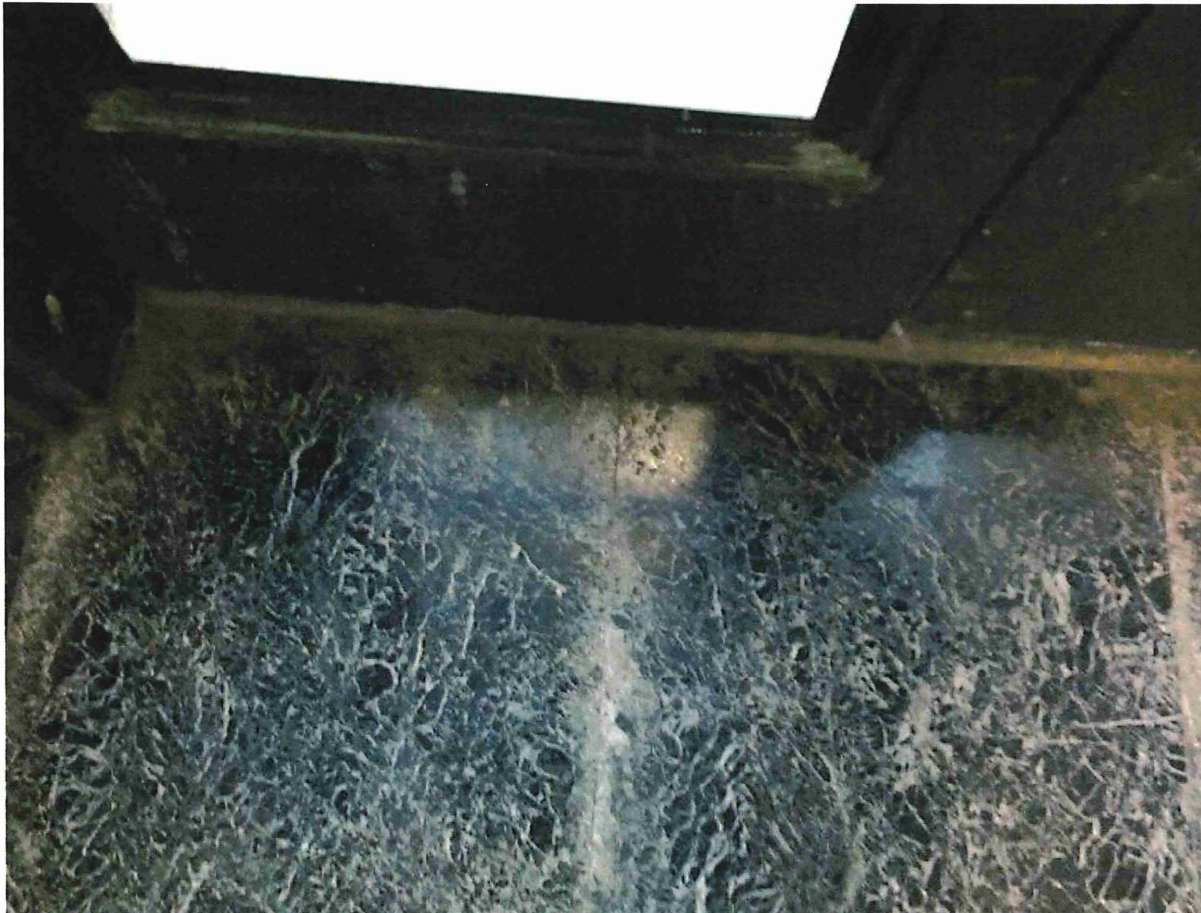
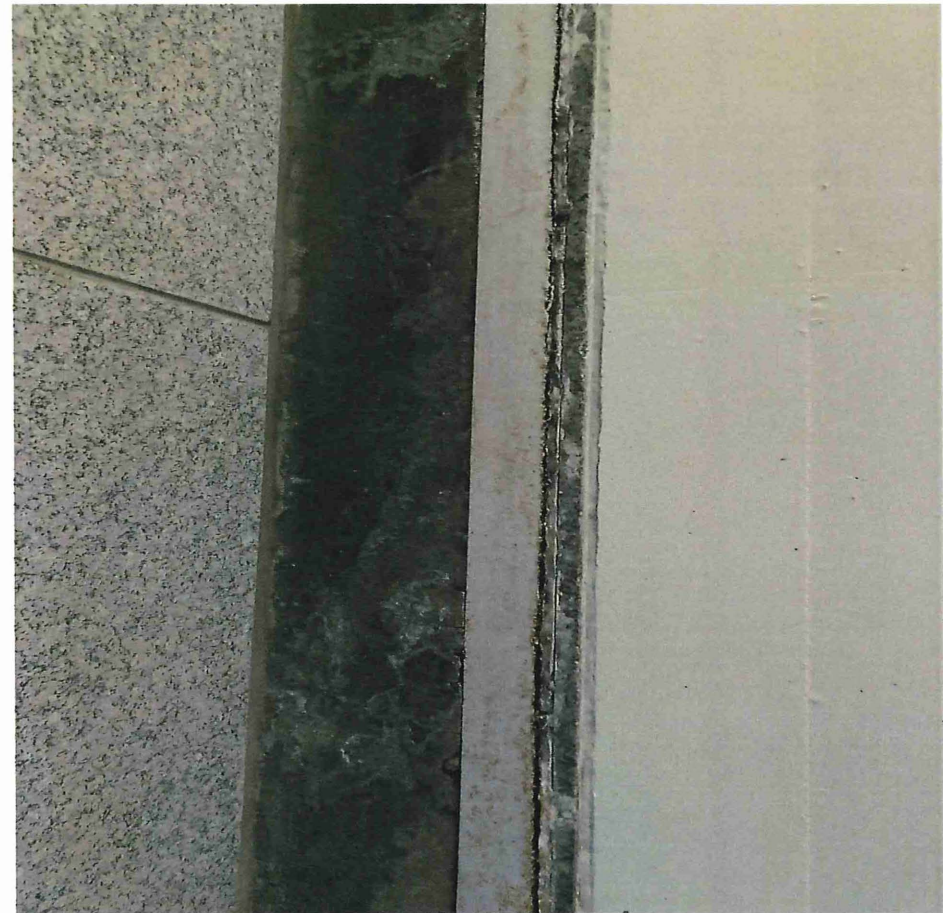
Exterior Doors

Fair

Age Seals Failing, Frames Rusting, Energy Inefficient

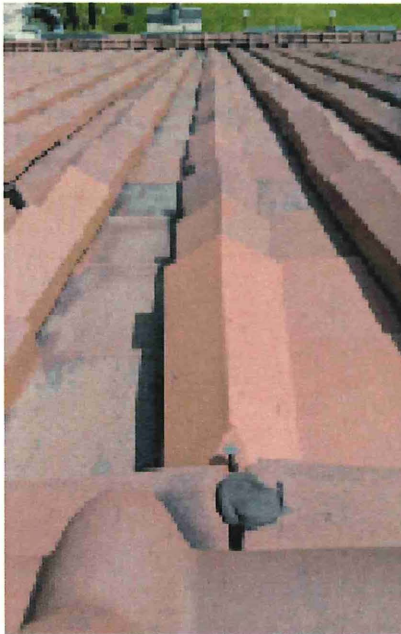
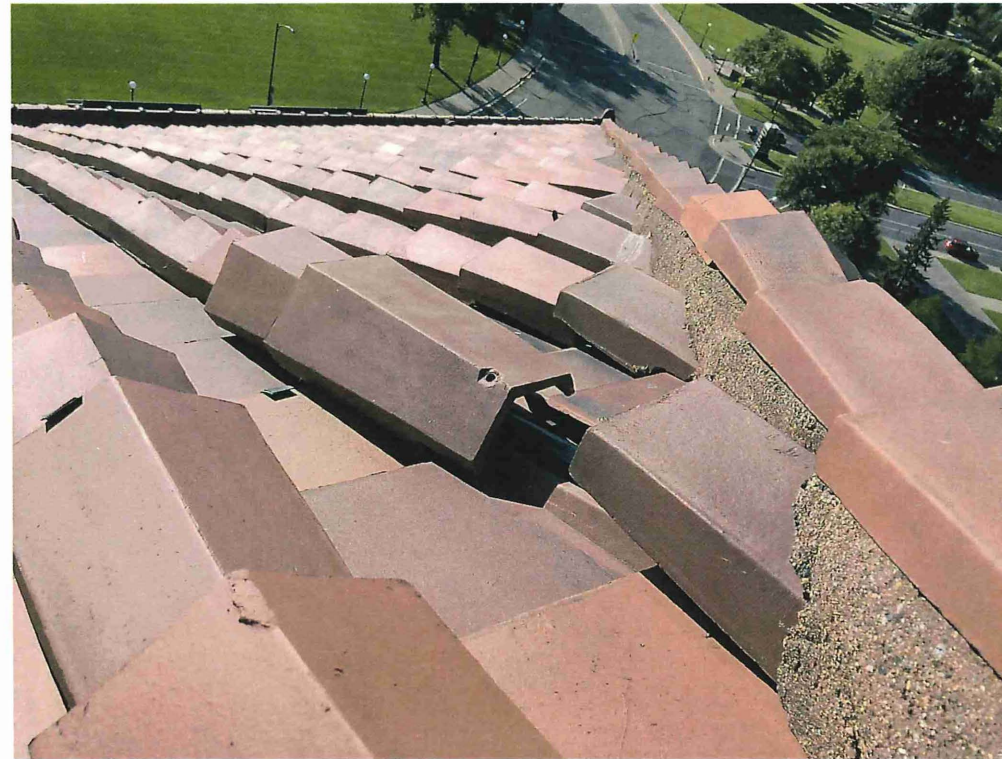
Roof Covering (Includes Drainage System)

Poor

Overall Age of Roofing System, Areas of Cracked Terra Cotta Tile, Missing Nails, Leaks in Various Locations, Roof Trusses and Joists Structurally Sound

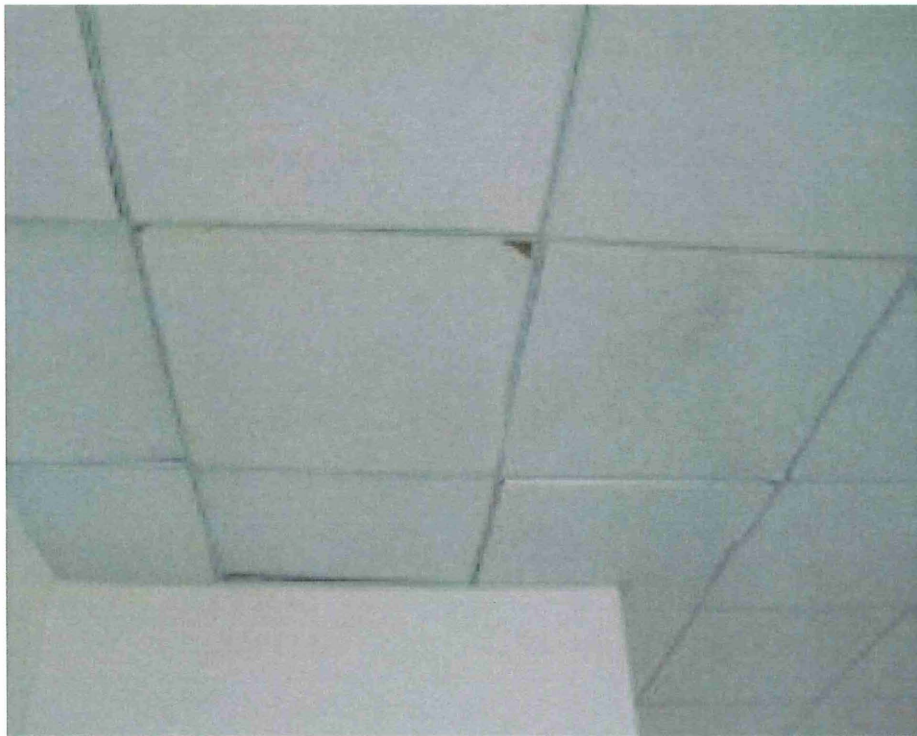
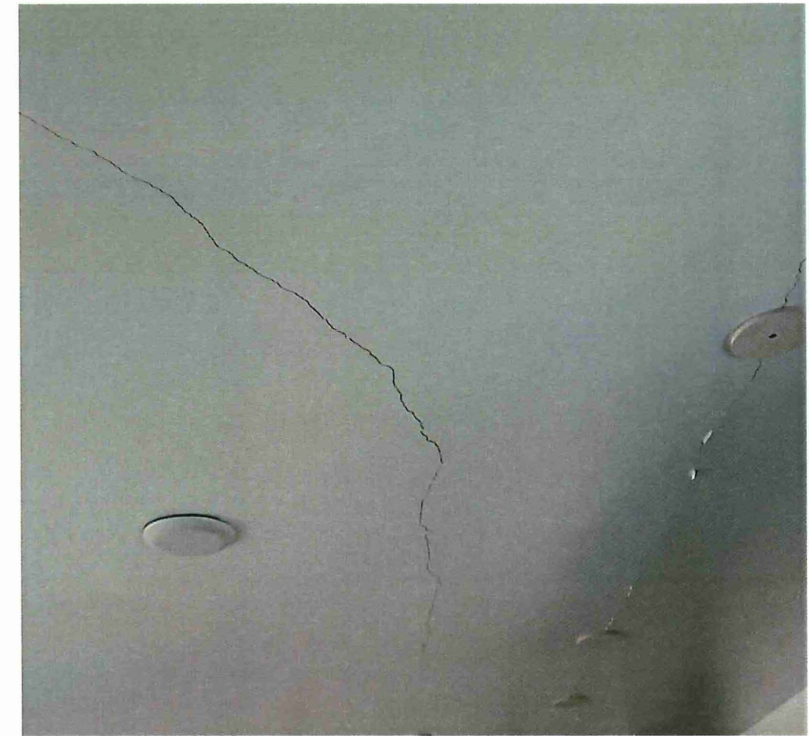
Ceilings

Fair

Age, Stains, Grime, Cracks

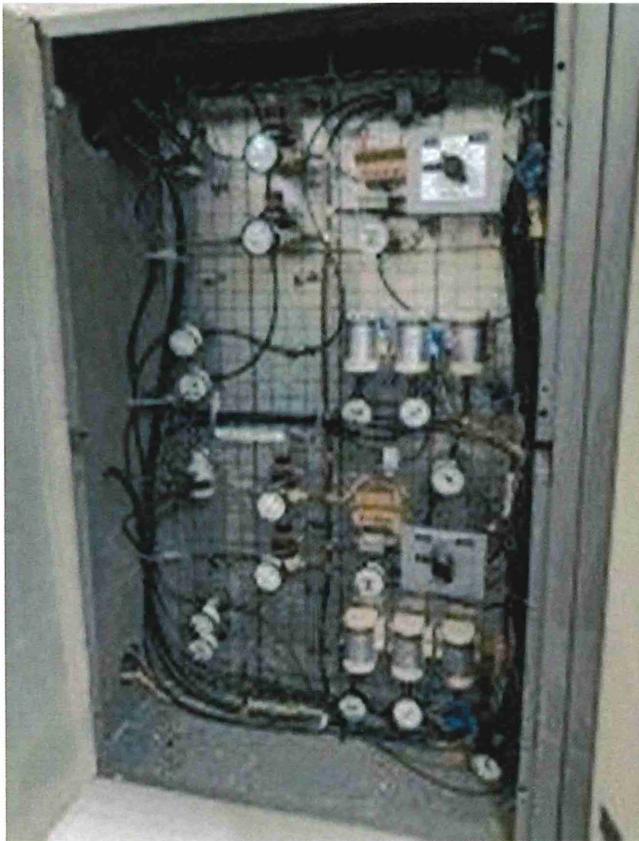
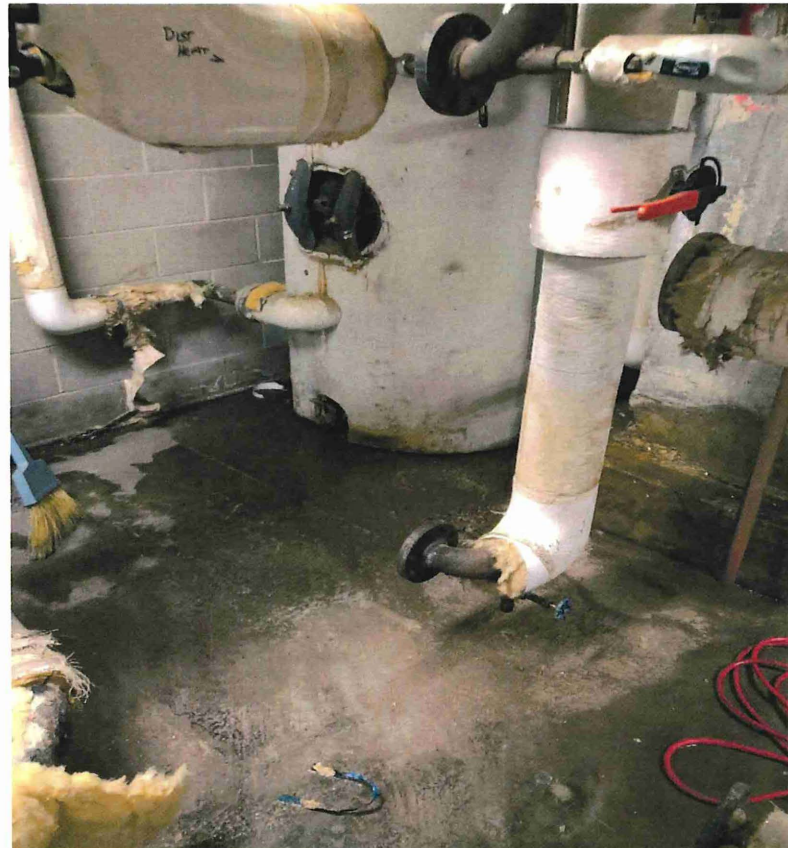
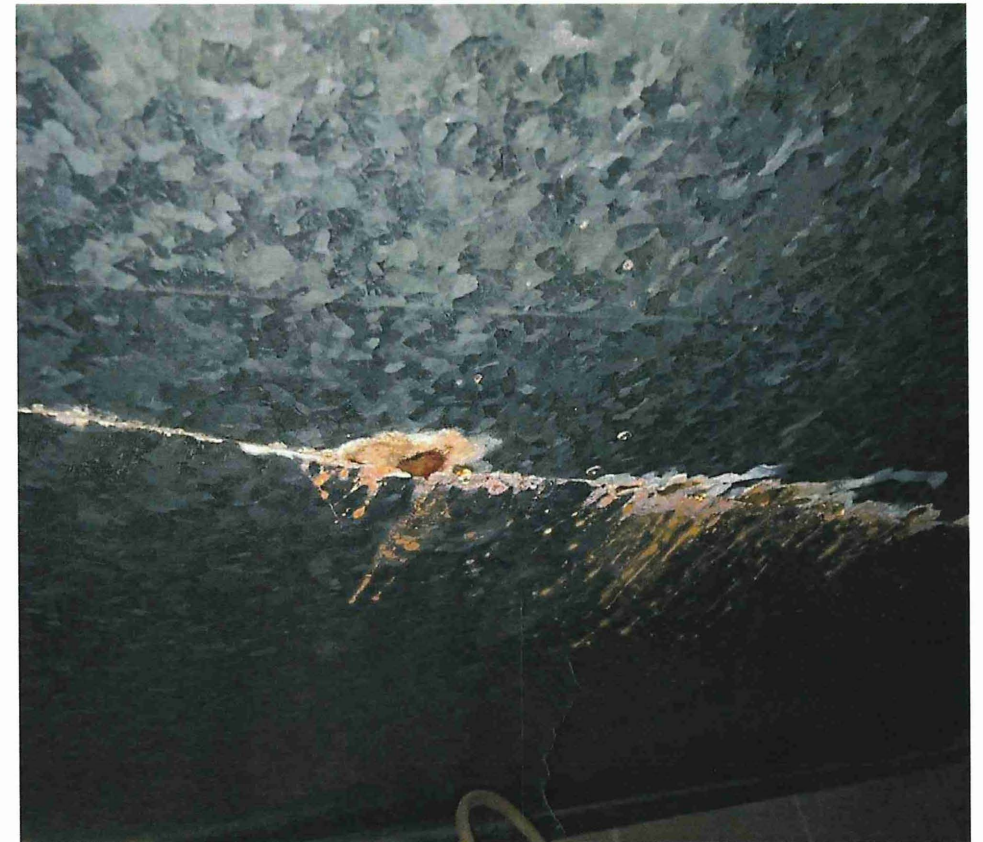
HVAC System (Controls & Distribution)

Poor

Piecemeal, Pneumatically Controlled, Pipe Connections Failing, Difficult to Maintain Constant Temps, Threat of Leaks

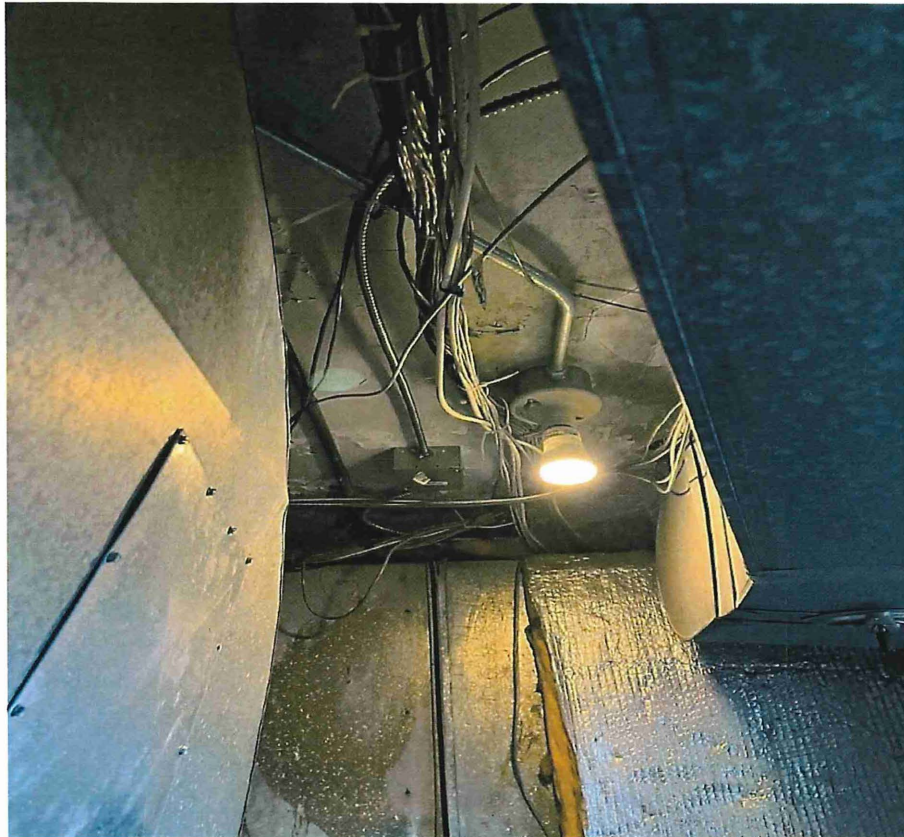
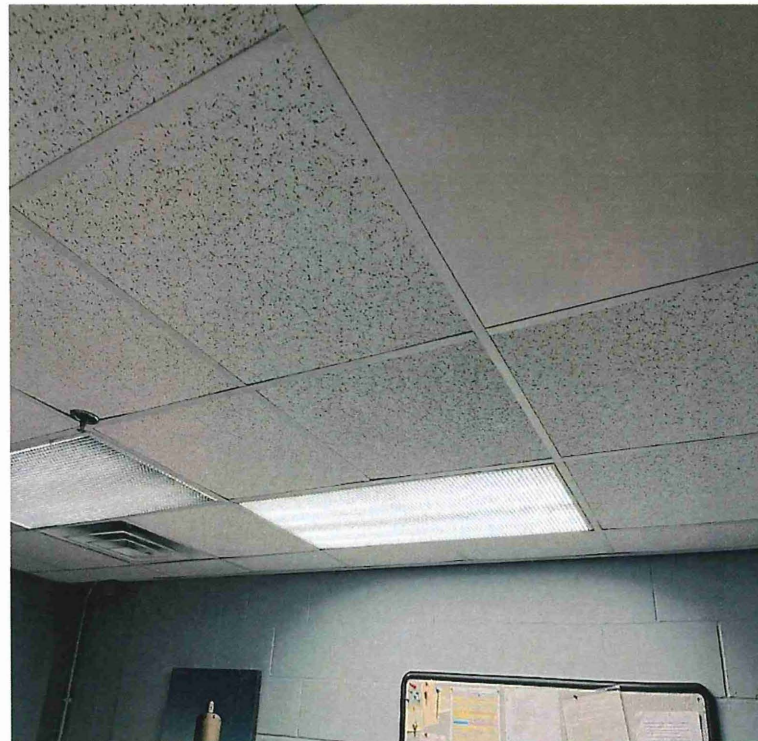
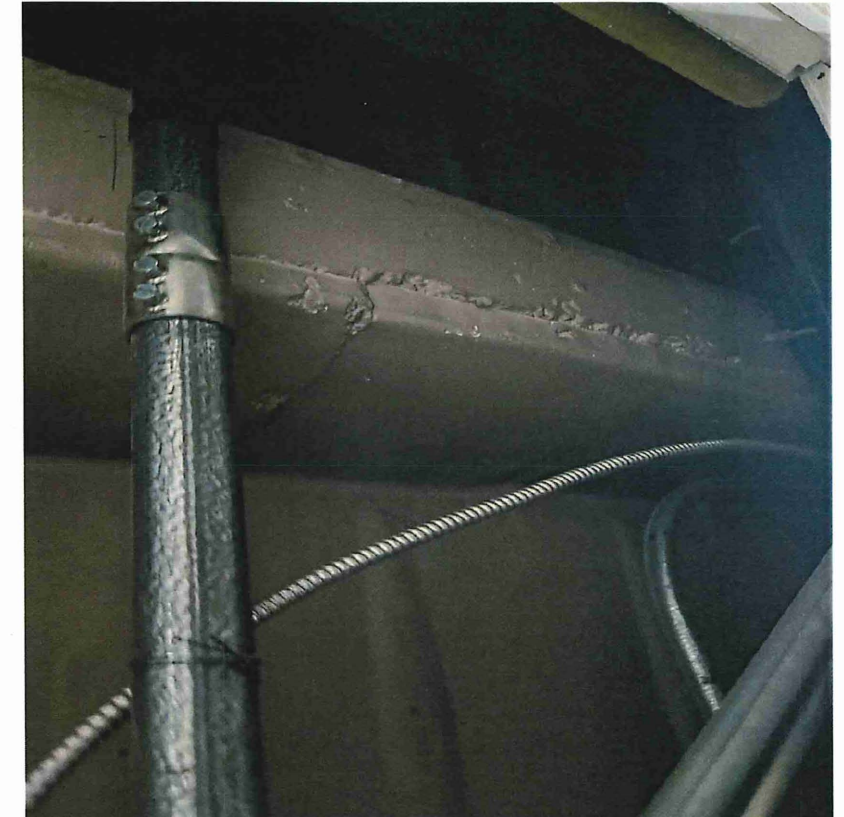
Electrical Systems & Lighting

Fair

Old, Undersized System, and Inefficient Lighting

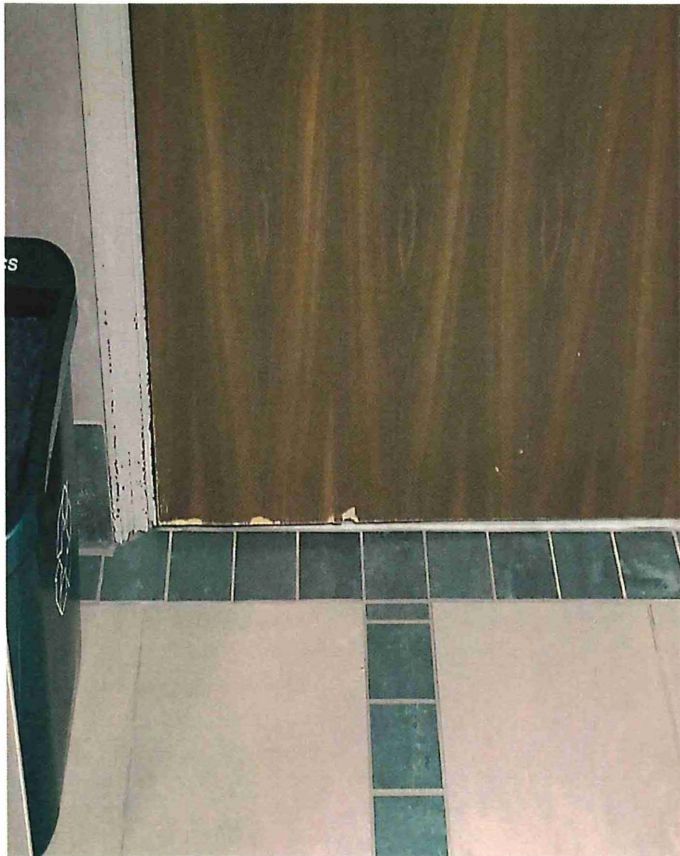
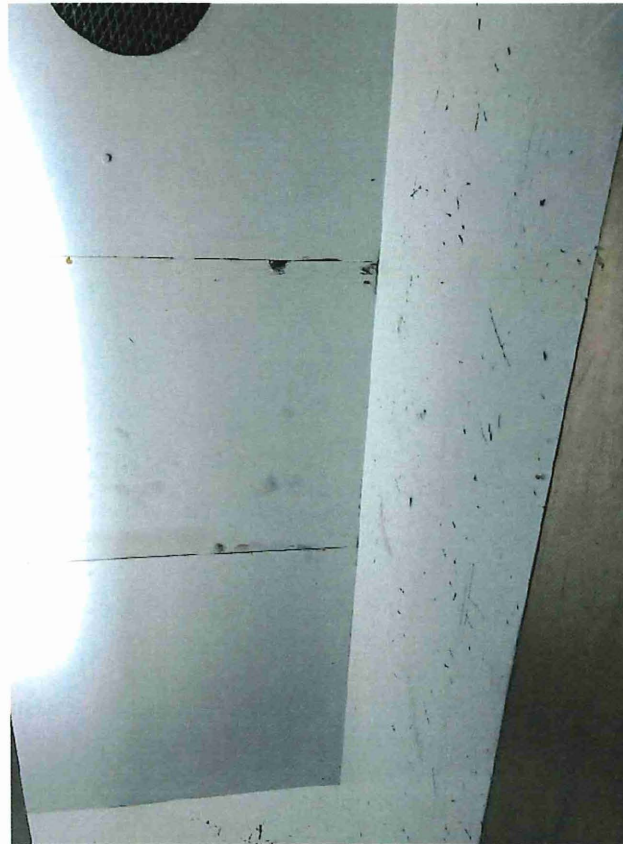
Interior Finishes

Fair

Age, Wear and Tear

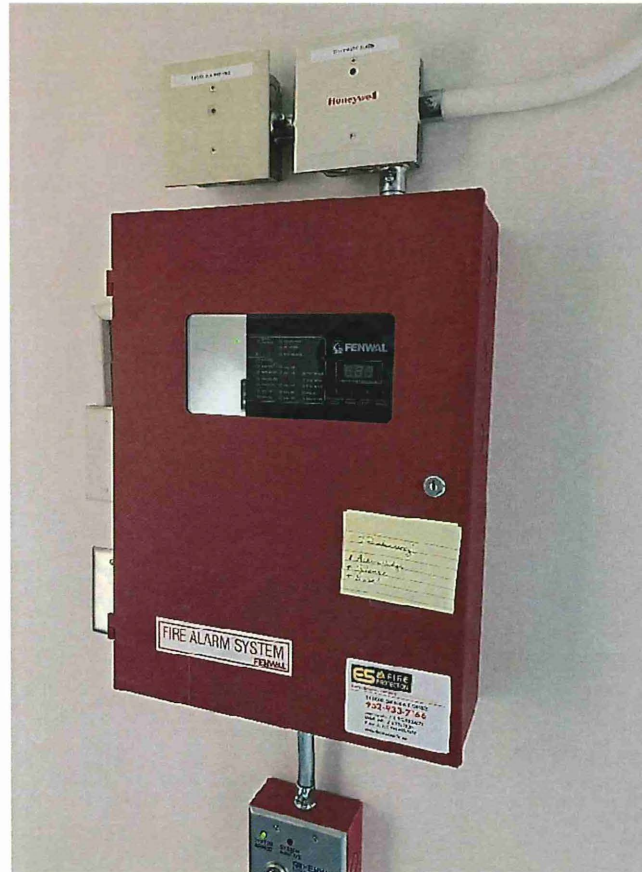
Fire Alarm System

Fair

Wiring and Field Devices Nearly 40 Years Old and Need Replacement

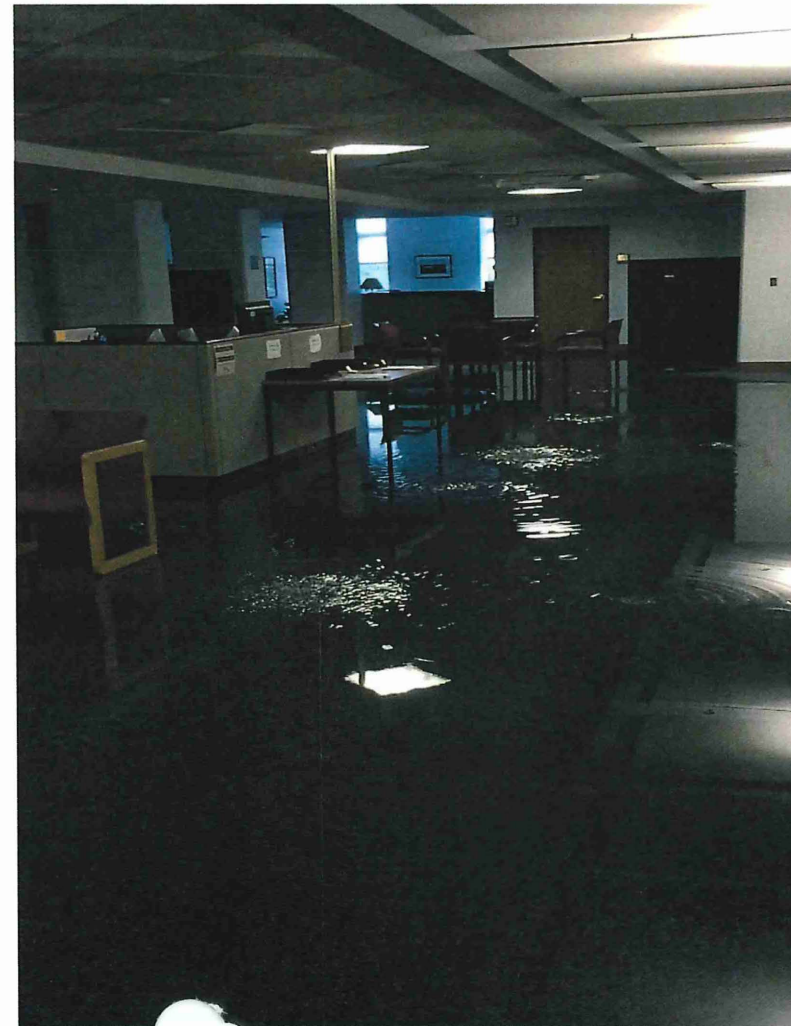
JUNE 2016

Broken element of the HVAC system resulted in flooding on six floors and required extensive remediation and repair.

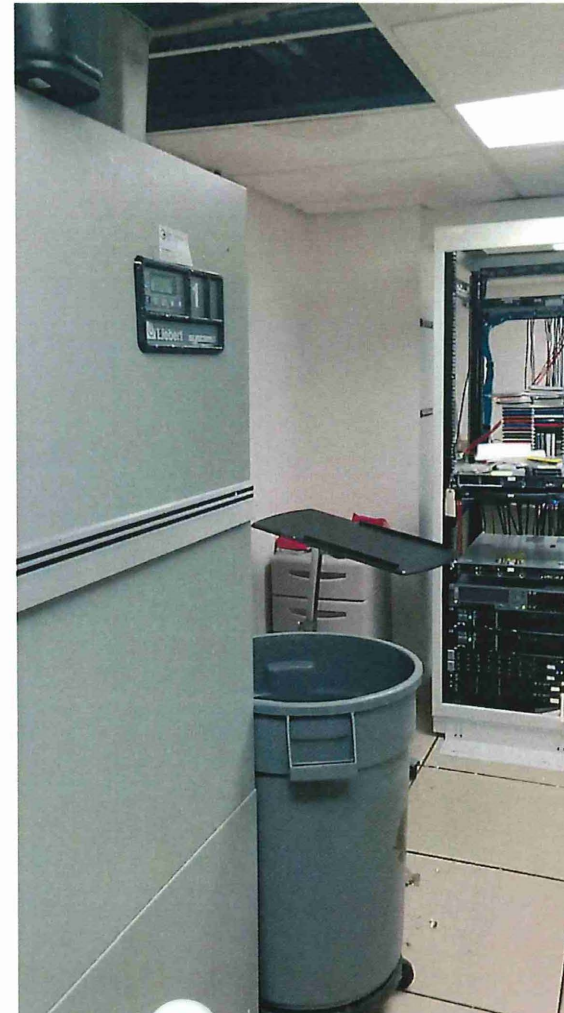
JUNE 2016

Broken element of the HVAC system resulted in flooding on six floors and required extensive remediation and repair.

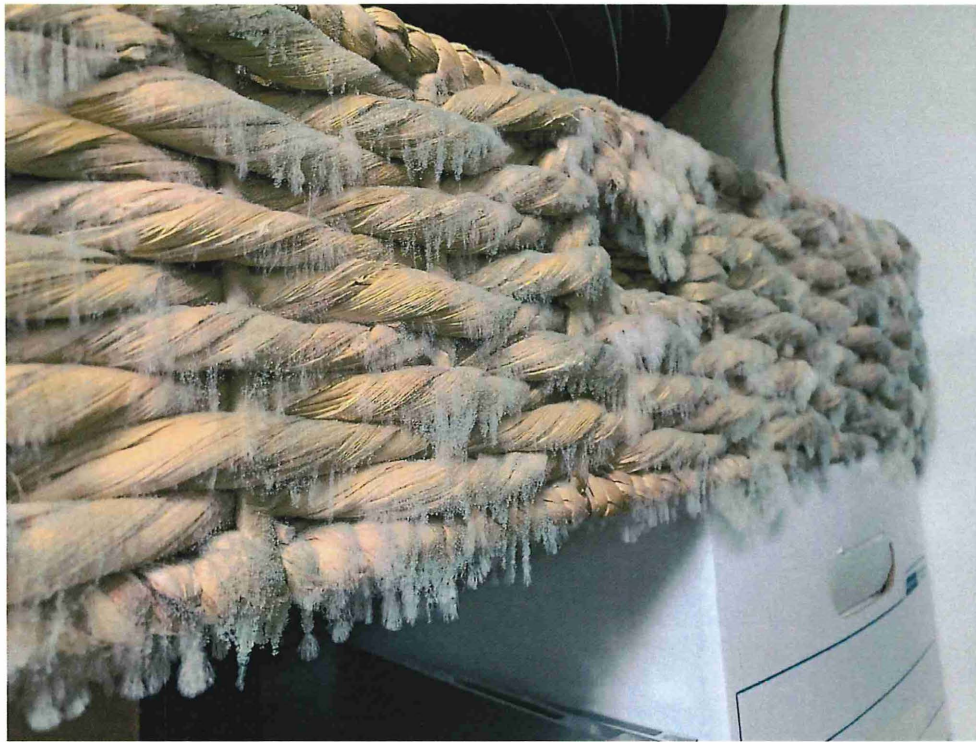
Mold growth in a basement area converted and used as staff office space with inadequate ventilation and high humidity levels

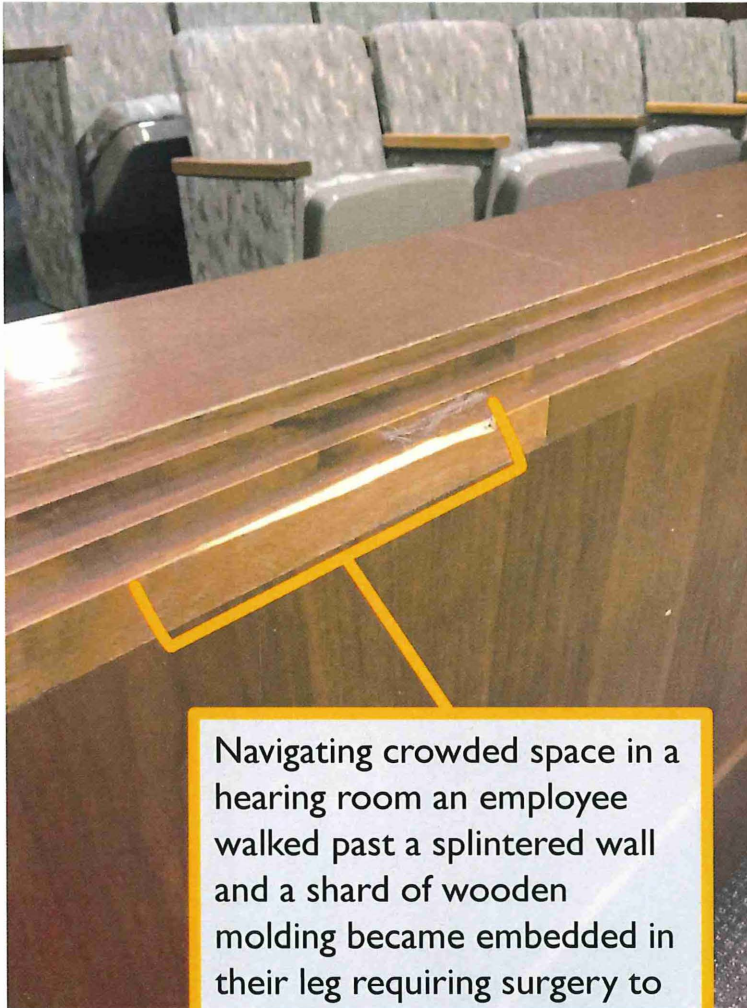
Navigating crowded space in a hearing room an employee walked past a splintered wall and a shard of wooden molding became embedded in their leg requiring surgery to move.

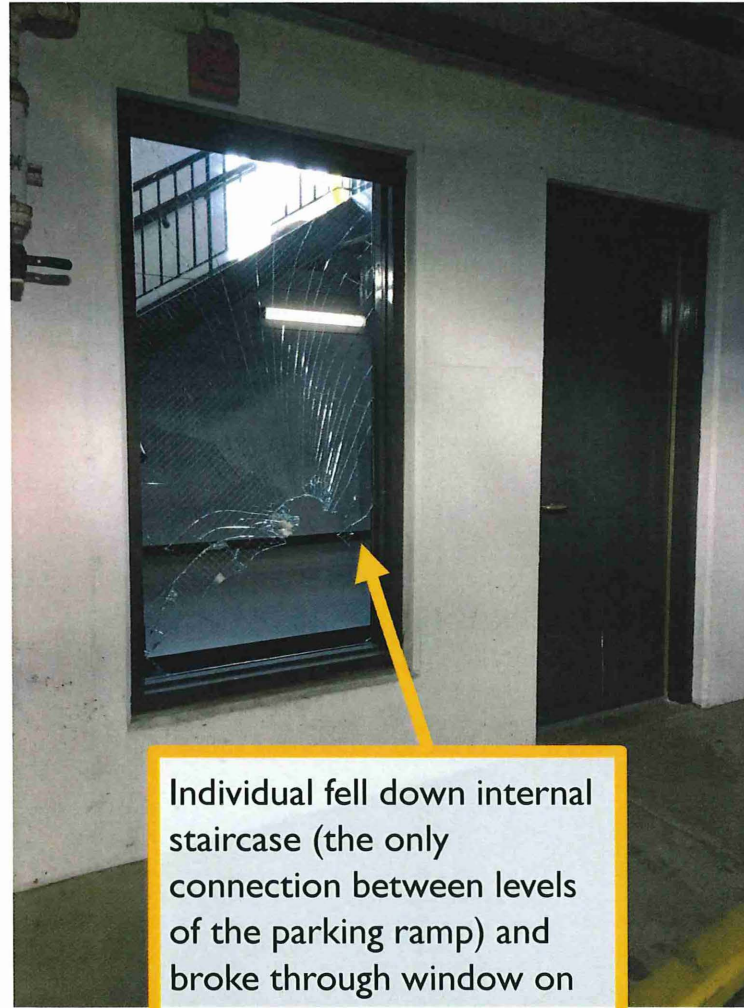
Individual fell down internal staircase (the only connection between levels of the parking ramp) and broke through window on impact.

Inadequate pedestrian pathways in ramp have encouraged pedestrian use of vehicular ramp, resulting in falls and injury

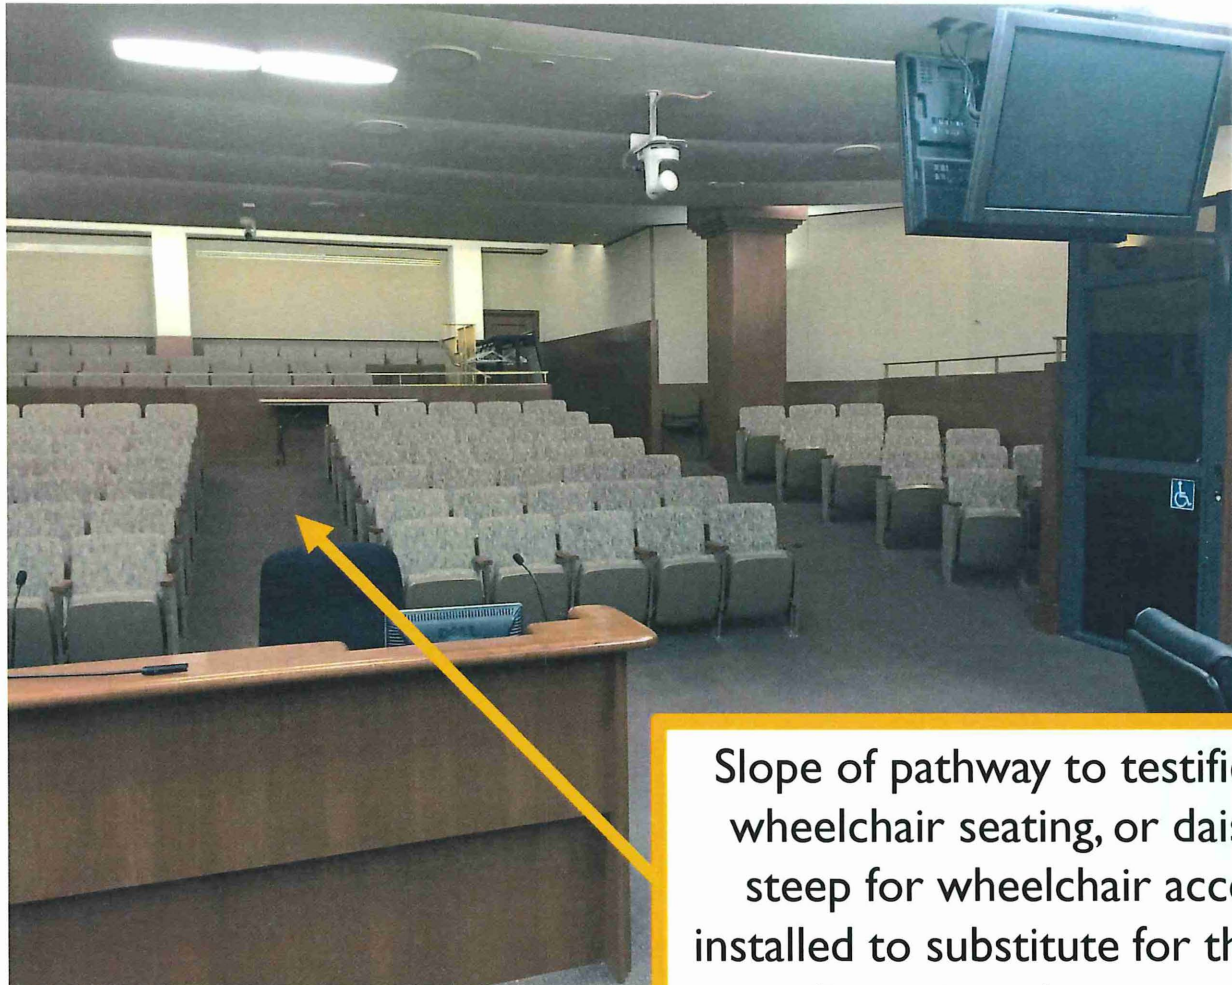
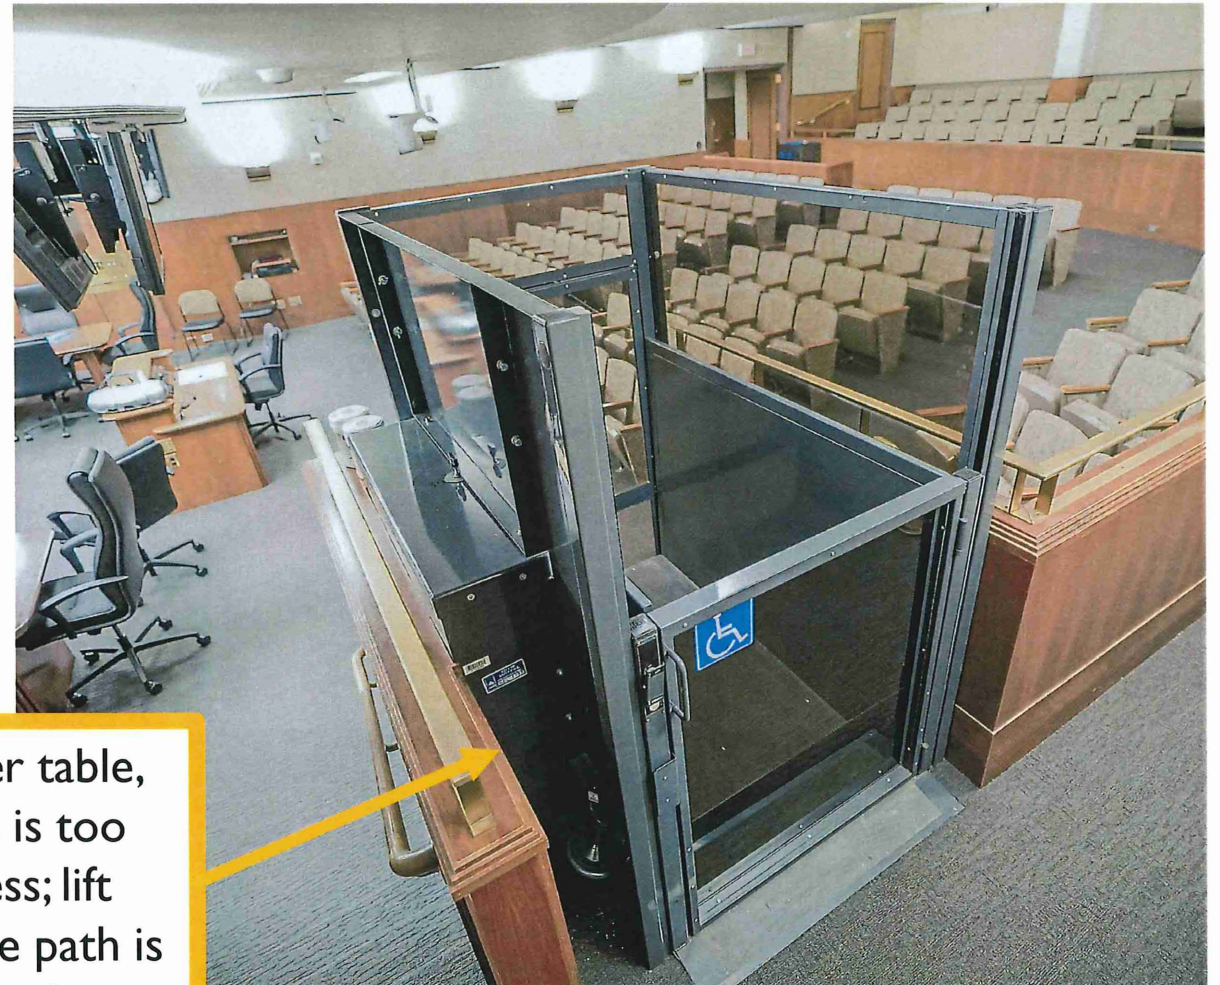
Slope of pathway to testifier table, wheelchair seating, or dais is too steep for wheelchair access; lift installed to substitute for the path is disruptive when operated

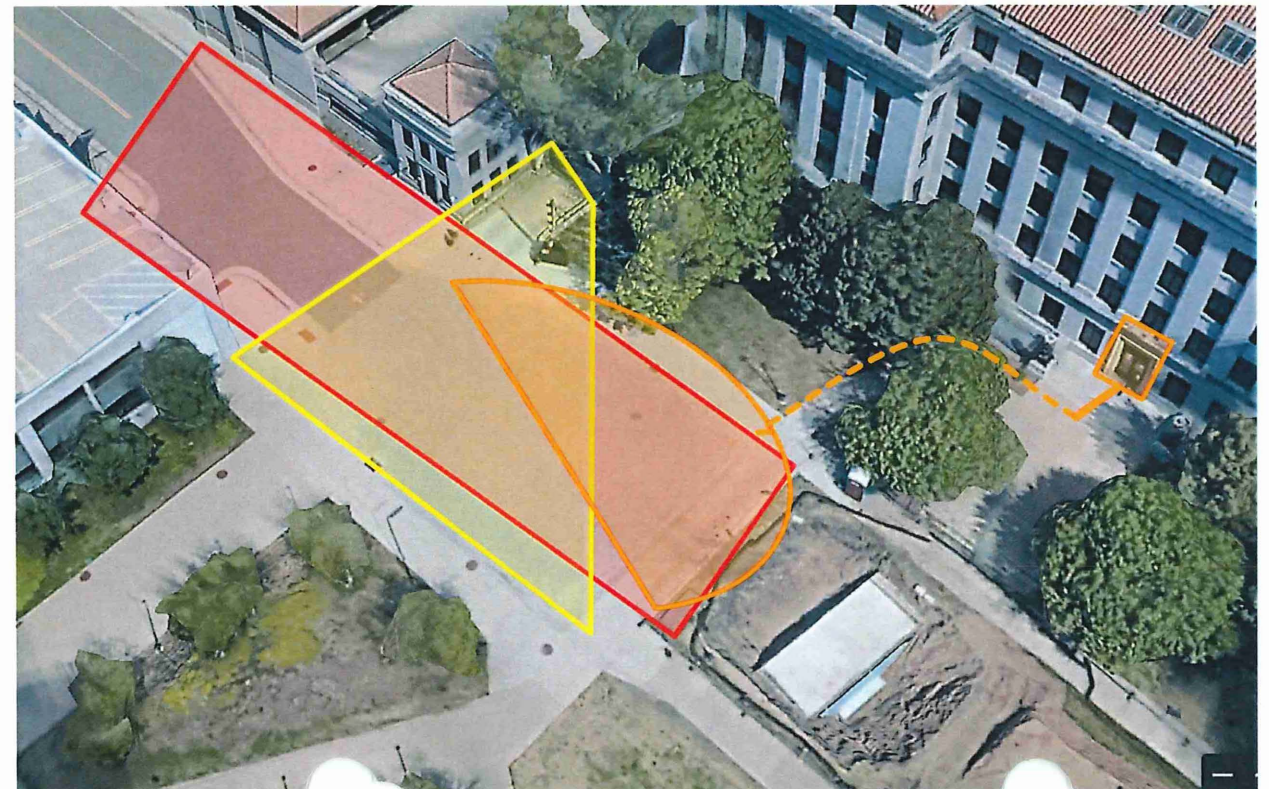
Only public vehicle access at grade is on the South side of the building

At the South side, designated areas for critical functions overlap:

- **Designated Fire Lane**
- **Accessible public entrance; mobility service drop-off and pick-up location**
 - Mobility shuttle/vehicles are not visible from vestibule waiting area
- **Entrance to Loading Dock ramp**
 - Steep grade limits access and maneuverability
 - Proximity to building presents safety and security concerns

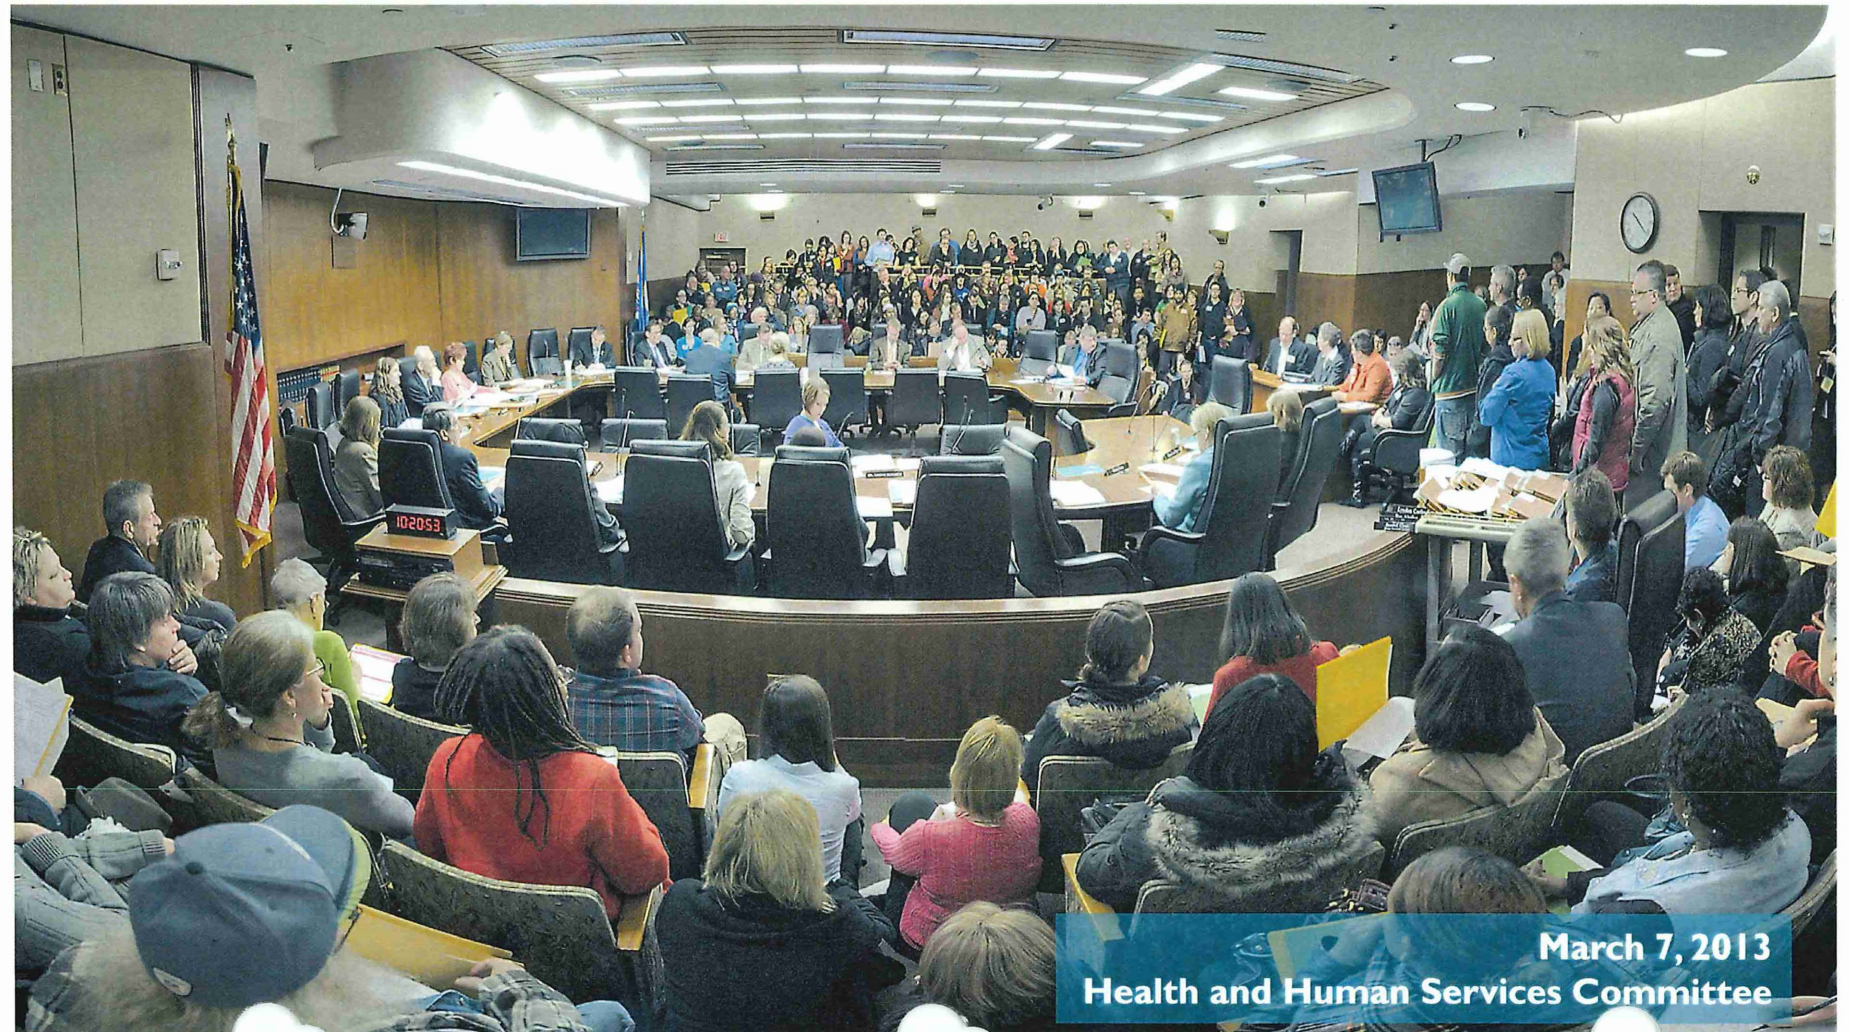
March 7, 2013
Health and Human Services Committee

Exit pathways blocked for members and audience by people standing in doorways, seated on stairs, and blocking emergency exits.

Members and staff do not have direct access to or egress from the hearing table.
