MINNESOTA STATE OFFICE BUILDING

ISSUES AND VULNERABILITIES

State Office Building Facility Condition Assessment

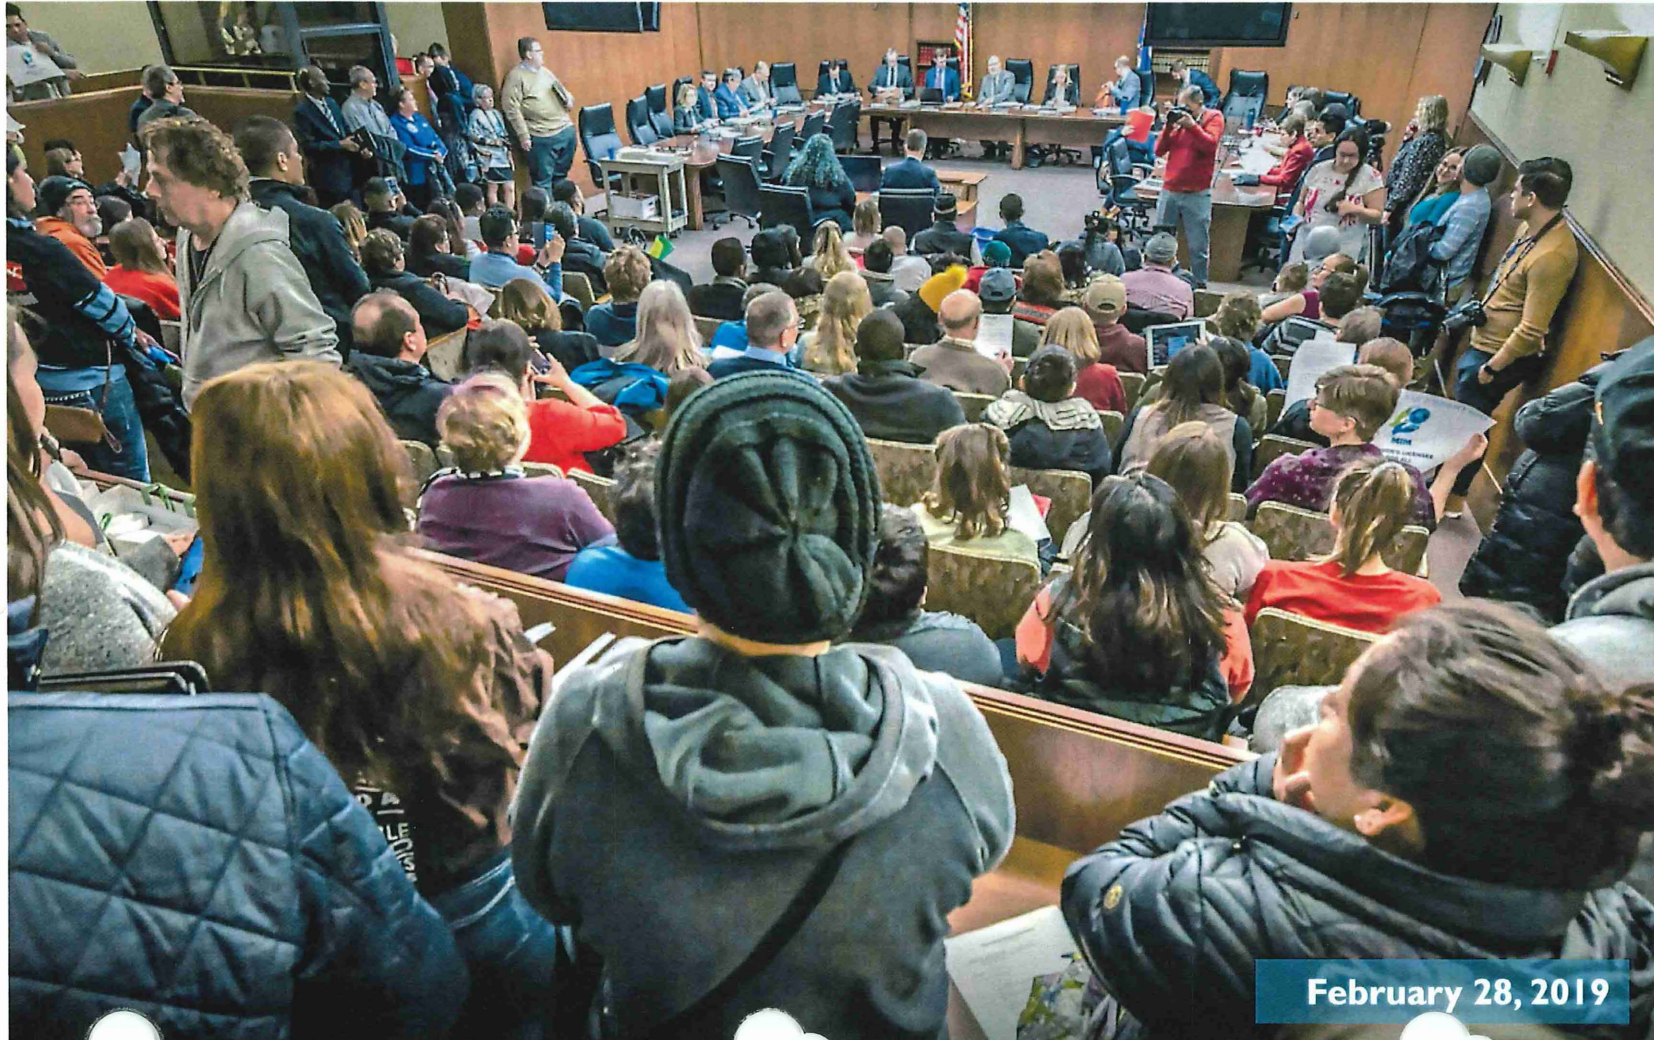
February 28, 2019

Exit pathways blocked for members and audience.

Members and staff do not have direct access to or egress from the hearing table.

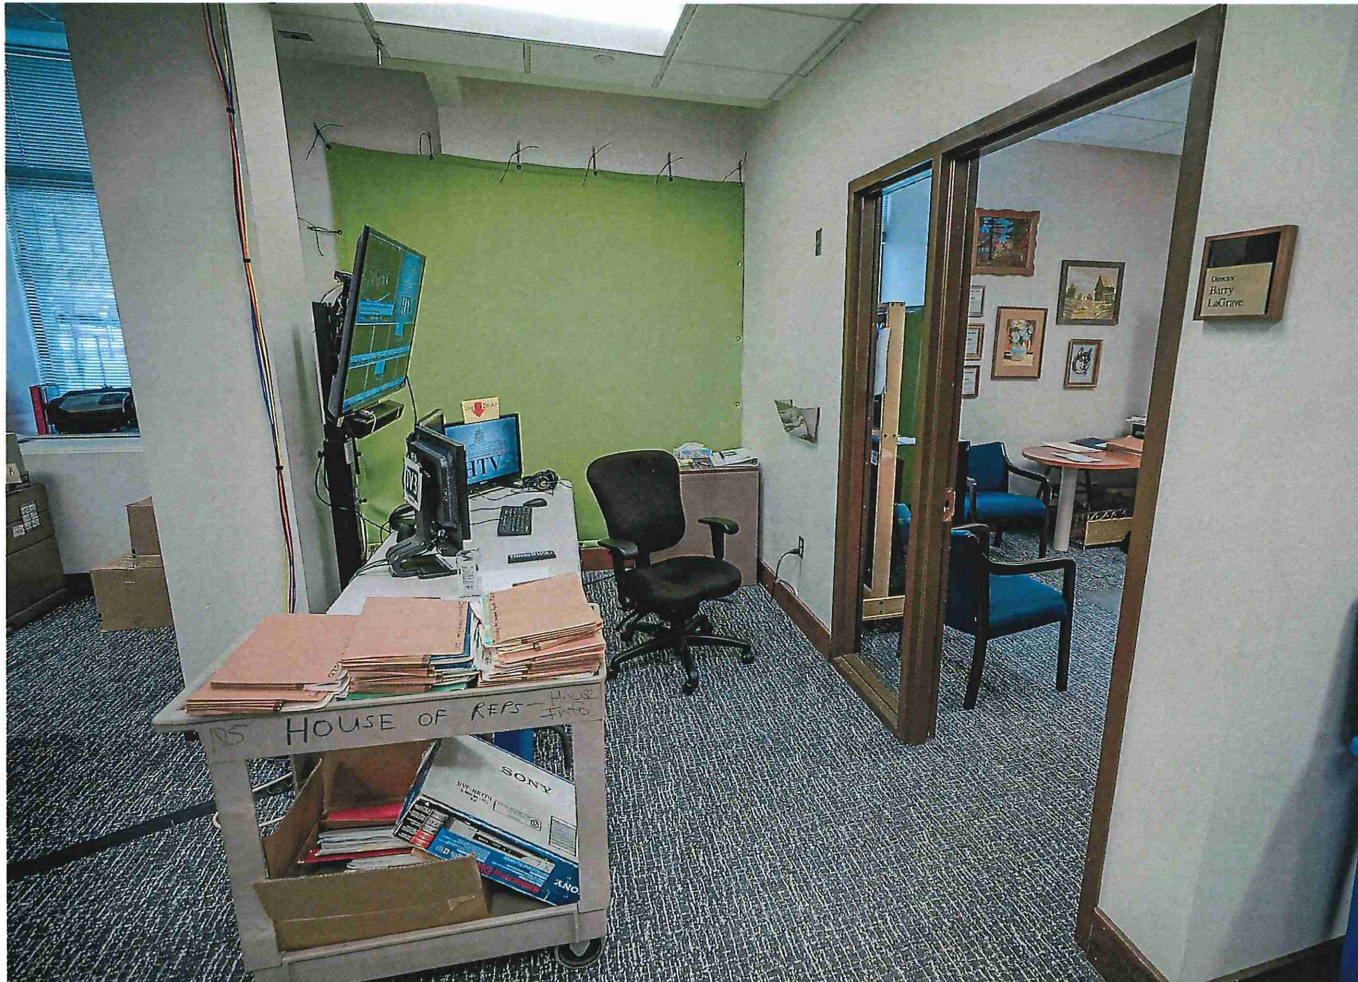
A television production area for broadcast content situated inside an open work area without visual or sound barriers.
