**BIRCH LAKE OUTLET DAM
on the WATER LEVELS of
BIRCH LAKE (11-412) and
TEN MILE LAKE (11-413)**

Cass County, Minnesota

**Minnesota
Department of Natural Resources
Waters**

by Dana Dostert

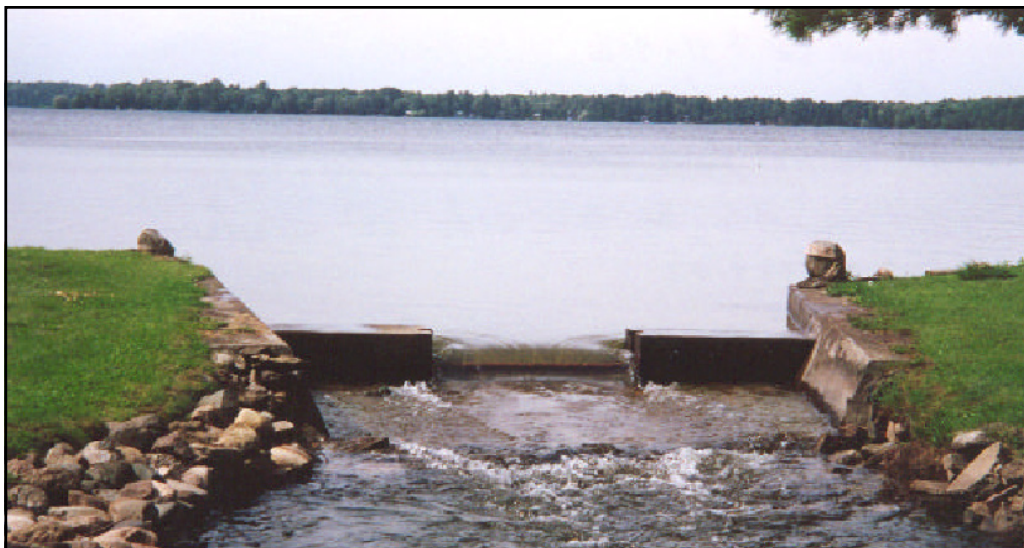
Birch Lake outlet dam, July 31, 2001.

Figure 1. Photograph and plan view of Birch Lake outlet dam; elevations from DNR Waters survey on August 1, 2001.

The Birch Lake outlet dam, located in Hackensack, Minnesota, is a small concrete dam used to maintain water levels on Birch Lake (Figure 1). The Birch Lake outlet dam is owned and operated by Cass County and was authorized by a Department of Natural Resources Permit (76-3435). This permit authorized the operation of the dam and defined the conditions of operation.

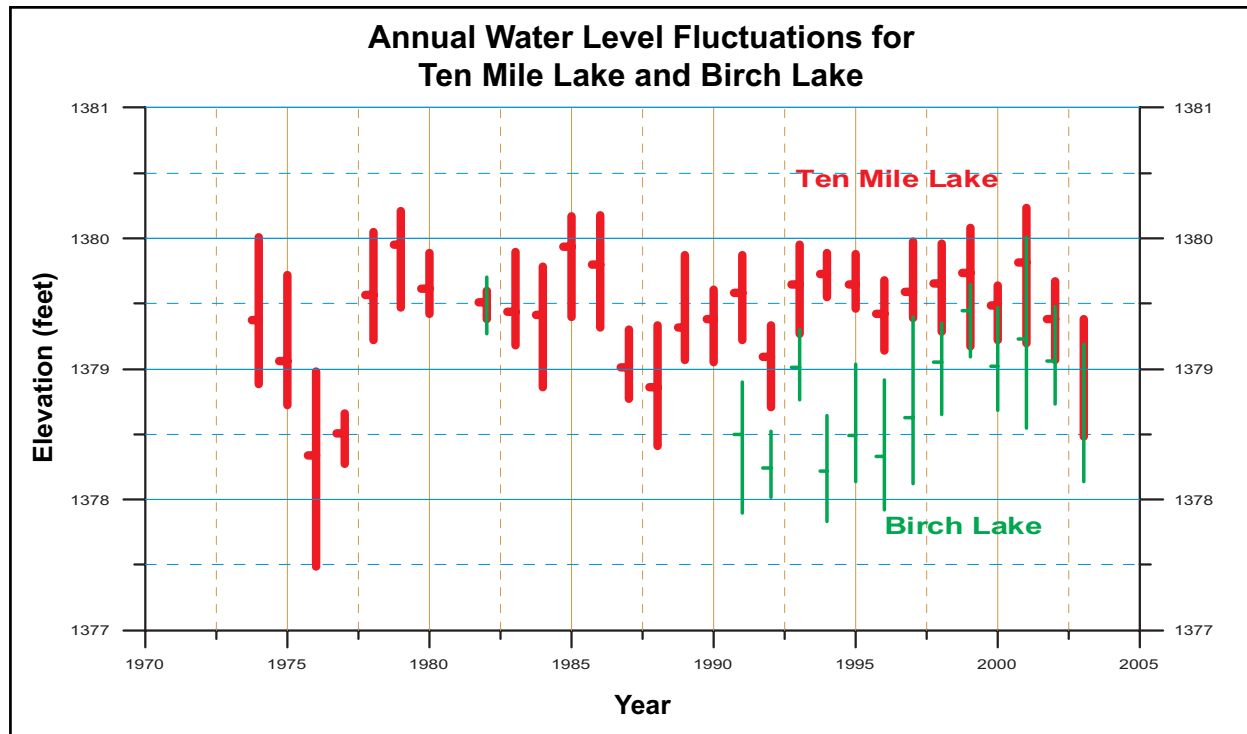
Figure 6 shows the reported annual range of water levels and the average annual level (hatch mark on bar) for Ten Mile Lake and Birch Lake. During the 27-year period of record, water levels for Ten Mile Lake are generally in the 1379 to 1380 range, except for the drought years of 1976-77 and 1987-88.

Figure 6. Annual variation in water levels for Ten Mile Lake and Birch Lake. The hatch mark on the bar represents the average annual elevation. Data from Lake Level Minnesota program.

For Birch Lake, the period of record is only 13 years. Water levels for the first seven years (1991 to 1997) generally fall between 1378.00 and 1379.25 feet, while the levels in the past six years (1998 to 2003) generally fall between 1378.50 and 1379.50 feet. This increase in water levels in recent years is likely due to a combination of factors, including increased precipitation, higher ground water levels, changing from an operable dam to a non-operable dam, and raising the runout from 1377.84 to 1378.15 by placing a four-inch stoplog in the dam.

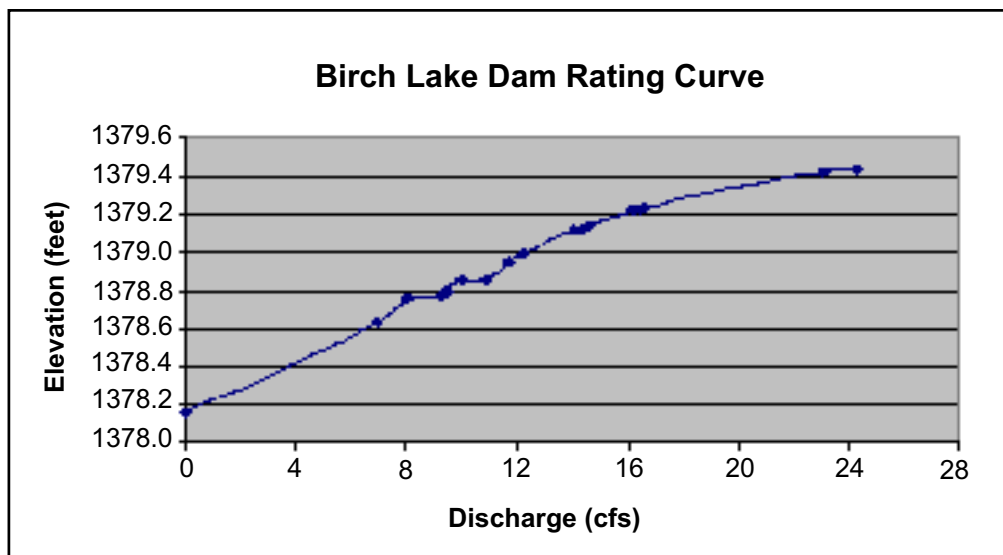
The measured discharges from Birch Lake were also used to create a rating curve for the Birch Lake outlet dam (Figure 11). As stated earlier in this report, a rating curve allows a known elevation (water level) to be converted to a discharge (water volume per unit time). By converting level to discharge, it is possible to do a variety of hydraulic and hydrological analyses including mass balance, momentum and energy grade calculations. A rating curve is also important in that it allows for the calibration of computer models using observed discharges. All computer models of the Boy River system were calibrated against the Birch Lake outlet dam rating curve.

Figure 11. Birch Lake dam rating curve with a four-inch stop log in place.

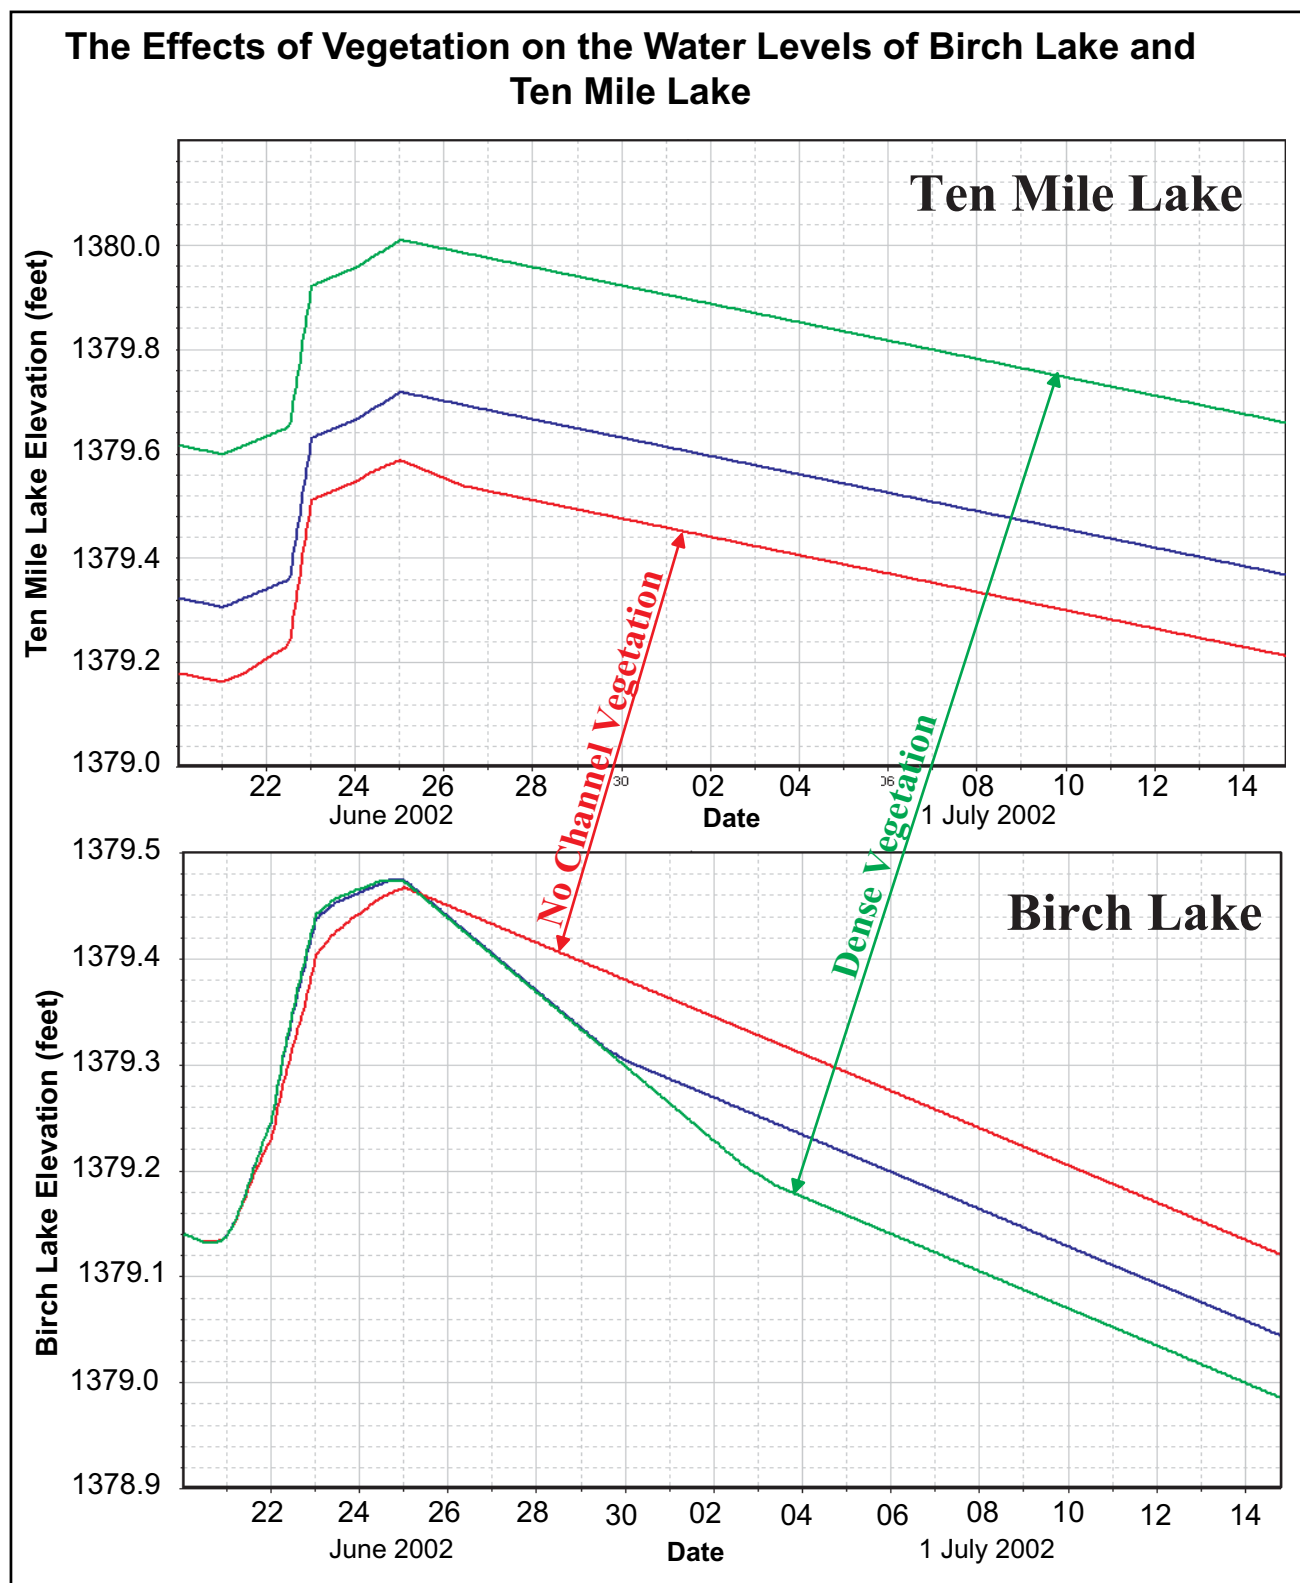
Figure 13 are two output hydrographs from HEC-RAS and shows the modeled elevations of Ten Mile Lake and Birch Lake based on the three vegetative conditions.

The top of Figure 13 shows the modeled water levels of Ten Mile Lake while the lower graph shows the modeled water levels on Birch Lake. The center line (blue) denoting elevation on each graph is the approximate observed elevation. Referring to the lower graph, the peak Birch Lake elevation on June 25 due to the storm is approximately the same elevation for each of the channel conditions. Channel vegetation had little affect on the peak elevation of Birch Lake.

Note the two lines connecting the two hydrographs; one line labeled "No Channel Vegetation" and the other labeled "Dense Vegetation". As can be seen on the graphs, when no vegetation exists in the Boy River channel, water quickly flows out of Ten Mile Lake and into Birch Lake. This process maintains a lower level on Ten Mile Lake while sustaining a higher level on Birch Lake. During periods of "Dense Vegetation", the volume of water flowing out of Ten Mile Lake is reduced, thereby causing the lake level to rise. With less water flowing out of Ten Mile Lake, the elevation of Birch Lake drops.

Figure 13. HEC-RAS output showing the expected water of Birch Lake and Ten Mile Lake for three different channel vegetative conditions.

While channel vegetation had no affect on the peak elevation of Birch Lake, the elevation of Birch Lake is affected by the channel vegetation. As seen in Figure 13, vegetation in the Boy River channel upstream of Birch Lake reduces the inflow to Birch Lake during the summer months. The storm event of June 22, 2002 was of sufficient magnitude that the peak was unaffected. However, several days after the storm peak, channel vegetation reduced the inflow into Birch Lake, causing the lake to decline to a lower level. This scenario simulated the interruptions of "pass through" waters observed during the summers of 2001 and 2002.
