# Hydraulic Impacts of Quarries and Gravel Pits

J.A. Green, J.A. Pavlish, R.G. Merritt, and J.L. Leete  
Minnesota Department of Natural Resources,  
Division of Waters

Legislative Commission on Minnesota Resources

2005

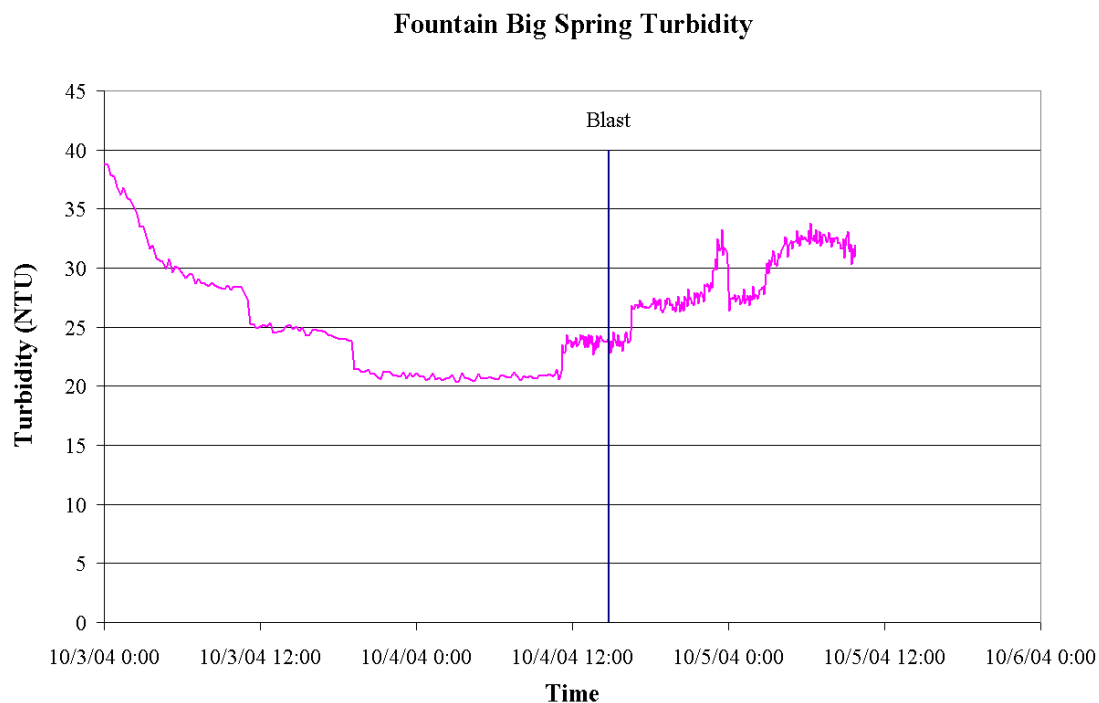
Figure 3. Monitoring showed slight turbidity increases after blasting at Fountain.

The Fountain quarry at Fountain in Fillmore County is a dry quarry (quarrying operations are above the water table) that has been shown by dye tracing to be hydraulically connected to a nearby spring. Project staff monitored this spring for blasting and quarrying impacts on spring turbidity. This setting was chosen by staff to be analogous to the numerous older wells in southeastern Minnesota that are finished in the surficial limestone deposits that are being quarried. Typically, citizens with these wells are those who complain about quarrying impacts on their wells. The monitoring showed slight increases in turbidity after blasting (Figure 3). Based on known ground-water travel times, this material had to be present in the limestone's conduits (enlarged joints) prior to the blast. The blasting shook the limestone and the ground water and released some sediment. In an older well finished in the surface limestone deposit, this mechanism could cause turbidity levels to increase after a blast.

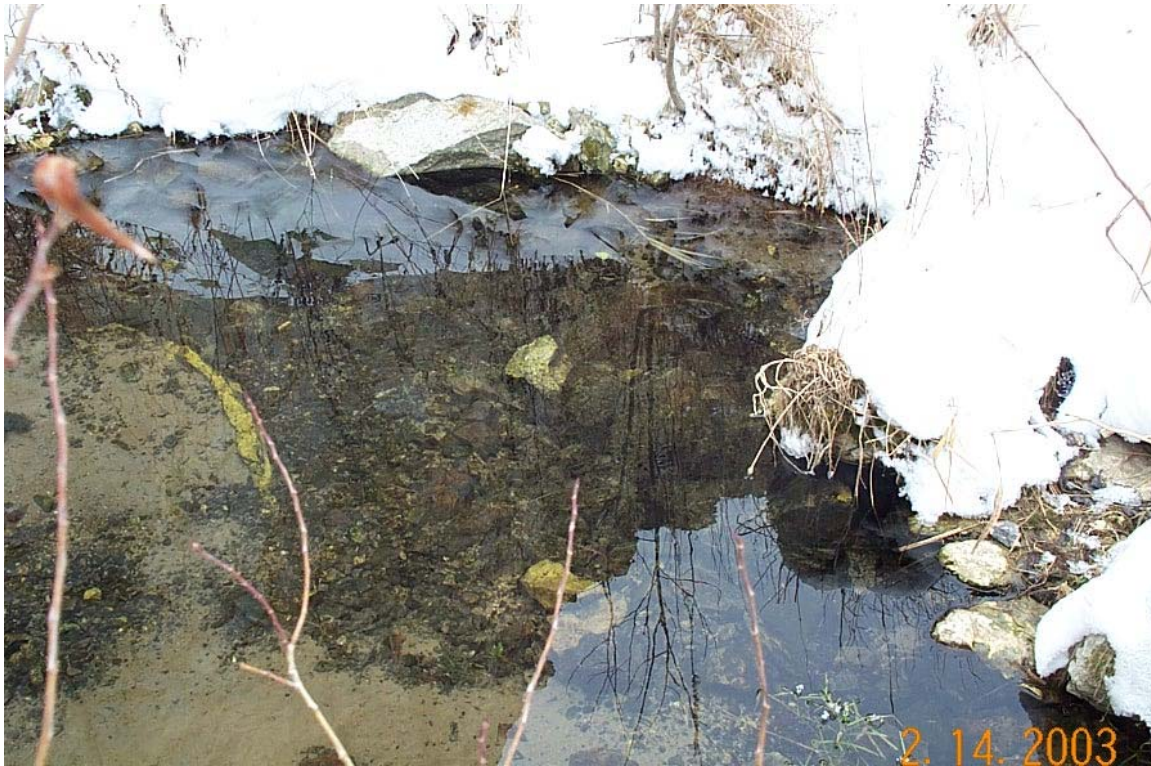
Figure 2.11. Big Spring East, the main discharge point in the eastern part of the quarry.

The area that is currently being mined is about 35 acres; however, the total disturbed area is closer to 47 acres. In the early 1960s, quarrying operations disrupted the conduits carrying flow to Big Spring (A24), the headwaters of a trout stream, Camp Creek, which lies 550 yards north of the quarry. The owners of the spring have stated that when this disruption occurred, the flow from the spring decreased. At that time, water started rising in the quarry at several different points; some flows overland to Camp Creek while the rest sinks back into the quarry and resurges in Big Spring (A24). This quarry is not actively dewatered. The ratio of overland flow versus resurging flow varies depending on spring stage and runoff events. As the quarry has expanded to the south, the points at which the water discharges in the quarry have migrated south also. Figure 2.11 below is a photograph of Big Spring East, A238, the main point where water discharges in the eastern part of the quarry.

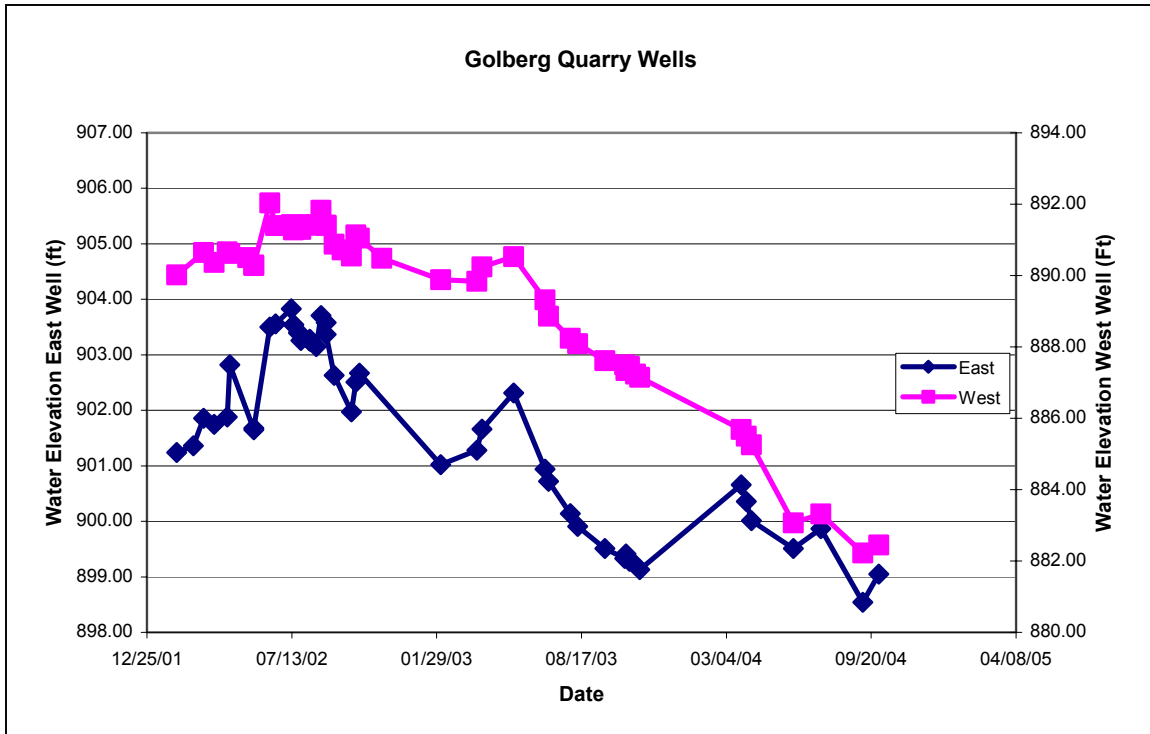
Figure 4.2. Seasonal variation of water levels in Golberg quarry wells.

The two drilled wells on the quarry site (Figure 4.1) were measured several times per month during quarrying activities, and pressure transducers measured water levels at 15-minute intervals. The quarry company does not turn off the pumps during winter, and the quarry expansion toward the wells has removed rock, which has caused ground-water levels to decline. Ground-water levels usually rise seasonally during late spring or early summer from snowmelt (Figure 4.2).

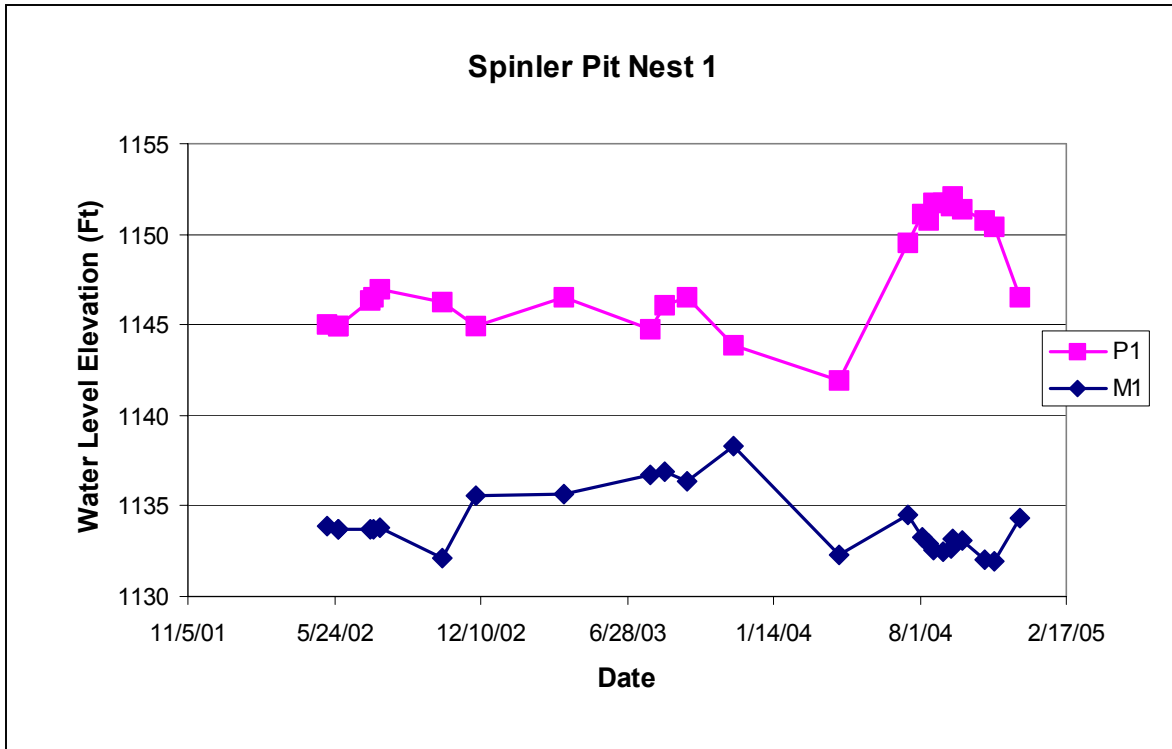
Figure 5.2. Seasonal variation of water levels in Spinler well nest 1.

Over the course of the study, the water levels in 11 wells (six wells in three well nests and five other wells) at the site (Figure 5.1) were monitored for changes due to pumping and seasonal variation. Six wells in three well nests around the quarry provide information about vertical directions of ground-water movement (Figures 5.2, 5.3, and 5.4).
