Background on the March 13-14, 2007 Flooding in
Browns Valley (Traverse County), Minnesota

Report to the Minnesota Governor's Office

Prepared by:
Minnesota Department of Natural Resources
Waters Division
April 20, 2007

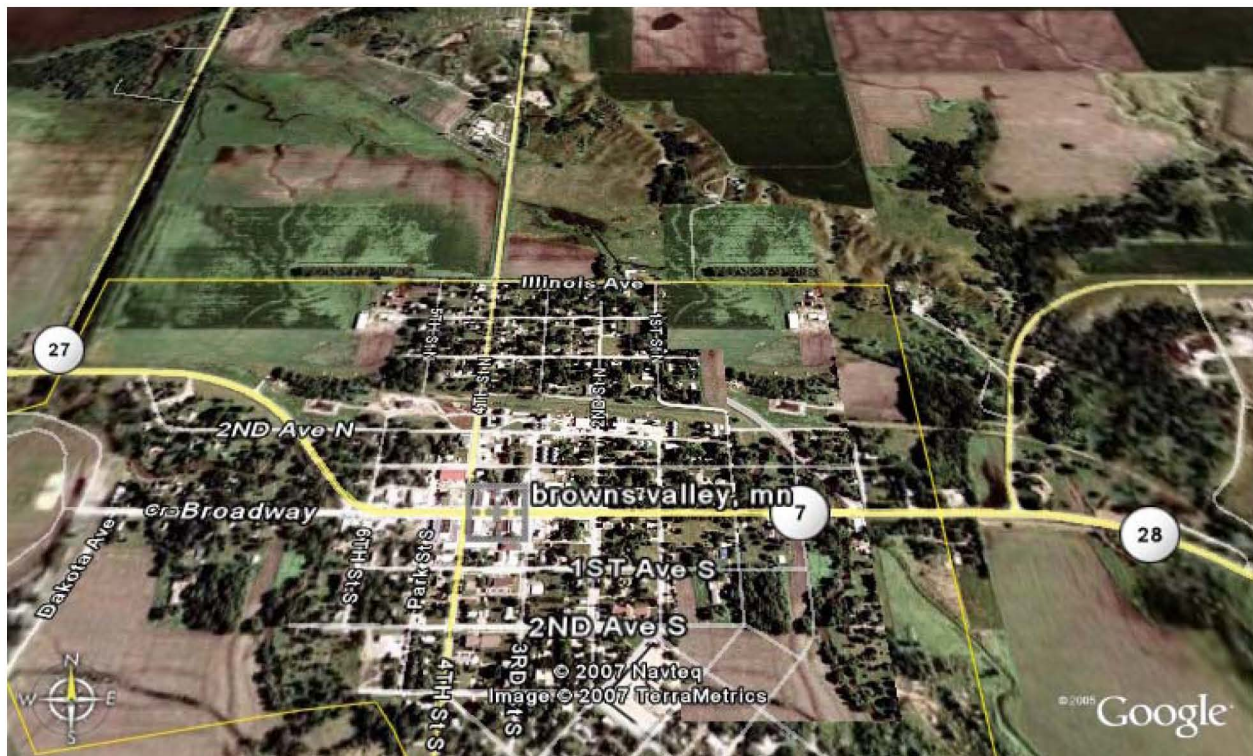
Figure 2. Aerial photo of Browns Valley that shows the transition from high lands in to the valley where the city is located. Source: Google Earth

through town. The city is located on an ancient floodplain, with very flat local topography, facilitating widespread flooding within the municipal limits. A ridge running northwest-southeast along the margin of the floodplain can increase flooding impacts to Browns Valley in two ways, by preventing the spread of flood waters in the ridgeward direction and by contributing surface runoff from the ridge down to the valley. Local hydrologic patterns are further complicated by the fact that Browns Valley is very near the watershed divide between the Minnesota River headwaters to the south and the Bois de Sioux watershed to the north.

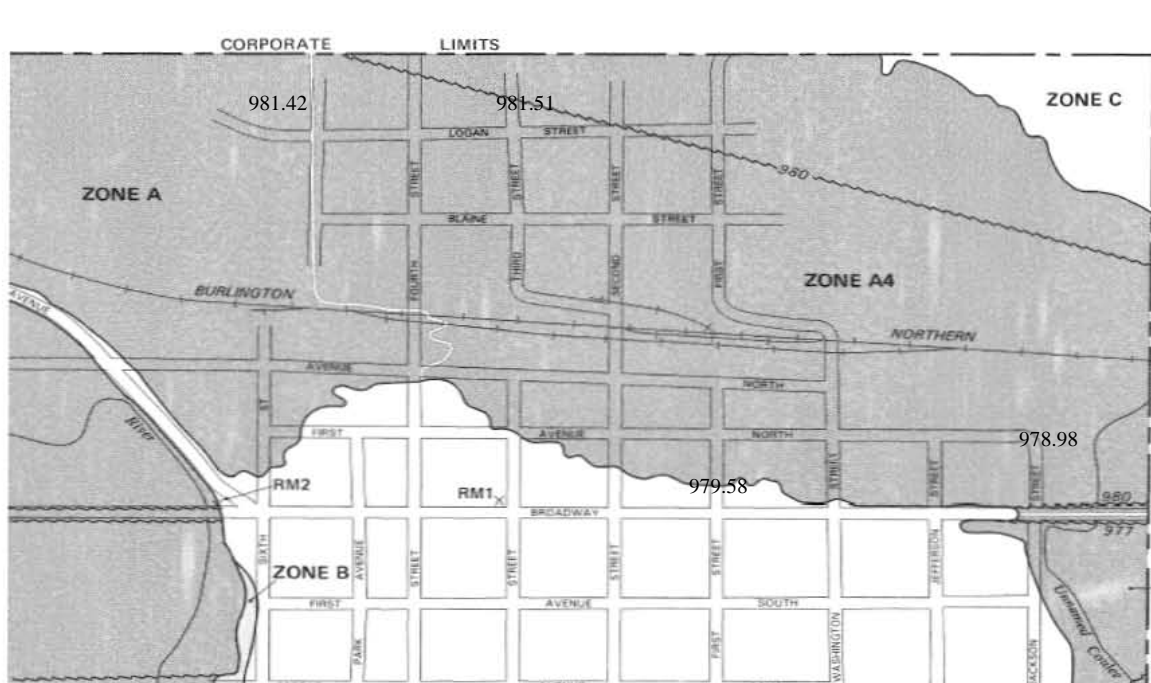
Figure 4. Spot elevations of high water from March 13-14, 2007 flood in Browns Valley (Traverse County) shown on the Flood Insurance Rate Map for Browns Valley

The FIS 1% annual chance (100-year) flood level elevations are indicated on the Flood Insurance Rate Map by waved contour lines labeled with the appropriate elevation. This reveals that the observed high water marks were higher than the 100-year flood elevation of 980 feet MSL at the north end of the city, and just below the 100-year flood elevation as you go further south towards Broadway.

Since the gage was compromised by ice, it is not possible to determine how the discharge (flow volume) for this flood compares to the 1% annual chance (100-year) flood discharge in the FIS. It was possible to compare the elevations of a few high water marks in the city and surrounding area with the 100-year flood elevation published by FEMA on the city’s Flood Insurance Rate Map (FIRM). See figure 4 below.

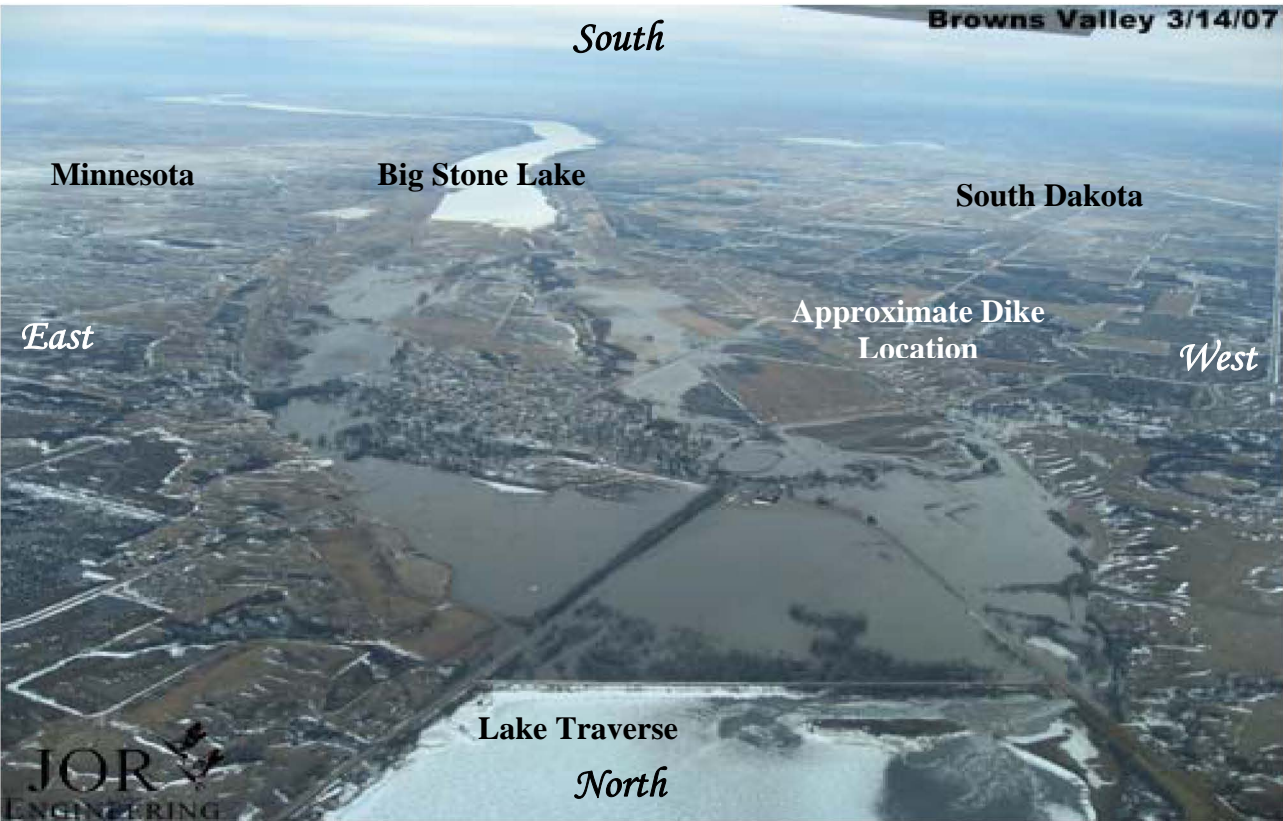
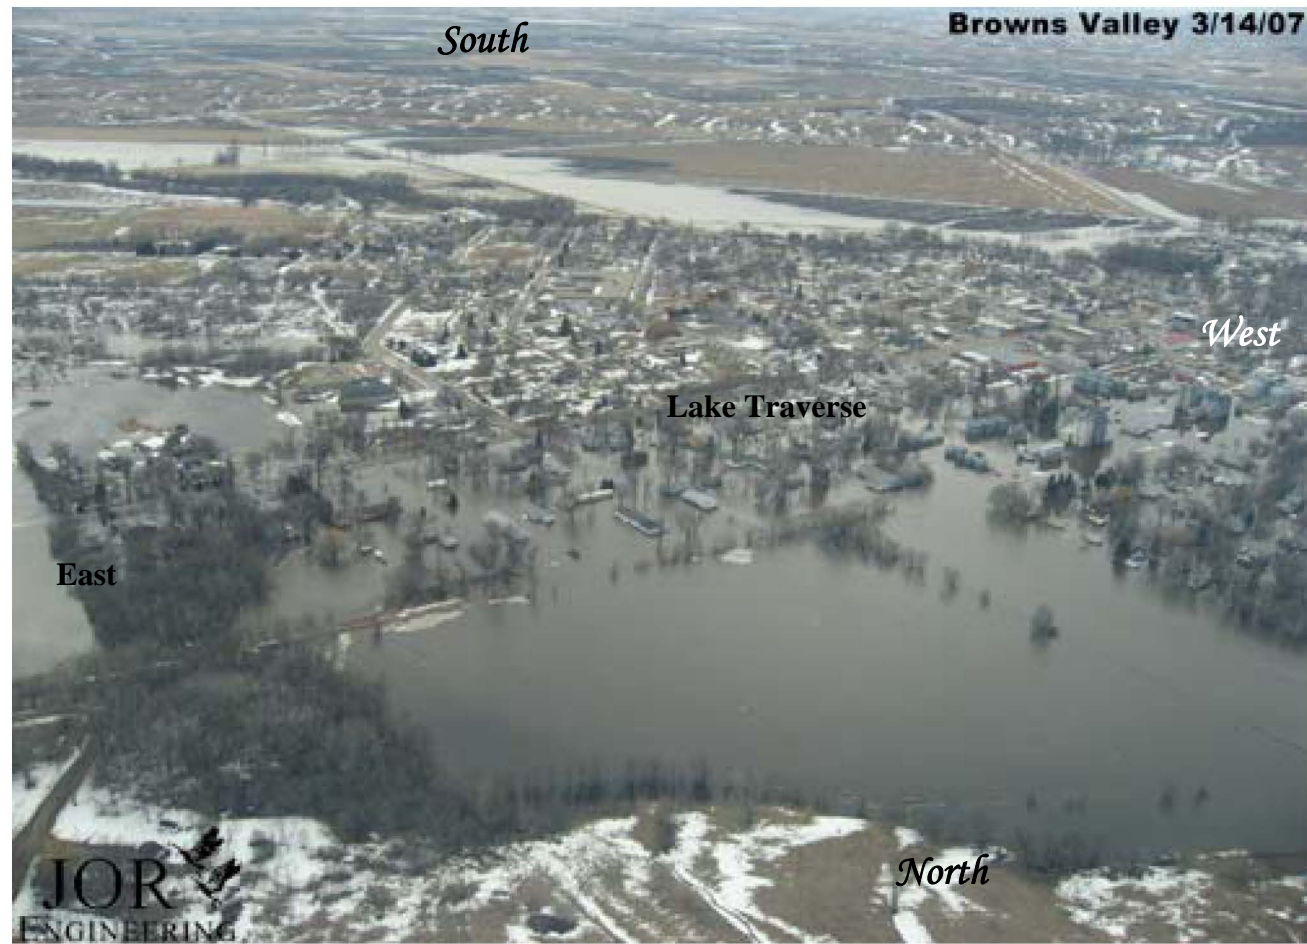
Photos taken by JOR Engineering on March 14, 2007, just after the peak of the flood, are included in figures 5a and 5b (on page 8). The location of the diking in question is labeled on the first photo. It can be observed that flood waters were backed up to the area that included the diking.

Figures 5a & 5b. JOR Engineering aerial photos taken March 14, 2007

Another potential factor in this event was diking in South Dakota by a farmer, Roger Haanen, on the side of the Little Minnesota River as the river enters the river valley from the Sisseton Hills of South Dakota. As discussed earlier, floodwaters typically breakout of the river channel here flowing north toward Lake Traverse. It has been reported but not verified that the dikes in the floodplain are higher on the south side of the river and lower on the north side. Locals report the south side dike may have been breached slightly. Evidence on the ground supports this, as the only flood debris in the flood plain is located in close proximity to the main river channel, and not at any obvious breakout locations, further toward the foothills.
