2001 Pavement Management Annual Report

May 2002
Office of Materials and Road Research
Pavement Management Unit

ANNUAL REPORT

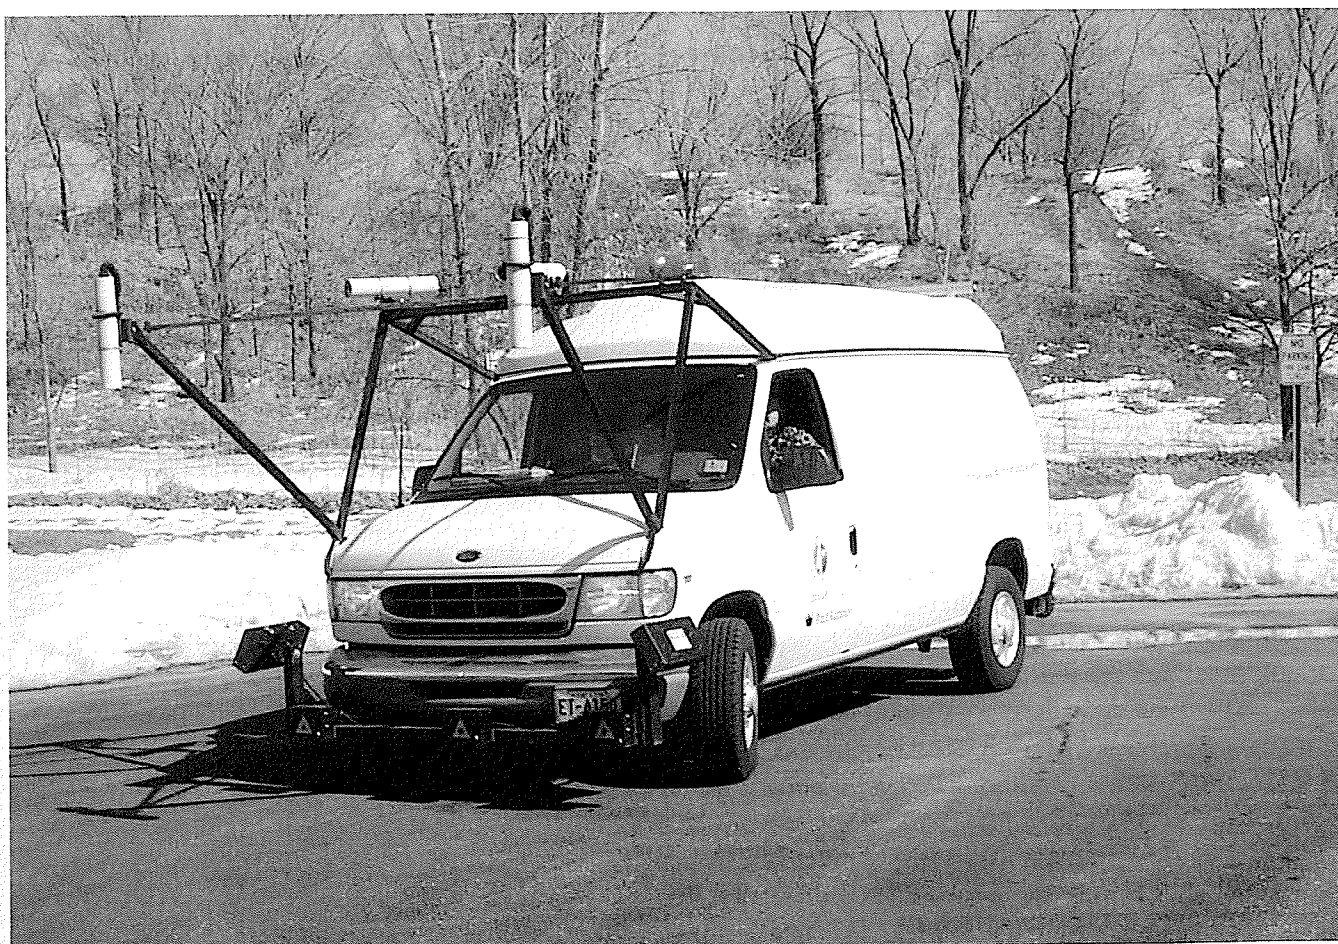
Figure 3-1 Pavement Management Van

Mn/DOT determines the pavement condition using a specially equipped Video Inspection Vehicle (VIV), manufactured by Pathways Services, Inc.

The VIV measures the longitudinal profile of the roadway in addition to capturing video images of the pavement surface and digital images of the surrounding area. In addition, transverse oriented distress such as rutting and faulting are measured.

The VIV is also equipped with five lasers mounted across the front of the vehicle. The lasers measure the distance from the van's reference bar to the pavement surface. Rutting and faulting are types of surface distress measured with the lasers. By comparing the value of the five lasers mounted across the front of the VIV, a rough estimate of the transverse profile can be made. Rut depths exceeding 0.5 inches are classified as a surface distress because they allow water to pond in the rut, resulting in icing or hydroplaning safety hazards. Excessive rut depths also indicate a lack of required structural strength for the loads to which the pavement is subjected. On concrete pavements, faulting over 0.25 inches is considered large enough to warrant attention. If either of these thresholds is exceeded, the SR is reduced.
