*Moving
Minnesota*

2002 Pavement Management Annual Report

March 2003

Office of Materials and Road Research
Pavement Management Unit

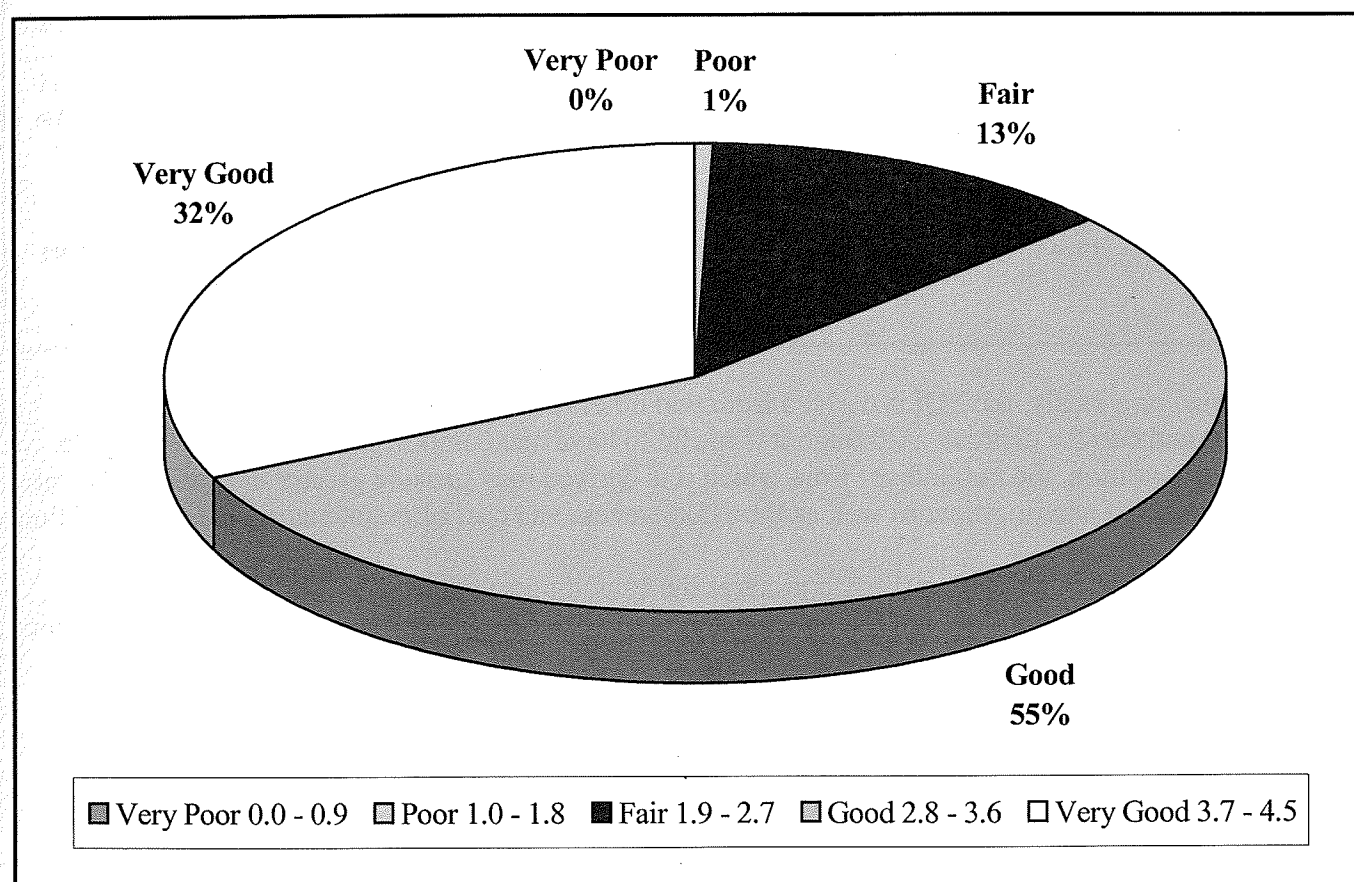
Figure 1-1 Statewide Pavement Quality Index (PQI) Distribution

This report documents the condition of highway pavements under the jurisdiction of the Minnesota Department of Transportation (Mn/DOT). Pavement condition ratings are based upon routine surveys conducted annually for pavement smoothness and biennially for surface distress (cracking, patching, etc.). Numerical indices are calculated for both smoothness and distress based on these surveys. In addition, a composite index of these two measurements, called the Pavement Quality Index (PQI), is used to represent the overall condition of the pavement. The value of the PQI ranges from 0.0 to 4.5. The PQI is divided into five equal parts and given a descriptive name, either "Very Good," "Good," "Fair," "Poor," or "Very Poor." Figure 1-1 shows the distribution of the current PQI values of Minnesota's highways.¹

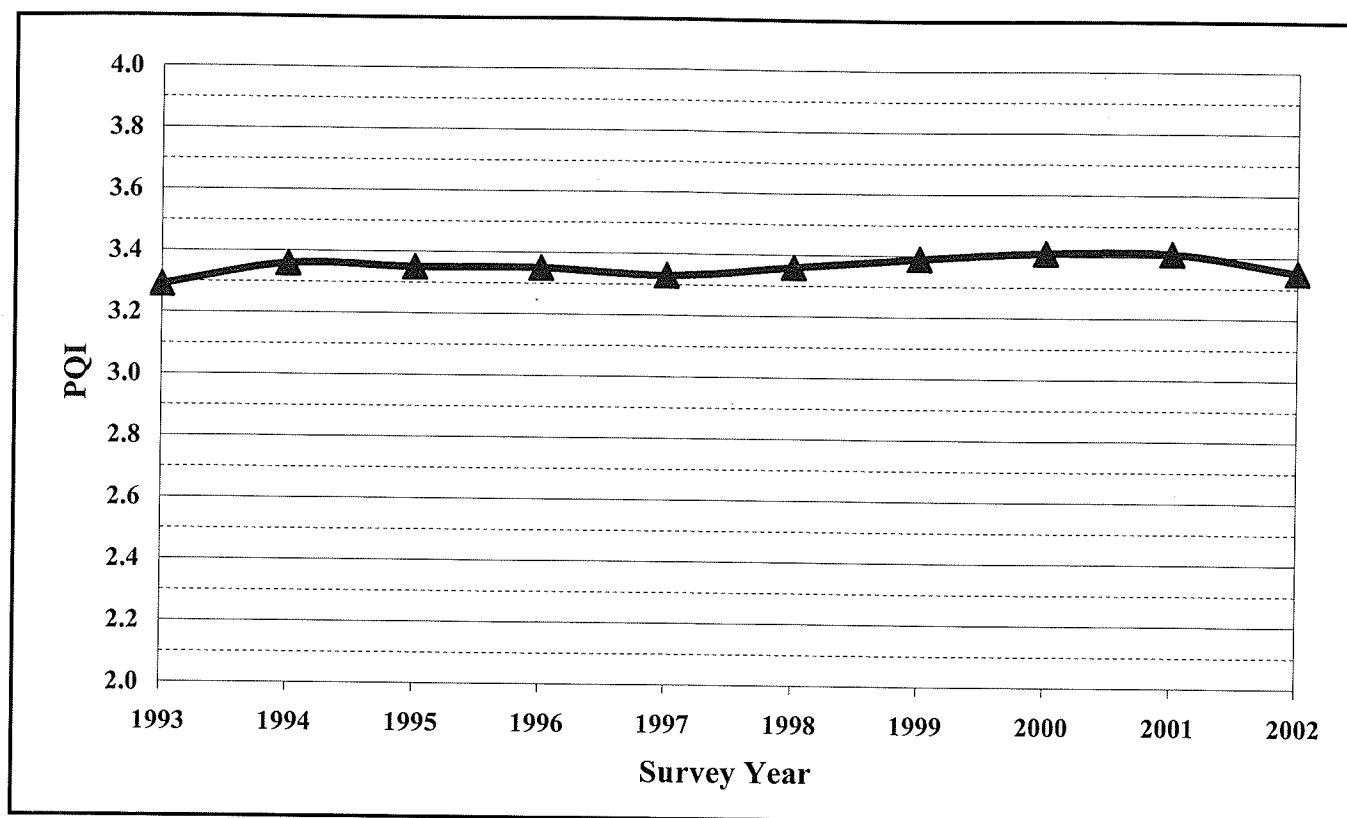
Figure 1-2 Statewide Pavement Quality Index (PQI), 1993-2002

The PQI of each segment of pavement can be used to compare the present and past conditions. From this comparison, trends can be developed and predictions of future condition can be made. Figure 1-2 shows the average PQI for the trunk highway system in Minnesota from 1993 to 2002. It is apparent from this figure that there has been a slight decline in the condition of Mn/DOT's highway pavements in 2002. An overview of Mn/DOT's highway system is provided in Chapter 2.

- The percentage of Minnesota trunk highway mileage that falls into either the “good” or “very good” categories for the PSR, SR and PQI is 69 percent, 92 percent, and 87 percent, respectively.
- Pavement surface distress, as characterized by the SR, decreased in 2002 for the second straight year.
- Pavement smoothness, as characterized by the PSR, also decreased in 2002, the first year it has decreased appreciably since 1995.
- The overall pavement condition, as characterized by the PQI, decreased in 2002 after having steadily increased from 1997 to 2001.

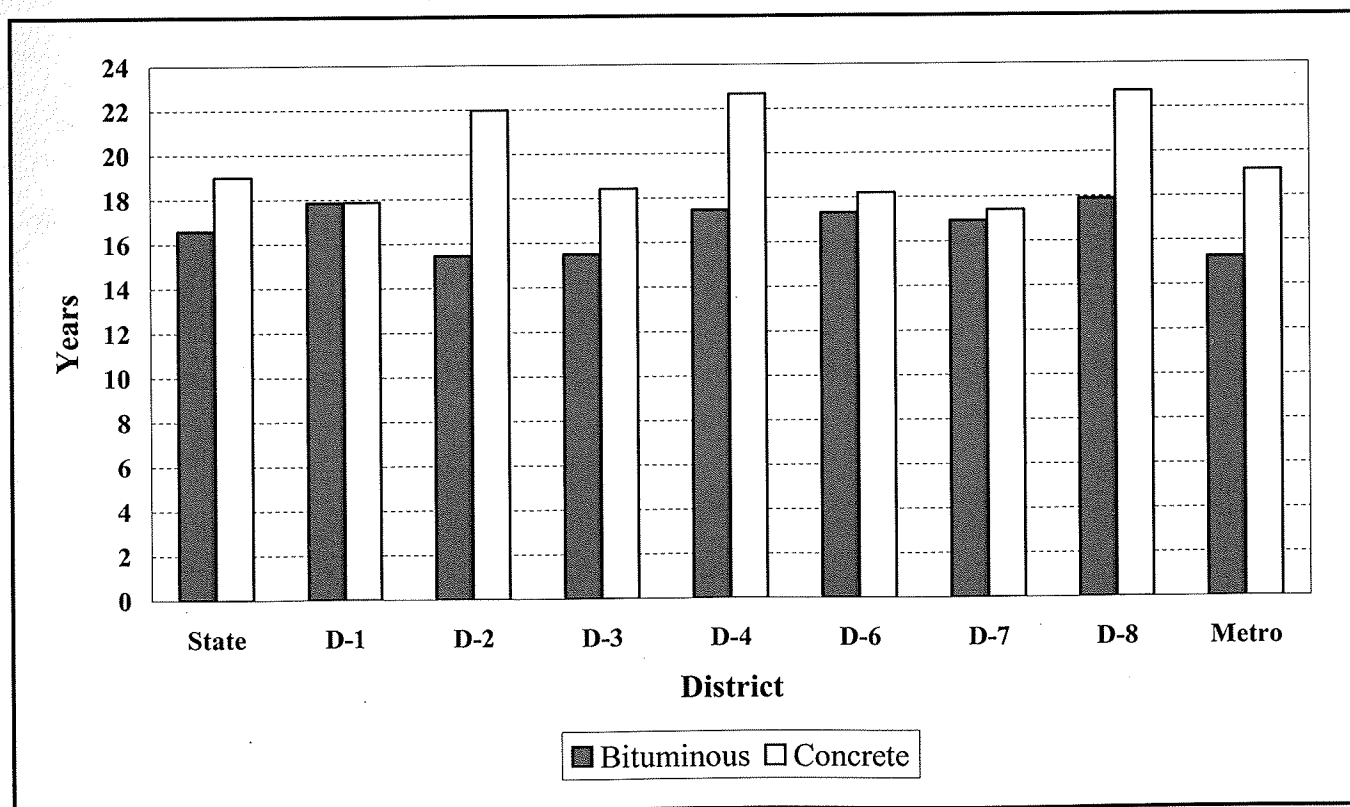
Figure 2-5 Average Time from Original Construction to First Rehabilitation/Reconstruction

The effects of repeated heavy loads and weather extremes on pavement condition necessitate an ongoing program of maintenance and rehabilitation. Rehabilitation and reconstruction are activities that upgrade the pavement structure of a highway after the cumulative loads exceed its actual capacity or the pavement has deteriorated for other reasons. Rehabilitation work is frequently undertaken with safety enhancements, intersection upgrades, or bridgework. Rehabilitation projects for bituminous pavements include medium or thick overlays, with and without milling. Rehabilitation projects for concrete pavements include major joint repairs and bituminous or unbonded concrete overlays. Figure 2-5 shows the average number of years between original construction and first rehabilitation for pavements built since 1955. Statewide, the average age when the first rehabilitation for bituminous and concrete pavements is performed is 16 and 19 years, respectively. For bituminous, the first rehabilitation is considered to be when an overlay is placed. For concrete, the first rehabilitation is considered to be when the pavement is overlaid or has a joint repair.

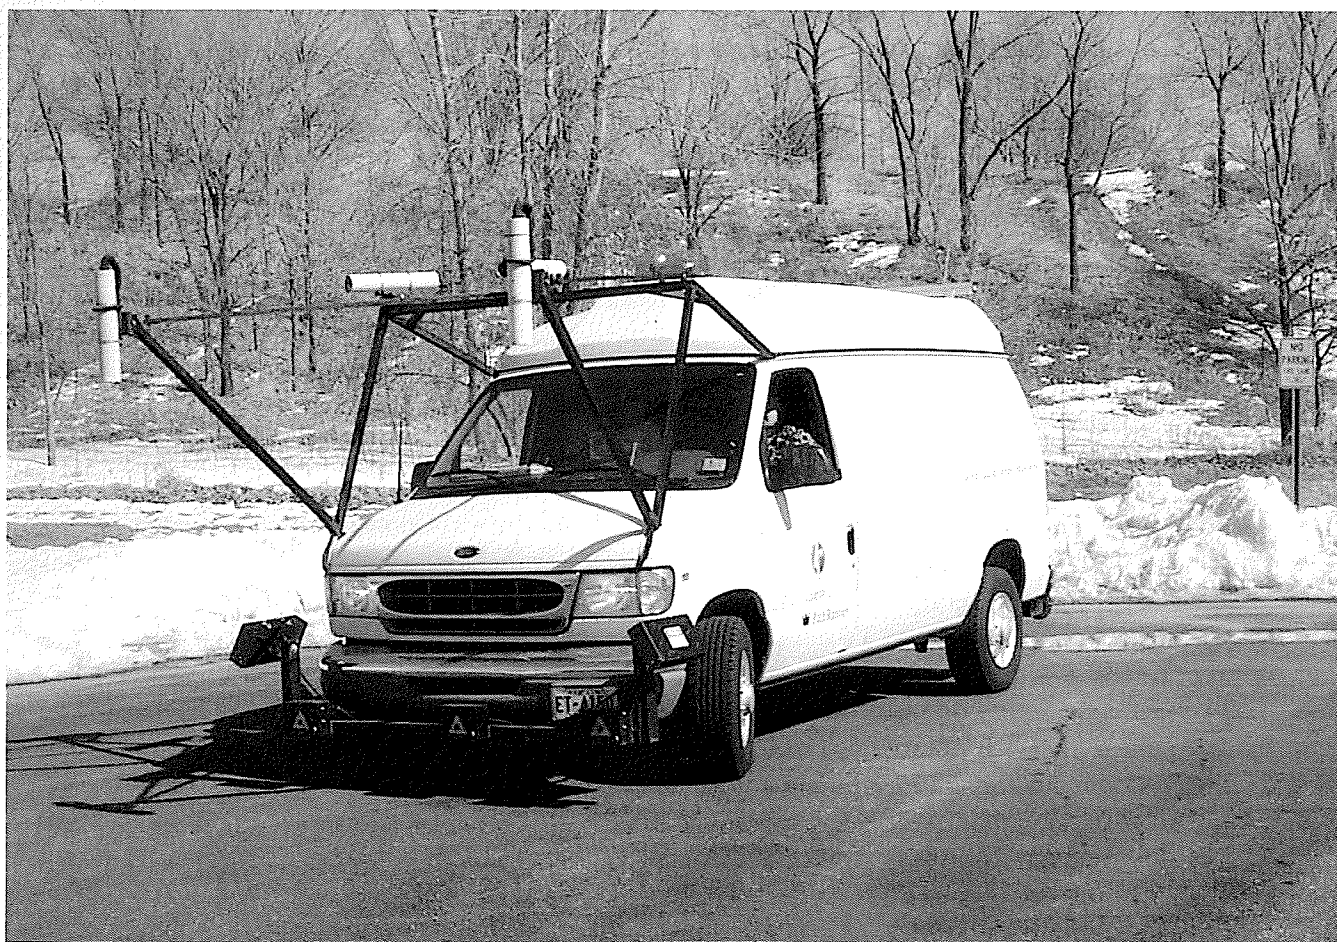
Figure 3-1 Pavement Management Van

Mn/DOT determines the pavement condition using a specially equipped Video Inspection Vehicle (VIV), manufactured by Pathways Services, Inc.

The VIV measures the longitudinal profile of the roadway in addition to capturing video images of the pavement surface and digital images of the surrounding area. In addition, transverse oriented distress such as rutting and faulting are measured.

The VIV is also equipped with five lasers mounted across the front of the vehicle. The lasers measure the distance from the van's reference bar to the pavement surface. Rutting and faulting are types of surface distress measured with the lasers. By comparing the value of the five lasers mounted across the front of the VIV, an estimate of the transverse profile can be made. Rut depths exceeding 0.5 inches are classified as a surface distress because they allow water to pond in the rut, resulting in icing or hydroplaning safety hazards. Excessive rut depths also indicate a lack of required structural strength for the loads to which the pavement is subjected. On concrete pavements, faulting over 0.25 inches is considered large enough to warrant attention. If either of these thresholds is exceeded, the SR is reduced.

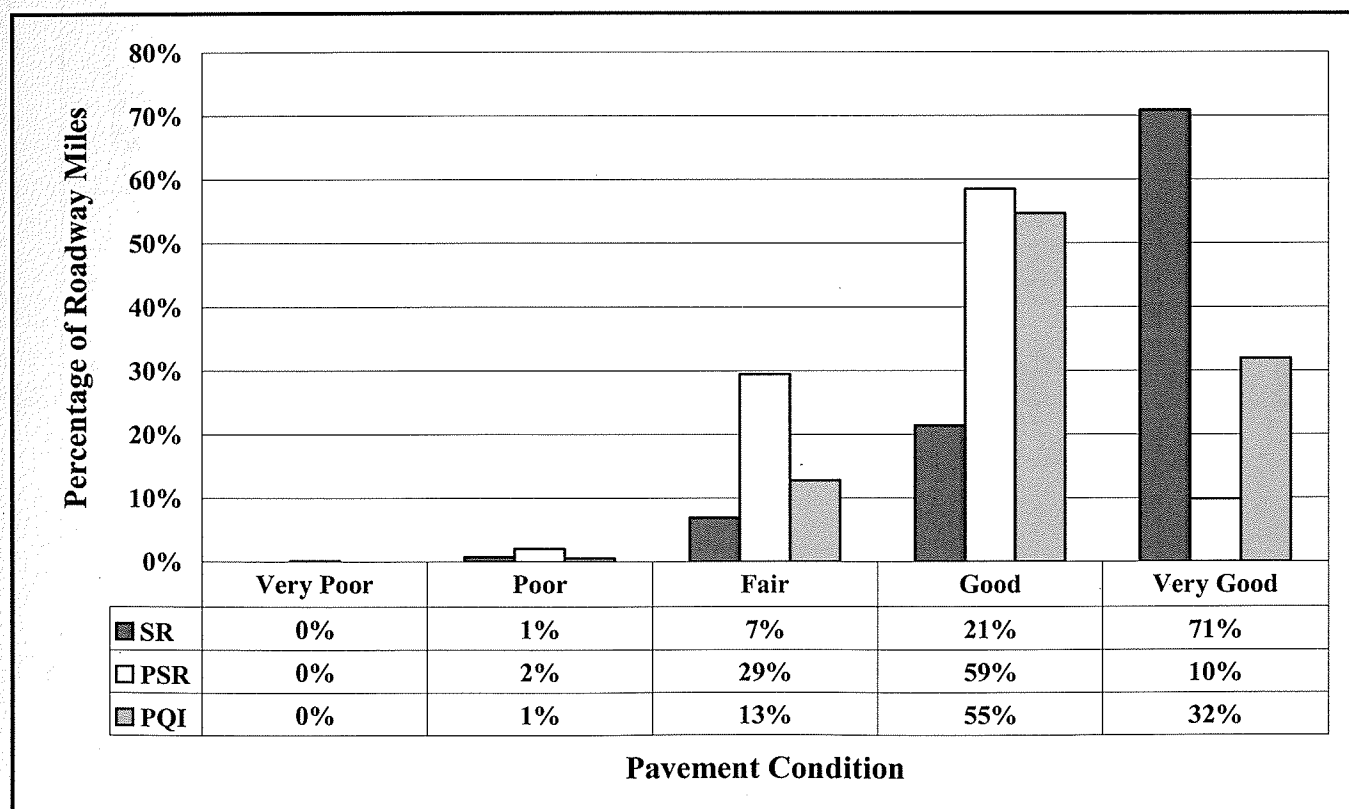
Figure 4-1 Statewide Performance Indices by Performance Classification

Figure 4-1 is a distribution of the current values of the PQI, PSR, and SR into five equal categories: "Very Poor," "Poor," "Fair," "Good," and "Very Good." The category ranges are shown in Table 4-1. The five categories are a change from the four categories used in previous annual reports. The new PSR categories are identical to those found in the Federal Highway Administration (FHWA) Order M 5600.1B, dated August 30, 1993. To be consistent, the SR and PQI are also broken down into five equal categories. The main reason for this change in reporting was to address concerns identified in a report by the Office of Legislative Auditor.ⁱ The report stated that the old method of reporting condition, with only four, unequal categories, overstated the number of miles in the "Poor" category and understated the number of miles in the "Good" and "Very Good" categories.

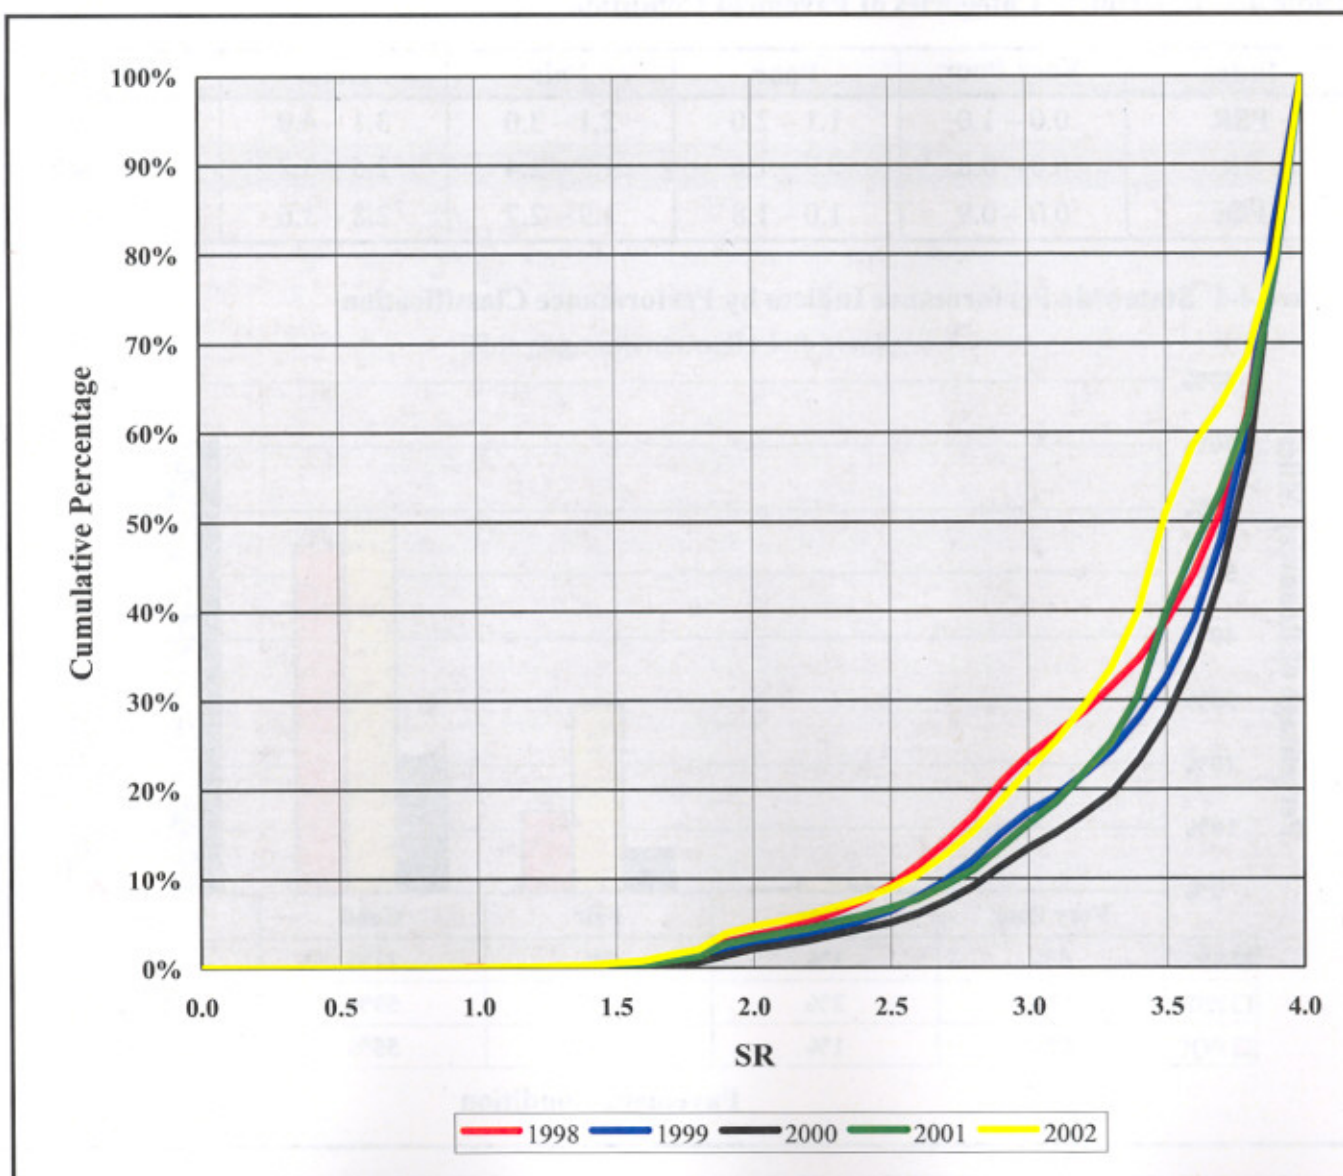
Figure 4-2 Cumulative Distribution of Statewide Surface Rating (SR), 1998-2002

In order to provide more detailed information about the historical shifts in pavement condition, cumulative distribution graphs are shown in Figures 4-2, 4-3 and 4-4 for SR, PSR and PQI, respectively. These distribution plots show the percentage of roadway miles with an index value equal to or less than the values shown on the horizontal axis.ⁱⁱ

Figures 4-2, 4-3, and 4-4 show the distribution curves for the SR, PSR, and PQI, respectively, for each of the last five years. Figure 4-2 shows a decrease in the SR from 2001 to 2002 (curve has shifted to the left). The major, though not the only, causes of this shift are the addition of longitudinal joint spalling as a distress on concrete pavements and the revised method of determining the percentage and weighting factors for transverse cracking on bituminous pavements, both of which were implemented in 2002.

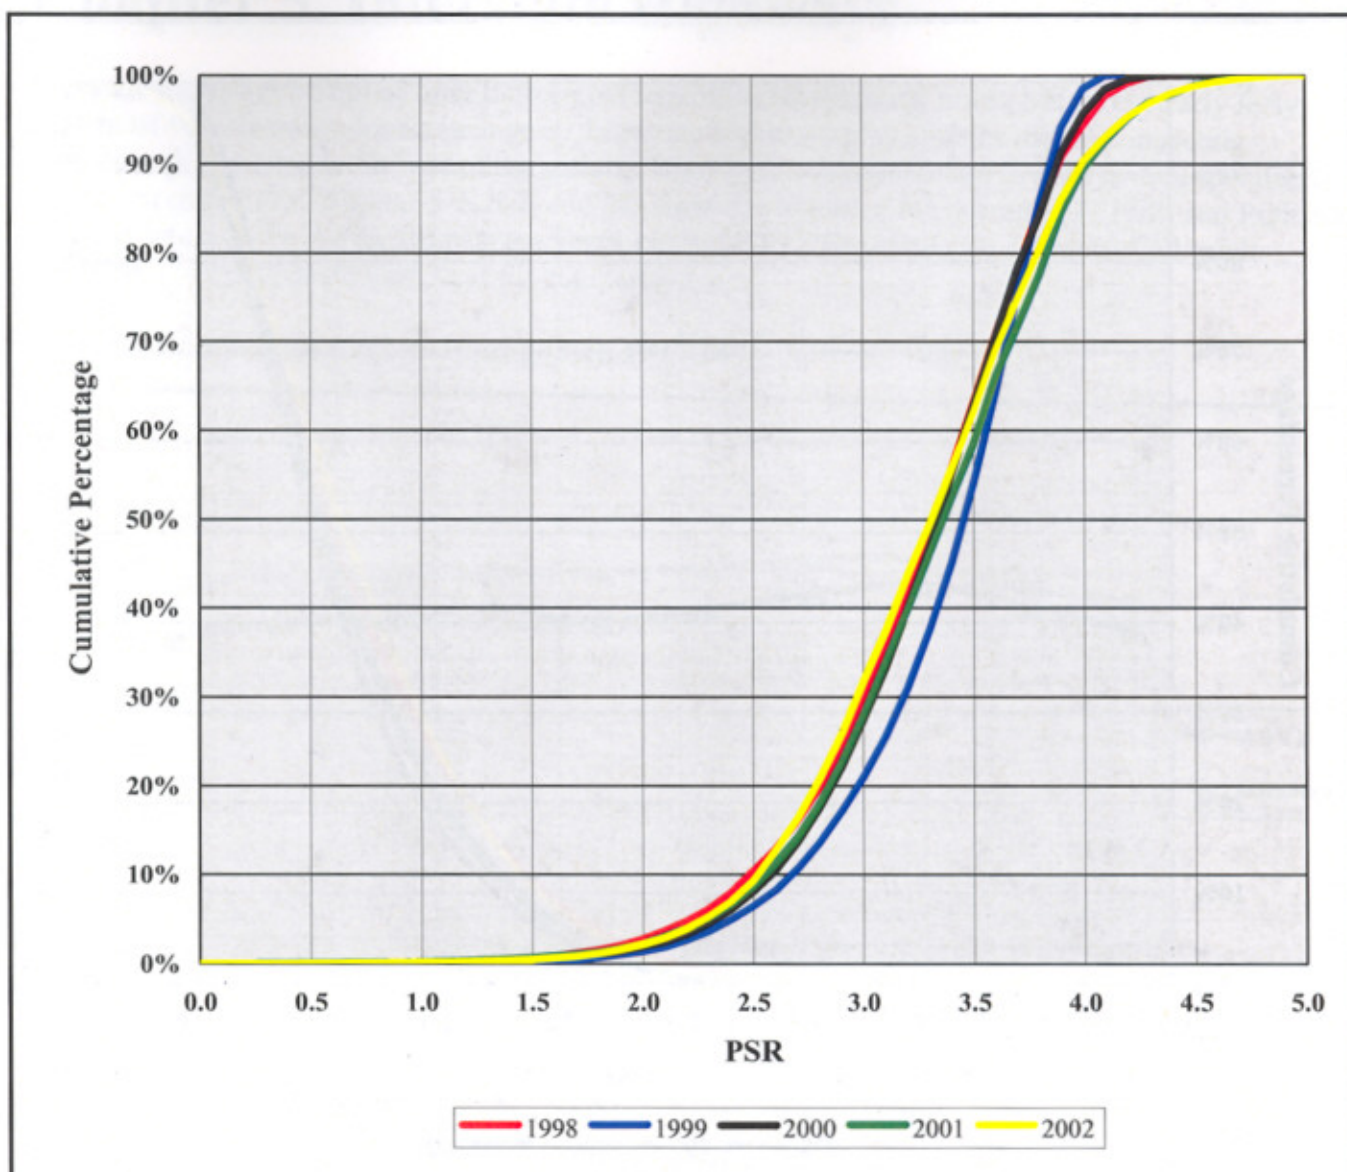
Figure 4-3 Cumulative Distribution of Statewide Present Serviceability Rating (PSR), 1998-2002

The change in the PSR distribution over the past five years is much more modest. The 2002 statewide PSR is slightly lower than in 2001 (curve has shifted to the left). The range of PSR values more evenly spans the classifications from "Poor" to "Very Good" than that of the SR. The situation for the PQI is intermediate, since it is a composite of the SR and PSR.

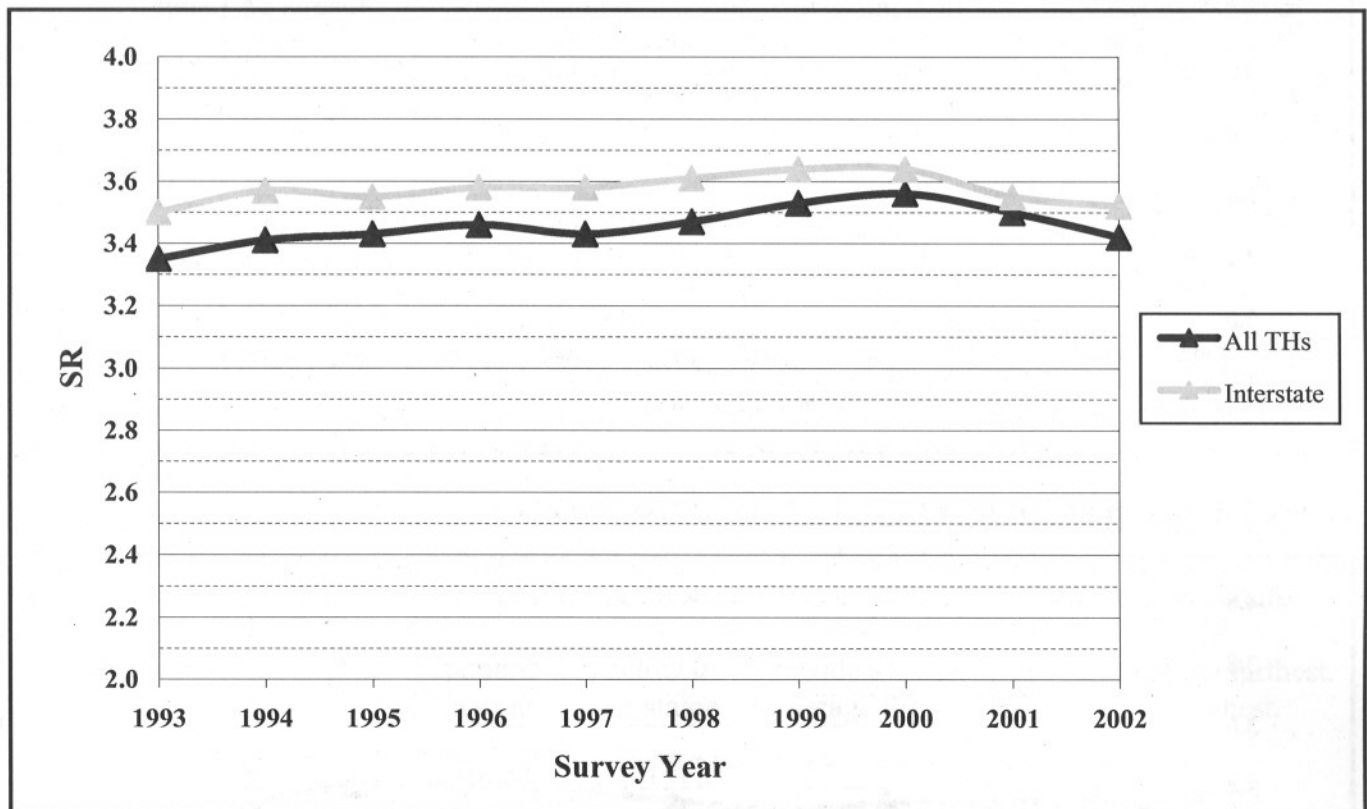
Figure 5-1 Interstate Surface Rating (SR), 1993-2002

Interstate highways comprise only thirteen percent of the total system miles, but carry nearly forty percent of vehicle miles driven each year. Interstate highways play a major role in connecting Minnesota's economy to the rest of the nation. Therefore, it is appropriate to present data specifically on their performance. Figures 5-1, 5-2, and 5-3 show the trends of the average SR, PSR, and PQI values for interstate highways over the past ten years, respectively. The statewide average of all trunk highways is displayed for each year for comparison.

The average SR of both the entire trunk highway system, as well as the interstate system, shows a fairly large decrease from 2000 to 2002. As stated earlier, a contributing factor is the changes made to SR procedure in 2001 and 2002. In 2001, longitudinal joint distress was added to bituminous pavements and in 2002, longitudinal joint spalling was added to concrete pavements. In addition, the weighting factor applied to medium and high severity transverse cracking increased in 2002. The result of these changes is a lower SR for any road with these types of distress in 2001 and/or 2002. It is felt that including this distress type provides a more realistic evaluation of the pavement condition.

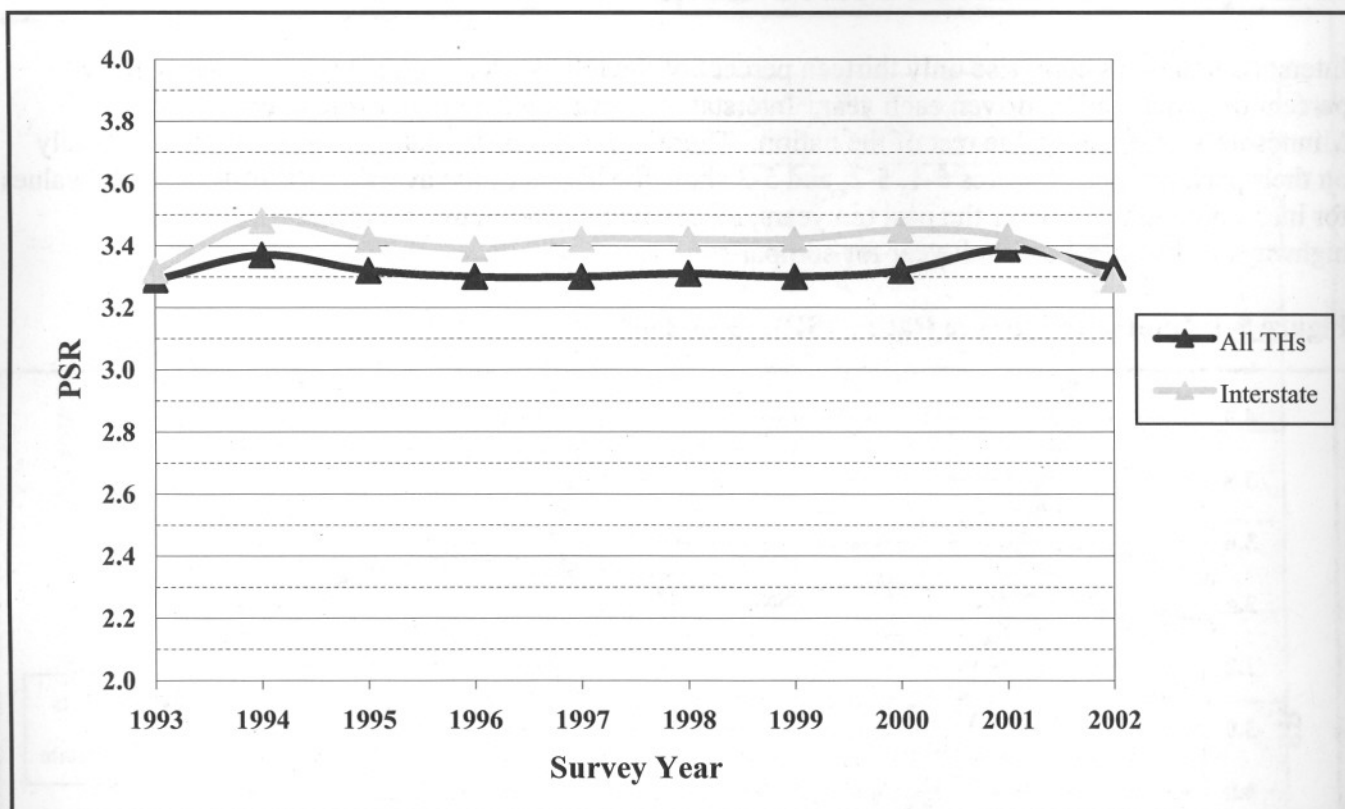
Figure 5-2 Interstate Present Serviceability Rating (PSR), 1993-2002

The data also shows that the average PSR on the interstate system decreased sharply from 2001 to 2002. For the first time since 1992, the condition of the Interstate system, as measured by the average PSR, fell below that of the non-Interstate system. Since there have been no changes to the PSR method or equipment since 2000, the decrease in the average PSR of the Interstate system likely reflects a decrease in pavement smoothness.

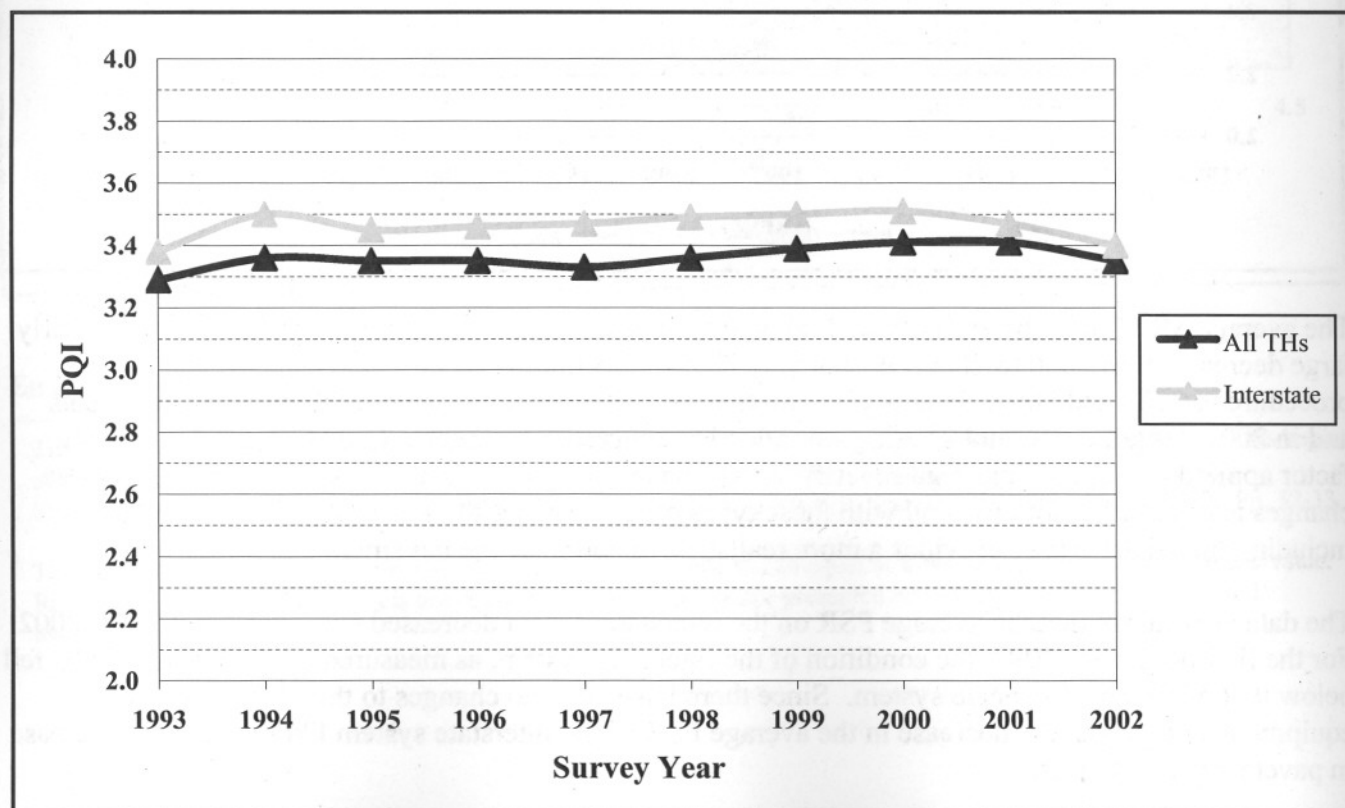
Figure 5-3 Interstate Pavement Quality Index (PQI), 1993-2002

The average PQI of the Interstate system remains above that of the entire system.

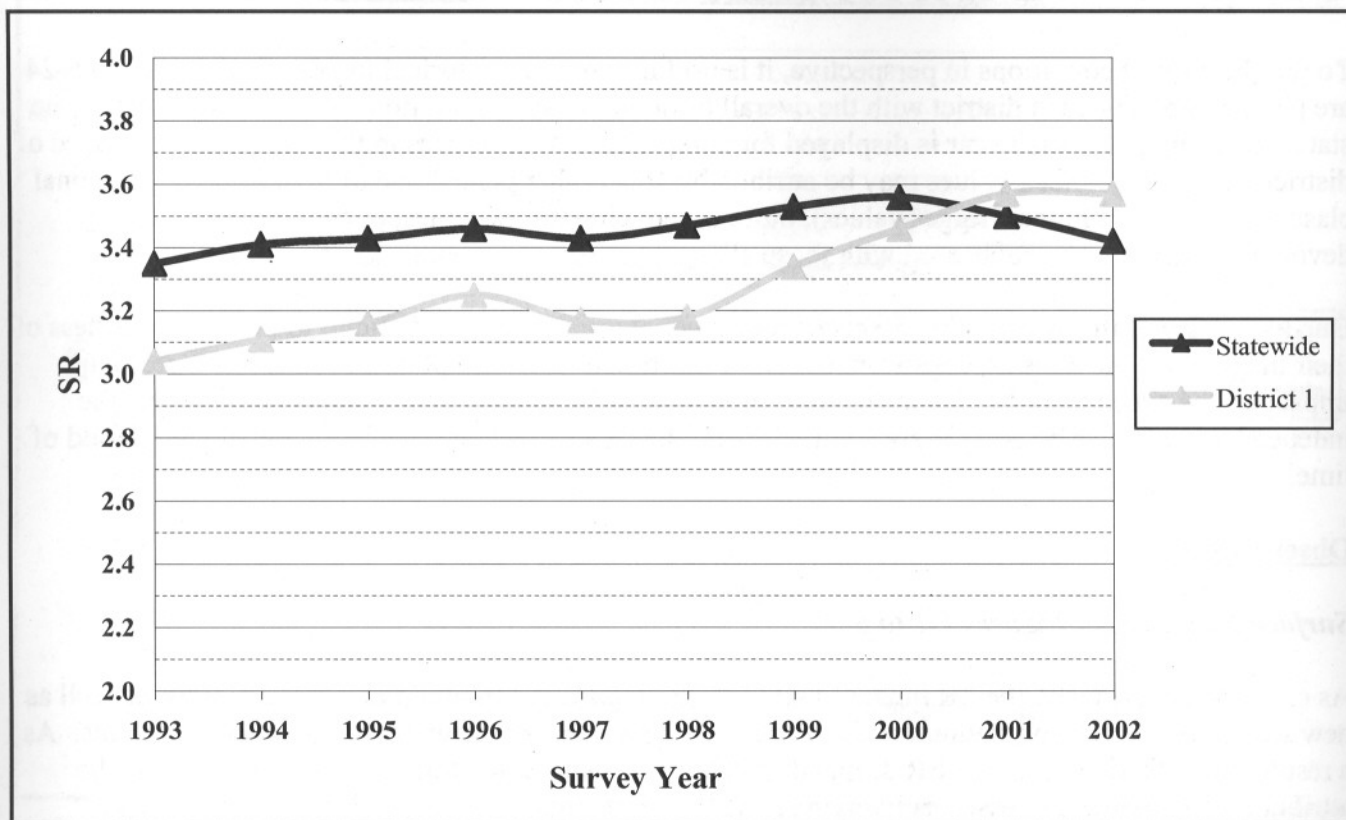
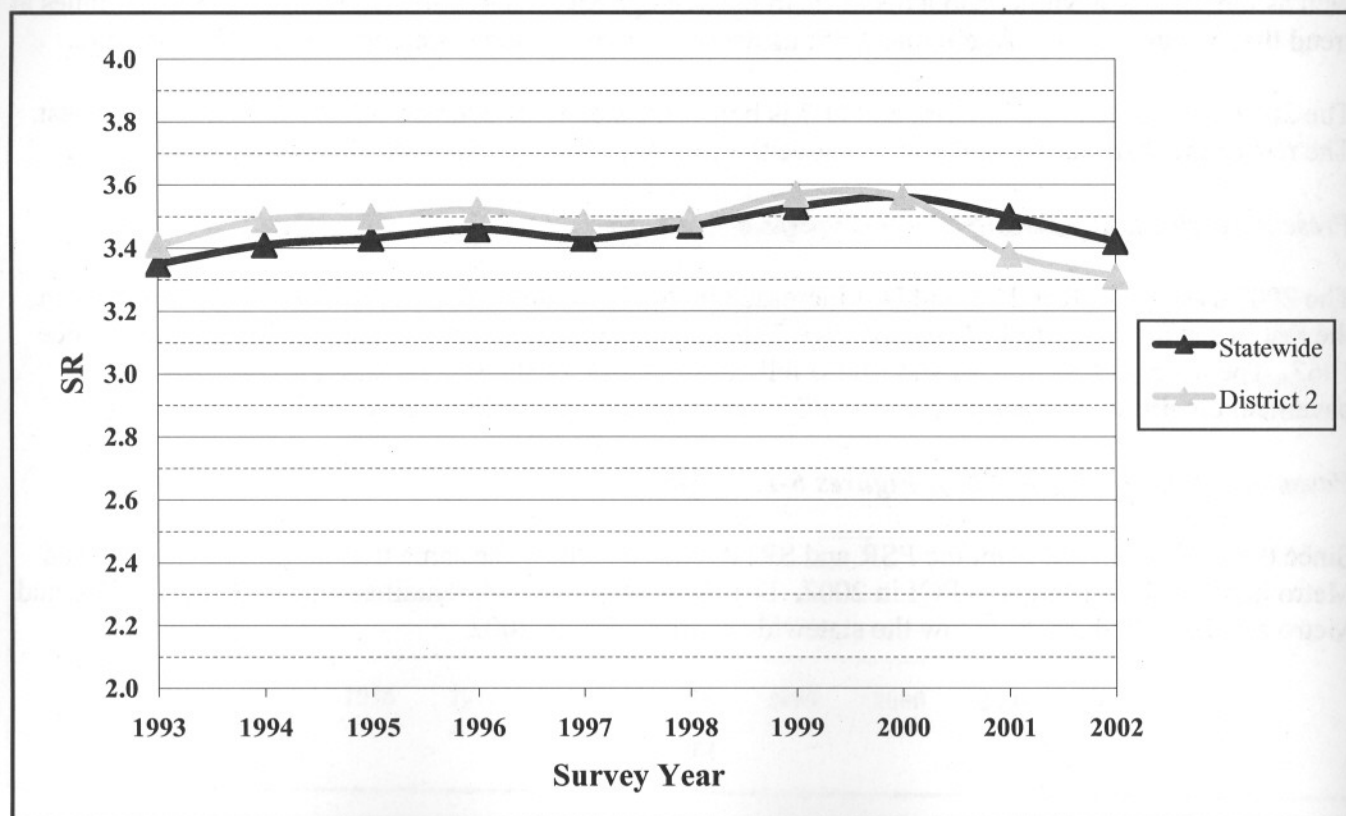
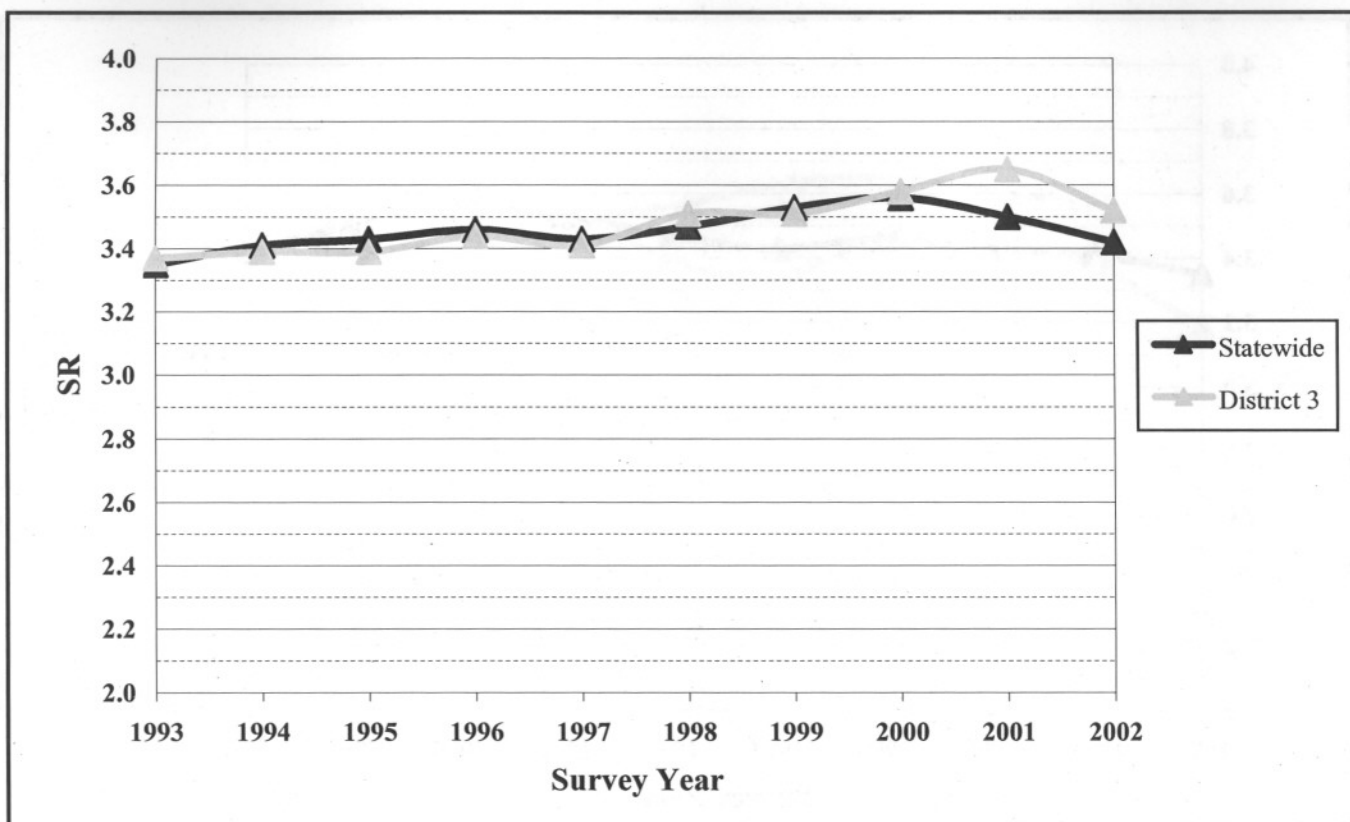
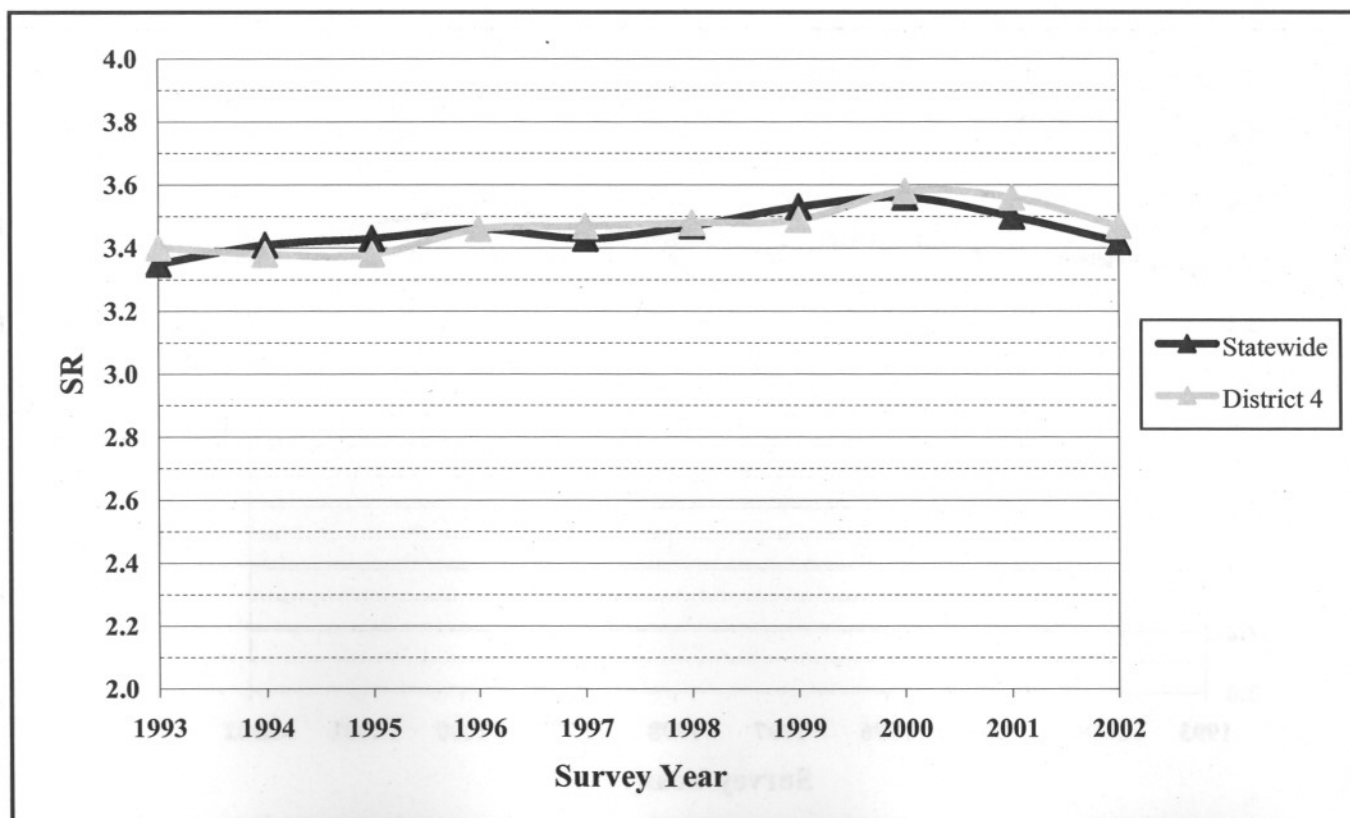
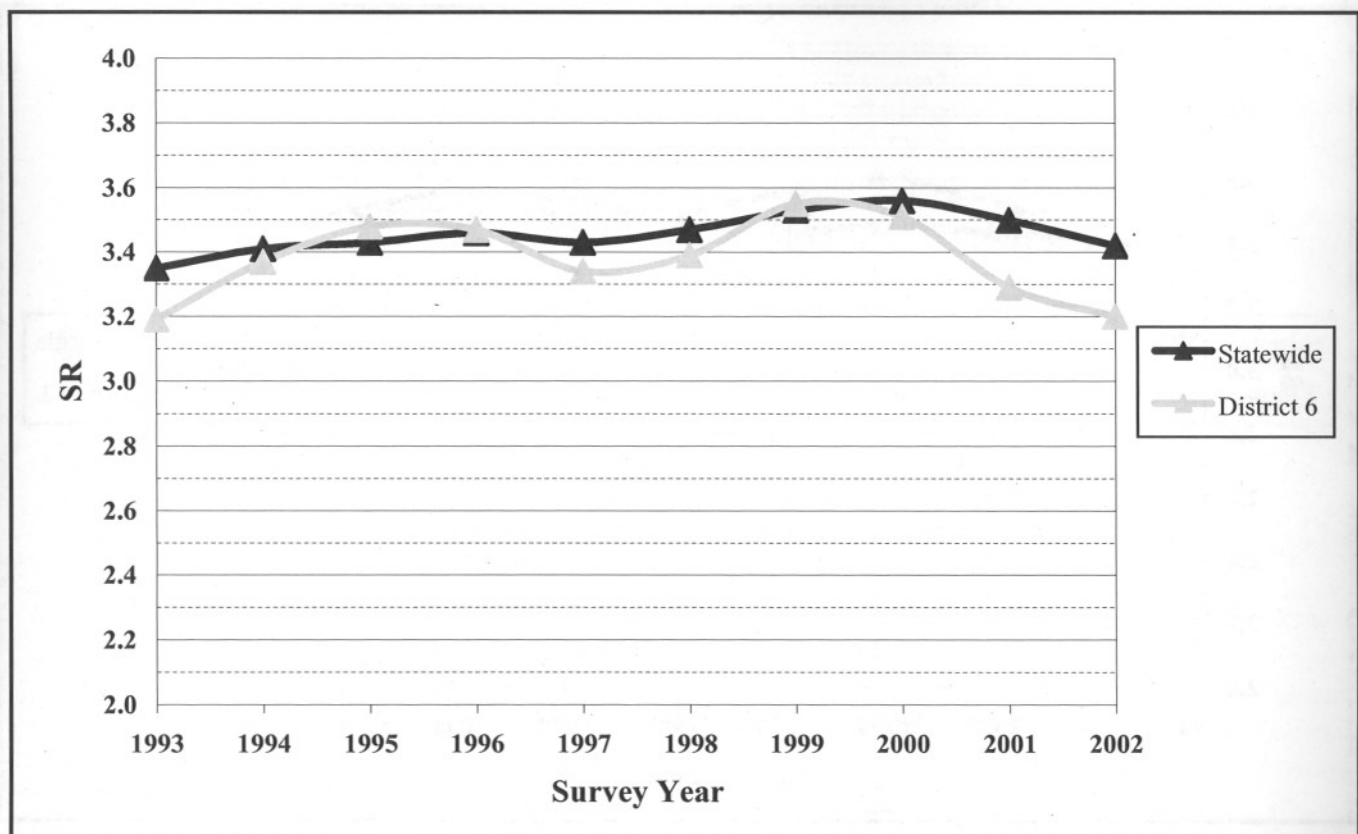
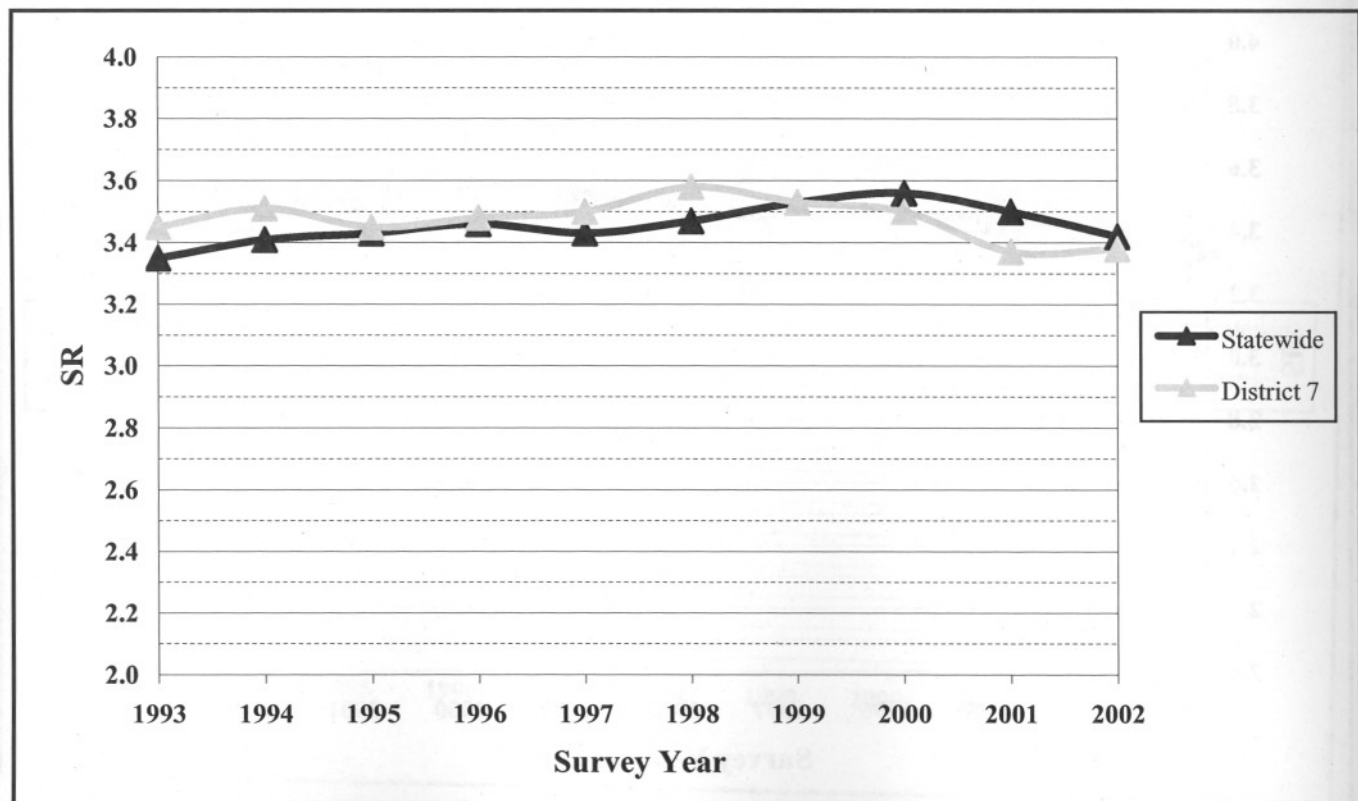
As explained previously, the SR in 2002 includes spalling along longitudinal concrete joints, as well as new weighting factors for medium and high severity transverse cracking on bituminous pavements. As a result, most districts' average SR dropped in 2002. Although not all of the decrease in SR can be attributed to this new distress, it is likely responsible for the majority of the decrease.

The 2002 average SR in both D-1 and D-7 were virtually the same as in 2001. All other districts, as well as the state as a whole, had a decrease in the average SR. This statewide decline in SR continues a trend that began in 2000. Again, most of this decrease is likely due to changes in the SR procedure.

The 2002 average SR in D-2, D-6, and D-7 is below the statewide average with D-6 being the furthest. The rest of the districts are either at or above the statewide average SR with D-1 being the highest.
