*Moving
Minnesota*

2002 Pavement Management Annual Report

March 2003

Office of Materials and Road Research
Pavement Management Unit

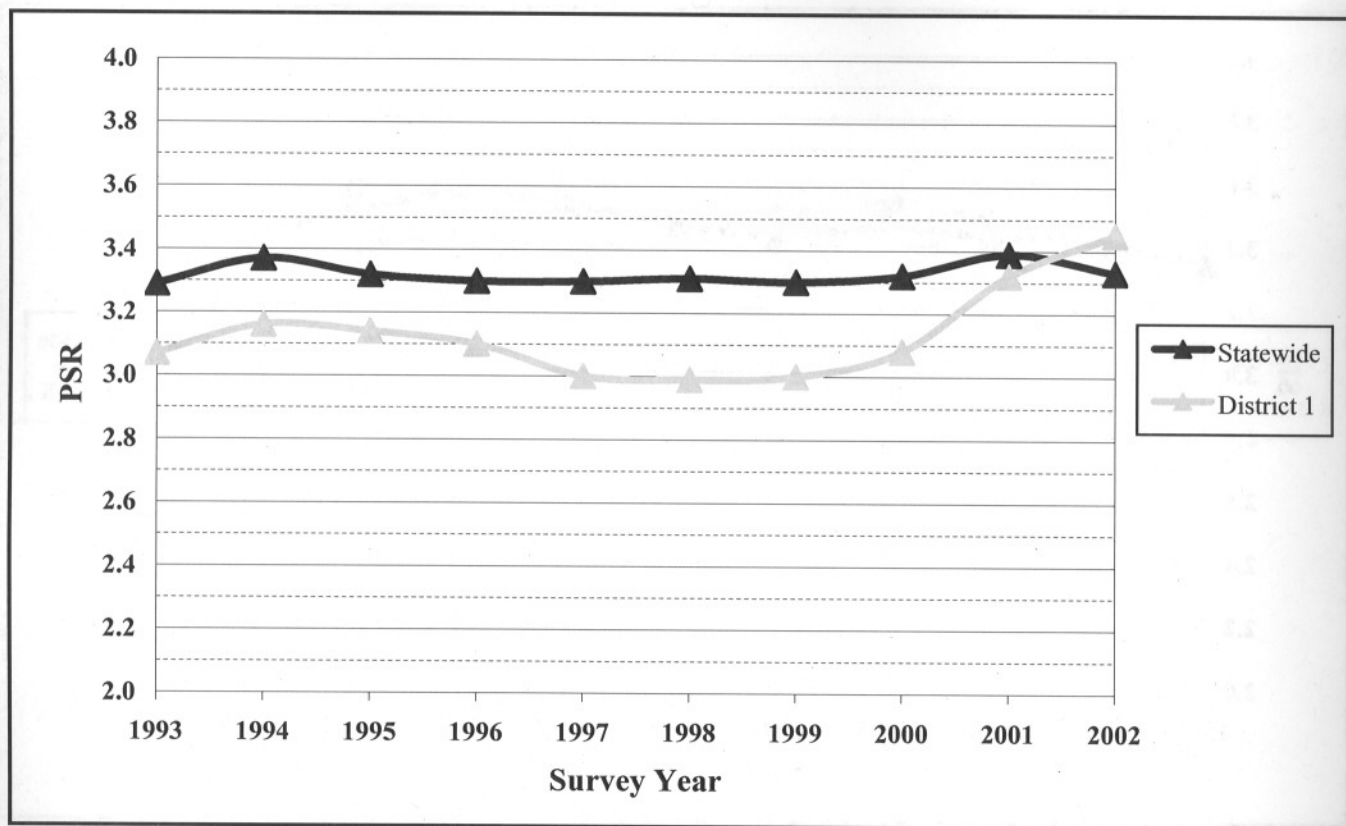
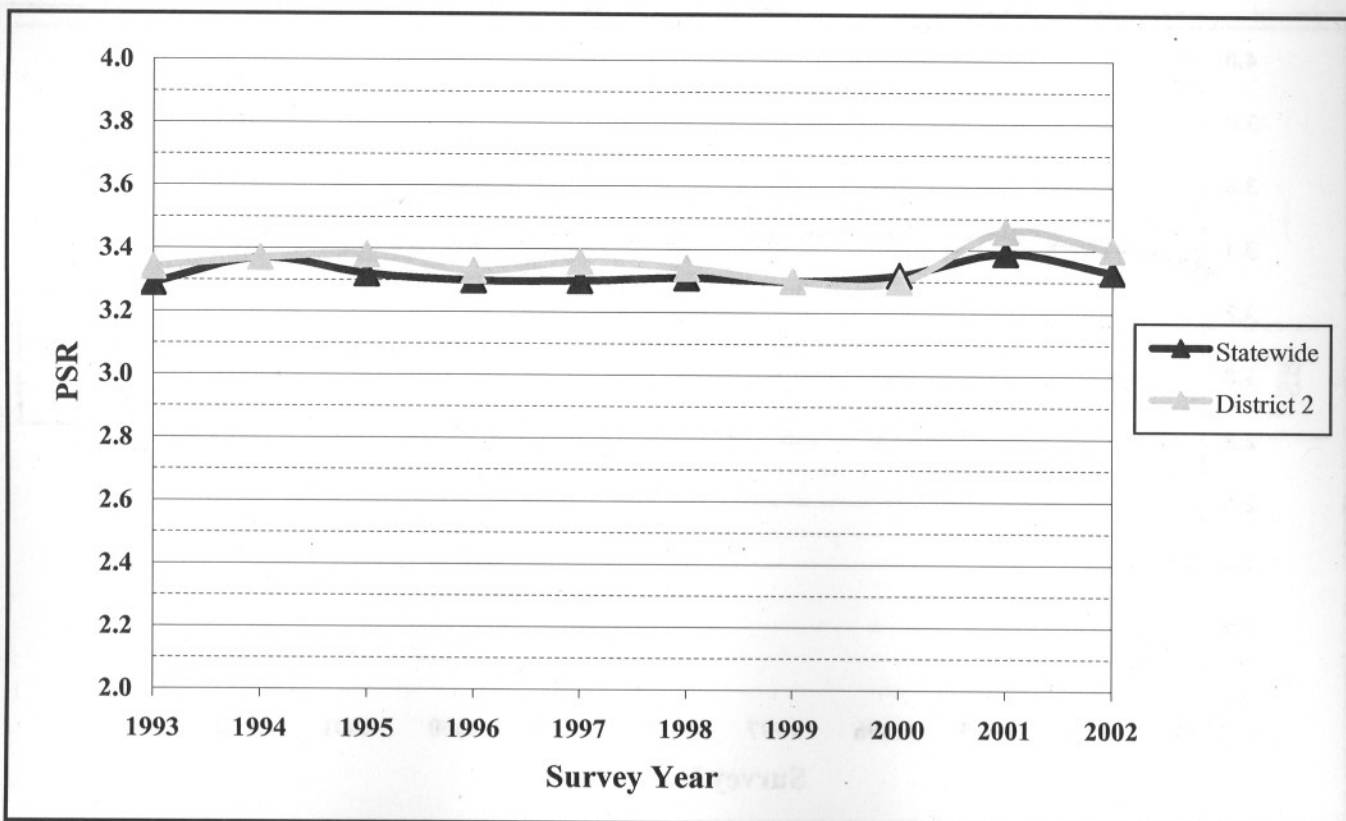
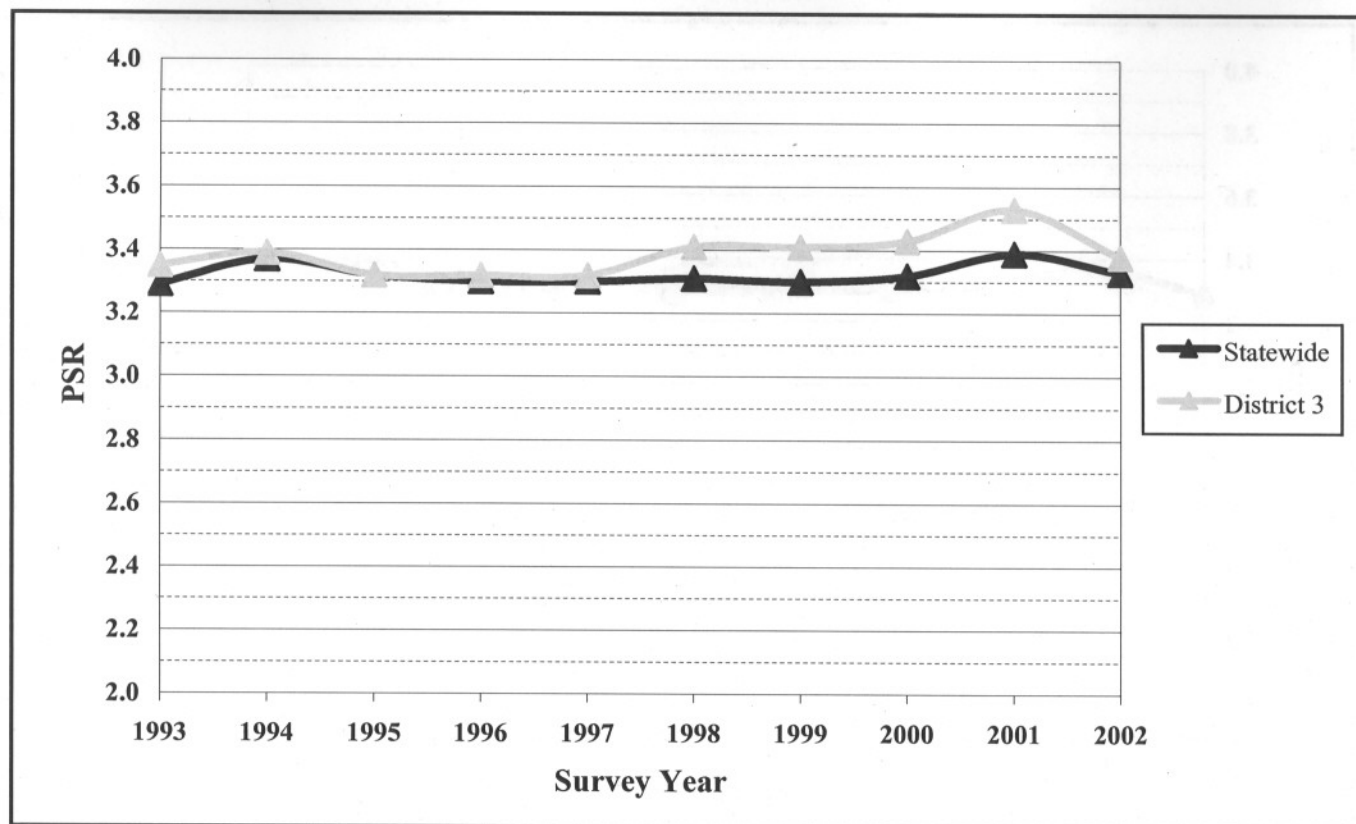
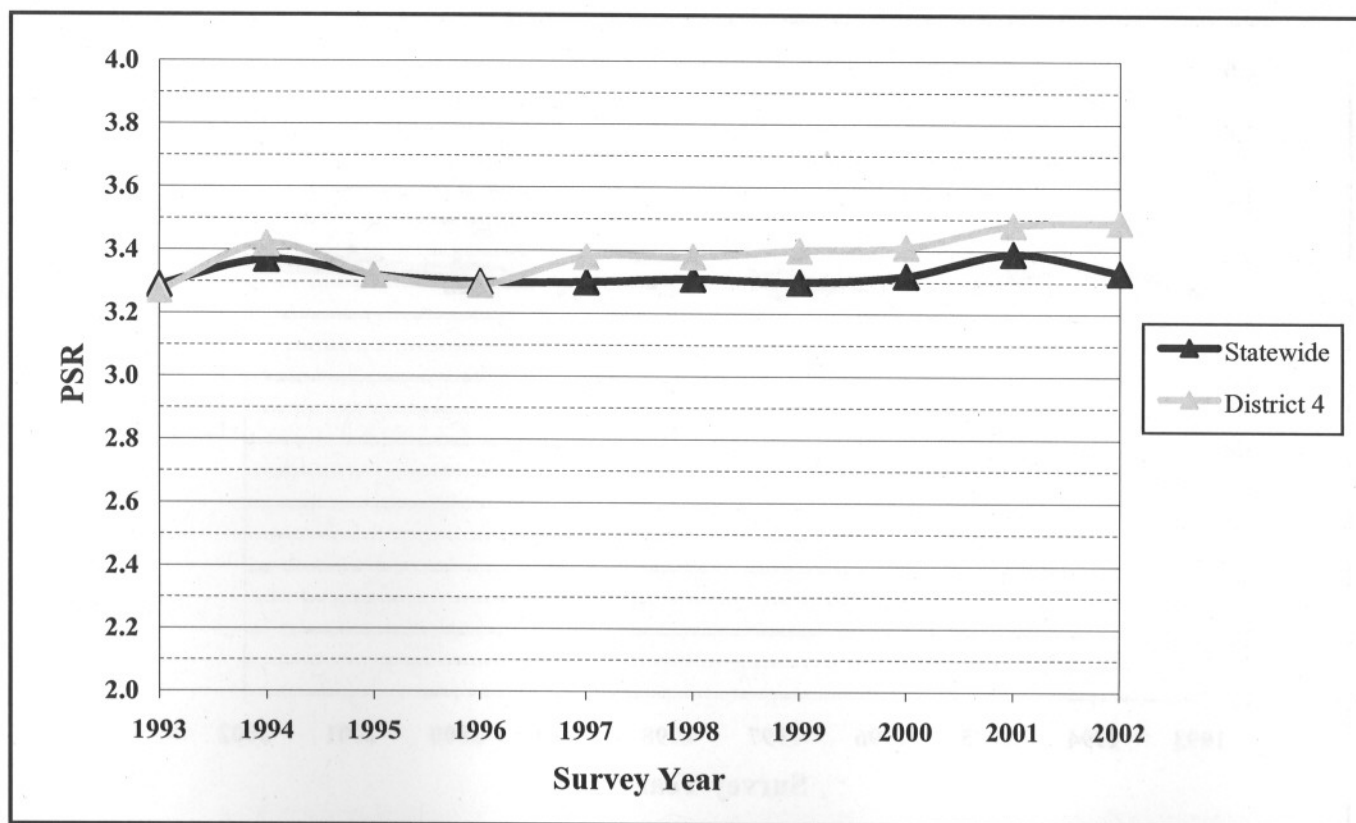
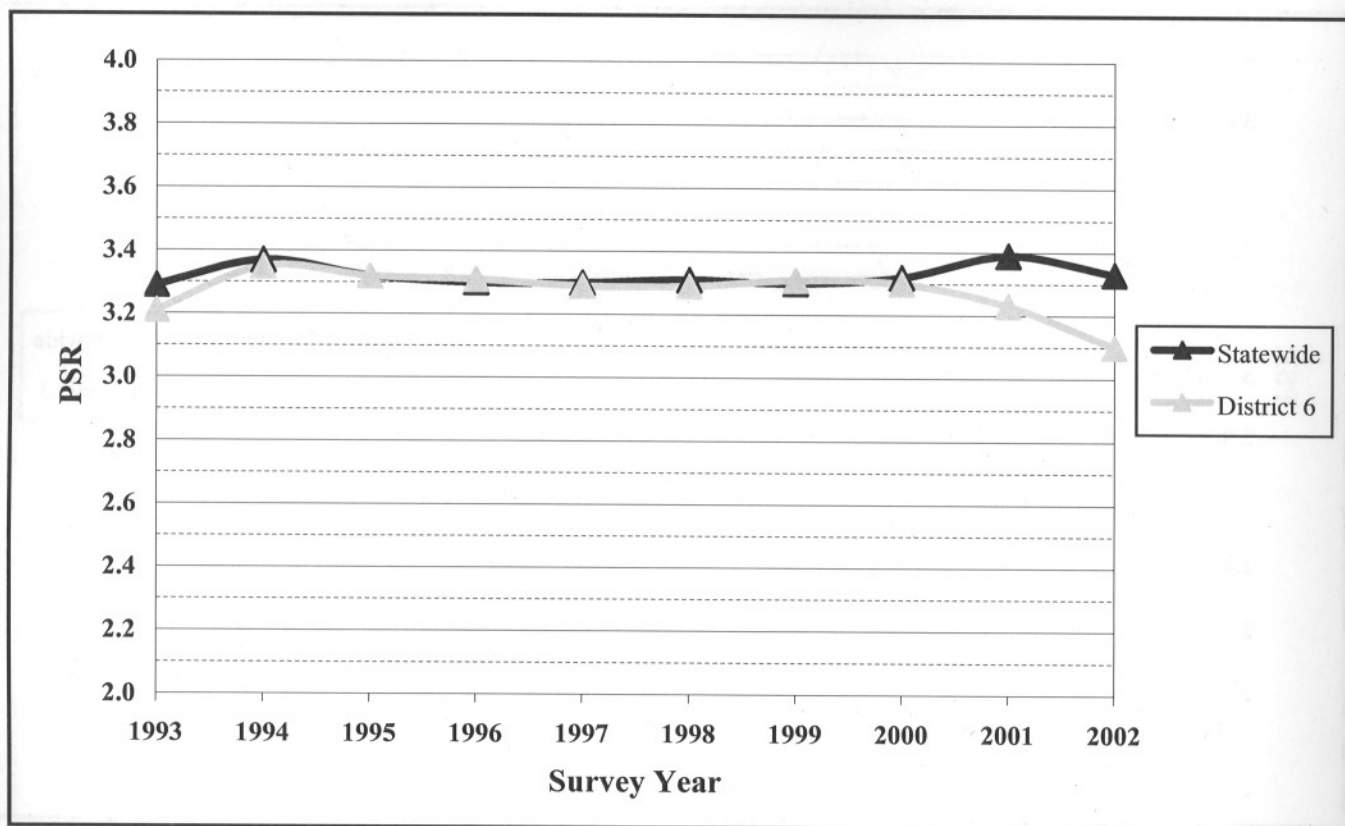
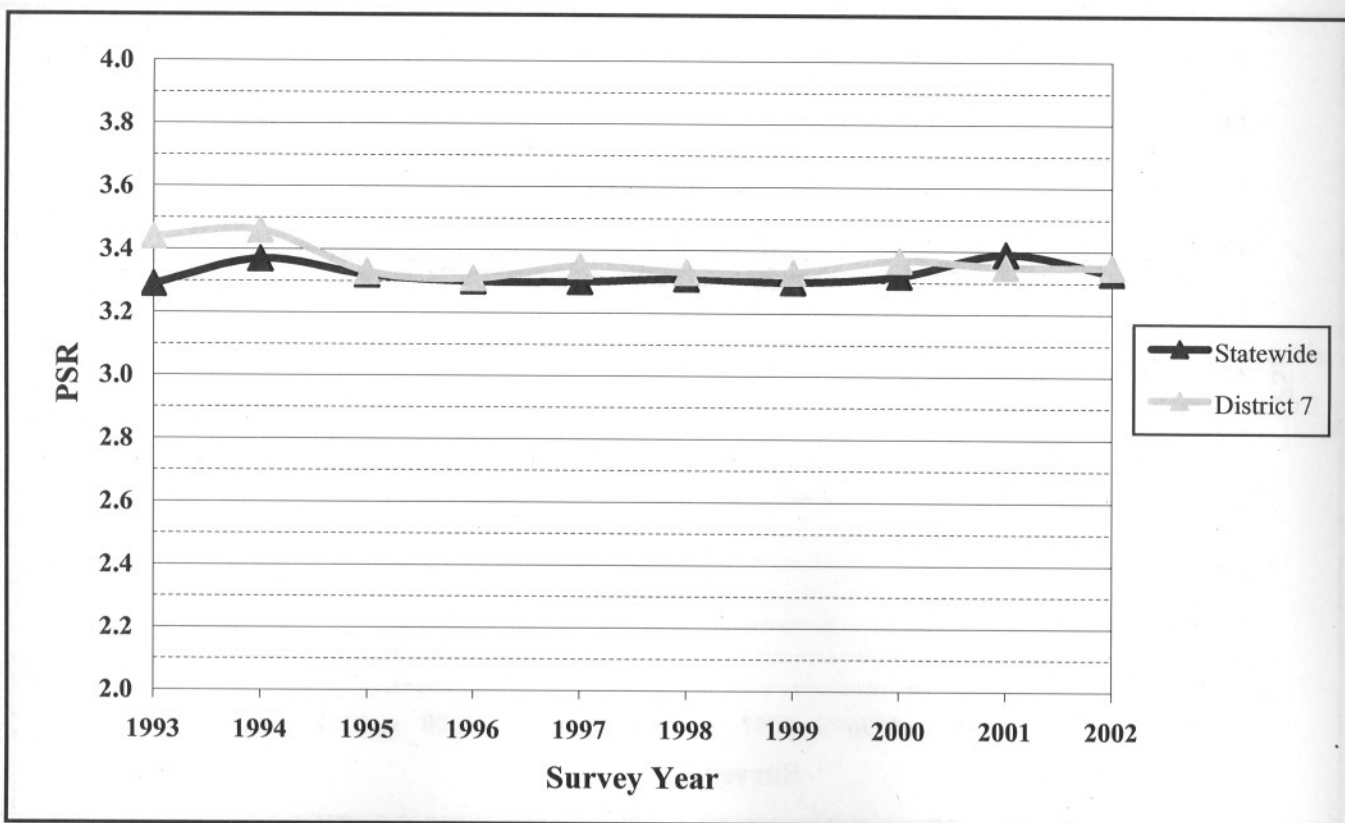
The 2002 average PSR in D-1 and D-4 increased in 2002, remained the same in D-7, and decreased in the rest of the districts. In D-1, the average PSR is above the statewide average for the first time since 1967. The average PSR in D-6 and Metro fell considerably for the second straight year. Metro's pavement condition, as measured by the PSR, has been steadily falling since 1995.

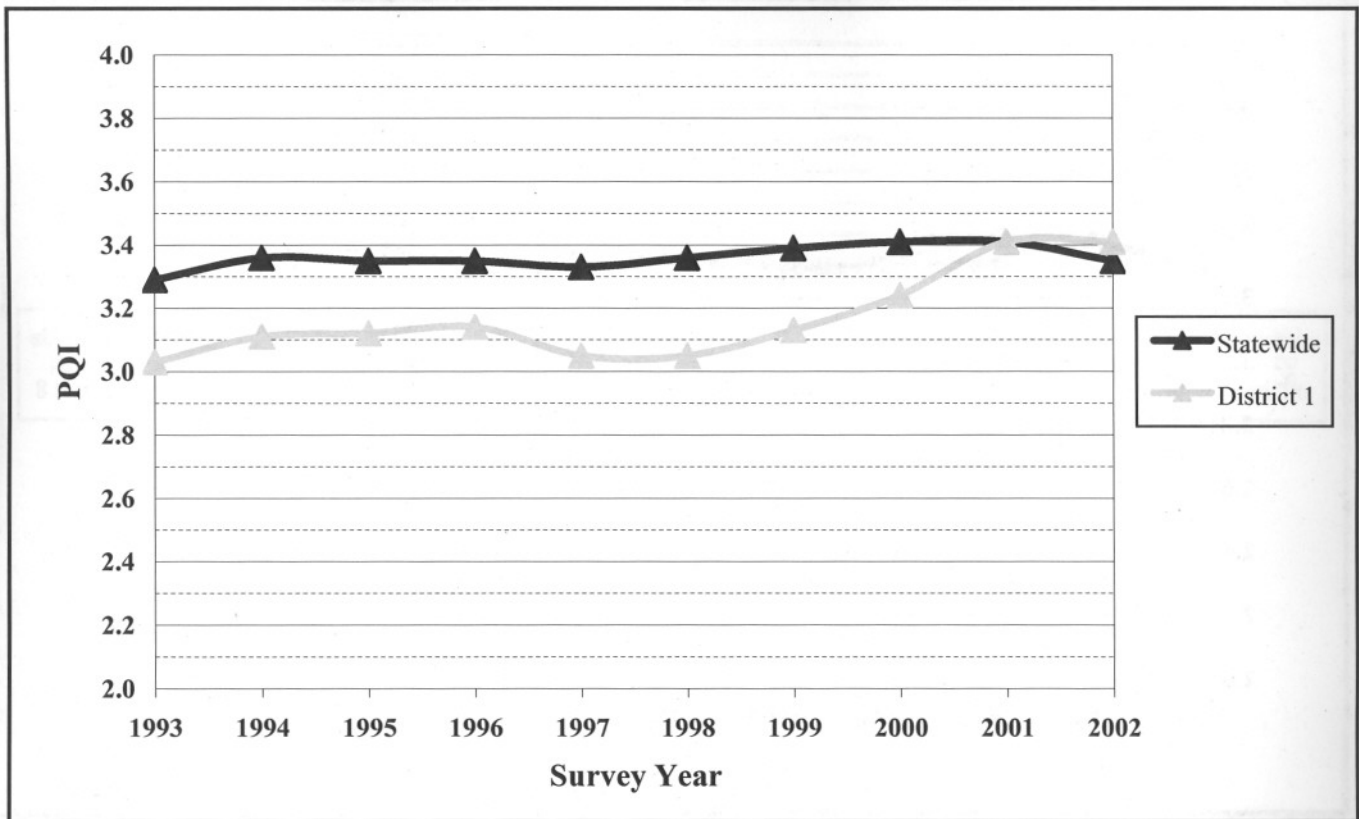
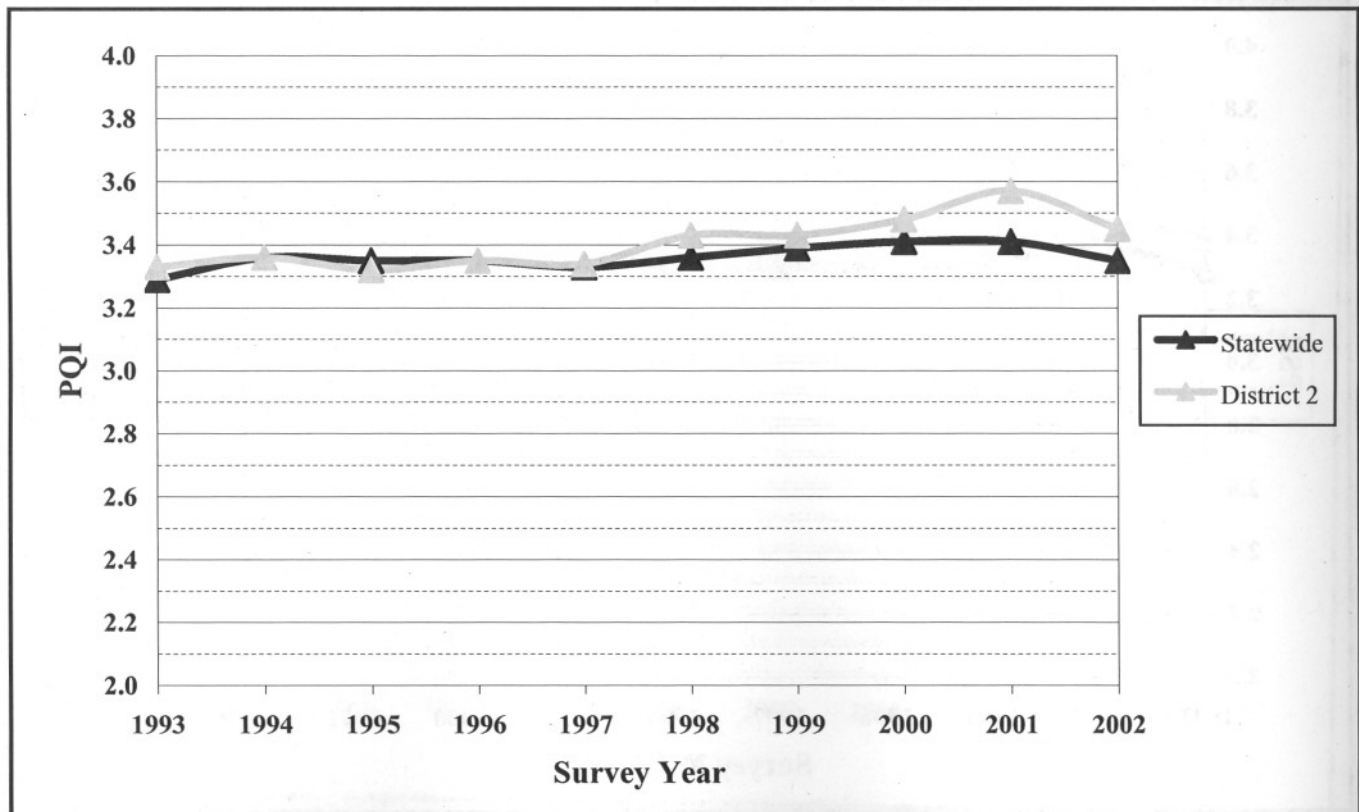
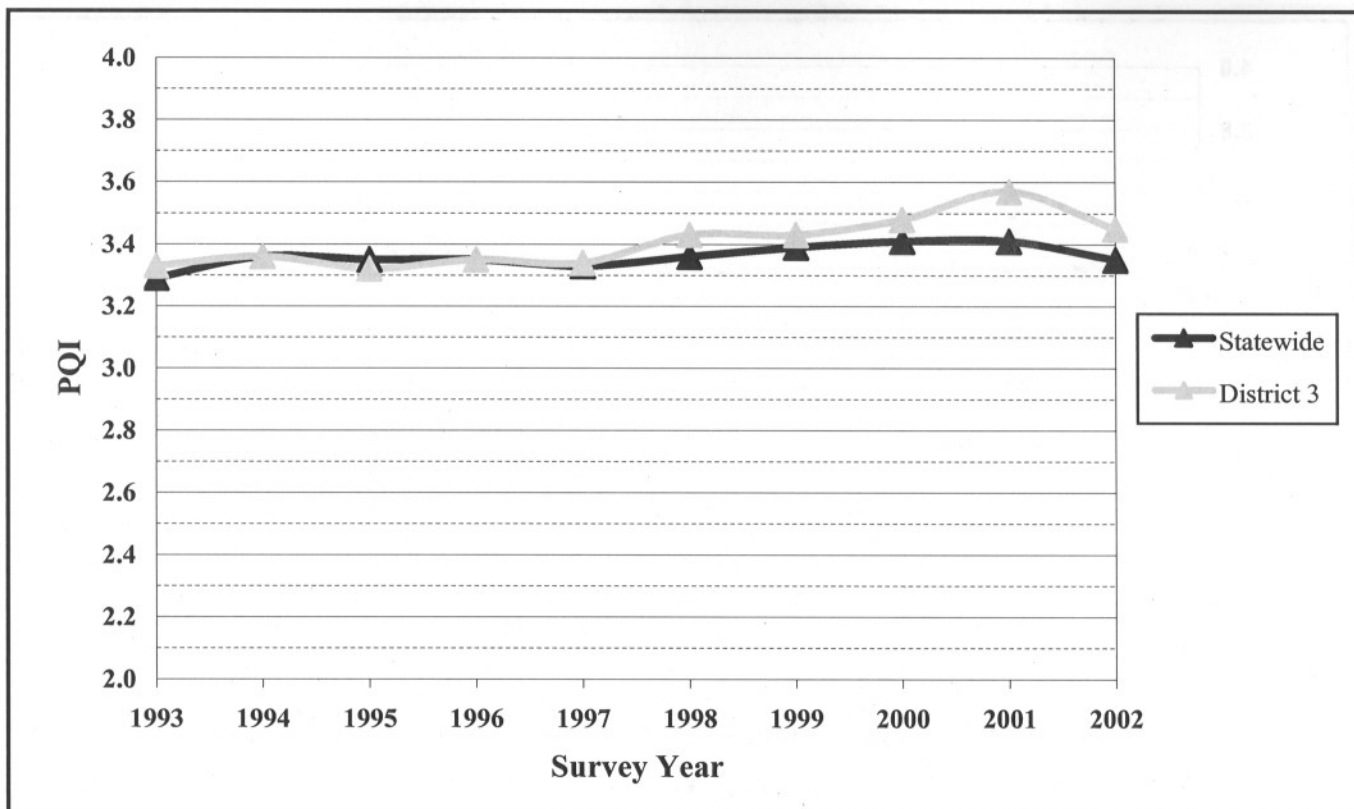
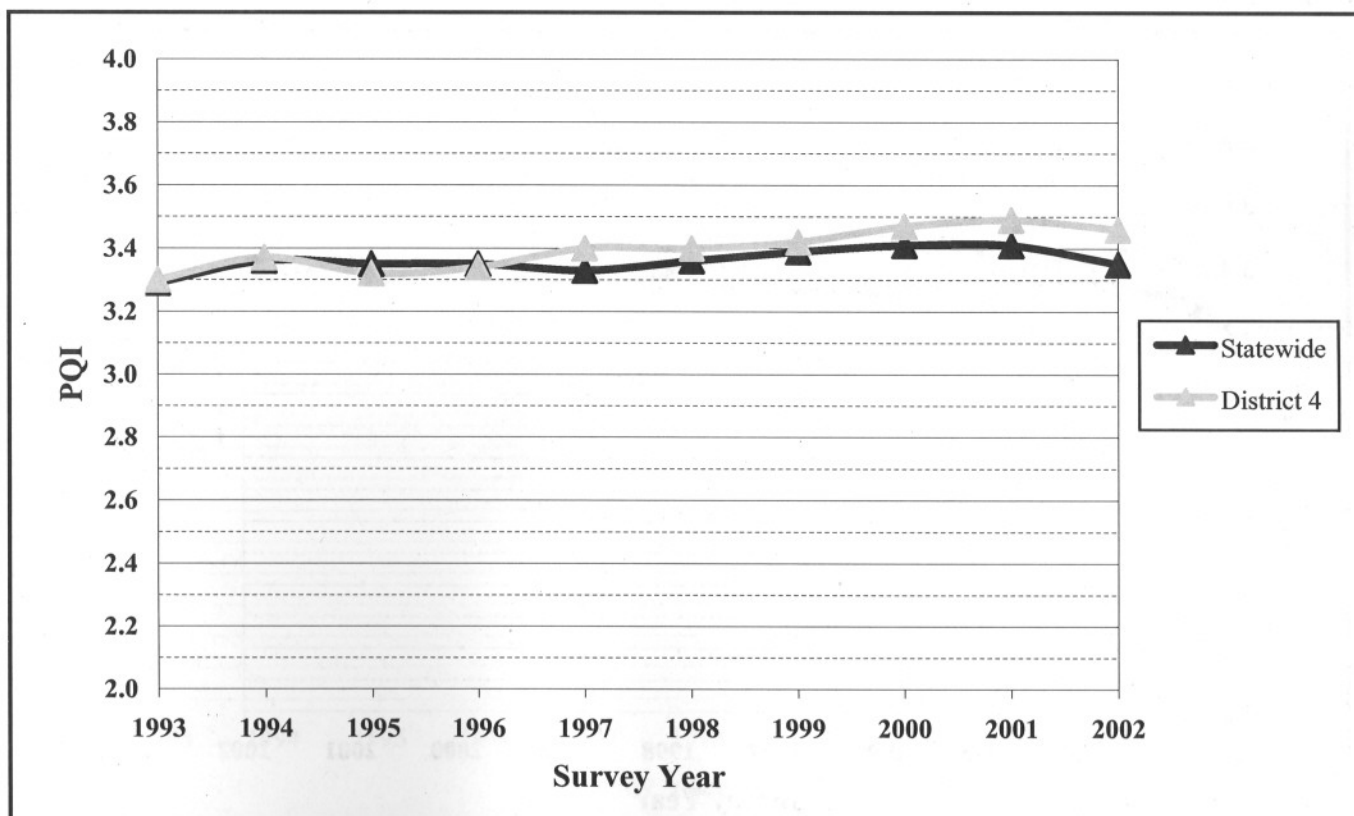
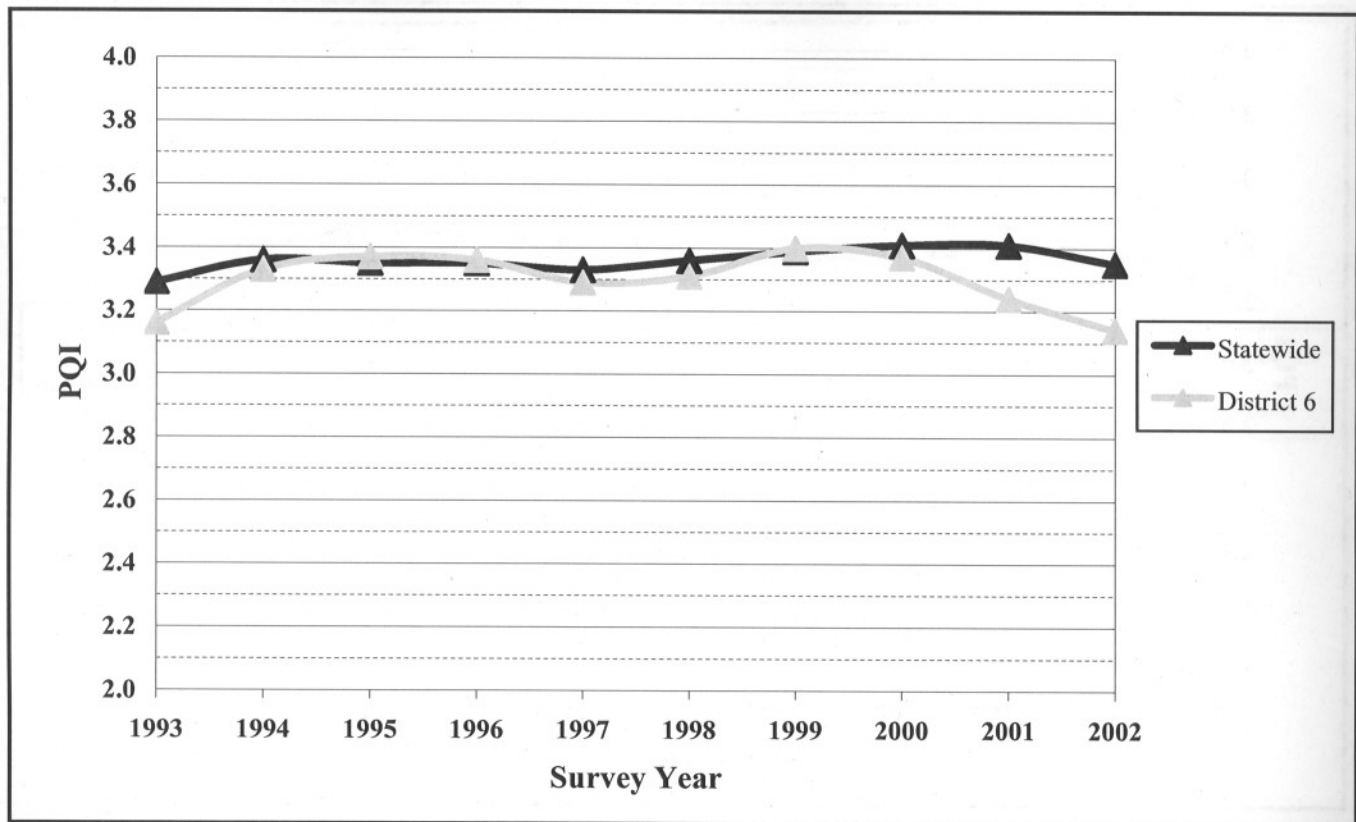
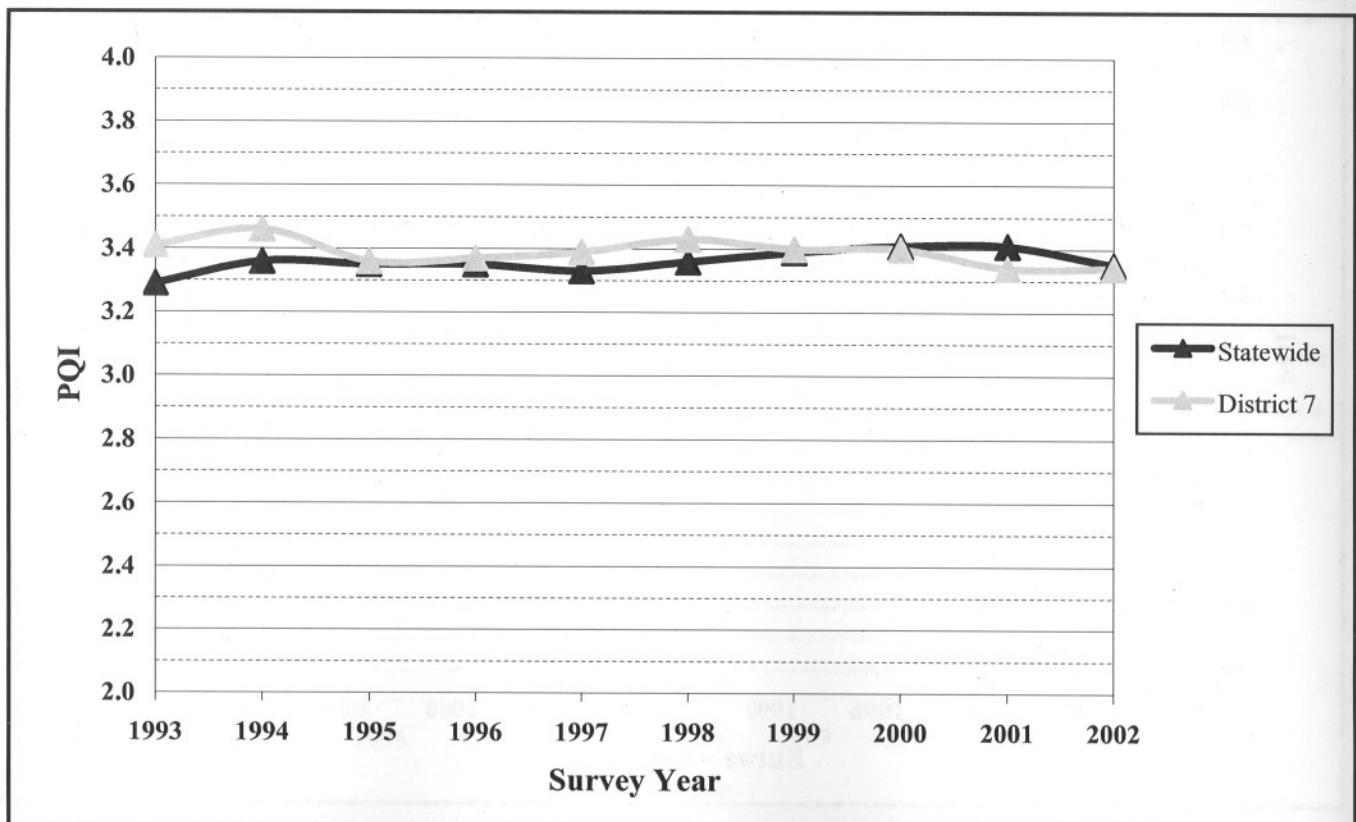
Since the PQI is derived from the PSR and SR, it tends to follow the same trends. D-2, D-3, D-6, and Metro had the largest drops in PQI in 2002. D-1, D-4, D-7, and D-8 remained about the same. D-6 and Metro are the only districts below the statewide average PQI in 2002.
