2004 Pavement Management Annual Report

Report#: MnDOT/OM-PM--2005-03

May 2005
Office of Materials
Pavement Management Unit

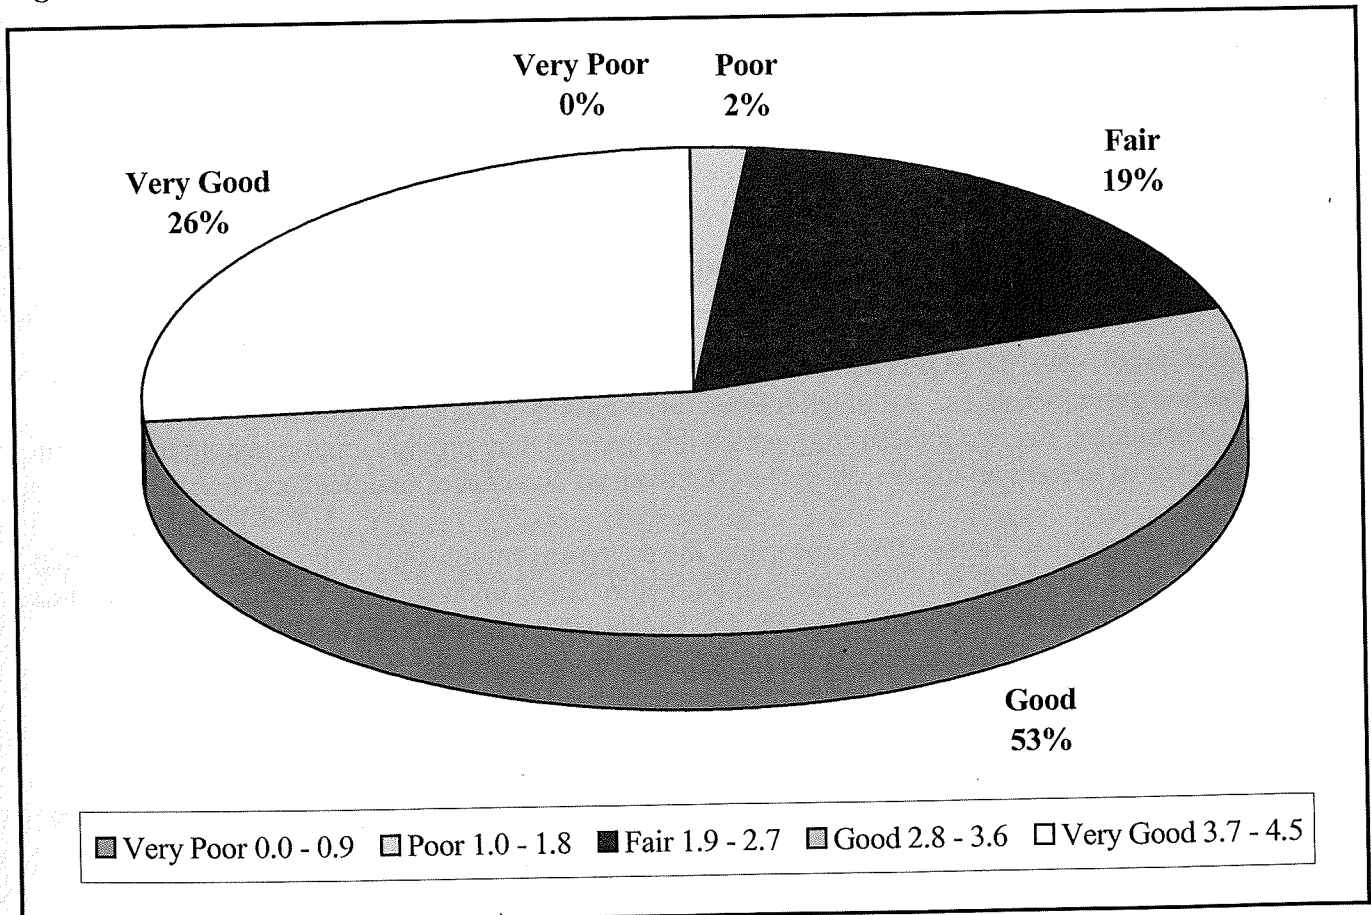
Figure 1-1 Statewide Pavement Quality Index (PQI) Distribution

Pavement condition ratings in this report are based on routine surveys conducted in 2004 for pavement smoothness and surface distress (cracking, patching, etc.). Numerical indices are calculated for both smoothness and distress based on these surveys. In addition, a composite index of these two measurements, called the Pavement Quality Index (PQI), is used to represent the overall condition of the pavement. The PQI ranges from 0.0 to 4.5 and is divided into five equal parts and given a descriptive name, either "Very Good," "Good," "Fair," "Poor," or "Very Poor." Figure 1-1 shows the distribution of the current PQI values of Minnesota's highways.¹

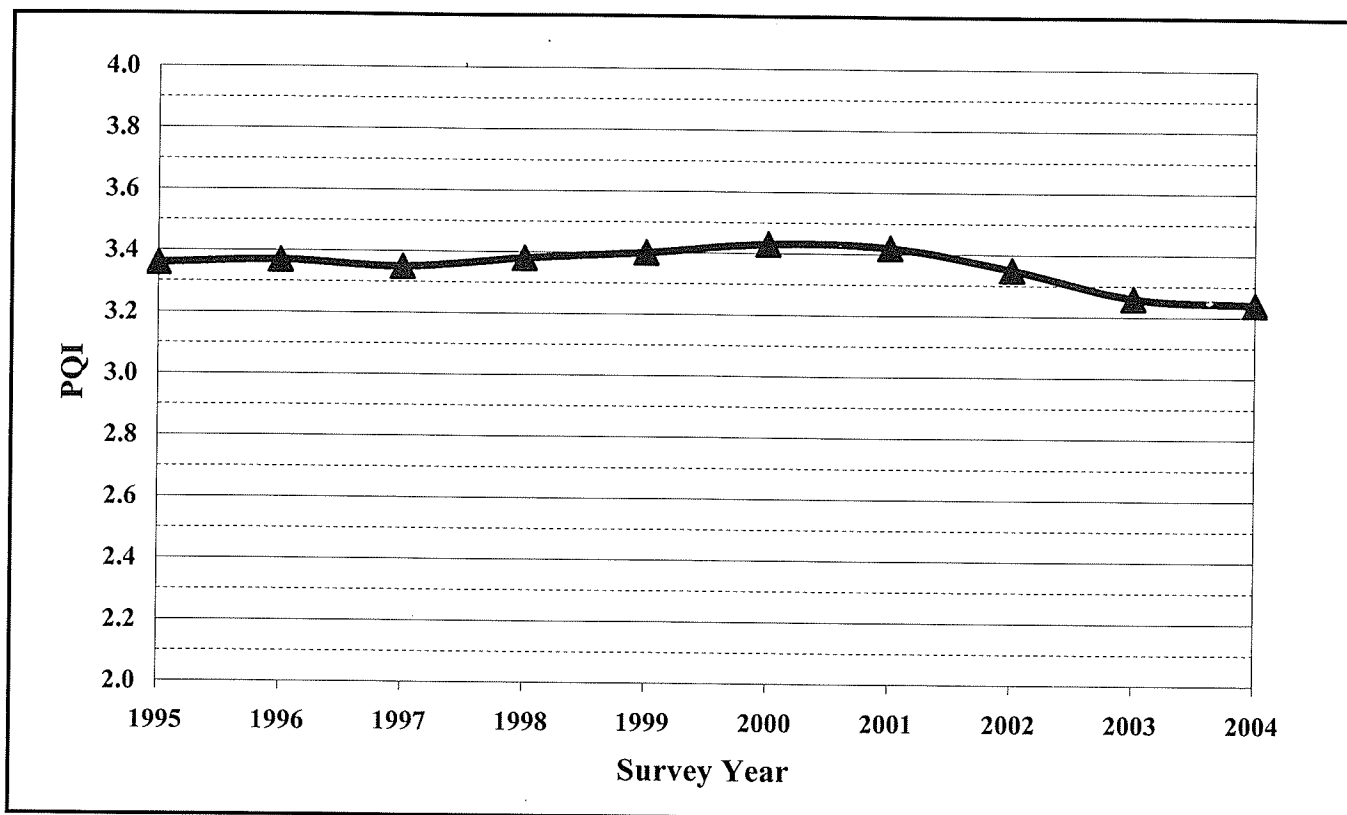
Figure 1-2 Statewide Pavement Quality Index (PQI), 1995-2004

The PQI of each segment of pavement can be used to compare current and past conditions. From this comparison, trends can be developed and predictions of future condition can be made. Figure 1-2 shows the average PQI for the trunk highway system in Minnesota from 1995 to 2004. It is apparent from this figure that there has been a steady decline in the condition of Mn/DOT's highway pavements, as measured by the average PQI, since 2001. An overview of Mn/DOT's highway system is provided in Chapter 2.

- The condition of the Minnesota trunk highway system, as measured by the average PQI, decreased slightly in 2004. Since the average PSR remained virtually the same as last year, the decrease in PQI is attributed to a decrease in the average SR. A drop in the SR indicates there were more cracks and/or higher severity cracks on Mn/DOT highways in 2004.

- The average PQI of the entire trunk highway system decreased slightly in 2004, the fourth straight year of decline. This is attributed to a matching decline of the average SR.

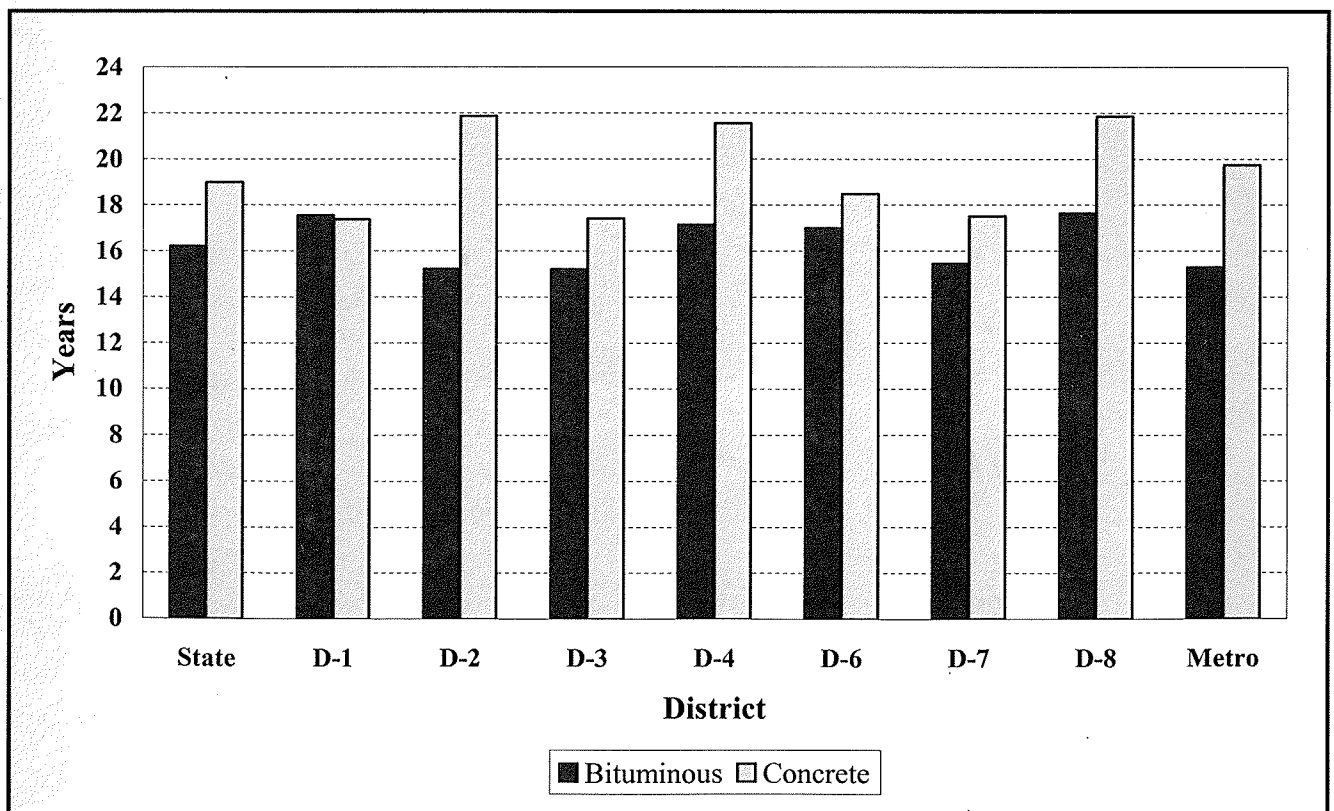
Figure 2-5 Average Time from Original Construction to First Rehabilitation/Reconstruction

The effects of repeated heavy loads and weather extremes on pavement condition necessitate an ongoing program of maintenance and rehabilitation. Rehabilitation and reconstruction are activities that upgrade the pavement structure of a highway after the cumulative loads exceed its actual capacity or the pavement has deteriorated for other reasons. Rehabilitation work is frequently undertaken with safety enhancements, intersection upgrades, or bridgework. Rehabilitation projects for bituminous pavements primarily include overlays, with or without milling. Rehabilitation projects for concrete pavements include major joint repairs and bituminous or unbonded concrete overlays. Figure 2-5 shows the average number of years between original construction and first rehabilitation for pavements built since 1955. Statewide, the average age when the first rehabilitation for bituminous and concrete pavements is performed is 16 and 19 years, respectively. For bituminous, the first rehabilitation is considered to be when an overlay is placed or the road is reconstructed. For concrete, the first rehabilitation is considered to be when the pavement is overlaid, reconstructed, or has a major joint repair project.

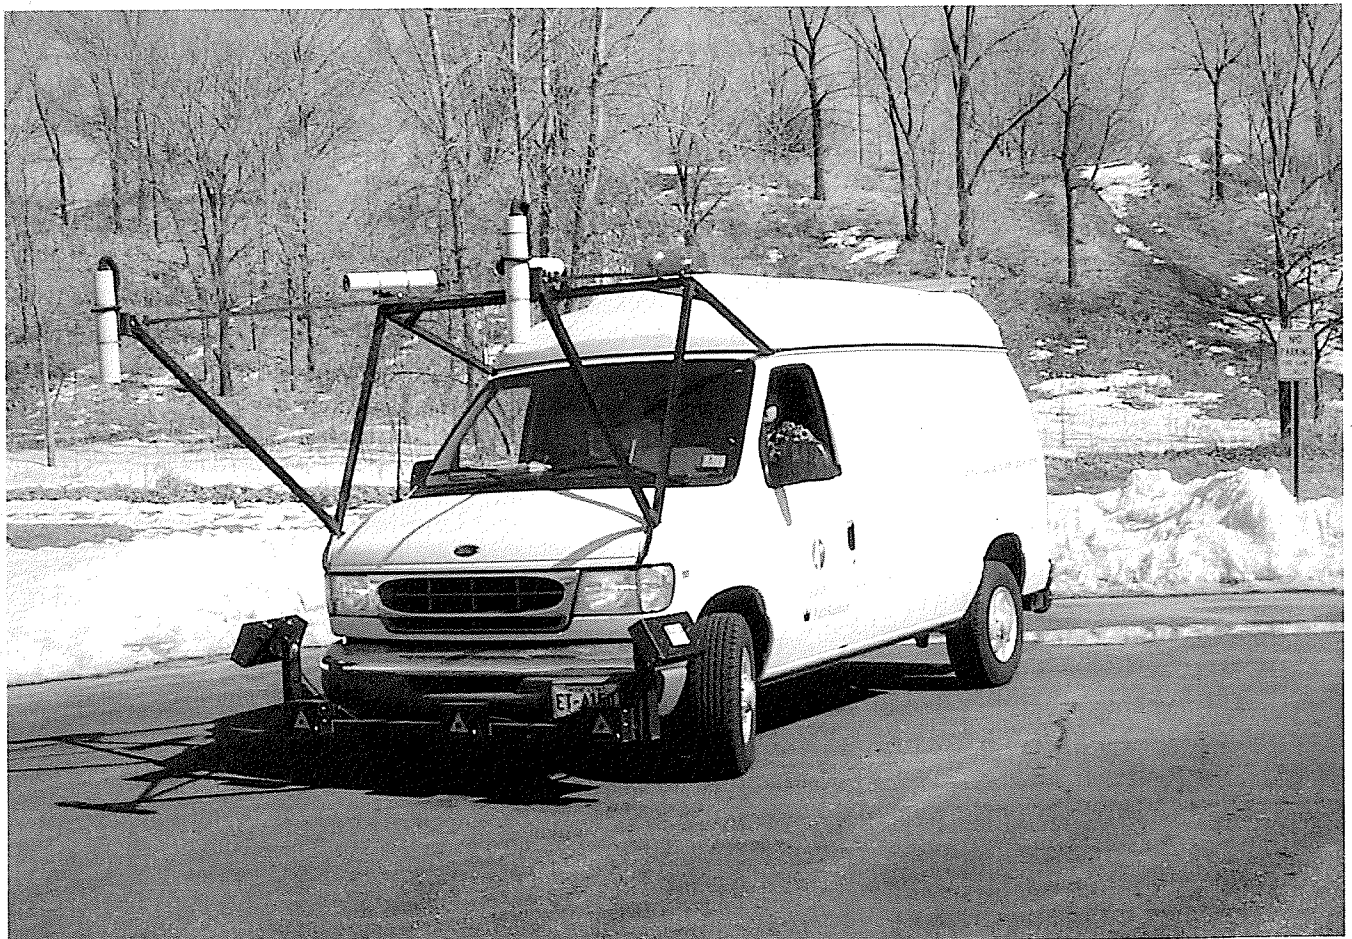
Figure 3-1 Pavement Management Van

Mn/DOT determines the pavement condition using a specially equipped Video Inspection Vehicle (VIV), manufactured by Pathways Services, Inc.

The VIV measures the longitudinal profile of the roadway in addition to capturing video images of the pavement surface and digital images of the surrounding area. In addition, transverse oriented distress such as rutting and faulting are measured.

Generally, pavement distress measurements are made over the first 500 feet of every mile, beginning at each reference post or change in pavement type.ⁱⁱ The pavement surface is filmed with two downward-looking cameras mounted on the VIV. Trained technicians at the Office of Materials view the images and determine the type, severity, and amount of the various pavement distresses using special computer workstations. This procedure provides consistent measurement of surface distresses for all trunk highway pavements throughout the state, as well as a permanent record of conditions at the time of rating. An index called the Surface Rating (SR) is calculated from the distress information. The SR is intended to correspond to a rating by a panel of experienced pavement engineers. SR values range from 0.0 to 4.0. An SR of 4.0 corresponds to a new pavement with no surface distresses. An extremely distressed pavement will have an SR below 2.0.

The VIV is also equipped with lasers mounted across the front of the vehicle. The lasers measure the distance from the van's reference bar to the pavement surface. Rutting and faulting are types of surface distress measured with the lasers. By comparing the value of the lasers mounted across the front of the VIV, an estimate of the transverse profile can be made. Rut depths exceeding 0.5 inches are classified as a surface distress because they allow water to pond in the rut, resulting in icing or hydroplaning. Excessive rut depths also indicate a lack of required structural strength for the loads to which the pavement is subjected. On concrete pavements, faulting over 0.25 inches is considered large enough to warrant attention. If either of these thresholds is exceeded, the SR is reduced.

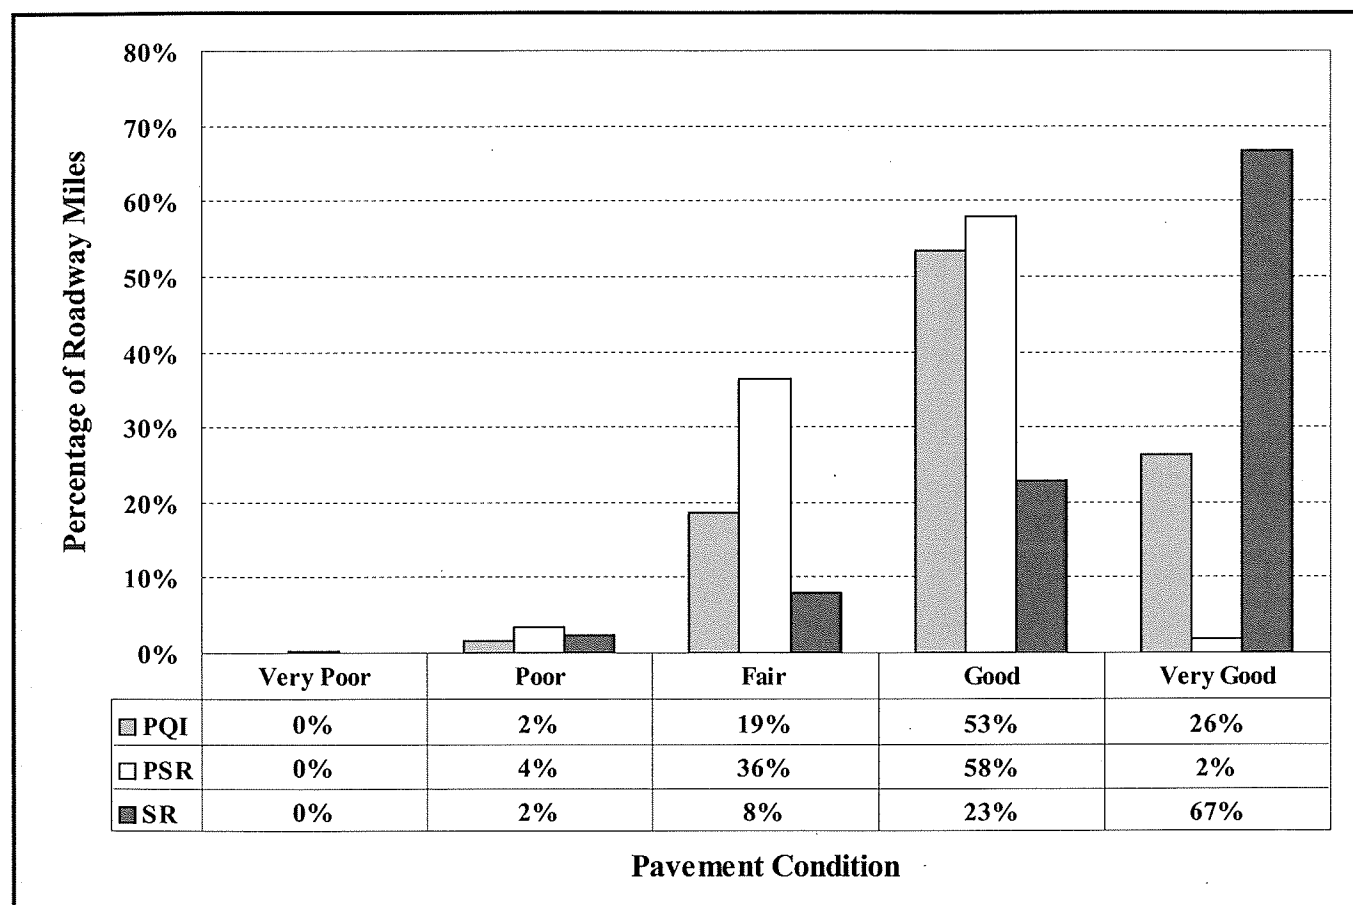
Figure 4-1 Statewide Performance Indices by Performance Classification

Figure 4-1 shows the distribution of the current values of the PQI, PSR, and SR into five equal categories: “Very Poor,” “Poor,” “Fair,” “Good,” and “Very Good.” The category ranges are shown in Table 4-1.

Some observations from Figure 4-1¹:

- The percent of the trunk highway mileage with a PQI in either the “Good” or “Very Good” category in 2004 is 80 percent, down from 83 percent in 2003.
- The percent of the trunk highway mileage with a PQI in either the “Poor” or “Very Poor” category in 2004 is 2 percent, up from 1 percent in 2003.

-
- The percent of the trunk highway mileage with a PSR in either the “Good” or “Very Good” category in 2004 is 60 percent, up from 59 percent in 2003.
 - The percent of the trunk highway mileage with a PSR in either the “Poor” or “Very Poor” category in 2004 is 4 percent, up from 3 percent in 2003.
 - The percent of the trunk highway mileage with an SR in either the “Good” or “Very Good” category in 2004 is 90 percent, down from 91 percent in 2003.

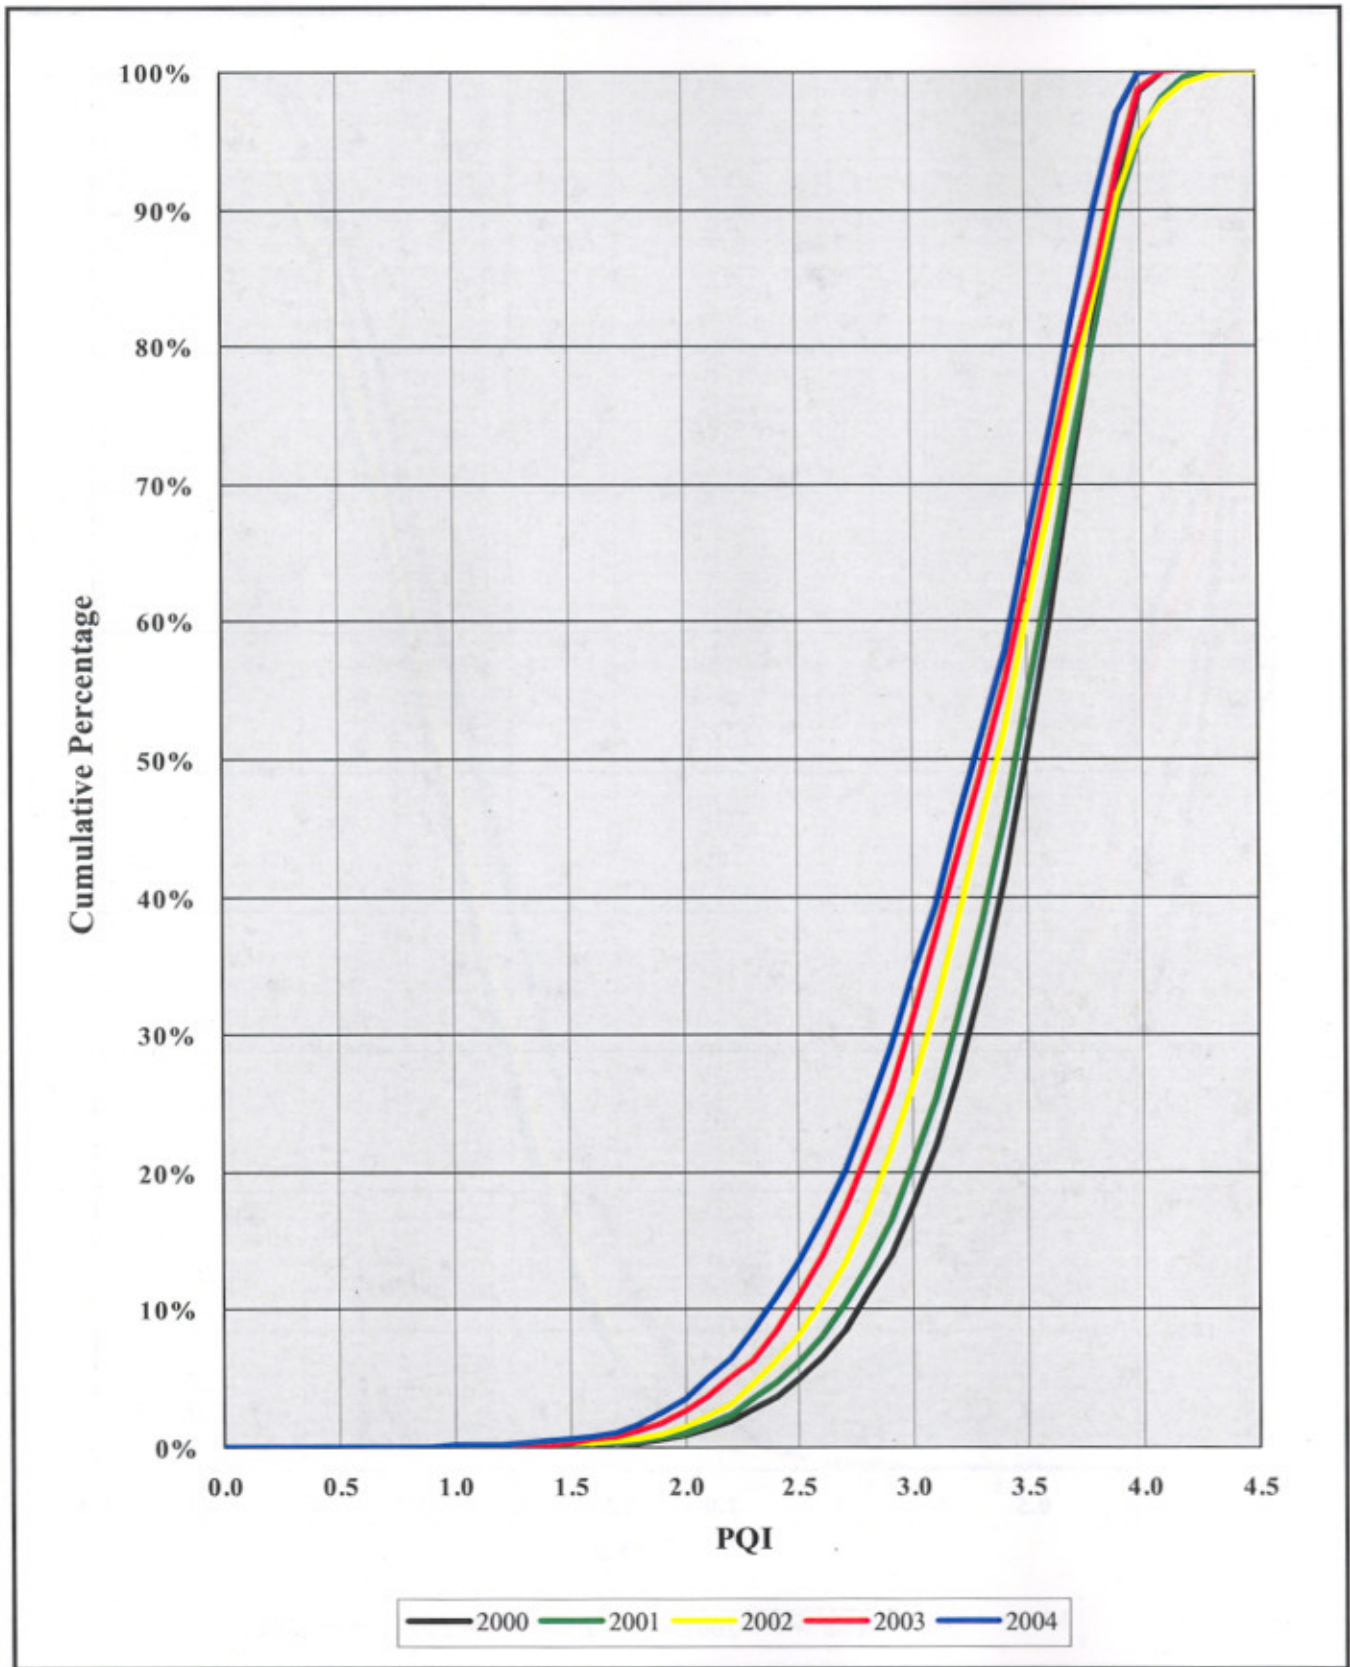
Figure 4-2 Cumulative Distribution of Statewide Pavement Quality Index (PQI), 2000-2004

Figure 4-2 shows a decrease in overall pavement condition, as measured by the PQI (curve is shifted to the left). The gap is fairly uniform, across the whole range of values, indicating a uniform decline in the system.

In order to provide more detailed information about the historical shifts in pavement condition, cumulative distribution graphs are shown in Figures 4-2, 4-3, and 4-4 for PQI, PSR, and SR, respectively. These distribution plots show the percentage of roadway miles with an index value equal to or less than the values shown on the horizontal axis.ⁱⁱ Figures 4-2, 4-3, and 4-4 show the distribution curves for the PQI, PSR, and SR, respectively, for each of the last five years.

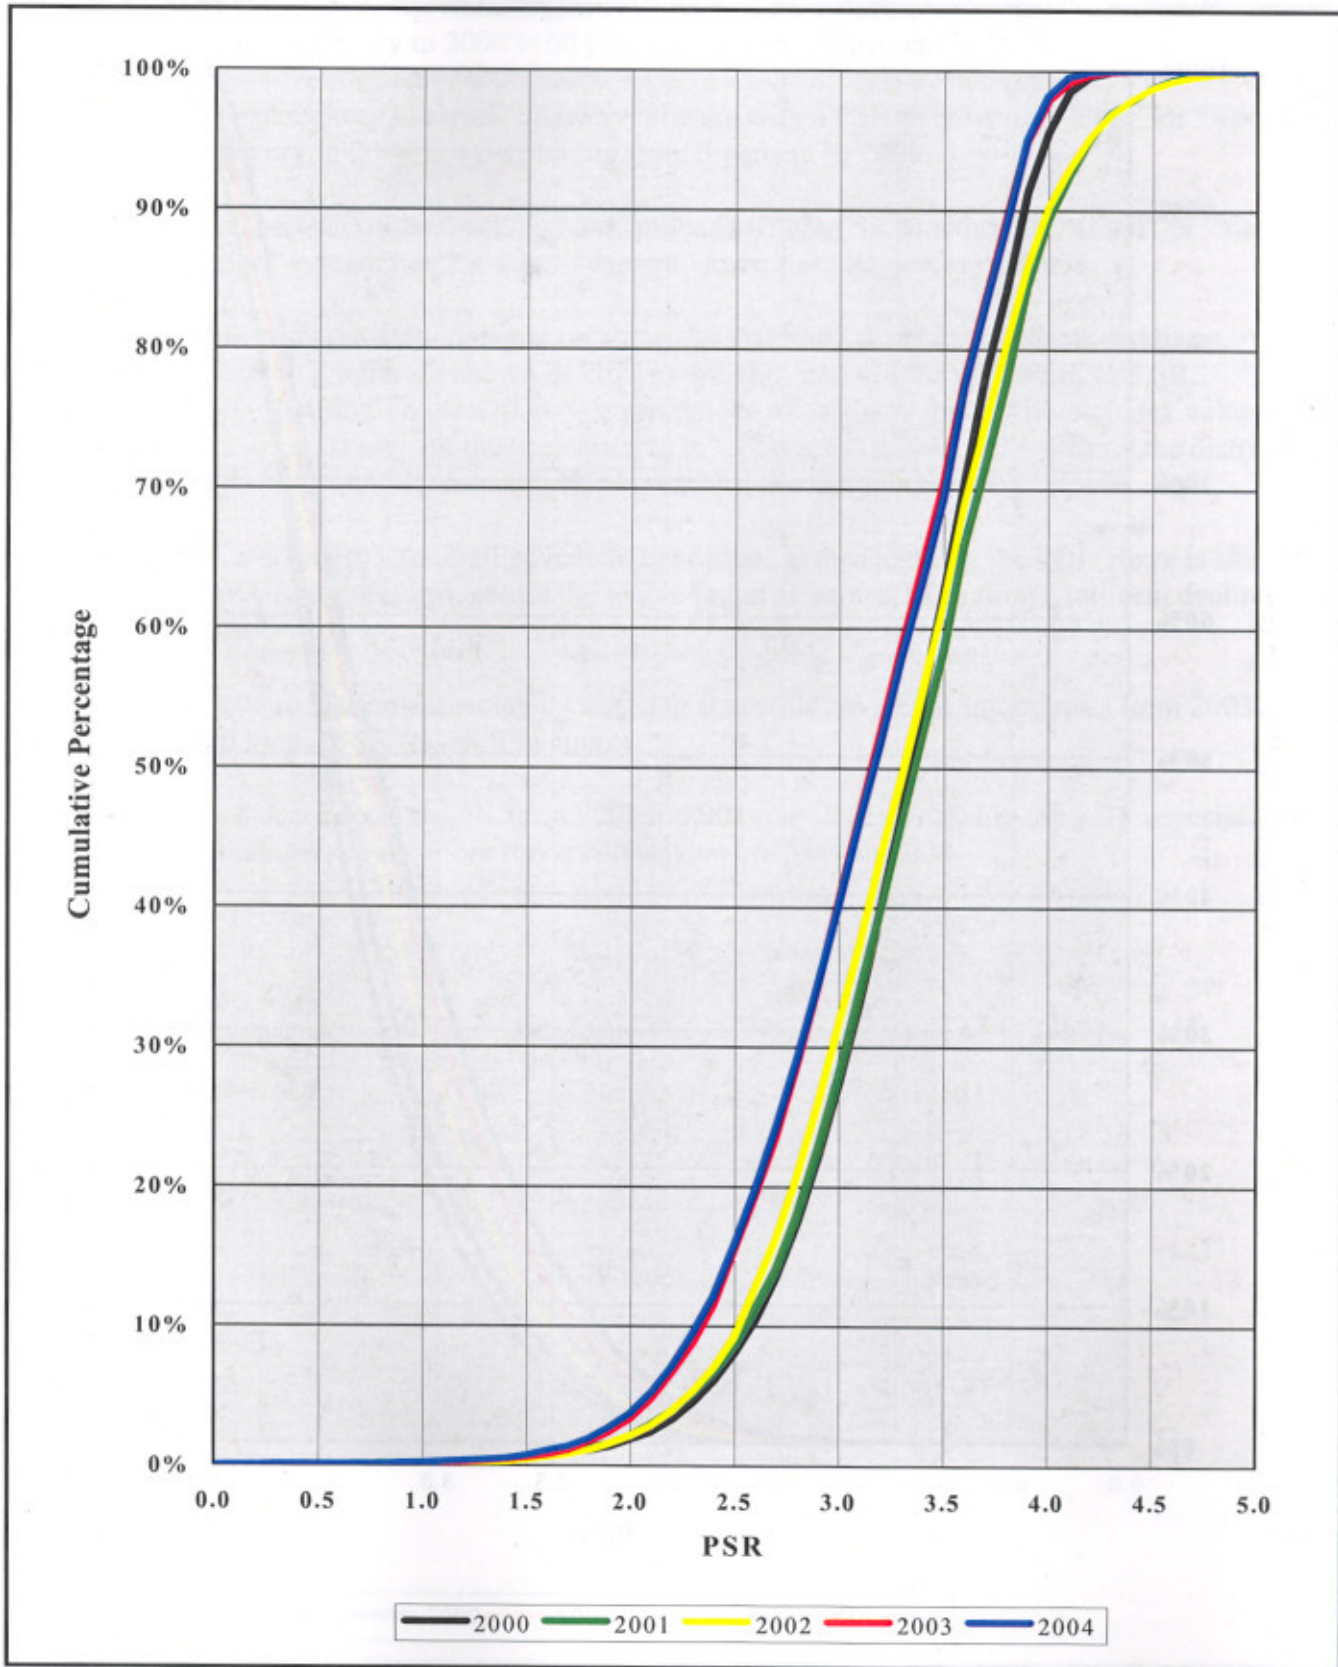
Figure 4-3 Cumulative Distribution of Statewide Present Serviceability Rating (PSR), 2000-2004

Figure 4-3 shows there was no appreciable change in statewide pavement smoothness from 2003 to 2004, as indicated by the PSR (no shift in curve).

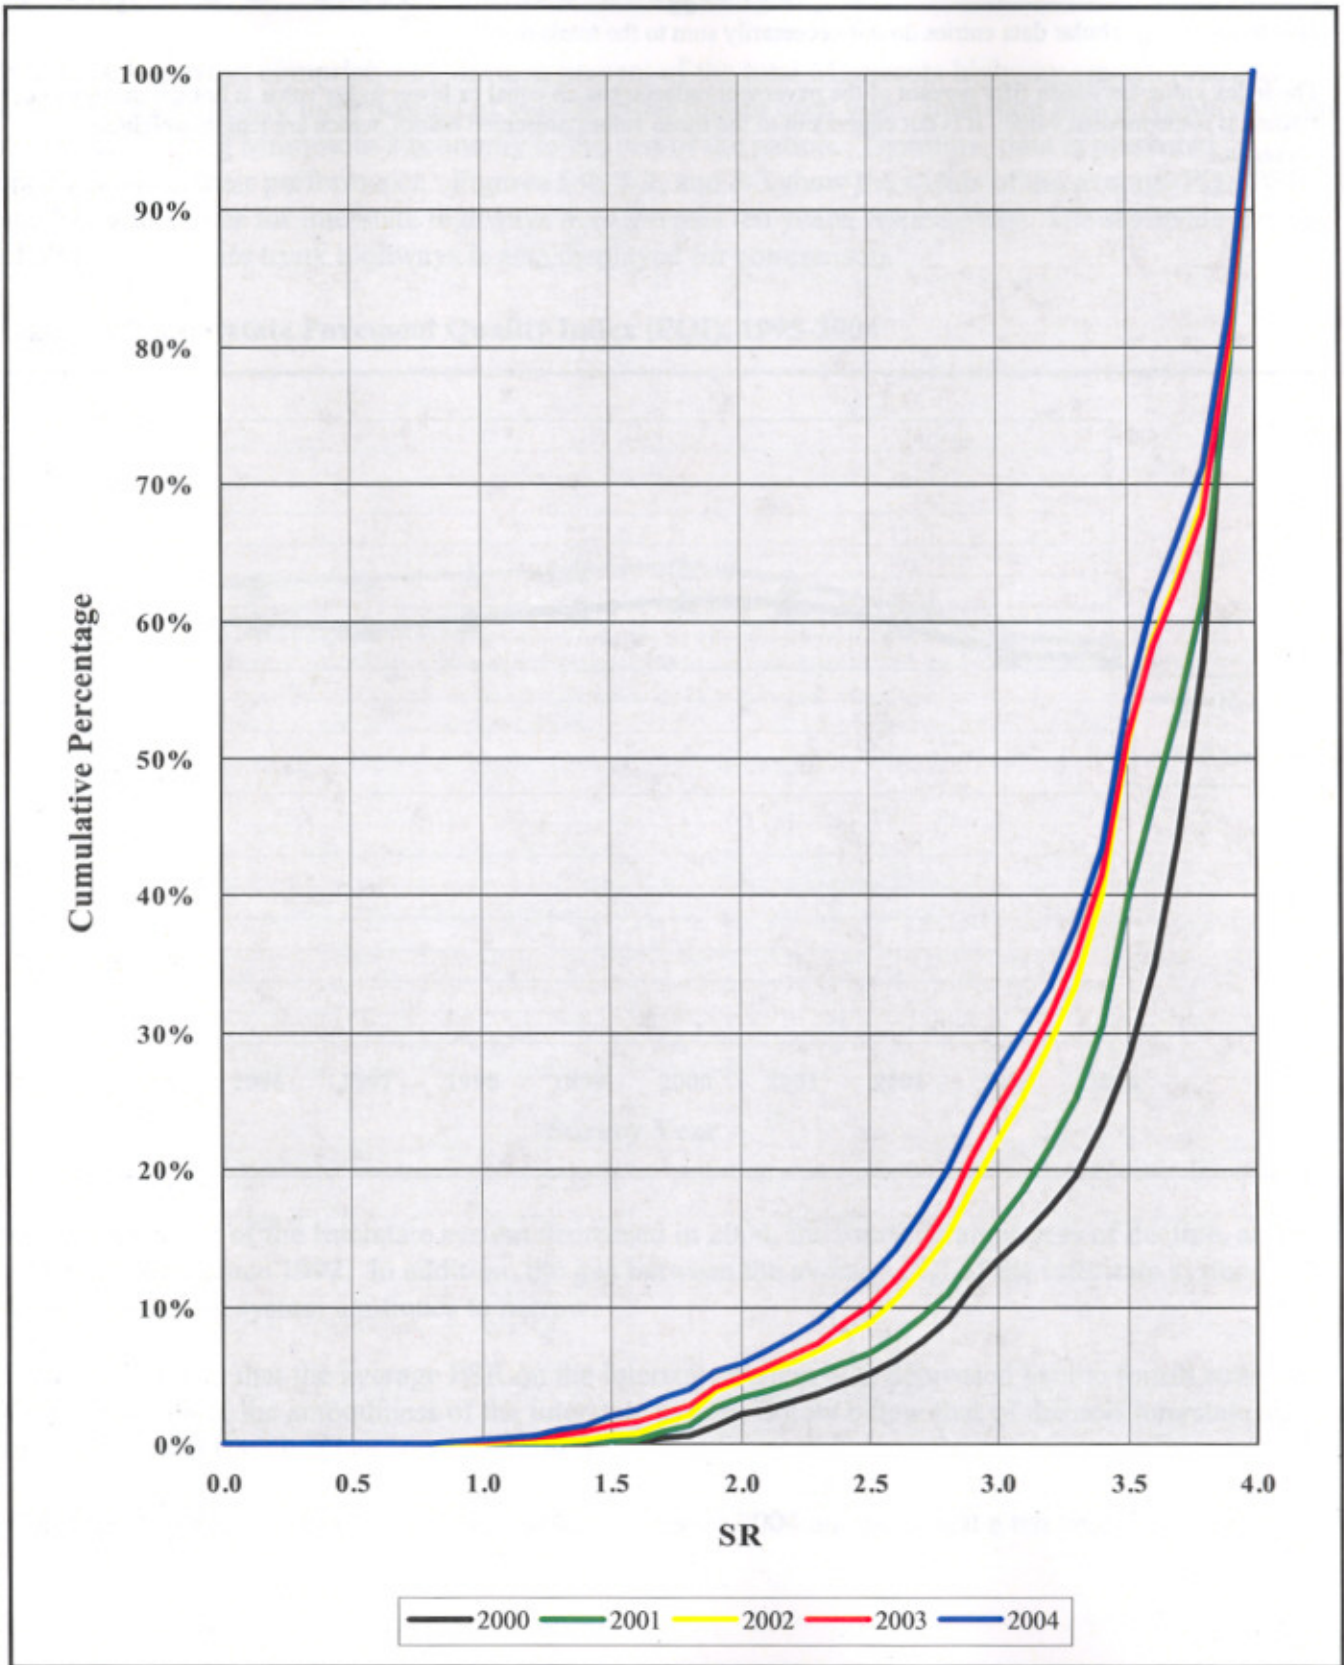
Figure 4-4 Cumulative Distribution of Statewide Surface Rating (SR), 2000-2004

Figure 4-4 shows a decrease in the SR from 2003 to 2004 (curve has shifted to the left), especially on the low end, indicating there are more roads with severe cracking in 2004.

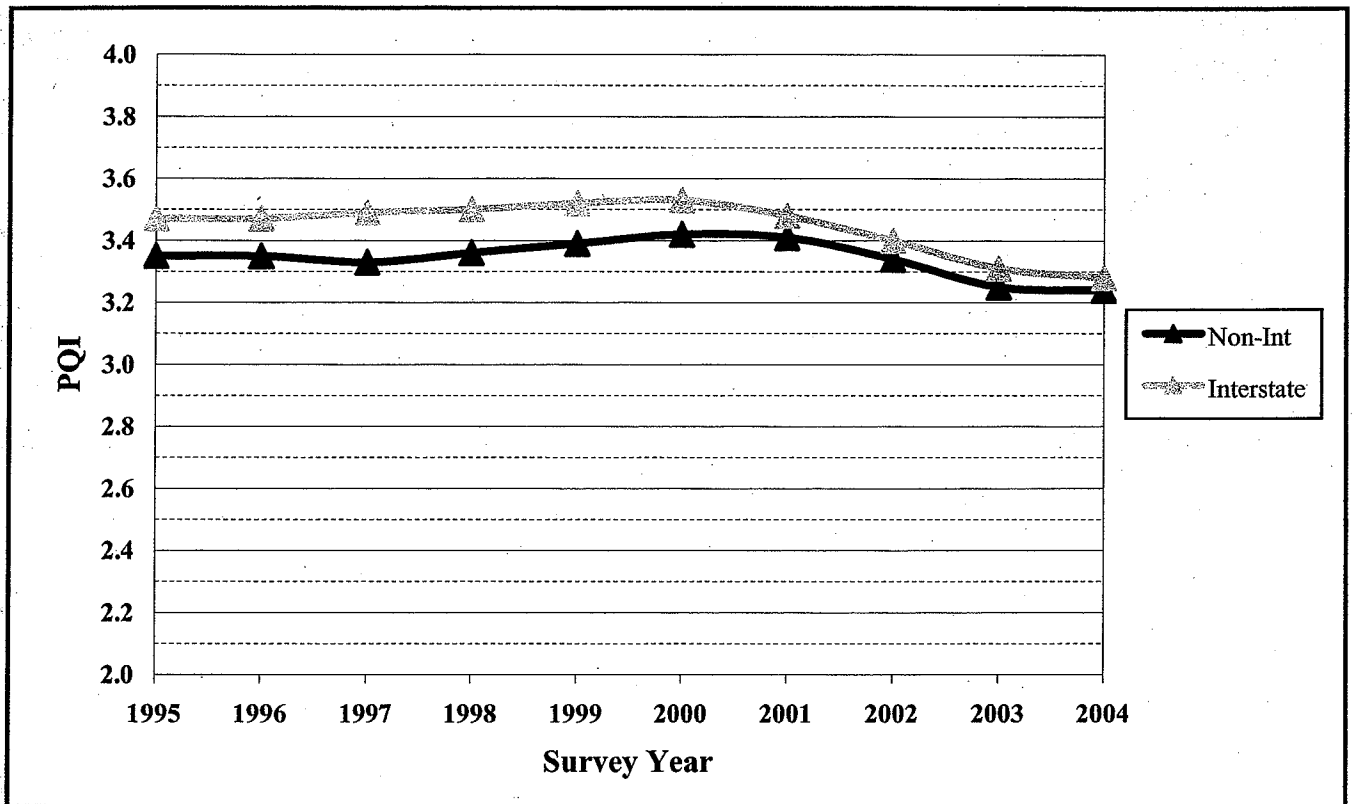
Figure 5-1 Interstate Pavement Quality Index (PQI), 1995-2004

The average PQI of the Interstate system decreased in 2004, the fourth straight year of decline, and is at its lowest level since 1992. In addition, the gap between the average PQI of the interstate system and the non-interstate system continues to narrow.

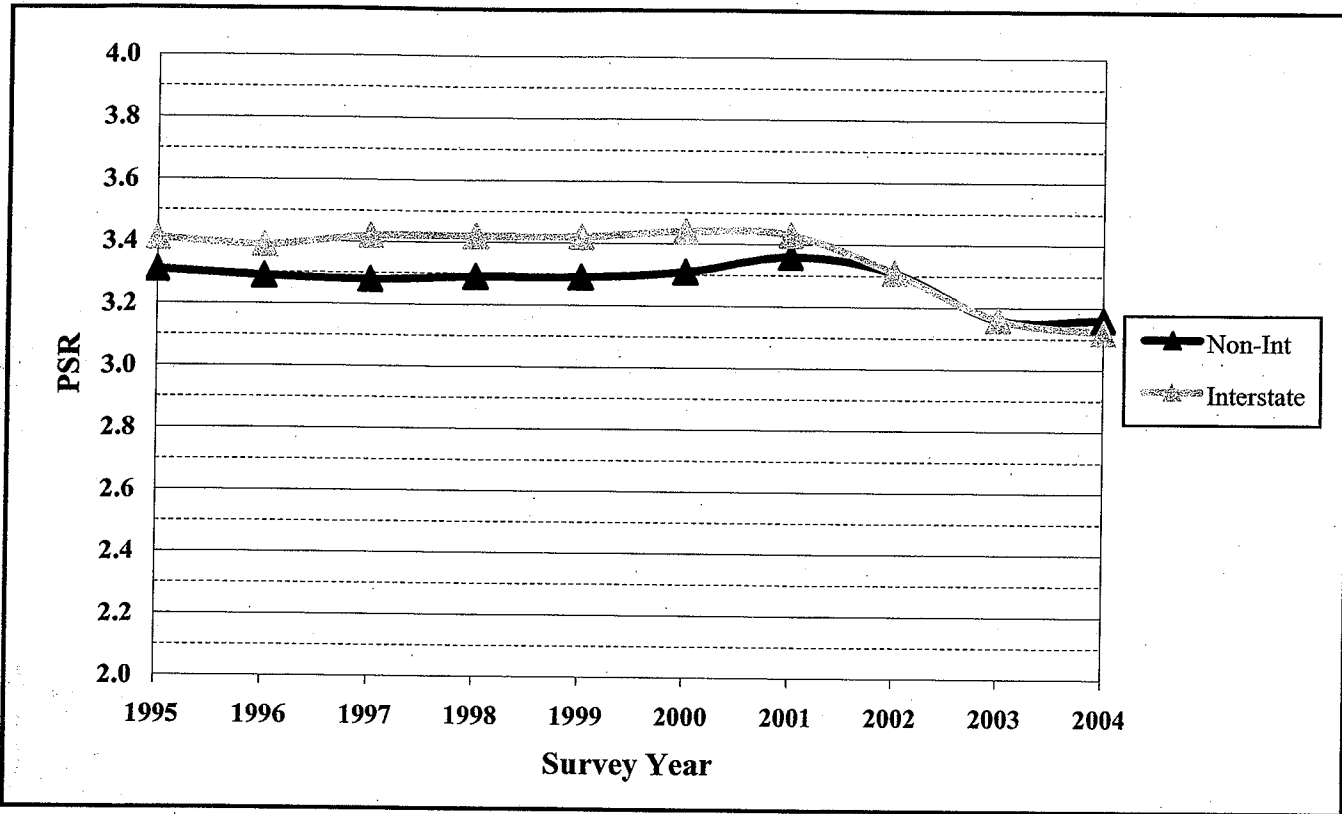
Figure 5-2 Interstate Present Serviceability Rating (PSR), 1995-2004

Figure 5-2 shows that the average PSR on the interstate system also decreased for the fourth straight year. In addition, the smoothness of the interstate system is now below that of the non-interstate system, only the second time this has occurred (1992).

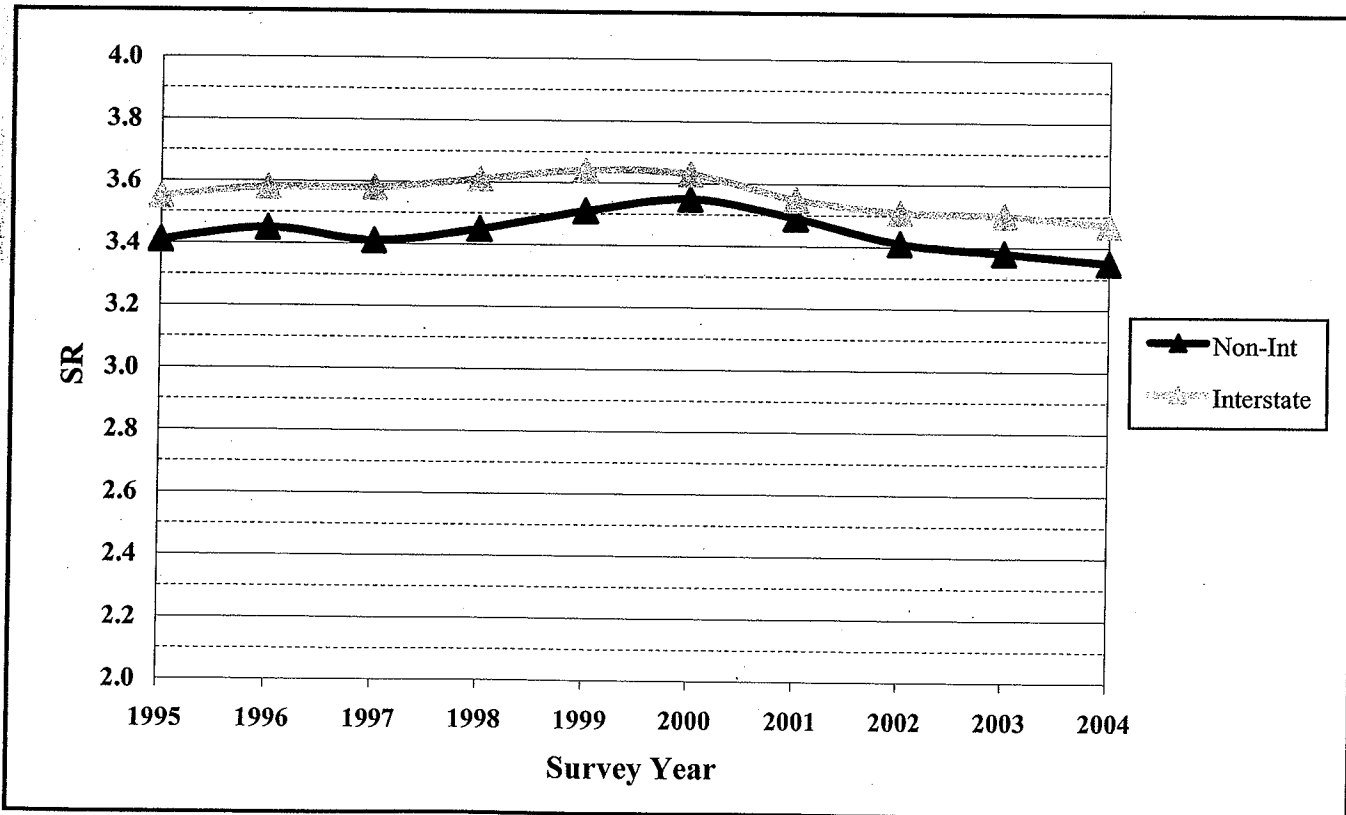
Figure 5-3 Interstate Surface Rating (SR), 1995-2004

The average SR of the interstate system also declined in 2004 and is now at a ten year low.
