2004 Pavement Management Annual Report

Report#: MnDOT/OM-PM--2005-03

May 2005
Office of Materials
Pavement Management Unit

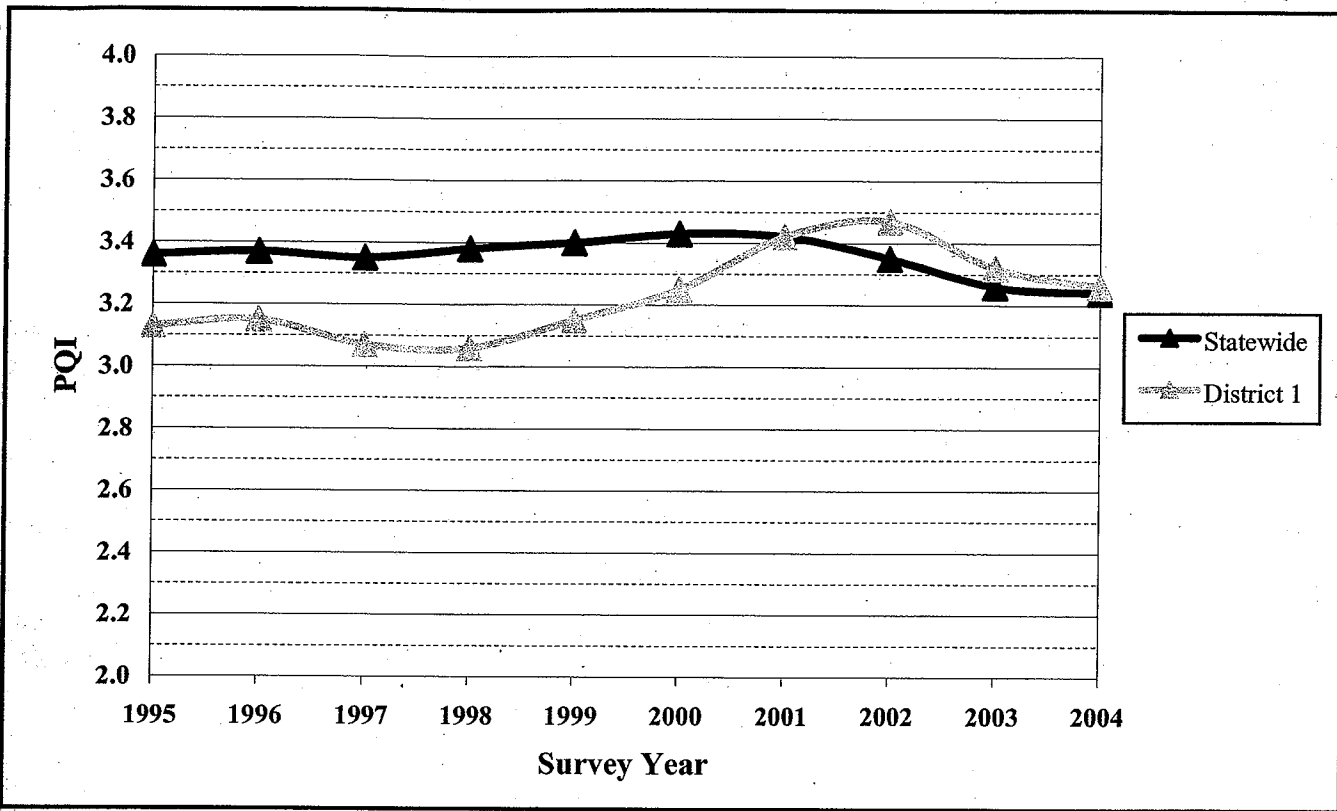
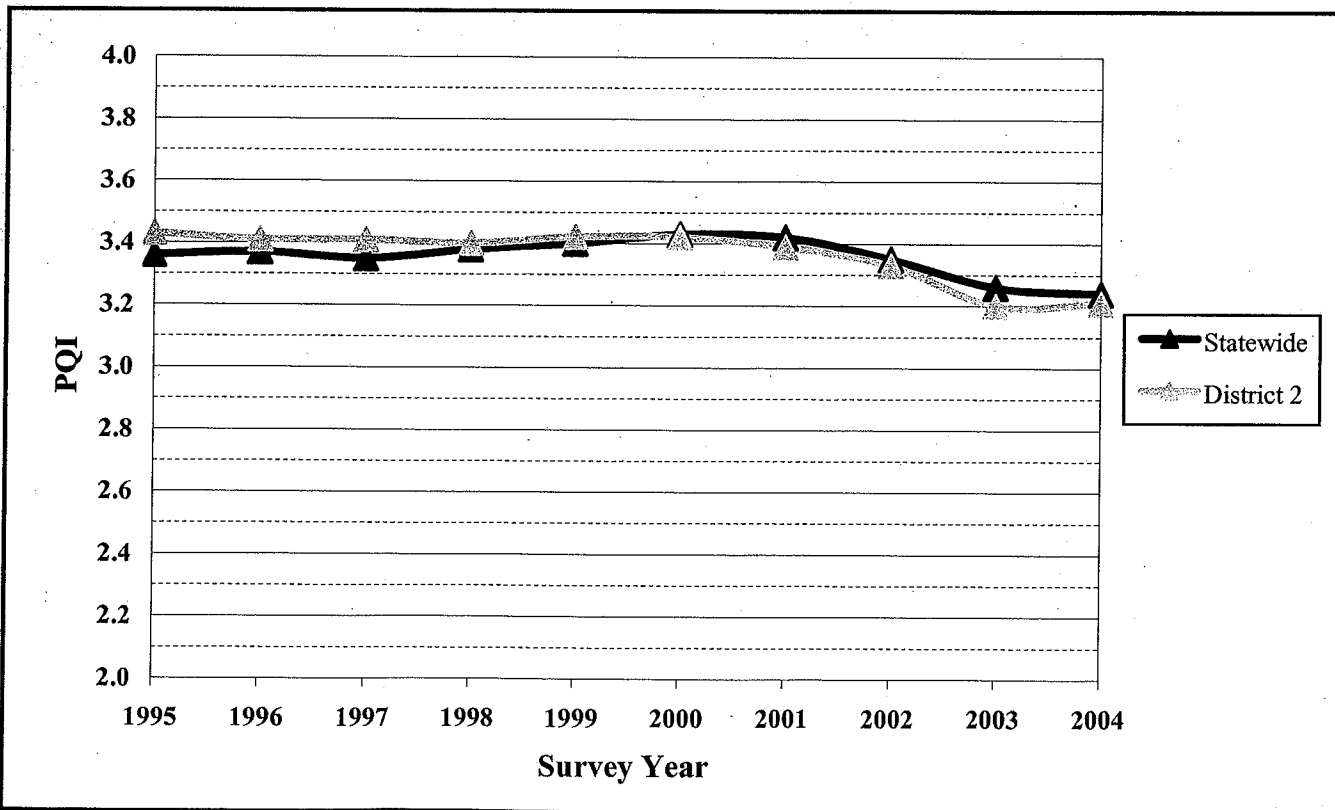
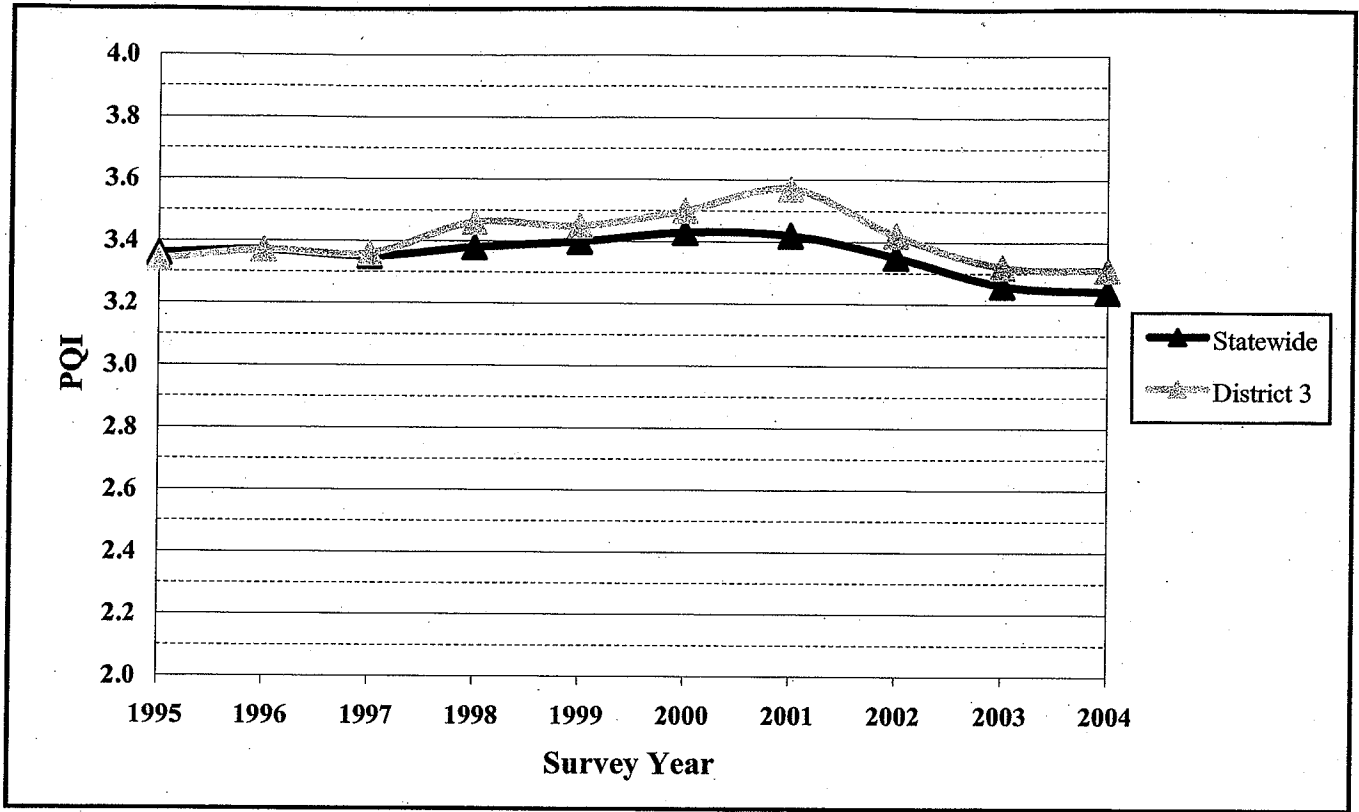
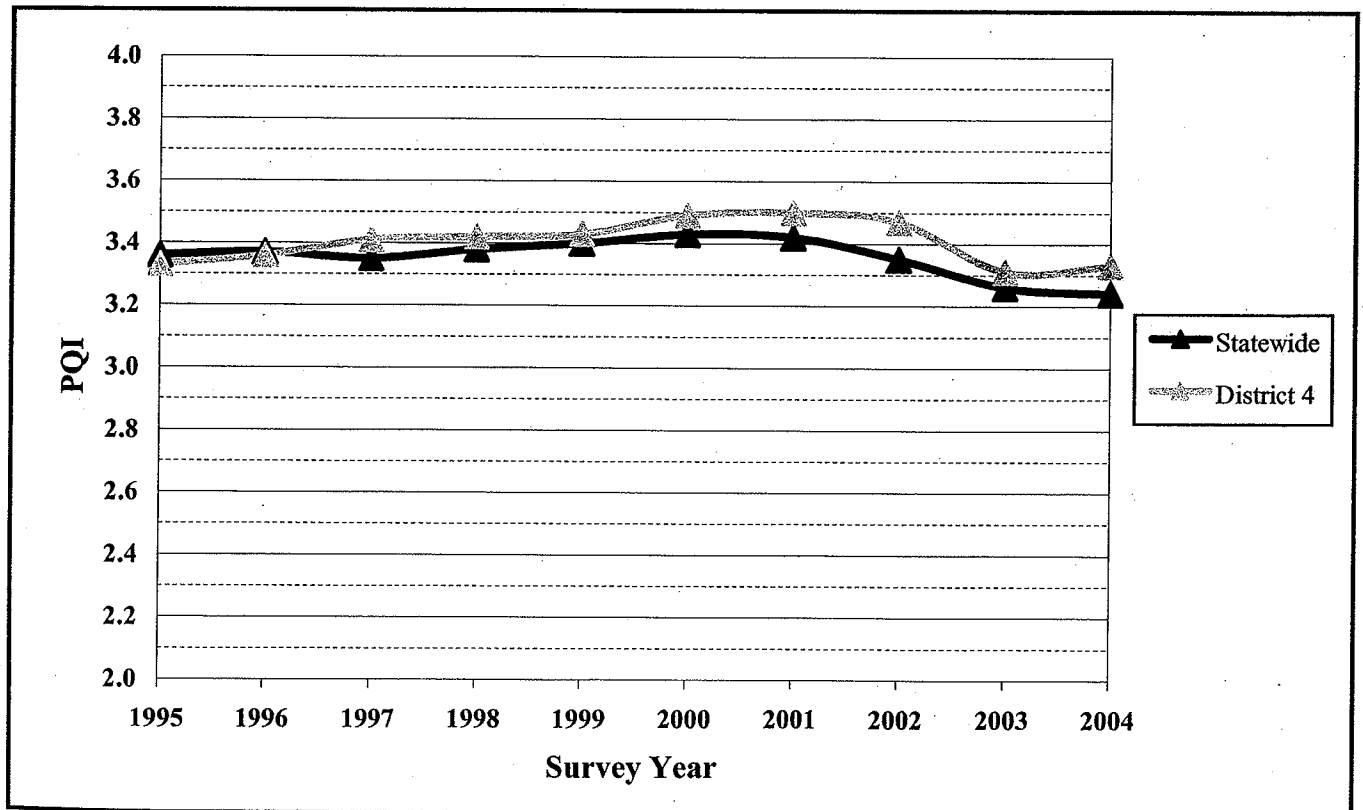
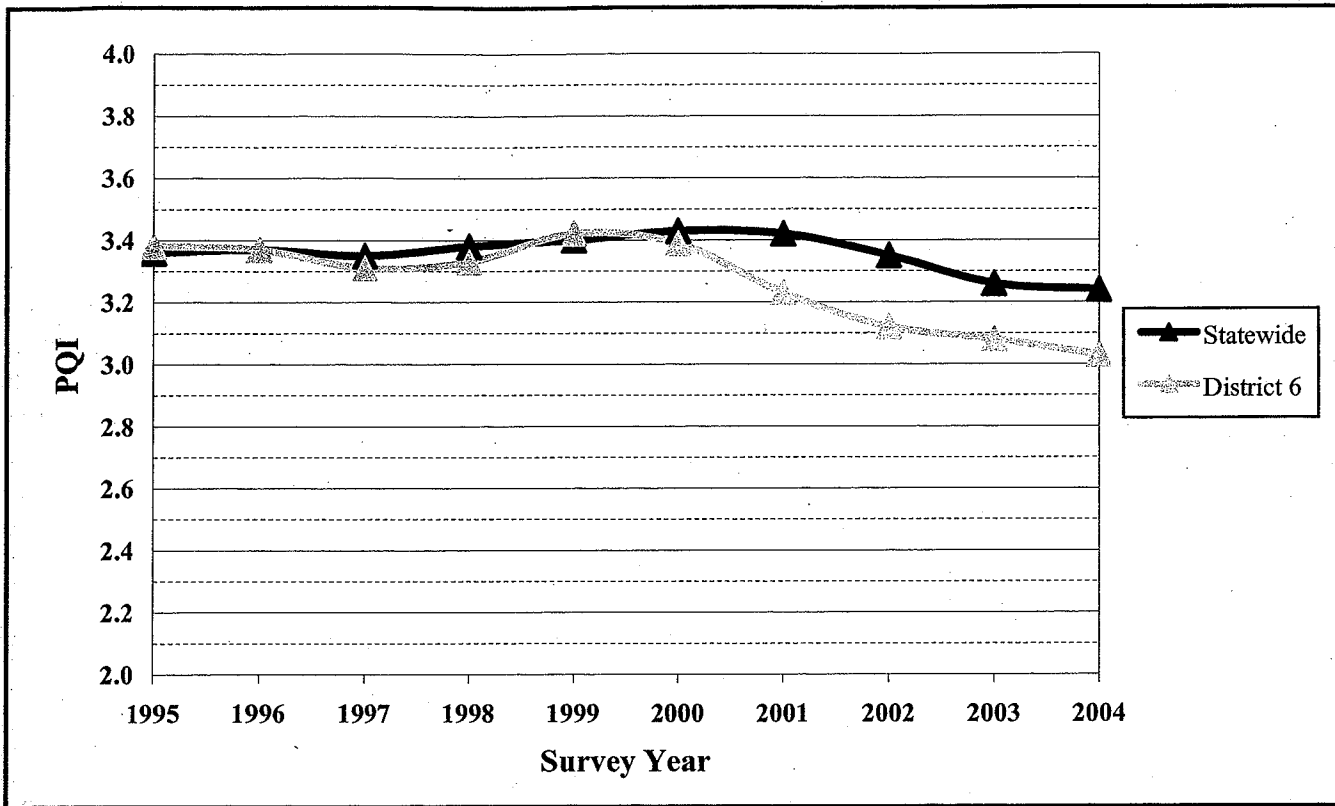
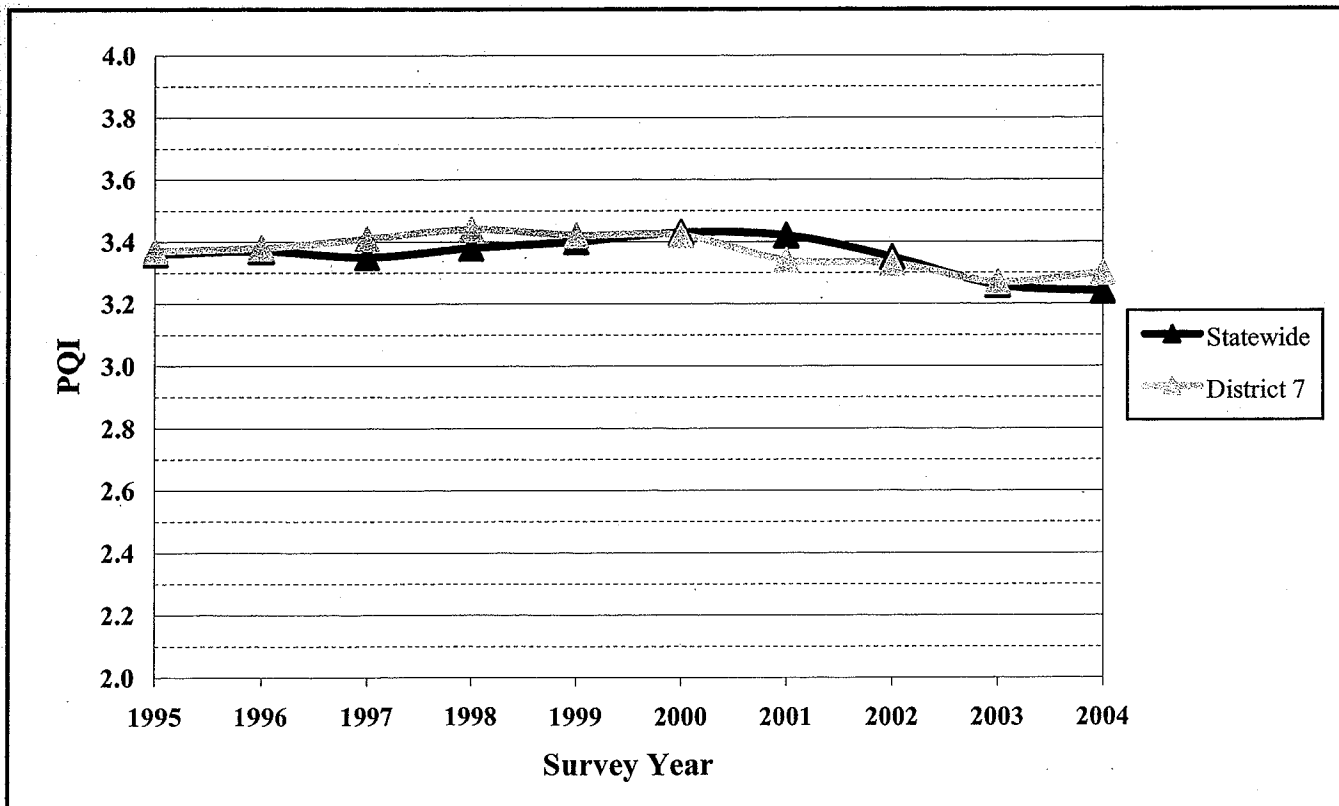
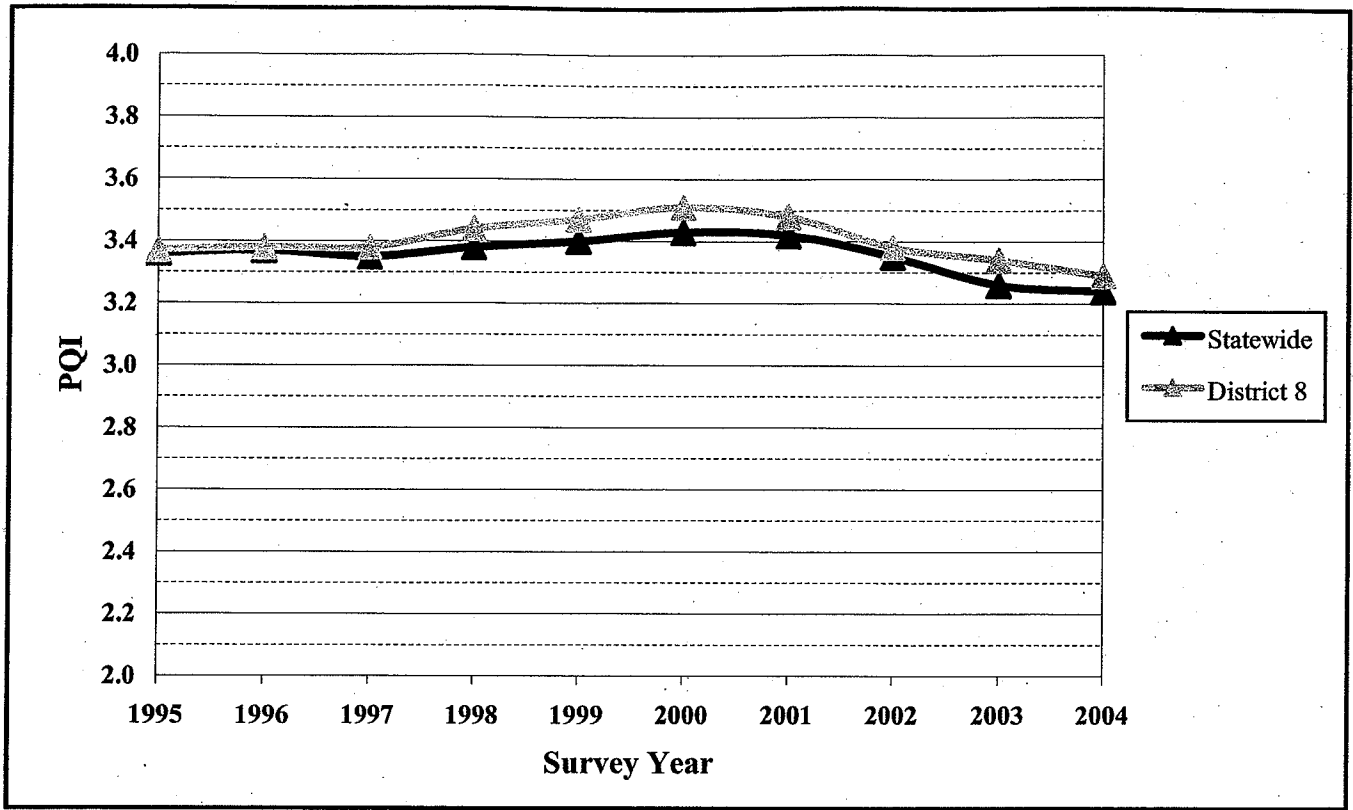
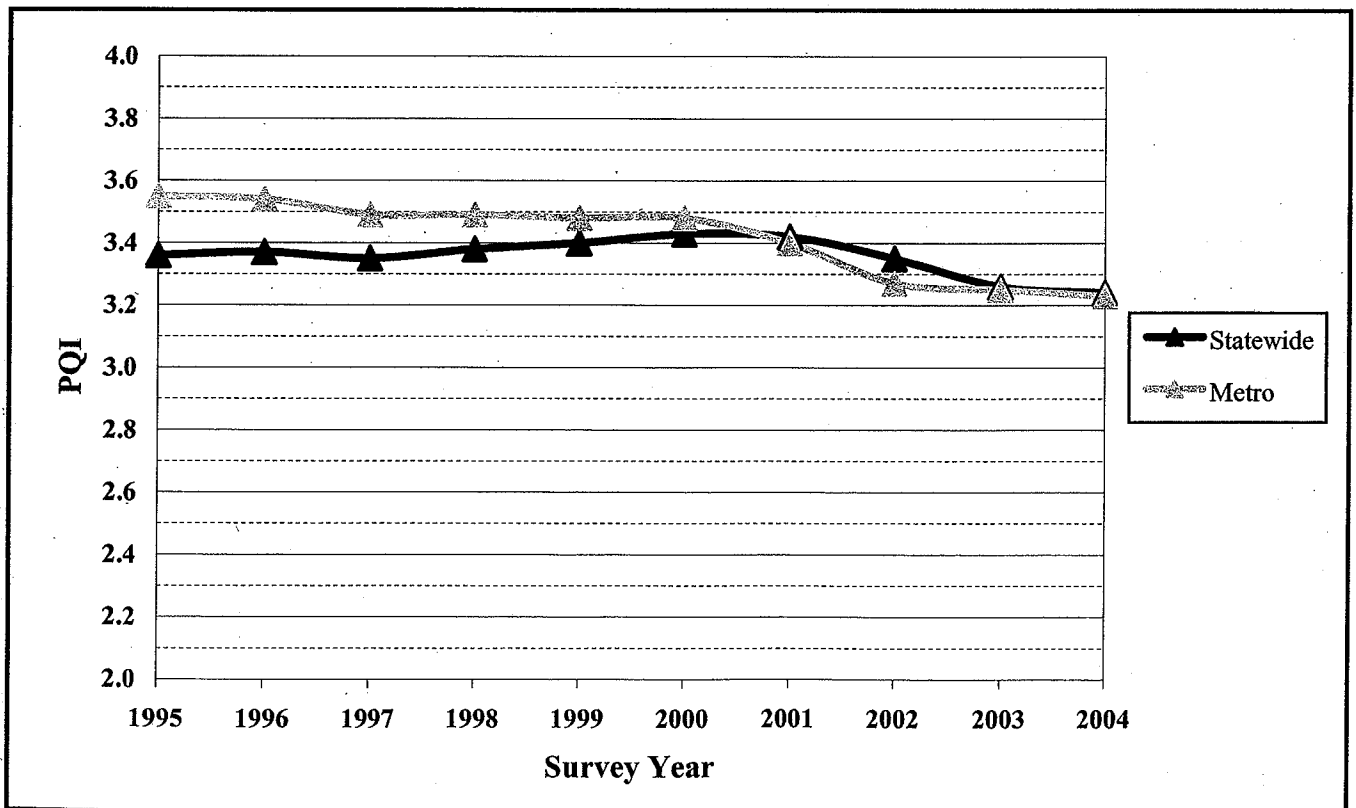
Pavement Quality Rating (PQI), Figures 6-1 to 6-8

The 2004 average PQI increased in districts 2, 4, and 7 while it declined in 1, 6, 8, and Metro. D-3 remained virtually the same as in 2004. District 6's average PQI has declined six years in a row, over 11 percent, since 1999, and is now well below any other district. Most of the decline can be attributed to a decline in their average SR (13 percent since 1999), indicating an increase in miles of highway with severe cracking.

District 7 was the only district to show an increase in the average of all three of the pavement condition indices in 2004 (PQI, PR, SR). Districts 2 and 4 showed an increase in two of the three indices (PQI & PSR). Districts 1 and 6 had a decrease in all three of the indices in 2004.

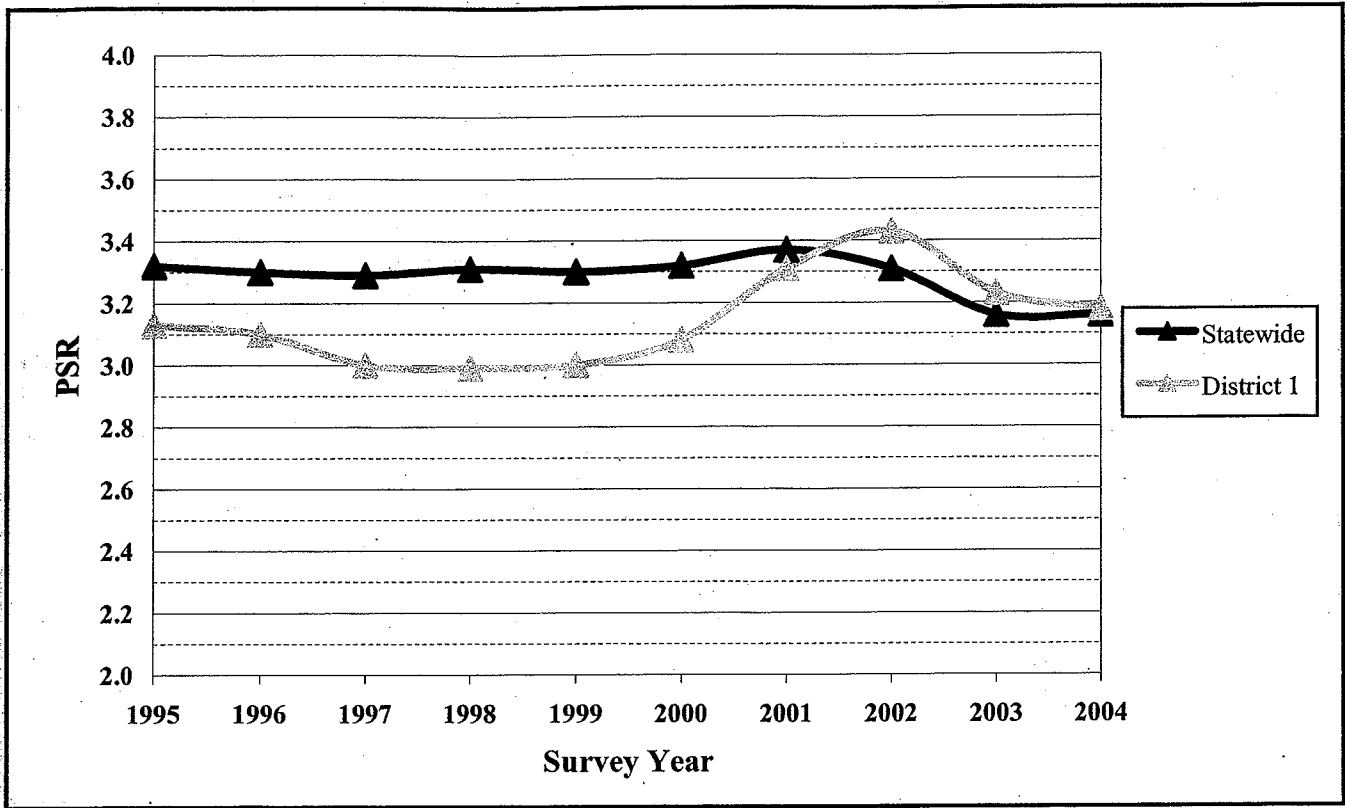
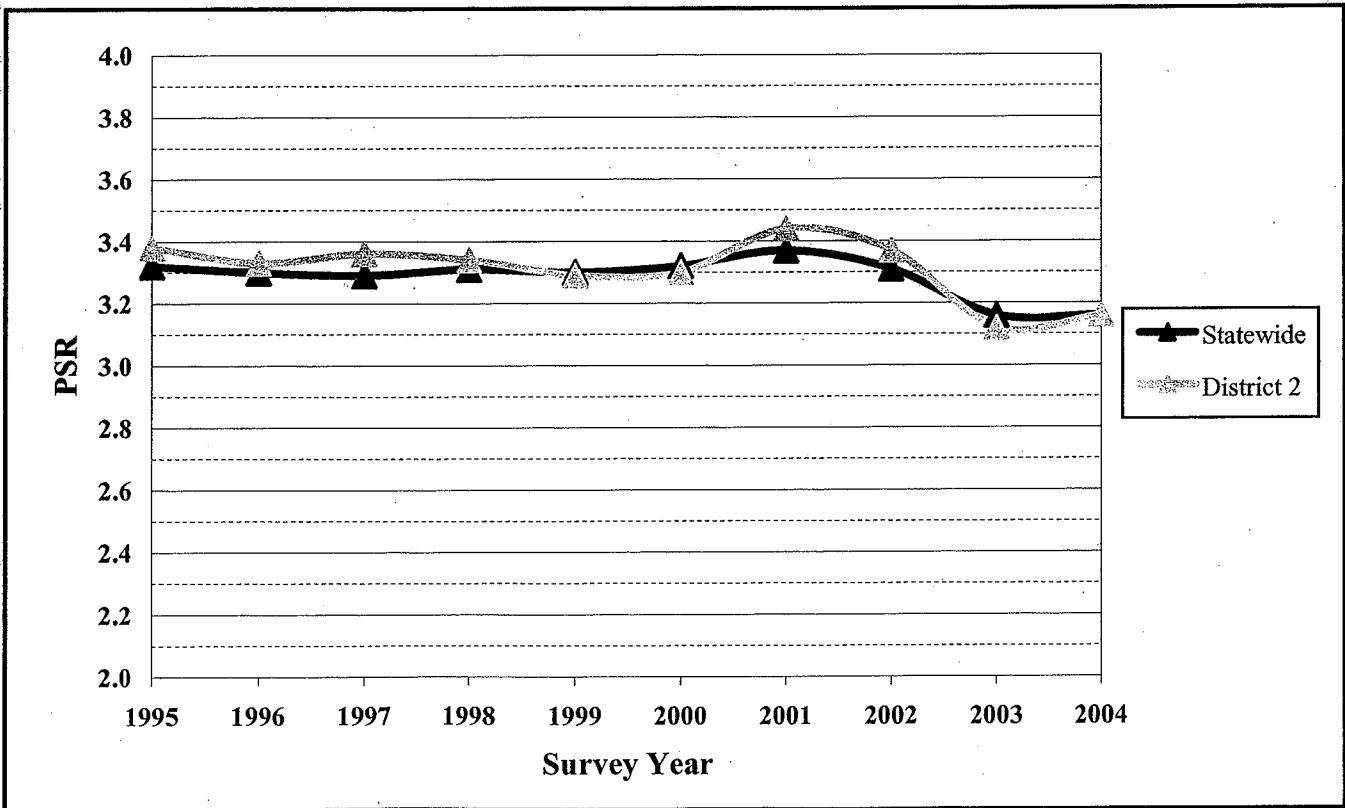
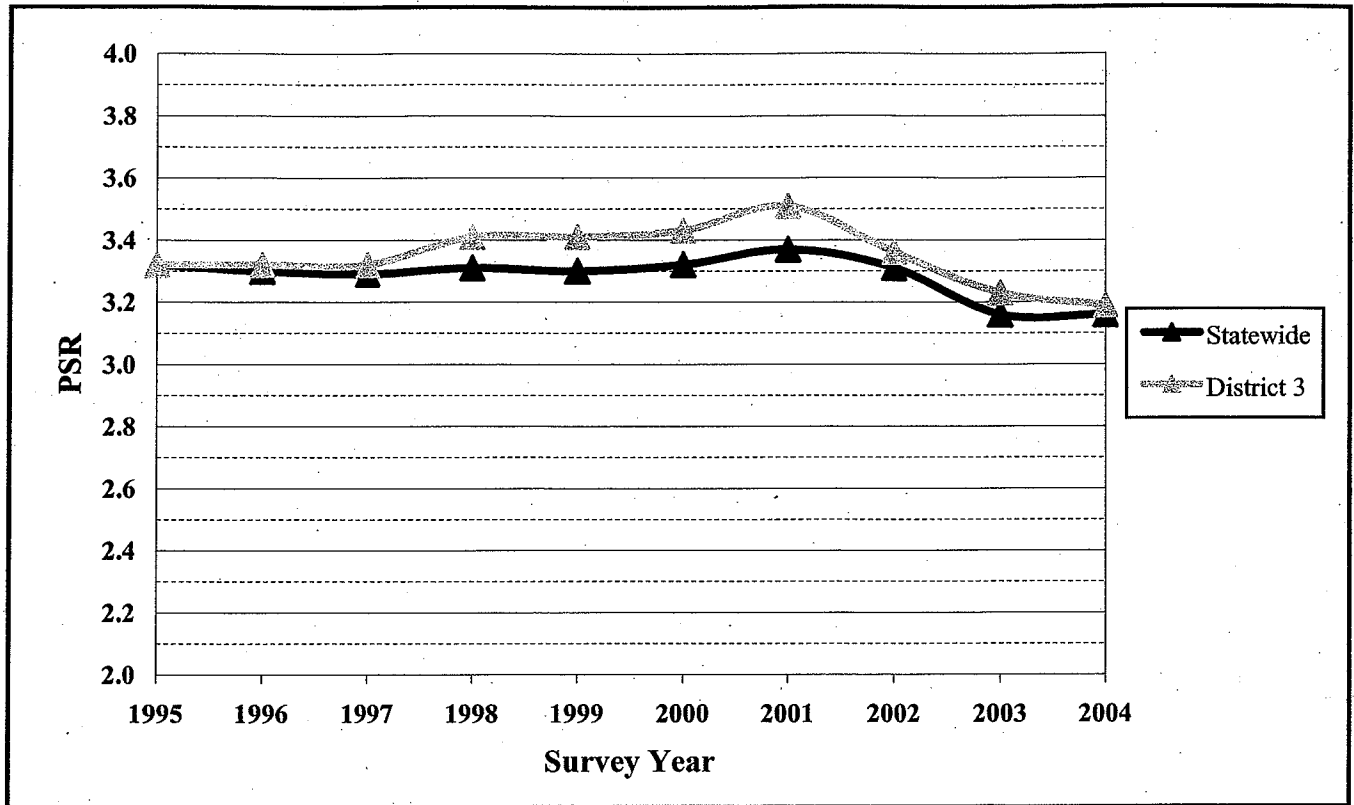
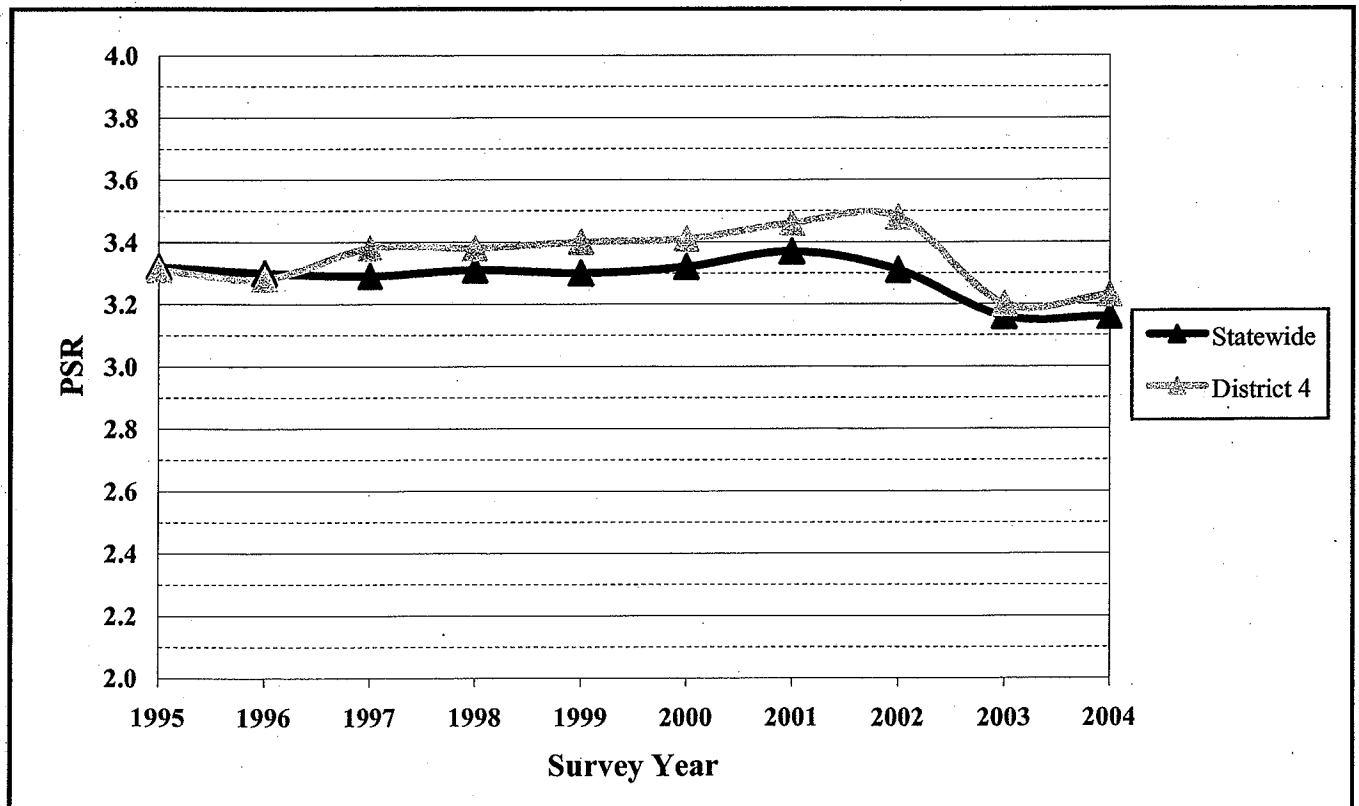
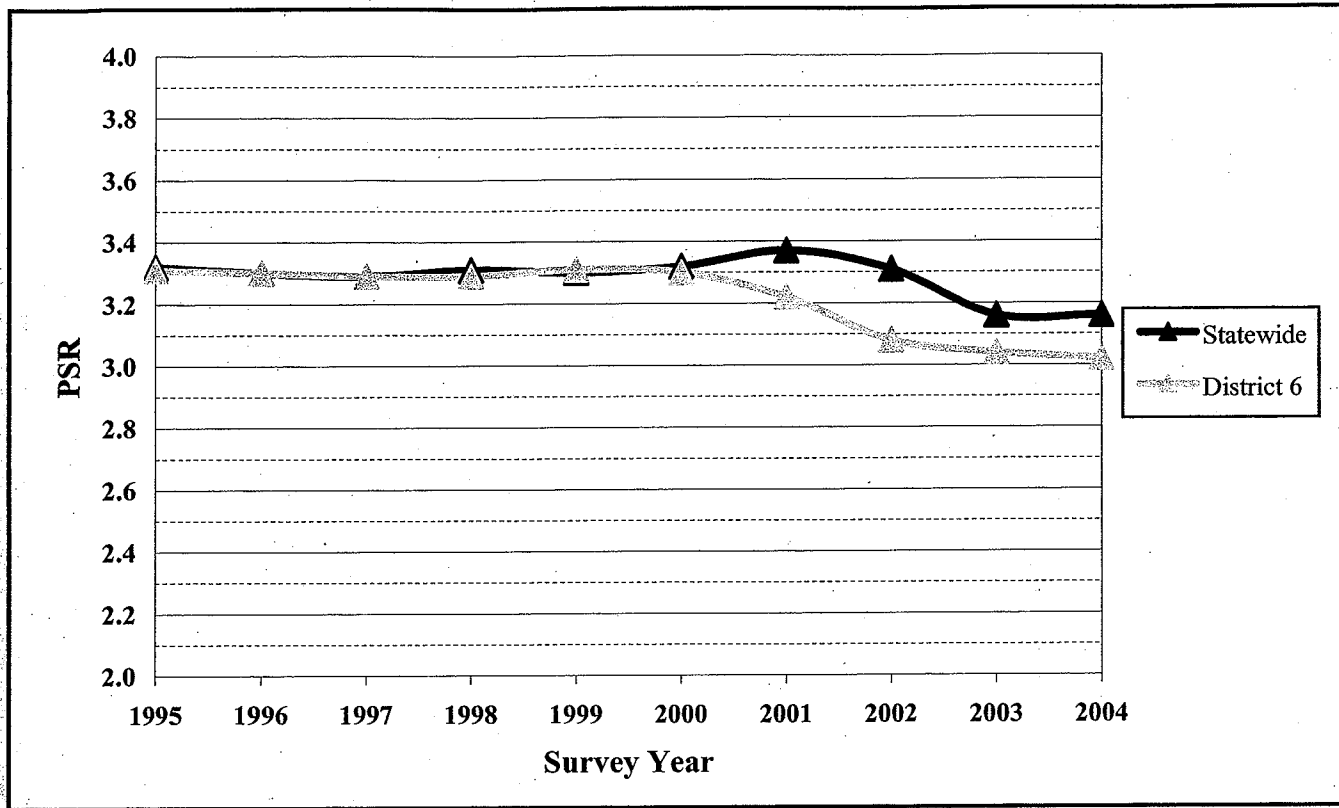
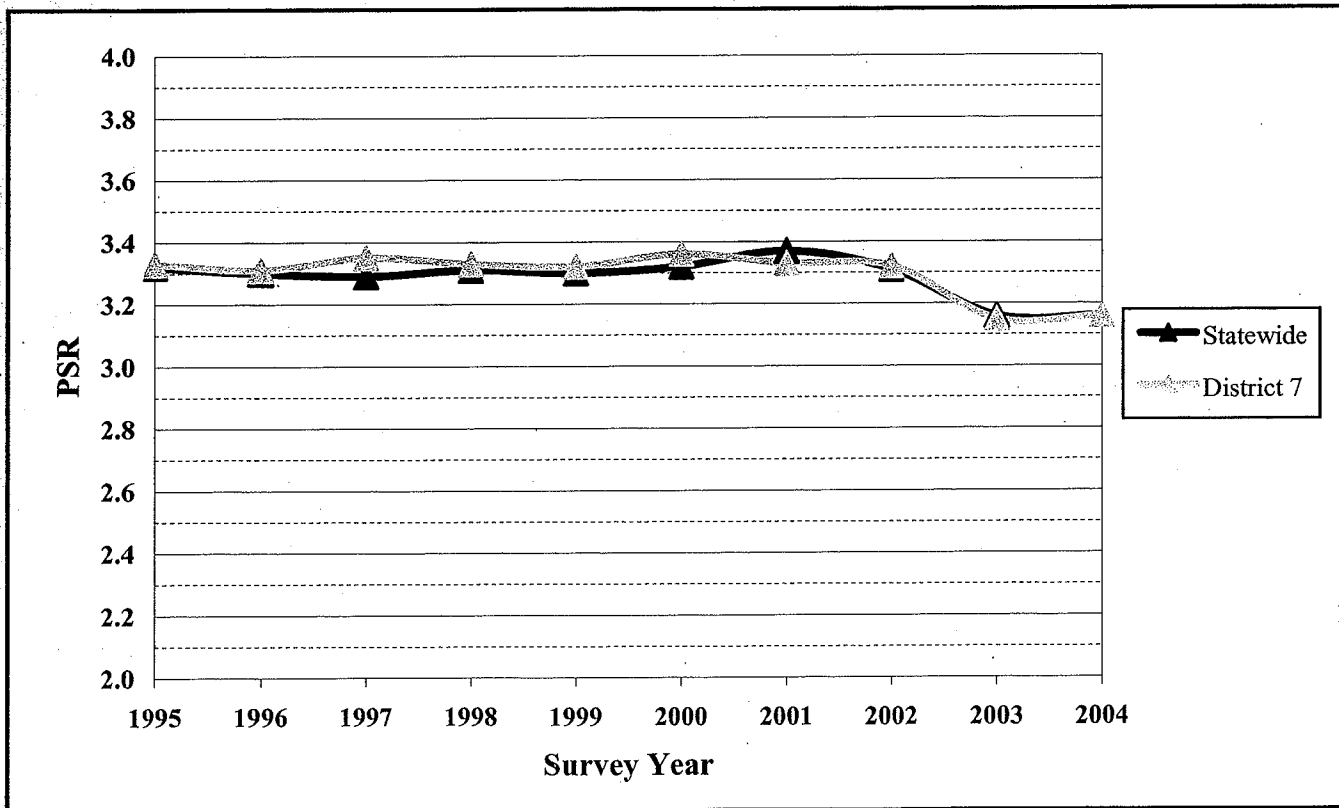
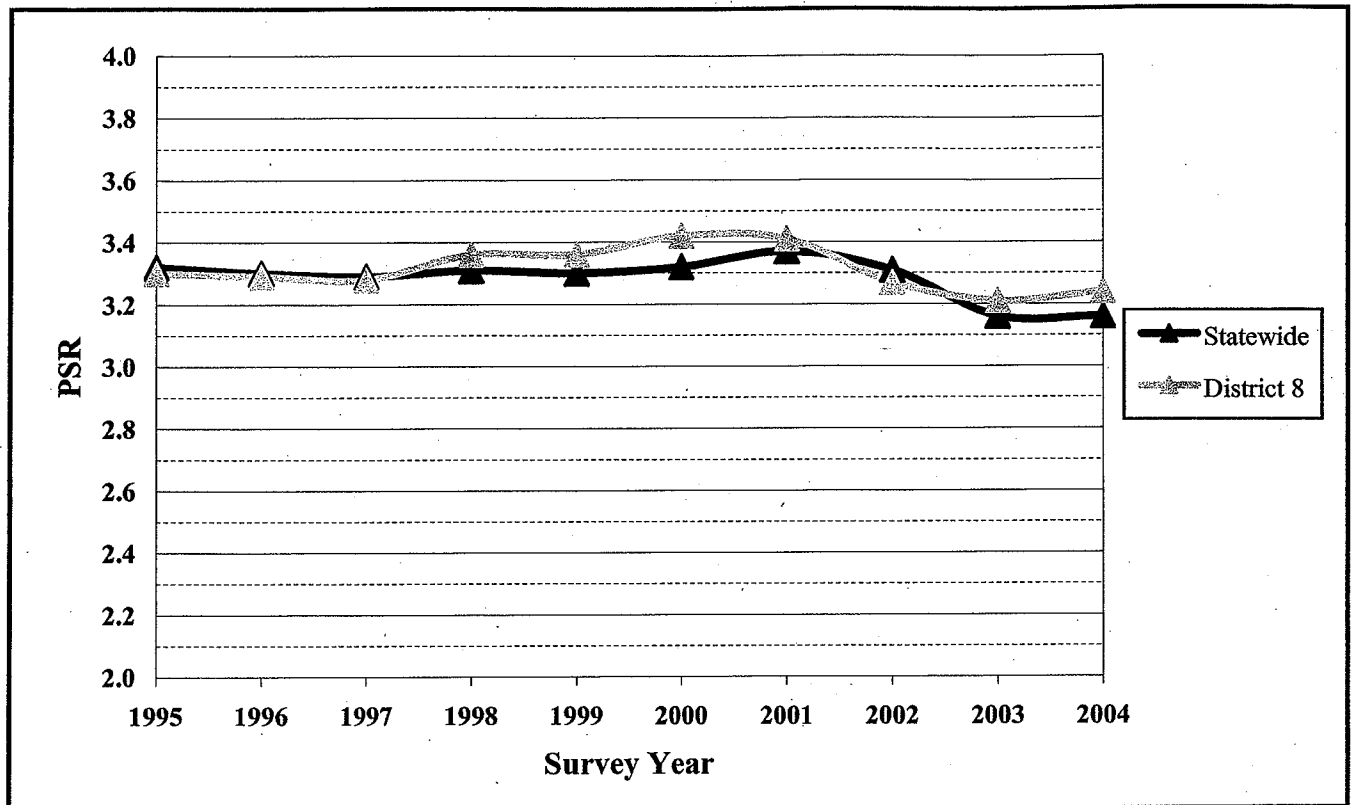
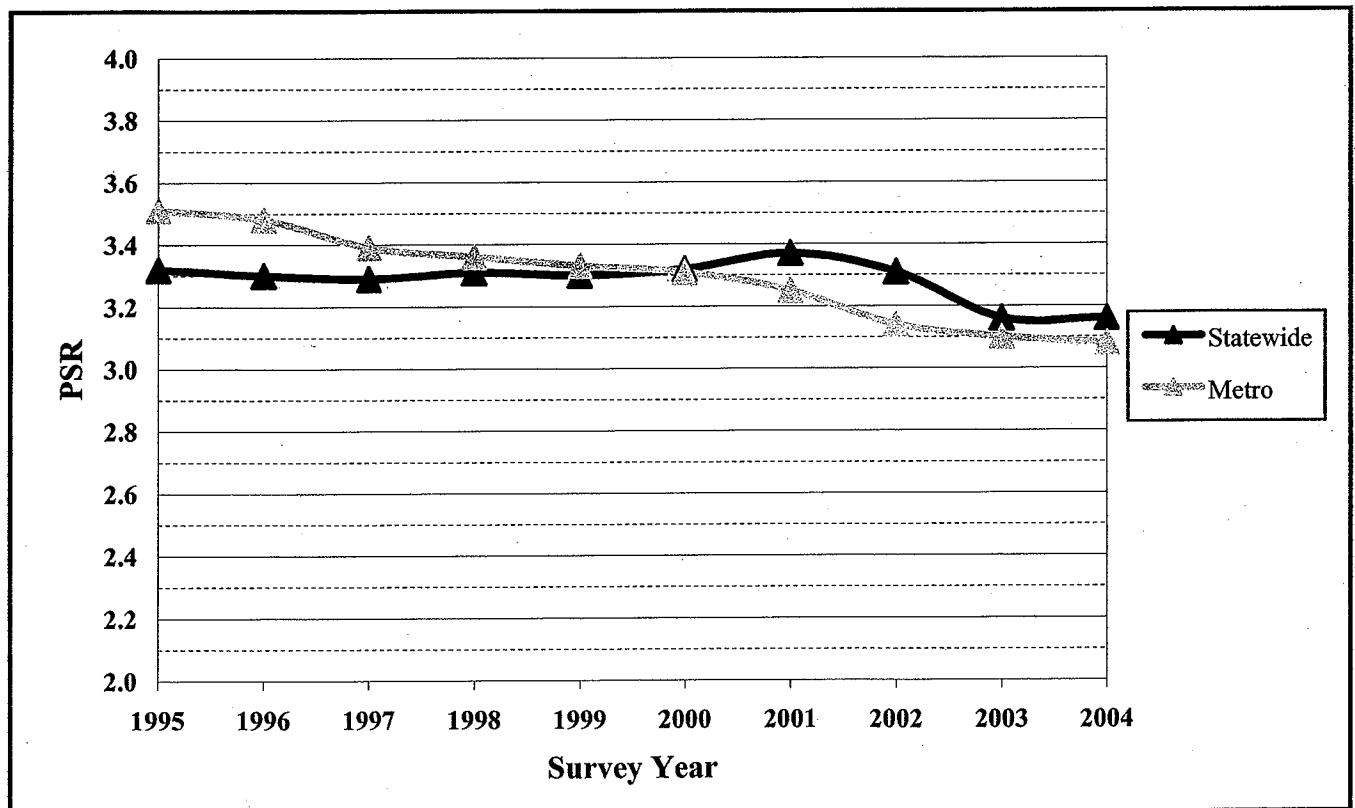
Present Serviceability Rating (PSR), Figures 6-9 to 6-16

In 2004, the average PSR increased in districts 2, 4, 7, and 8 while decreasing in 1, 3, 6, and Metro. While D-3's average PSR is still slightly above the statewide average it has decreased three years in a row, a decline of almost 9 percent. District 6 has the lowest average PSR, which has declined five straight years.
